MISSOURI DEPARTMENT OF NATURAL RESOURCES
STATE HISTORIC PRESERVATION OFFICE, P.O. Box 176, Jefferson City, MO 65102
ARCHITECTURAL/HISTORIC INVENTORY FORM

1. Survey No. JP-AS-007-001		2. Survey name: East Town (Original Joplin) Historic Survey Phase 2	
3. County: JASPER		4. Address (Street No.) 618	Street (name) E. 2 nd Street
5. City: Joplin	Vicinity: <input type="checkbox"/>	6. Geographical Reference:	7. Township/Range/Section: T: R: S:
8. Historic name (if known):		9. Present/other name (if known):	
10. Ownership: <input checked="" type="checkbox"/> Private <input type="checkbox"/> Public		11a. Historic use (if known): Domestic: Single Dwelling	11b. Current use: Domestic: Single Dwelling

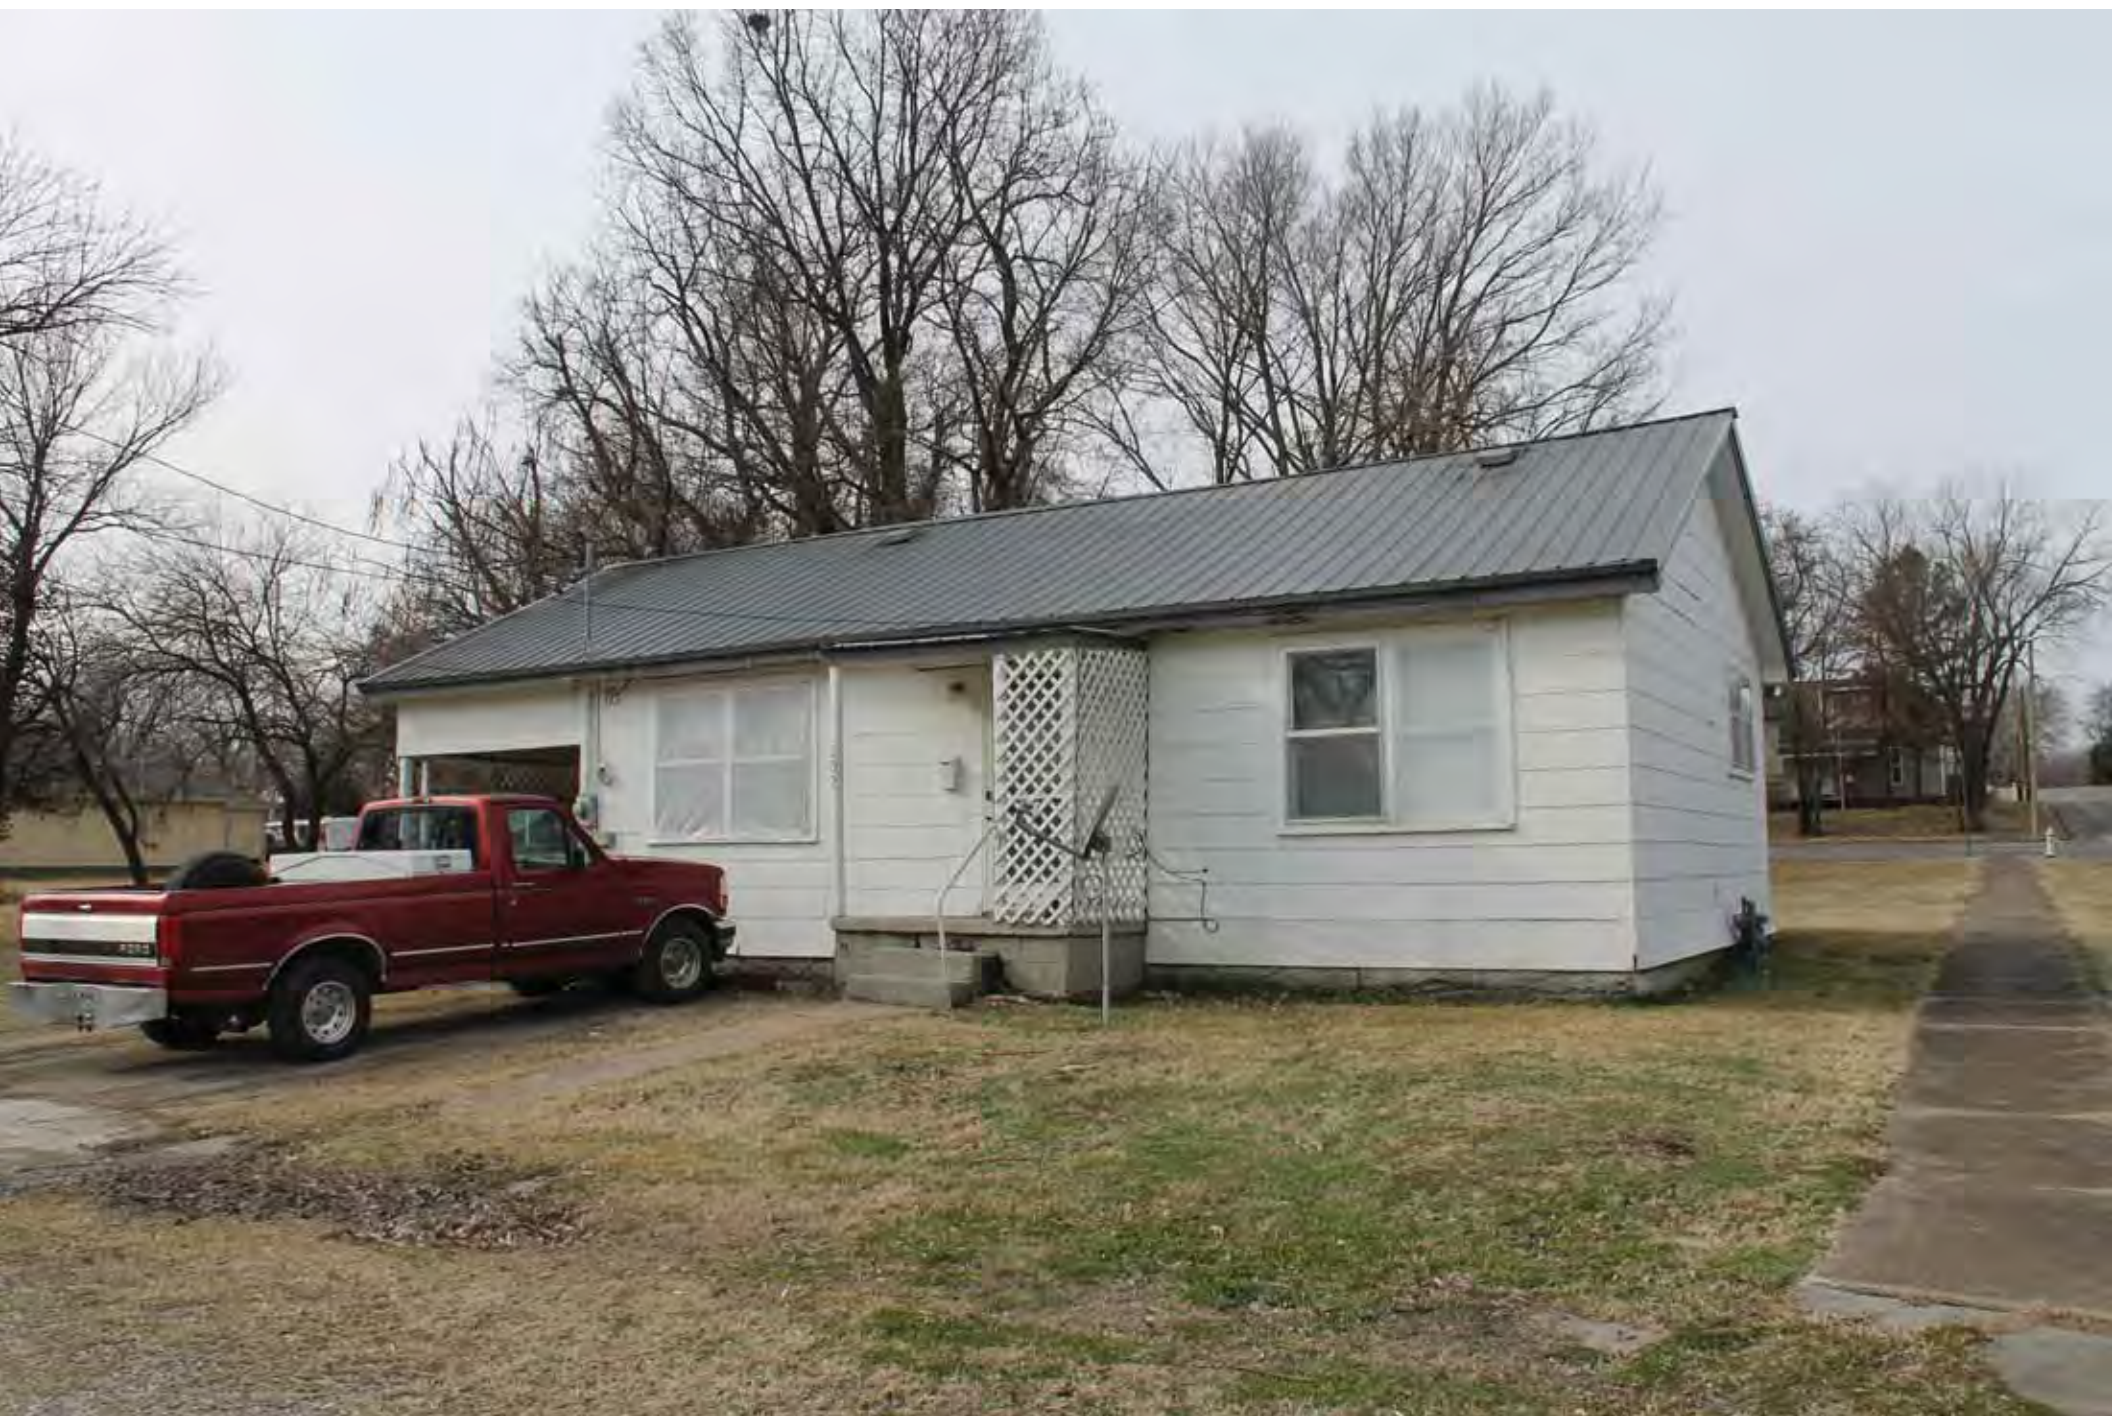
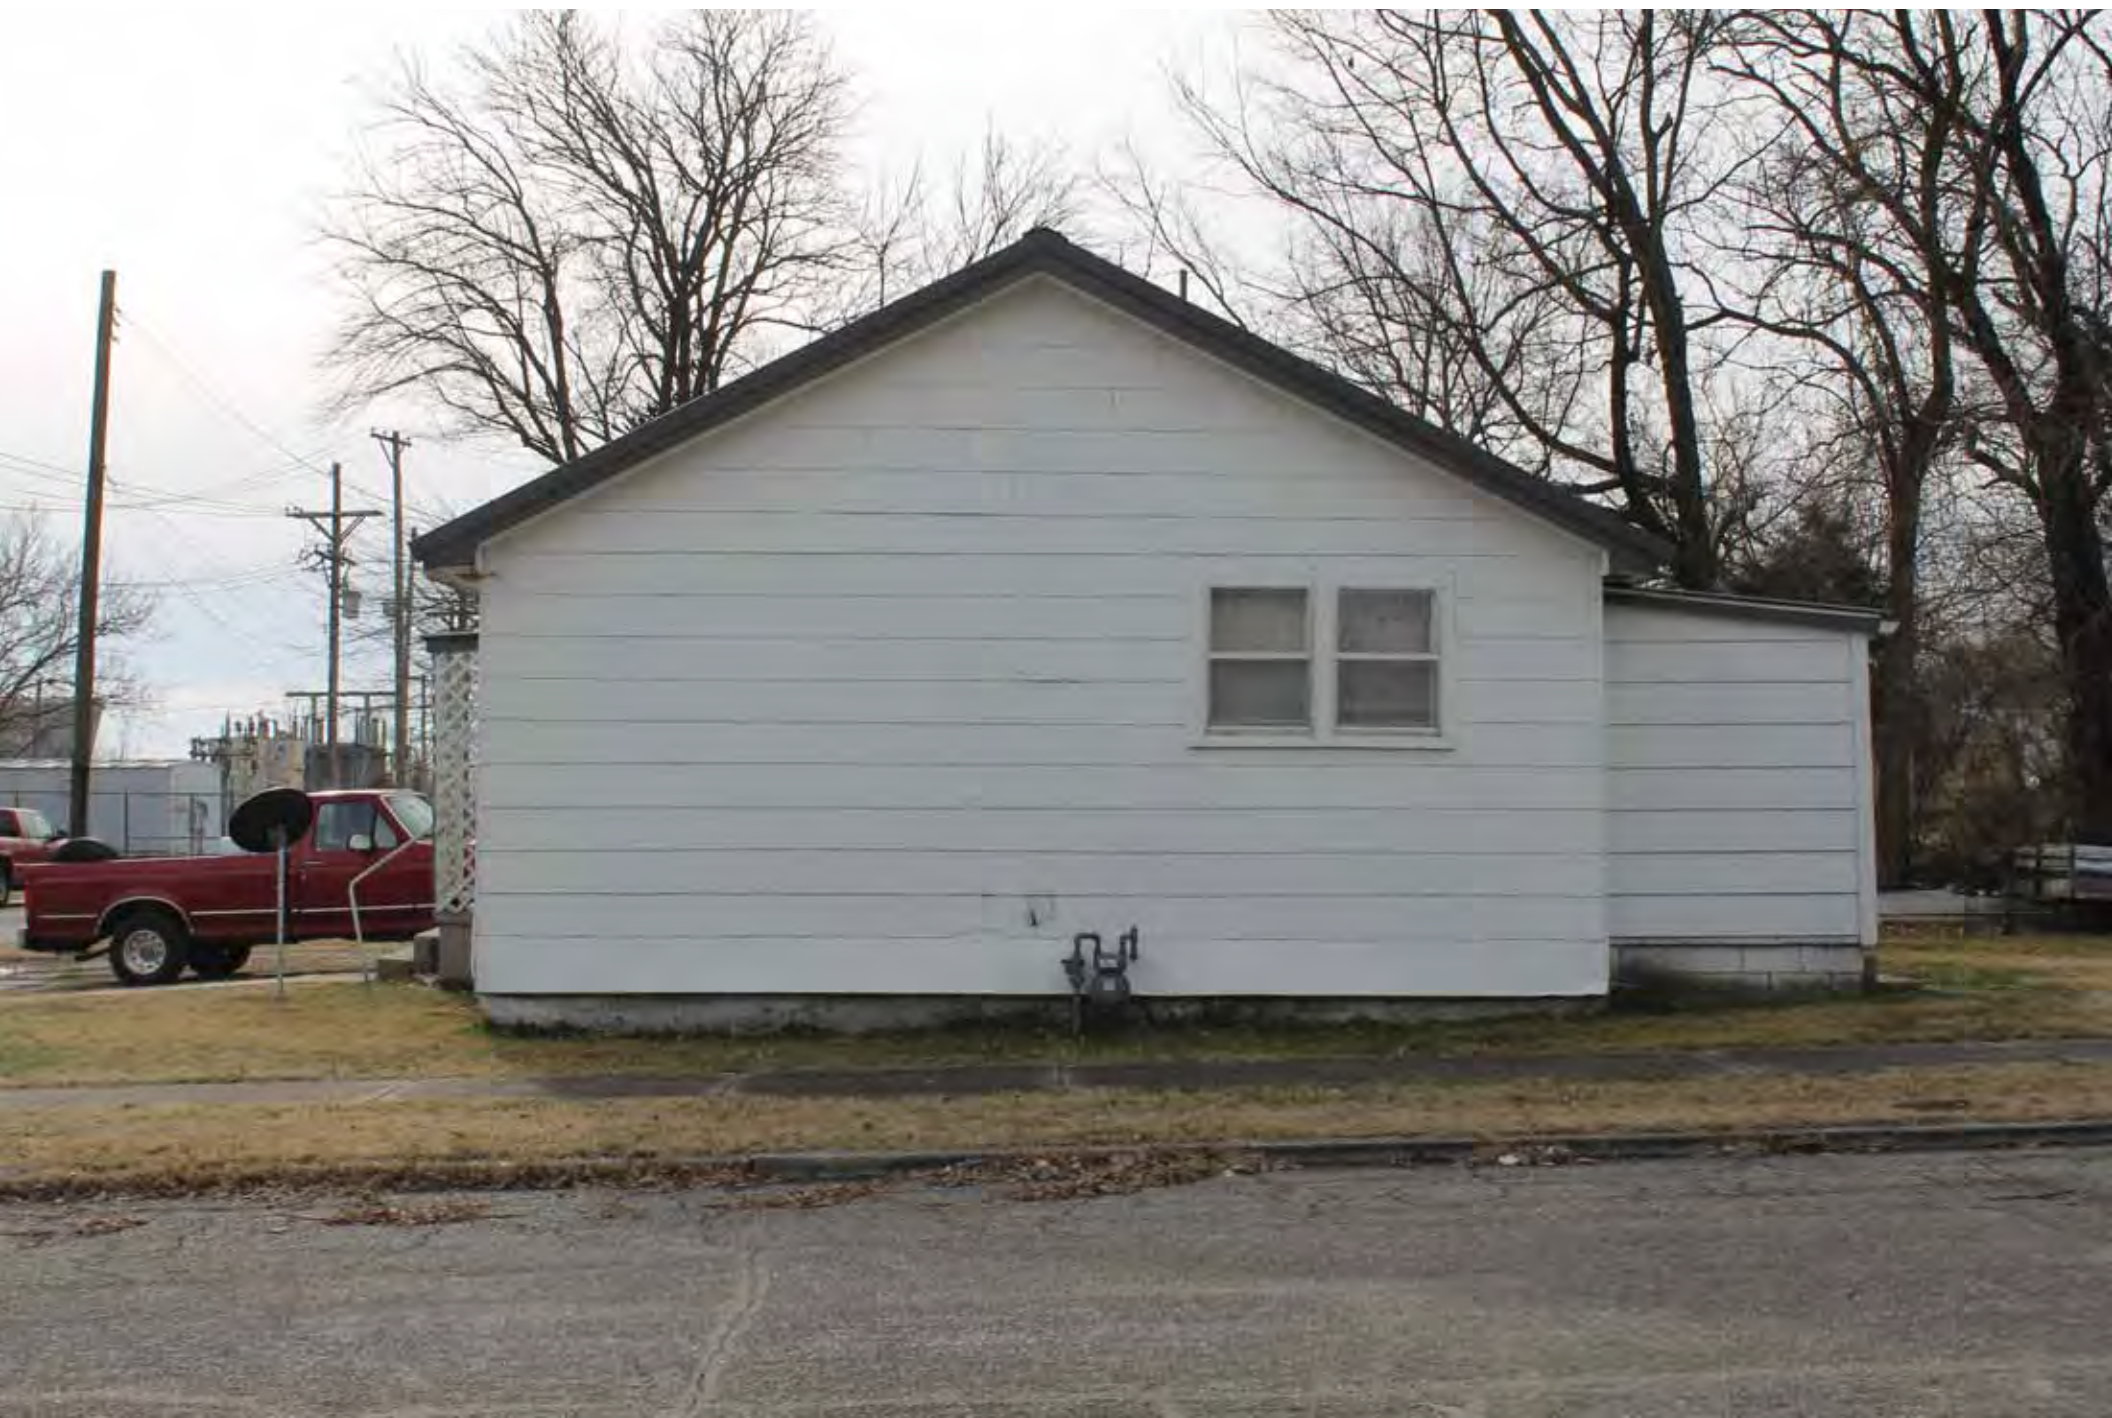
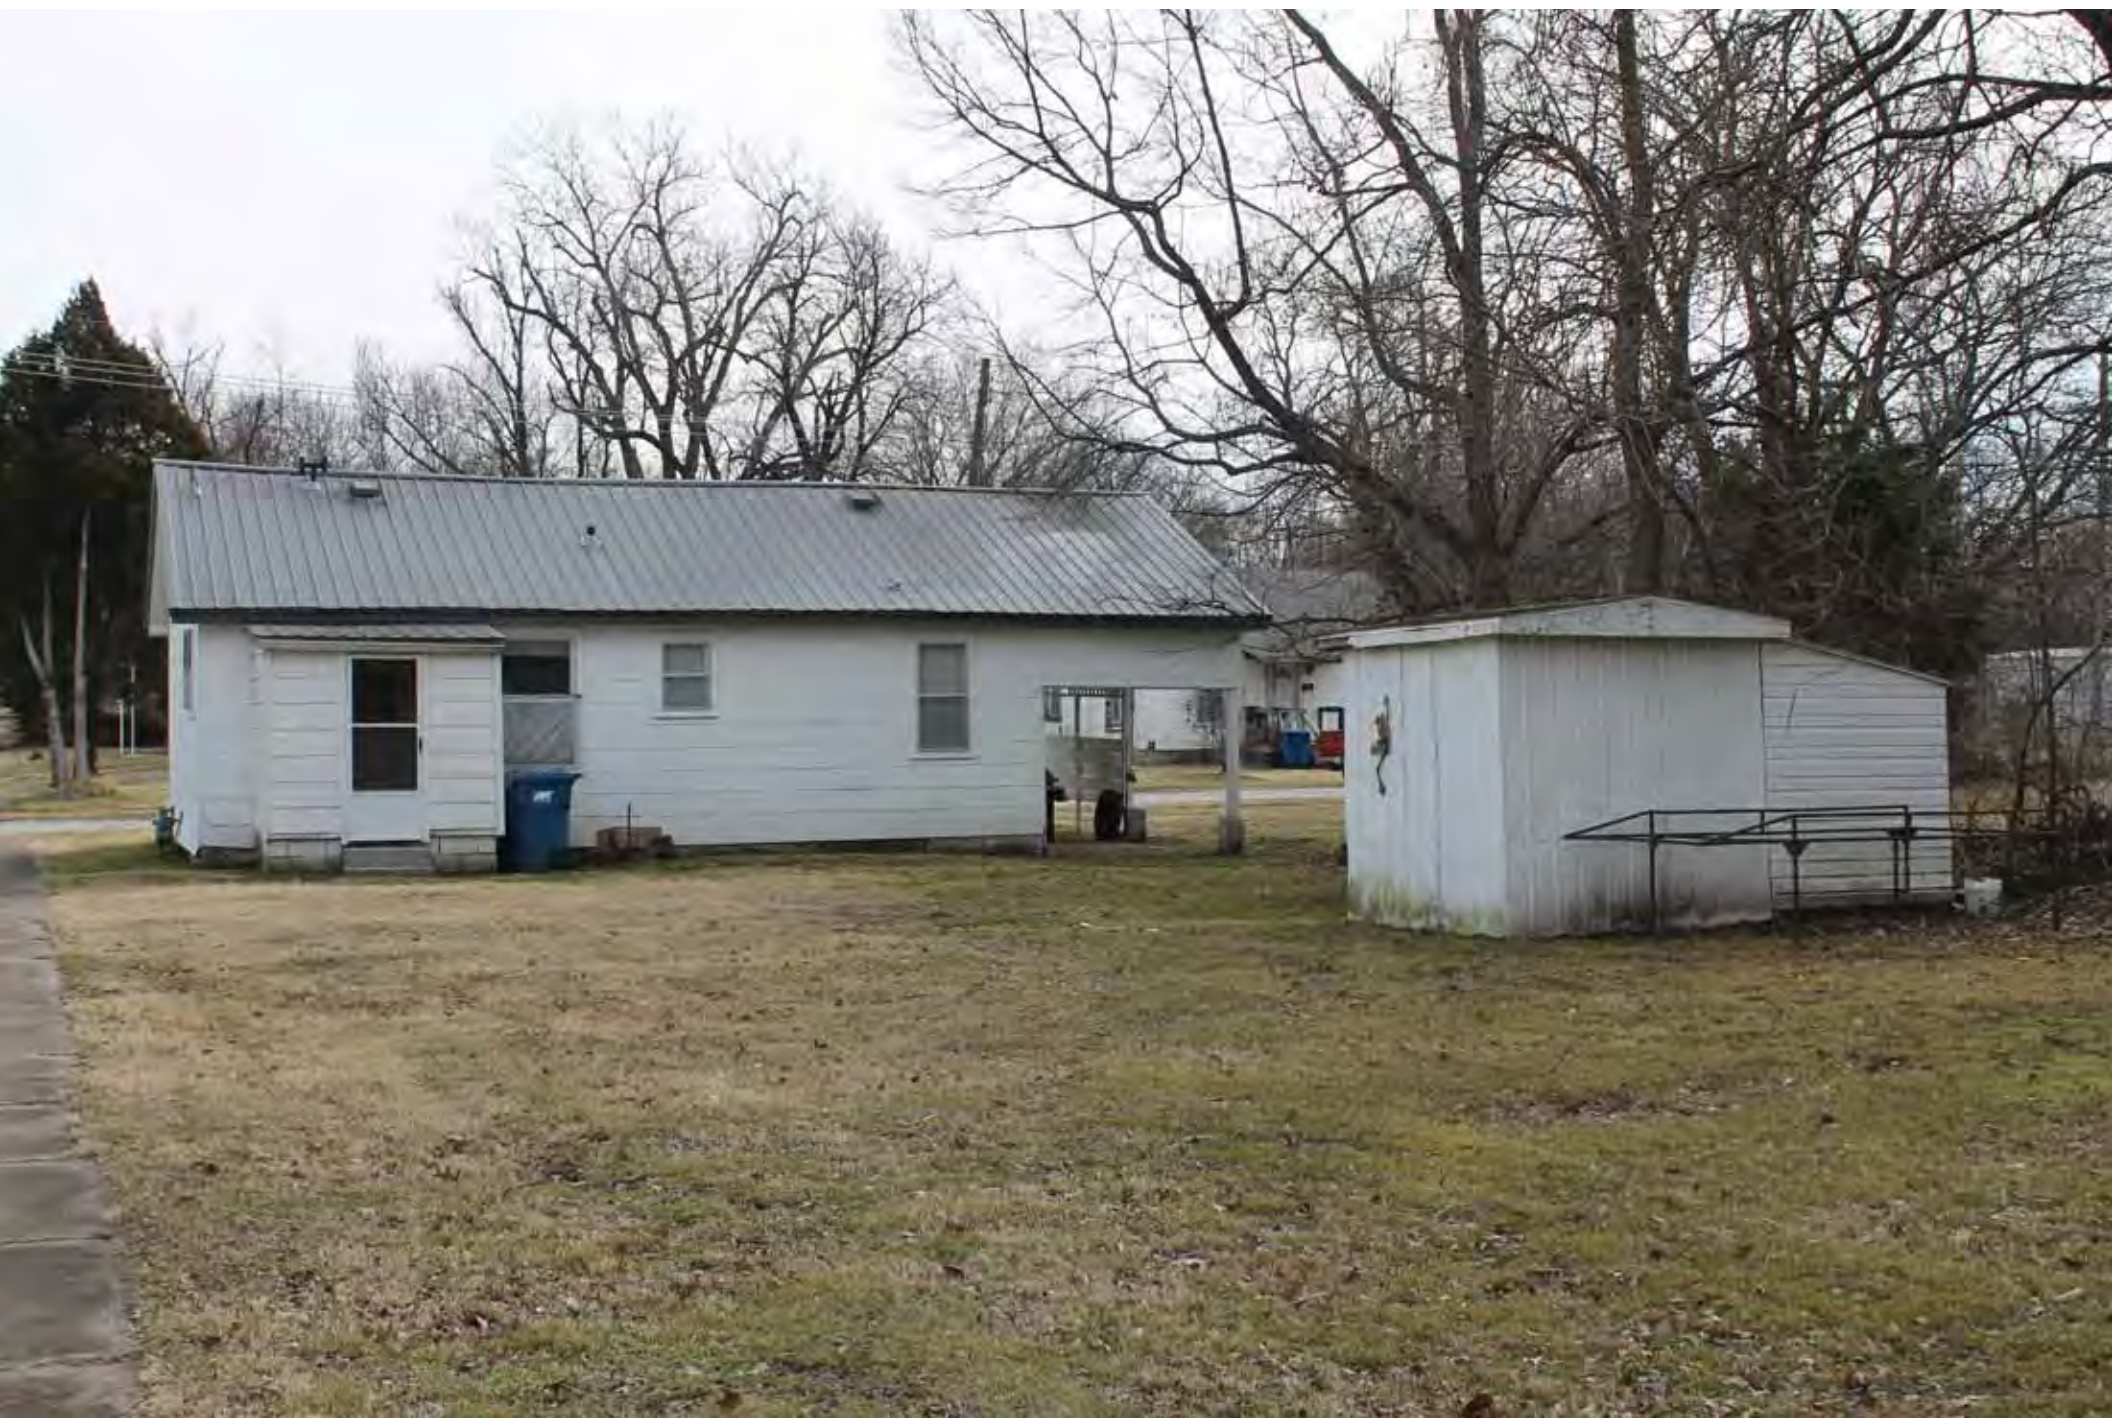
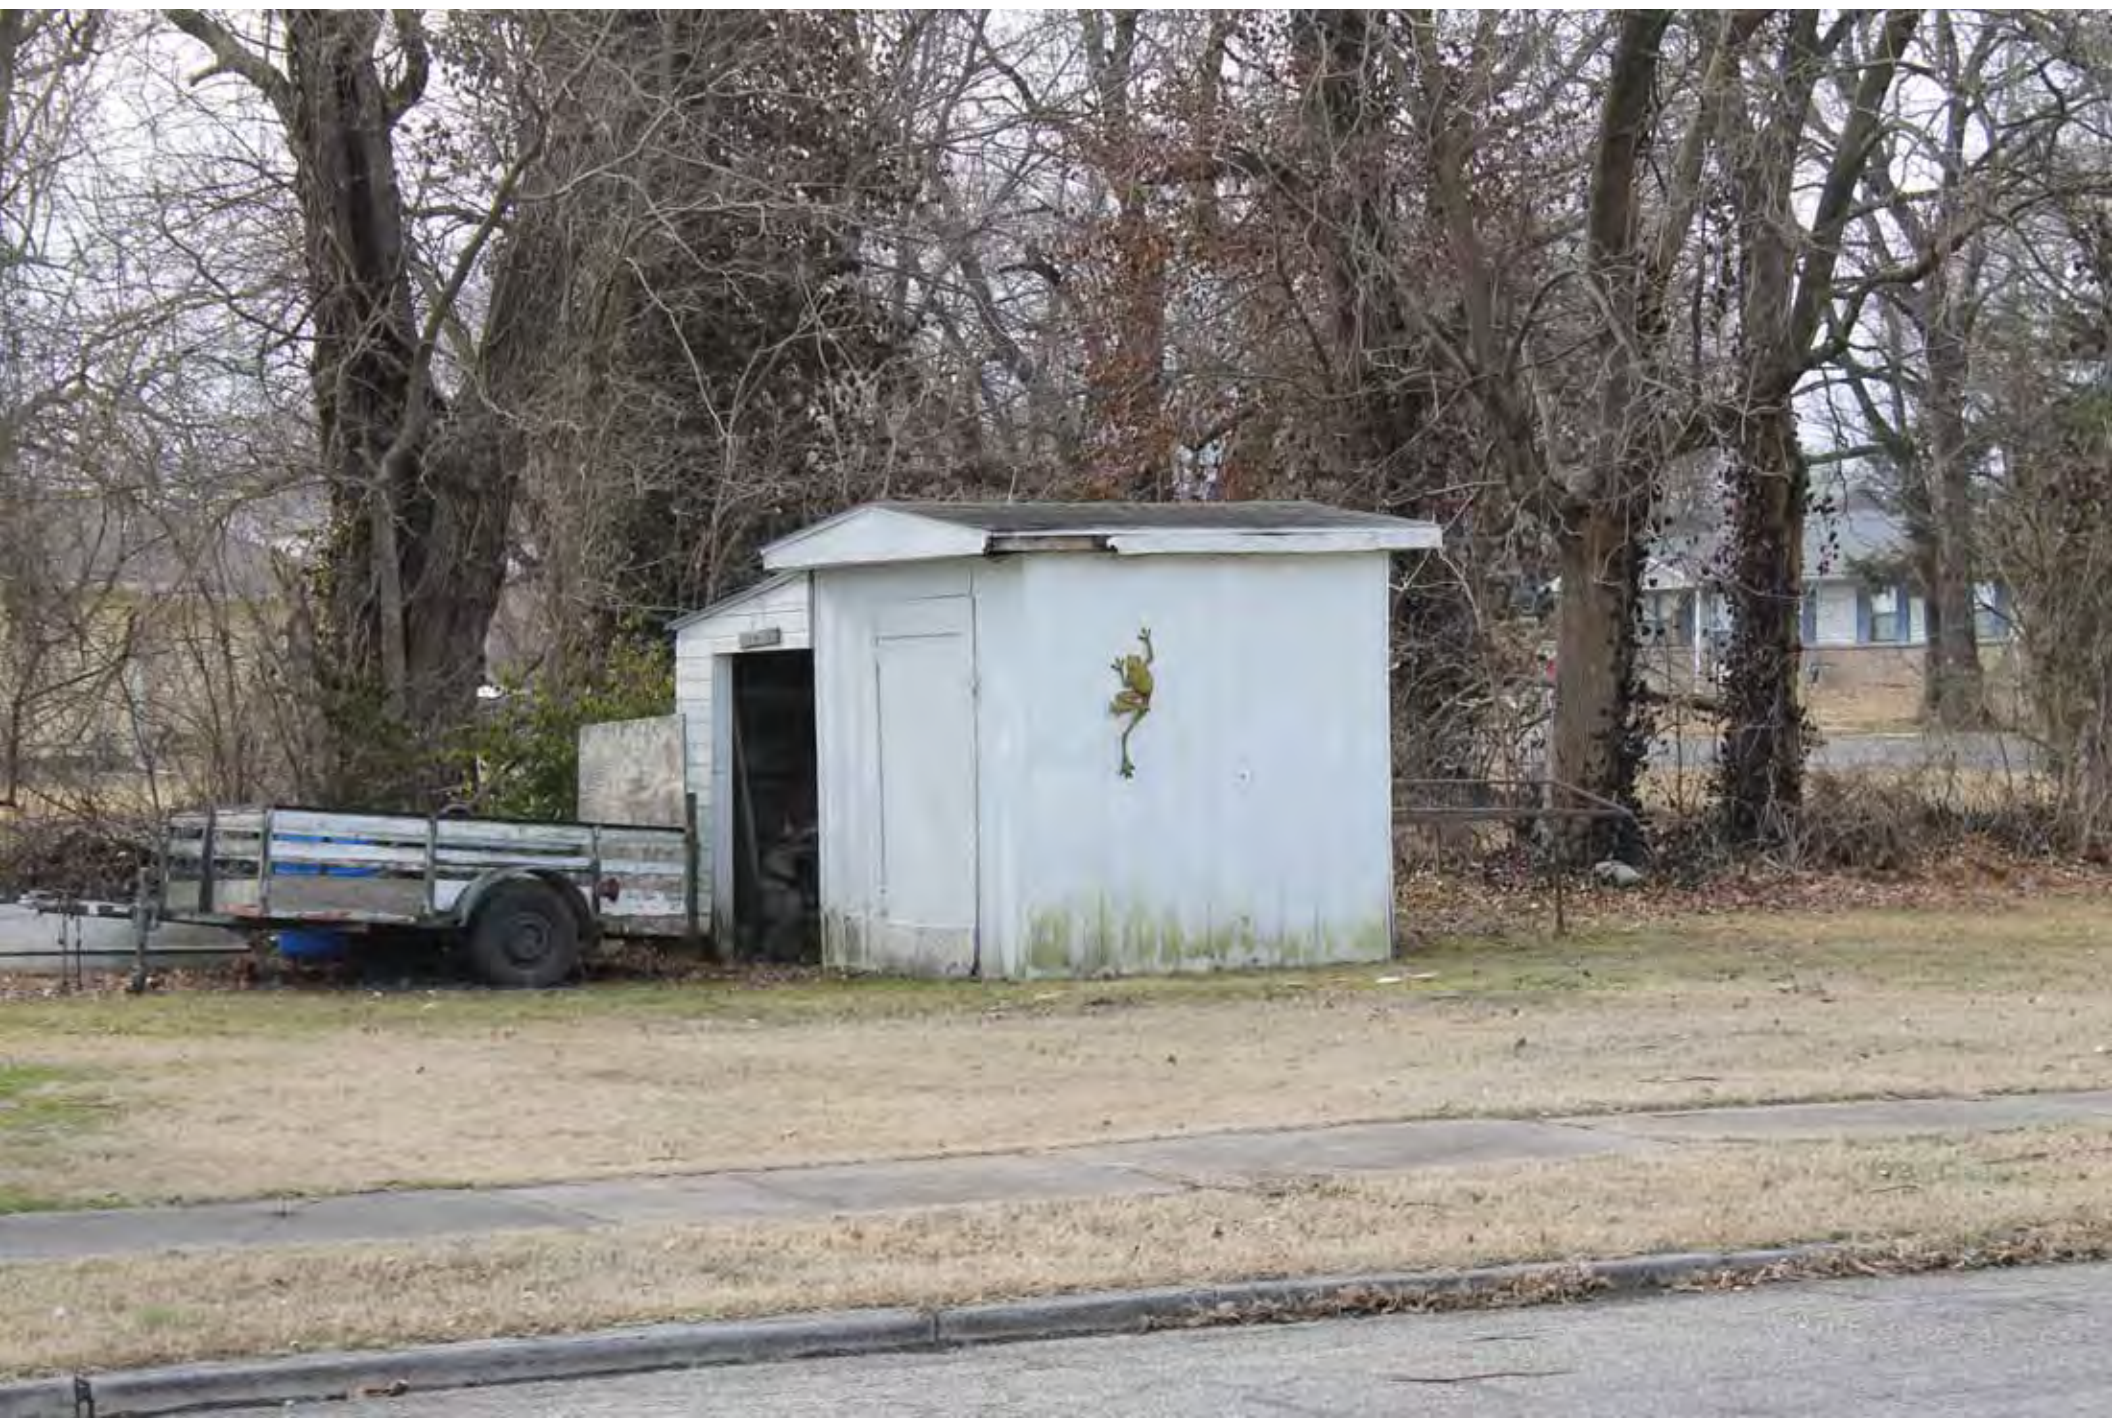
The property at 202 S. Division Avenue features a one story dwelling, with a side gabled roof. The roof is covered in metal. In the middle of the front façade is a simple entrance door. There is a small concrete and wood front porch that leads to the door. The porch has a flat roof. Flanking the entrance on either side are double one-over-one windows. On the south side of the house is an attached carport that is also under the gable roof of the house. On the north elevation is a small double window. On the rear of the house is a small addition that houses a rear entrance. It has a shed roof, also covered in metal. To the south of this addition, on the rear elevation, are there separate one-over-one windows.

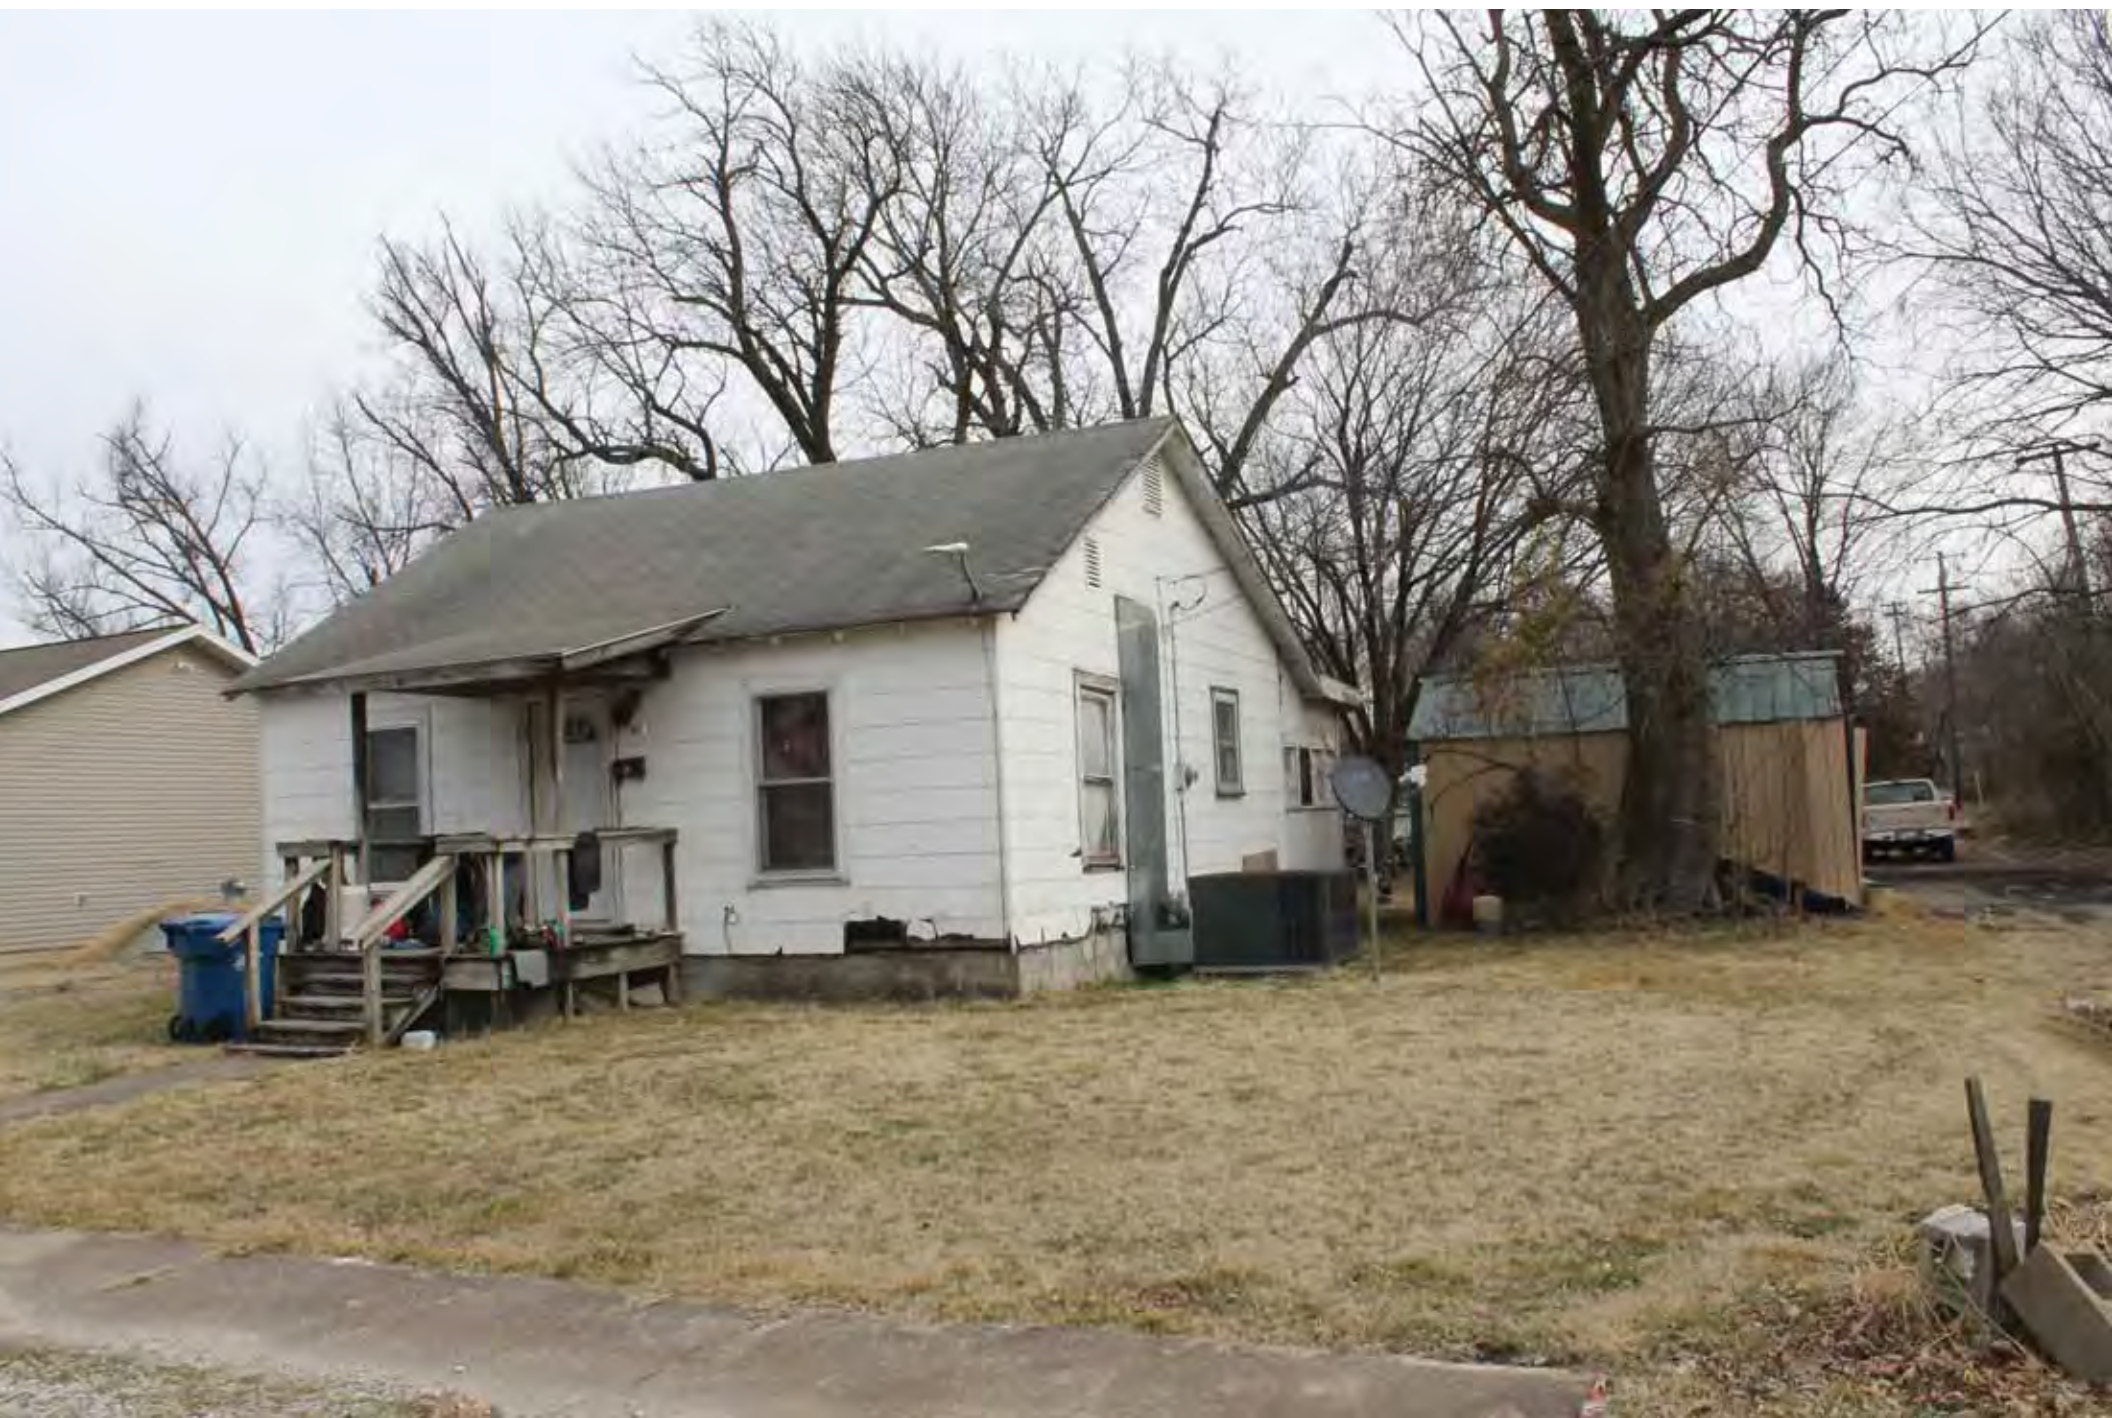
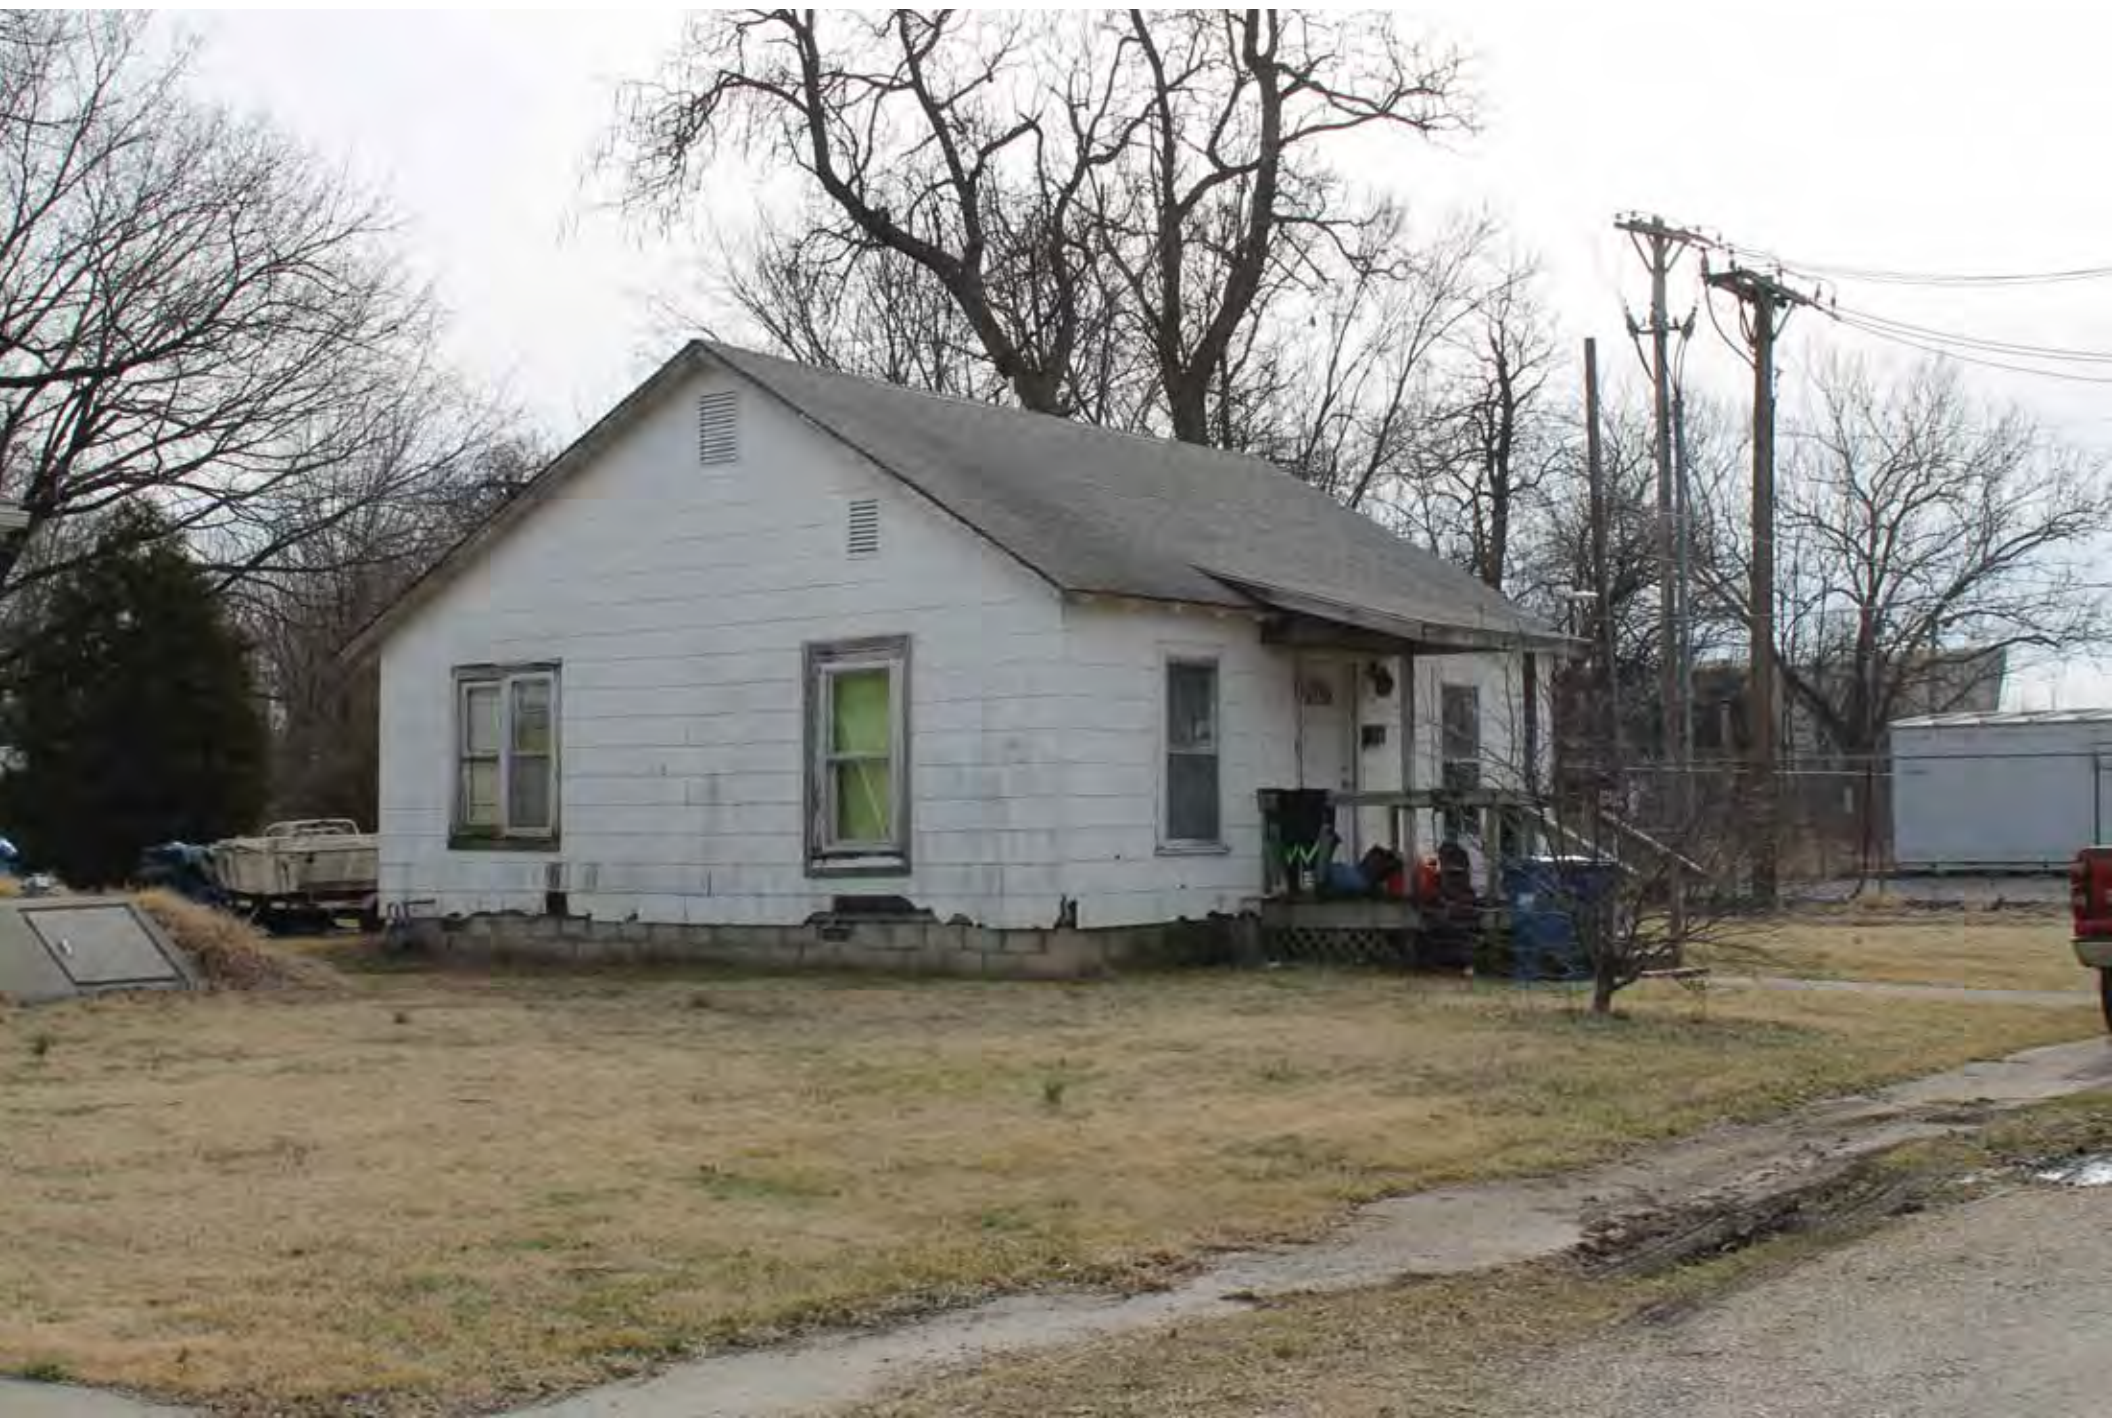
This dwelling has been extensively altered. The dwelling does not retain integrity that would render it individually eligible for the National Register of Historic Places. The dwelling is not situated in an area recommended as a historic district.

The property at 211 S. Division Avenue is a one story dwelling, with a side gabled roof with exposed rafters. The roof is covered in asphalt shingles. In the middle of the front façade is a simple entrance door. There is a small wooden front porch that leads to the door. The porch has a shed roof. Flanking the entrance on either side are single one-over-one windows with wood sills. The foundation is concrete blocks.

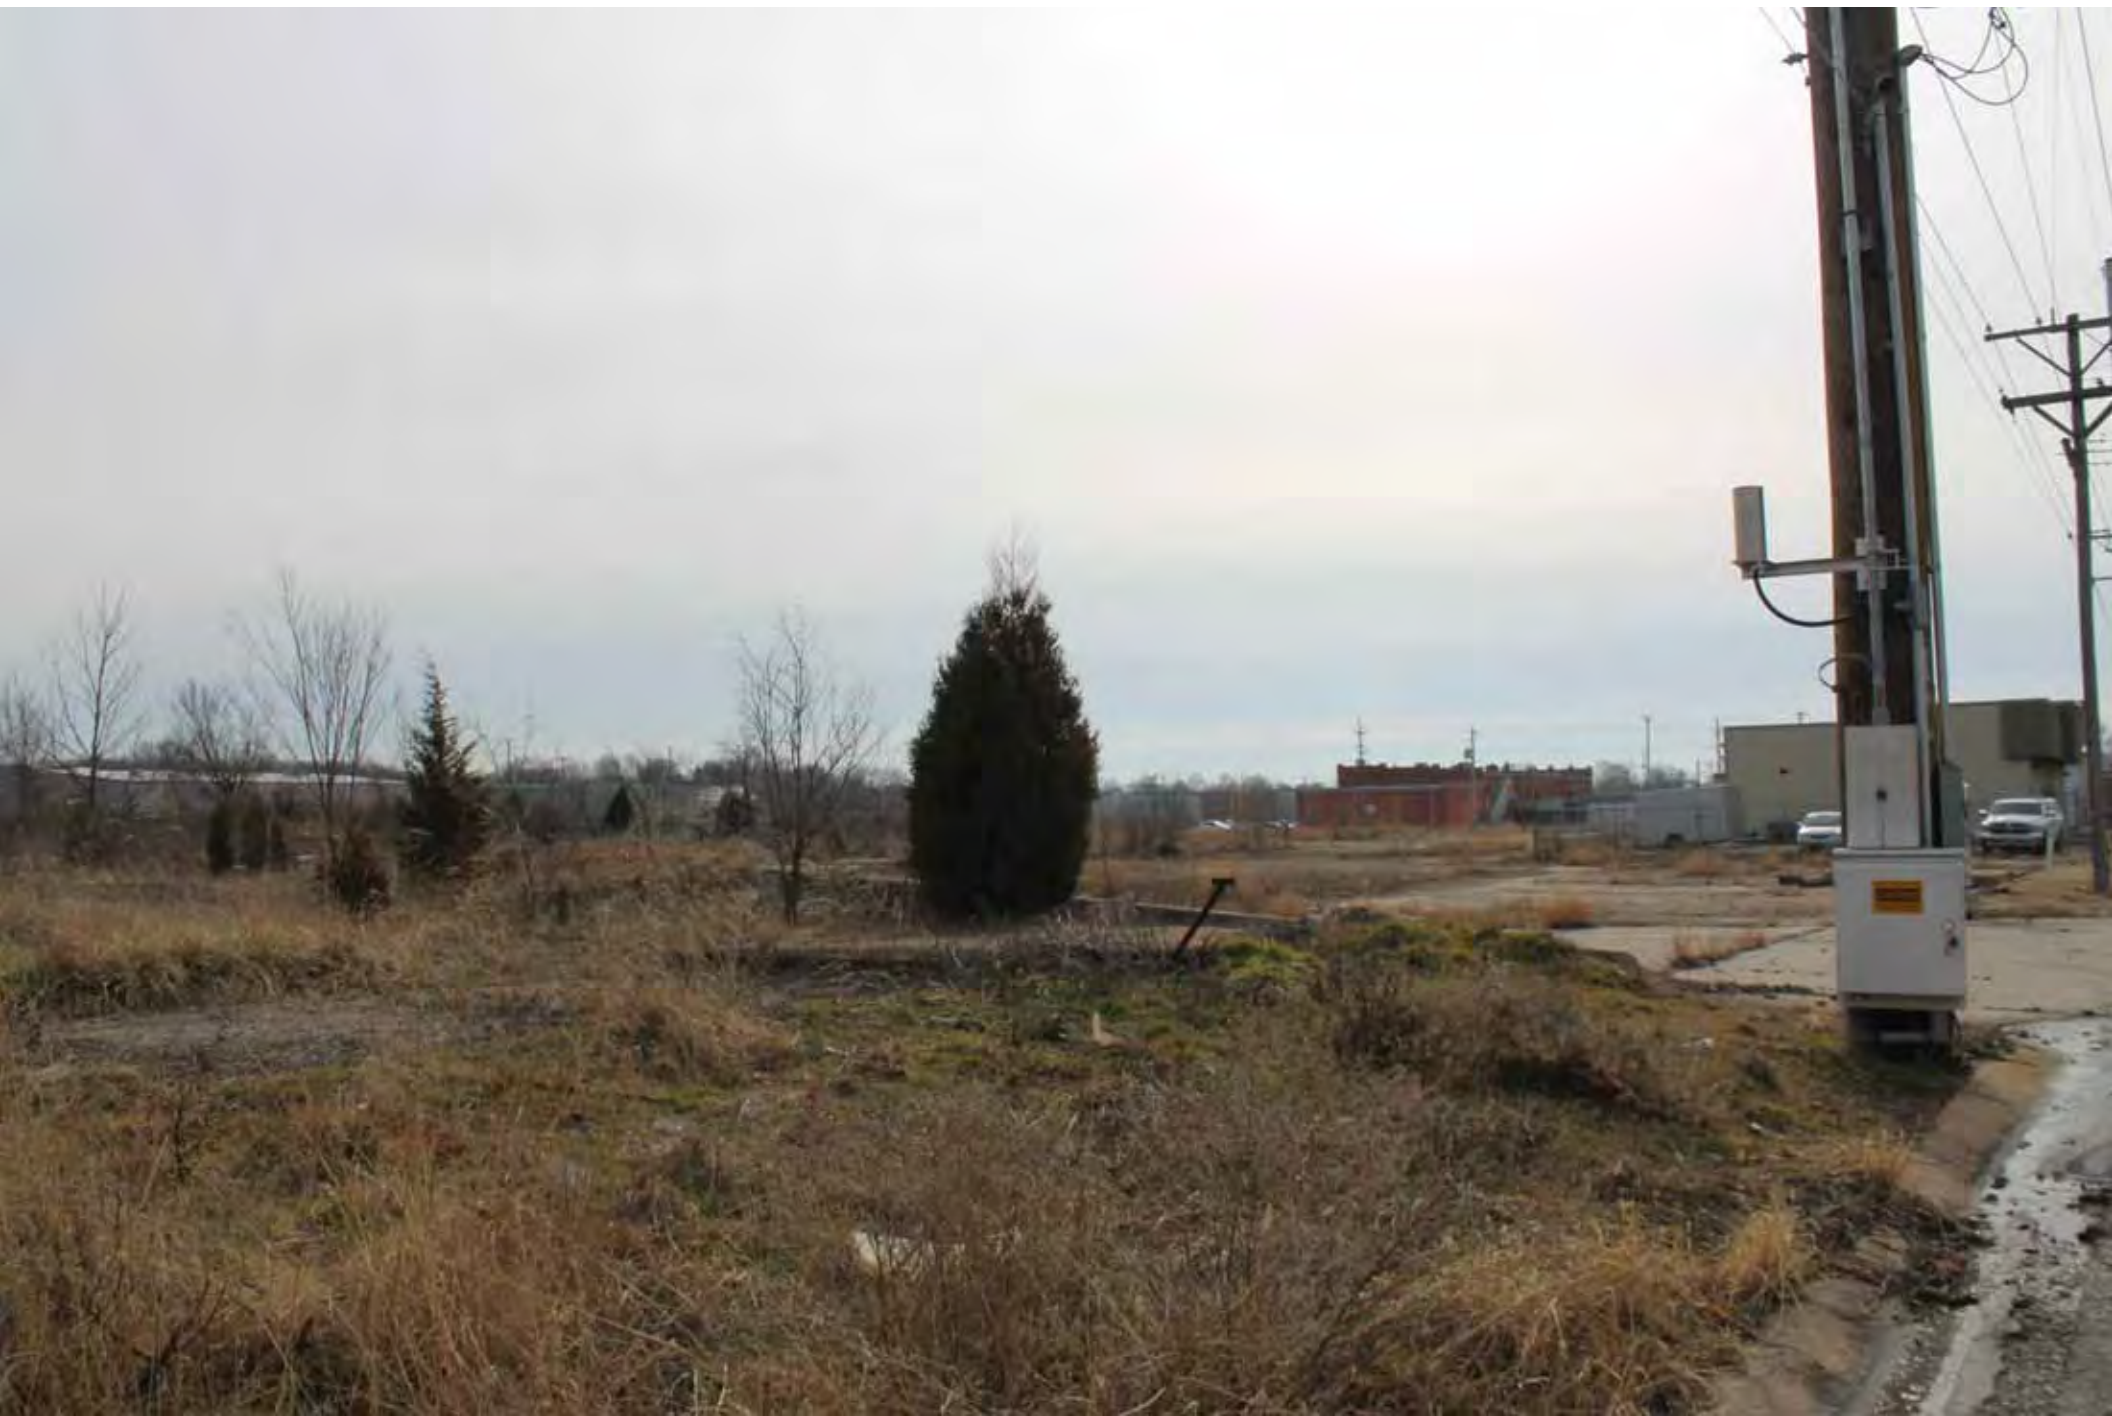
The lot at the NE corner of S. Division Avenue and E. 2nd Street has a concrete foundation on the site. The site is vacant in the 1939 Sanborn map.

This property is a vacant lot with a concrete foundation and overgrown foliage.
