MISSOURI DEPARTMENT OF NATURAL RESOURCES
STATE HISTORIC PRESERVATION OFFICE, P.O. Box 176, Jefferson City, MO 65102
ARCHITECTURAL/HISTORIC INVENTORY FORM

1. Survey No. JP-AS-007-001		2. Survey name: East Town (Original Joplin) Historic Survey Phase 2	
3. County: JASPER		4. Address (Street No.) 618	Street (name) E. 2 nd Street
5. City: Joplin	Vicinity: <input type="checkbox"/>	6. Geographical Reference:	7. Township/Range/Section: T: R: S:
8. Historic name (if known):		9. Present/other name (if known):	
10. Ownership: <input checked="" type="checkbox"/> Private <input type="checkbox"/> Public		11a. Historic use (if known): Domestic: Single Dwelling	11b. Current use: Domestic: Single Dwelling

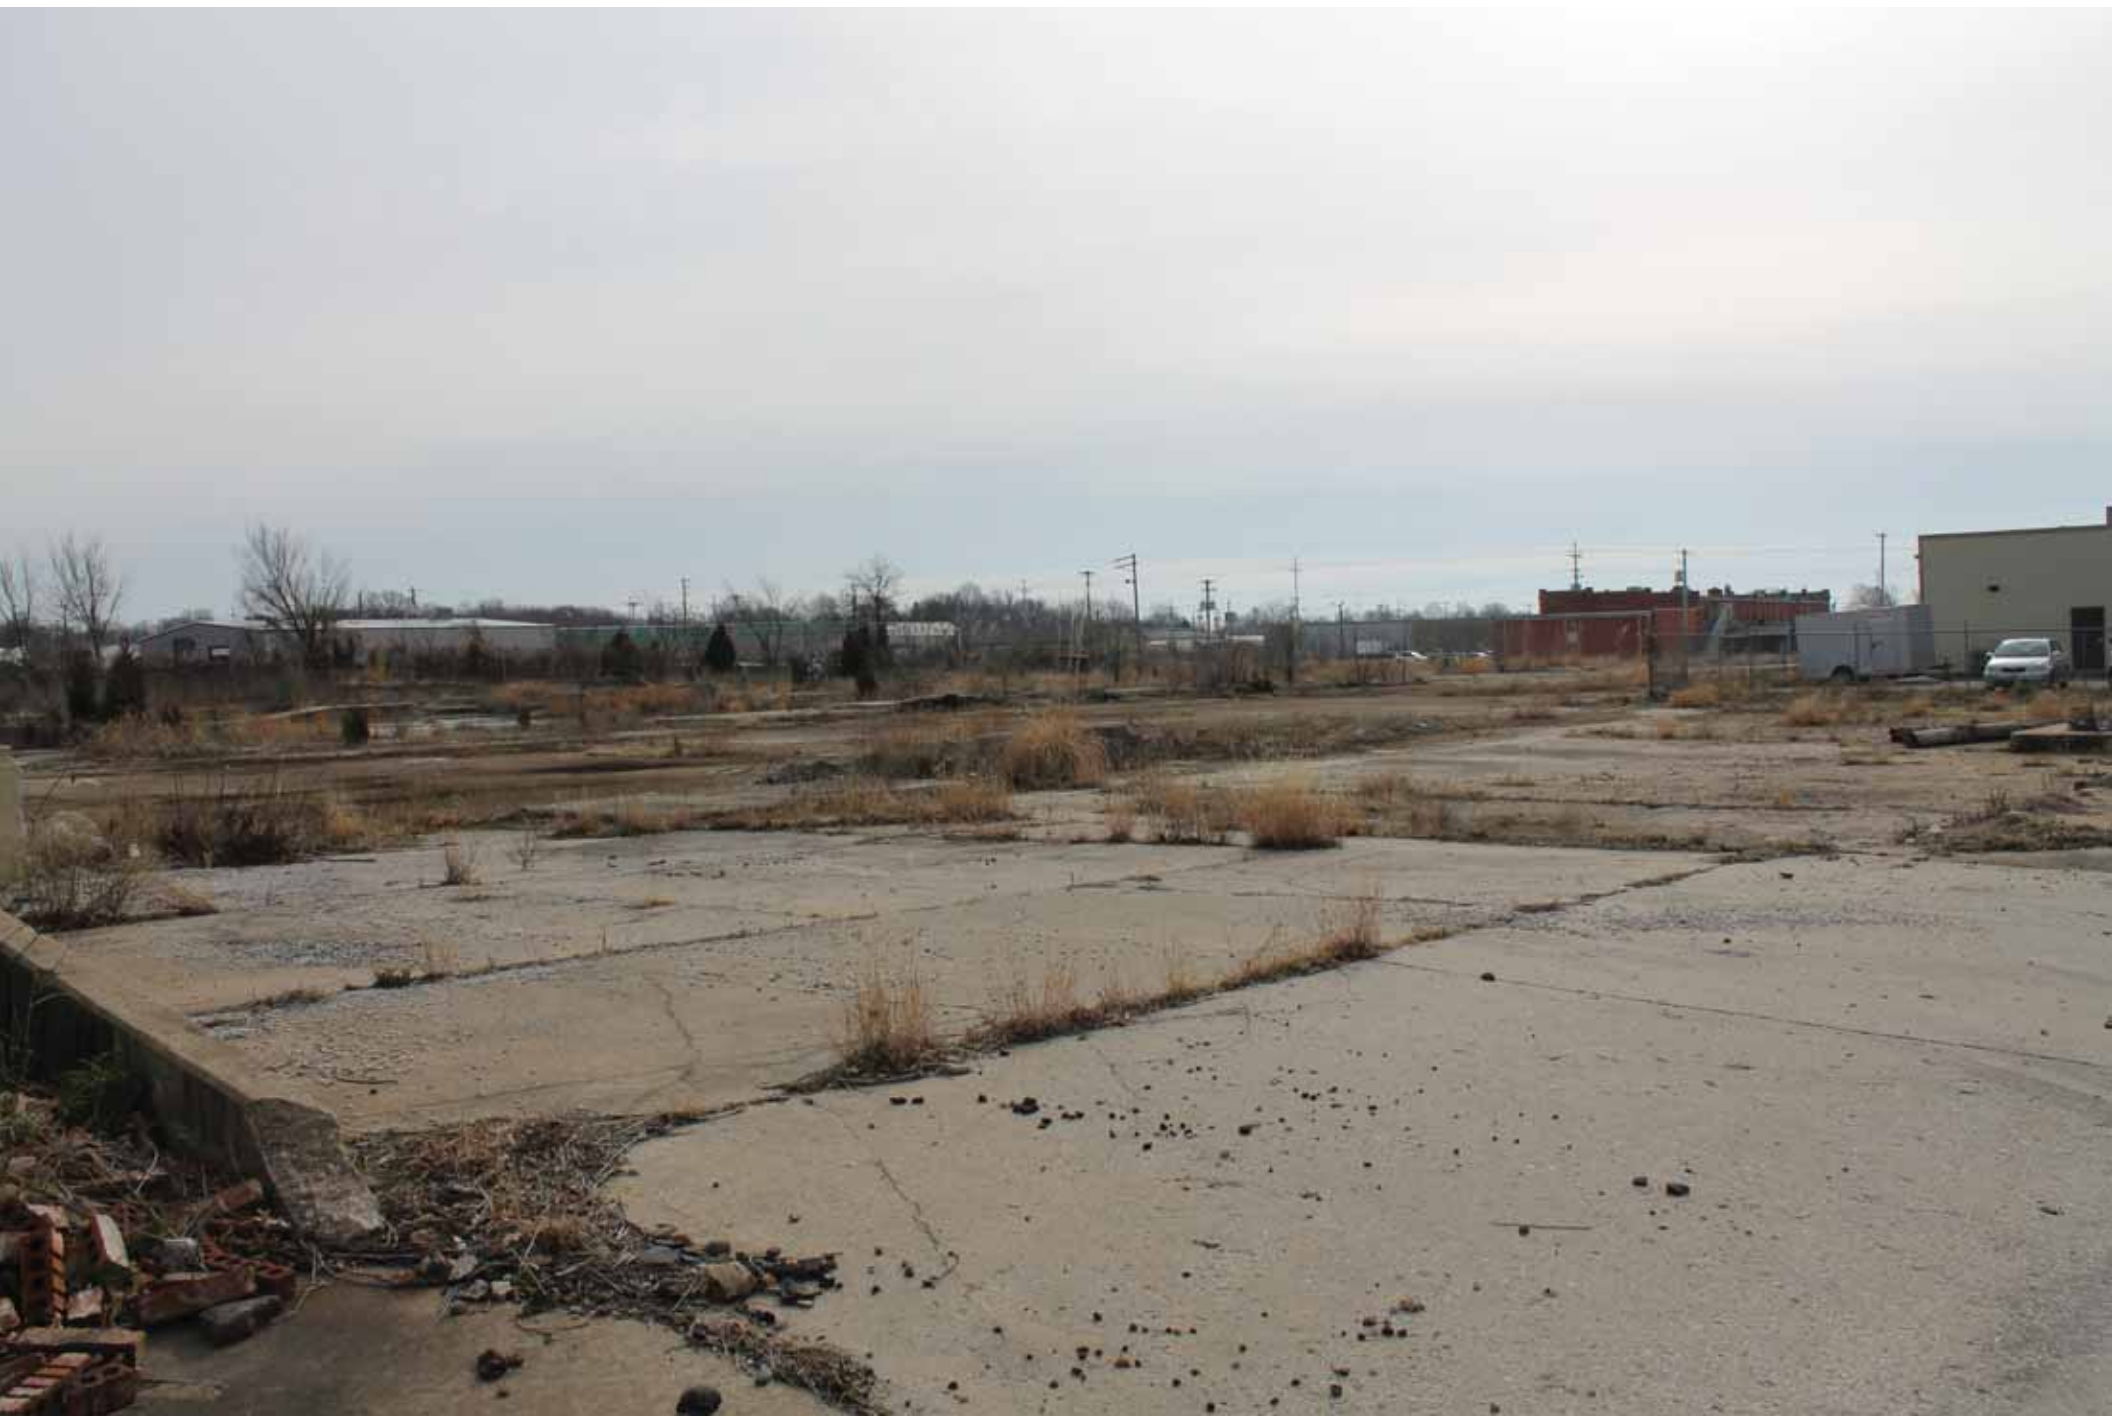
This property is a vacant lot with a concrete foundation and overgrown foliage.

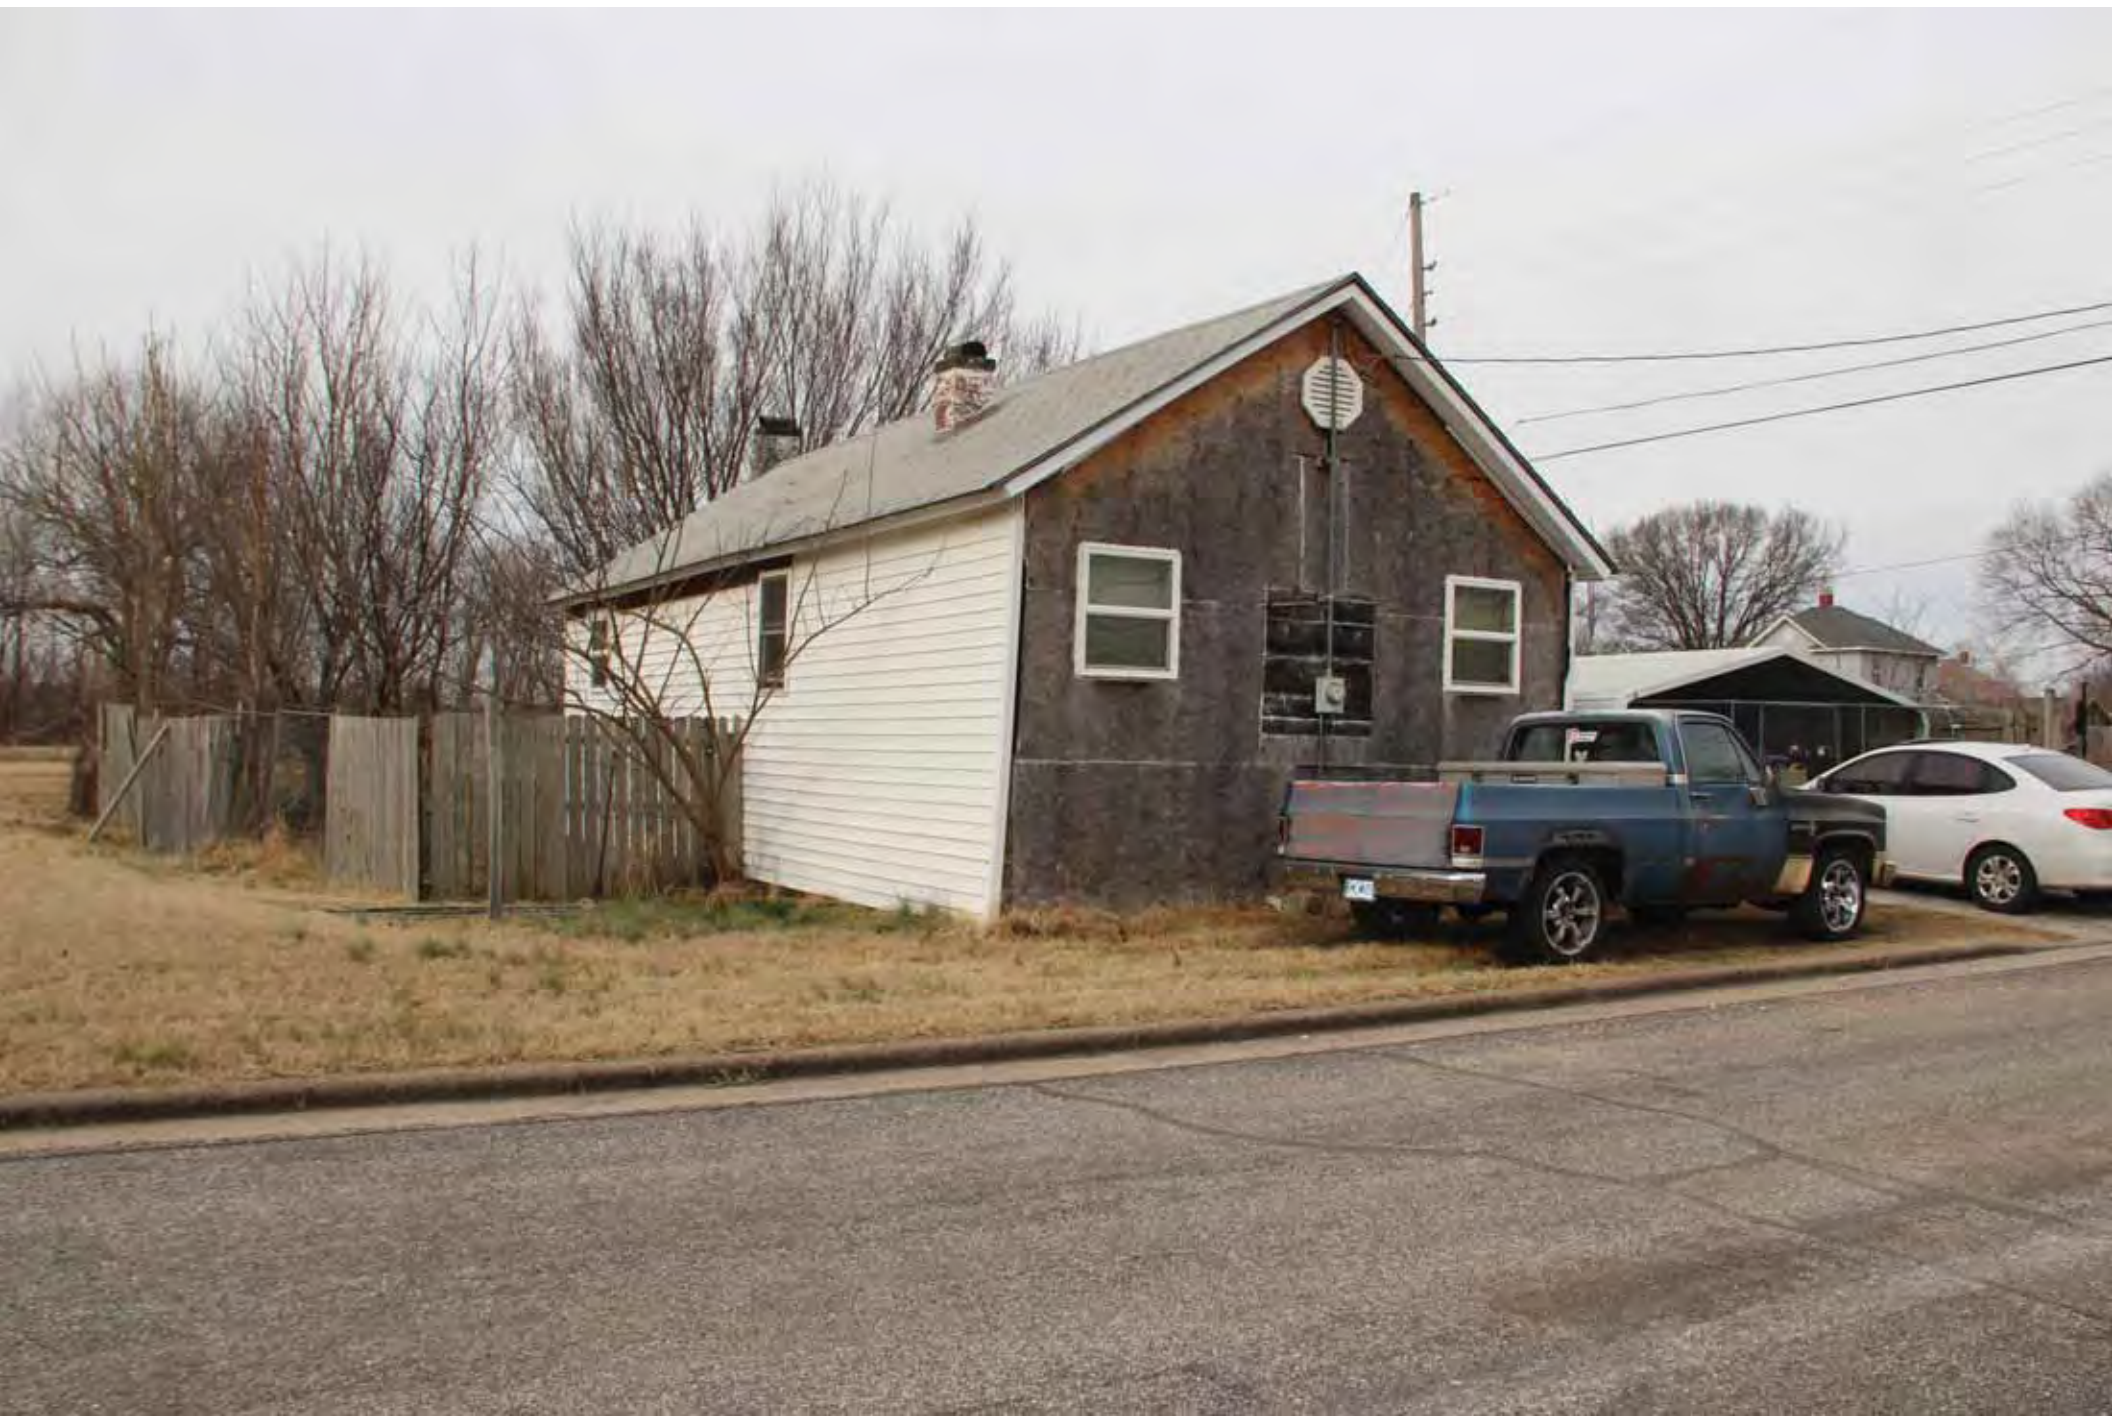
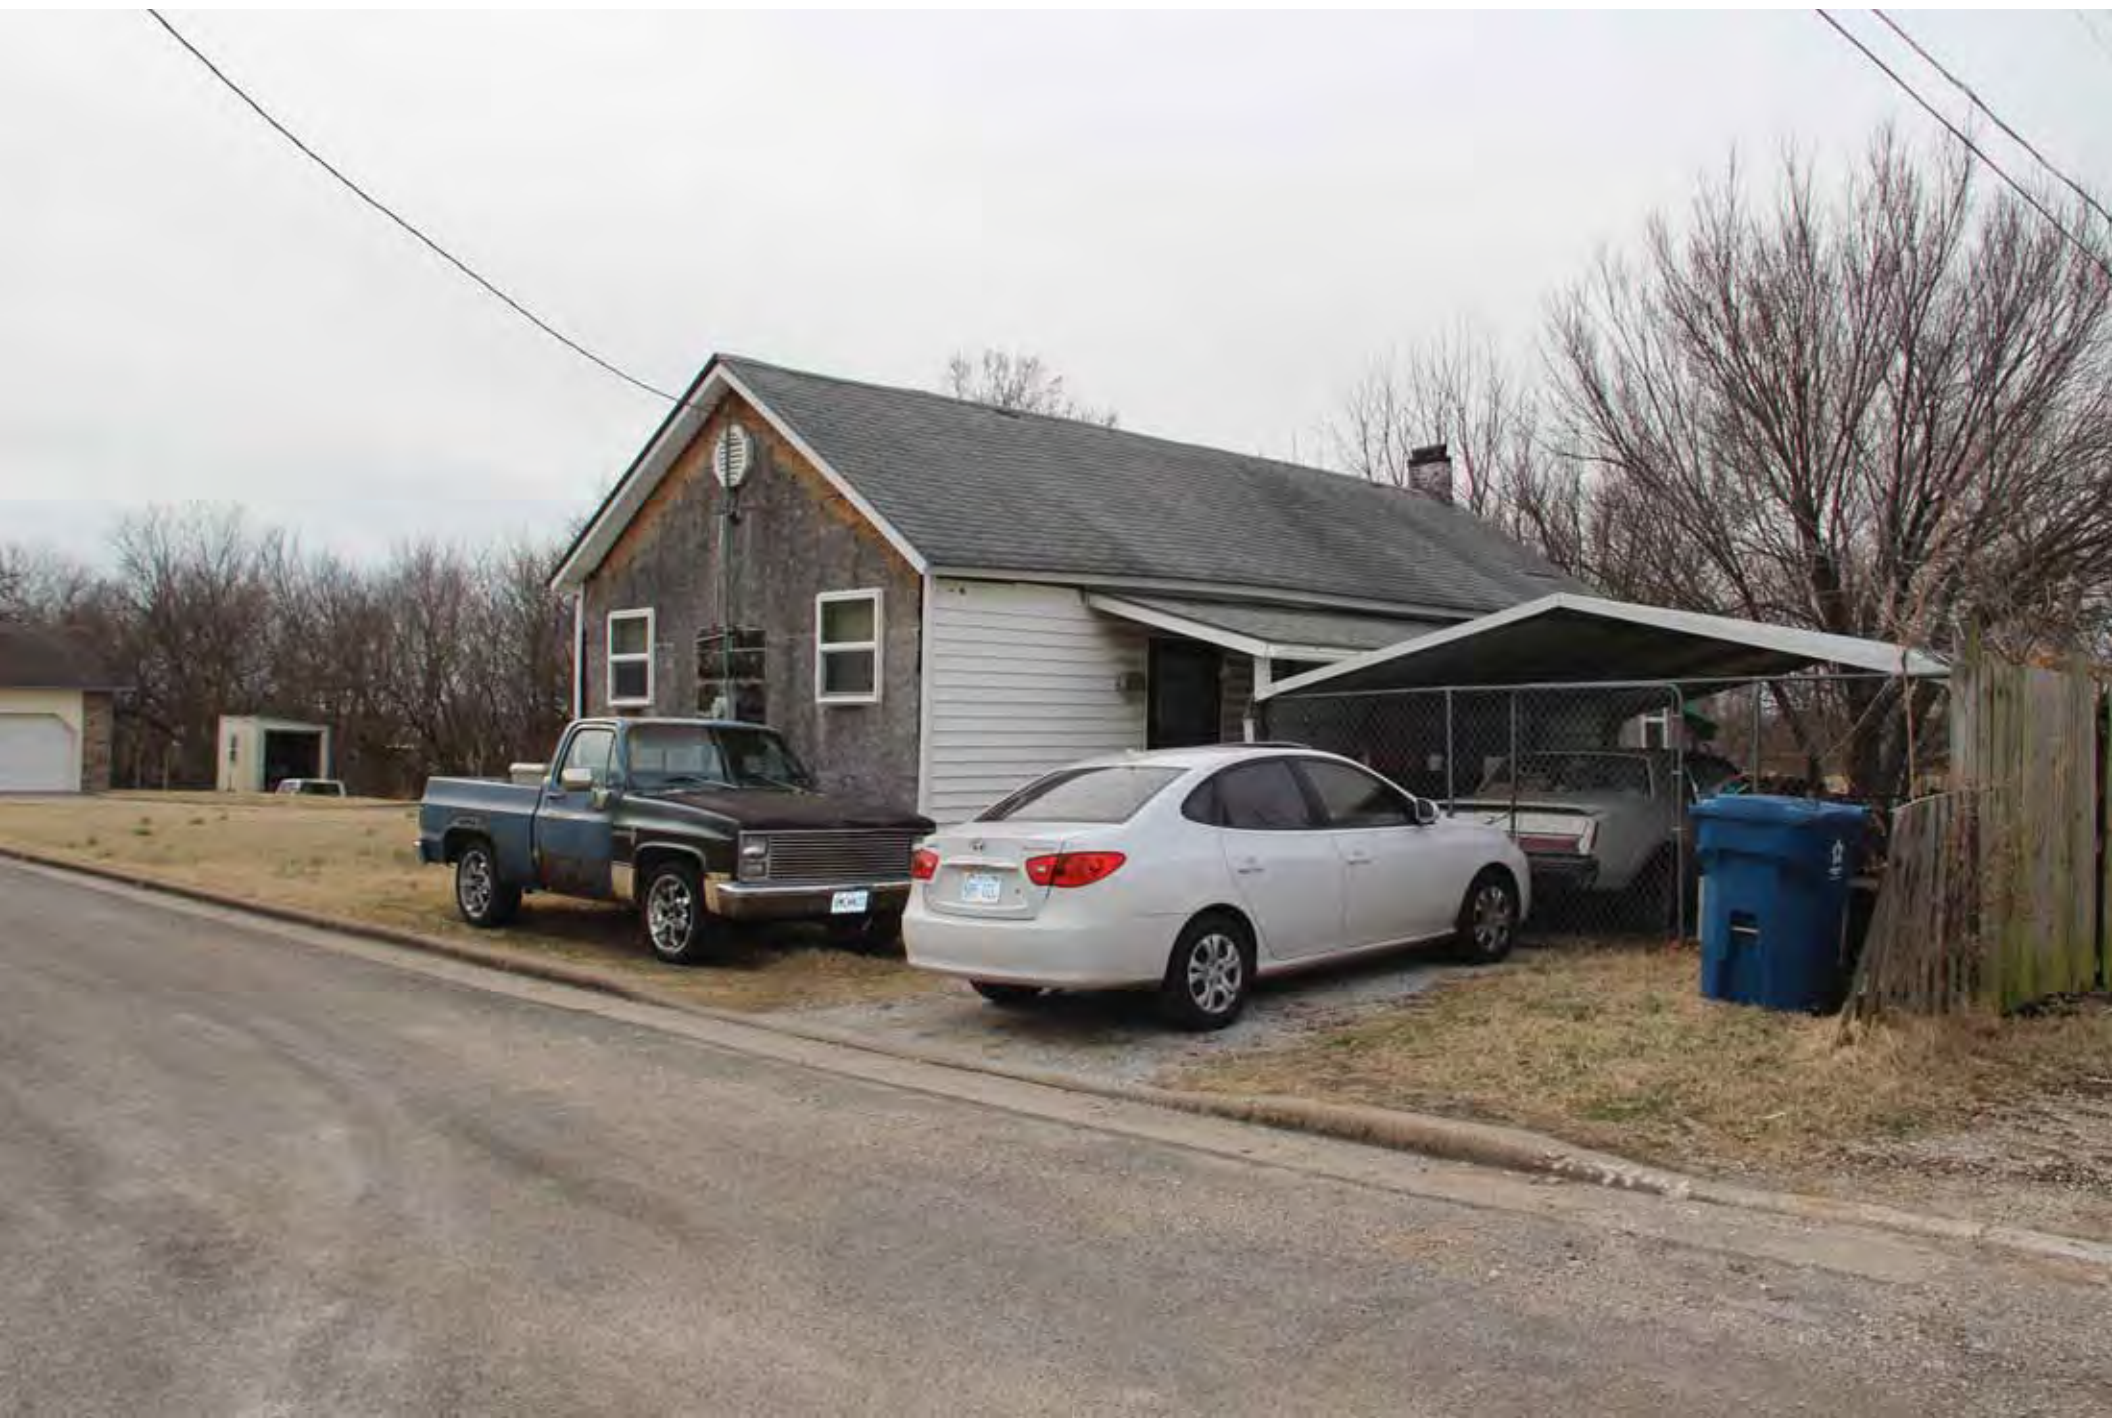
This dwelling has been extensively altered through vinyl siding and vinyl windows. Siding is missing on the front façade. Due to the lack of exterior original siding, the dwelling does not retain integrity that would render it individually eligible for the National Register of Historic Places. The dwelling is not situated in an area recommended as a historic district.

The property 114 S. Galena Street features a one-story, gable-front plan National style dwelling with exterior vinyl siding and an asphalt shingled roof consisting of a rectangular plan. The primary façade is symmetrical with two one-over-one vinyl replacement windows. The front façade is missing siding and is particleboard. The entrance of the house is located on the side, or north façade. It is sheltered by a lean-to frame roof, which connects to a metal carport. Windows on the south side façade are vinyl one-over-one replacement windows. There are two interior brick chimneys.

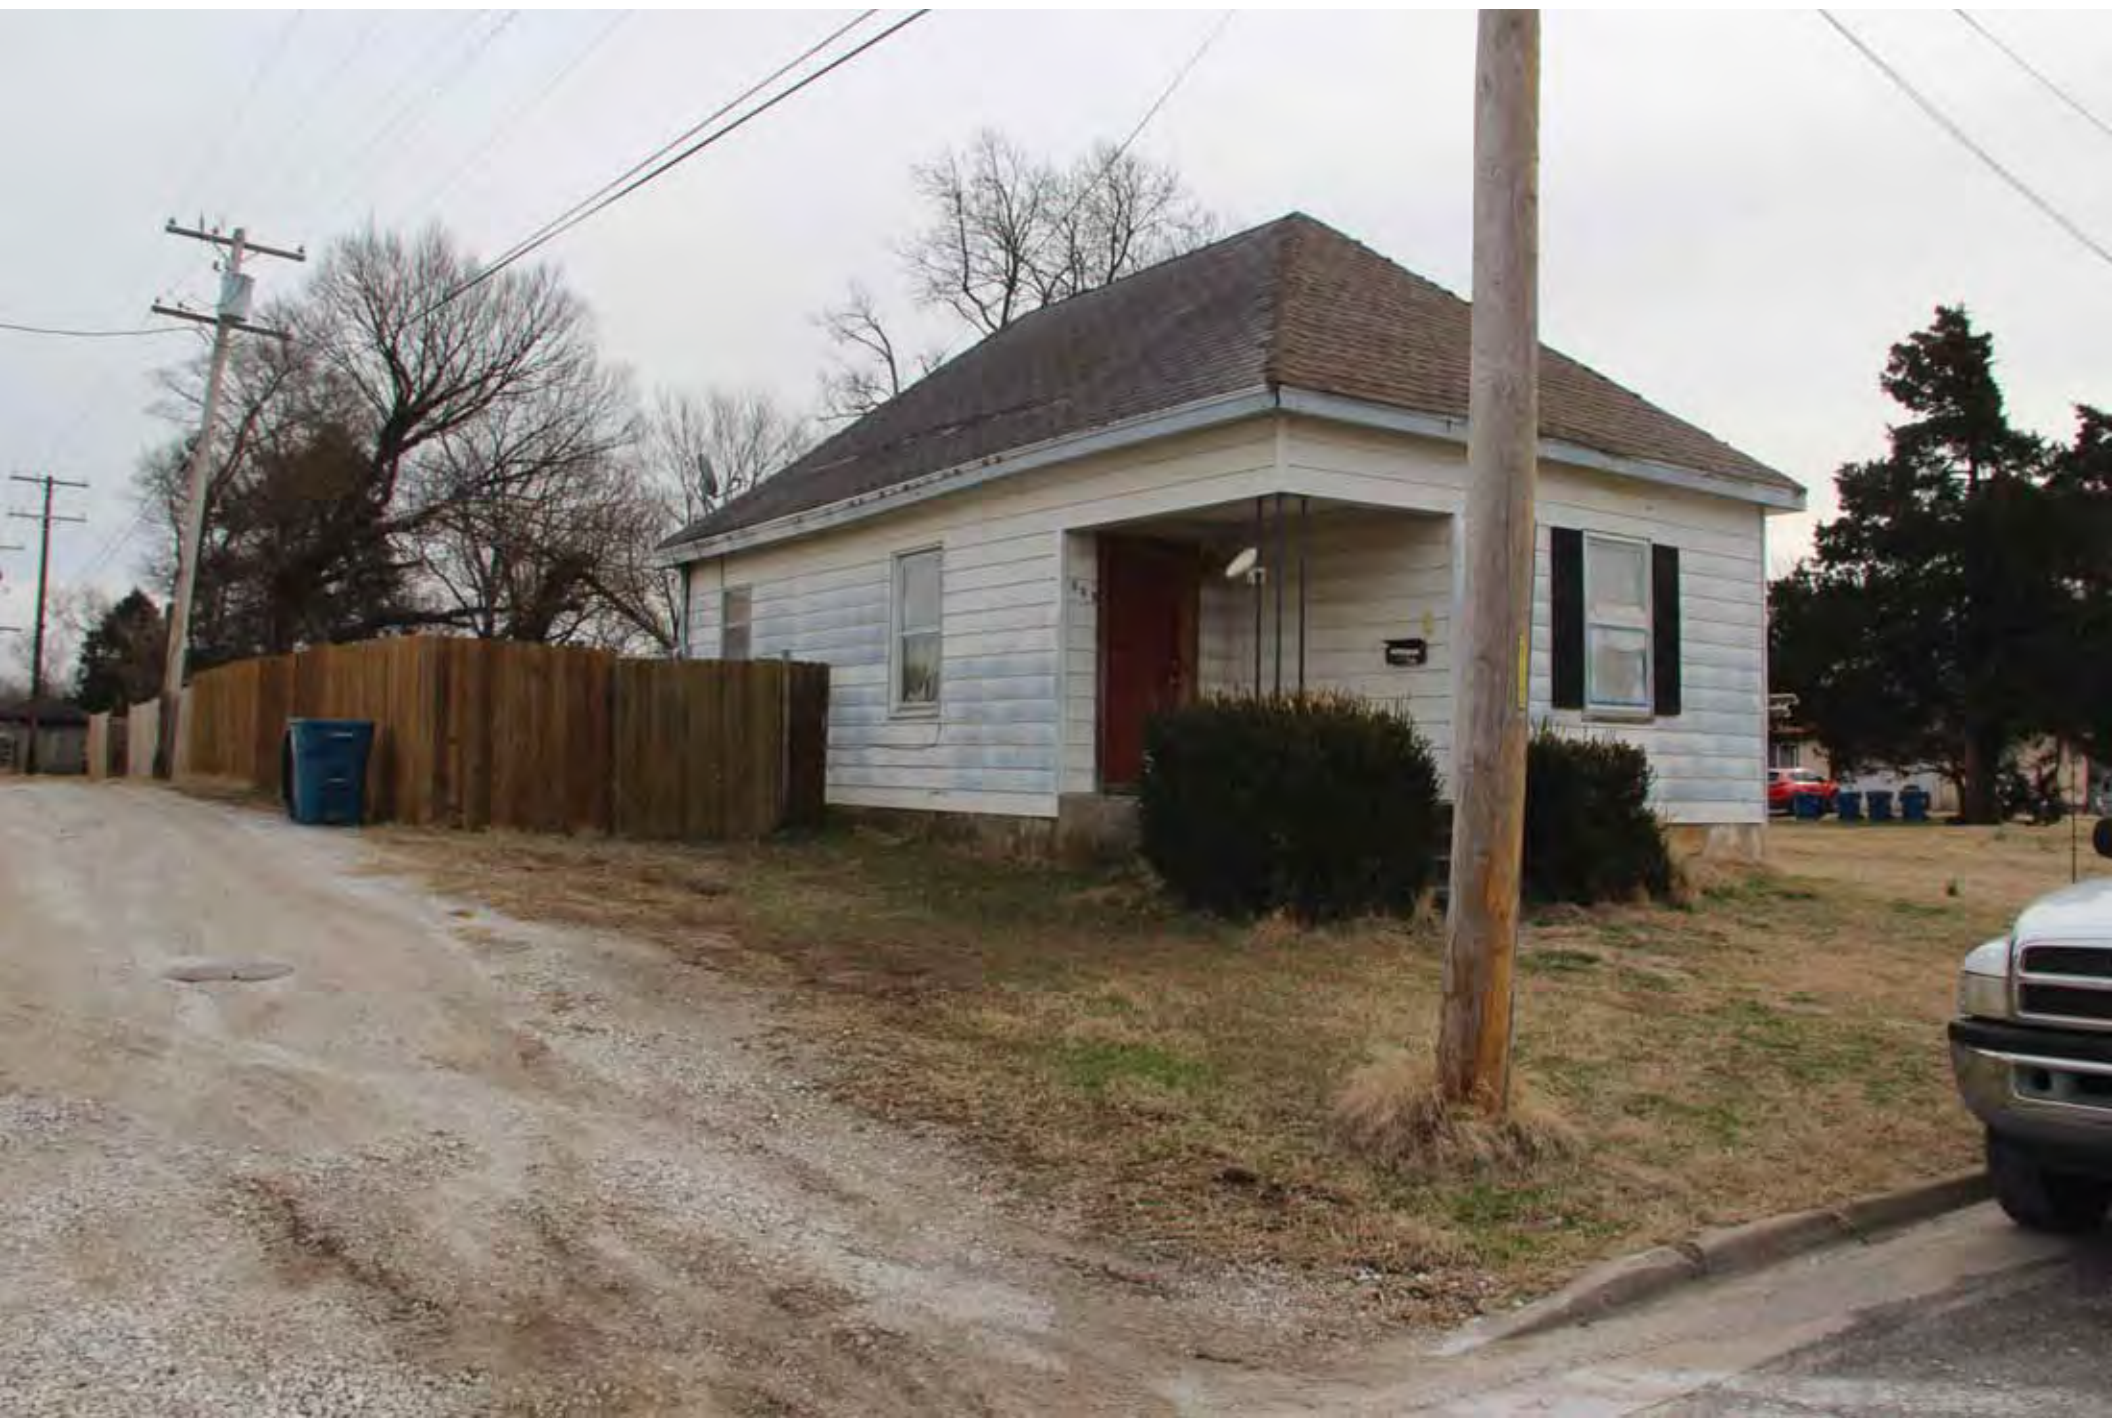
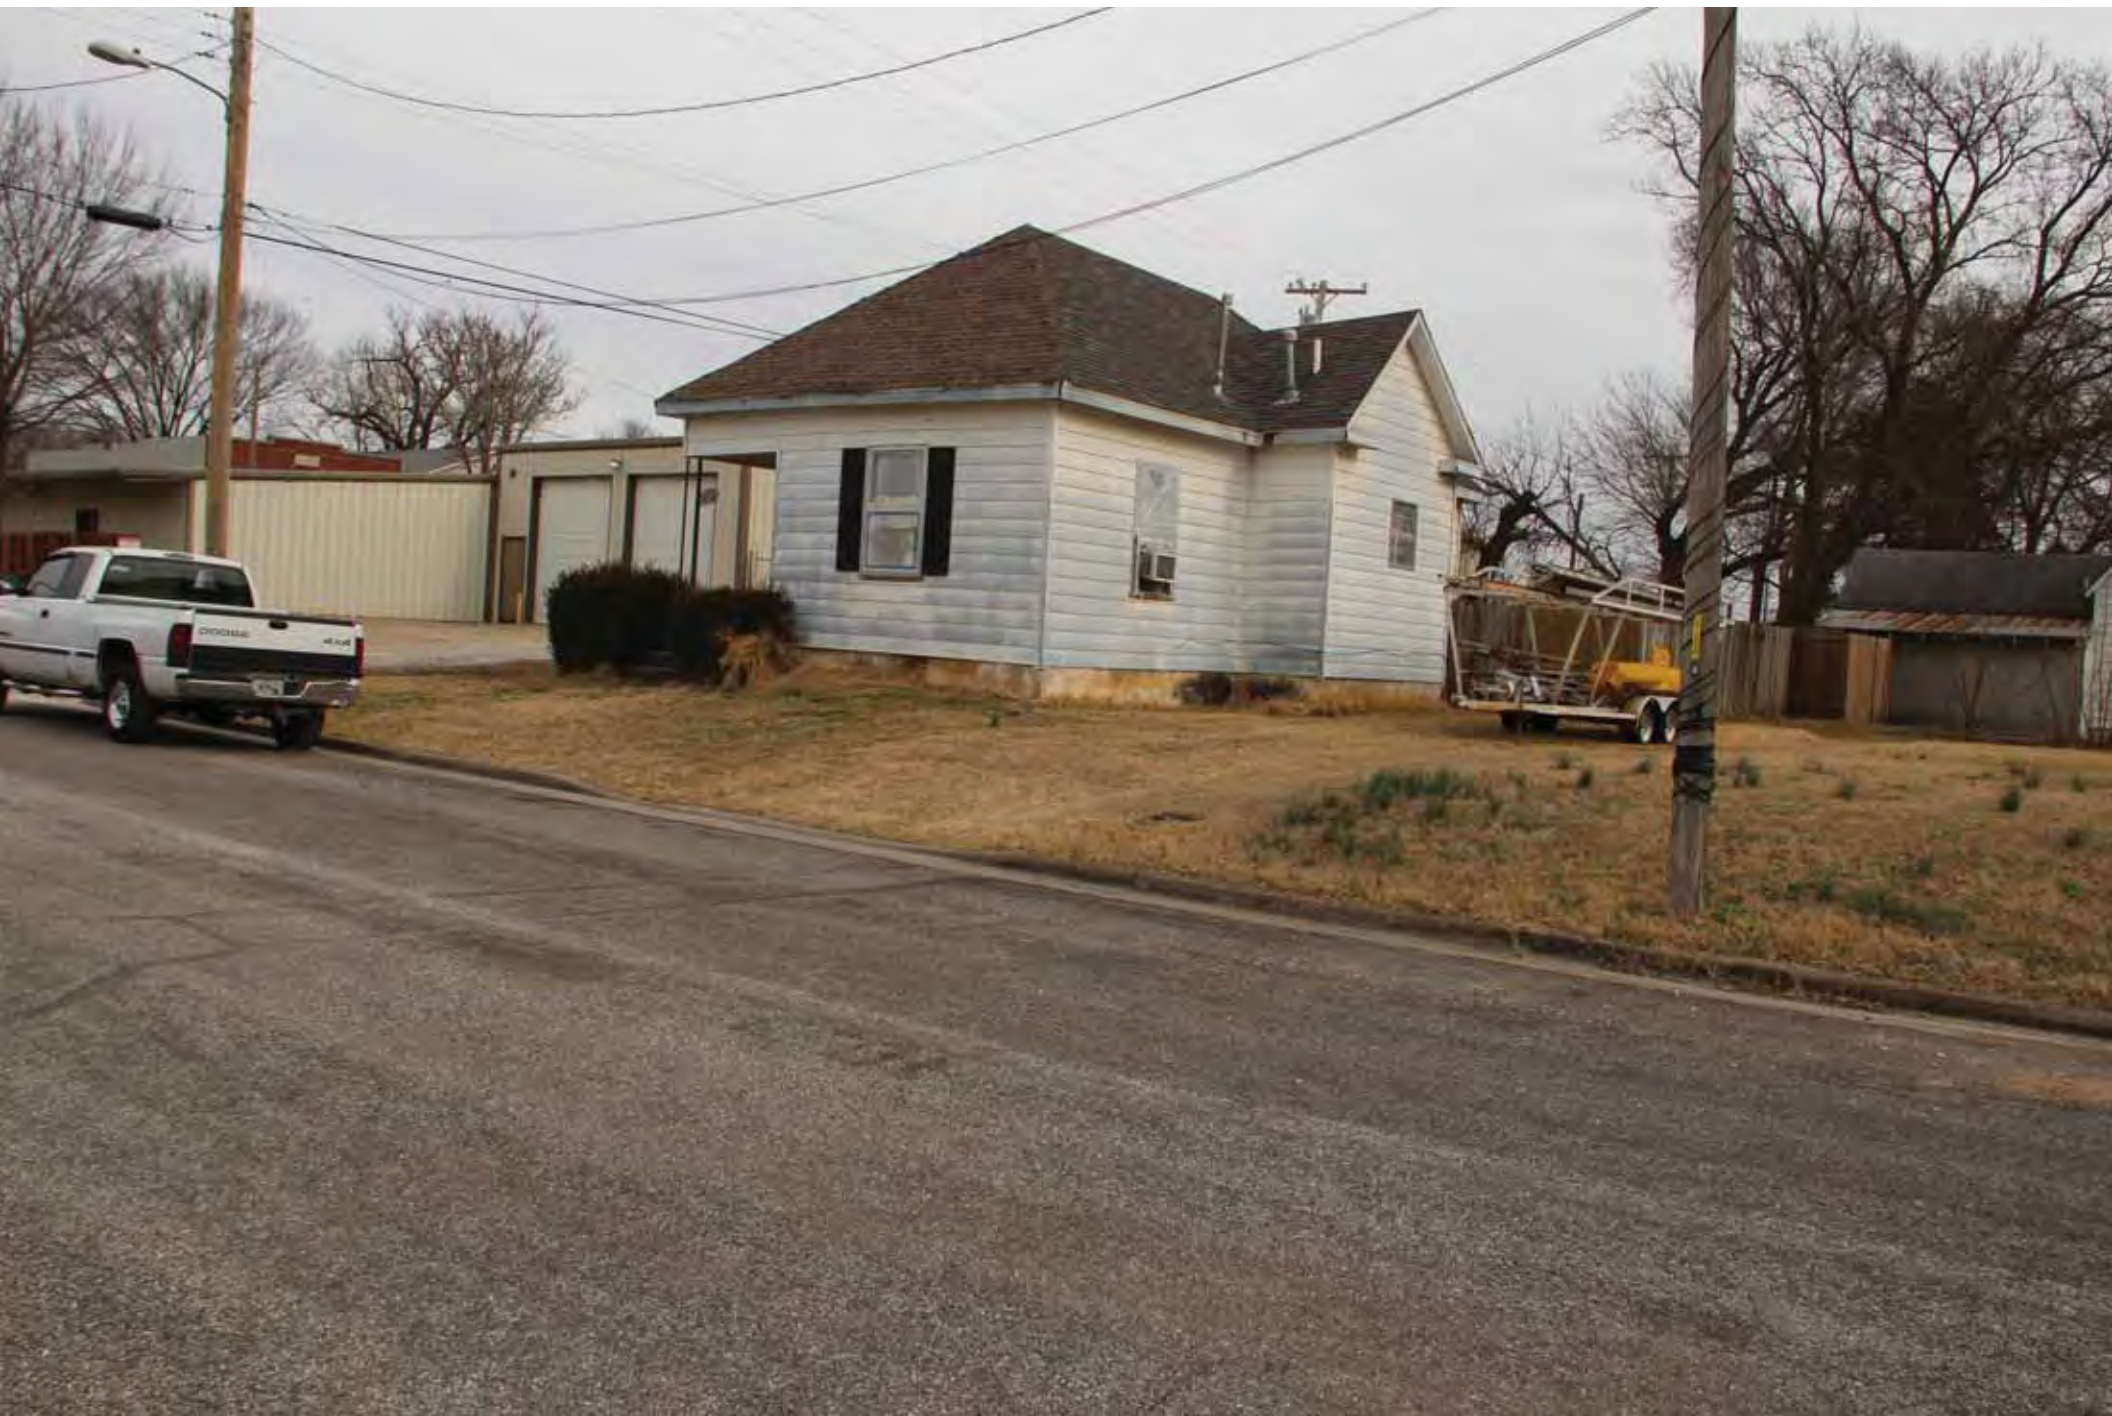
This dwelling has been extensively altered with the addition of metal siding and vinyl windows. Due to the lack of exterior original siding, the dwelling does not retain integrity that would render it individually eligible for the National Register of Historic Places. The dwelling is not situated in an area recommended as a historic district.

The property 115 S. Galena Street features a one-story, hipped-roof National style dwelling with exterior metal siding and an asphalt-shingled roof consisting of a rectangular plan. The primary façade has a recessed porch on the northwest corner, which leads to the front door. To the south of the entrance is one bay, with a single one-over-one vinyl replacement window with metal awnings. Each side of the house has two one-over-one vinyl replacement windows.
