MISSOURI DEPARTMENT OF NATURAL RESOURCES
STATE HISTORIC PRESERVATION OFFICE, P.O. Box 176, Jefferson City, MO 65102
ARCHITECTURAL/HISTORIC INVENTORY FORM

1. Survey No. JP-AS-007-001		2. Survey name: East Town (Original Joplin) Historic Survey Phase 2	
3. County: JASPER		4. Address (Street No.) 618	Street (name) E. 2 nd Street
5. City: Joplin	Vicinity: <input type="checkbox"/>	6. Geographical Reference:	7. Township/Range/Section: T: R: S:
8. Historic name (if known):		9. Present/other name (if known):	
10. Ownership: <input checked="" type="checkbox"/> Private <input type="checkbox"/> Public		11a. Historic use (if known): Domestic: Single Dwelling	11b. Current use: Domestic: Single Dwelling

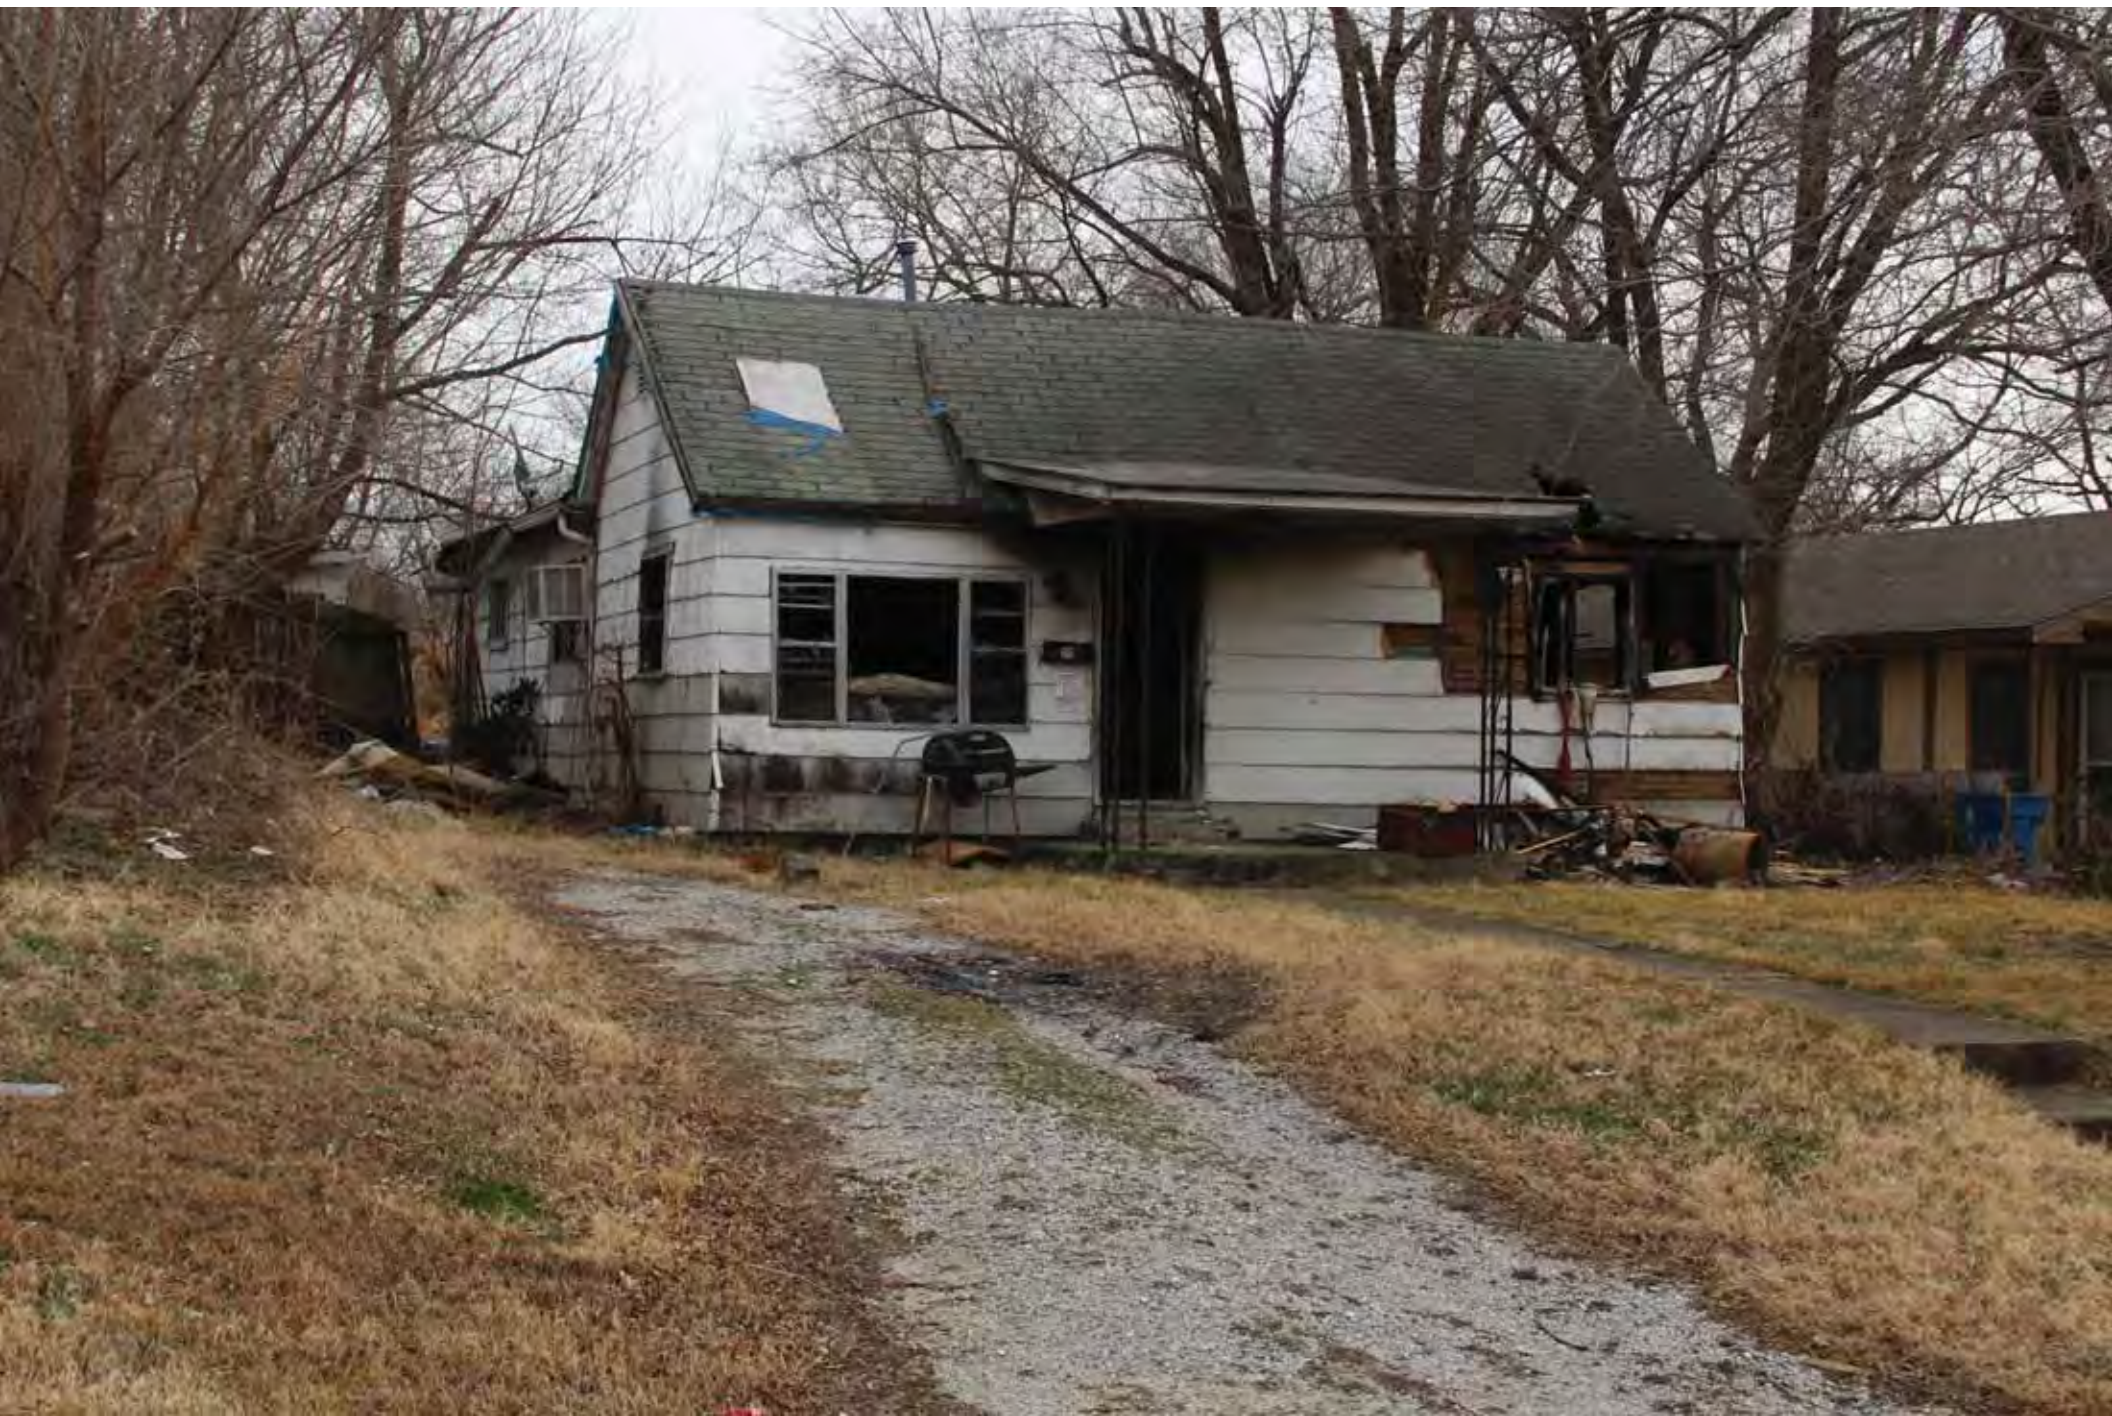
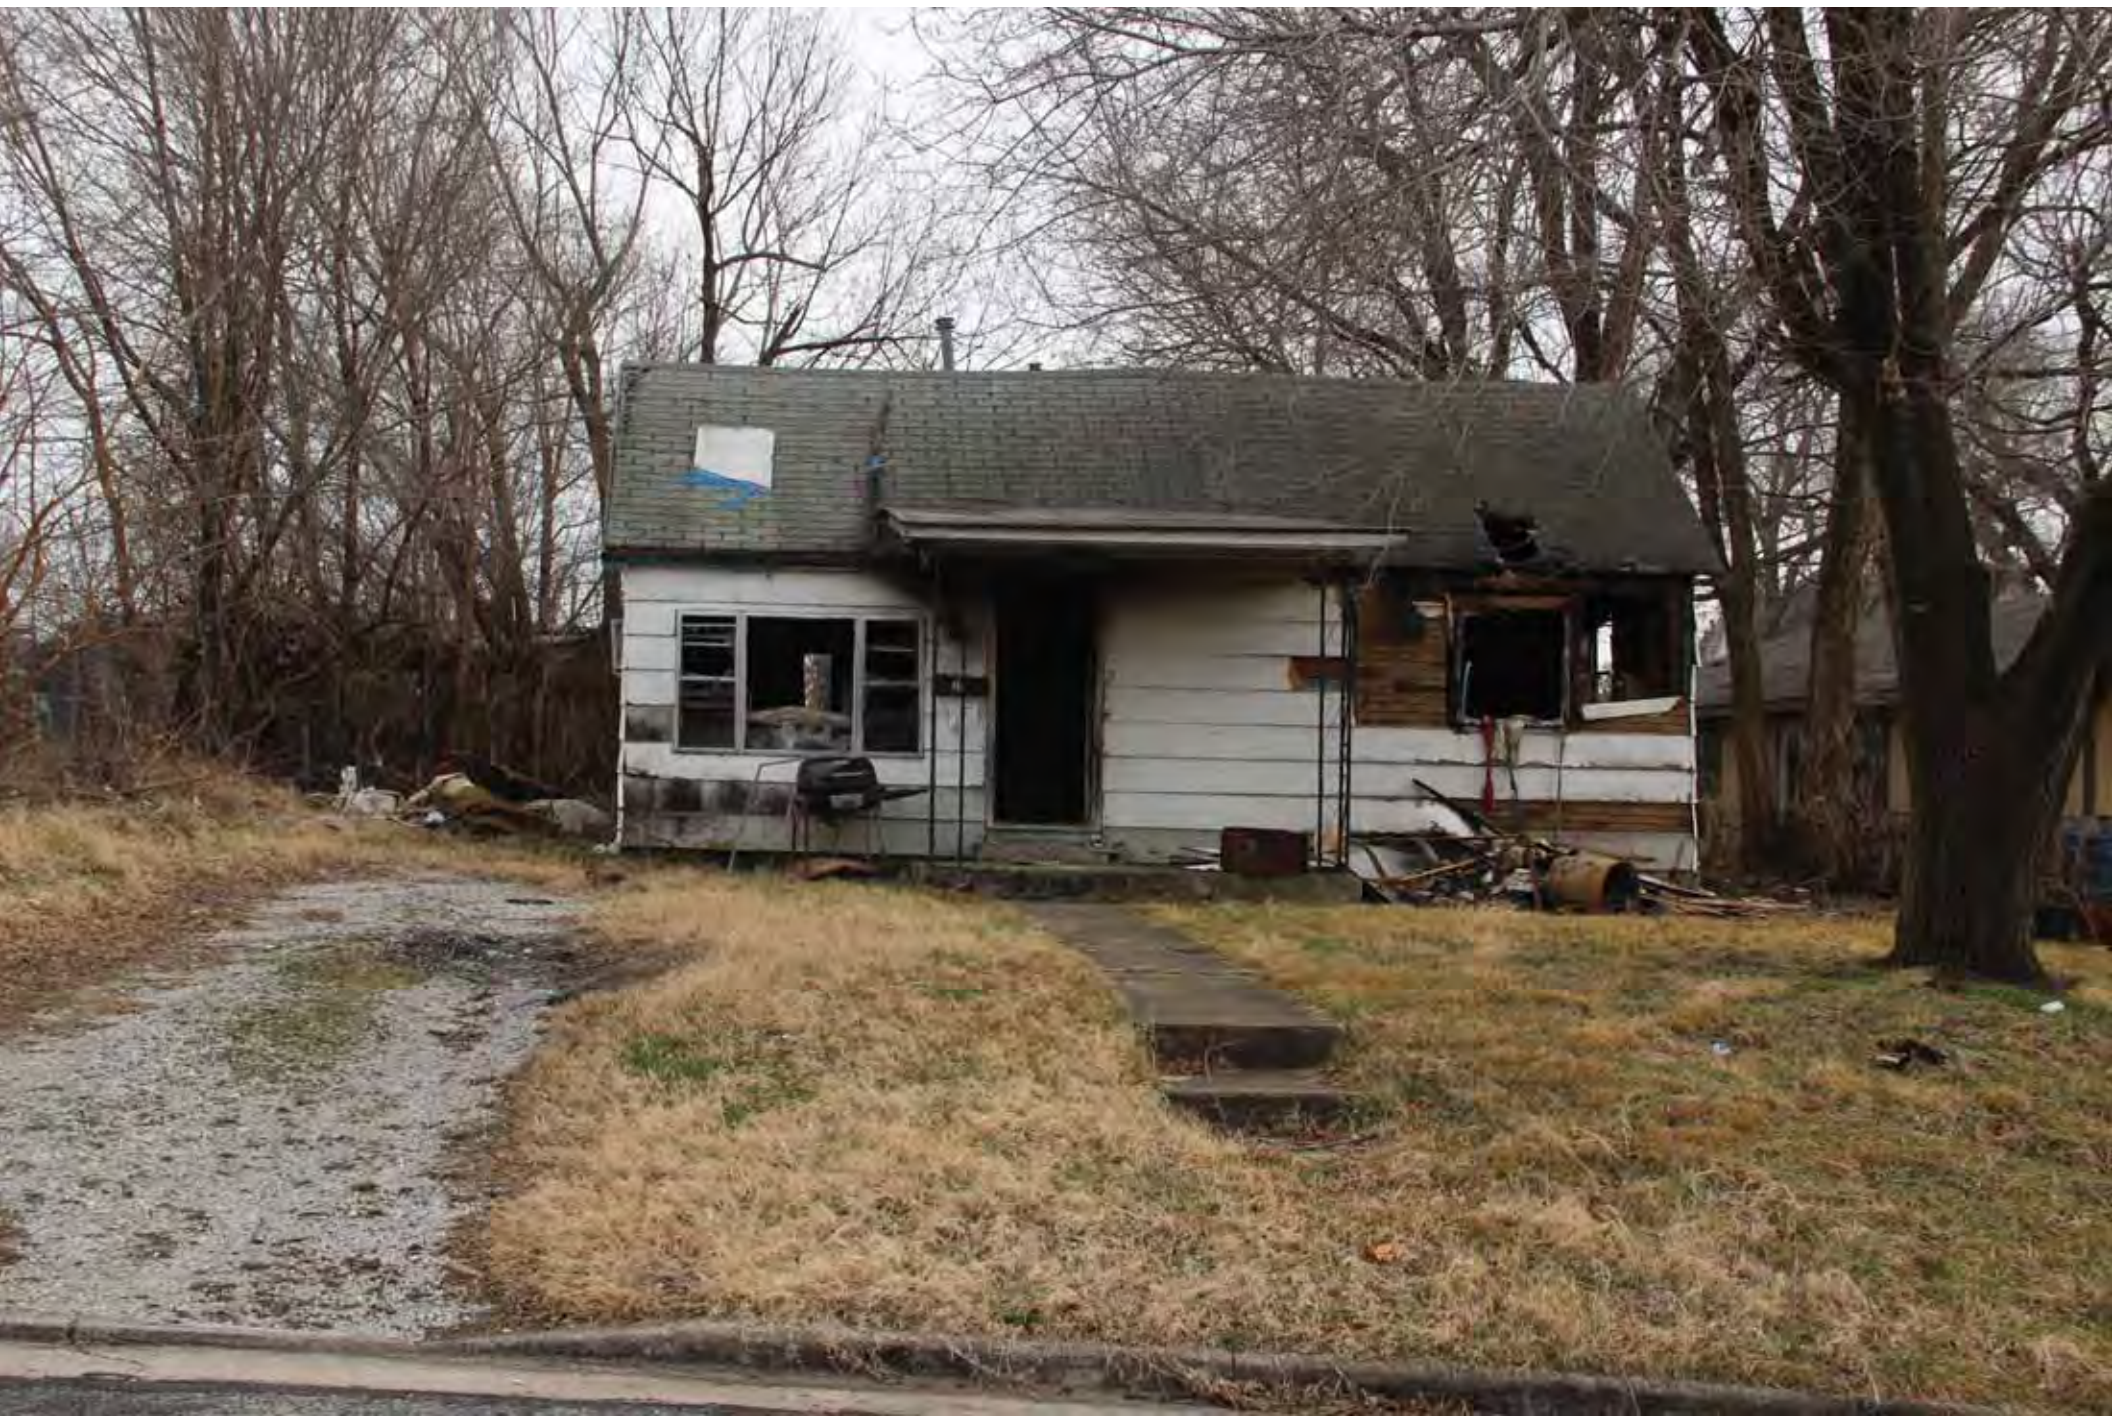
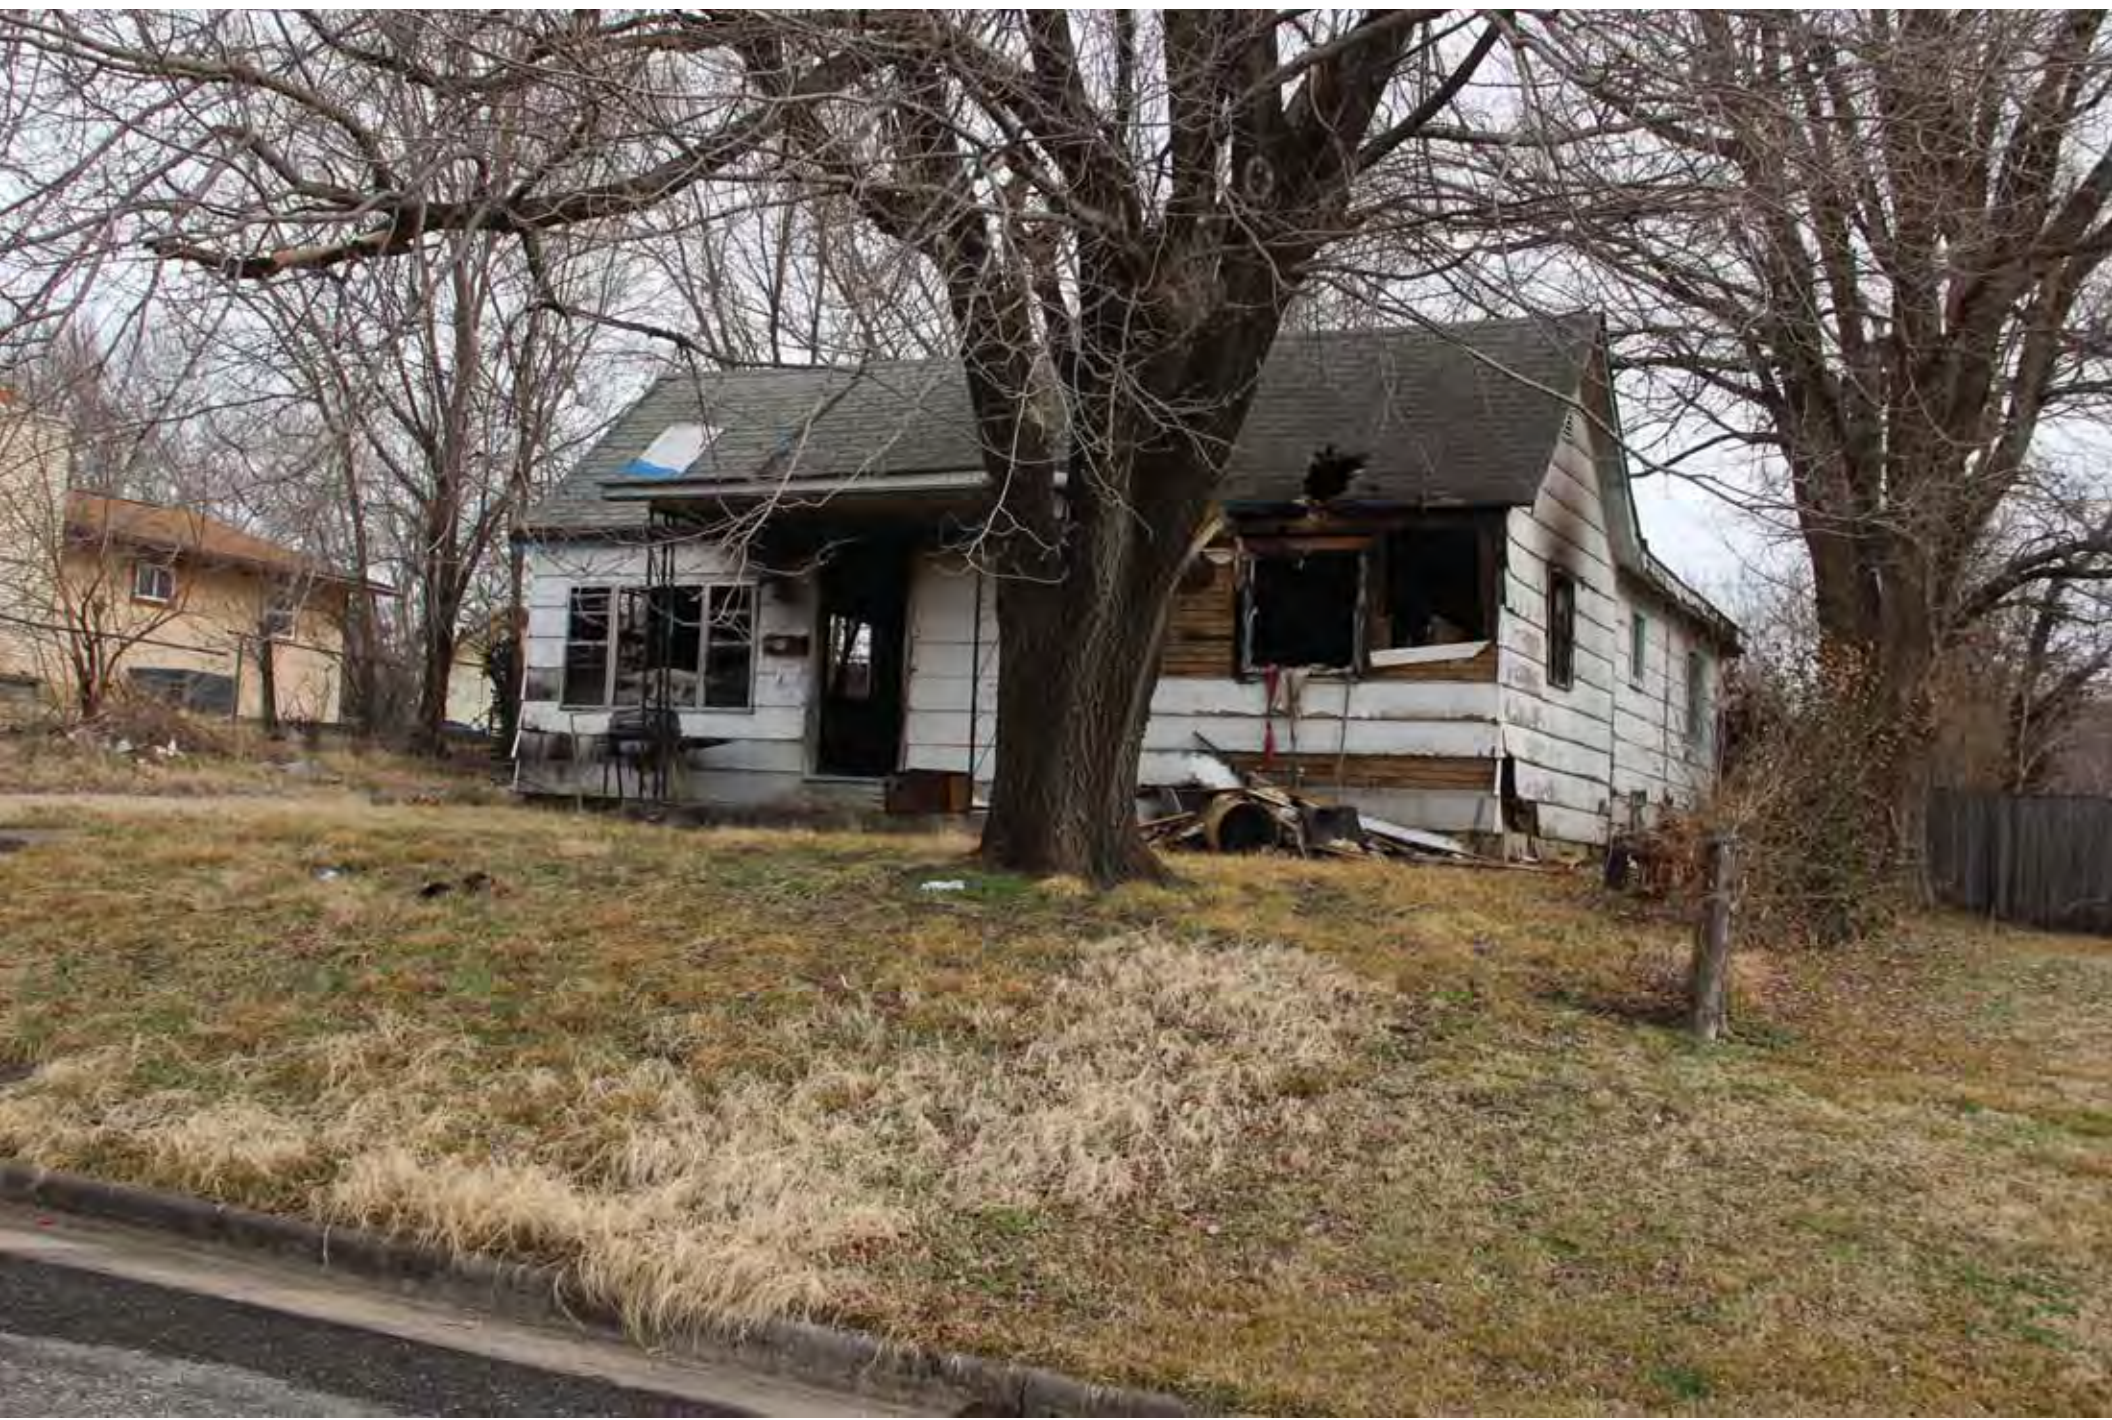
This dwelling has been extensively altered with the addition of metal siding and vinyl windows. It is vacant due to a recent fire. Due to the lack of exterior original siding, the dwelling does not retain integrity that would render it individually eligible for the National Register of Historic Places. The dwelling is not situated in an area recommended as a historic district.

The property 211 S. Galena Street features a one-story, National style dwelling with side-gabled roof. It has exterior metal siding and an asphalt-shingled roof consisting of a rectangular plan. The primary façade has a small frame shed roof porch addition, with metal supports on a concrete base. To the north of the front door is a large aluminum replacement window with sidelights. To the south of the entrance is one bay, with a single one-over-one replacement window.

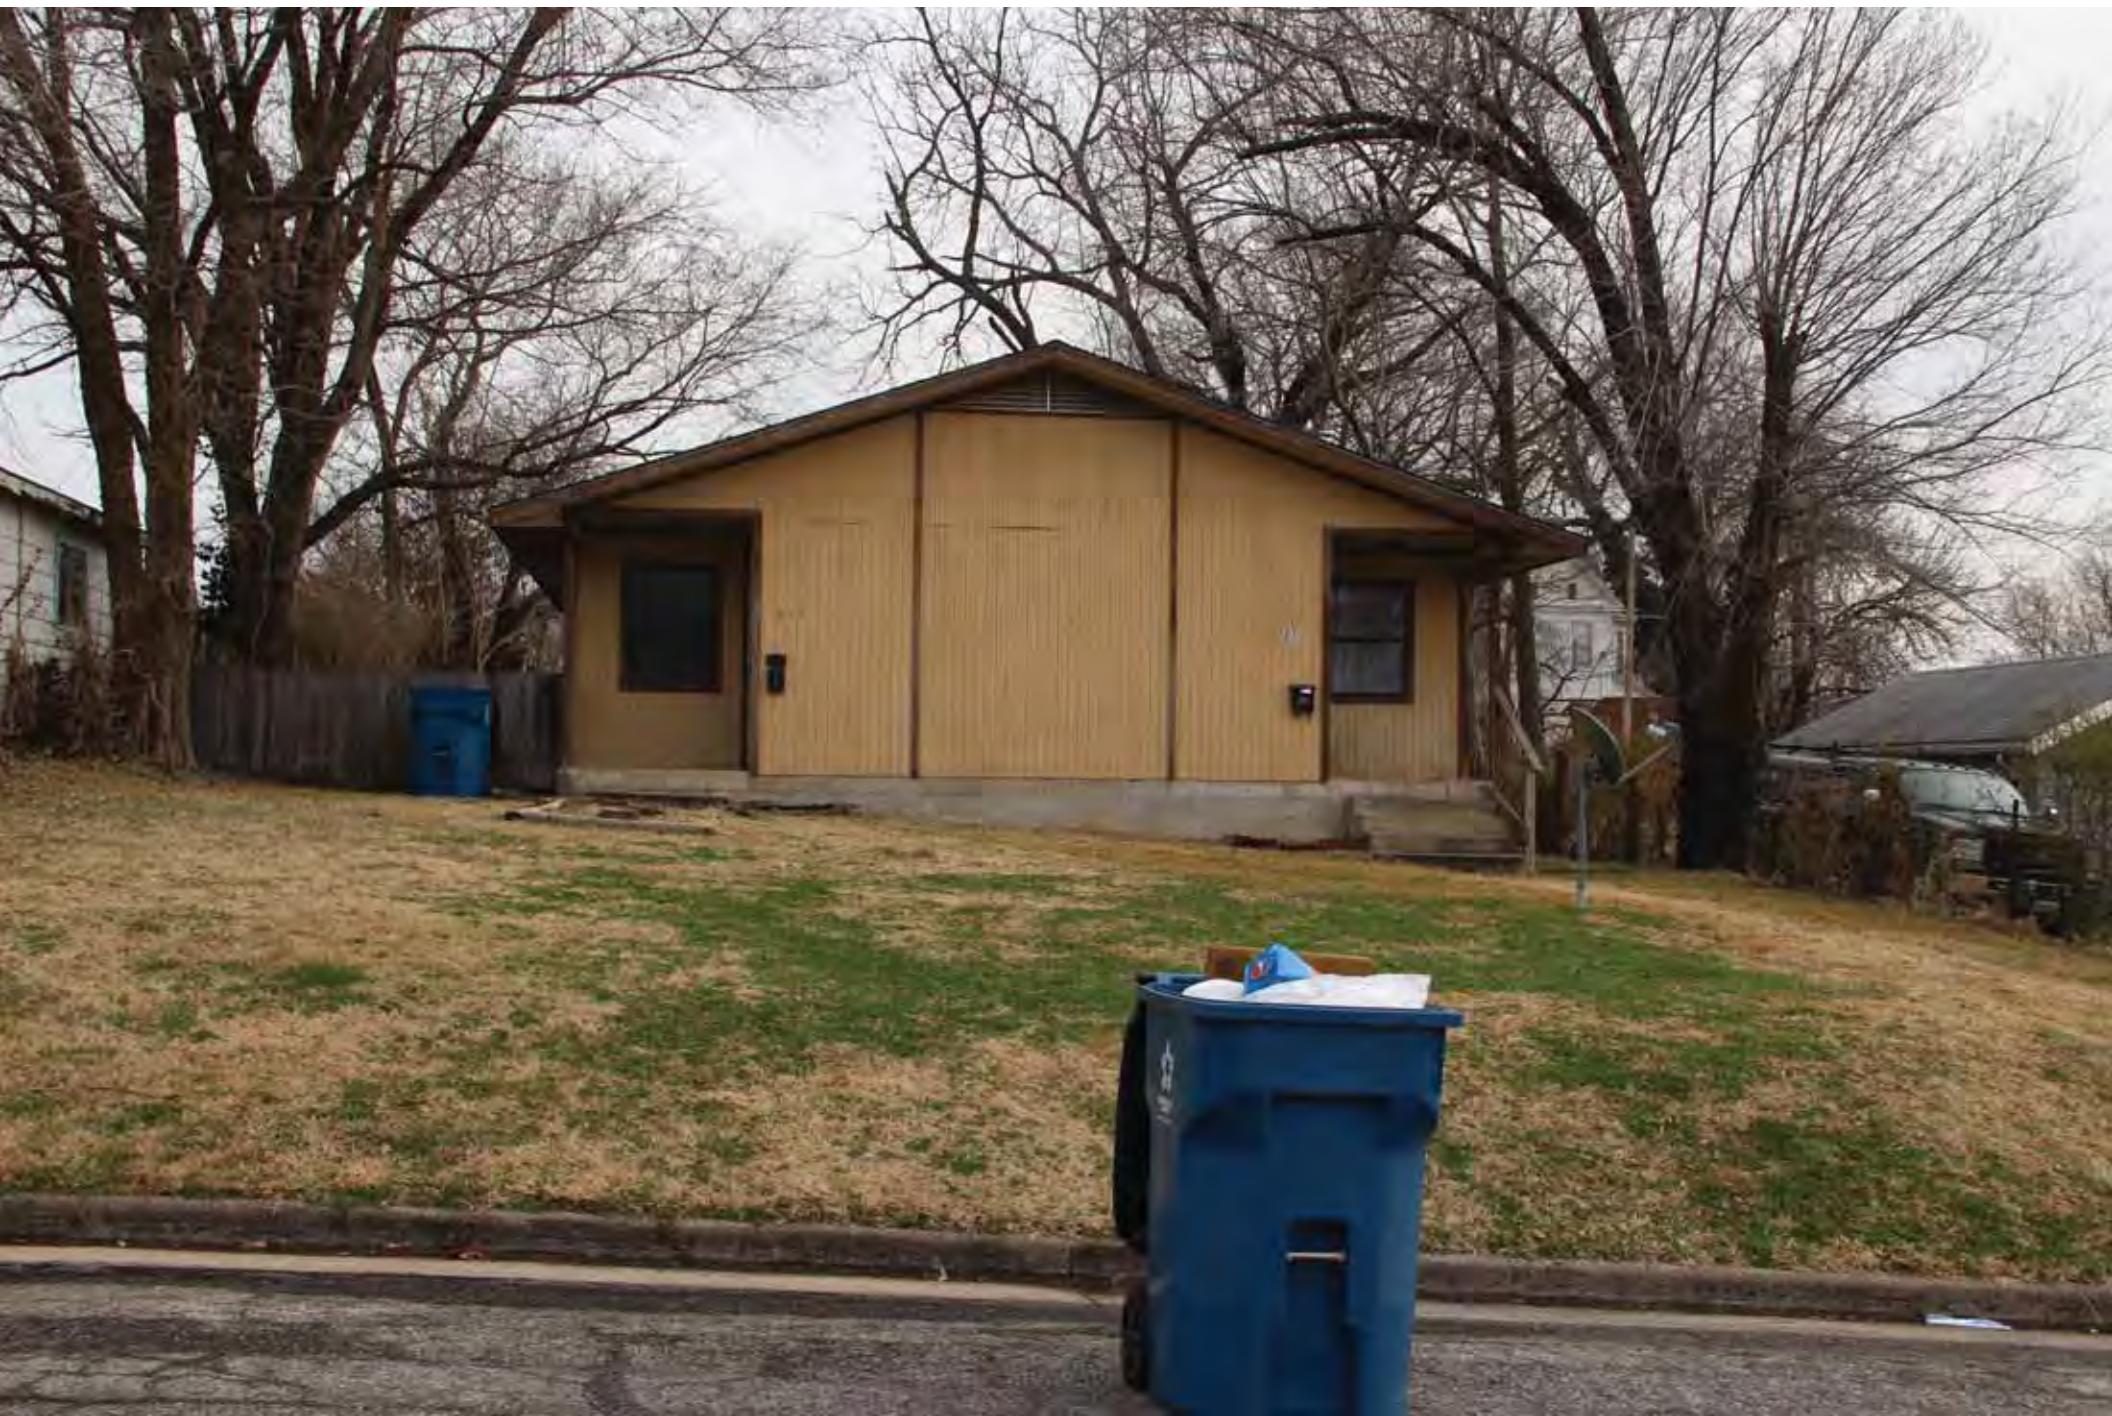
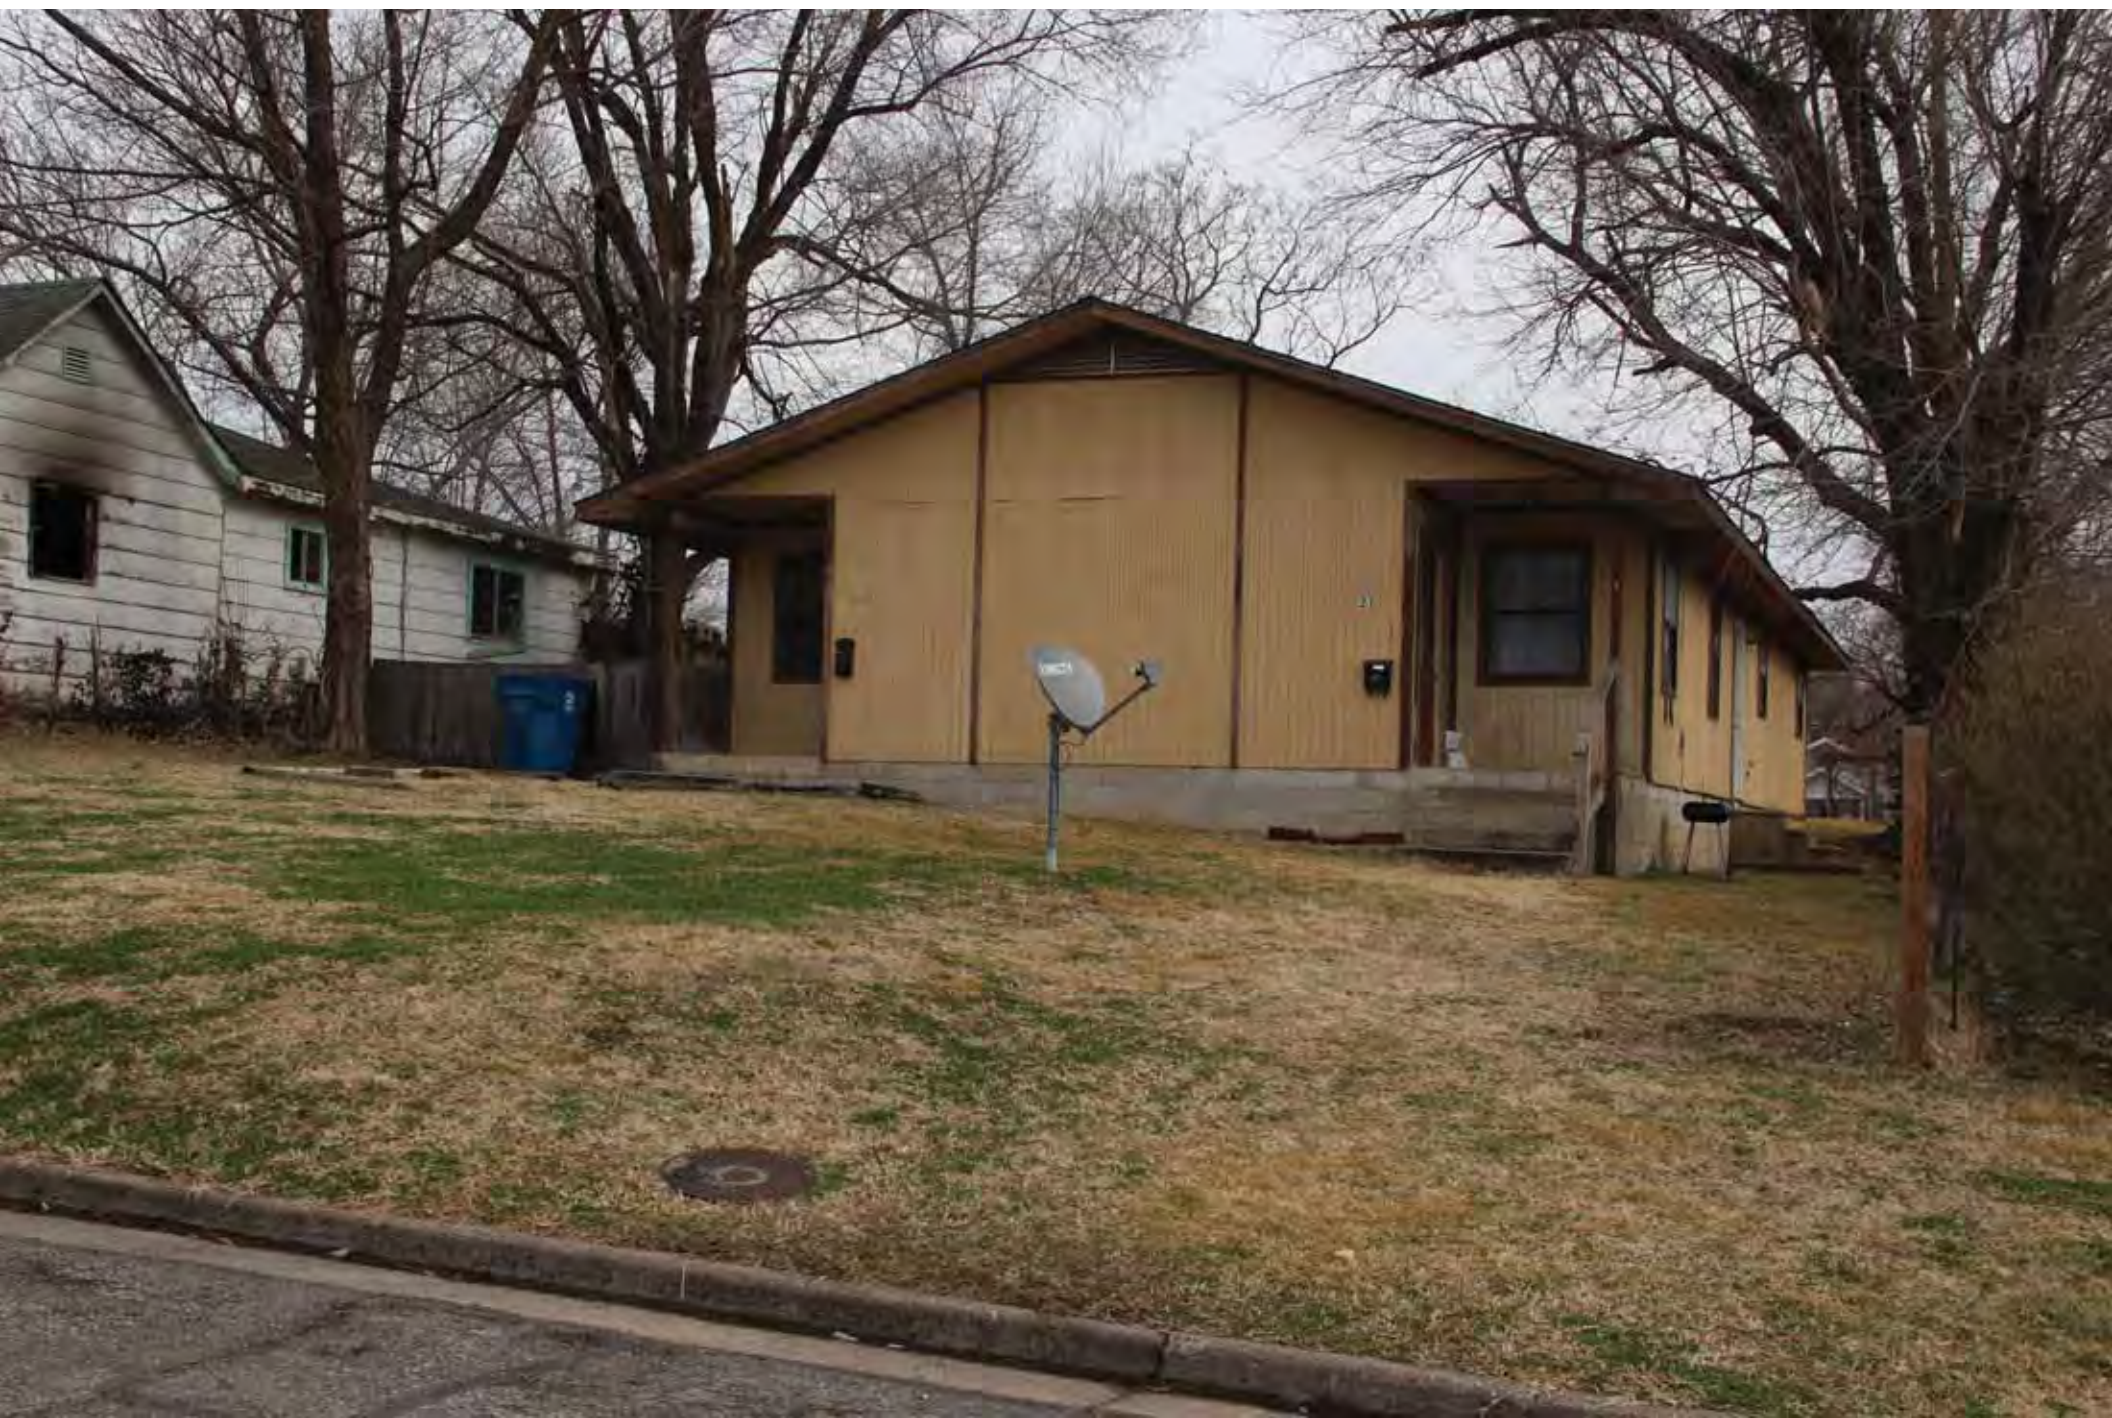
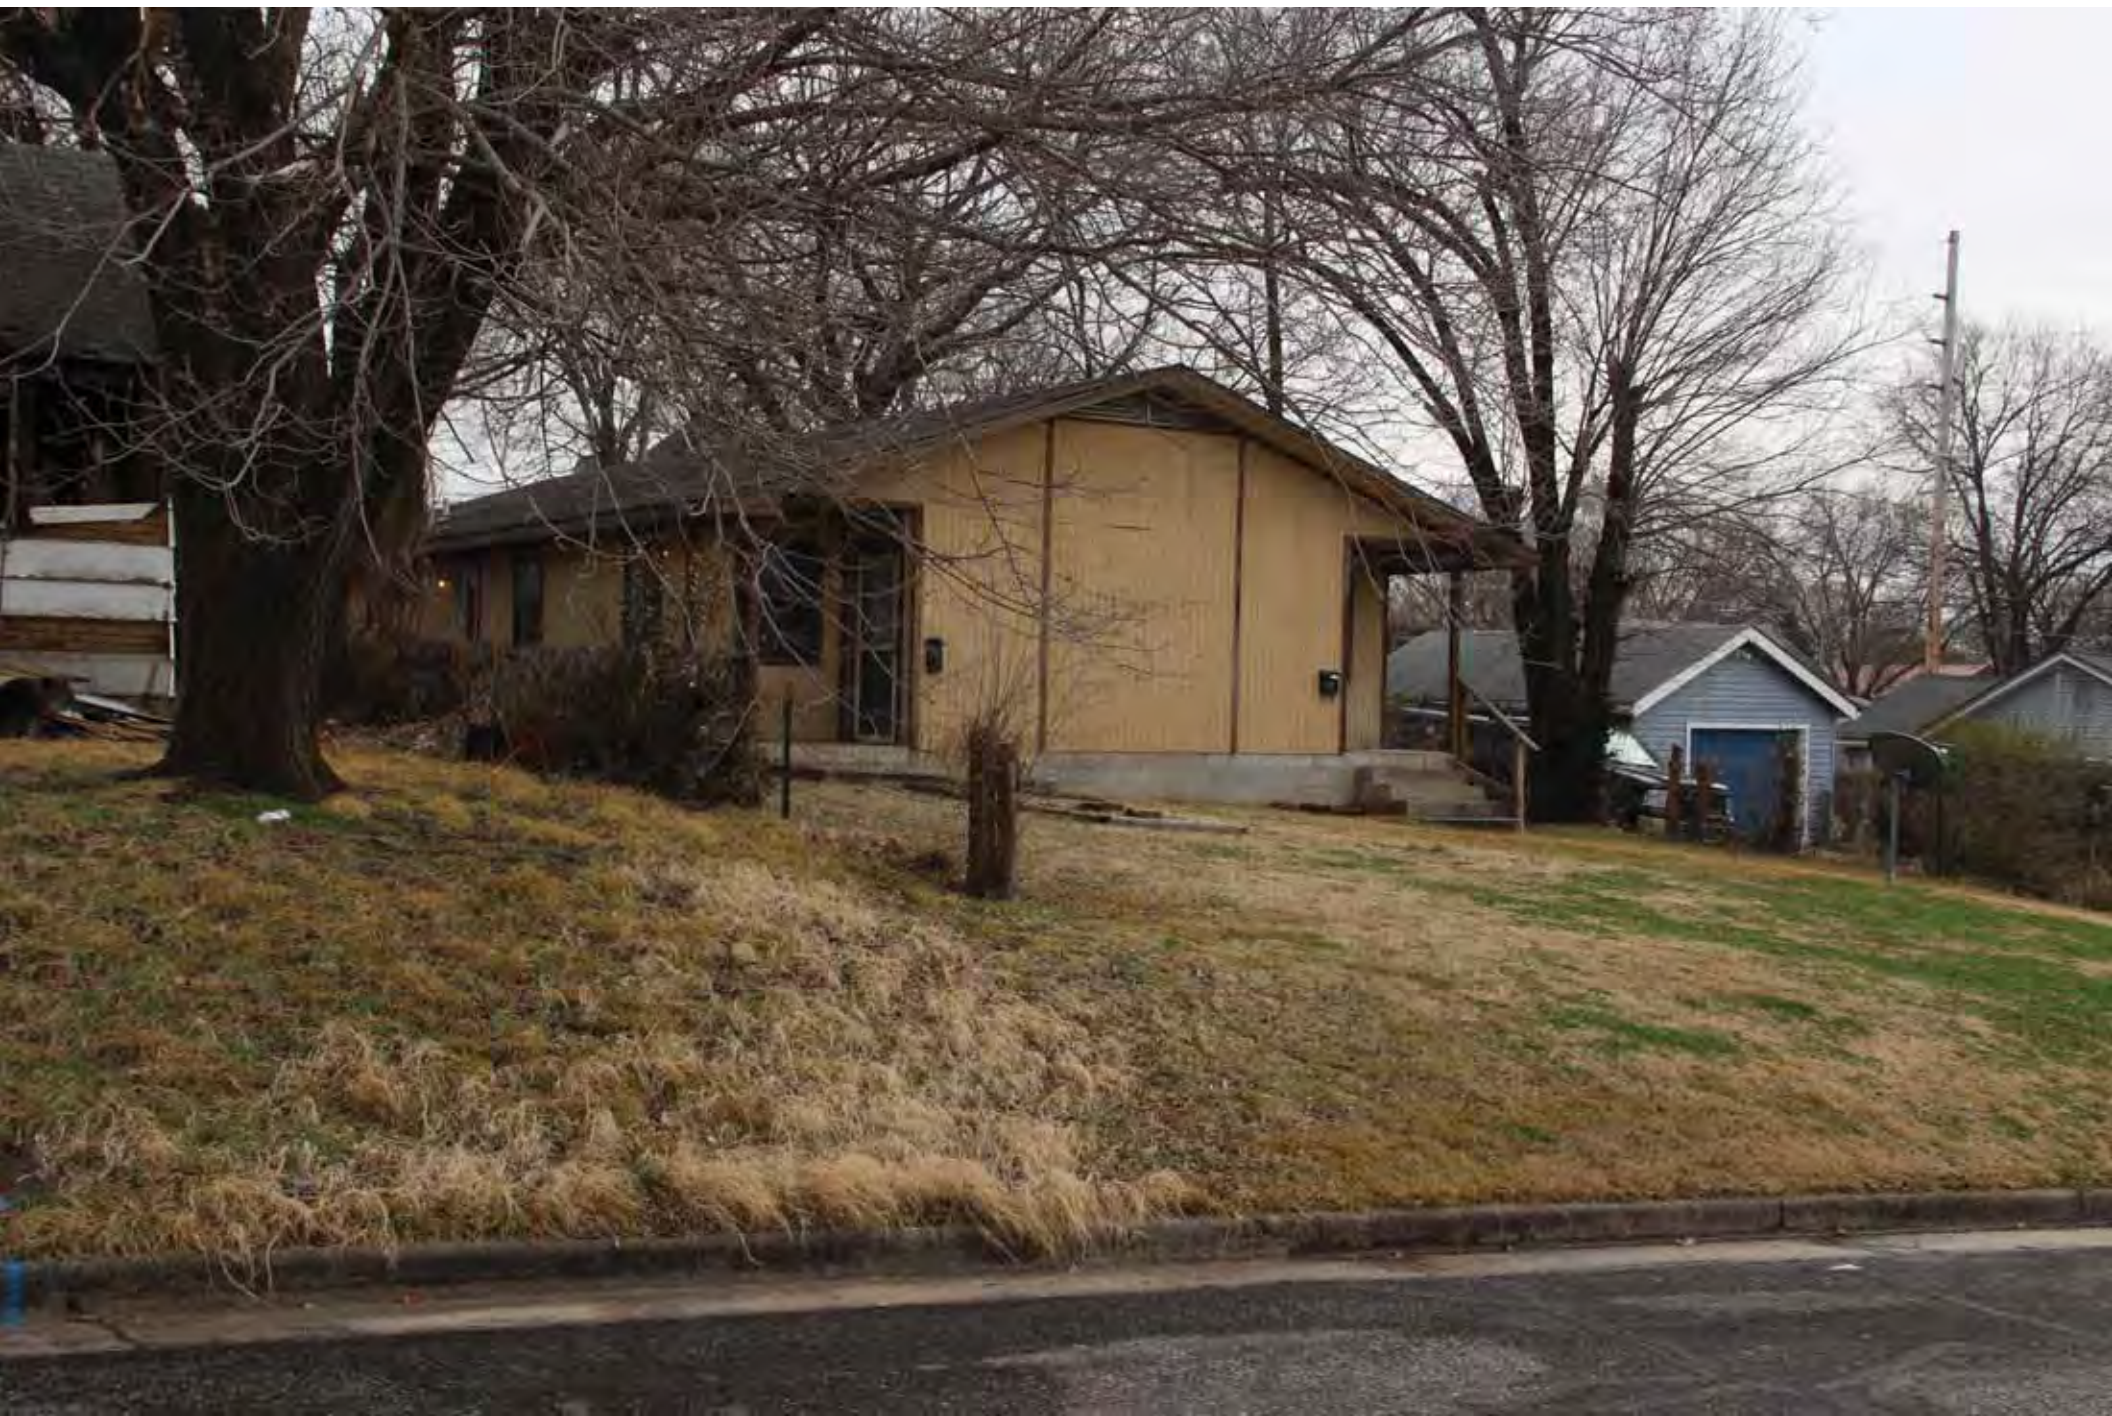
The property 215 S. Galena Street features a one-story, National style duplex with a front-facing gable roof. It has exterior wood siding and an asphalt-shingled roof consisting of a rectangular plan. The two separate entrances are recessed, located at the corners of the building along the front façade. At each entrance, facing the street, are single one-over-one windows. Along each side of the dwelling are four single one-over-one windows.
