MISSOURI DEPARTMENT OF NATURAL RESOURCES
STATE HISTORIC PRESERVATION OFFICE, P.O. Box 176, Jefferson City, MO 65102
ARCHITECTURAL/HISTORIC INVENTORY FORM

1. Survey No. JP-AS-007-001		2. Survey name: East Town (Original Joplin) Historic Survey Phase 2	
3. County: JASPER		4. Address (Street No.) 618	Street (name) E. 2 nd Street
5. City: Joplin	Vicinity: <input type="checkbox"/>	6. Geographical Reference:	7. Township/Range/Section: T: R: S:
8. Historic name (if known):		9. Present/other name (if known):	
10. Ownership: <input checked="" type="checkbox"/> Private <input type="checkbox"/> Public		11a. Historic use (if known): Domestic: Single Dwelling	11b. Current use: Domestic: Single Dwelling

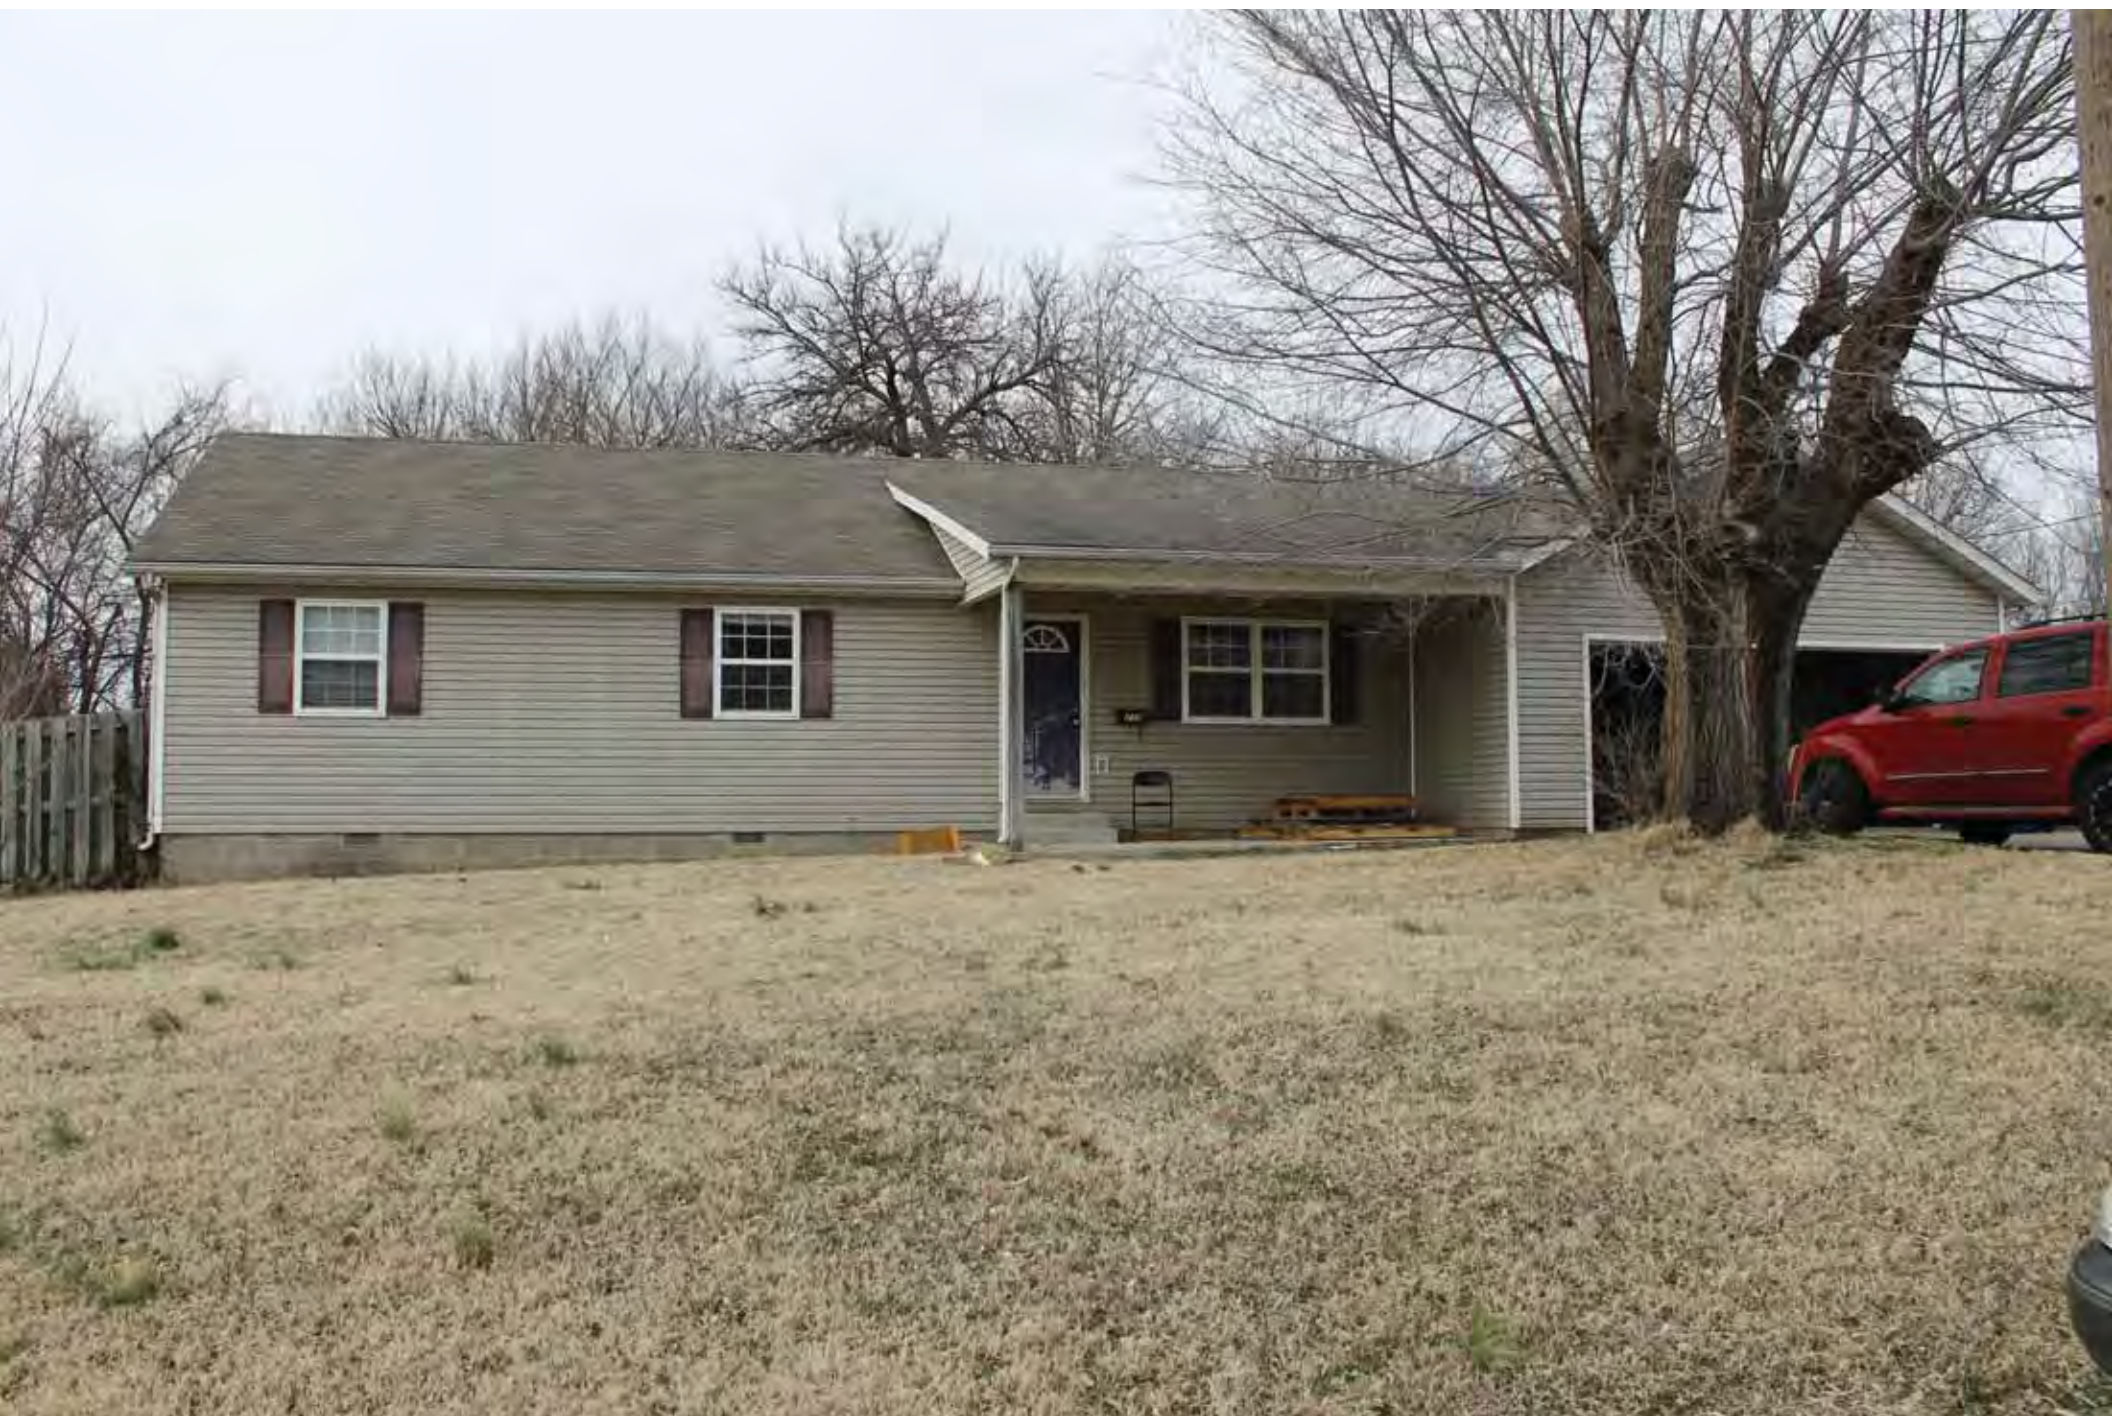
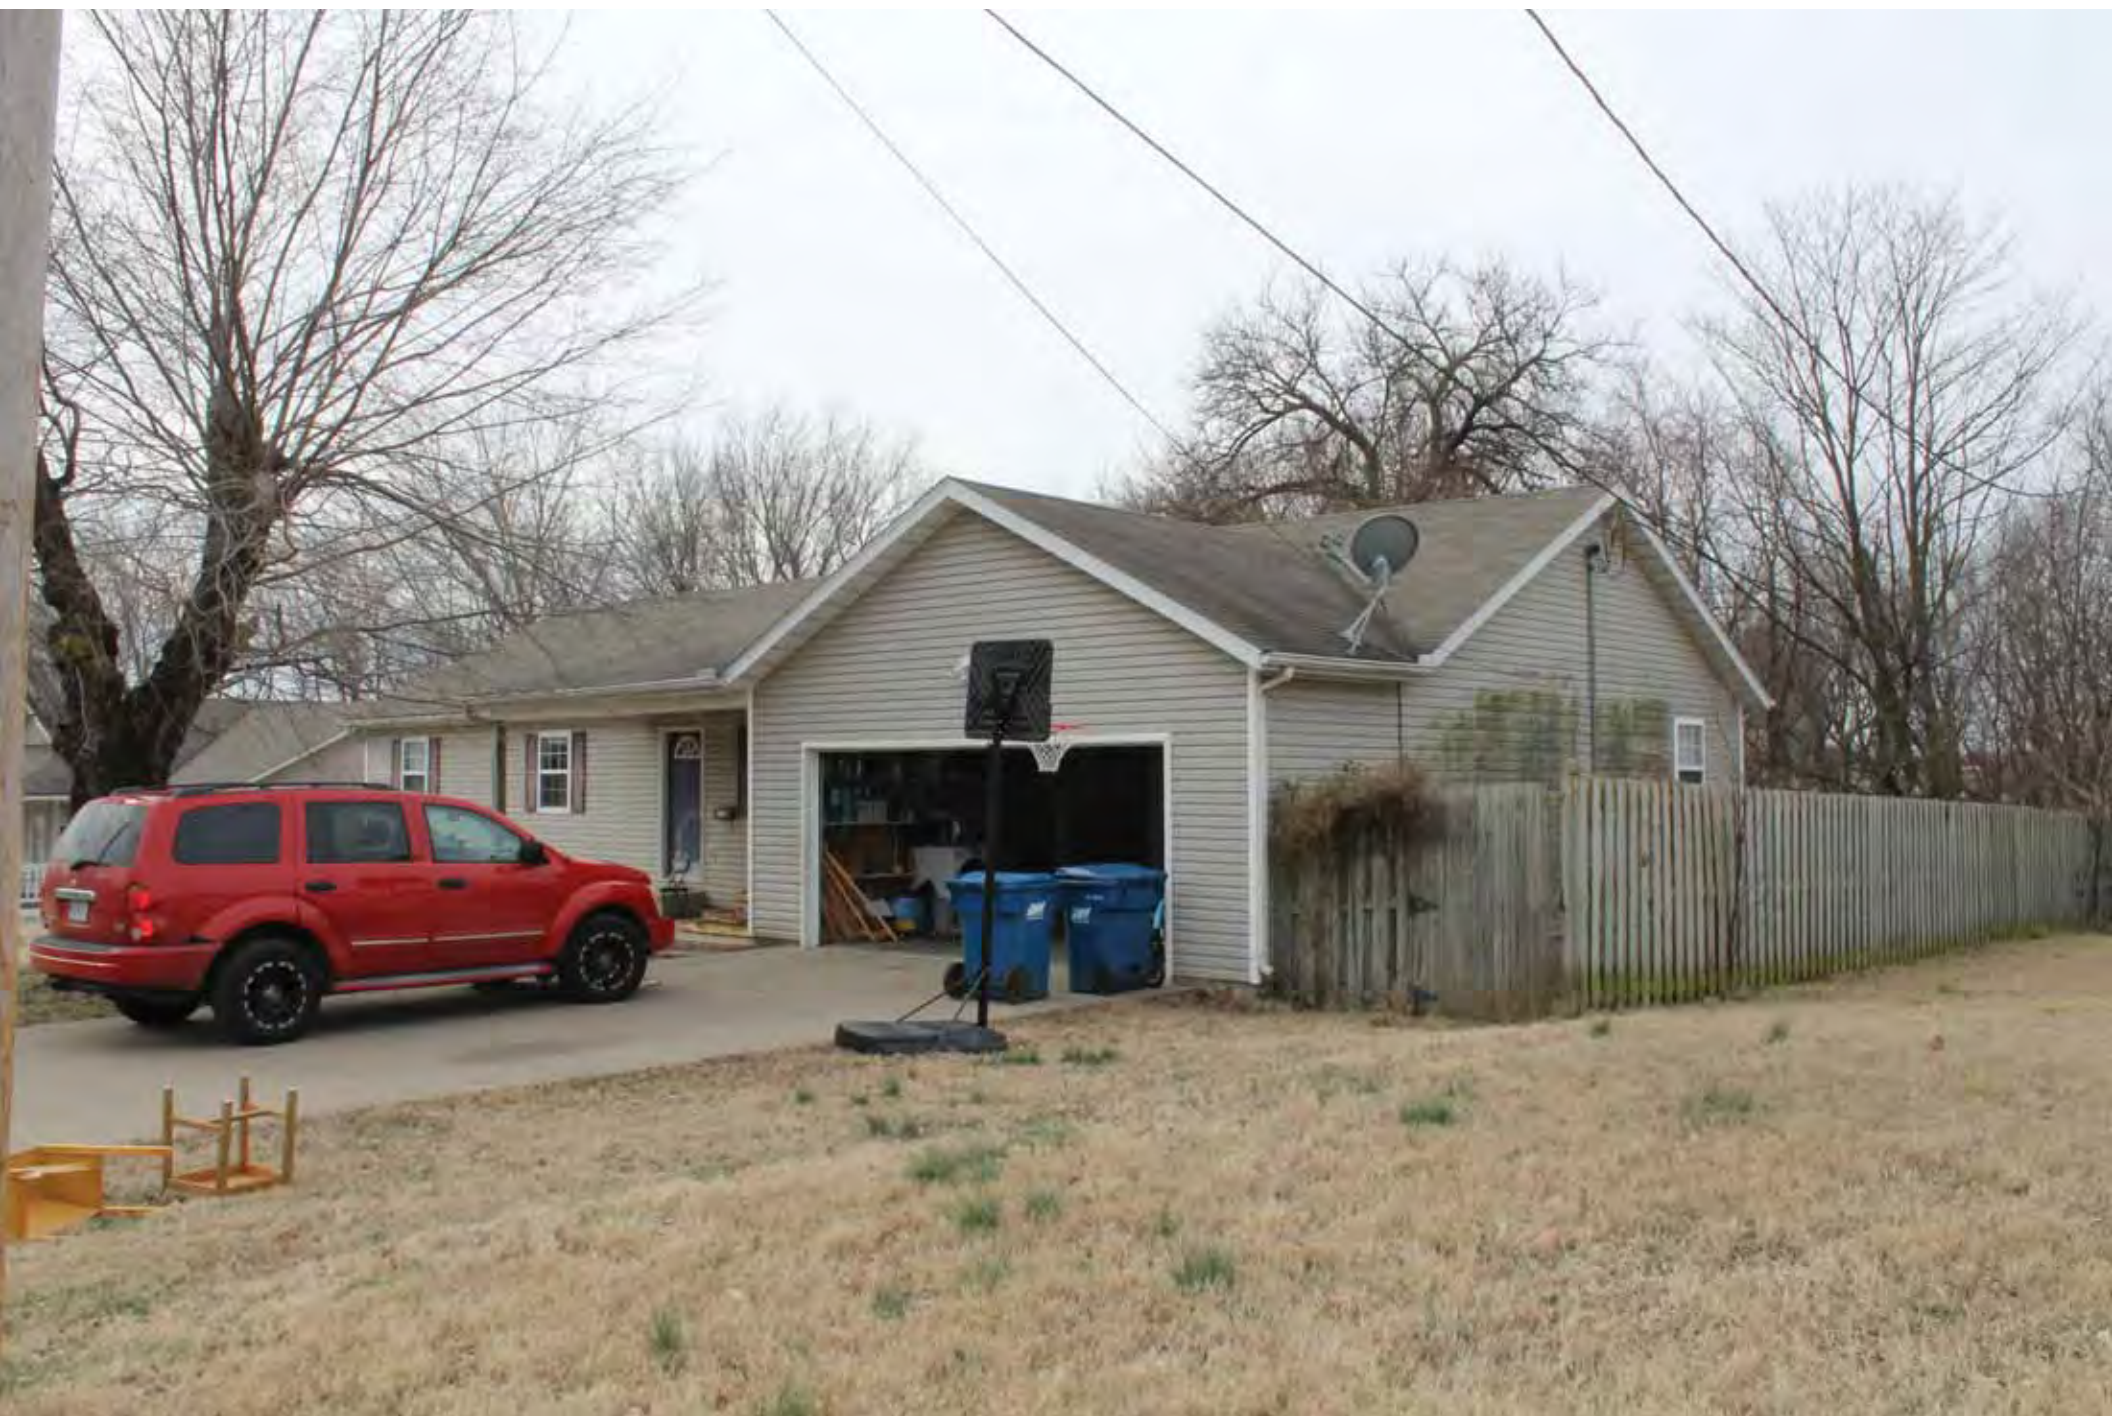
The property 220 S. Galena Street features a one-story, frame ranch house with a side gable roof. It has exterior vinyl siding and an asphalt-shingled roof consisting of a rectangular plan. The entrance is located in the middle of the front façade, beneath a shed-roofed porch. On the front façade are four one-over-one vinyl windows. To the right of the front porch is an attached two car garage, with a metal garage door.

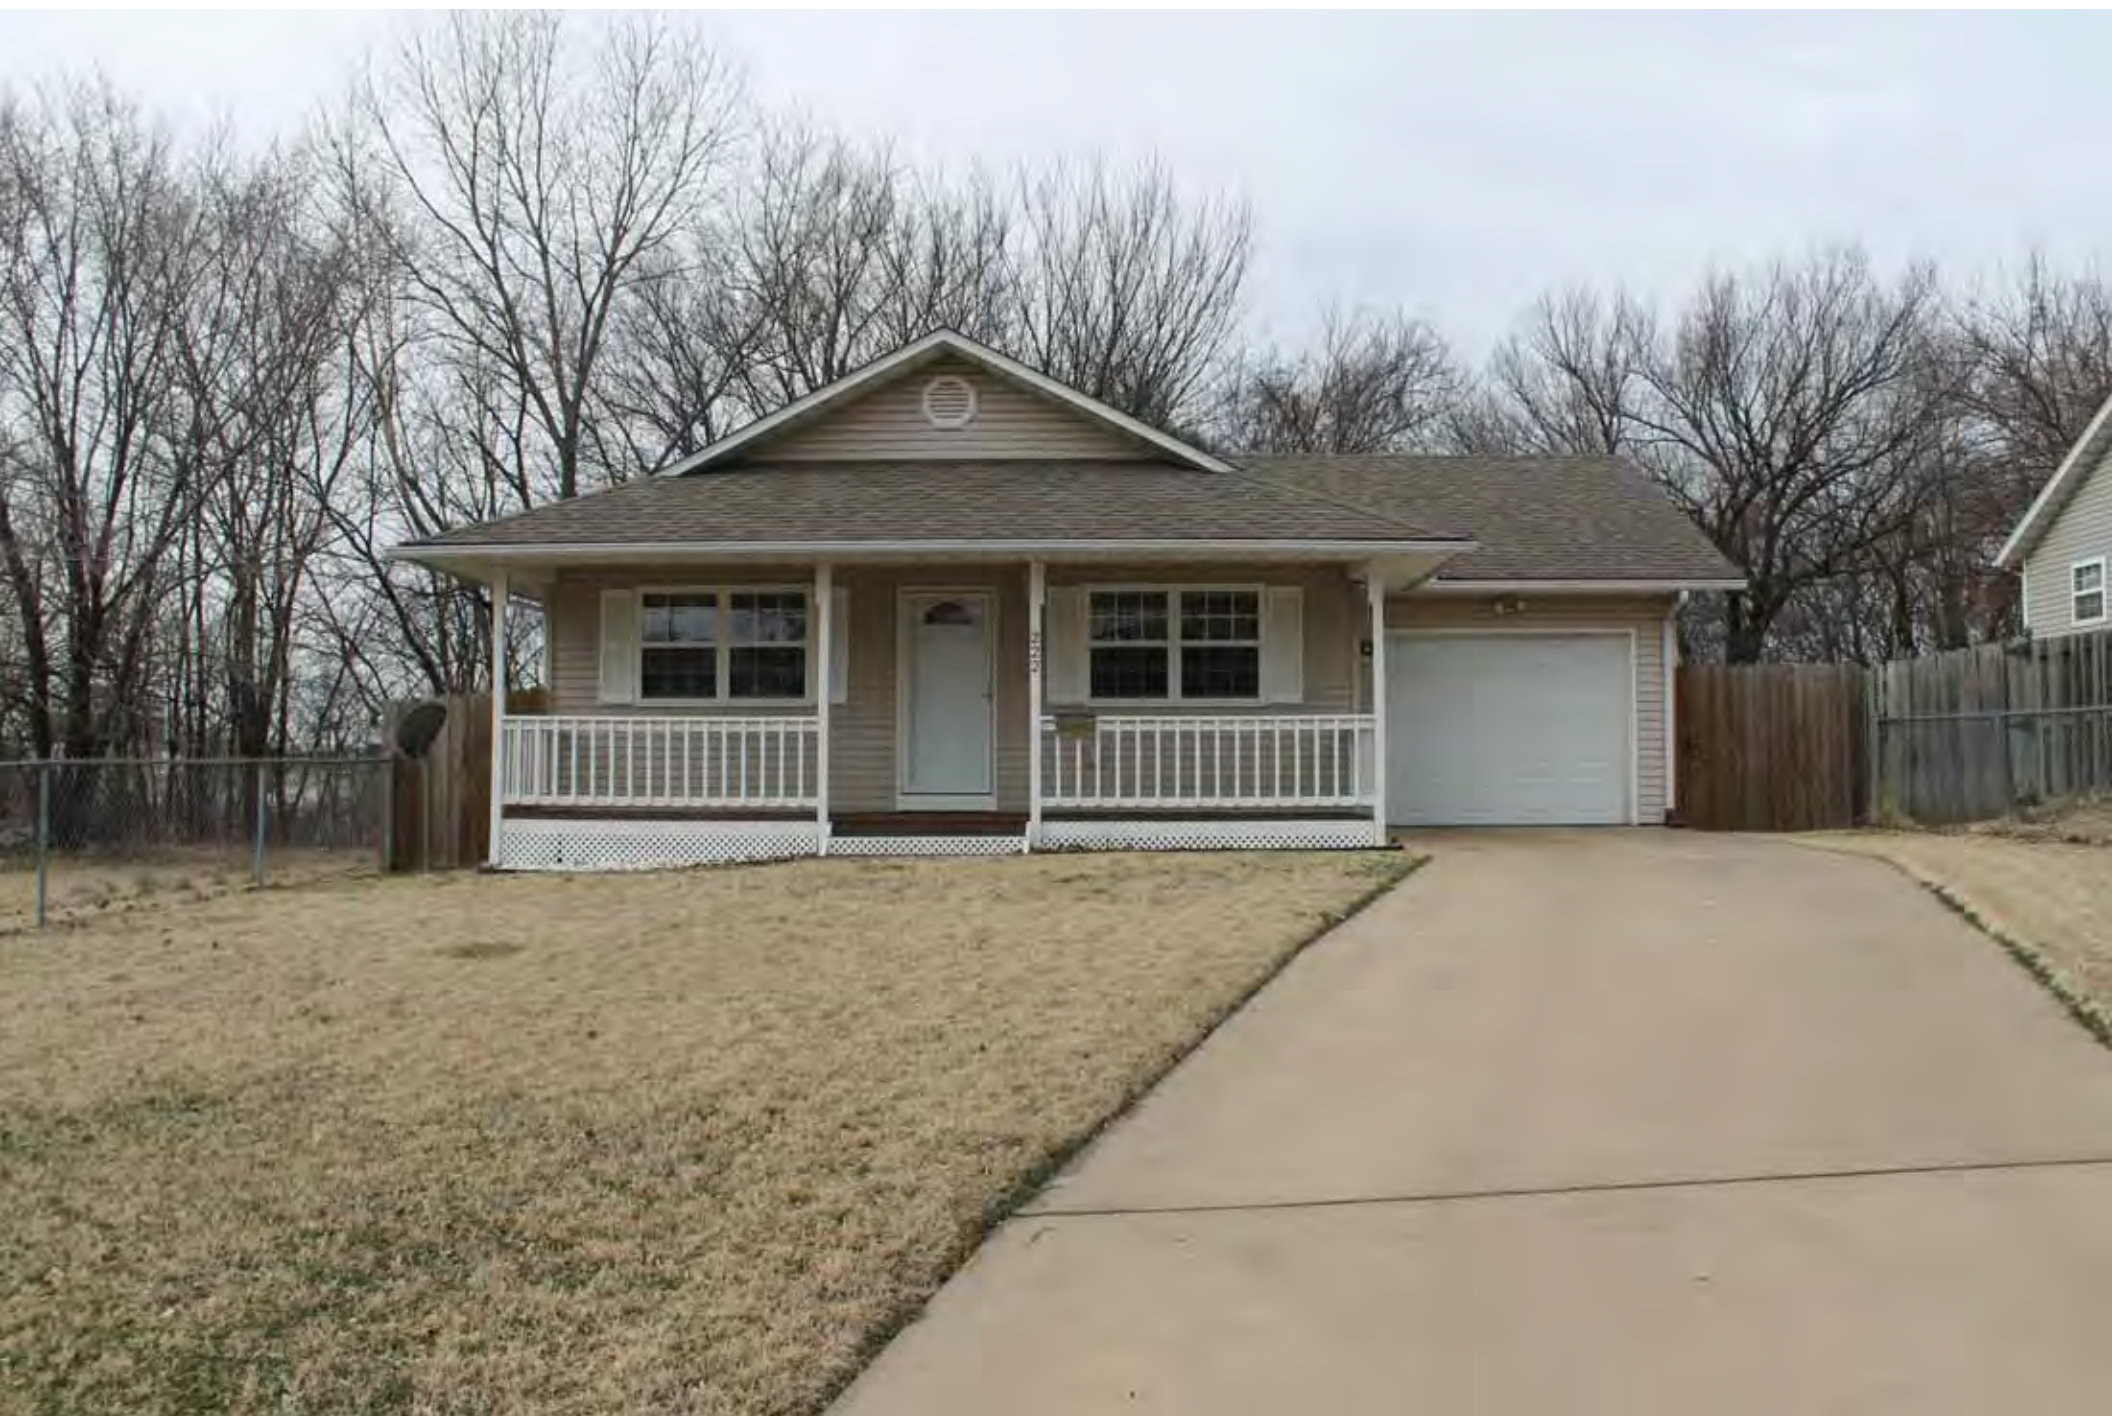
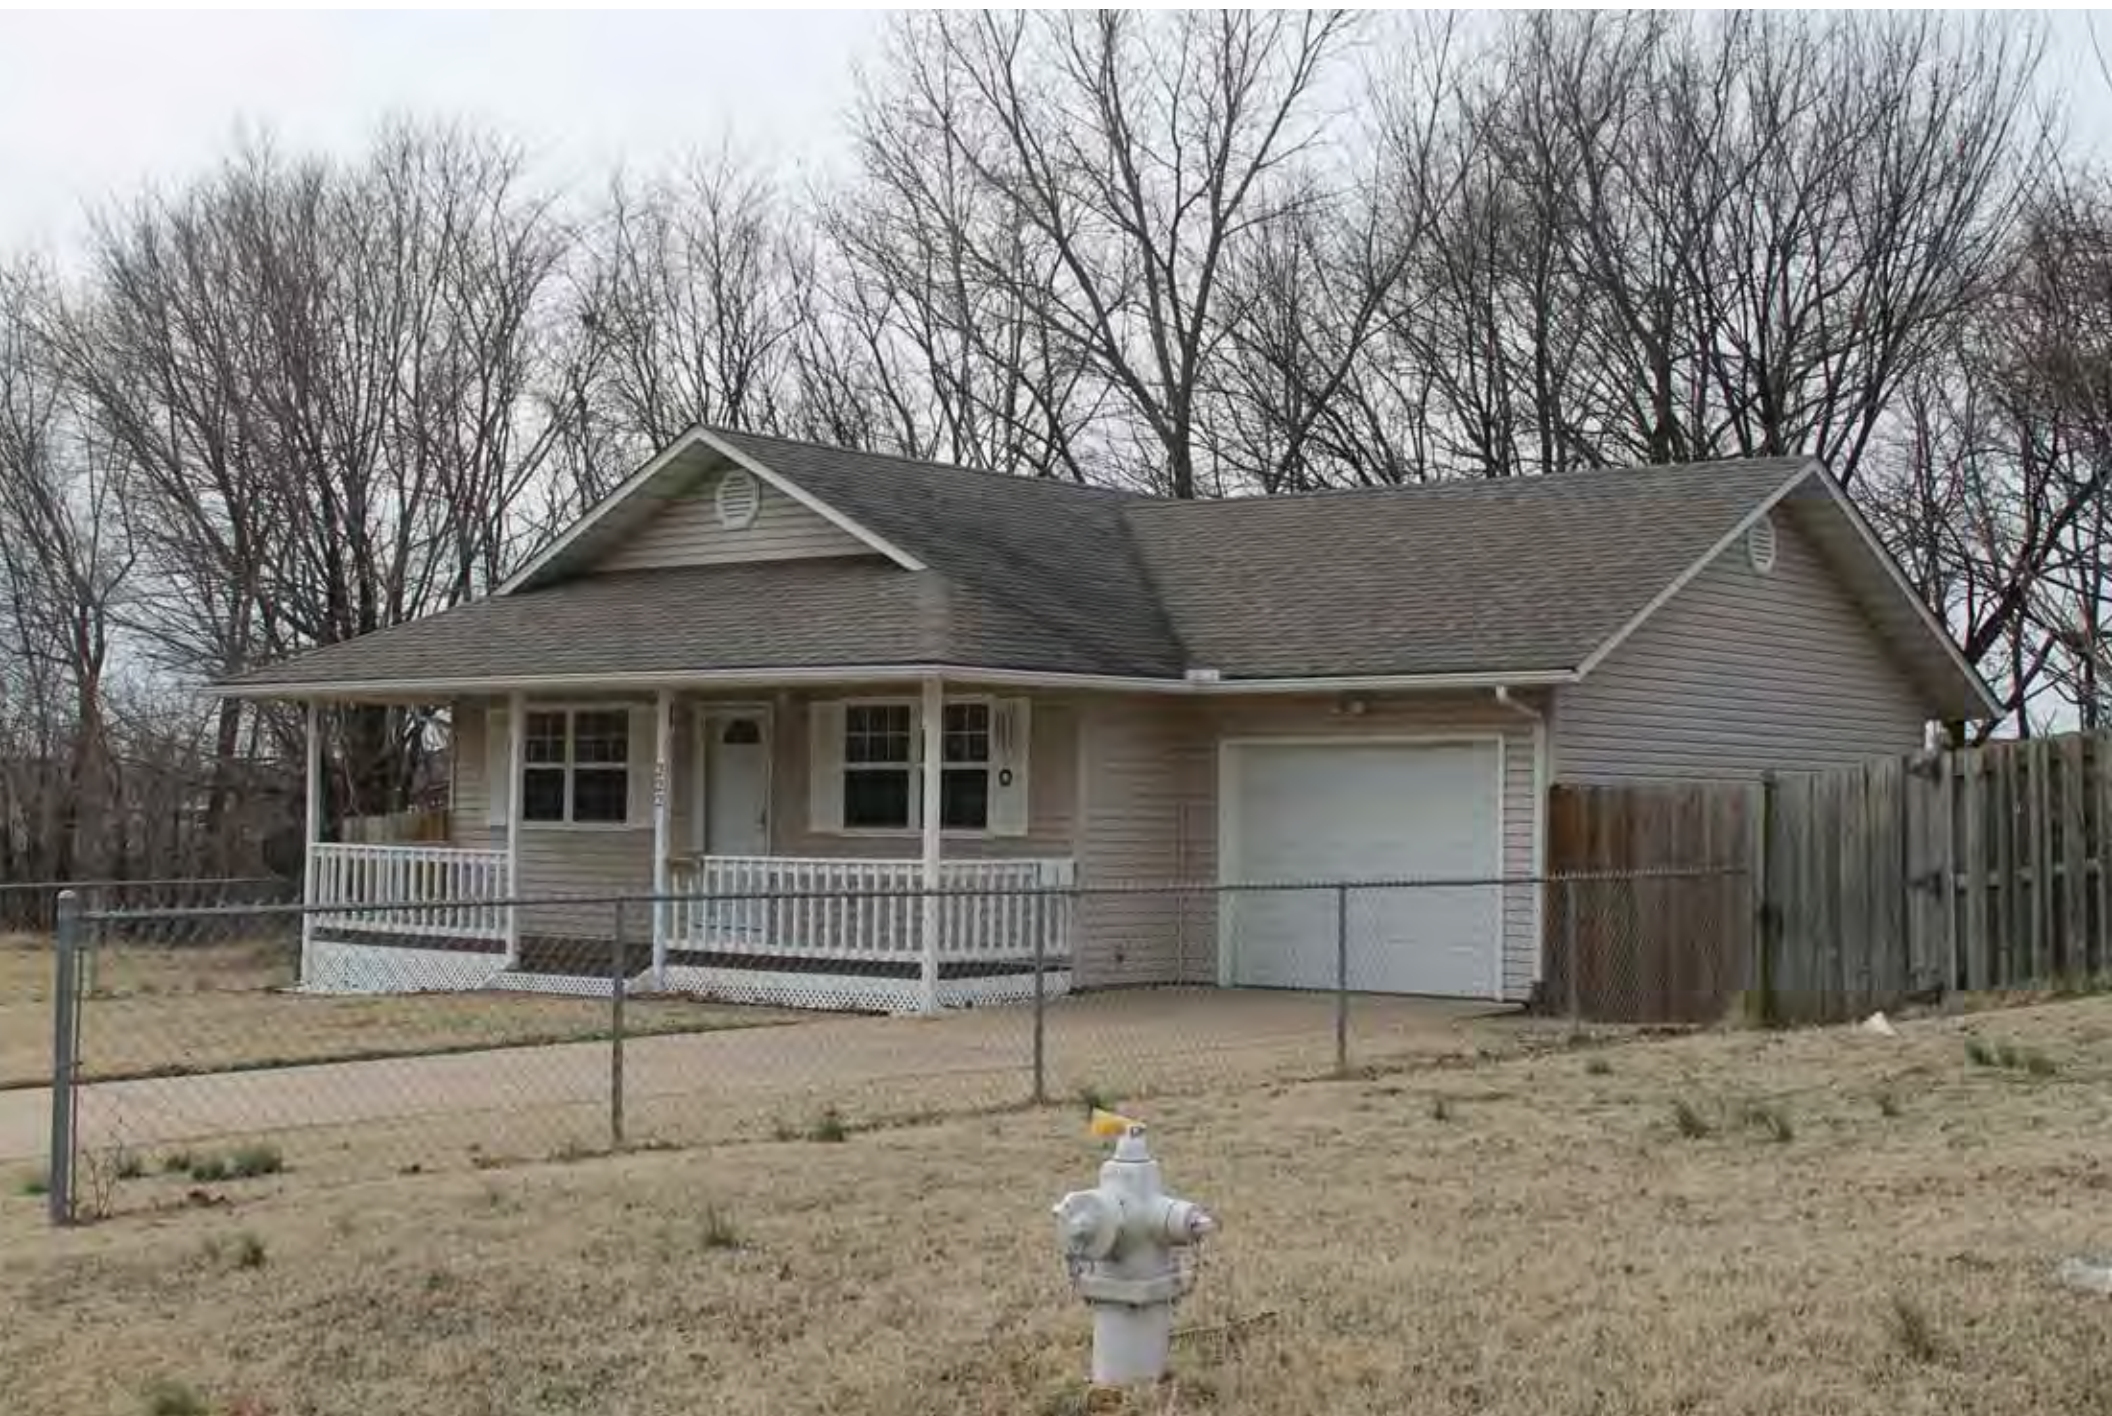
The property 222 S. Galena Street features a one-story, frame house with a gable hip roof. It has exterior vinyl siding and an asphalt-shingled roof. The entrance is located in the middle of the front façade, beneath a veranda that extends the length of the front façade and has simple turned wood supports and a banister. Flanking the front door on either side are single one-over-one vinyl windows with metal non-functioning shutters. On the north side of the building is an attached one-car garage, with a metal garage door.
