MISSOURI DEPARTMENT OF NATURAL RESOURCES
STATE HISTORIC PRESERVATION OFFICE, P.O. Box 176, Jefferson City, MO 65102
ARCHITECTURAL/HISTORIC INVENTORY FORM

1. Survey No. JP-AS-007-001		2. Survey name: East Town (Original Joplin) Historic Survey Phase 2	
3. County: JASPER		4. Address (Street No.) 618	Street (name) E. 2 nd Street
5. City: Joplin	Vicinity: <input type="checkbox"/>	6. Geographical Reference:	7. Township/Range/Section: T: R: S:
8. Historic name (if known):		9. Present/other name (if known):	
10. Ownership: <input checked="" type="checkbox"/> Private <input type="checkbox"/> Public		11a. Historic use (if known): Domestic: Single Dwelling	11b. Current use: Domestic: Single Dwelling

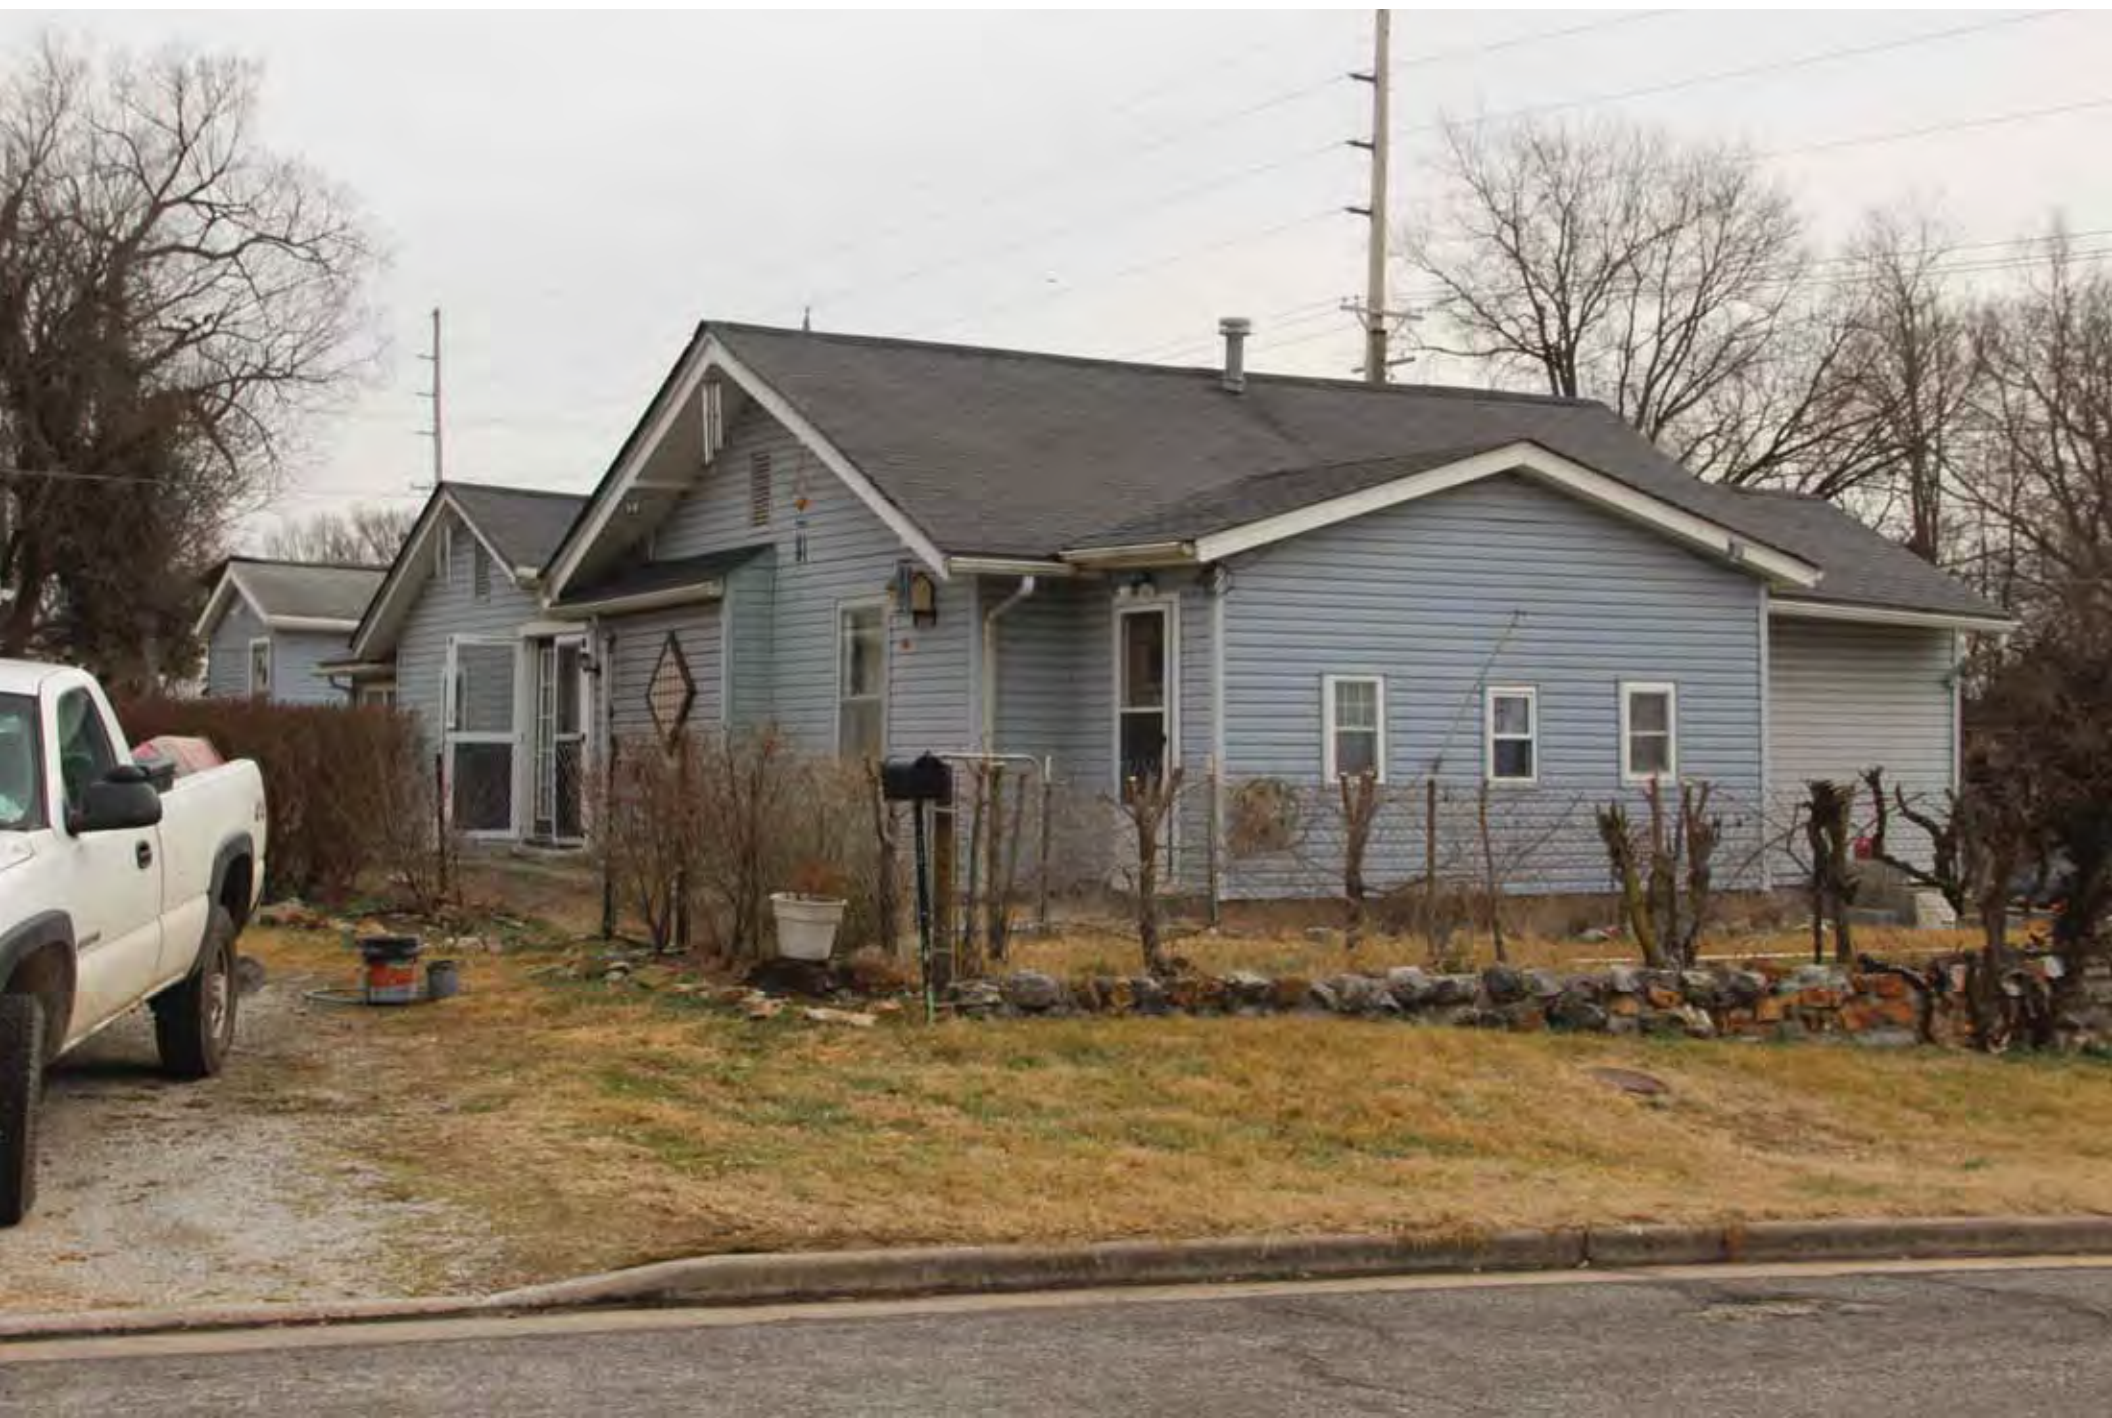
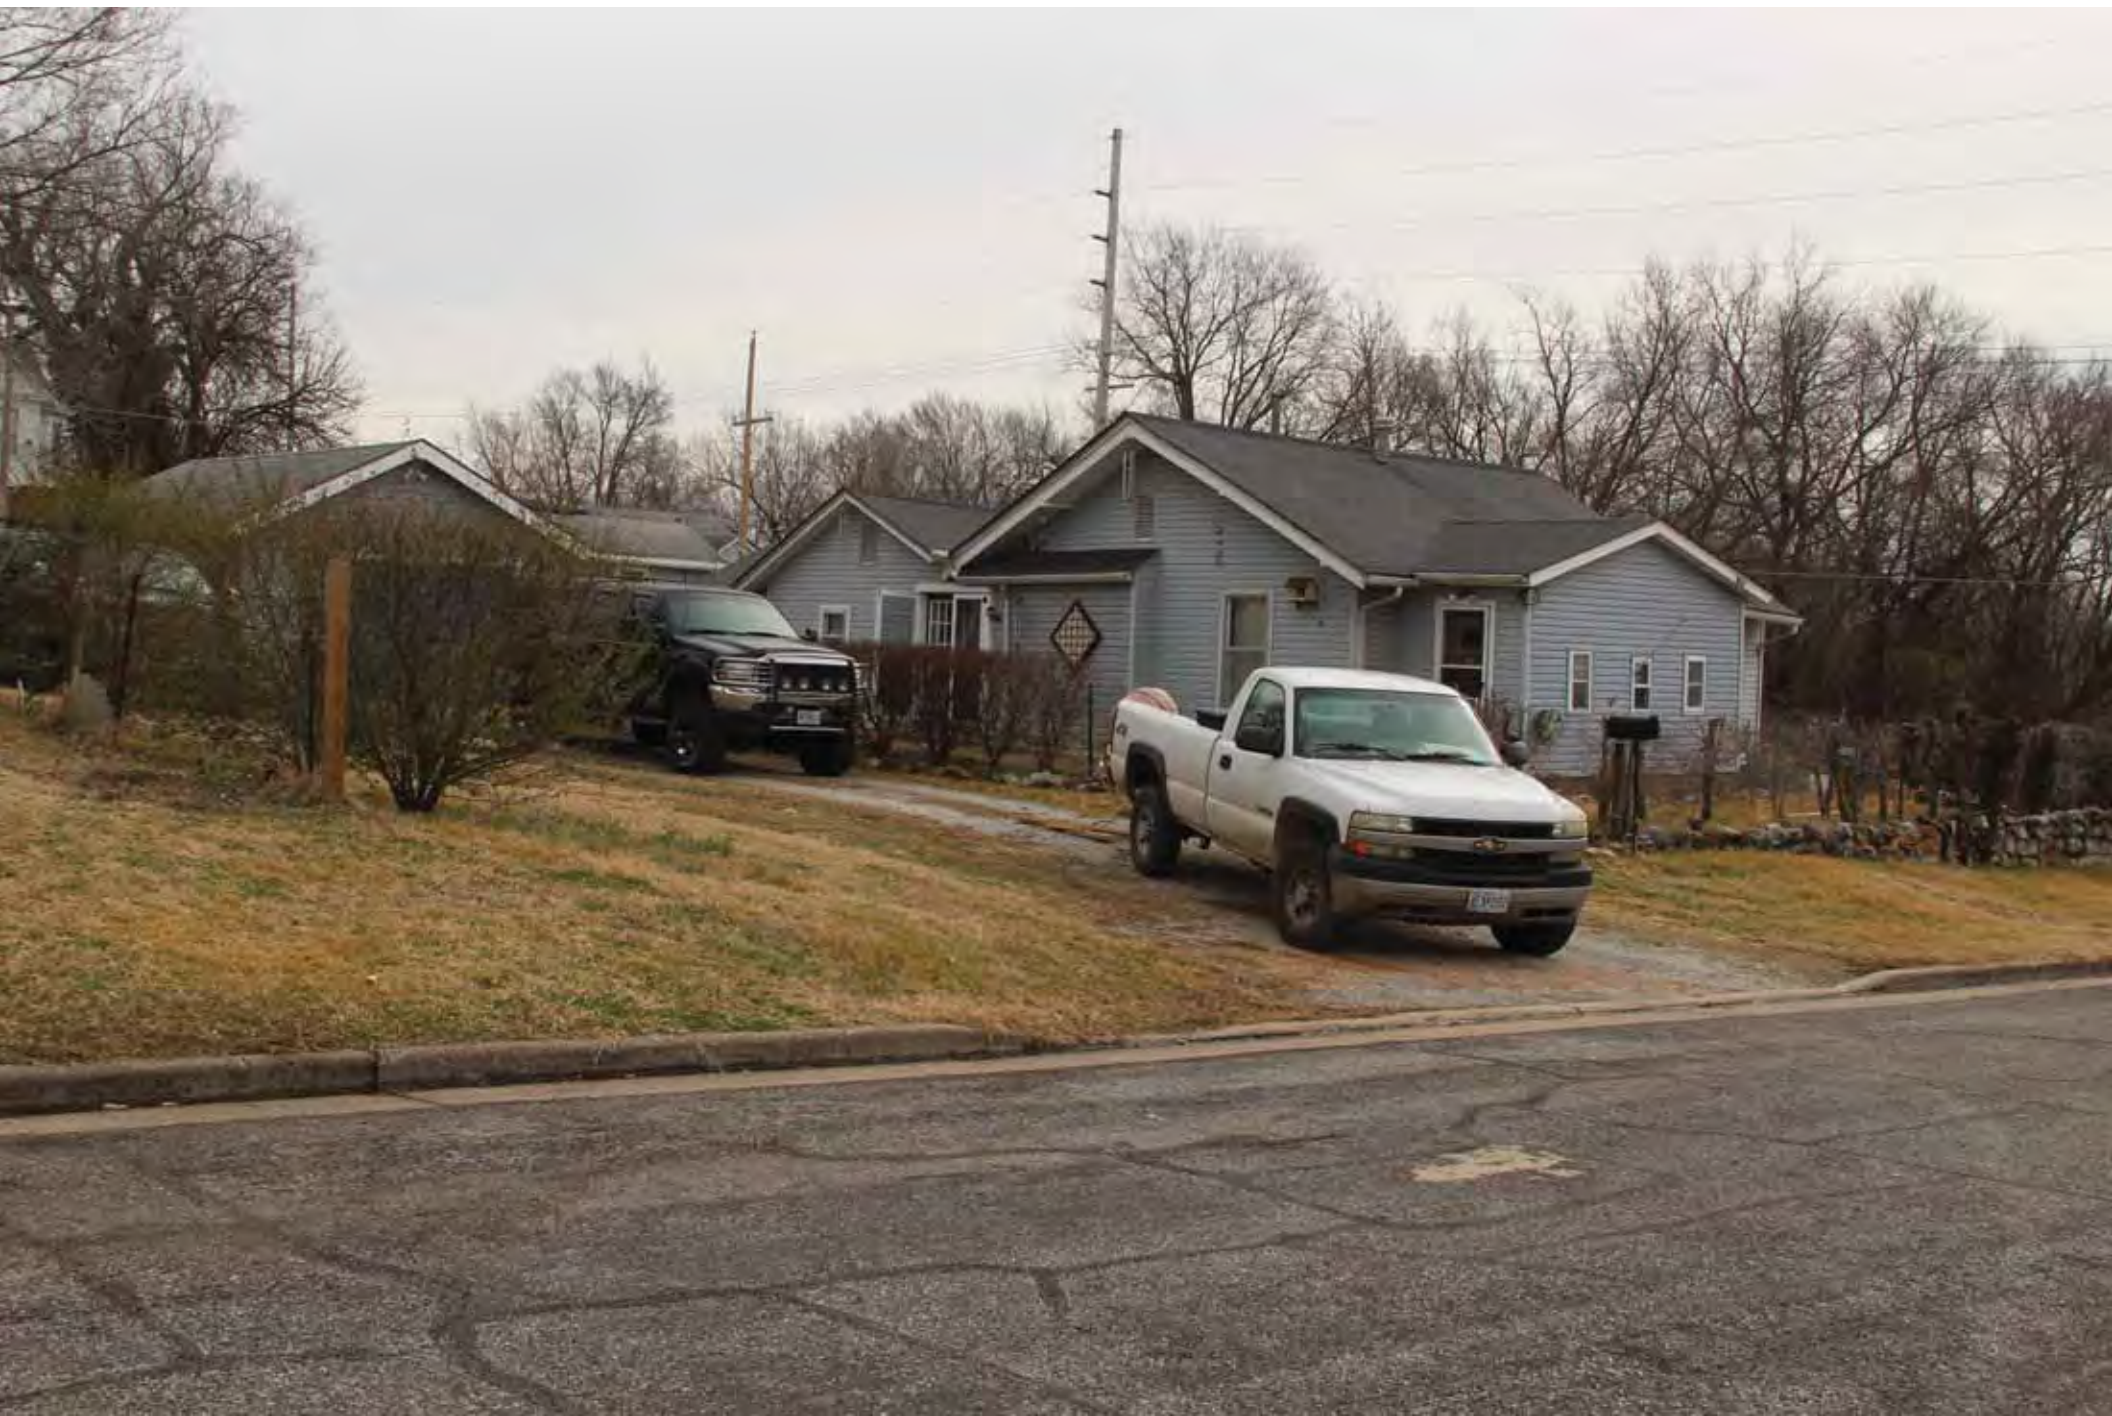
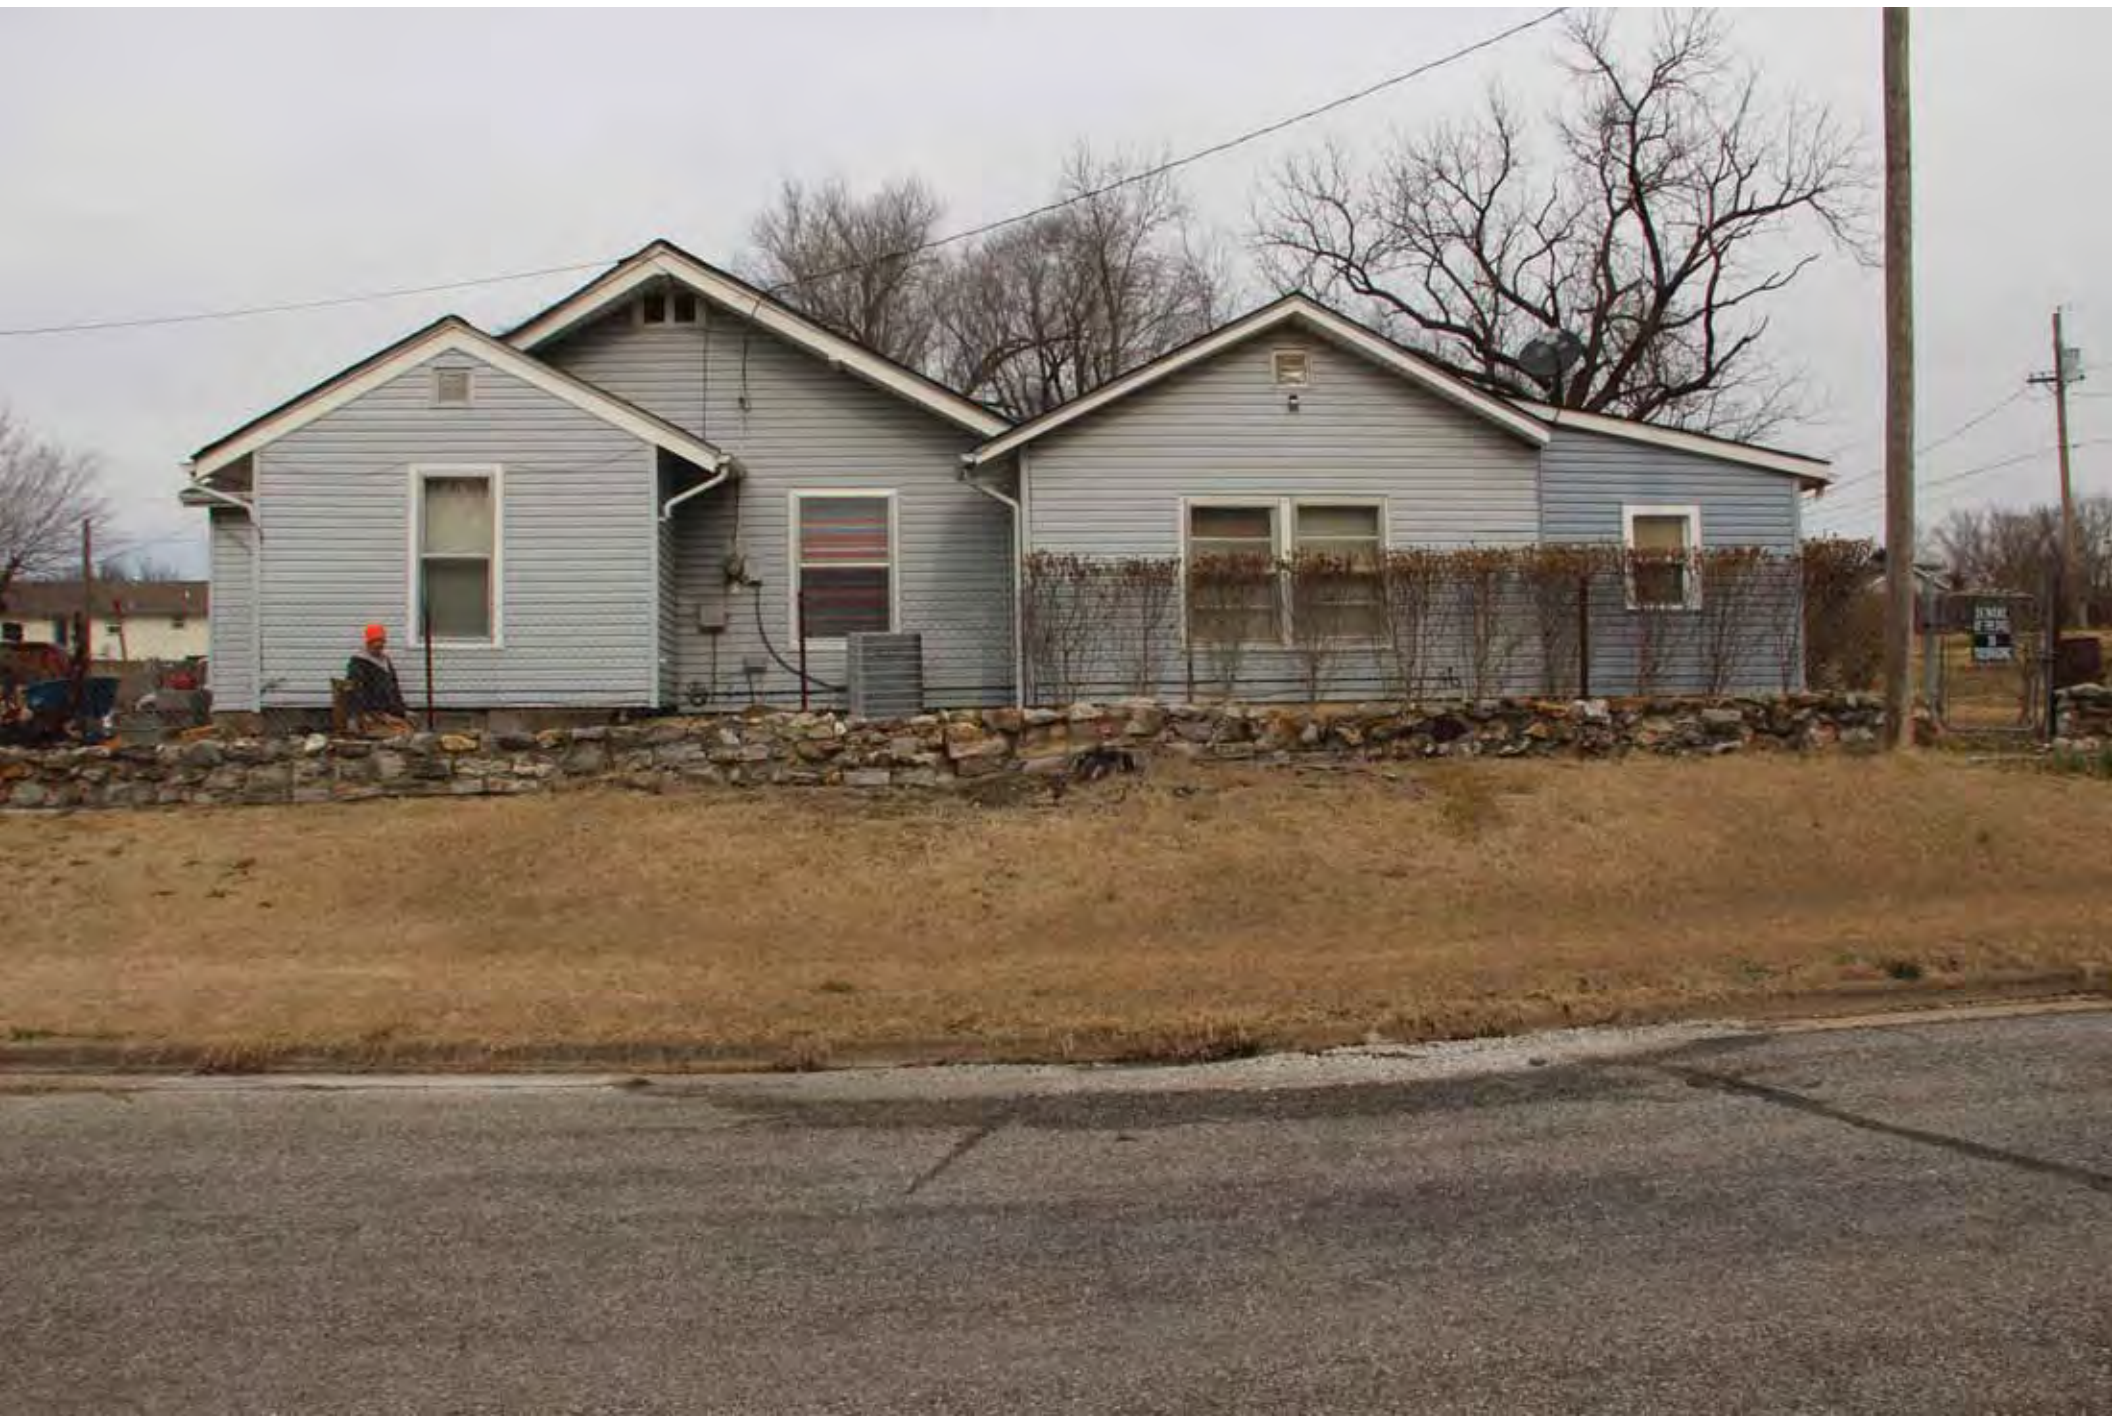
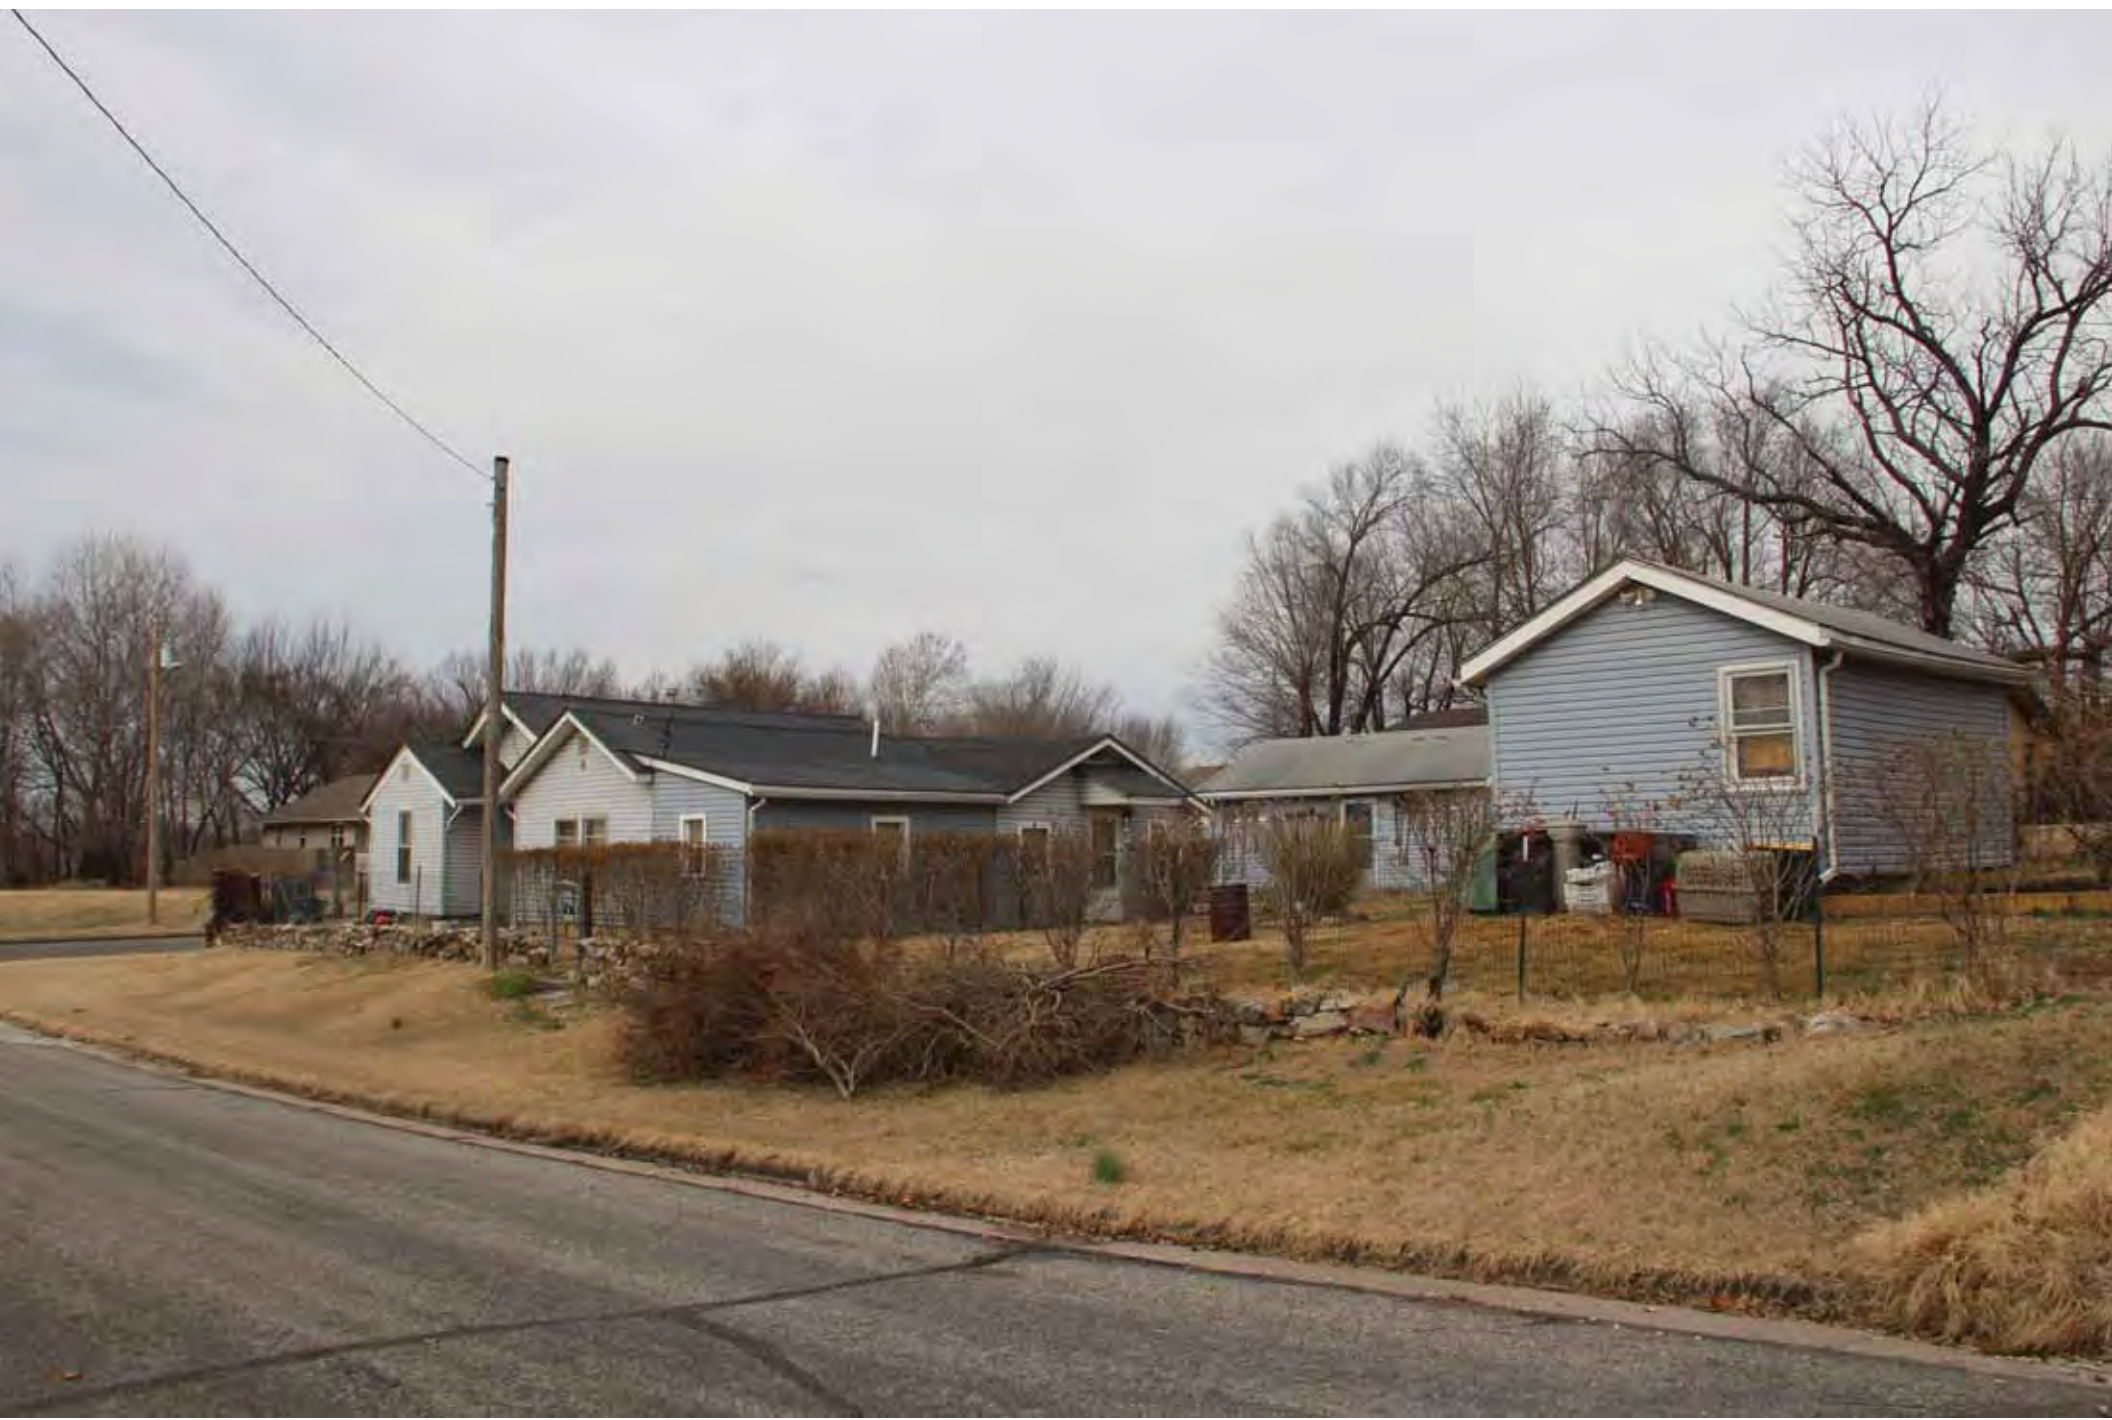
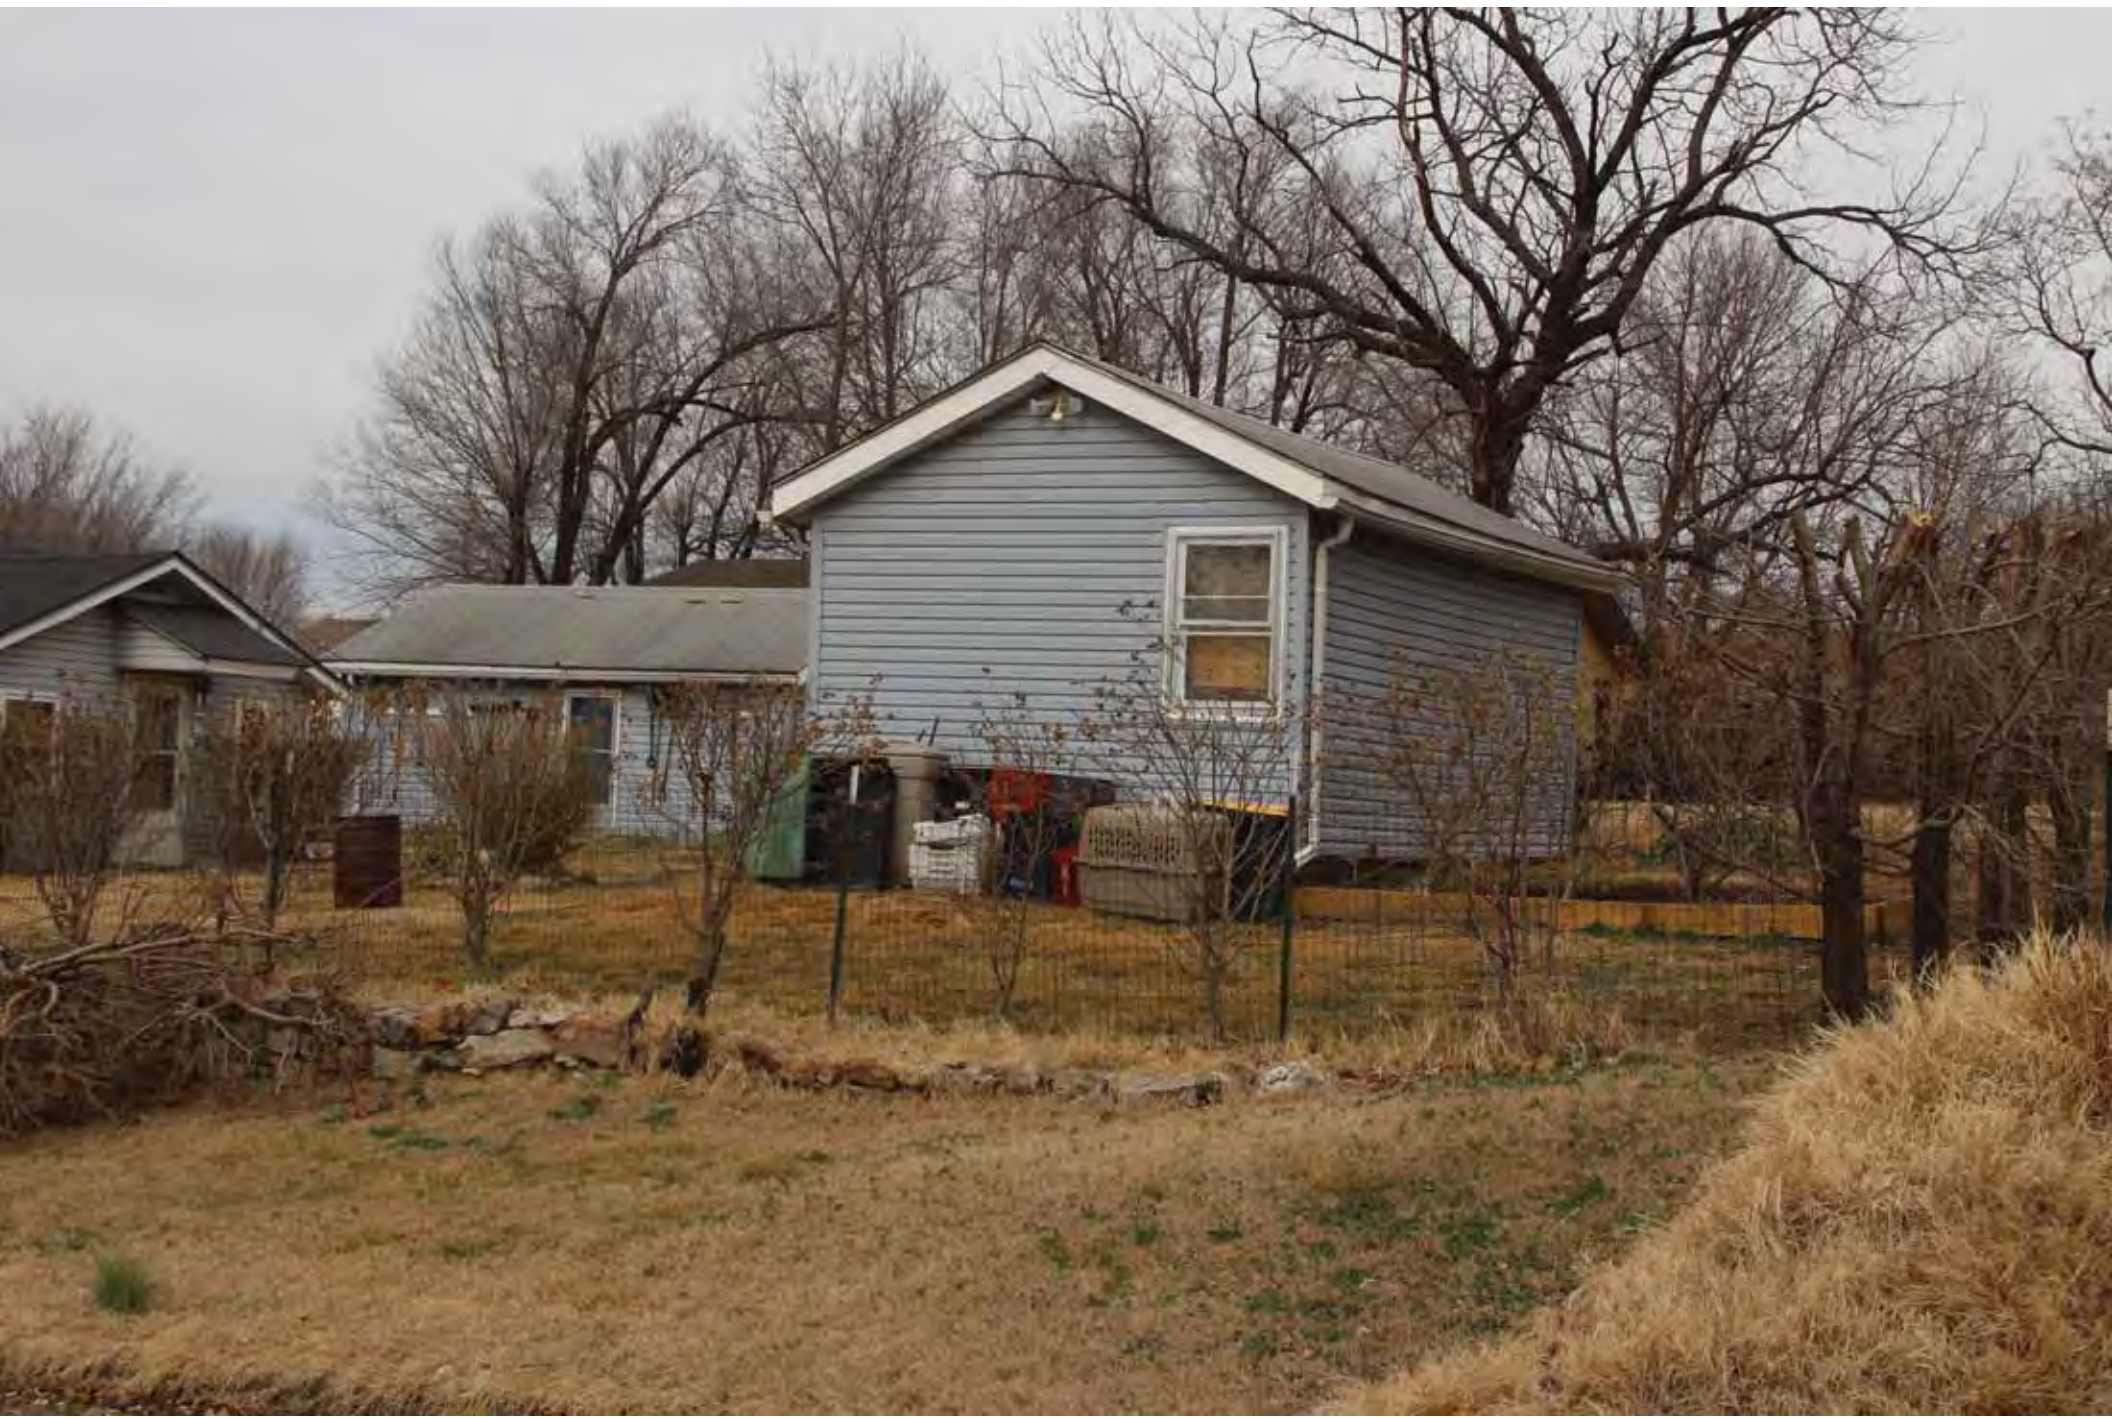
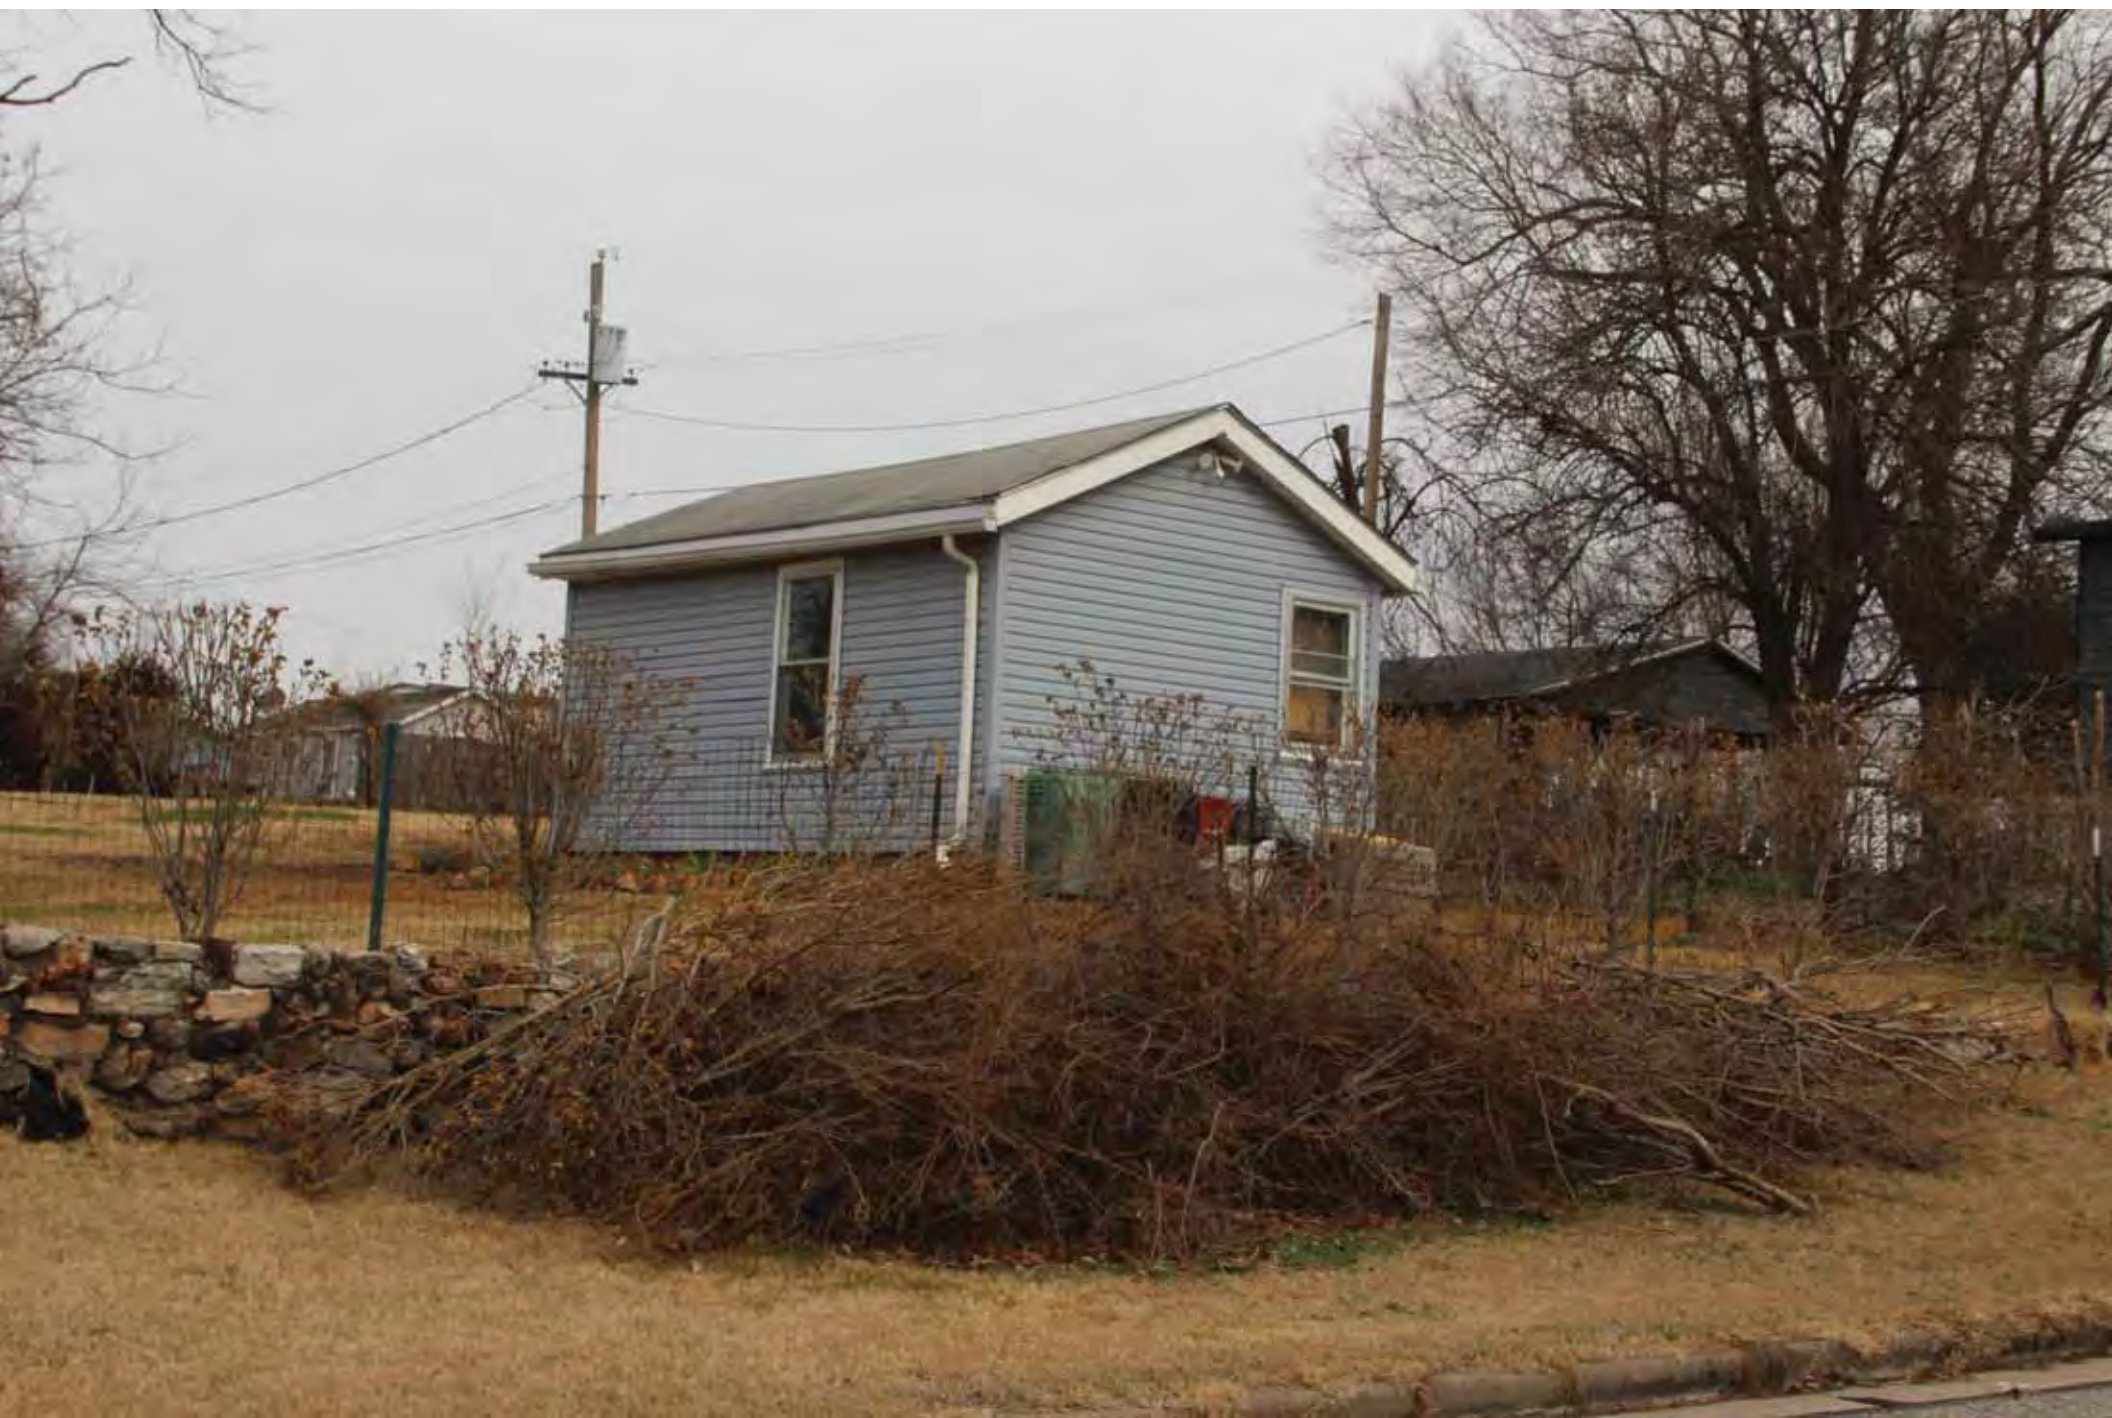
The property 223 S. Galena Street features a one-story, cross gable dwelling with multiple additions resulting in an irregular floor plan. The exterior is covered in vinyl siding and it has an asphalt-shingled roof. The primary façade has three front-facing gables, with a lean-to or shed roofed addition on the south side of the building, likely an enclosed porch. The entrance of the house is located on the south side, beneath a wooden awning. All windows on the house are vinyl one-over-one replacement windows.
