MISSOURI DEPARTMENT OF NATURAL RESOURCES
STATE HISTORIC PRESERVATION OFFICE, P.O. Box 176, Jefferson City, MO 65102
ARCHITECTURAL/HISTORIC INVENTORY FORM

1. Survey No. JP-AS-007-001		2. Survey name: East Town (Original Joplin) Historic Survey Phase 2	
3. County: JASPER		4. Address (Street No.) 618	Street (name) E. 2 nd Street
5. City: Joplin	Vicinity: <input type="checkbox"/>	6. Geographical Reference:	7. Township/Range/Section: T: R: S:
8. Historic name (if known):		9. Present/other name (if known):	
10. Ownership: <input checked="" type="checkbox"/> Private <input type="checkbox"/> Public		11a. Historic use (if known): Domestic: Single Dwelling	11b. Current use: Domestic: Single Dwelling

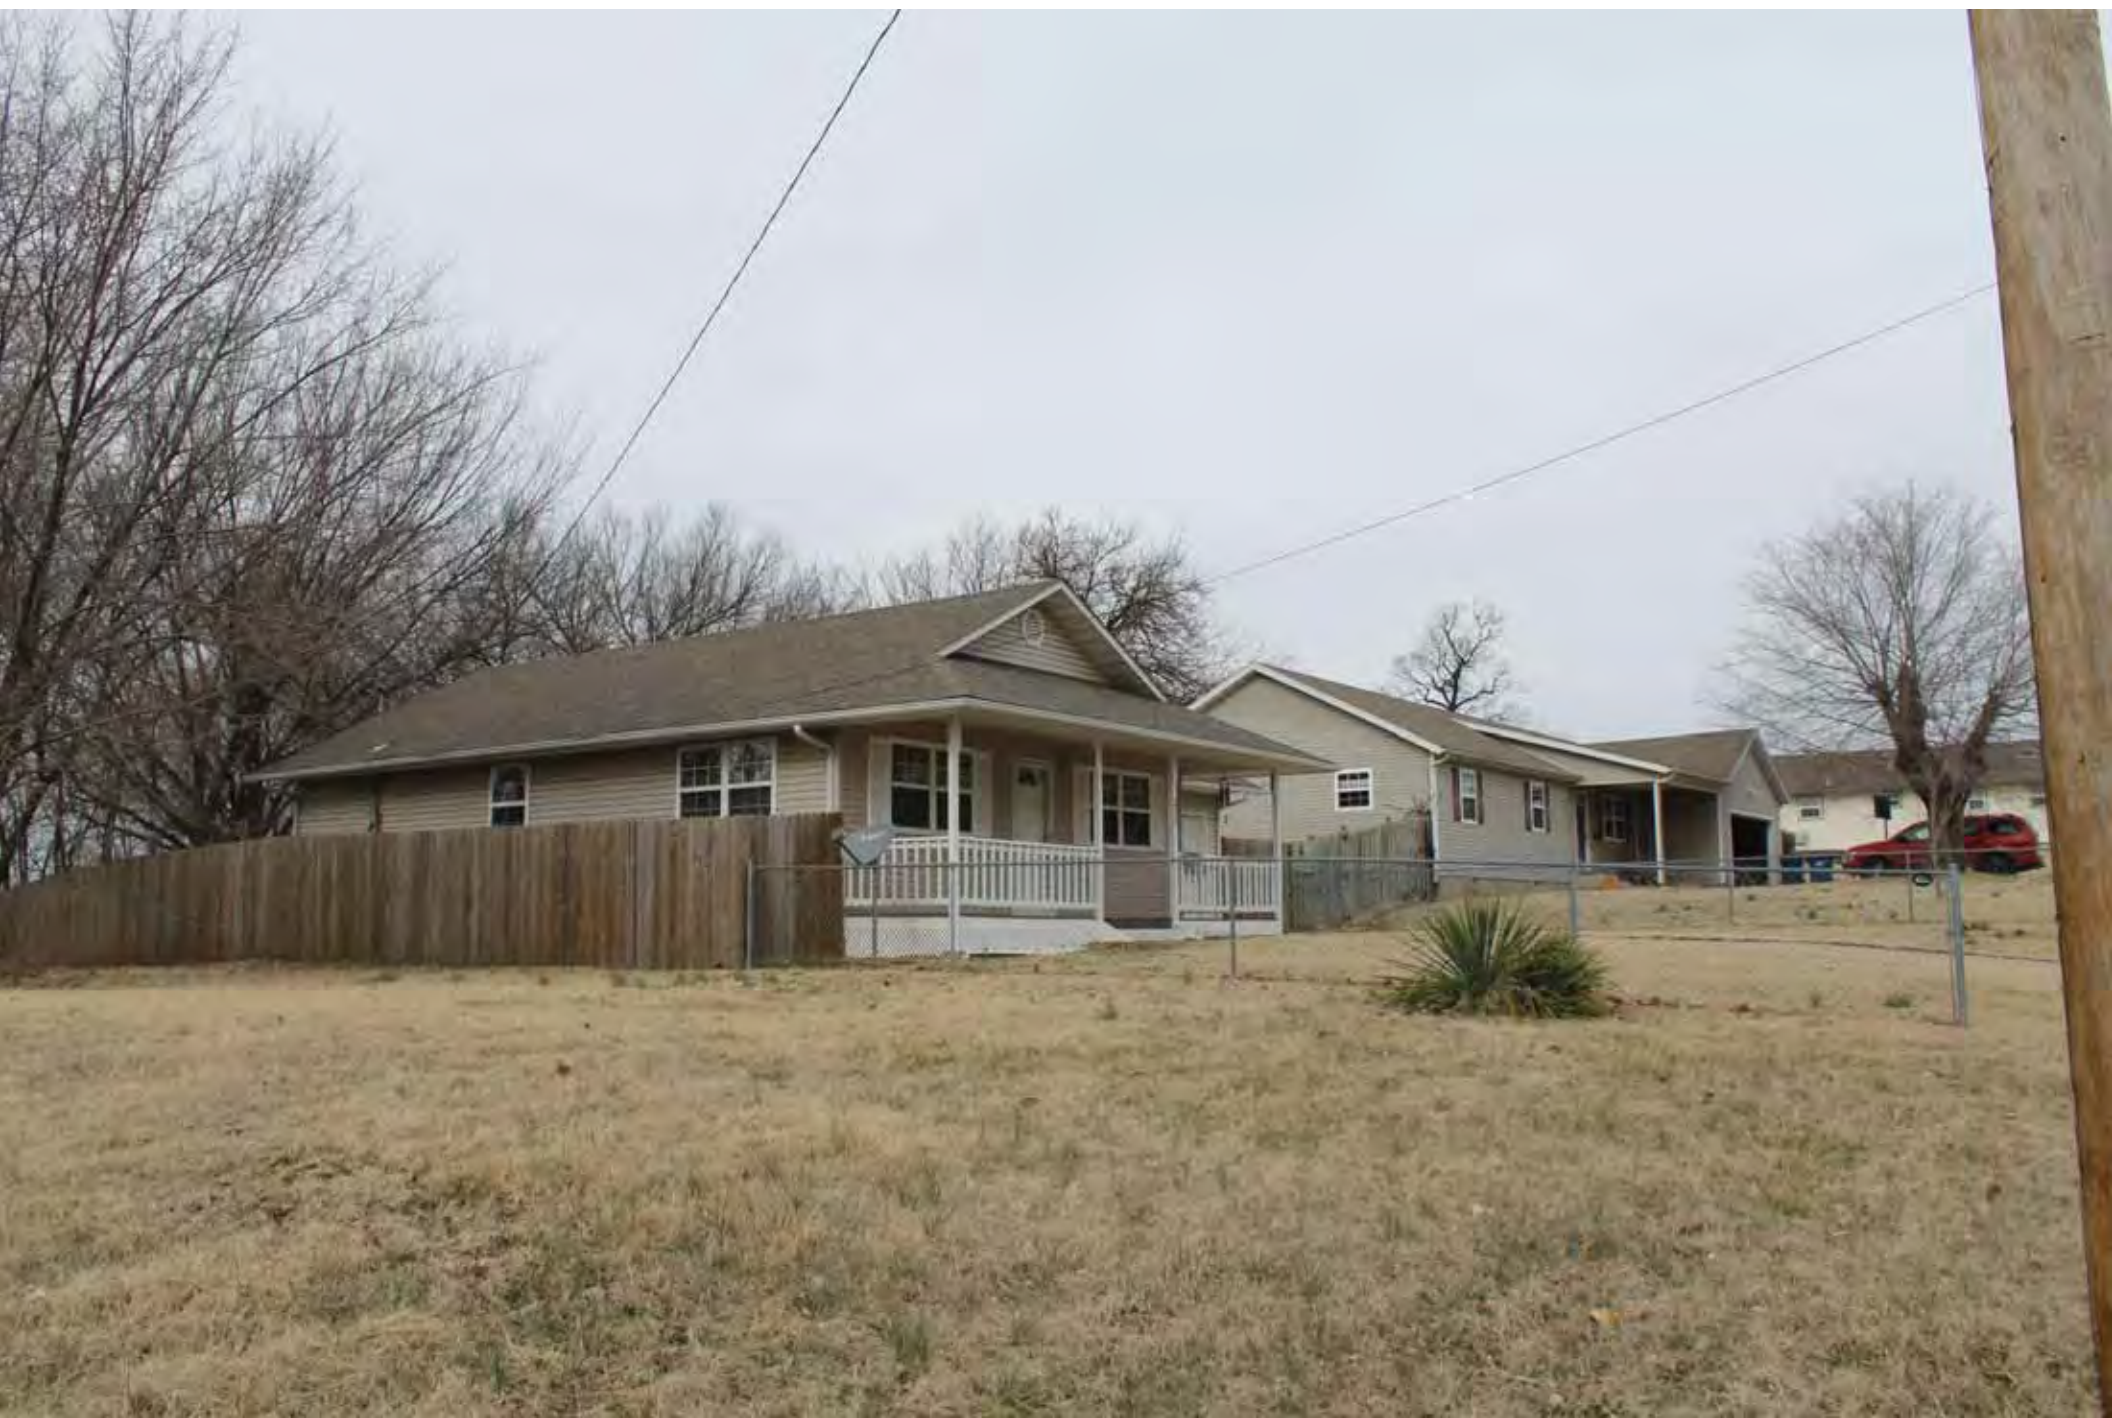
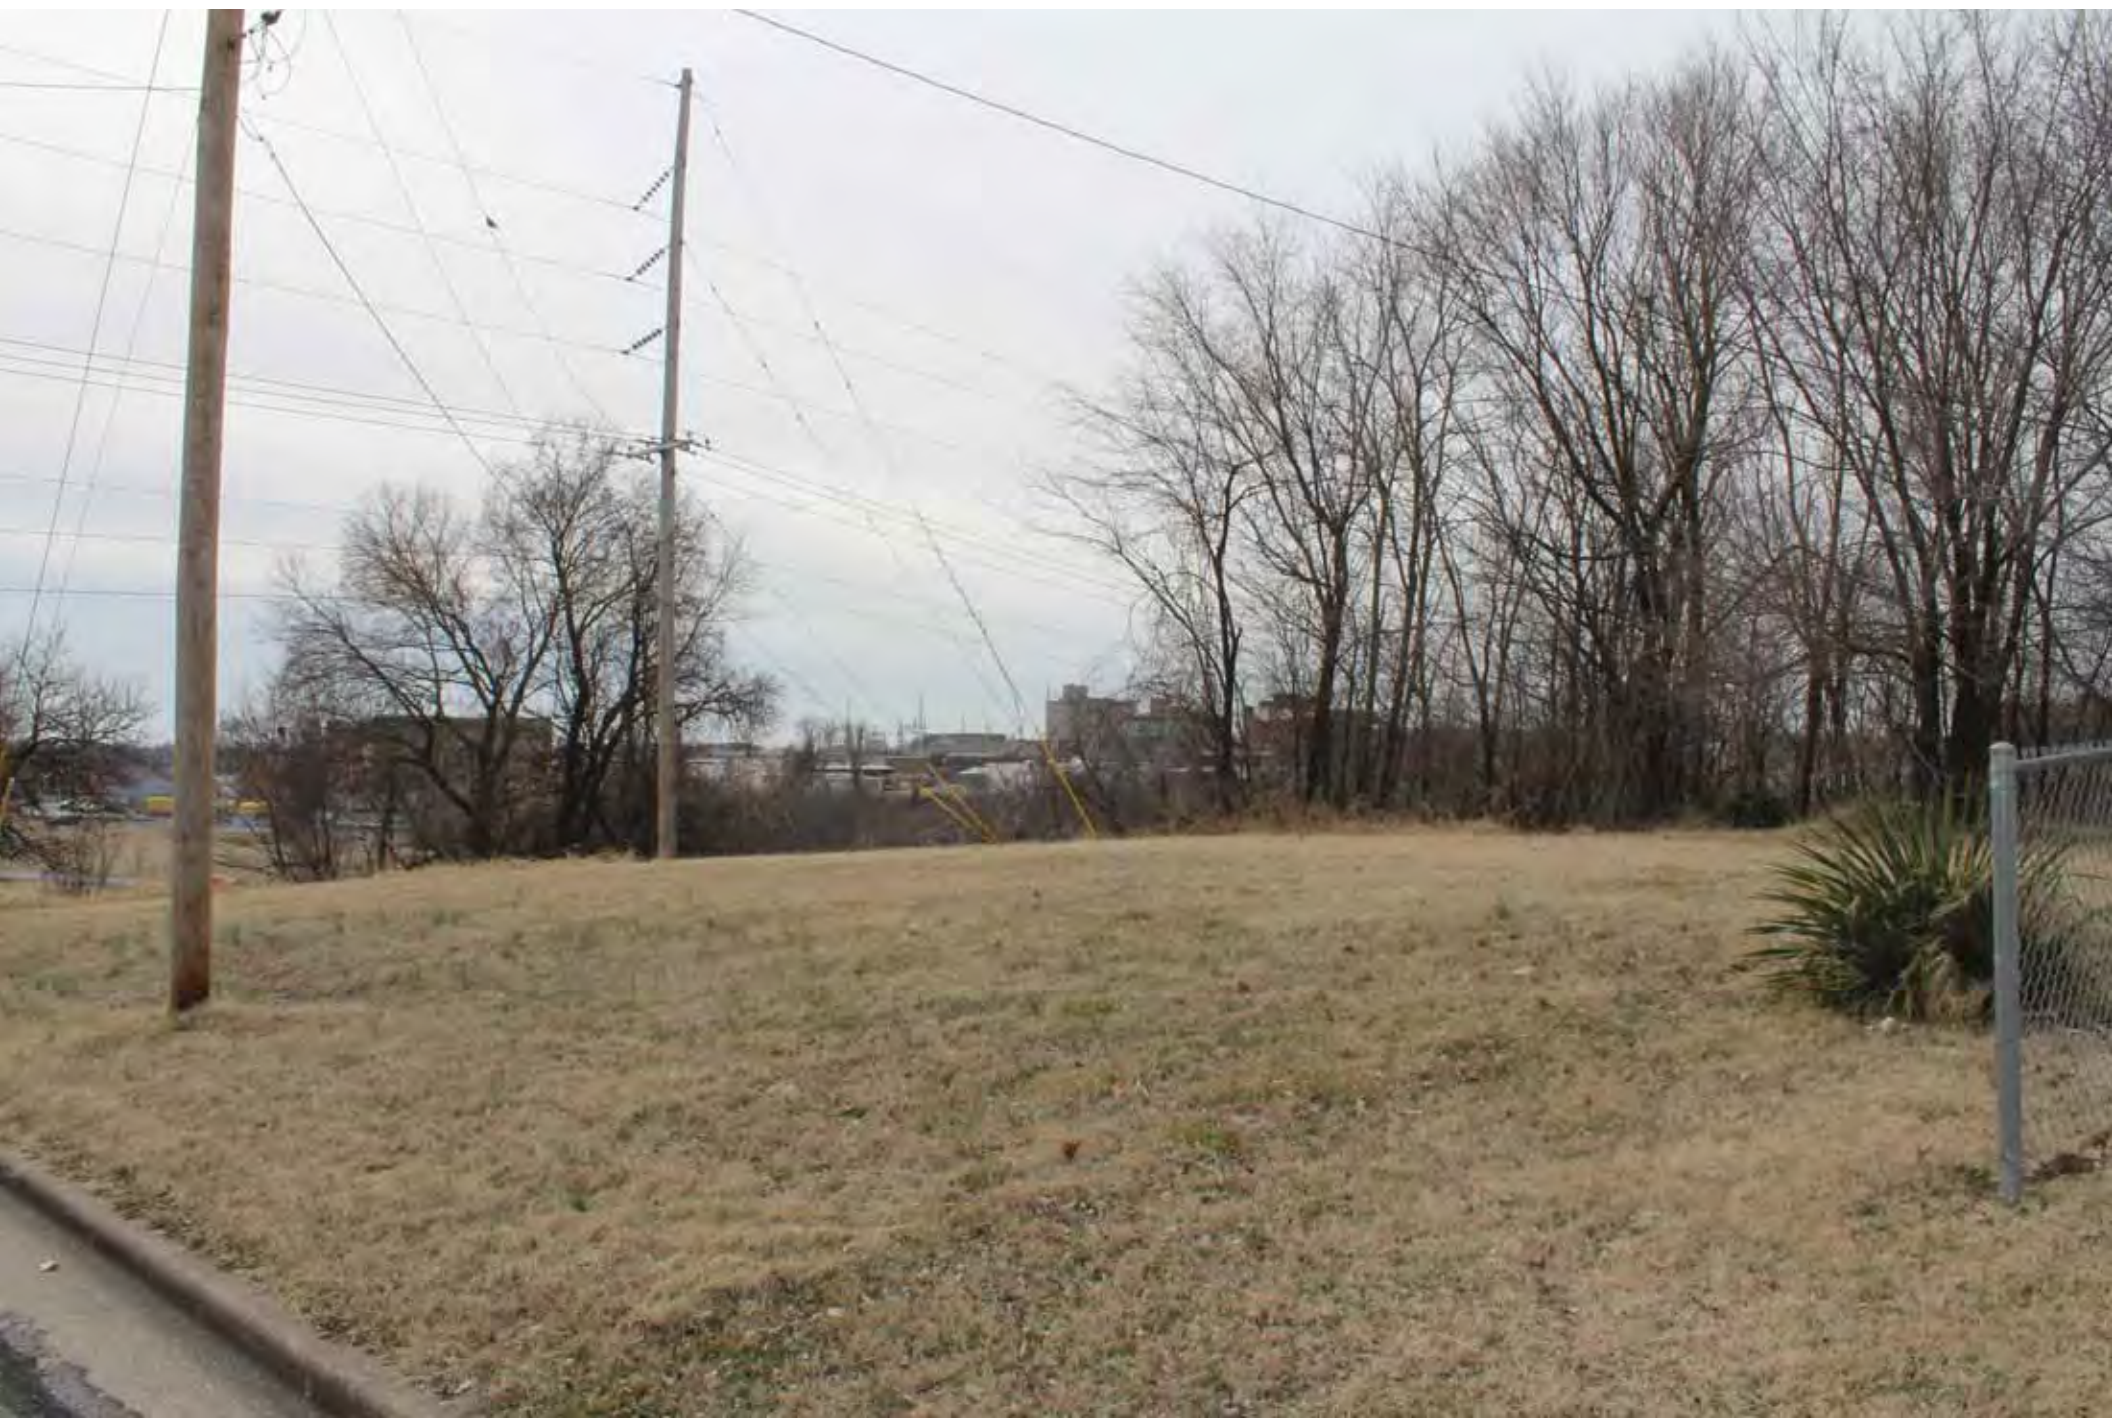
The lot has no buildings but does have several large trees and plants, as well as utility poles and lines.

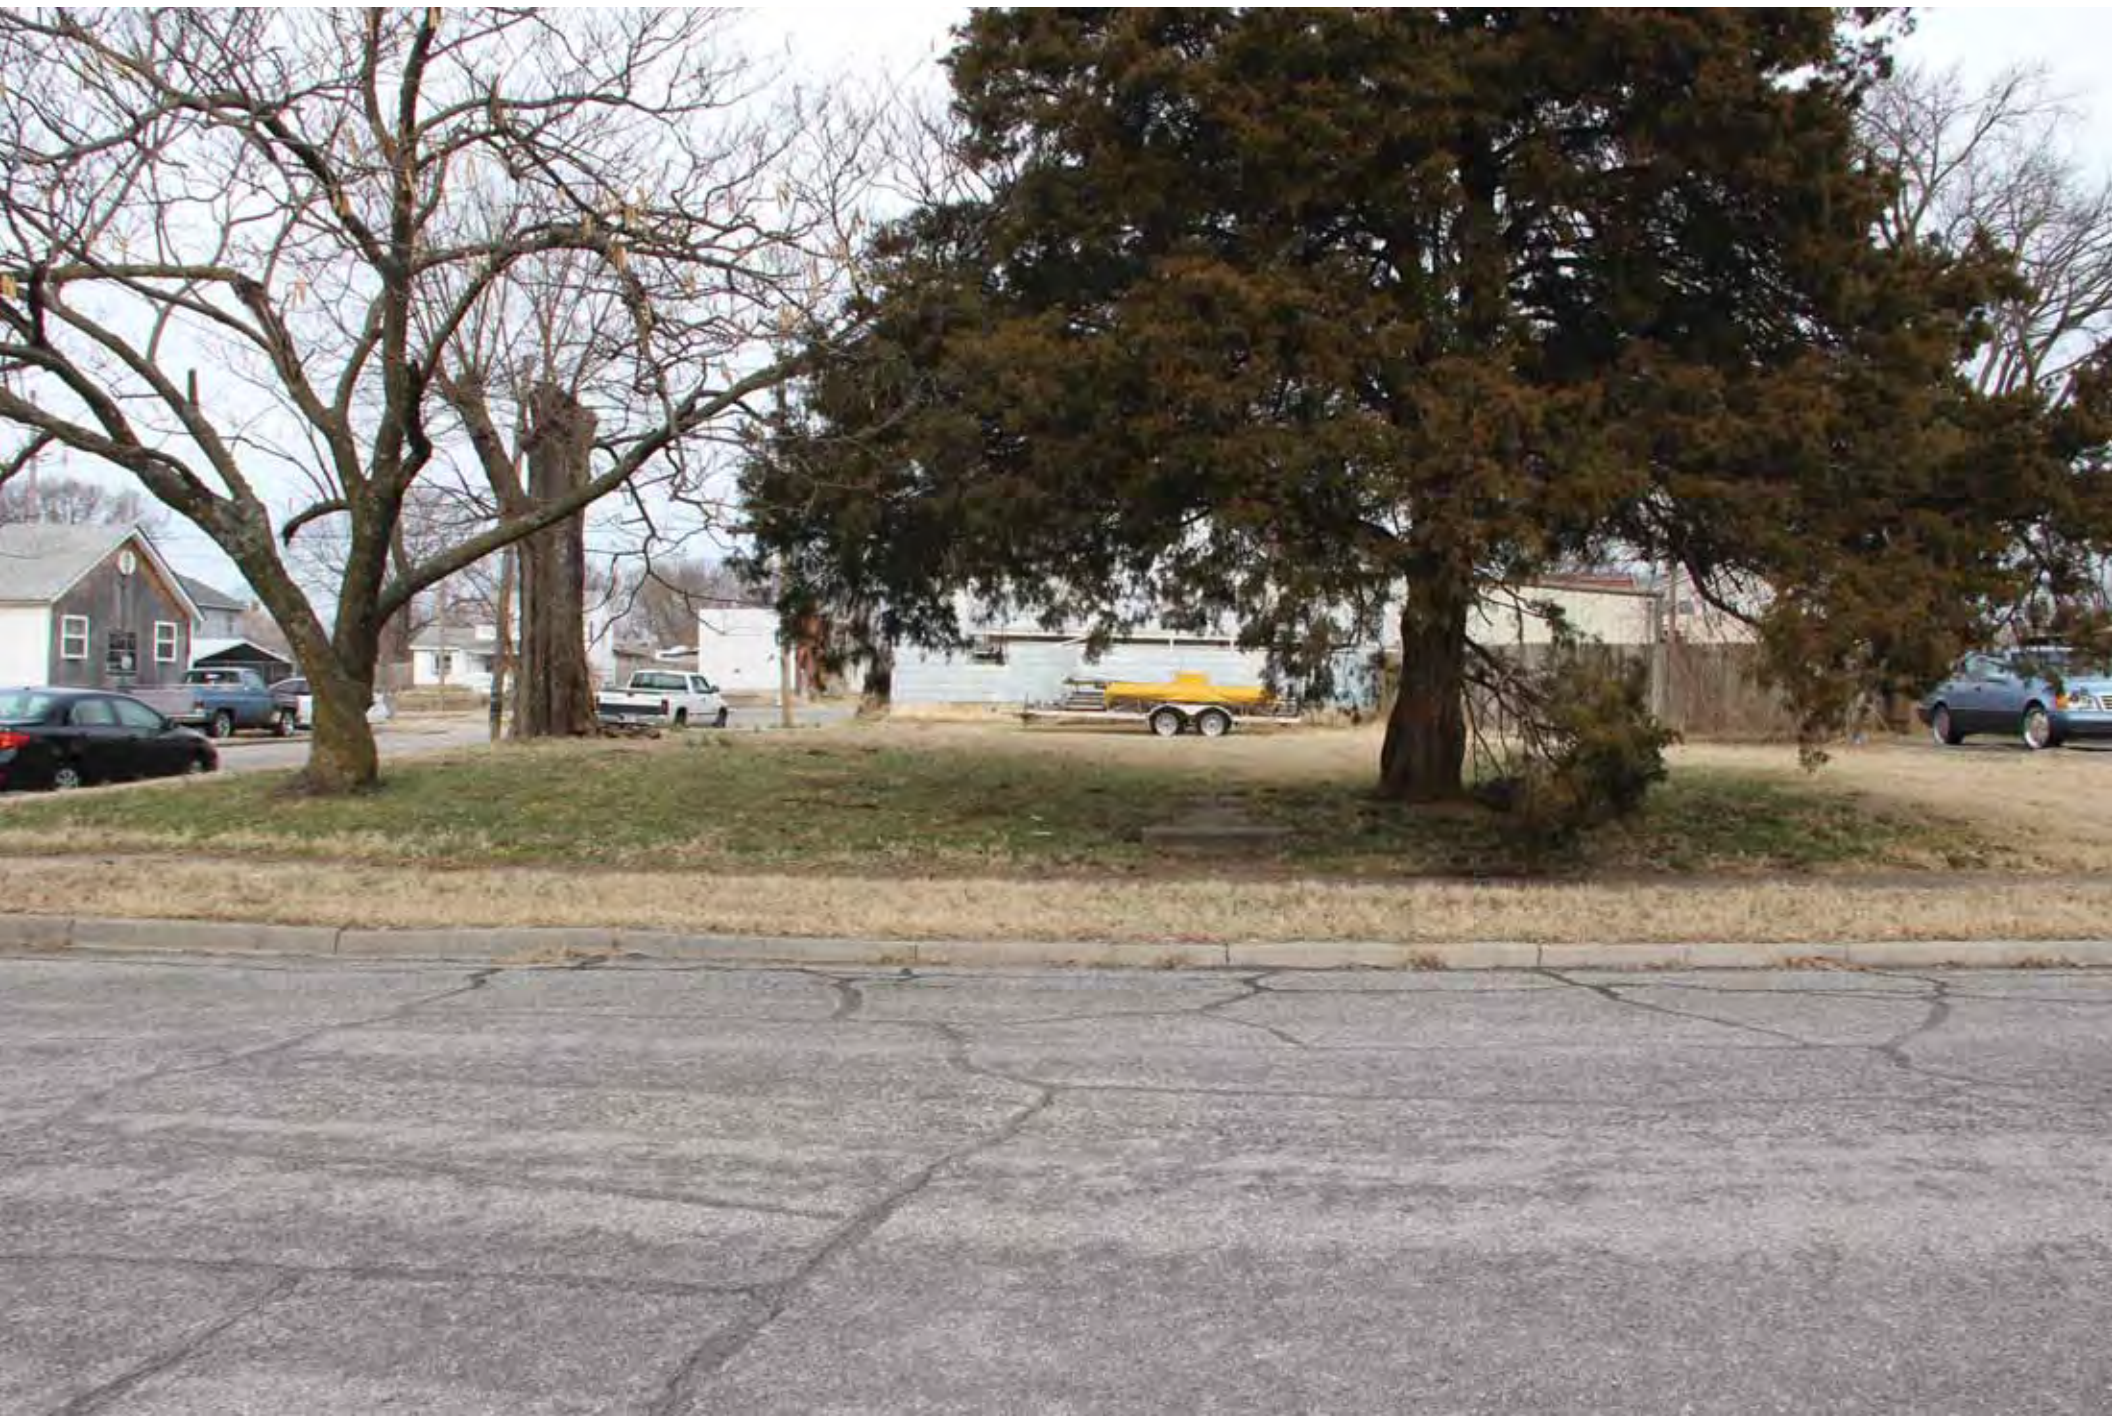
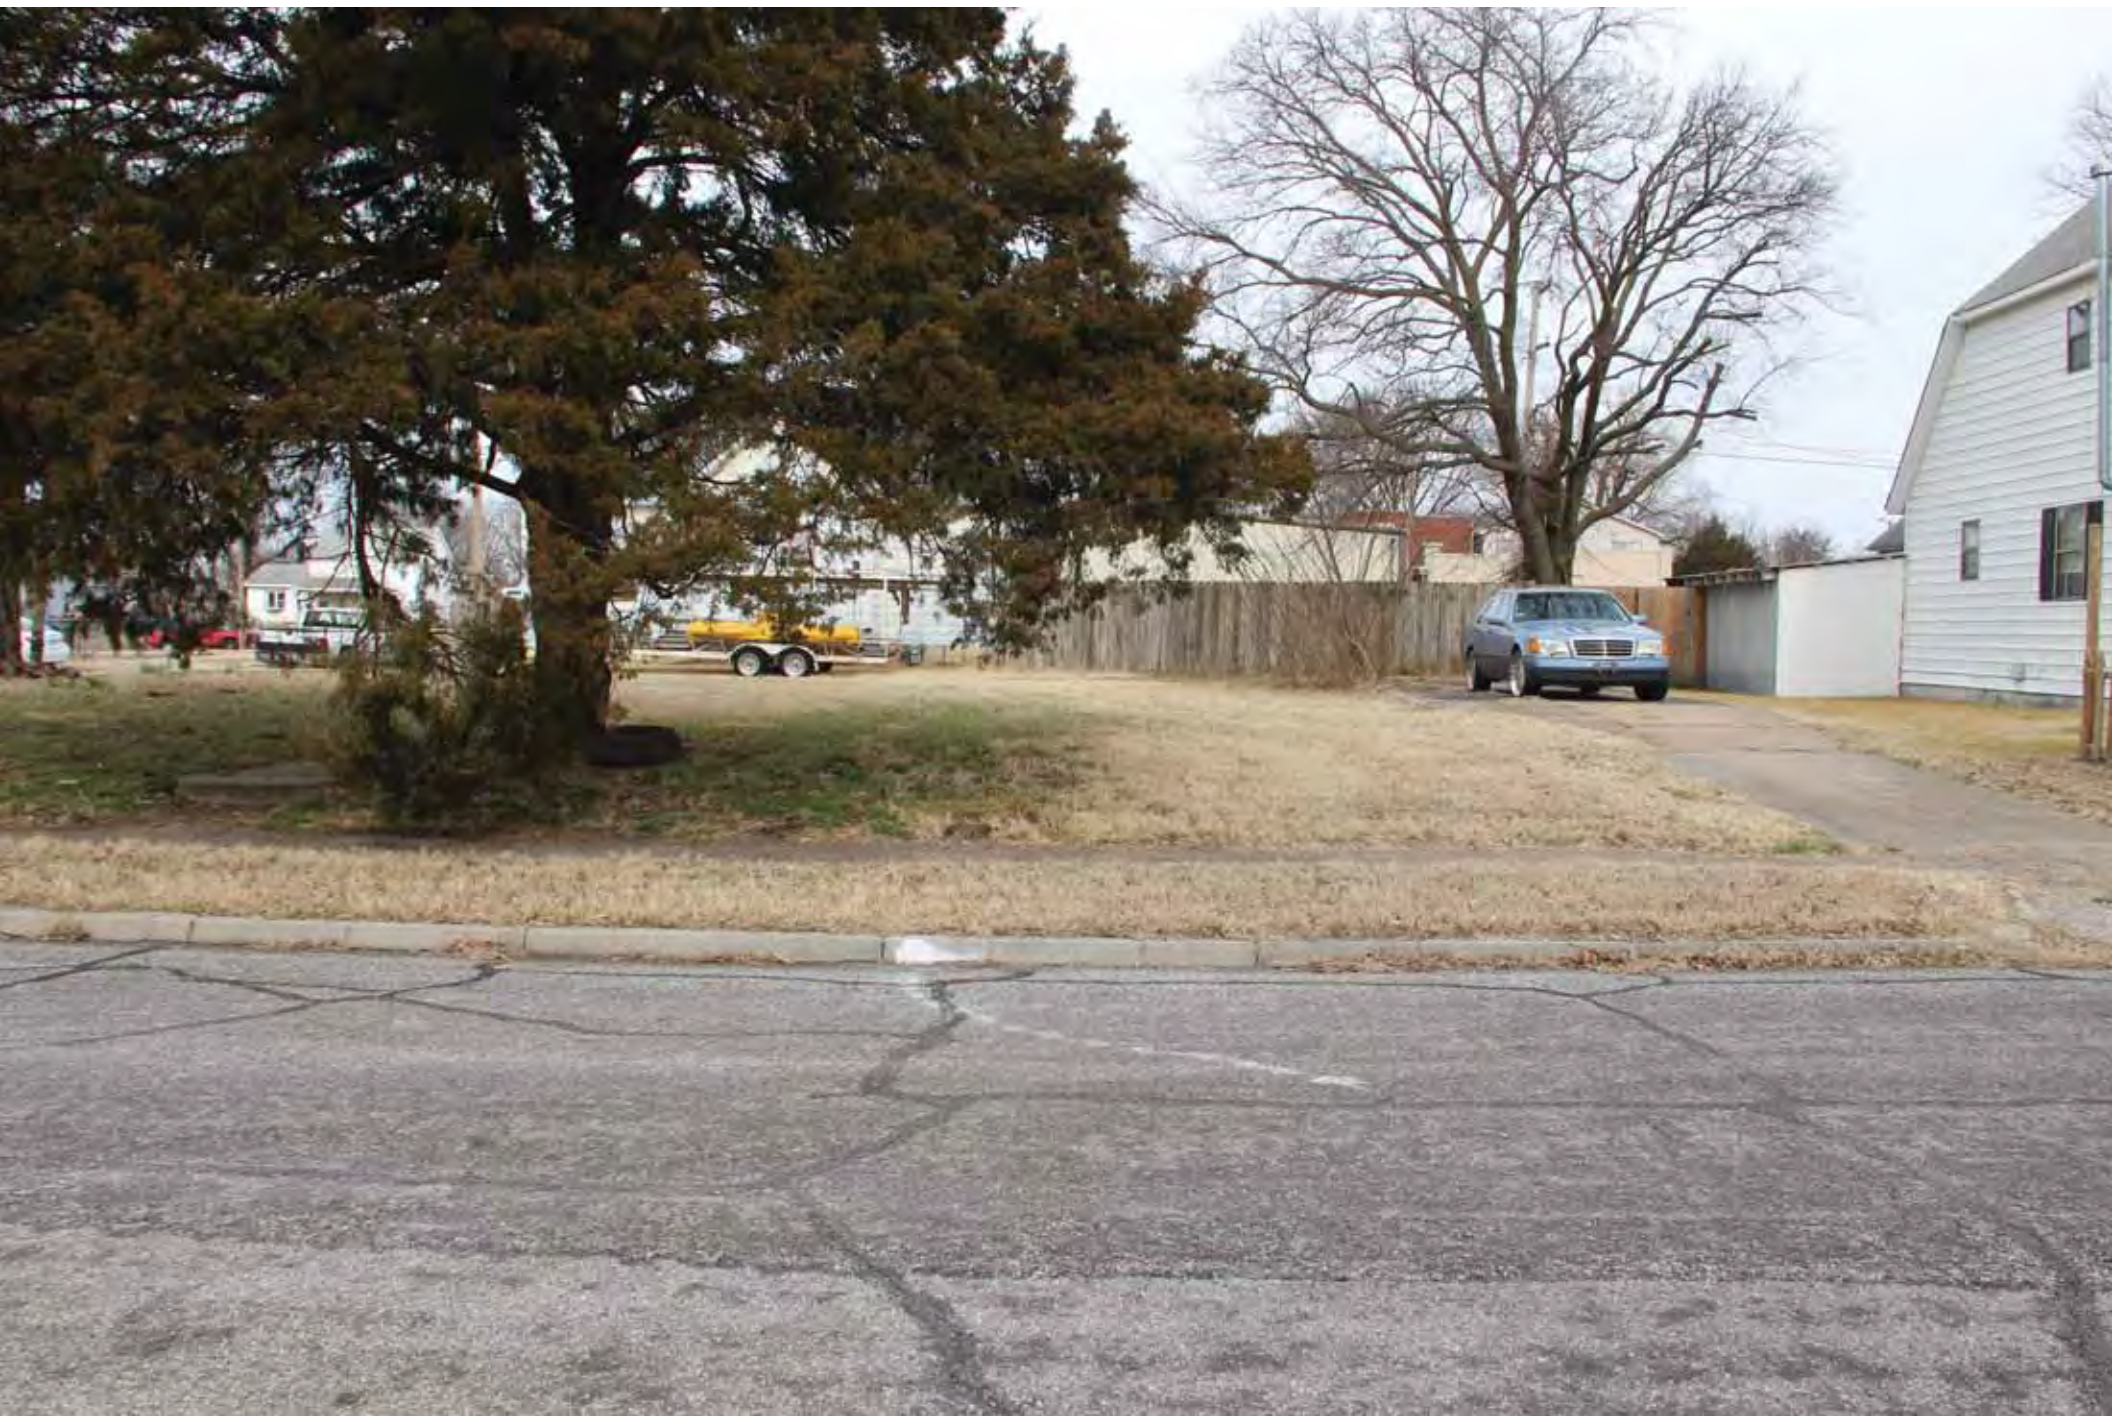
The lot has no buildings, but does have several large trees.
