MISSOURI DEPARTMENT OF NATURAL RESOURCES
STATE HISTORIC PRESERVATION OFFICE, P.O. Box 176, Jefferson City, MO 65102
ARCHITECTURAL/HISTORIC INVENTORY FORM

1. Survey No. JP-AS-007-001		2. Survey name: East Town (Original Joplin) Historic Survey Phase 2	
3. County: JASPER		4. Address (Street No.) 618	Street (name) E. 2 nd Street
5. City: Joplin	Vicinity: <input type="checkbox"/>	6. Geographical Reference:	7. Township/Range/Section: T: R: S:
8. Historic name (if known):		9. Present/other name (if known):	
10. Ownership: <input checked="" type="checkbox"/> Private <input type="checkbox"/> Public		11a. Historic use (if known): Domestic: Single Dwelling	11b. Current use: Domestic: Single Dwelling

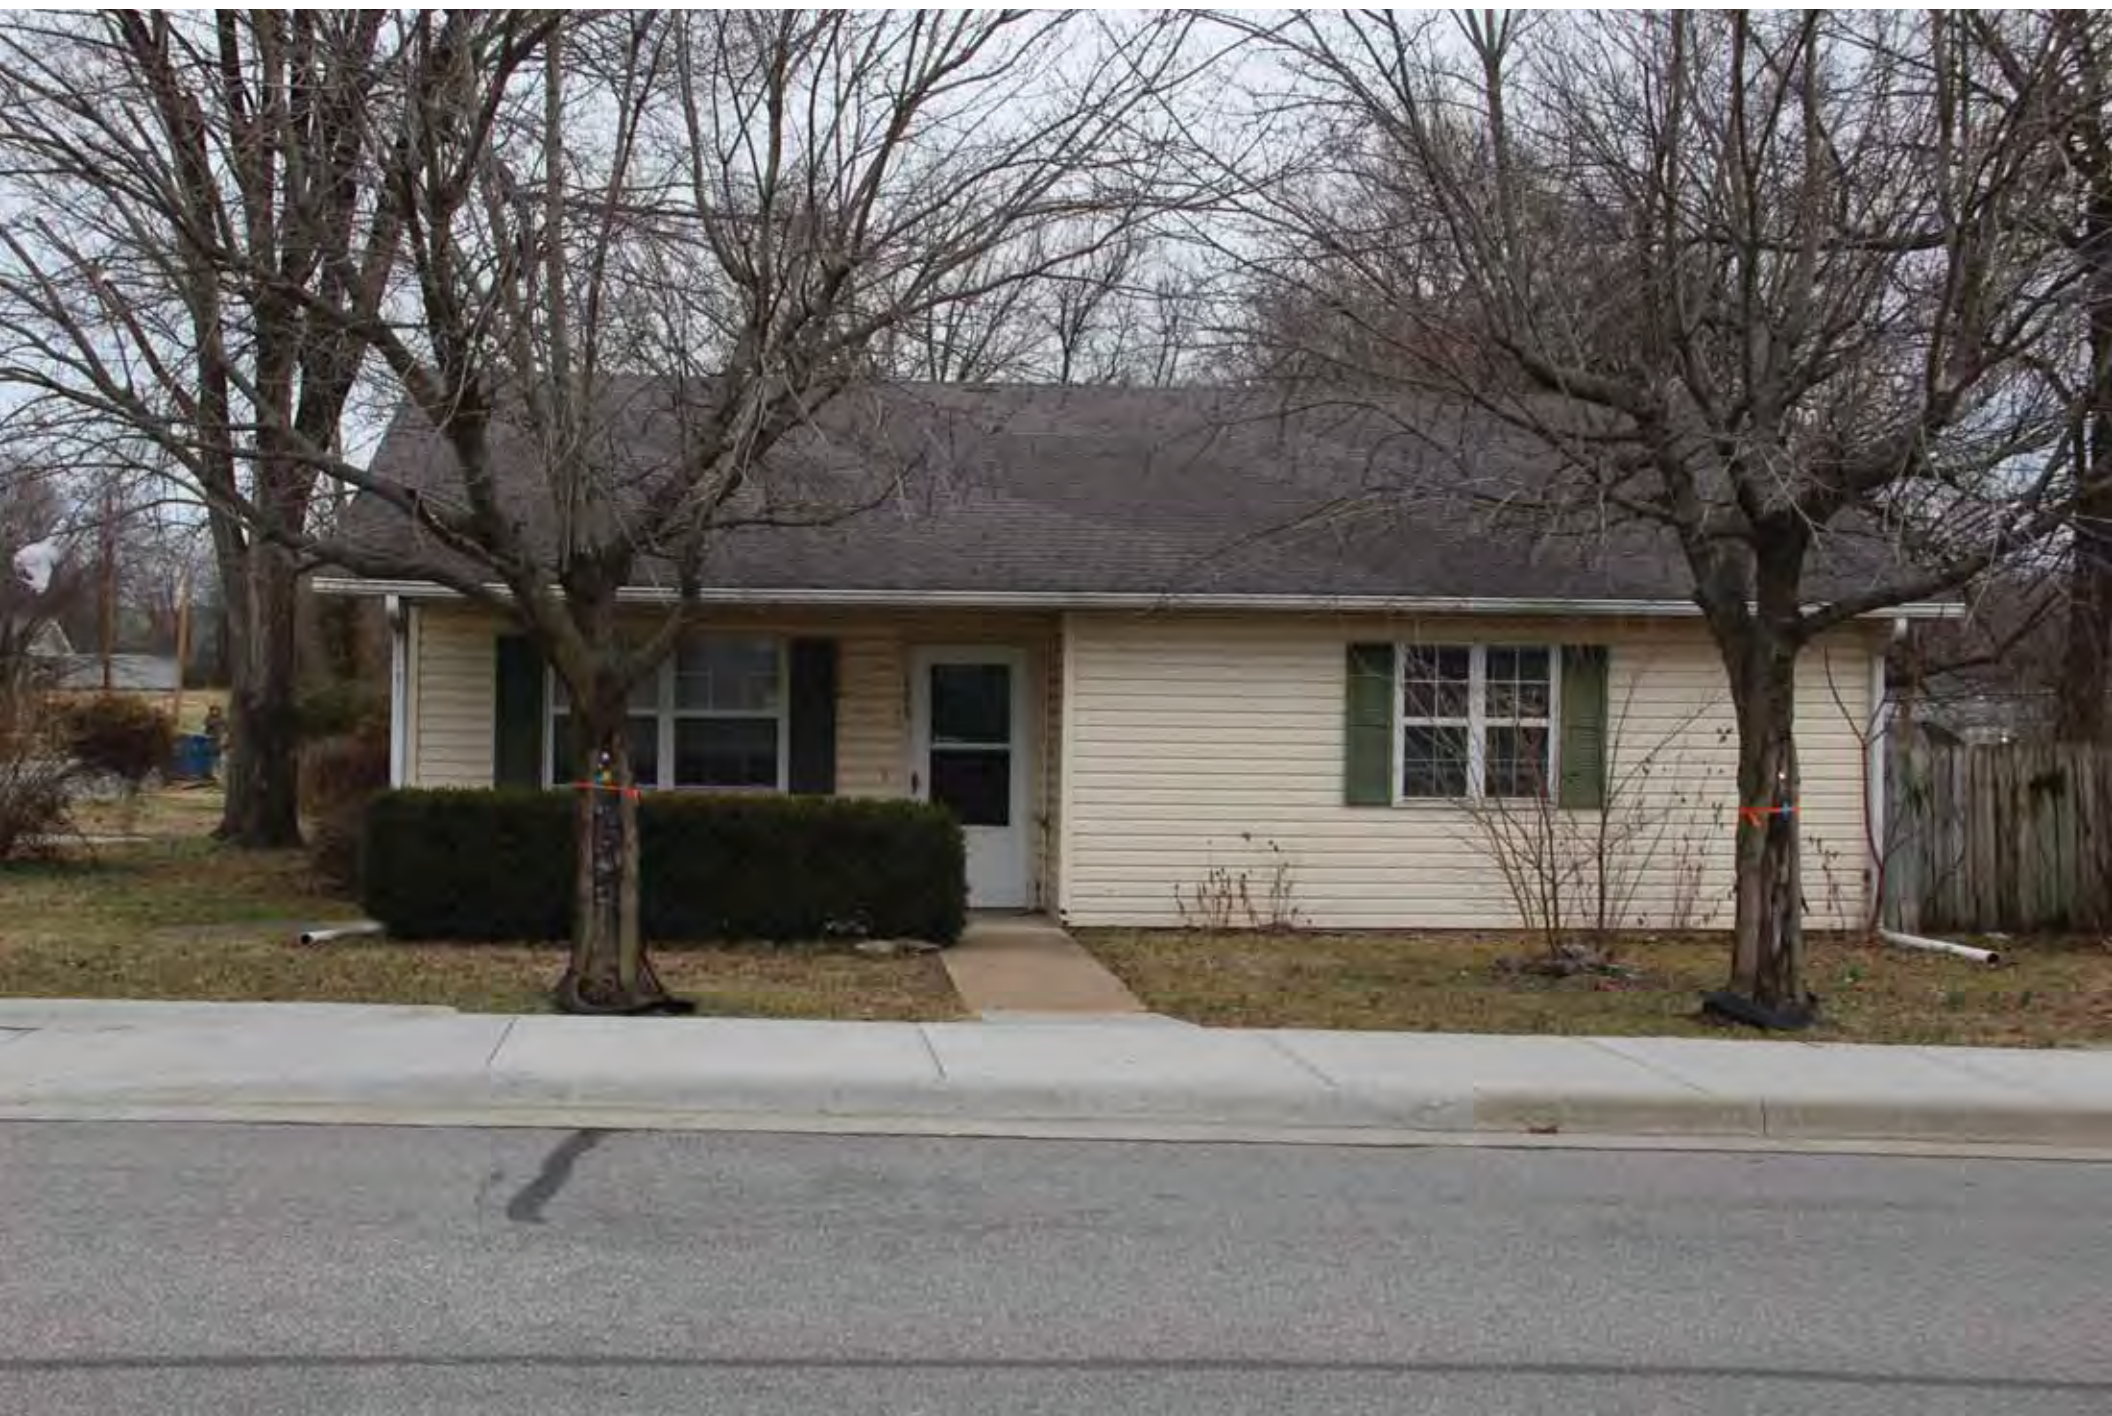
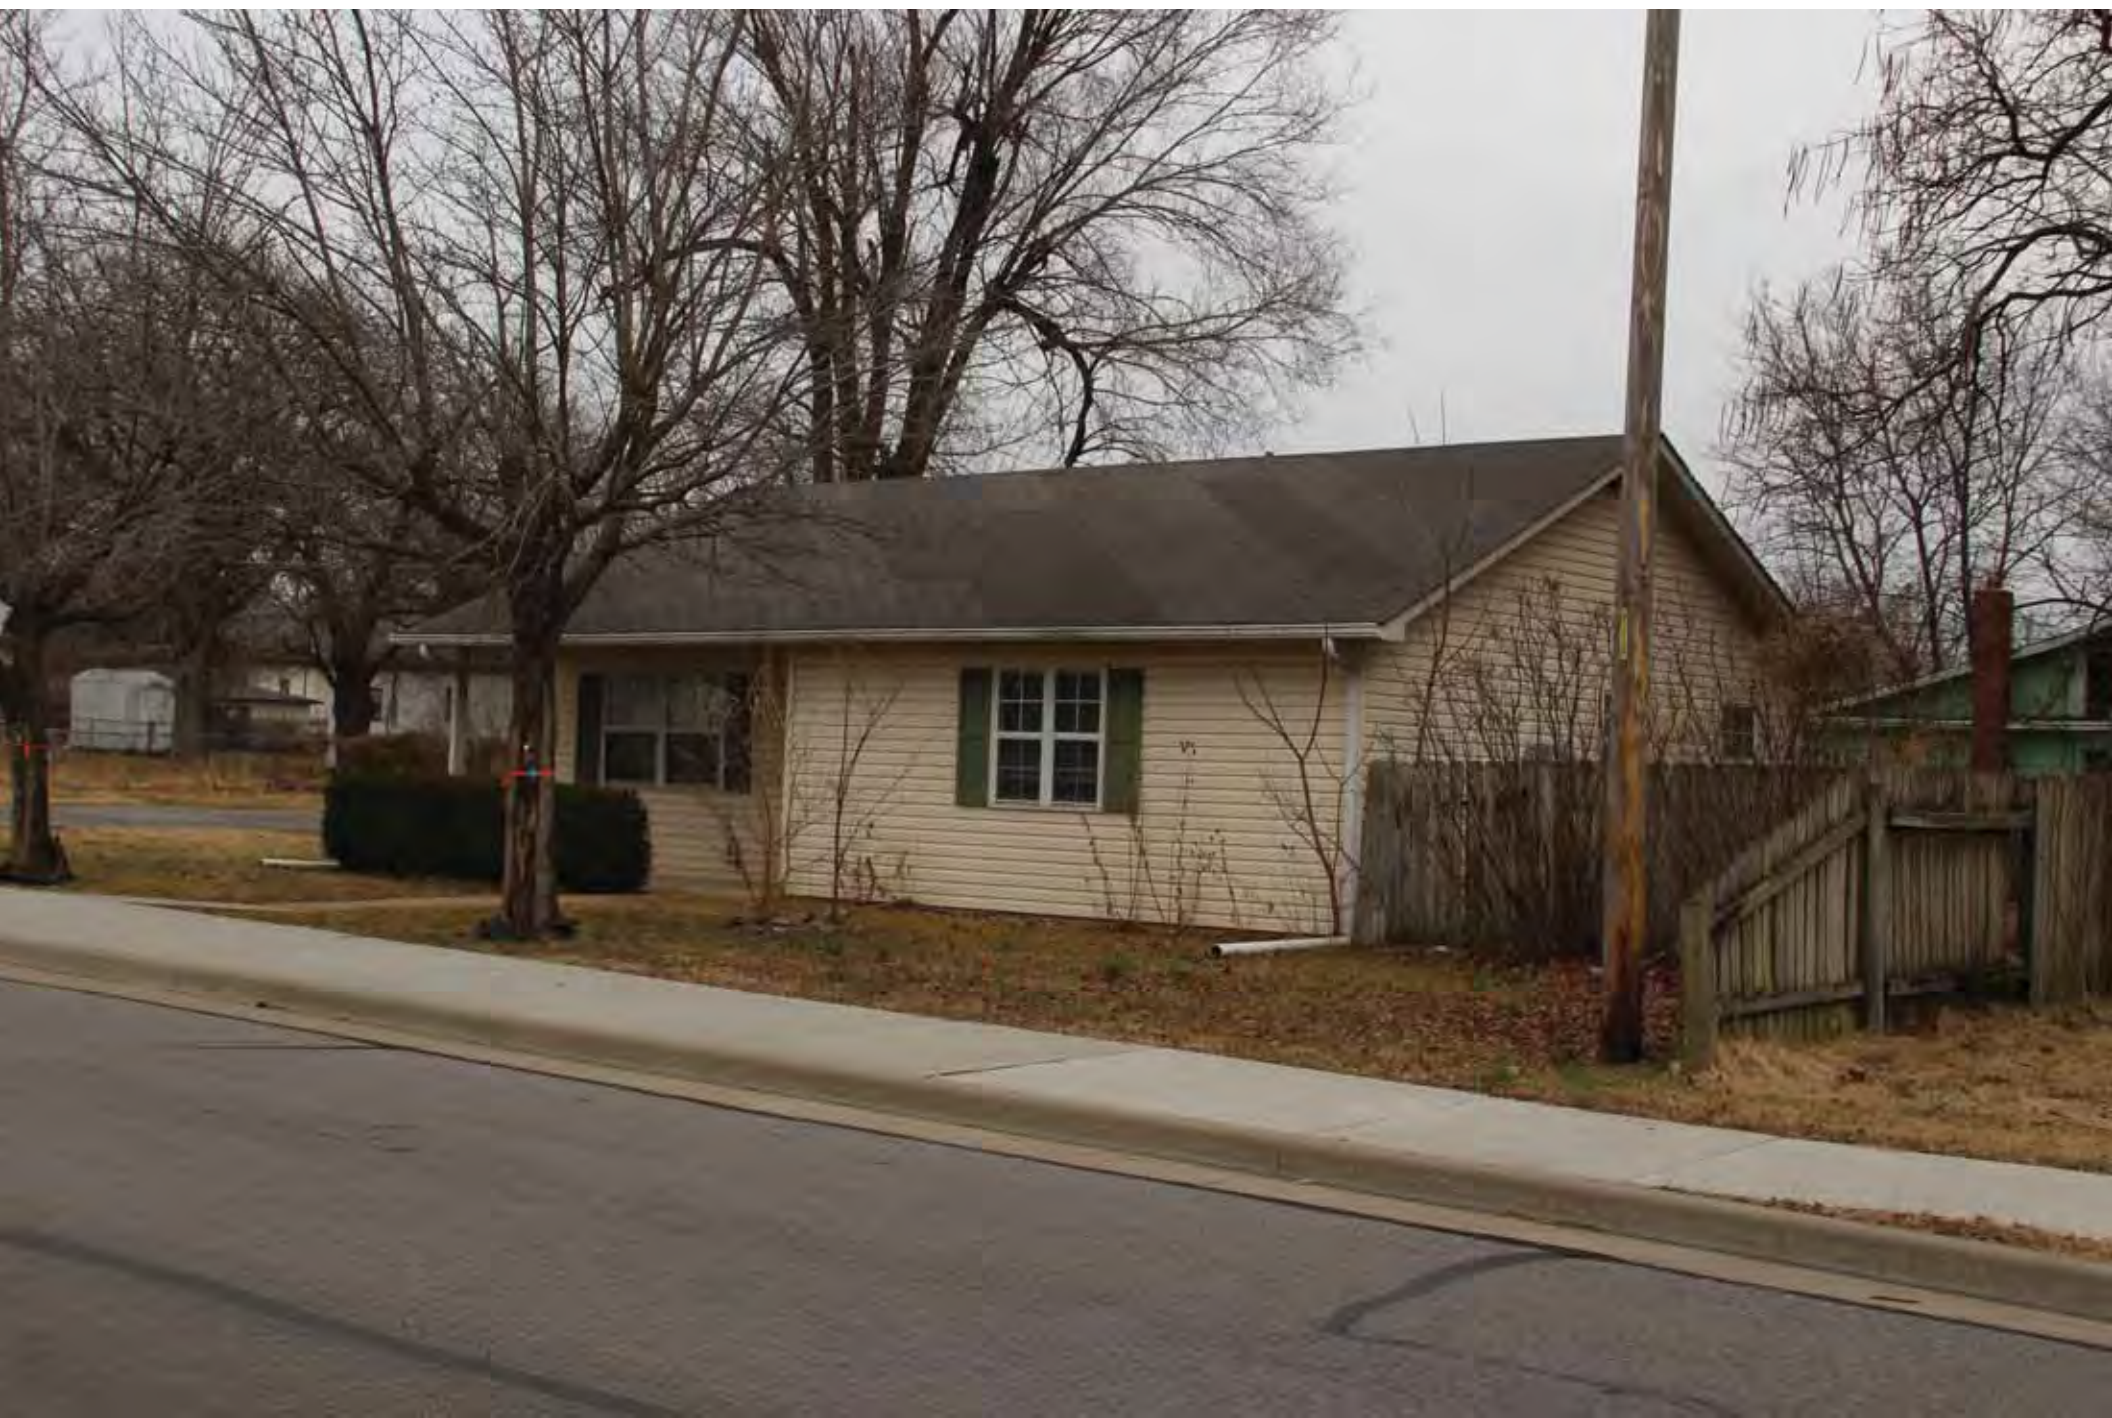
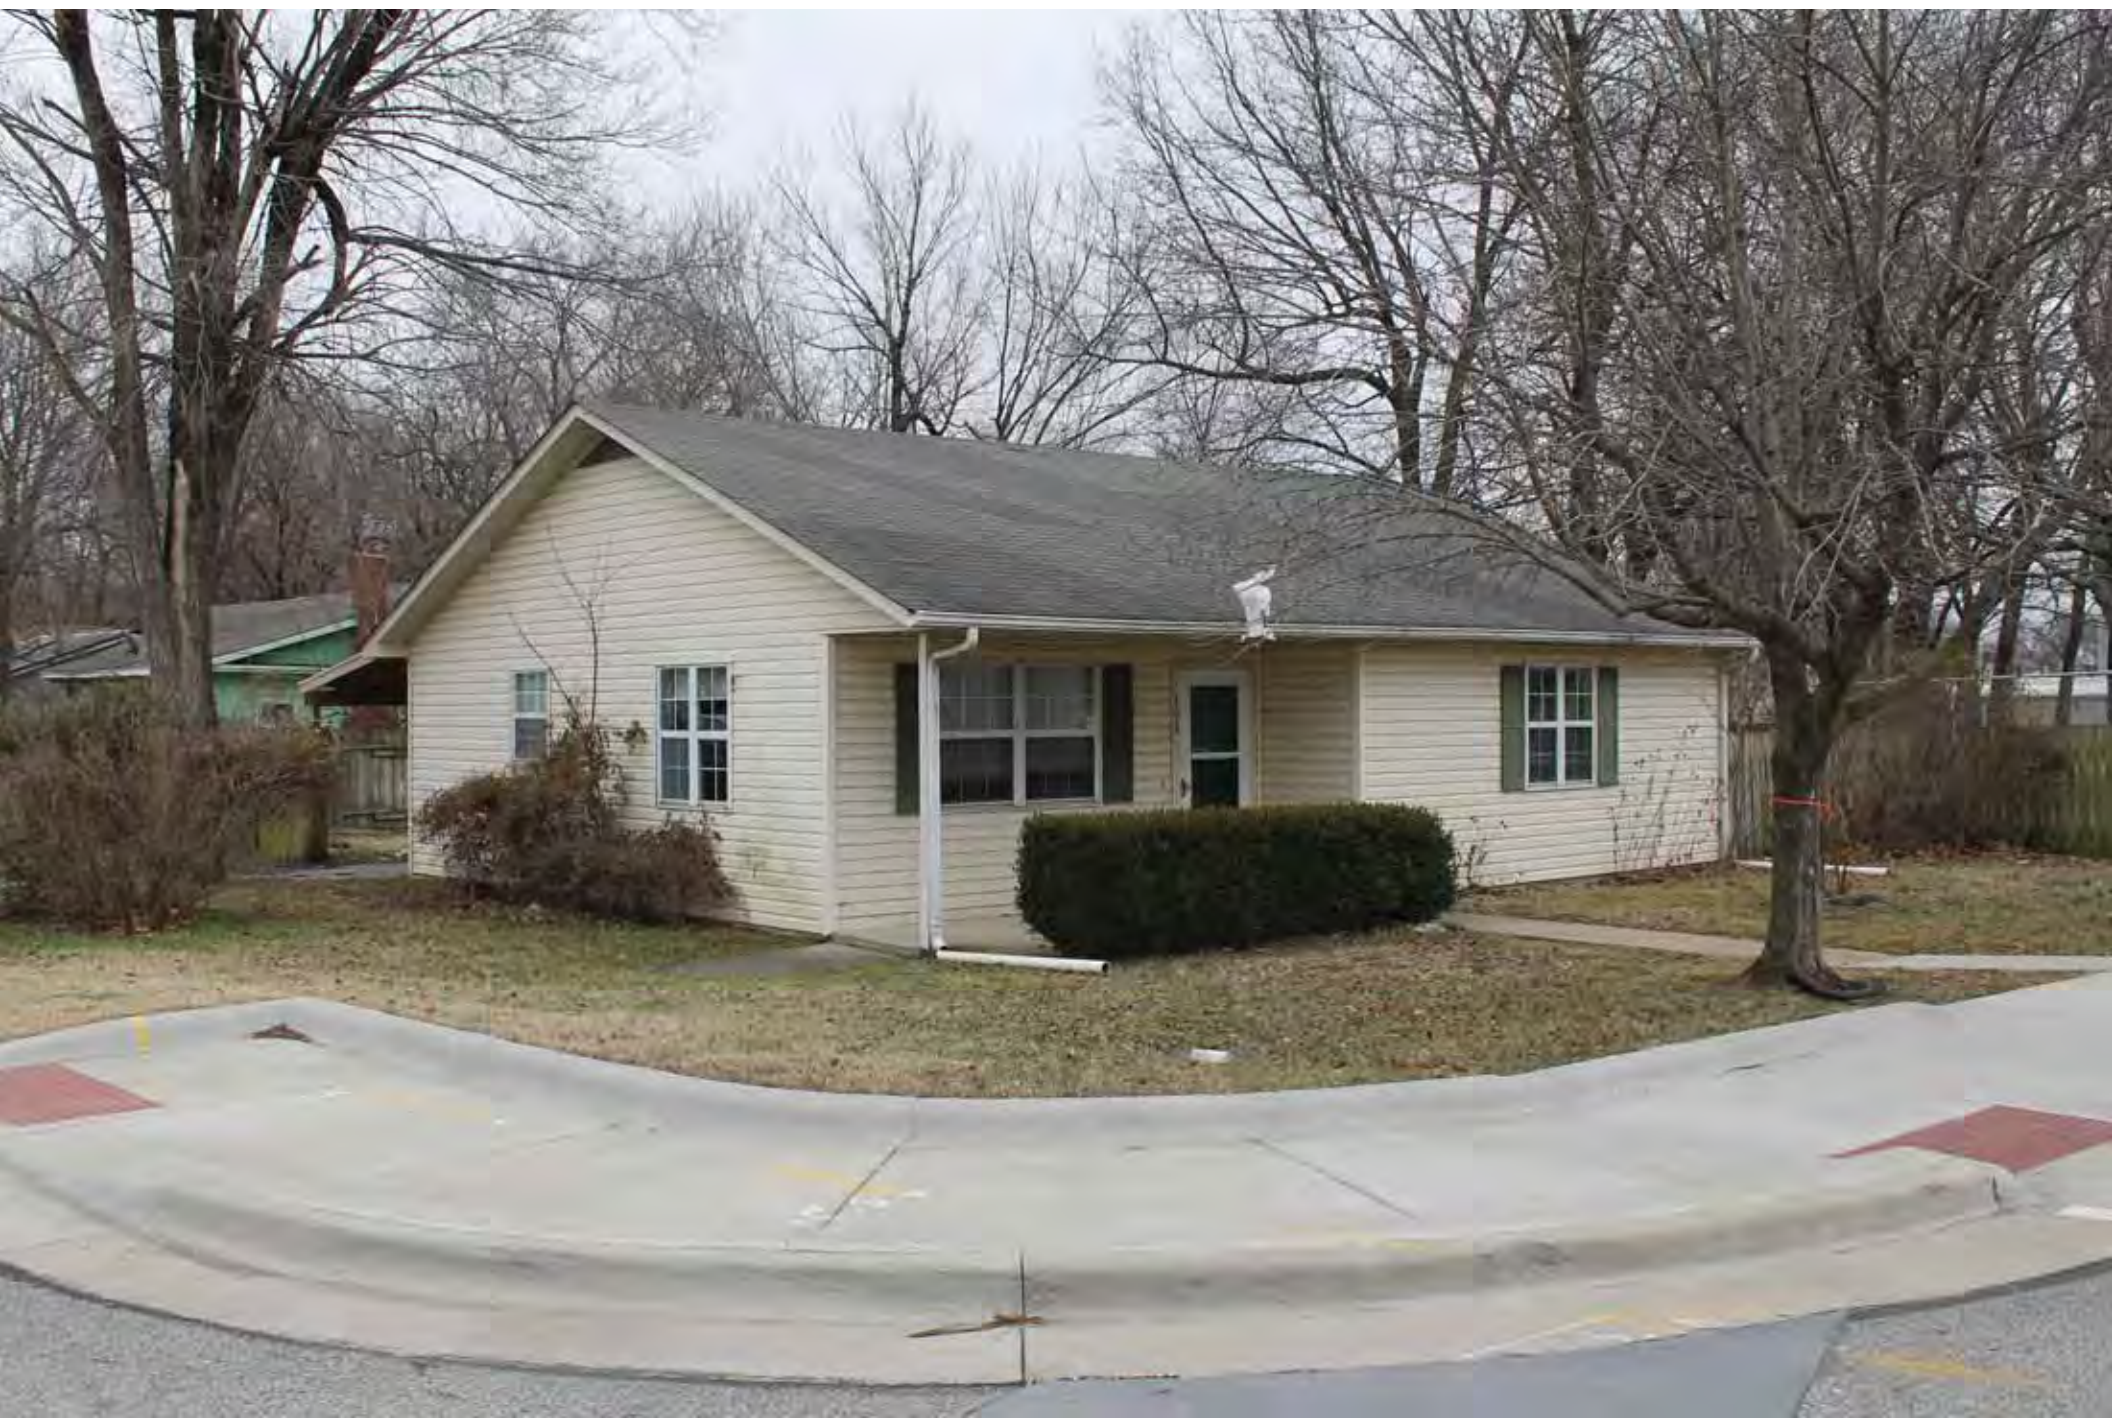
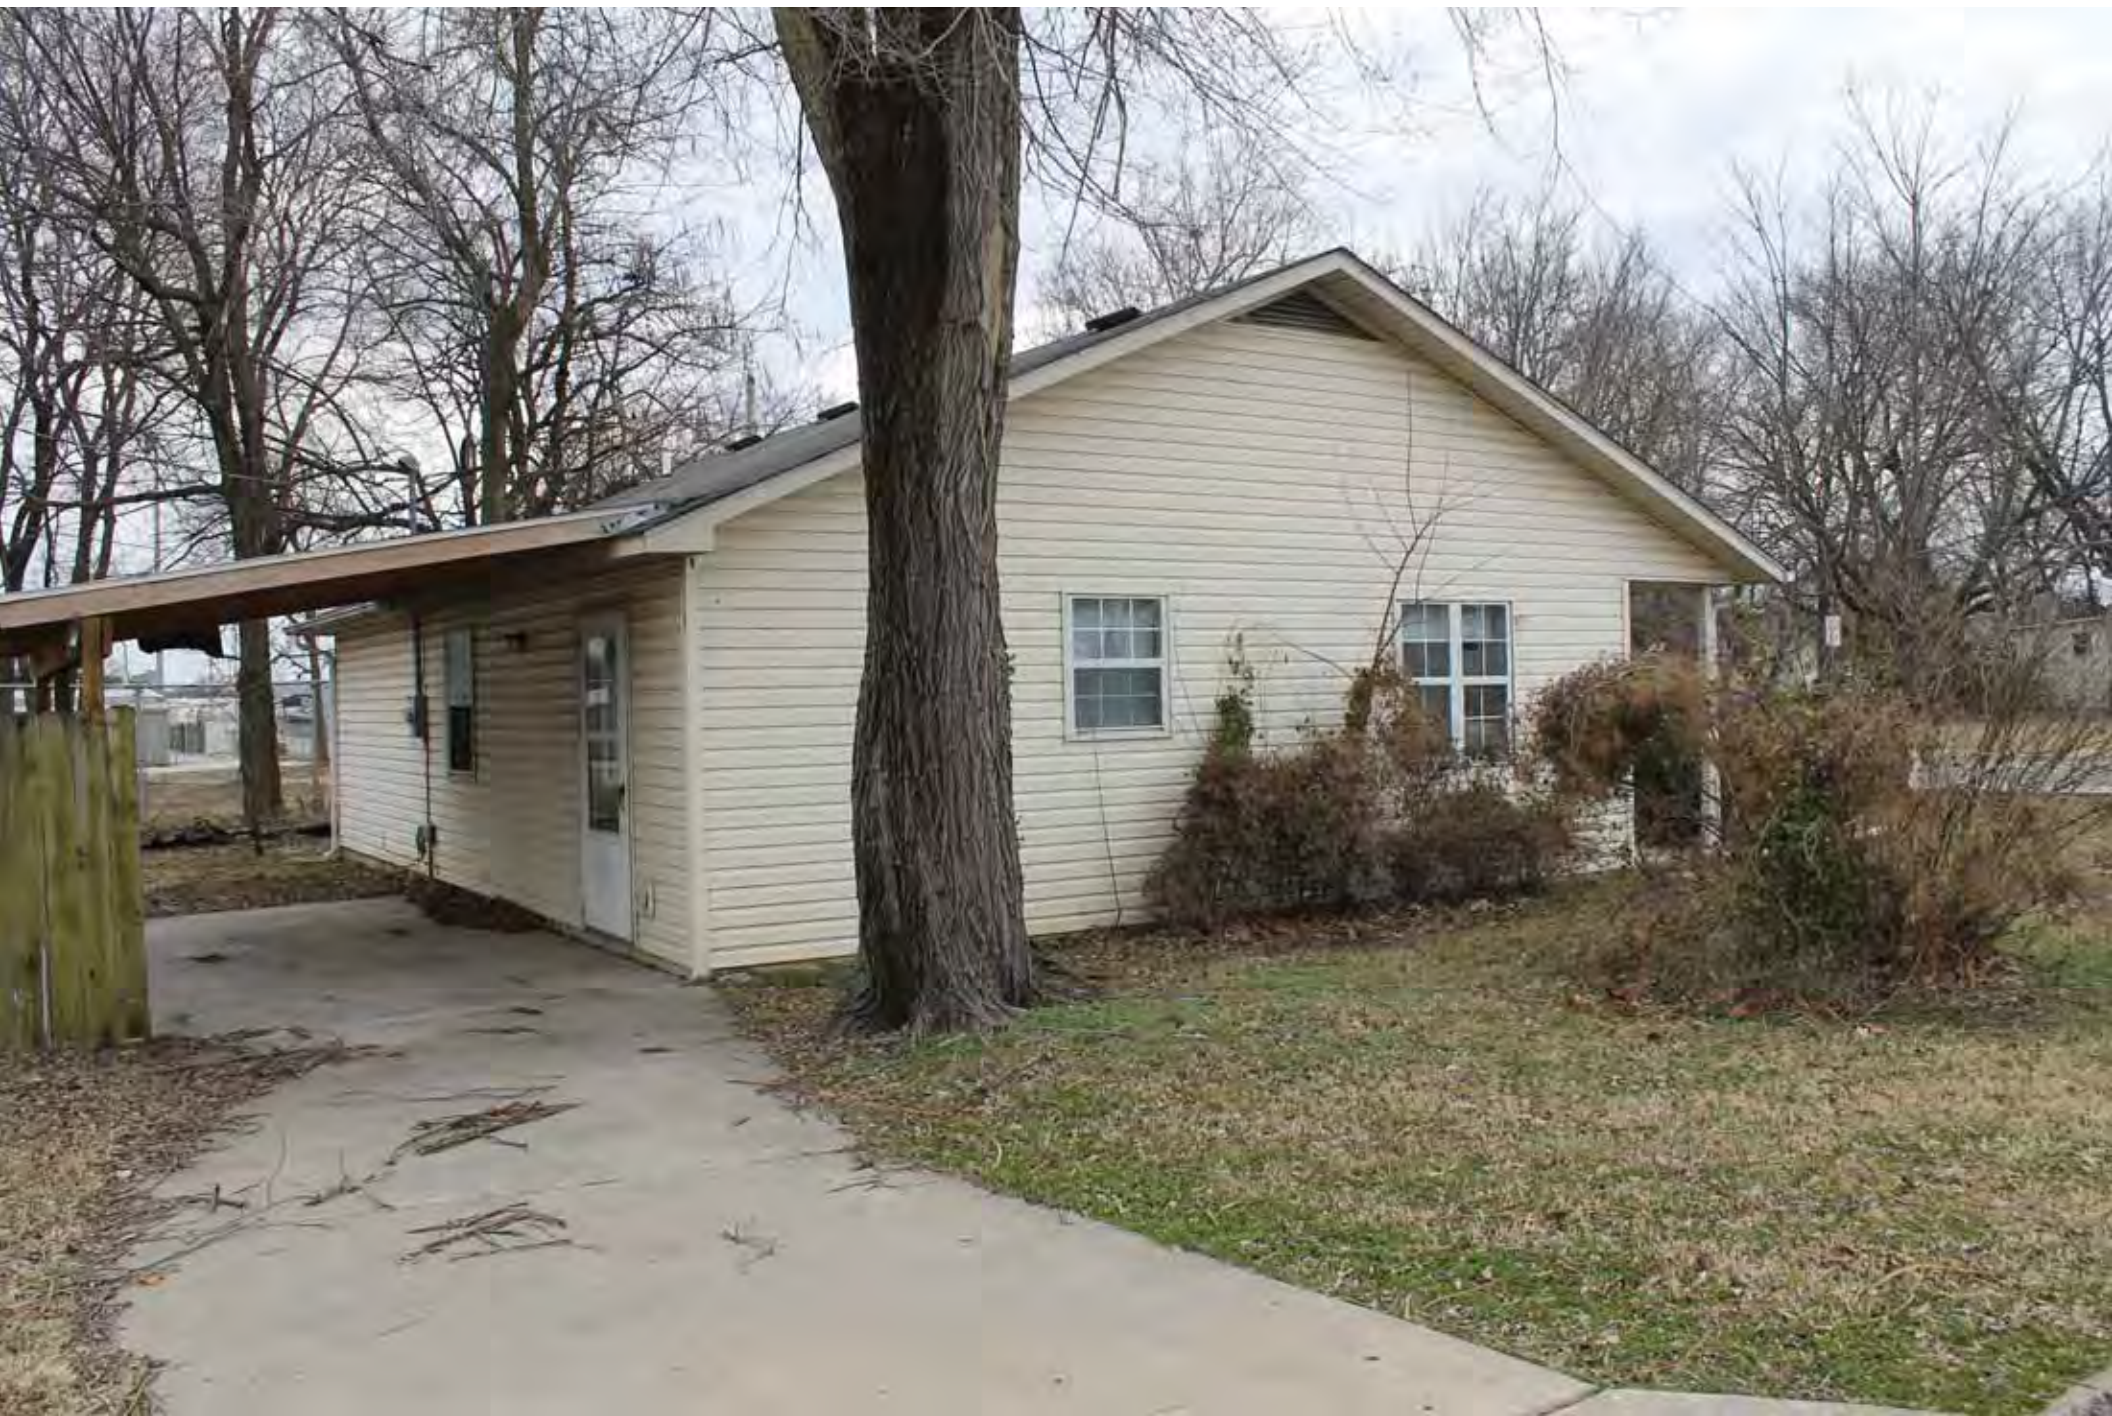
The property at 103 S. High Avenue features a single-story dwelling with an asphalt shingled gable roof, exterior vinyl siding and a concrete foundation. The primary (west) elevation features a half-width incised porch at the north end of the façade. Within the porch bay is a single door offset by paired six-over-six windows with faux shutters. The remaining elevation holds paired four-over-four windows with faux shutters. The north elevation holds paired four-over-four windows and a single six-over-six window. The south elevation holds two windows. The rear (east) elevation holds a door and a single window. A shed roof extends above the rear elevation, creating a carport.

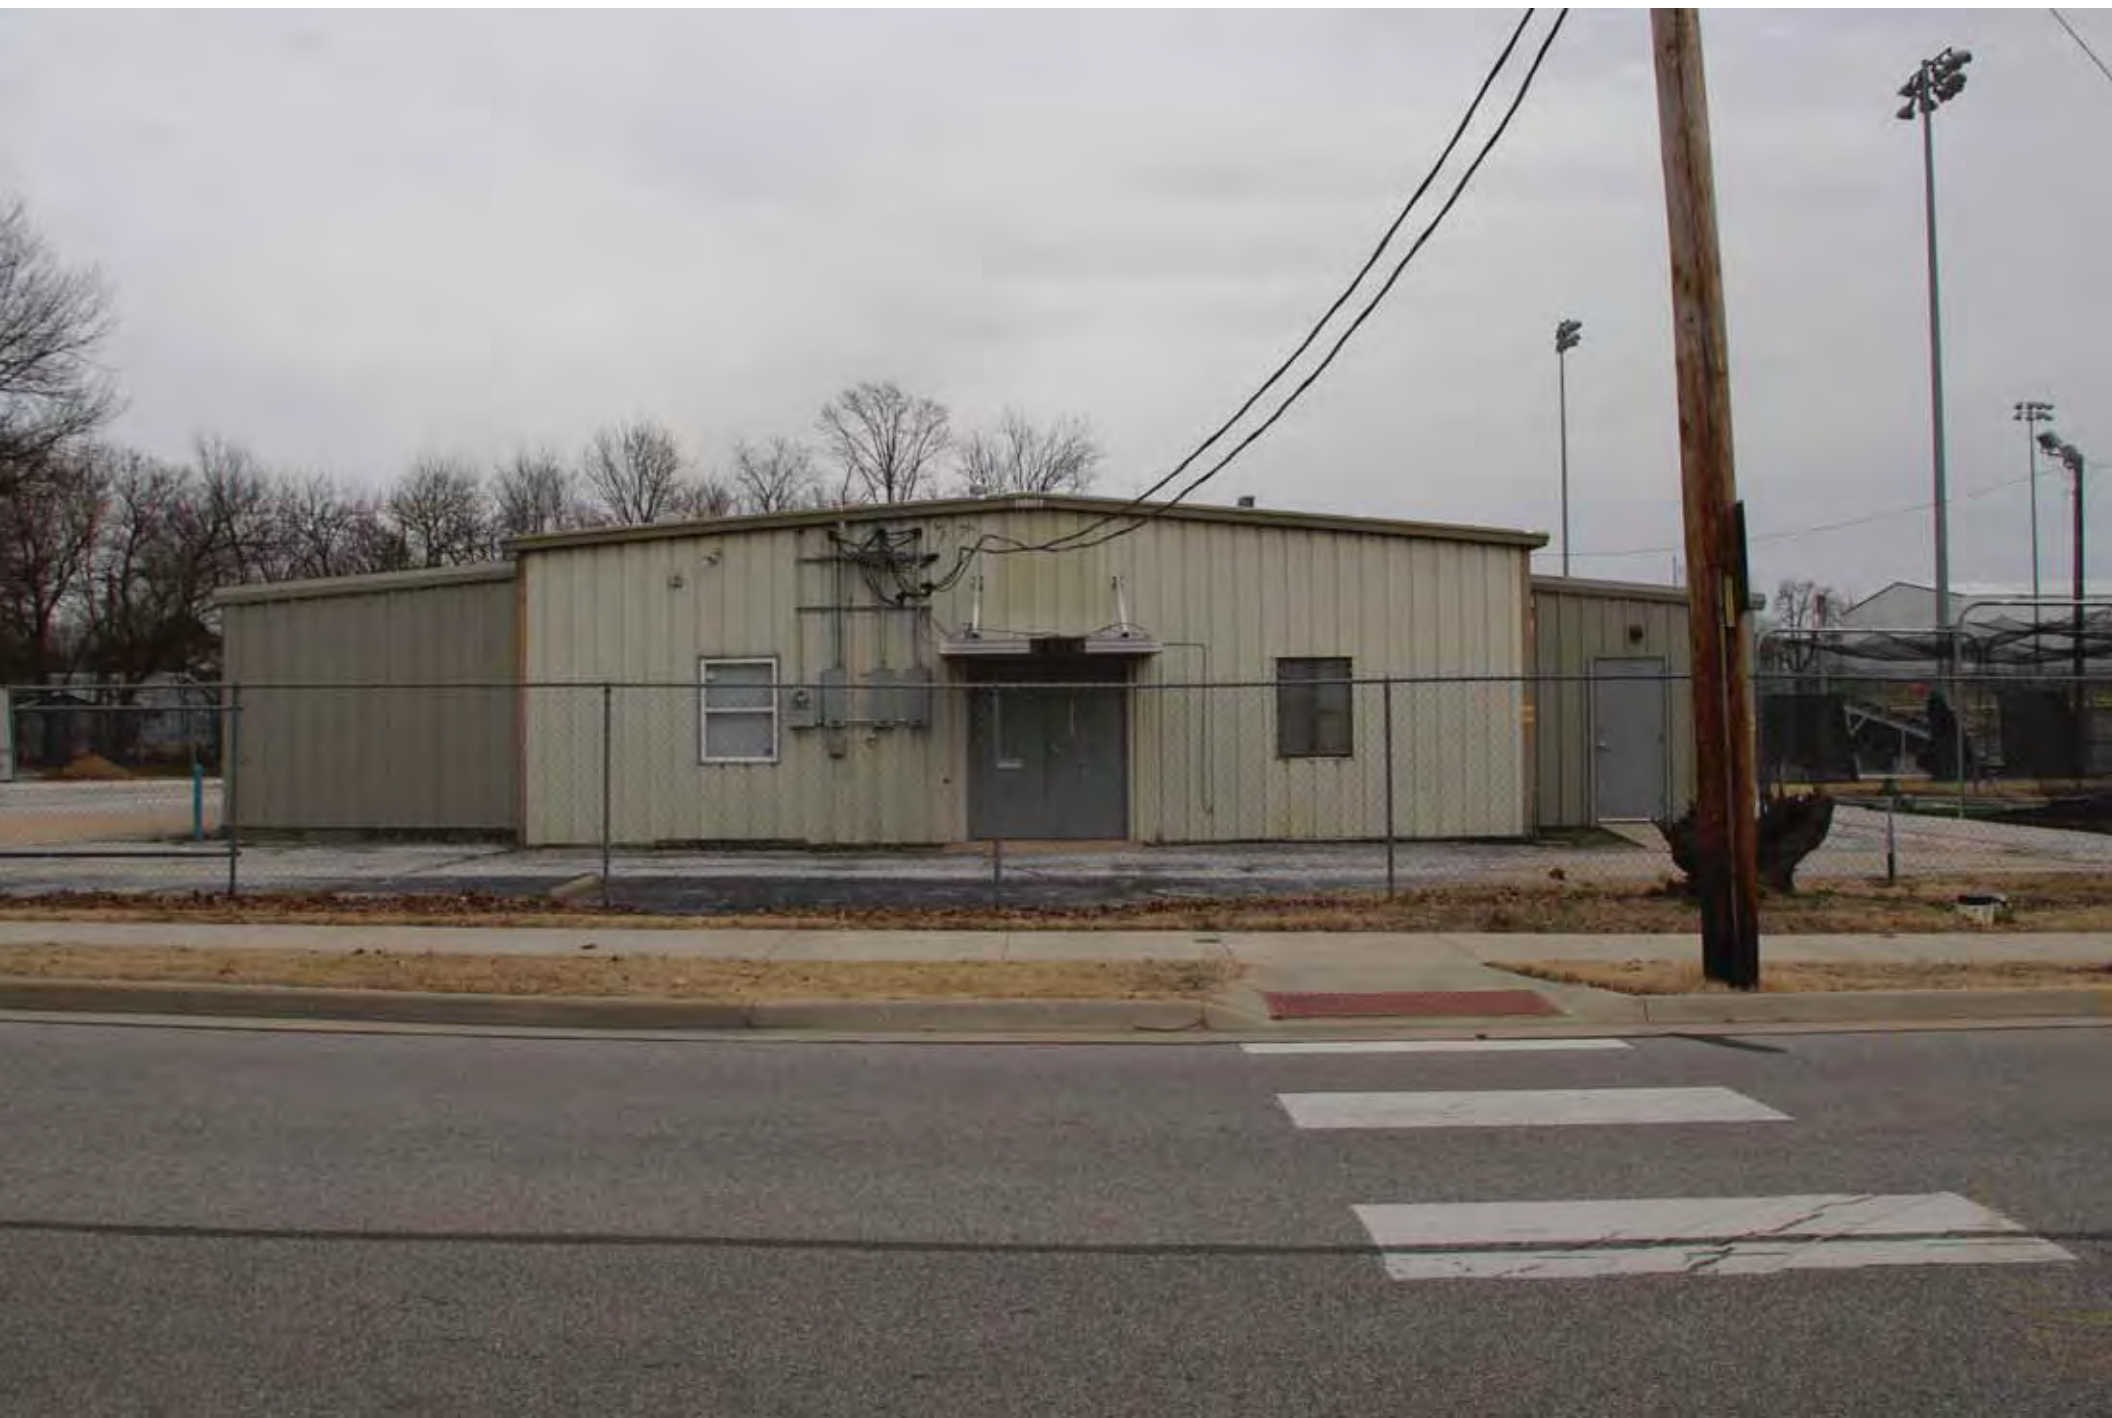
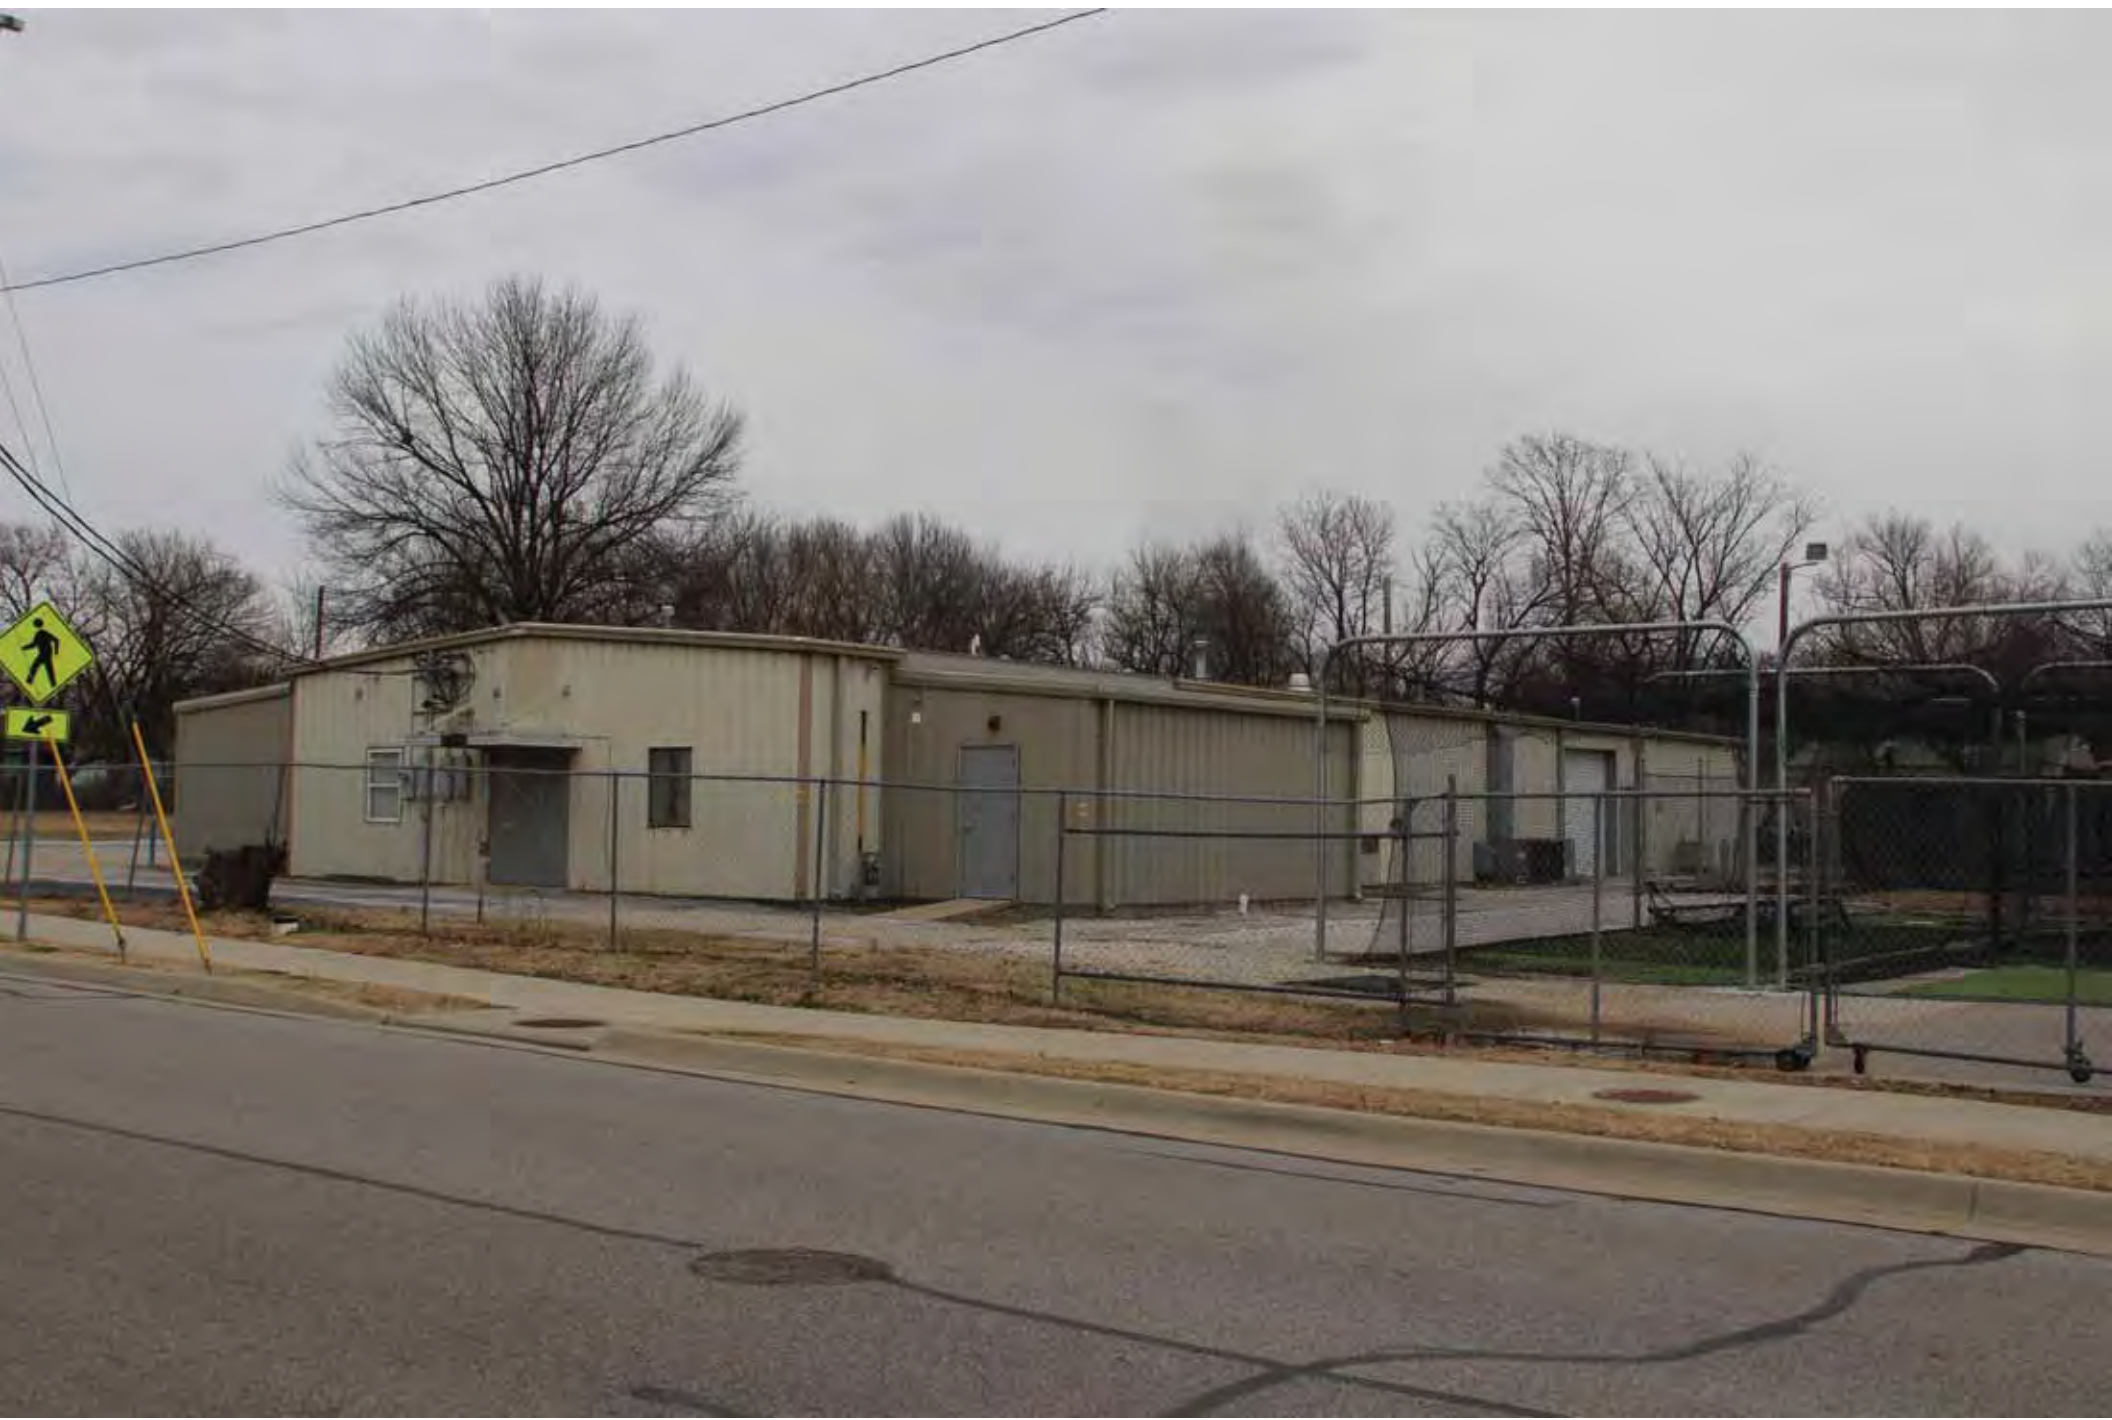
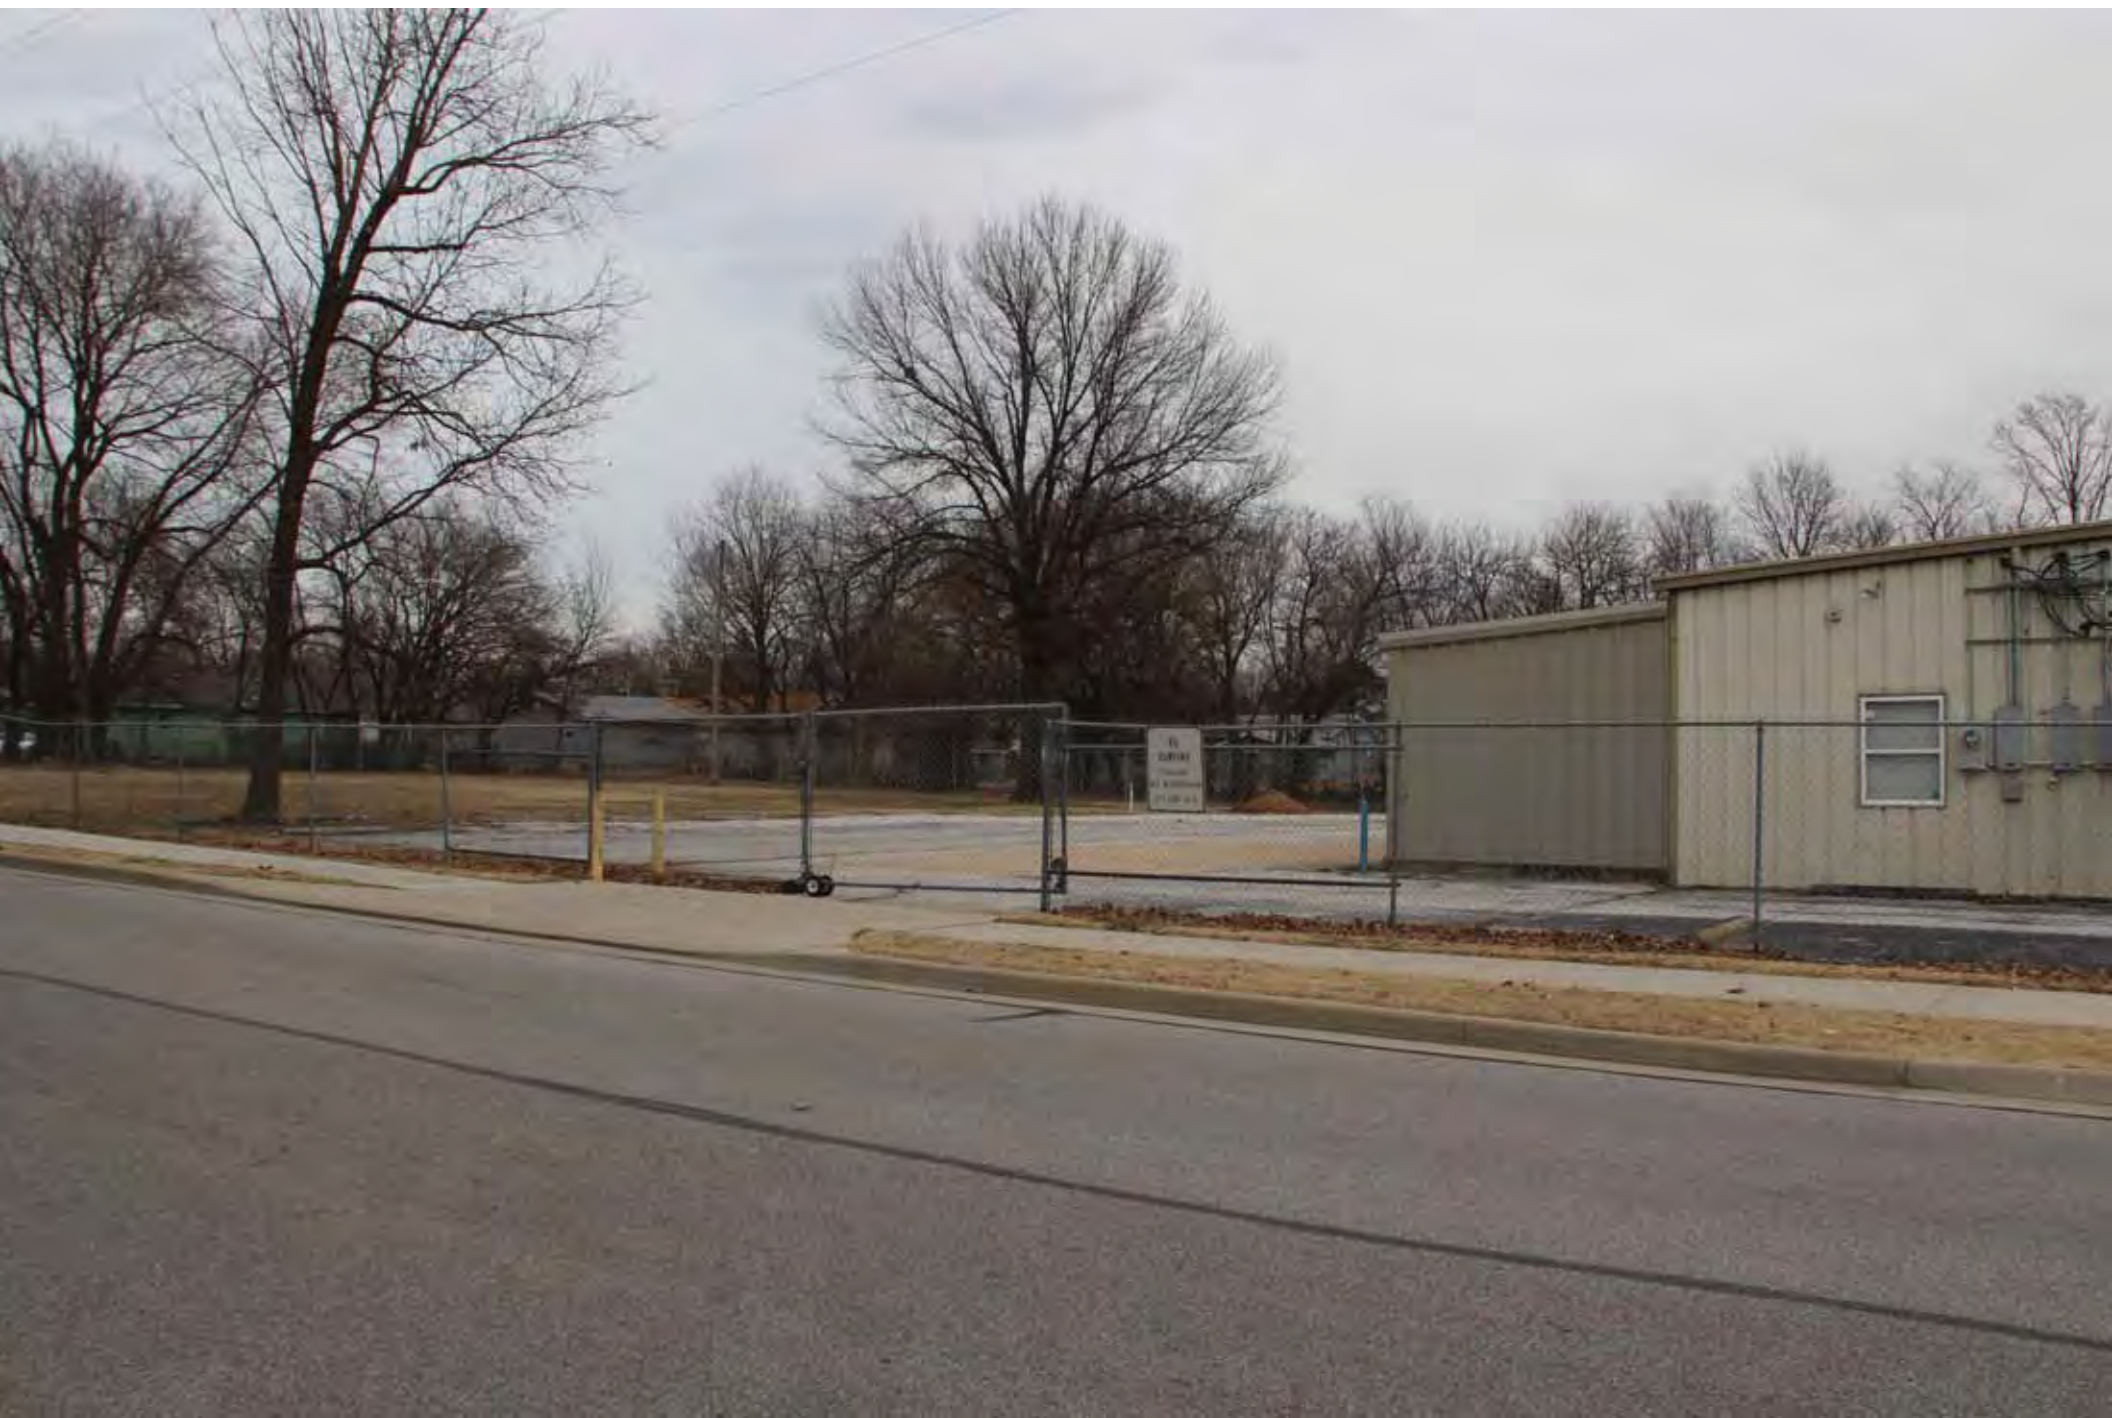
The property at 131 S. High Avenue is a single-story prefabricated metal warehouse. The primary (west) elevation features paired metal doors below a metal flat awning. The doors are flanked by one-over-one and one-by-one (sliding) windows. Shed wings are situated at the north and south elevations. The west elevation of the south shed wing supports a solid metal door. The south elevation supports an overhead track door.
