MISSOURI DEPARTMENT OF NATURAL RESOURCES
STATE HISTORIC PRESERVATION OFFICE, P.O. Box 176, Jefferson City, MO 65102
ARCHITECTURAL/HISTORIC INVENTORY FORM

1. Survey No. JP-AS-007-001		2. Survey name: East Town (Original Joplin) Historic Survey Phase 2	
3. County: JASPER		4. Address (Street No.) 618	Street (name) E. 2 nd Street
5. City: Joplin	Vicinity: <input type="checkbox"/>	6. Geographical Reference:	7. Township/Range/Section: T: R: S:
8. Historic name (if known):		9. Present/other name (if known):	
10. Ownership: <input checked="" type="checkbox"/> Private <input type="checkbox"/> Public		11a. Historic use (if known): Domestic: Single Dwelling	11b. Current use: Domestic: Single Dwelling

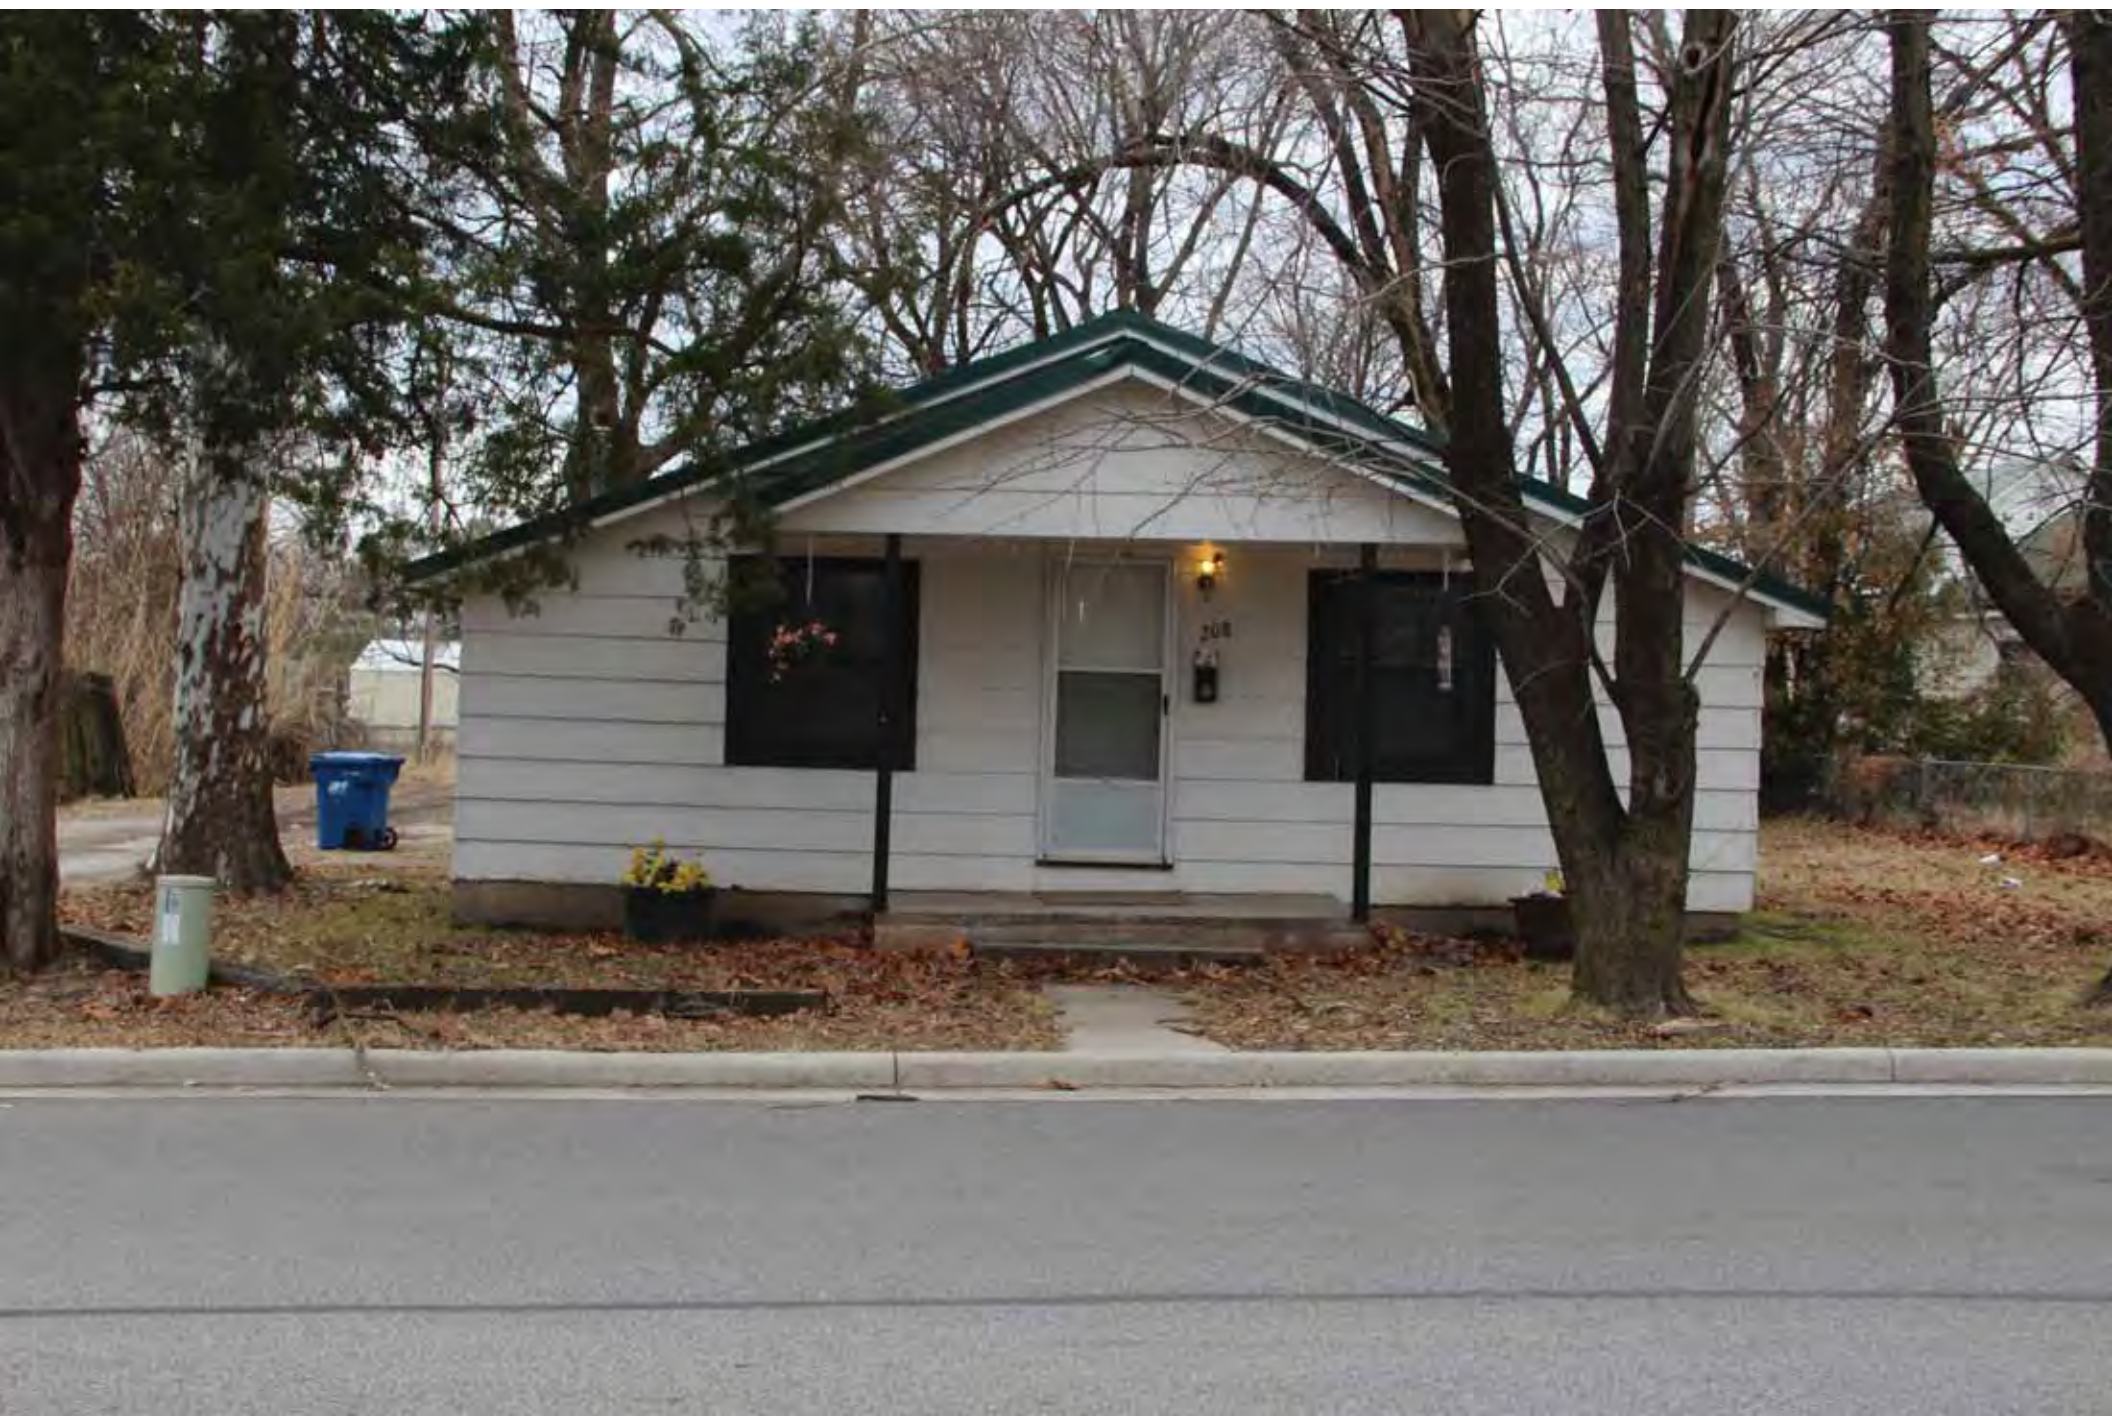
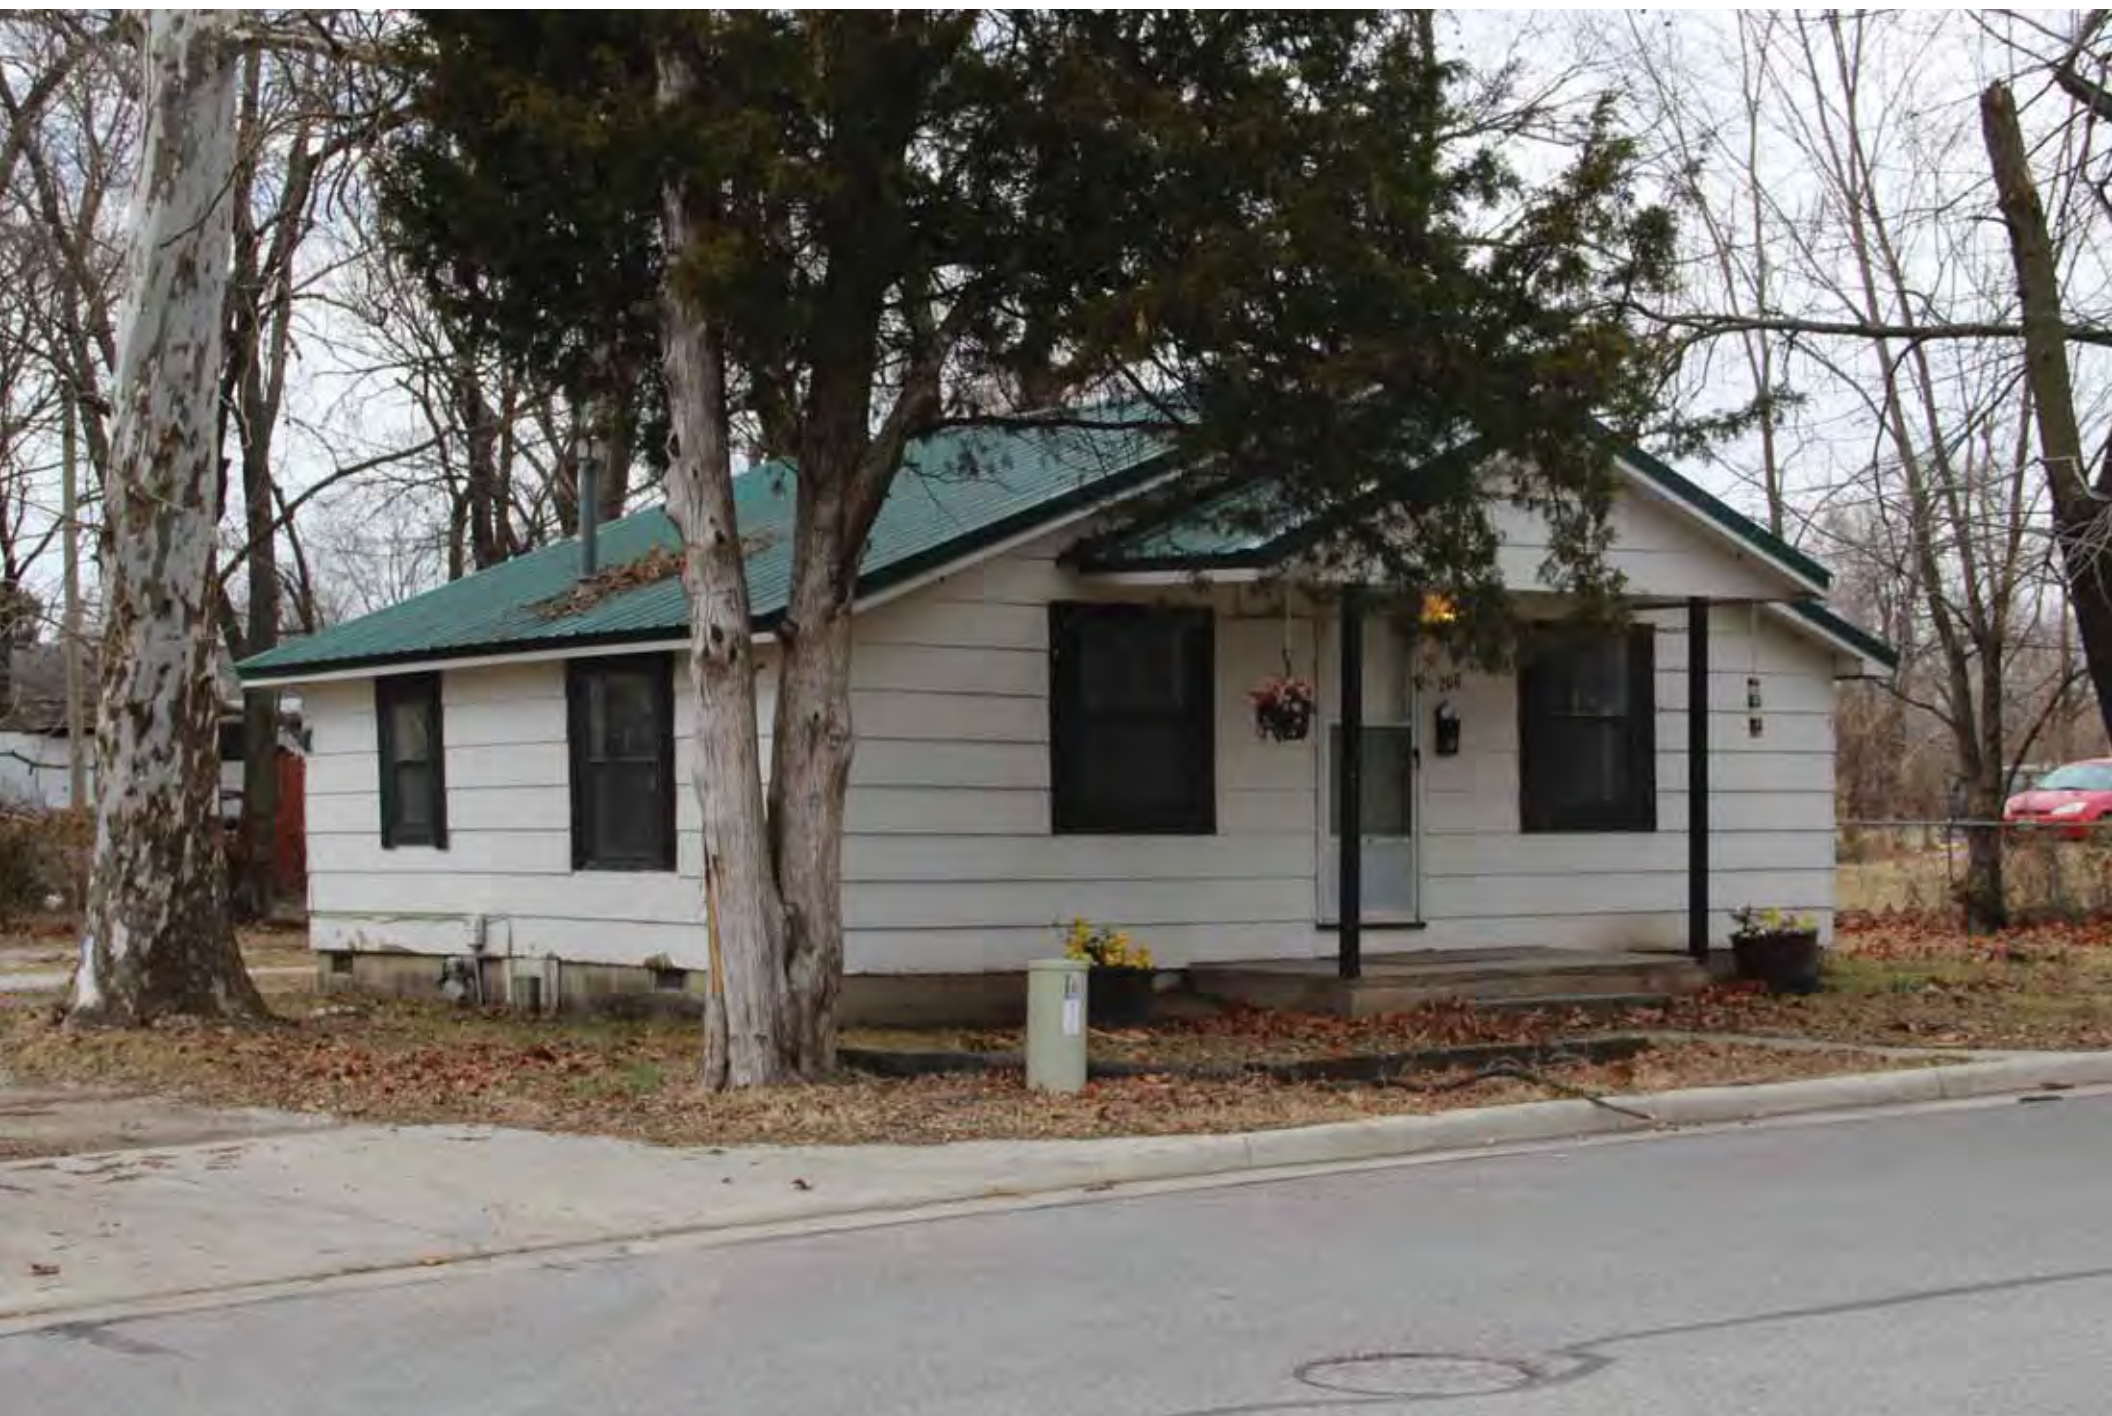
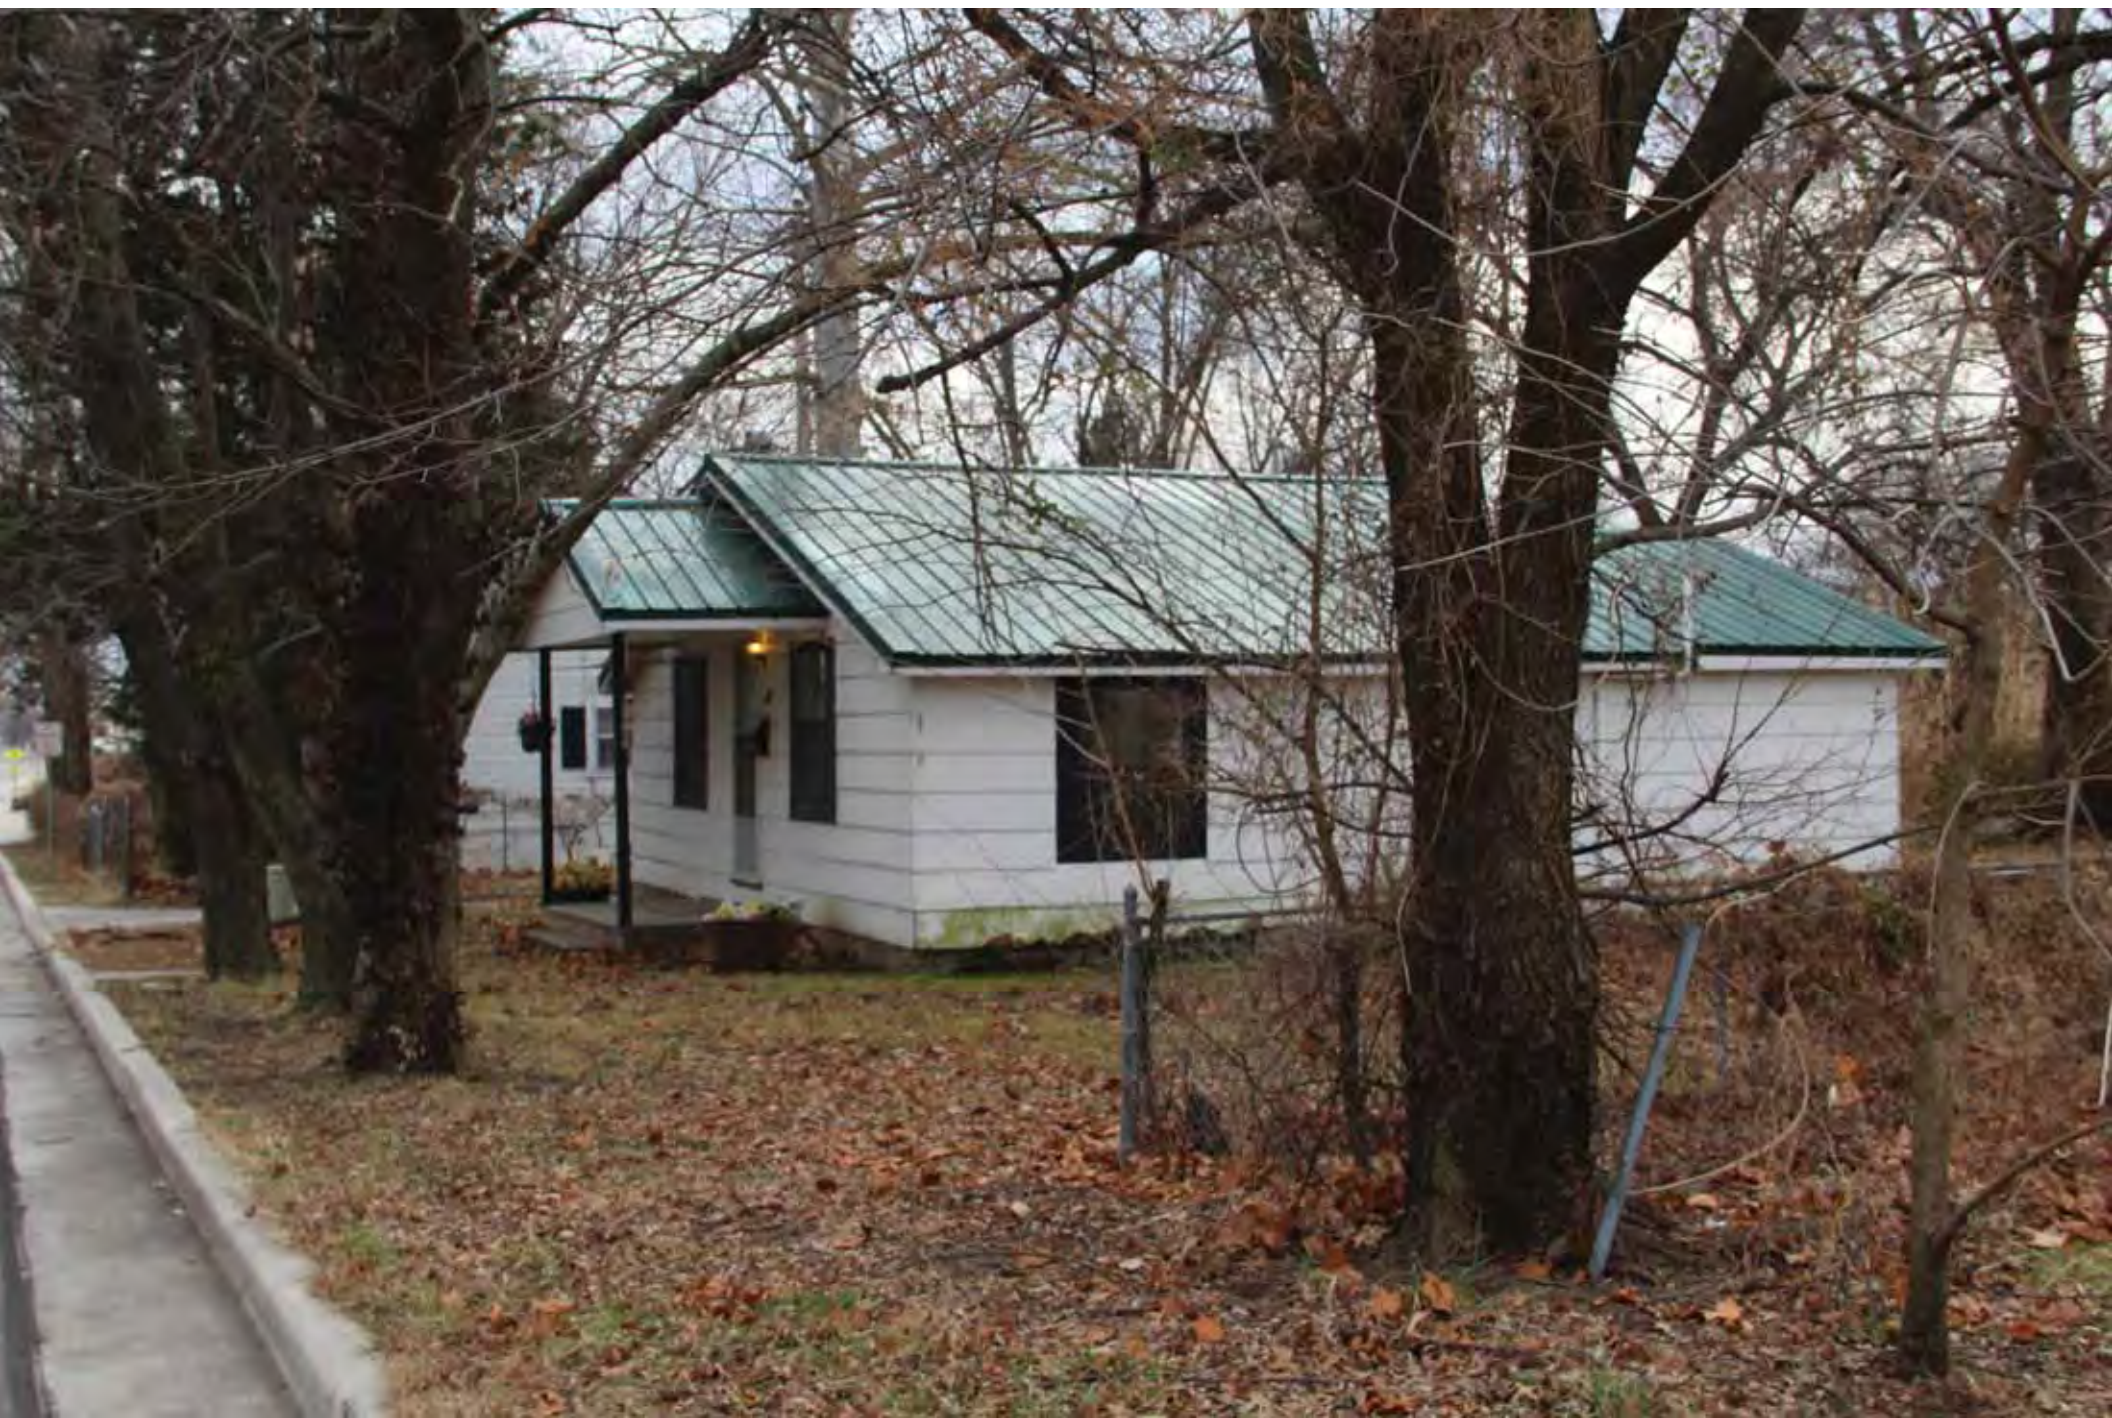
The property at 208 S. High Avenue features a single-story dwelling with an asphalt shingled gable roof, exterior wide board (replacement) siding and a concrete foundation. The primary (east) elevation supports a central gabled porch supported by slender columns. Within the porch bay is a solid door. The porch and entry are flanked by six-over-six windows. The south elevation holds two windows. The north elevation holds one window.

This dwelling has been altered (c. 1980) per assessor's records. Alterations appear to include replacement siding, windows and doors. These changes compromise the property's architectural integrity, rendering it individually ineligible for the National Register of Historic Places. The dwelling is not situated in an area recommended as a historic district.

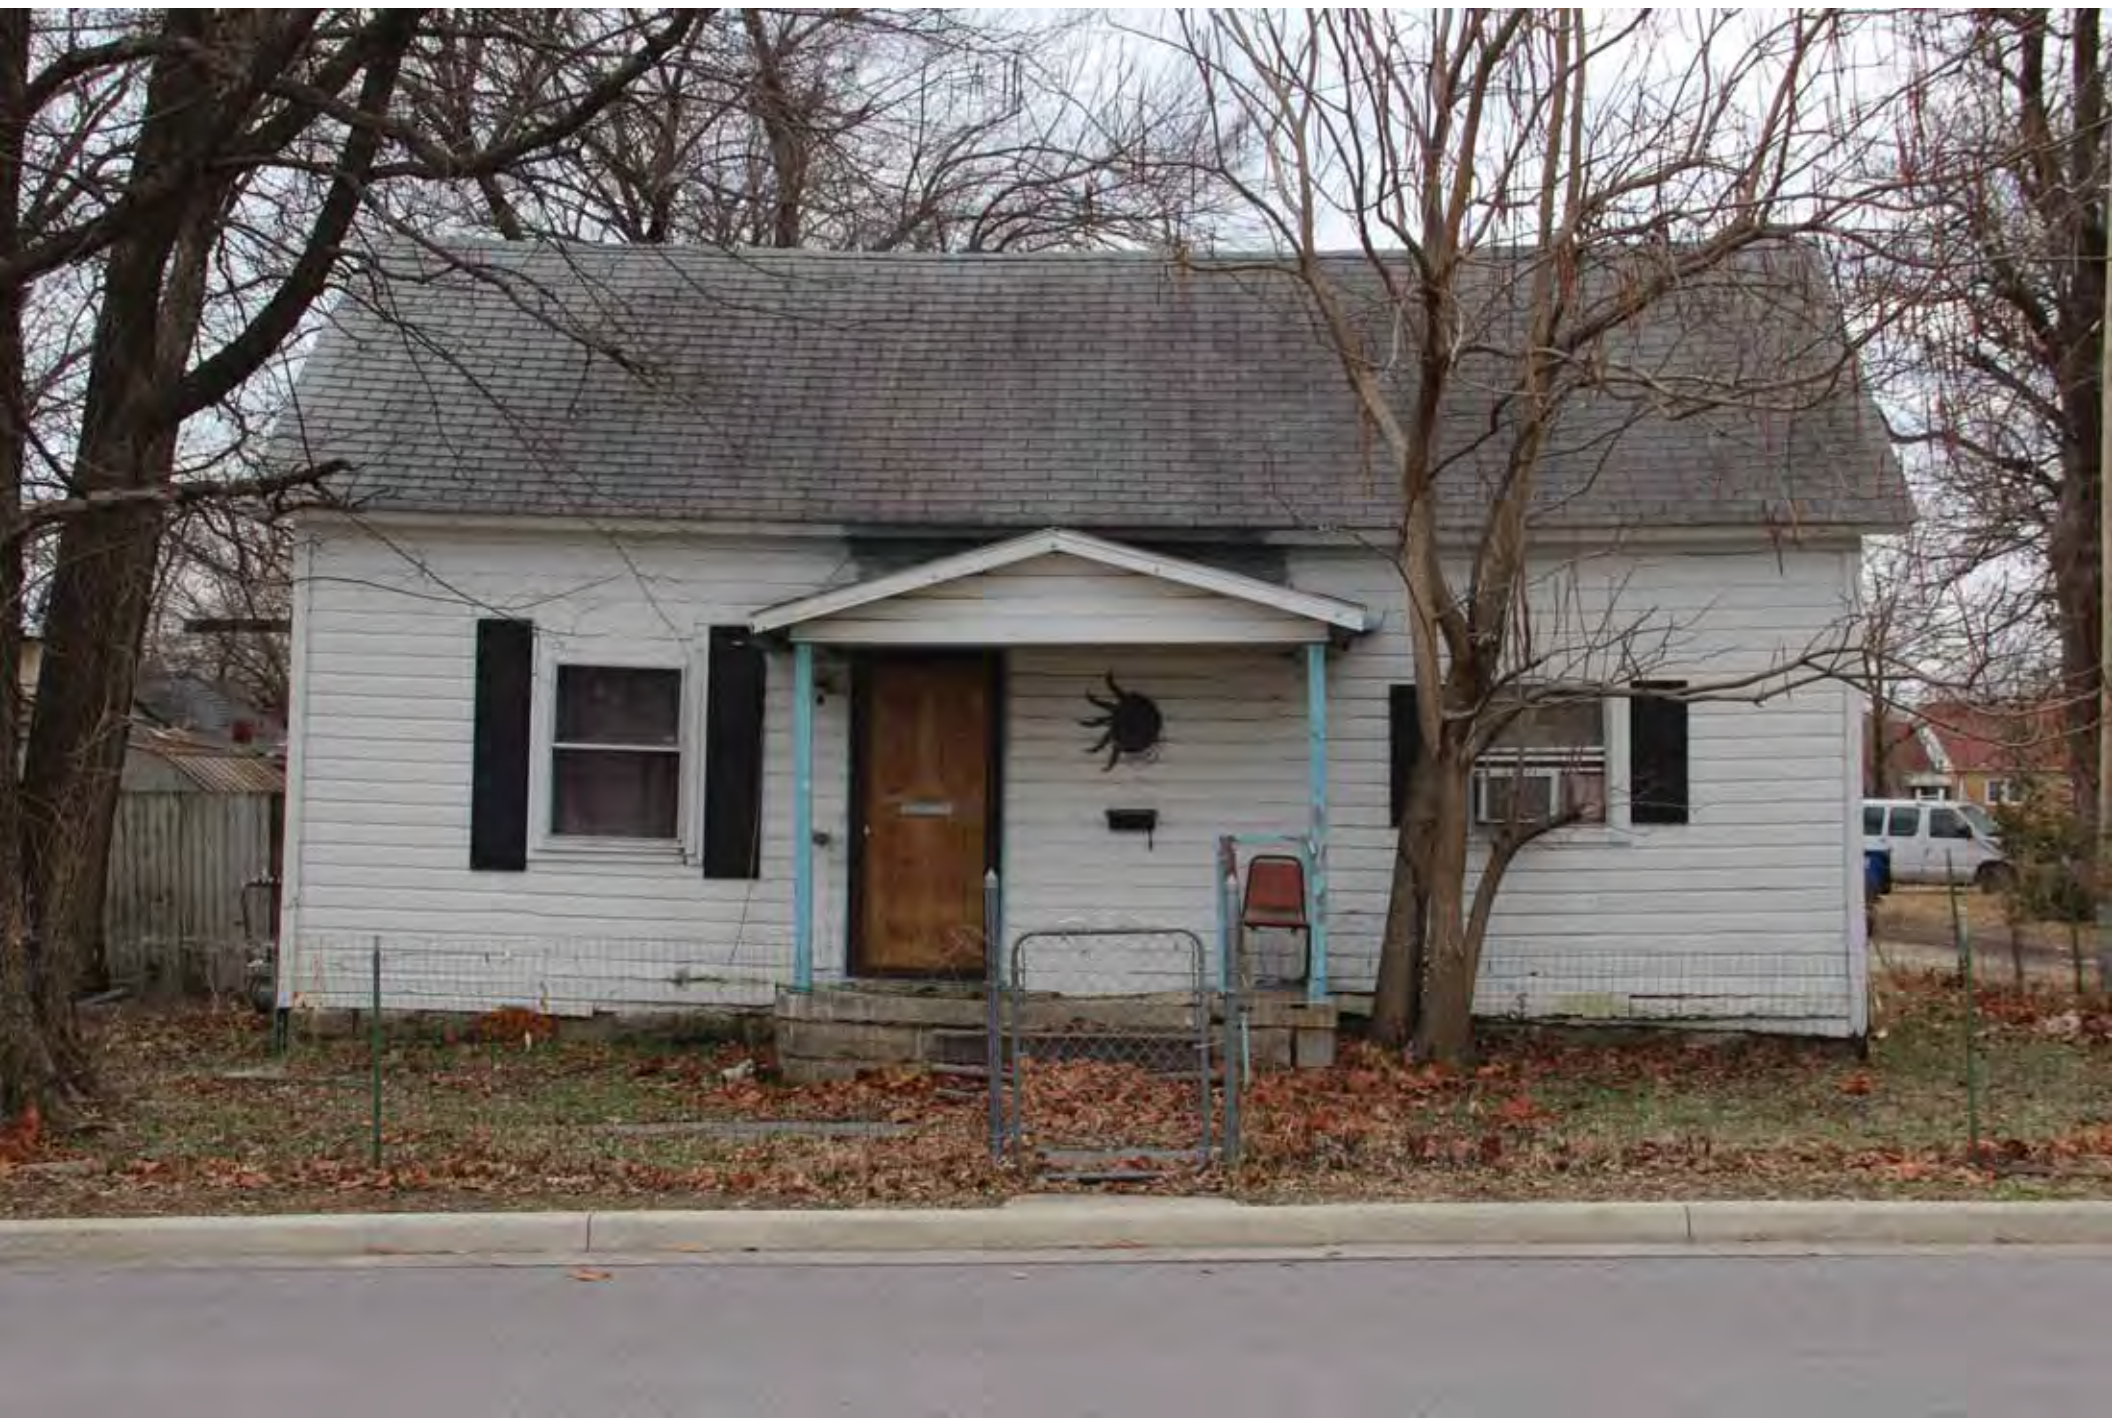
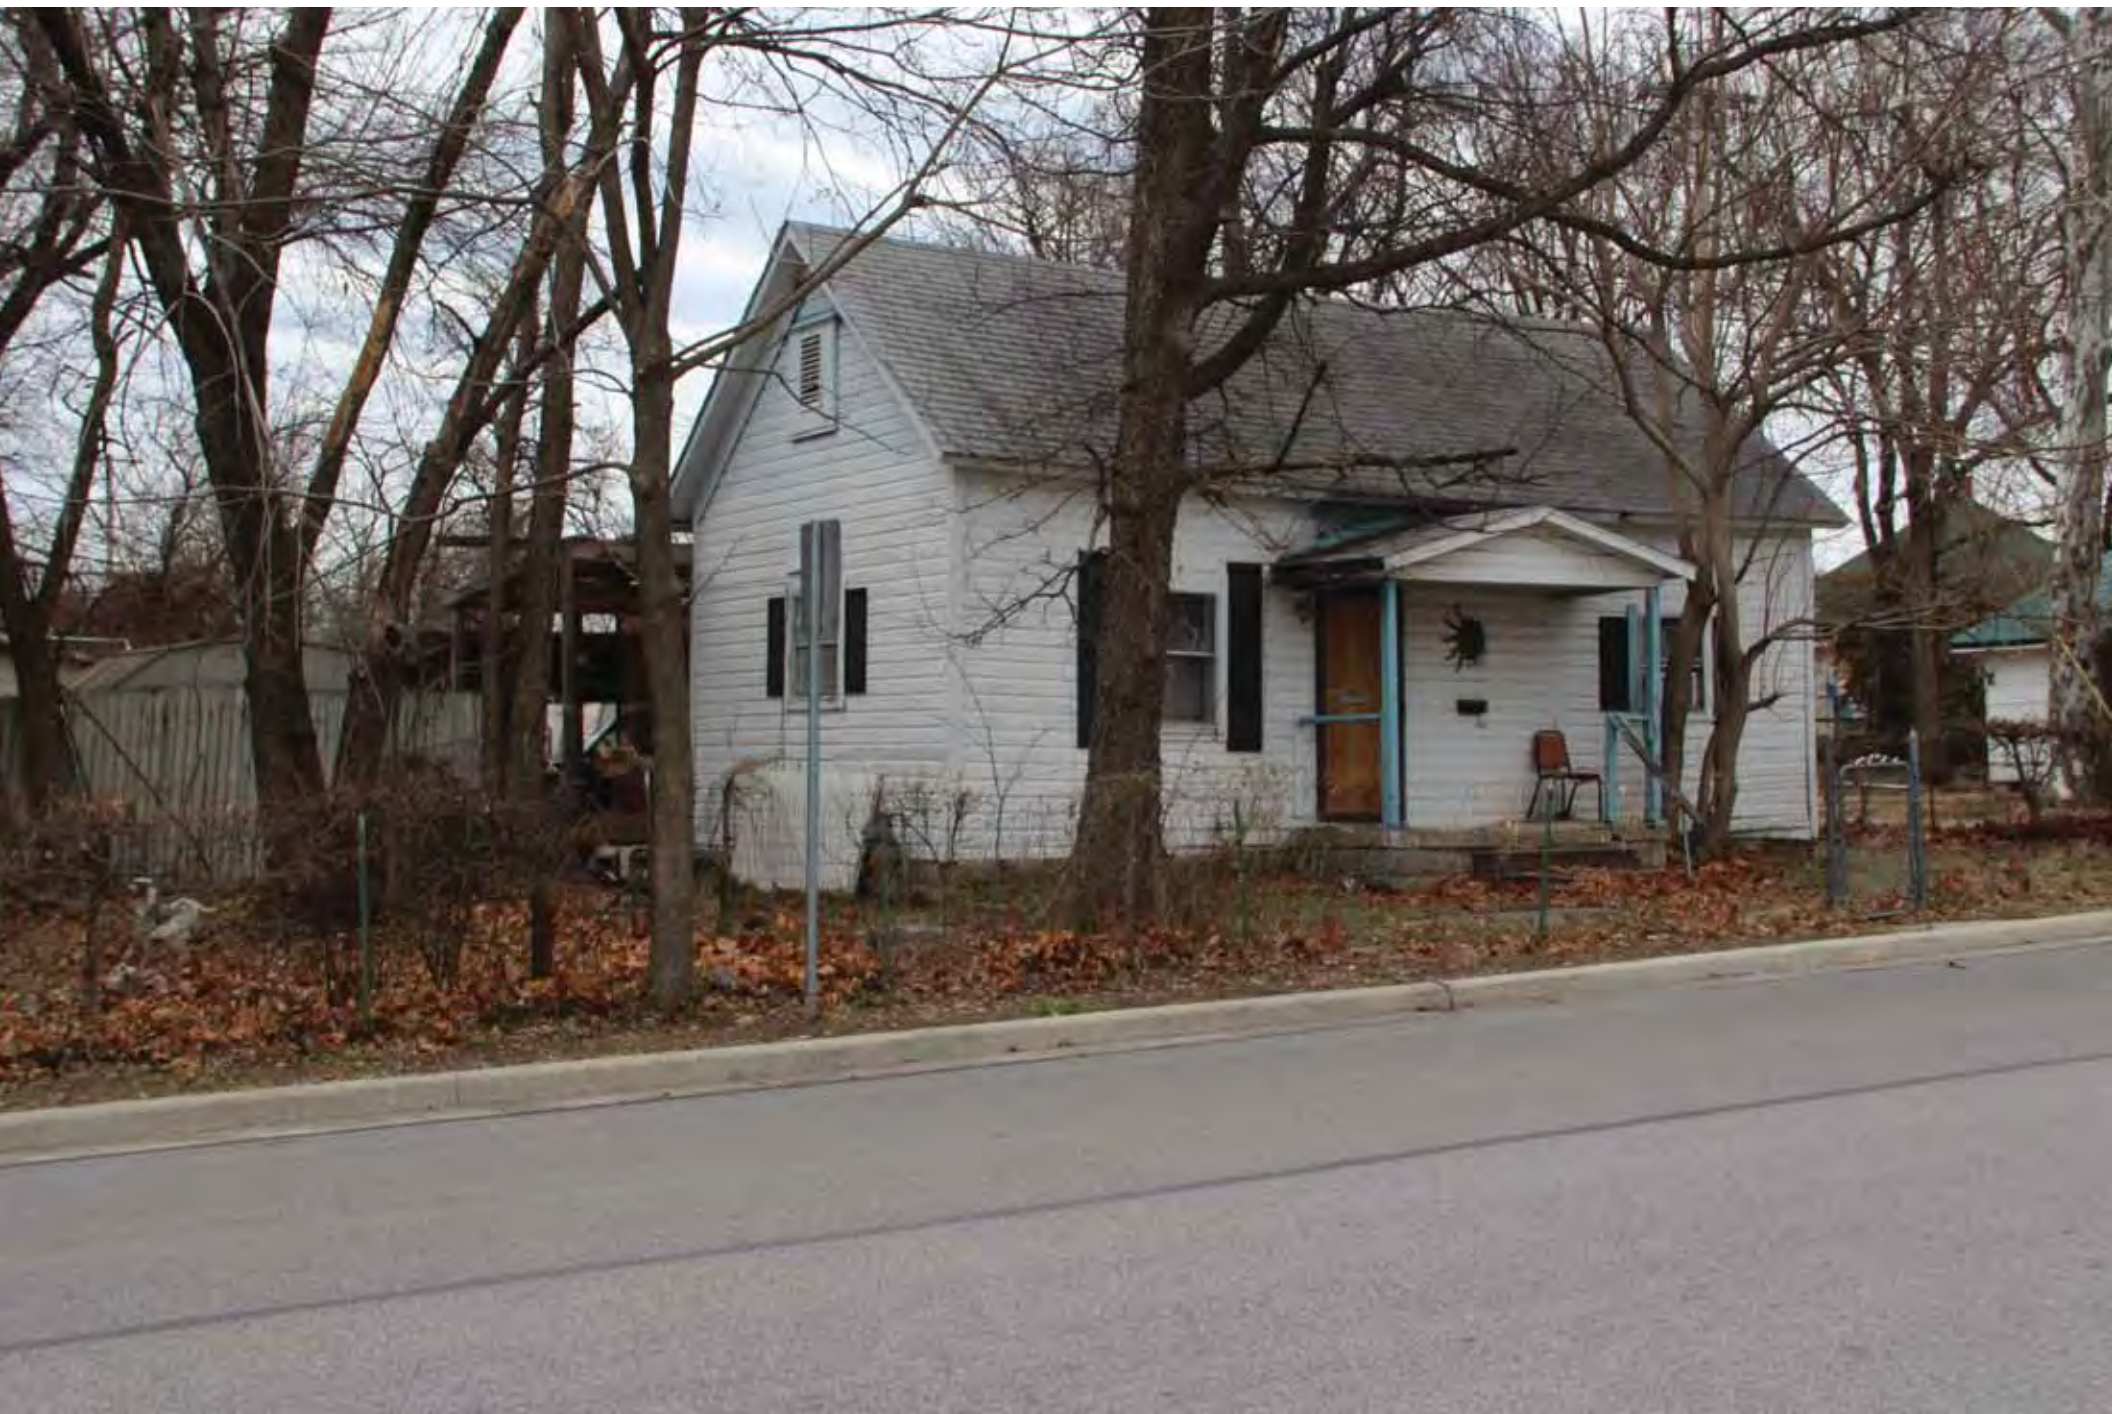
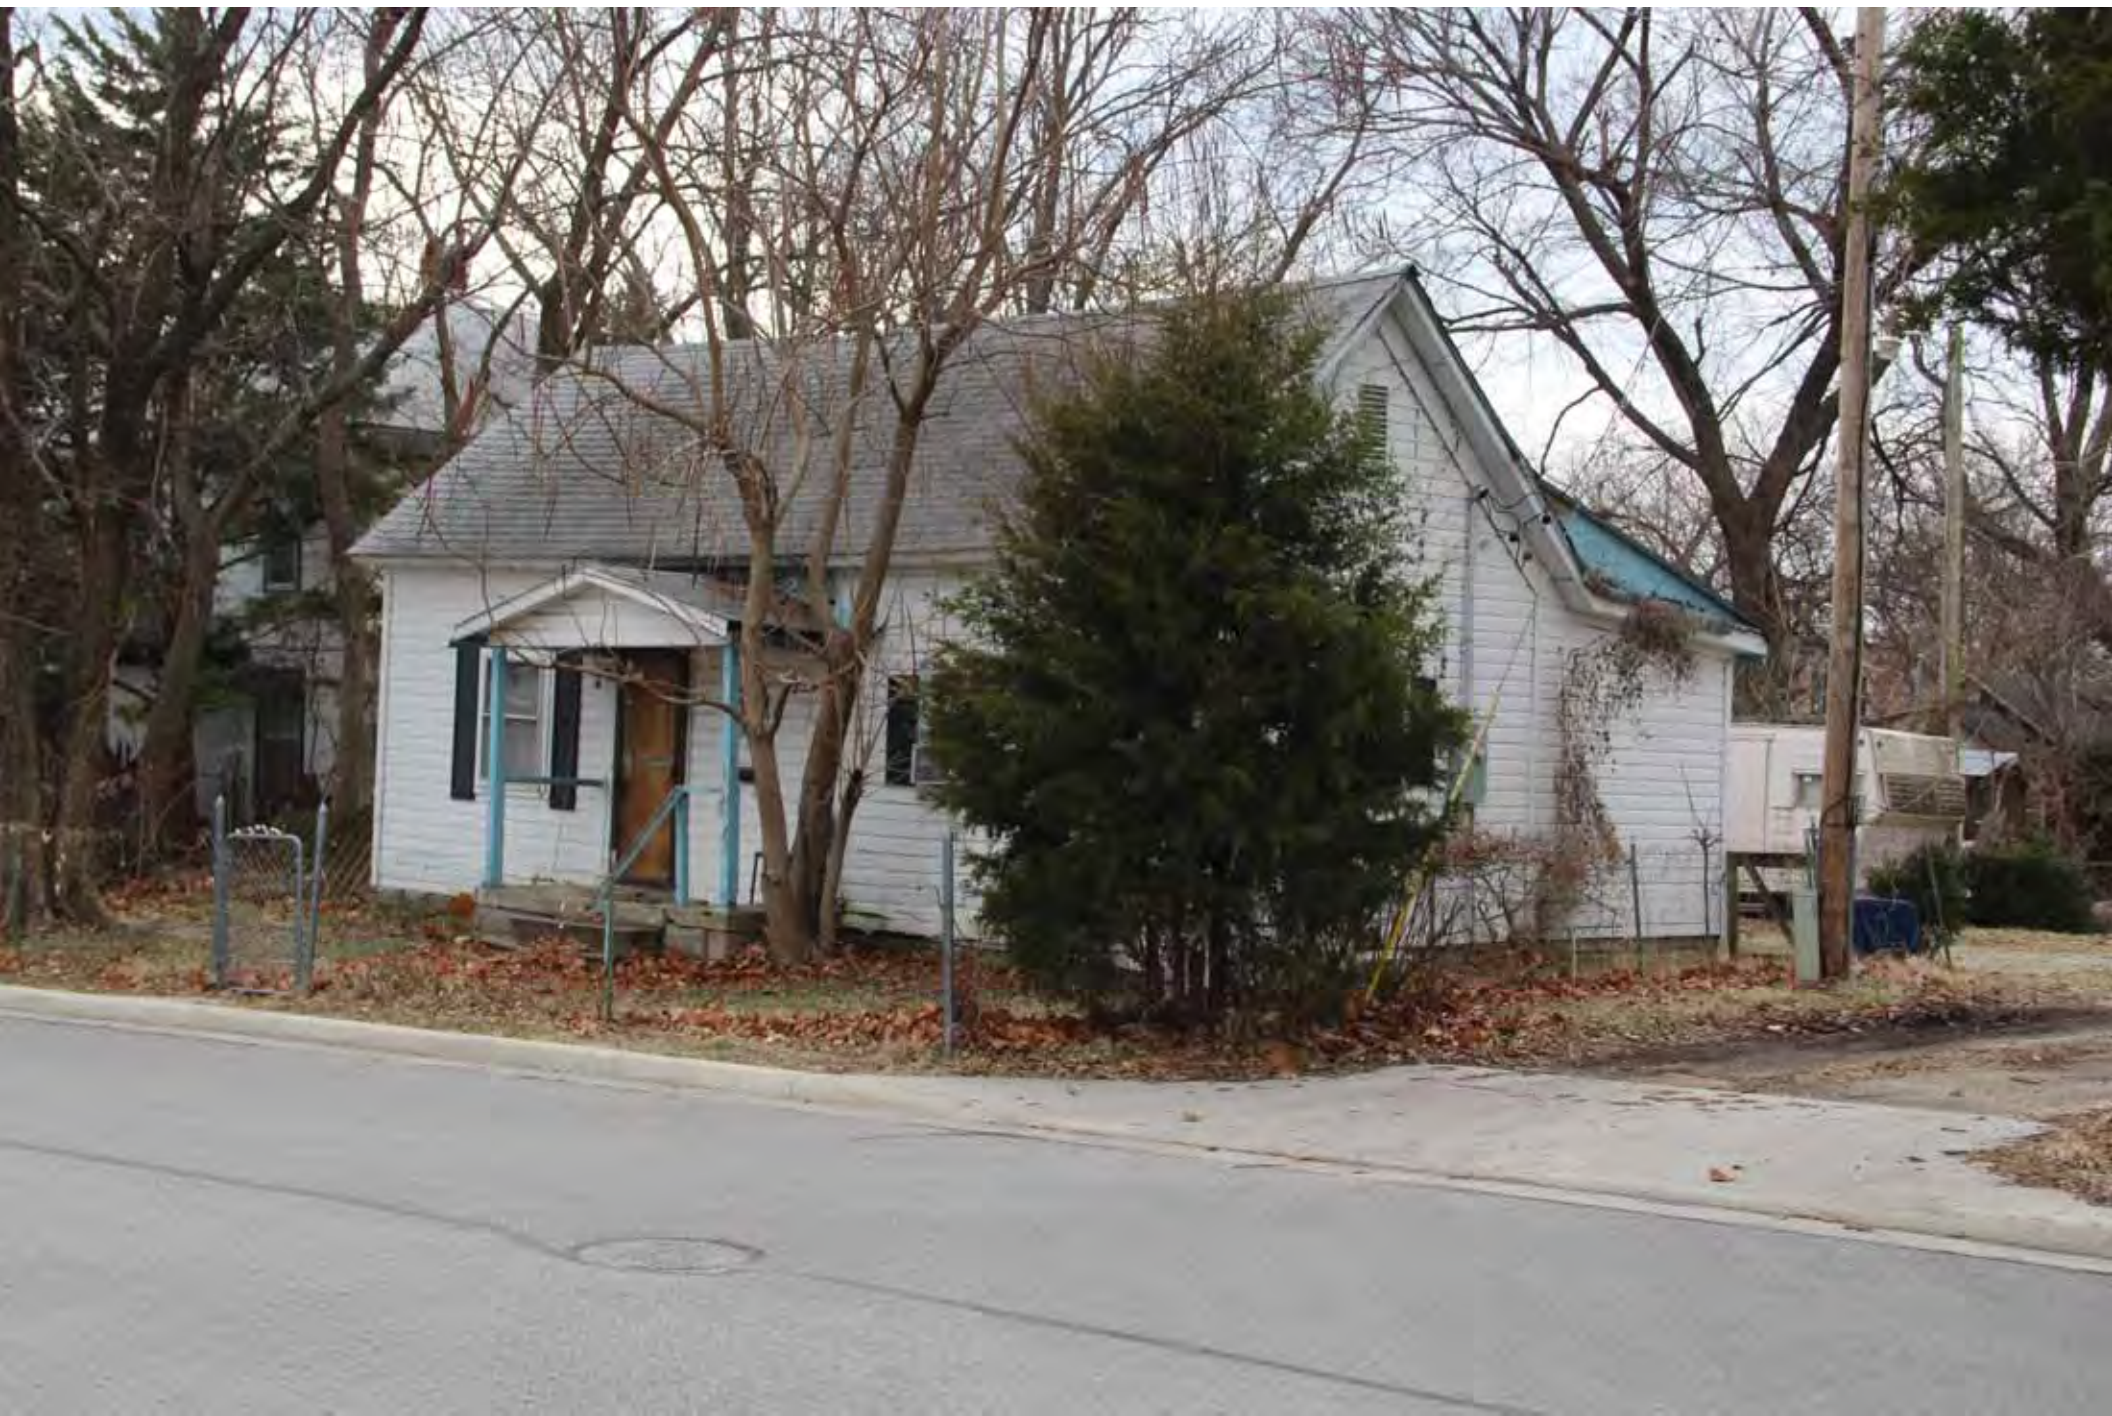
The property at 212 S. High Avenue features a single-story dwelling with an asphalt shingled gable roof, exterior vinyl siding and a concrete foundation. The primary (east) elevation supports a central open gabled porch with slender columns. Within the porch bay is a wood solid door. Flanking the porch and entry are replacement one-over-one windows with faux shutters. Side elevations support single windows of similar configuration. Gable fields hold louvered vents. The dwelling has a rear shed wing.

This dwelling has been altered with replacement siding, windows and doors (c. 1990). These changes compromise the property's architectural integrity, rendering it individually ineligible for the National Register of Historic Places. The dwelling is not situated in an area recommended as a historic district.
