MISSOURI DEPARTMENT OF NATURAL RESOURCES
STATE HISTORIC PRESERVATION OFFICE, P.O. Box 176, Jefferson City, MO 65102
ARCHITECTURAL/HISTORIC INVENTORY FORM

1. Survey No. JP-AS-007-001		2. Survey name: East Town (Original Joplin) Historic Survey Phase 2	
3. County: JASPER		4. Address (Street No.) 618	Street (name) E. 2 nd Street
5. City: Joplin	Vicinity: <input type="checkbox"/>	6. Geographical Reference:	7. Township/Range/Section: T: R: S:
8. Historic name (if known):		9. Present/other name (if known):	
10. Ownership: <input checked="" type="checkbox"/> Private <input type="checkbox"/> Public		11a. Historic use (if known): Domestic: Single Dwelling	11b. Current use: Domestic: Single Dwelling

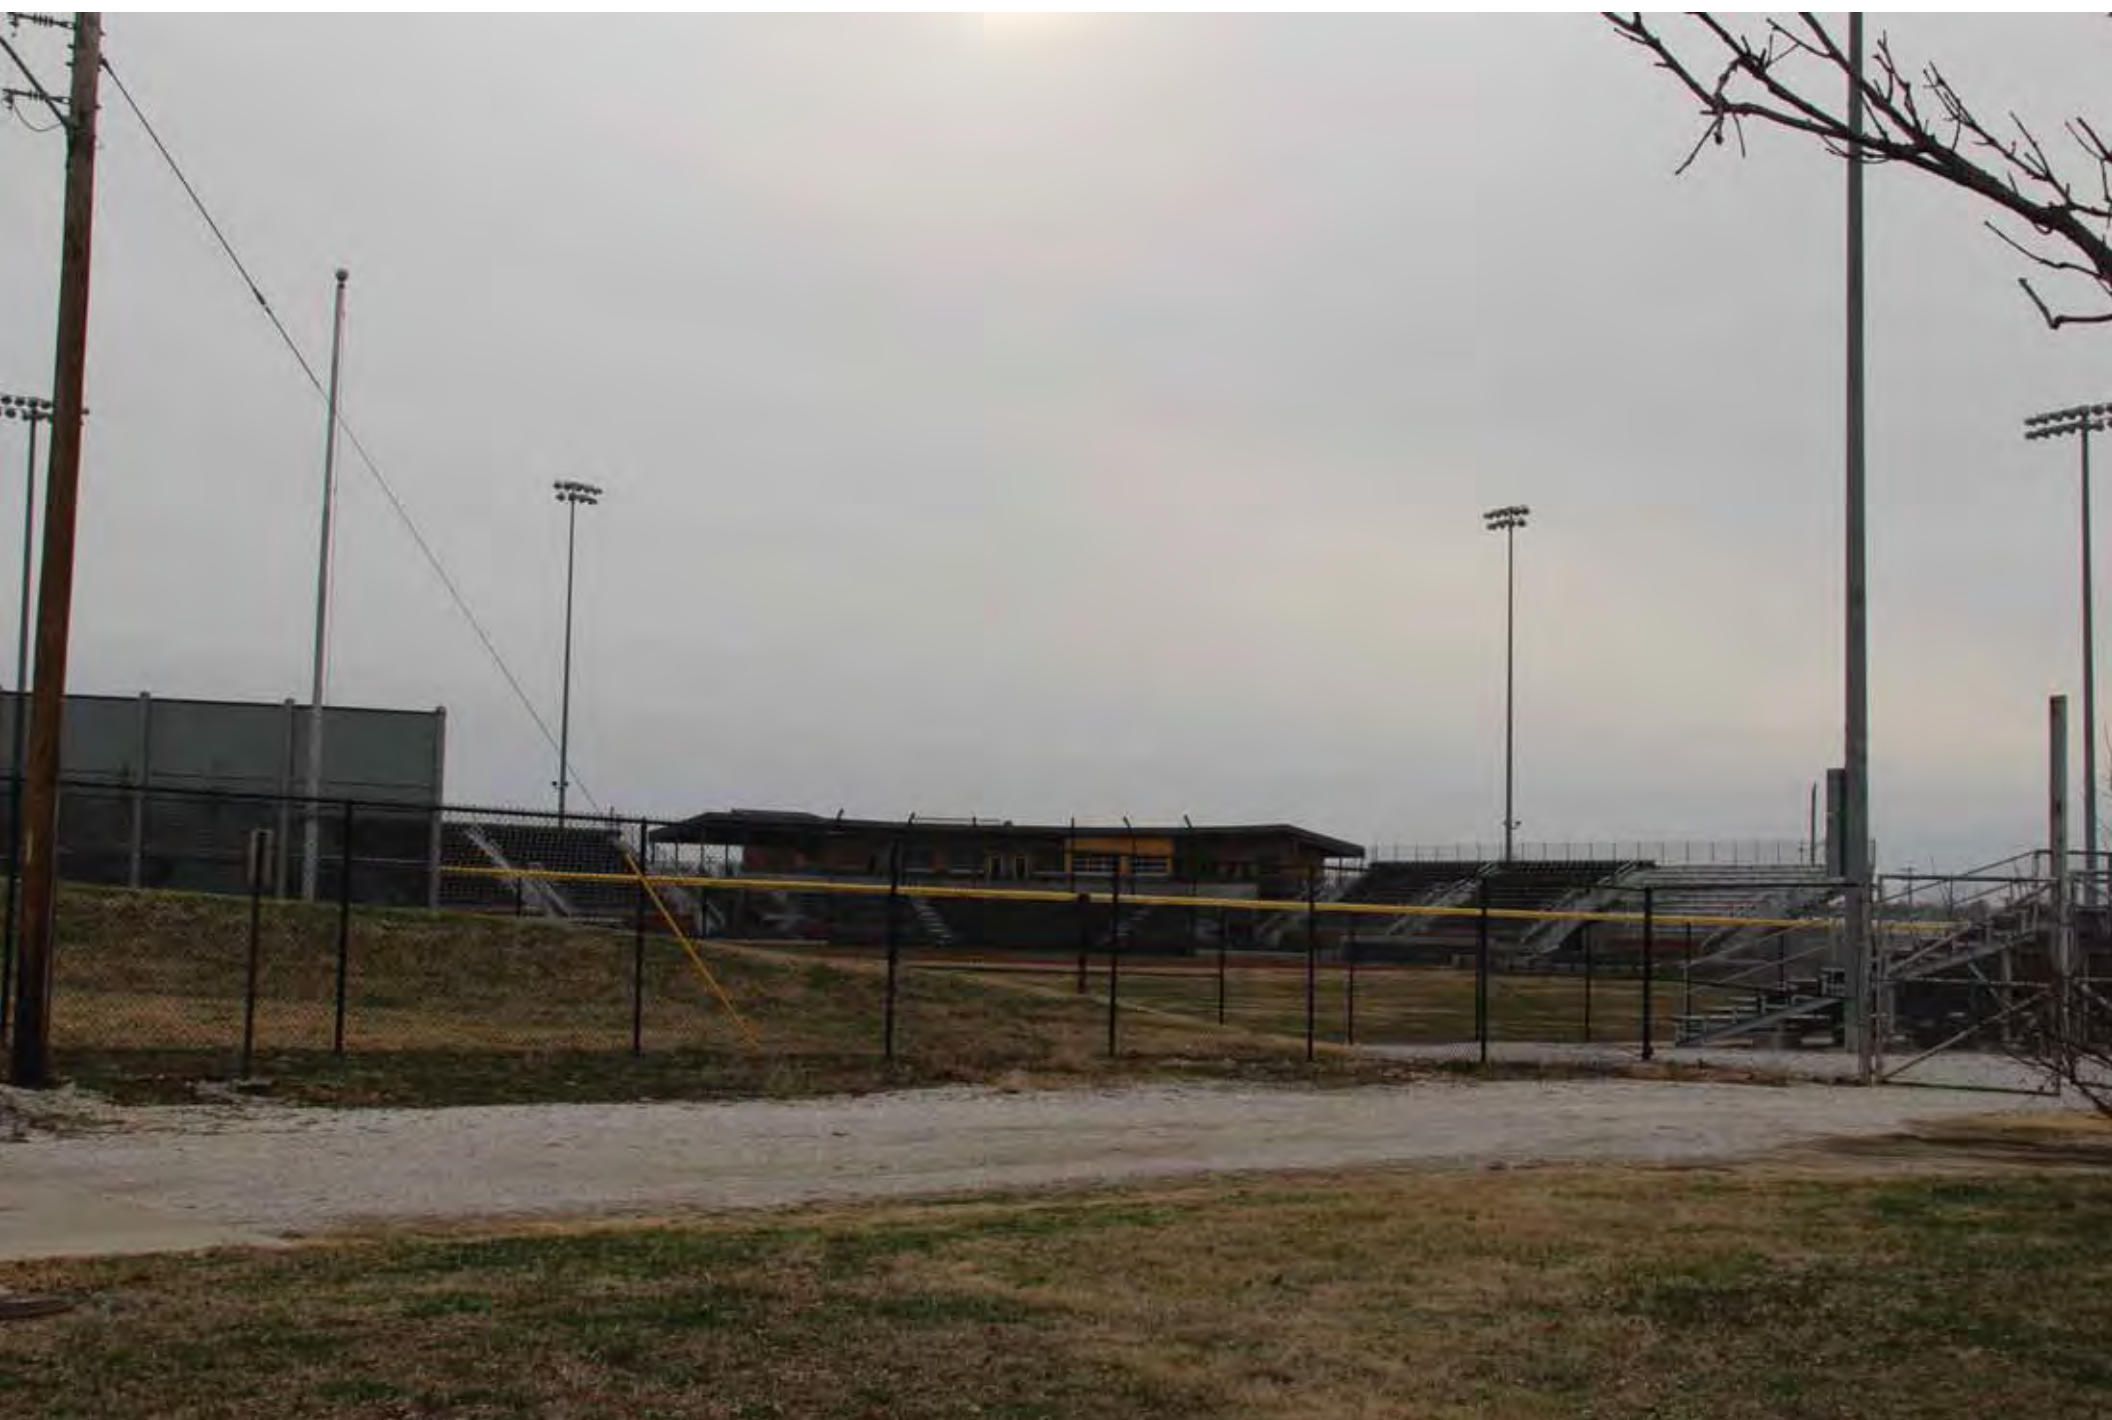
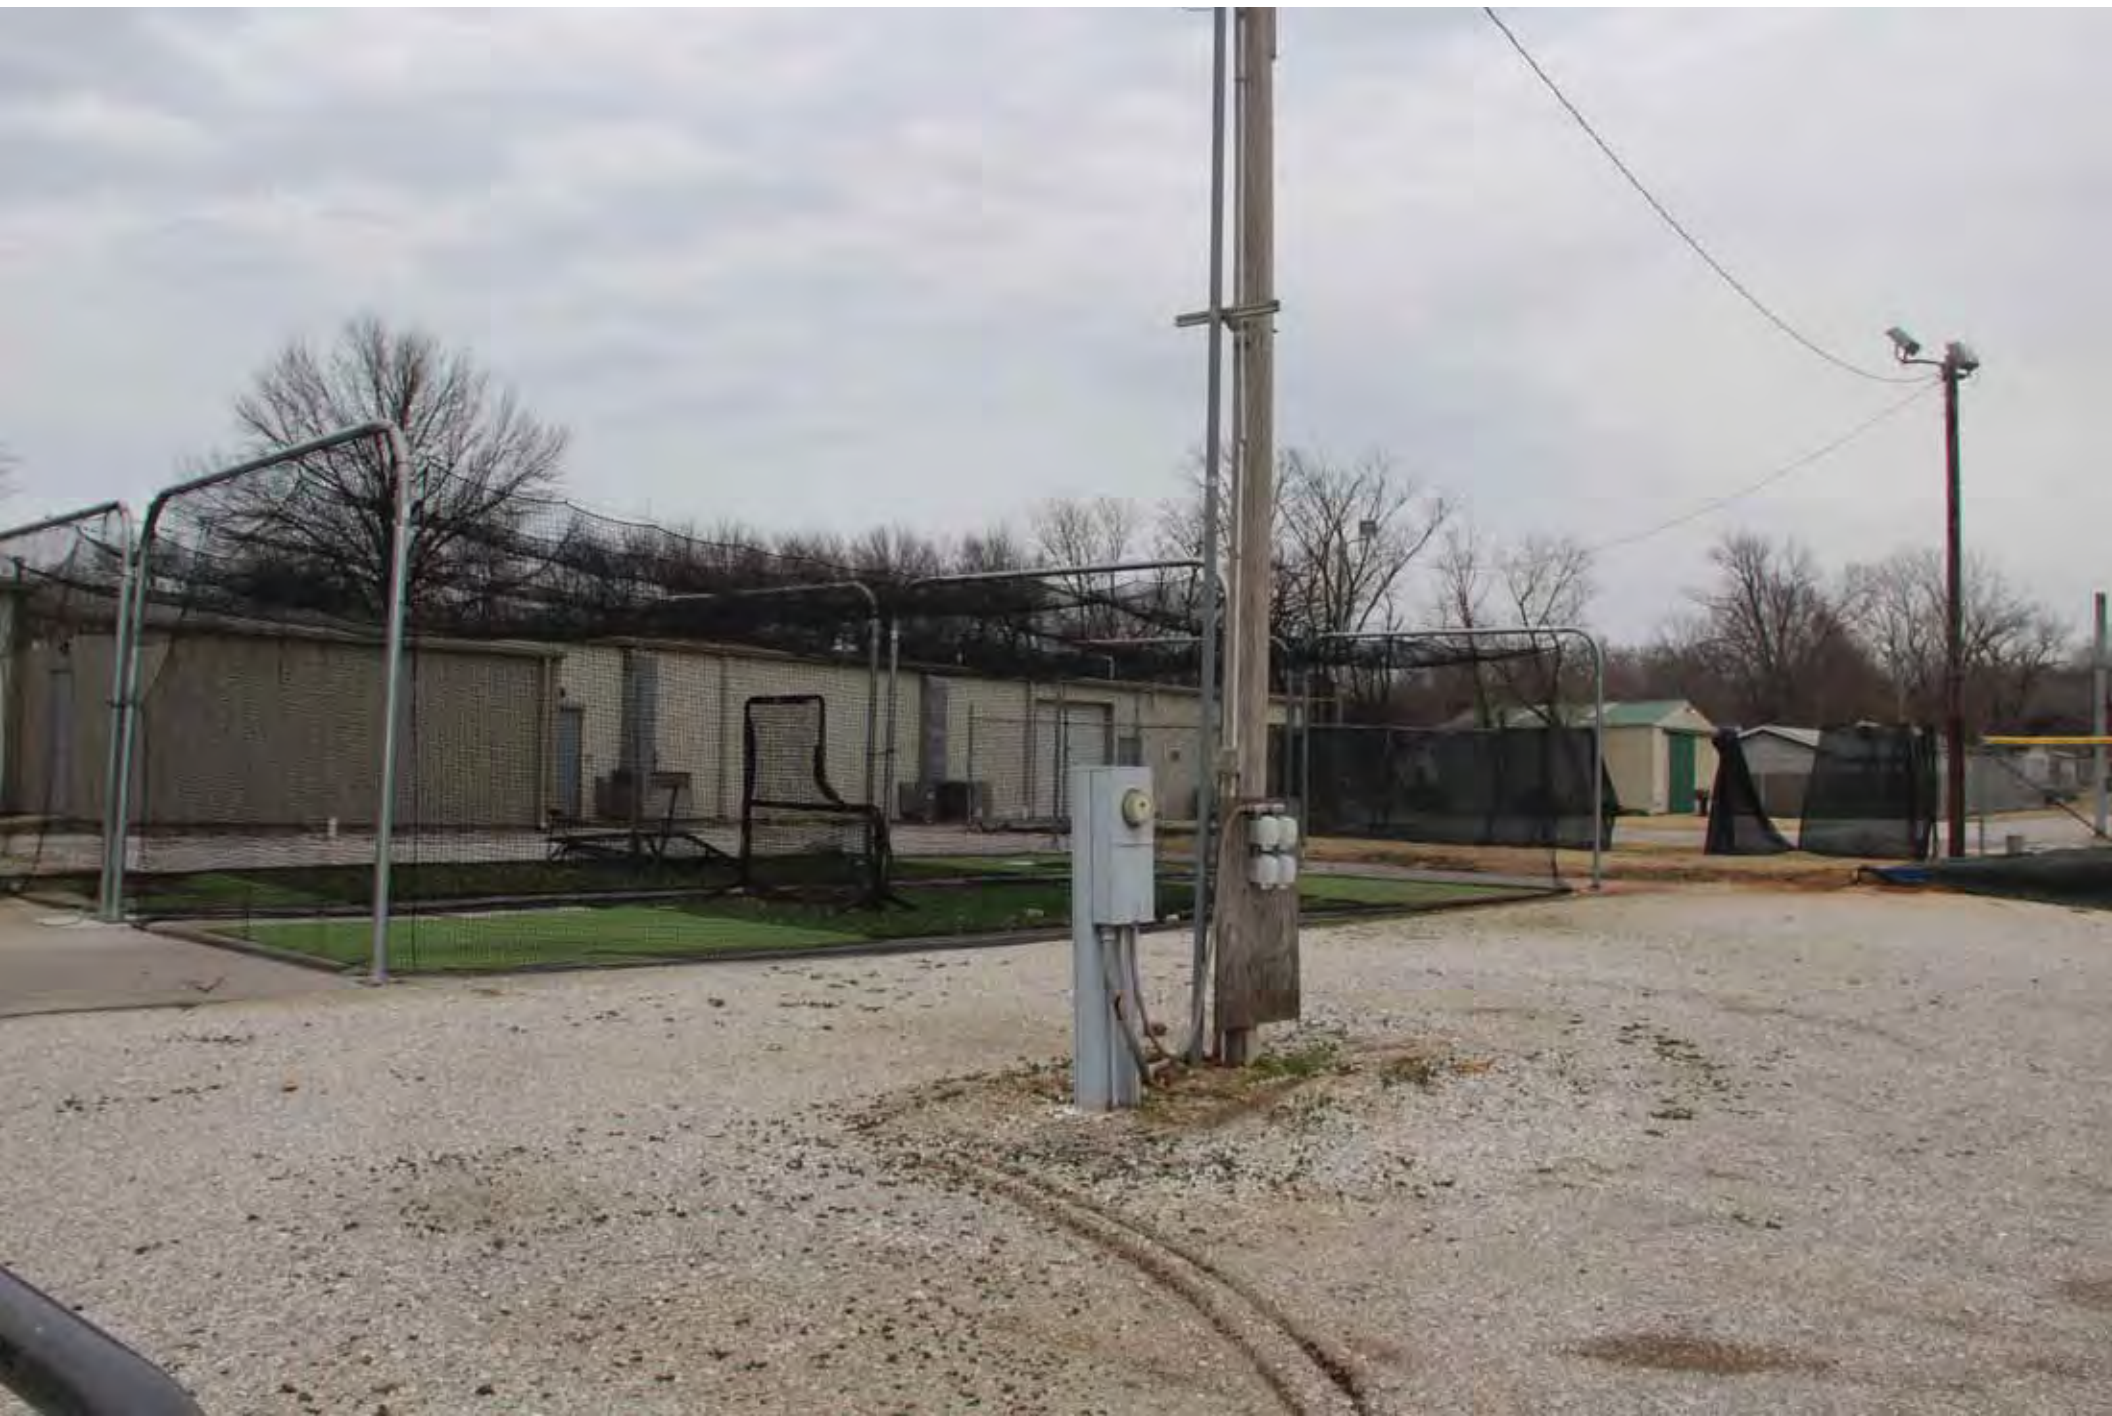
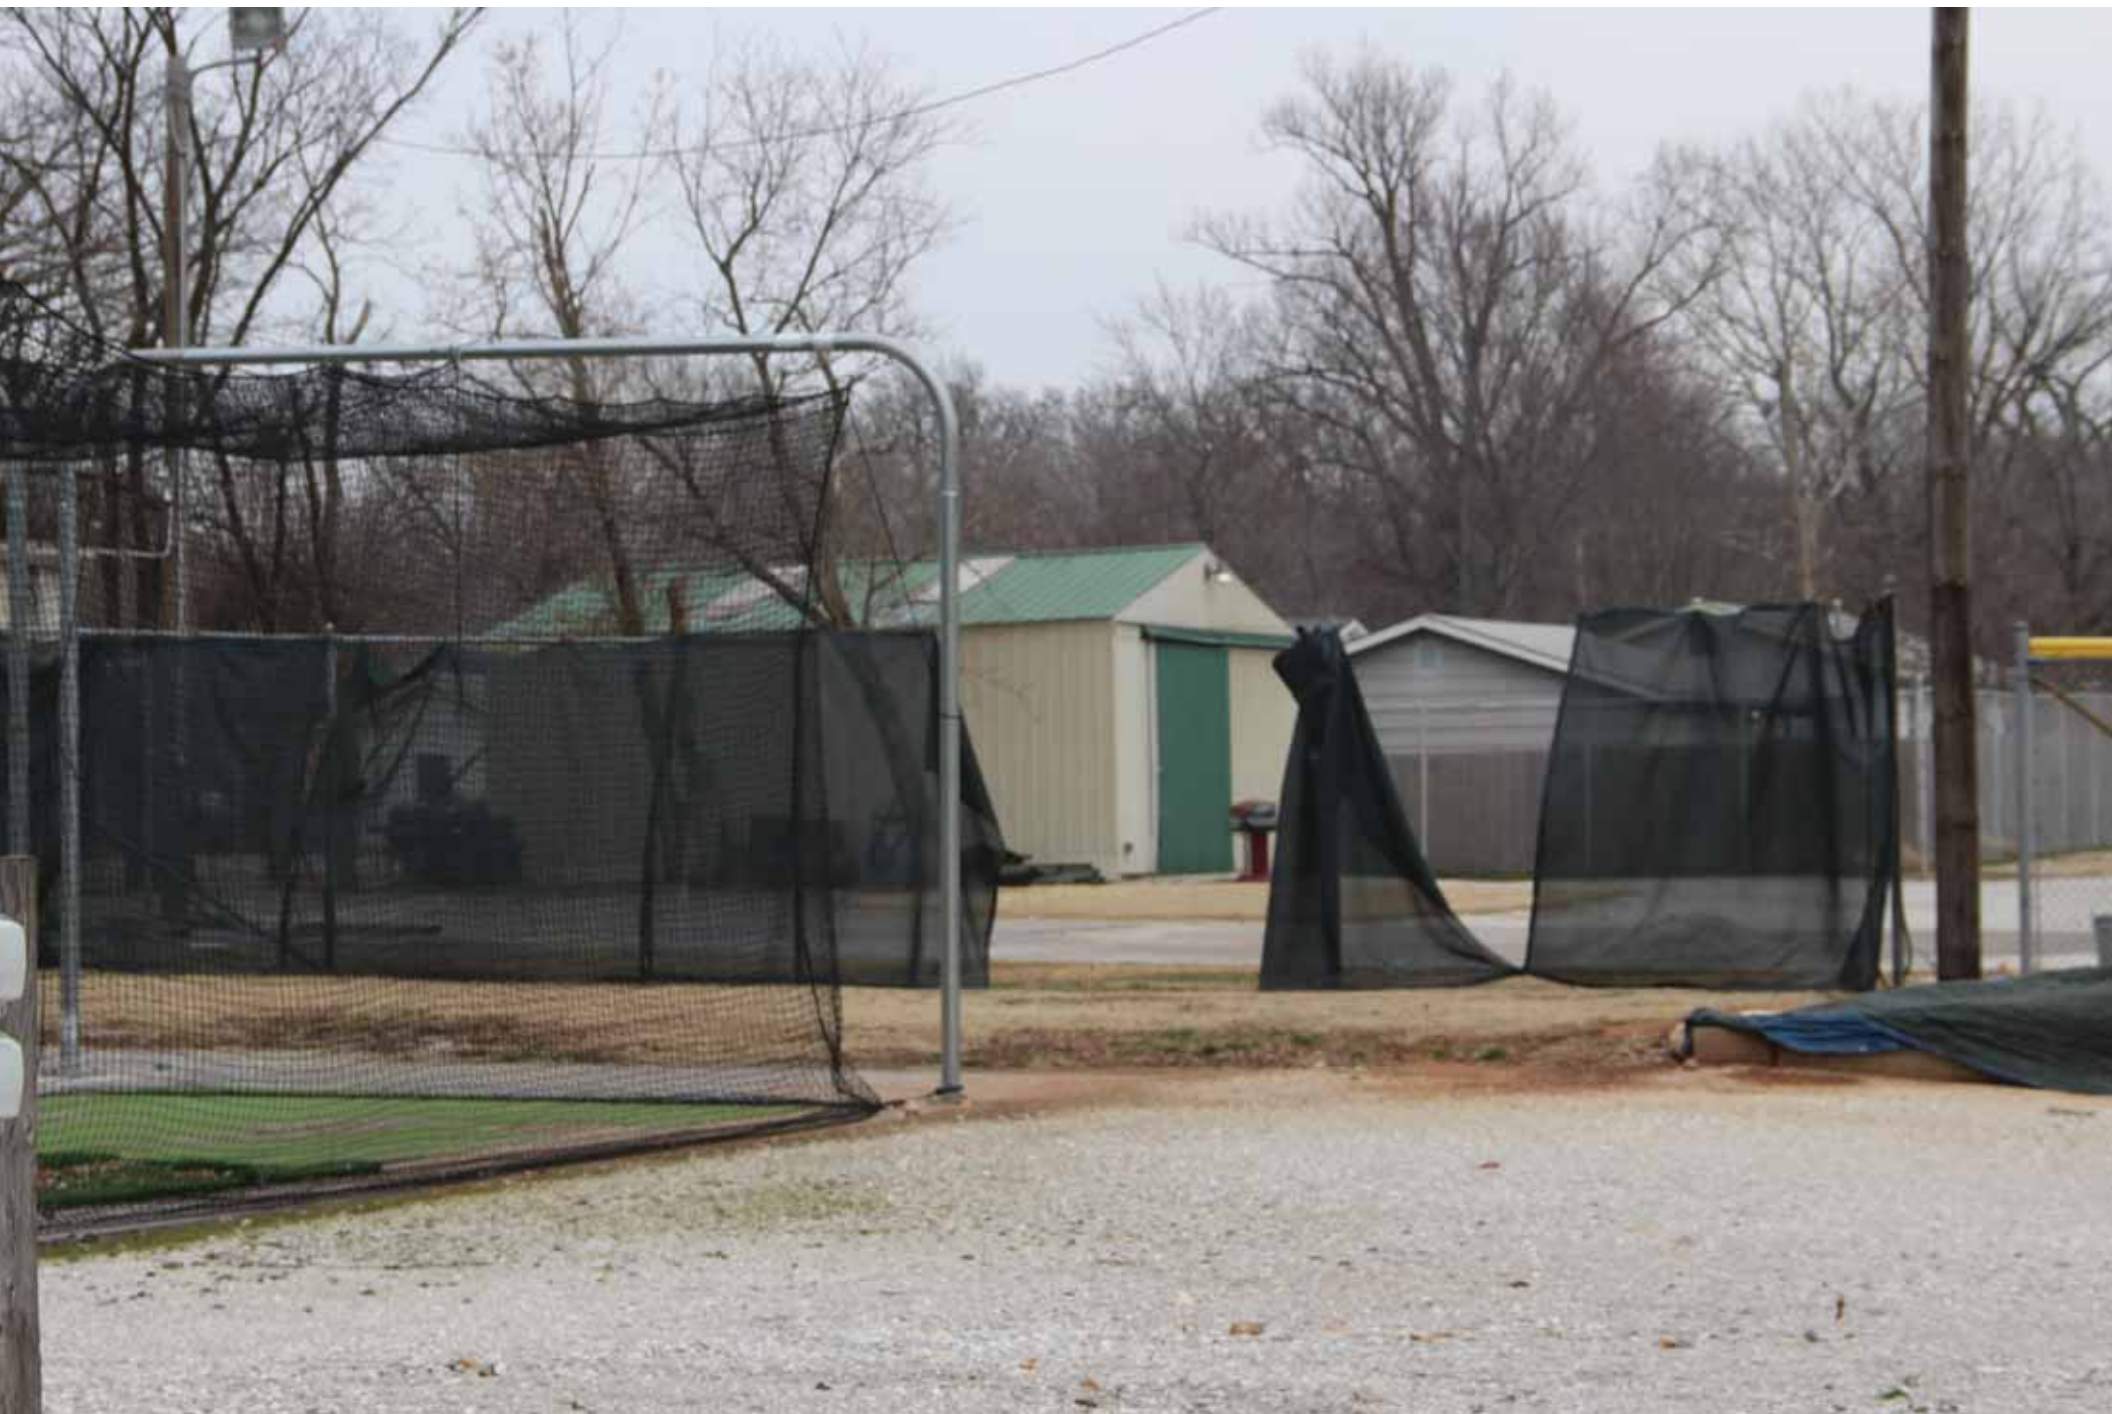
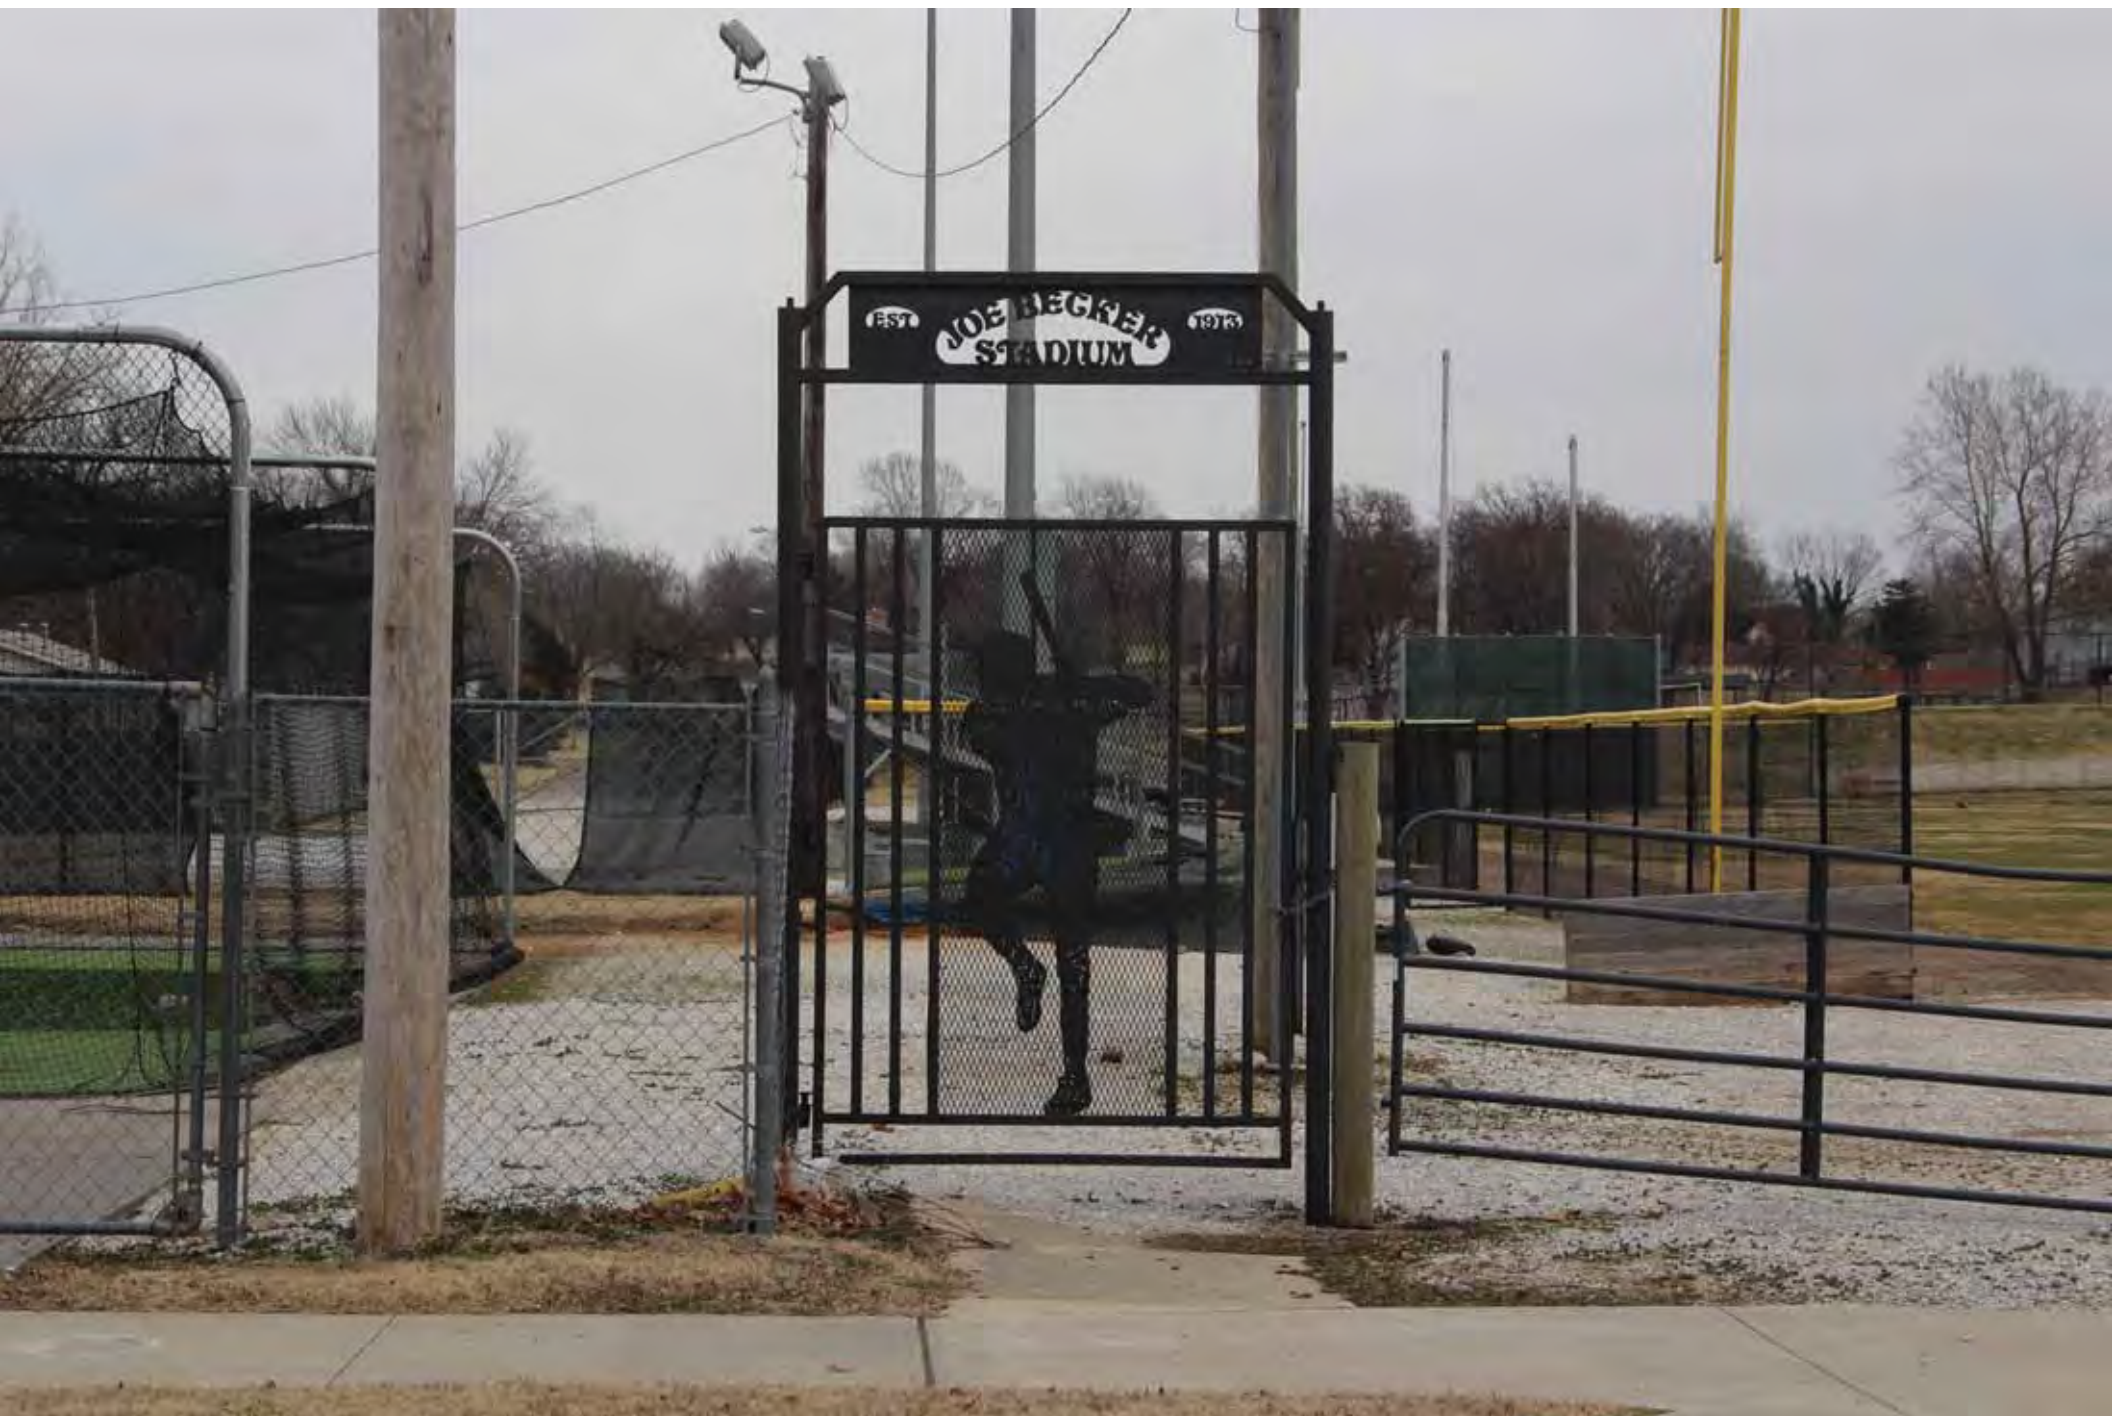
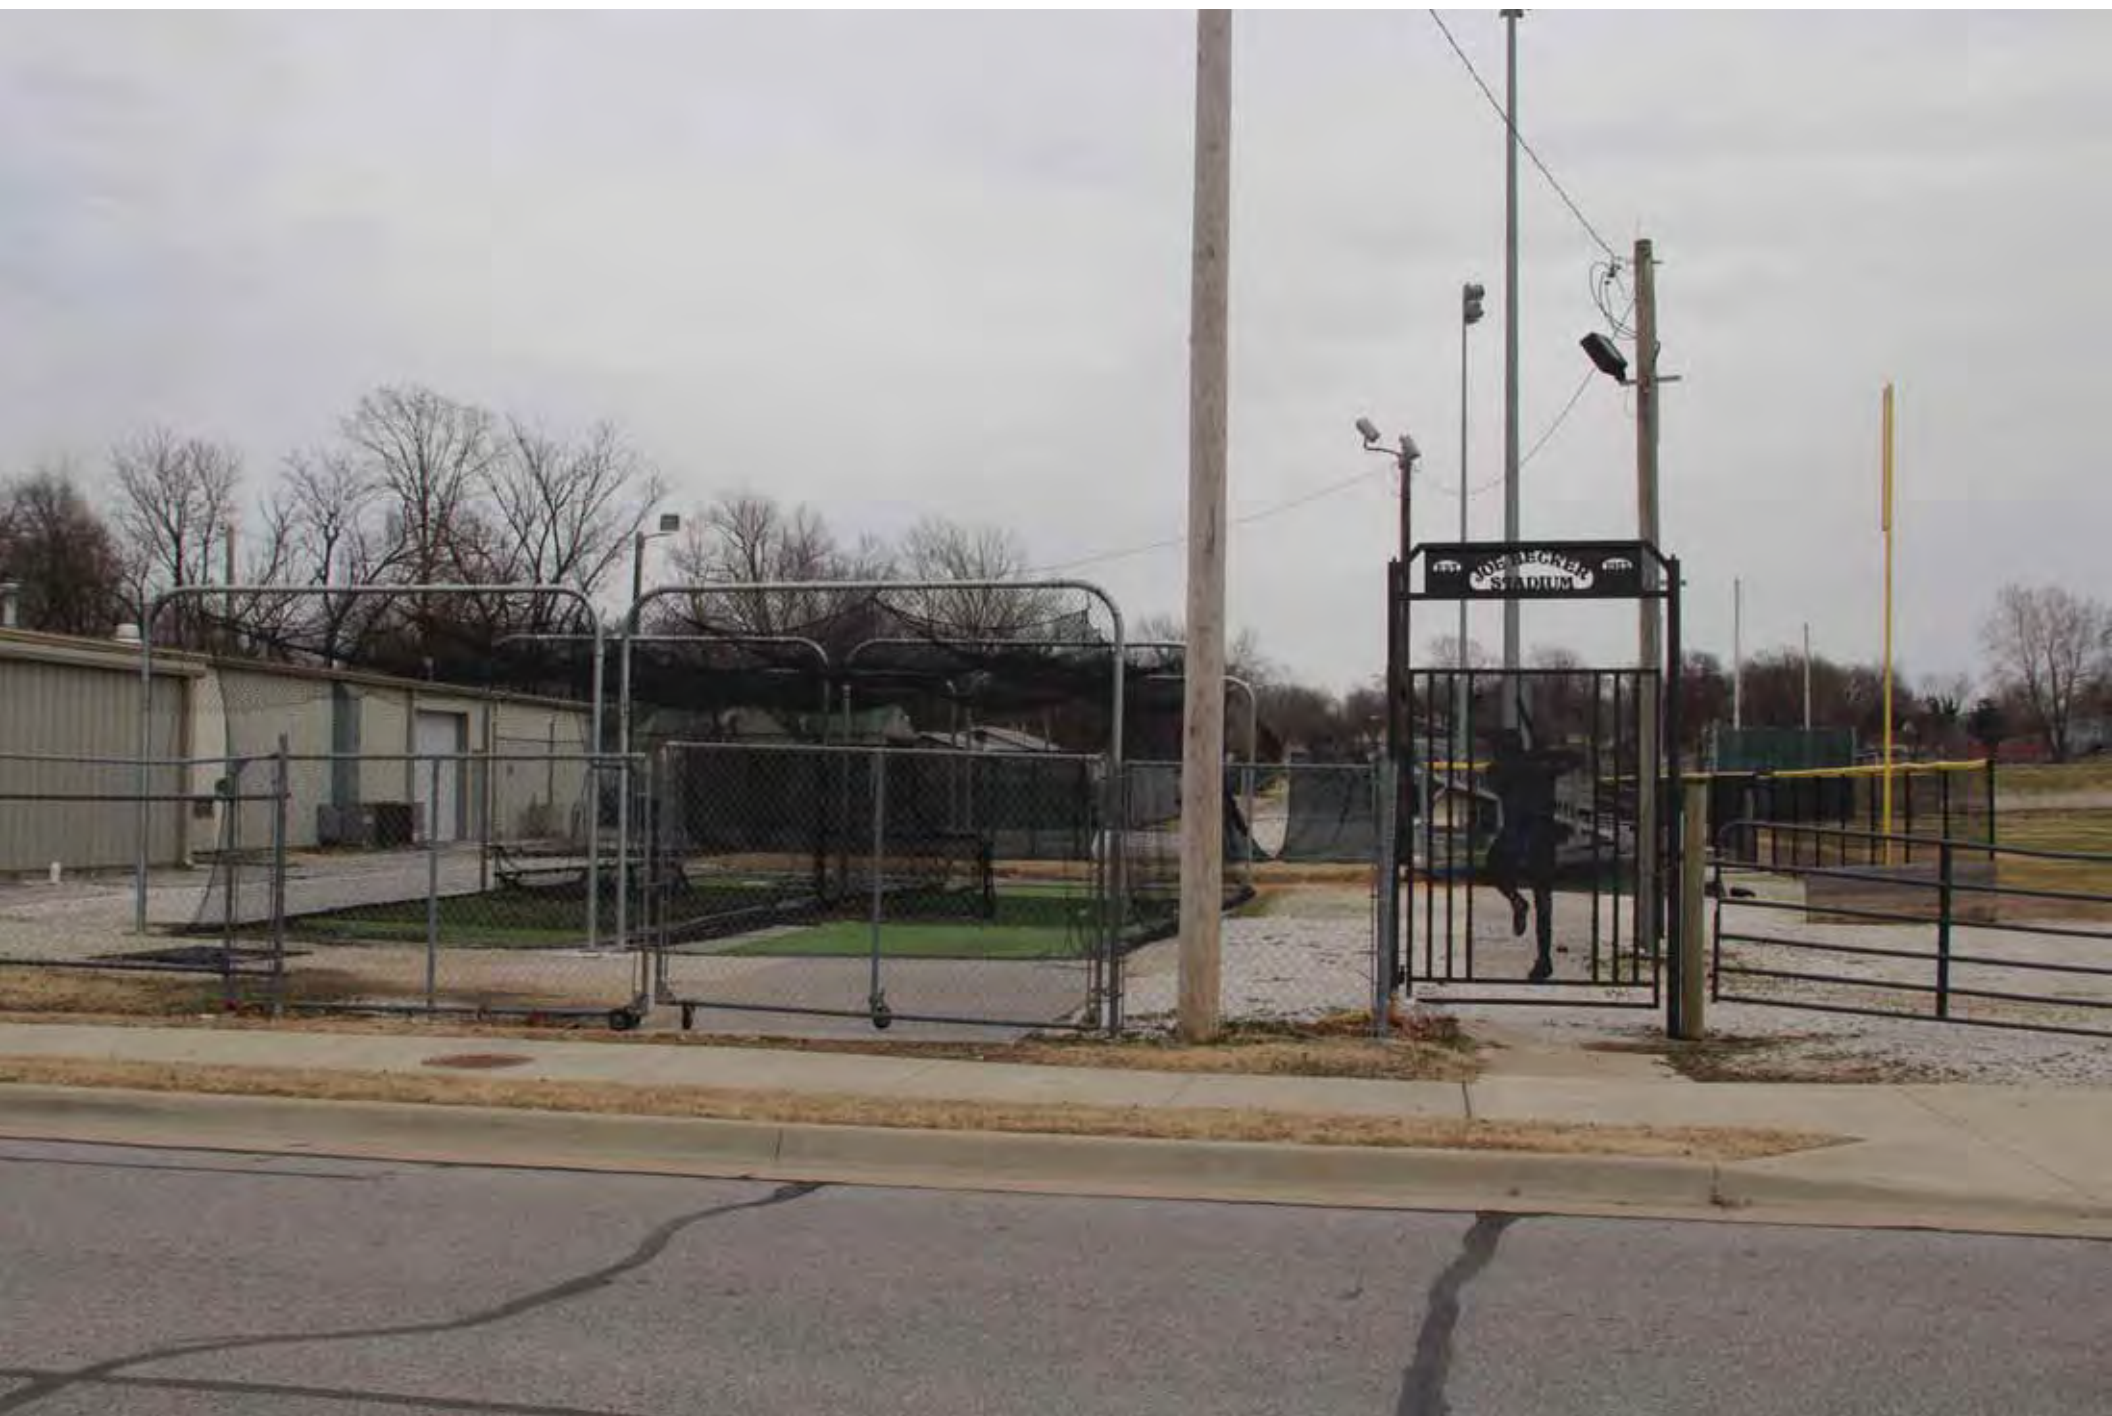
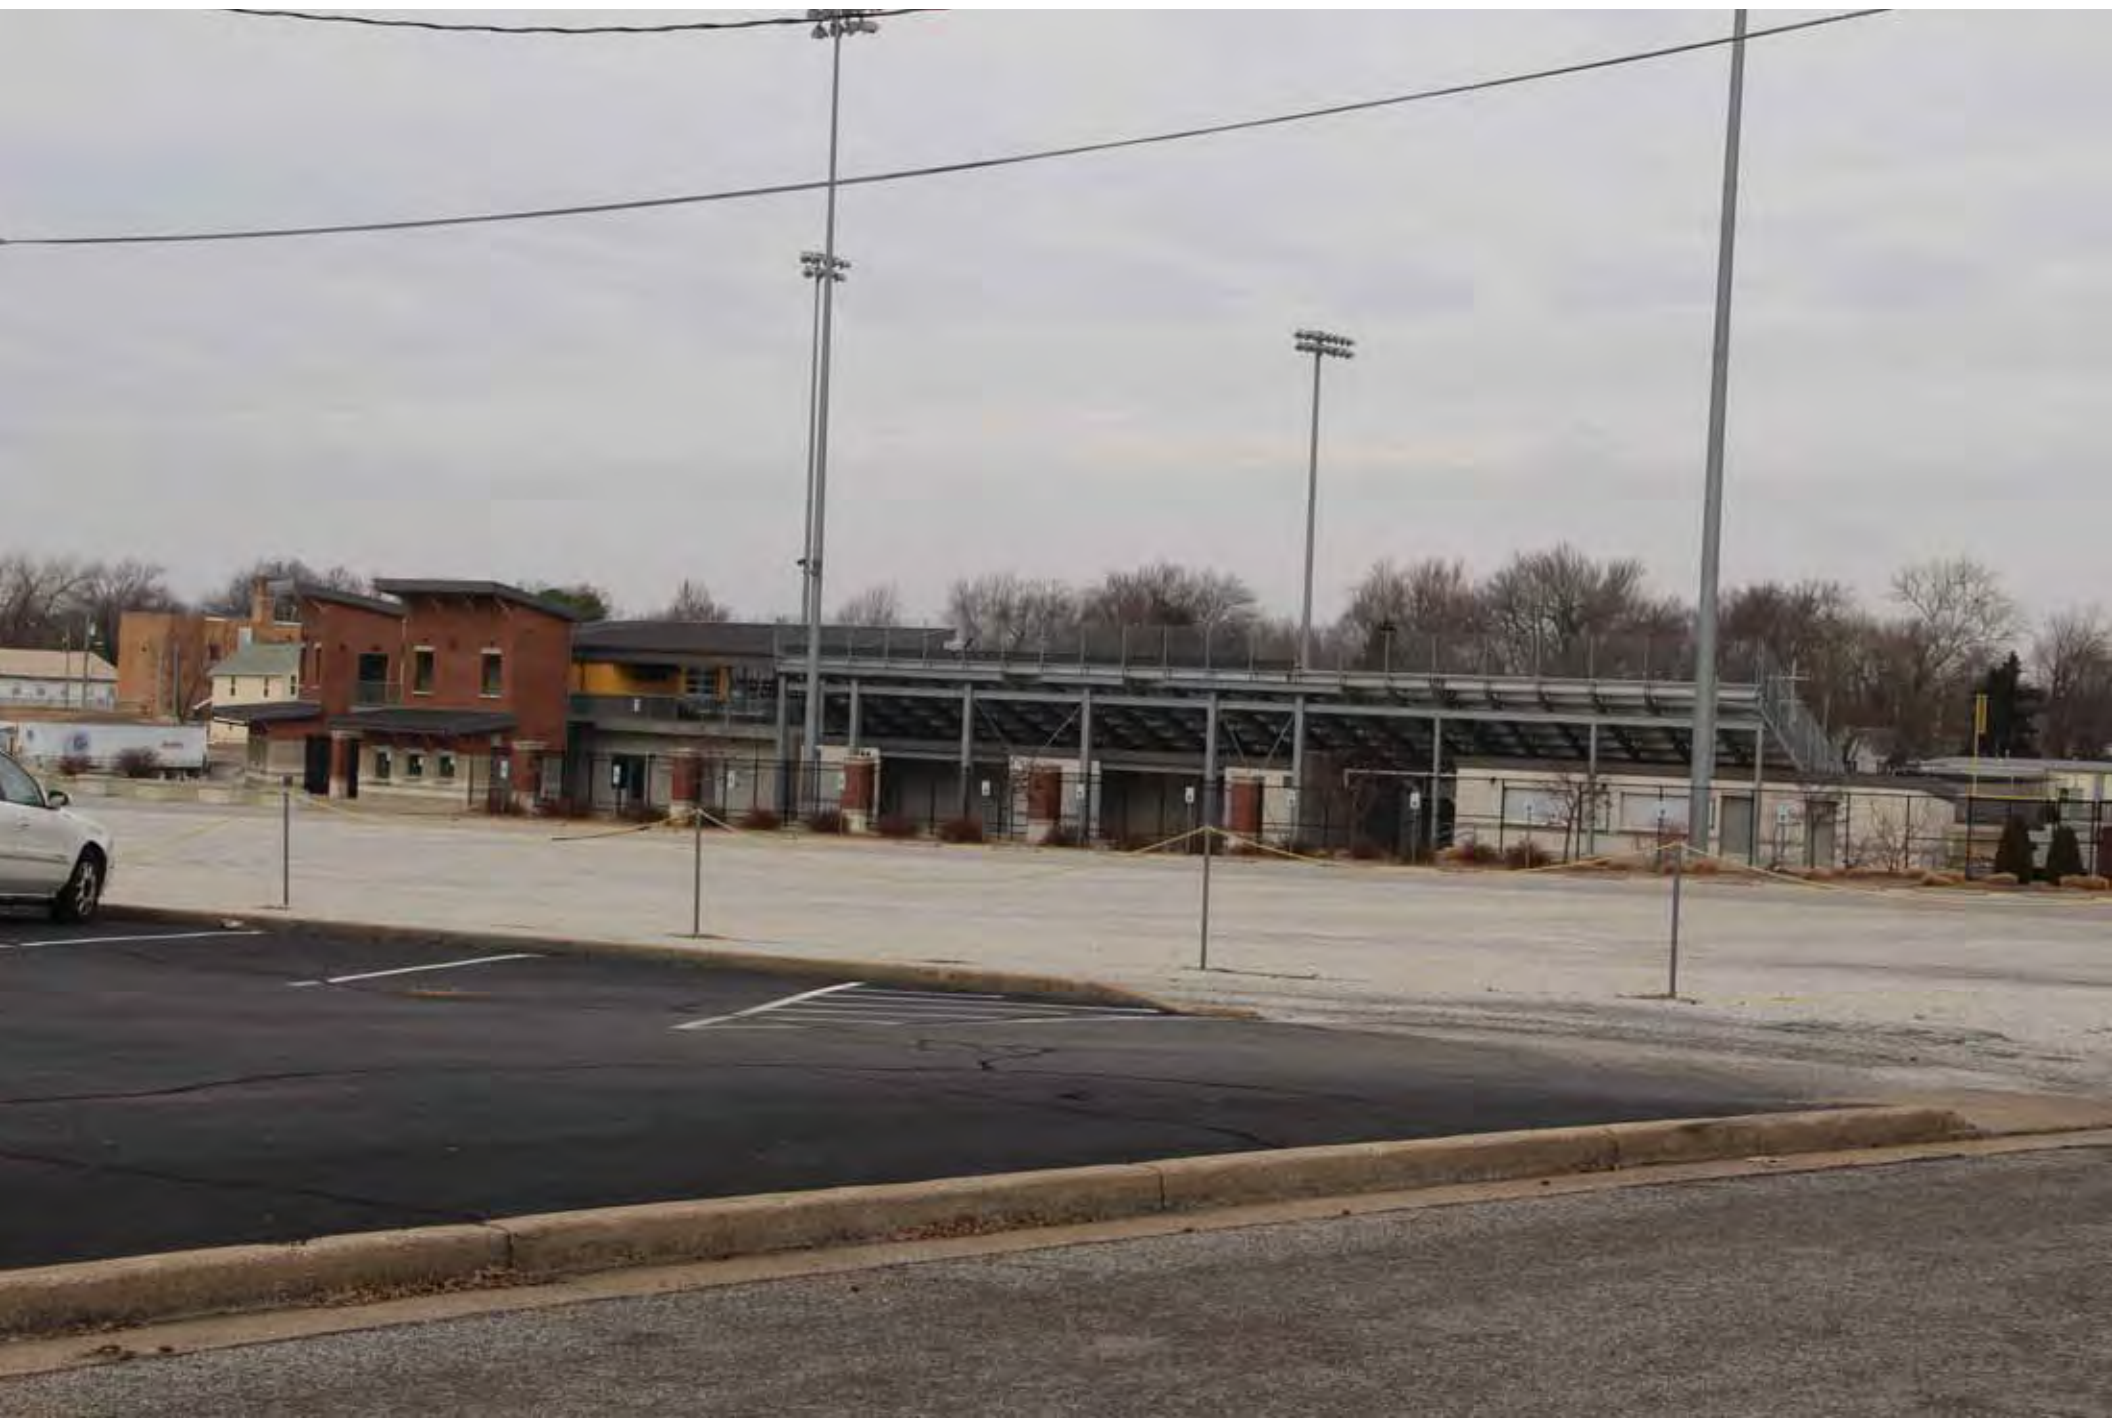
The property at 300 S. High Avenue is a baseball stadium that includes a baseball field partially surrounded by metal bleachers and a larger stadium area composed of bleachers and individual seats. This larger permanent stadium has exterior brick walls and a concrete foundation. The larger seating section features two-story brick faced concrete "buildings" with shed roofs near the center of the structure. The upper portion of the two-story section's north elevation is clad with brick and faces the baseball field – open windows for viewing support sports announcers and related personnel. The lower elevation's south elevation faces away from the stadium area and supports concessions windows. The enclosed areas include public restrooms.

The property currently reflects alterations and an appearance of less than 50 years of age (2014). None of the supporting structures on the property are original. The stadium does not reflect exceptional historical associations that would render it individually eligible for the National Register of Historic Places. The property is not situated in an area recommended as a historic district.
