MISSOURI DEPARTMENT OF NATURAL RESOURCES
STATE HISTORIC PRESERVATION OFFICE, P.O. Box 176, Jefferson City, MO 65102
ARCHITECTURAL/HISTORIC INVENTORY FORM

1. Survey No. JP-AS-007-001		2. Survey name: East Town (Original Joplin) Historic Survey Phase 2	
3. County: JASPER		4. Address (Street No.) 618	Street (name) E. 2 nd Street
5. City: Joplin	Vicinity: <input type="checkbox"/>	6. Geographical Reference:	7. Township/Range/Section: T: R: S:
8. Historic name (if known):		9. Present/other name (if known):	
10. Ownership: <input checked="" type="checkbox"/> Private <input type="checkbox"/> Public		11a. Historic use (if known): Domestic: Single Dwelling	11b. Current use: Domestic: Single Dwelling

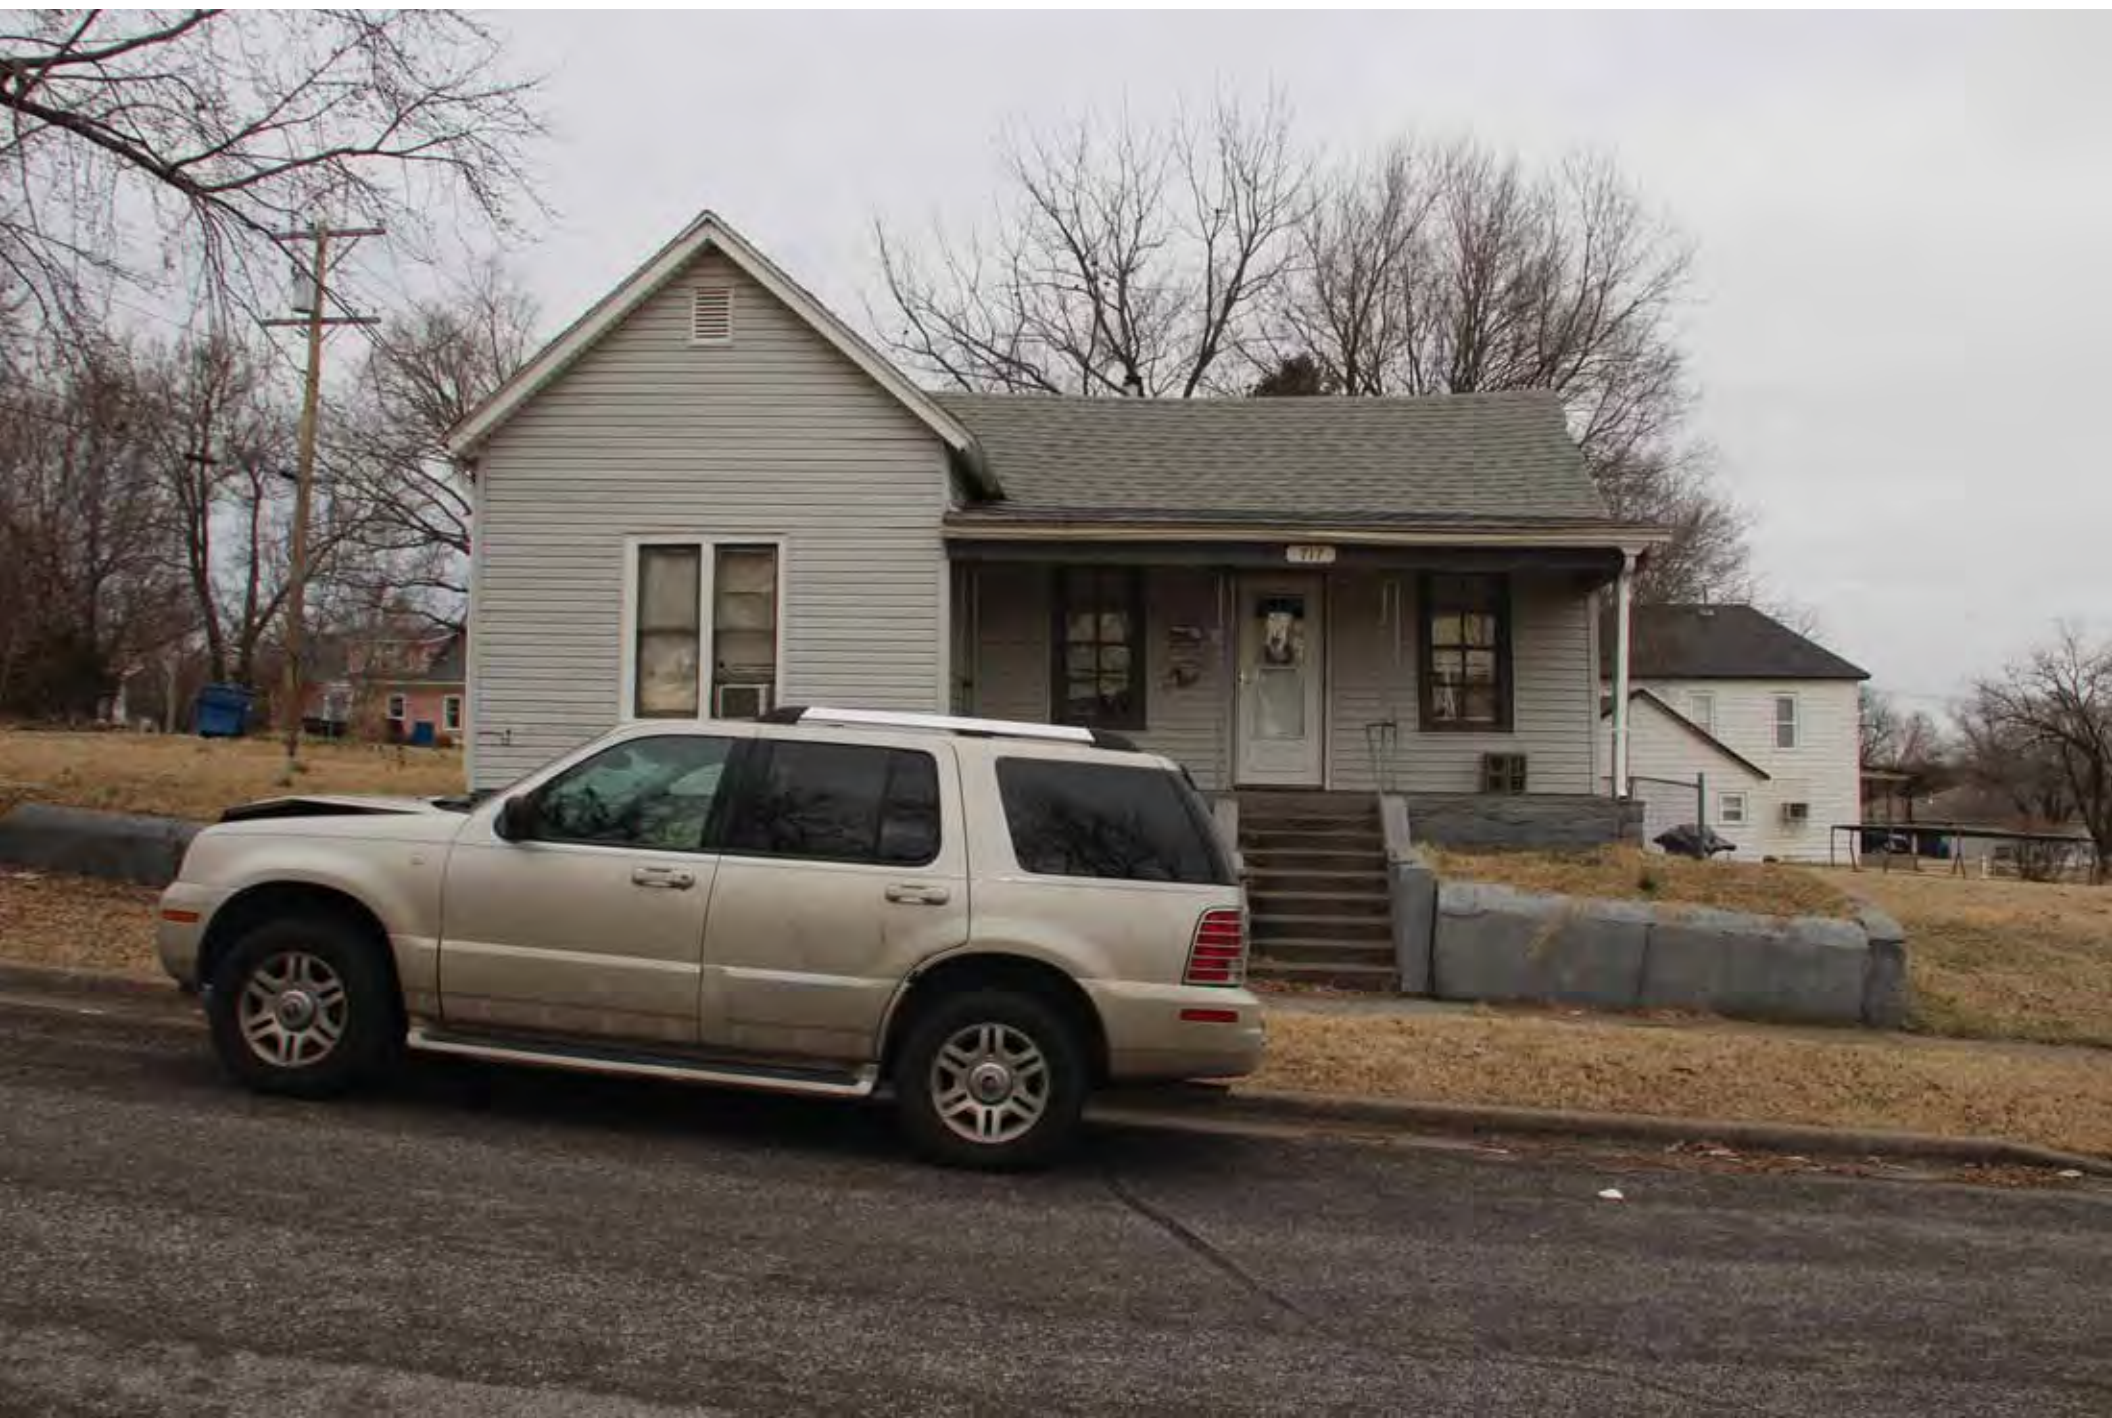
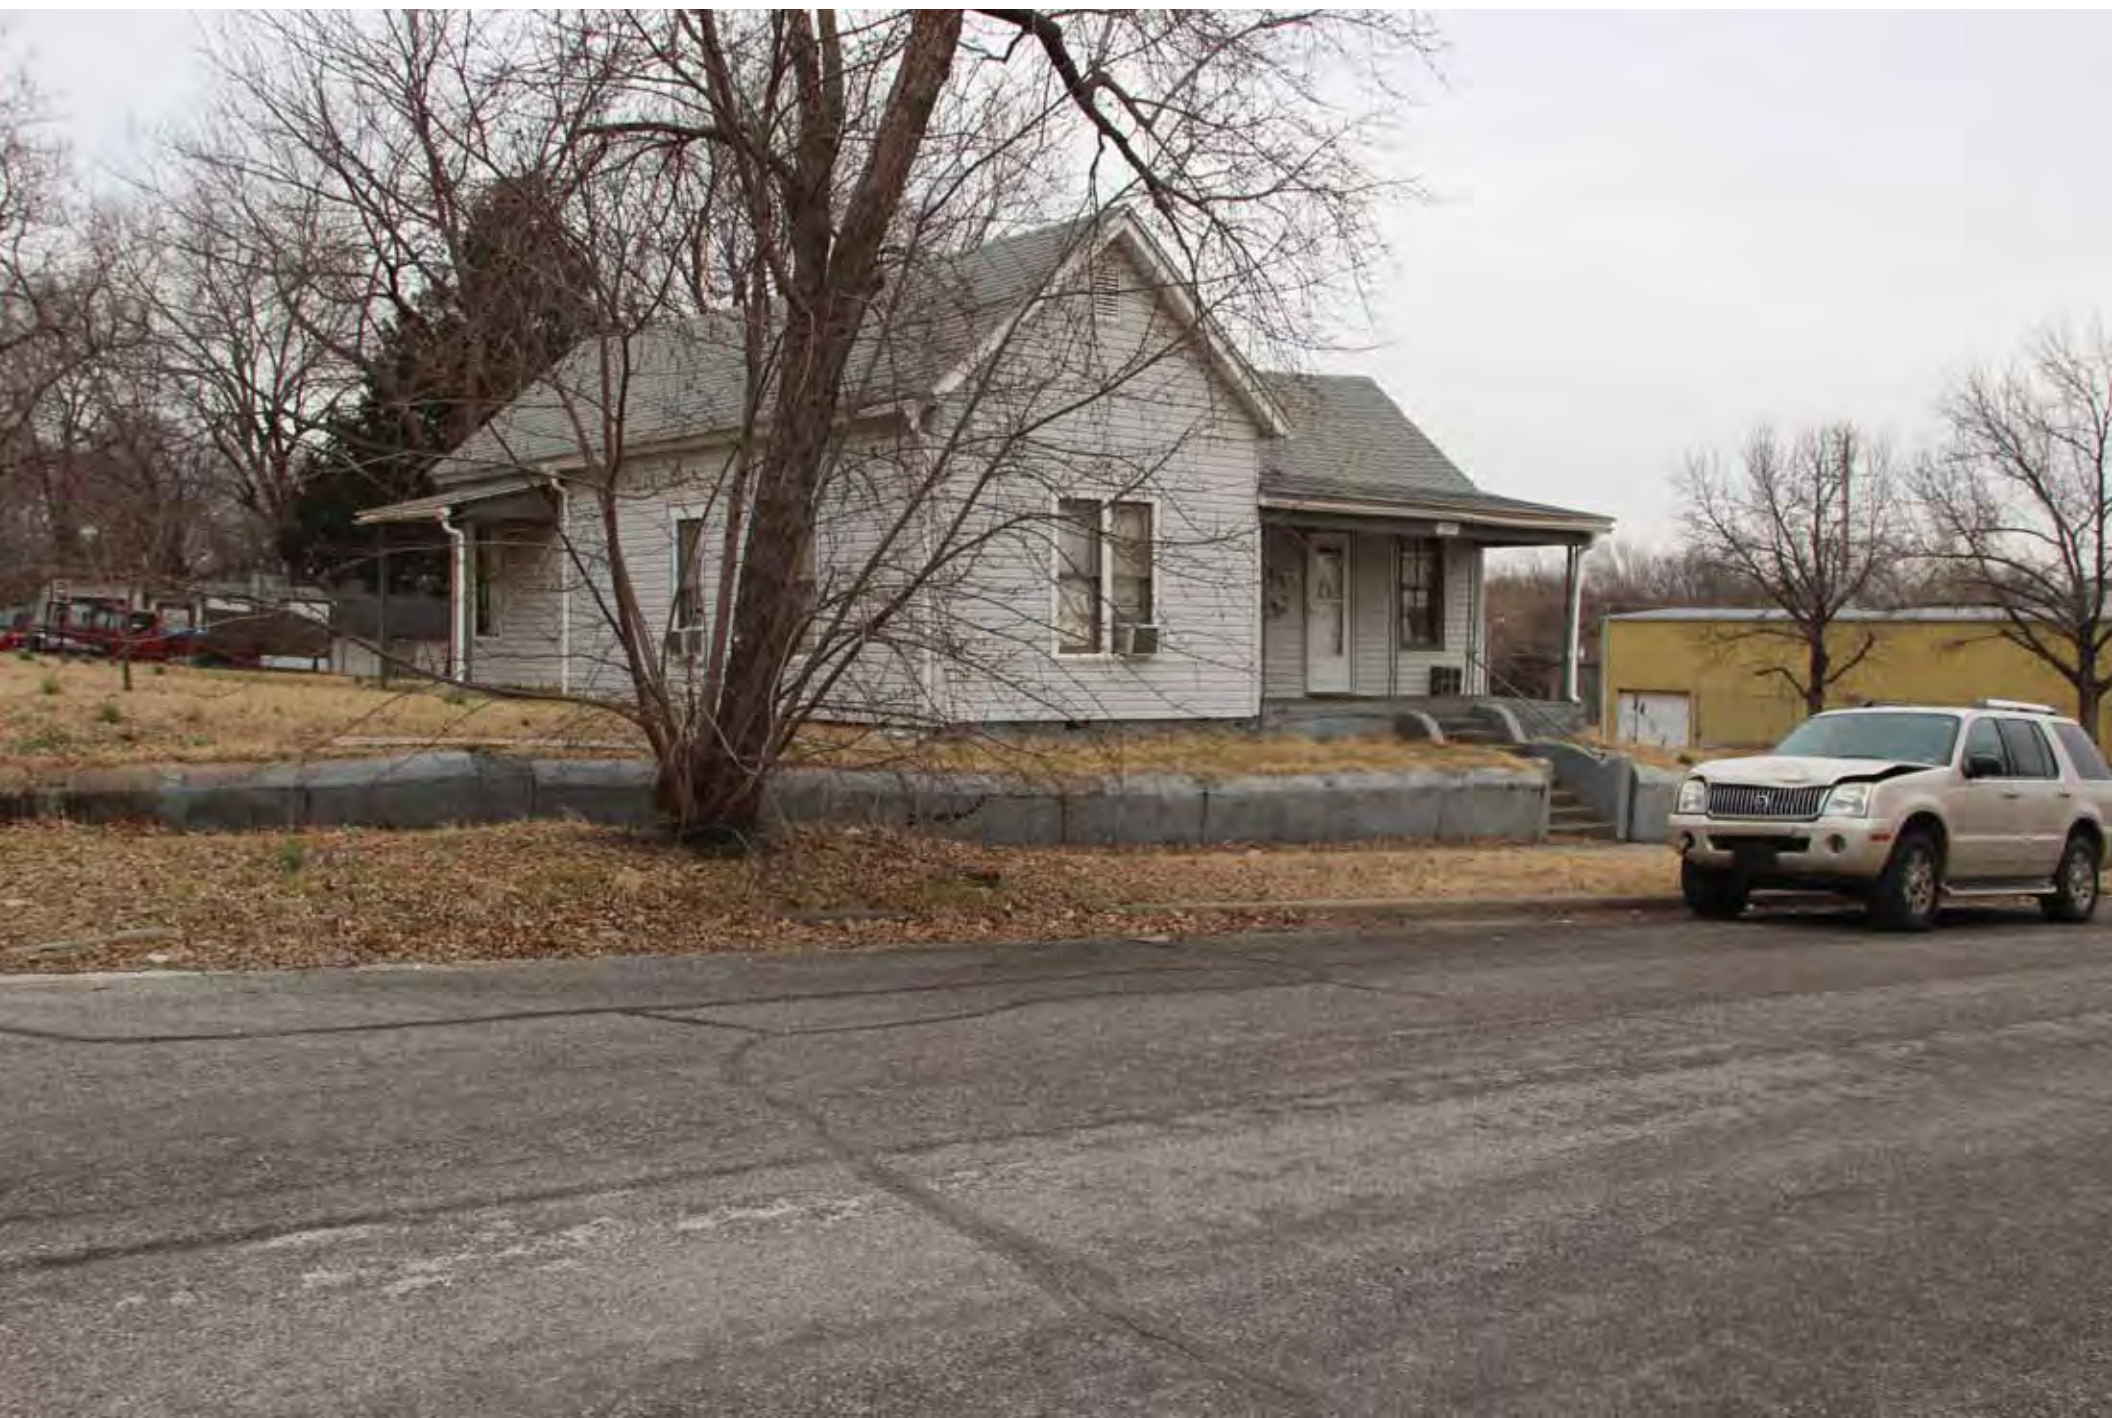
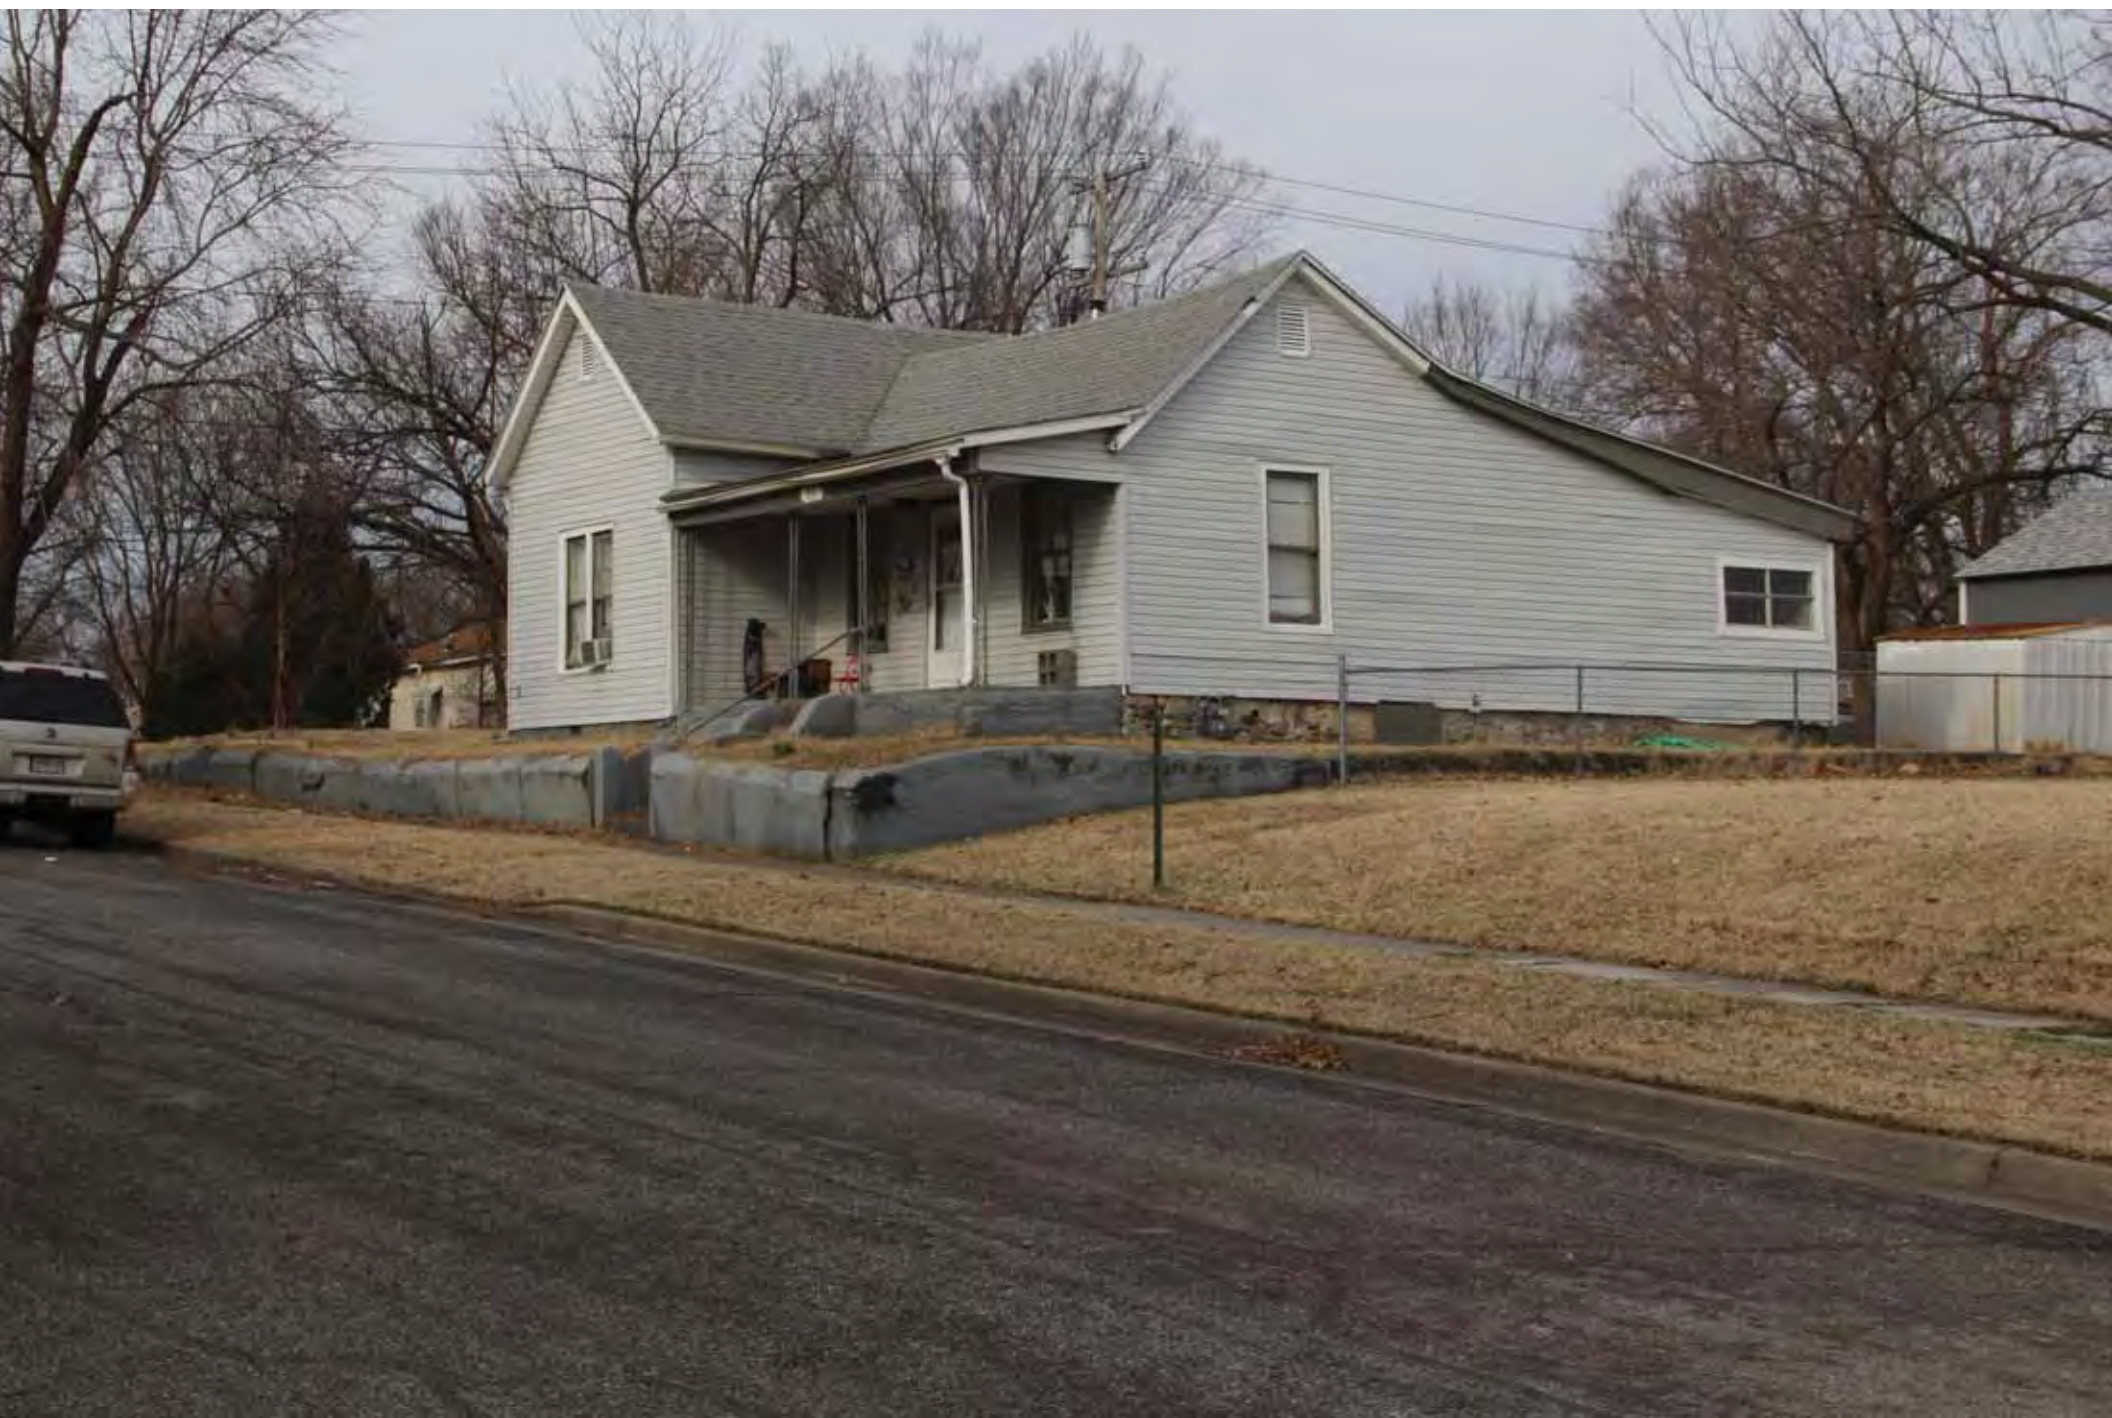
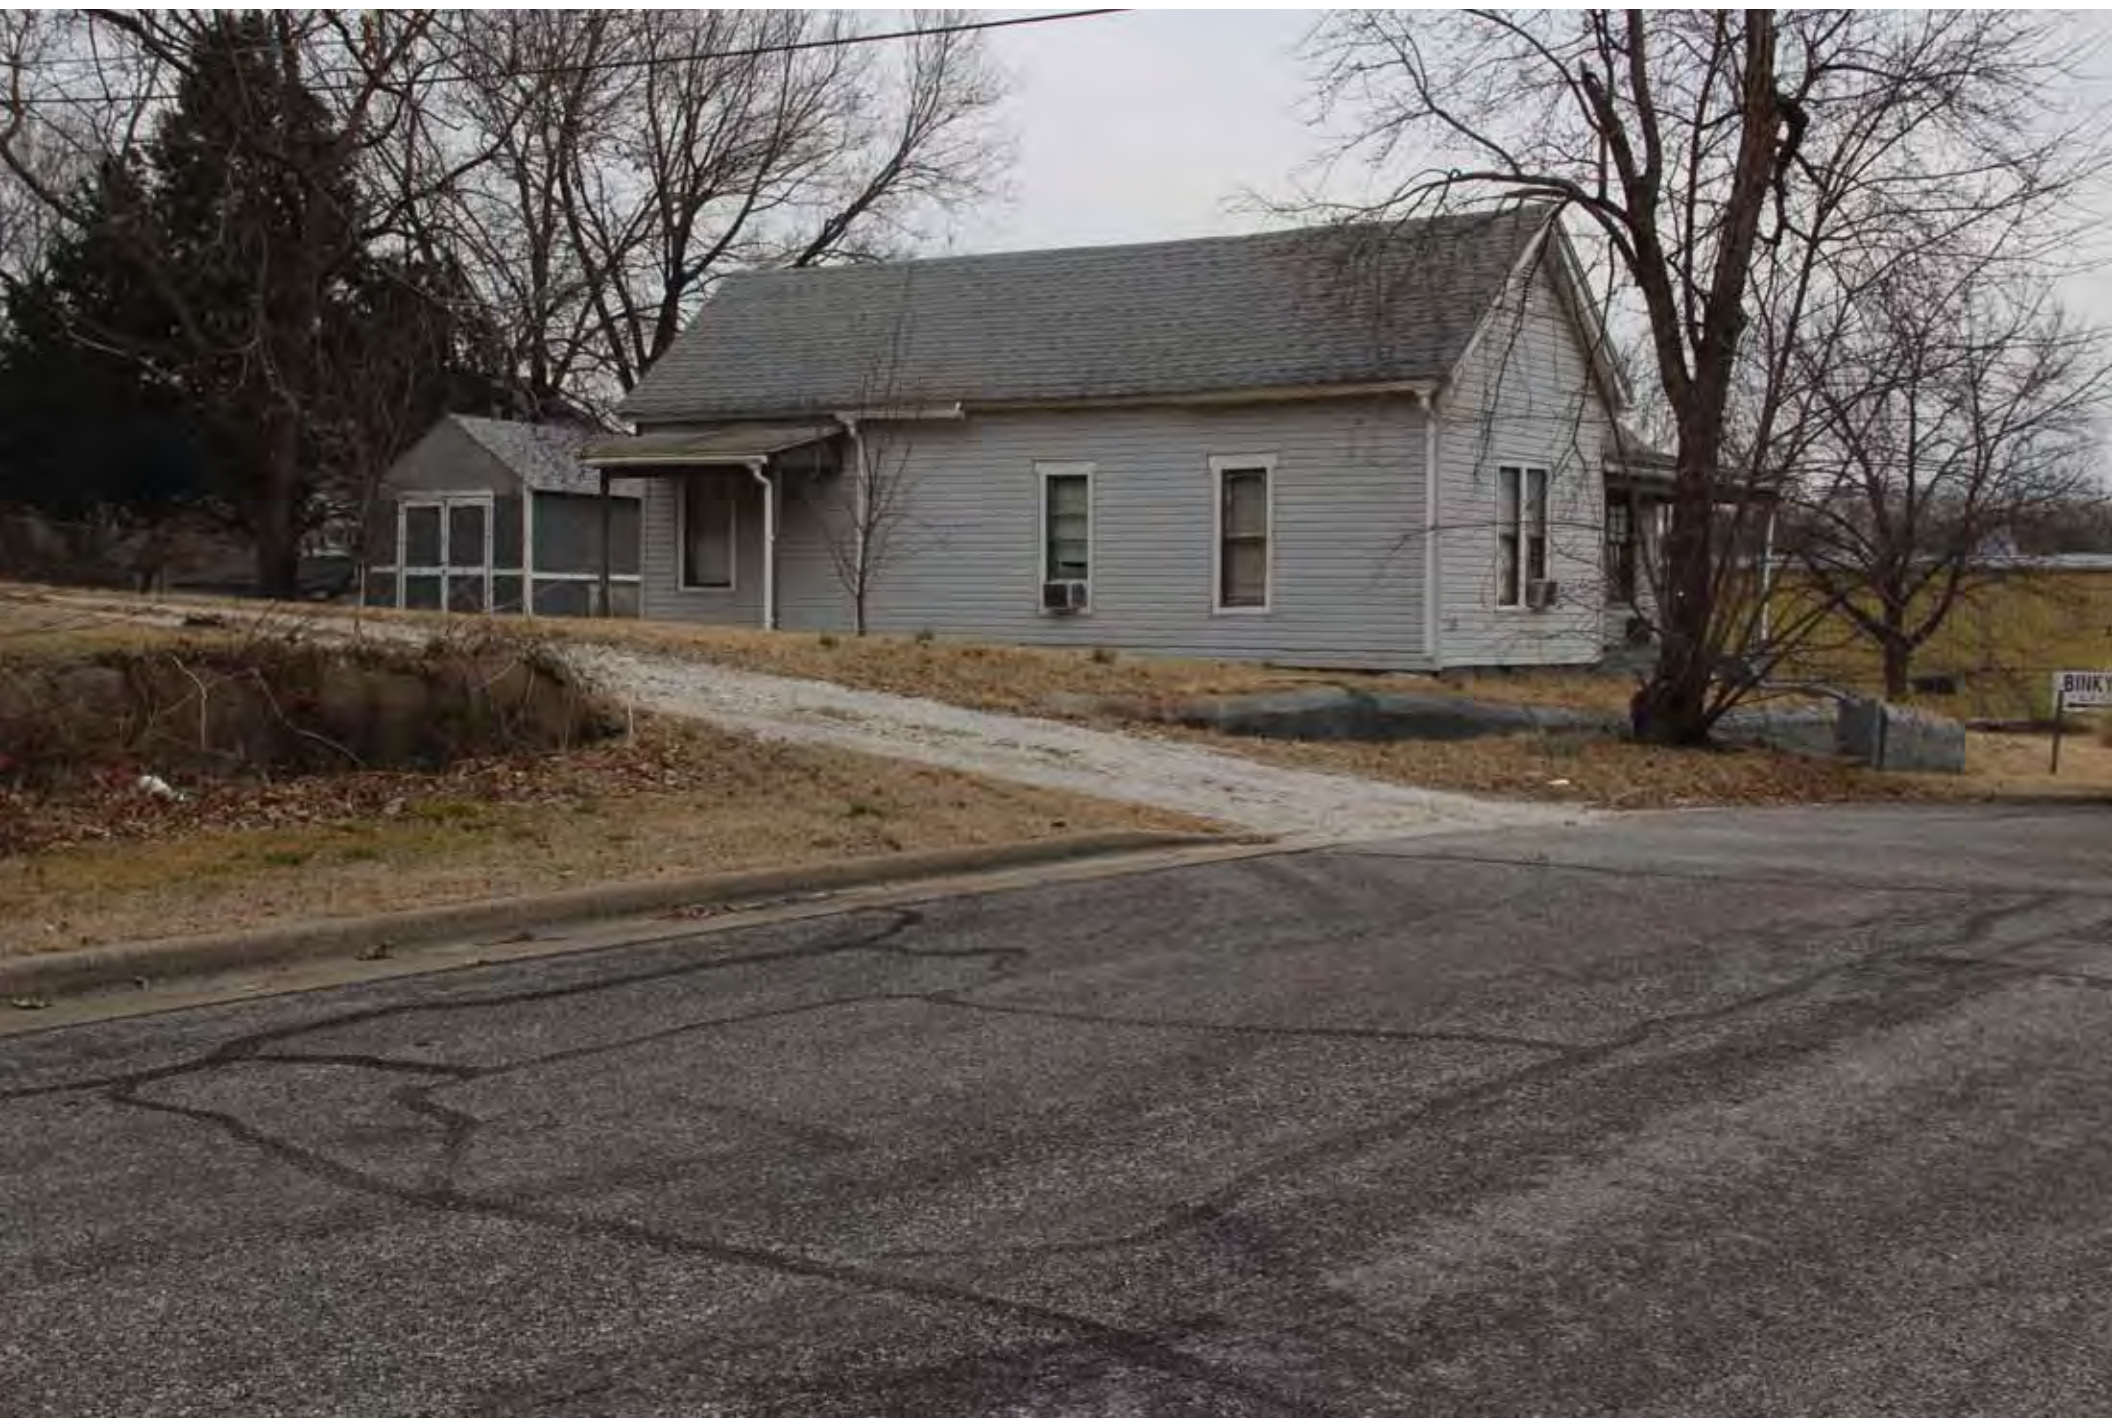
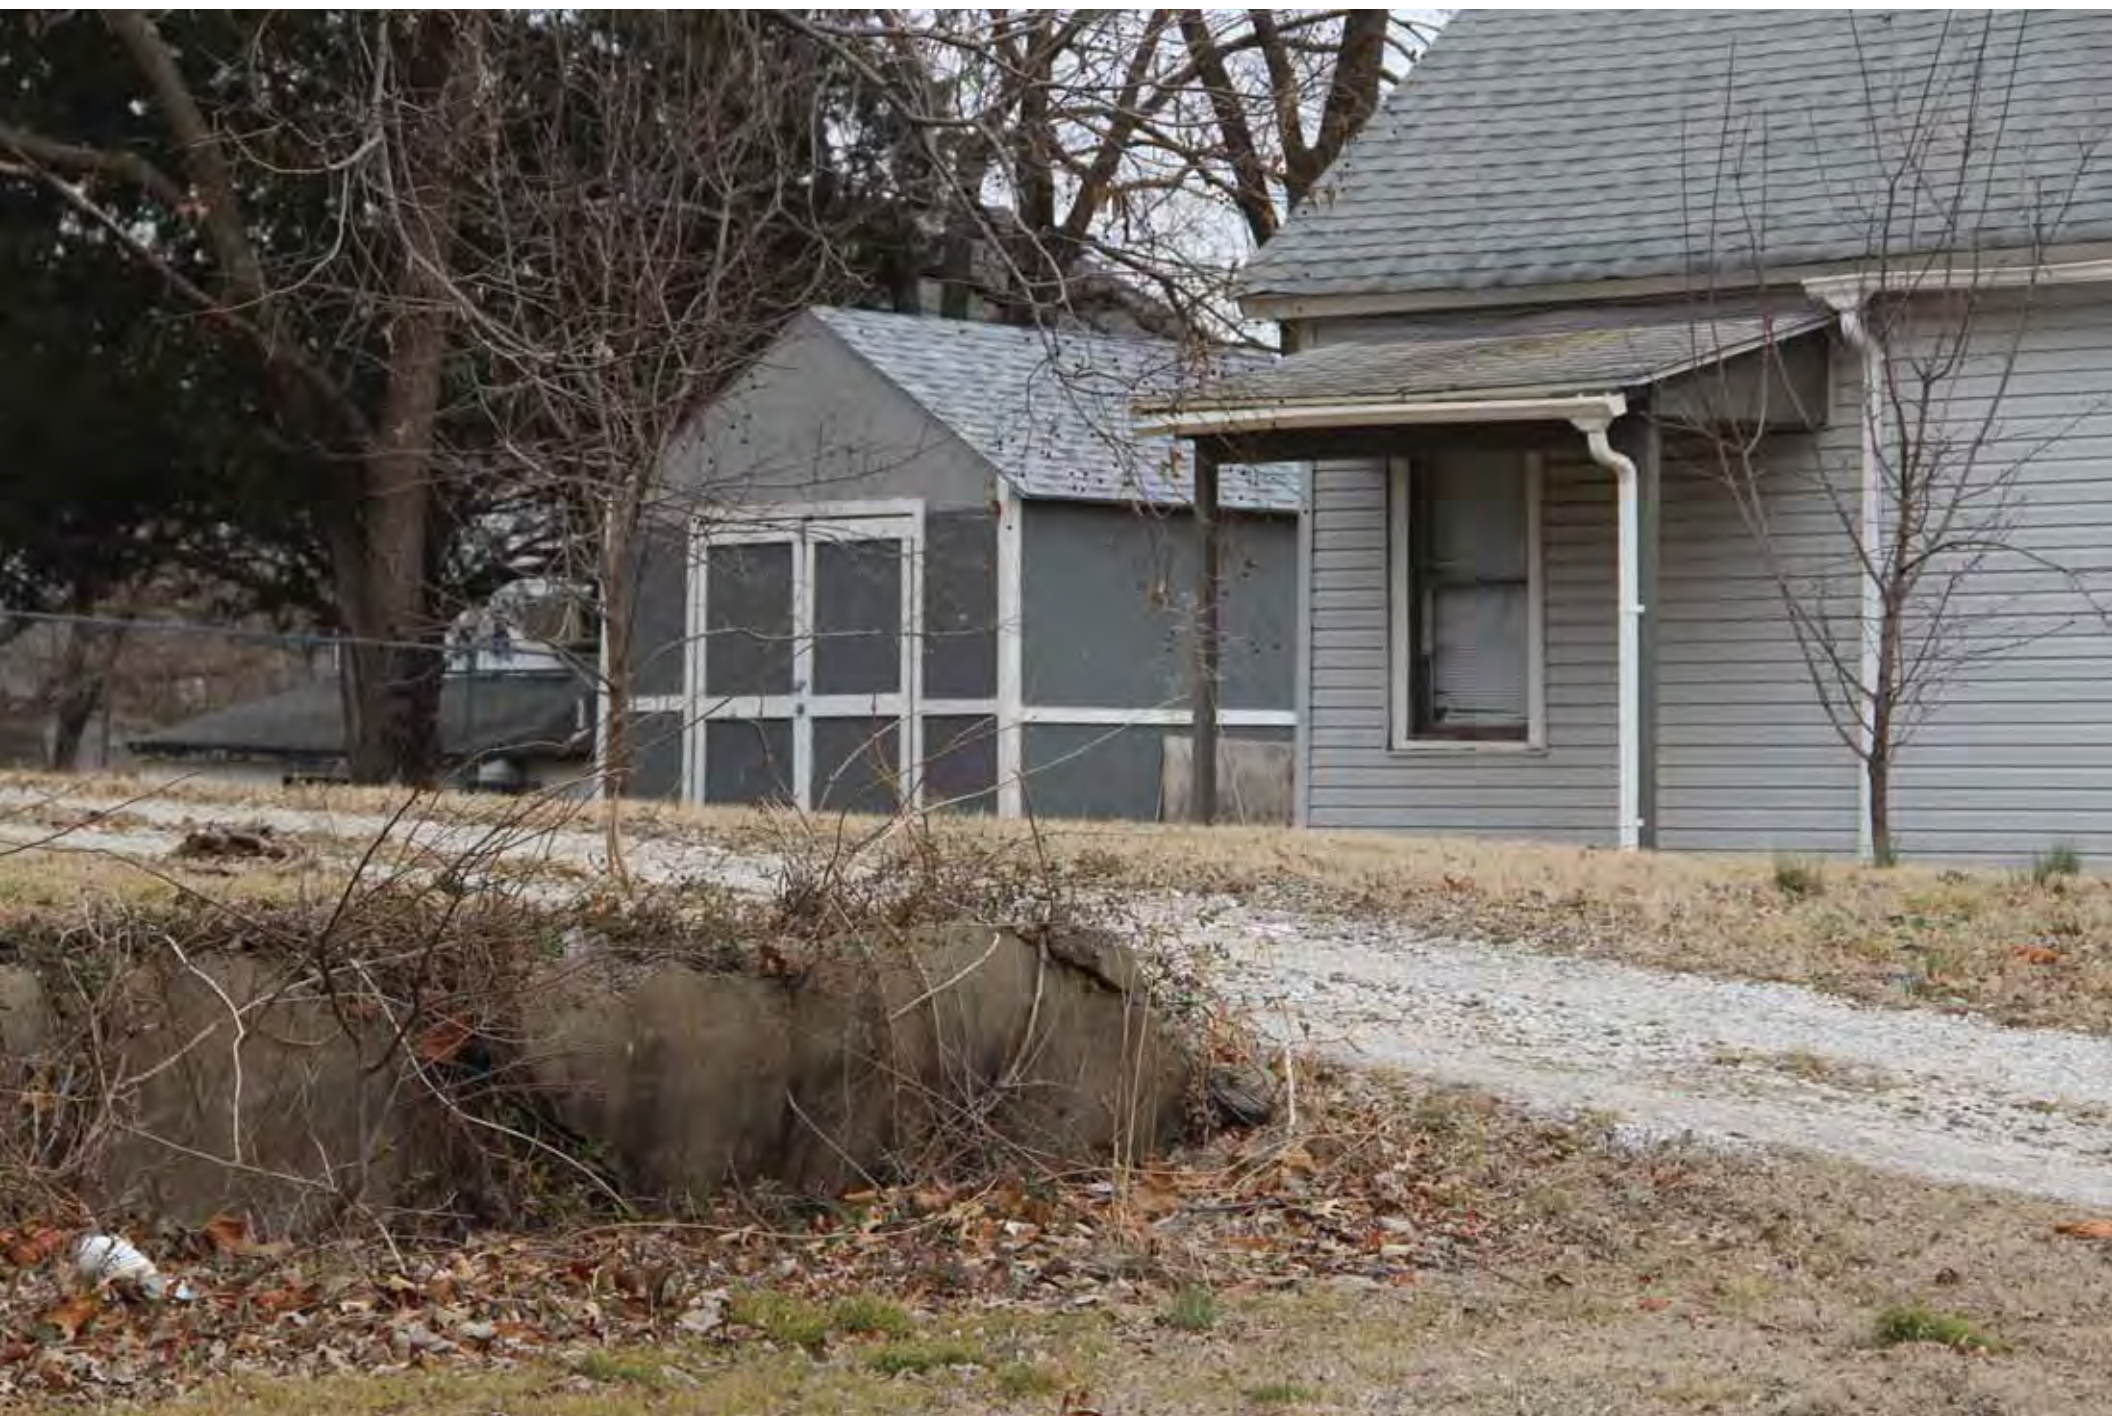
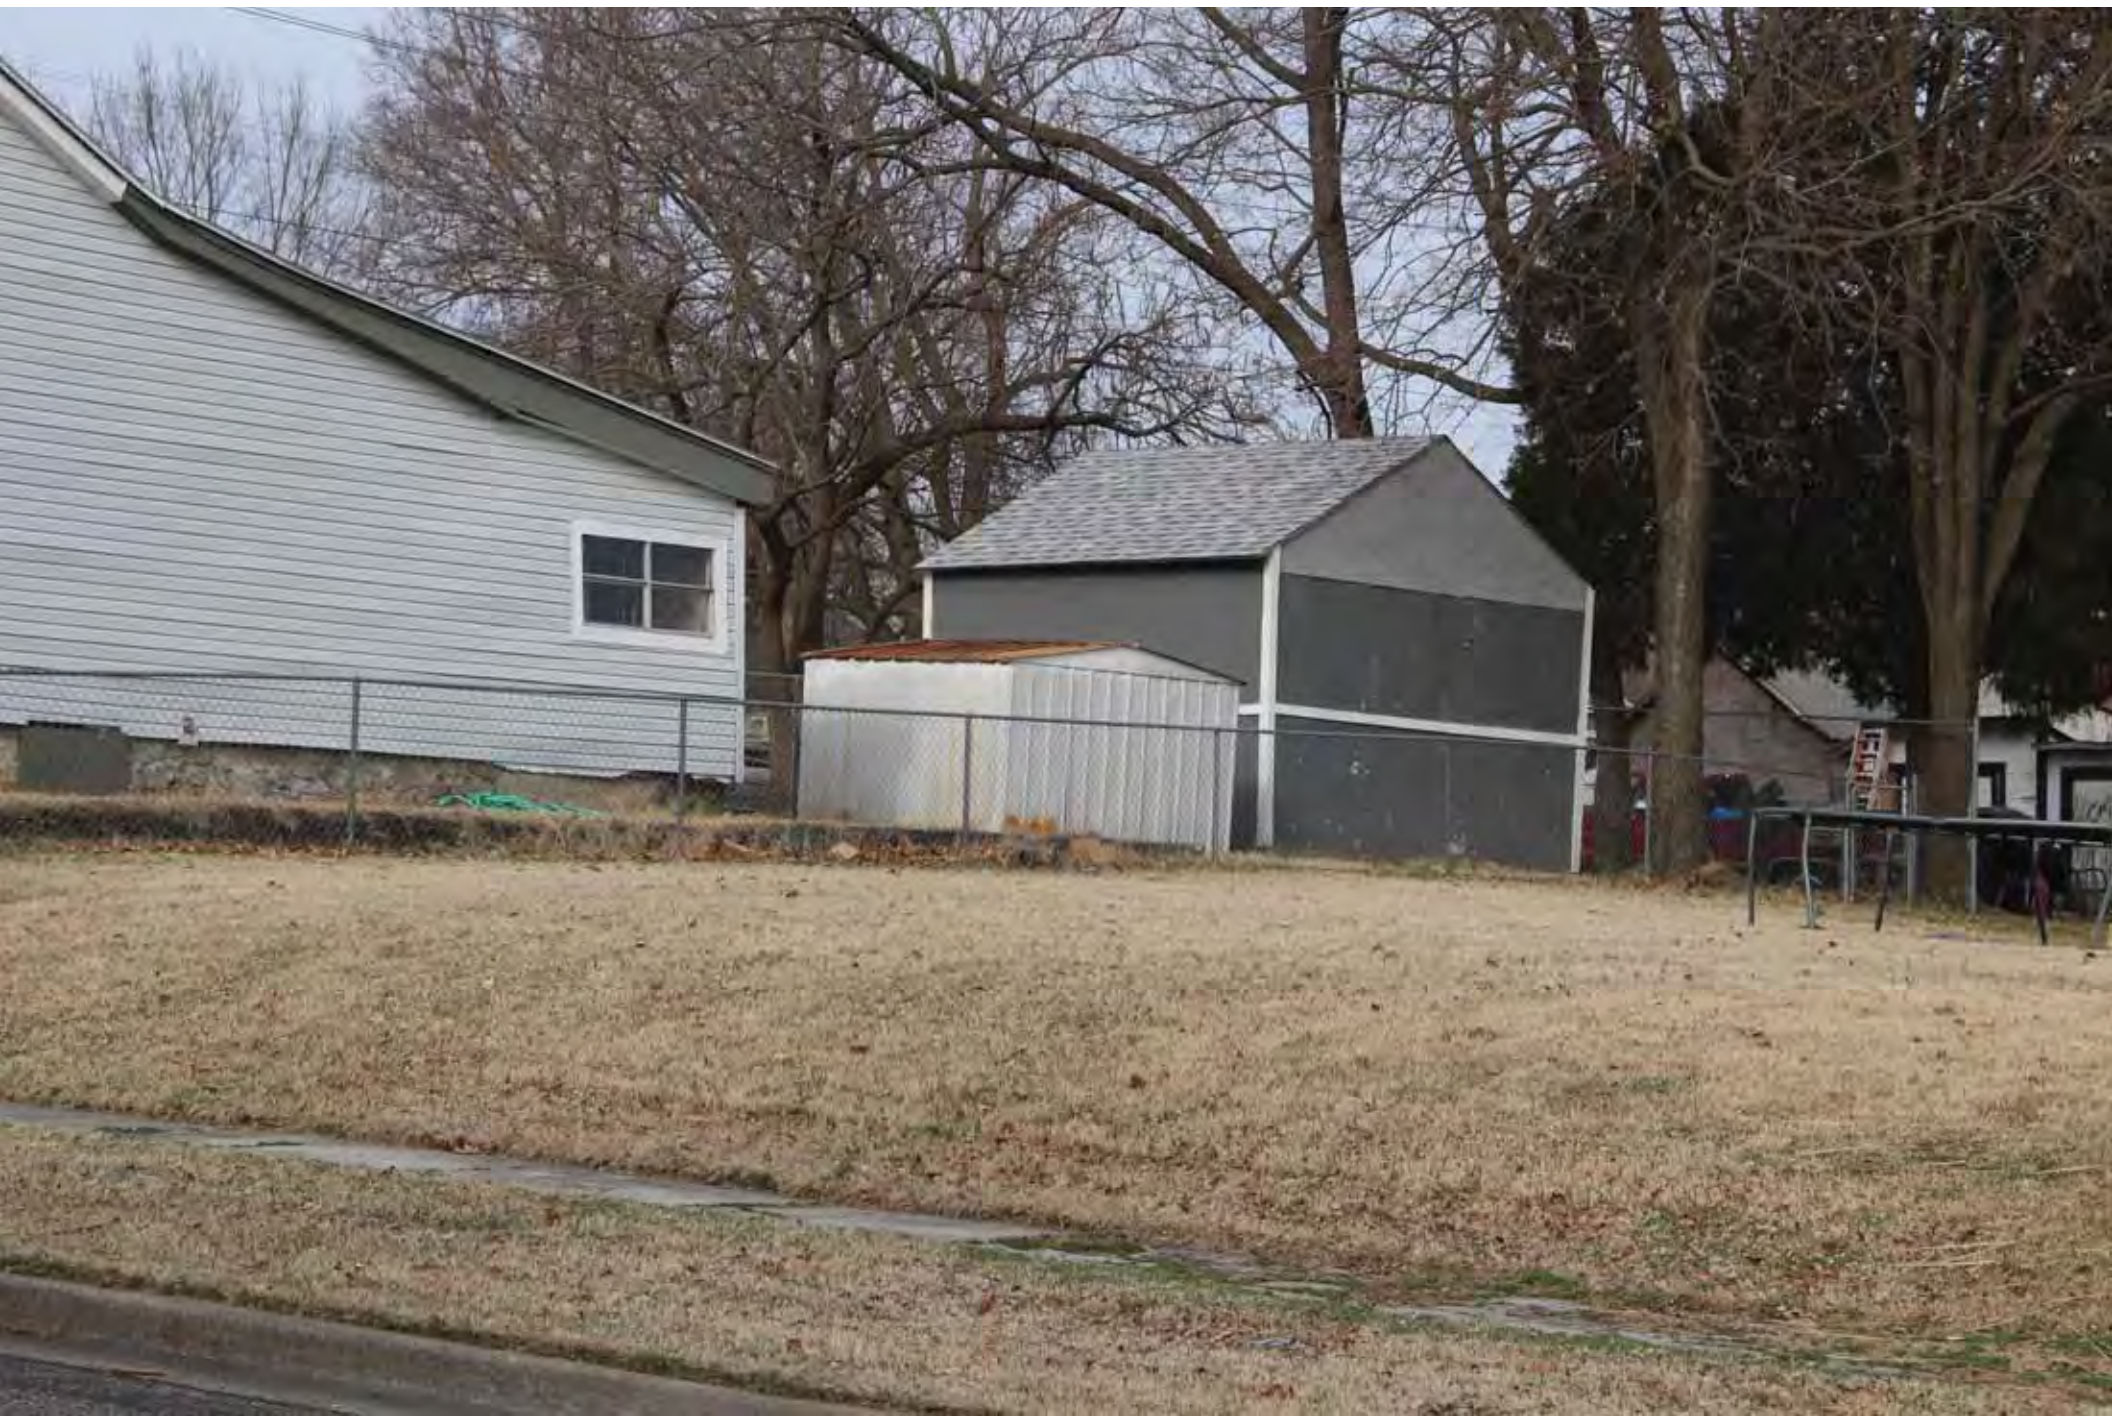
The property at 717 Jasper Street is a one-story dwelling, with a cross gable roof on a T-shaped plan. The entire roof is covered in asphalt siding. The house is covered in vinyl siding. On the left front elevation is a gable-facing end, with a pair of one-over-one wood windows. To the right, on the side-gabled end portion of the front façade, is a shed-roofed wooden porch. It has metal posts on a concrete foundation. It shelters a central entrance door, flanked on either side by two-over-two wood windows. On the rear of the house is a lean-to or shed roofed addition. On the east elevation the original portion of the house has one wood one-over-one window. At the rear addition is a single casement window. The west elevation of the house has three single one-over-one wood windows, with wooden surrounds. At the rear of the house, on this west elevation, is a side entrance, sheltered by a small porch with a shed roof on turned wood posts.

The dwelling does not retain sufficient integrity that would render it individually eligible for the National Register of Historic Places. The dwelling is not situated in an area recommended as a historic district.
