MISSOURI DEPARTMENT OF NATURAL RESOURCES
STATE HISTORIC PRESERVATION OFFICE, P.O. Box 176, Jefferson City, MO 65102
ARCHITECTURAL/HISTORIC INVENTORY FORM

1. Survey No. JP-AS-007-001		2. Survey name: East Town (Original Joplin) Historic Survey Phase 2	
3. County: JASPER		4. Address (Street No.) 618	Street (name) E. 2 nd Street
5. City: Joplin	Vicinity: <input type="checkbox"/>	6. Geographical Reference:	7. Township/Range/Section: T: R: S:
8. Historic name (if known):		9. Present/other name (if known):	
10. Ownership: <input checked="" type="checkbox"/> Private <input type="checkbox"/> Public		11a. Historic use (if known): Domestic: Single Dwelling	11b. Current use: Domestic: Single Dwelling

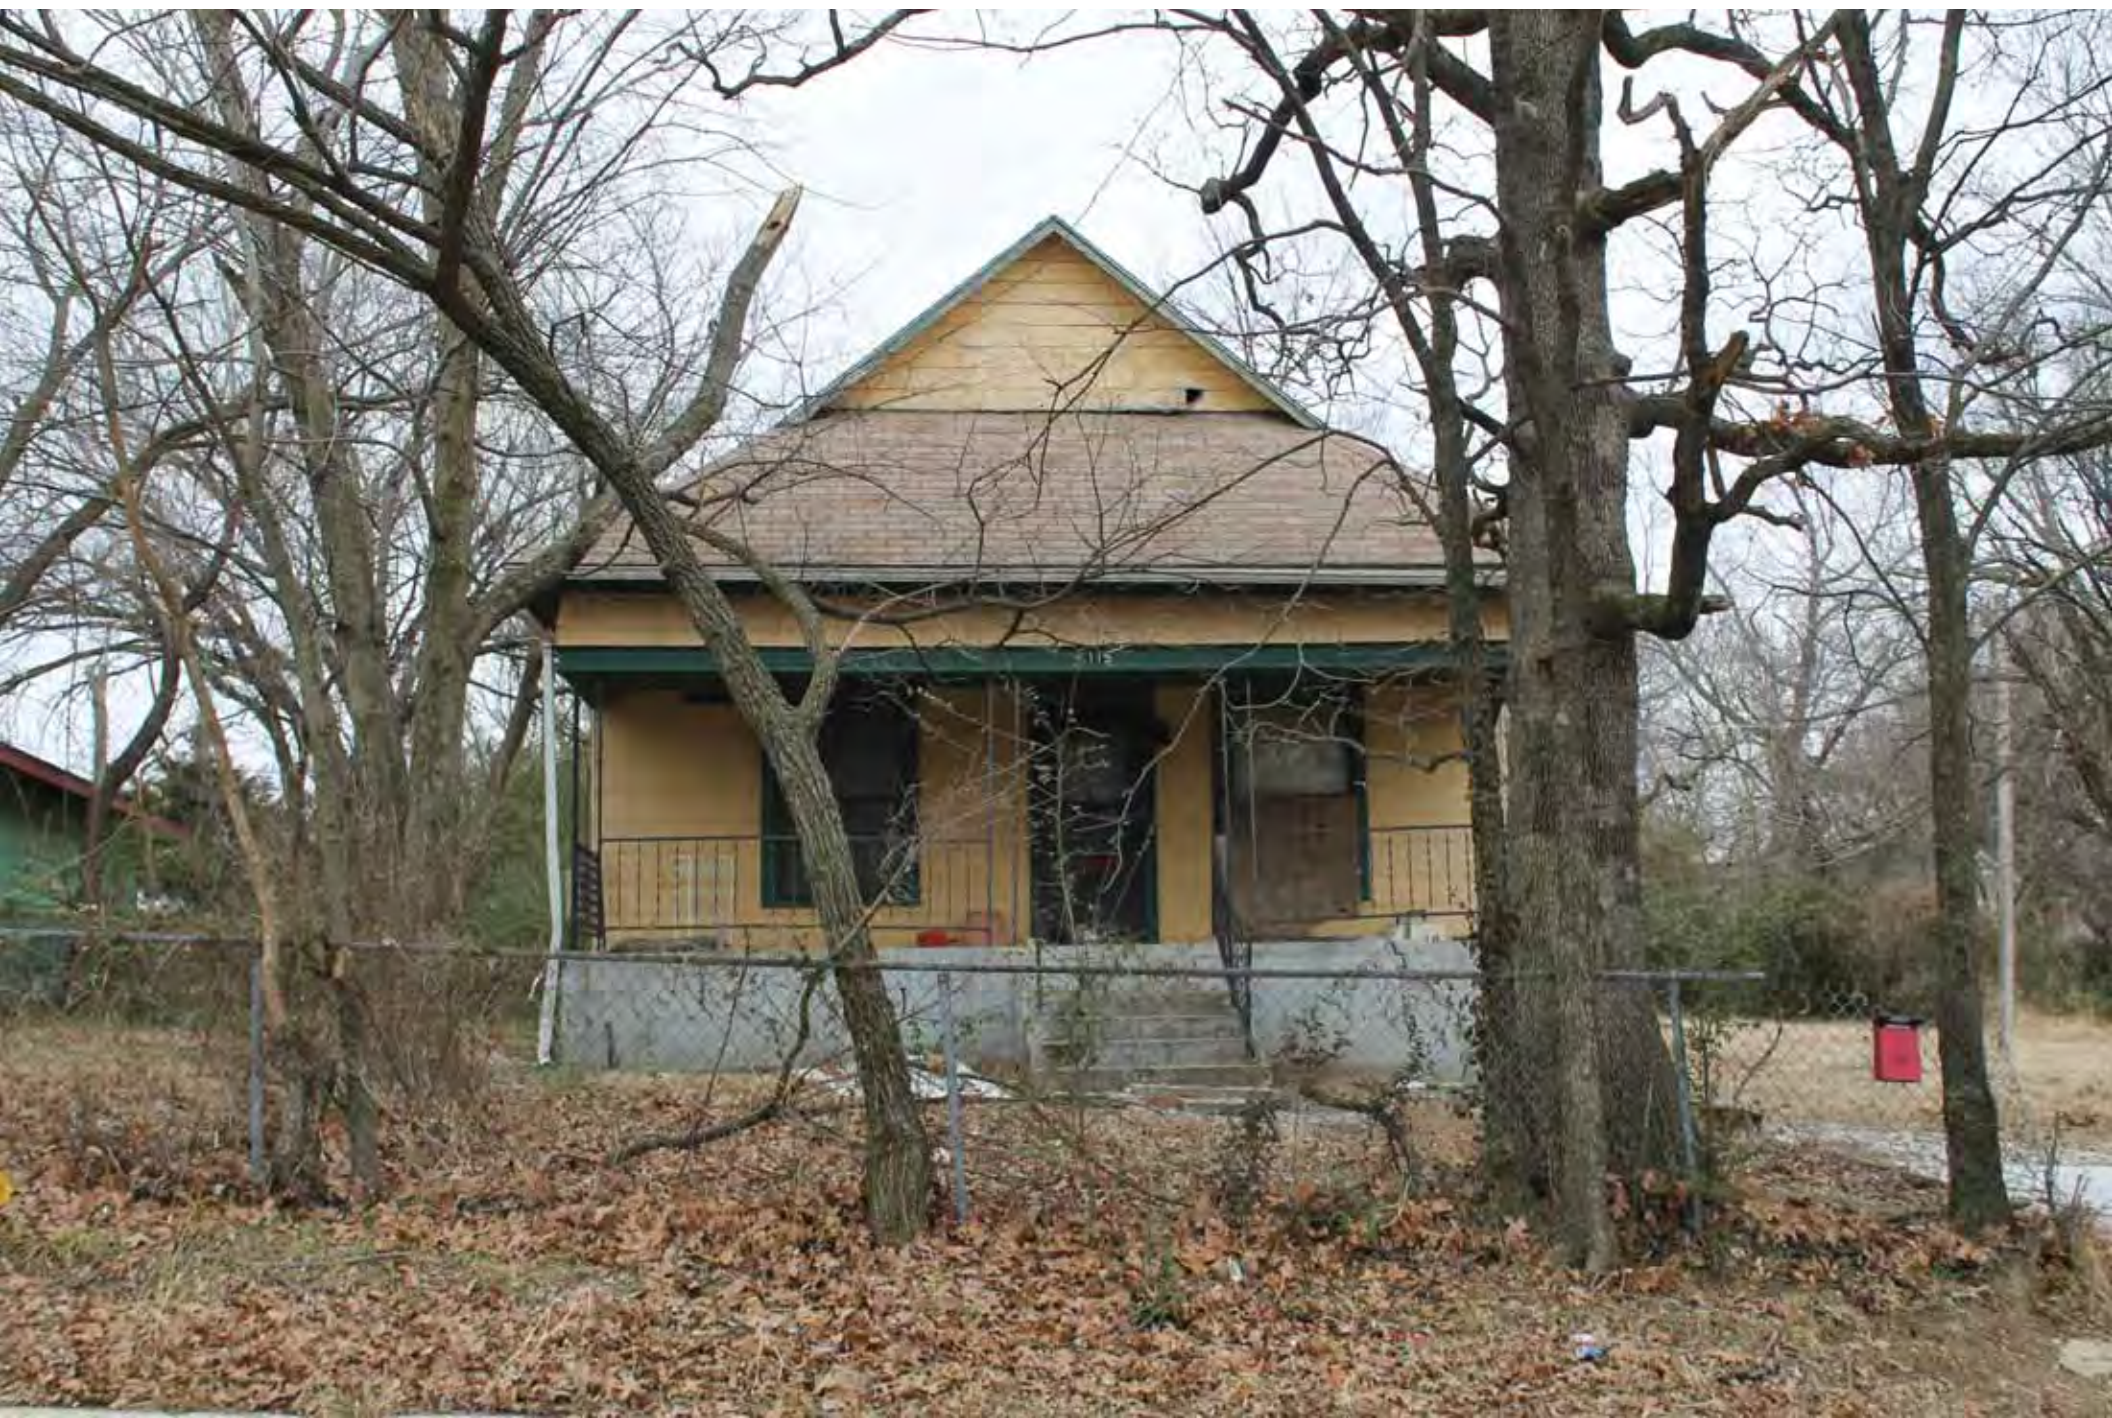
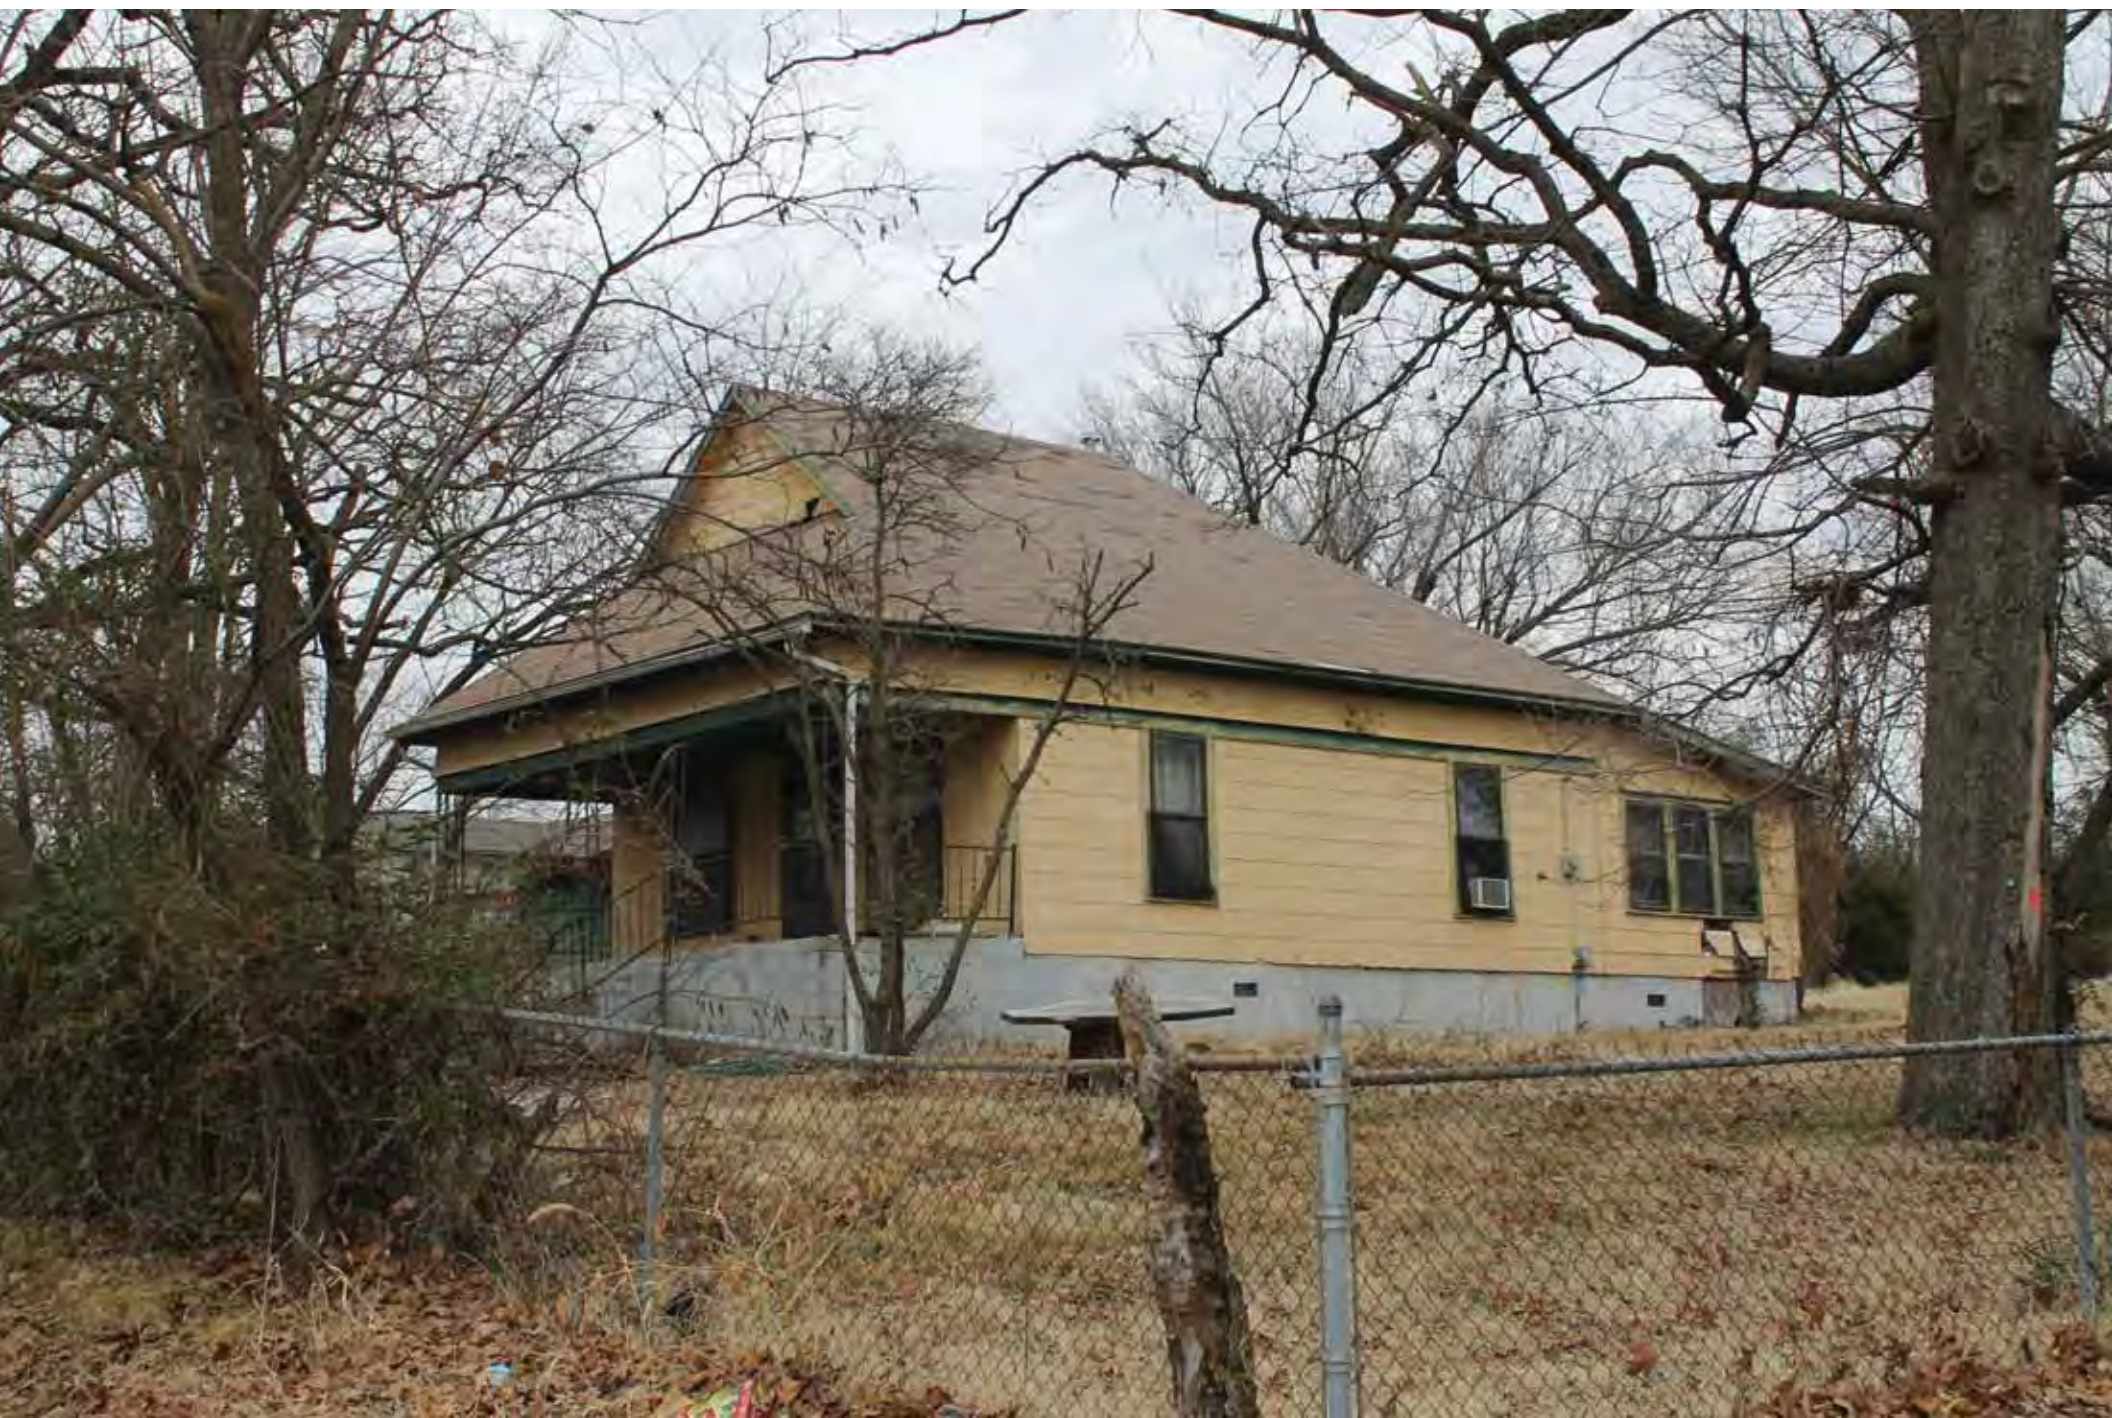
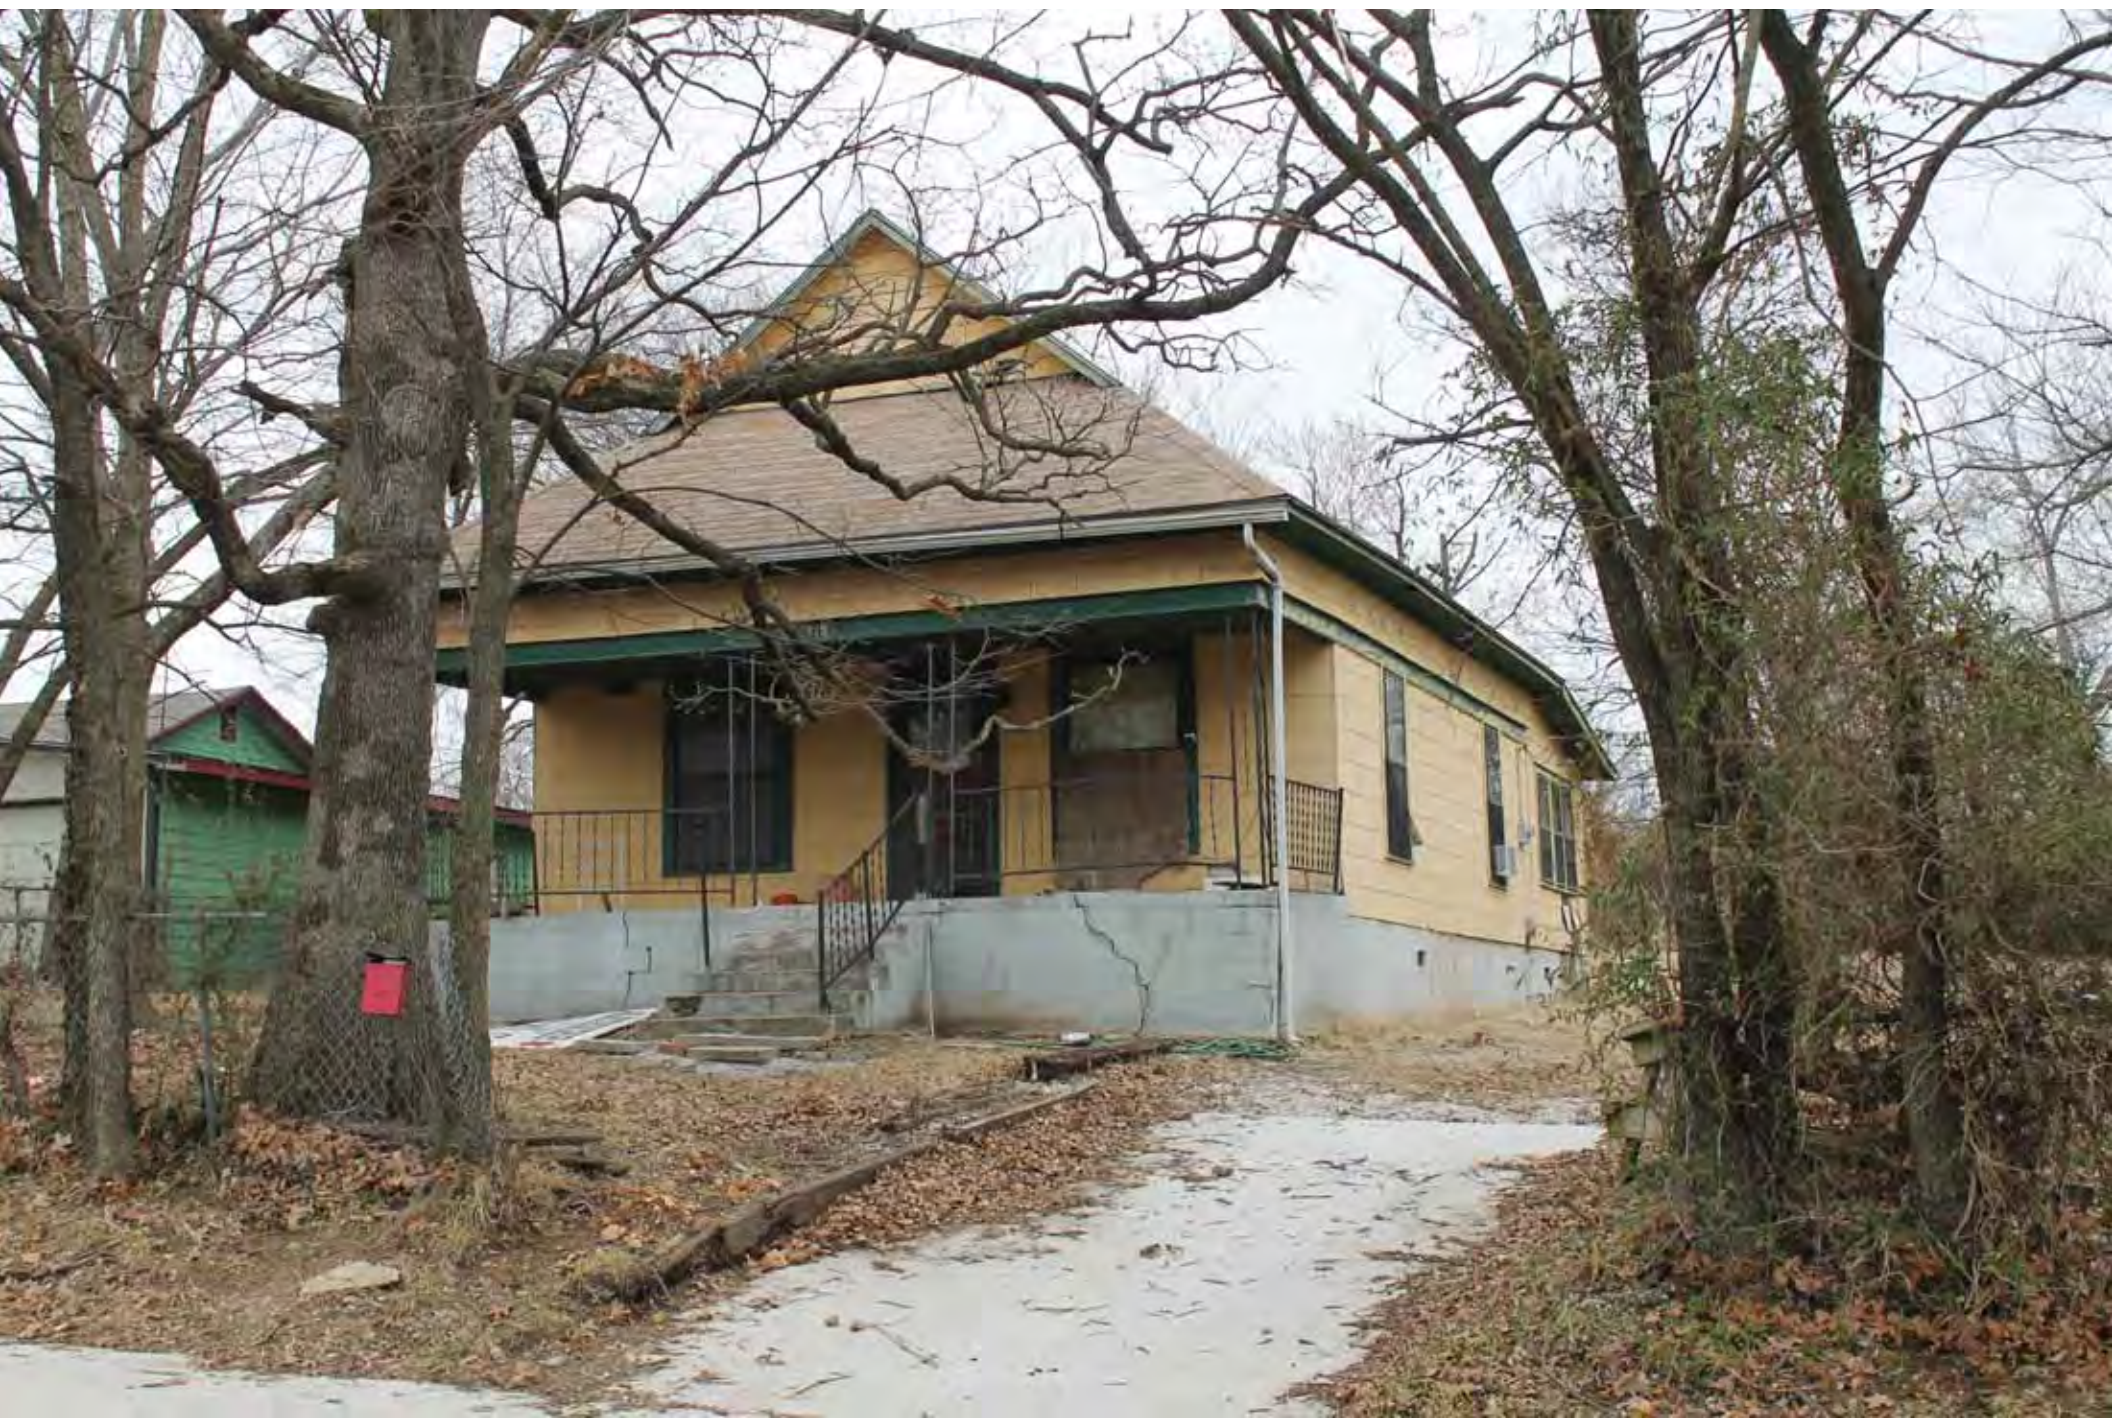
The property at 115 S. McKee Avenue features a gable-front plan dwelling with an asphalt shingled gable-on-hip roof, exterior asbestos shingle siding (c. 1960) and a concrete block foundation. The primary (west) elevation has a full integral porch supported by wrought iron columns (c. 1960). A wrought iron balustrade (c. 1960) surrounds the porch. Within the porch bay is a central original door with a single upper light. The door is flanked by original one-over-one windows. The primary elevation window south of the door is partially covered with plywood. The area just below the hipped roof overhang is clad with original wood shingle siding and visible on all upper elevations. The dwelling has a rear shed wing. The south and north elevations each hold two double hung windows. The south elevation of the rear shed wing supports a band of three continuous double-hung windows.

The dwelling is a common property type that fails to illustrate architectural and/or historical significance rendering the property individually eligible for the National Register. The dwelling is not within an area recommended as a historic district. For these reasons, the property does not appear eligible for the National Register of Historic Places.

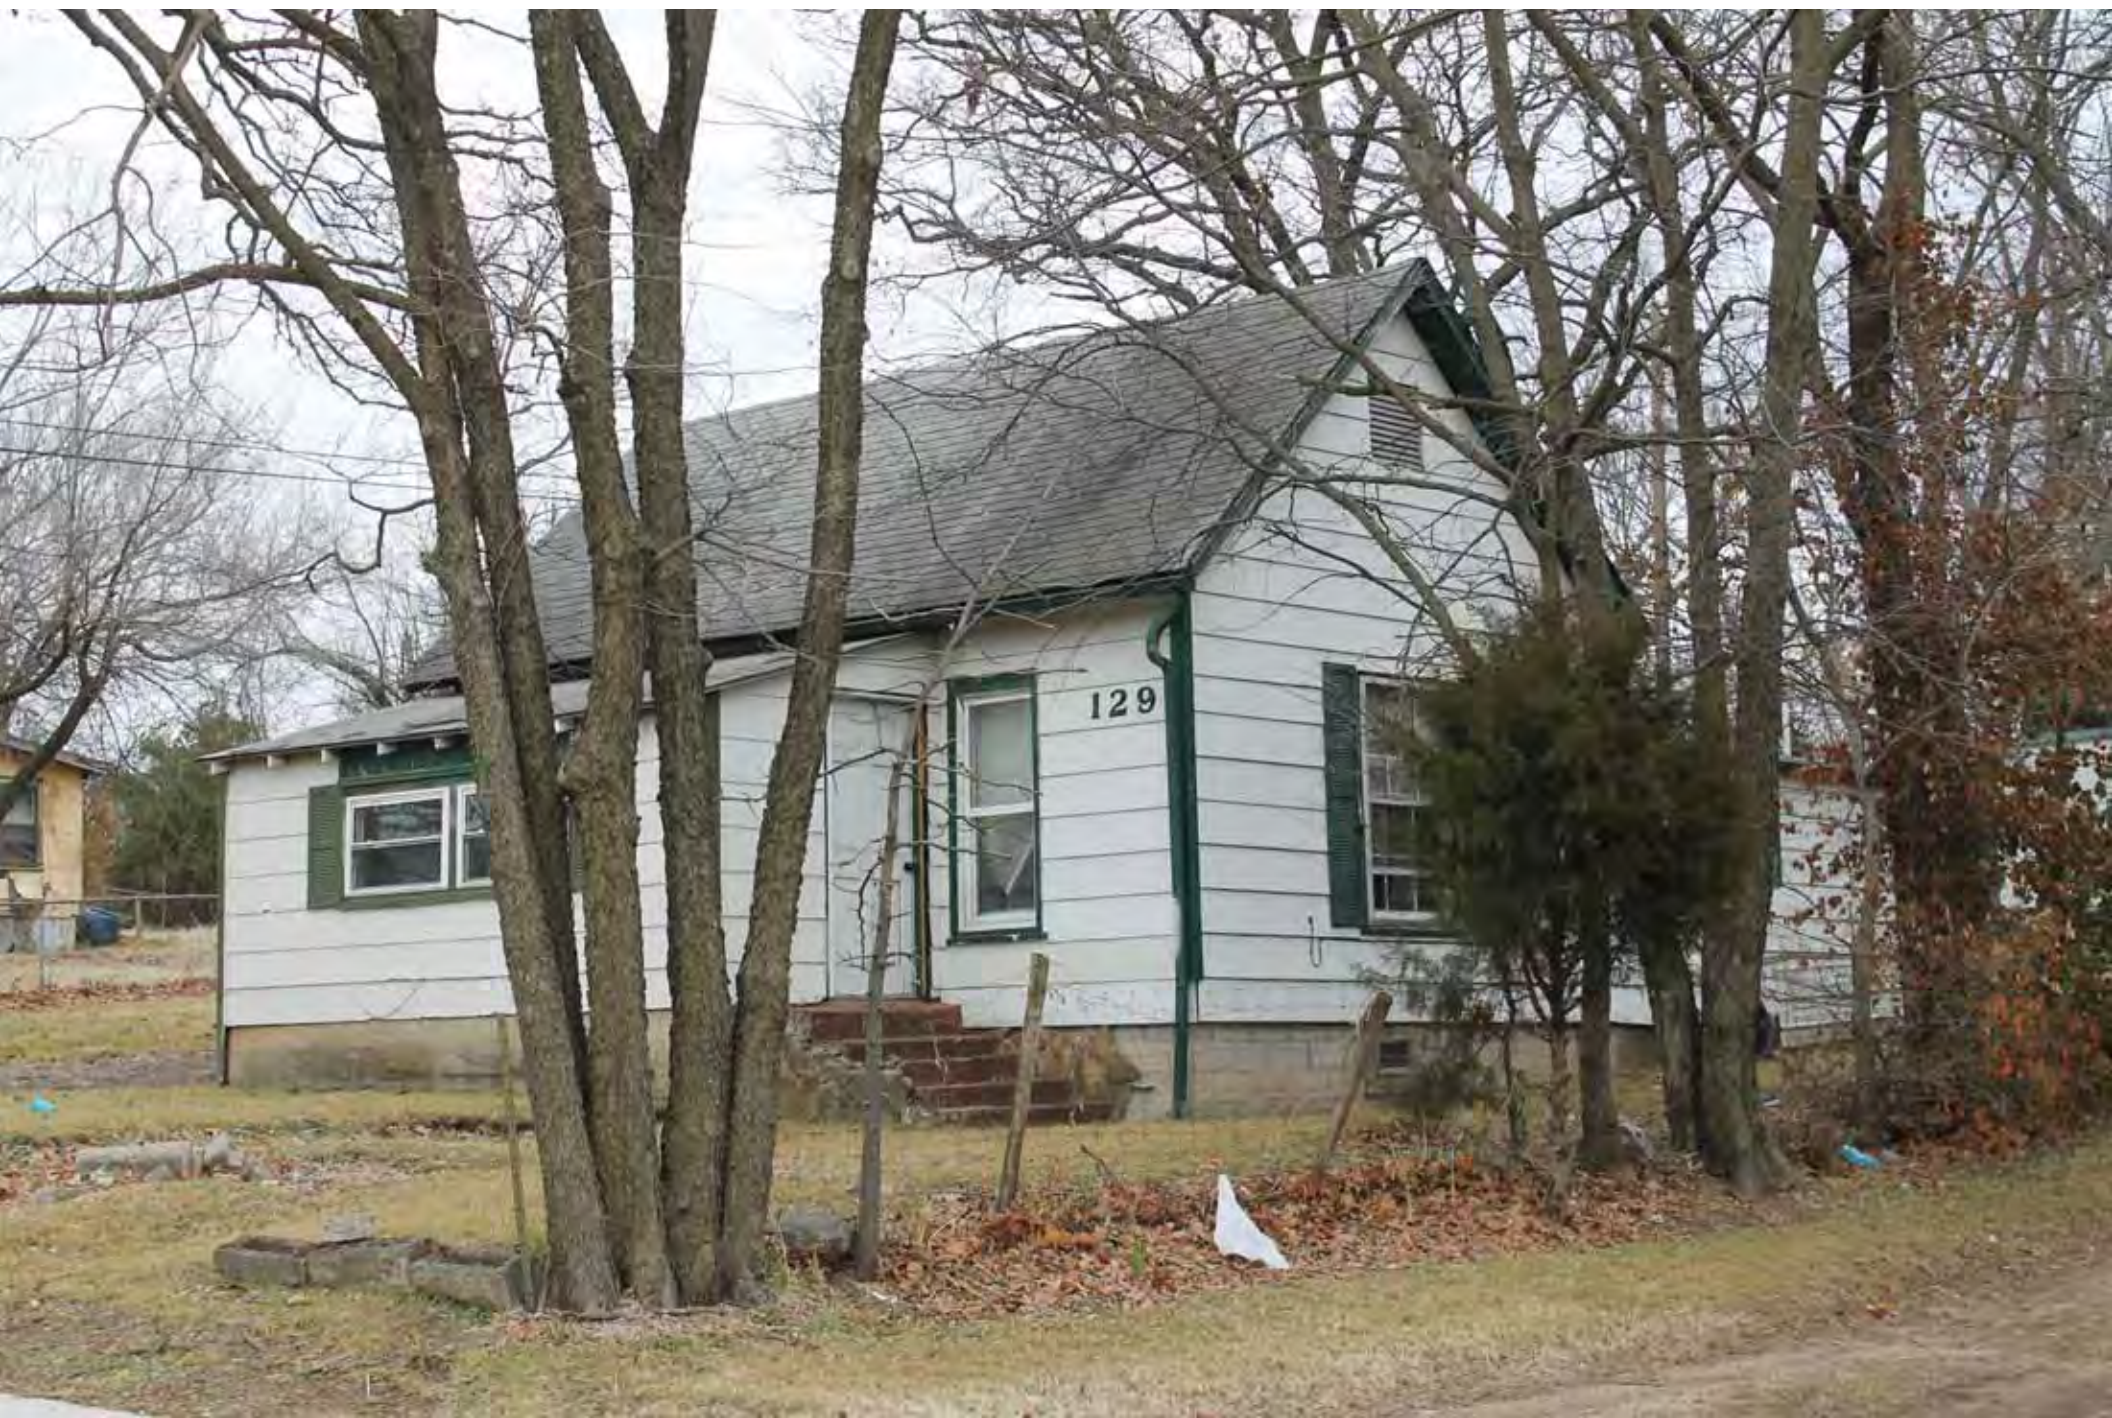
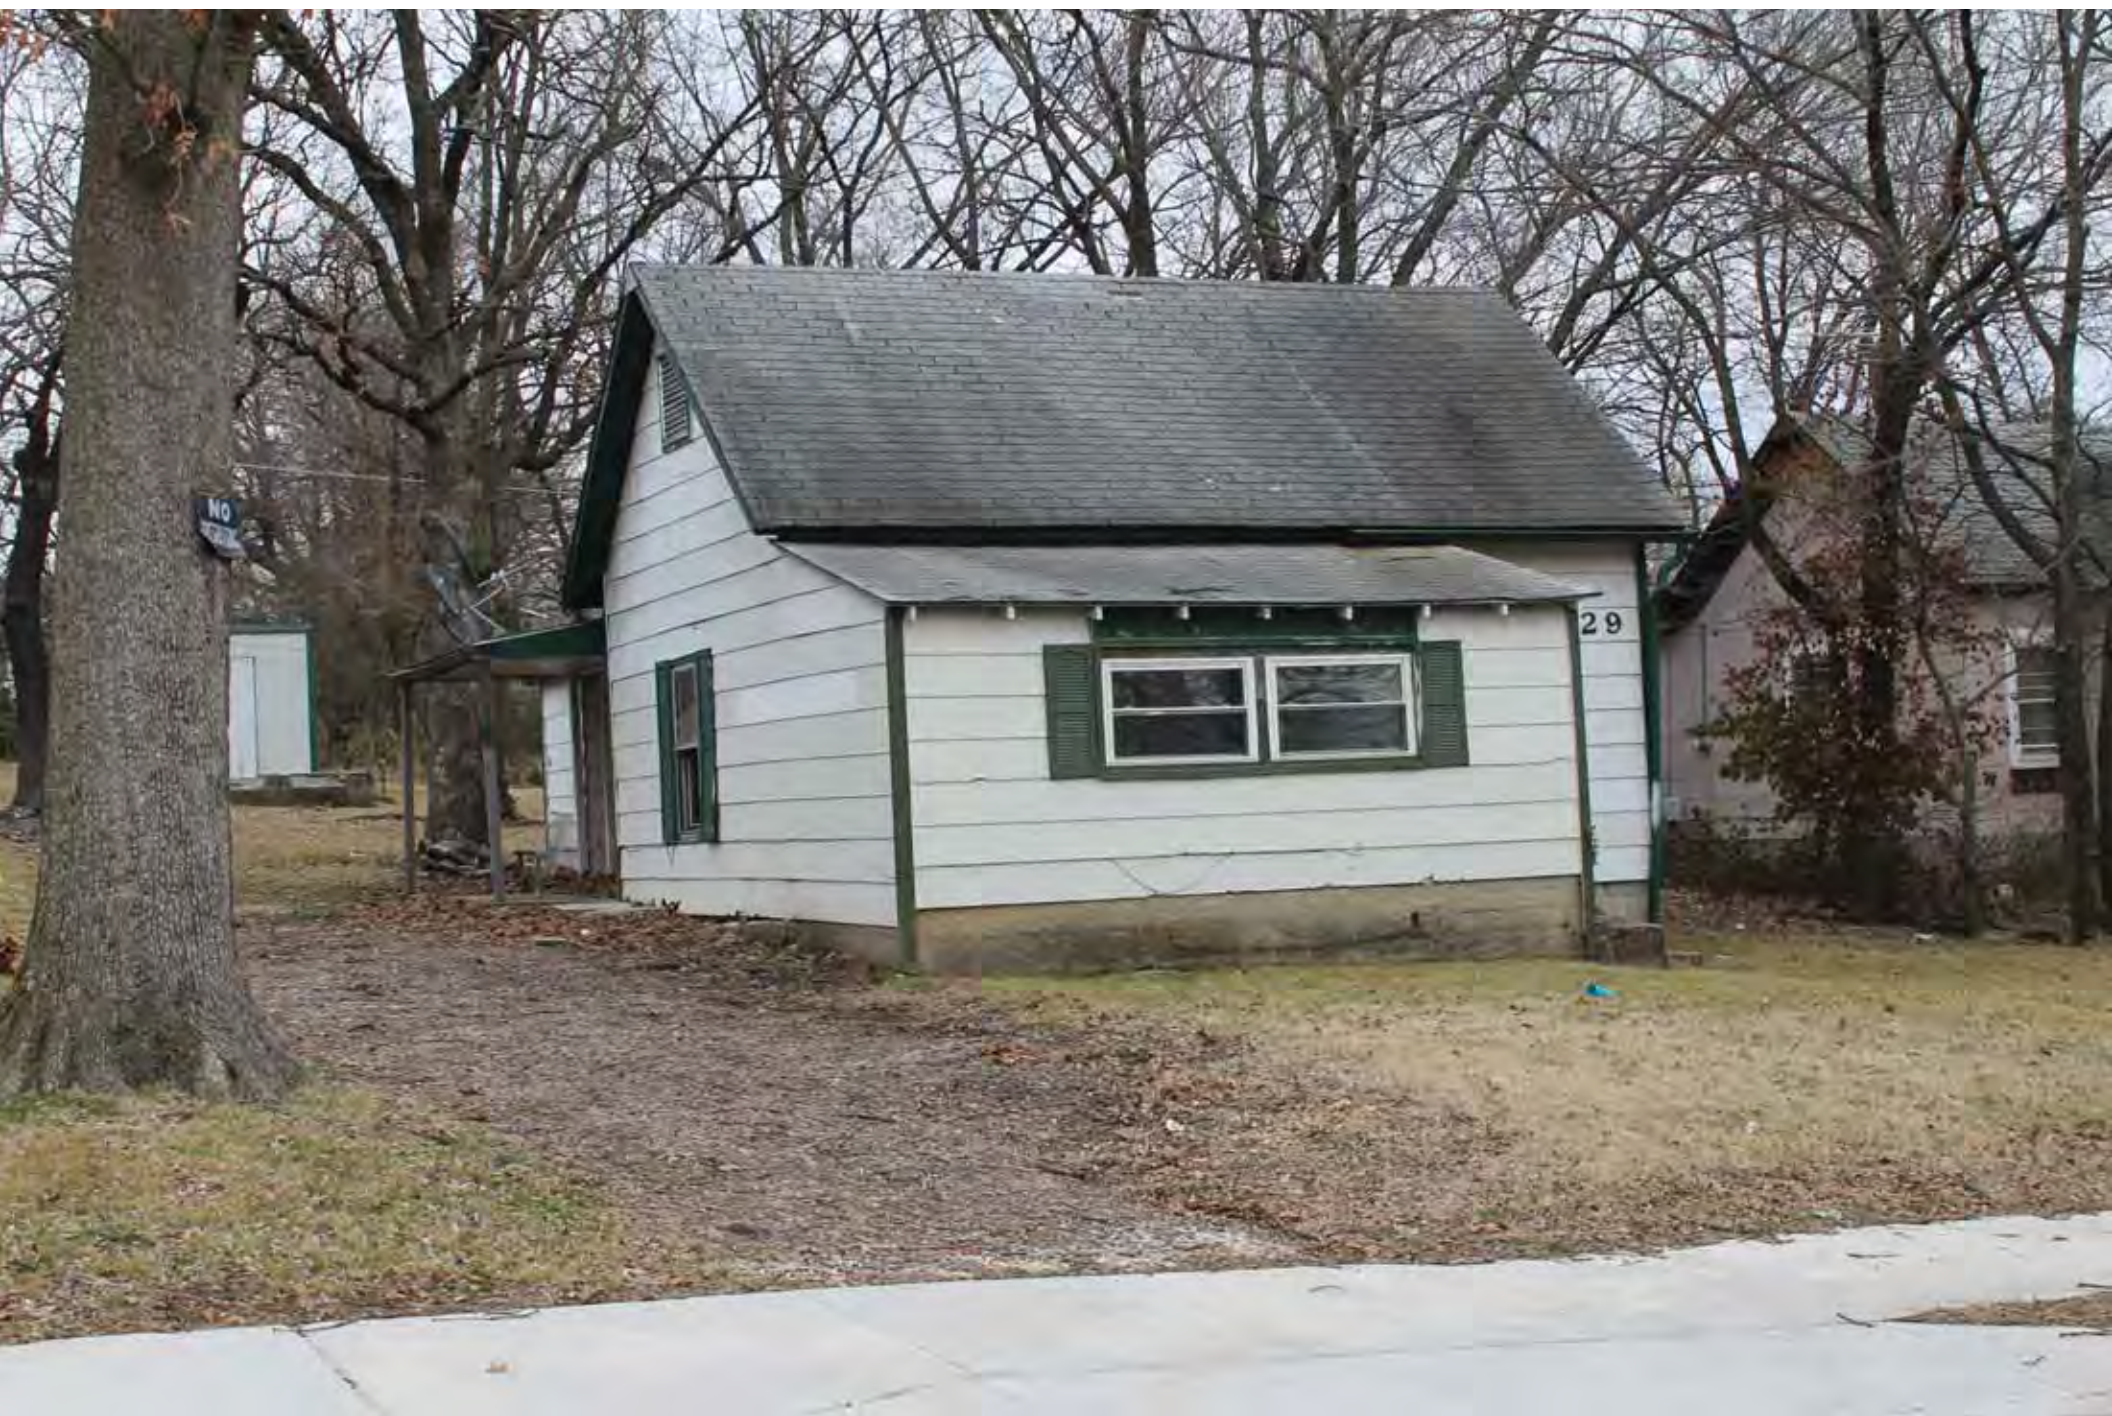
The property at 129 S. McKee Avenue features a single-story dwelling with an asphalt shingled gabled roof, exterior wide board siding and a concrete foundation. The primary (west) elevation has an enclosed shed porch (c. 1960). Porch and house siding does not appear original (c. 1960). The enclosed porch has paired one-over-one windows with faux shutters on the west elevation. A solid paneled door (c. 2010) is situated on the south elevation of the enclosed porch. Offsetting the enclosed porch to the south is a façade window bay (with replacement lights, c. 2010). The porch roof retains exposed rafter tails. The dwelling has a rear shed wing. The south elevation holds an original six-over-six window. Above the window, the gable field supports a louvered vent. The north elevation holds a one-over-one window, a gable field louvered vent and a secondary porch with a shed roof near the east end of the elevation. An entry bay is accessible via the porch.

The dwelling is a common property type that fails to illustrate architectural and/or historical significance rendering the property individually eligible for the National Register. The dwelling has been altered with enclosure of the primary porch and is not within an area recommended as a historic district. For these reasons, the property does not appear eligible for the National Register of Historic Places.
