MISSOURI DEPARTMENT OF NATURAL RESOURCES
STATE HISTORIC PRESERVATION OFFICE, P.O. Box 176, Jefferson City, MO 65102
ARCHITECTURAL/HISTORIC INVENTORY FORM

1. Survey No. JP-AS-007-001		2. Survey name: East Town (Original Joplin) Historic Survey Phase 2	
3. County: JASPER		4. Address (Street No.) 618	Street (name) E. 2 nd Street
5. City: Joplin	Vicinity: <input type="checkbox"/>	6. Geographical Reference:	7. Township/Range/Section: T: R: S:
8. Historic name (if known):		9. Present/other name (if known):	
10. Ownership: <input checked="" type="checkbox"/> Private <input type="checkbox"/> Public		11a. Historic use (if known): Domestic: Single Dwelling	11b. Current use: Domestic: Single Dwelling

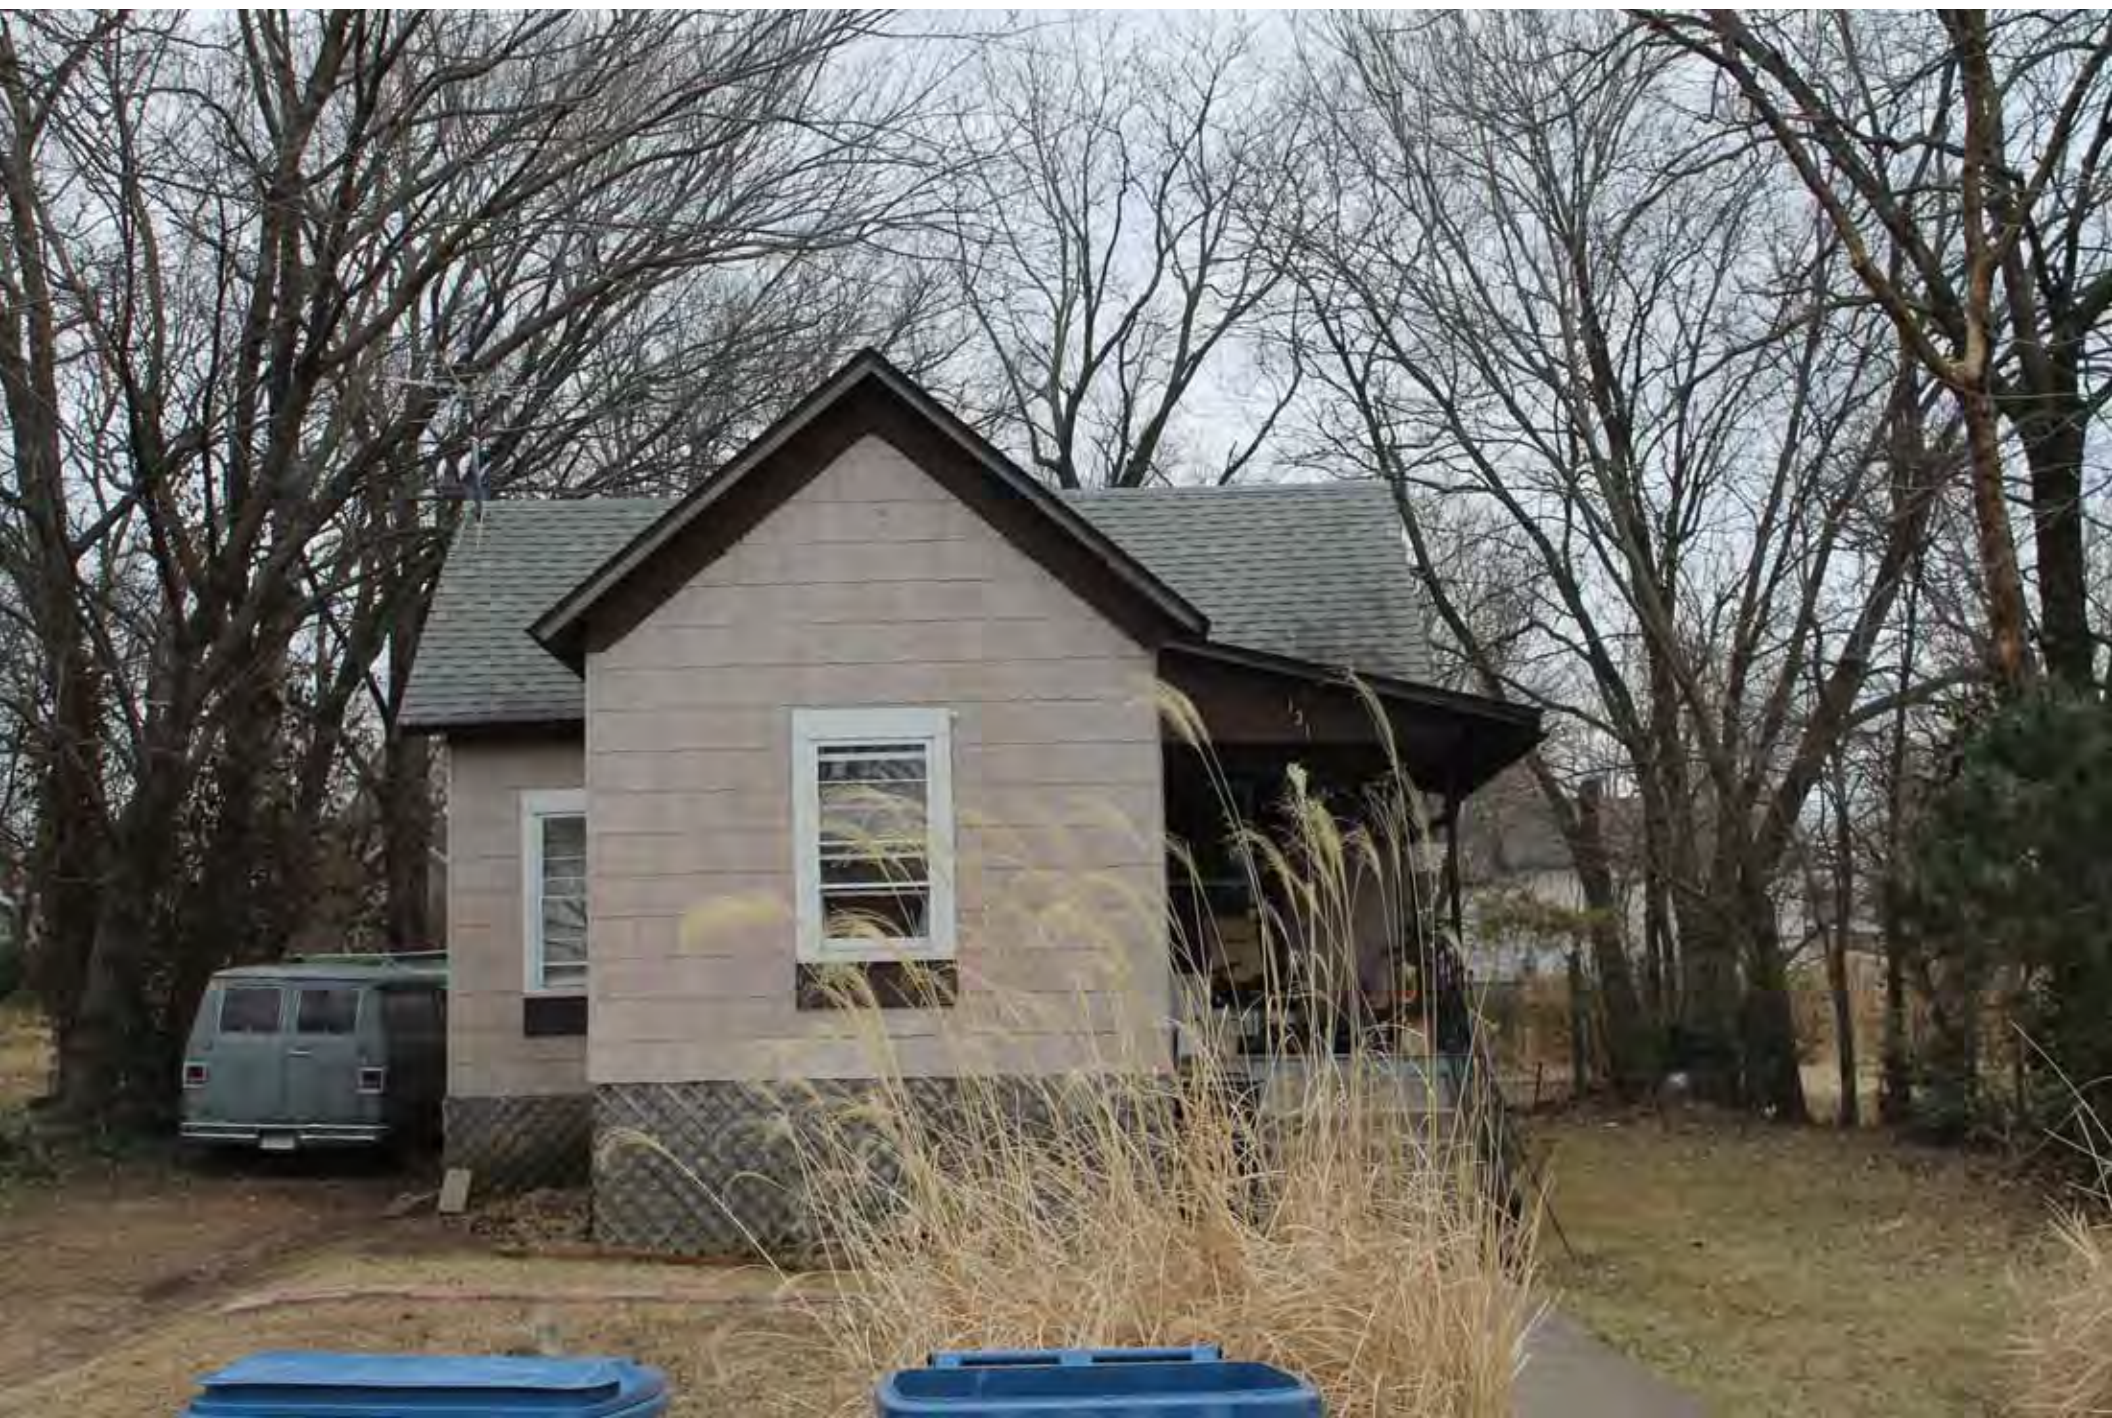
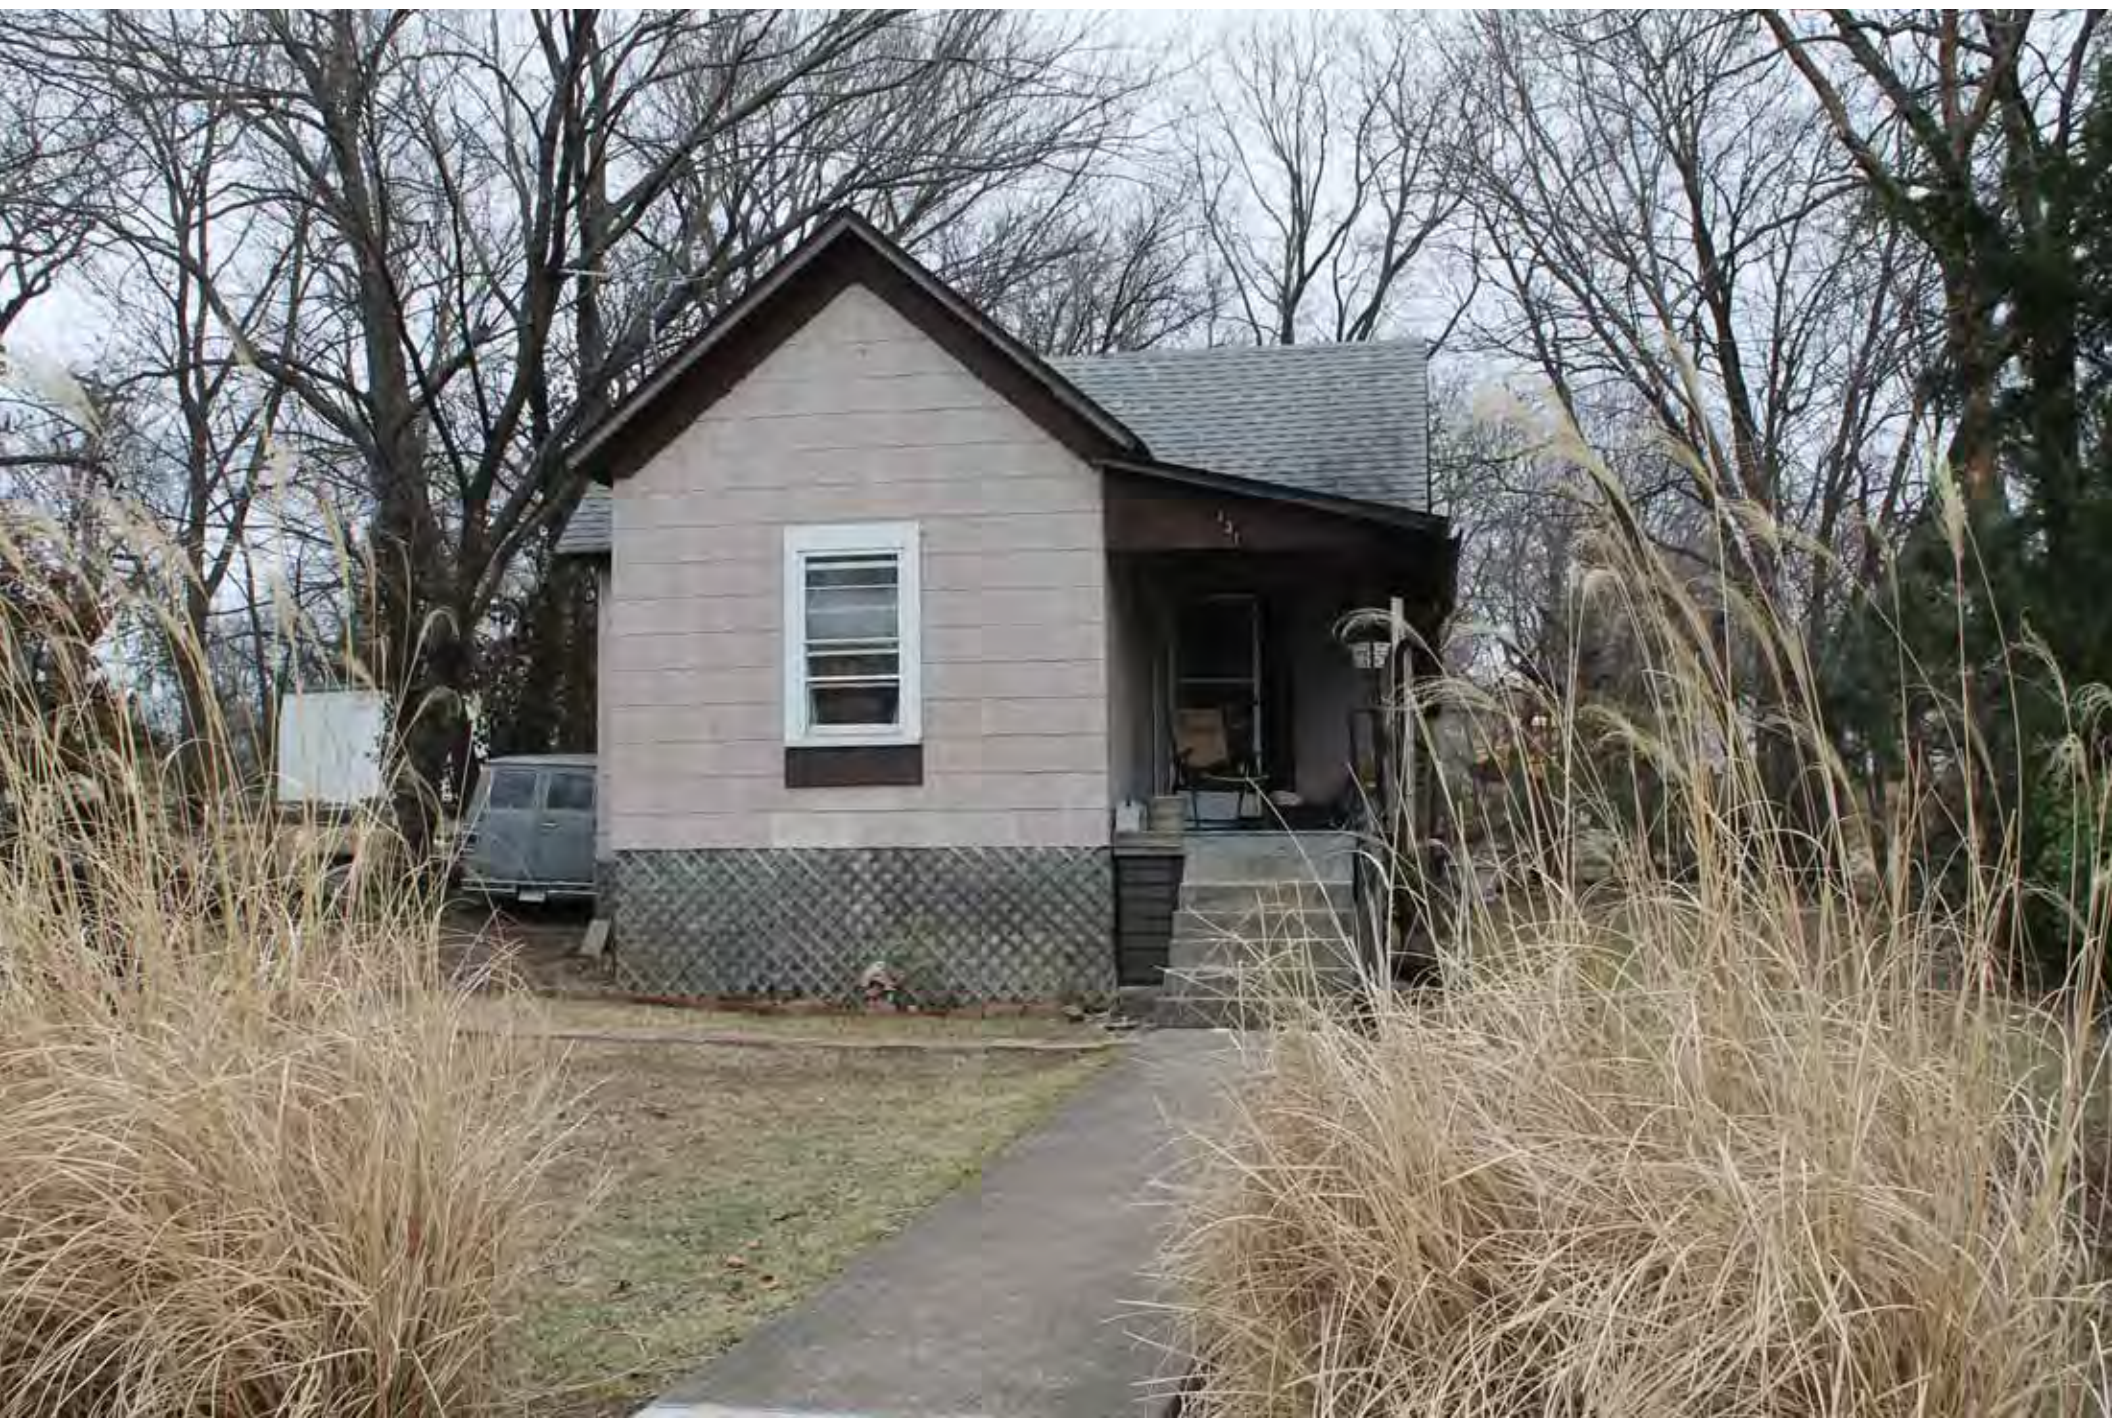
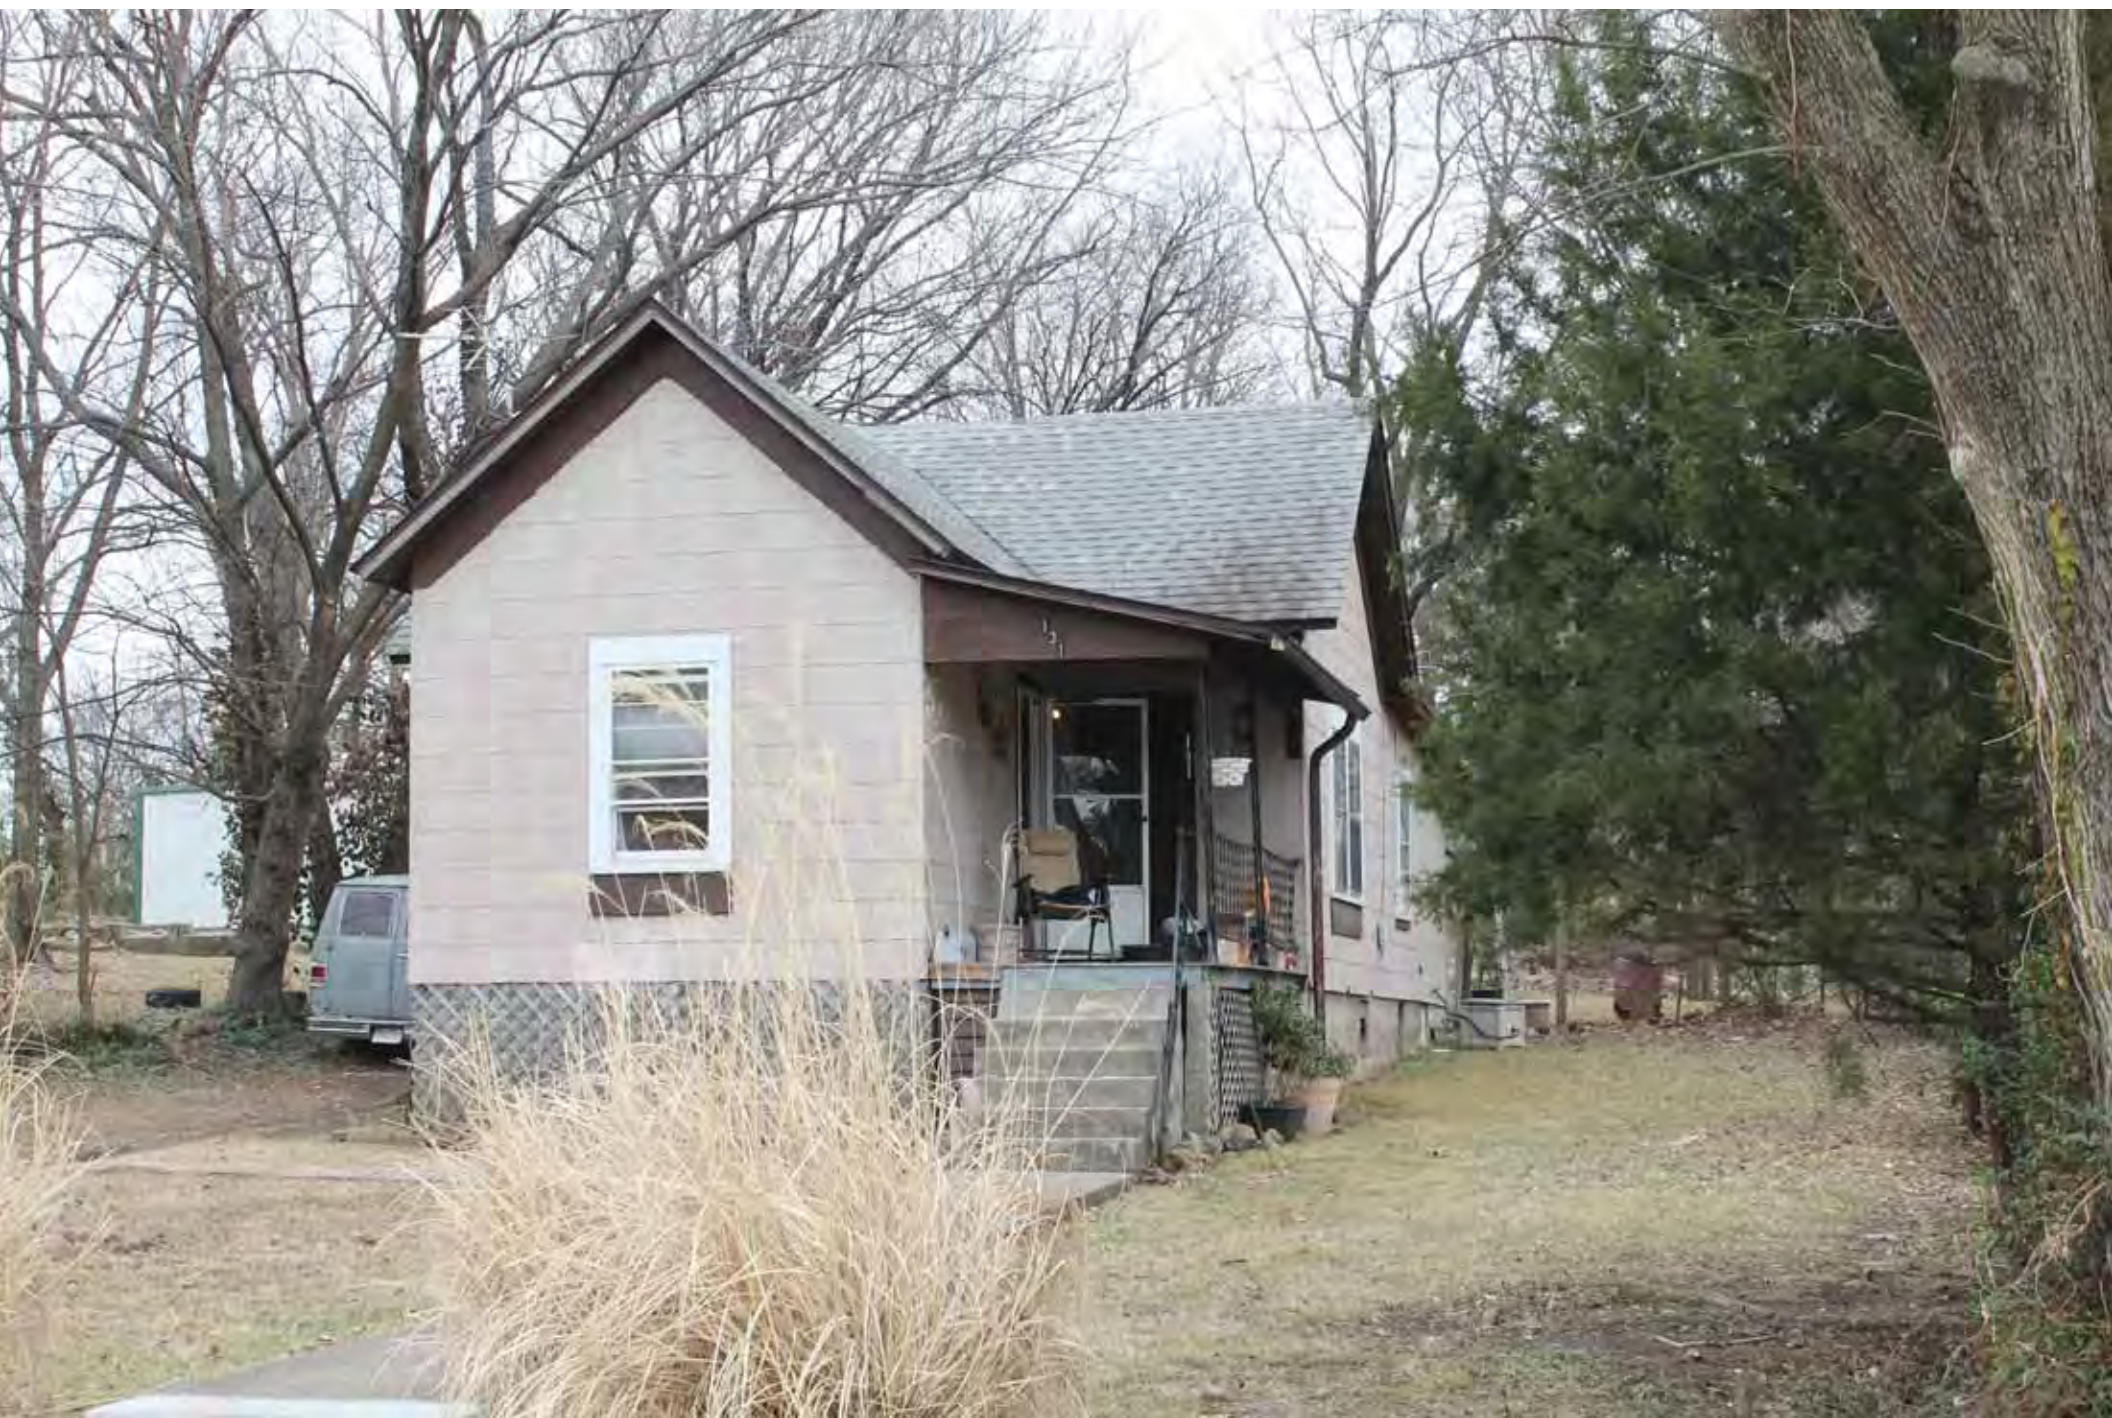
The property at 131 S. McKee Avenue features a cross gabled plan dwelling with an asphalt shingled roof, exterior asbestos shingle siding (c. 1960) and a concrete foundation. The primary (west) elevation has a front facing gable that holds a one-over-one window. A shed roof extends from the south elevation of the gabled wing, creating a primary porch supported by wrought iron columns (c. 1960). A wrought iron balustrade (c. 1960) extends along the south end of the porch. Within the porch bay are two doors – one on the south wall and one on the west wall. The dwelling has a rear shed wing. The south elevation holds one set of paired windows and one individual window. The cross-gabled wing (set back from the façade) holds a single window on the west elevation.

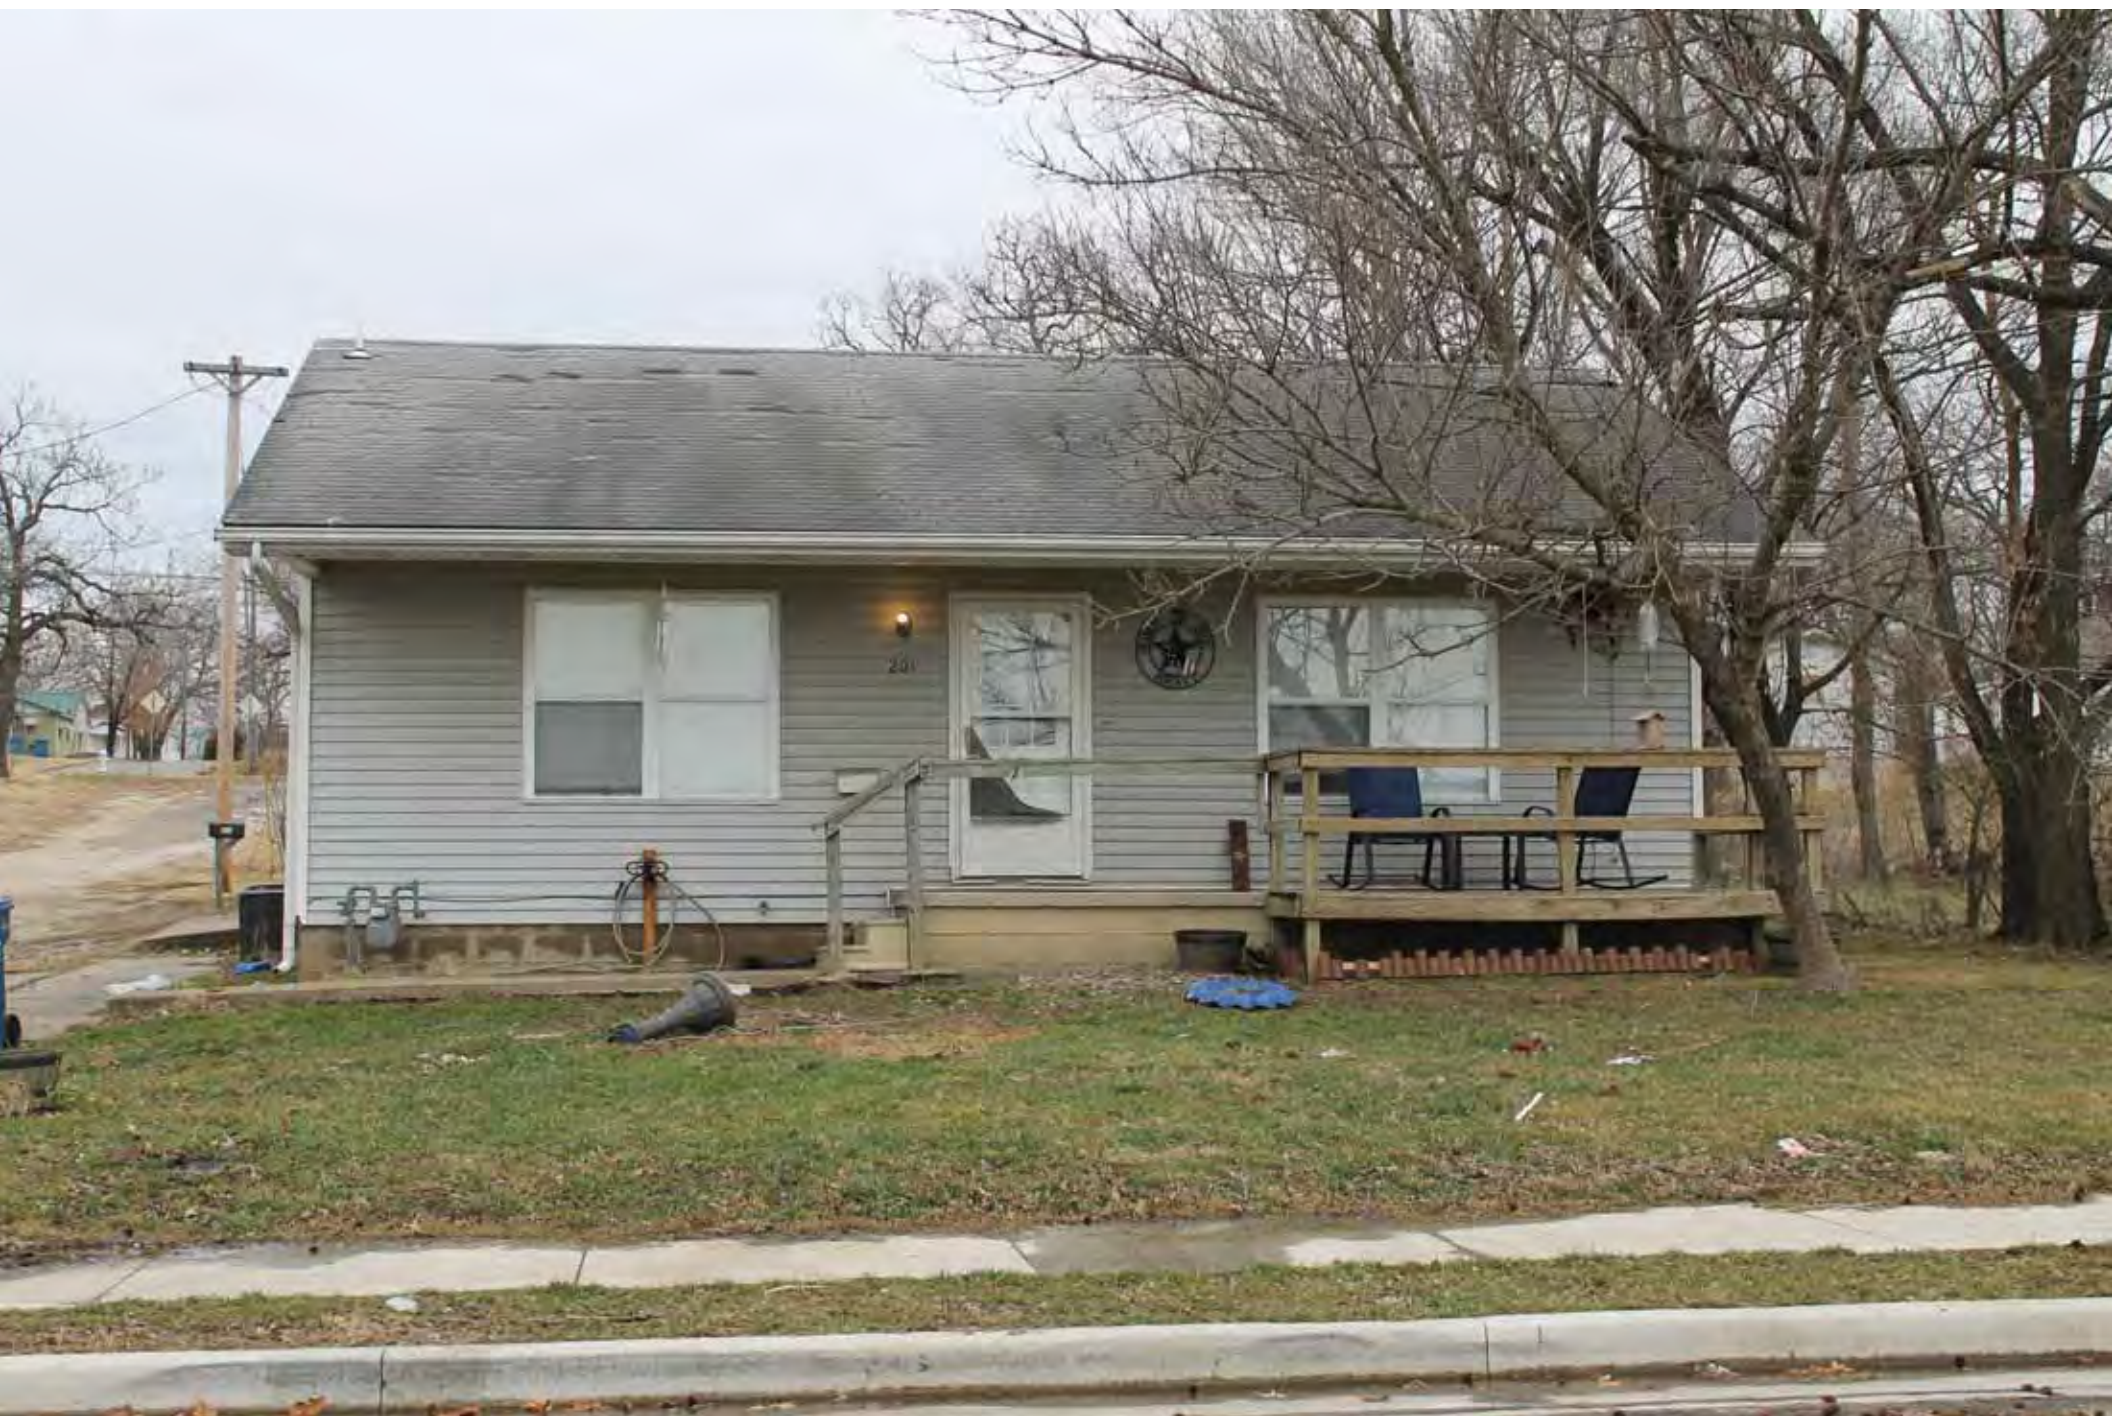
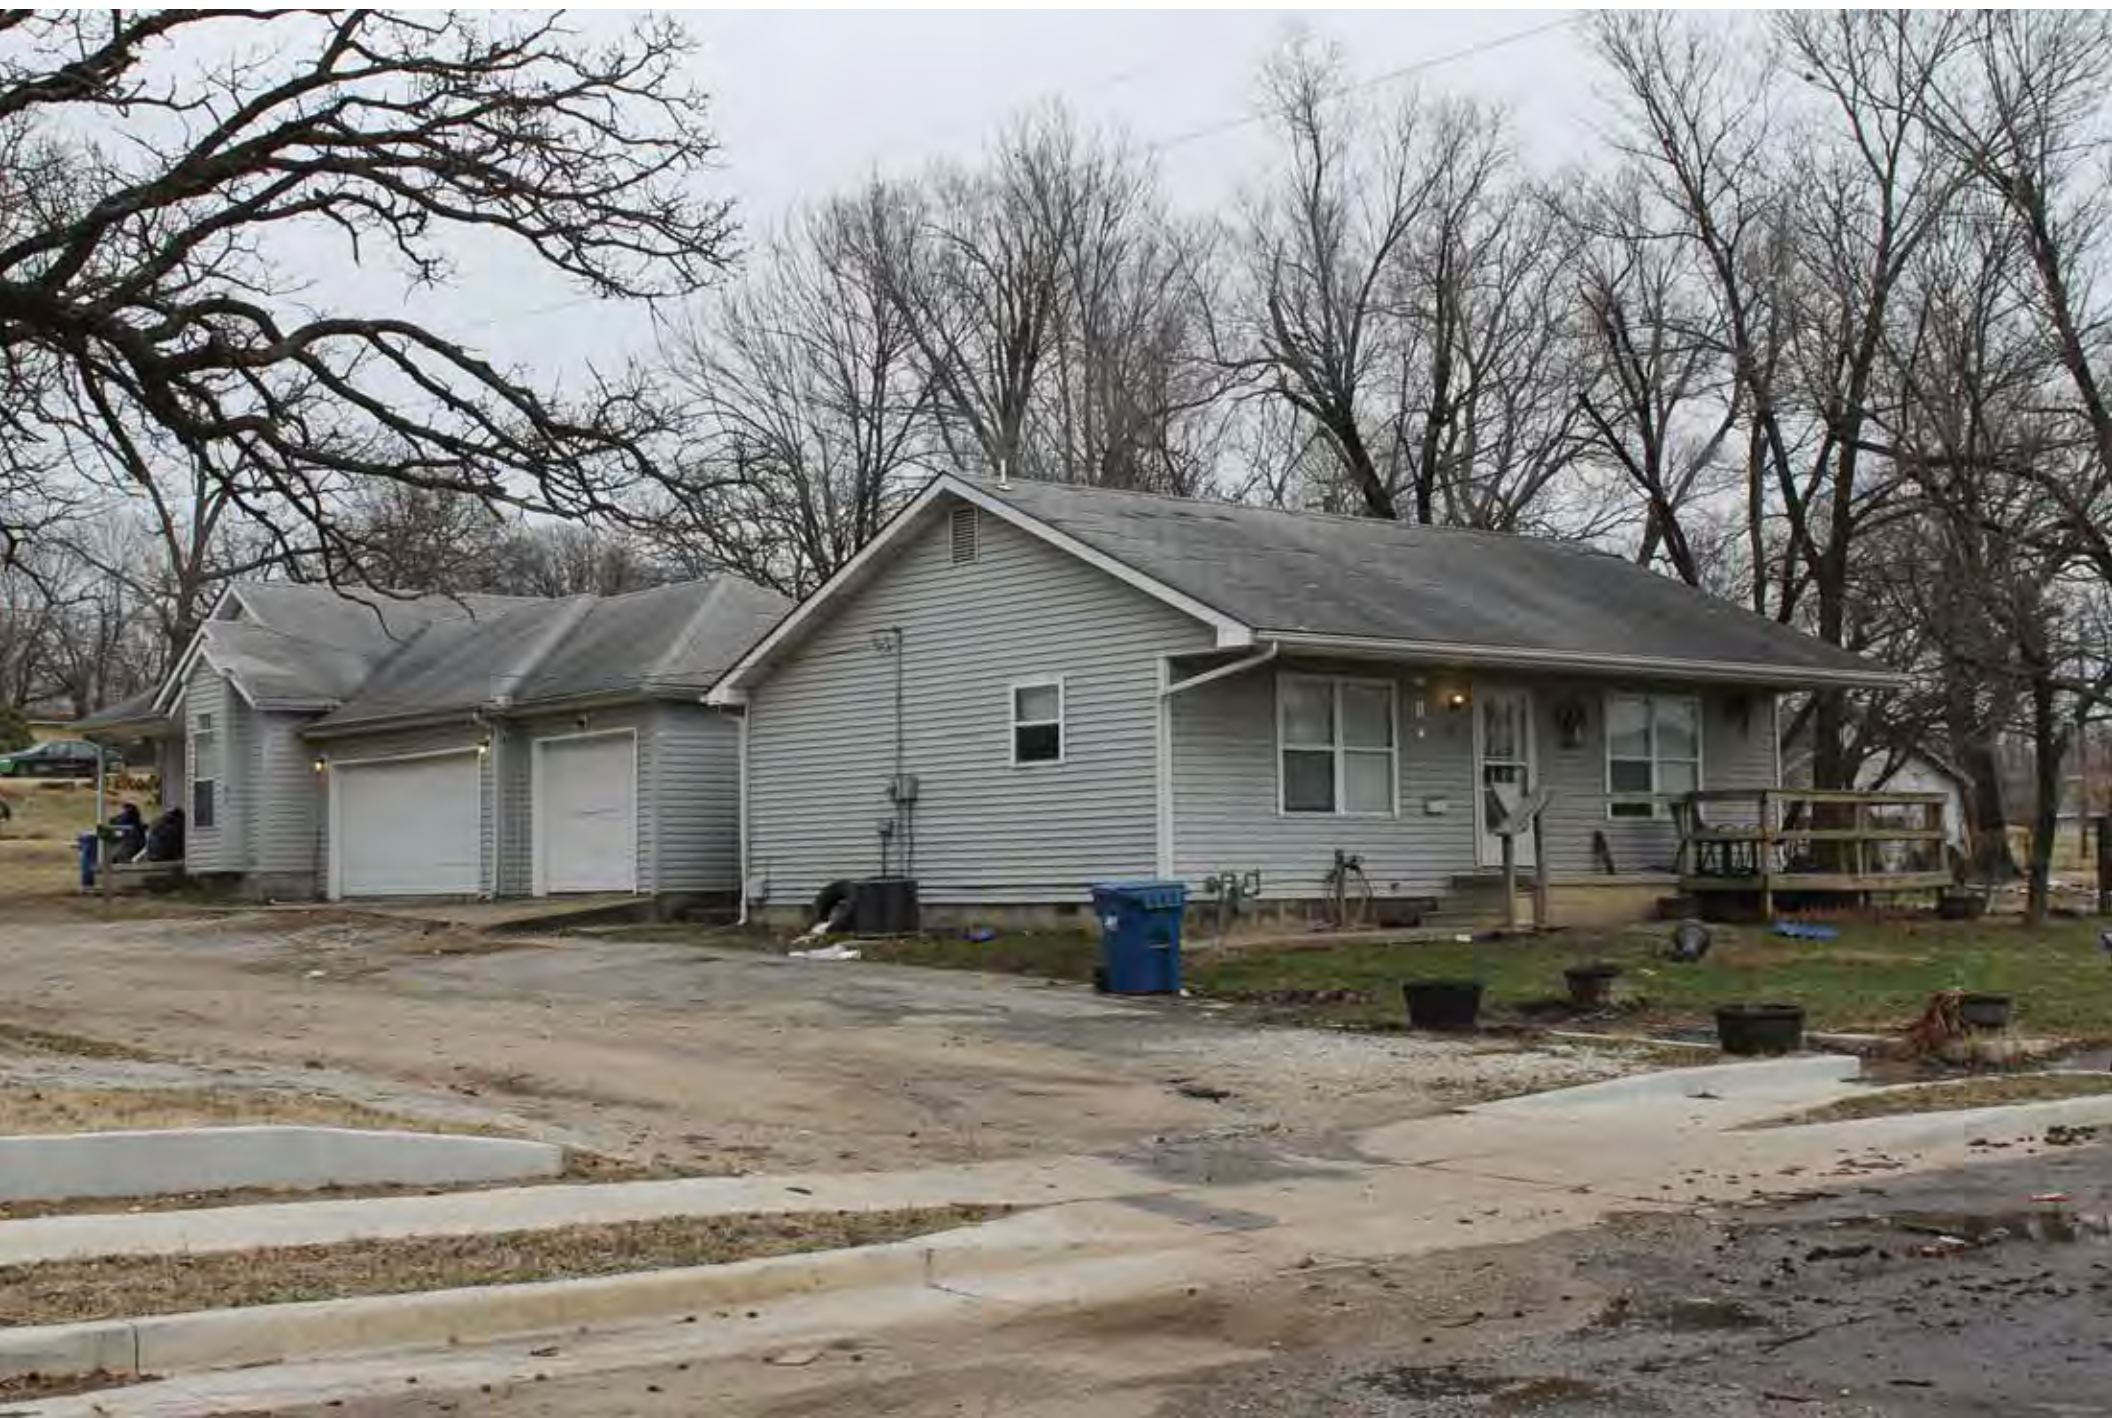
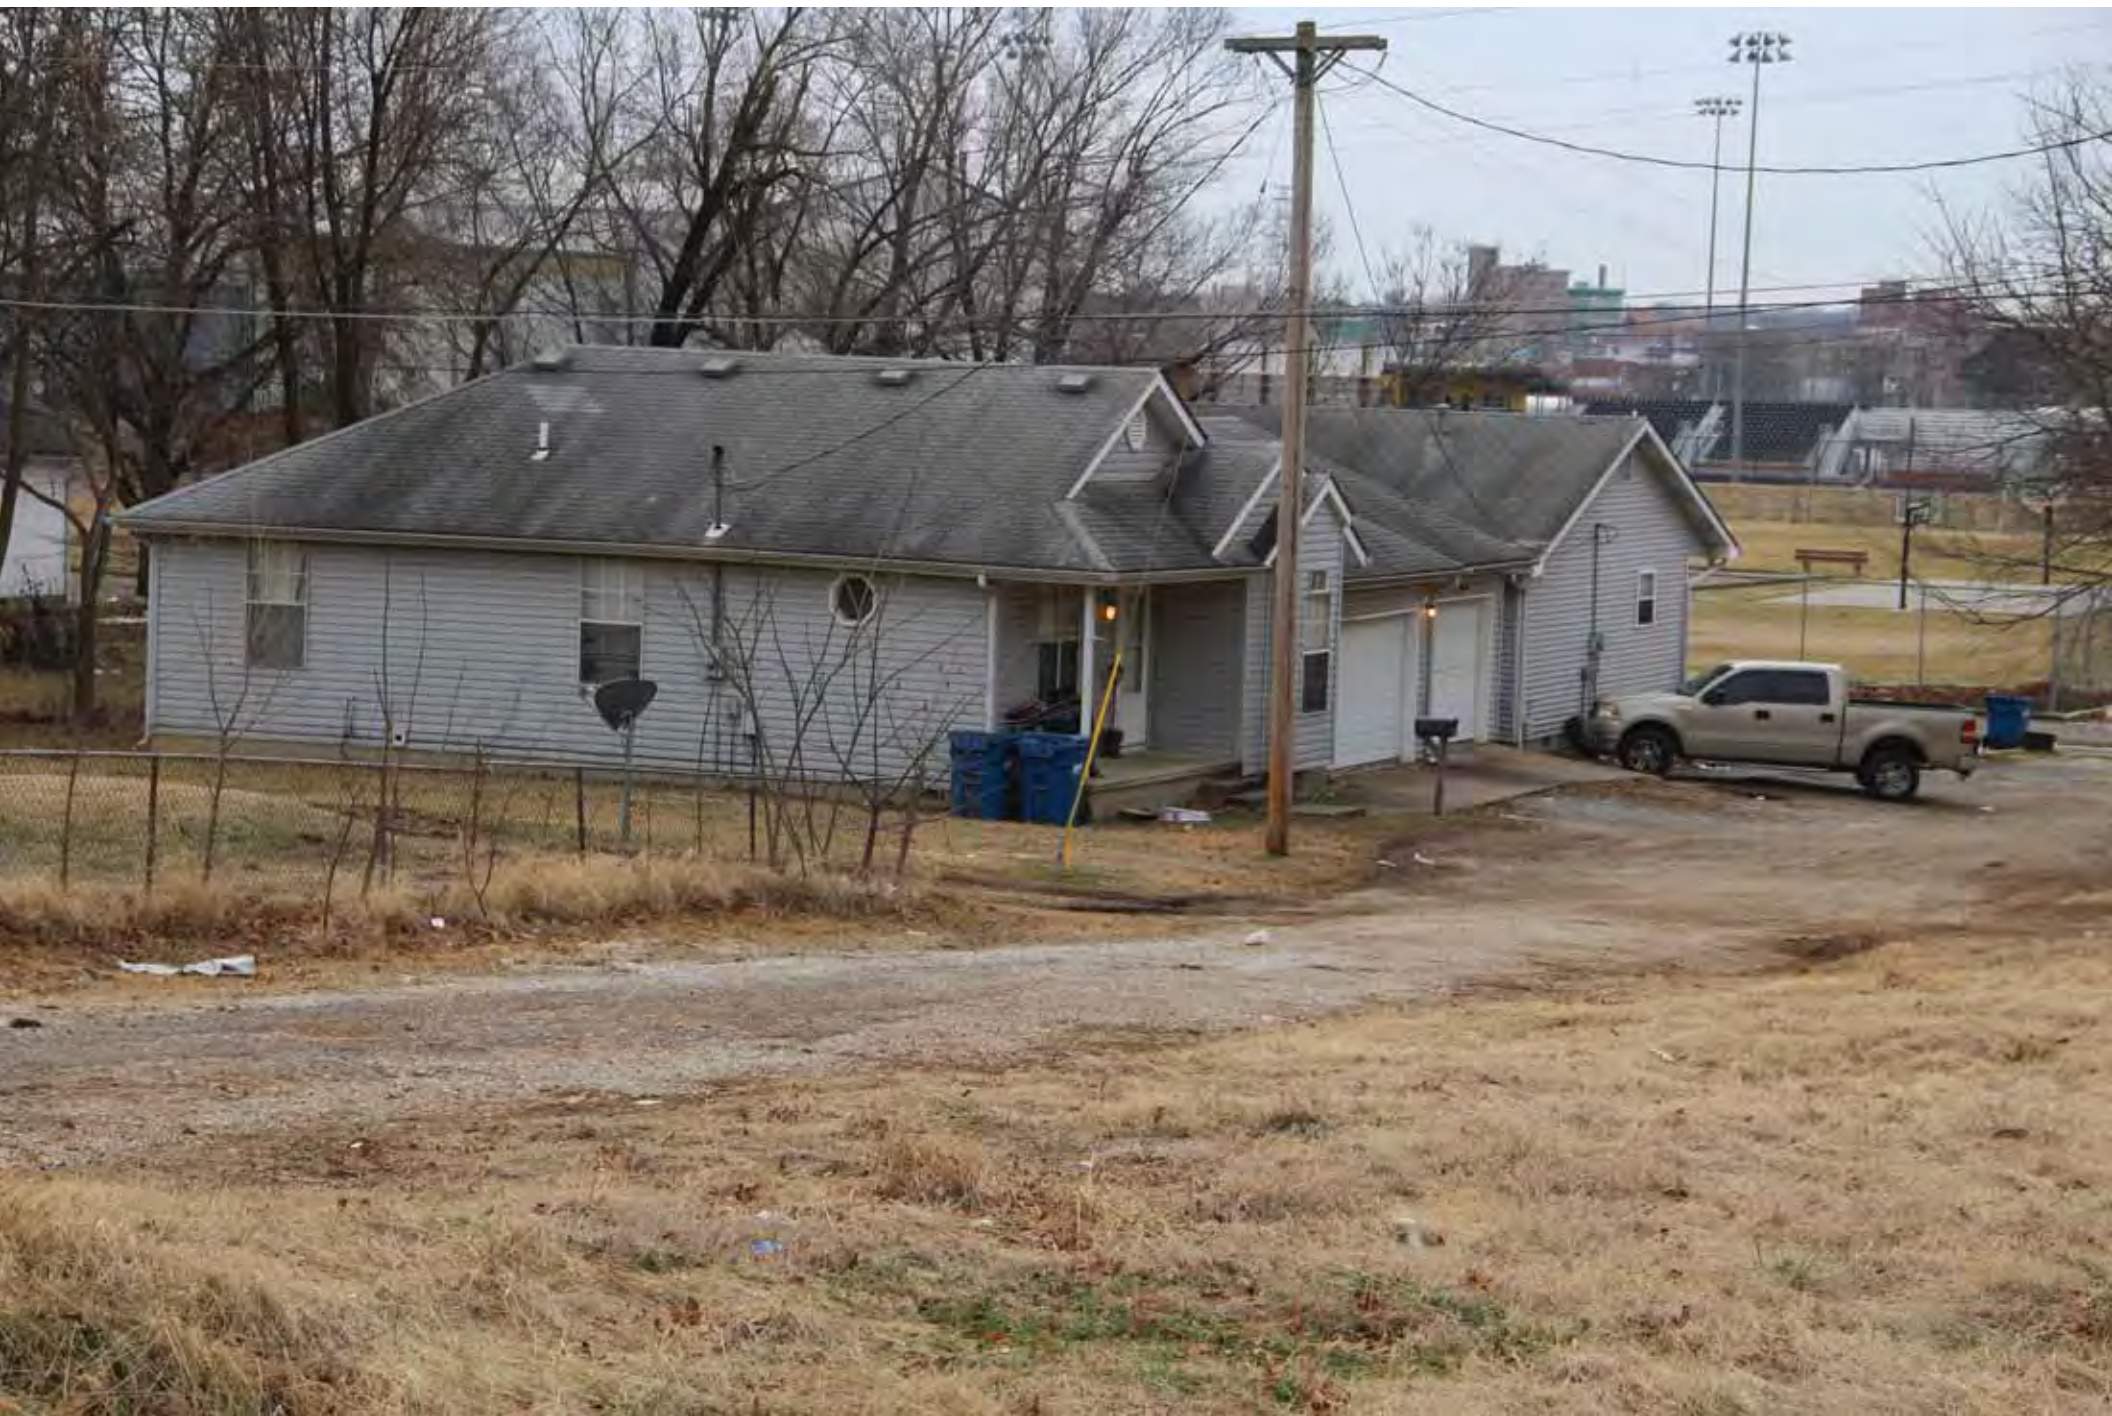
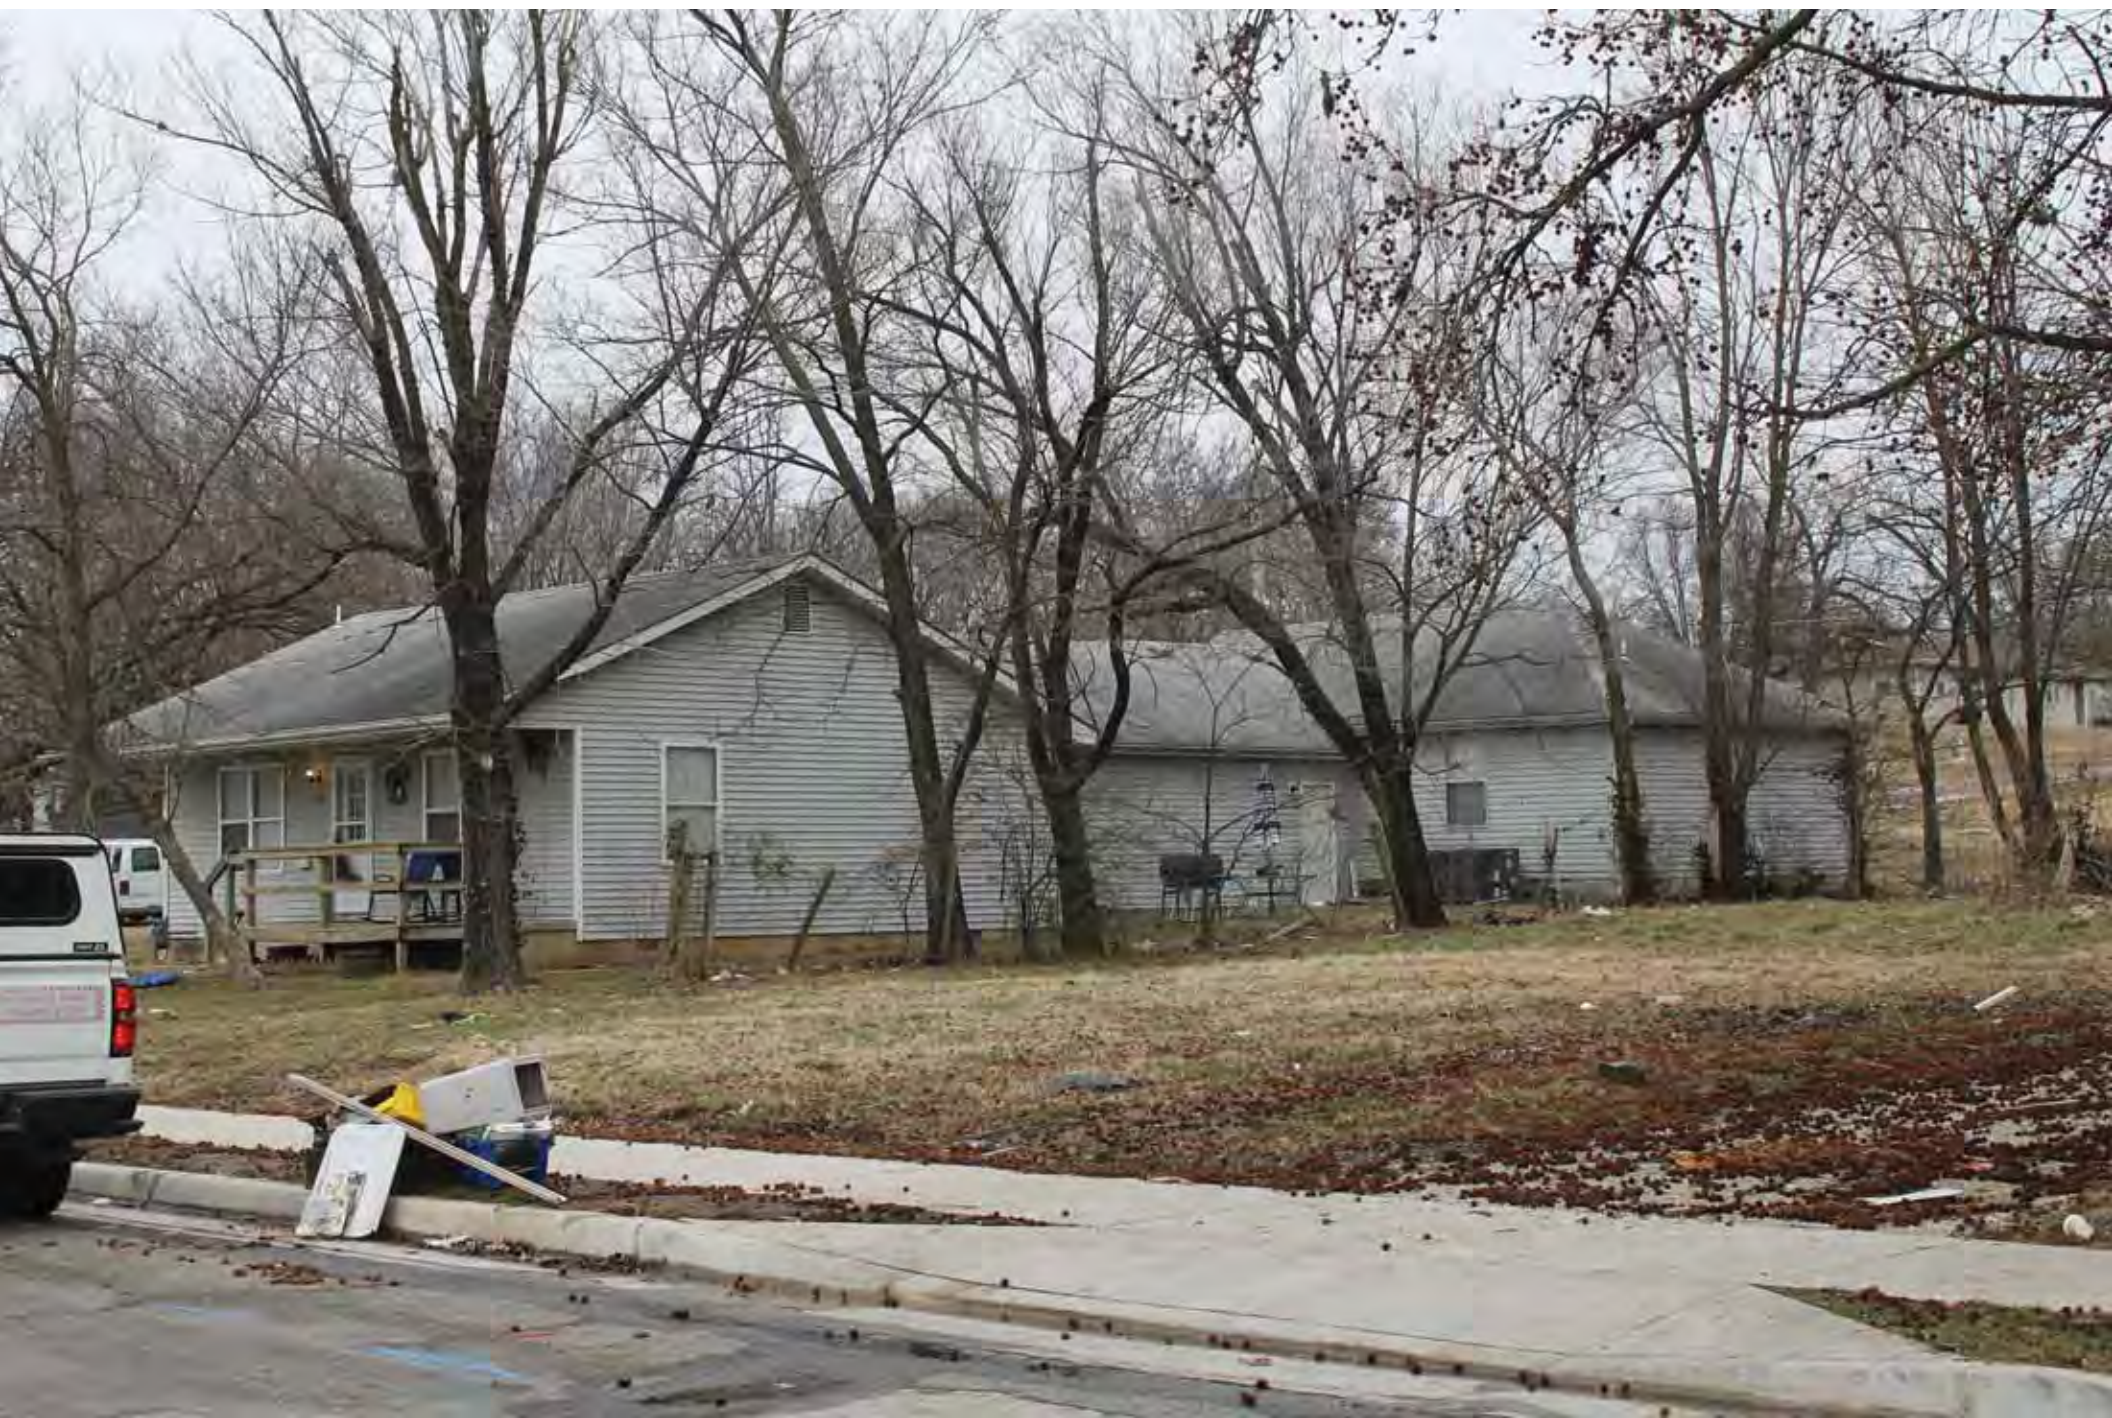
The property at 201 S. McKee Avenue features a multi-family dwelling. The dwelling has an asphalt shingled roof, exterior vinyl siding and a concrete foundation. The primary (west) elevation supports a shed roof porch supported by brackets below the roofline. A wood deck spans the elevation. A single door entry is situated centrally on the west elevation, flanked by paired one-over-one windows. The north elevation features a single double-hung window offset on the east by a two-car garage with overhead track doors (north elevation). At the east end of the north elevation is a residential entry bay. The entrance is within a small gabled porch offset by a projecting gabled wing. Paired windows offset the door in the north porch bay. The east elevation holds two six-over-six windows. This elevation also holds a small octagonal fixed light window. The south elevation holds a one-over-one window (west end) and paneled door (central part of the elevation). At the southeast end of the dwelling is a six-over-six window on the west elevation of the rear projecting hipped wing.
