MISSOURI DEPARTMENT OF NATURAL RESOURCES
STATE HISTORIC PRESERVATION OFFICE, P.O. Box 176, Jefferson City, MO 65102
ARCHITECTURAL/HISTORIC INVENTORY FORM

1. Survey No. JP-AS-007-001		2. Survey name: East Town (Original Joplin) Historic Survey Phase 2	
3. County: JASPER		4. Address (Street No.) 618	Street (name) E. 2 nd Street
5. City: Joplin	Vicinity: <input type="checkbox"/>	6. Geographical Reference:	7. Township/Range/Section: T: R: S:
8. Historic name (if known):		9. Present/other name (if known):	
10. Ownership: <input checked="" type="checkbox"/> Private <input type="checkbox"/> Public		11a. Historic use (if known): Domestic: Single Dwelling	11b. Current use: Domestic: Single Dwelling

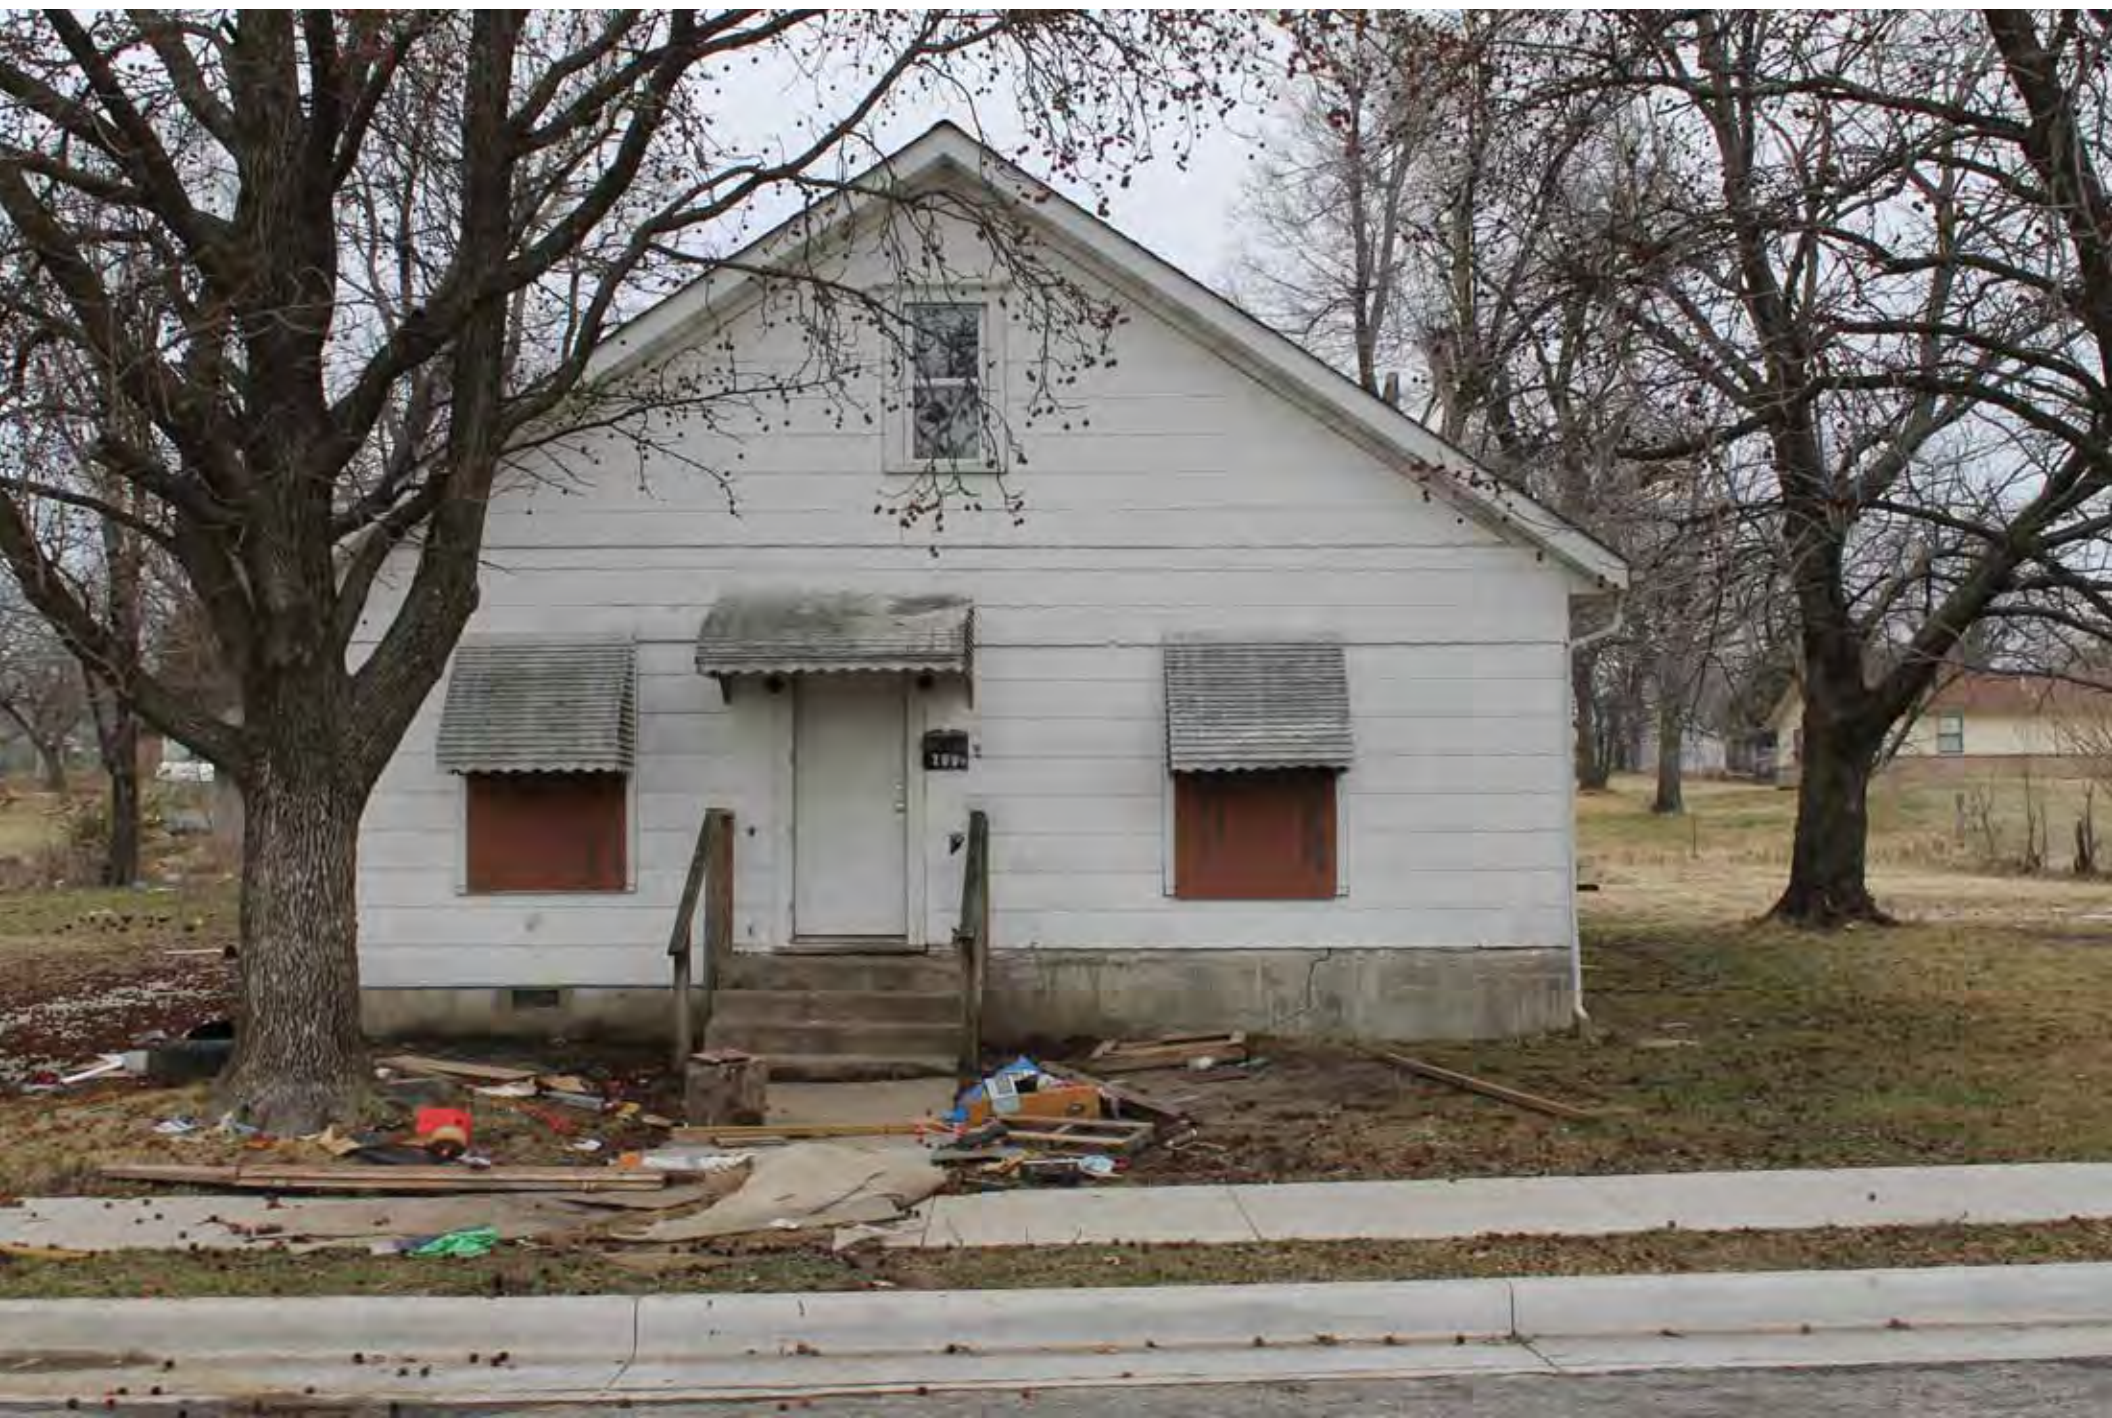
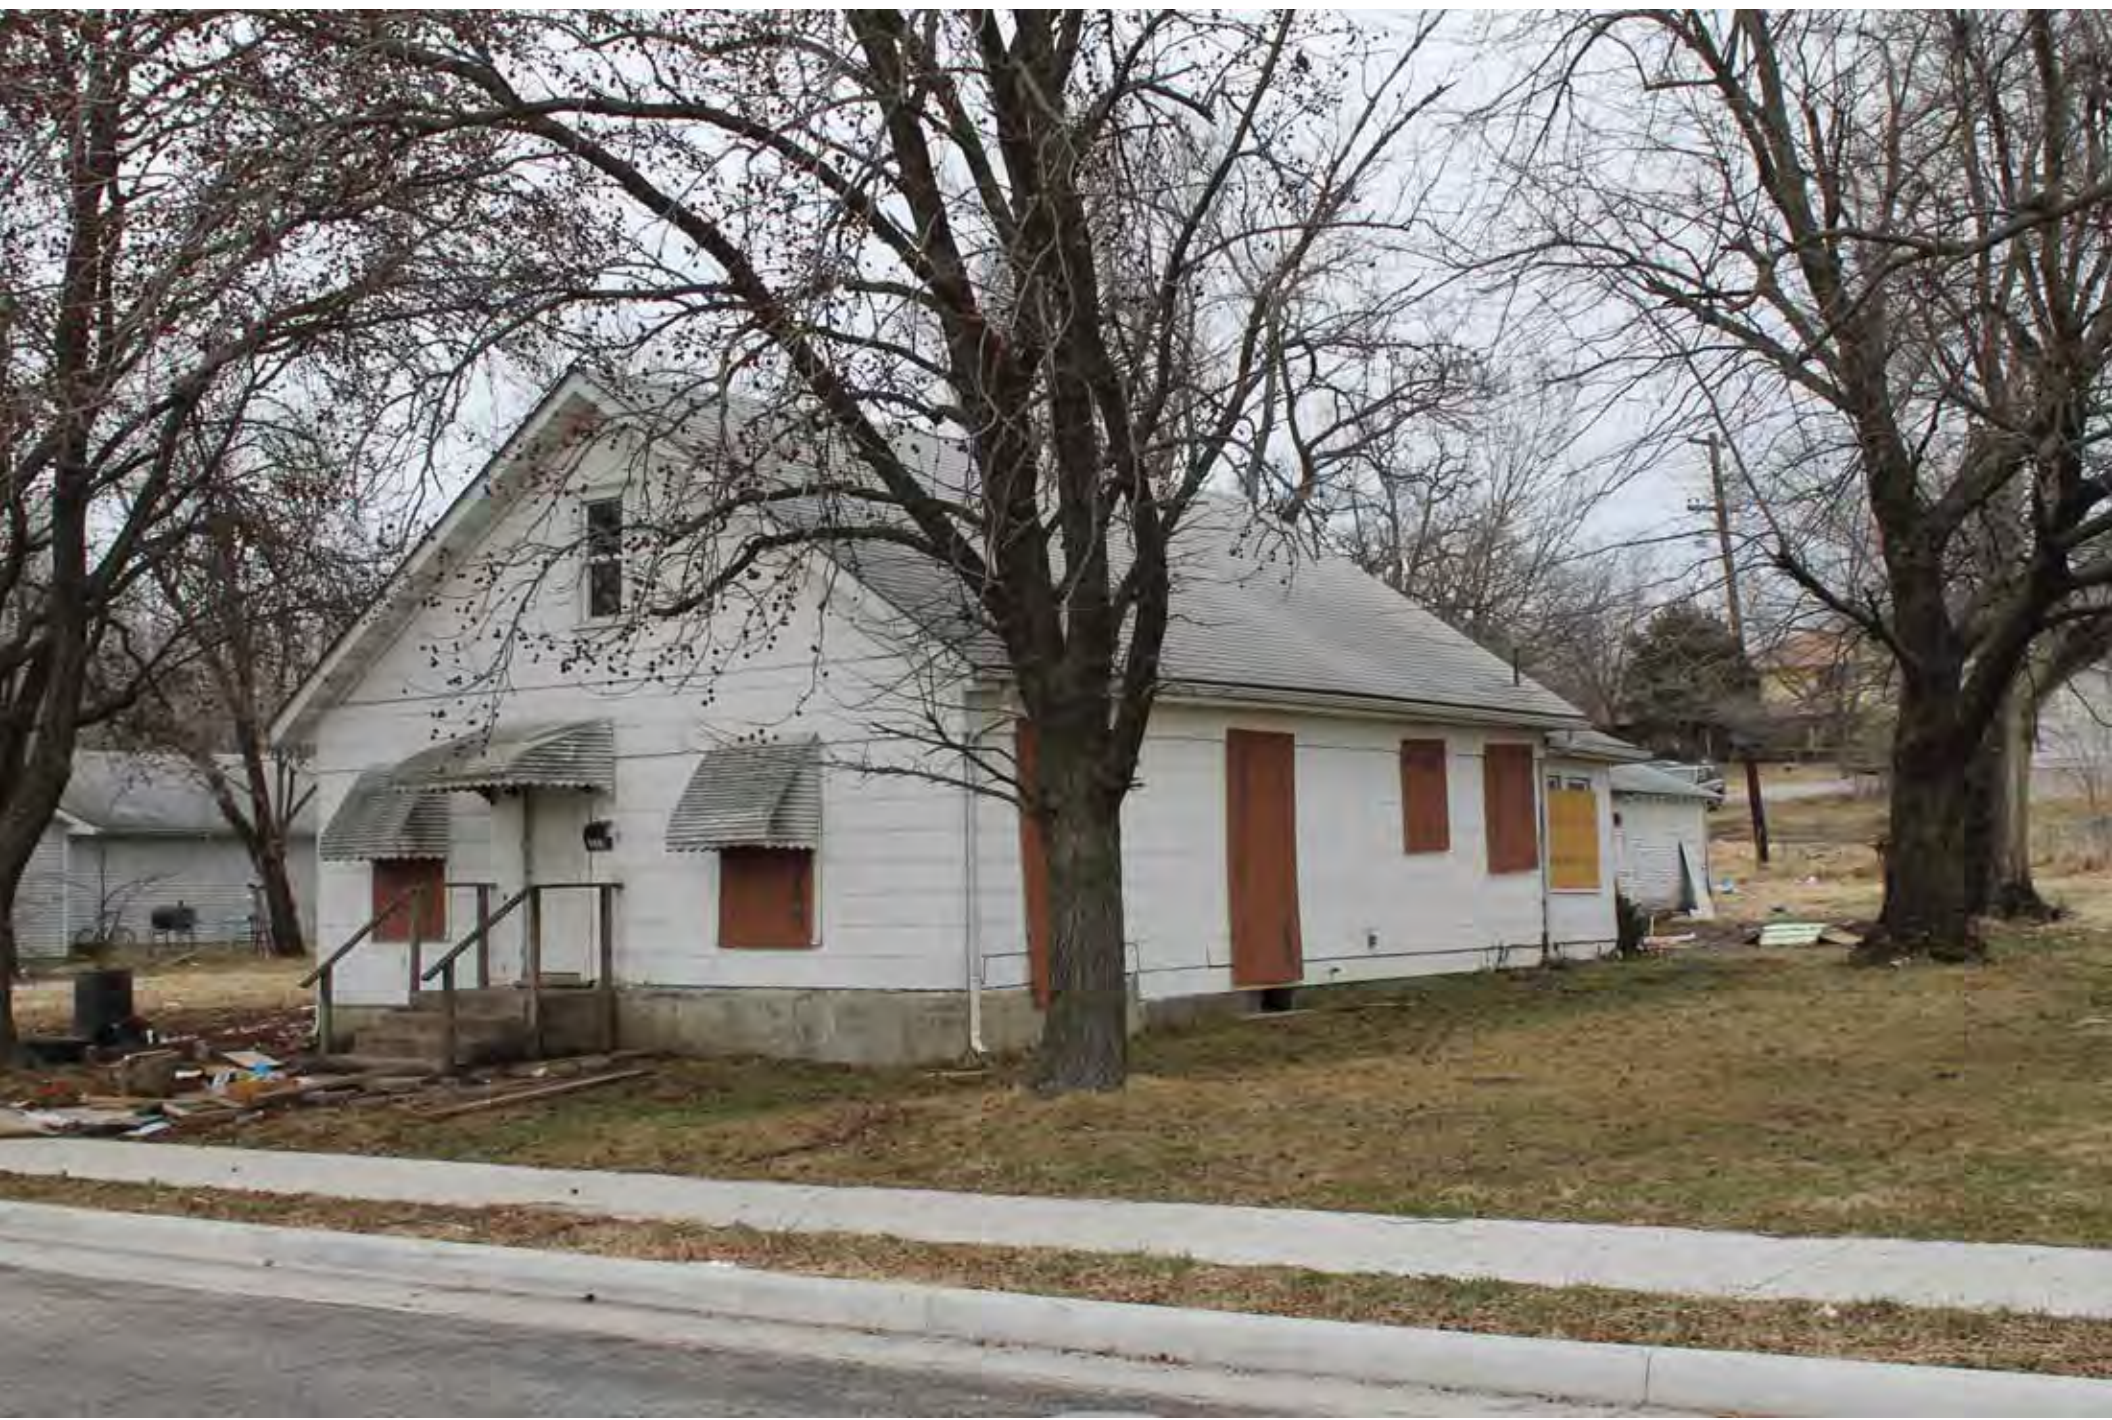
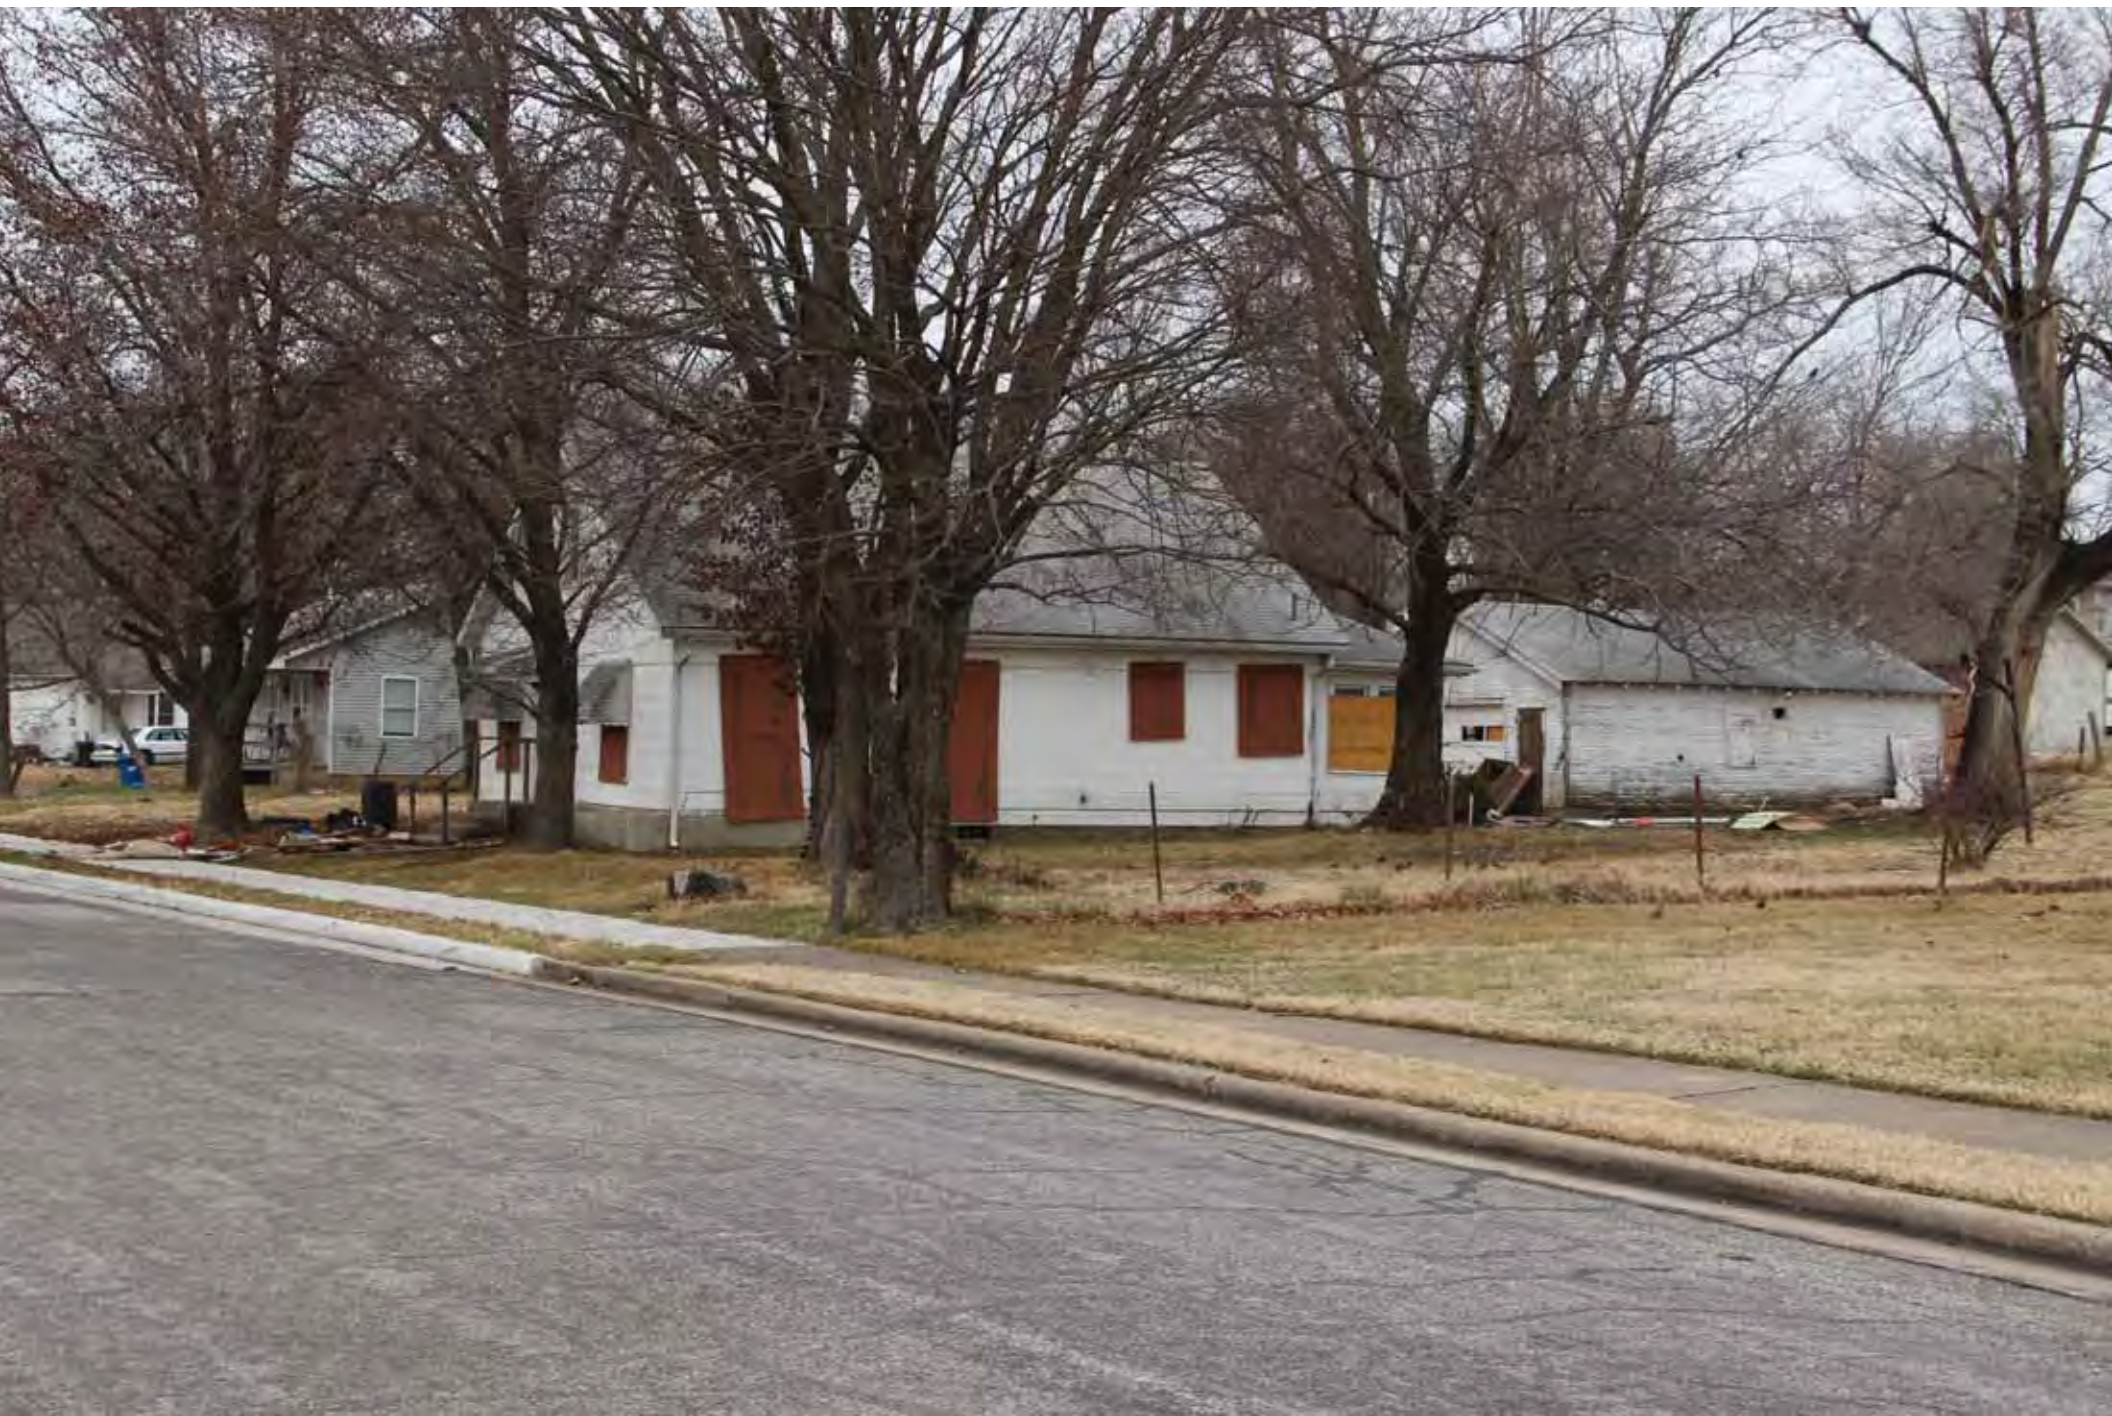
The property at 209 S. McKee Avenue features a gable-front plan dwelling with an asphalt-shingled roof, exterior asbestos shingle siding (c. 1960) and a concrete foundation. On the west elevation is a central concrete stoop with wood handrails. The stoop leads to a single door flanked by single windows. The entry bay holds a paneled c. 2015 door below a metal awning. Windows are covered with wood. Above each façade window is a metal awning. The gable field on the façade holds a replacement one-over-one window (c.2015). All bays on the north and south elevations are covered with wood.

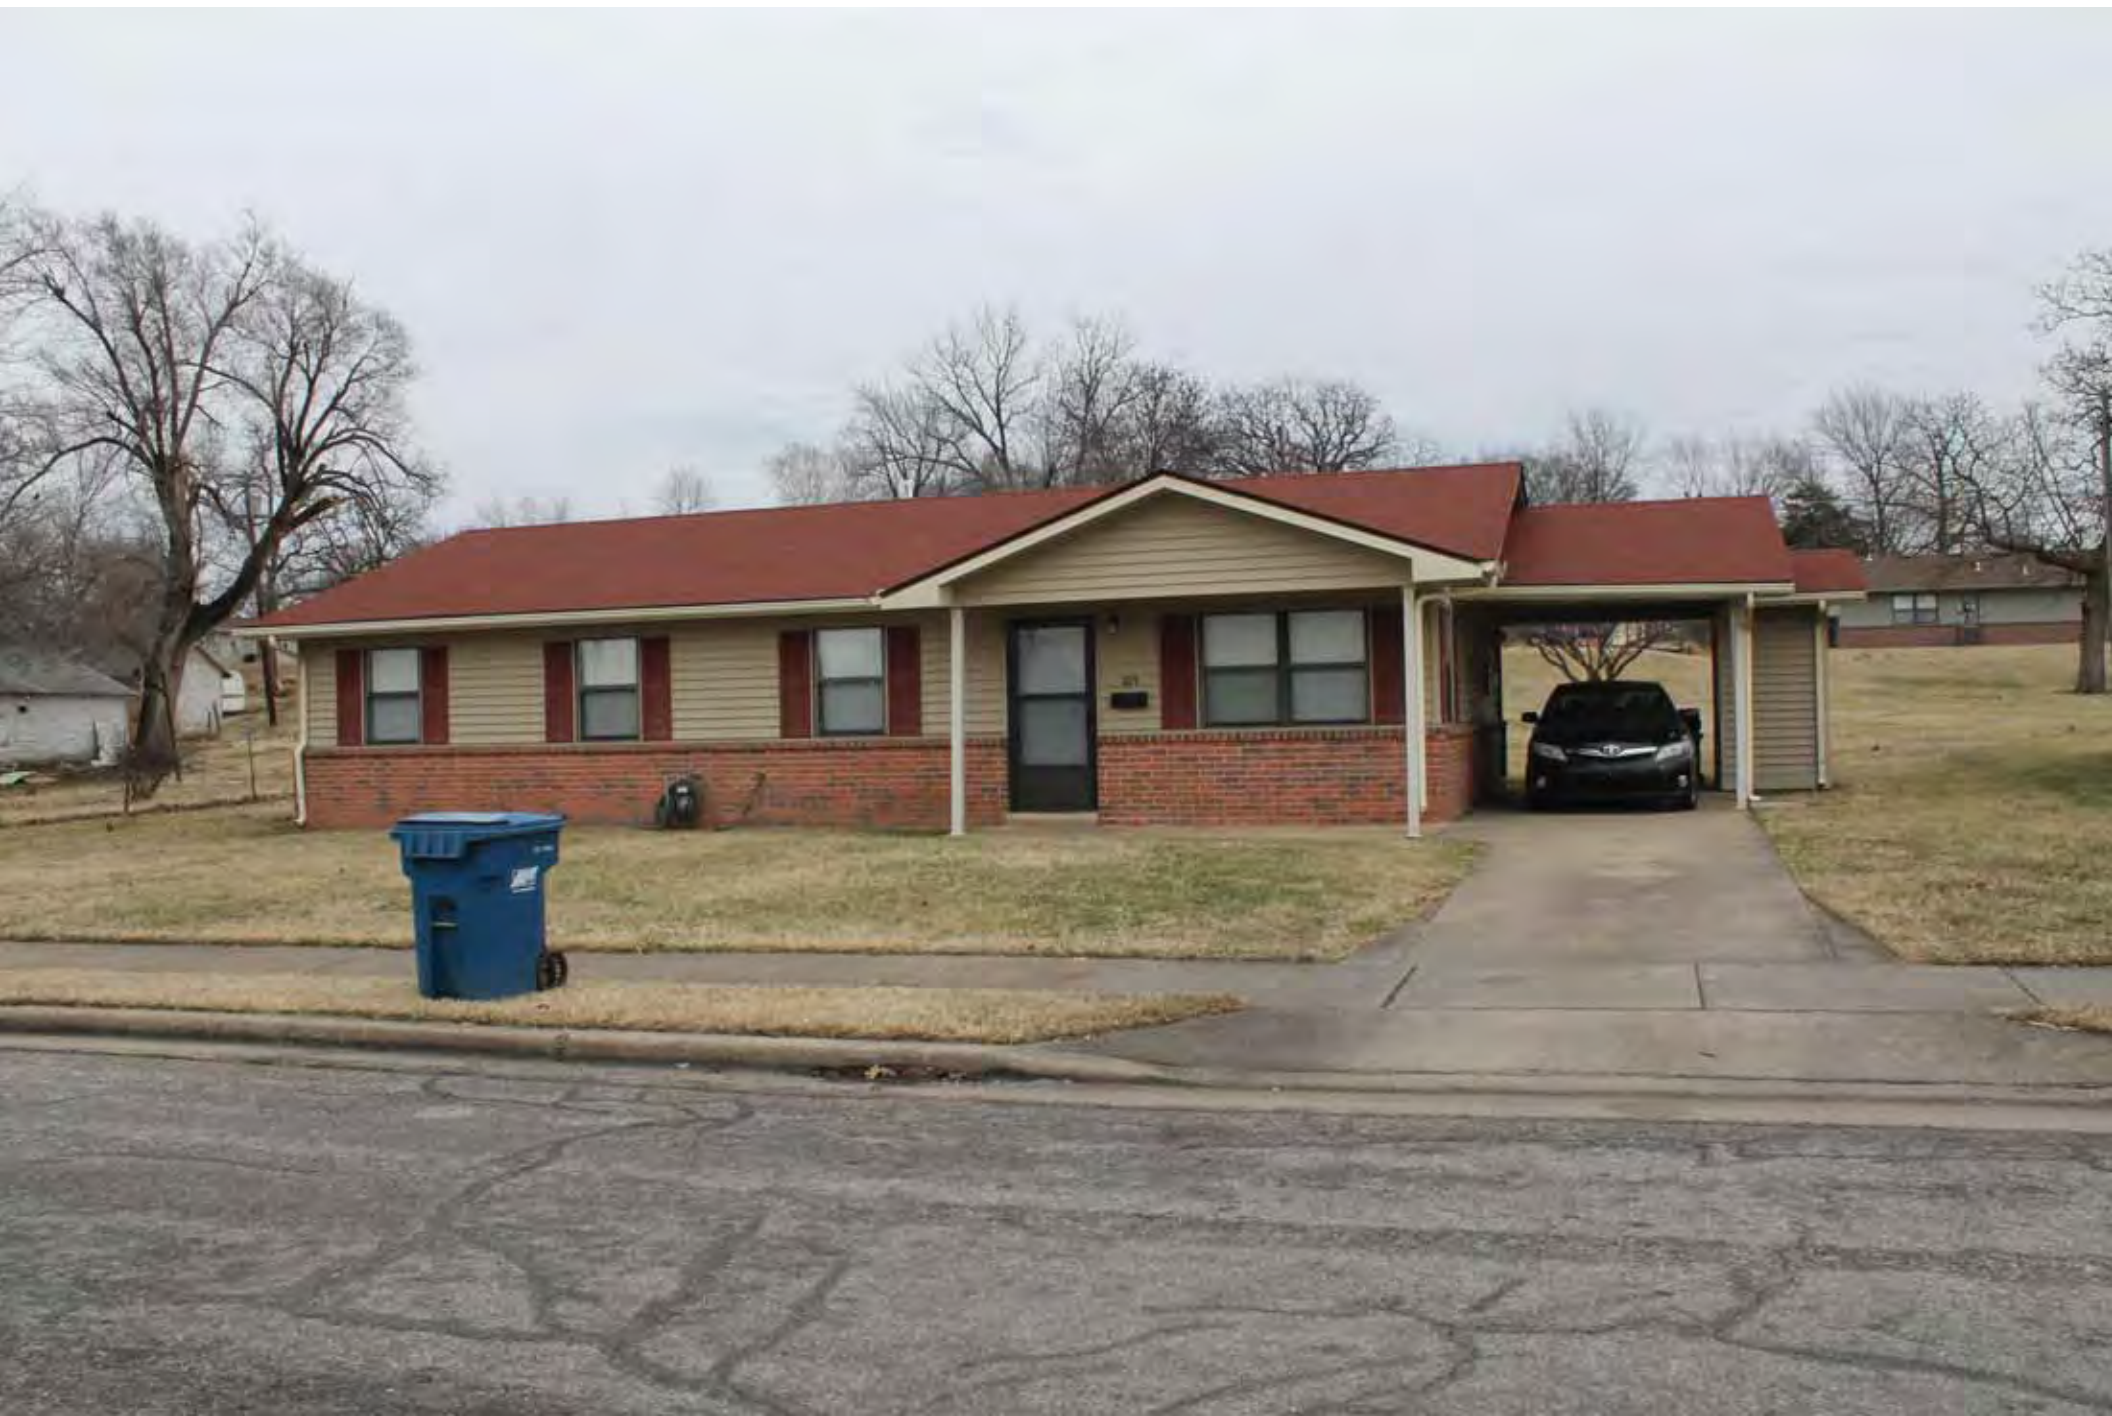
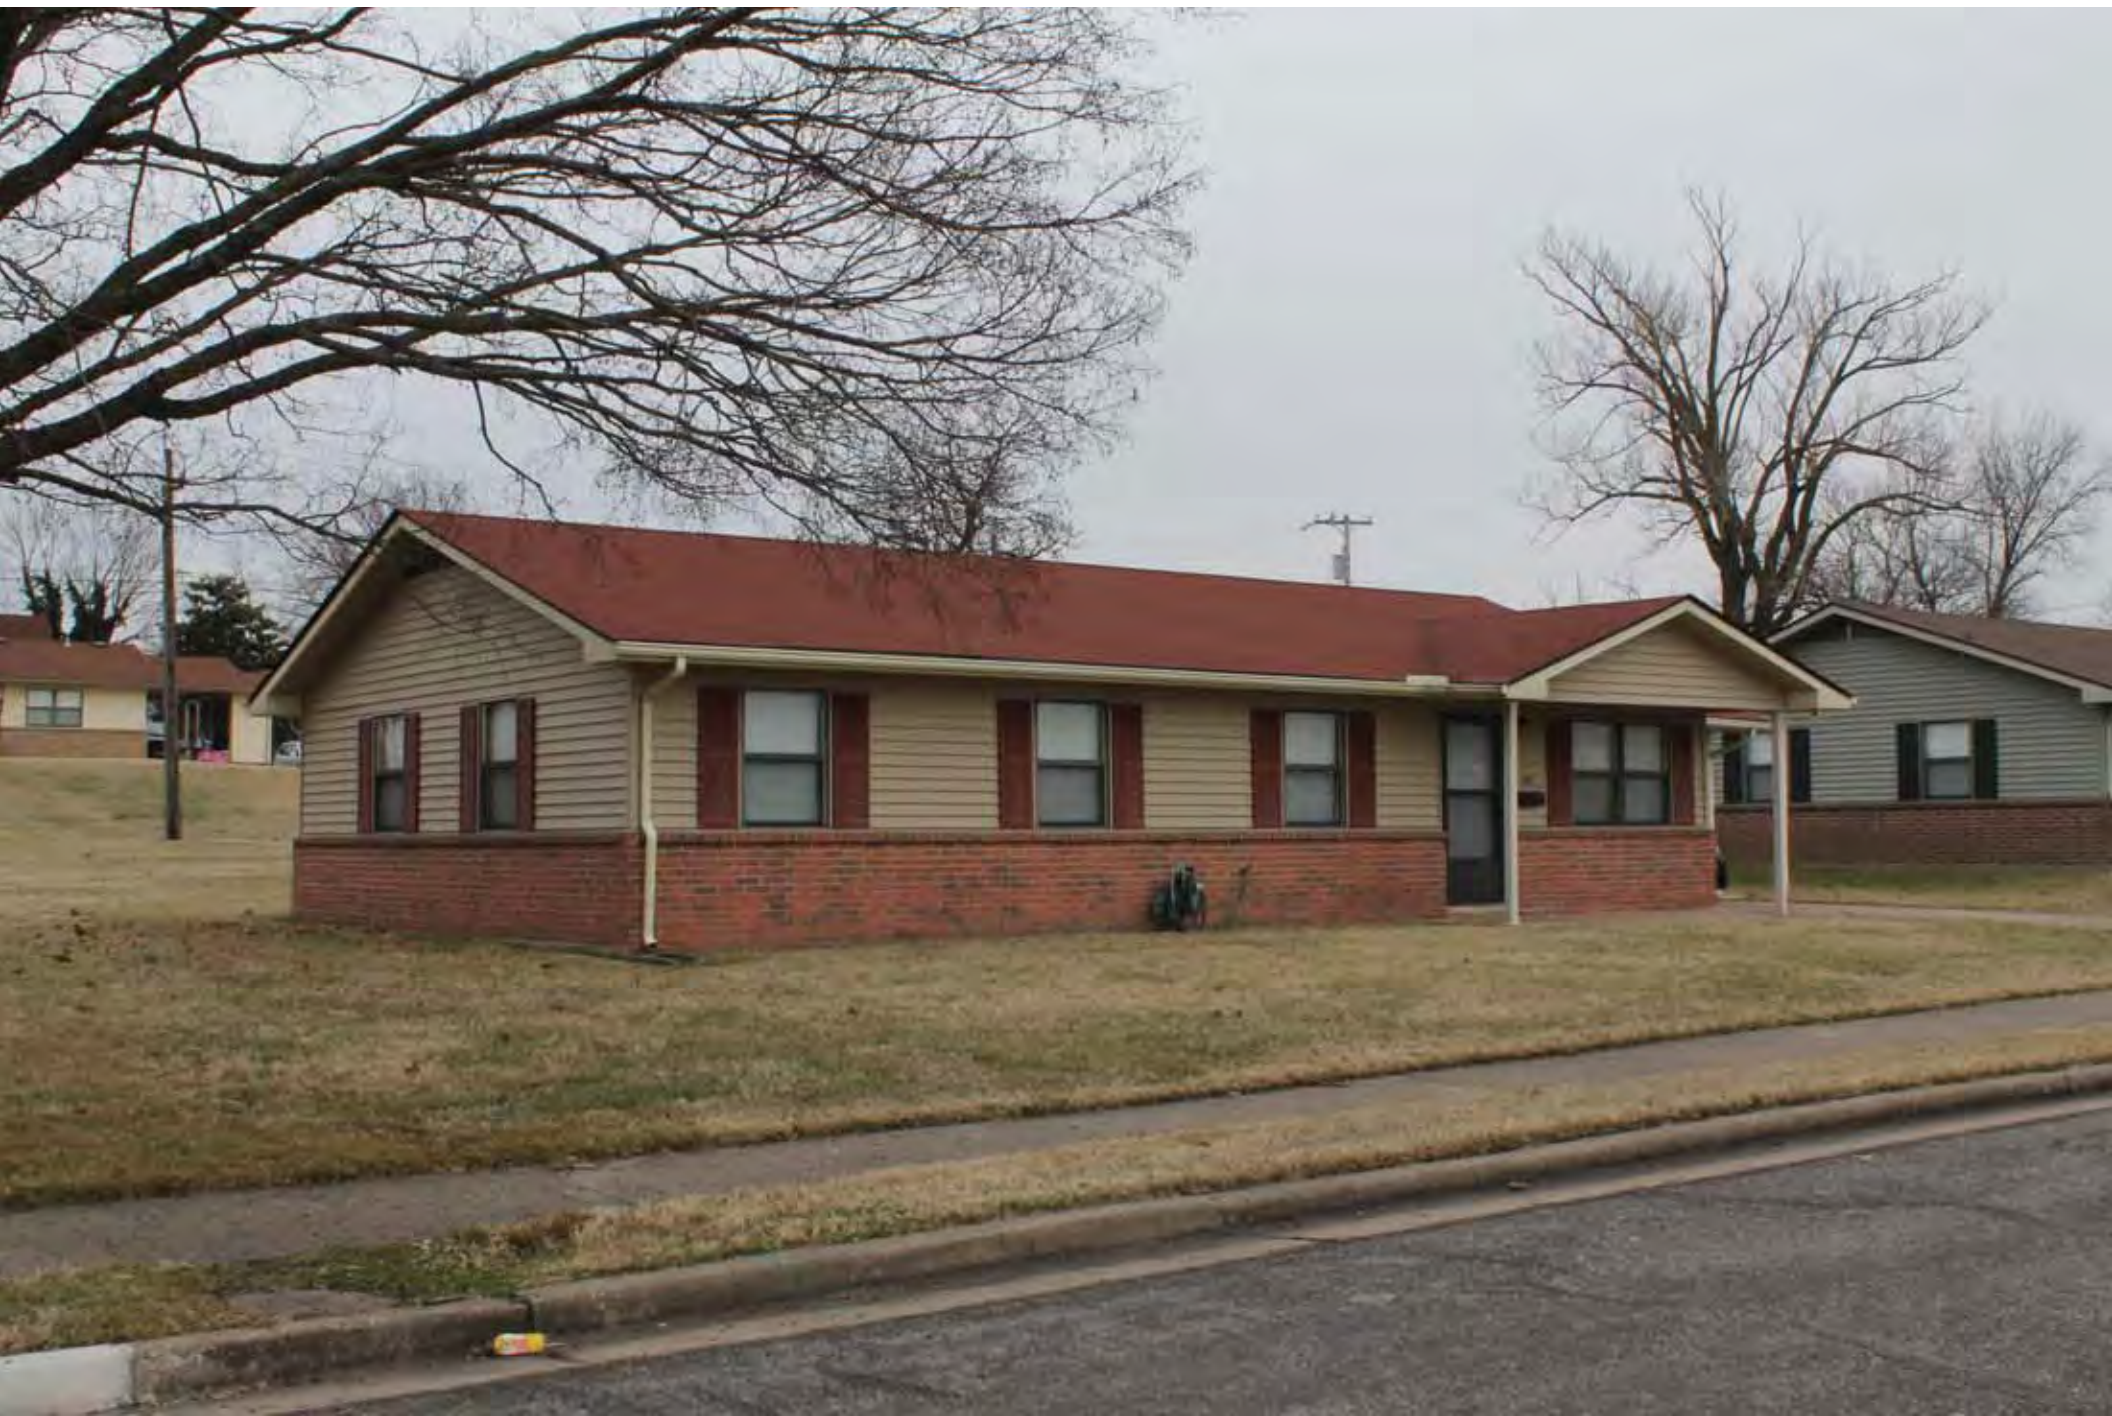
The property at 225 S. McKee Avenue features a single-story dwelling with an asphalt-shingled gabled roof, exterior vinyl siding and a concrete foundation. The lower elevations (below windows) are clad with brick veneer capped by a band of continuous brick headers. Windows are one-over-one with faux shutters. On the façade (west elevation) is a small gabled porch near the south end of the elevation. The porch is supported by two columns resting on a concrete pad. Within the porch bay is a single solid door flanked by paired windows (south) and a single window (north). The remaining elevation supports two single windows. The north elevation holds two windows. At the south elevation is a gabled carport, which extends above the concrete drive. The south elevation of the dwelling holds a secondary entry below the carport roof. The entry is offset on the west by a single window. The south end of the carport roof attaches to a small utility shed clad with vinyl siding.
