MISSOURI DEPARTMENT OF NATURAL RESOURCES
STATE HISTORIC PRESERVATION OFFICE, P.O. Box 176, Jefferson City, MO 65102
ARCHITECTURAL/HISTORIC INVENTORY FORM

1. Survey No. JP-AS-007-001		2. Survey name: East Town (Original Joplin) Historic Survey Phase 2	
3. County: JASPER		4. Address (Street No.) 618	Street (name) E. 2 nd Street
5. City: Joplin	Vicinity: <input type="checkbox"/>	6. Geographical Reference:	7. Township/Range/Section: T: R: S:
8. Historic name (if known):		9. Present/other name (if known):	
10. Ownership: <input checked="" type="checkbox"/> Private <input type="checkbox"/> Public		11a. Historic use (if known): Domestic: Single Dwelling	11b. Current use: Domestic: Single Dwelling

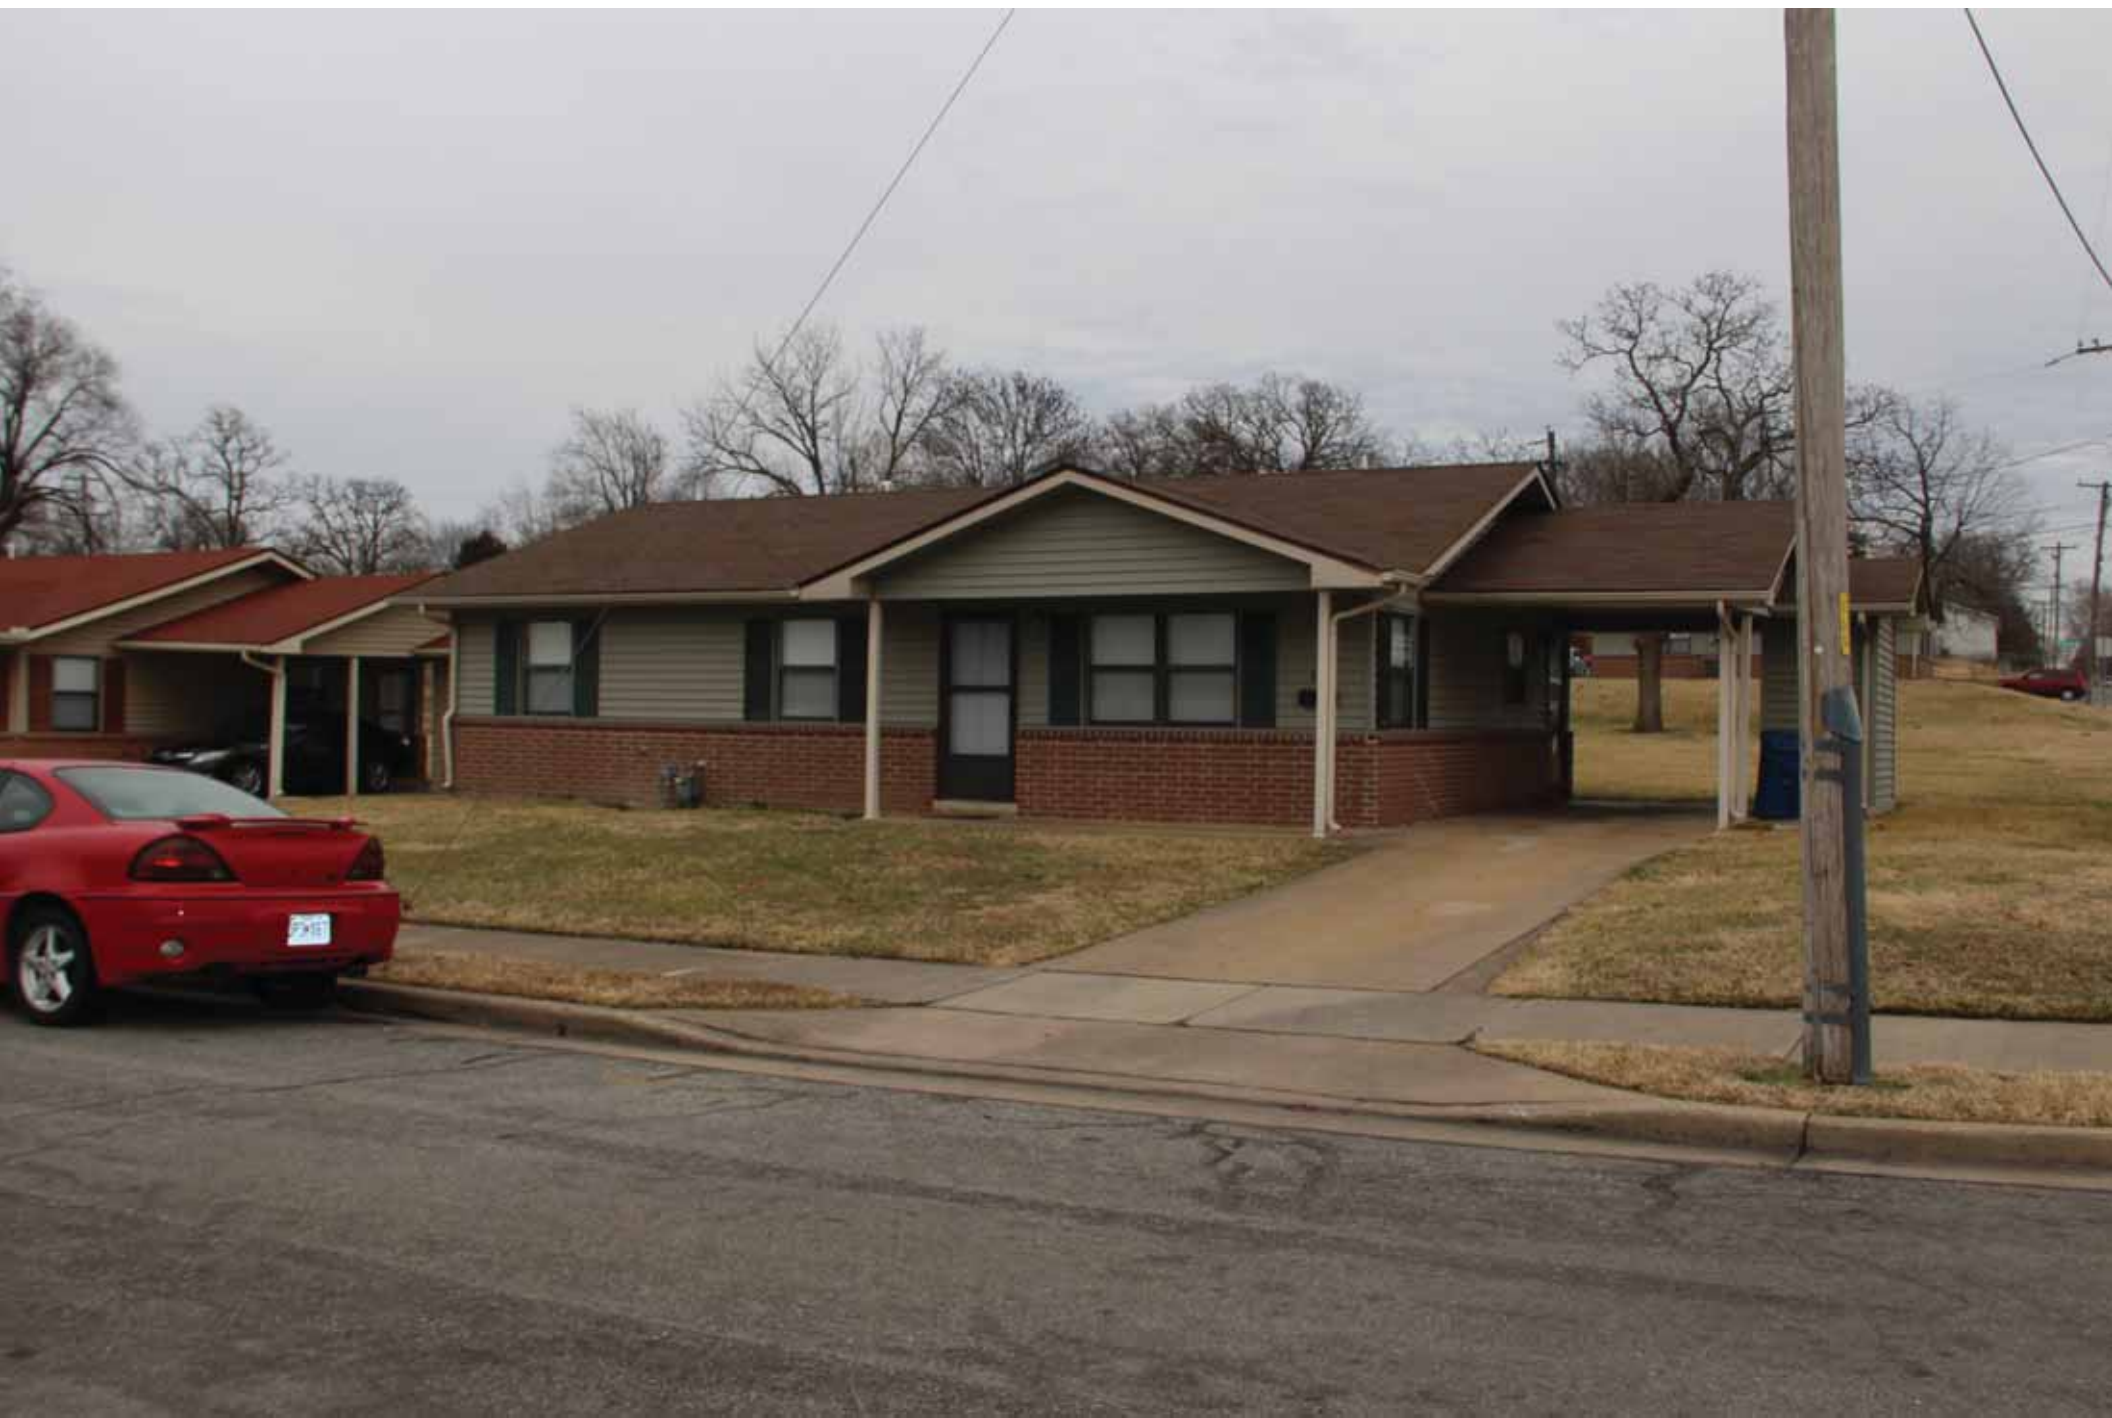
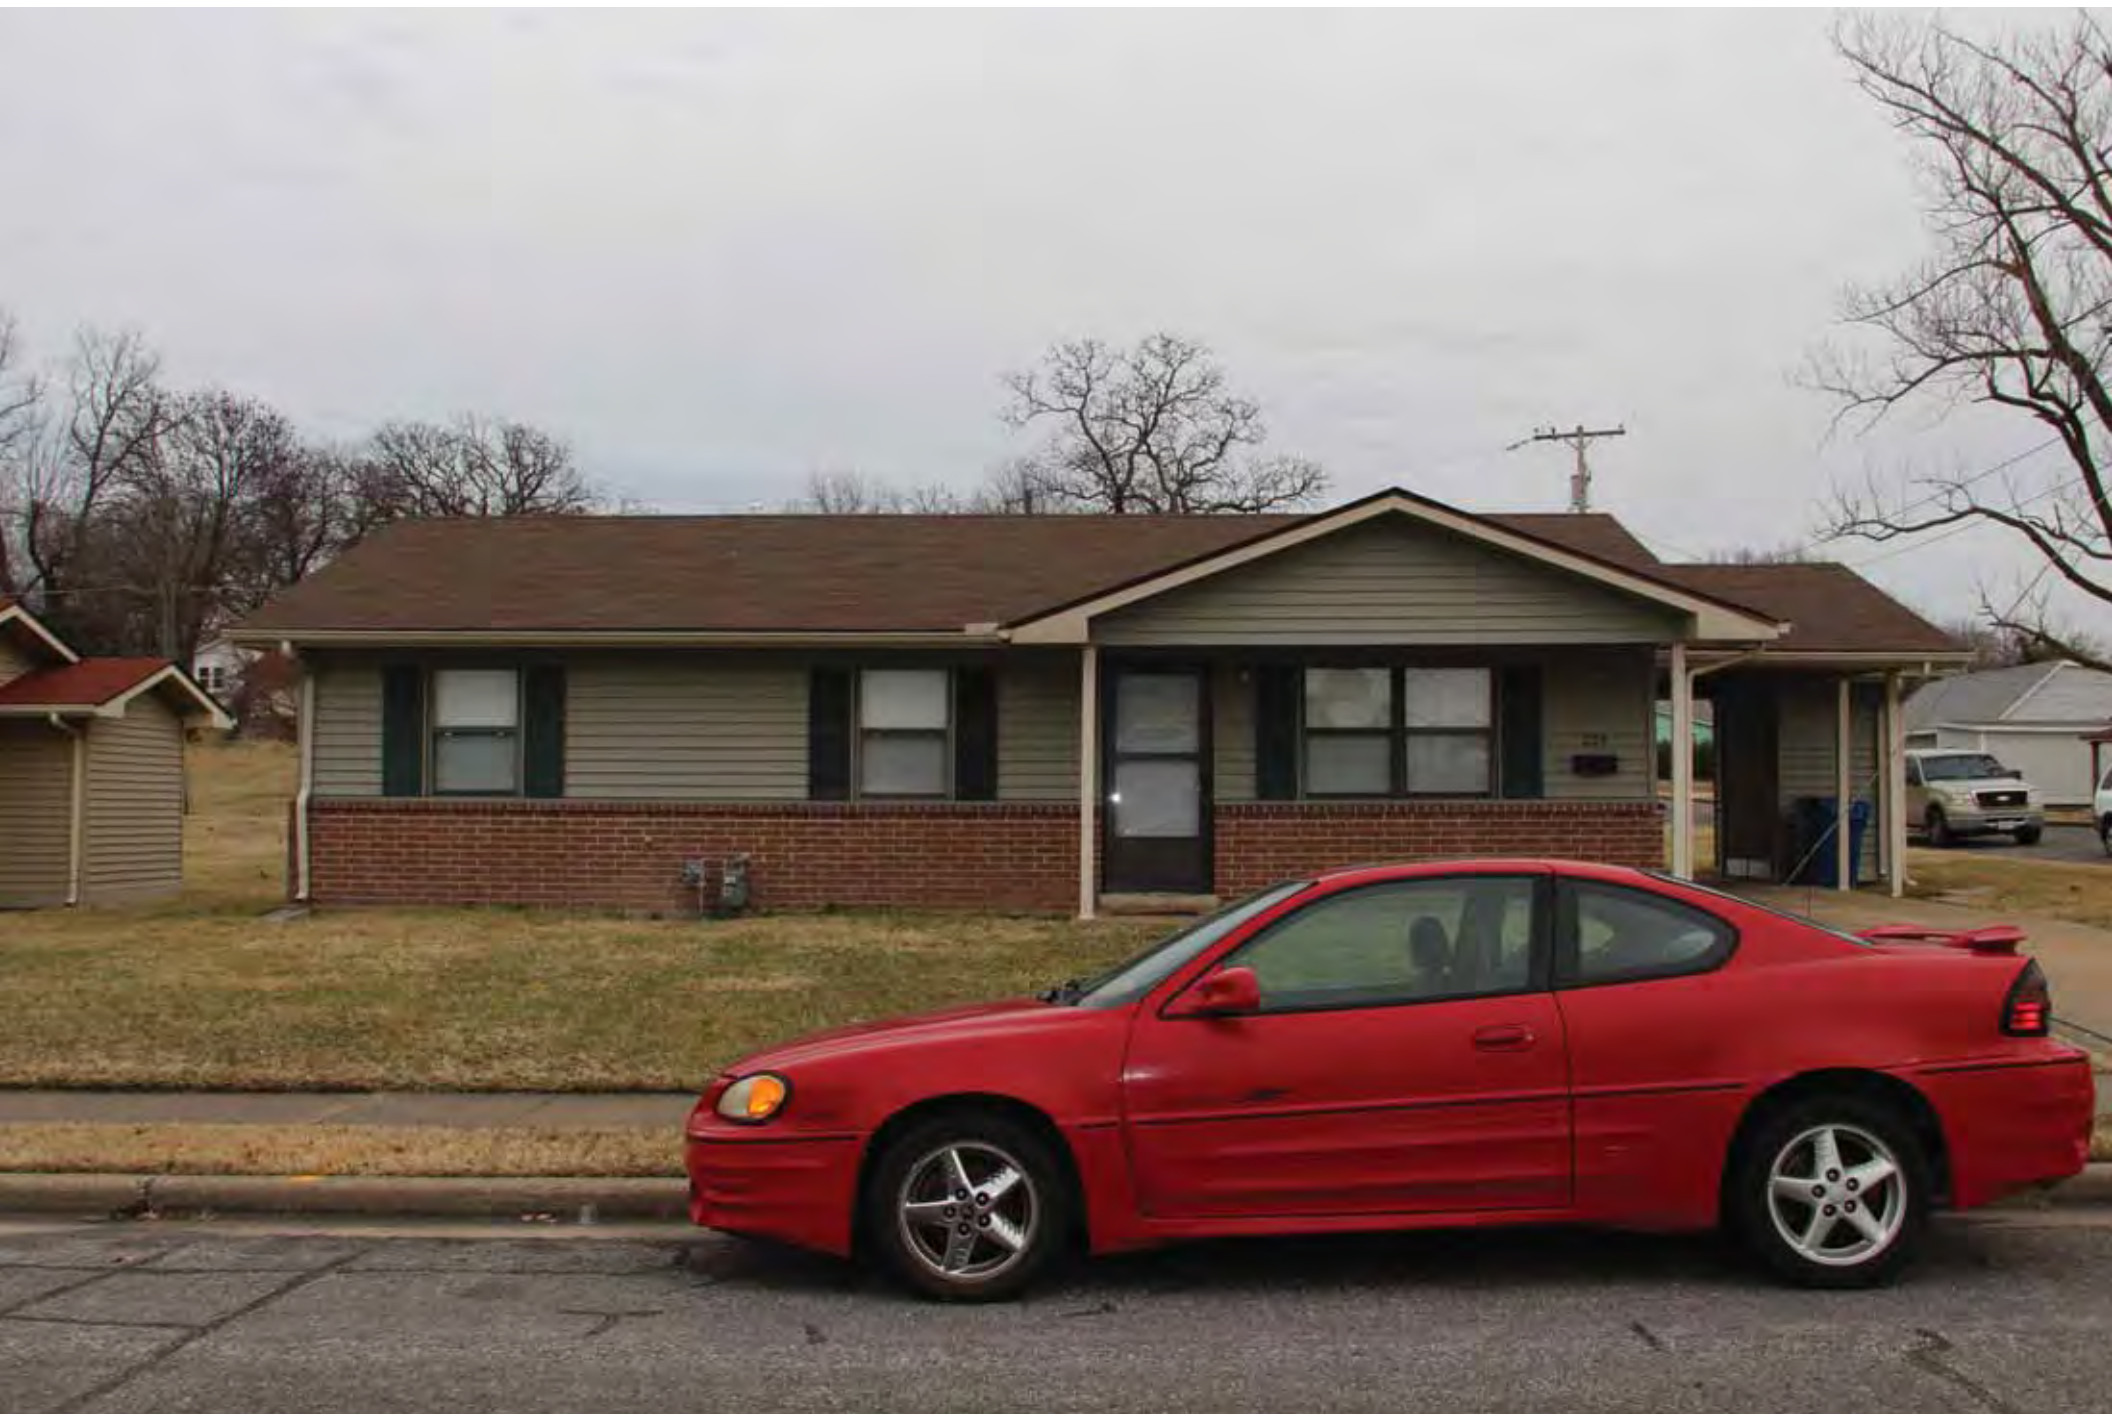
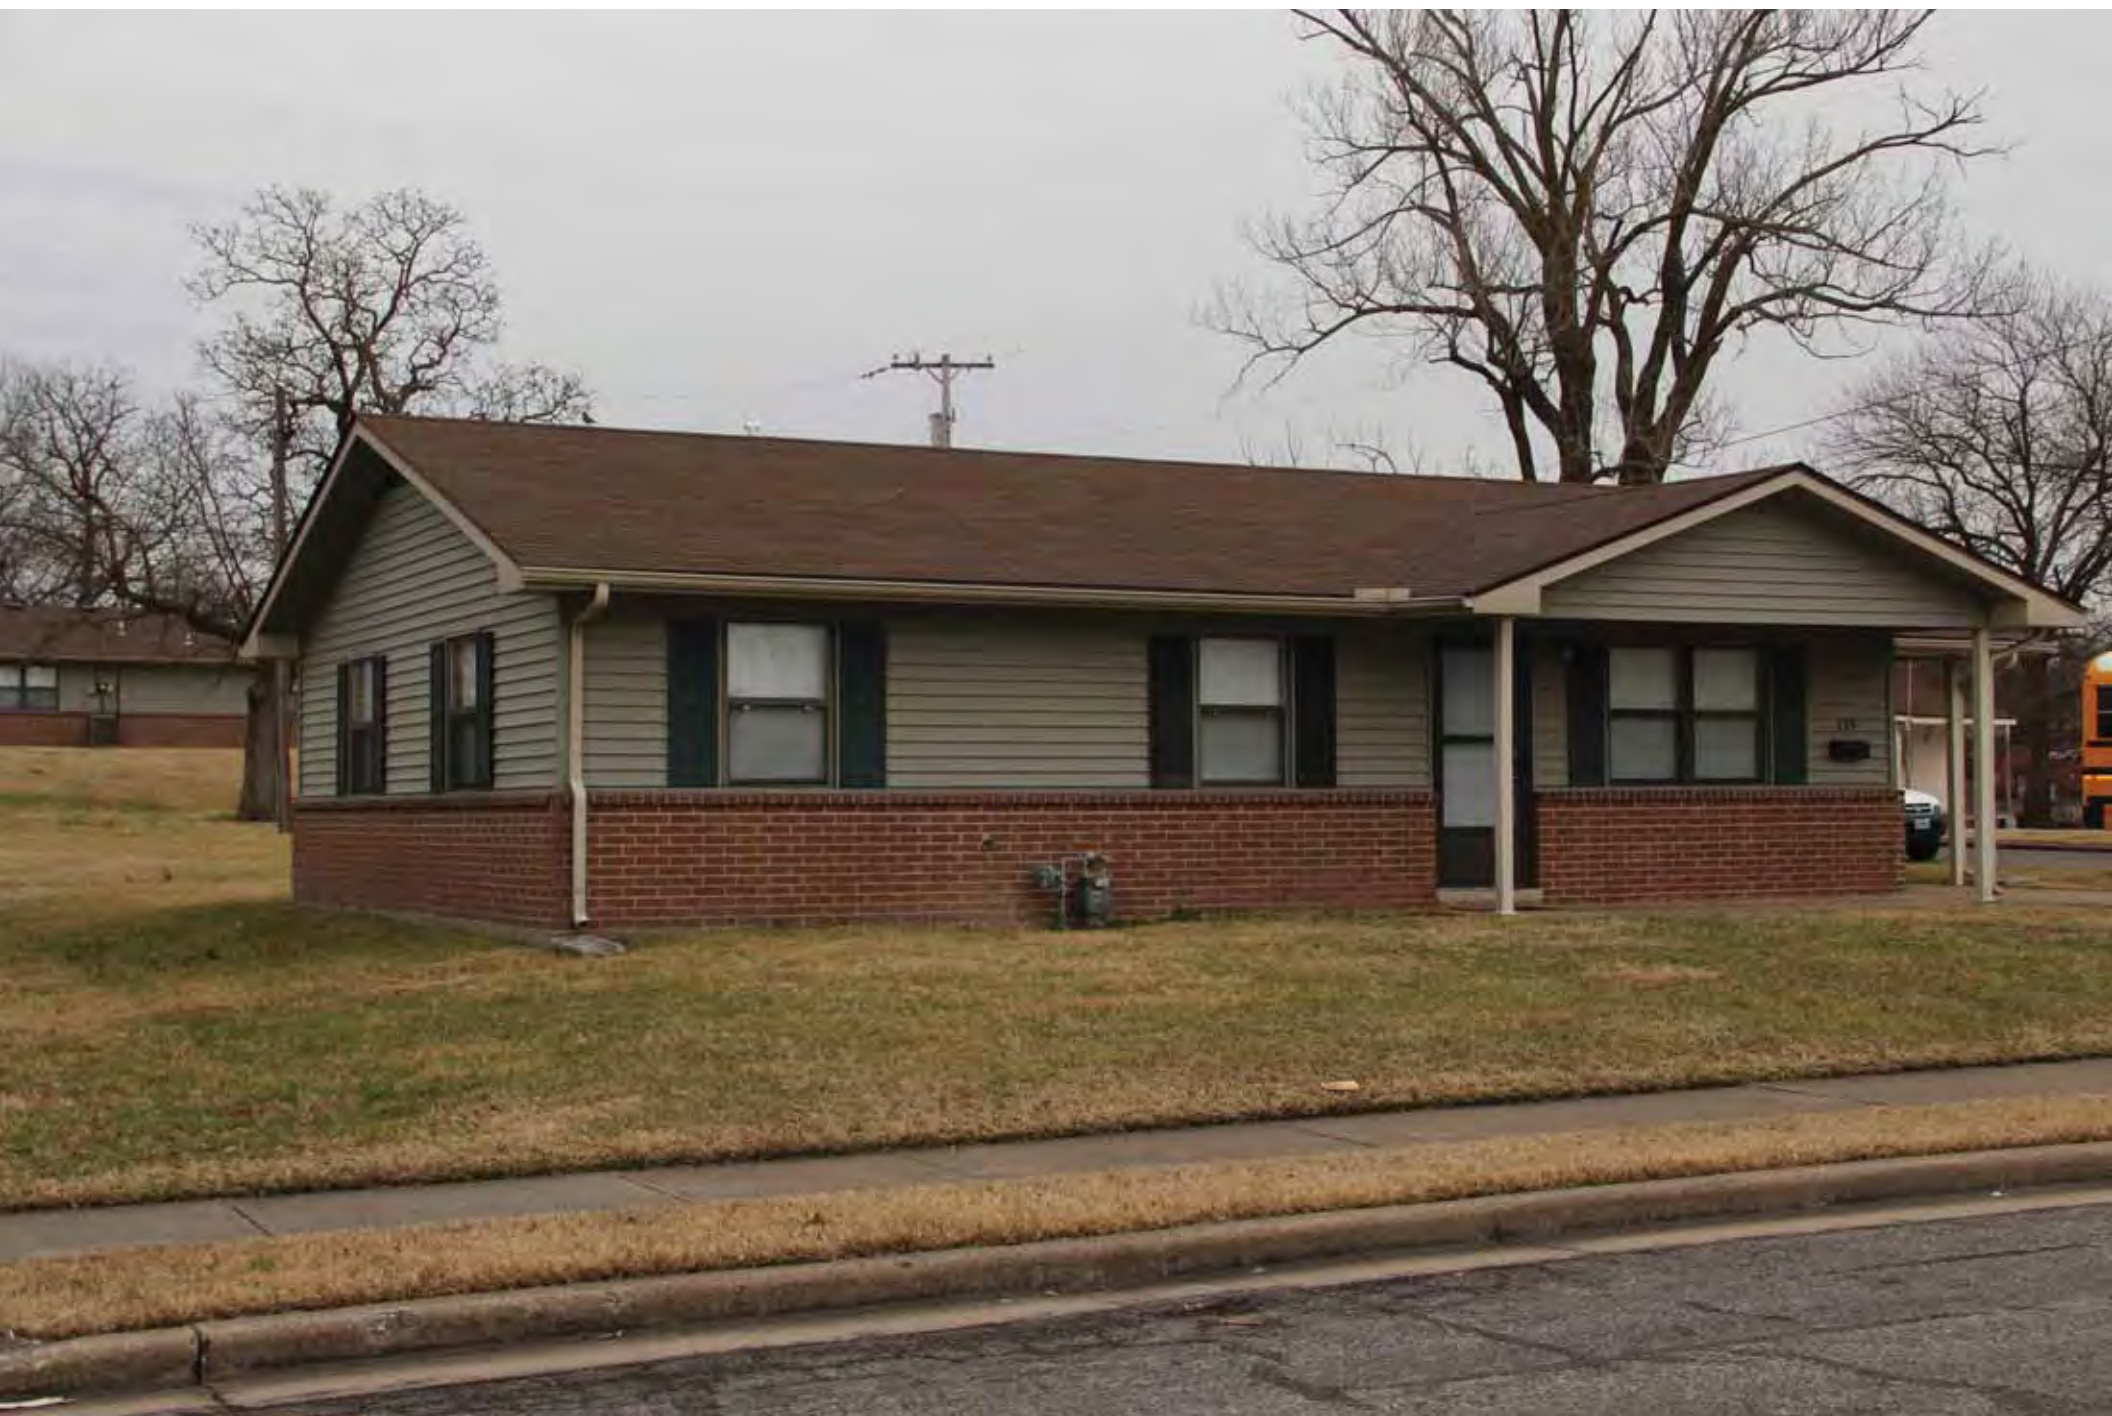
The property at 229 S. McKee Avenue features a single-story dwelling with an asphalt-shingled gabled roof, exterior vinyl siding and a concrete foundation. The lower elevations (below windows) are clad with brick veneer capped by a band of continuous brick headers. Windows are one-over-one with faux shutters. On the façade (west elevation) is a small gabled porch near the south end of the elevation. The porch is supported by two columns resting on a concrete pad. Within the porch bay is a single solid door flanked by paired windows (south) and a single window (north). The remaining elevation supports two single windows. The north elevation holds two windows. At the south elevation is a gabled carport, which extends above the concrete drive. The south elevation of the dwelling holds a secondary entry below the carport roof. The entry is offset on the west by a single window. The south end of the carport roof attaches to a small utility shed clad with vinyl siding.

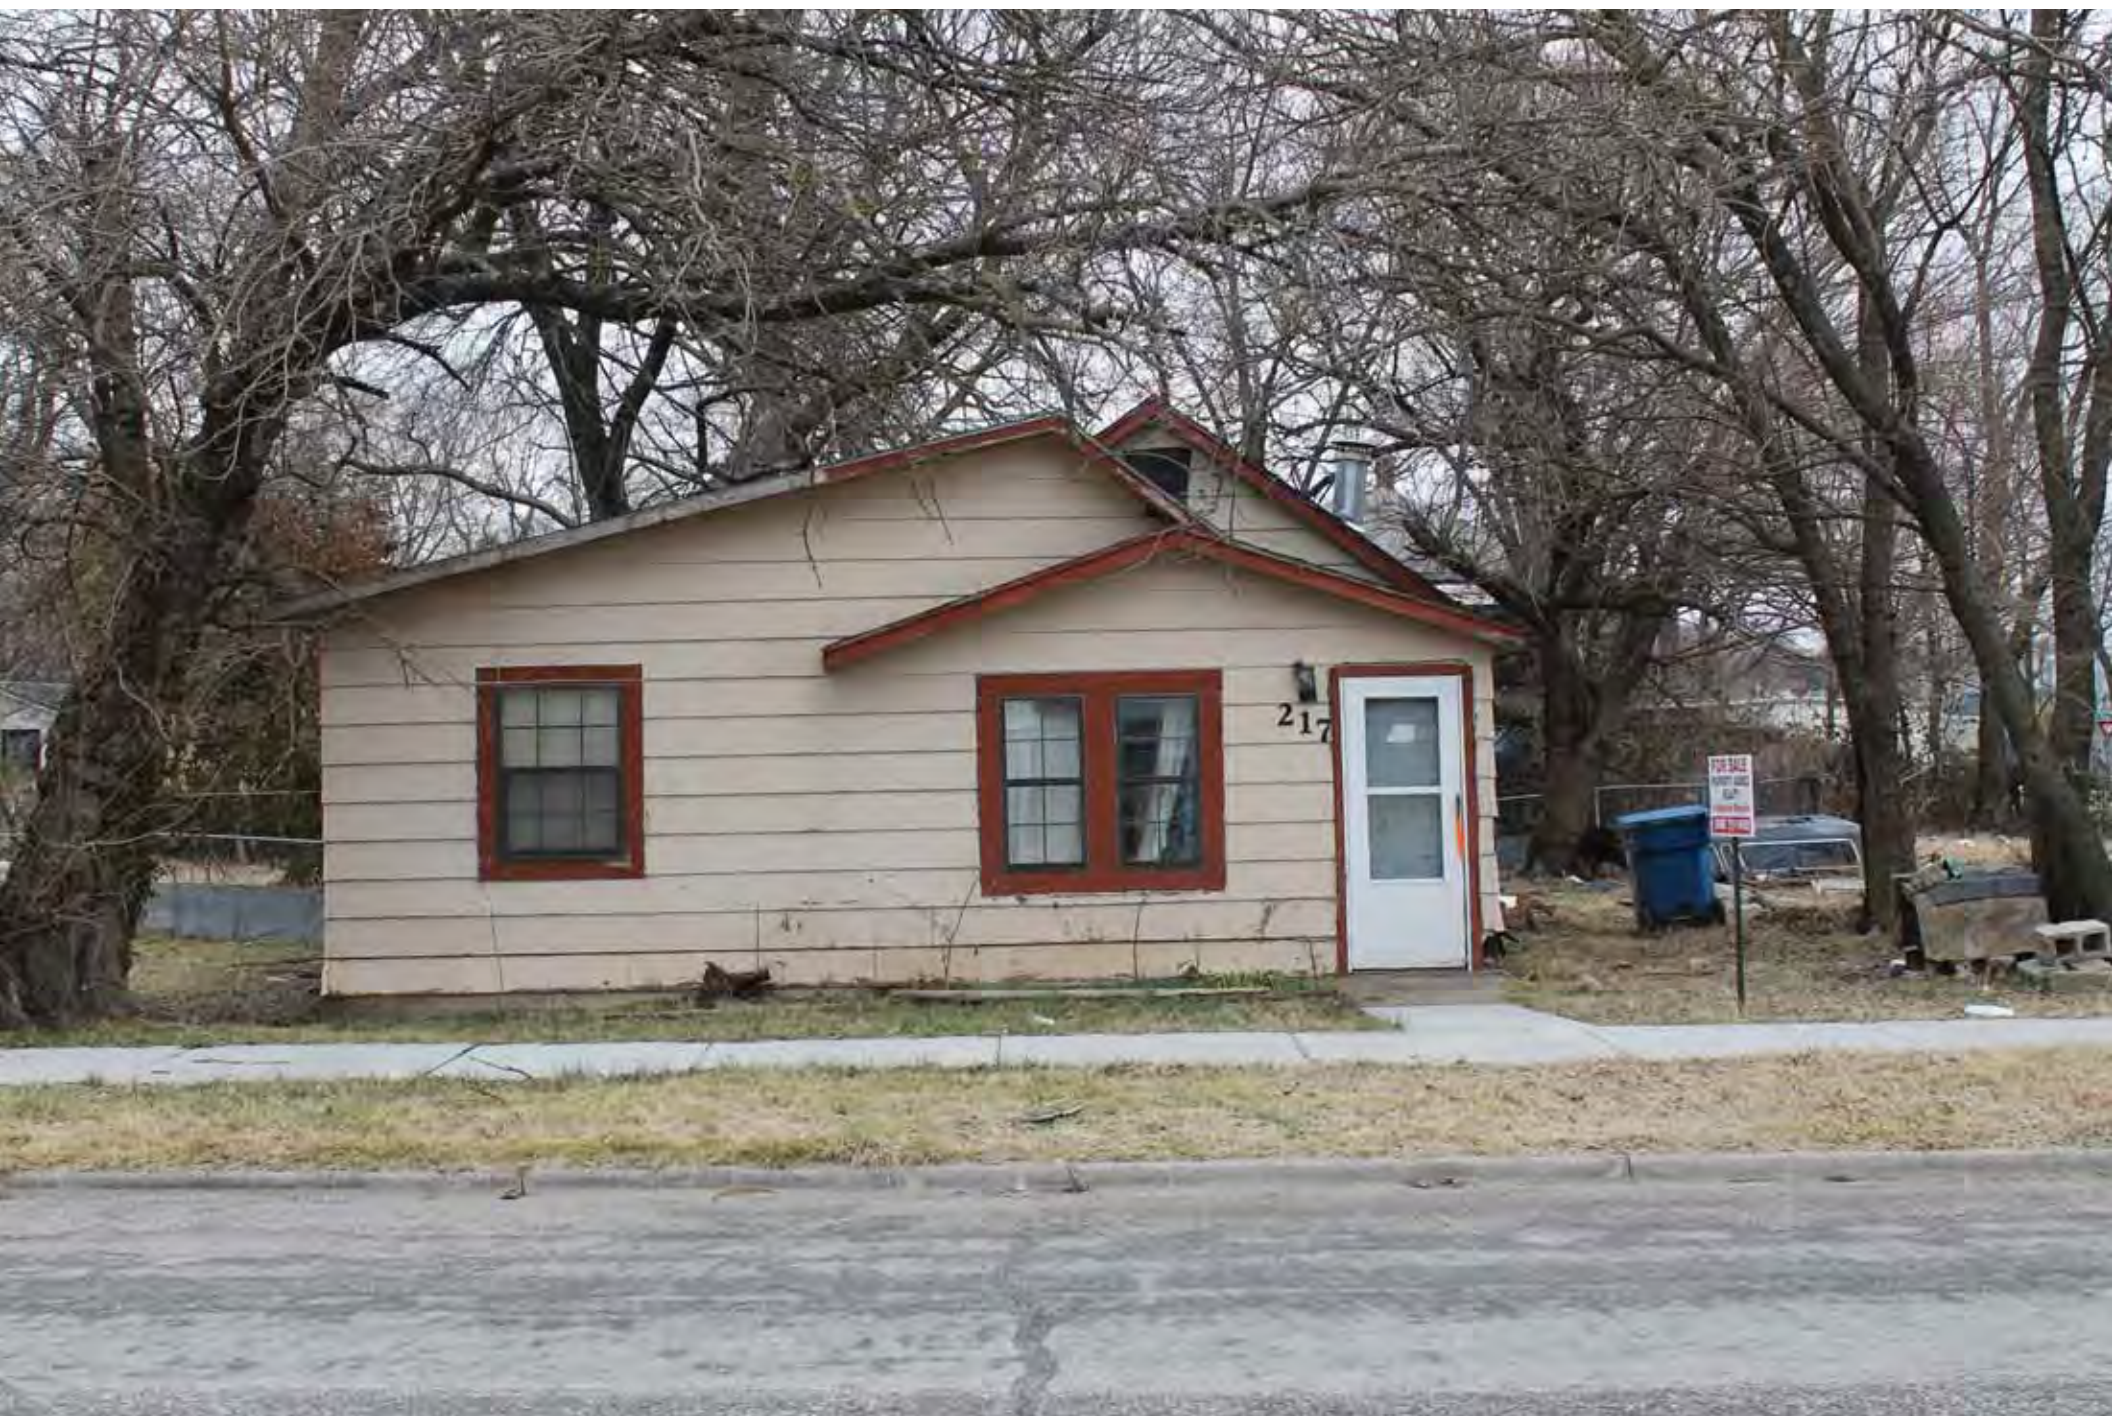
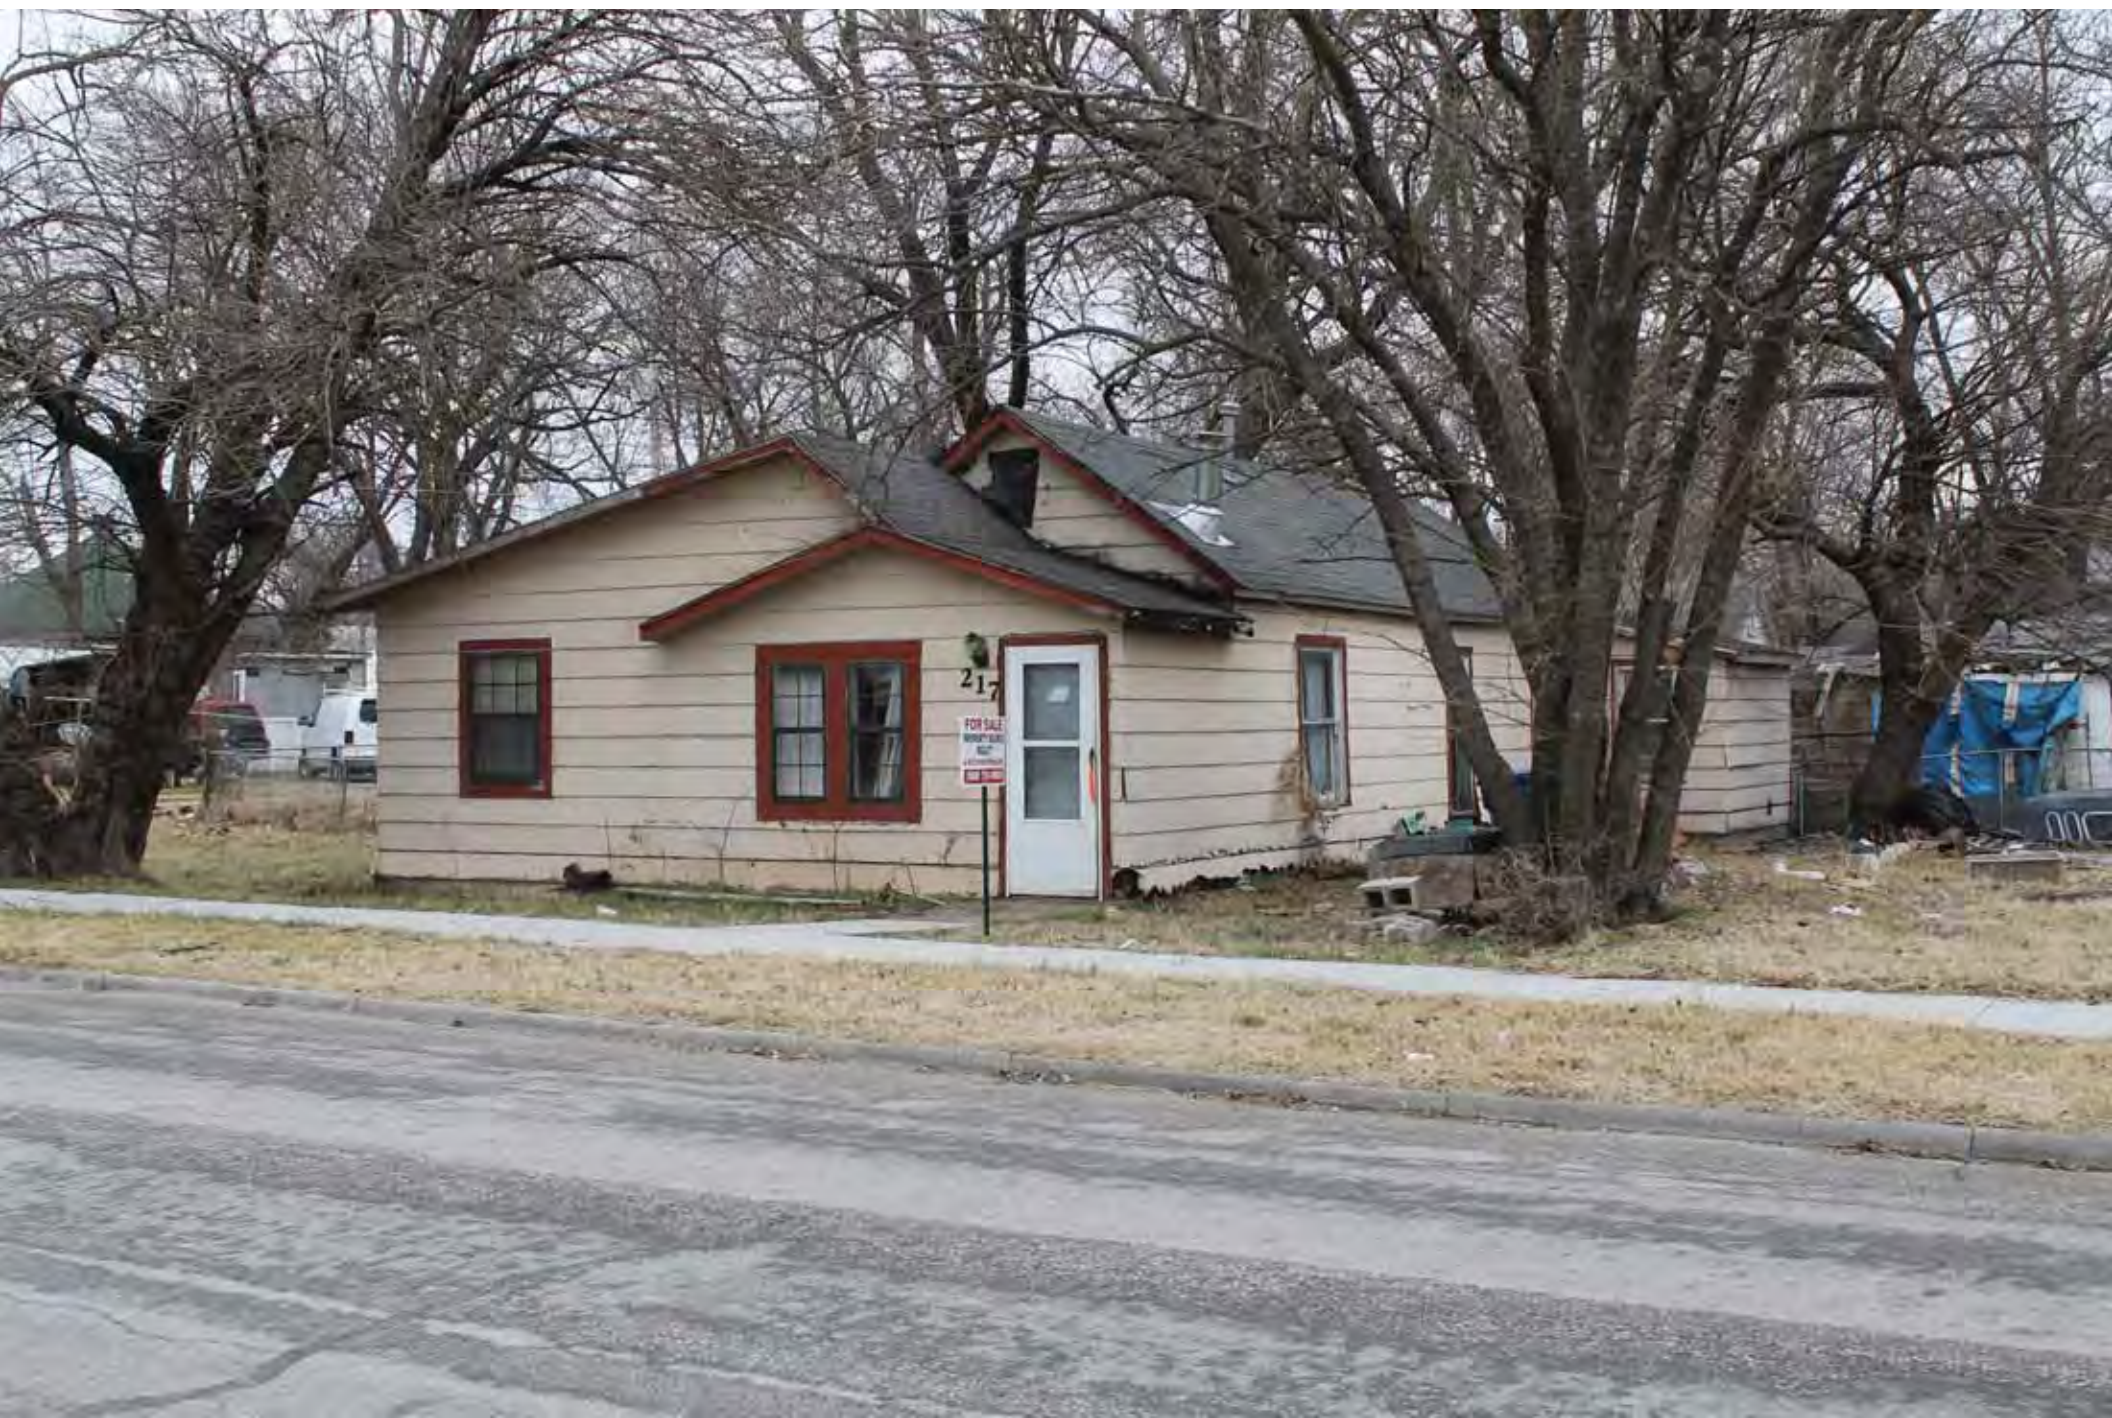
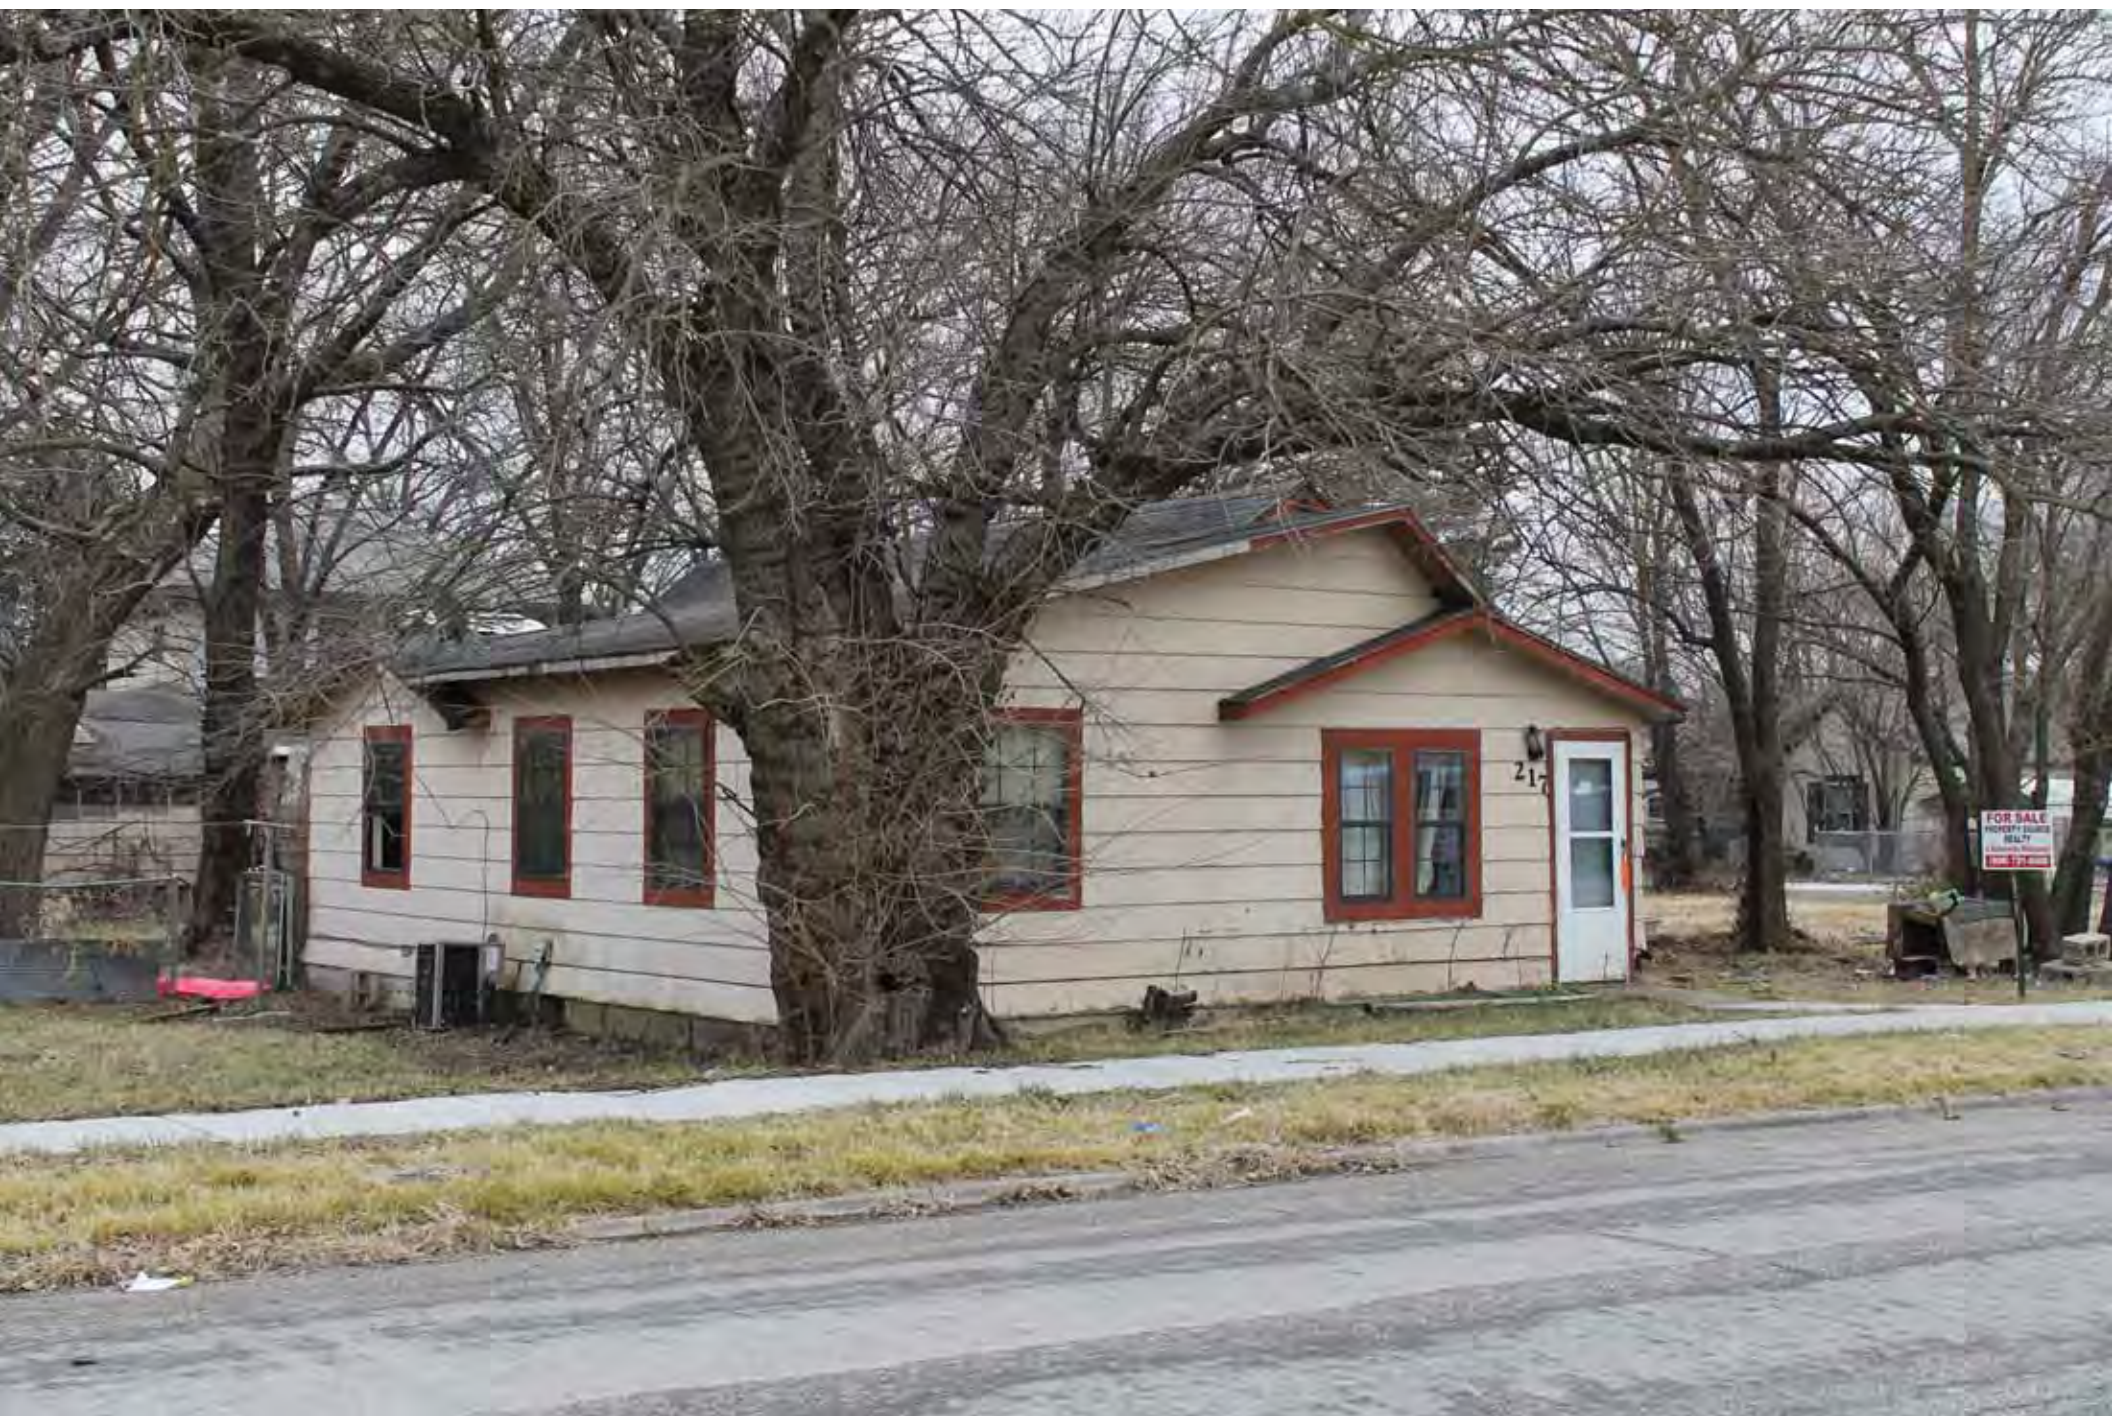
This dwelling has been altered with a post-1950 primary façade wing that incorporates an original porch (per Sanborn maps) and the application of exterior synthetic siding (c. 1960). These alterations compromise the dwelling's architectural integrity, rendering it individually ineligible for the National Register of Historic Places. The property is not within an area recommended as a historic district.

The property at 217 S. Michigan Avenue features a single-story altered dwelling with an asphalt-shingled gable roof, exterior asbestos siding and a concrete (covered) foundation. The primary (north) elevation has an engaged gable above the entry bay, which is filled with a contemporary paneled door offset on the north by paired four-over-four windows. The elevation also holds six-over-six paired windows. The north end of the house is composed of a shed wing, which holds three windows (6/6) on the east elevation. The south elevation holds three windows. At the southeast corner of the dwelling is a small shed wing that supports a single window on the west elevation.
