MISSOURI DEPARTMENT OF NATURAL RESOURCES
STATE HISTORIC PRESERVATION OFFICE, P.O. Box 176, Jefferson City, MO 65102
ARCHITECTURAL/HISTORIC INVENTORY FORM

1. Survey No. JP-AS-007-001		2. Survey name: East Town (Original Joplin) Historic Survey Phase 2	
3. County: JASPER		4. Address (Street No.) 618	Street (name) E. 2 nd Street
5. City: Joplin	Vicinity: <input type="checkbox"/>	6. Geographical Reference:	7. Township/Range/Section: T: R: S:
8. Historic name (if known):		9. Present/other name (if known):	
10. Ownership: <input checked="" type="checkbox"/> Private <input type="checkbox"/> Public		11a. Historic use (if known): Domestic: Single Dwelling	11b. Current use: Domestic: Single Dwelling

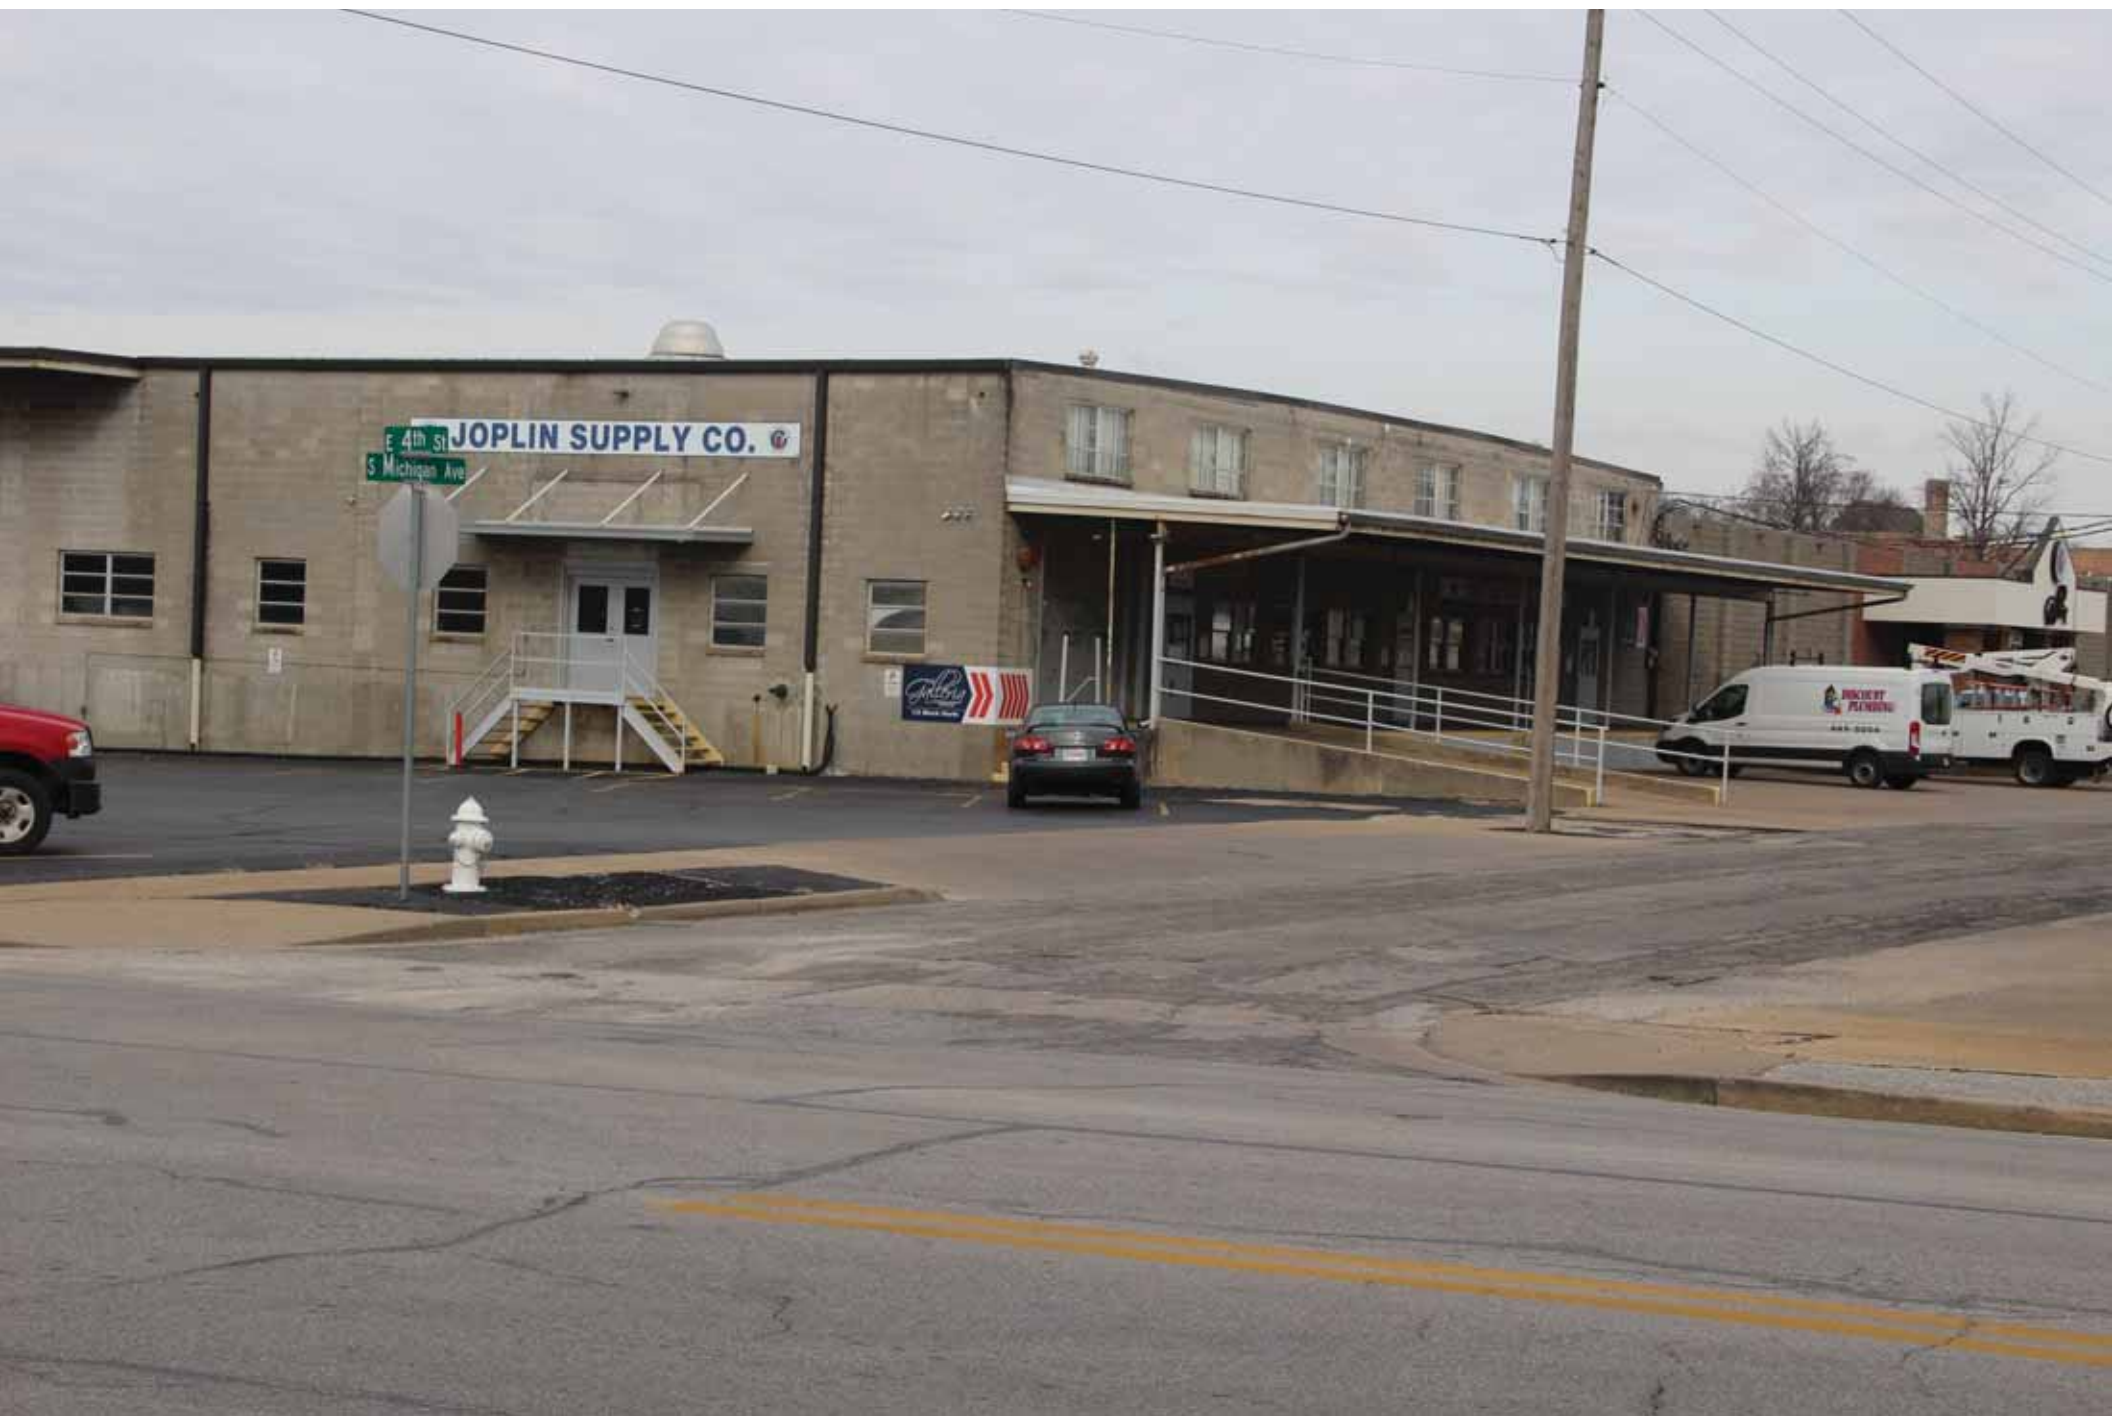
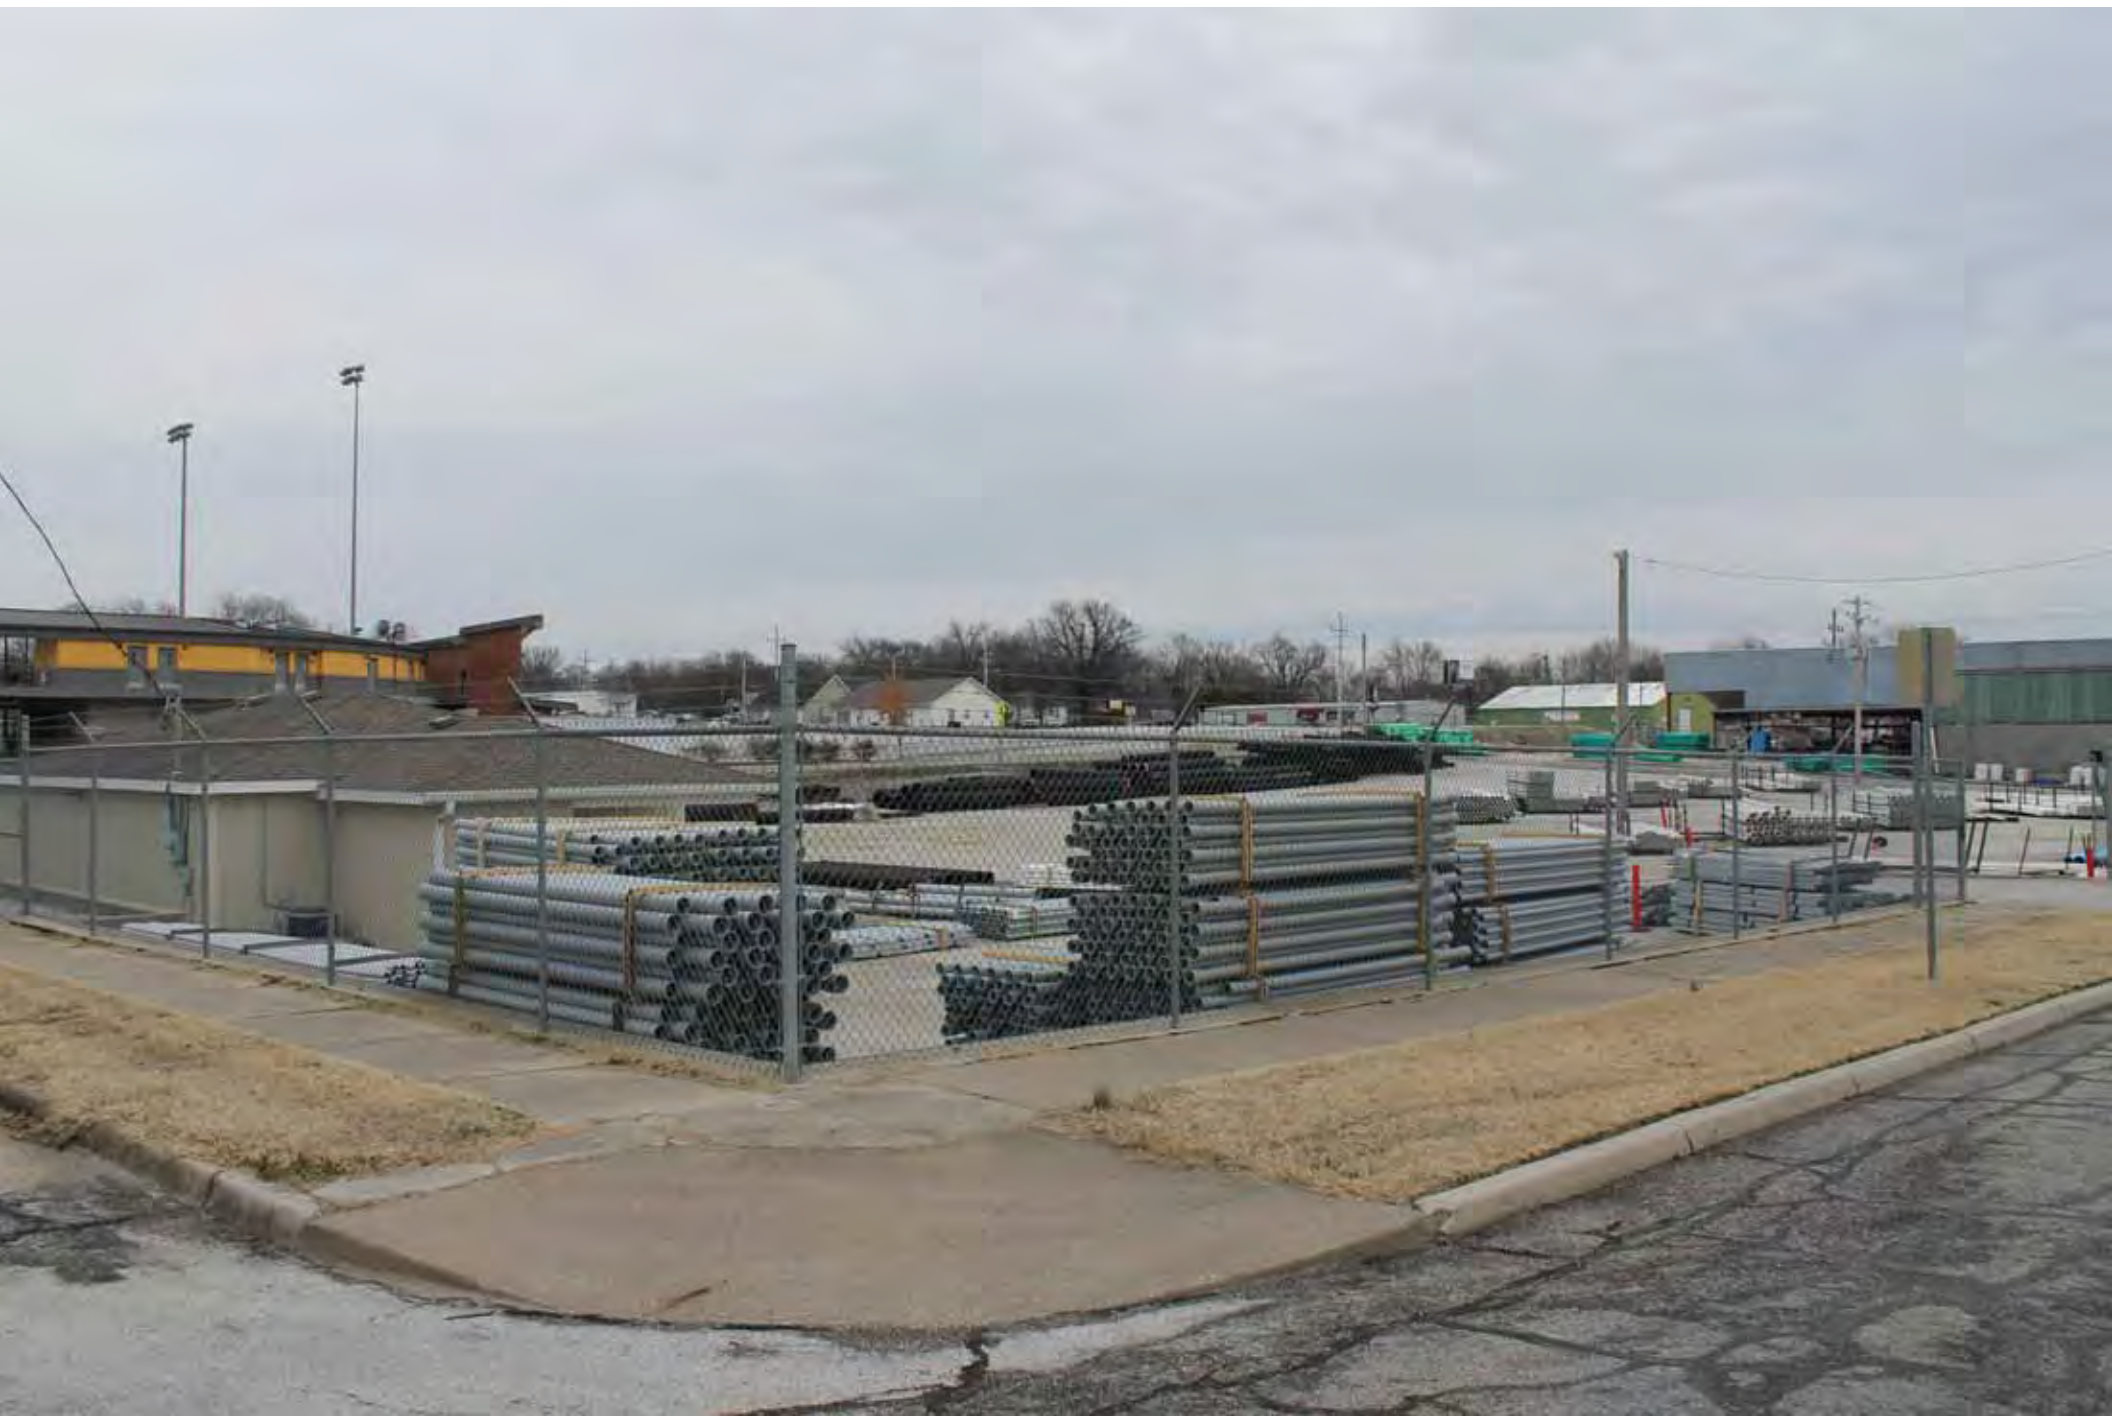
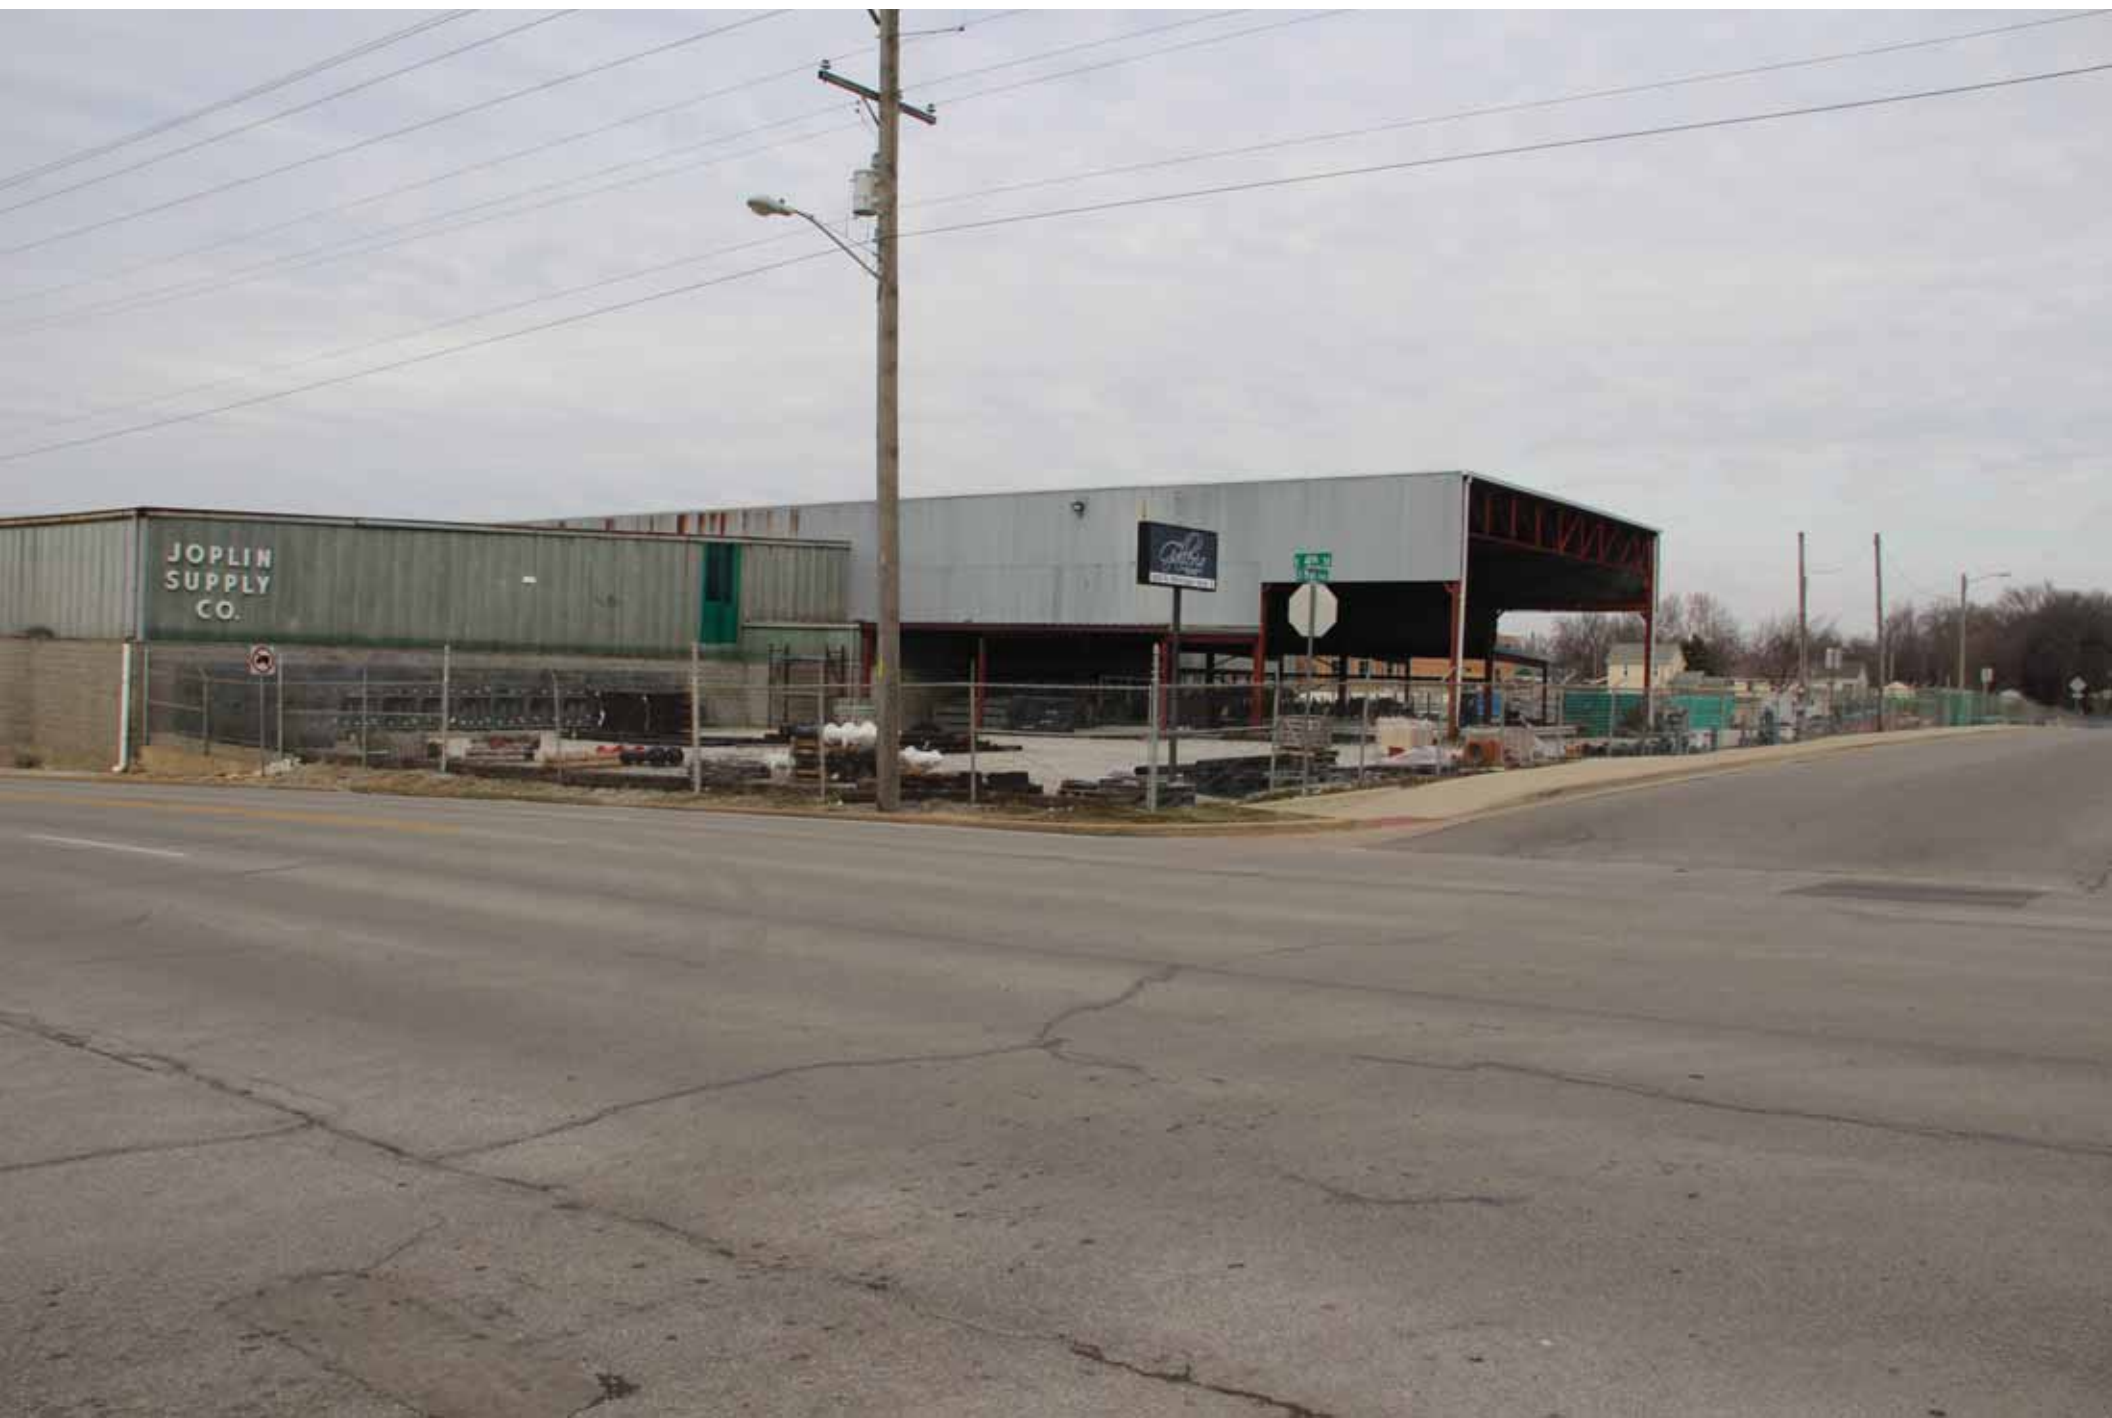
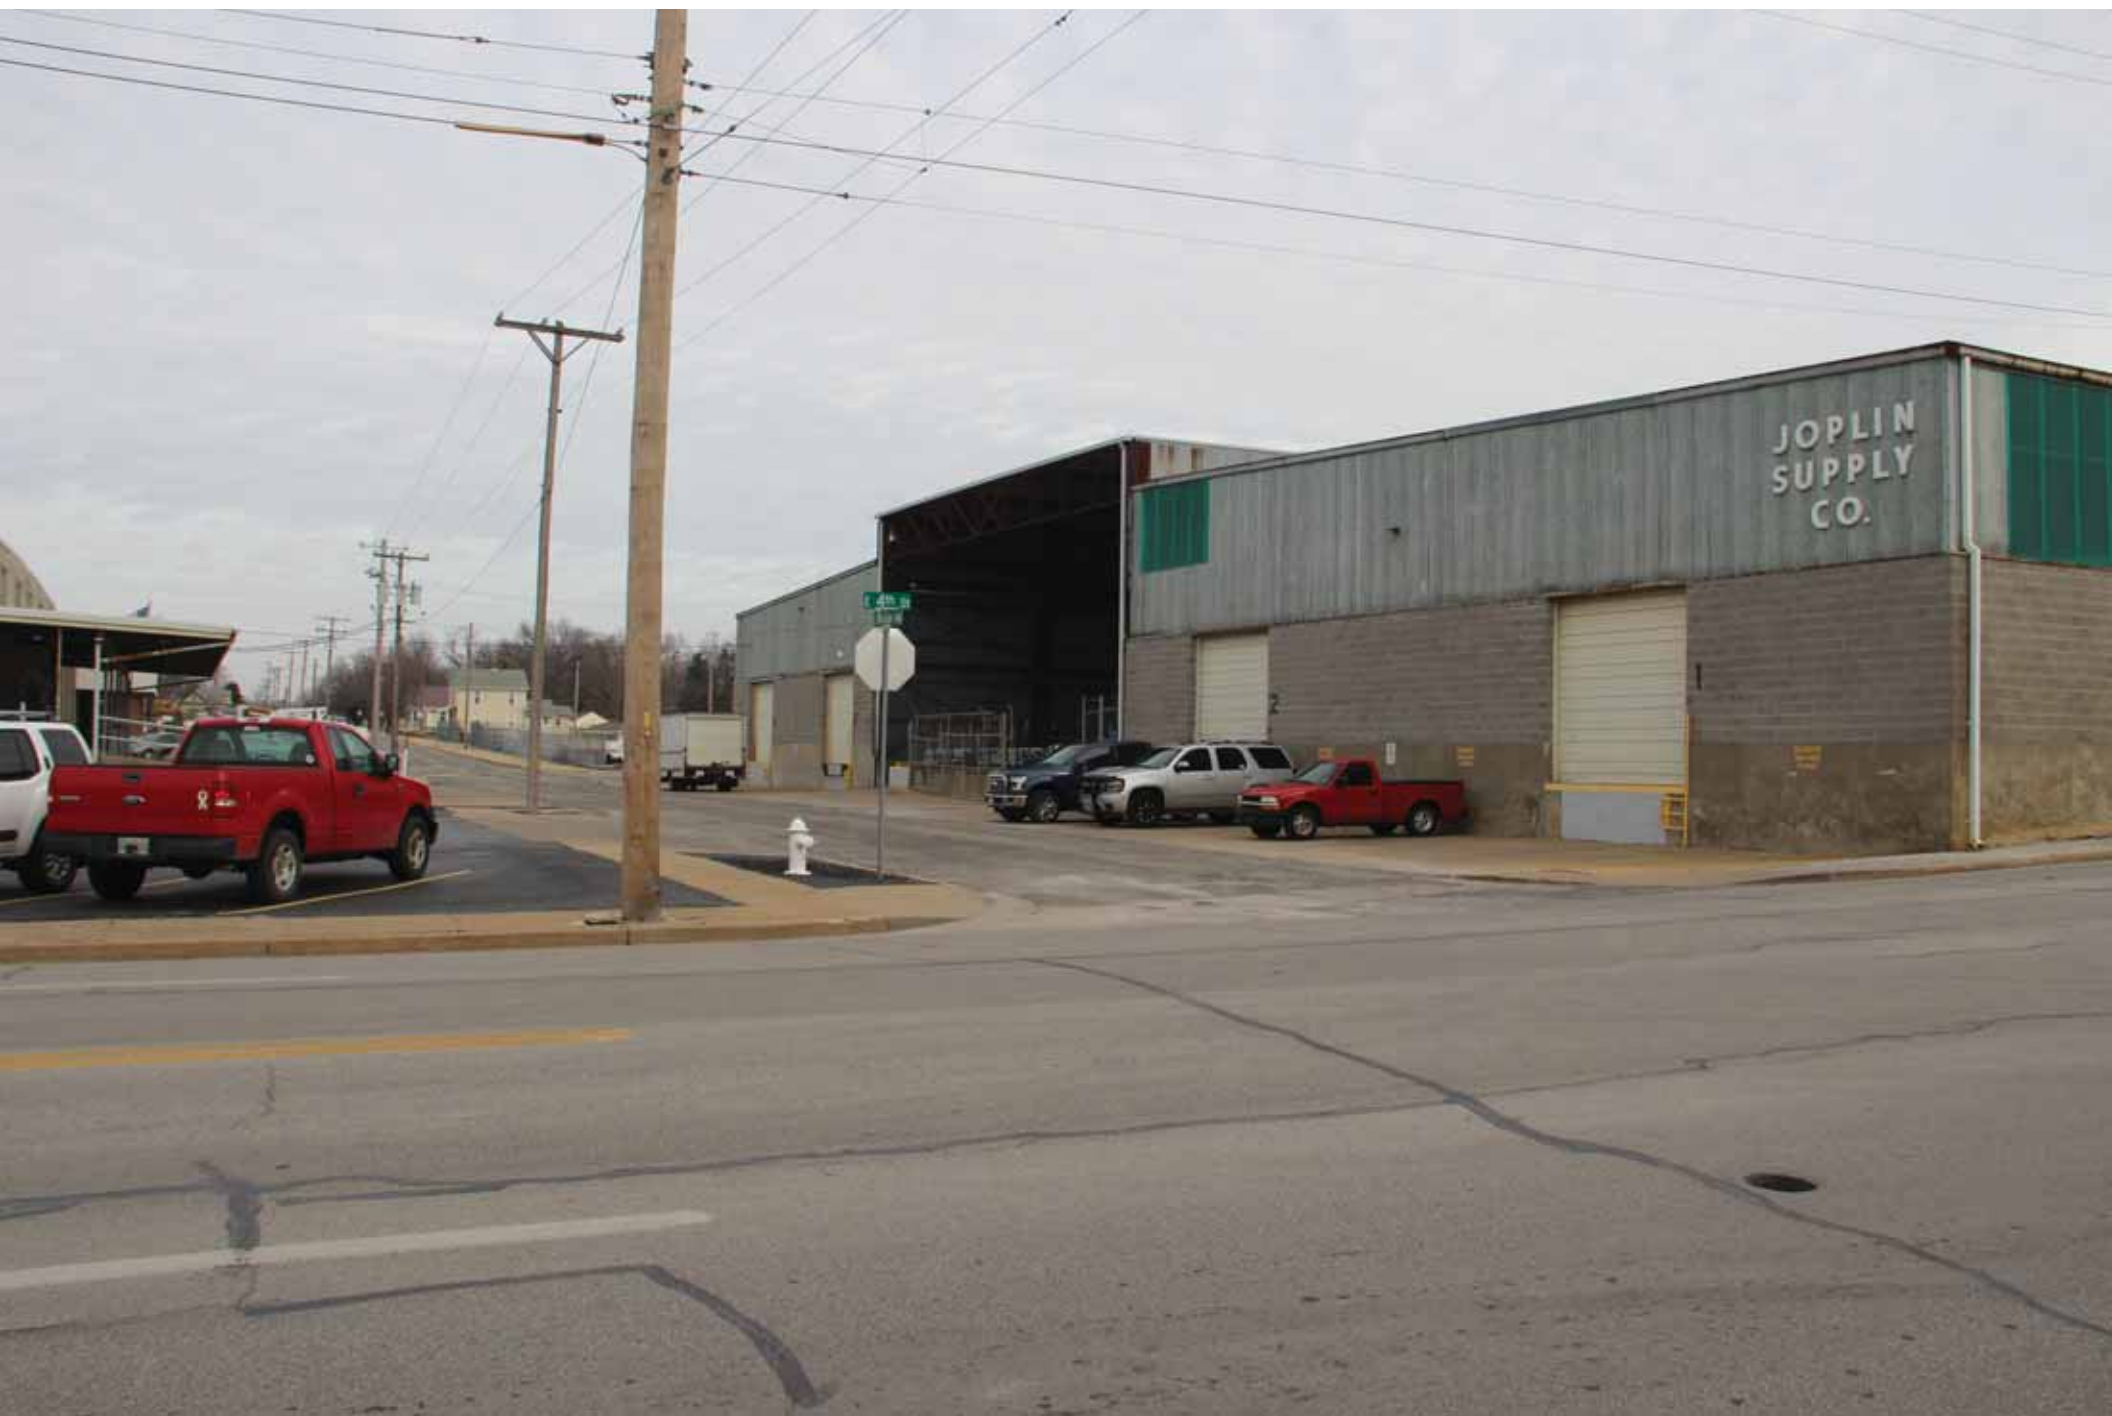
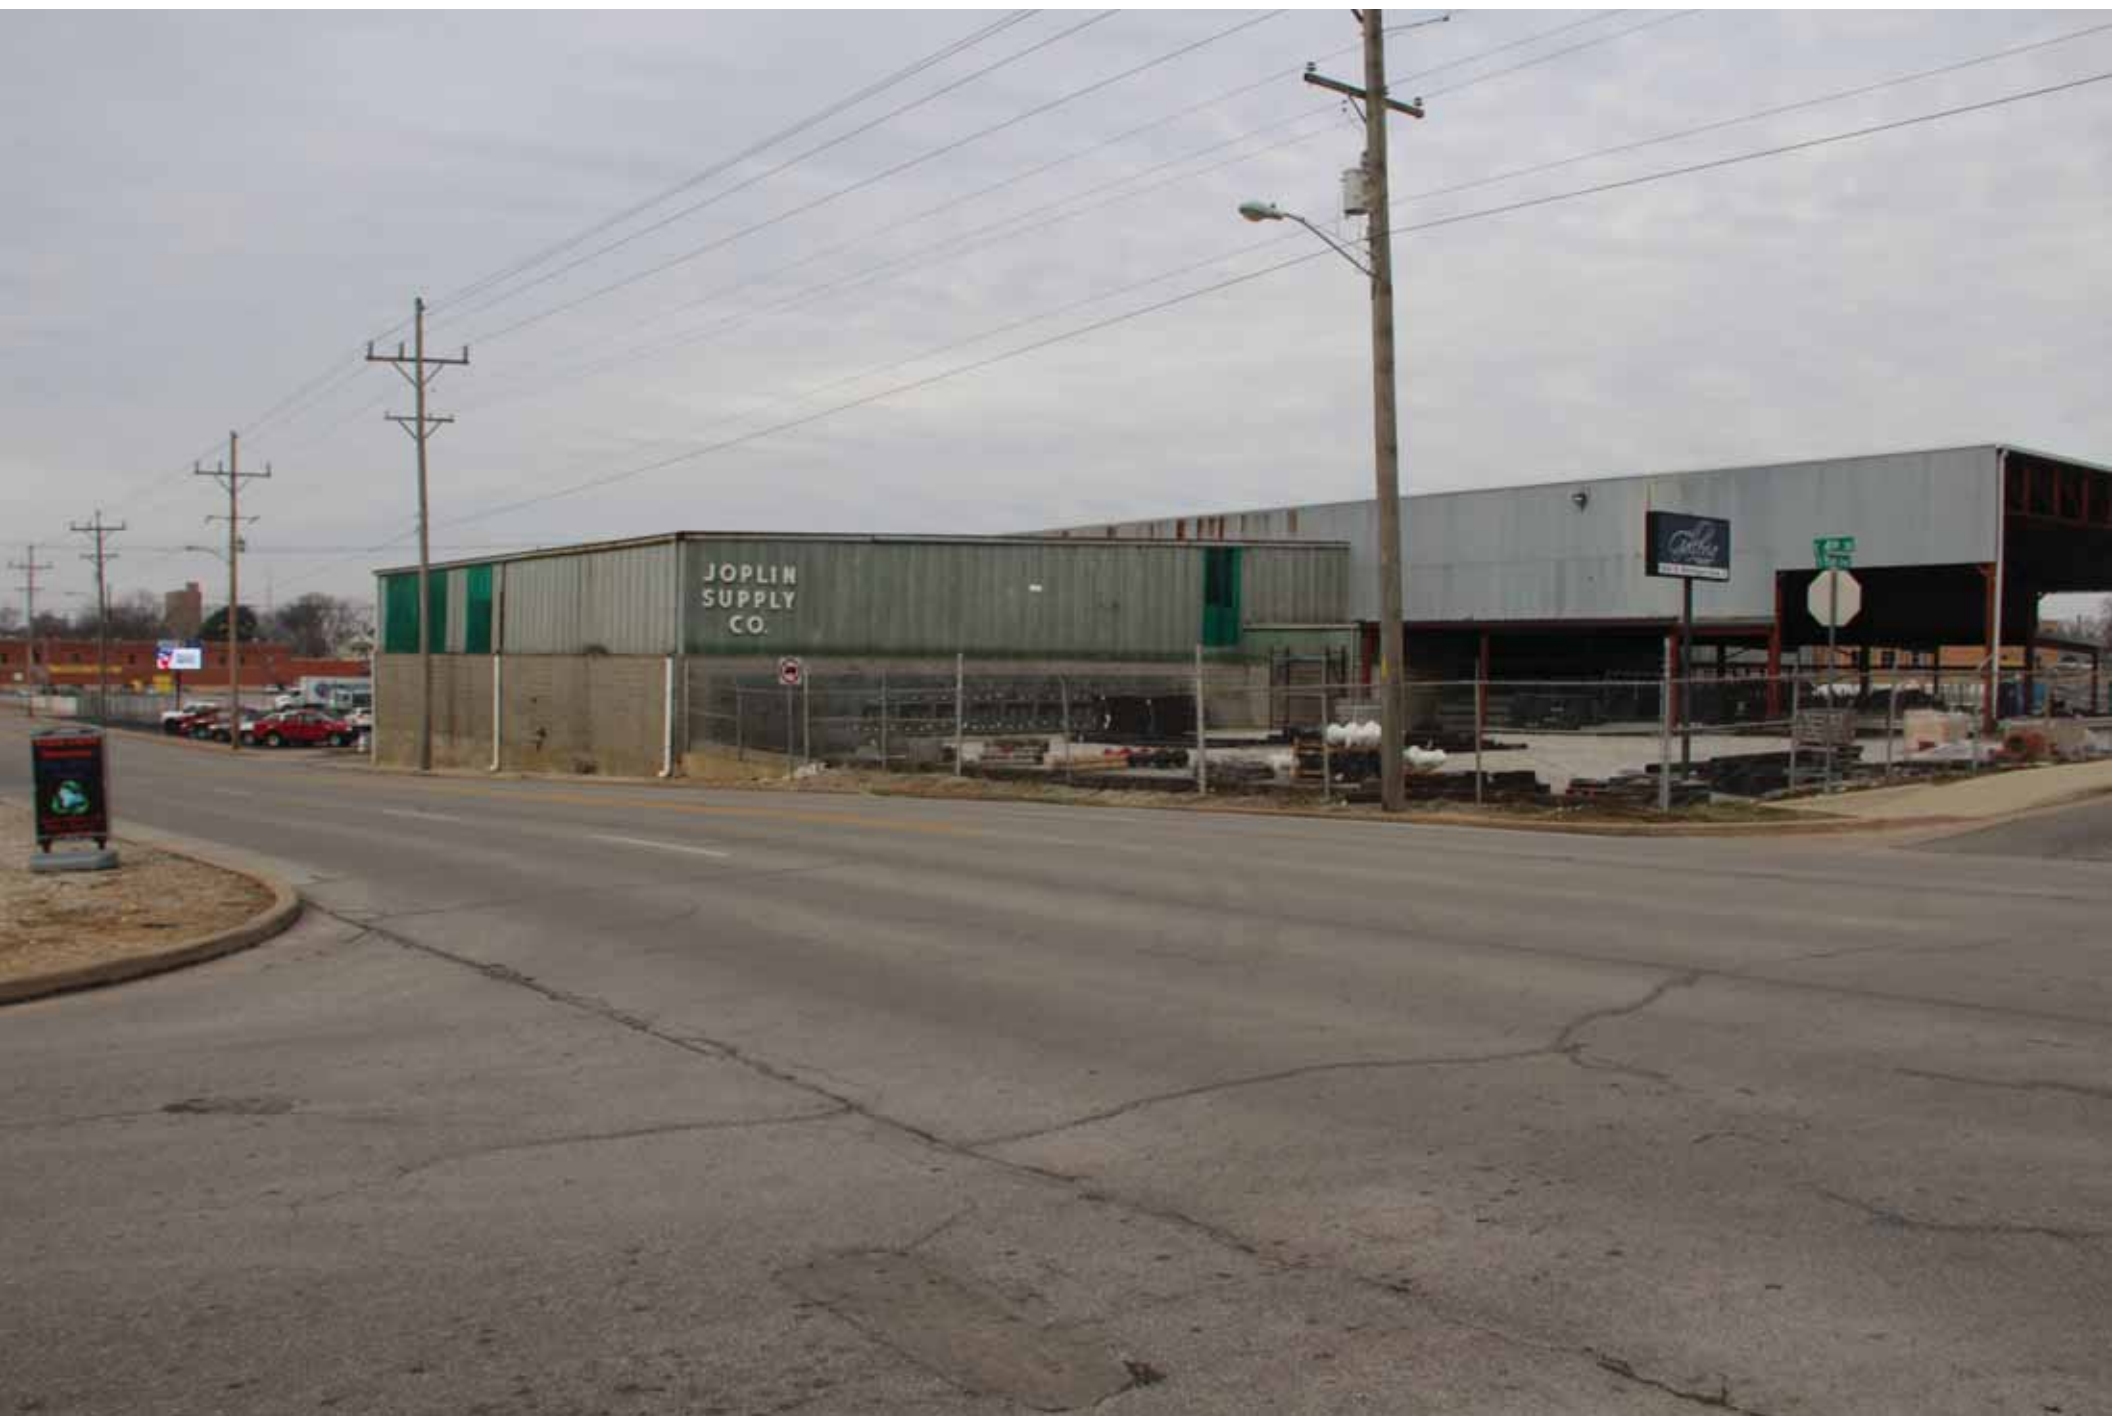
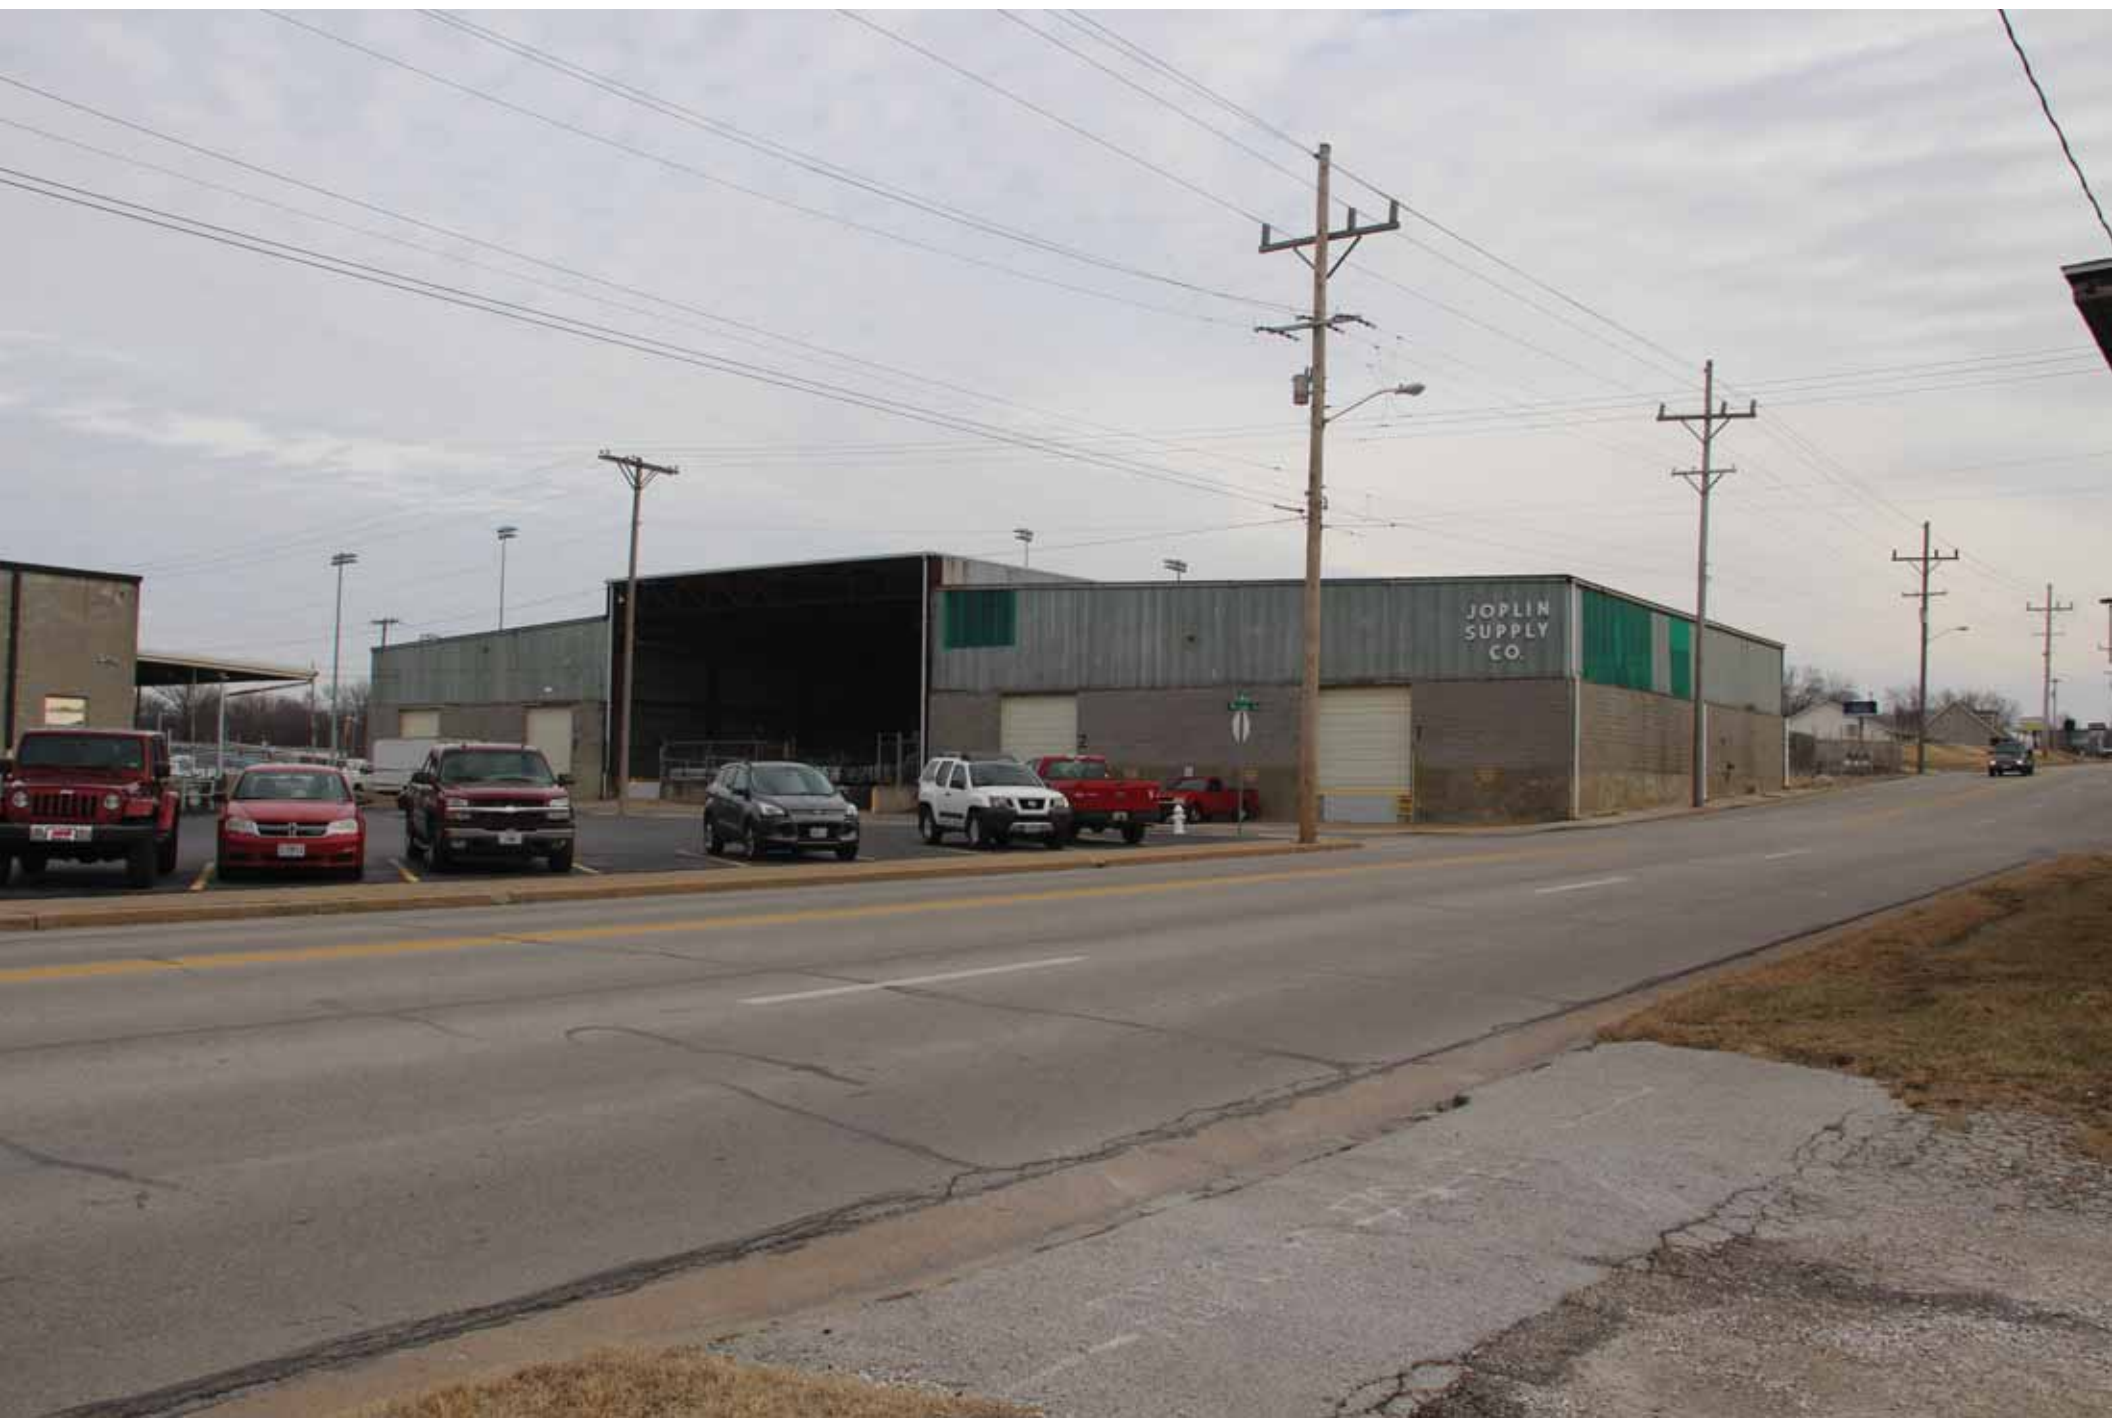
The east elevation of the west warehouse faces S. Michigan Avenue. The lower floor holds two pedestrian doors at either end of the elevation. Offsetting the south door is an overhead track bay. A concrete ramp leads to the bay, allowing goods to be wheeled in and out of the warehouse. The ramp leads to a concrete dock that spans the elevation. Seven bays of paired windows are situated between the pedestrian doors. A metal shed awning extends above the first floor of the elevation. The upper story of the east elevation supports six original metal sash hopper windows. At the north end of the warehouse is a concrete block wing, void of fenestration on the east elevation.

The warehouse to the east (at the northeast intersection of S. Michigan and E. 4th Street) is constructed of concrete block – wings on the north and south end flank a taller central open bay with openings on the east and west ends of the warehouse. The upper walls of the warehouse are composed of corrugated metal. At the southwest and southeast corners of the building (facing street intersections) are letters that bear the name of the business, "Joplin Supply Co." There is no fenestration on the south elevation facing E. 4th Street or the east elevation facing S. High Avenue. A large flat roof open shed wing (c. 1990) is situated at the northeast corner and covers some of the supplies stacked on the open lot surrounding the warehouse. The warehouse's west elevation (facing S. Michigan Avenue) features four overhead track doors – two on either side of the central open bay.
