MISSOURI DEPARTMENT OF NATURAL RESOURCES
STATE HISTORIC PRESERVATION OFFICE, P.O. Box 176, Jefferson City, MO 65102
ARCHITECTURAL/HISTORIC INVENTORY FORM

1. Survey No. JP-AS-007-001		2. Survey name: East Town (Original Joplin) Historic Survey Phase 2	
3. County: JASPER		4. Address (Street No.) 618	Street (name) E. 2 nd Street
5. City: Joplin	Vicinity: <input type="checkbox"/>	6. Geographical Reference:	7. Township/Range/Section: T: R: S:
8. Historic name (if known):		9. Present/other name (if known):	
10. Ownership: <input checked="" type="checkbox"/> Private <input type="checkbox"/> Public		11a. Historic use (if known): Domestic: Single Dwelling	11b. Current use: Domestic: Single Dwelling

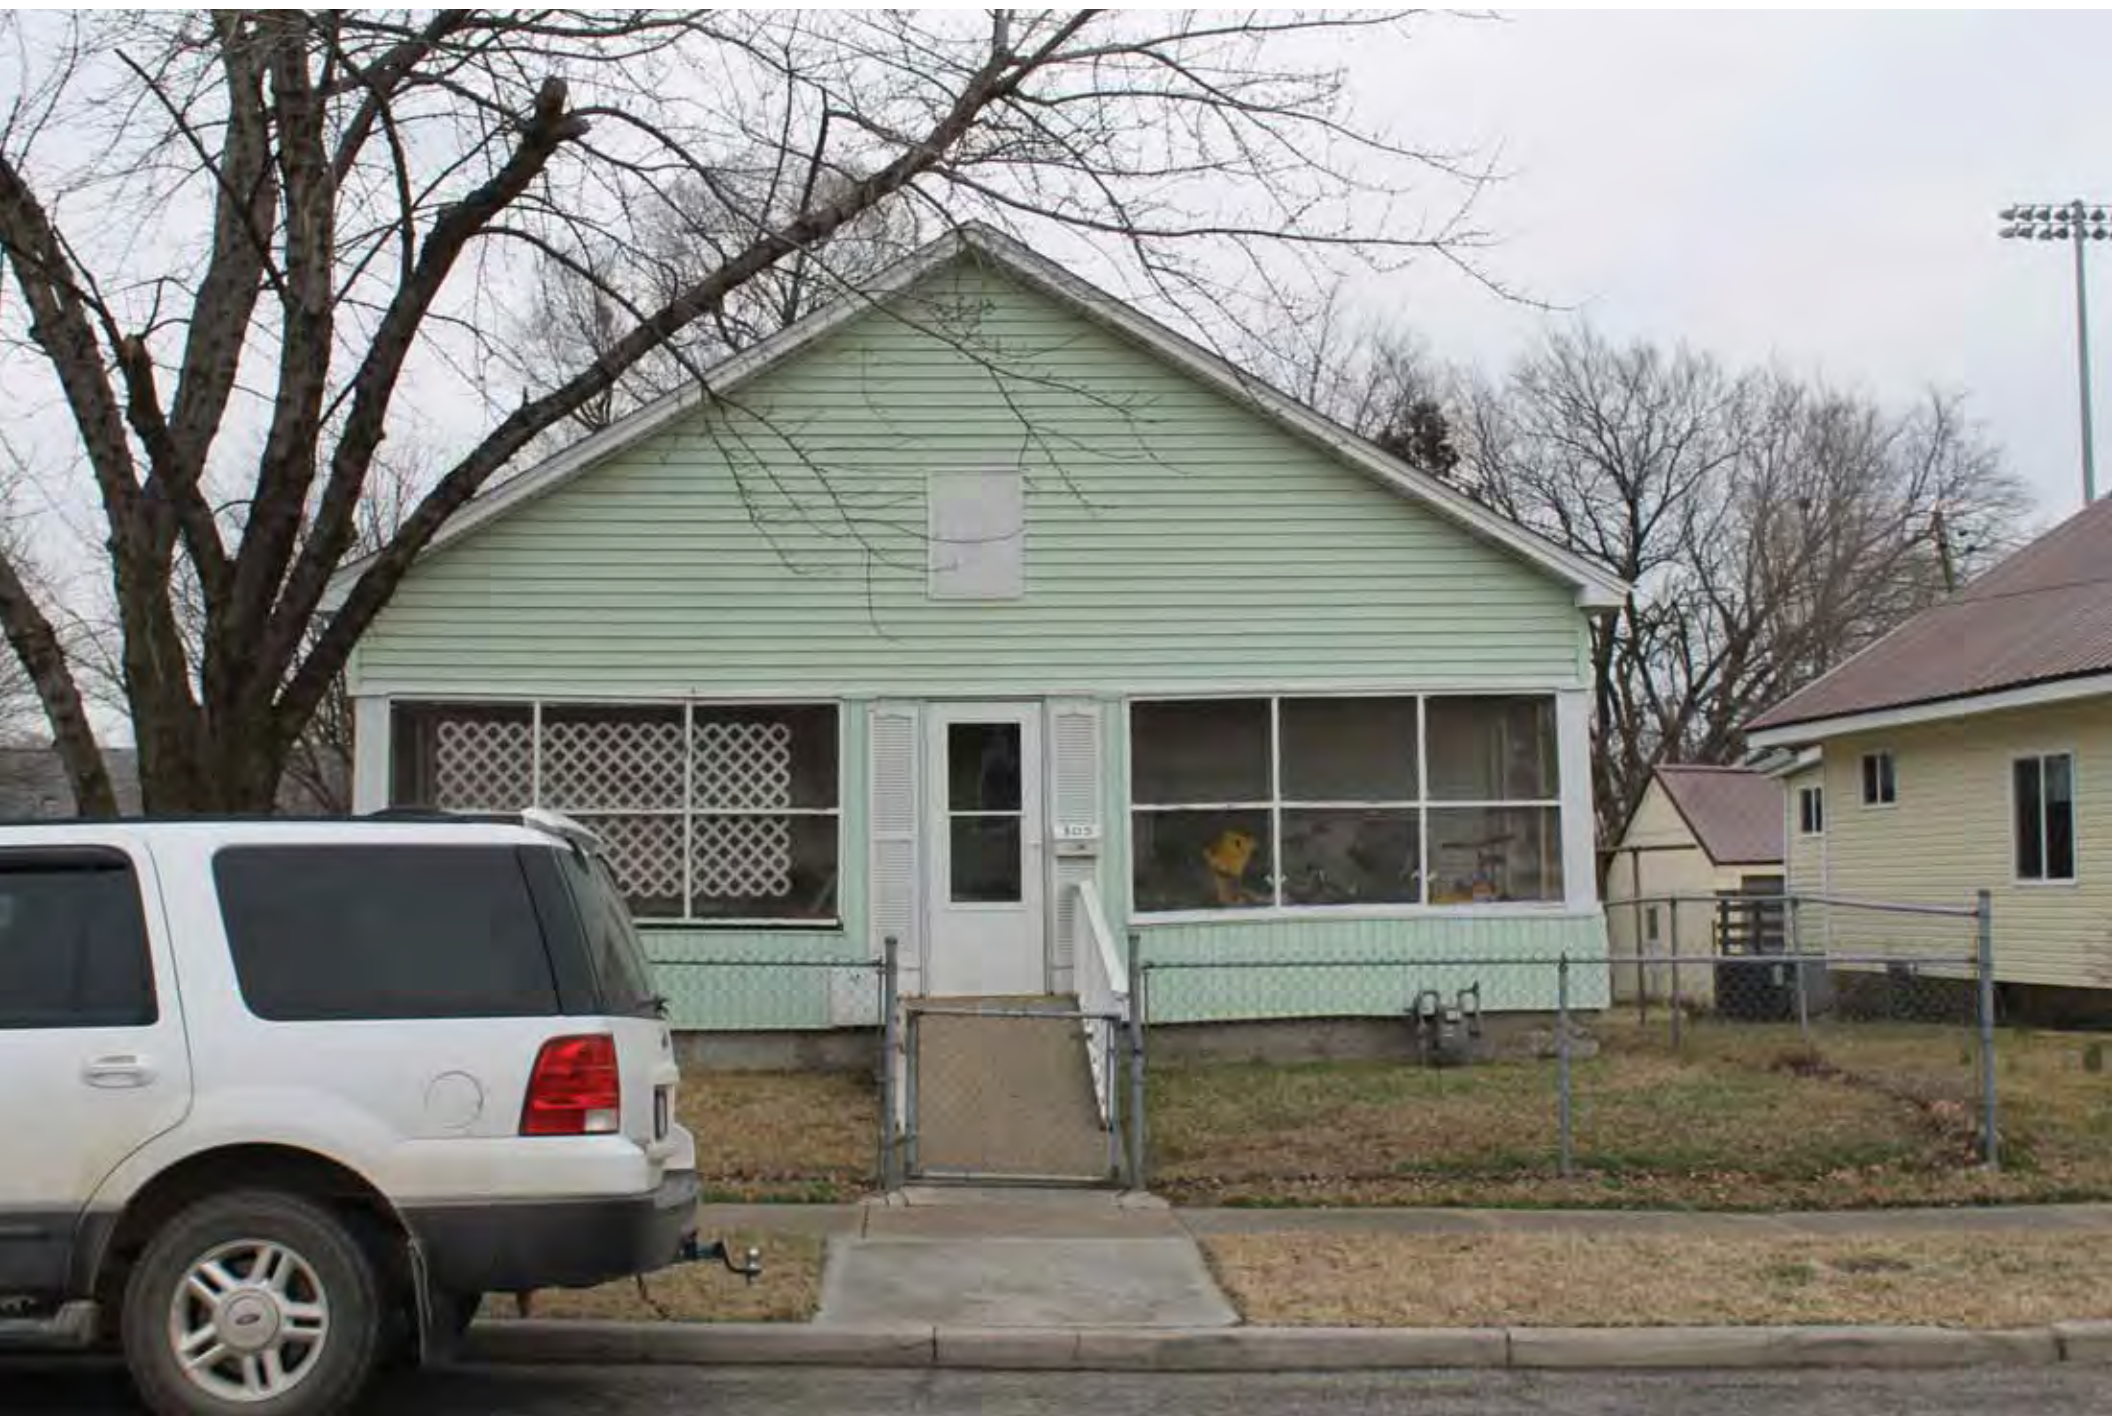
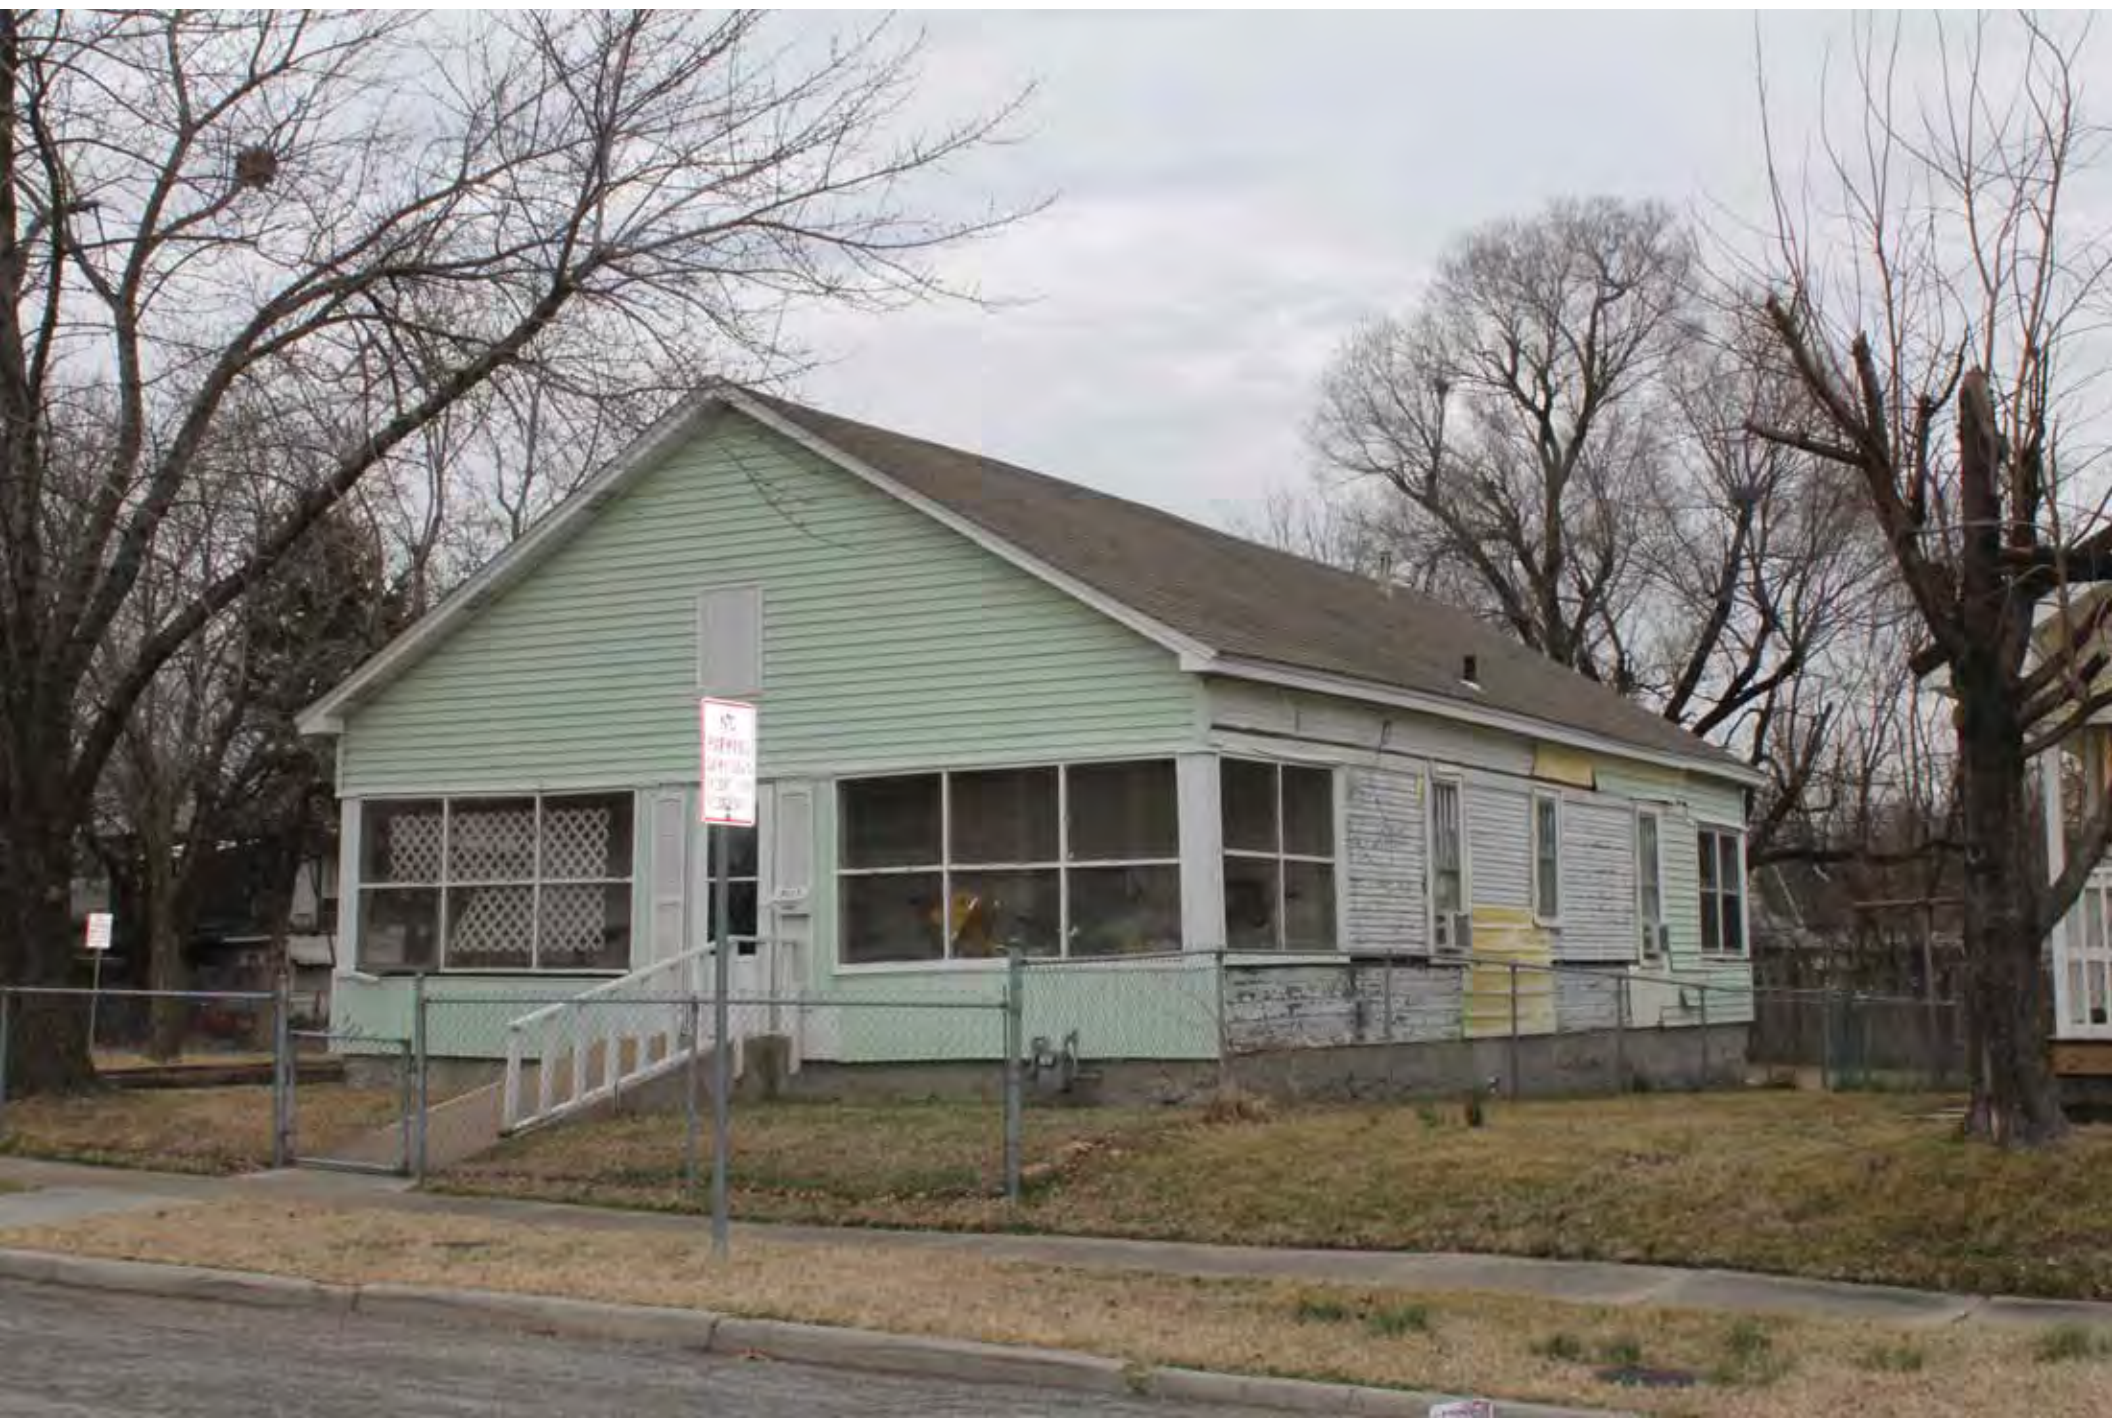
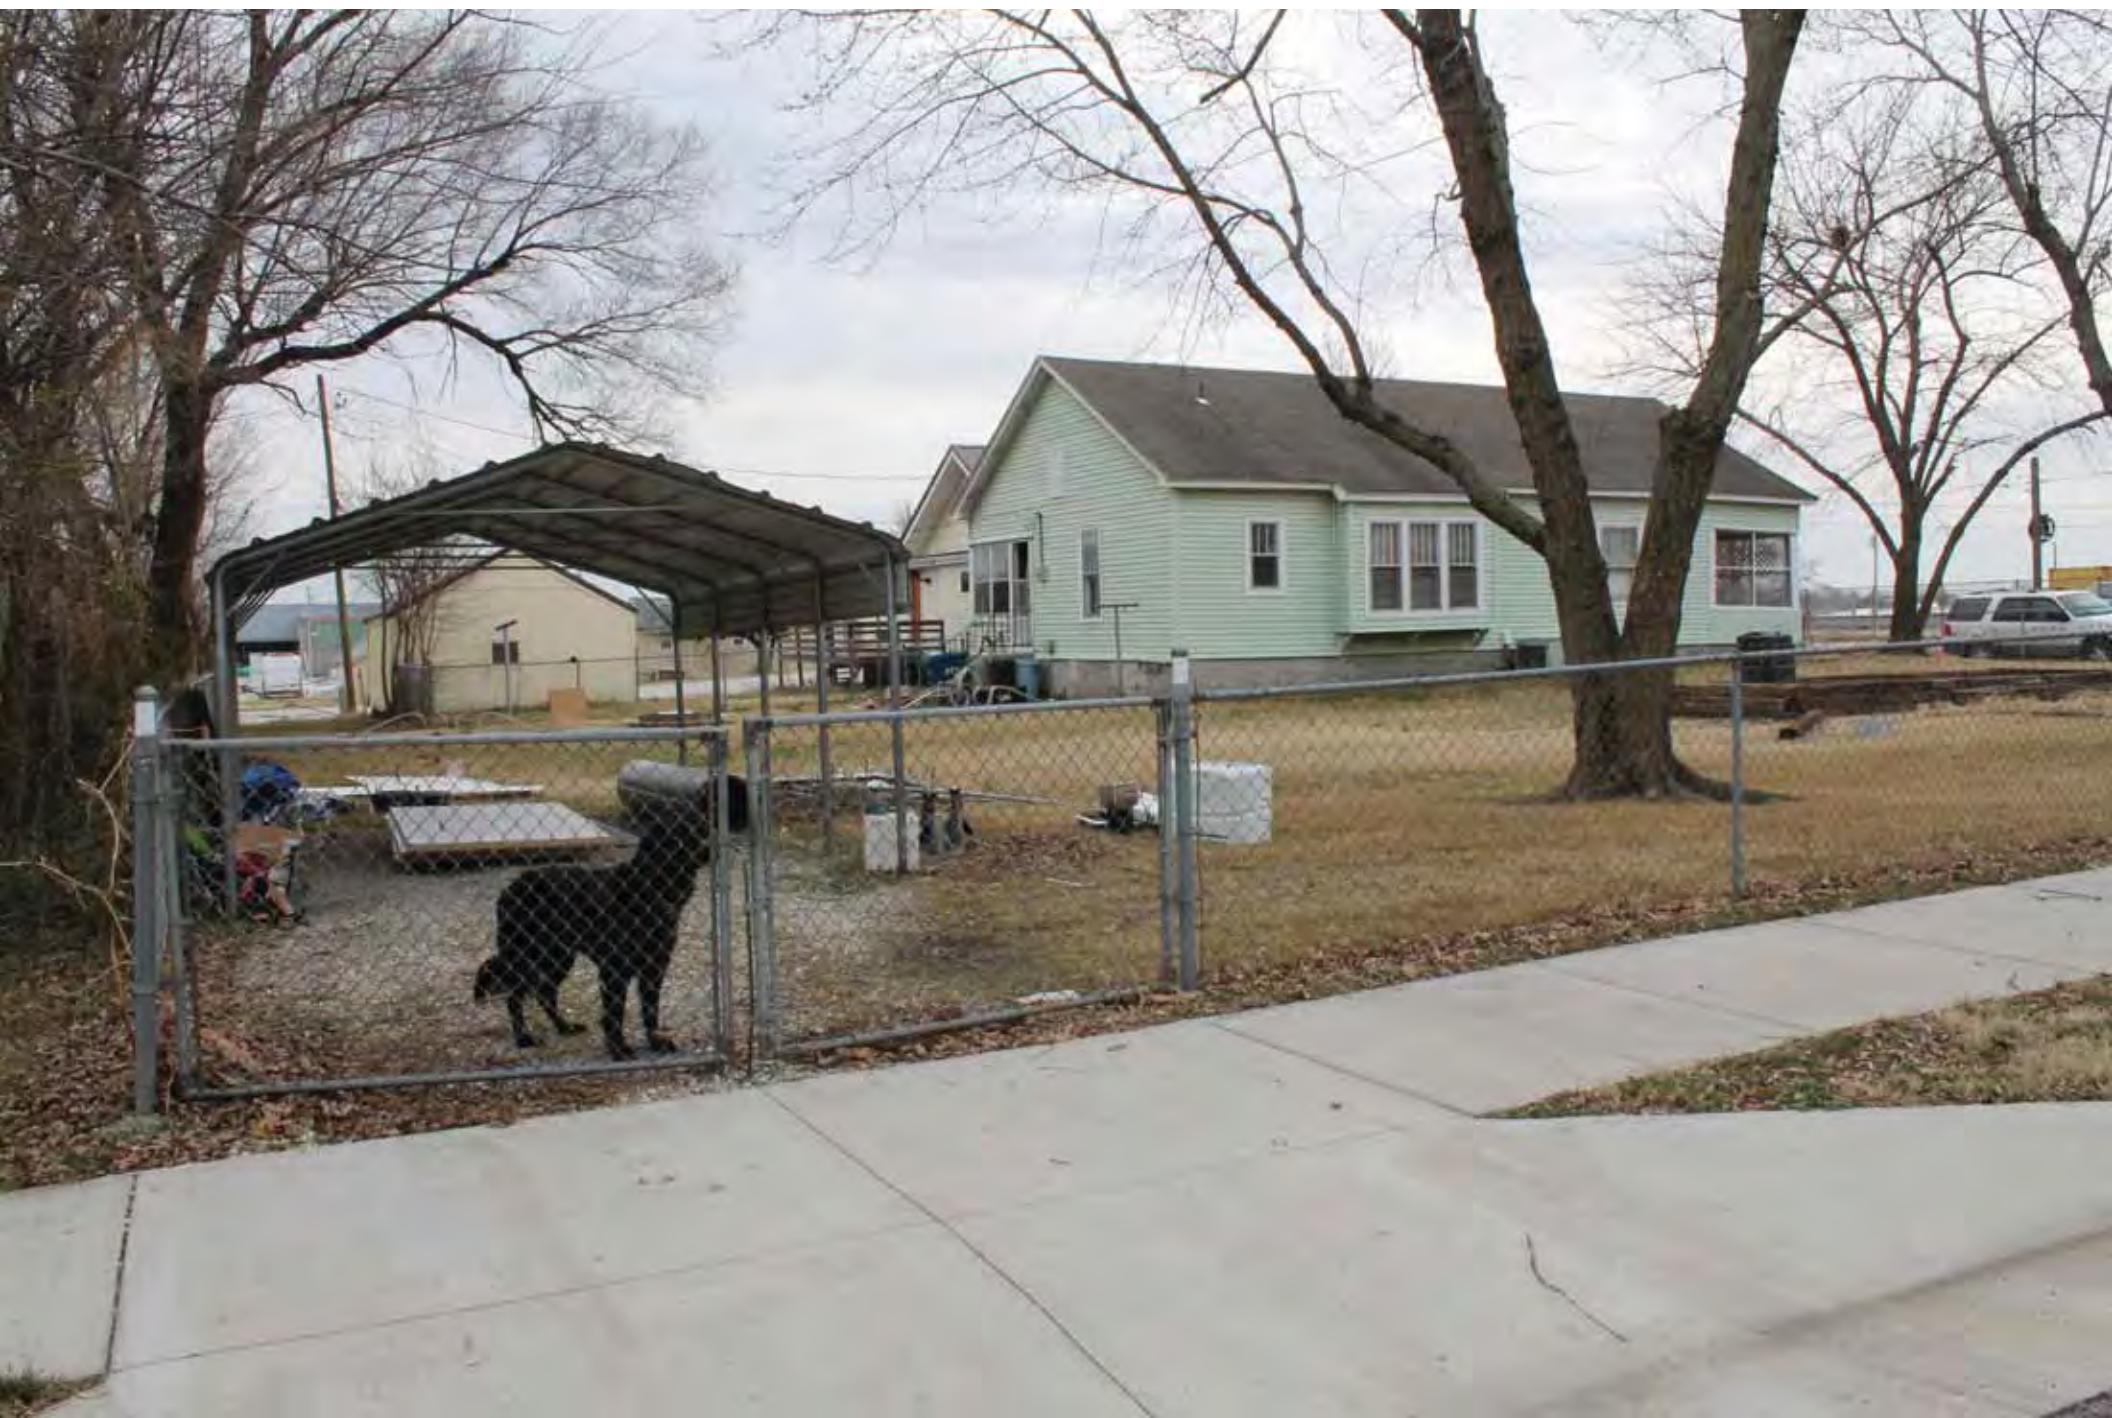
41. (cont.) Description of primary resource. Expand box as necessary, or add continuation pages. The property at 305 S. Michigan Avenue features a single-story altered dwelling with an asphalt-shingled gable roof, exterior vinyl siding on three elevations (east, north, west) and weatherboard siding (south elevation only). The primary (west) elevation supports an enclosed full gabled porch. The upper half of the porch walls are composed of continuous window screens that wrap the elevation on the north and south. The primary entry is within the porch bay and retains an original Craftsman style door. Original windows are visible on all elevations – these are composed of three-over-one lights. The south elevation's west end supports paired replacement one-over-one windows. The north elevation holds a projecting window bay with three original three-over-one windows. The rear porch is situated at the southeast corner of the dwelling. This porch appears to have always been enclosed with upper continuous windows. A secondary entry leads to the porch on the east elevation.

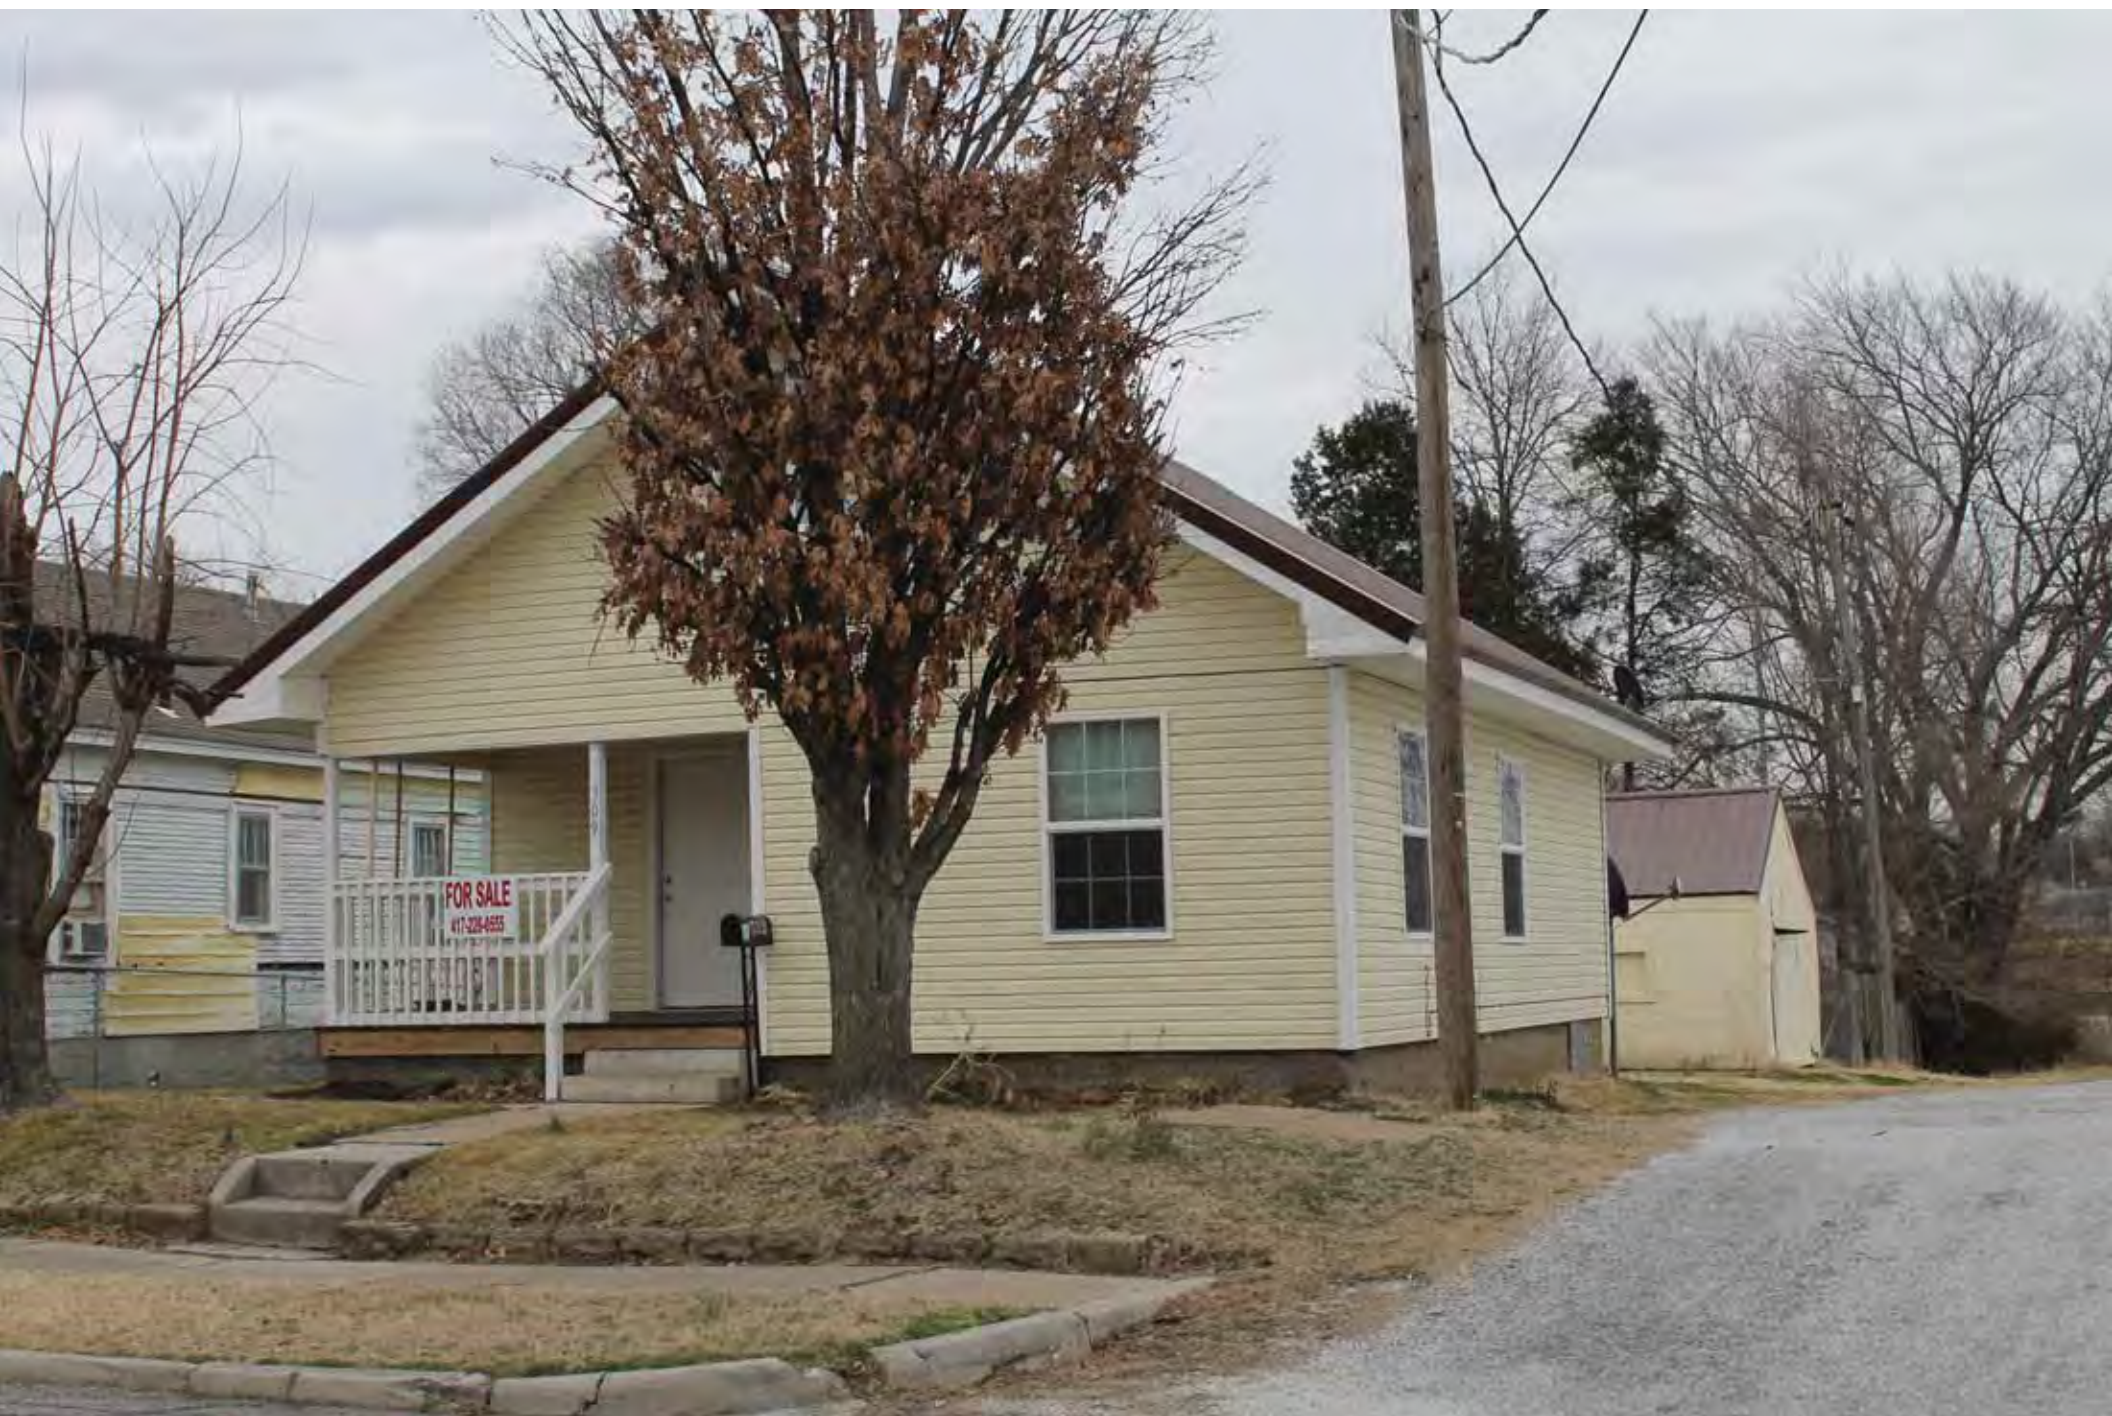
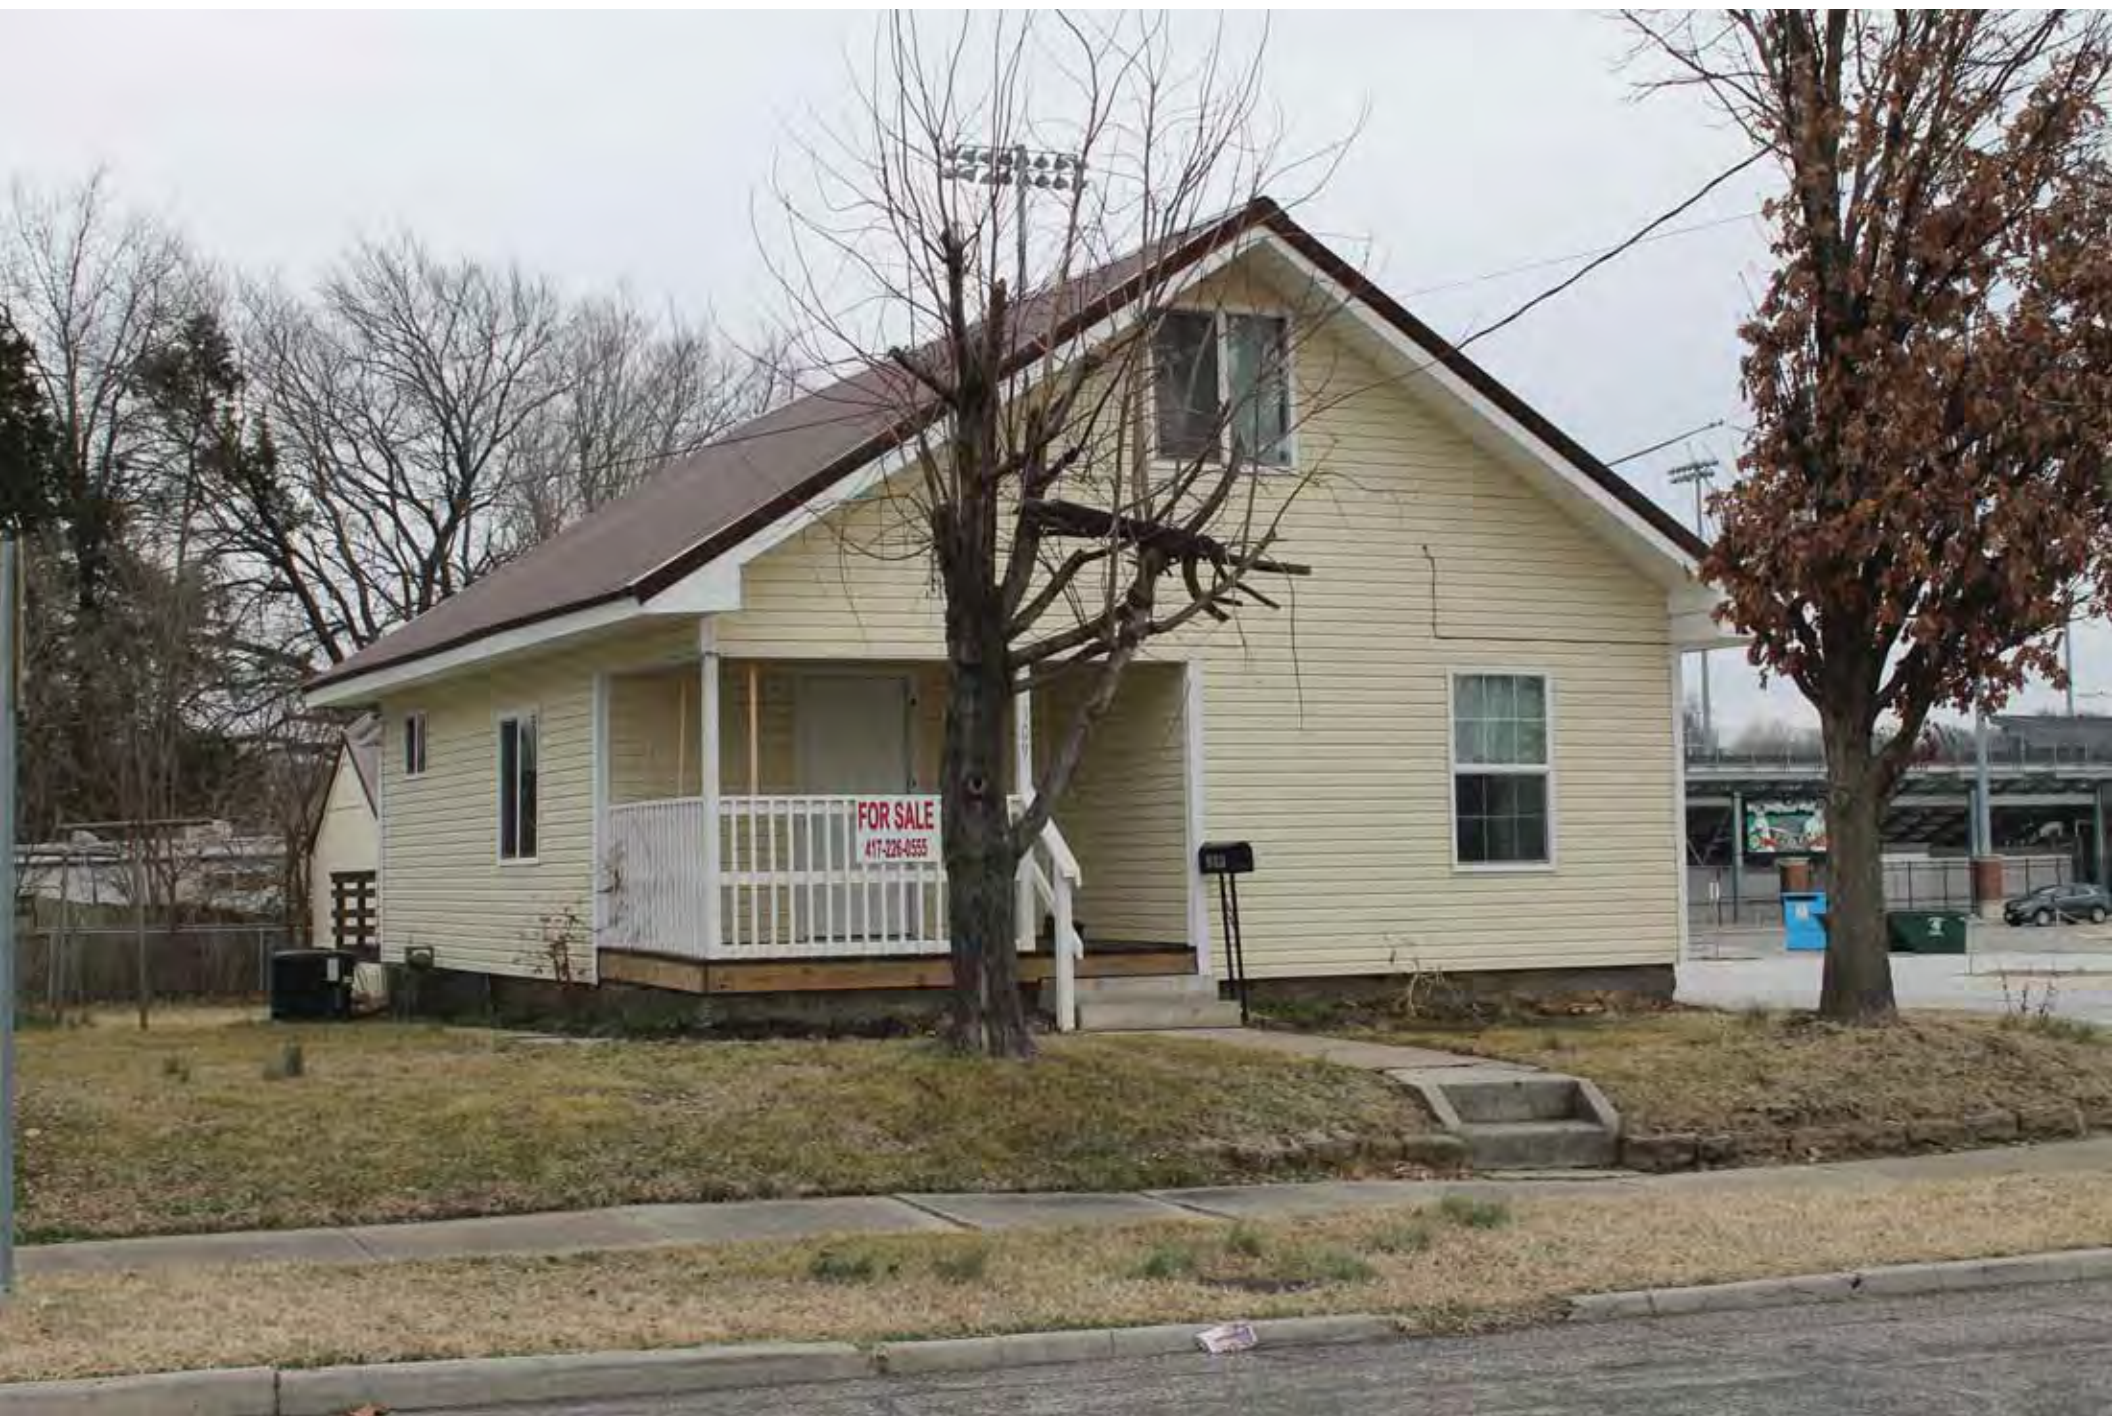
<p>40. (cont.) Description of environment and outbuildings. Expand box as necessary, or add continuation pages.</p> <p>The dwelling is situated in a mixed use neighborhood on the east side of S. Michigan Avenue. The yard features mature trees. A chain link fence surrounds the rear lot. The lot is flanked by a concrete sidewalk on the west and a vacant lot on the south. East of the dwelling is a gable-front plan frame garage. The garage is clad with vertical board siding and supports a garage bay with vertical board doors on the south elevation. The outbuilding is not individually eligible for listing on the National Register.</p>
<p>41. (cont.) Description of primary resource. Expand box as necessary, or add continuation pages.</p> <p>The property at 309 S. Michigan Avenue features an altered (formerly Craftsman influenced) Bungalow with an asphalt-shingled gable roof, exterior vinyl siding and a concrete foundation. The primary (west) elevation features a corner incised porch at the north end. Within the porch bay is a paneled contemporary door. The porch is surrounded by a contemporary balustrade. A single six-over-six replacement window is situated on the projecting front gabled wing south of the porch. The upper gable field holds a contemporary two-light sliding window. The north elevation features two windows – also two-light sliding design of which one is small. The south elevation holds two six-over-six windows. The rear (east) elevation has a frame deck and enclosed rear shed porch.</p>
