MISSOURI DEPARTMENT OF NATURAL RESOURCES
STATE HISTORIC PRESERVATION OFFICE, P.O. Box 176, Jefferson City, MO 65102
ARCHITECTURAL/HISTORIC INVENTORY FORM

1. Survey No. JP-AS-007-001		2. Survey name: East Town (Original Joplin) Historic Survey Phase 2	
3. County: JASPER		4. Address (Street No.) 618	Street (name) E. 2 nd Street
5. City: Joplin	Vicinity: <input type="checkbox"/>	6. Geographical Reference:	7. Township/Range/Section: T: R: S:
8. Historic name (if known):		9. Present/other name (if known):	
10. Ownership: <input checked="" type="checkbox"/> Private <input type="checkbox"/> Public		11a. Historic use (if known): Domestic: Single Dwelling	11b. Current use: Domestic: Single Dwelling

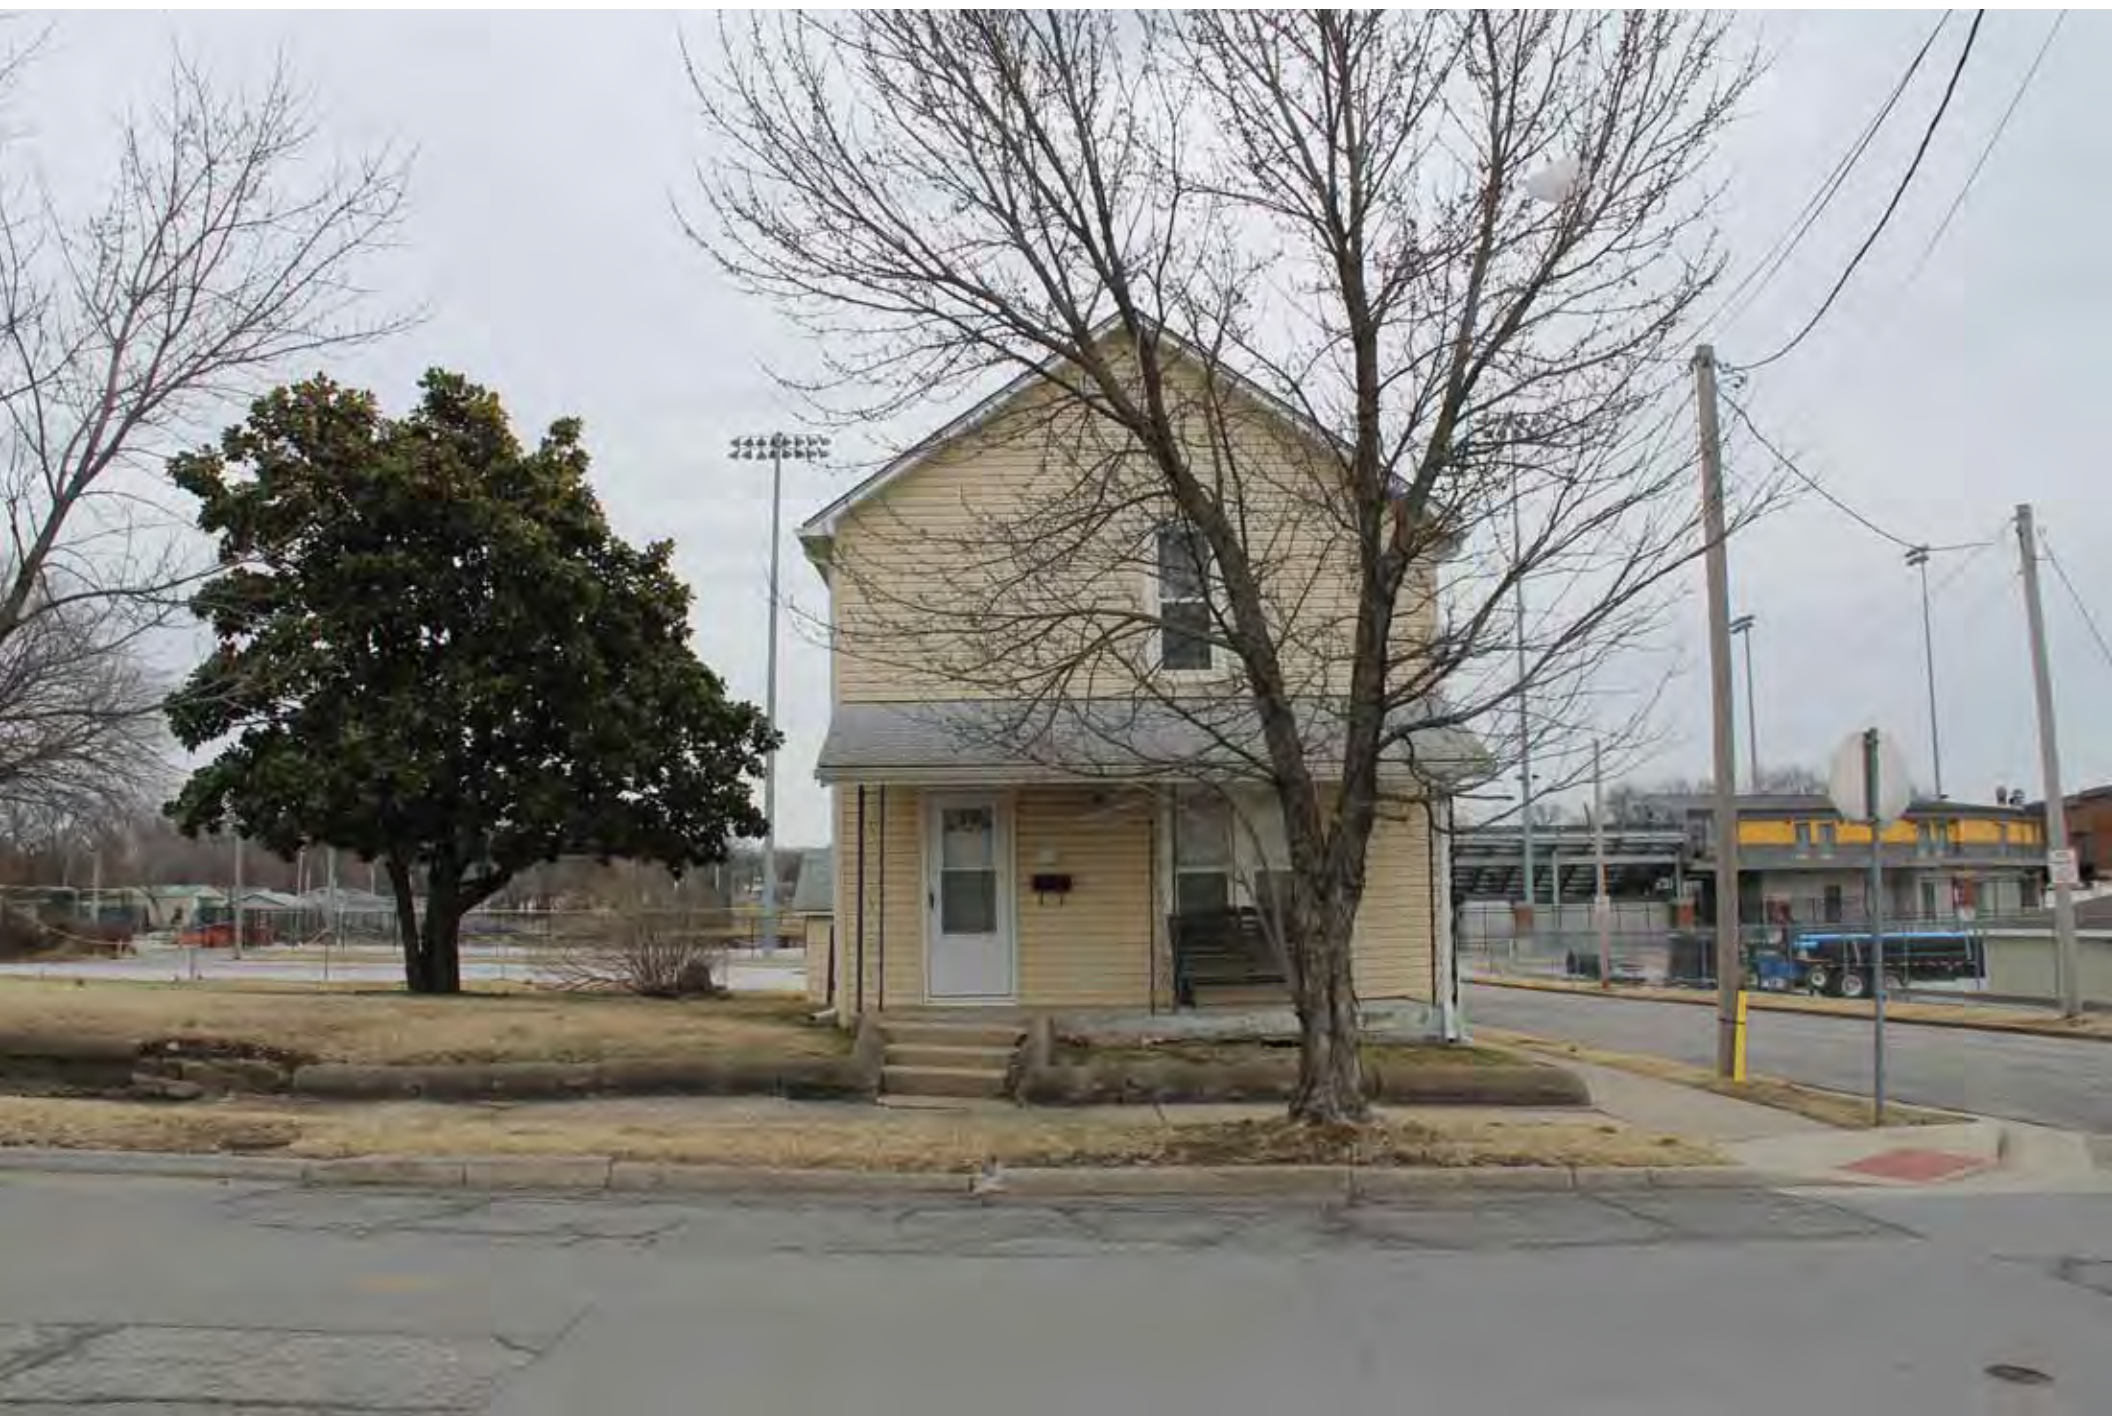
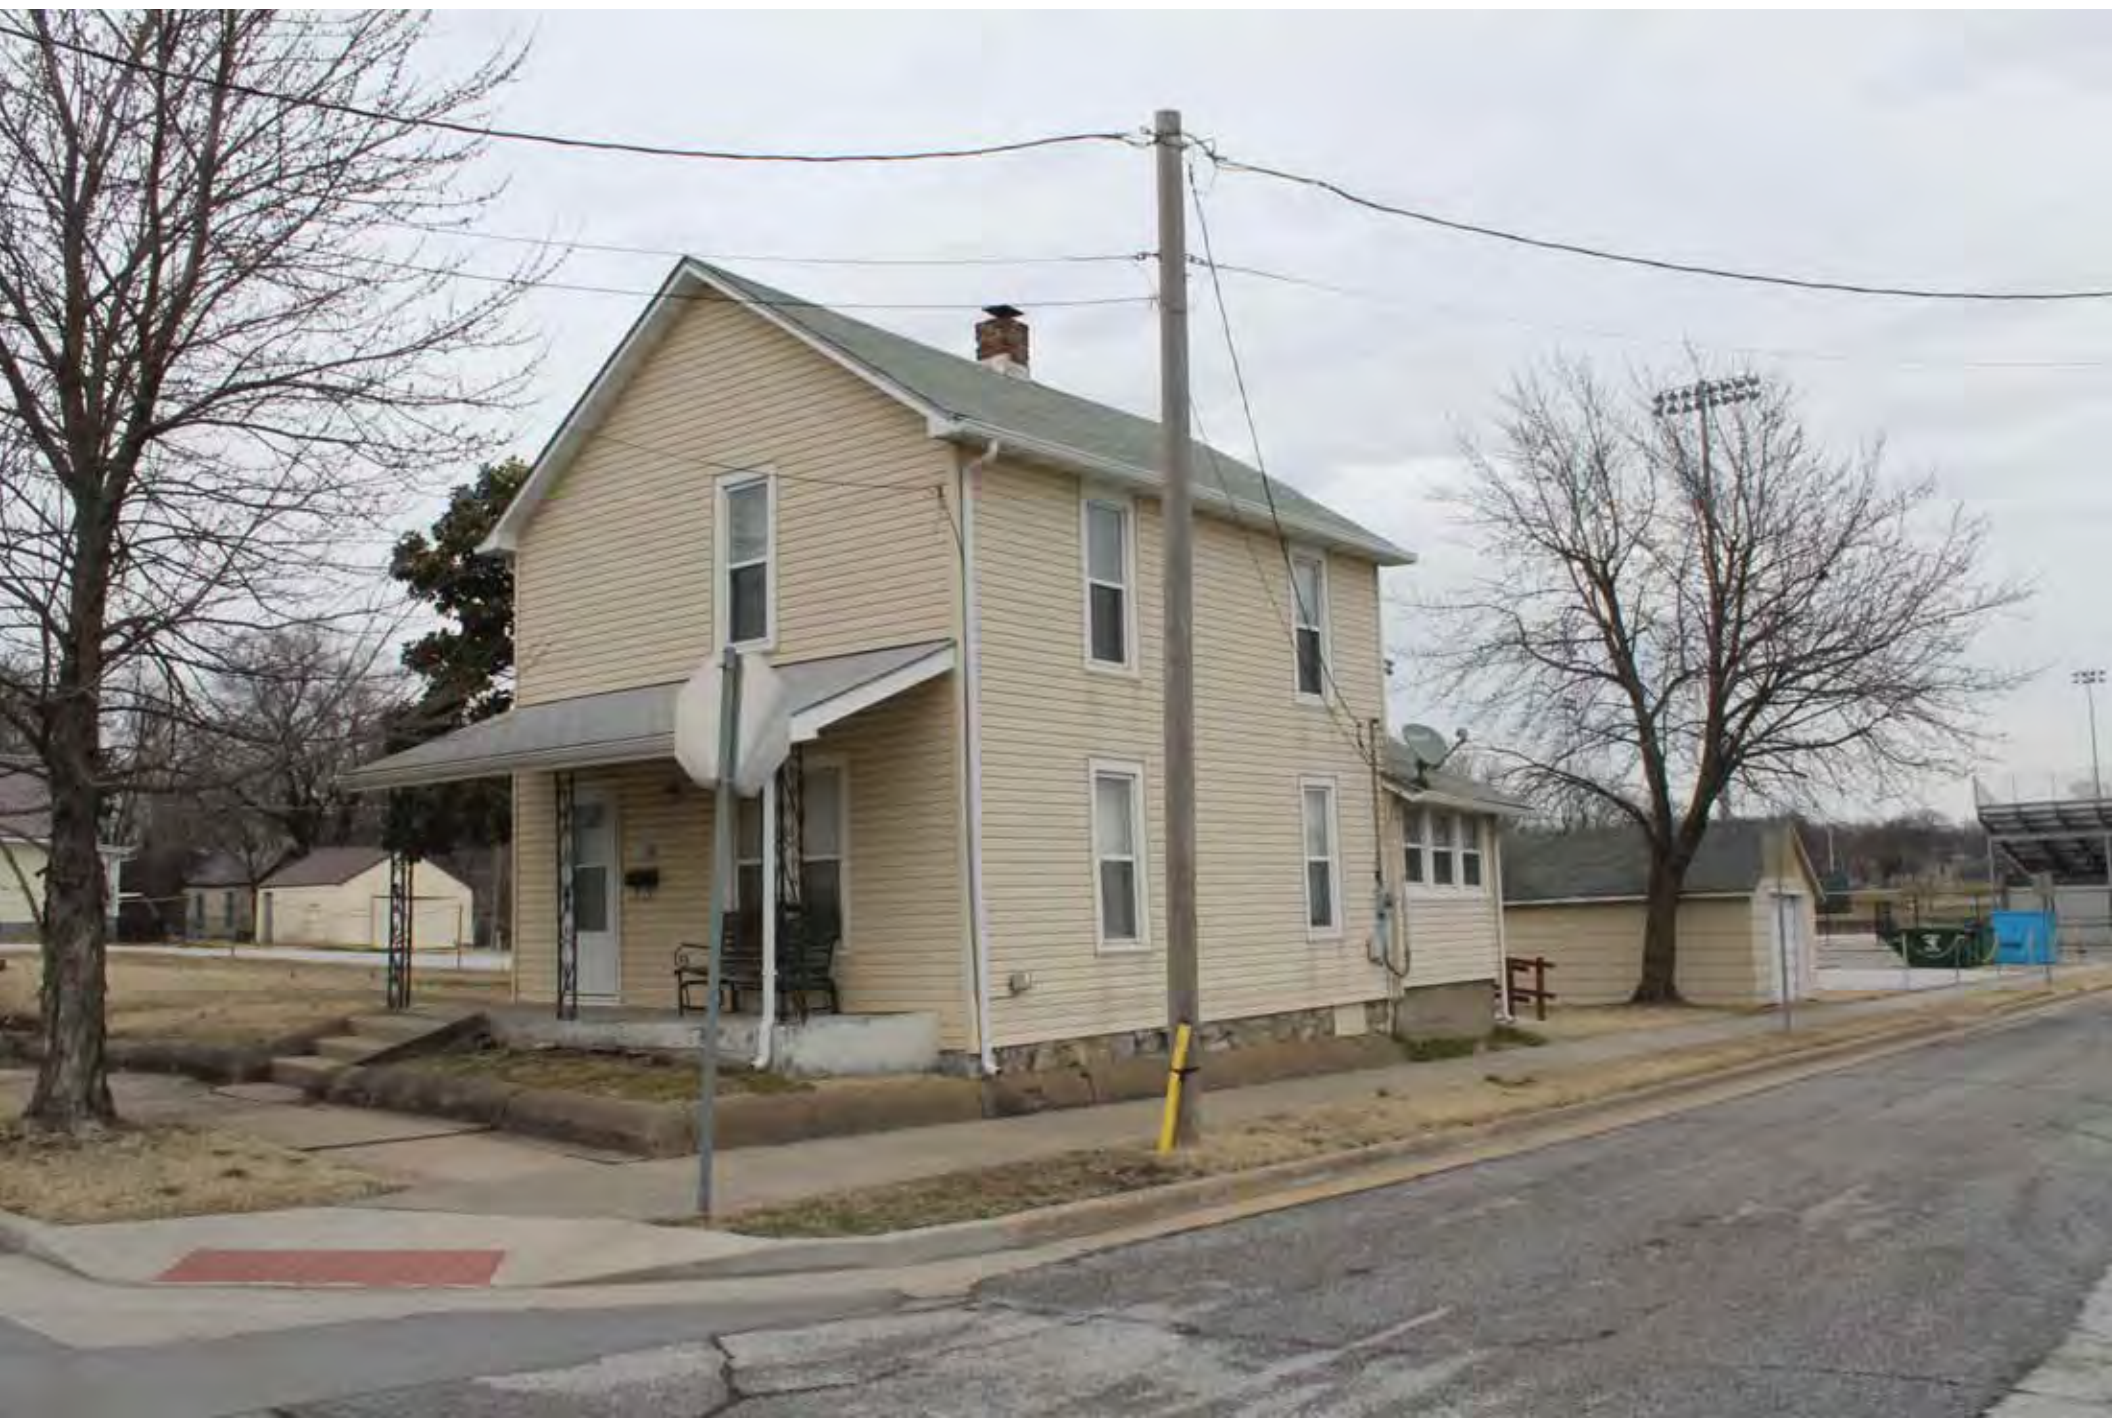
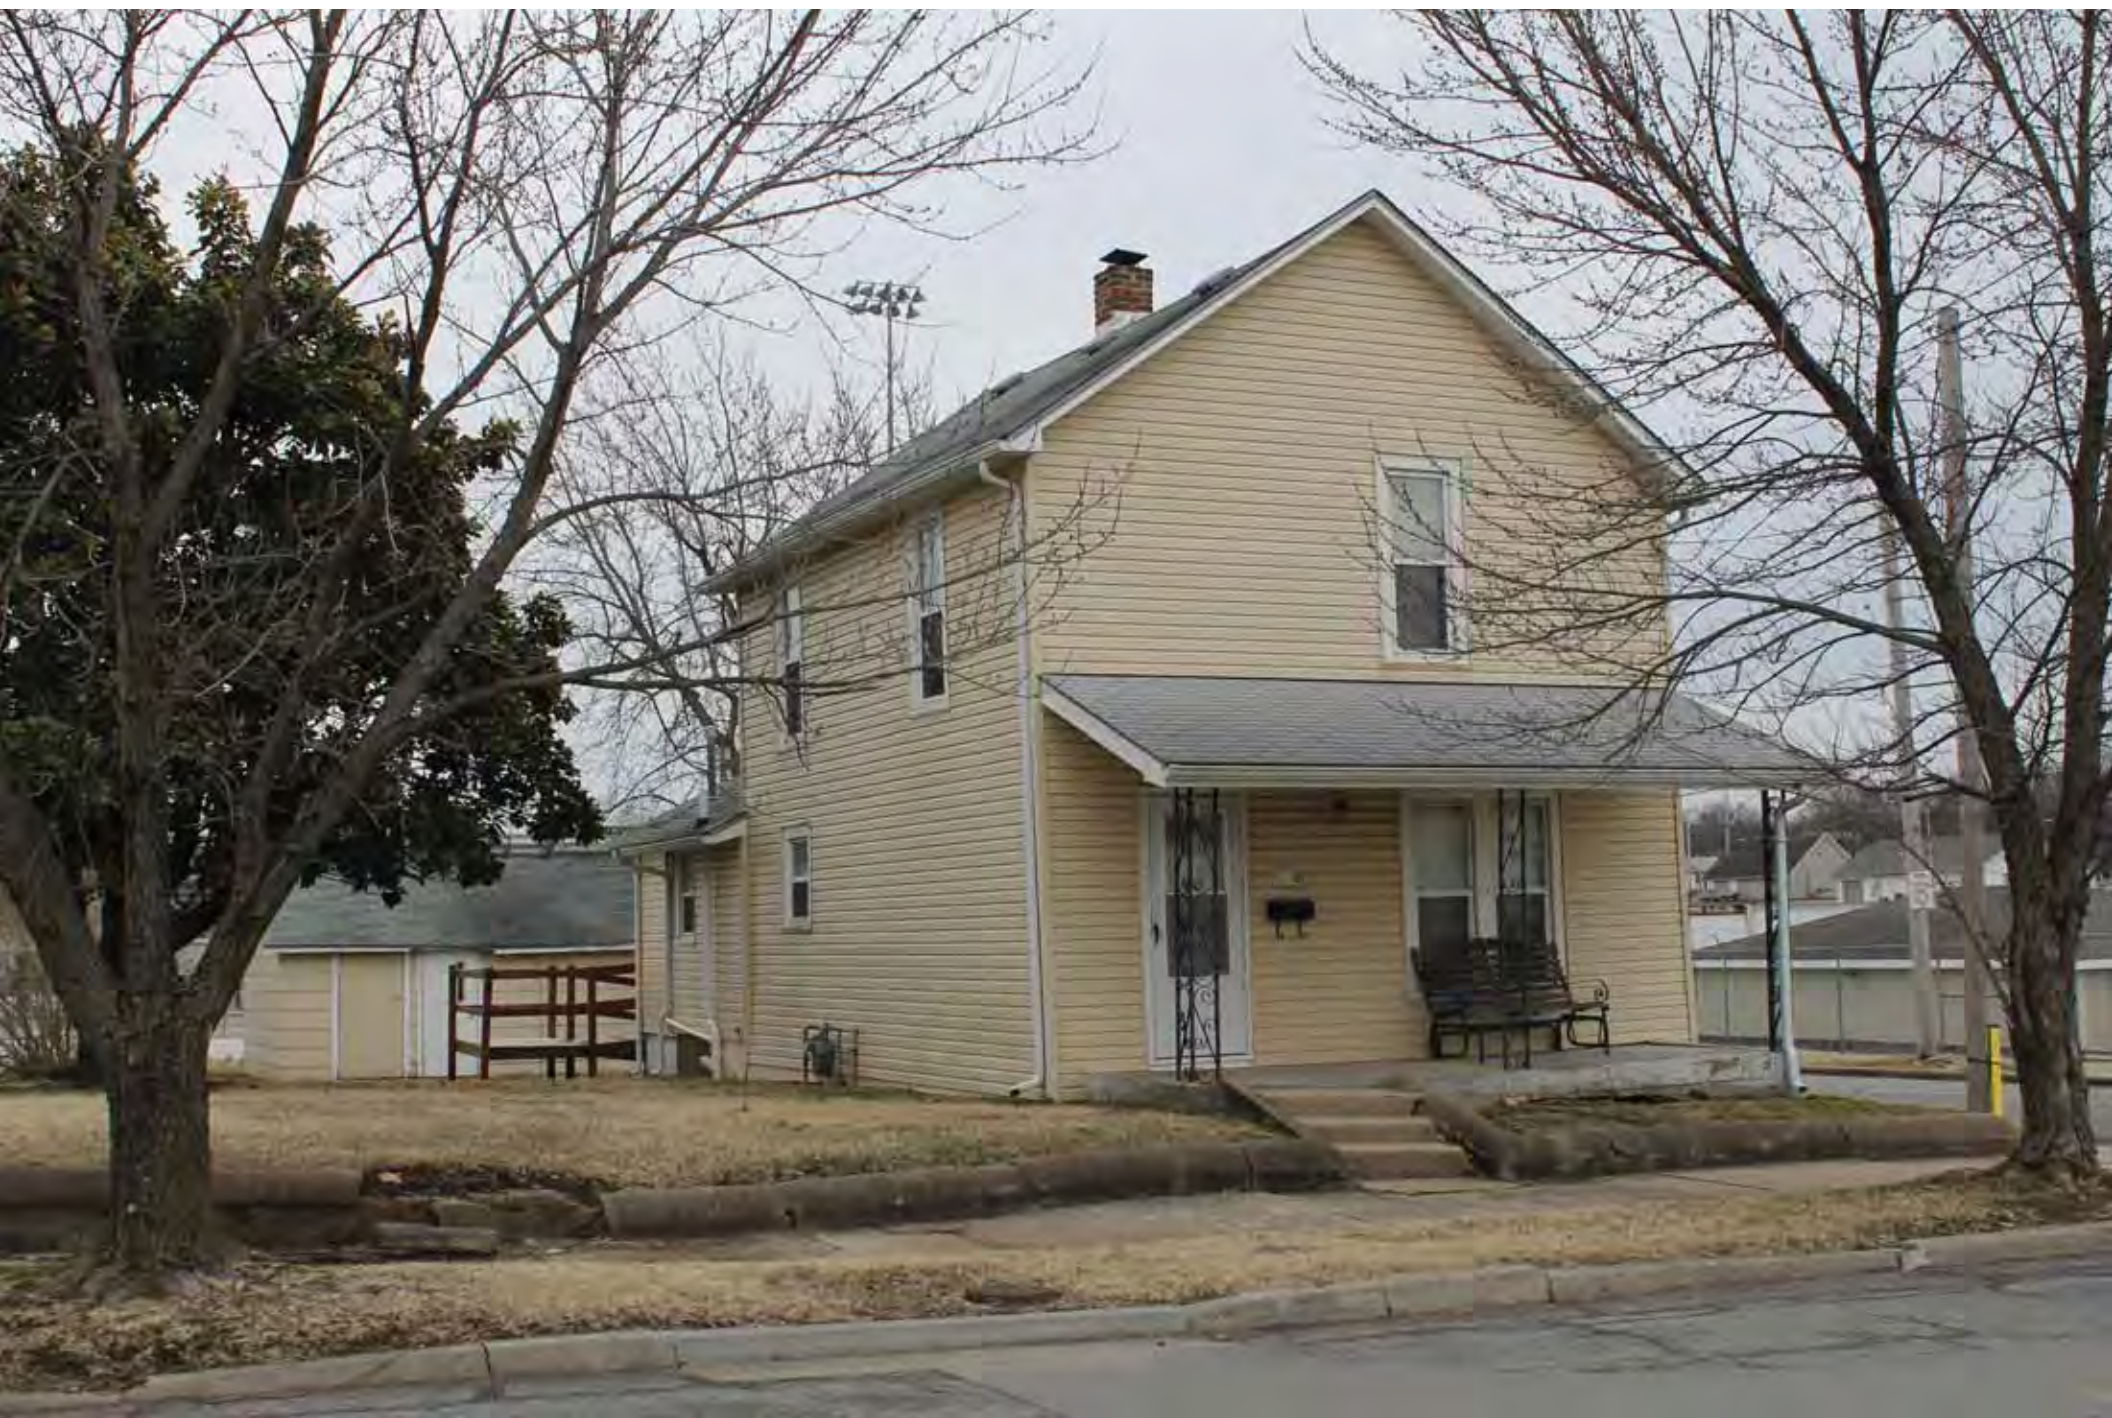
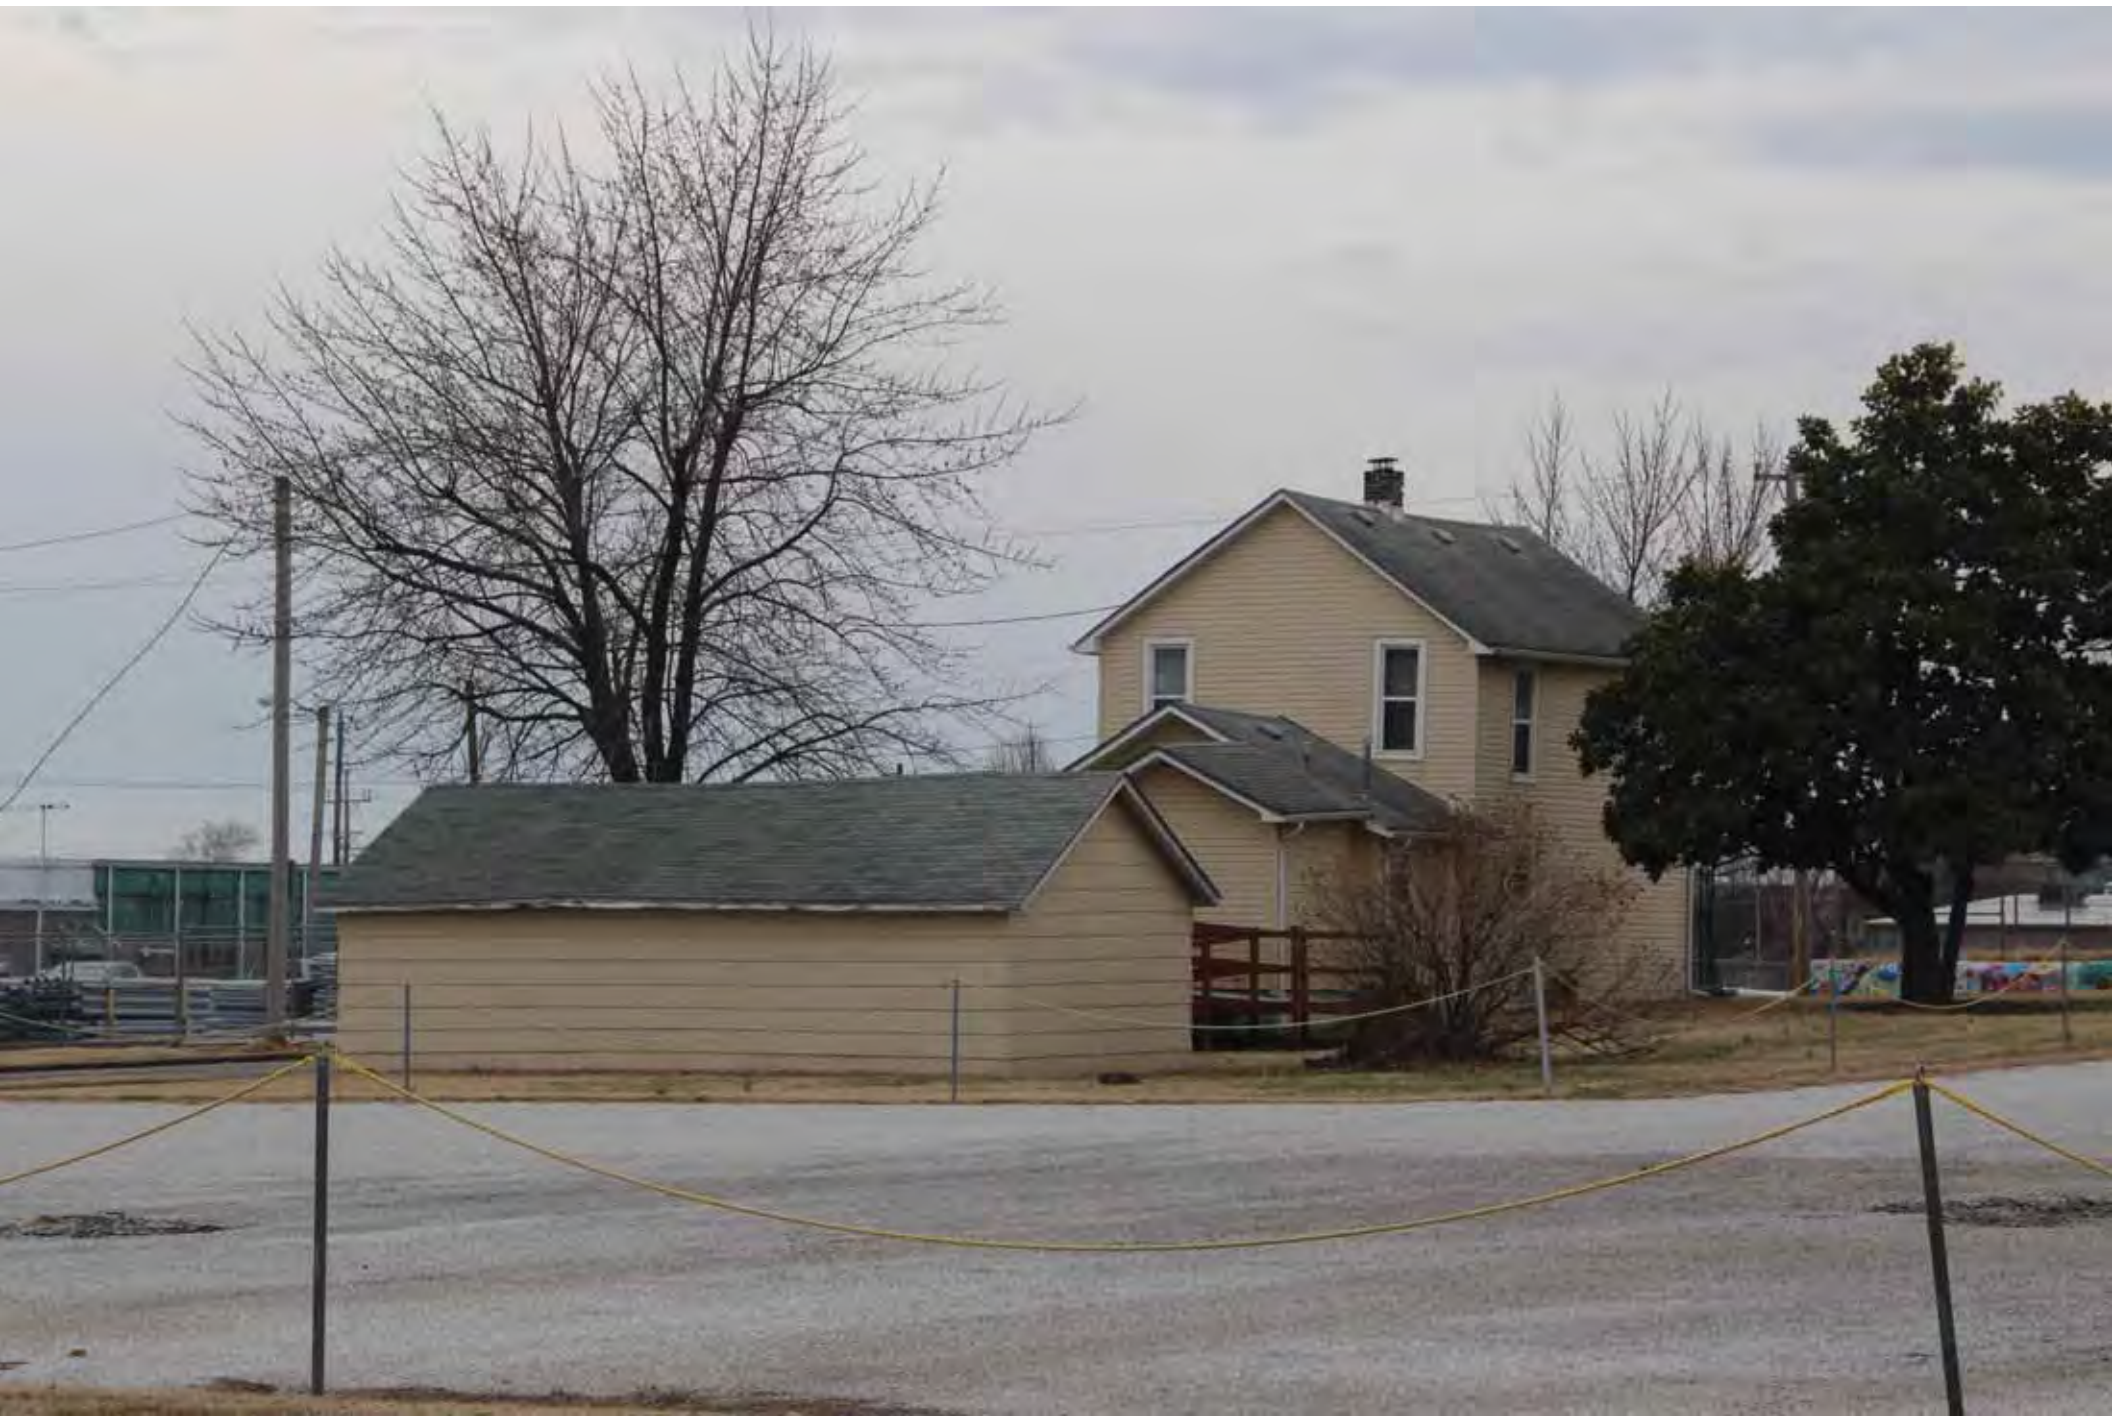
<p>40. (cont.) Description of environment and outbuildings. Expand box as necessary, or add continuation pages.</p> <p>The dwelling is situated in a mixed use neighborhood on the east side of S. Michigan Avenue. The yard features mature trees. The lot is flanked by concrete sidewalks on the west (S. Michigan Avenue) and south (Jasper Street). East of the dwelling is a gable-front plan frame garage that faces Jasper Street. The garage is clad with wide board siding and supports a garage bay (south elevation) with an overhead track door. The garage holds a secondary entry bay on the east elevation. The outbuilding is not individually eligible for listing on the National Register.</p>
<p>41. (cont.) Description of primary resource. Expand box as necessary, or add continuation pages.</p> <p>The property at 319 S. Michigan Avenue features an altered two-story dwelling with an asphalt shingled gable roof, exterior vinyl siding and a stone foundation. The primary (west) elevation holds a single-story shed porch supported by wrought iron columns. Within the porch bay is an off-center entry with an upper fanlight door. The door is offset to the south by paired one-over-one windows. All windows appear to be replacement. The upper façade elevation holds an off-center one-over-one window. The south two-story elevation holds symmetrically placed windows – two on each floor. At the east end of the elevation is a rear single-story gabled wing. The south wall of the rear wing has a continuous band of three small one-over-one windows. The two-story north elevation holds two windows on the upper floor and a small single window on the first floor. The rear one-story wing's south elevation holds a single double-hung window. The rear wing's east elevation supports a frame deck.</p>
