MISSOURI DEPARTMENT OF NATURAL RESOURCES
STATE HISTORIC PRESERVATION OFFICE, P.O. Box 176, Jefferson City, MO 65102
ARCHITECTURAL/HISTORIC INVENTORY FORM

1. Survey No. JP-AS-007-001		2. Survey name: East Town (Original Joplin) Historic Survey Phase 2	
3. County: JASPER		4. Address (Street No.) 618	Street (name) E. 2 nd Street
5. City: Joplin	Vicinity: <input type="checkbox"/>	6. Geographical Reference:	7. Township/Range/Section: T: R: S:
8. Historic name (if known):		9. Present/other name (if known):	
10. Ownership: <input checked="" type="checkbox"/> Private <input type="checkbox"/> Public		11a. Historic use (if known): Domestic: Single Dwelling	11b. Current use: Domestic: Single Dwelling

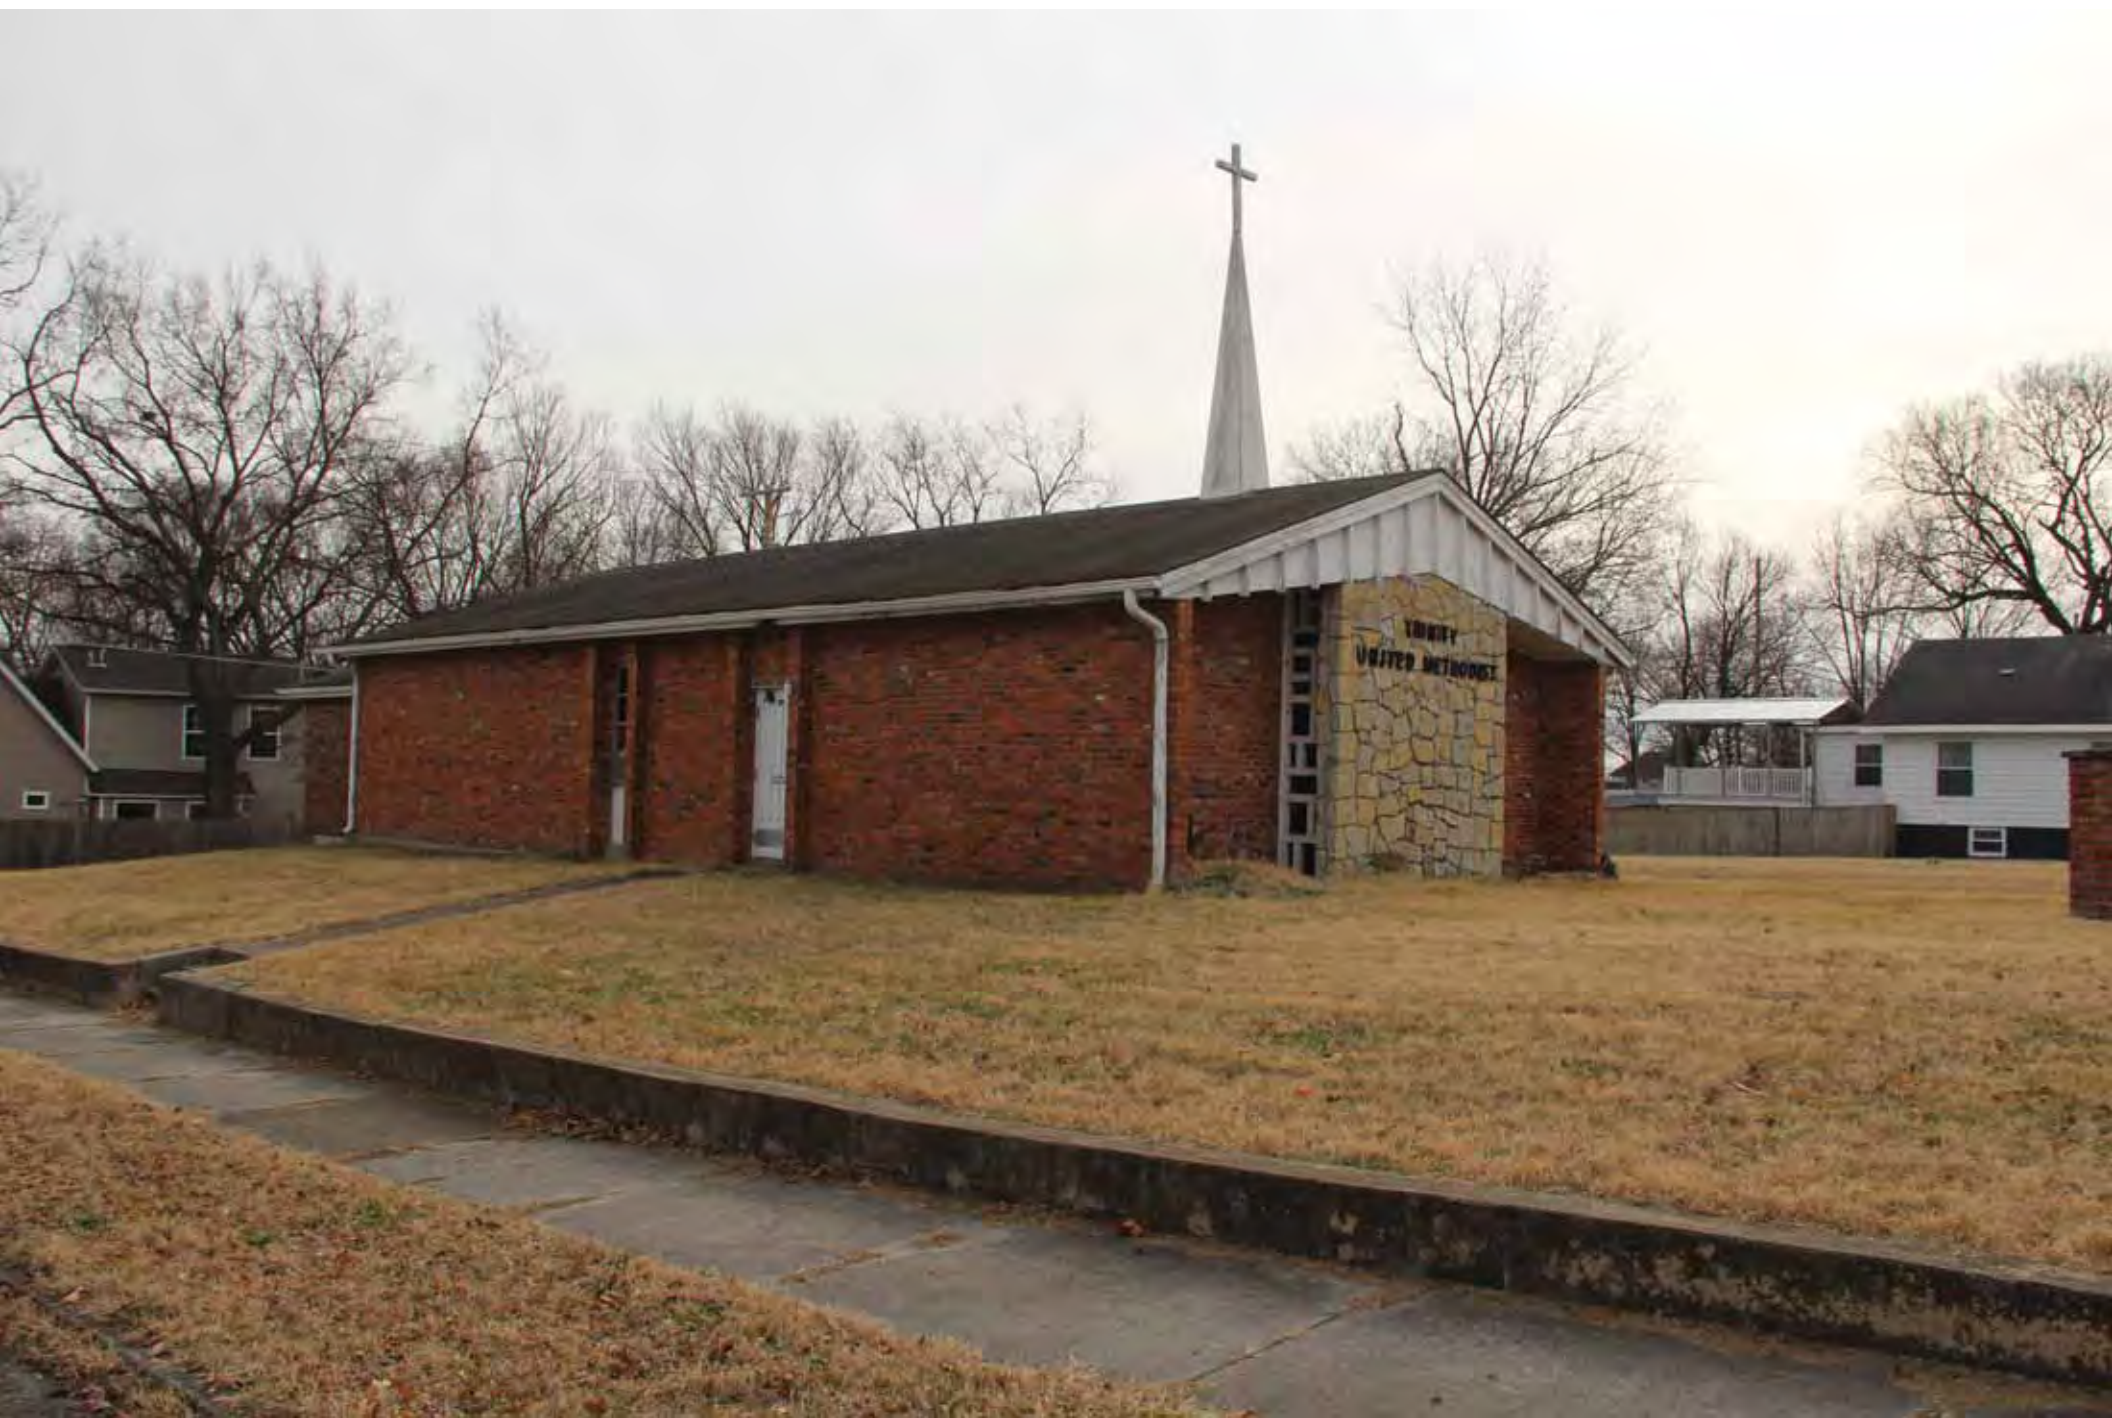
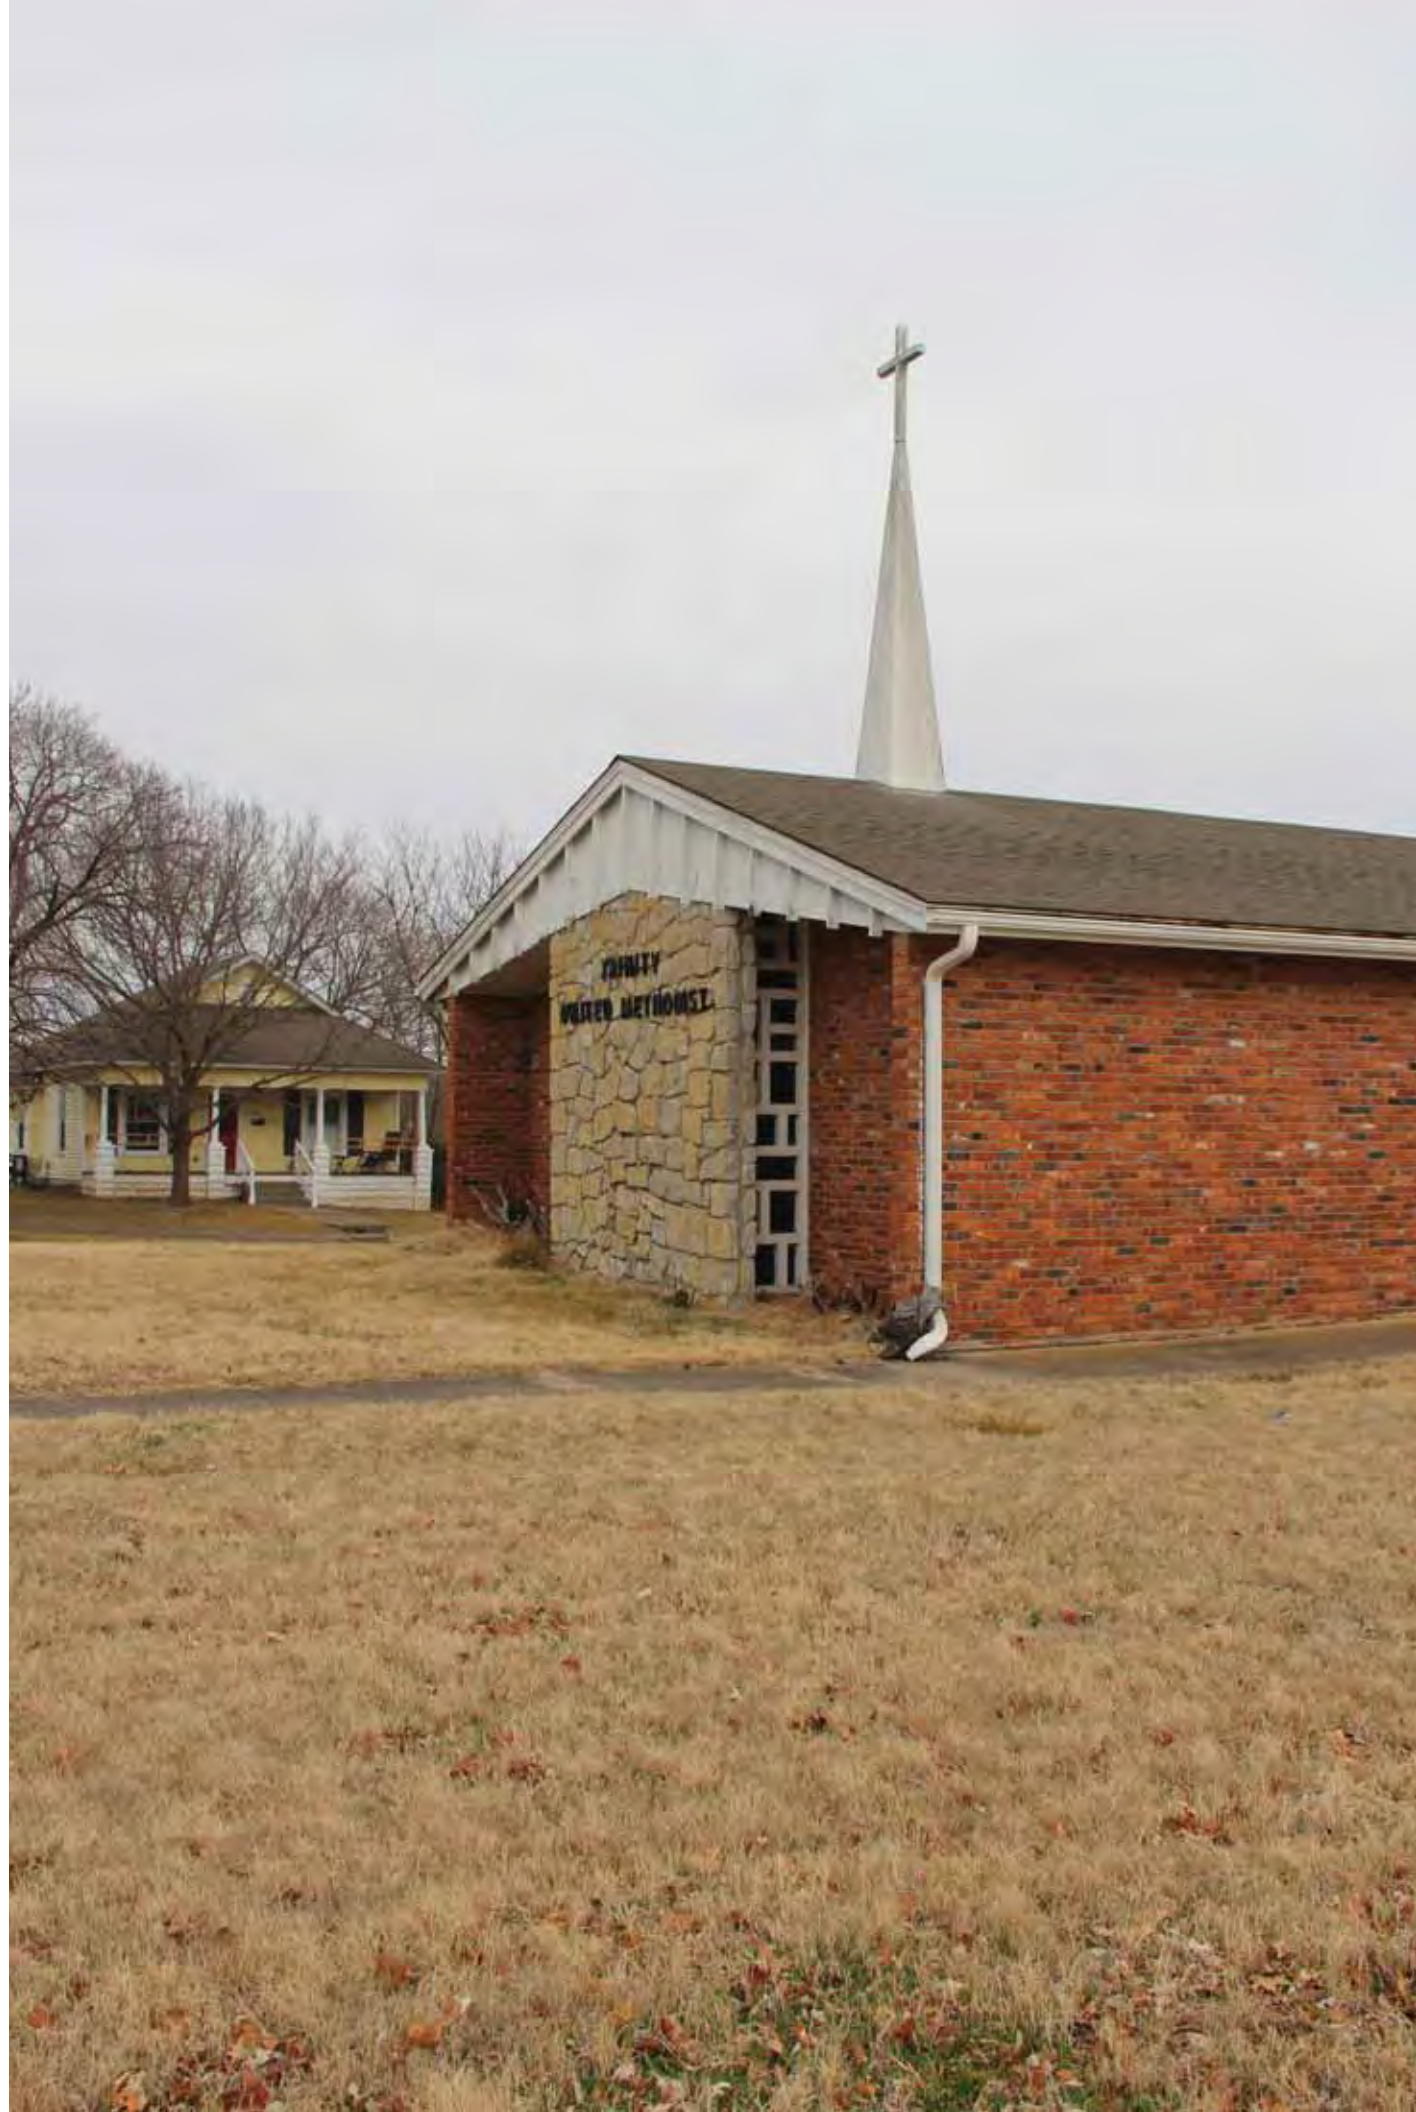
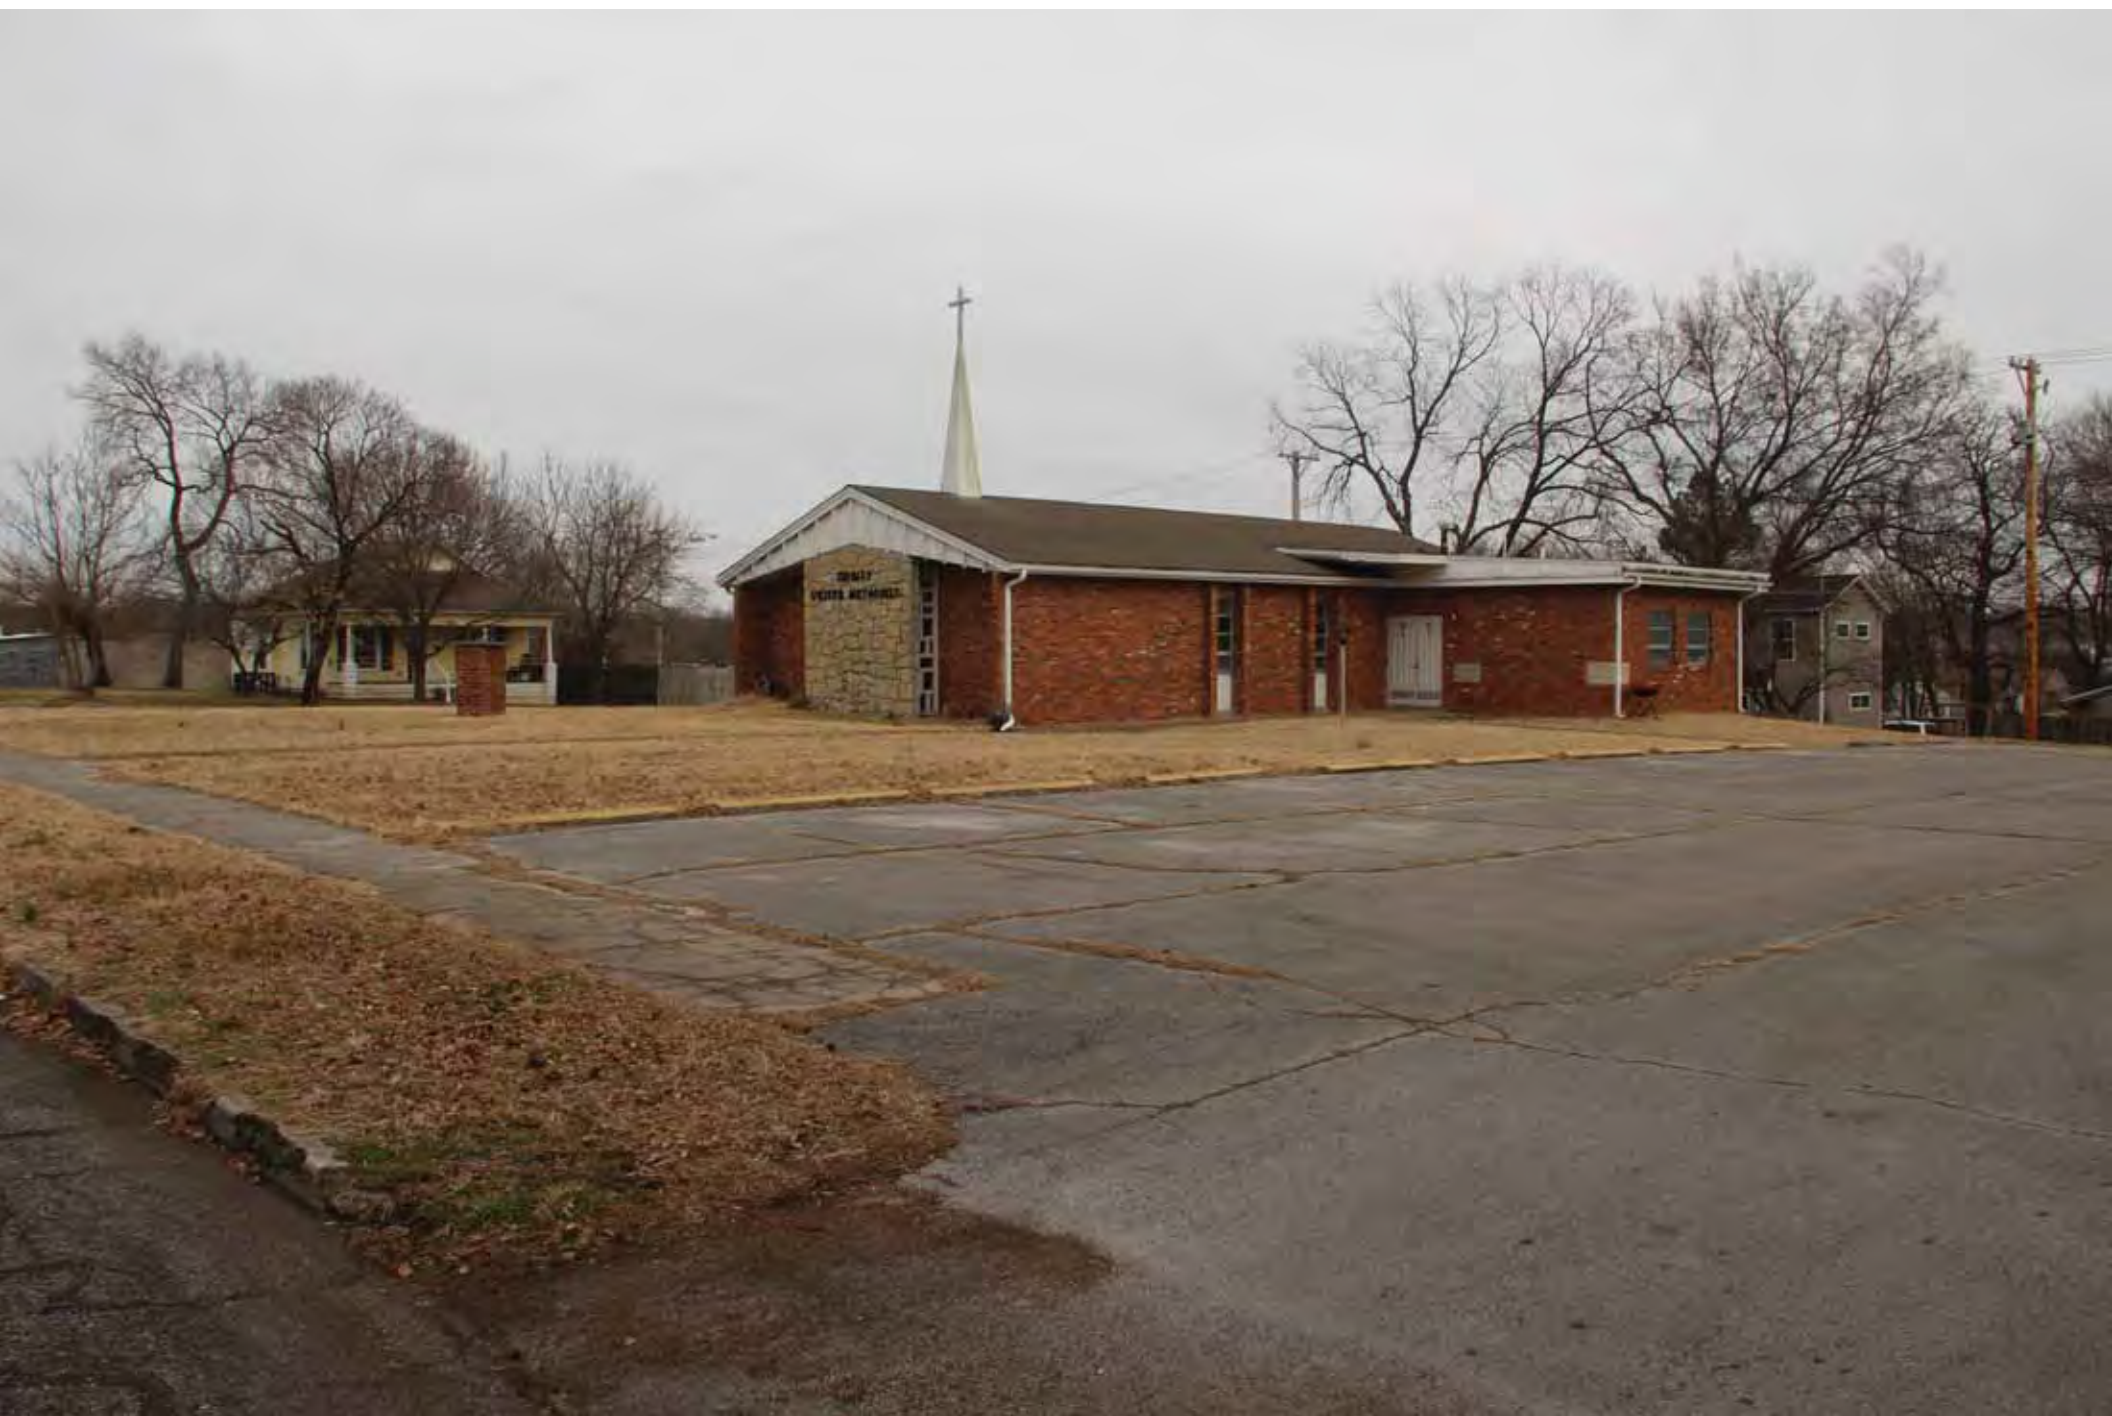
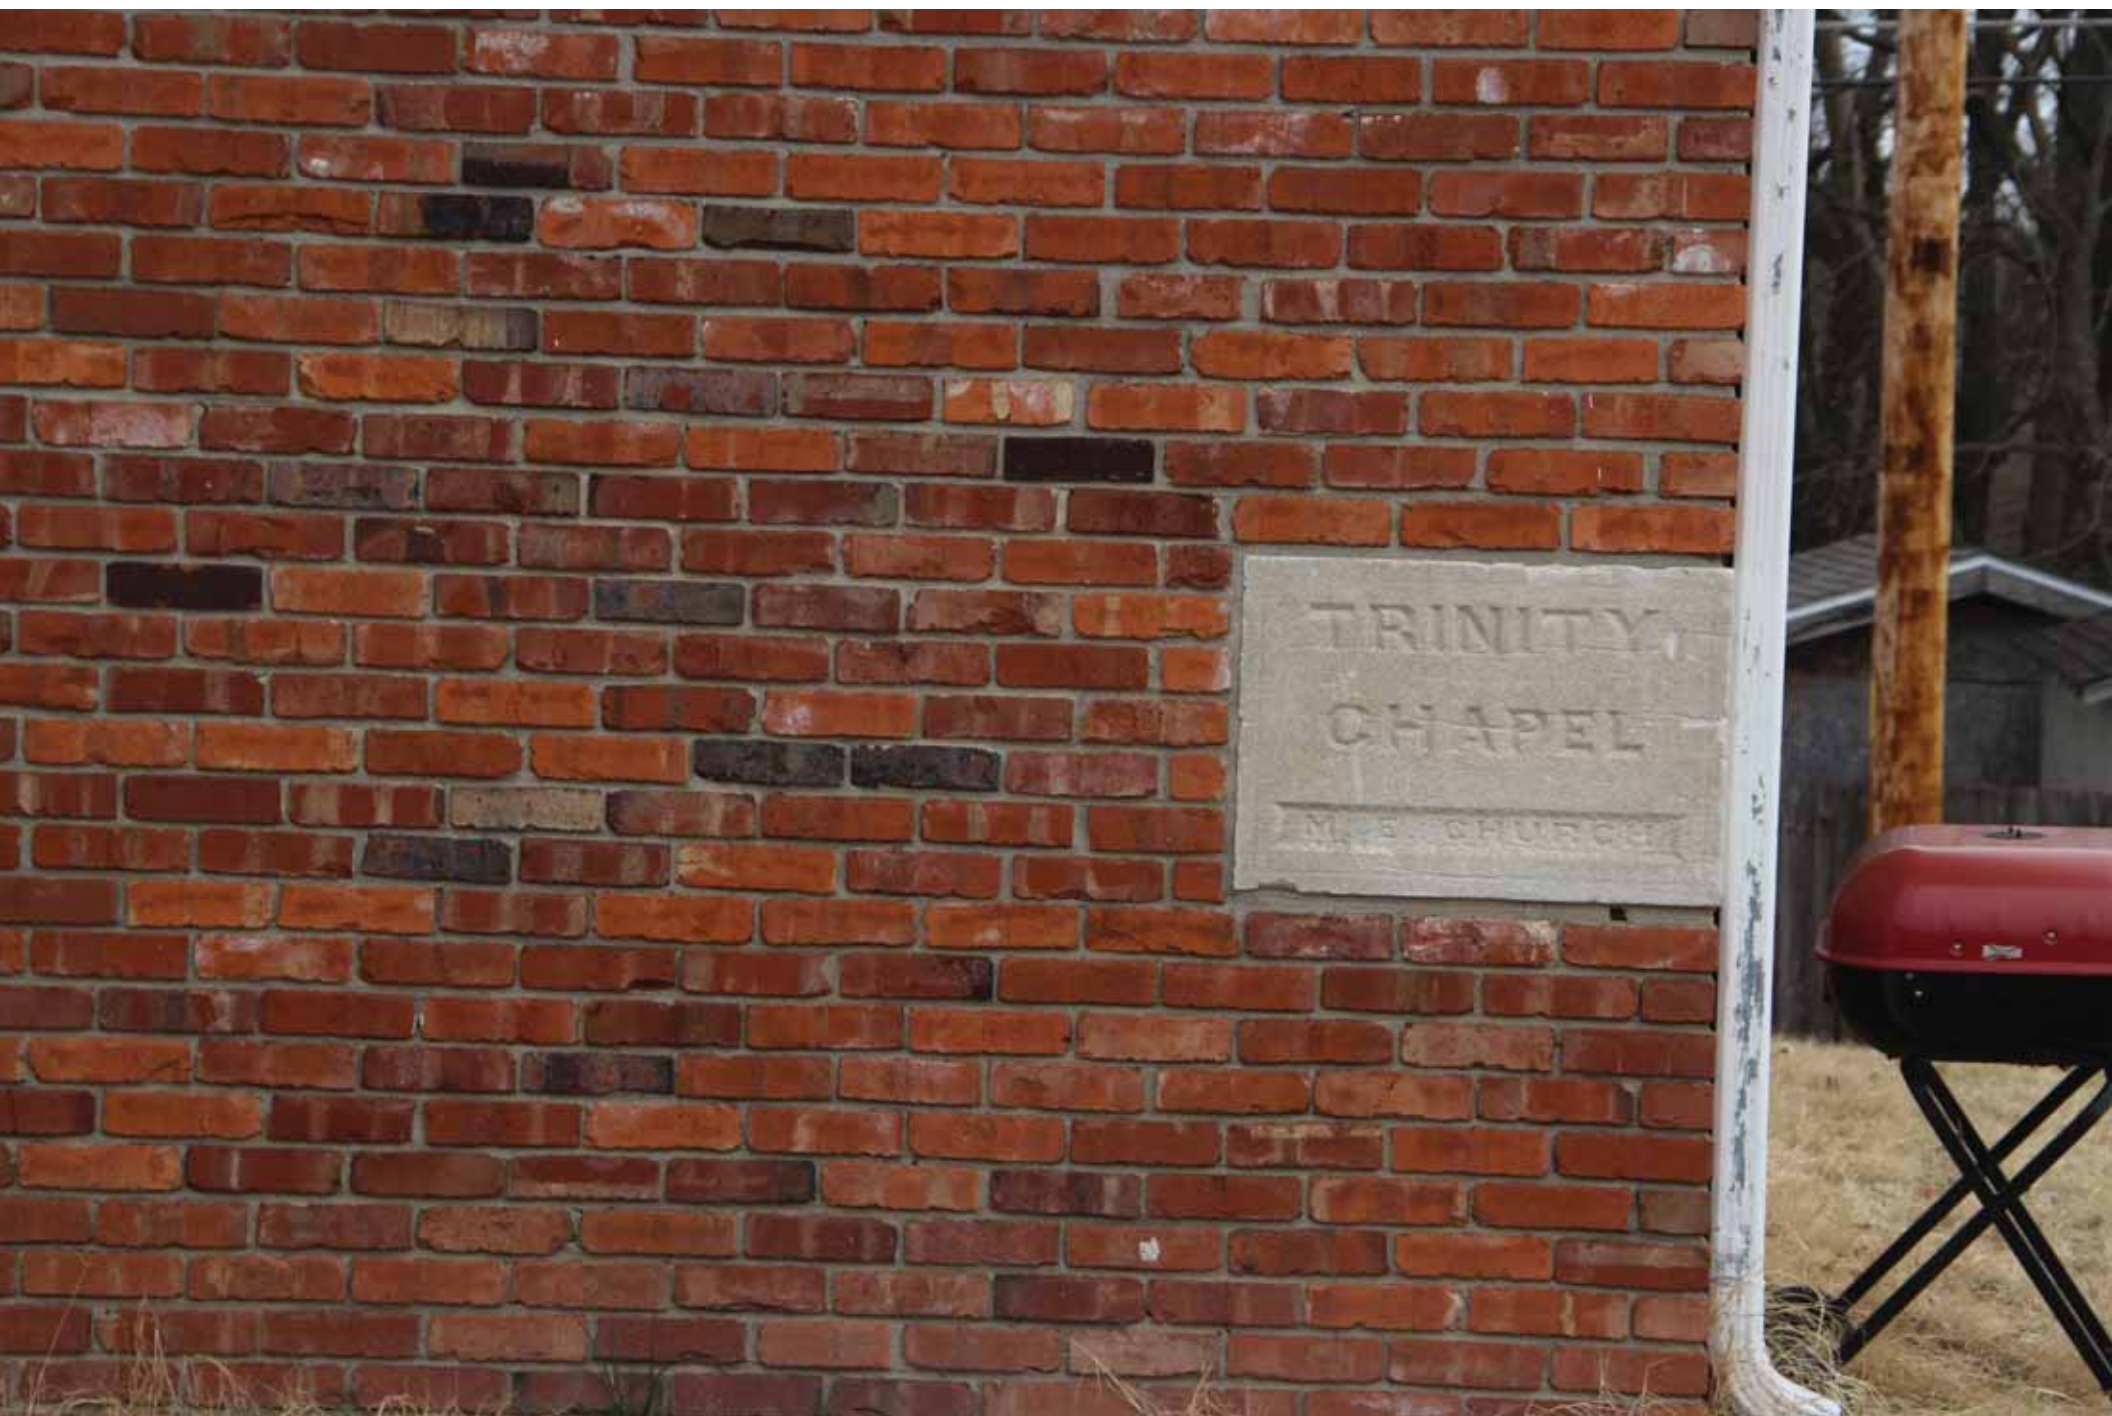
The one-story church was built in 1966. It has a low-pitched front facing gable roof covered in asphalt siding. The plan of the church is irregular and slightly L-shaped, with a wing on the rear, or north side of the building. In the center of the gable is a simple pointed steeple with a cross on top. The front façade is covered in a stone veneer. Recessed along the side of the stone veneer are fixed stain glass windows in a simple Mid-Century design. On the side of the building are fixed metal windows of various colors, recessed within brick horizontal bands. The church is entered at the rear of the building; in the low-pitched shed roof section of the building. Doors appear to be the original double wooden doors. At the back of the building is a small, hipped roof addition, also of brick construction, with a concrete foundation.

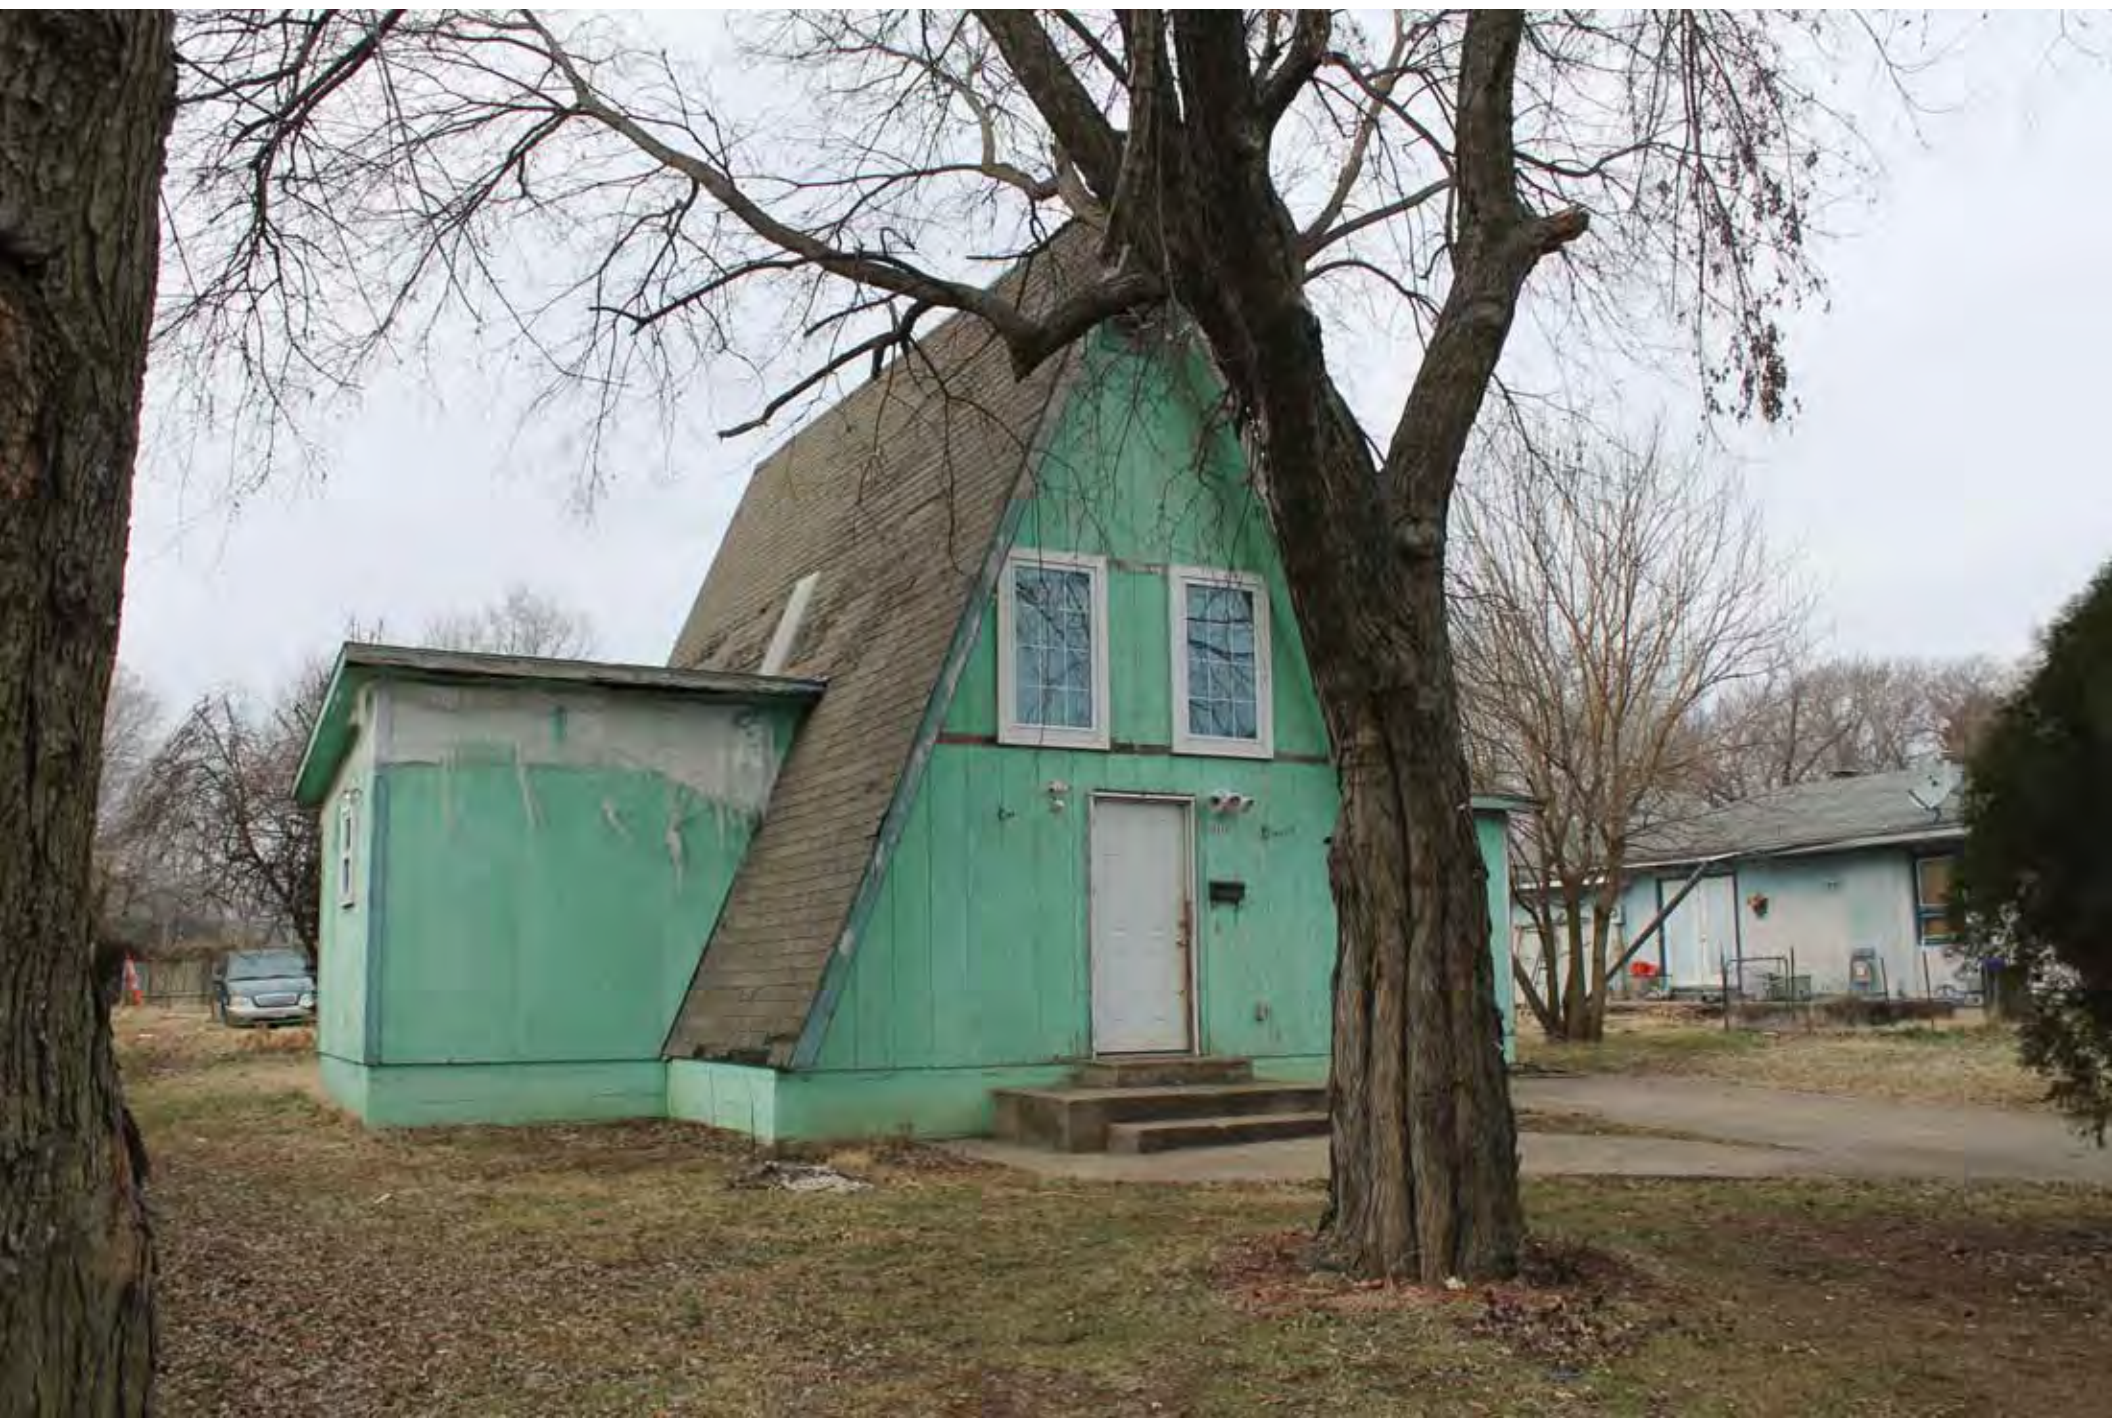
The property at 210 S. Mineral Avenue is an A-frame vernacular residence built in 1988. The front of the gable or A-frame roof faces the street. The roof is covered in asphalt shingles. The front façade is symmetrical with a central front door and two vinyl windows above at the half story level. On each side of the building, south and north sides, are small one-story frame additions with shed roofs. The entire building is covered in wood paneling or plywood. It sits on a concrete foundation.
