MISSOURI DEPARTMENT OF NATURAL RESOURCES
STATE HISTORIC PRESERVATION OFFICE, P.O. Box 176, Jefferson City, MO 65102
ARCHITECTURAL/HISTORIC INVENTORY FORM

1. Survey No. JP-AS-007-001		2. Survey name: East Town (Original Joplin) Historic Survey Phase 2	
3. County: JASPER		4. Address (Street No.) 618	Street (name) E. 2 nd Street
5. City: Joplin	Vicinity: <input type="checkbox"/>	6. Geographical Reference:	7. Township/Range/Section: T: R: S:
8. Historic name (if known):		9. Present/other name (if known):	
10. Ownership: <input checked="" type="checkbox"/> Private <input type="checkbox"/> Public		11a. Historic use (if known): Domestic: Single Dwelling	11b. Current use: Domestic: Single Dwelling

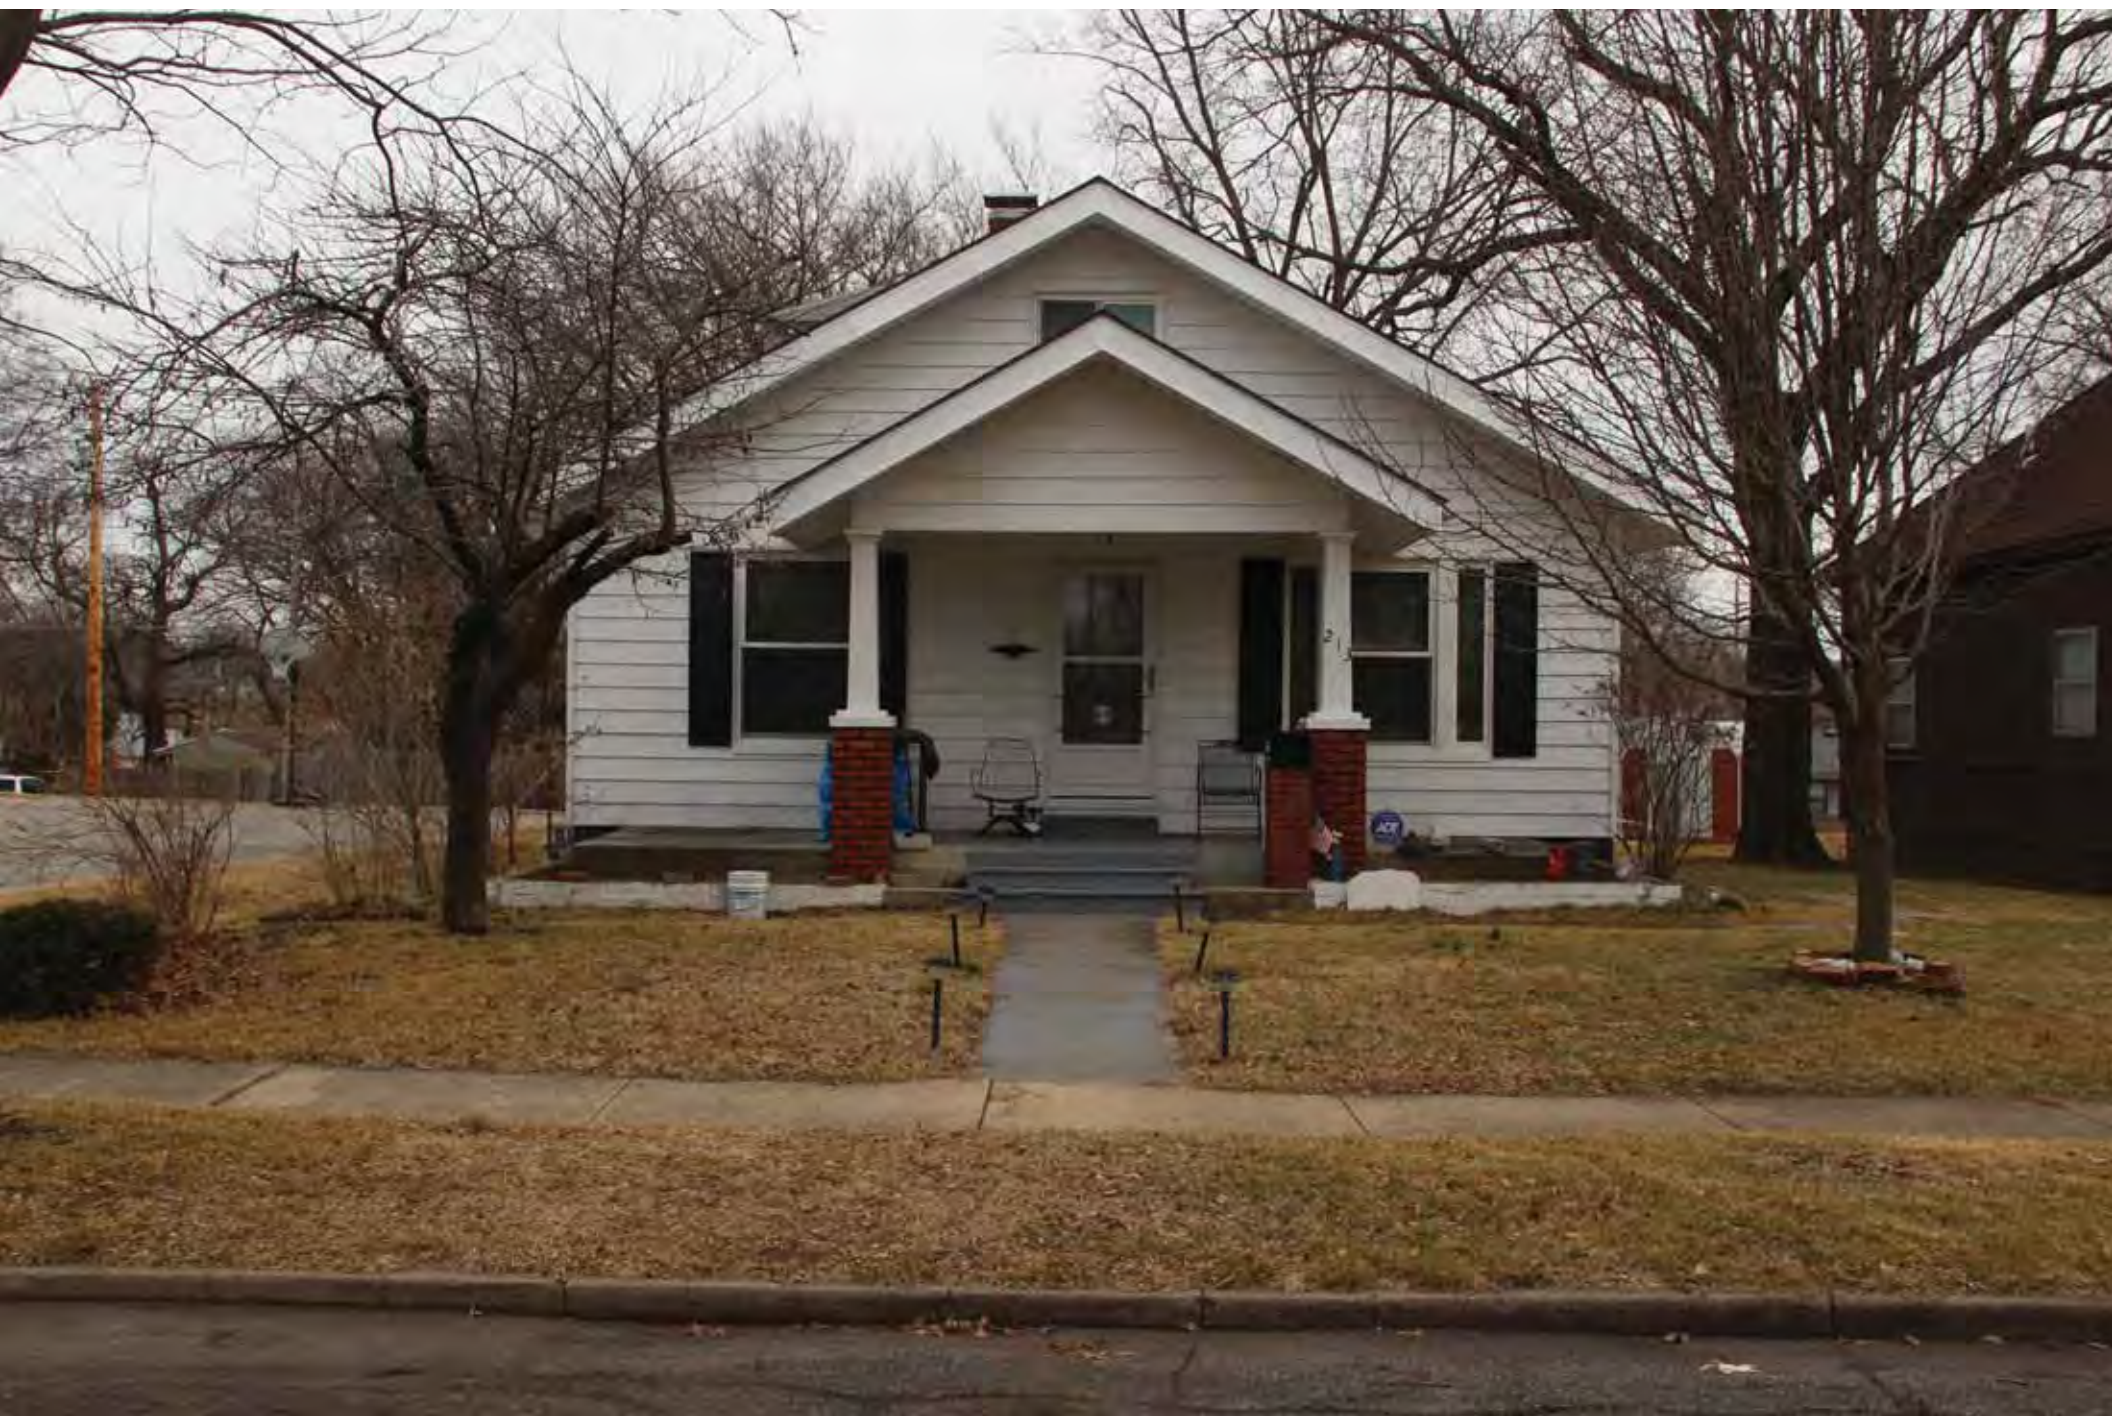
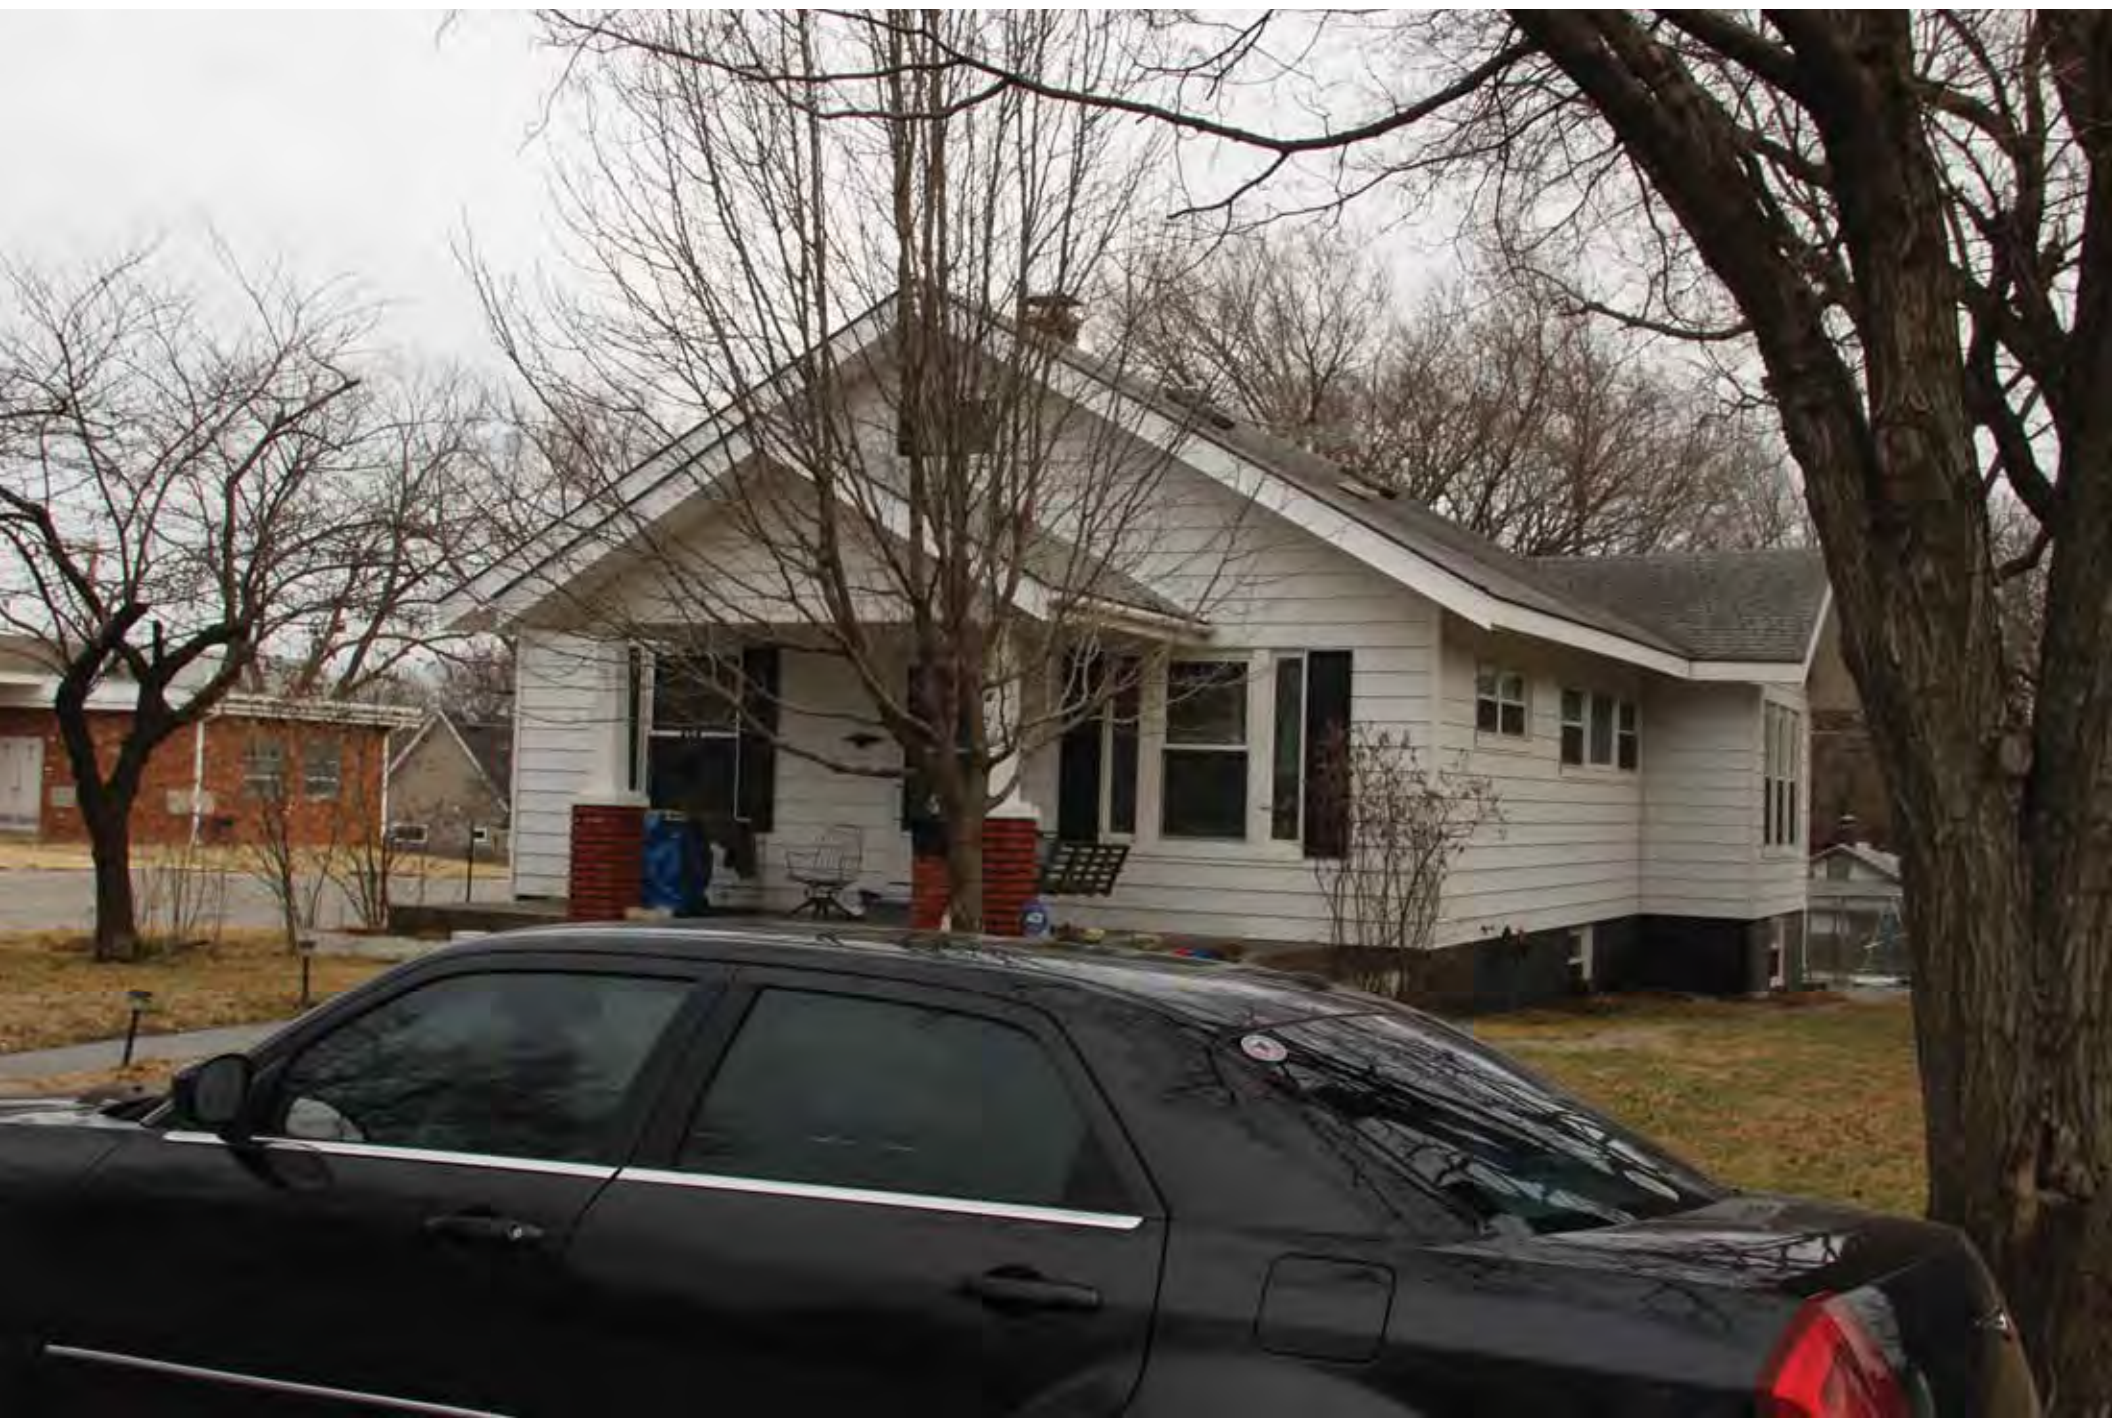
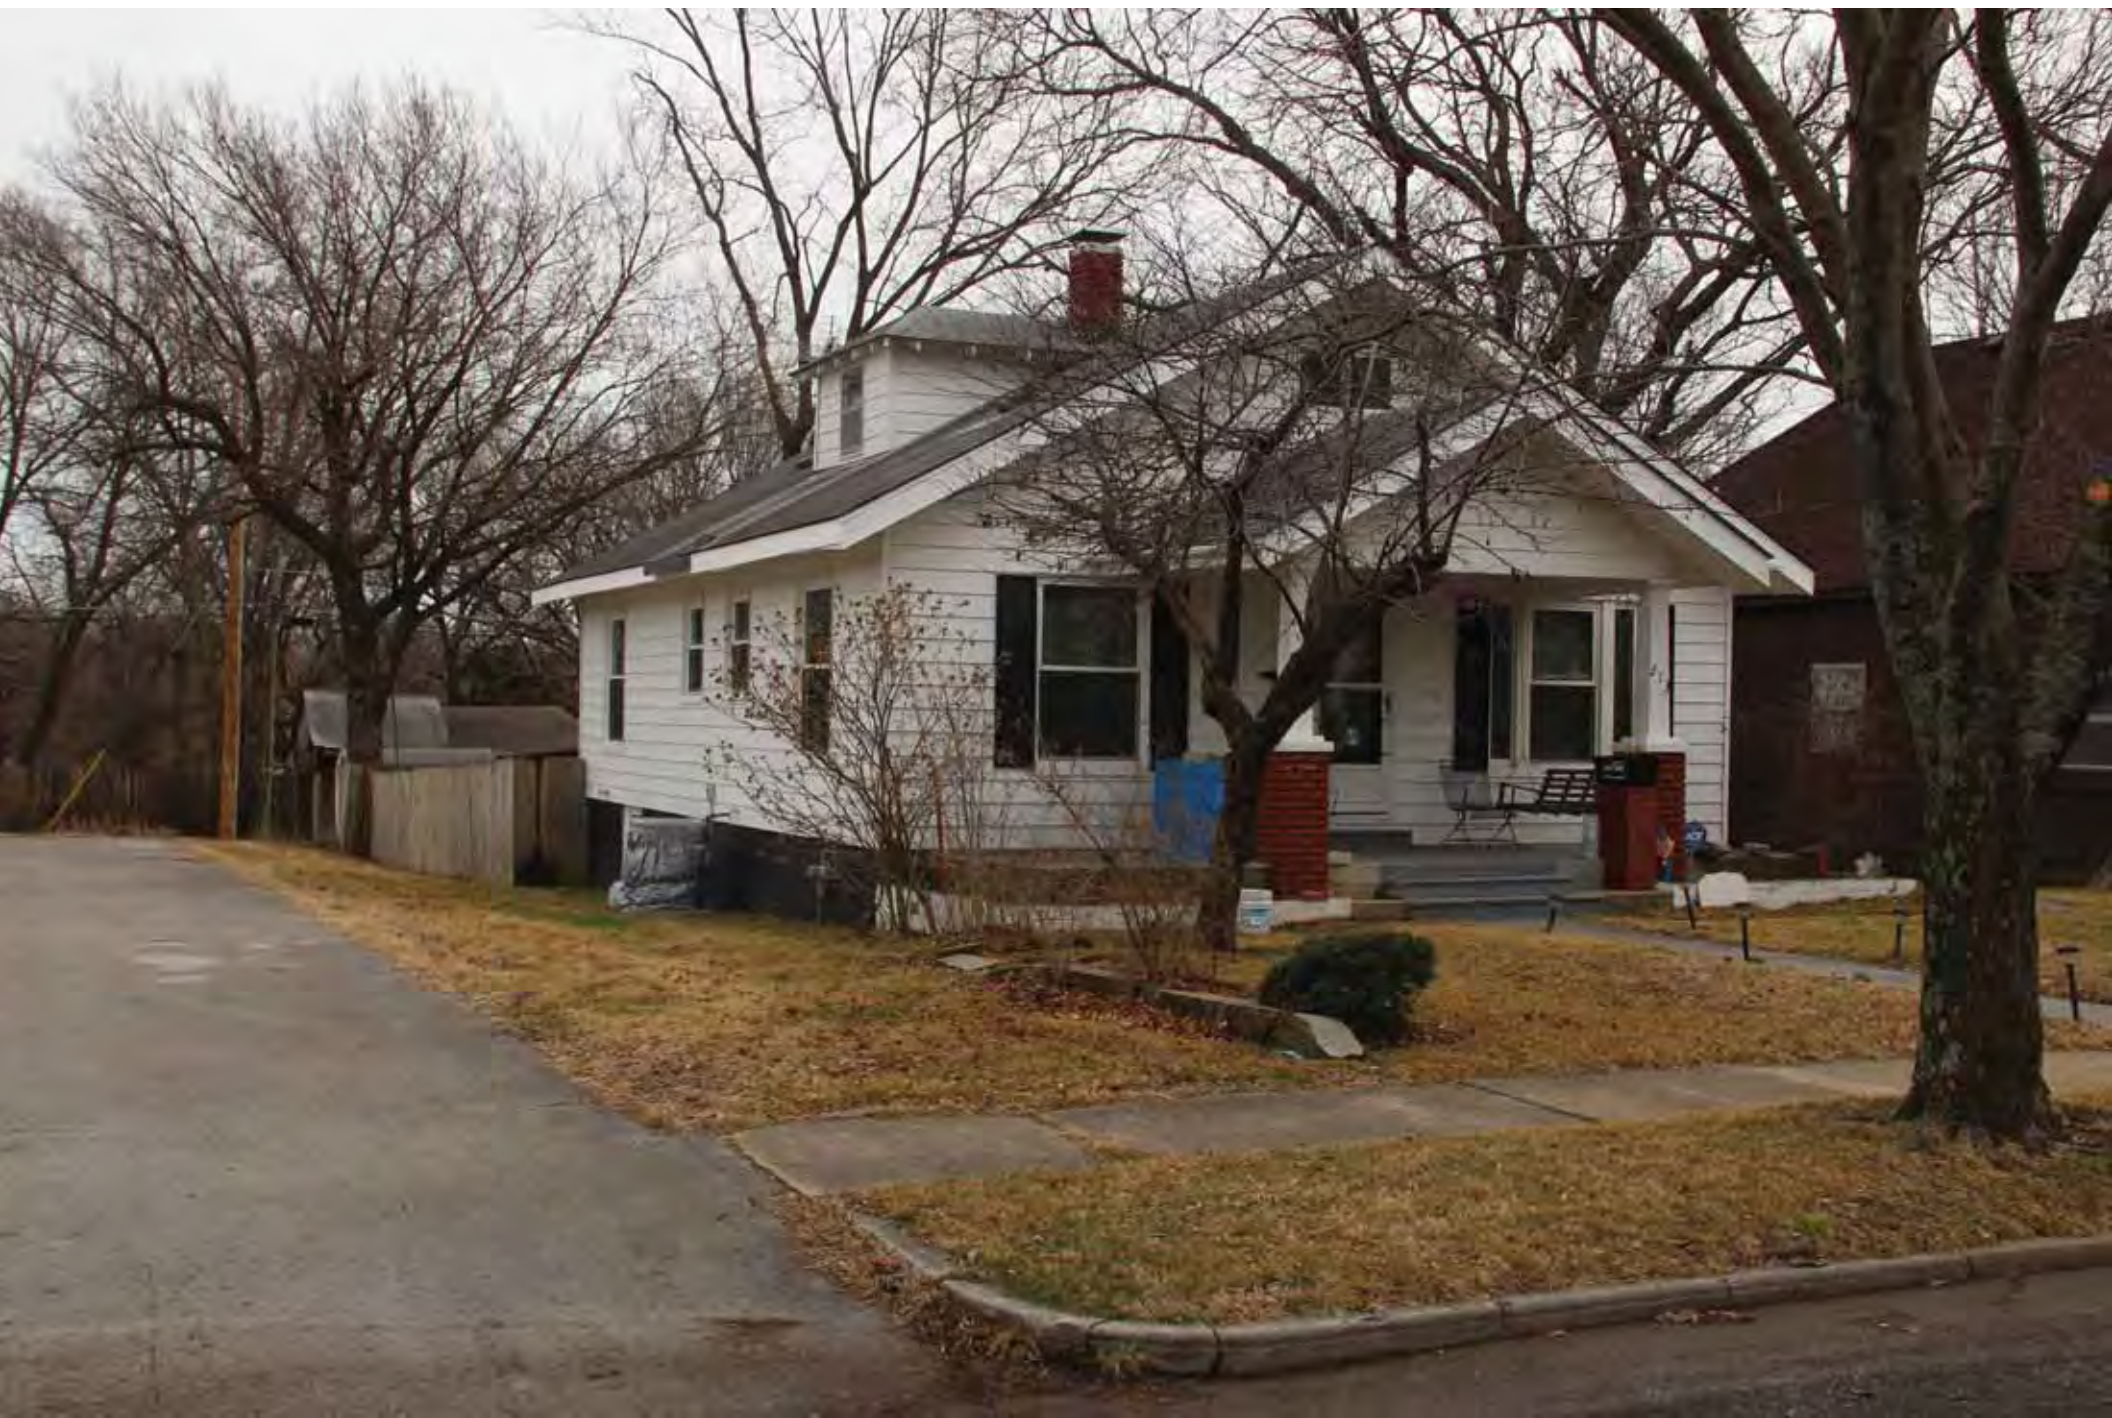
This dwelling has been extensively altered through the addition of metal siding and replacement of original windows. Due to the lack of exterior original siding, the dwelling does not retain integrity that would render it individually eligible for the National Register of Historic Places. The dwelling is not situated in an area recommended as a historic district.

The property at 213 Mineral Avenue features a one-story, gable-front bungalow dwelling with exterior metal siding and an asphalt shingled roof with a medium front facing gable. The front façade is symmetrical, with a central entrance door flanked on either side by one-over-one vinyl replacement windows with non-functioning metal shutters. There is a small front facing gable roof front porch, with wood supports on brick bases. On the side facades are one-over-one vinyl replacement windows. There is a central, interior brick chimney. On the north side of the house is a hipped roof dormer.

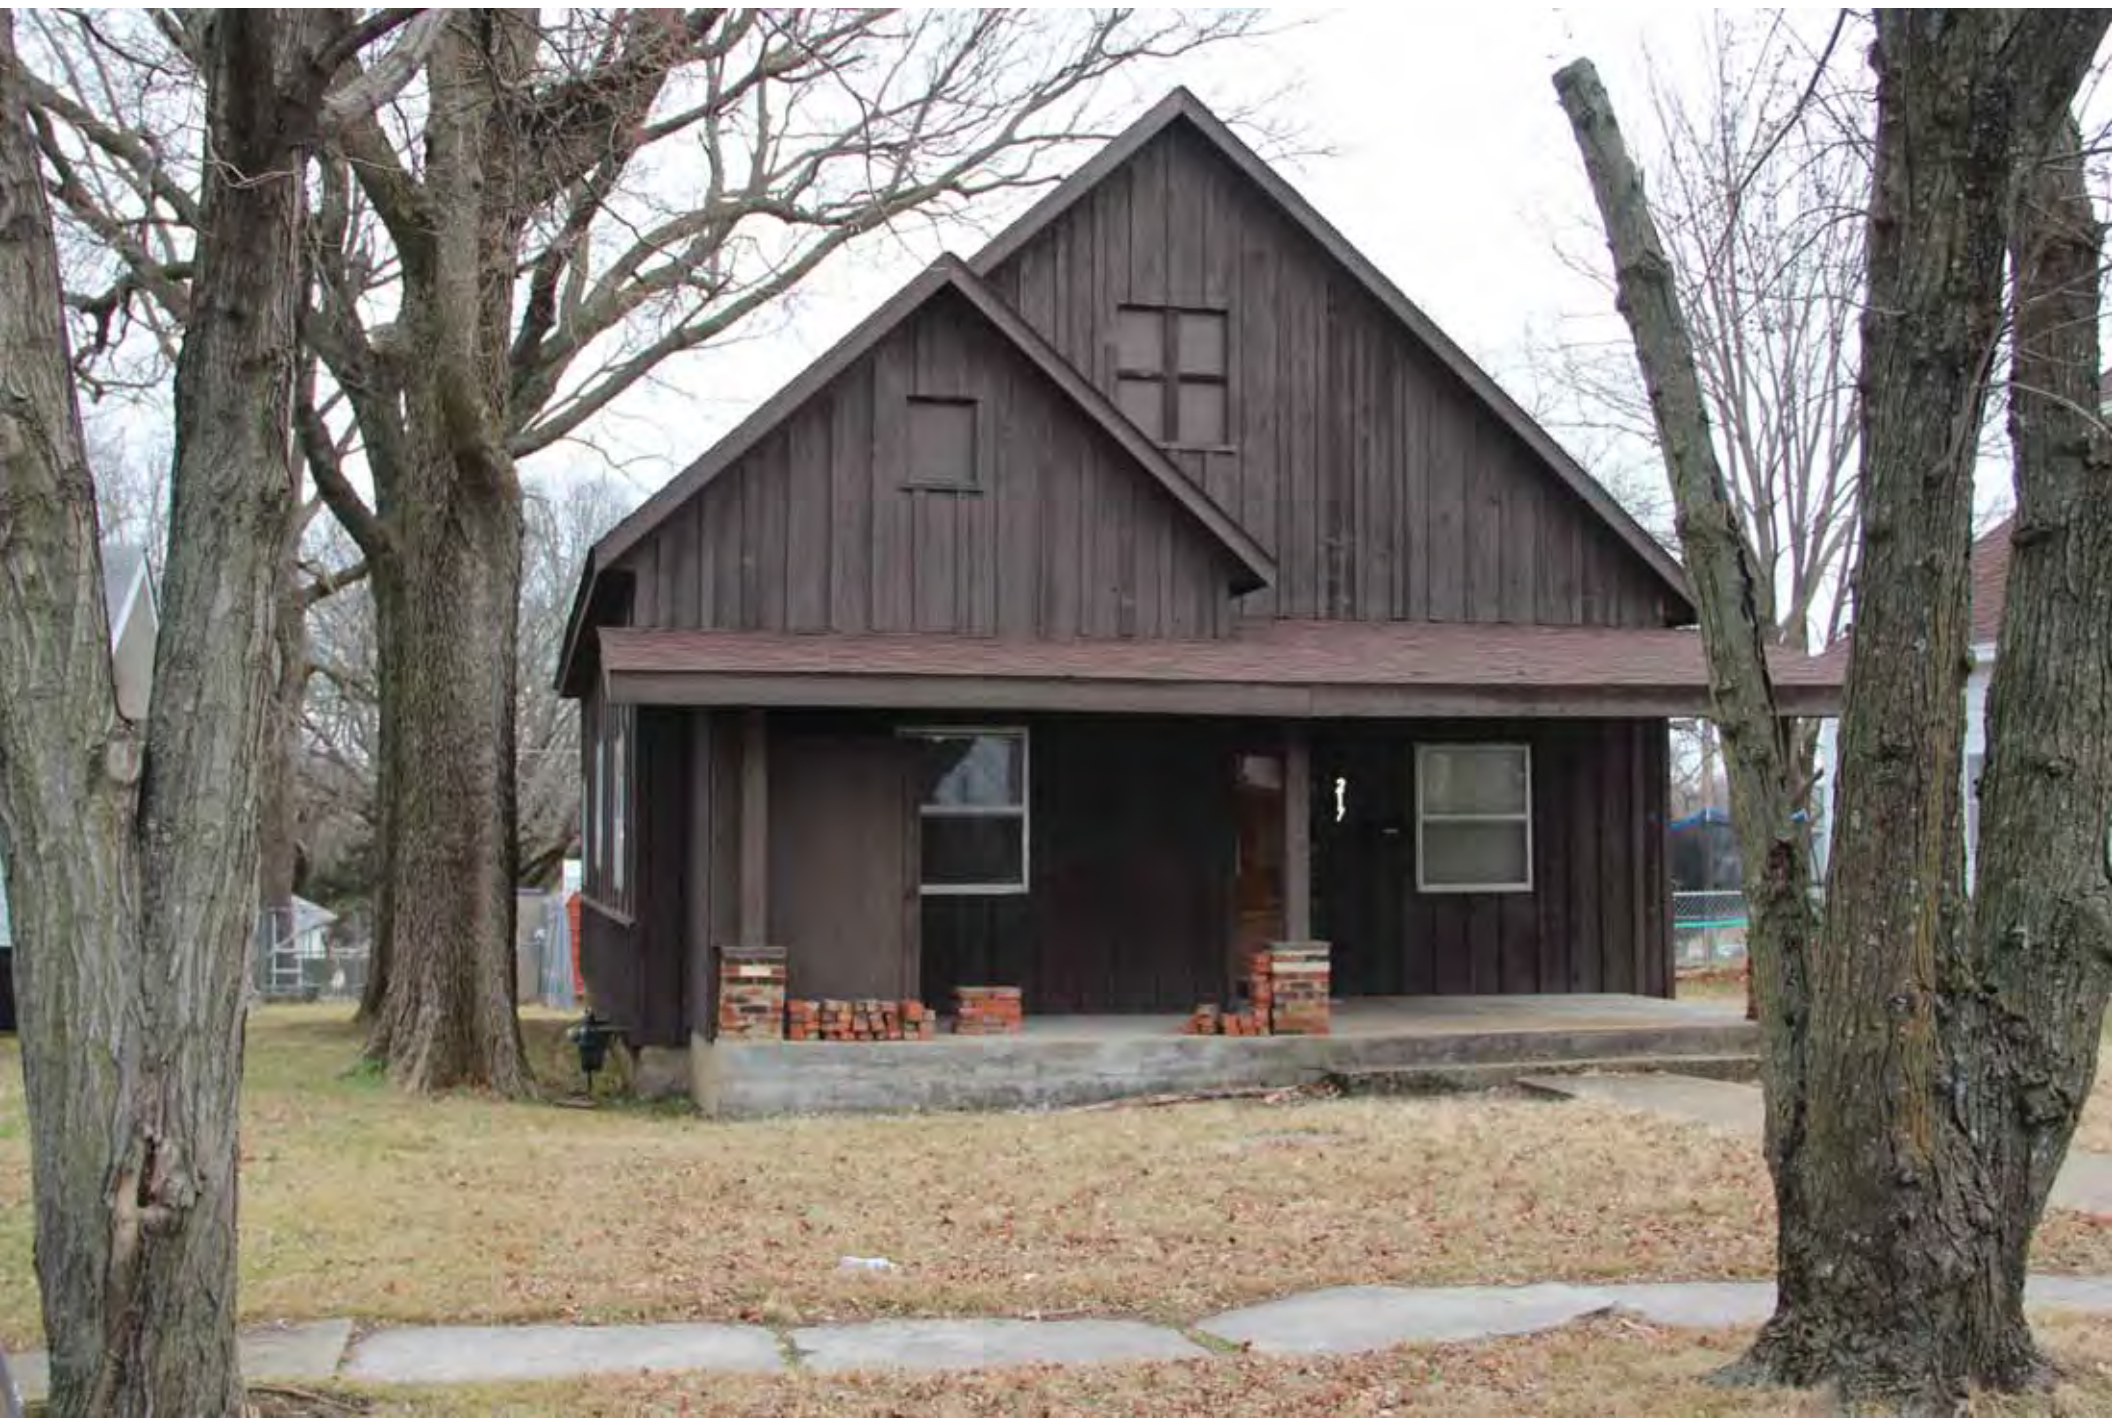
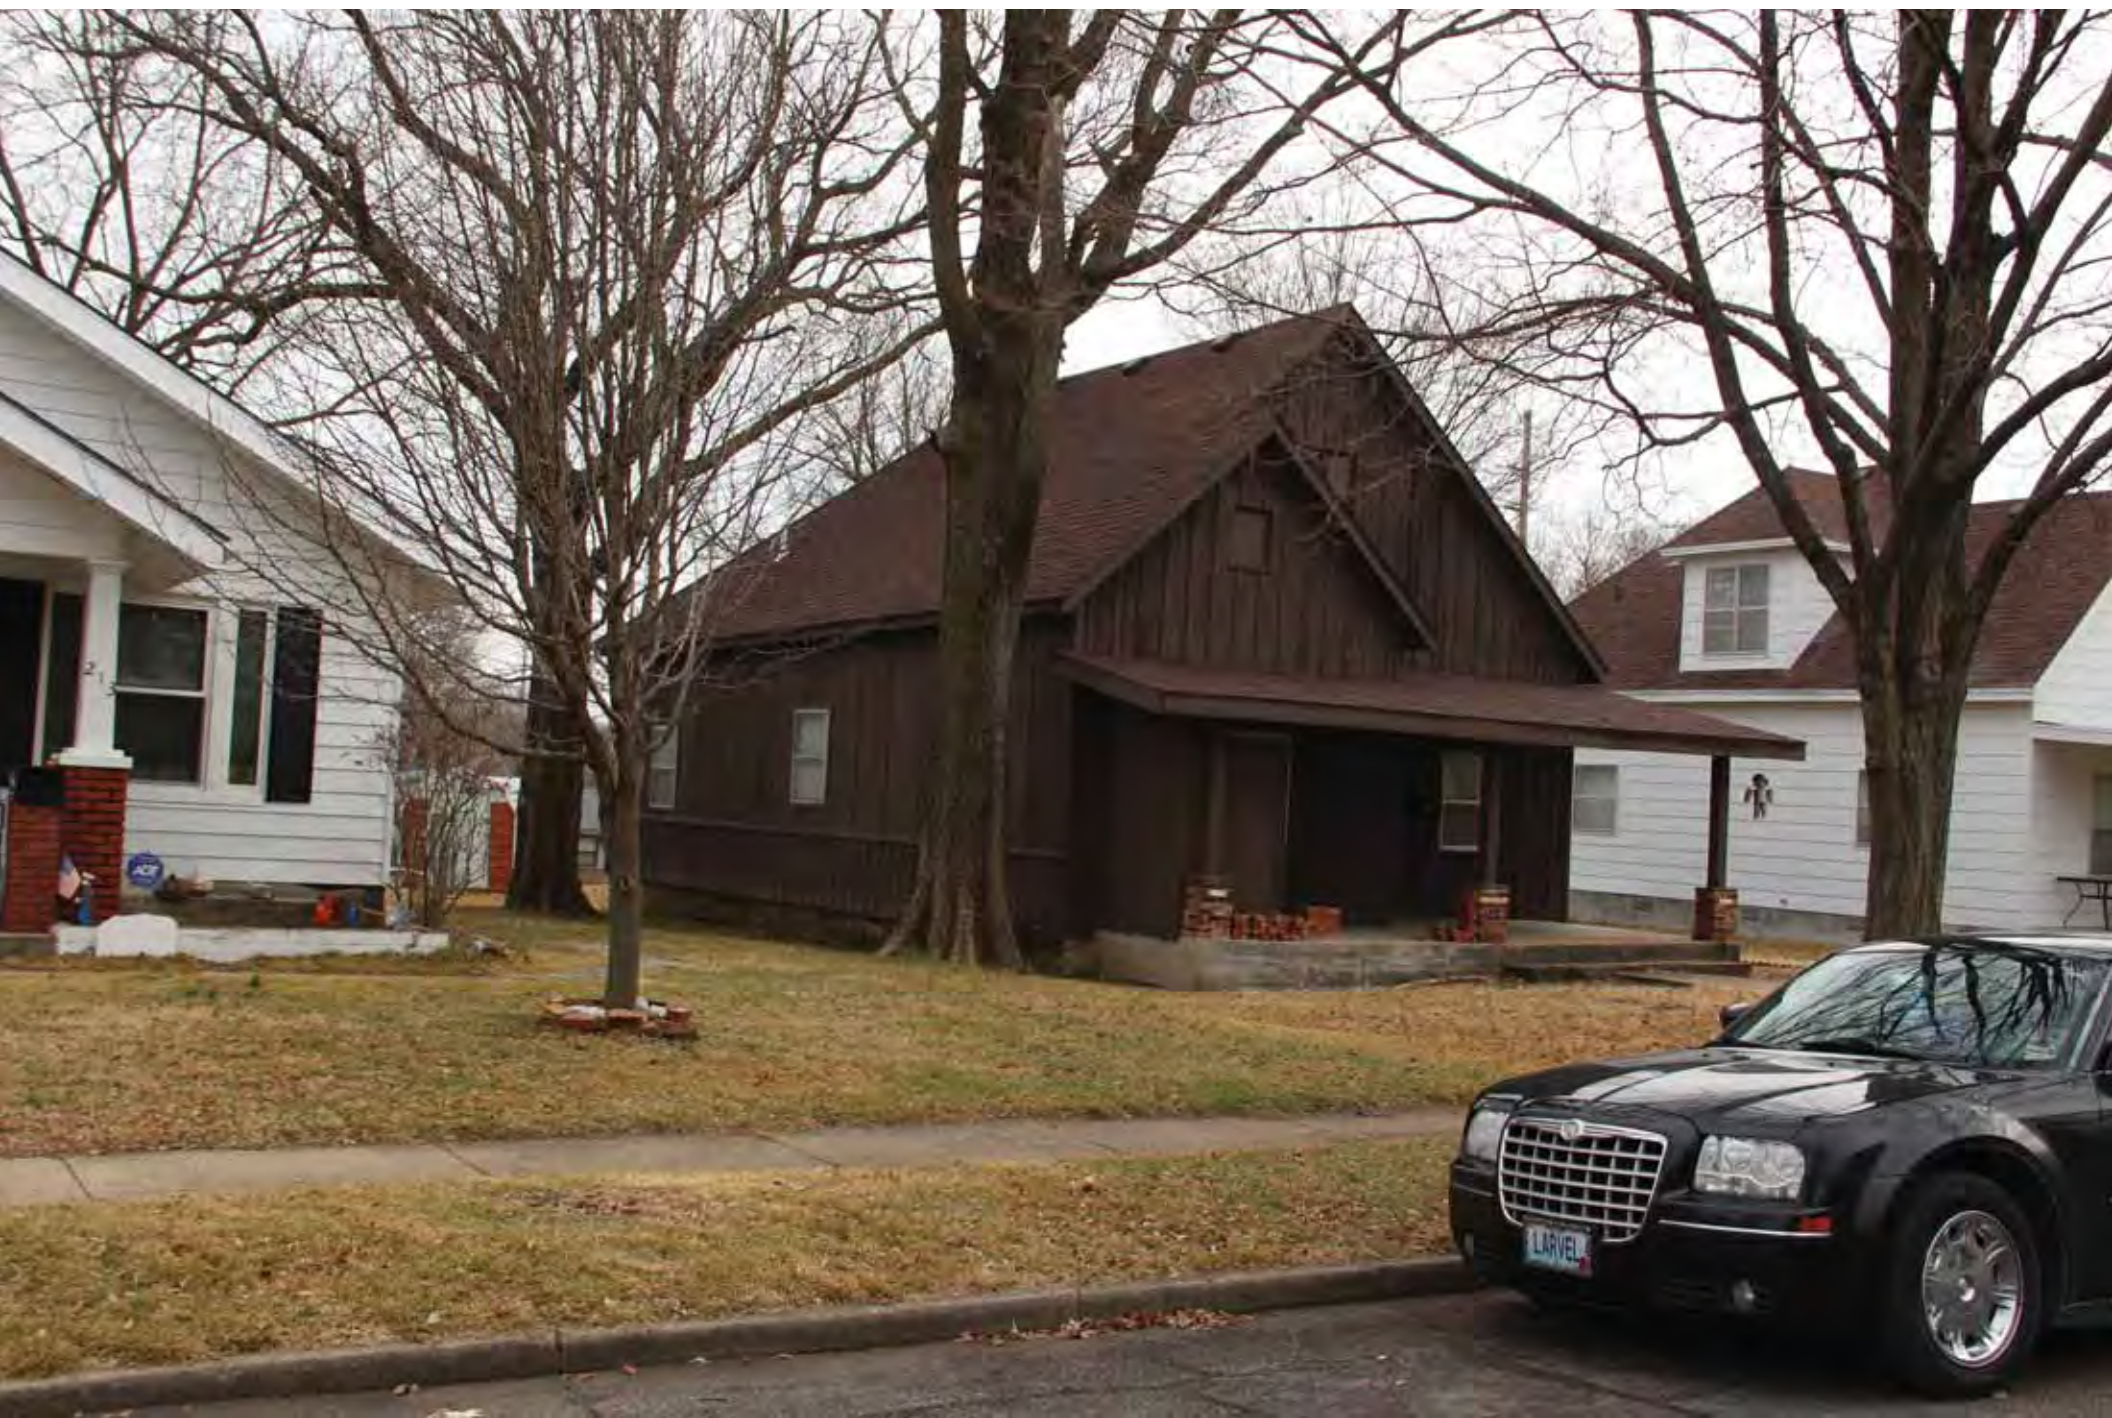
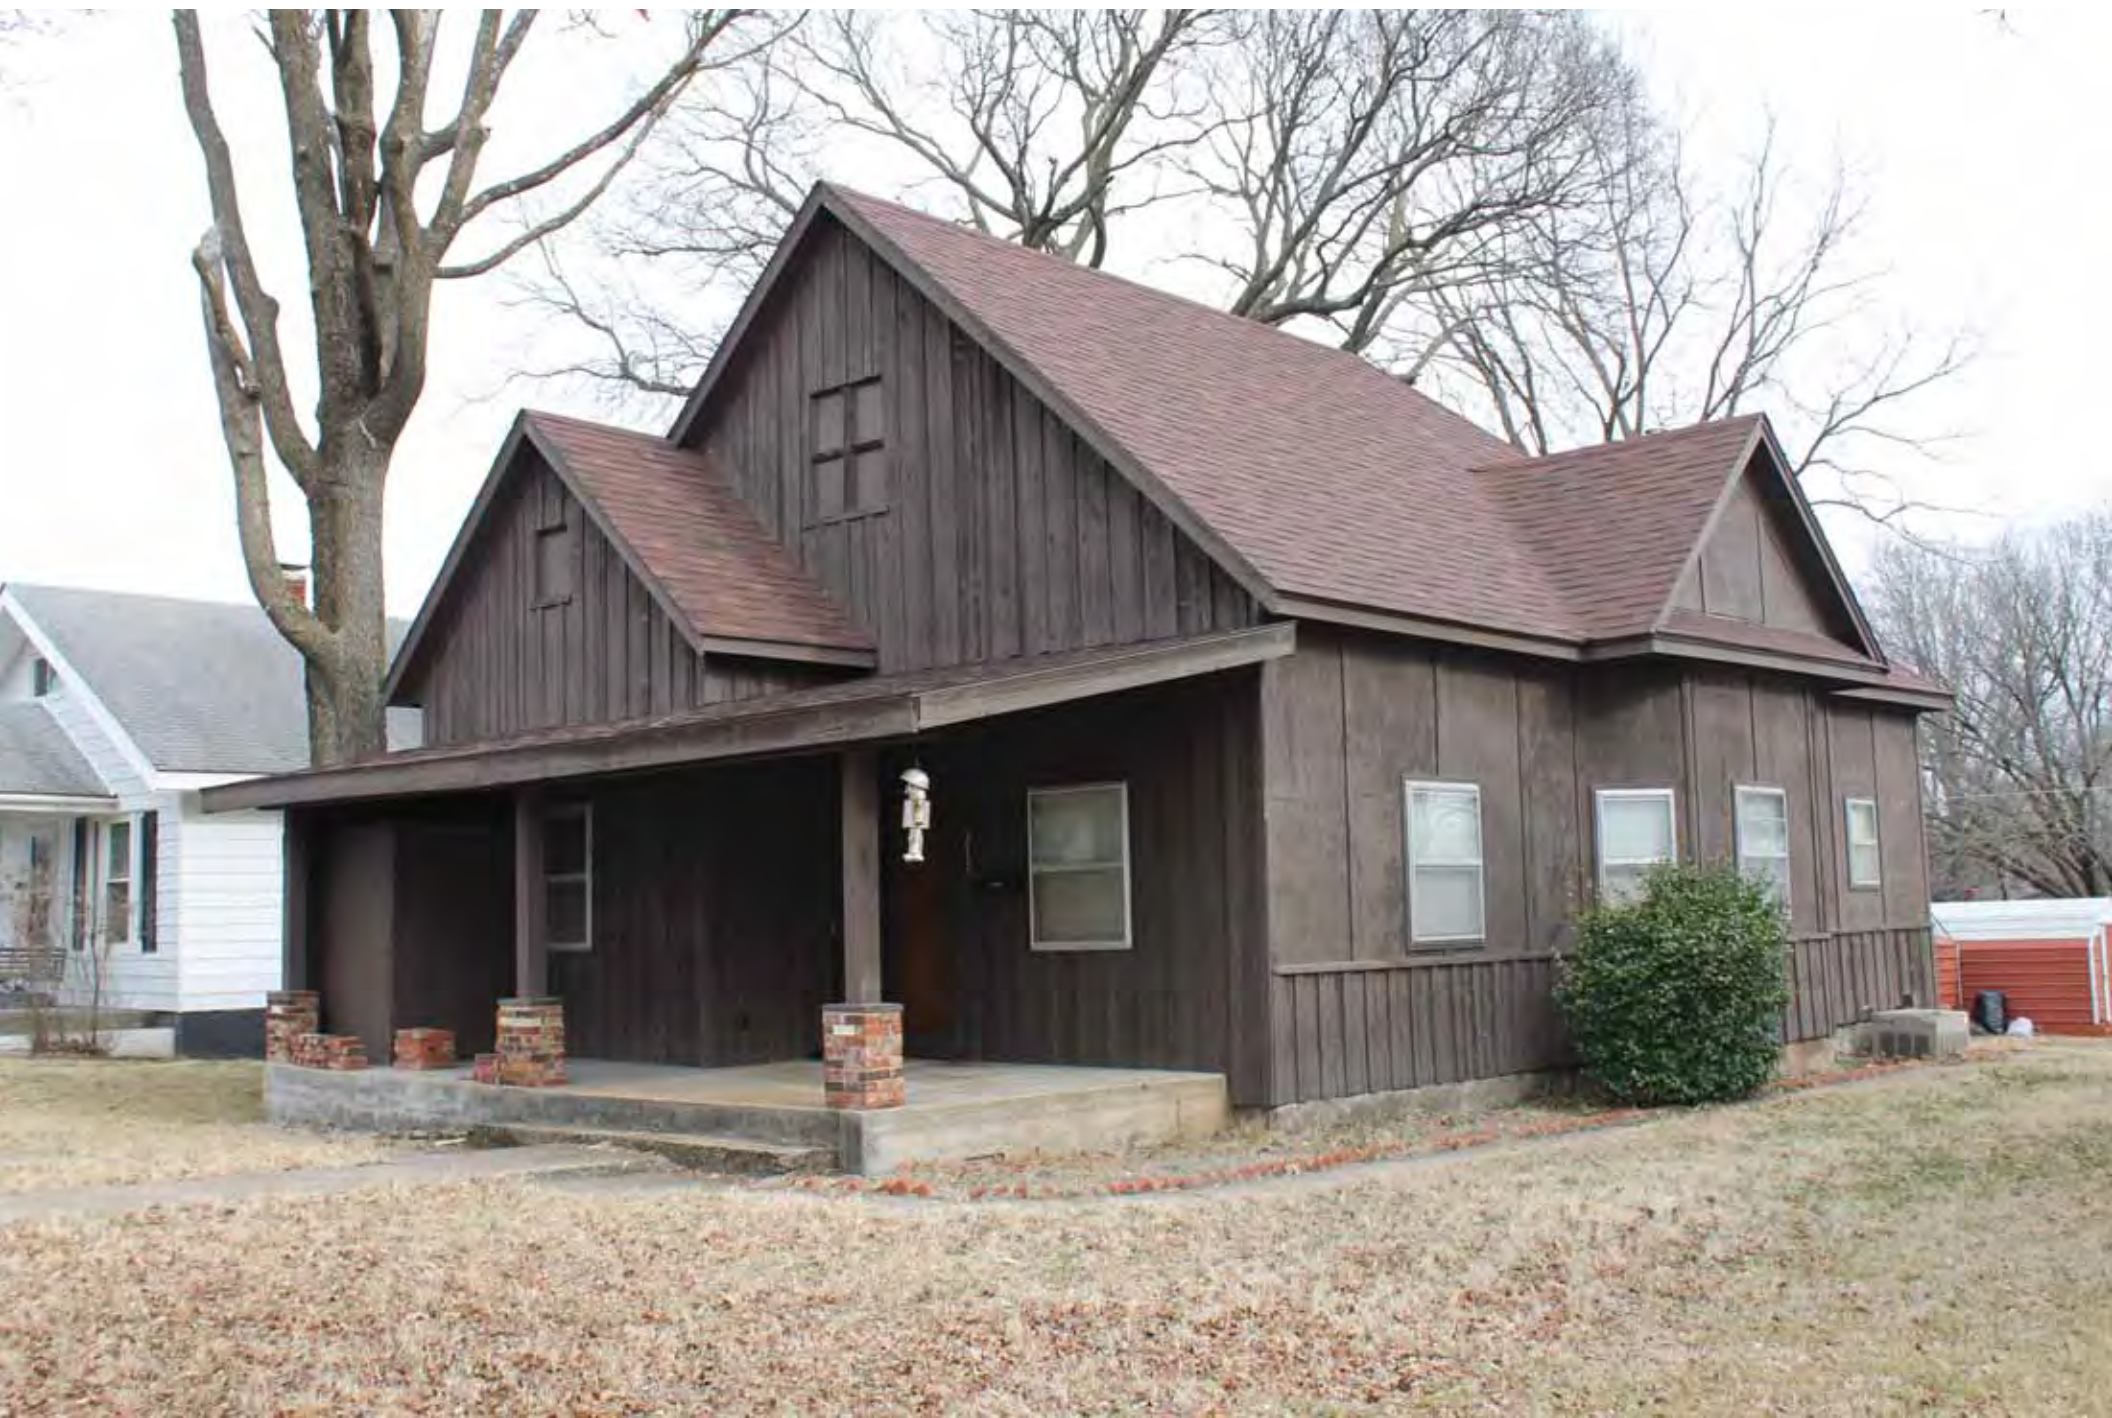
This dwelling has been extensively altered through the addition of non-historic wood siding and replacement of original windows. Due to the lack of exterior original siding, the dwelling does not retain integrity that would render it individually eligible for the National Register of Historic Places. The dwelling is not situated in an area recommended as a historic district.

According to Jasper County records the house at 217 S. Mineral Avenue was constructed in 1906. It has an irregular floor plan with a front facing gable roof covered in asphalt siding. The entire house has been covered in non-historic painted board and batten siding. At the half story level windows have been covered and are non-functioning. On the first floor all windows are vinyl one-over-one replacement windows. On the front of the house is a non-historic open front porch, with a concrete foundation and brick supports.
