MISSOURI DEPARTMENT OF NATURAL RESOURCES
STATE HISTORIC PRESERVATION OFFICE, P.O. Box 176, Jefferson City, MO 65102
ARCHITECTURAL/HISTORIC INVENTORY FORM

1. Survey No. JP-AS-007-001		2. Survey name: East Town (Original Joplin) Historic Survey Phase 2	
3. County: JASPER		4. Address (Street No.) 618	Street (name) E. 2 nd Street
5. City: Joplin	Vicinity: <input type="checkbox"/>	6. Geographical Reference:	7. Township/Range/Section: T: R: S:
8. Historic name (if known):		9. Present/other name (if known):	
10. Ownership: <input checked="" type="checkbox"/> Private <input type="checkbox"/> Public		11a. Historic use (if known): Domestic: Single Dwelling	11b. Current use: Domestic: Single Dwelling

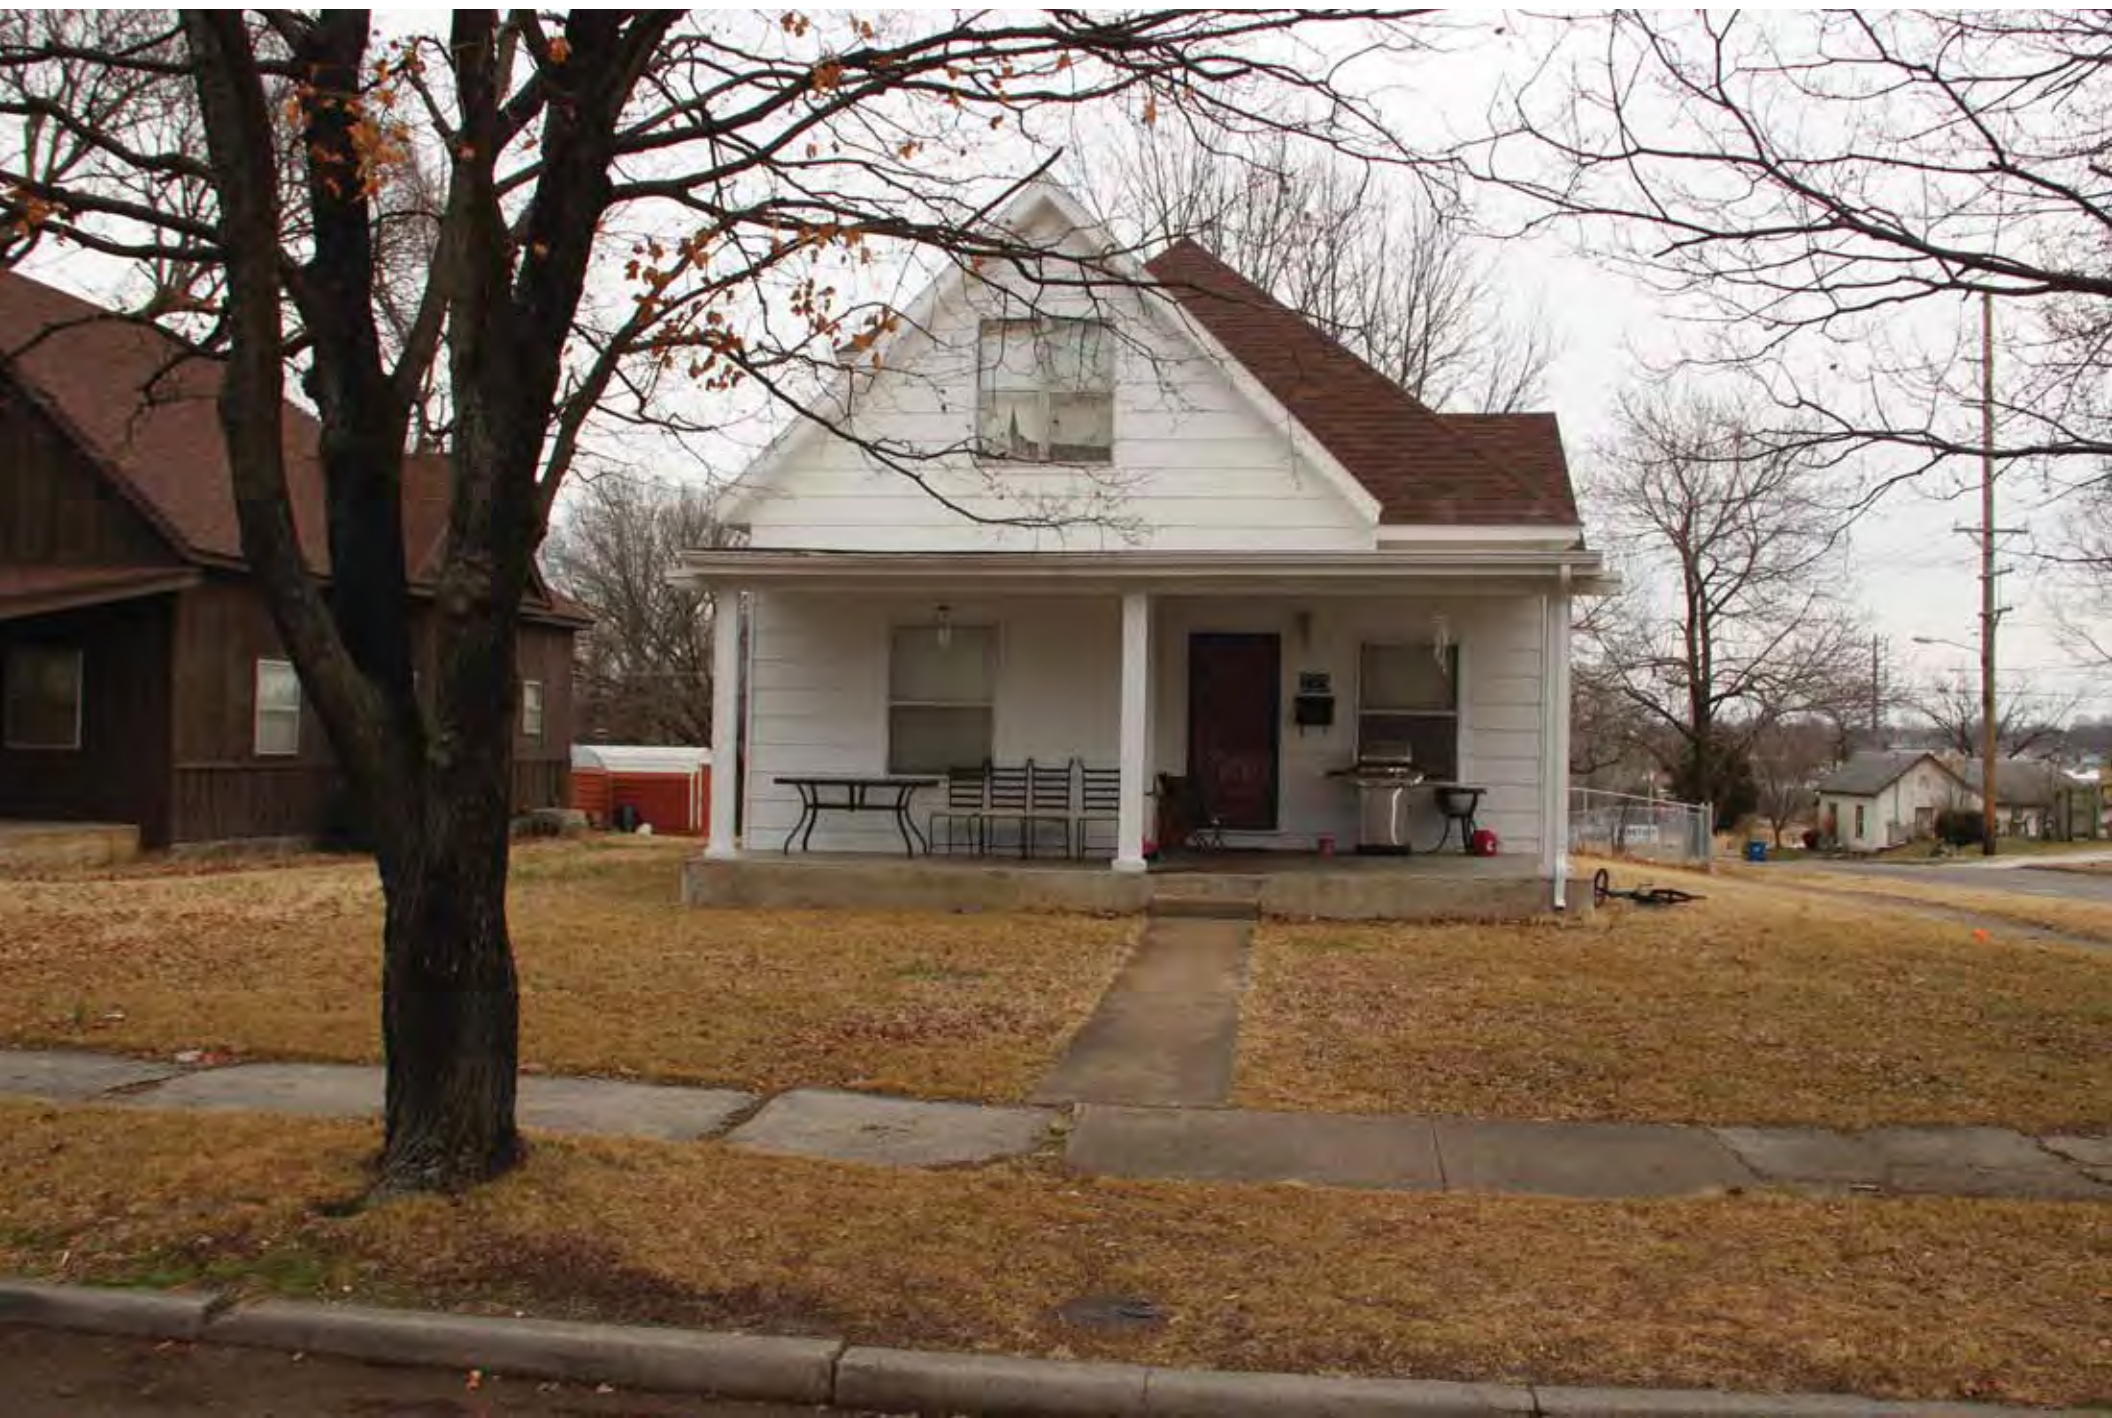
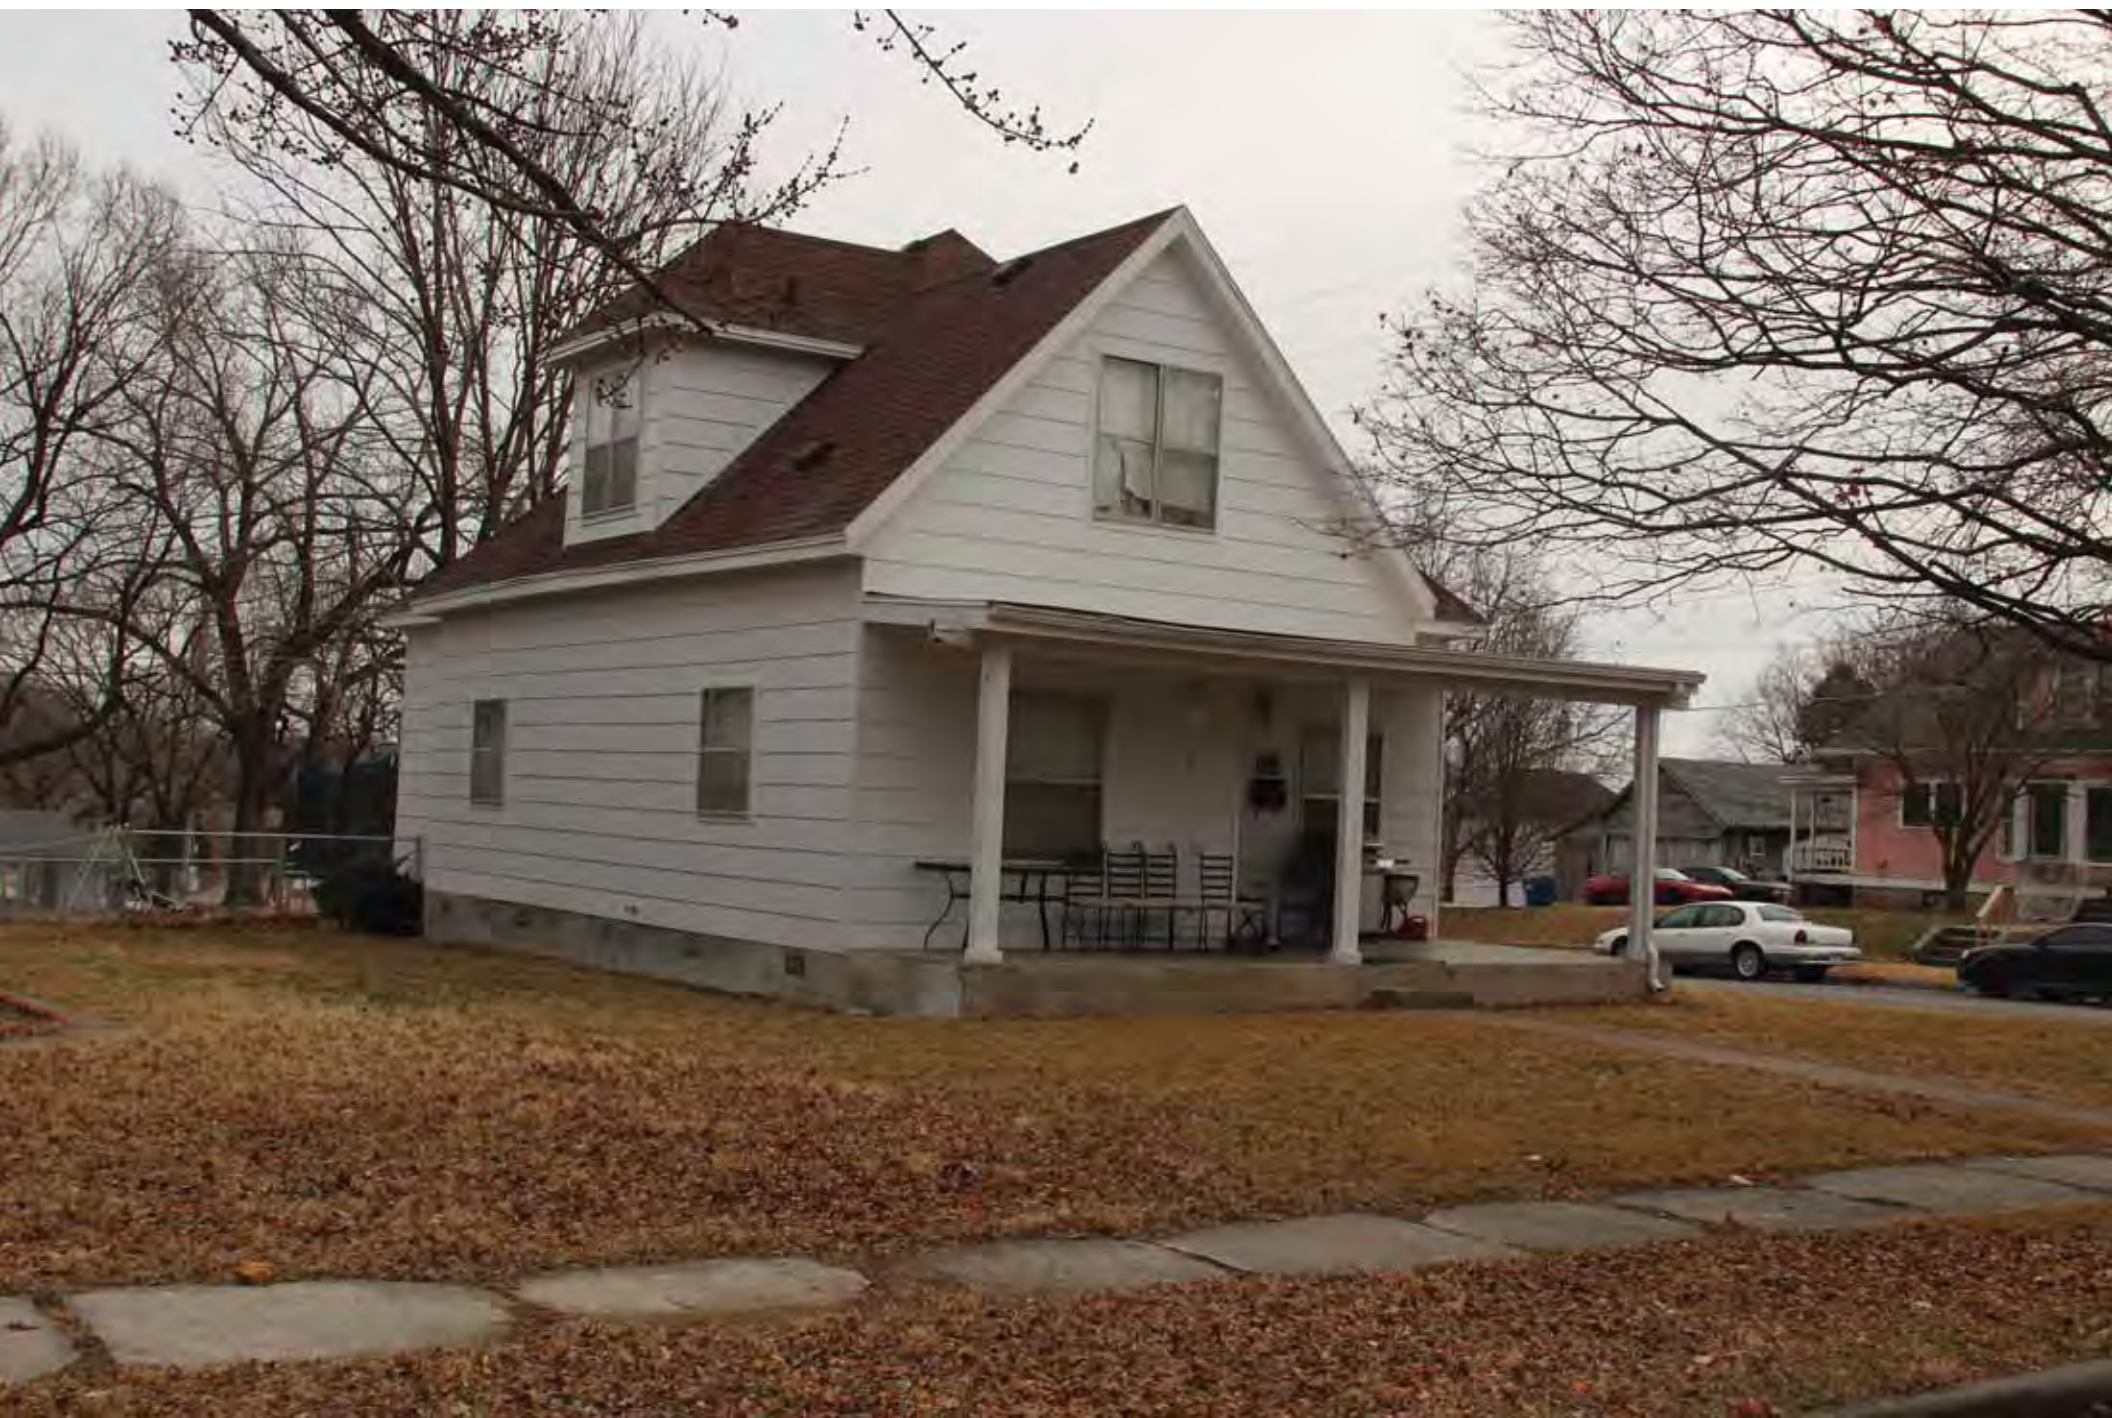
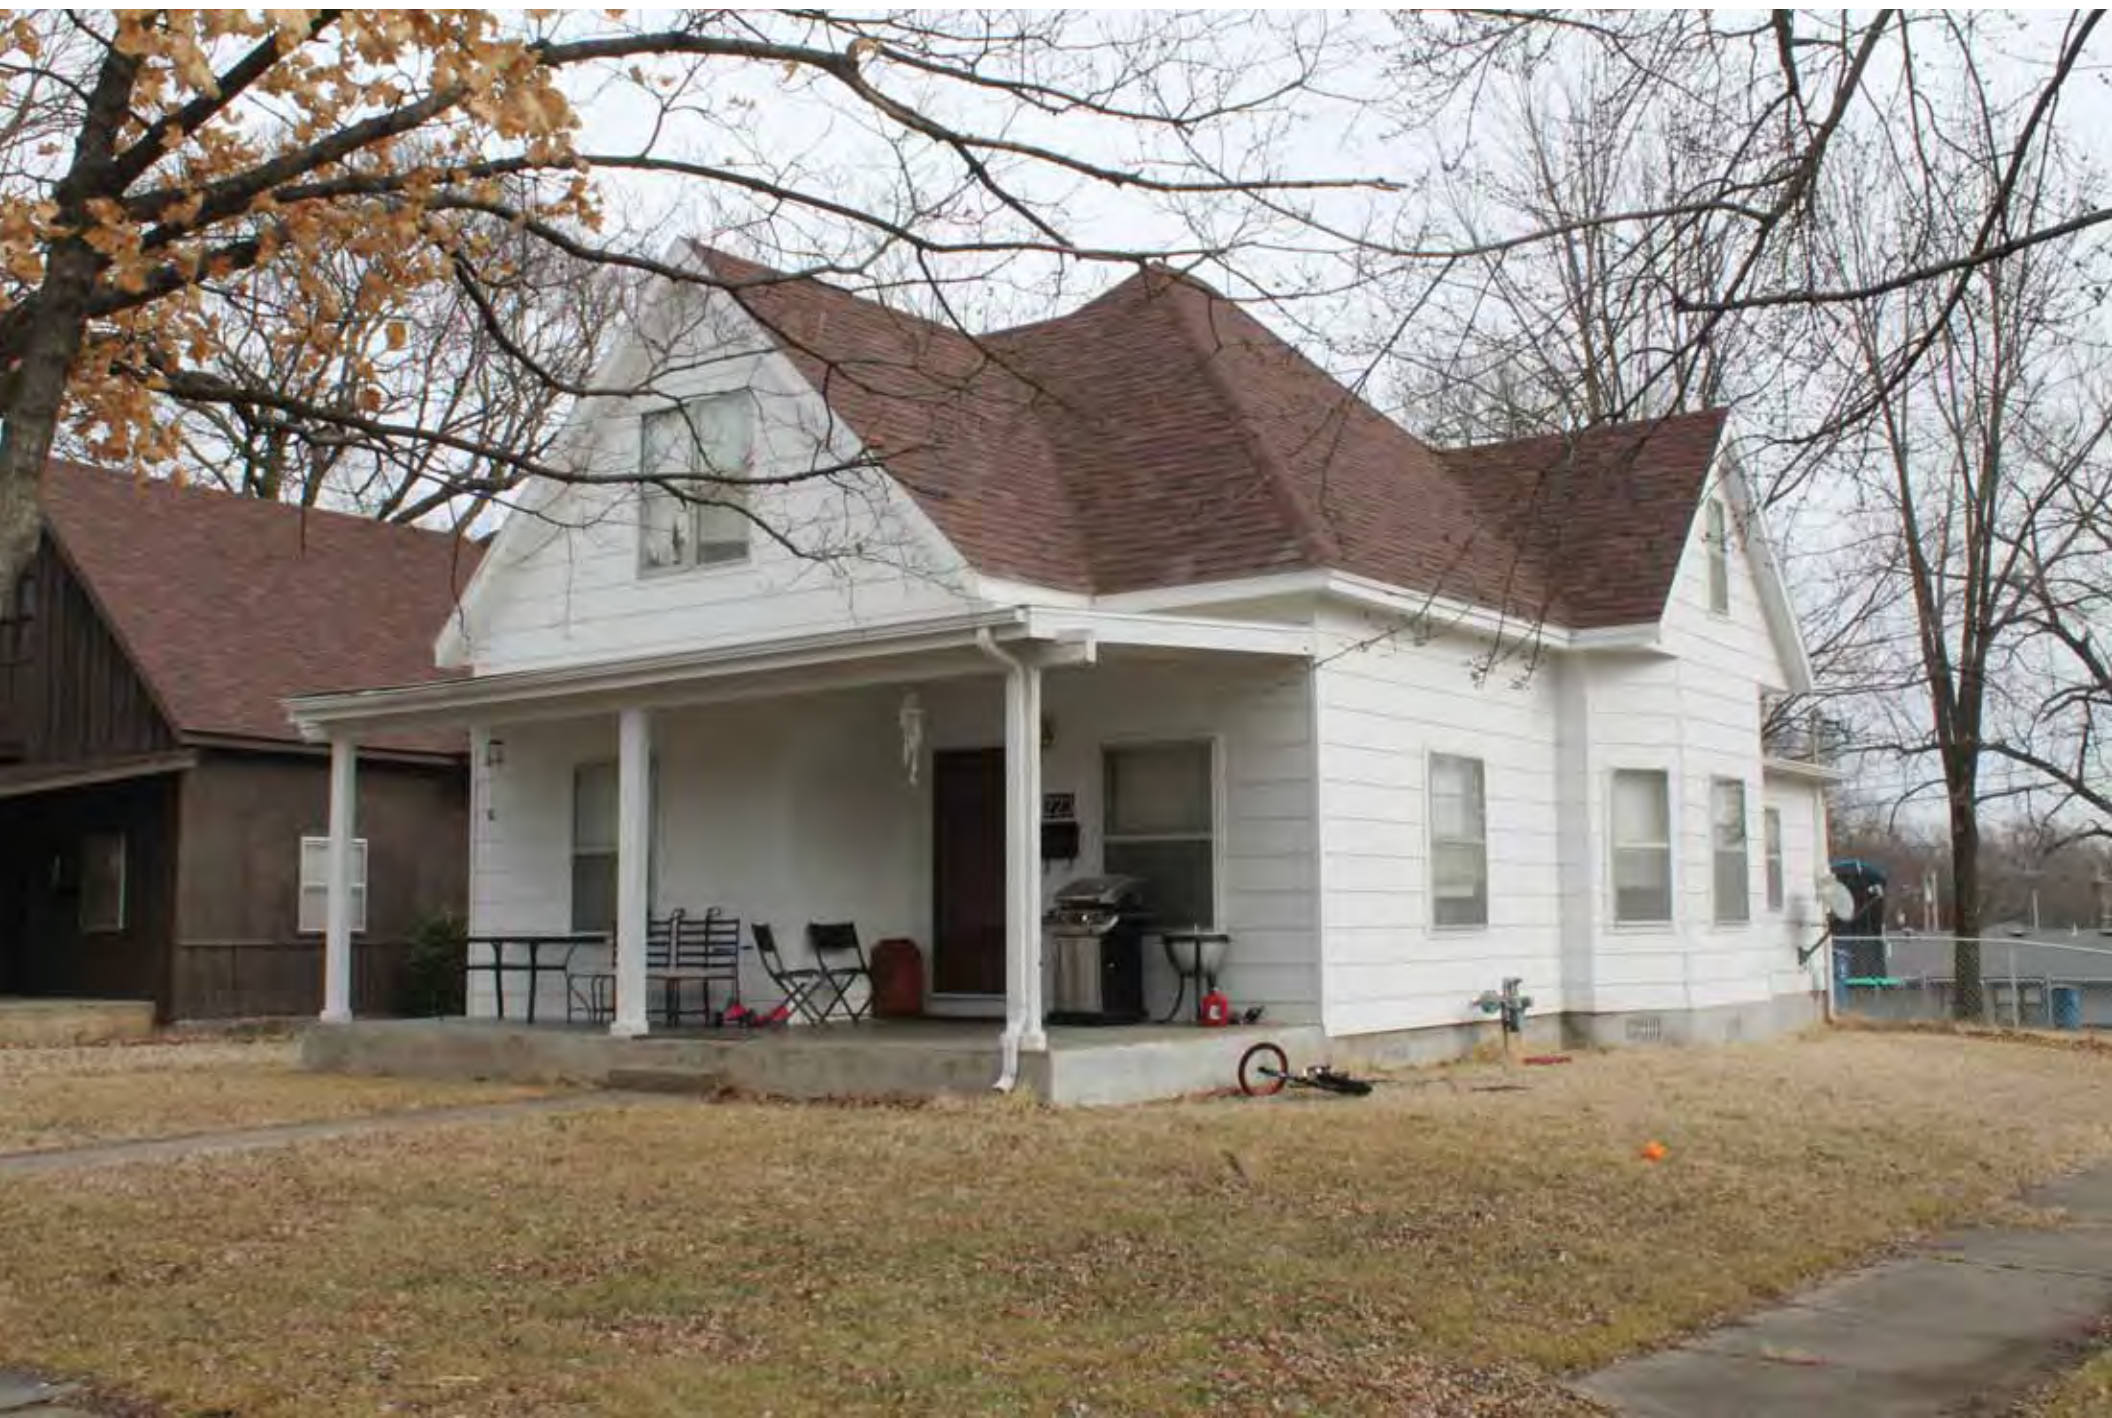
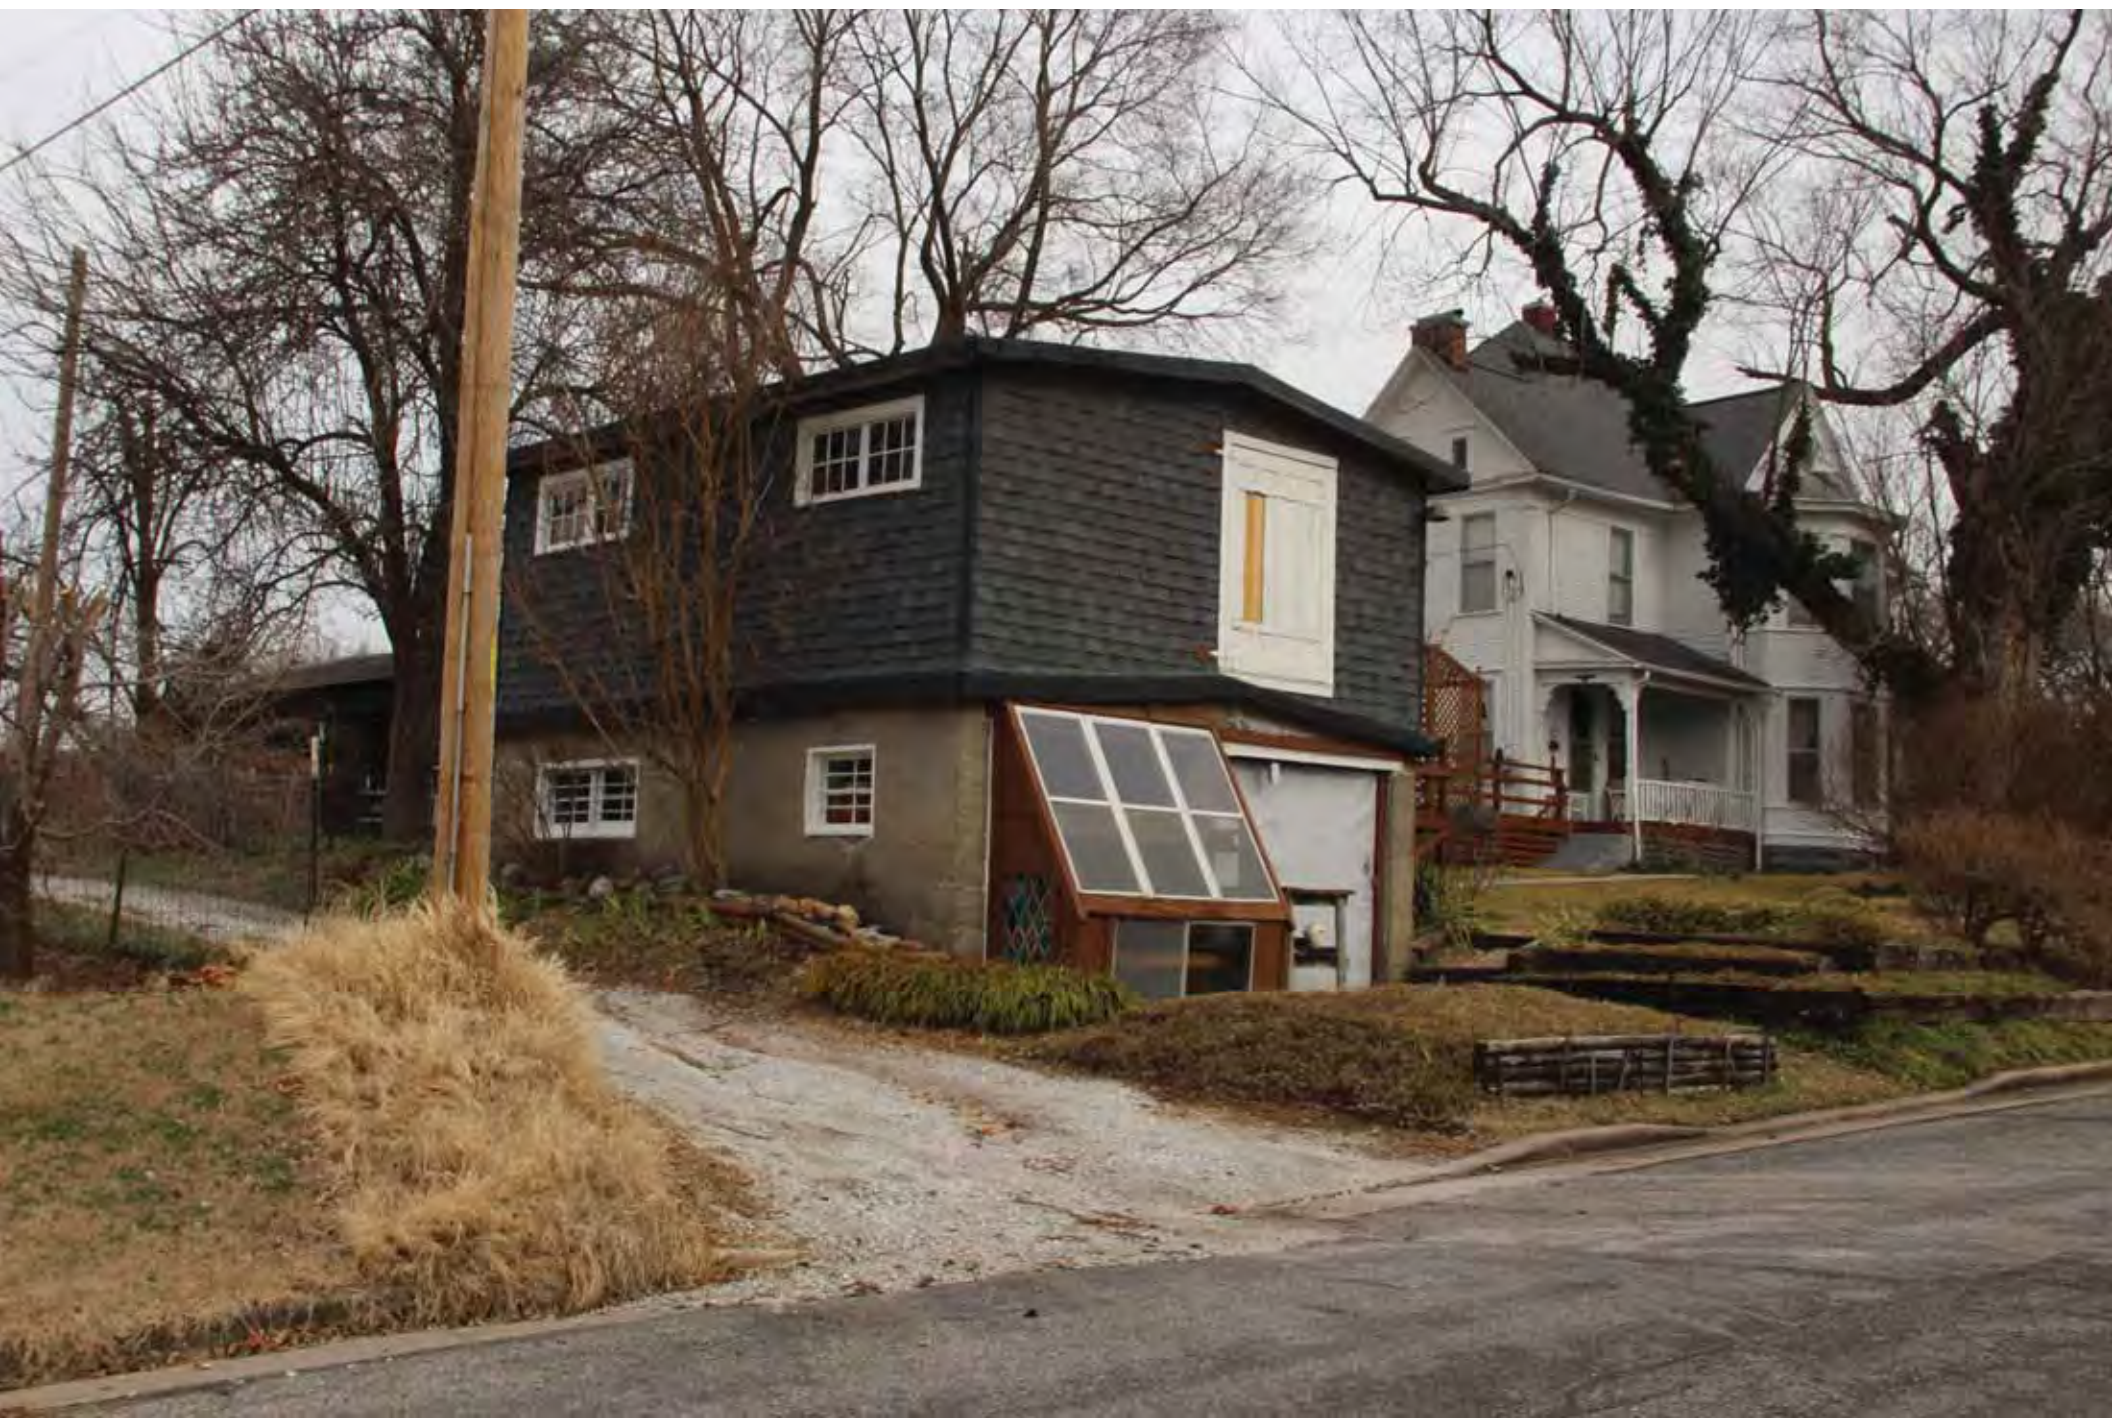
This dwelling has been extensively altered through the addition of metal siding and replacement of original windows. Due to the lack of exterior original siding, the dwelling does not retain integrity that would render it individually eligible for the National Register of Historic Places. The dwelling is not situated in an area recommended as a historic district.

The property at 223 Mineral Avenue features a 1.5 story, with a high-pitched hipped roof with gable front and side ends. It has exterior metal siding and an asphalt-shingled roof with a medium front facing gable. The front façade has a central entrance door flanked on either side by one-over-one vinyl replacement windows. There is a non-historic shed roof front porch, with a concrete foundation, which extends the length of the front facade. On the side facades are one-over-one vinyl replacement windows. On the north side of the house is a hipped roof dormer.
