MISSOURI DEPARTMENT OF NATURAL RESOURCES
STATE HISTORIC PRESERVATION OFFICE, P.O. Box 176, Jefferson City, MO 65102
ARCHITECTURAL/HISTORIC INVENTORY FORM

1. Survey No. JP-AS-007-001		2. Survey name: East Town (Original Joplin) Historic Survey Phase 2	
3. County: JASPER		4. Address (Street No.) 618	Street (name) E. 2 nd Street
5. City: Joplin	Vicinity: <input type="checkbox"/>	6. Geographical Reference:	7. Township/Range/Section: T: R: S:
8. Historic name (if known):		9. Present/other name (if known):	
10. Ownership: <input checked="" type="checkbox"/> Private <input type="checkbox"/> Public		11a. Historic use (if known): Domestic: Single Dwelling	11b. Current use: Domestic: Single Dwelling

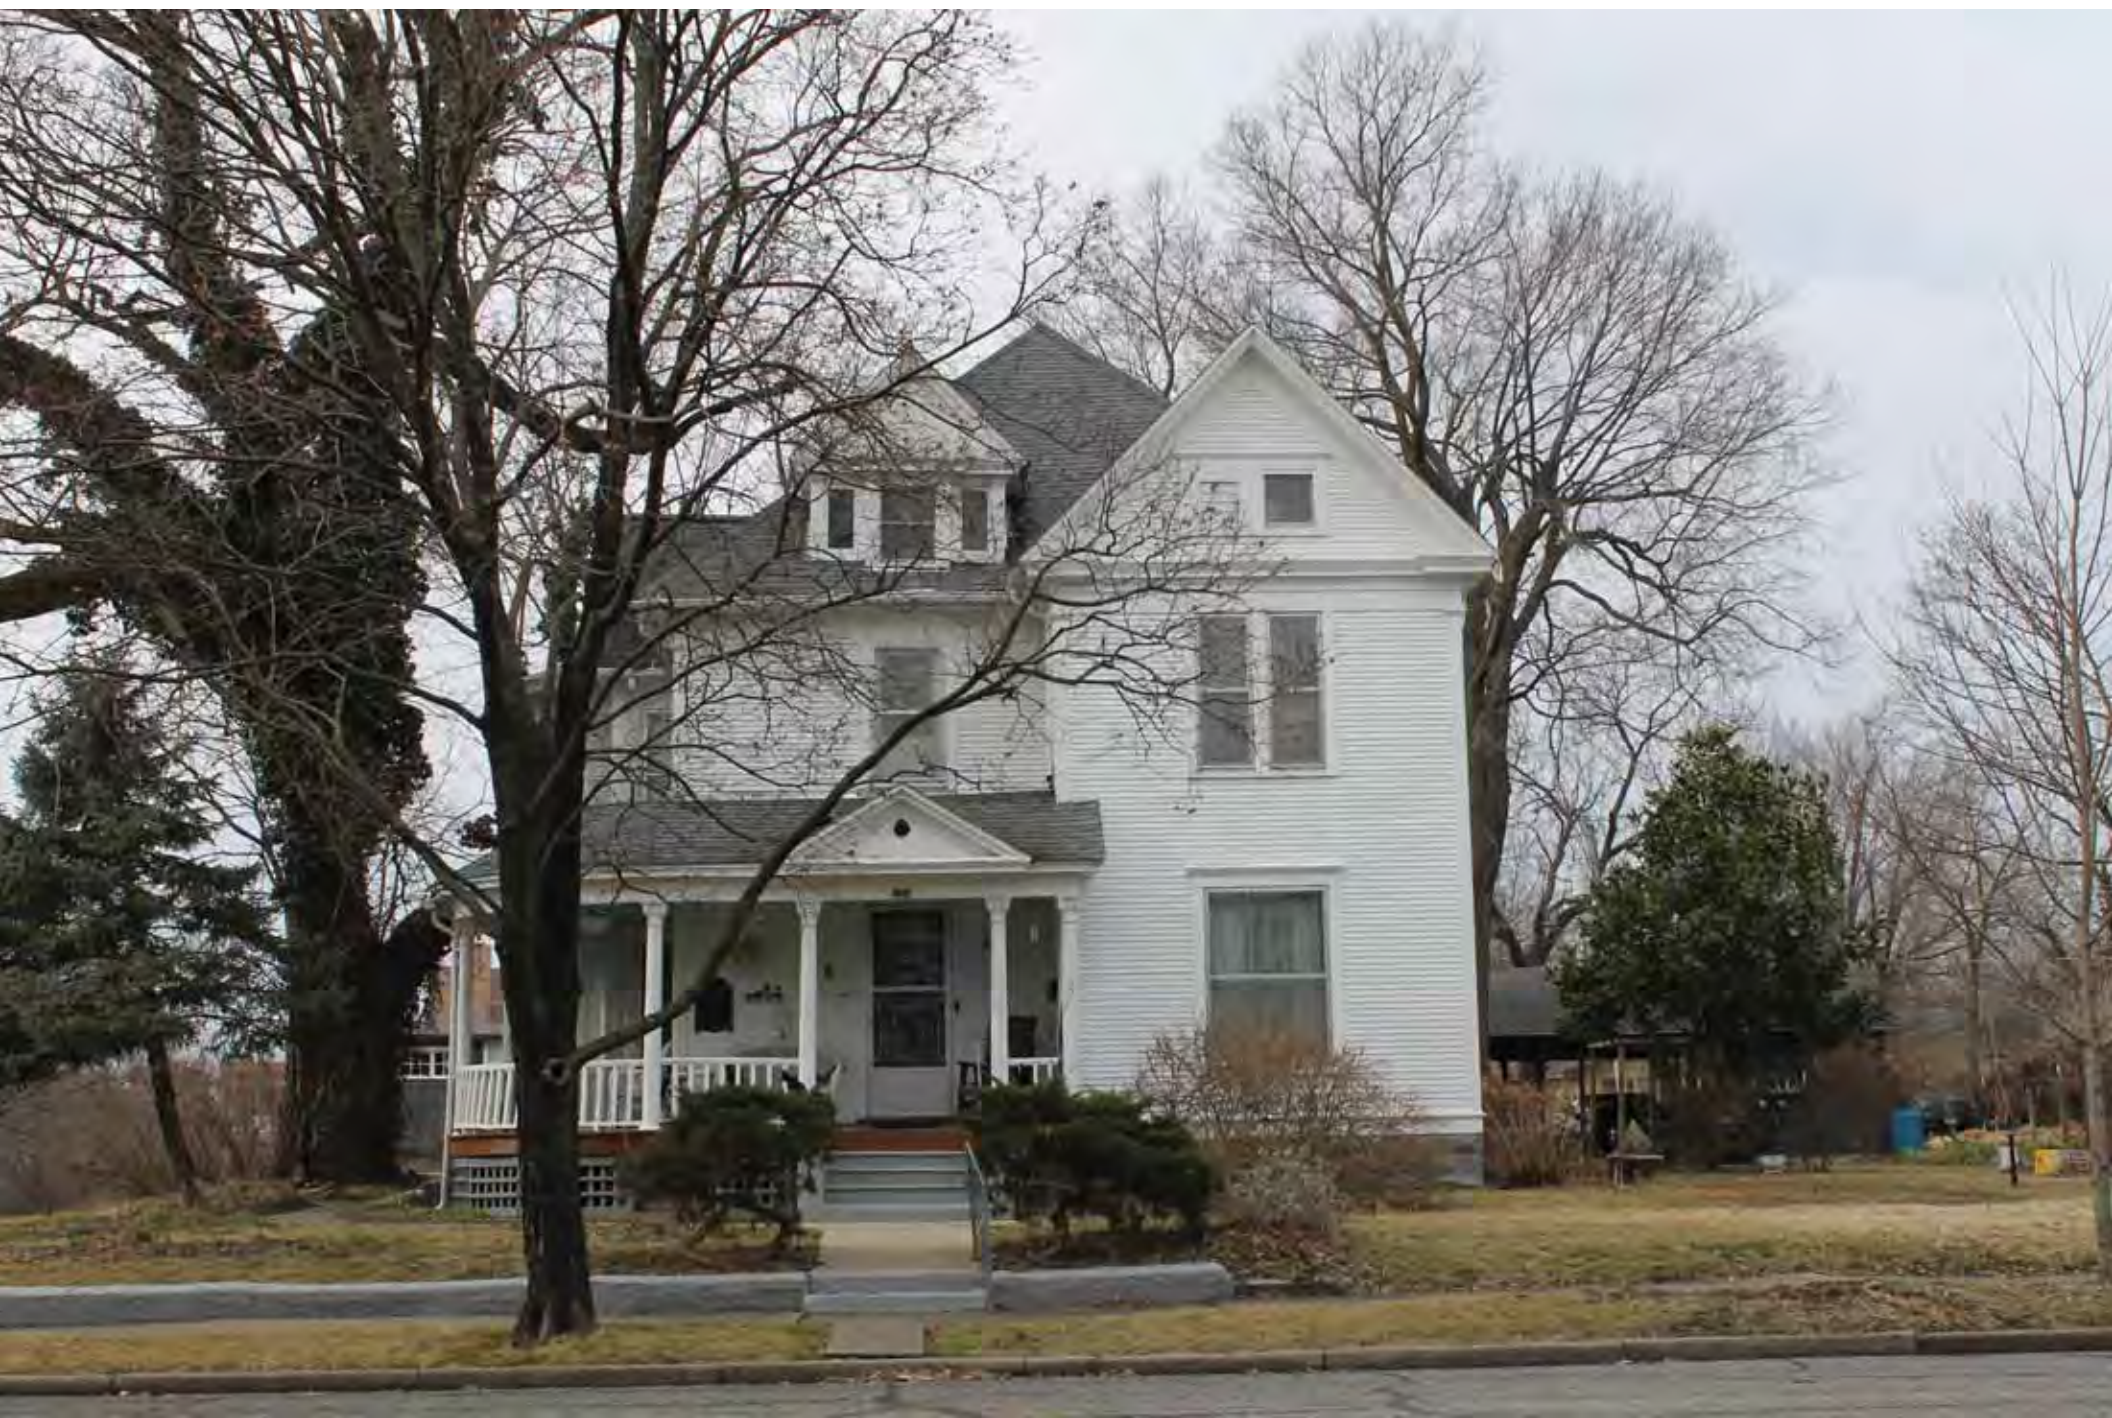
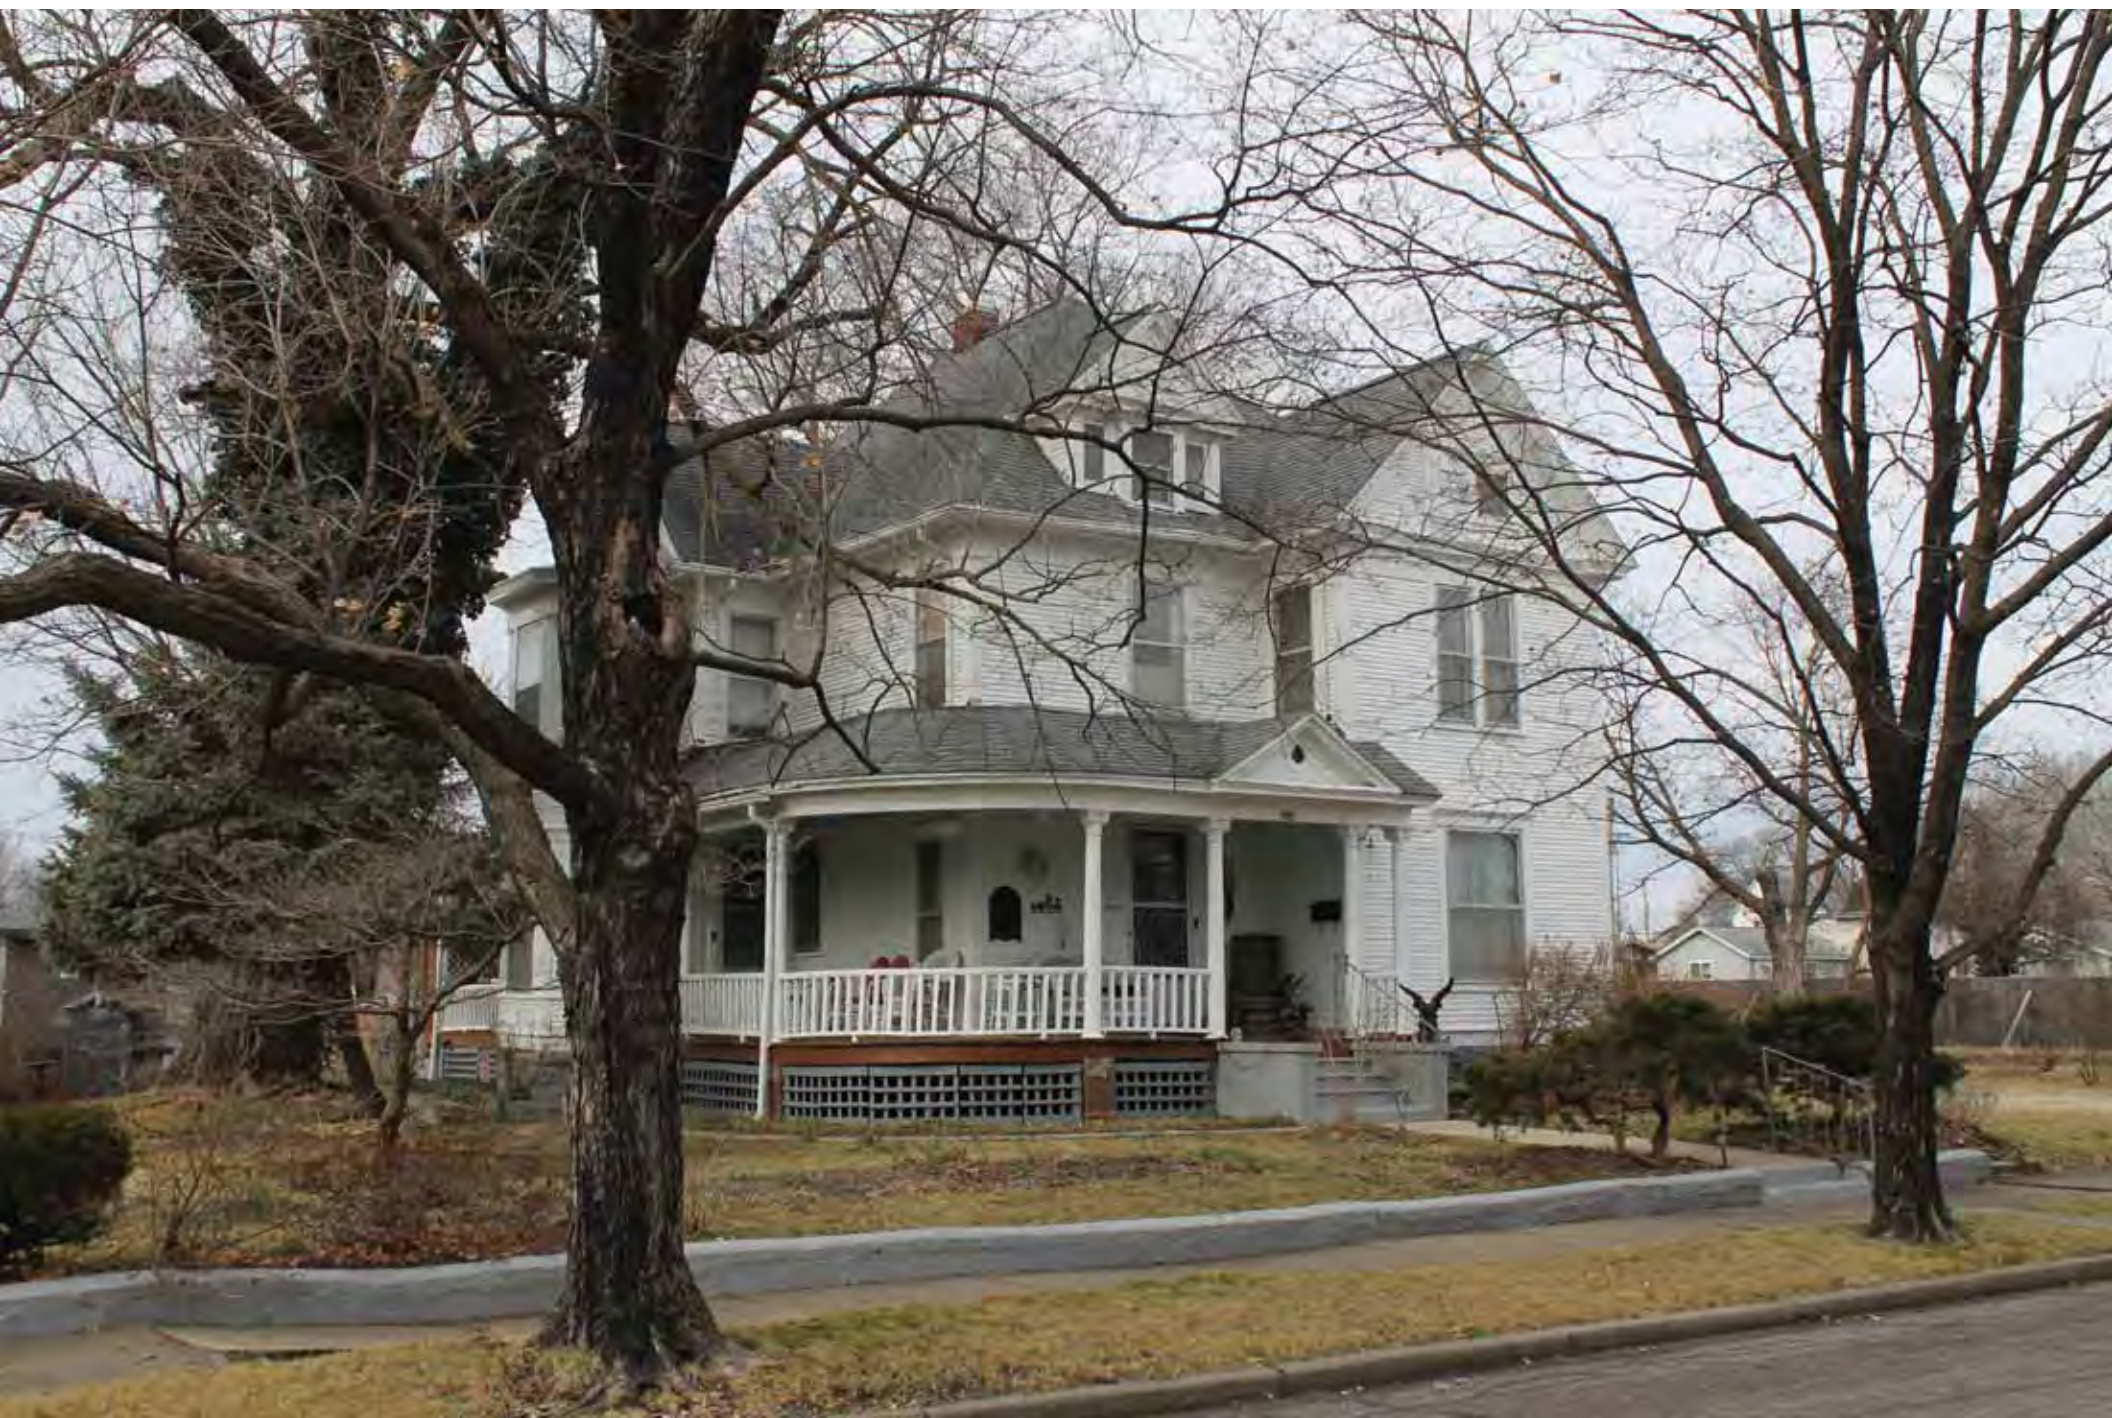
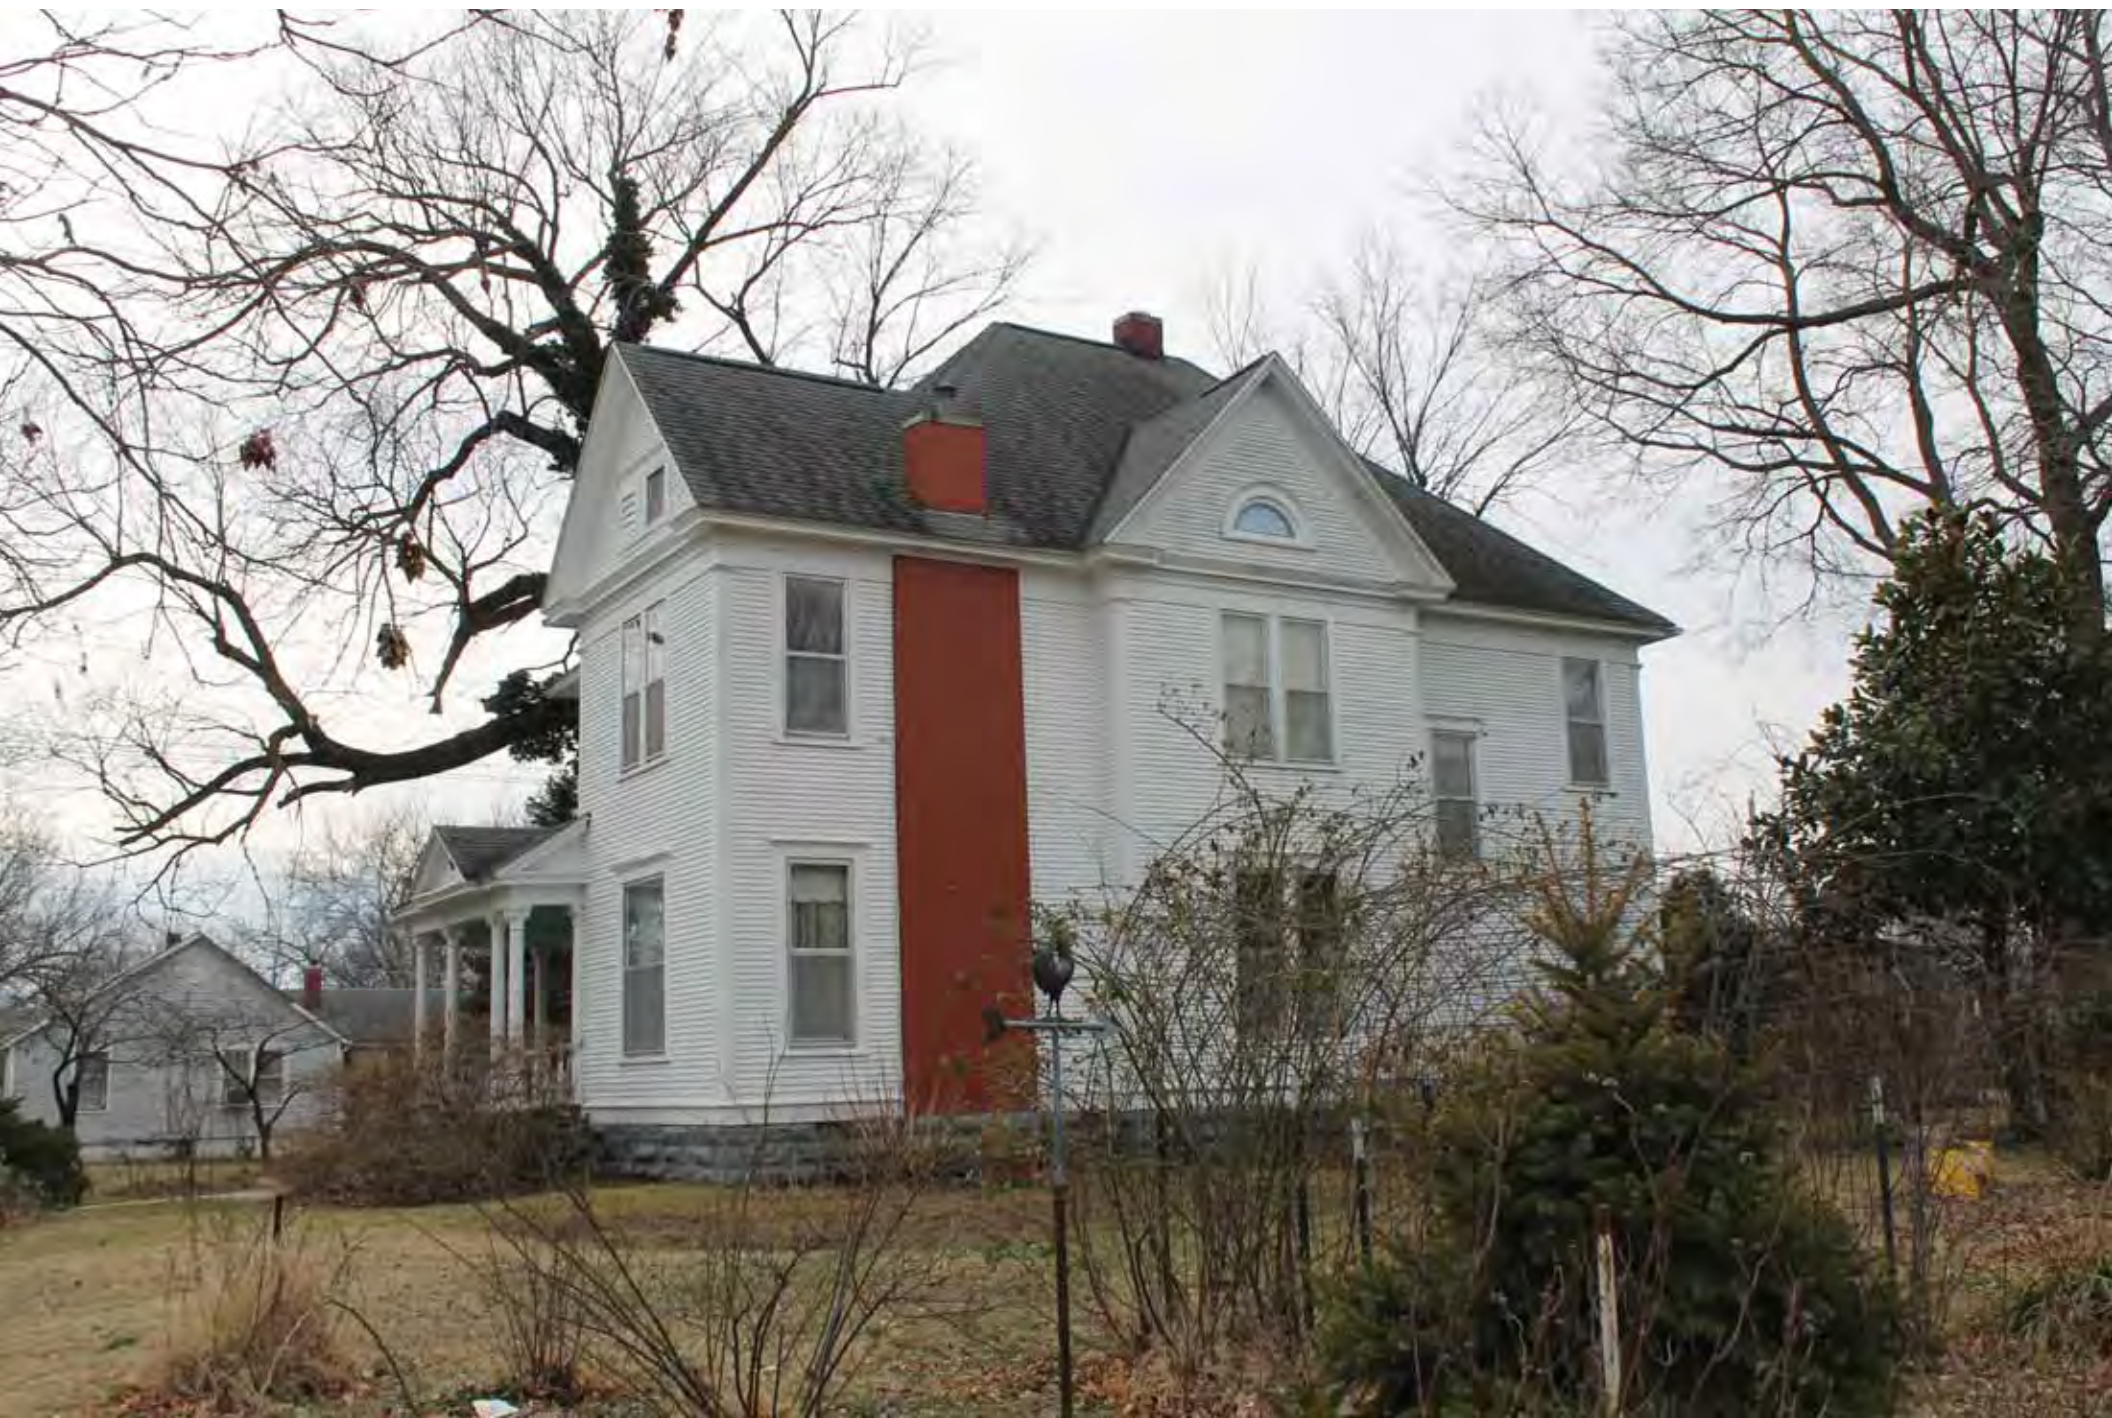
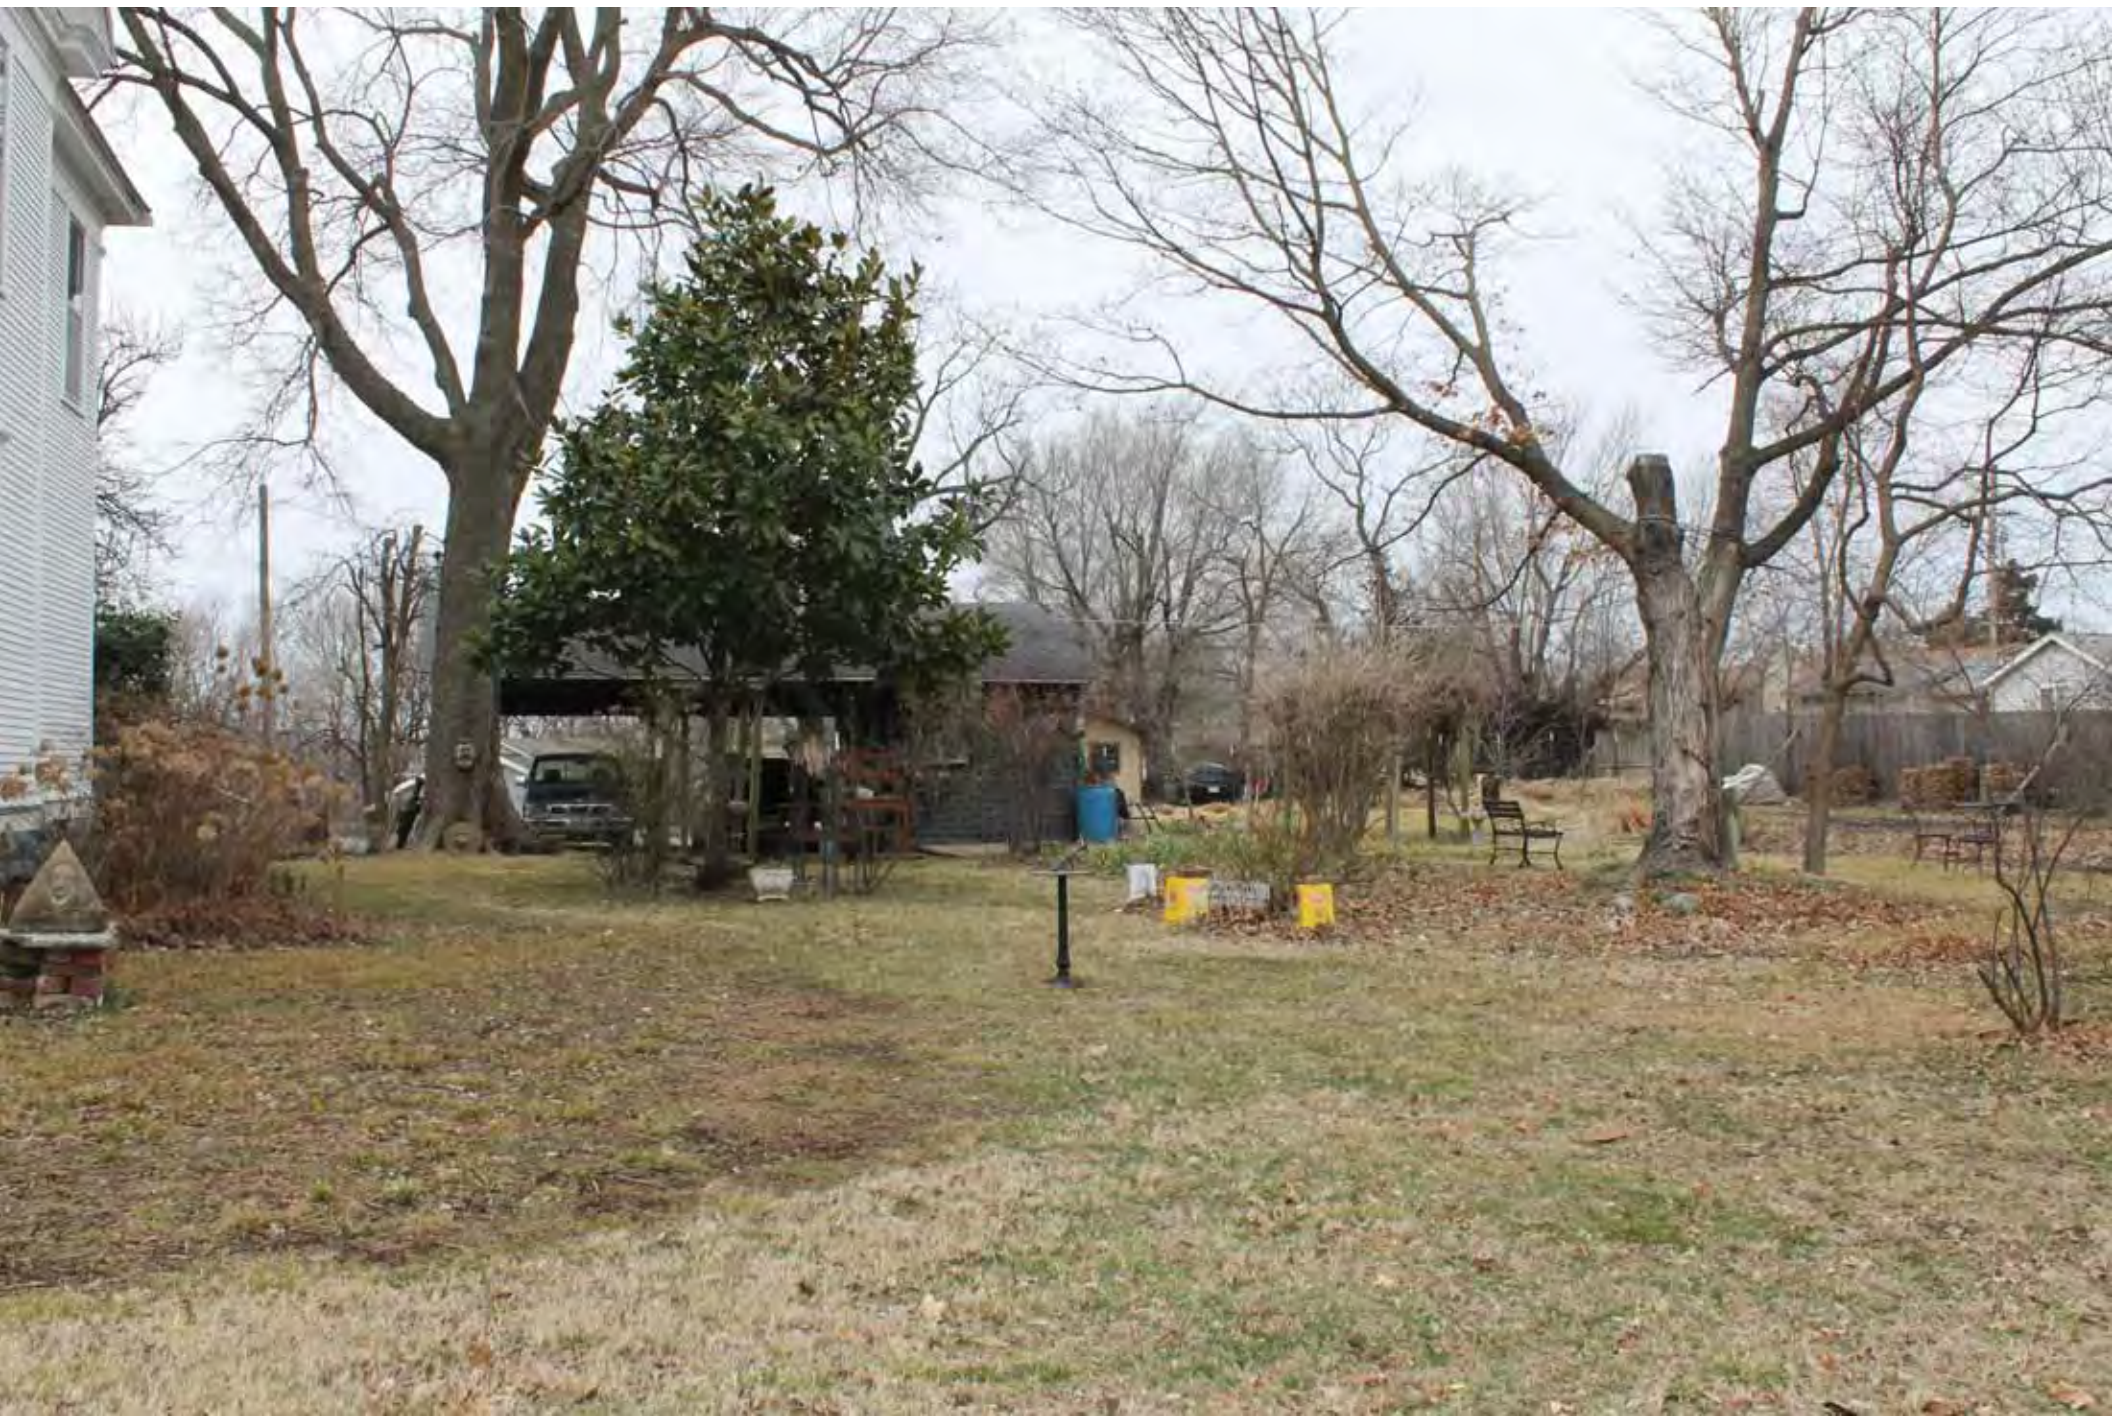
This dwelling retains a high degree of integrity and is a great example of Late 19th Century Victorian architecture. It appears to have several original features including original siding and the original wrap-around porch. It is eligible for individual listing on the National Register for Criterion C: Architecture, with its Period of Significance being 1904, the time of construction. The dwelling is not situated in an area recommended as a historic district.

Behind the house, to the northwest, is a frame open outbuilding or carport. It has a rectangular plan a gable roof on a concrete foundation. Most of this structure is open, although a portion is enclosed and covered in asphalt siding.

The property at 224 S. Mineral Avenue is a 2.5 story Queen Anne Victorian home, with an irregular floor plan and high-pitched gables on hipped roof covered in asphalt siding. The entire house is covered in the original wood siding. On the south corner of the house is a wrap-around wooden front porch, supported on wooden Corinthian columns. It has a pediment end on the front façade above the front steps. The front entrance is a single front door. Windows on all sides of the first and second floor are single one-over-one and appear to be the original wood windows. At the half story level there is a front facing gable pediment end on the right side of the front of the house. To the south of this pediment is a large pediment end gable with a one-over-one window with sidelights.
