MISSOURI DEPARTMENT OF NATURAL RESOURCES
STATE HISTORIC PRESERVATION OFFICE, P.O. Box 176, Jefferson City, MO 65102
ARCHITECTURAL/HISTORIC INVENTORY FORM

1. Survey No. JP-AS-007-001		2. Survey name: East Town (Original Joplin) Historic Survey Phase 2	
3. County: JASPER		4. Address (Street No.) 618	Street (name) E. 2 nd Street
5. City: Joplin	Vicinity: <input type="checkbox"/>	6. Geographical Reference:	7. Township/Range/Section: T: R: S:
8. Historic name (if known):		9. Present/other name (if known):	
10. Ownership: <input checked="" type="checkbox"/> Private <input type="checkbox"/> Public		11a. Historic use (if known): Domestic: Single Dwelling	11b. Current use: Domestic: Single Dwelling

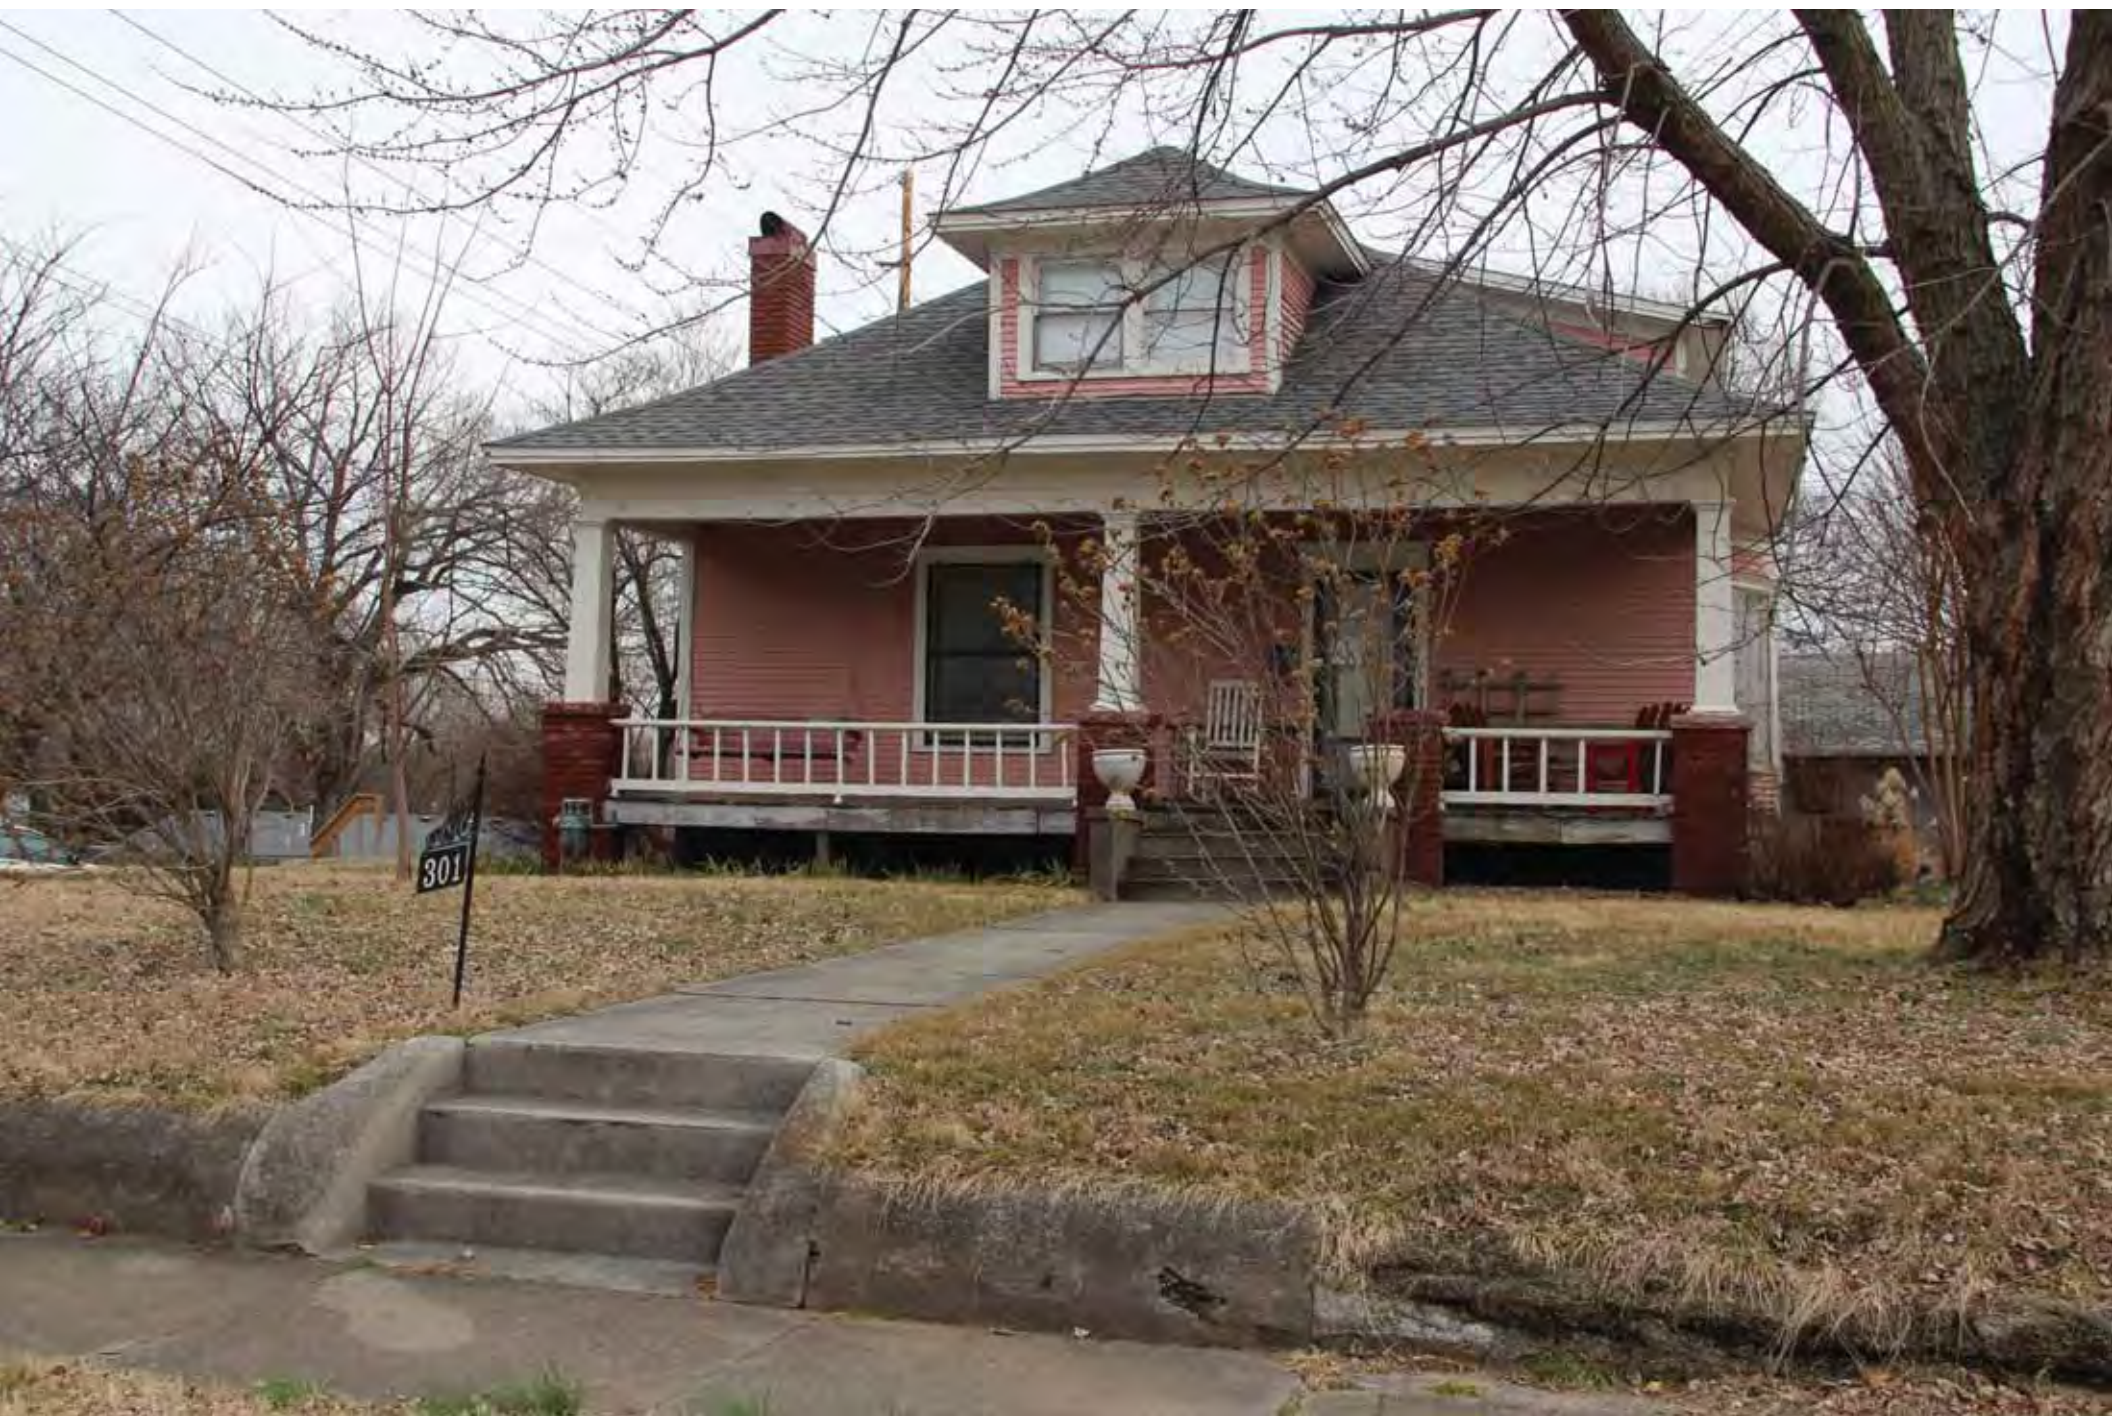
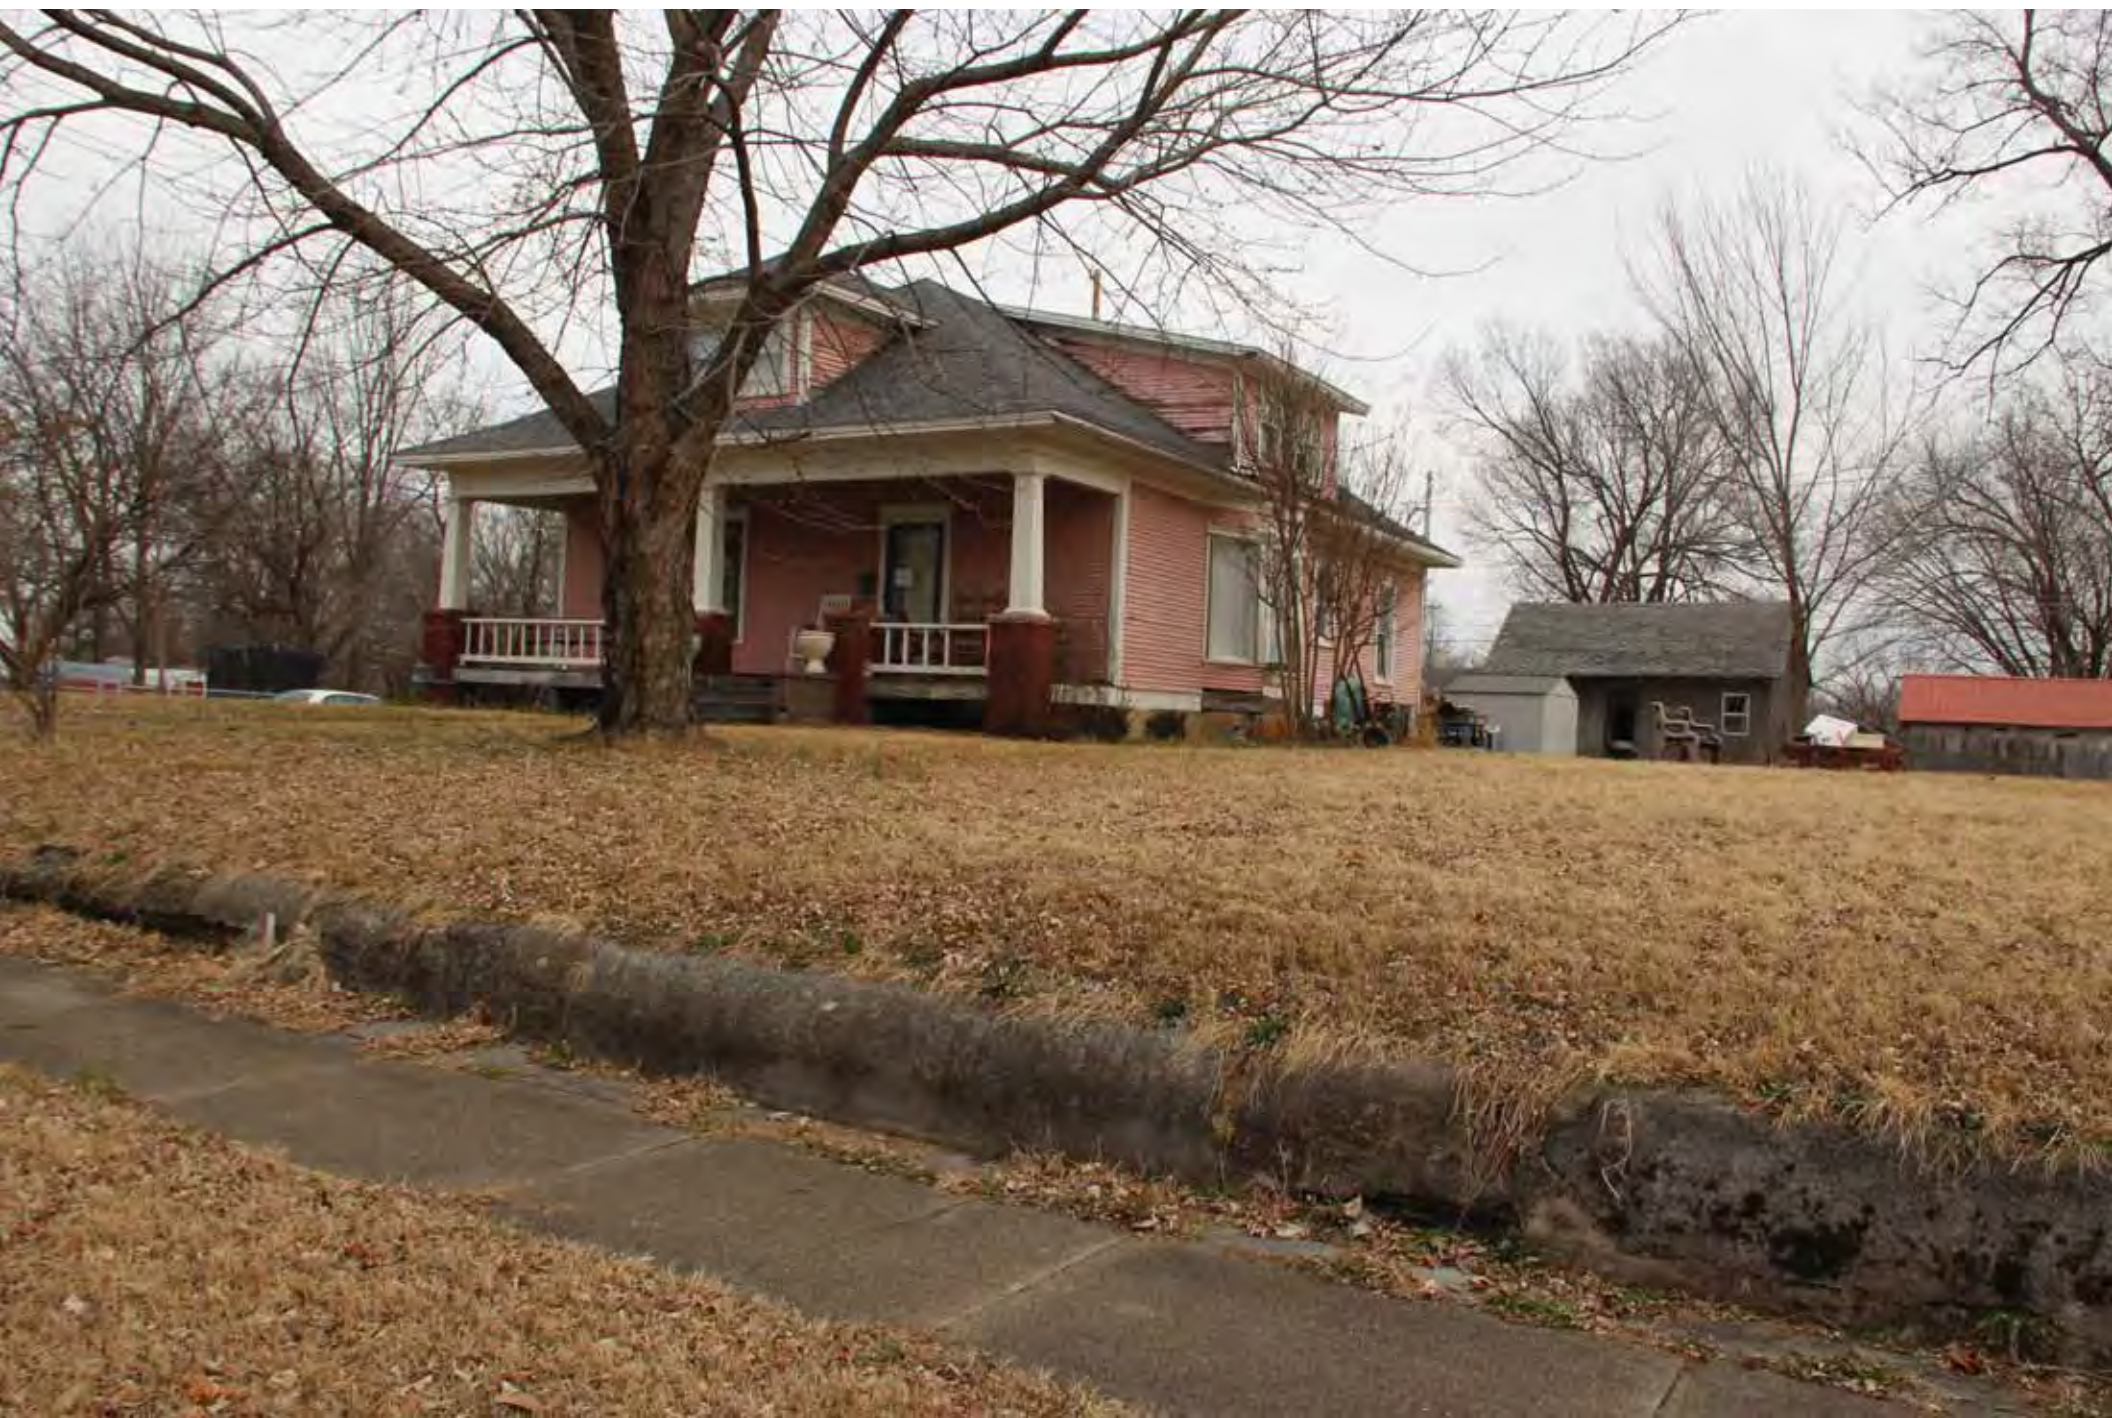
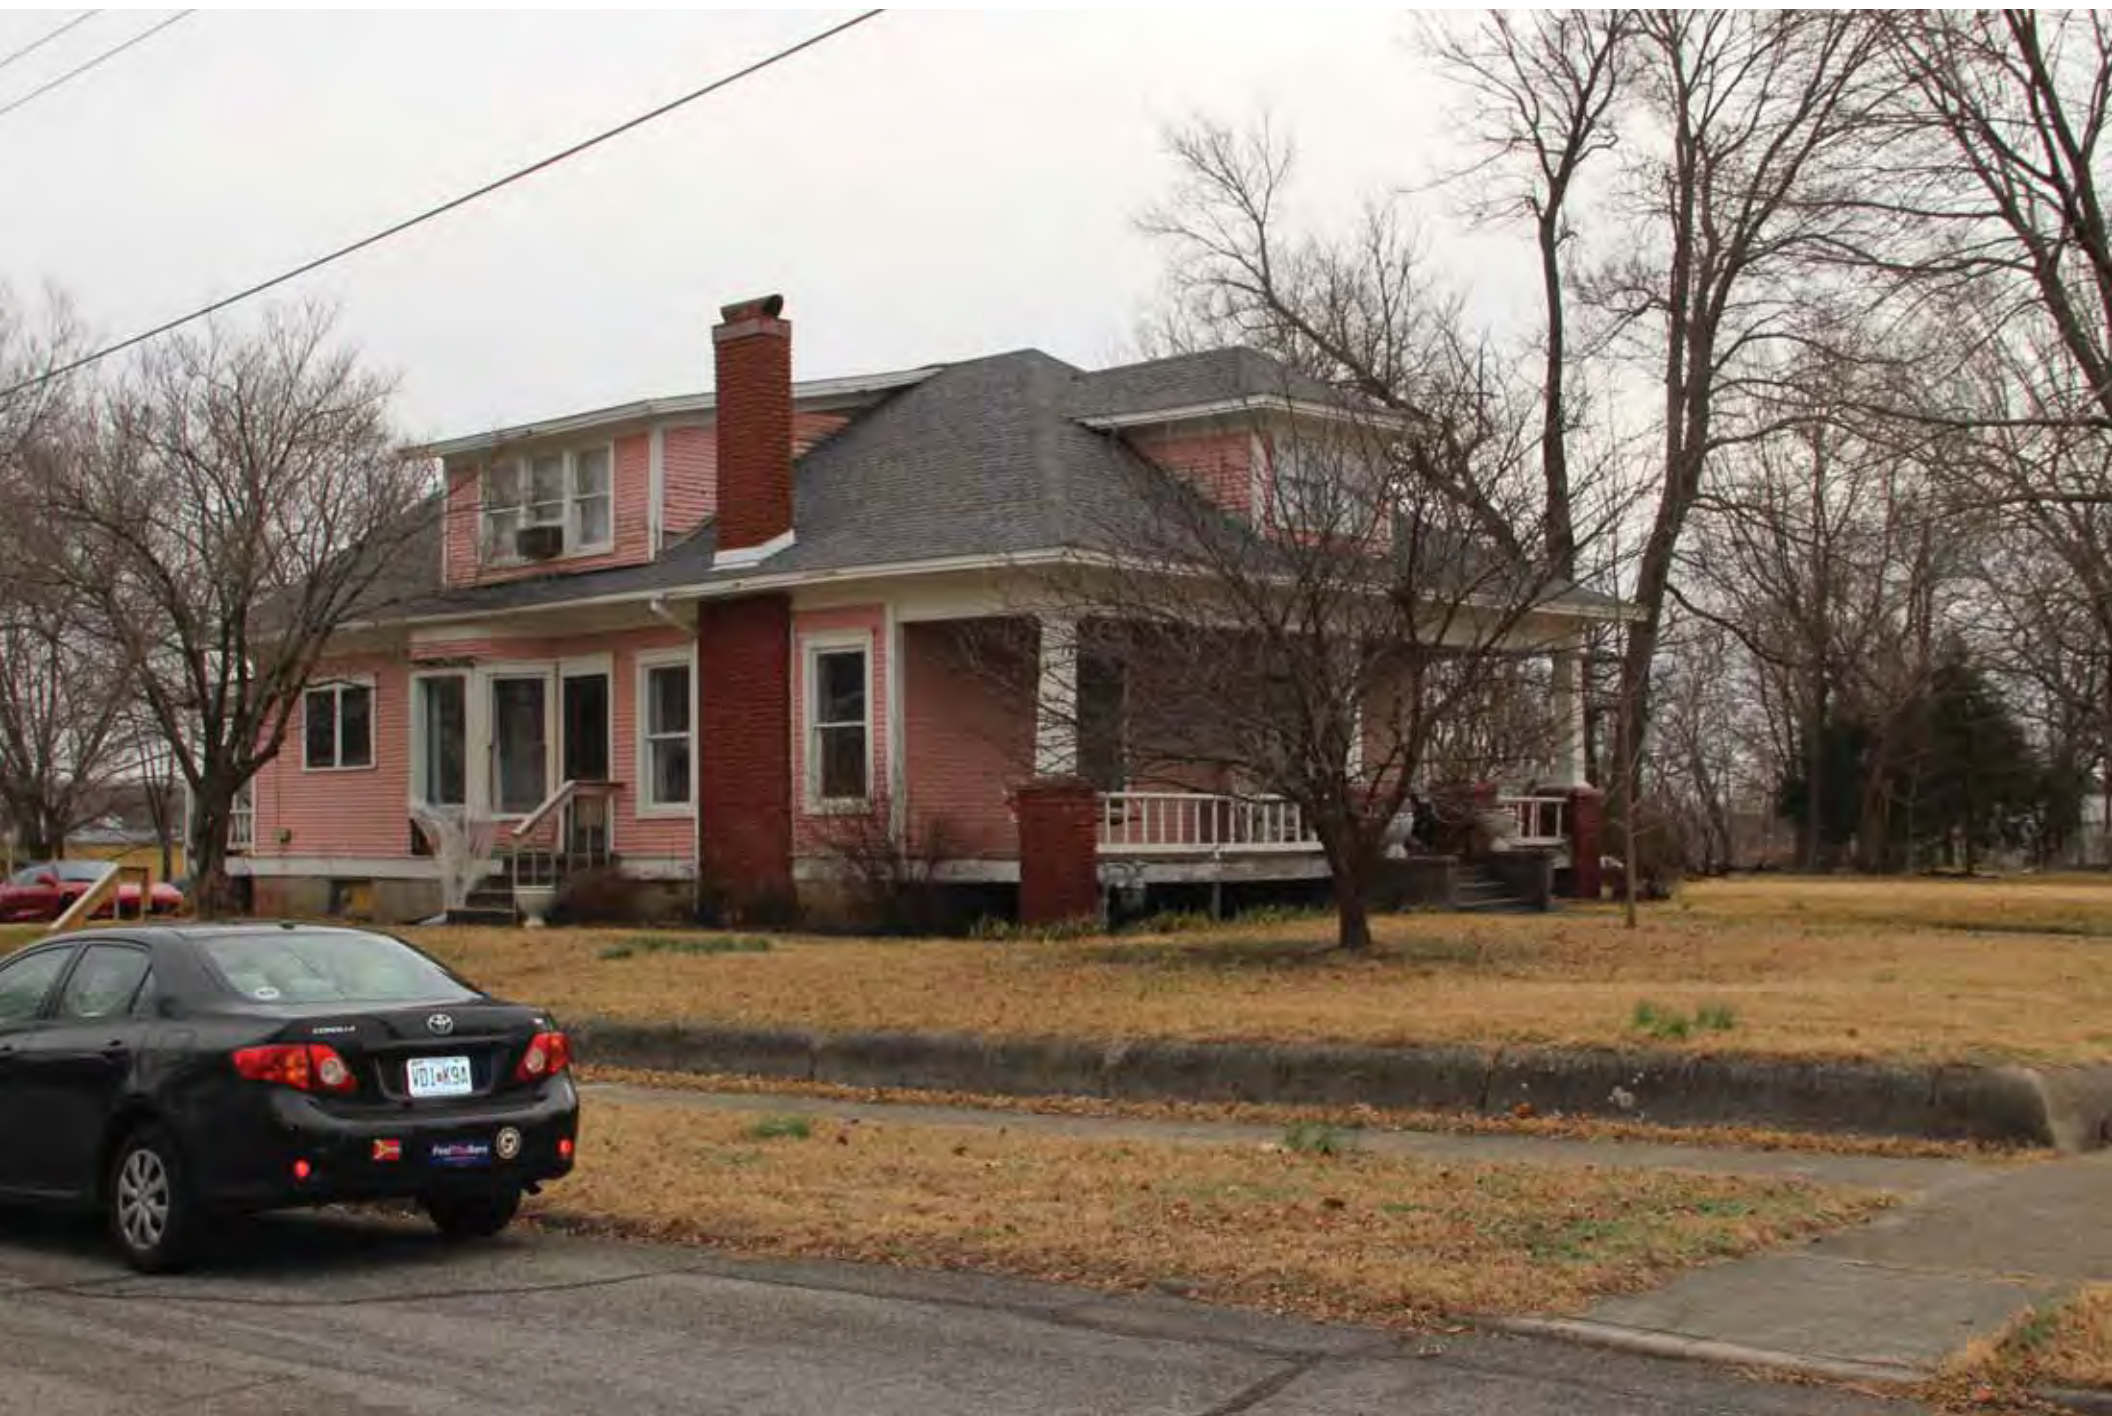
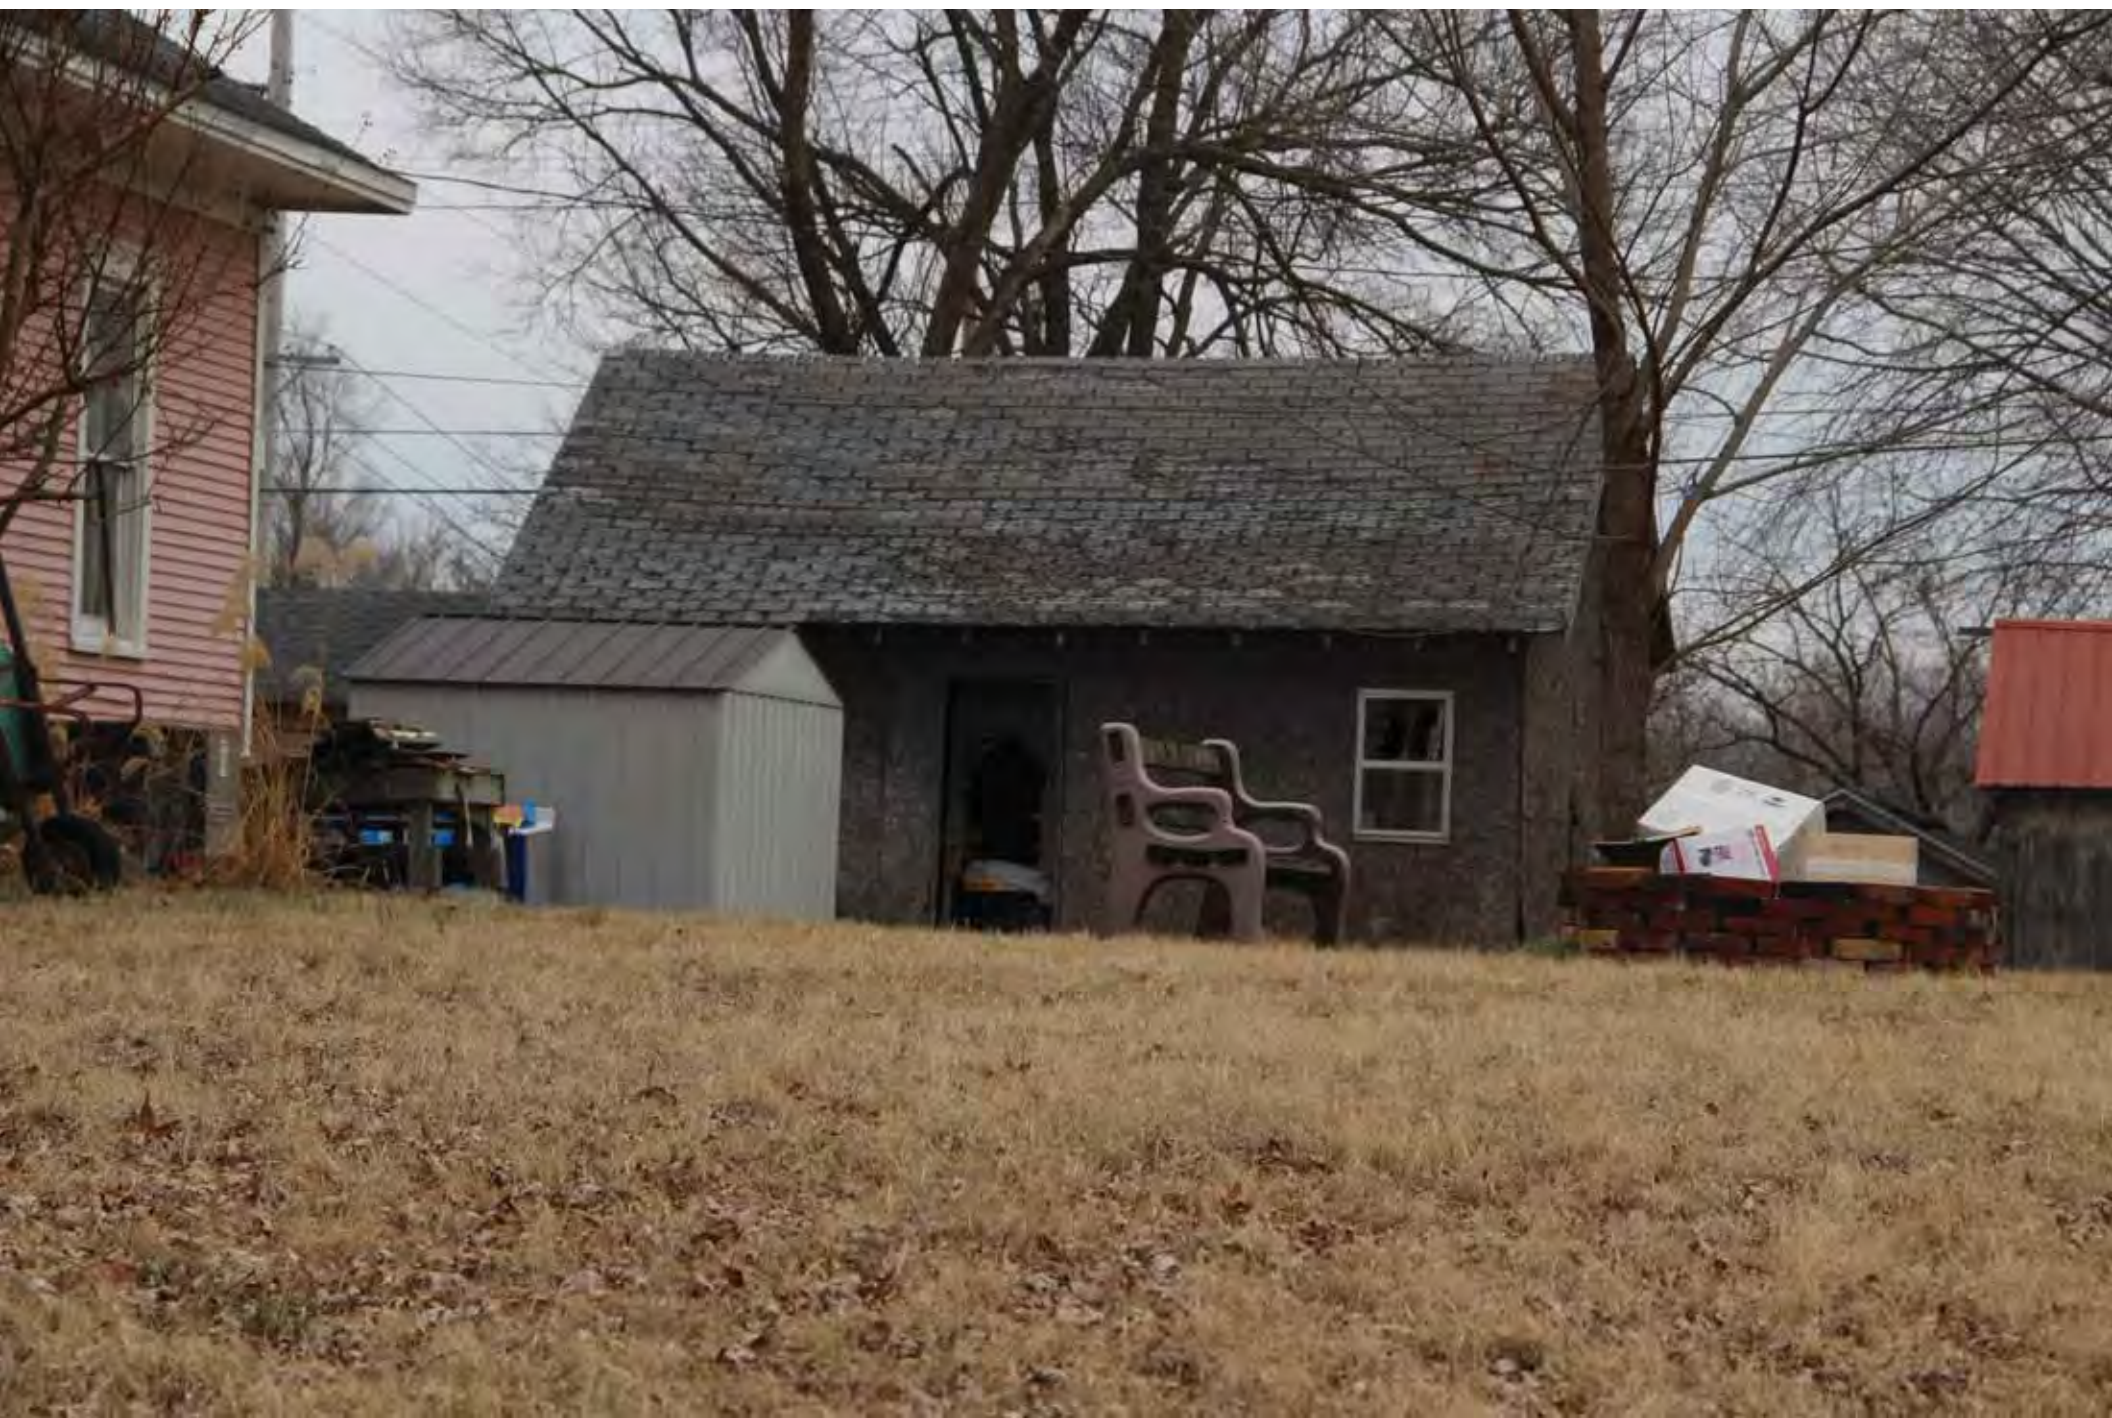
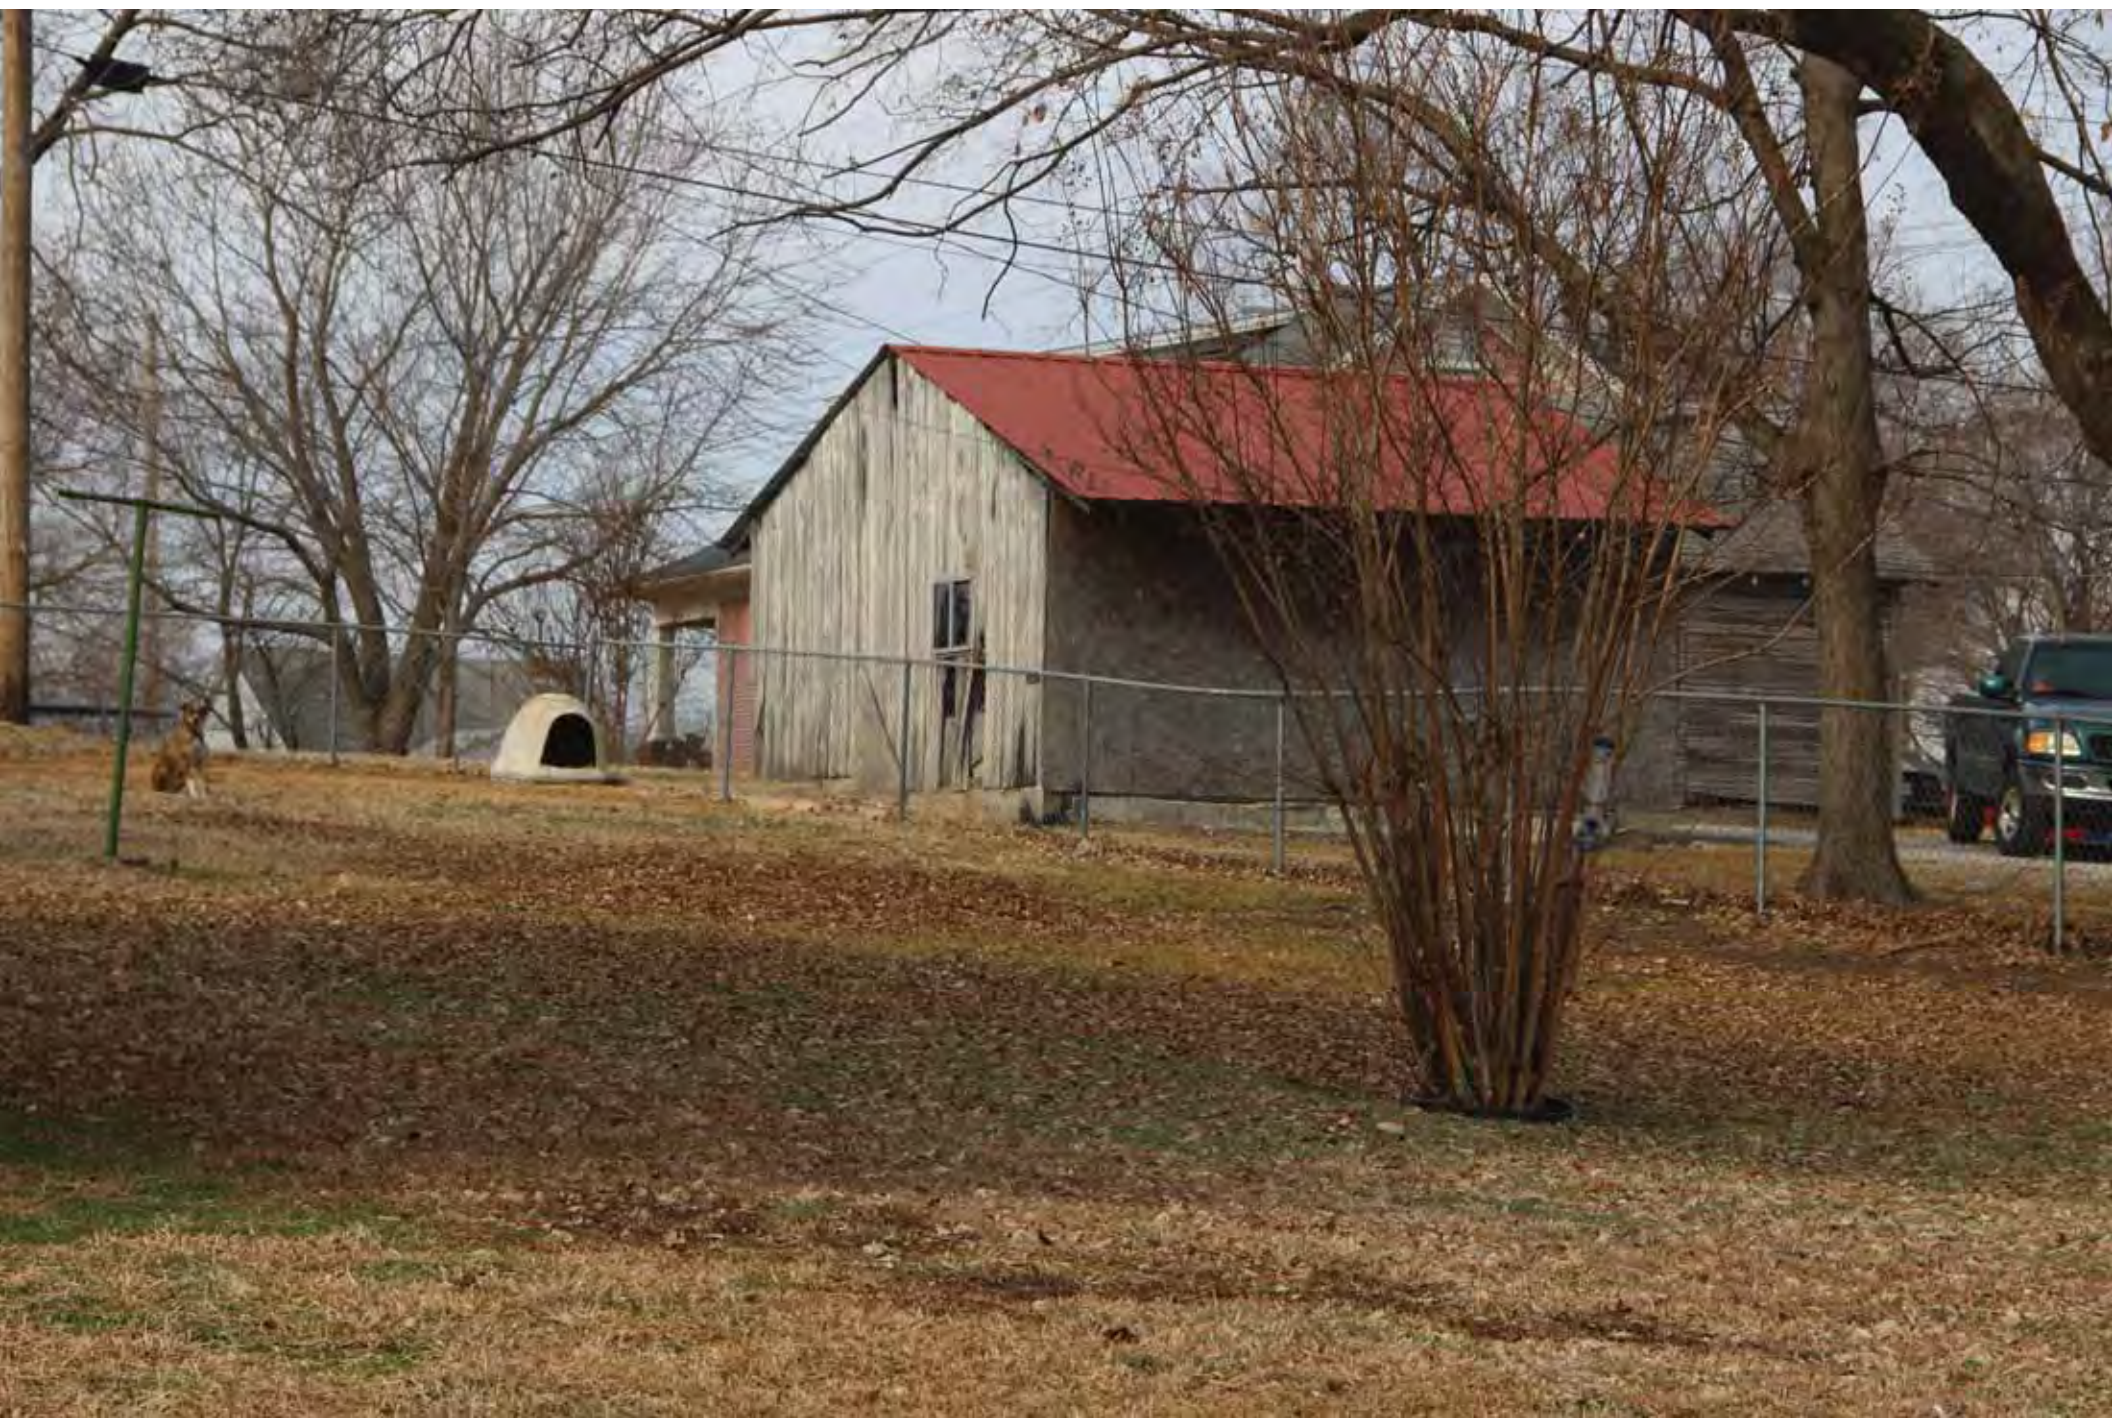
This dwelling does not retain integrity that would render it individually eligible for the National Register of Historic Places. The dwelling is not situated in an area recommended as a historic district.

According to Jasper County records the house at 301 S. Mineral Avenue was constructed in 1910. It has a rectangular floor plan with a hipped roof covered in asphalt siding. The entire house has been covered painted wood siding. A veranda extends the length of the front façade. It has square wooden supports on a brick base. It shelters a front door and a single one-over-one window. At the half story level there is a hipped roof dormer on the front façade. On the south side of the house is a shed roof dormer.
