MISSOURI DEPARTMENT OF NATURAL RESOURCES
STATE HISTORIC PRESERVATION OFFICE, P.O. Box 176, Jefferson City, MO 65102
ARCHITECTURAL/HISTORIC INVENTORY FORM

1. Survey No. JP-AS-007-001		2. Survey name: East Town (Original Joplin) Historic Survey Phase 2	
3. County: JASPER		4. Address (Street No.) 618	Street (name) E. 2 nd Street
5. City: Joplin	Vicinity: <input type="checkbox"/>	6. Geographical Reference:	7. Township/Range/Section: T: R: S:
8. Historic name (if known):		9. Present/other name (if known):	
10. Ownership: <input checked="" type="checkbox"/> Private <input type="checkbox"/> Public		11a. Historic use (if known): Domestic: Single Dwelling	11b. Current use: Domestic: Single Dwelling

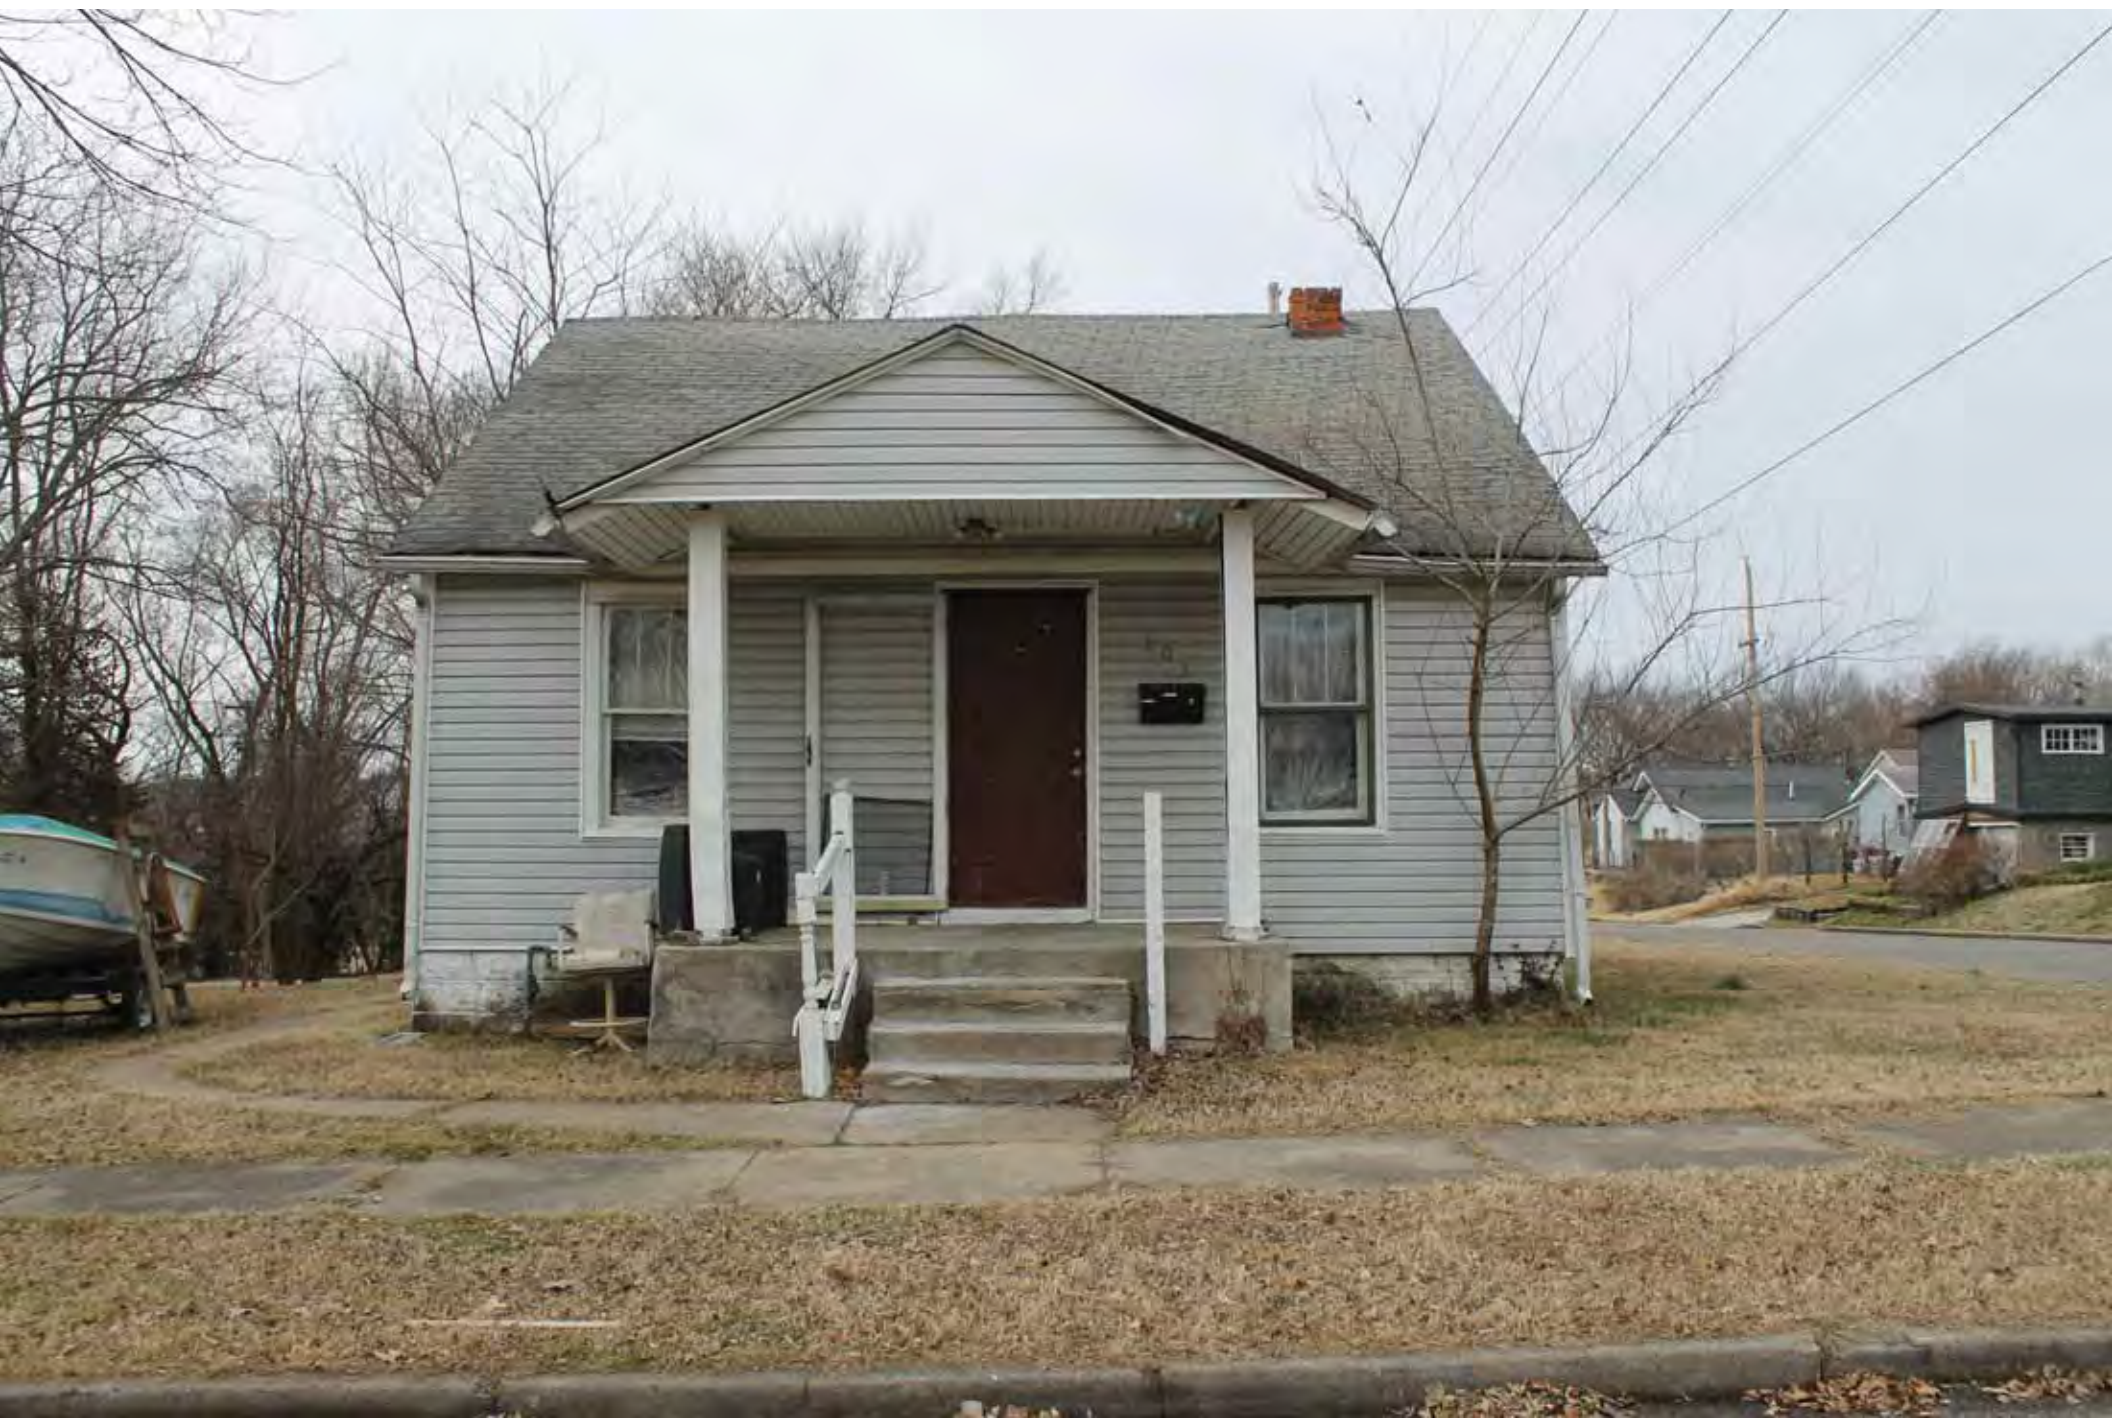
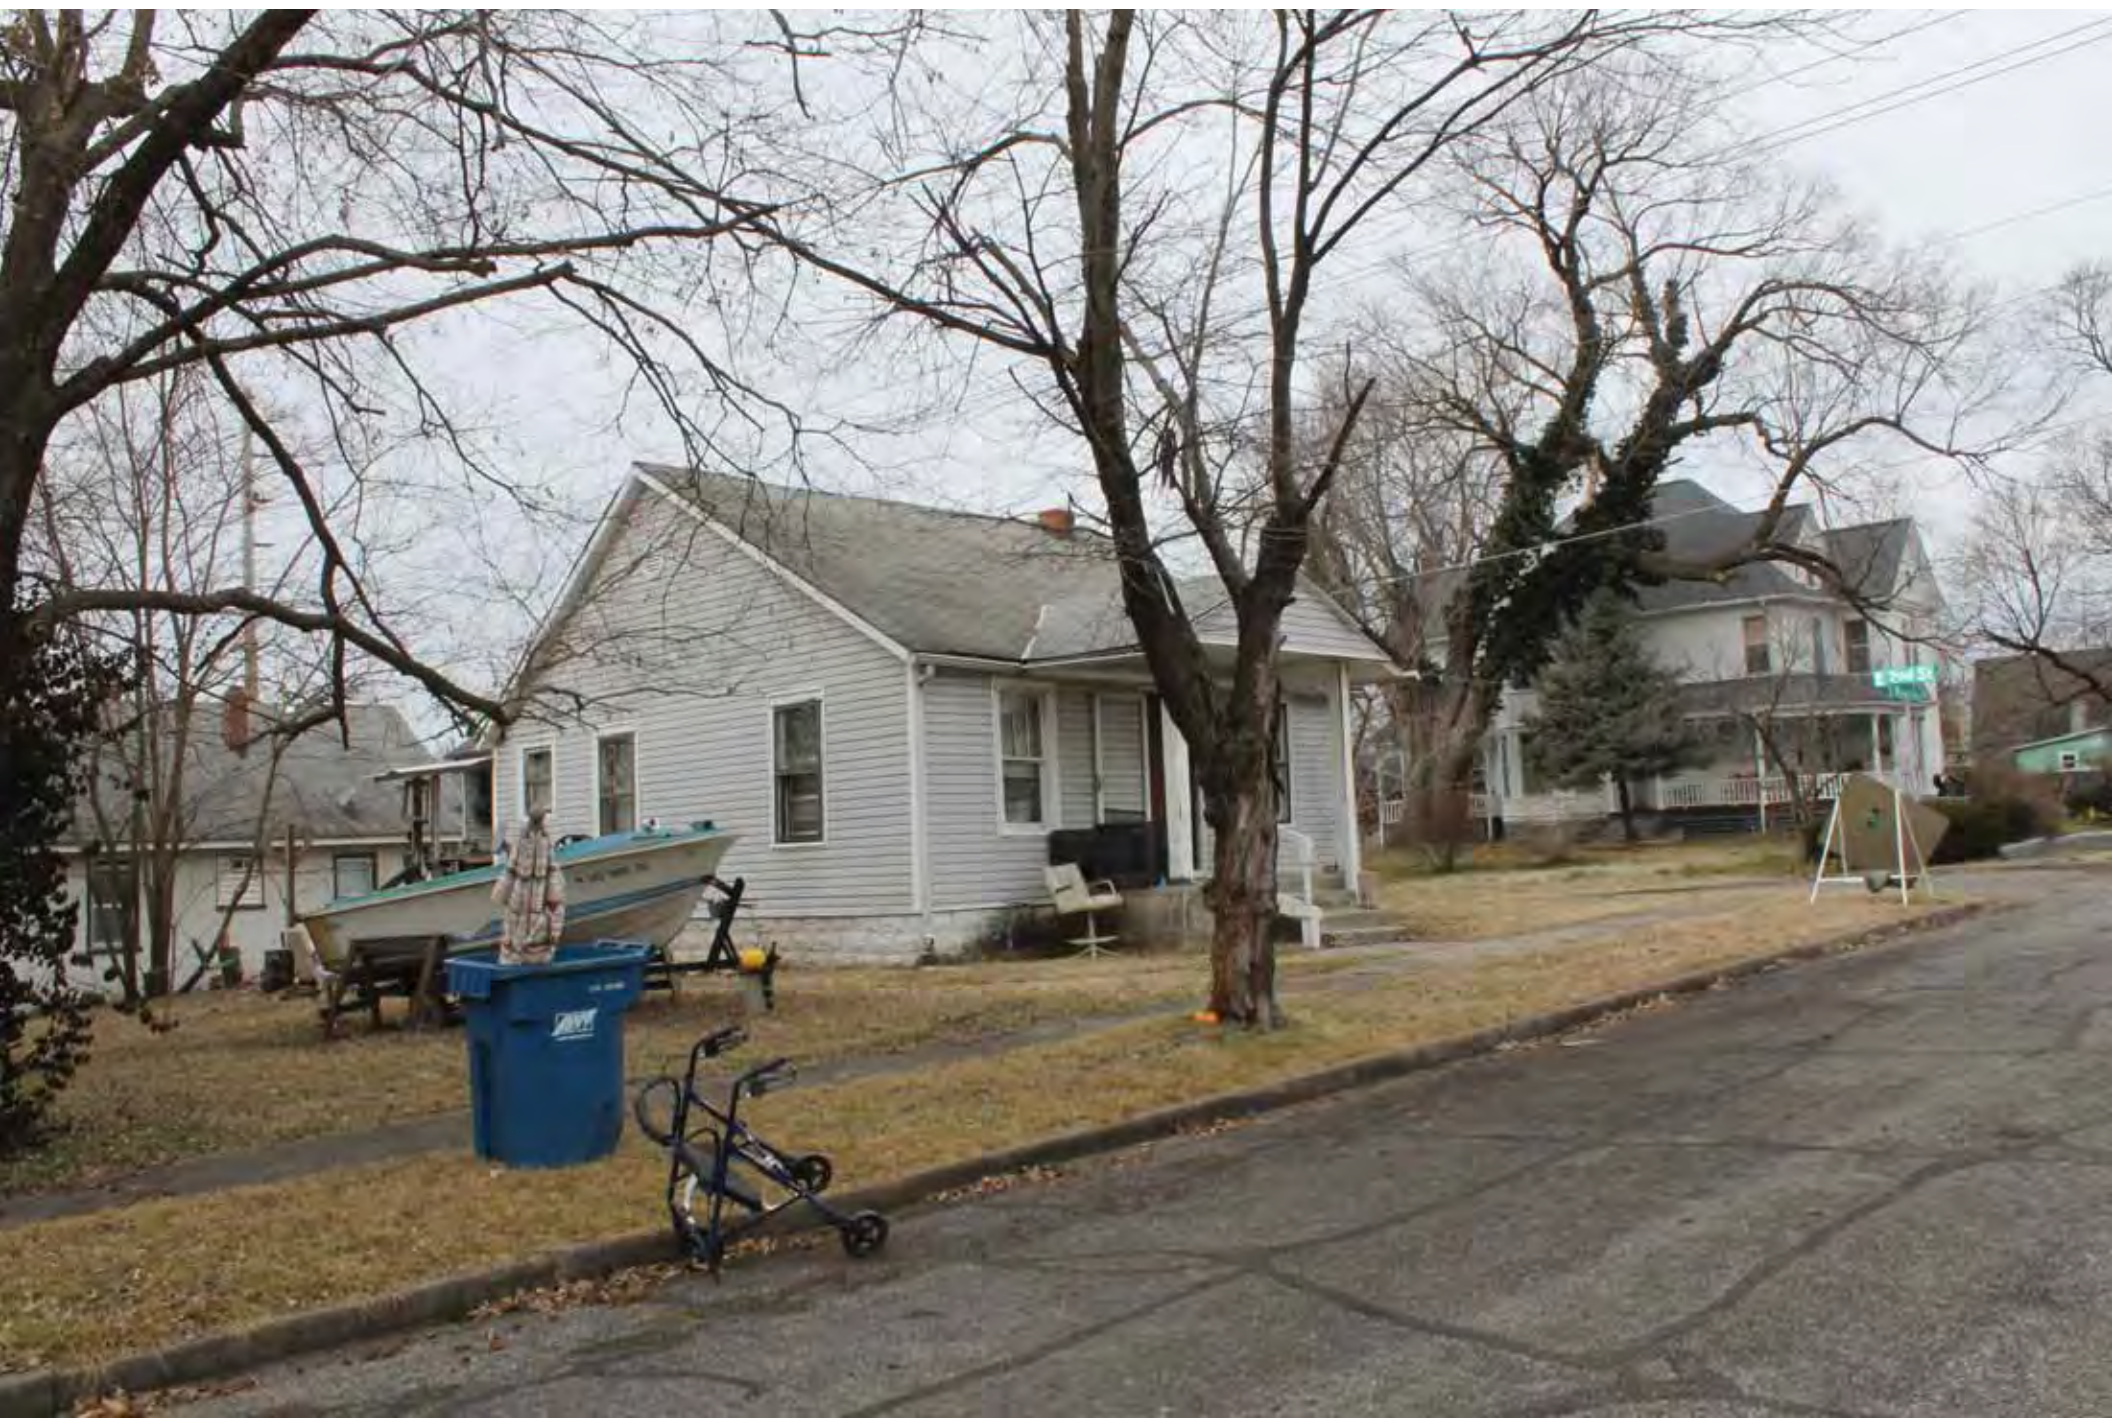
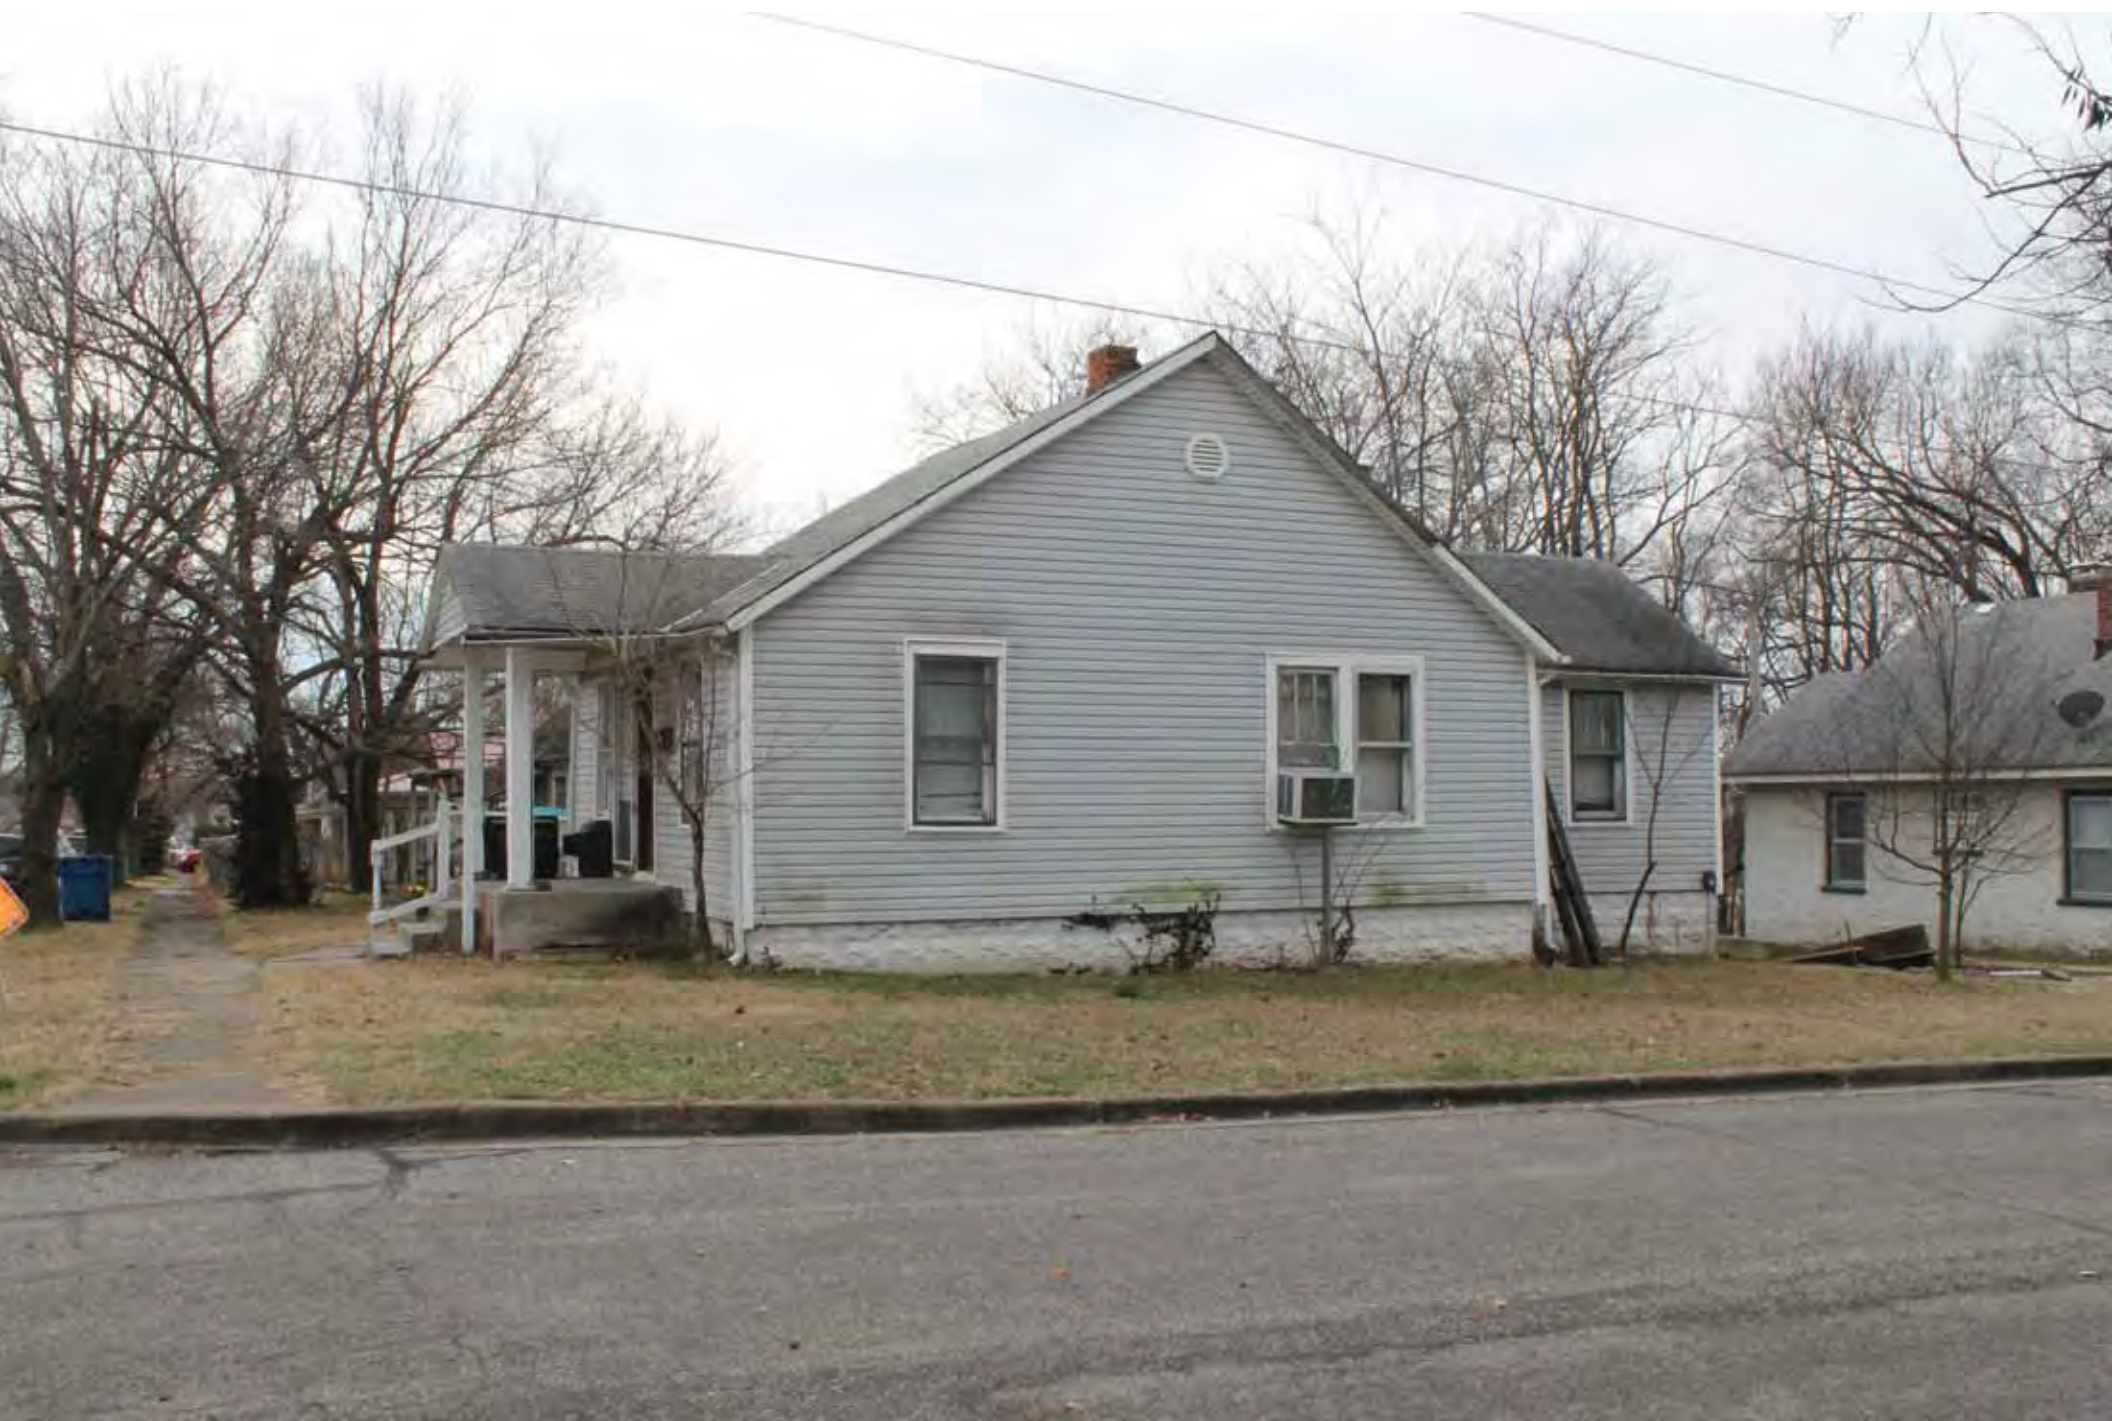
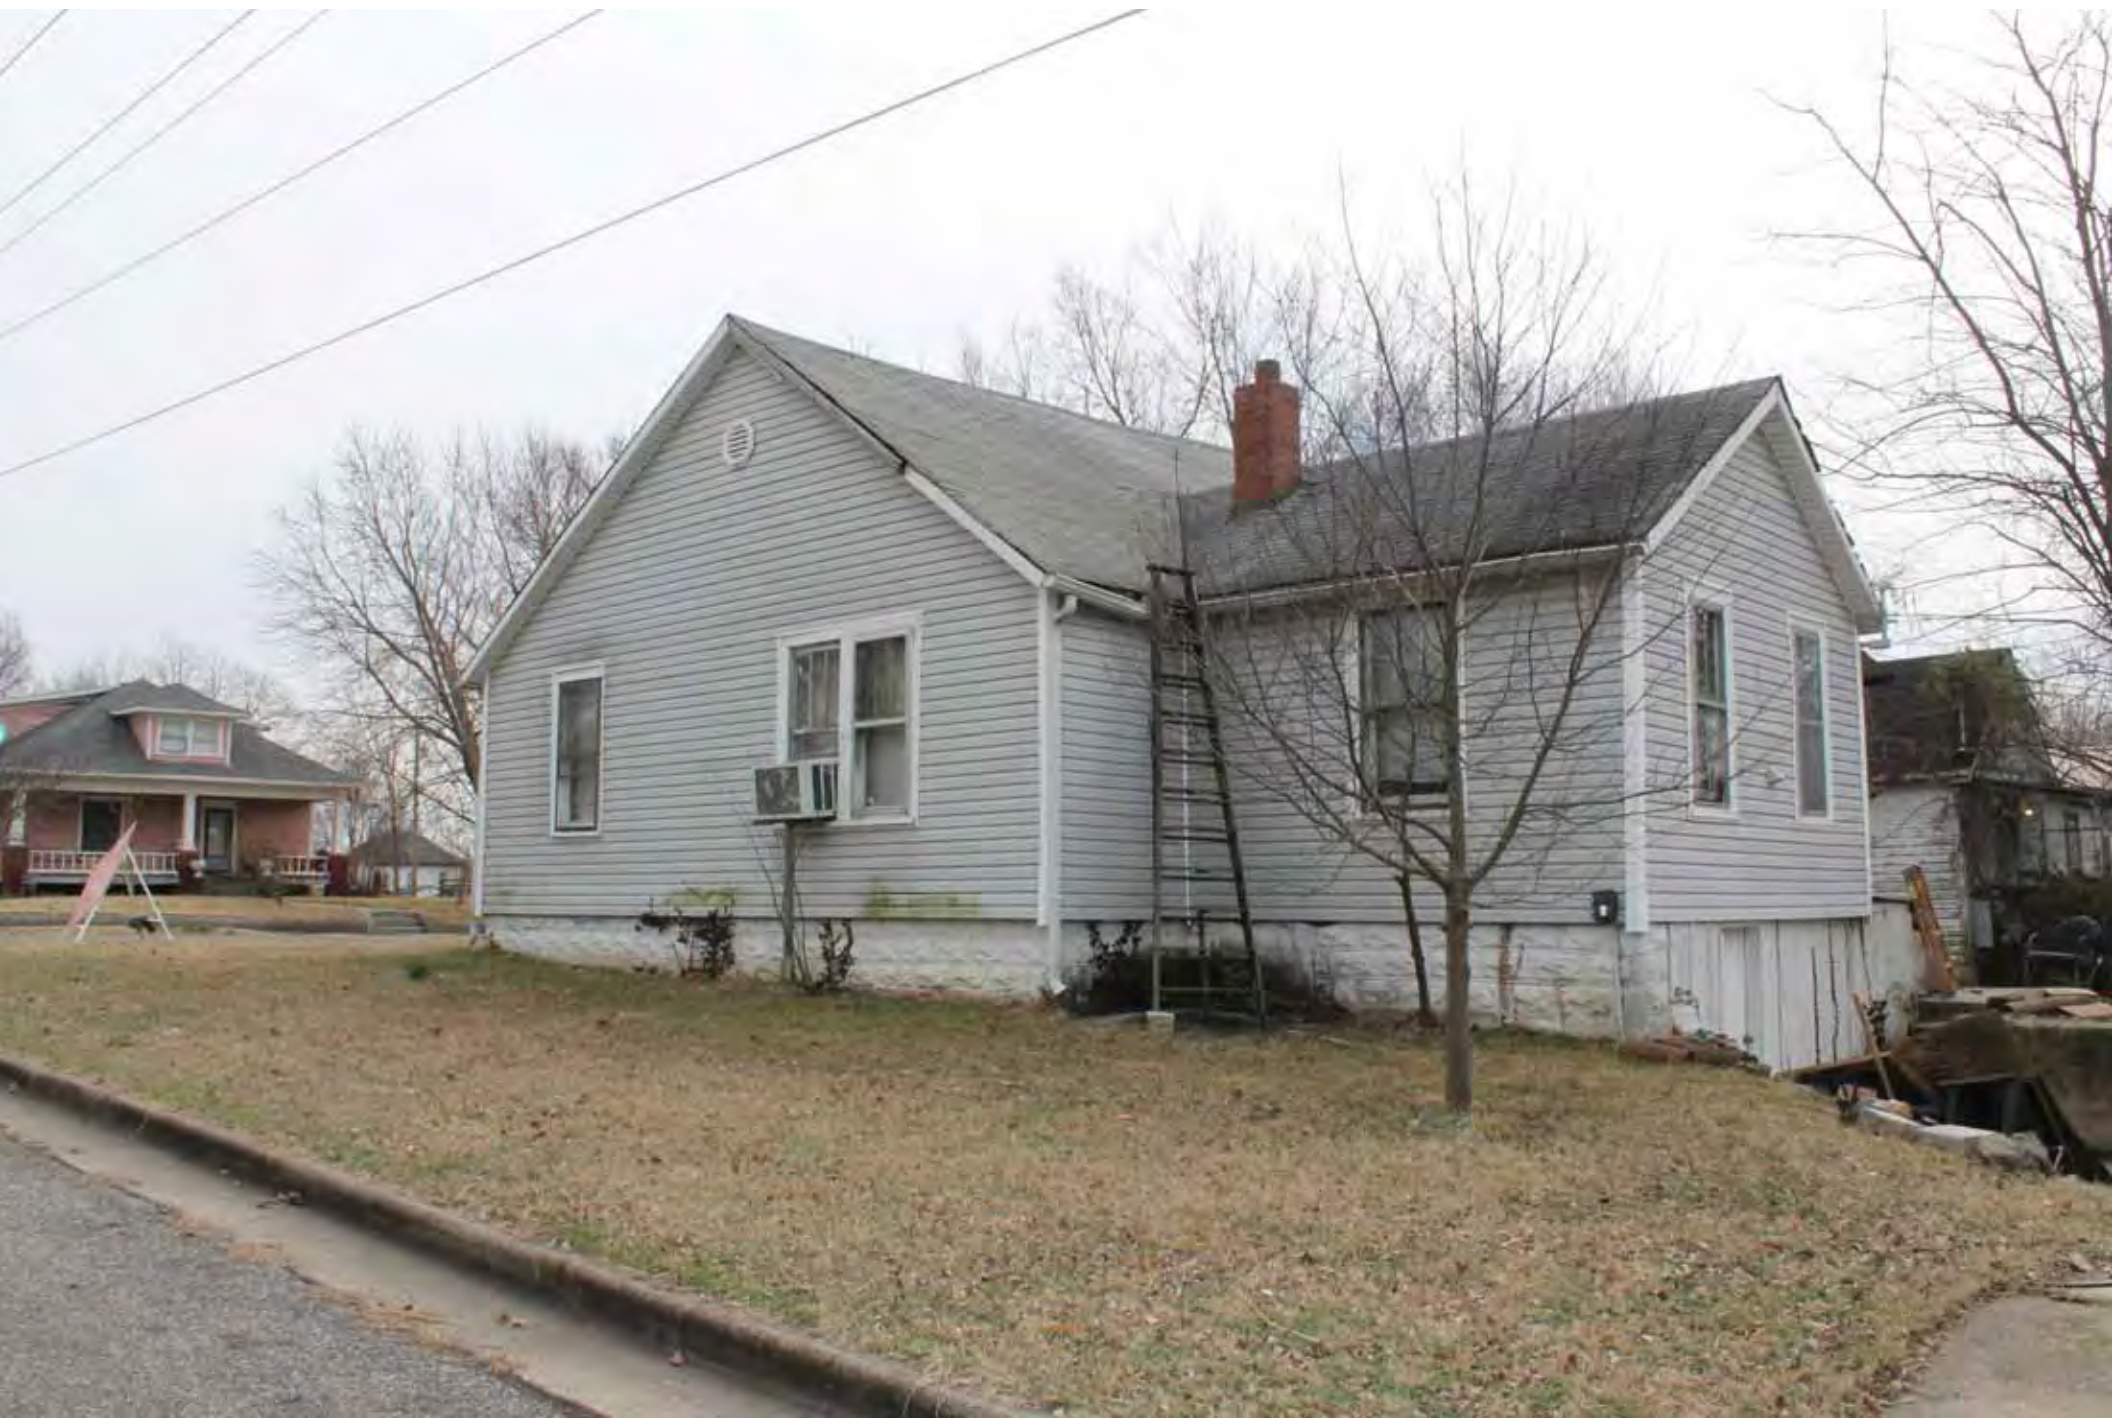
This dwelling has been extensively altered through the addition of vinyl siding and replacement of some of the original windows. Due to the lack of exterior original siding, the dwelling does not retain integrity that would render it individually eligible for the National Register of Historic Places. The dwelling is not situated in an area recommended as a historic district.

The property at 302 S. Mineral Avenue features a one story, with a side-gabled roof. It has exterior vinyl siding and an asphalt-shingled roof. The front façade has a central entrance door flanked on either side by three-over-one wood windows. There is a non-historic front porch, with a low-pitched front facing gable roof and vinyl siding. It has a concrete foundation. The house has a rough-cut concrete foundation. On the side facades are a combination of one-over-one vinyl replacement windows and three-over-one wood windows.

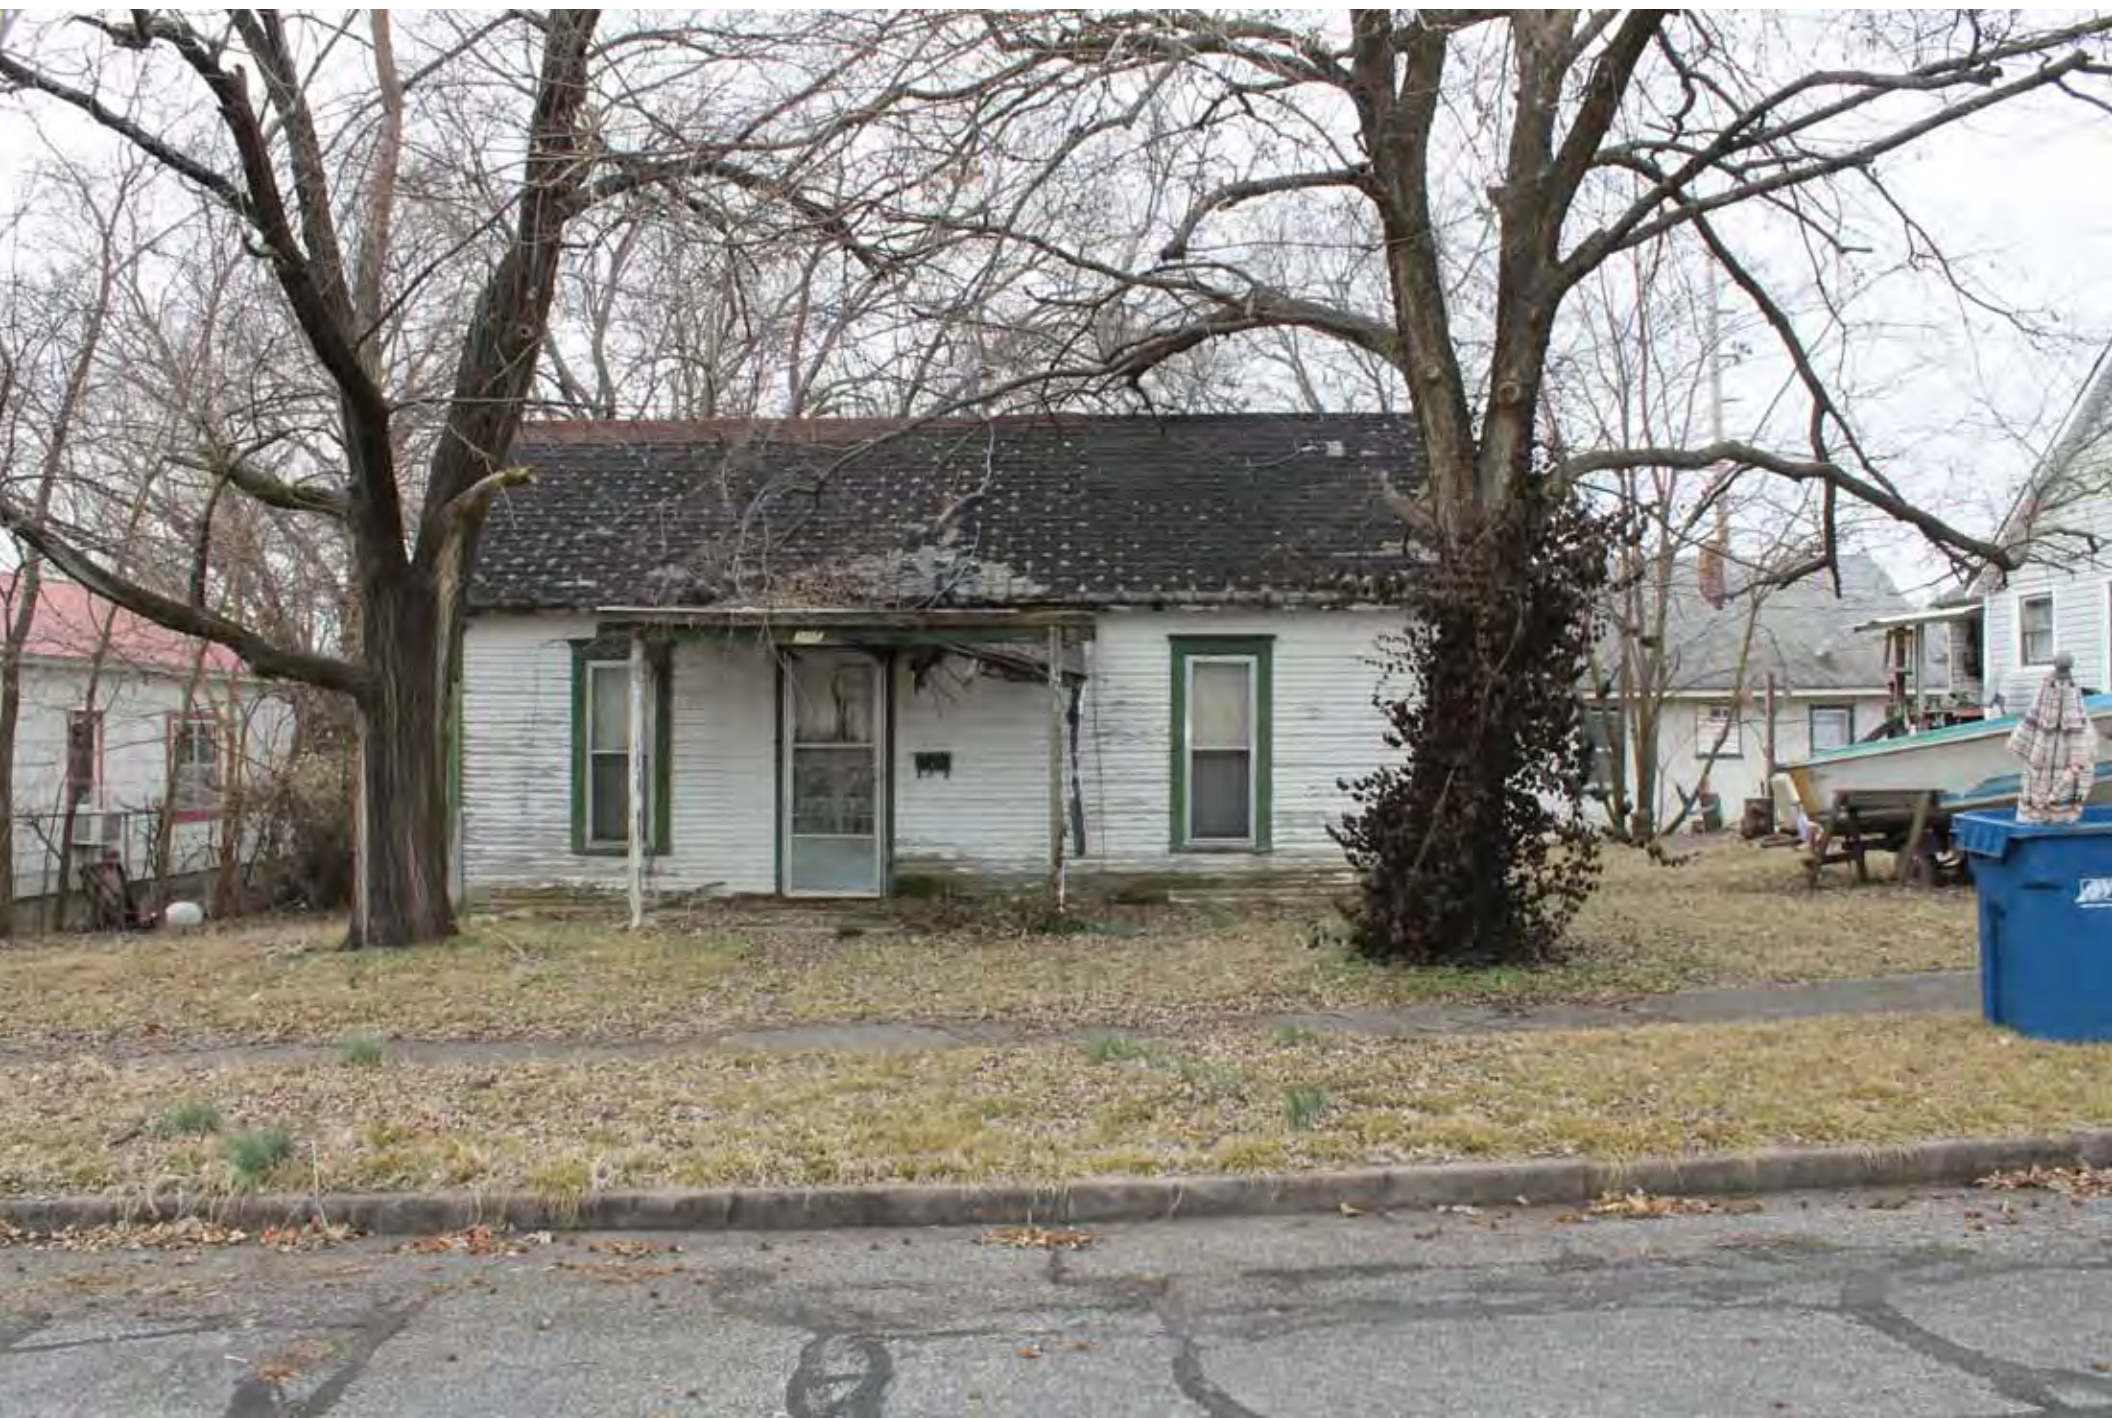
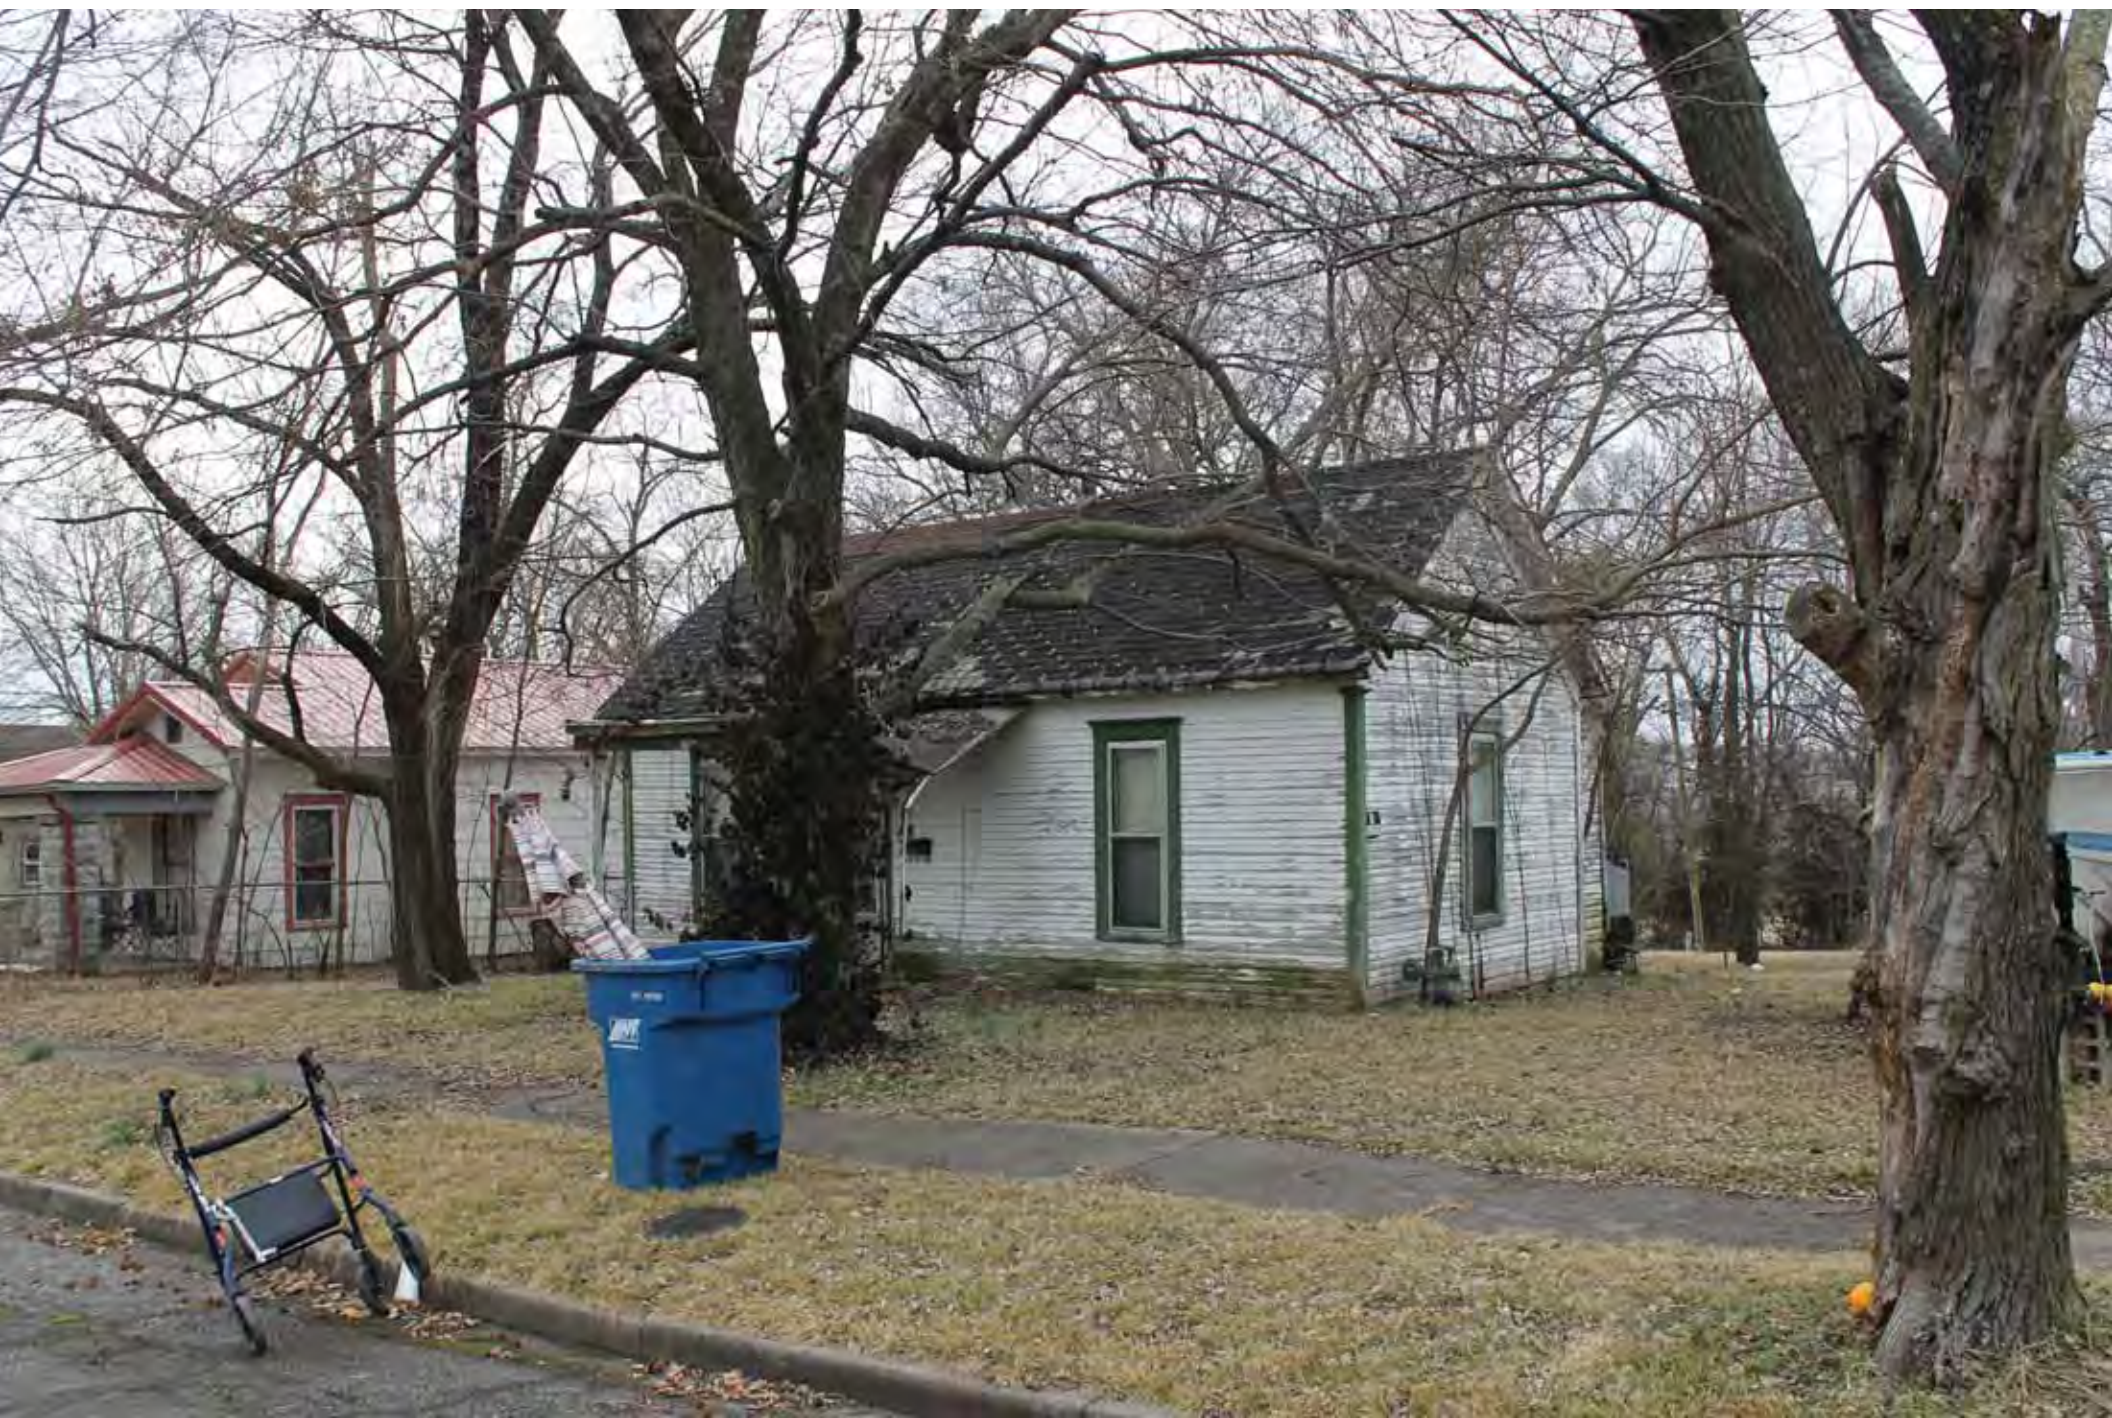
The building is not individually eligible for the National Register of Historic Places. The dwelling is not situated in an area recommended as a historic district.

The property at 306S. Mineral Avenue features a one-story house, with a side-gabled roof. It has exterior wood siding and an asphalt-shingled roof. The front façade has a central entrance door flanked on either side by single one-over-one windows with wood surround trim. There is a simple wood porch with flat roof on wood posts. Each side of the house has single one-over-one windows.
