MISSOURI DEPARTMENT OF NATURAL RESOURCES
STATE HISTORIC PRESERVATION OFFICE, P.O. Box 176, Jefferson City, MO 65102
ARCHITECTURAL/HISTORIC INVENTORY FORM

1. Survey No. JP-AS-007-001		2. Survey name: East Town (Original Joplin) Historic Survey Phase 2	
3. County: JASPER		4. Address (Street No.) 618	Street (name) E. 2 nd Street
5. City: Joplin	Vicinity: <input type="checkbox"/>	6. Geographical Reference:	7. Township/Range/Section: T: R: S:
8. Historic name (if known):		9. Present/other name (if known):	
10. Ownership: <input checked="" type="checkbox"/> Private <input type="checkbox"/> Public		11a. Historic use (if known): Domestic: Single Dwelling	11b. Current use: Domestic: Single Dwelling

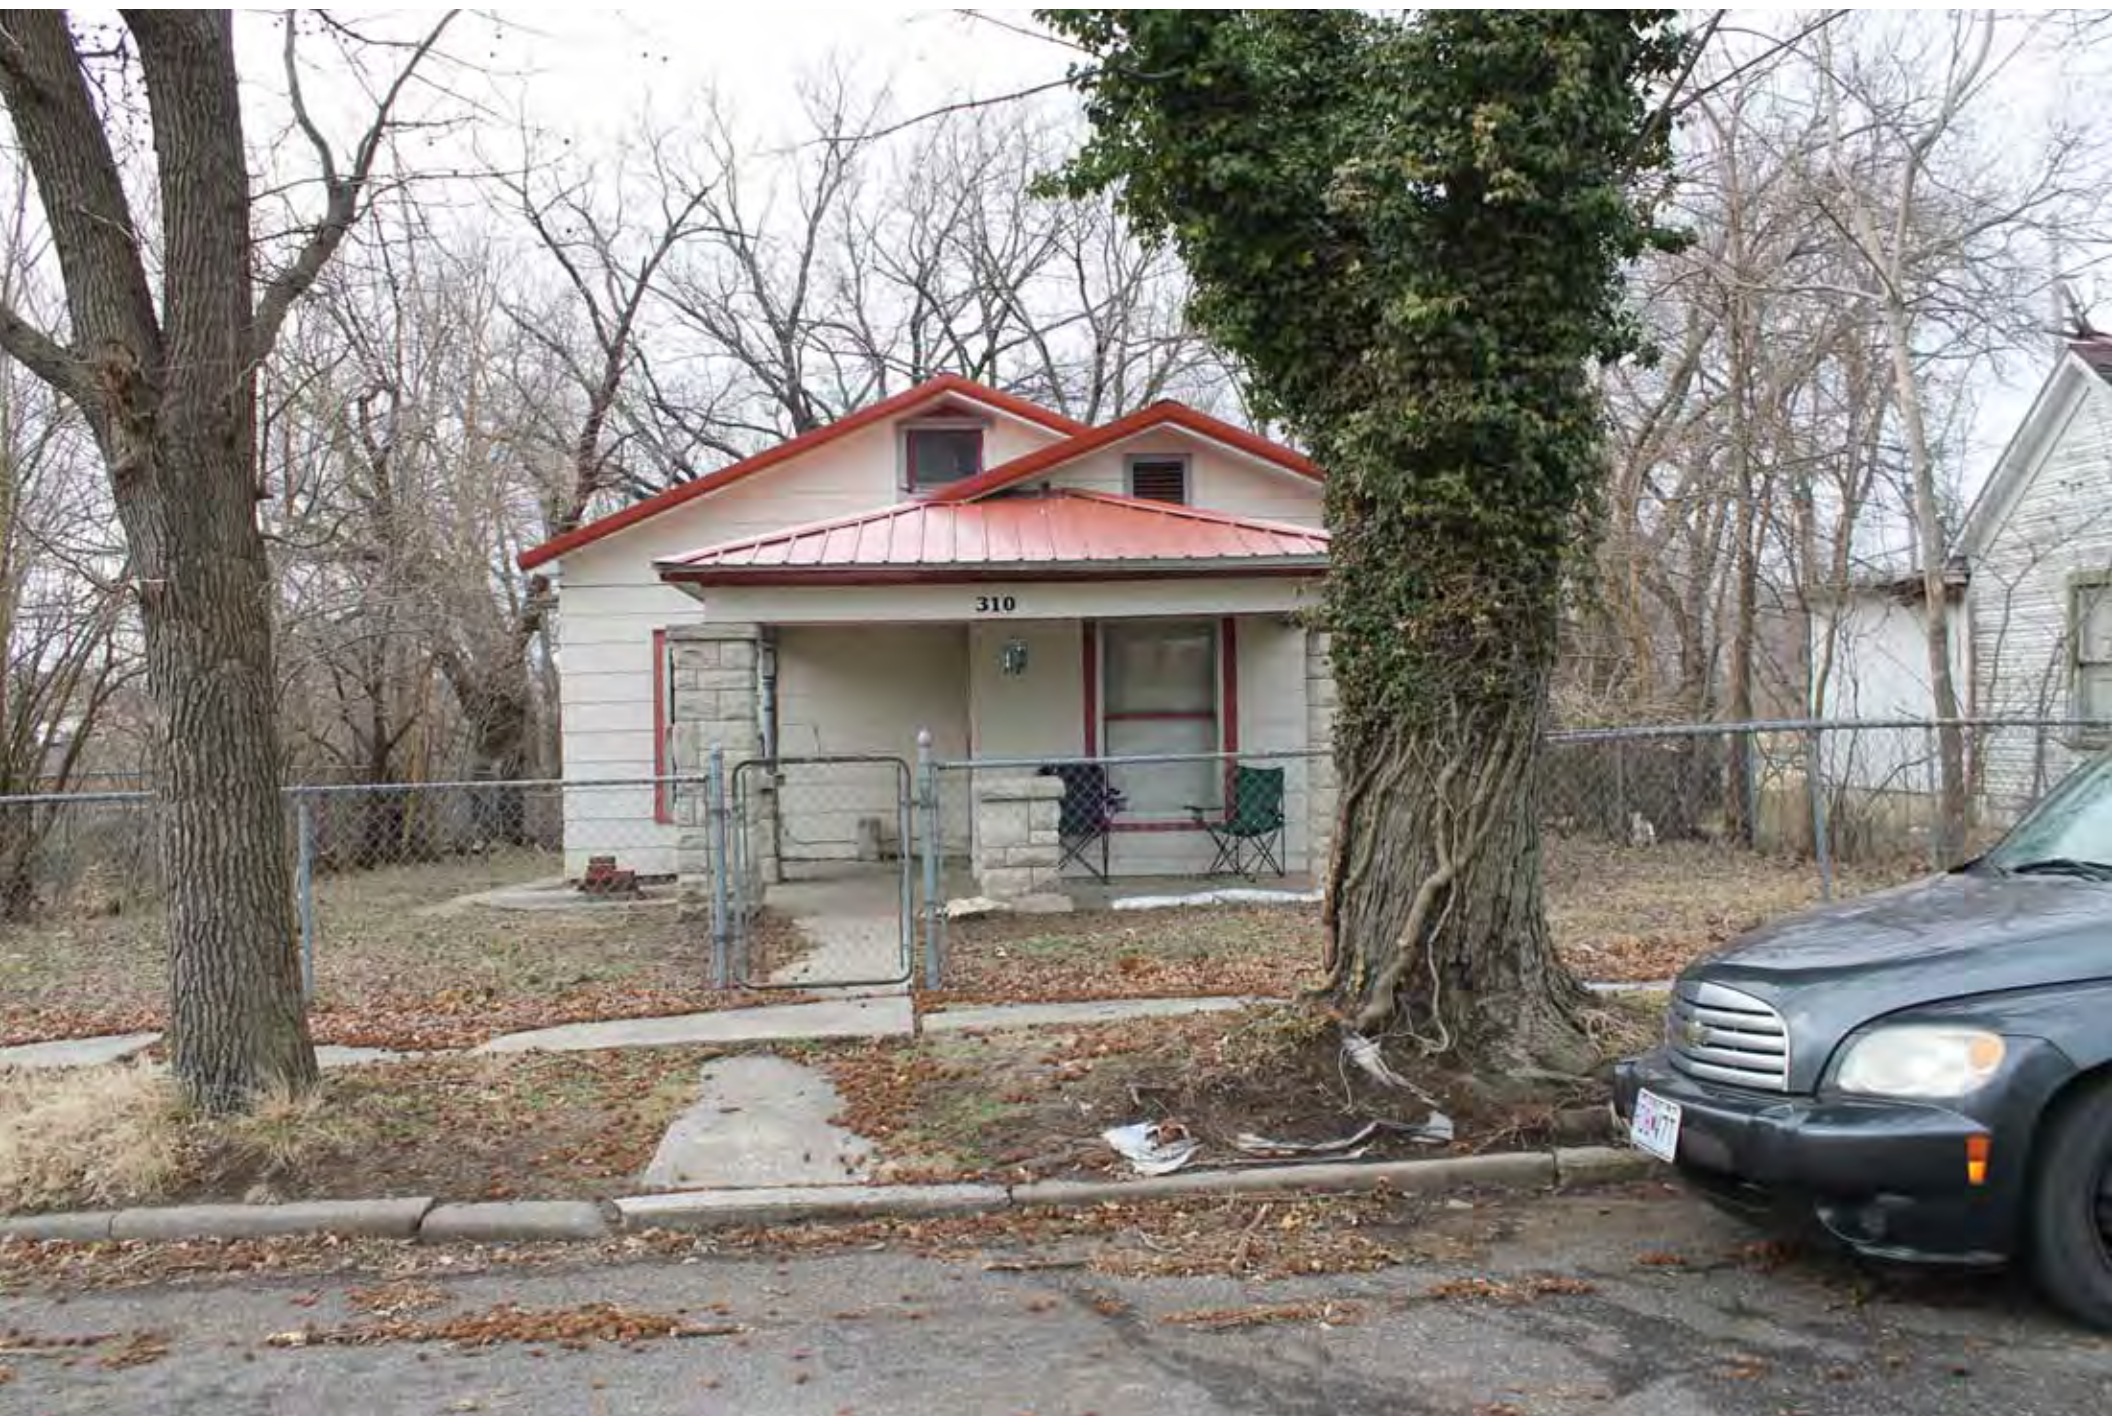
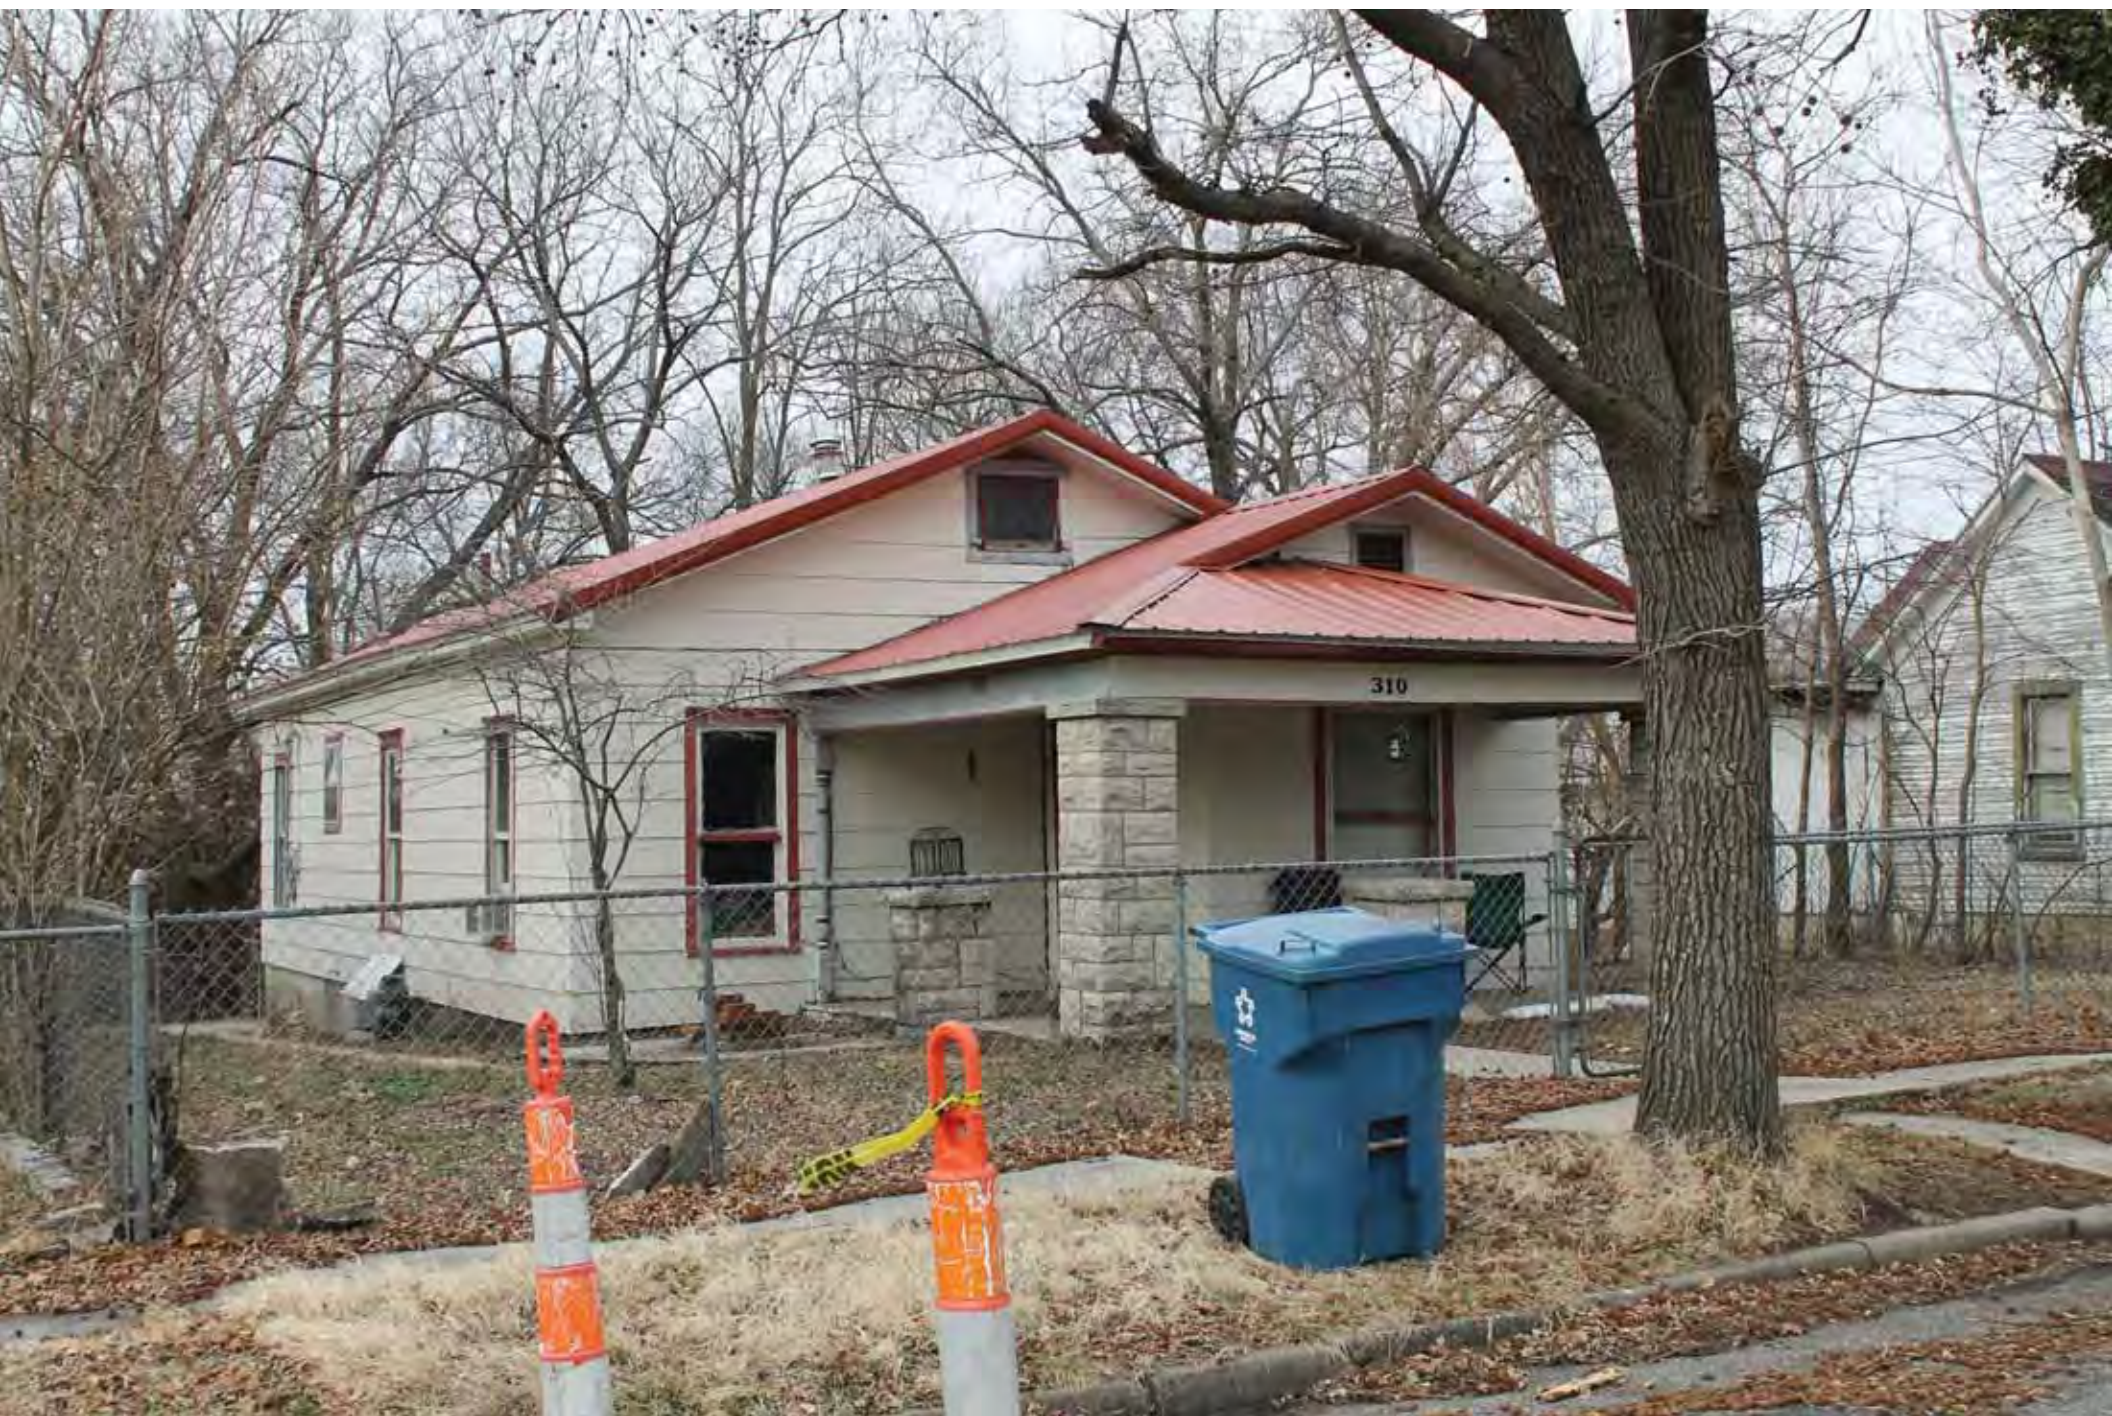
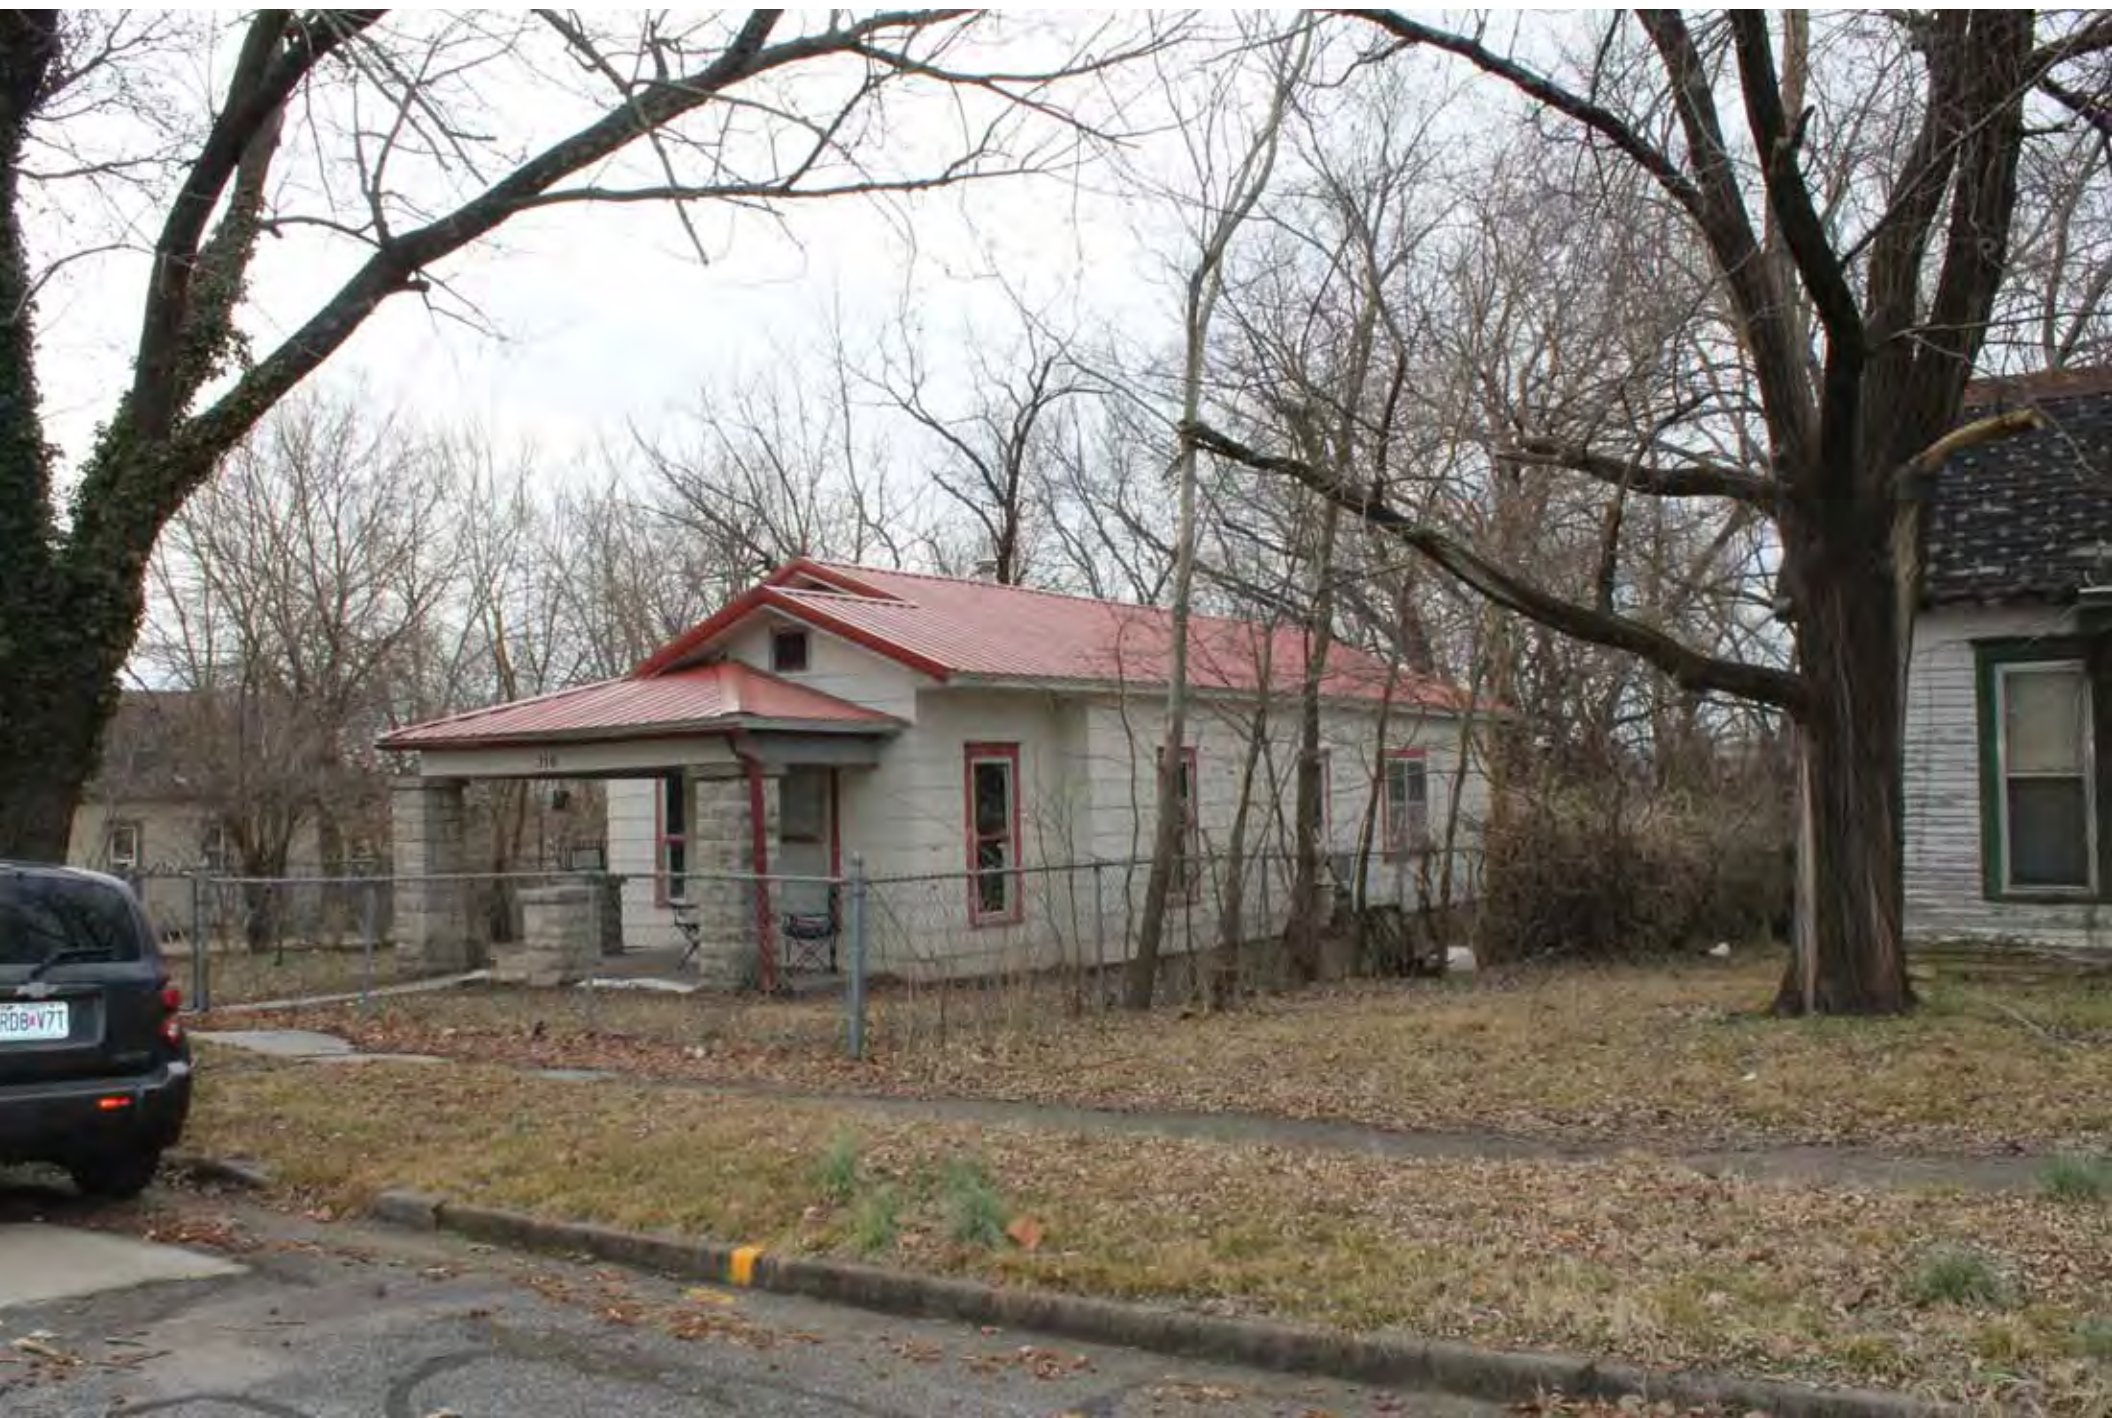
The building is not individually eligible for the National Register of Historic Places, as it does not retain enough integrity. The dwelling is not situated in an area recommended as a historic district.

The property at 310 S. Mineral Avenue is a one-story house frame house with a low-pitched front-facing gable roof. It is covered is what appears to be asbestos siding. The roof has been recently clad in metal. The front façade has a central entrance door flanked on either side by single one-over-one windows. There is a large front porch with a gable on hip roof. The porch is supported on square concrete columns. Each side of the house has four one-over-one windows.

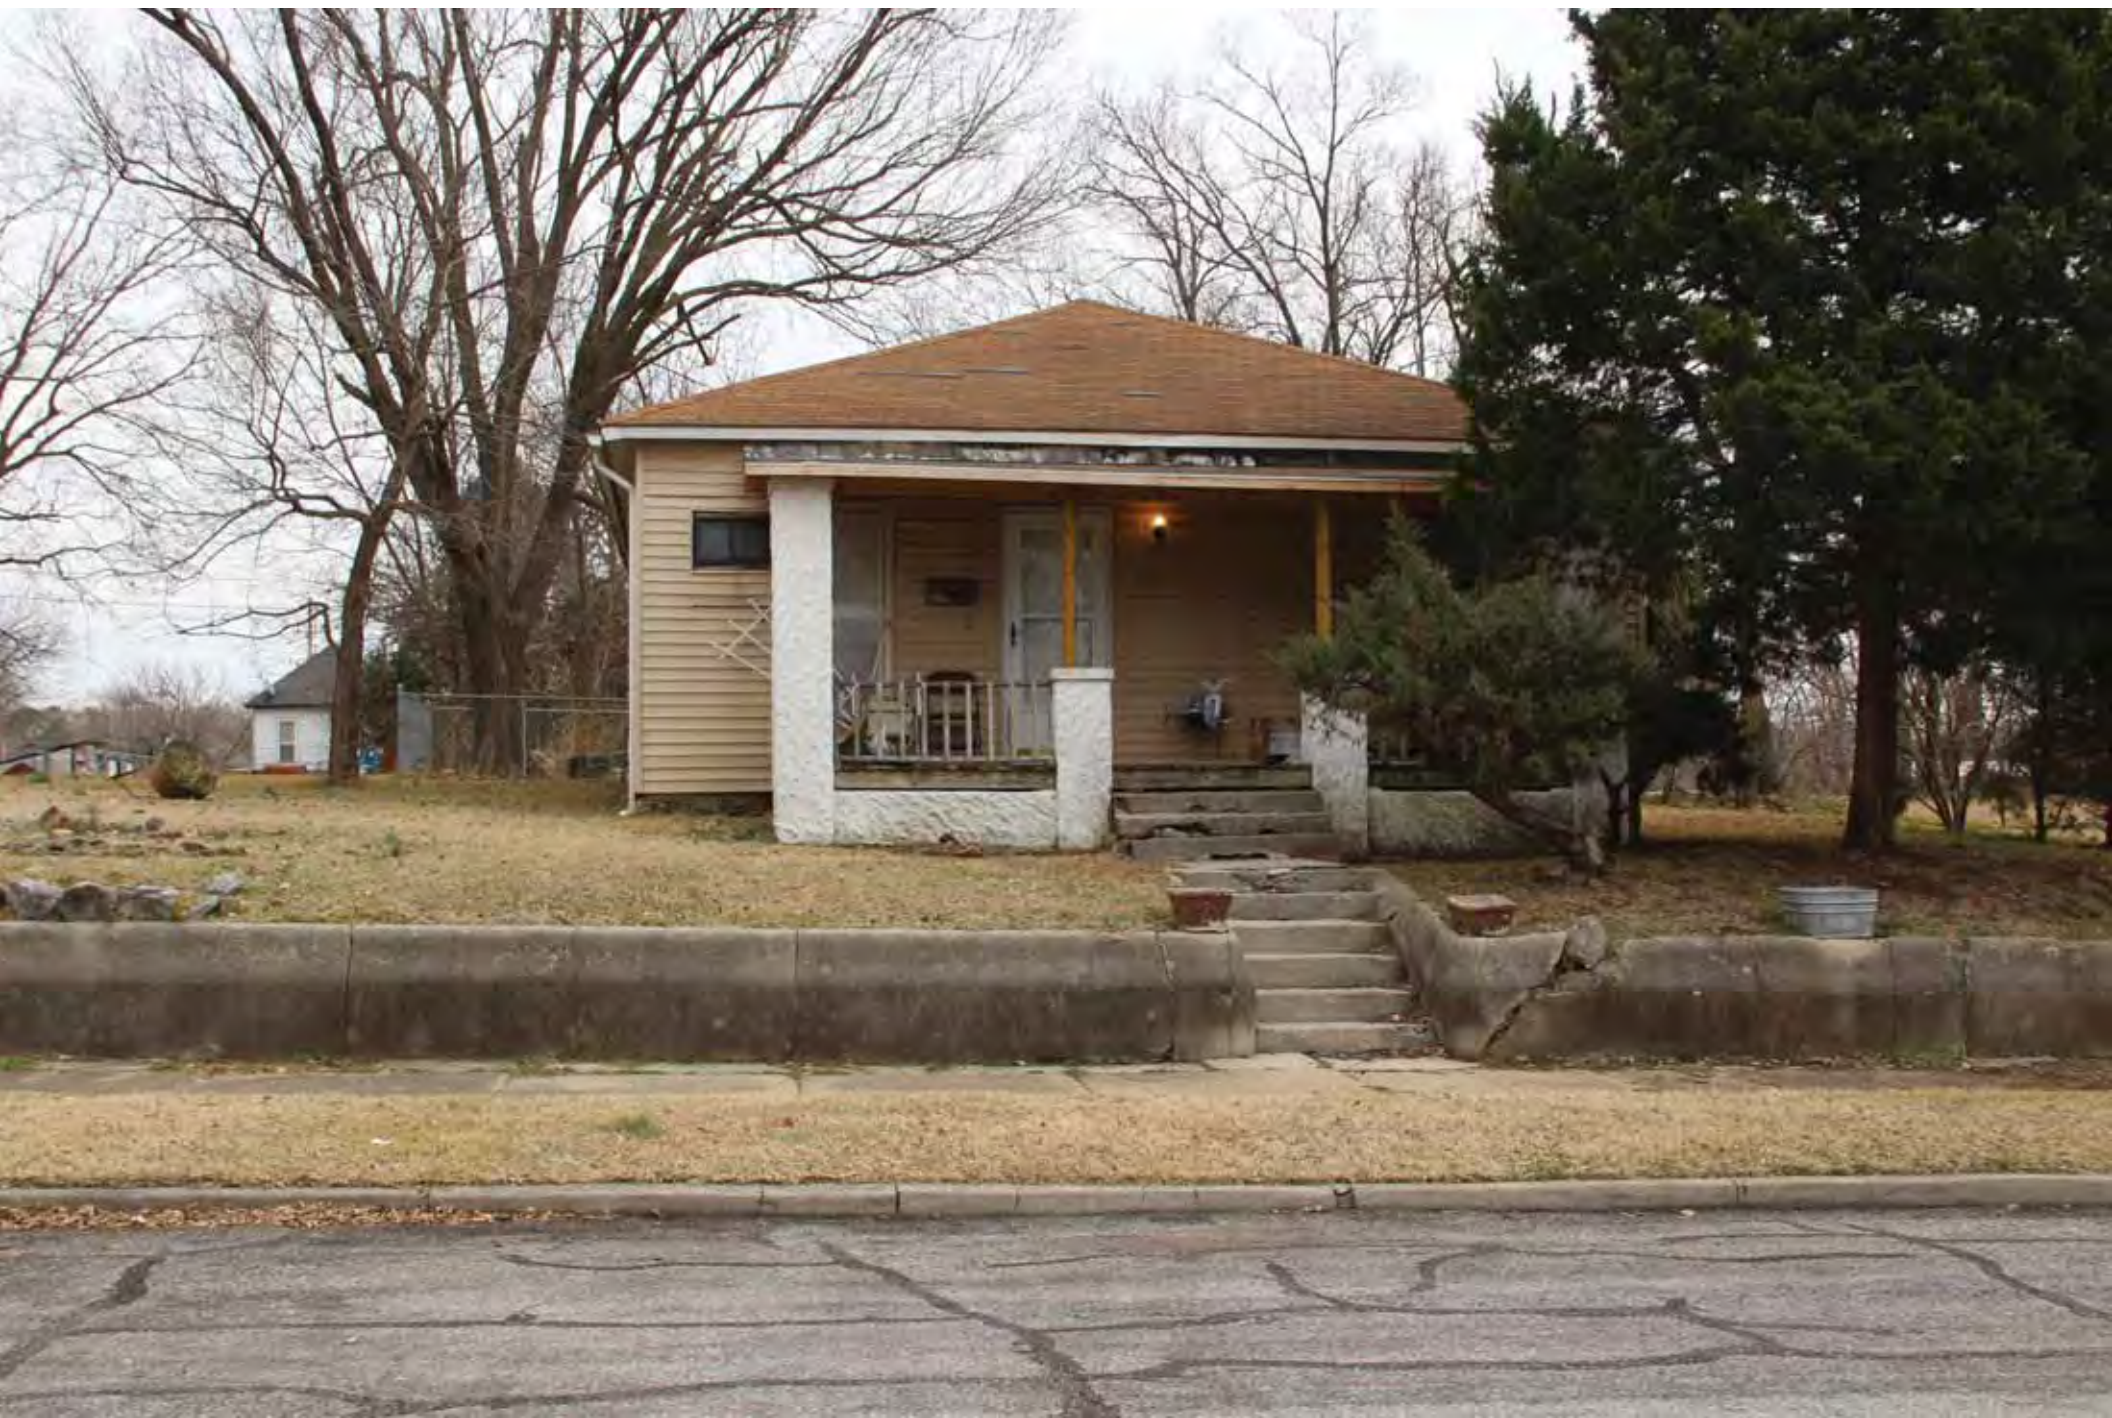
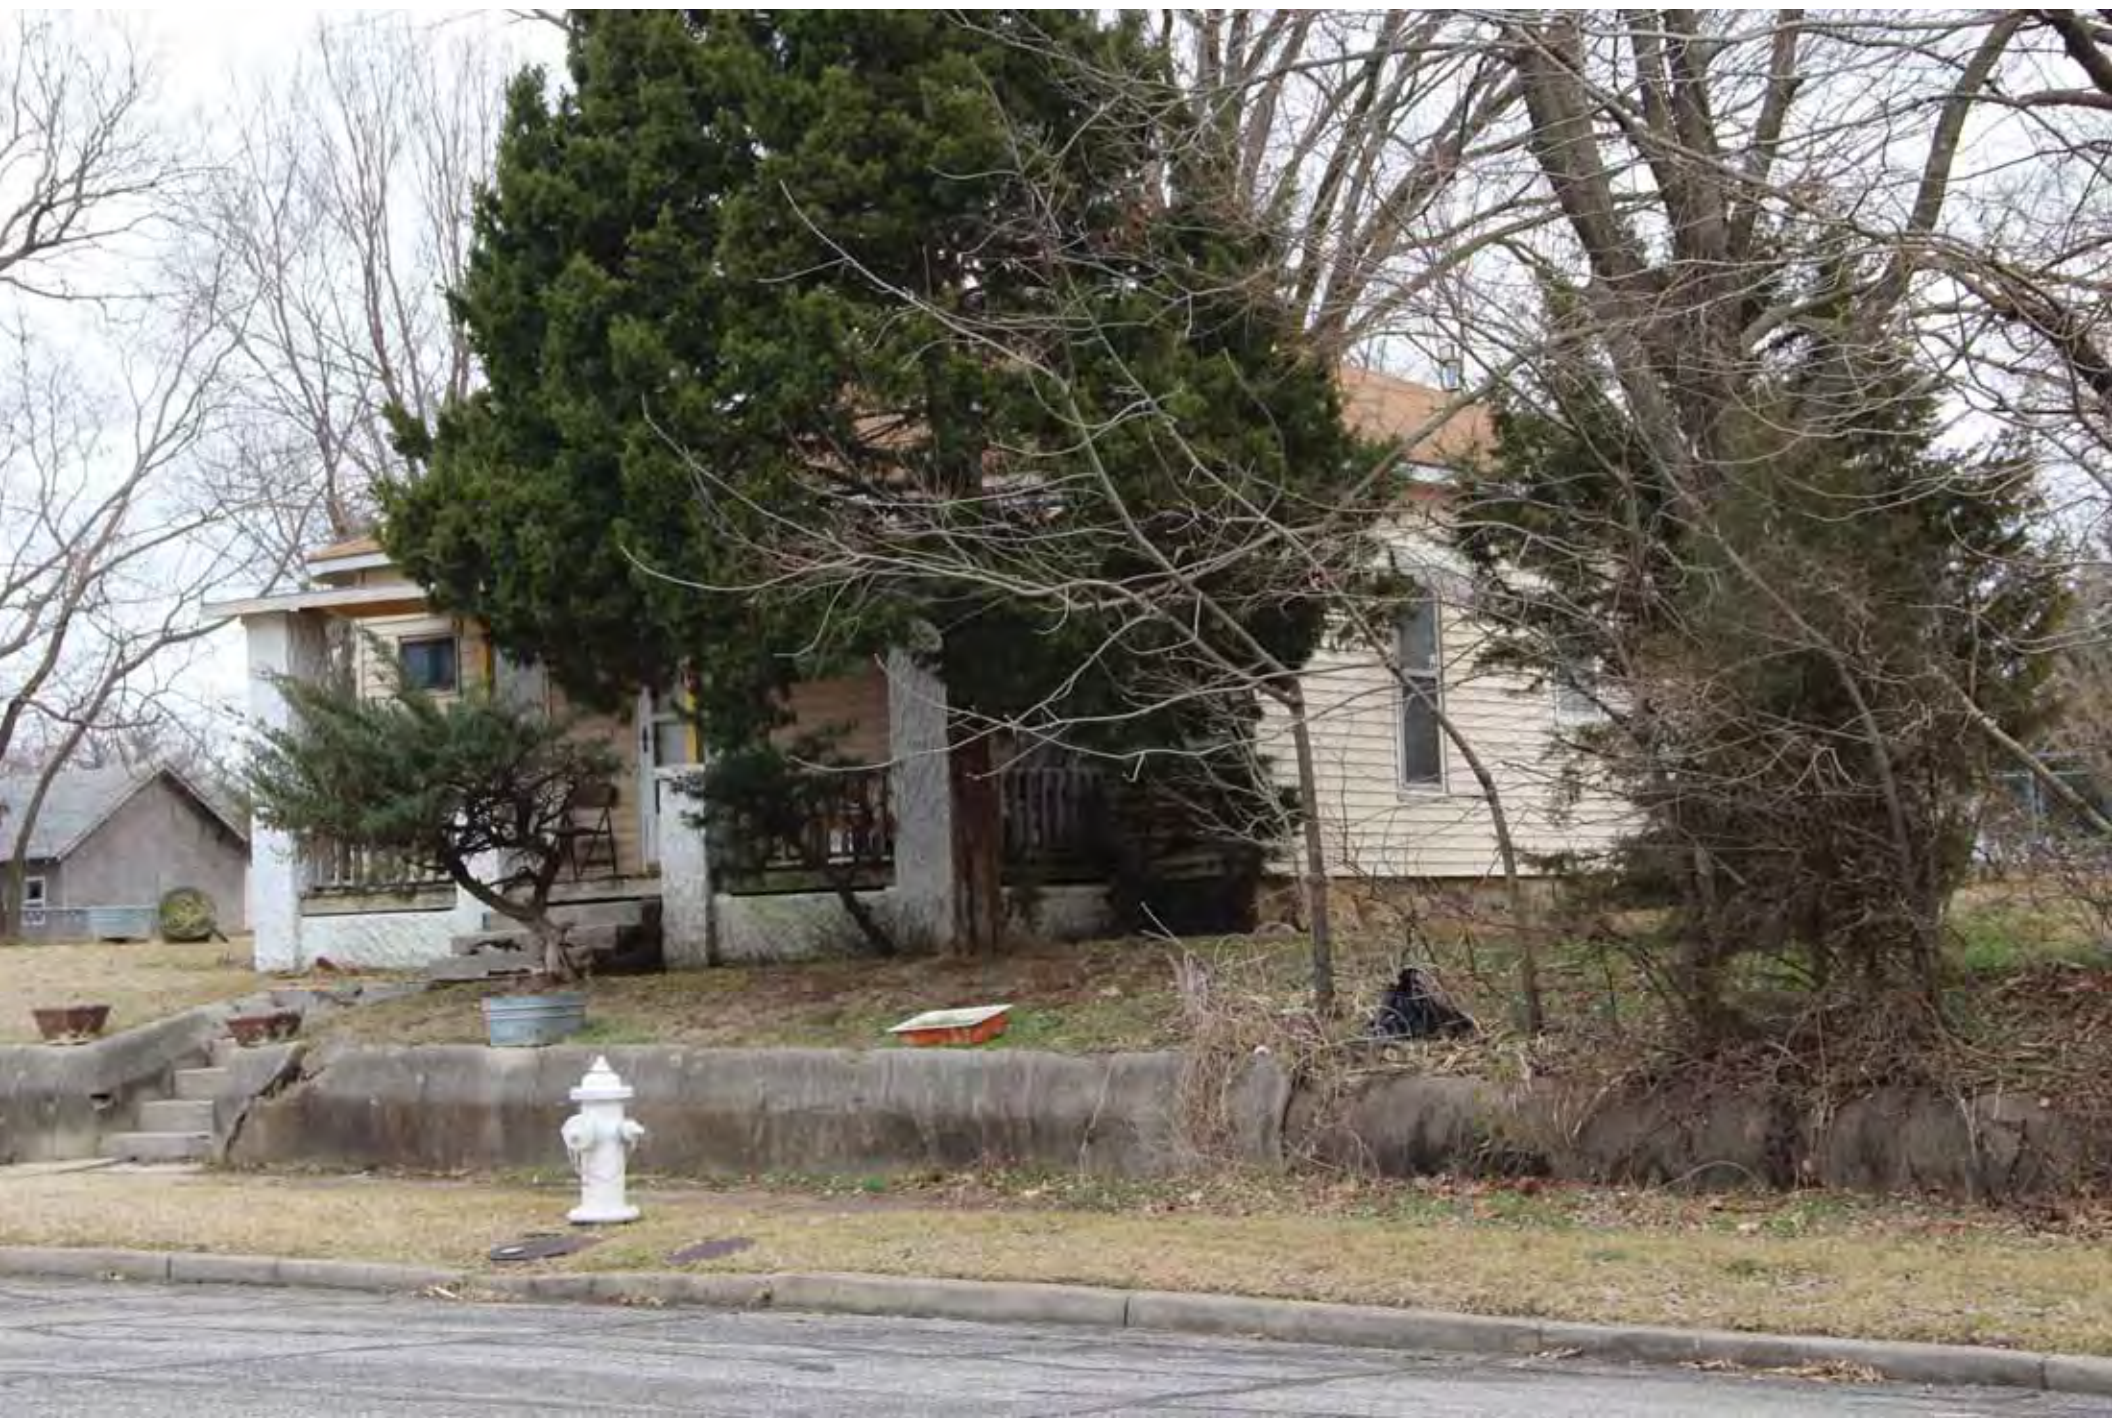
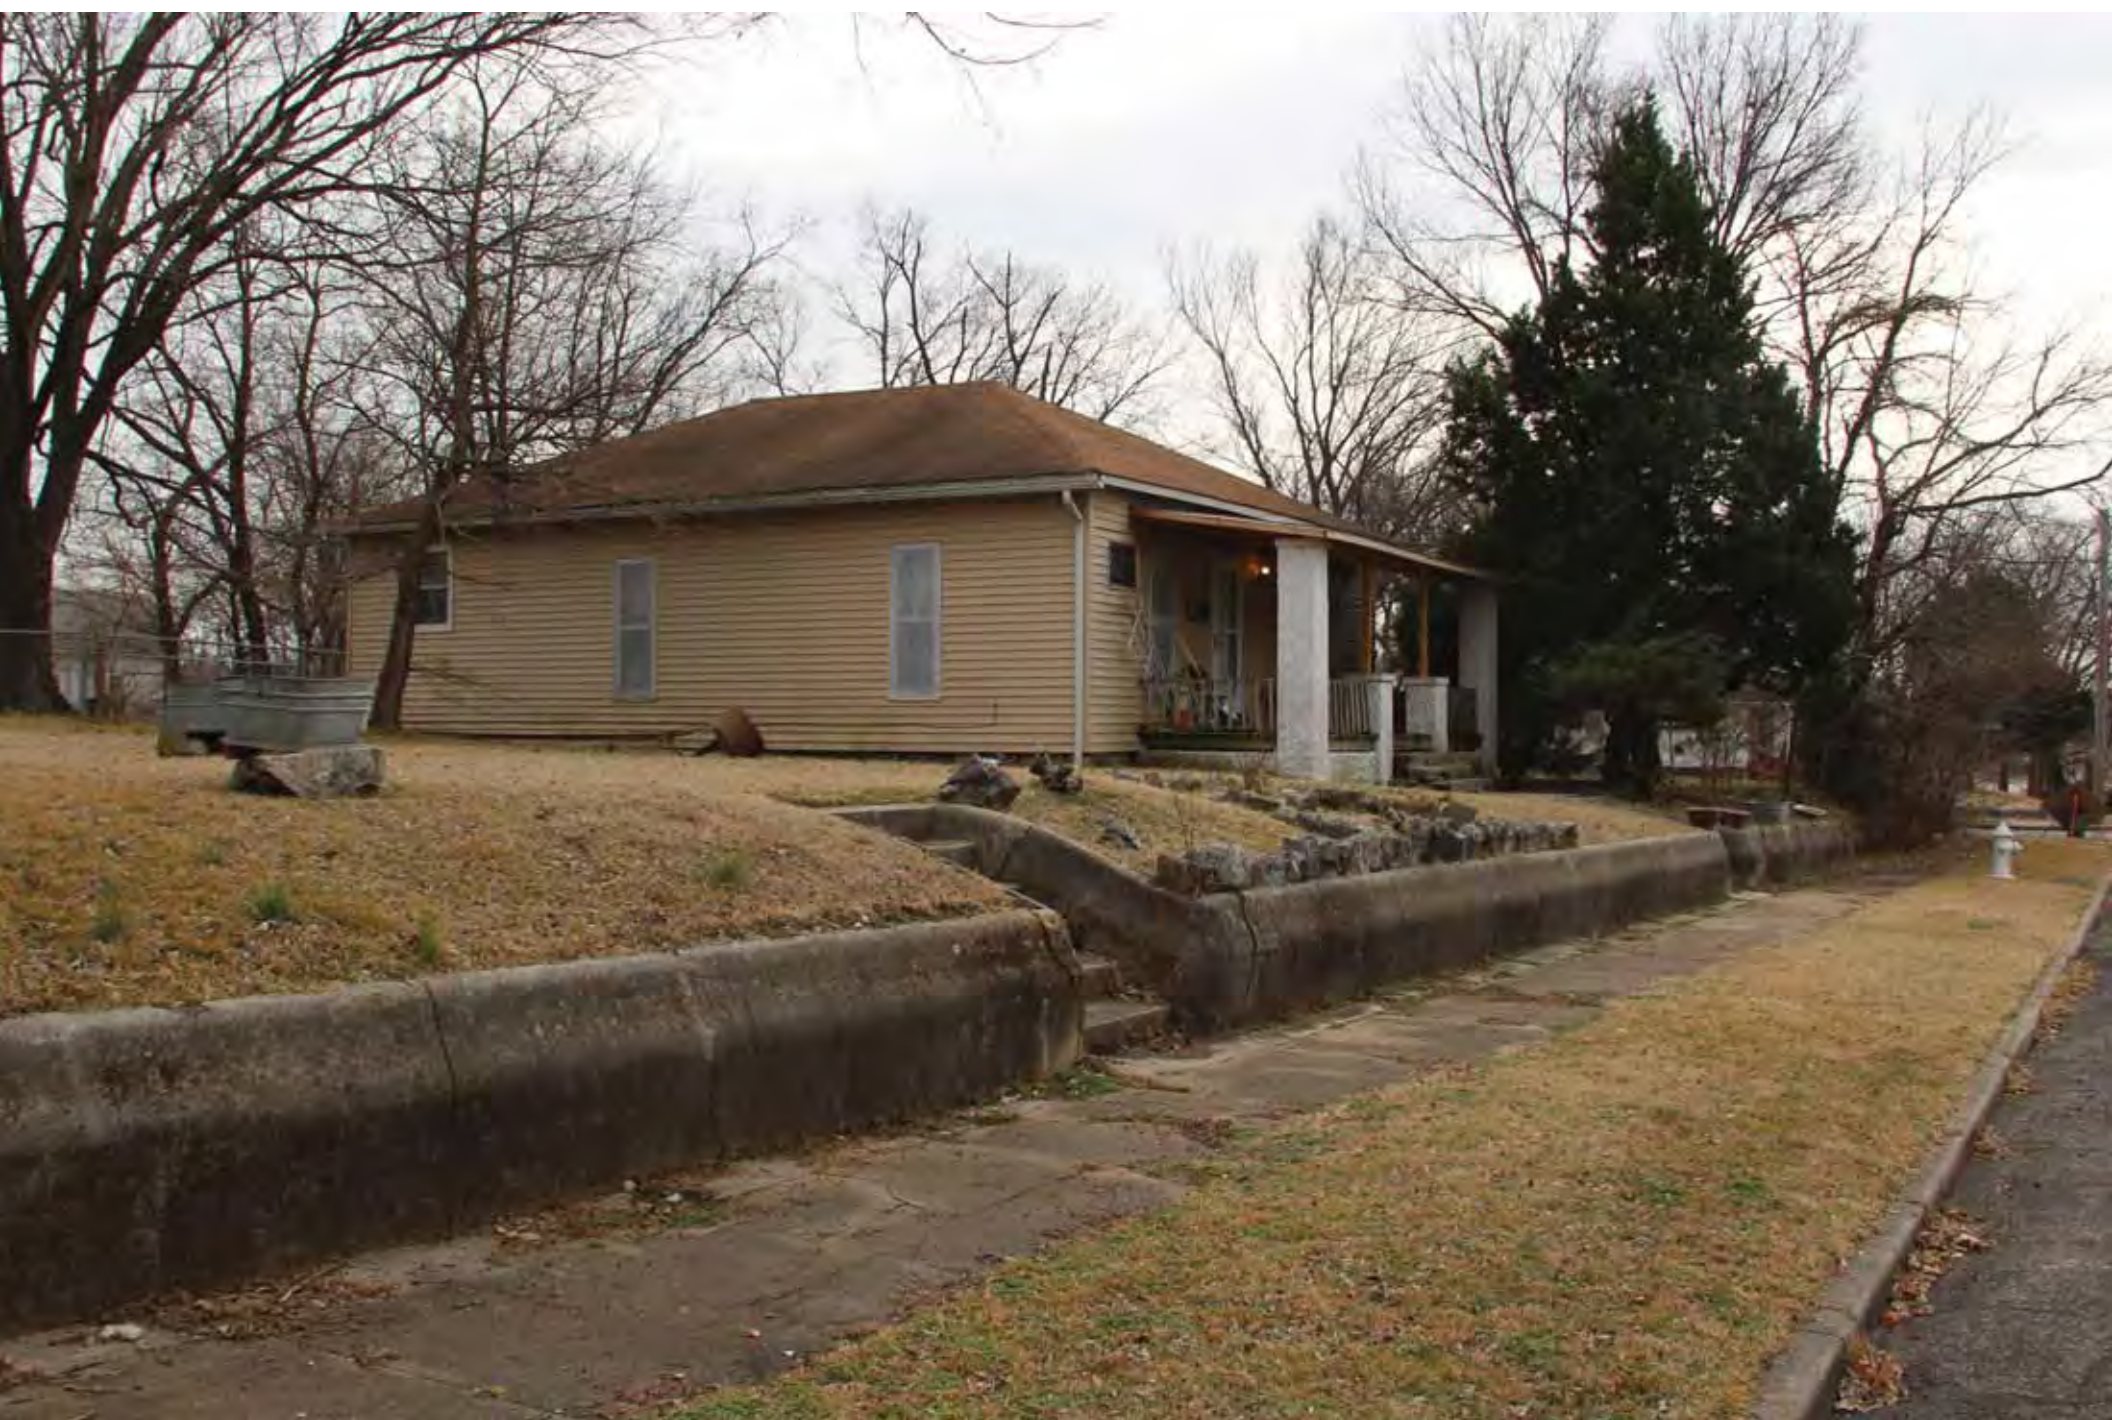
<p>21. (cont.) History and significance. Expand box as necessary, or add continuation pages.</p> <p>The dwelling at 317 S. Mineral Avenue was constructed c.1910 per Jasper County property records. It does not appear in the 1921 or 1931 City Directory. In 1941, Arthur Thomas occupied the dwelling.</p> <p>This dwelling has been extensively altered through the addition of vinyl siding and replacement of some of the original windows. Due to the lack of exterior original siding, the dwelling does not retain integrity that would render it individually eligible for the National Register of Historic Places. The dwelling is not situated in an area recommended as a historic district.</p>
<p>22. (cont.) Sources of information. Expand box as necessary, or add continuation pages.</p> <p>Jasper County GIS (Beacon) Database (https://beacon.schneidercorp.com/), Access date: 26 March 2020. Leshnick's Joplin City Directory, 1921. Polk's Joplin City Directories, 1931 and 1941. Sanborn Fire Insurance Maps, Joplin (Jasper County), 1906; Updated 1939; Sheet 63.</p>

<p>40. (cont.) Description of environment and outbuildings. Expand box as necessary, or add continuation pages.</p> <p>The building is situated on S. Mineral Avenue (east). The site has a concrete sidewalk and concrete retaining wall along the perimeter, and concrete stairs to the front door.</p>
<p>41. (cont.) Description of primary resource. Expand box as necessary, or add continuation pages.</p> <p>The property at 317 S. Mineral Avenue features a one story dwelling, with a low-pitched hipped roof. It has exterior vinyl siding and an asphalt-shingled roof. The front façade has a central entrance door flanked on either side by one-over-one vinyl windows. There is a front porch, with a flat roof on wood supports resting on painted concrete blocks. On the side facades are single one-over-one vinyl replacement windows.</p>
