MISSOURI DEPARTMENT OF NATURAL RESOURCES
STATE HISTORIC PRESERVATION OFFICE, P.O. Box 176, Jefferson City, MO 65102
ARCHITECTURAL/HISTORIC INVENTORY FORM

1. Survey No. JP-AS-007-001		2. Survey name: East Town (Original Joplin) Historic Survey Phase 2	
3. County: JASPER		4. Address (Street No.) 618	Street (name) E. 2 nd Street
5. City: Joplin	Vicinity: <input type="checkbox"/>	6. Geographical Reference:	7. Township/Range/Section: T: R: S:
8. Historic name (if known):		9. Present/other name (if known):	
10. Ownership: <input checked="" type="checkbox"/> Private <input type="checkbox"/> Public		11a. Historic use (if known): Domestic: Single Dwelling	11b. Current use: Domestic: Single Dwelling

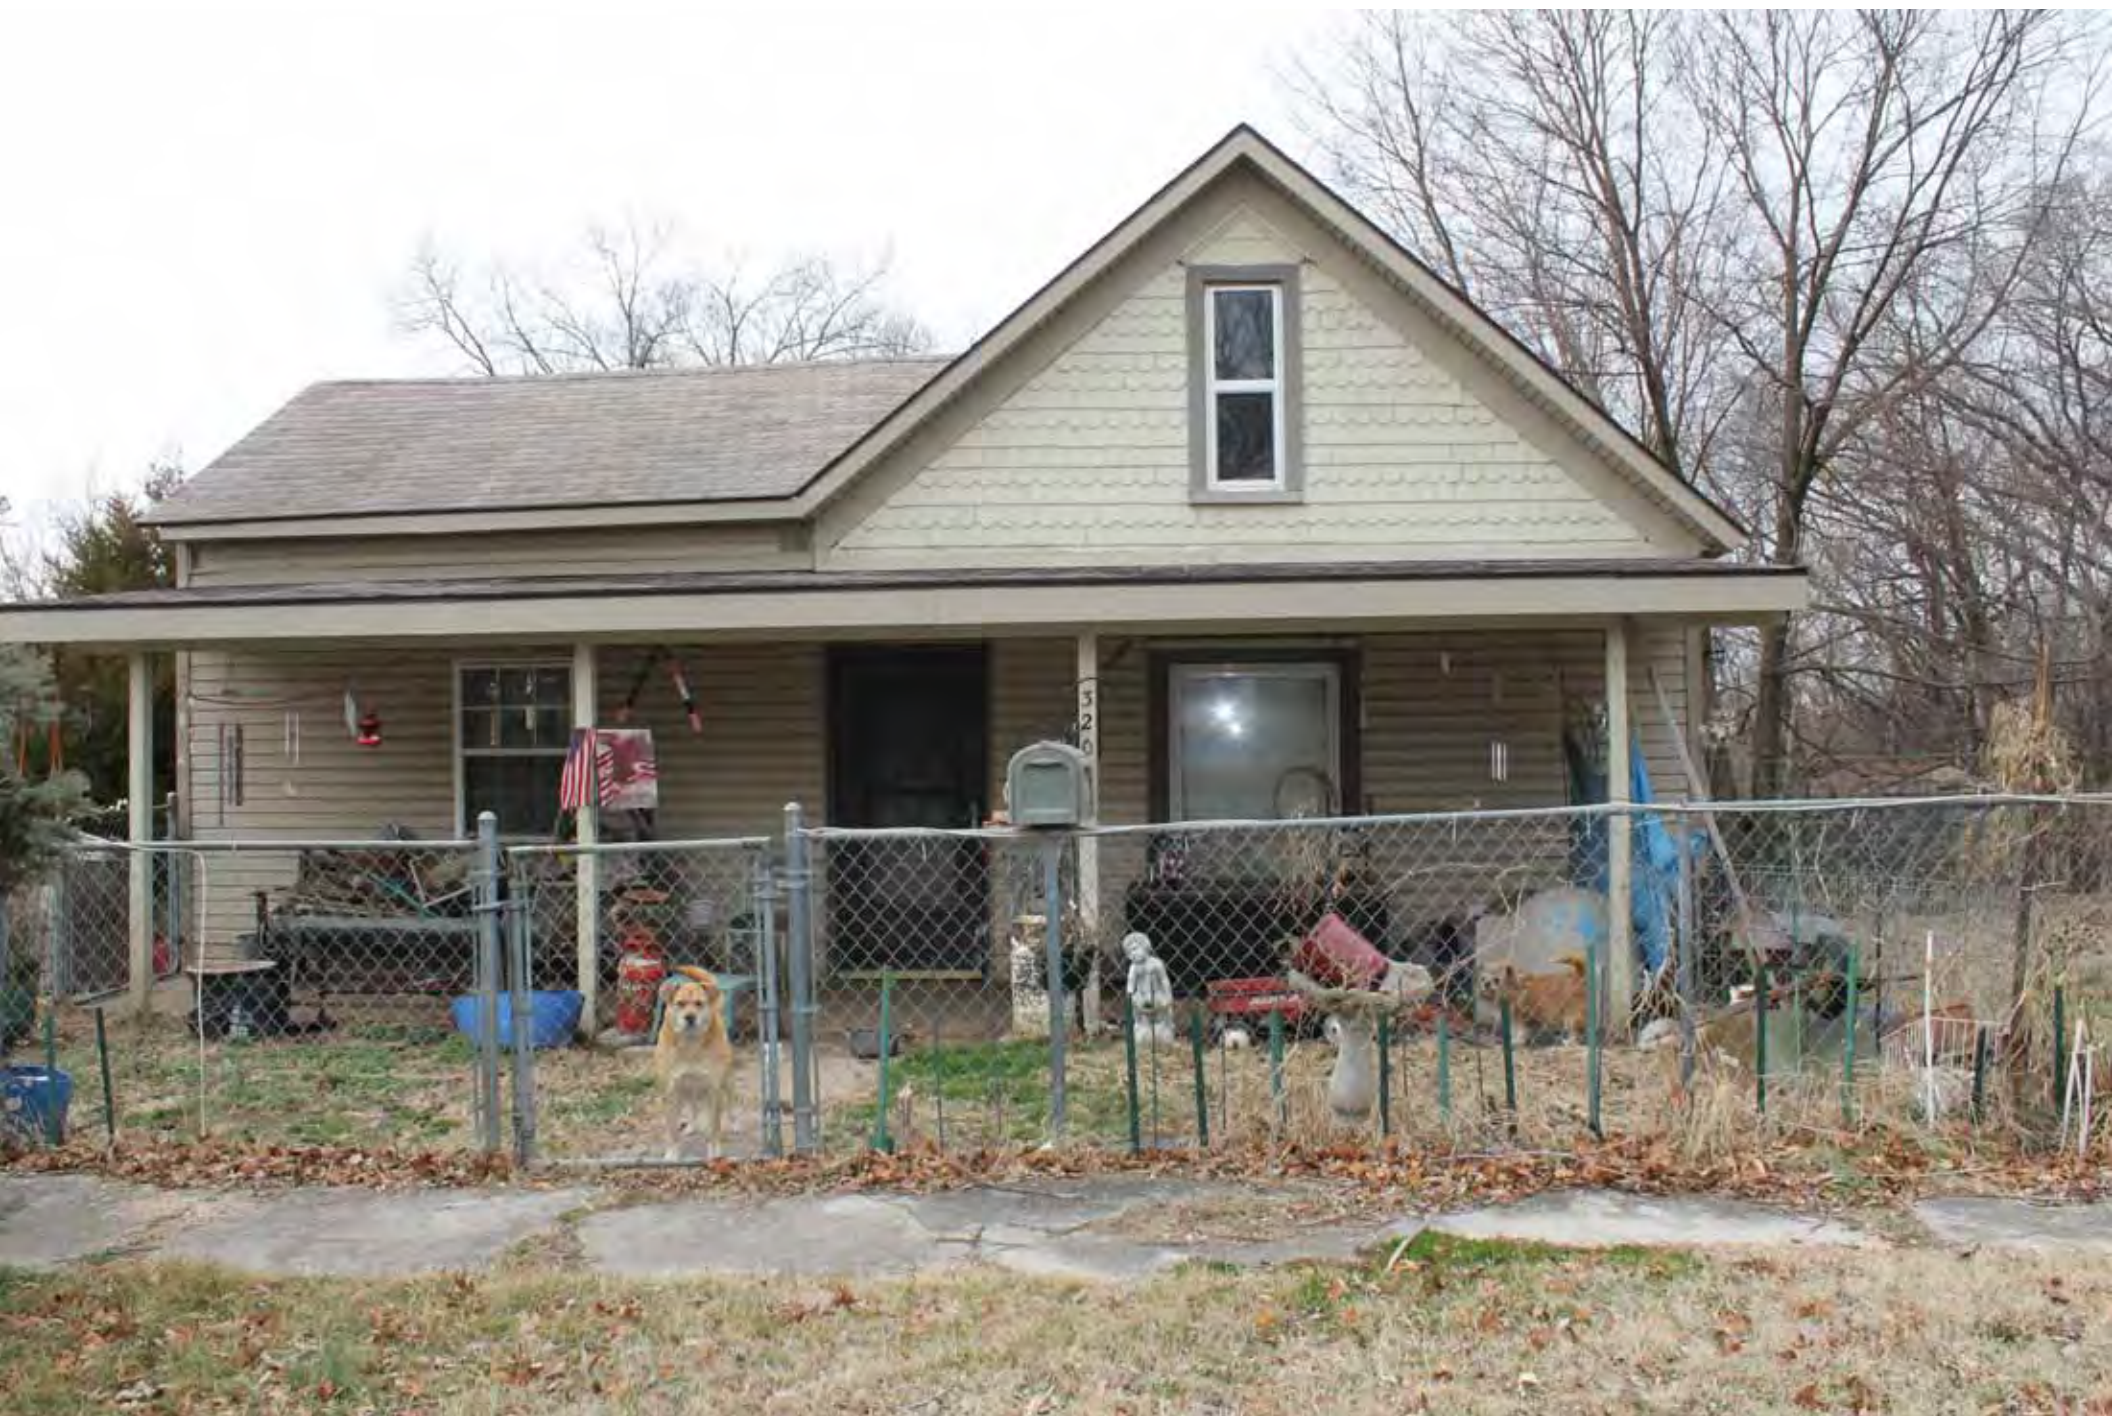
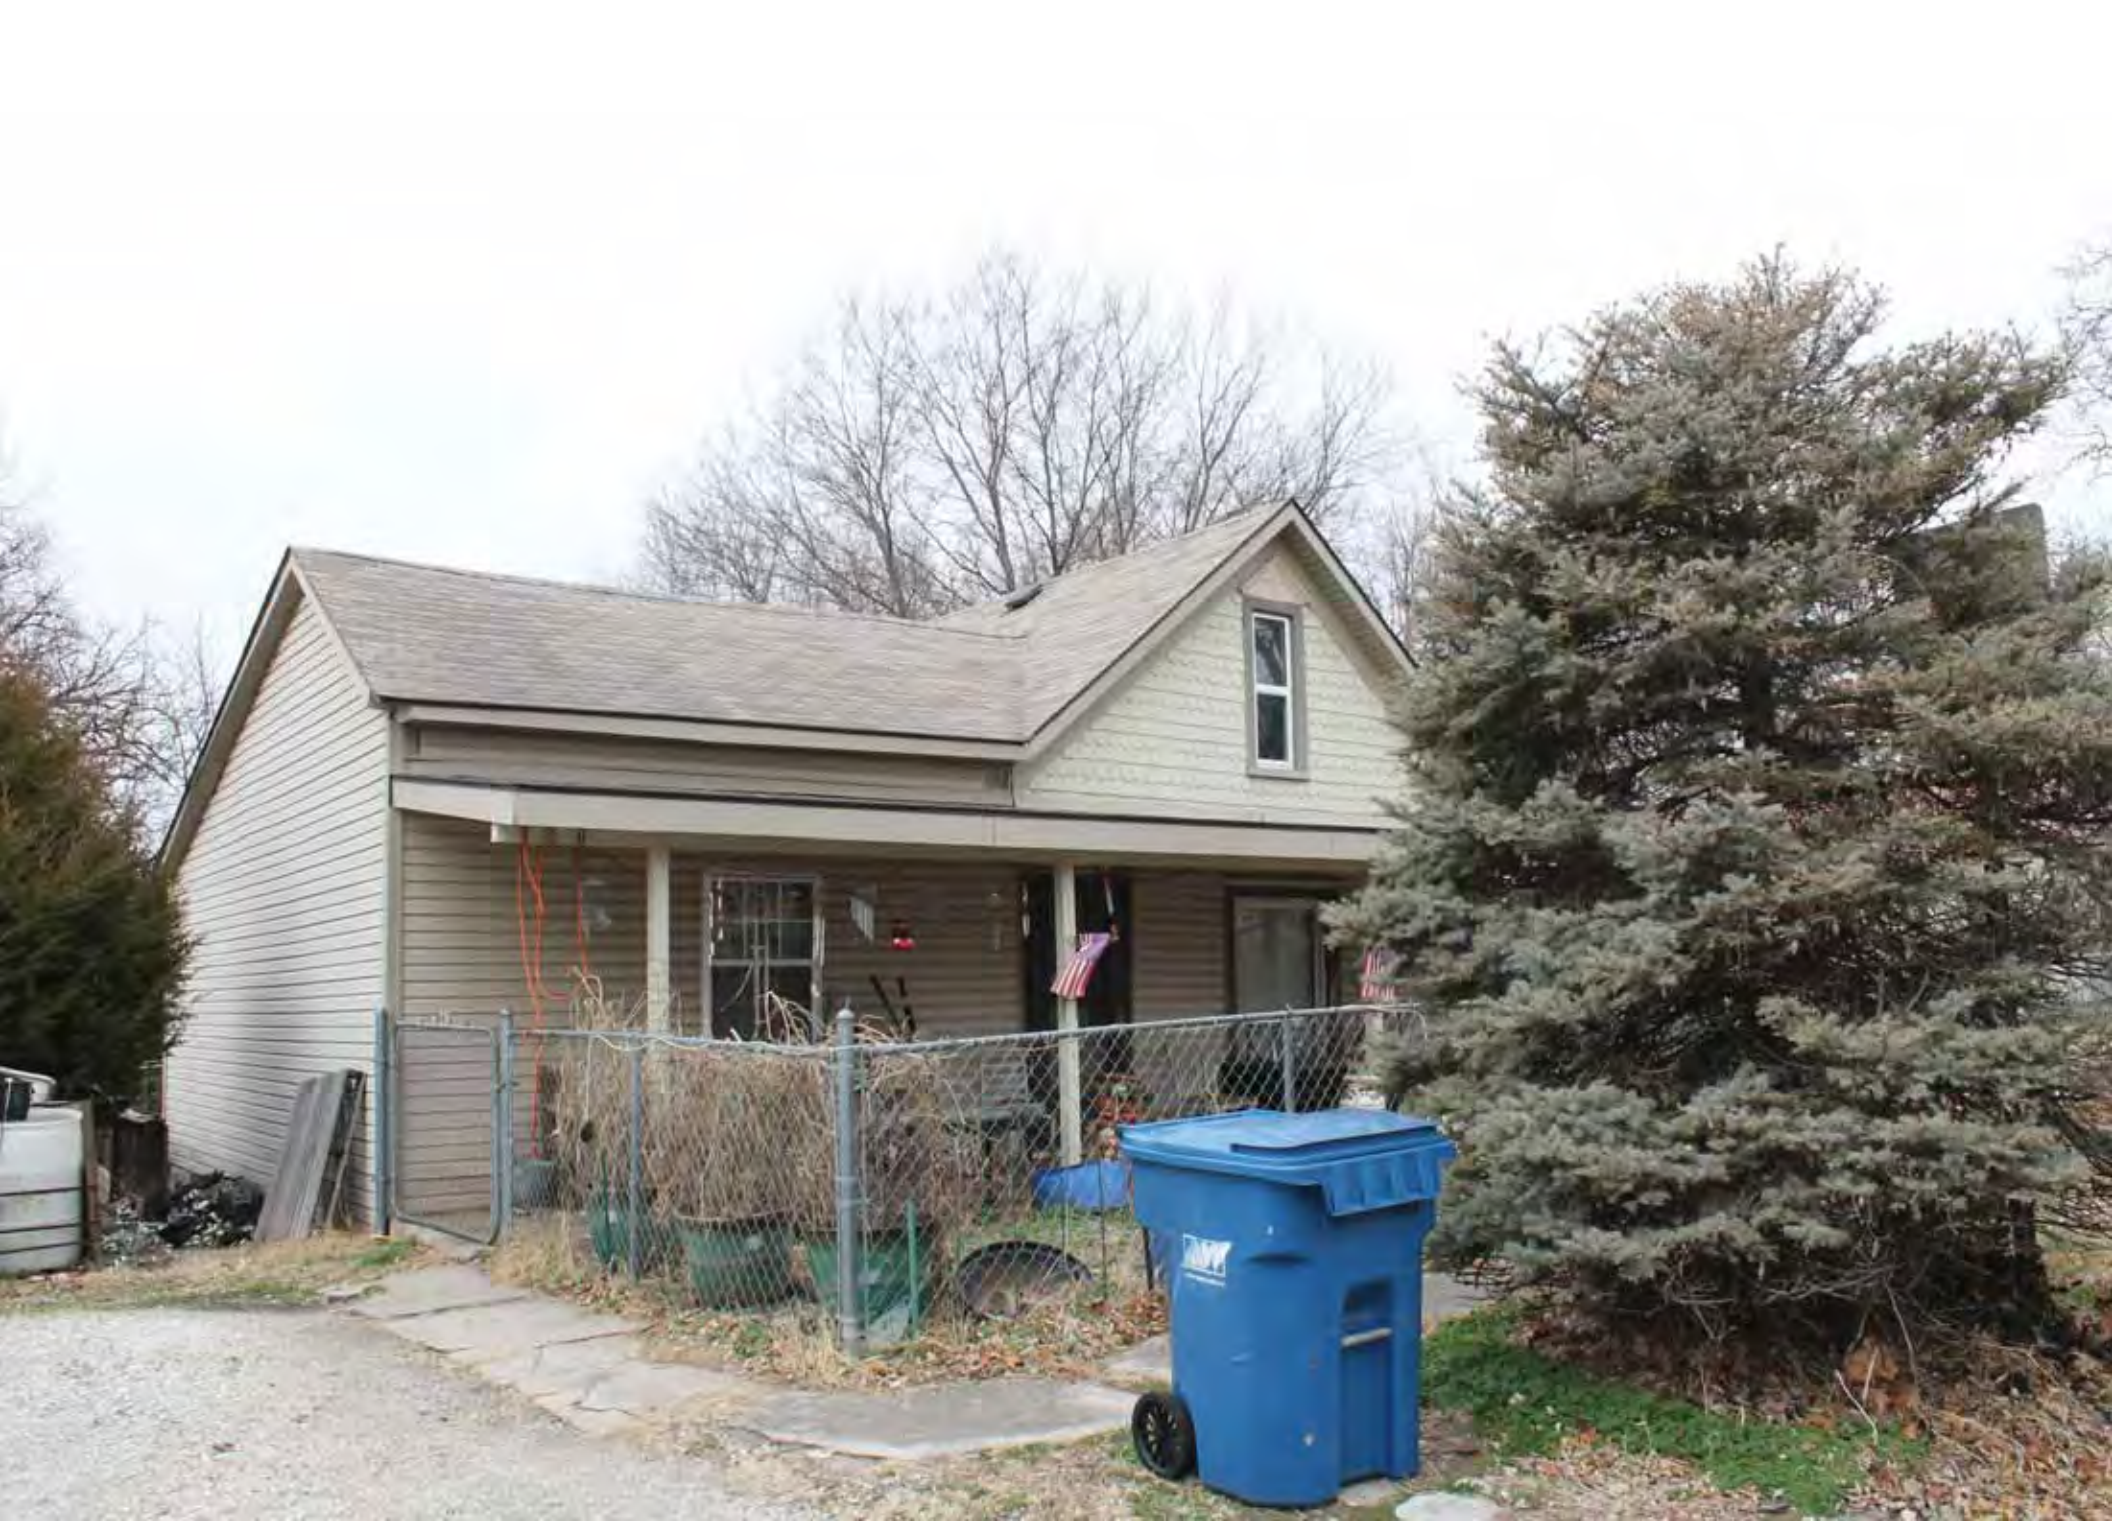
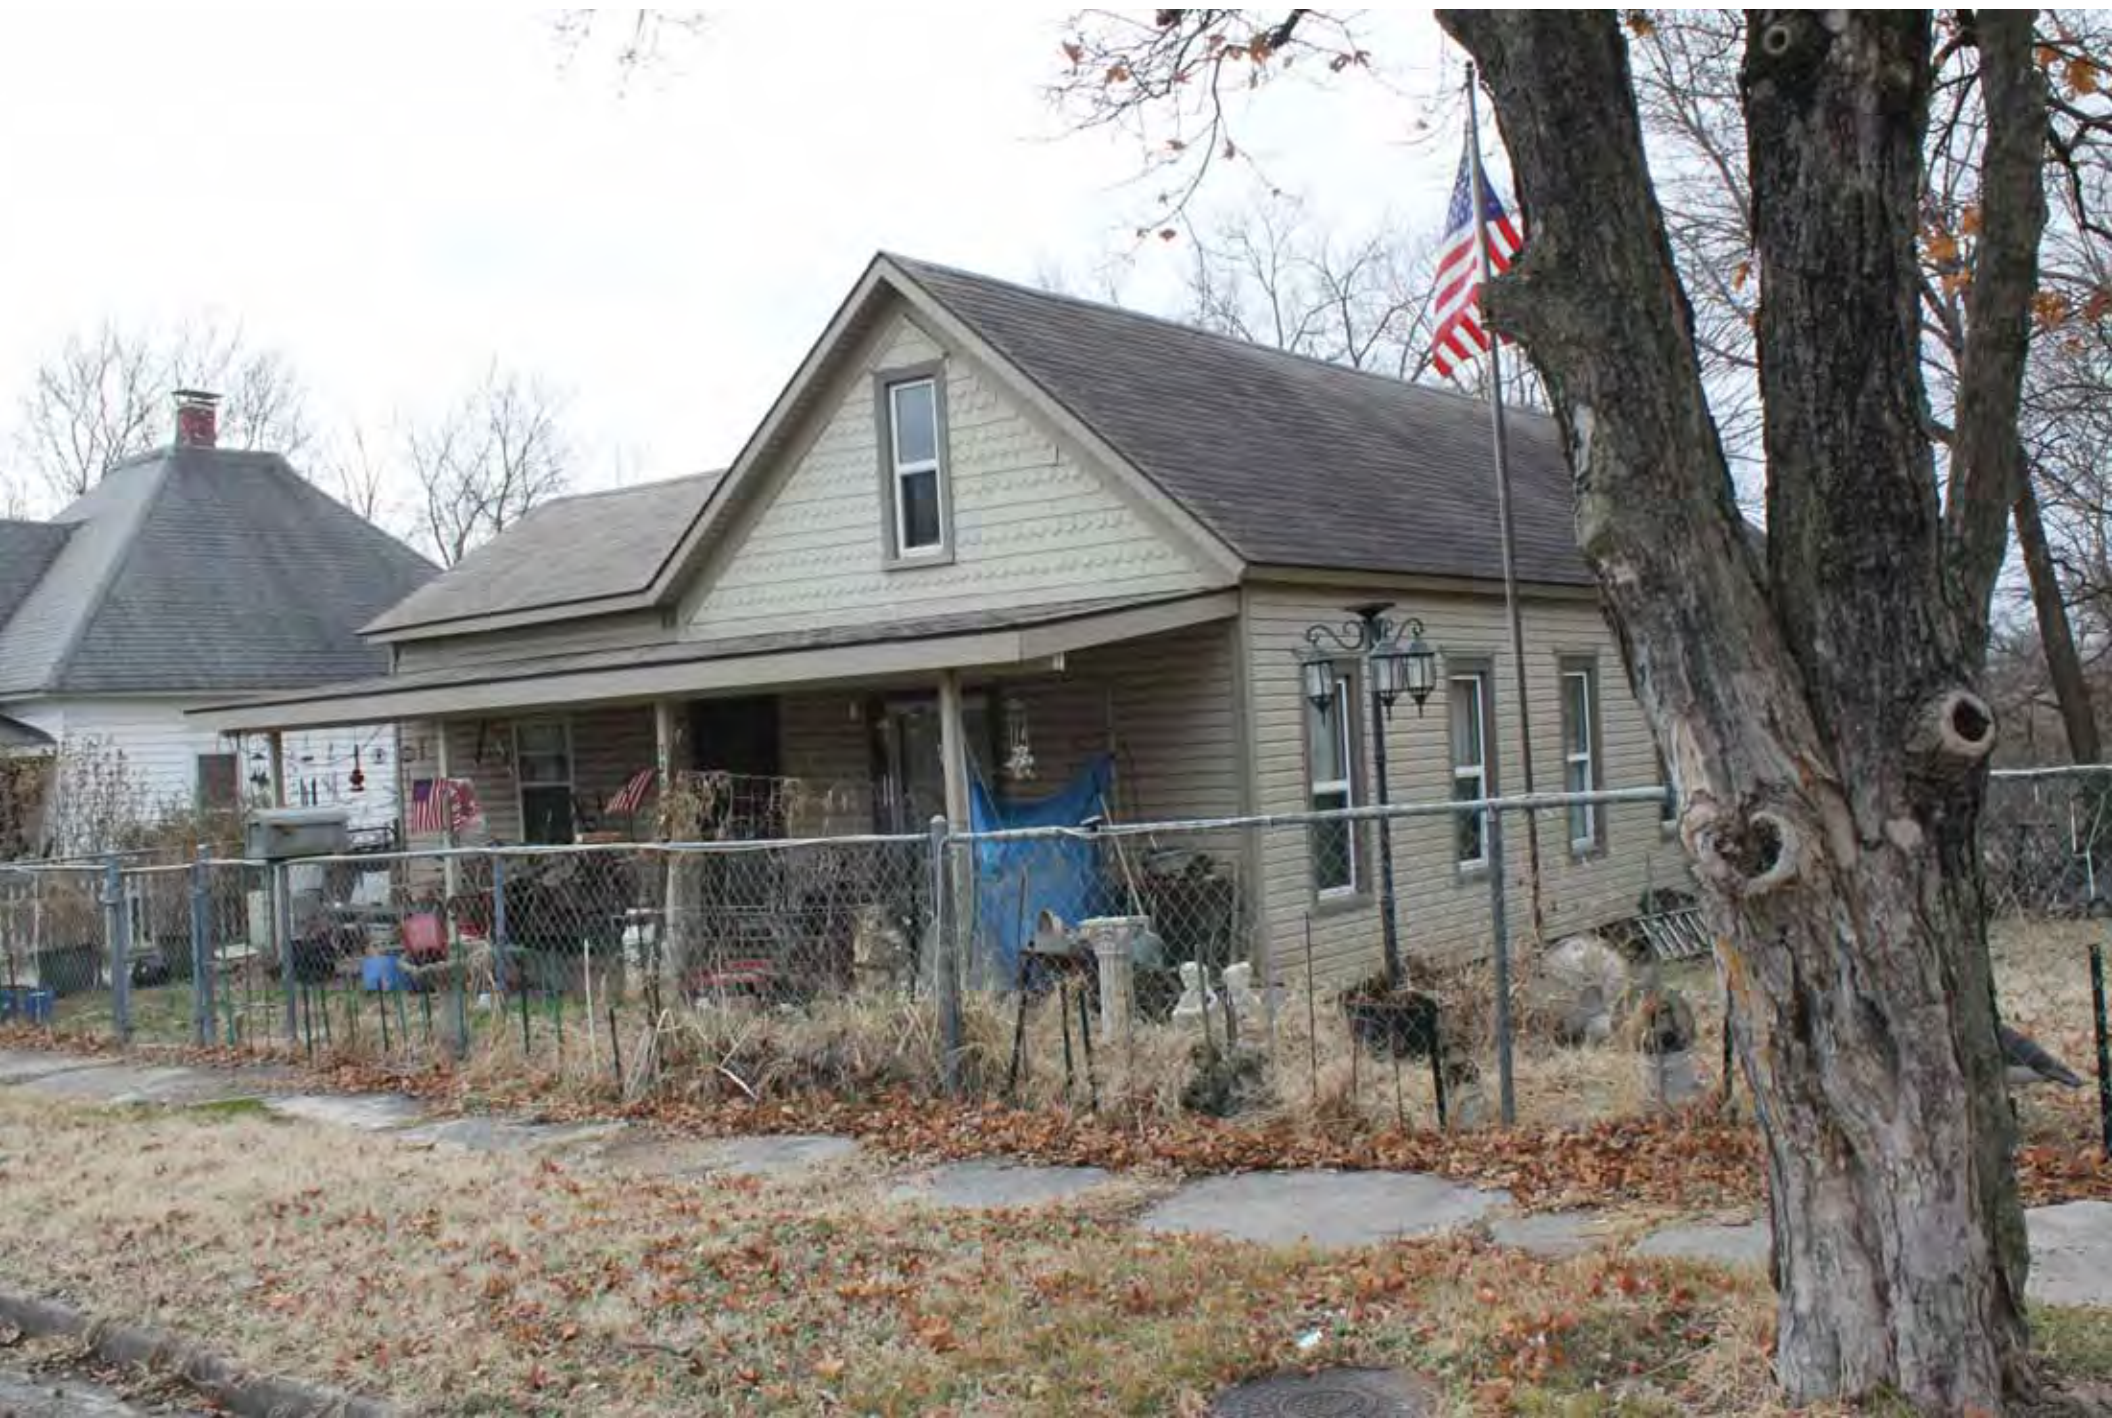
The property at 320 S. Mineral Avenue is a one story dwelling, with a cross-gable roof. The roof is covered in asphalt shingles. It has exterior vinyl siding although retains some wood decorative shingles at the pediment of the front facing gable. The front façade has a central entrance door flanked on either side by single windows. To the right of the front door is a large window with wood surrounds. To the left of the front door is a single six-over-one window. There is a front porch, with a flat roof on wood supports on a concrete foundation.

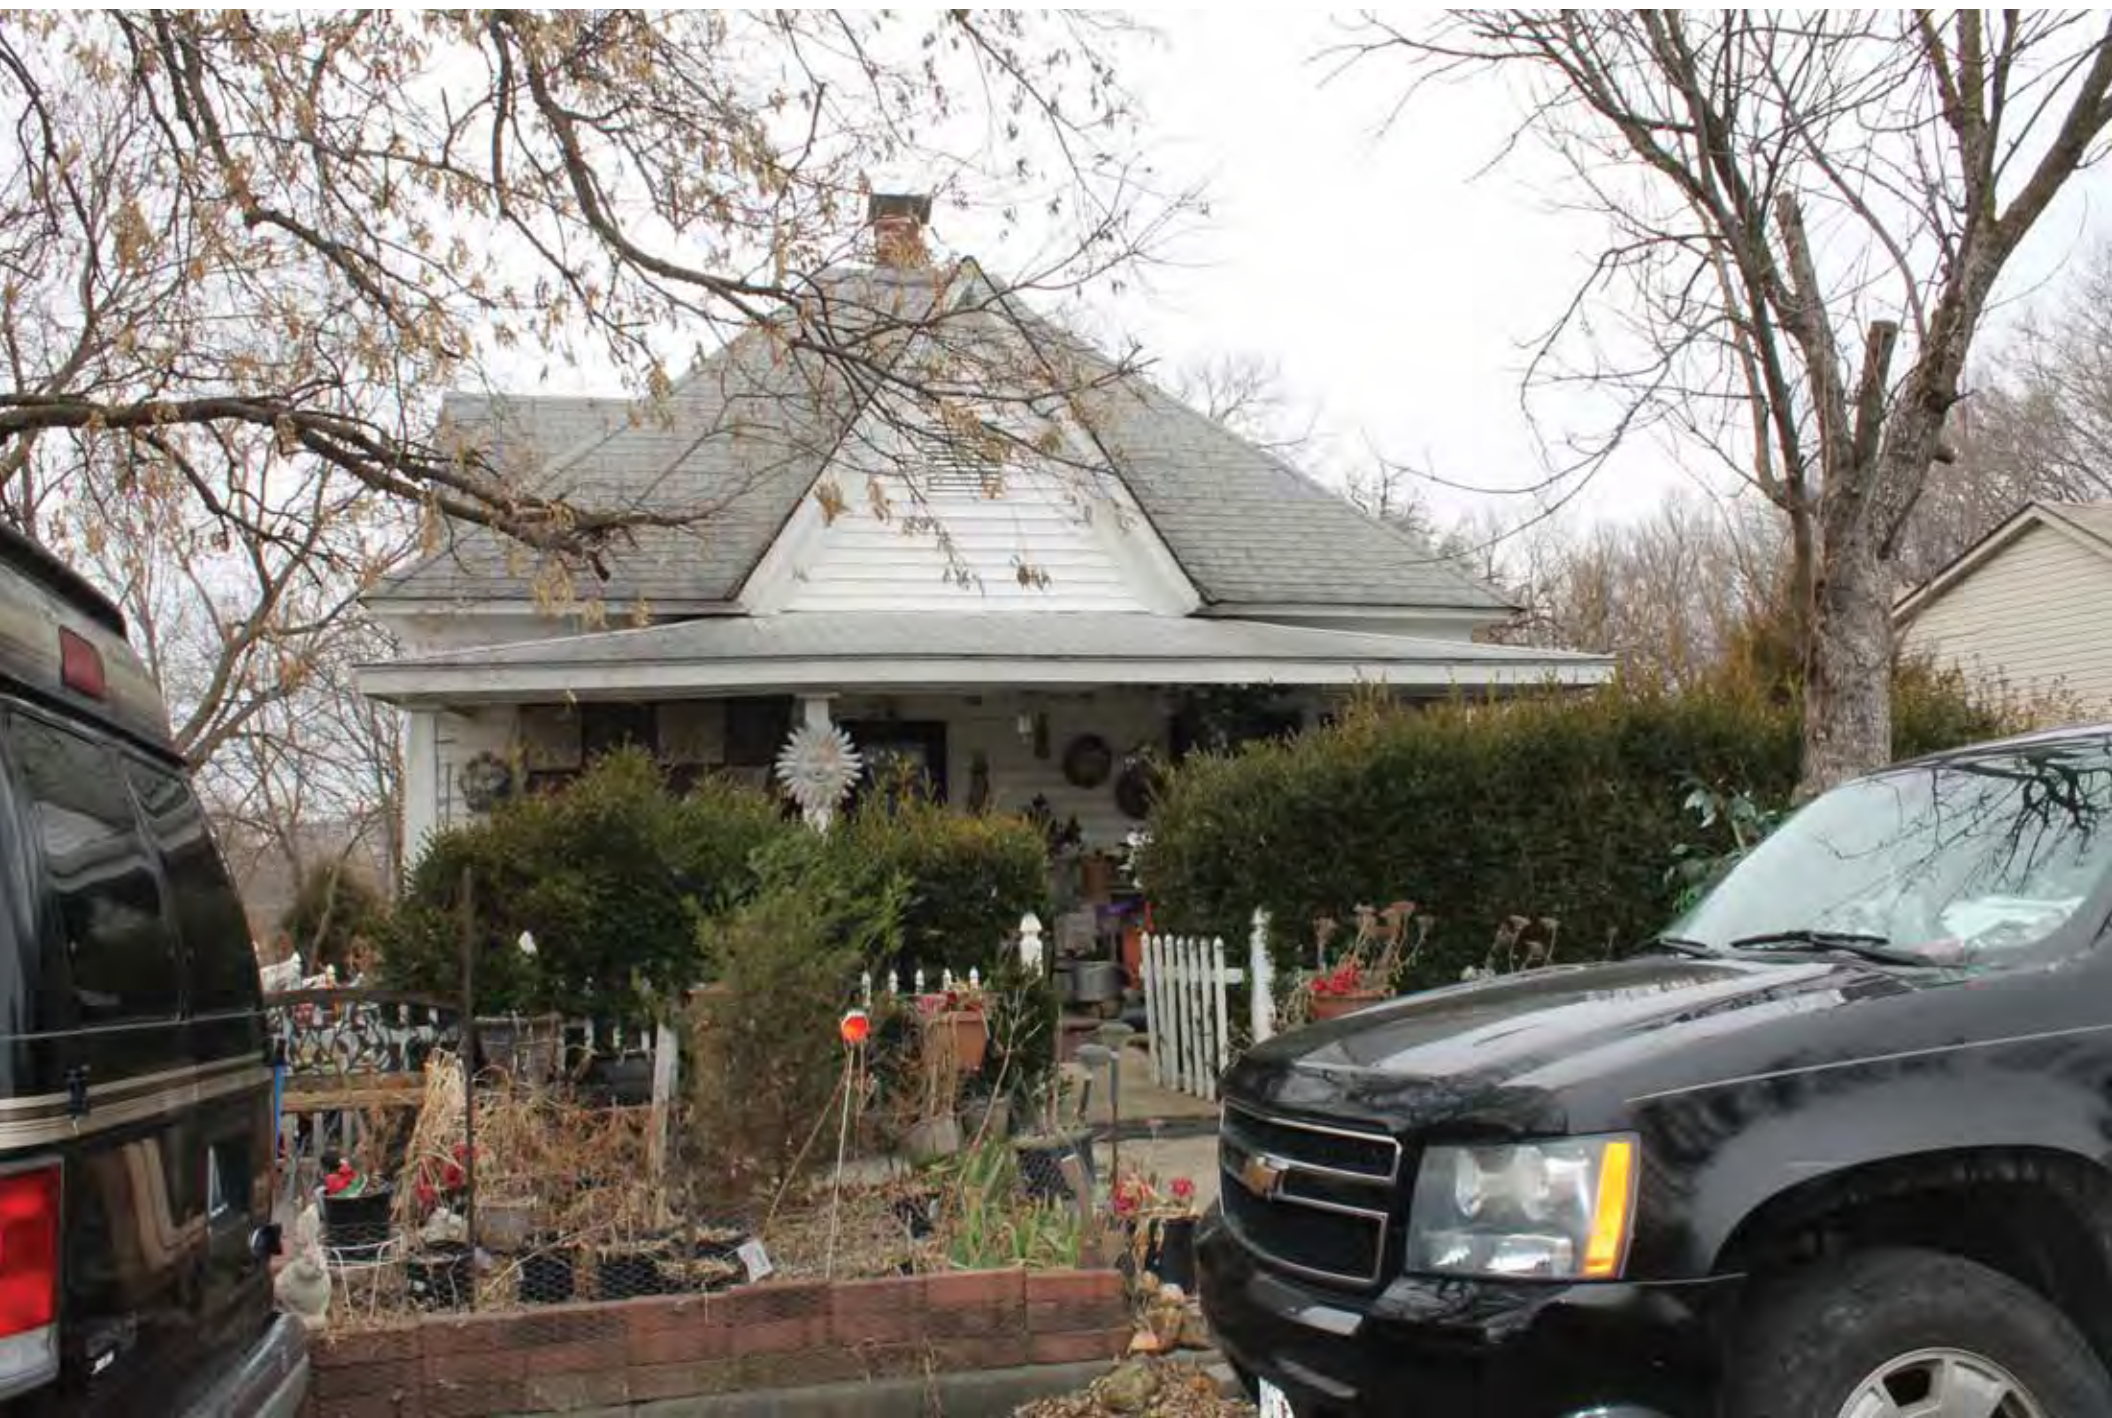
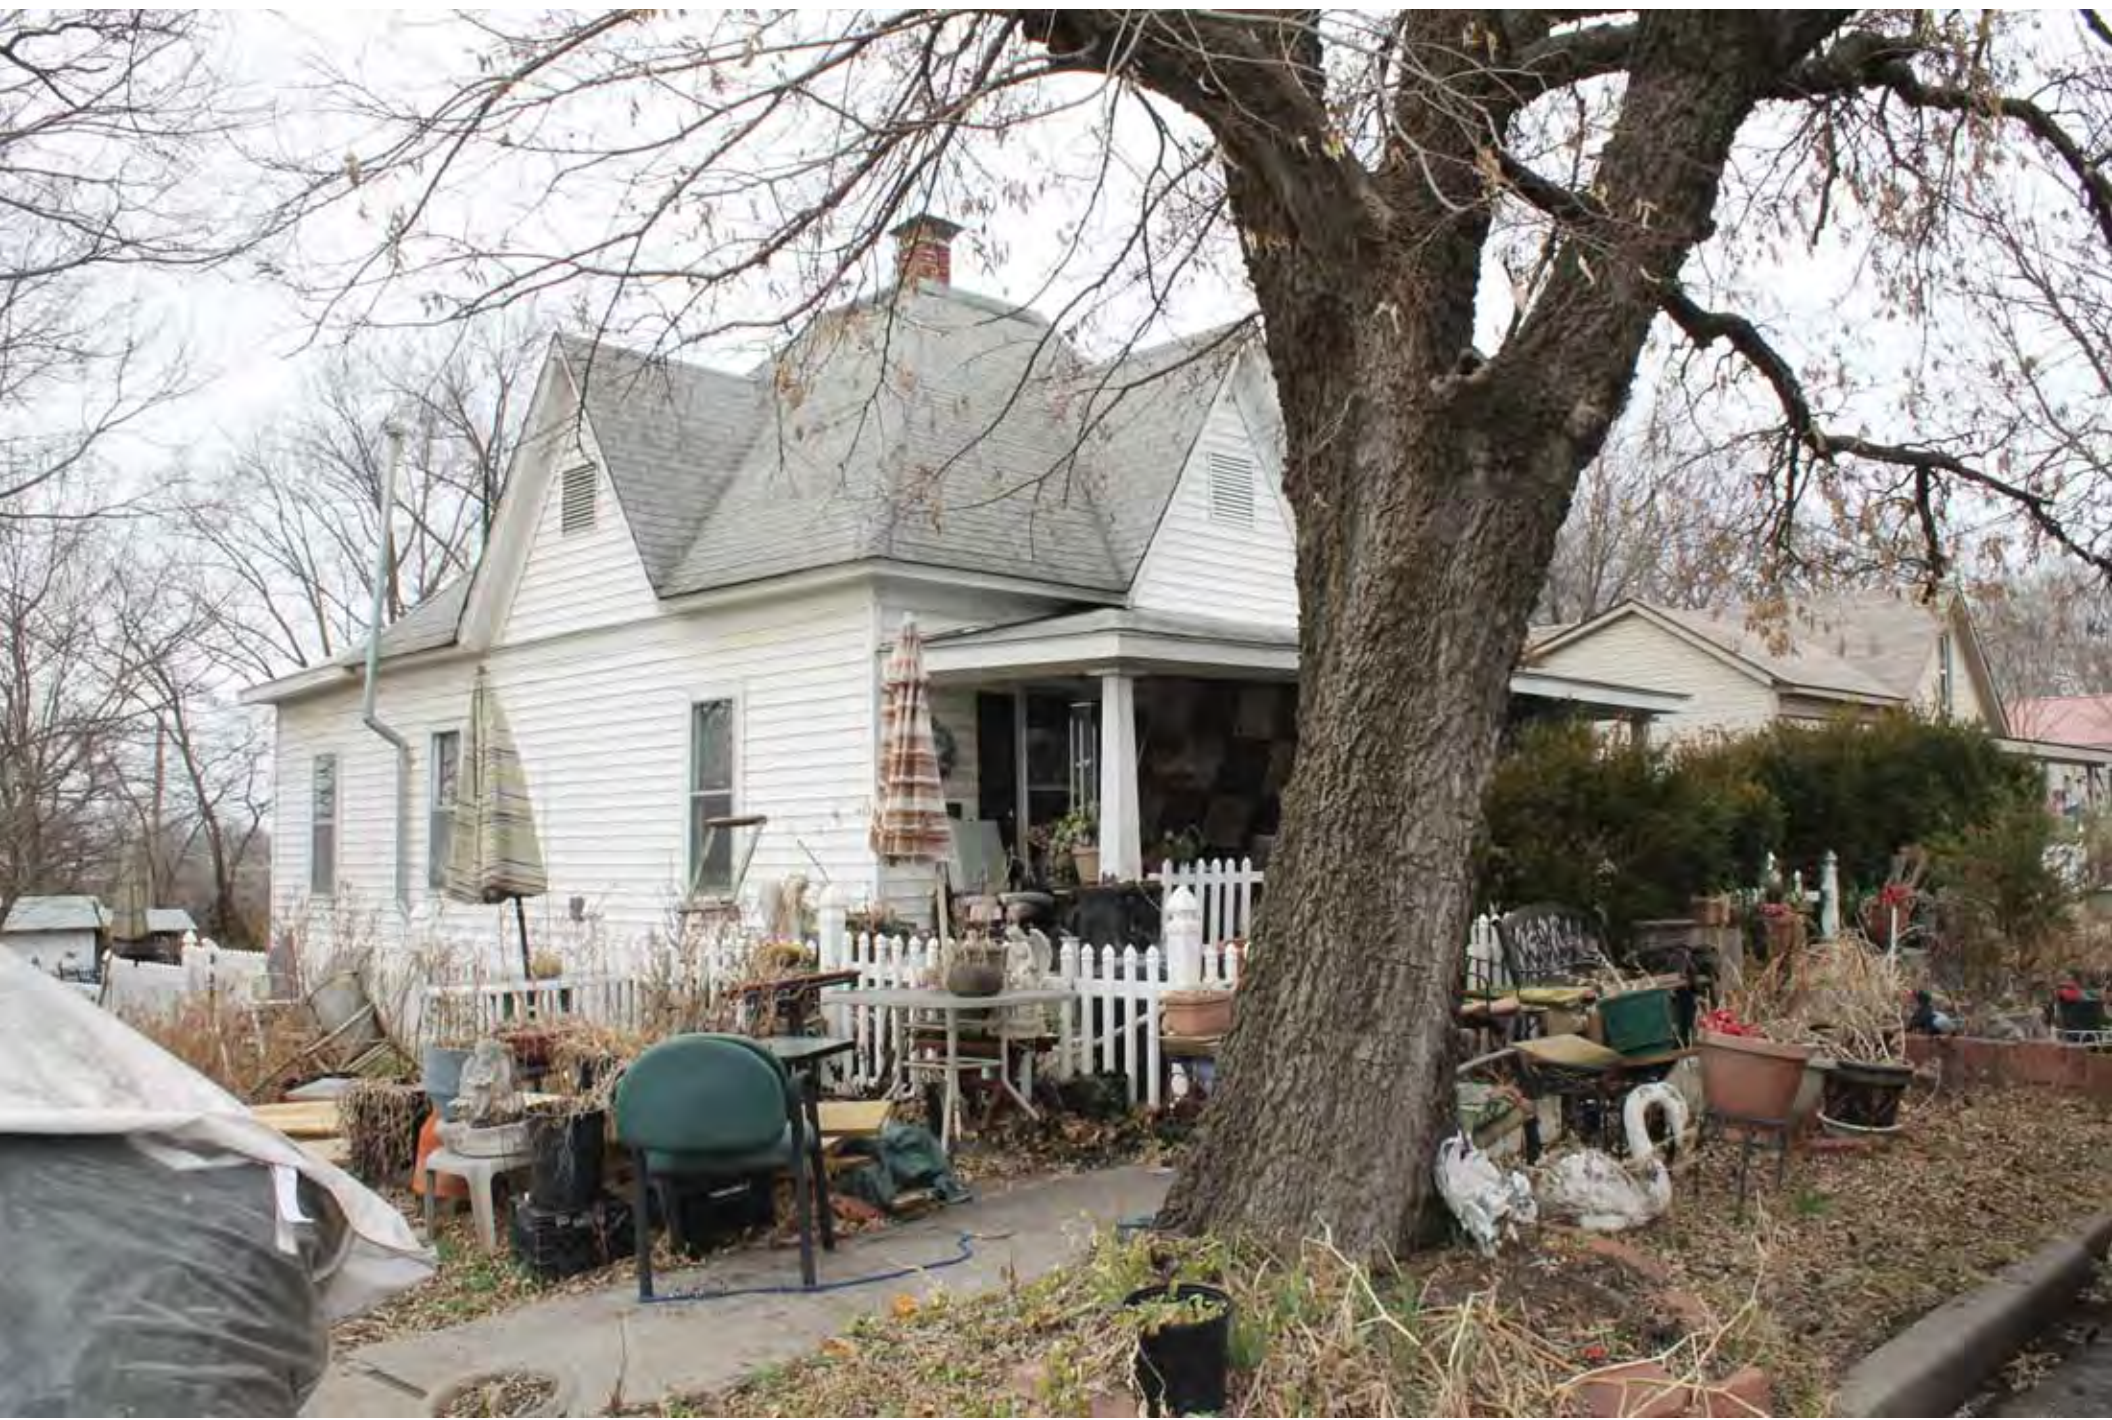
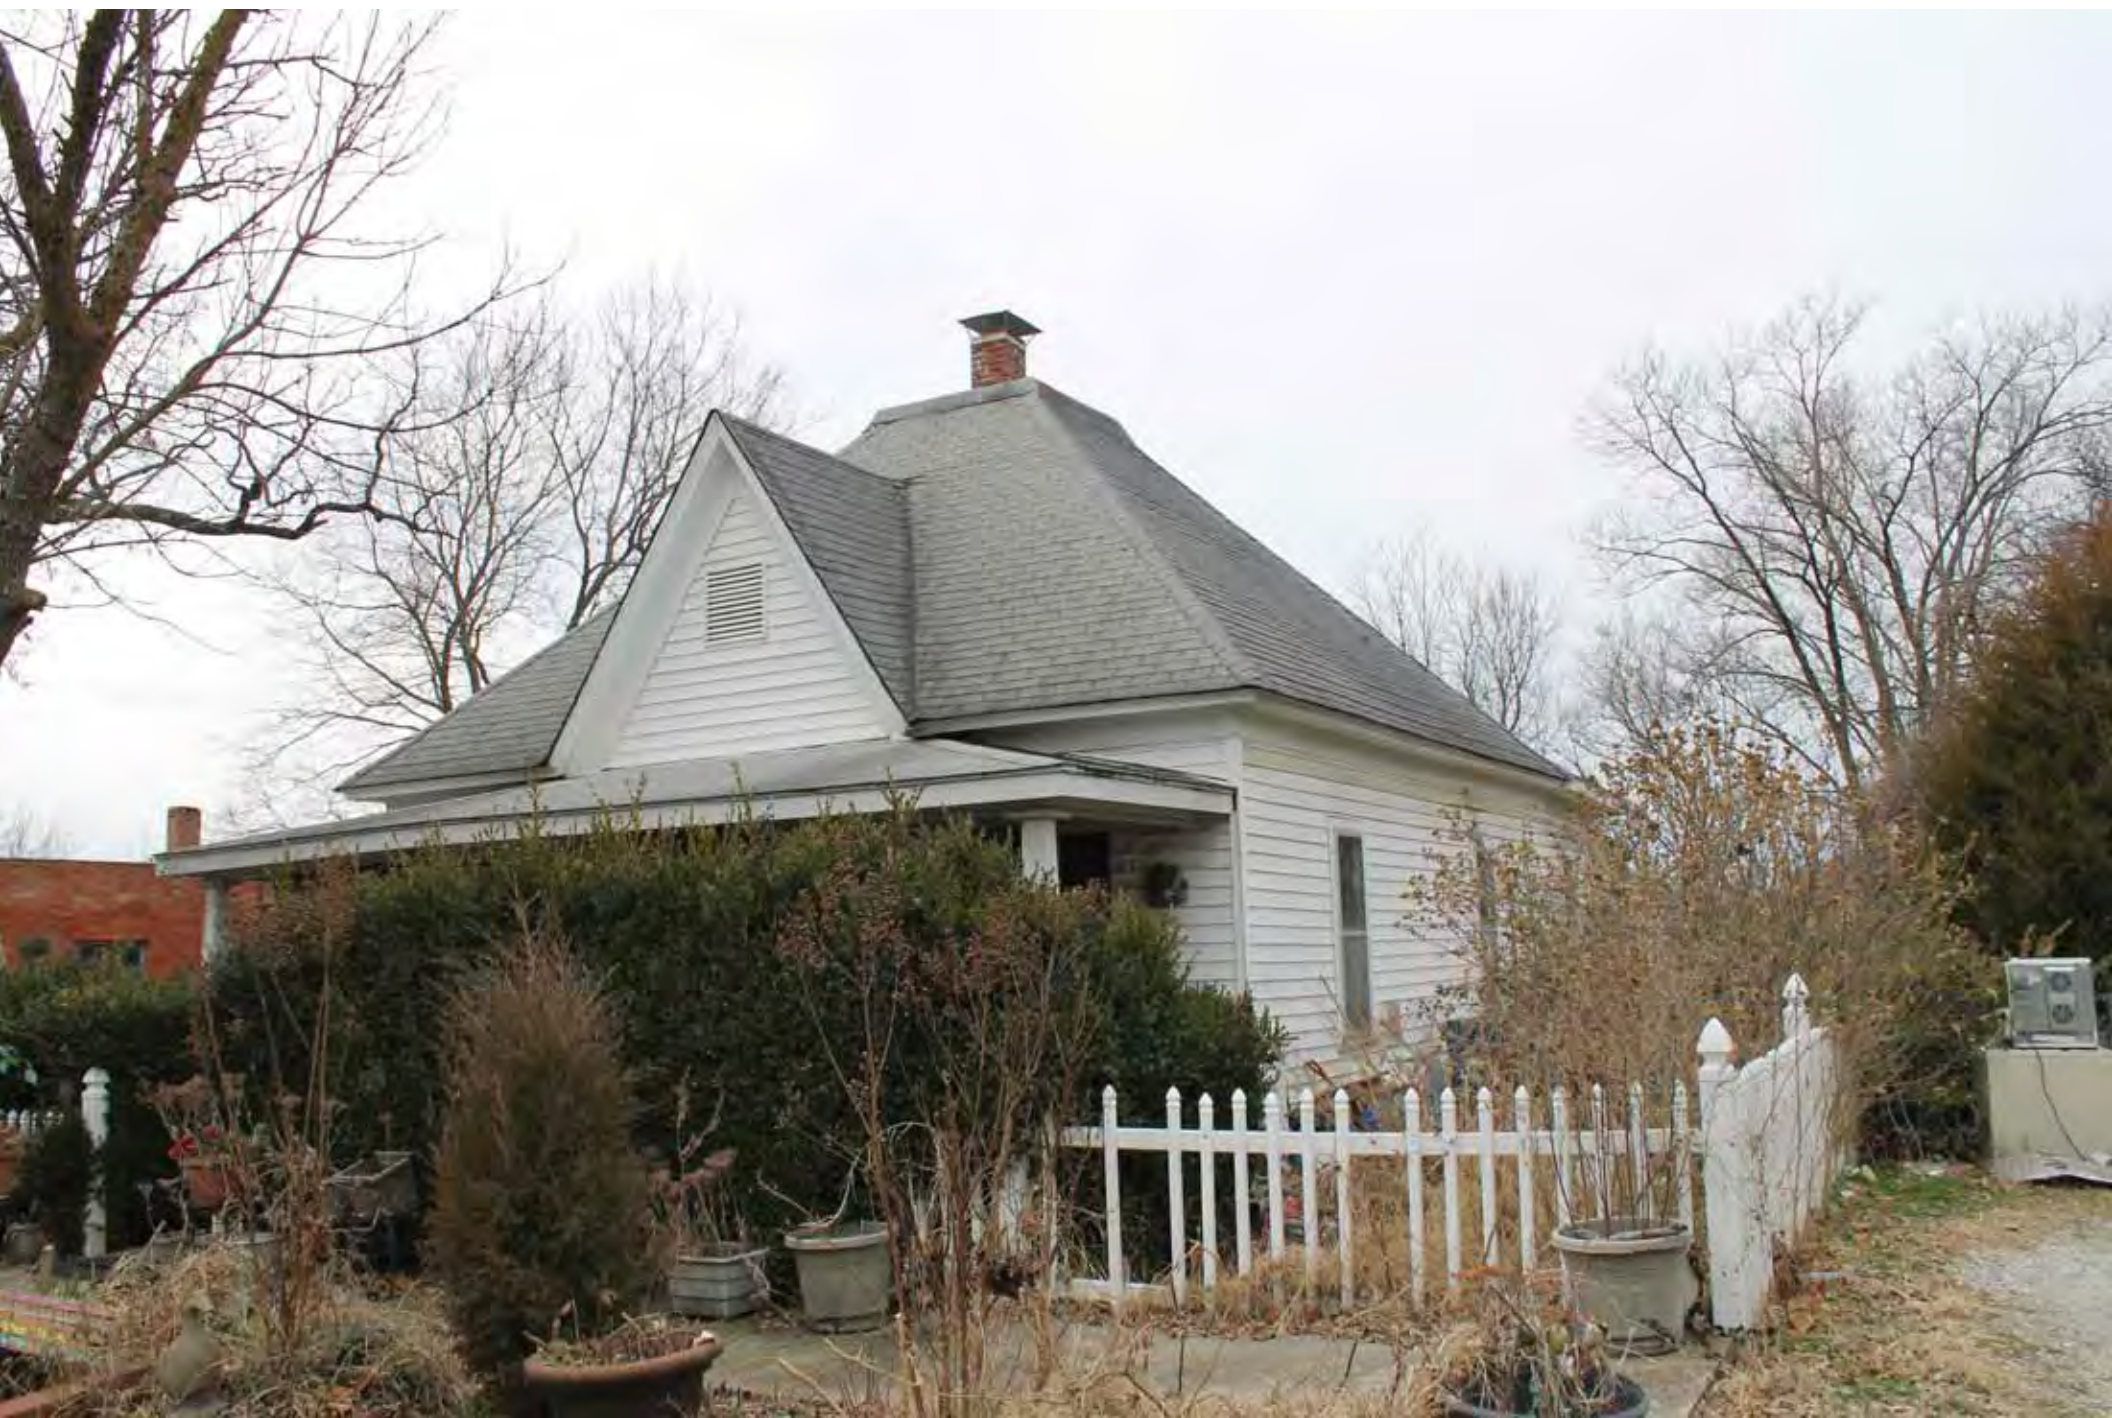
The property at 320 S. Mineral Avenue is a one story dwelling, with a high-pitched hip on center gable roof. There is a gable pediment end in the middle of the front façade. The roof is covered in asphalt shingles. It has exterior vinyl siding although retains some wood siding. The front façade has a central entrance door flanked on either side by single windows.. There is a front porch, with a low-pitched hipped roof. Many of the details of the home are obscured by bushes and plants.

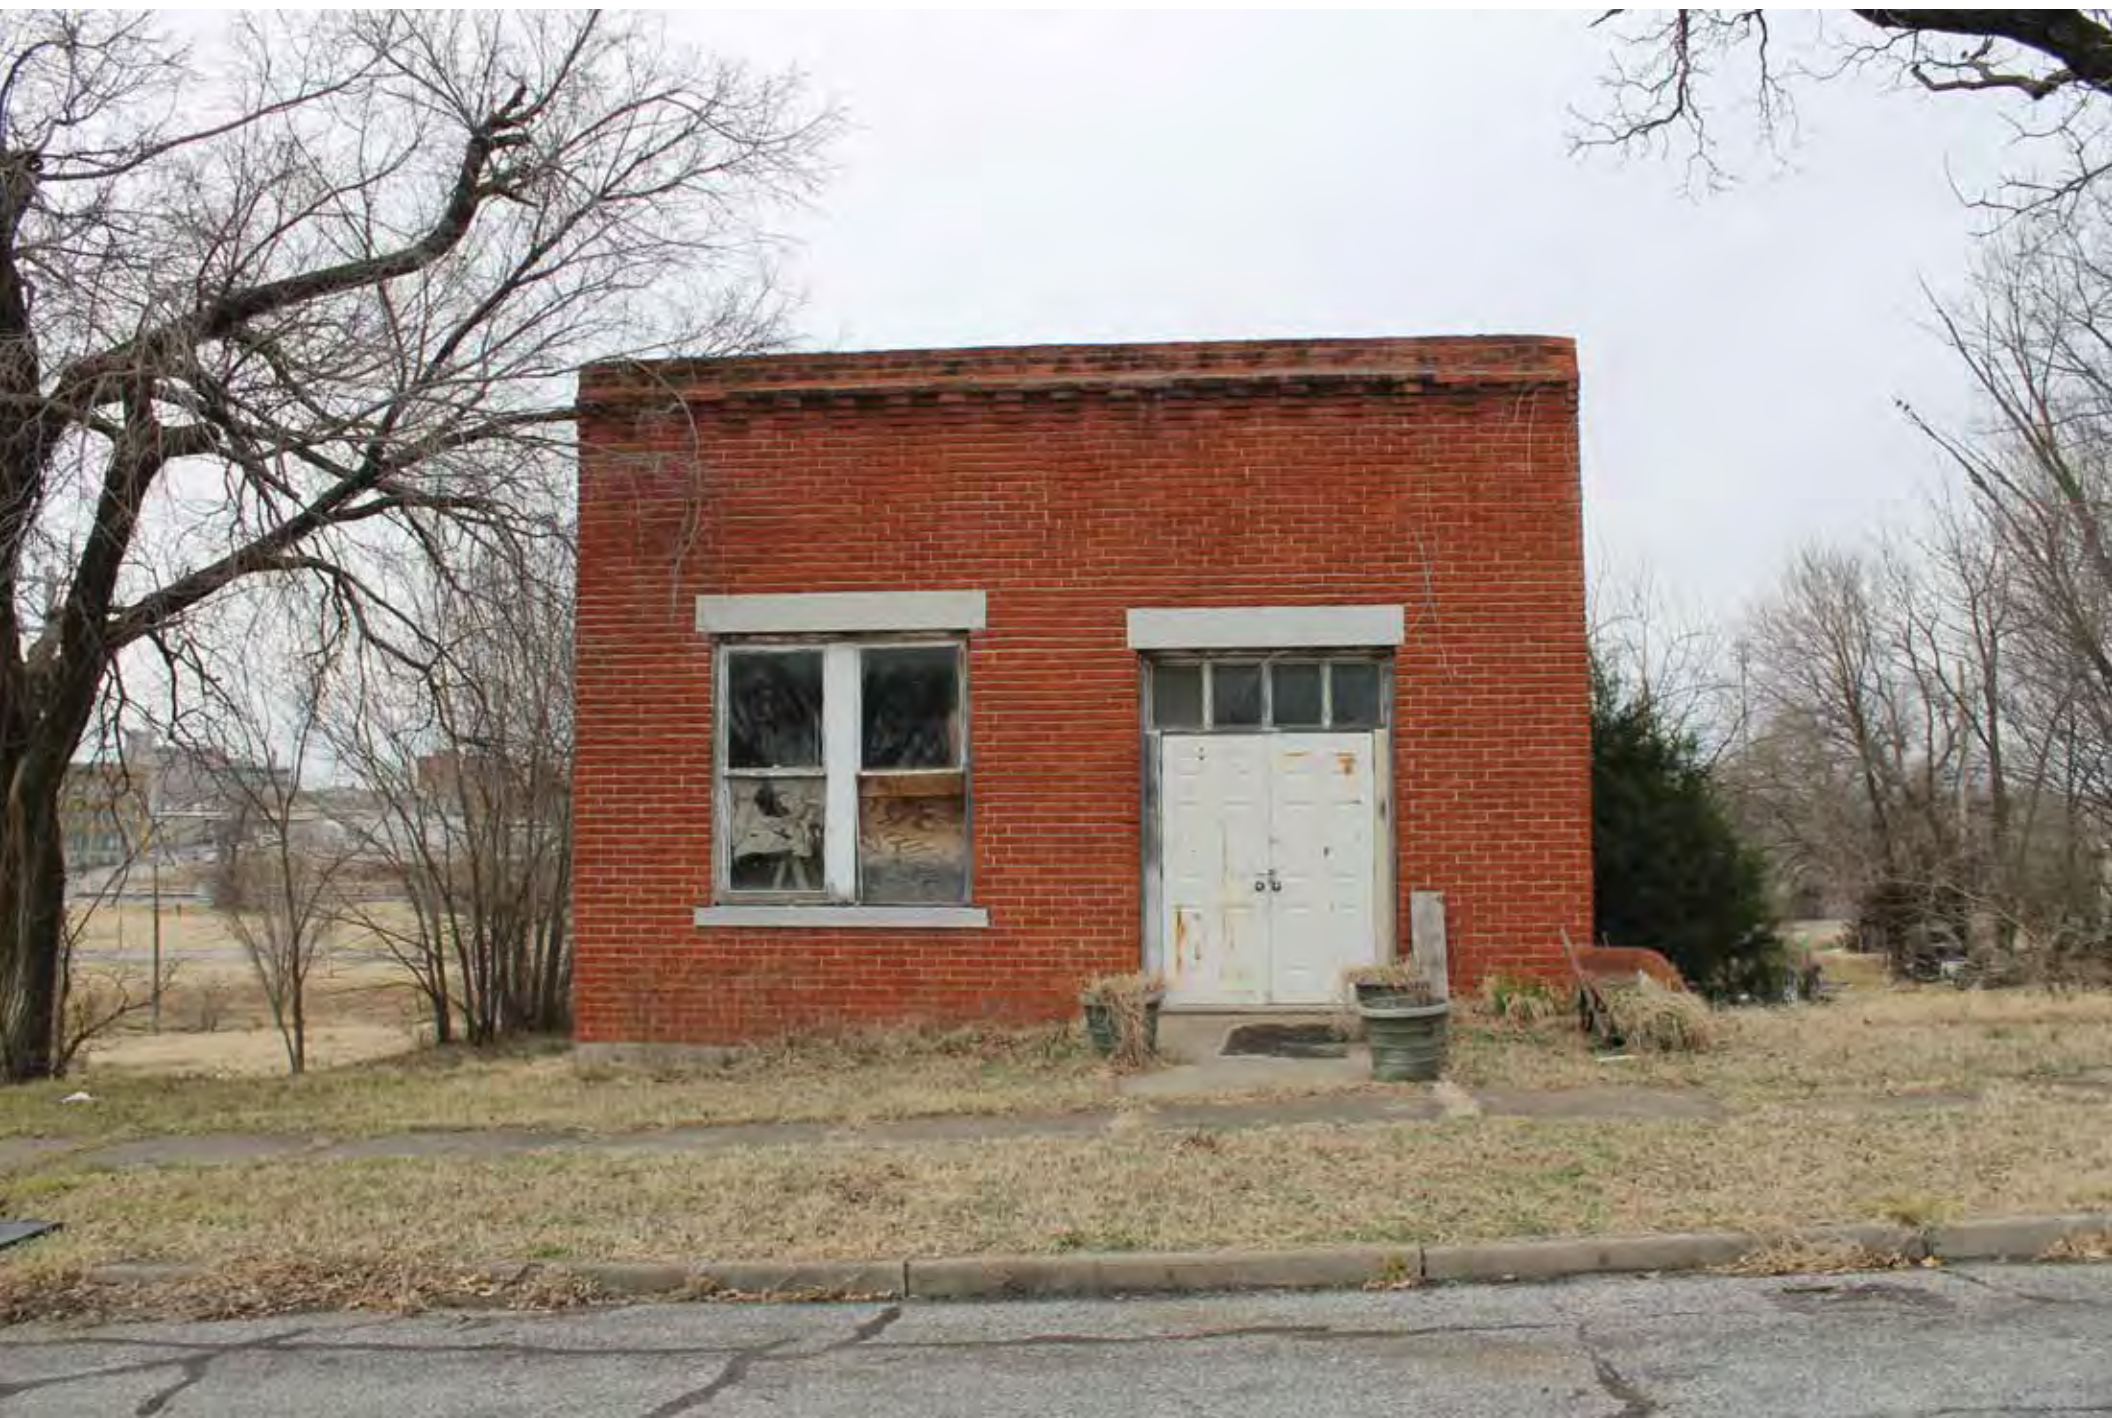
The property at 320 S. Mineral Avenue is a one-story brick commercial building. It has a flat brick parapet roof with simple brick corbelling along the cornice on the front facade. The front is two bays wide, with a double entrance door on the right. It sits below a stone lintel. On the left (south) side of the front façade are double wood one-over-one windows, sharing a stone sill and prominent stone lintel. On the north side façade is a wood double utility doors and several single wood one-over-one windows with stone sills, which appear to be original to the building. An exterior brick chimney is still intact. On the south side façade there are several double wood one-over-one windows, also with stone sills. There is another exterior brick chimney closer to the front façade.

The building sits on a hill, which allows the basement level to be accessible and exposed everywhere except at the front of the building. The basement /foundation is constructed of poured concrete. There are several one-over-one replacement windows at this level.
