MISSOURI DEPARTMENT OF NATURAL RESOURCES
STATE HISTORIC PRESERVATION OFFICE, P.O. Box 176, Jefferson City, MO 65102
ARCHITECTURAL/HISTORIC INVENTORY FORM

1. Survey No. JP-AS-007-001		2. Survey name: East Town (Original Joplin) Historic Survey Phase 2	
3. County: JASPER		4. Address (Street No.) 618	Street (name) E. 2 nd Street
5. City: Joplin	Vicinity: <input type="checkbox"/>	6. Geographical Reference:	7. Township/Range/Section: T: R: S:
8. Historic name (if known):		9. Present/other name (if known):	
10. Ownership: <input checked="" type="checkbox"/> Private <input type="checkbox"/> Public		11a. Historic use (if known): Domestic: Single Dwelling	11b. Current use: Domestic: Single Dwelling

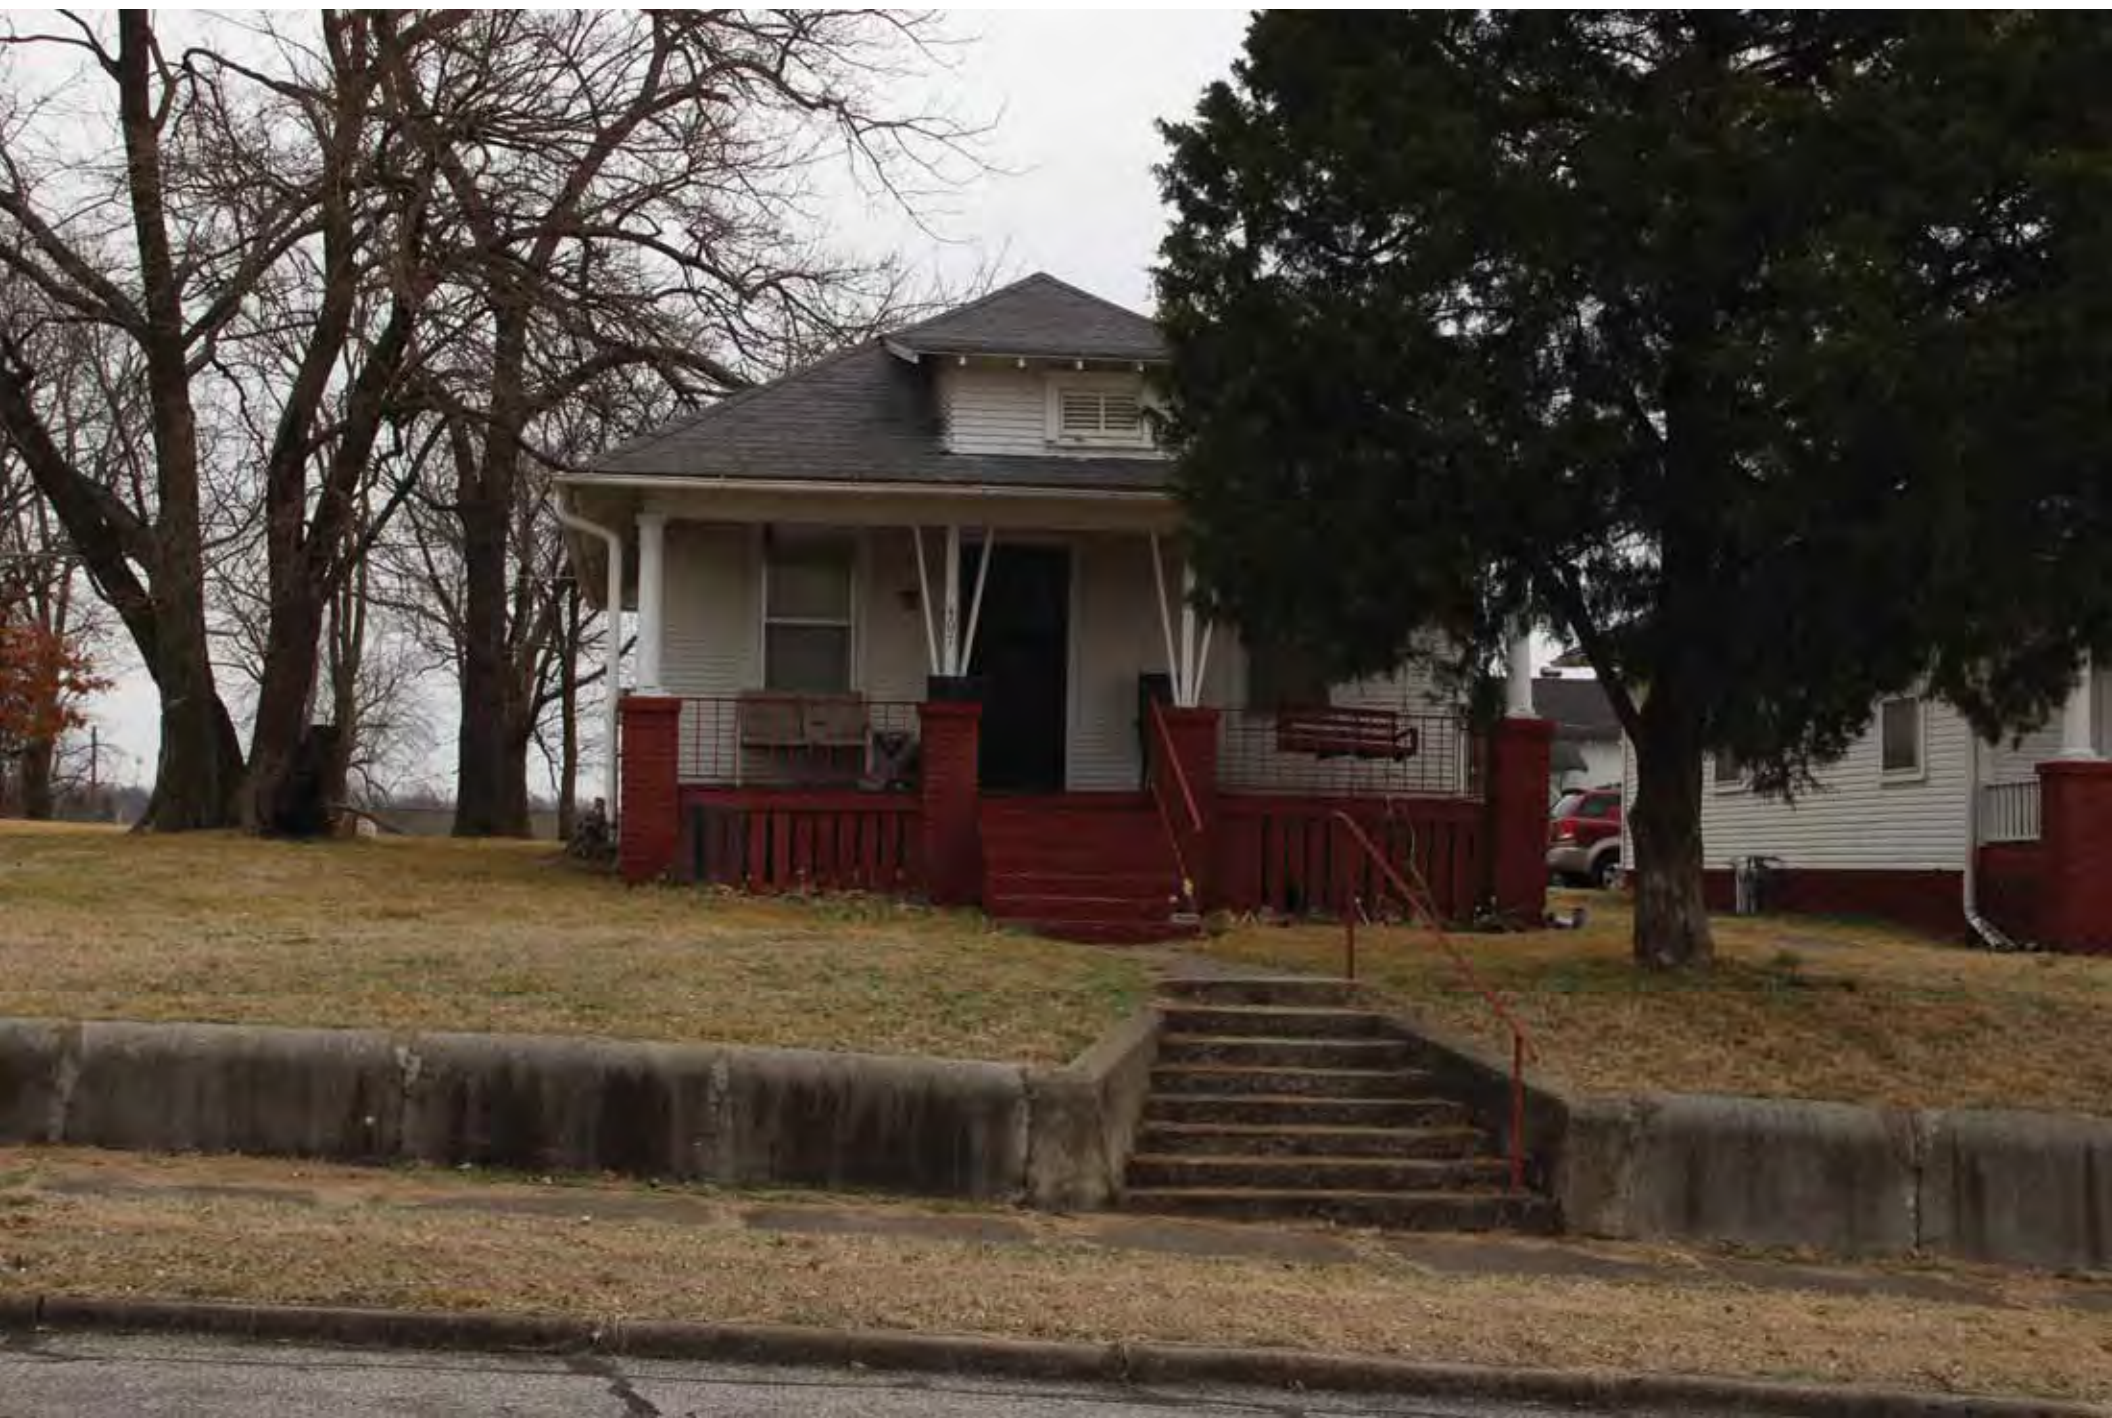
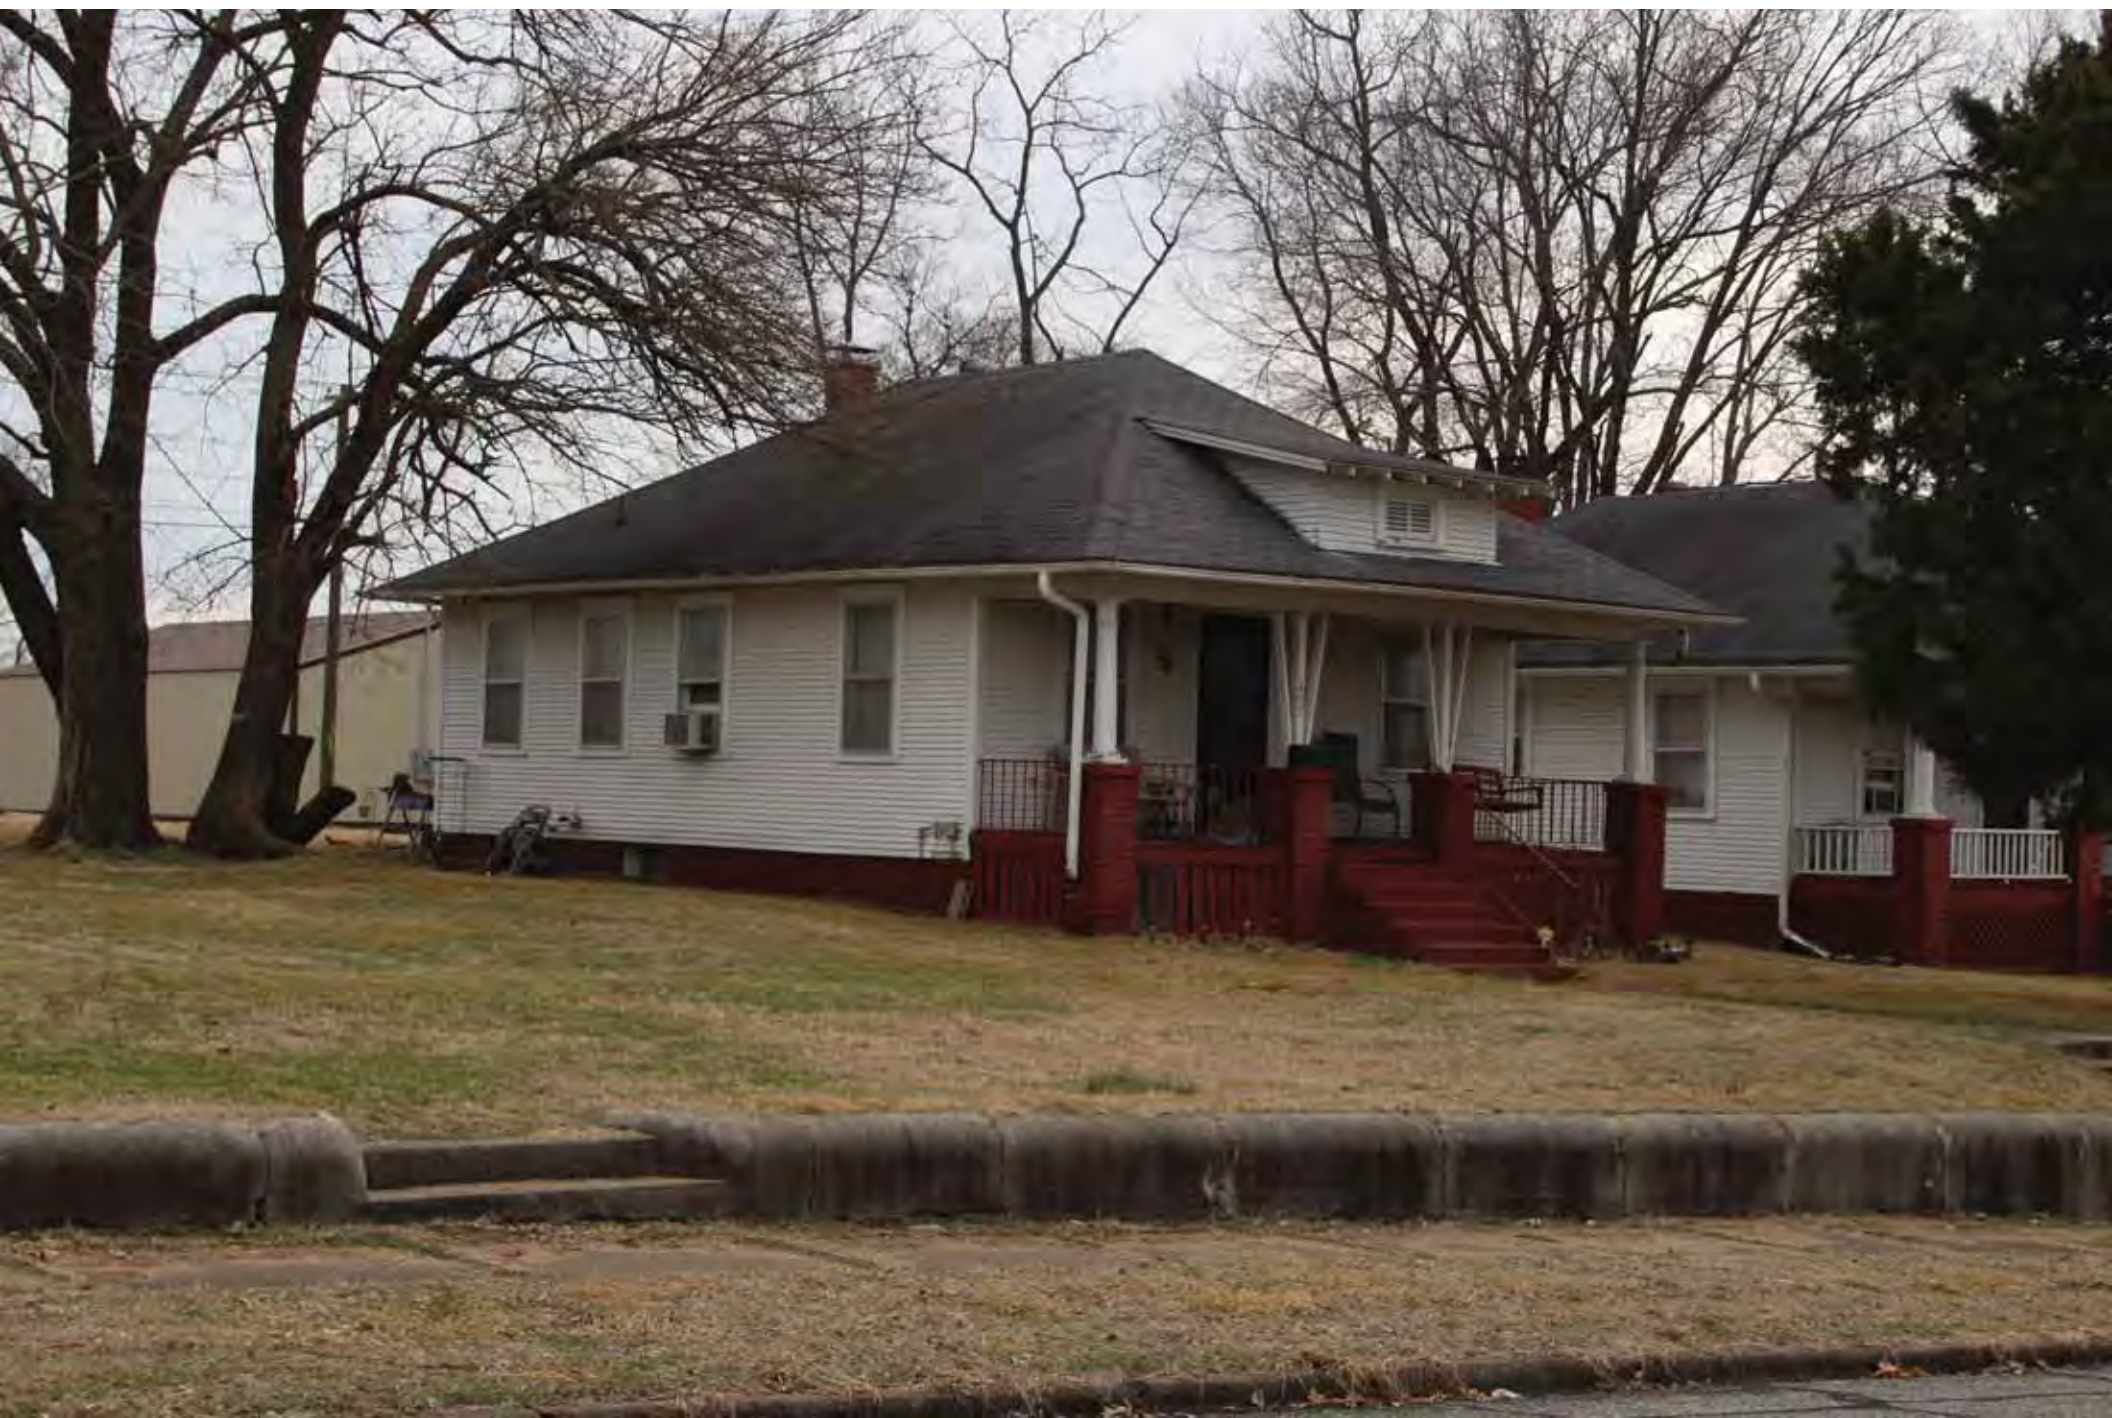
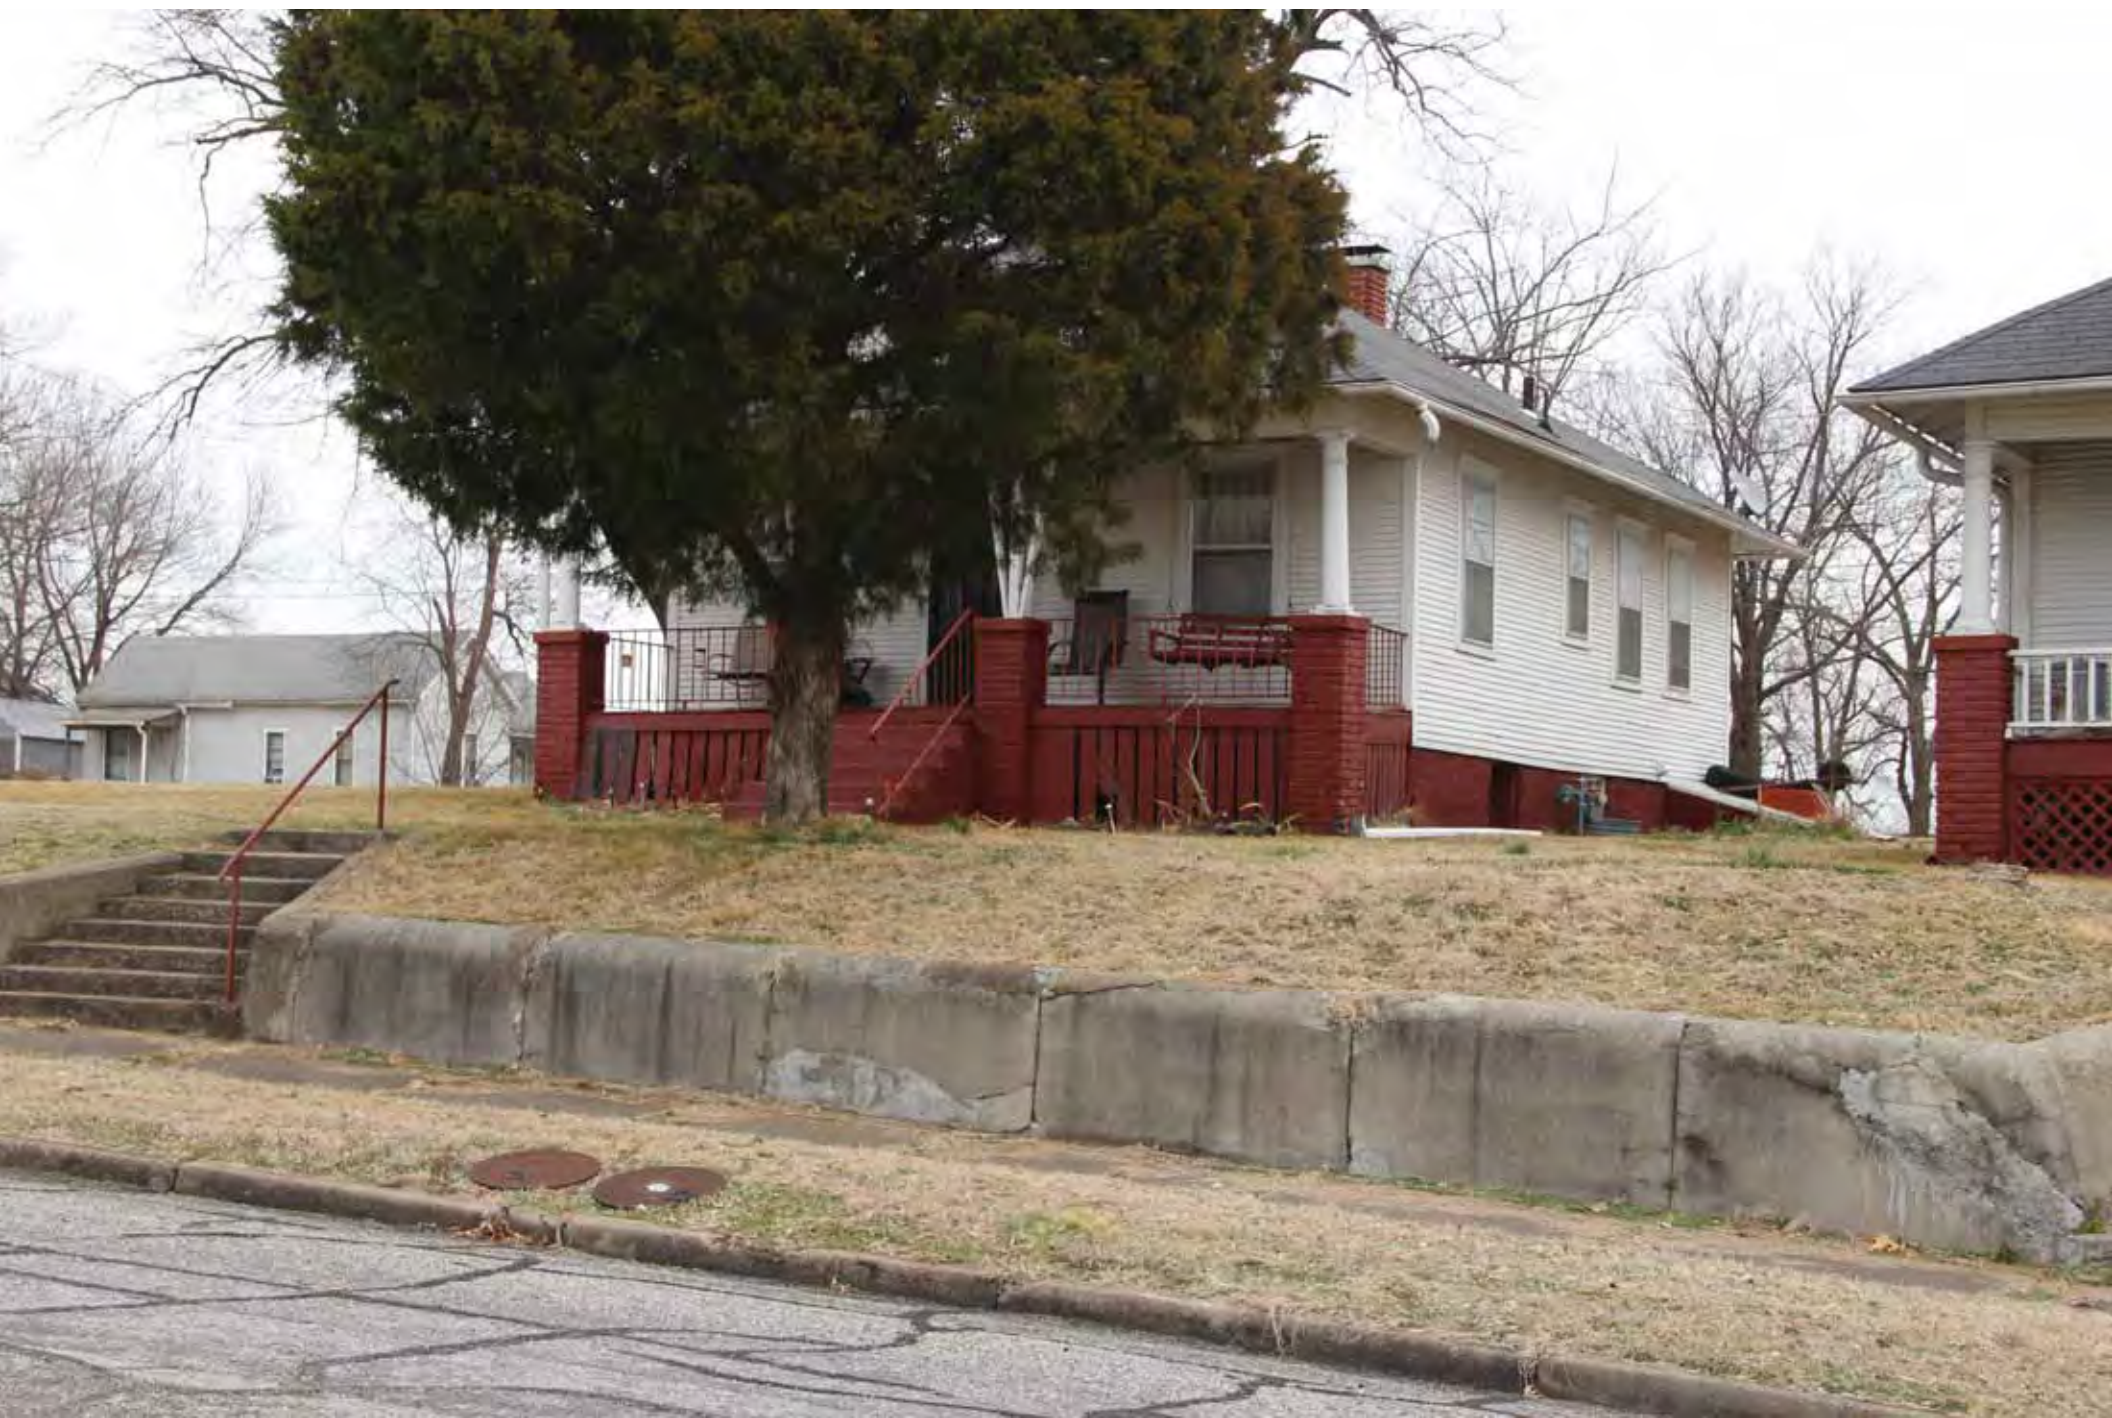
This dwelling has been extensively altered replacement of some of the original windows. It does not retain integrity that would render it individually eligible for the National Register of Historic Places and is not an exceptional example of its style. The dwelling is not situated in an area recommended as a historic district.

The property at 407S. Mineral Avenue features a one story dwelling, with a medium-pitched hipped roof. It has exterior wood siding and an asphalt-shingled roof. At the roof on the front façade is a shed roof dormer. The front façade has a central entrance door flanked on either side by one-over-one windows. There is a wooden veranda, which extends the length of the front façade, and is sheltered by the hip roof of the house. It has round wood columns supported on brick masonry bases. On the side facades are four single one-over-one windows.
