MISSOURI DEPARTMENT OF NATURAL RESOURCES
STATE HISTORIC PRESERVATION OFFICE, P.O. Box 176, Jefferson City, MO 65102
ARCHITECTURAL/HISTORIC INVENTORY FORM

1. Survey No. JP-AS-007-001		2. Survey name: East Town (Original Joplin) Historic Survey Phase 2	
3. County: JASPER		4. Address (Street No.) 618	Street (name) E. 2 nd Street
5. City: Joplin	Vicinity: <input type="checkbox"/>	6. Geographical Reference:	7. Township/Range/Section: T: R: S:
8. Historic name (if known):		9. Present/other name (if known):	
10. Ownership: <input checked="" type="checkbox"/> Private <input type="checkbox"/> Public		11a. Historic use (if known): Domestic: Single Dwelling	11b. Current use: Domestic: Single Dwelling

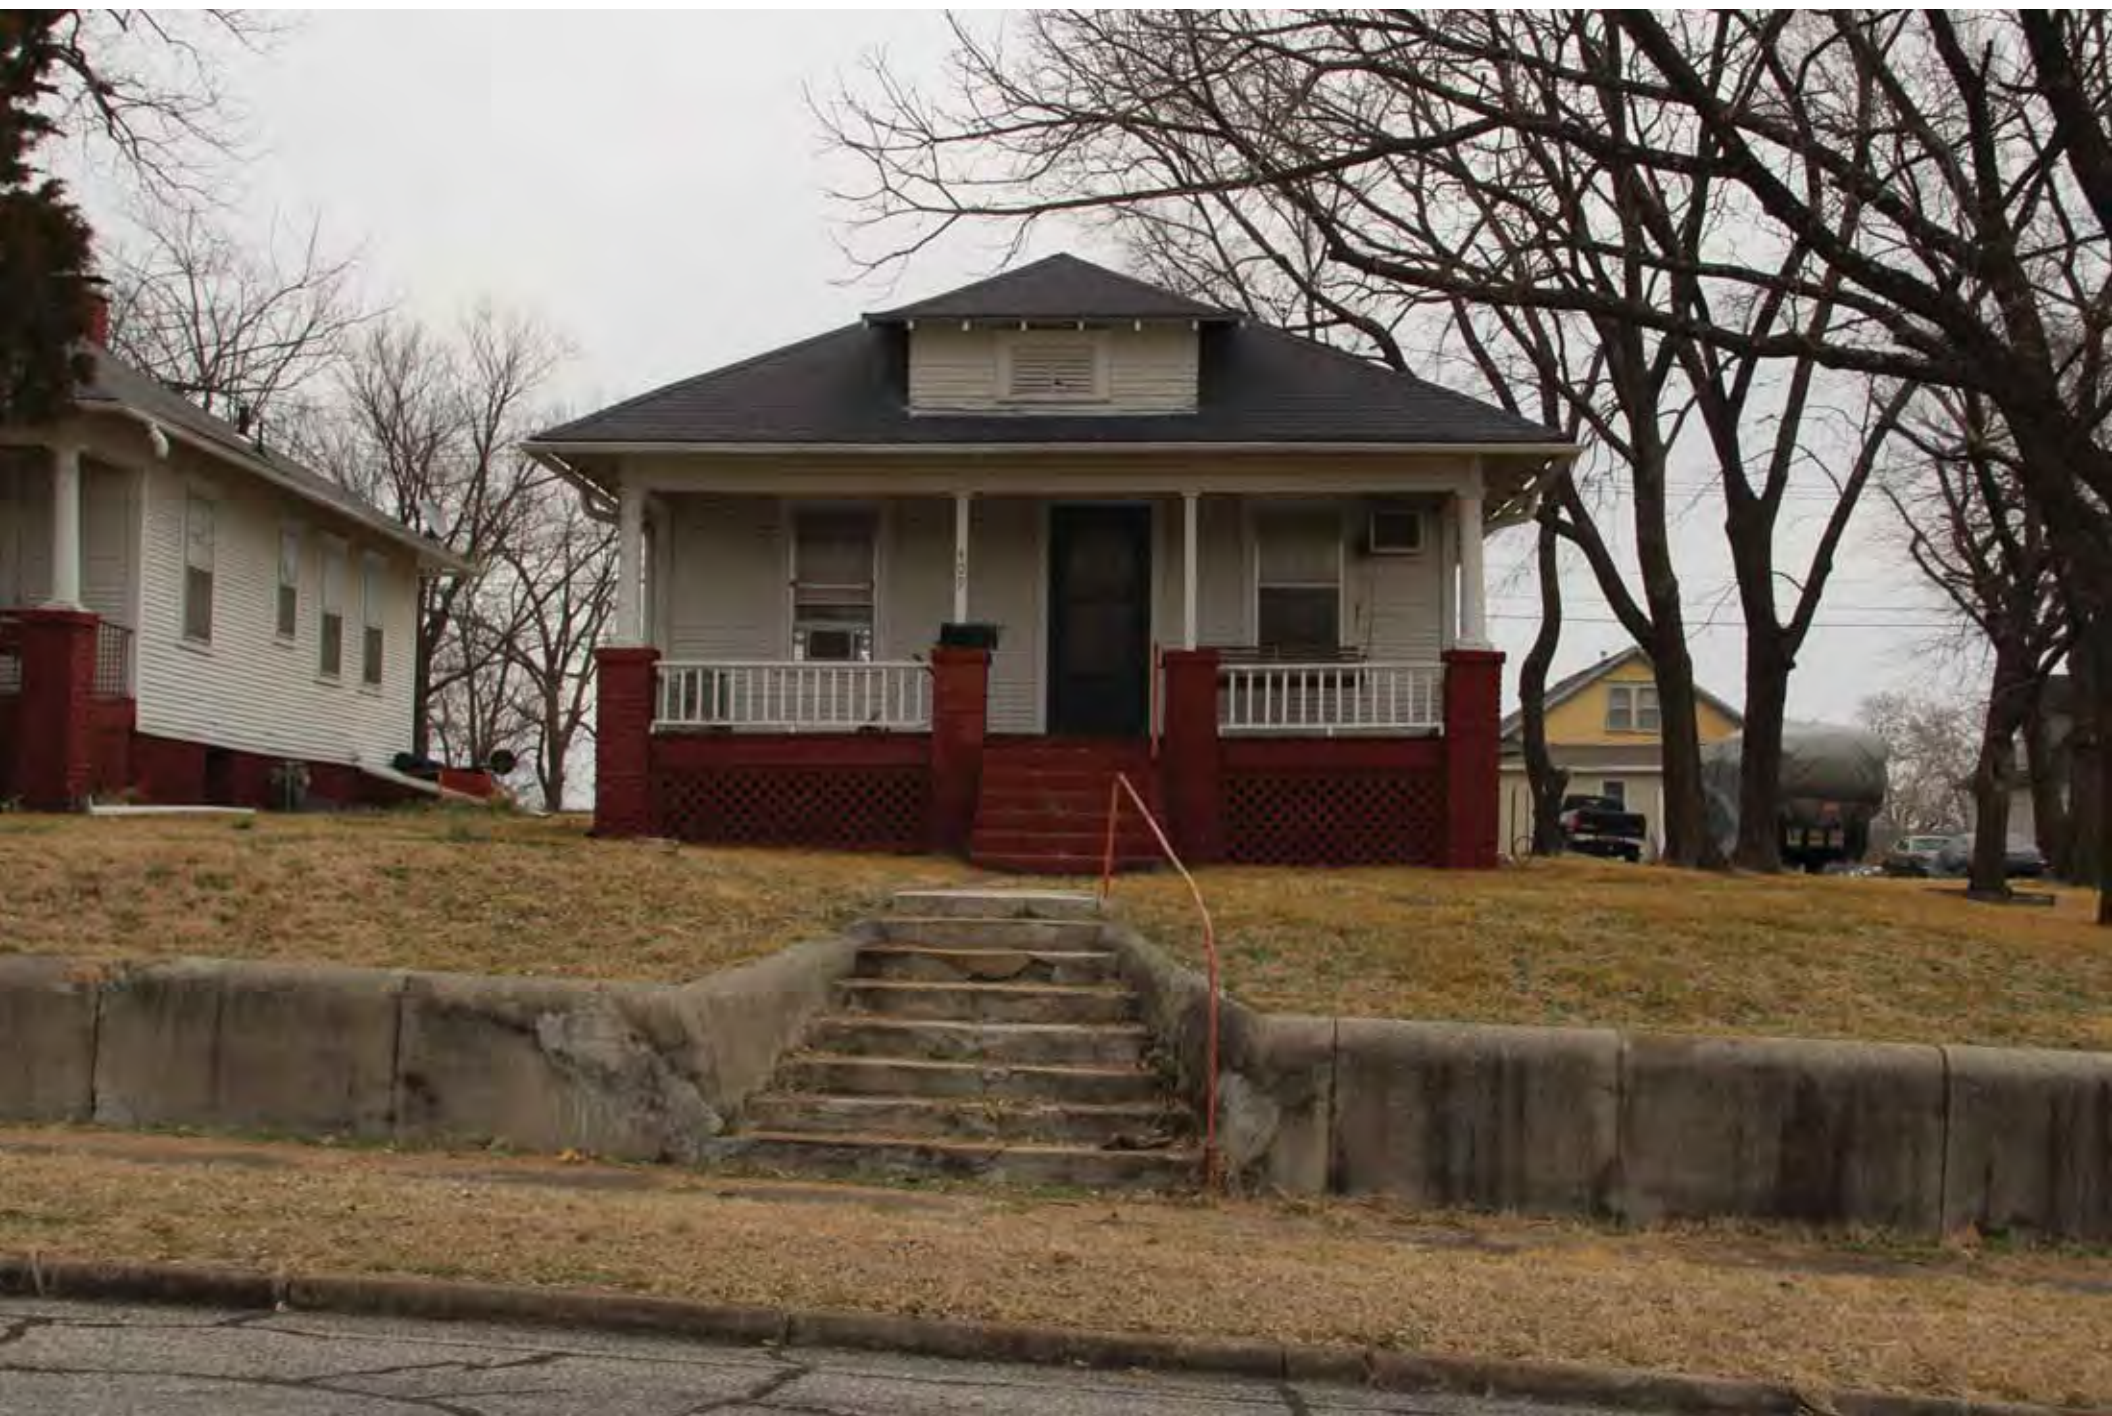
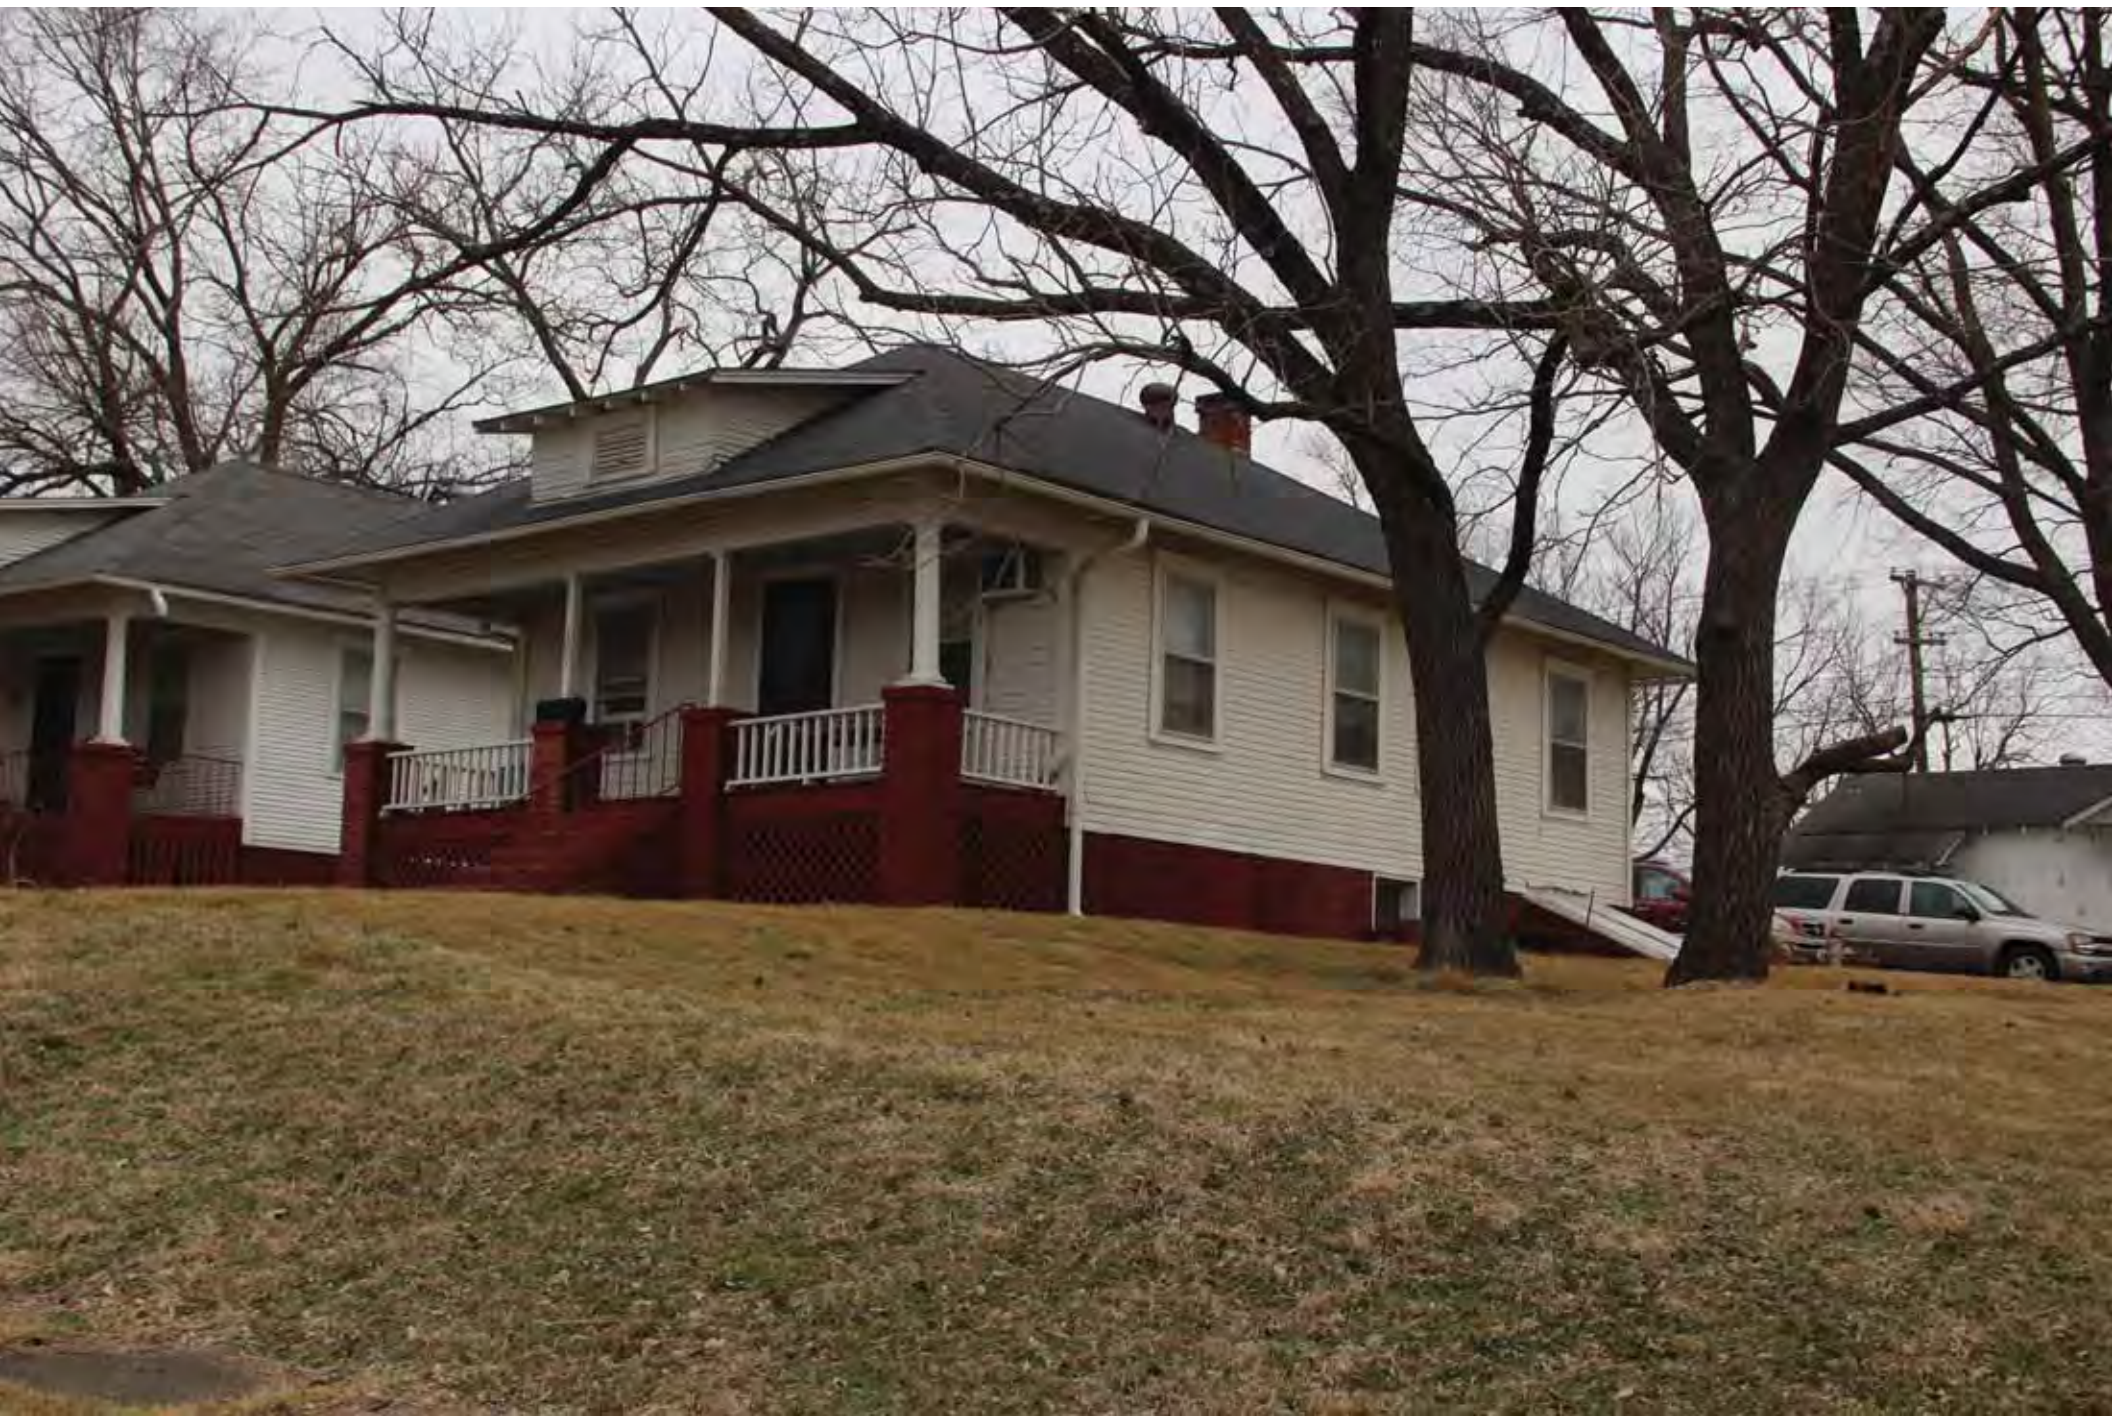
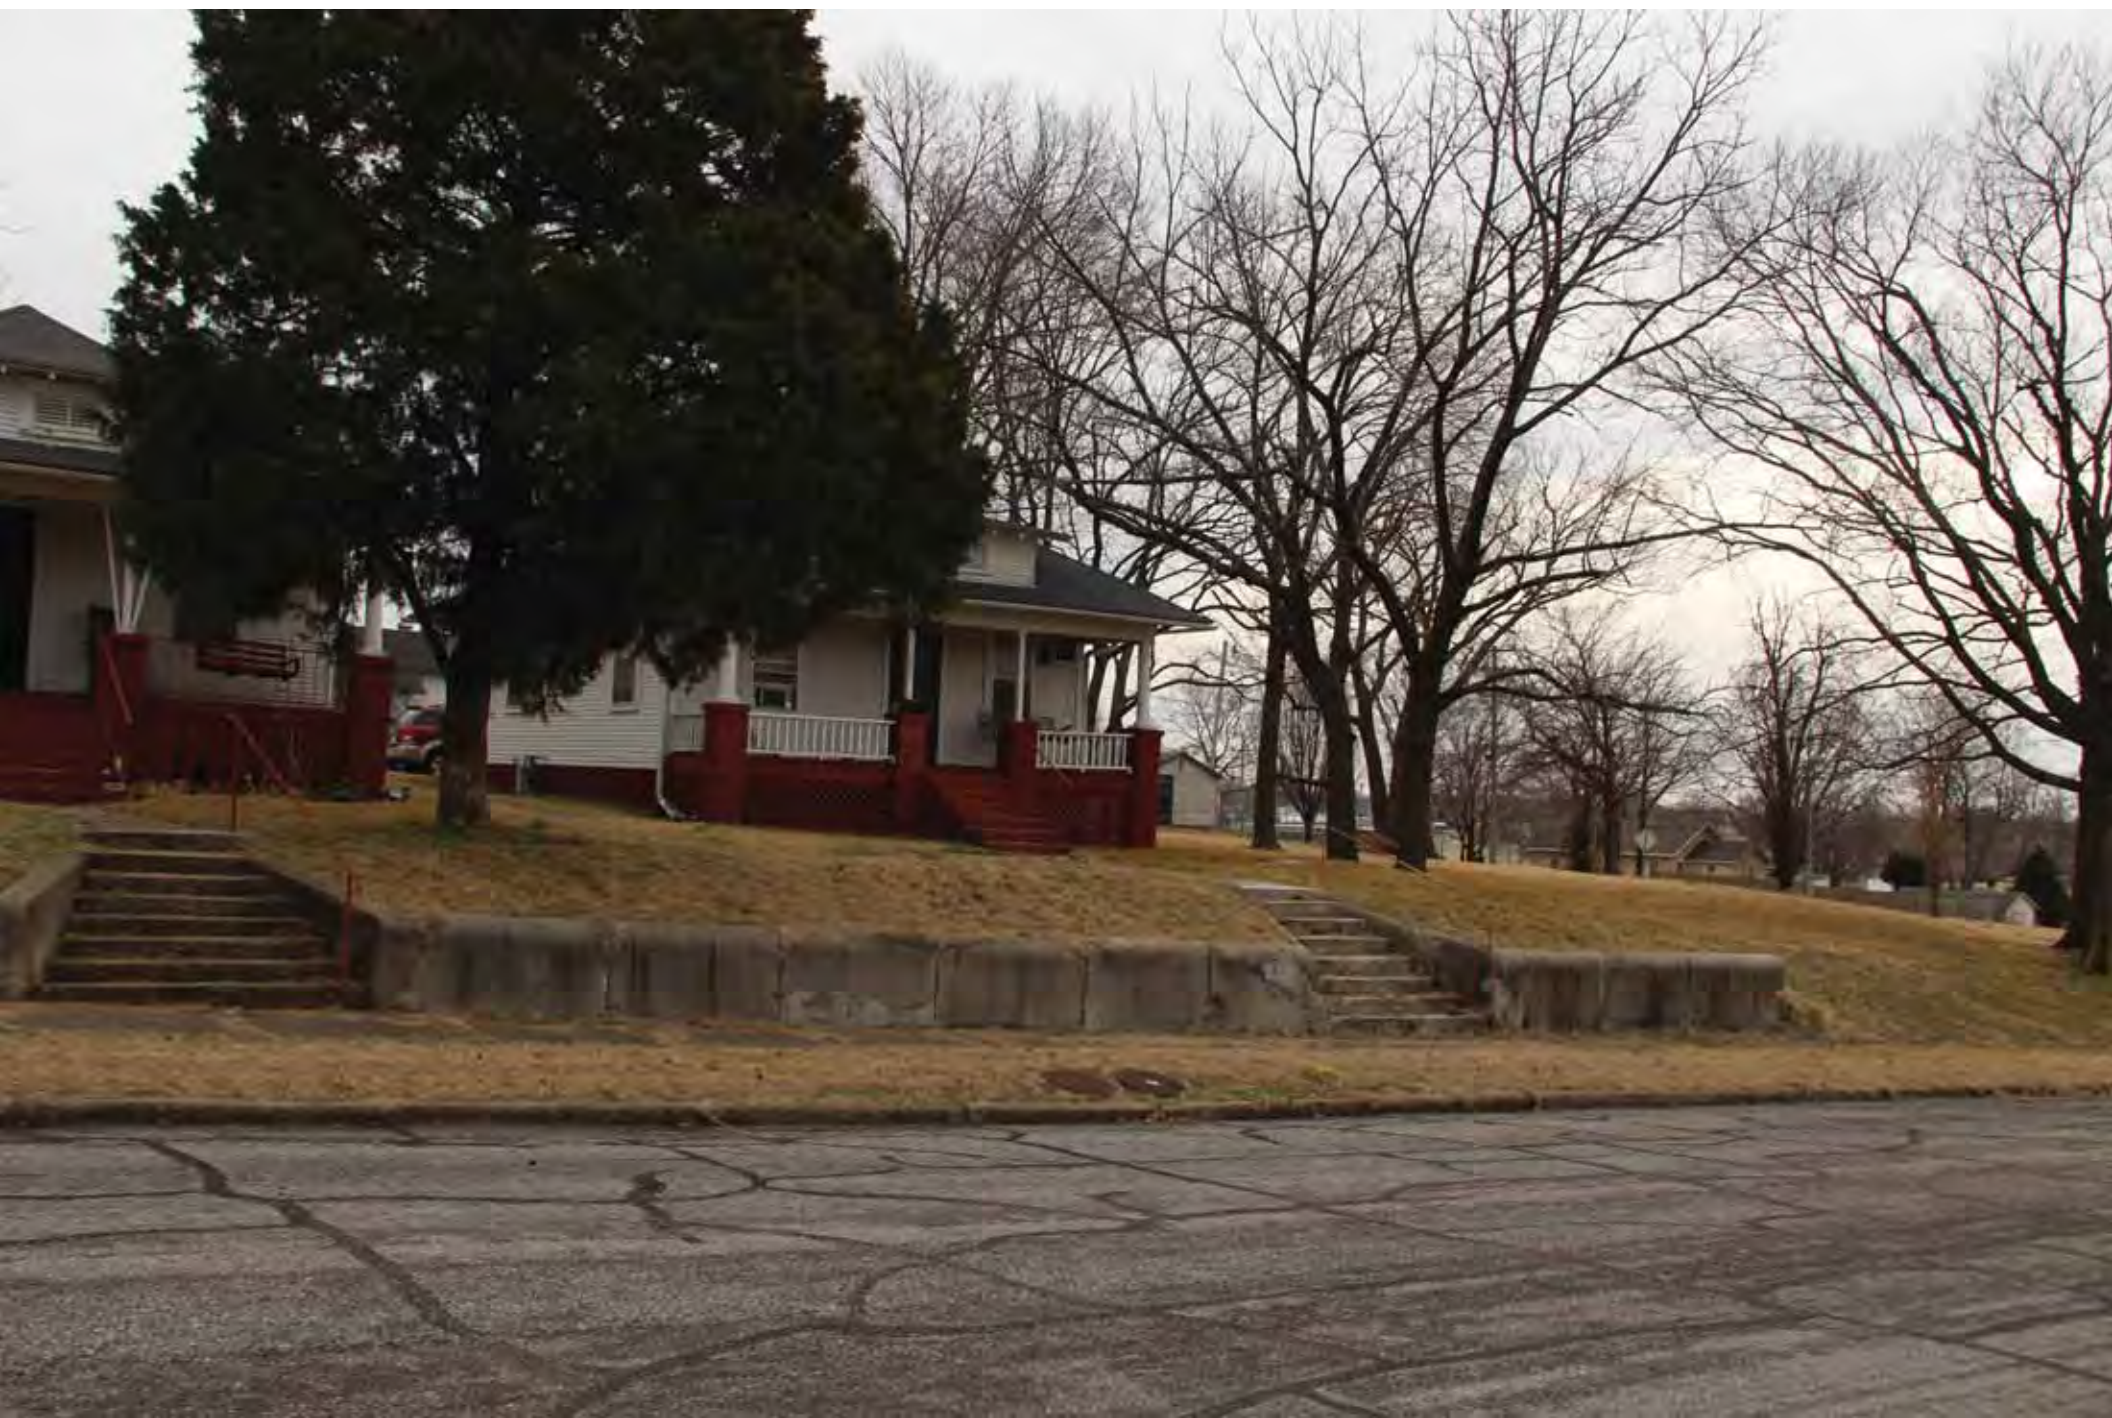
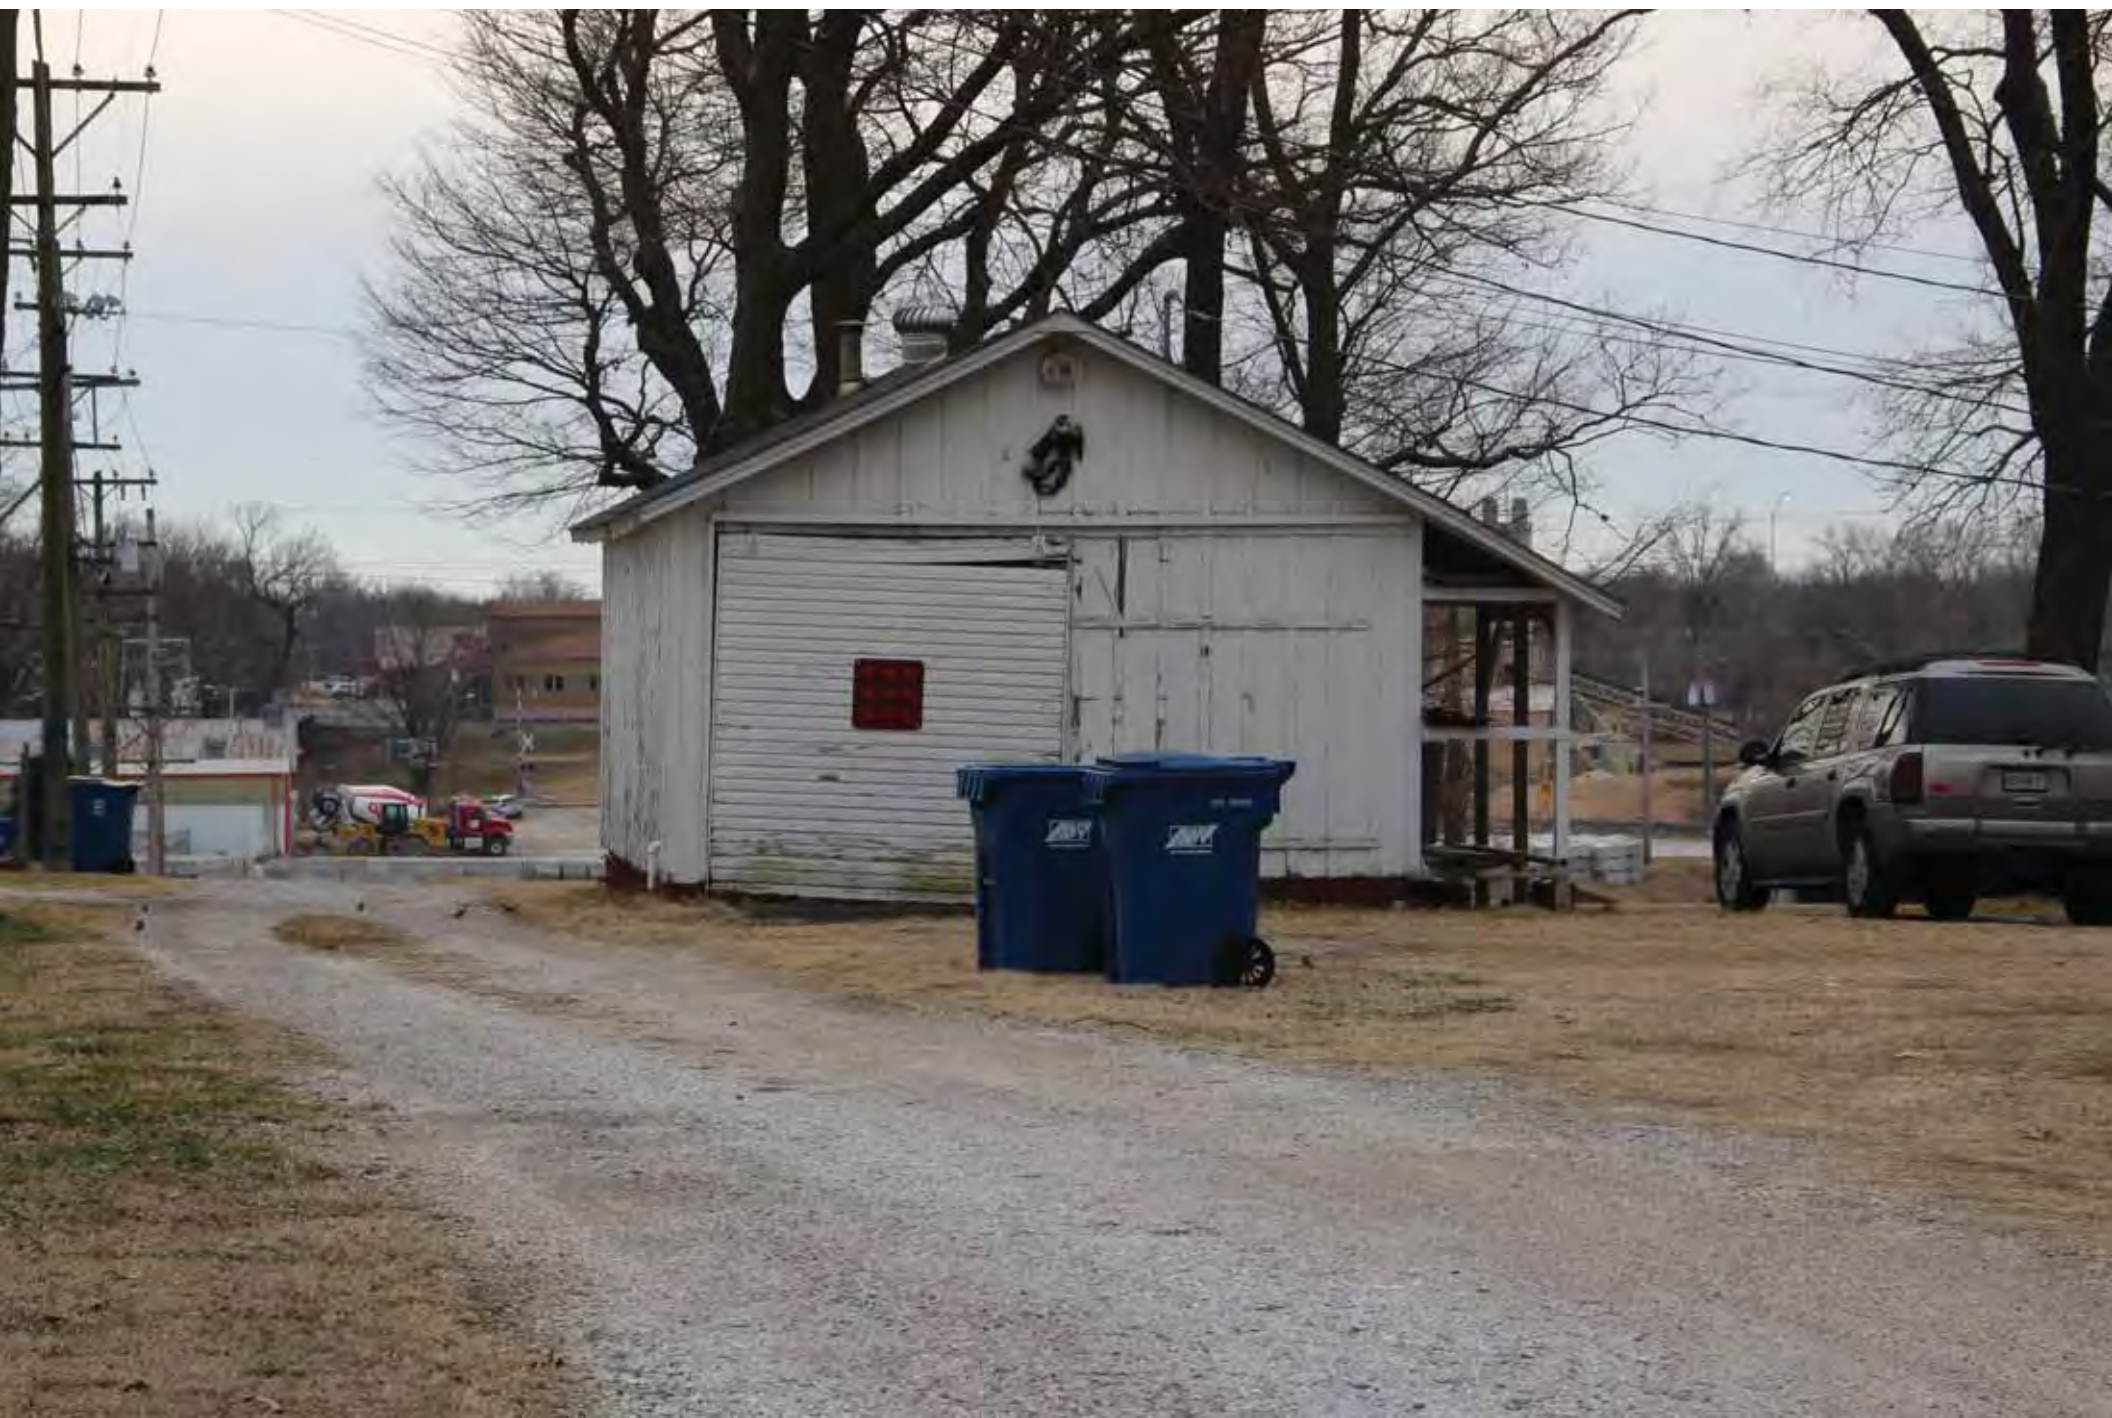
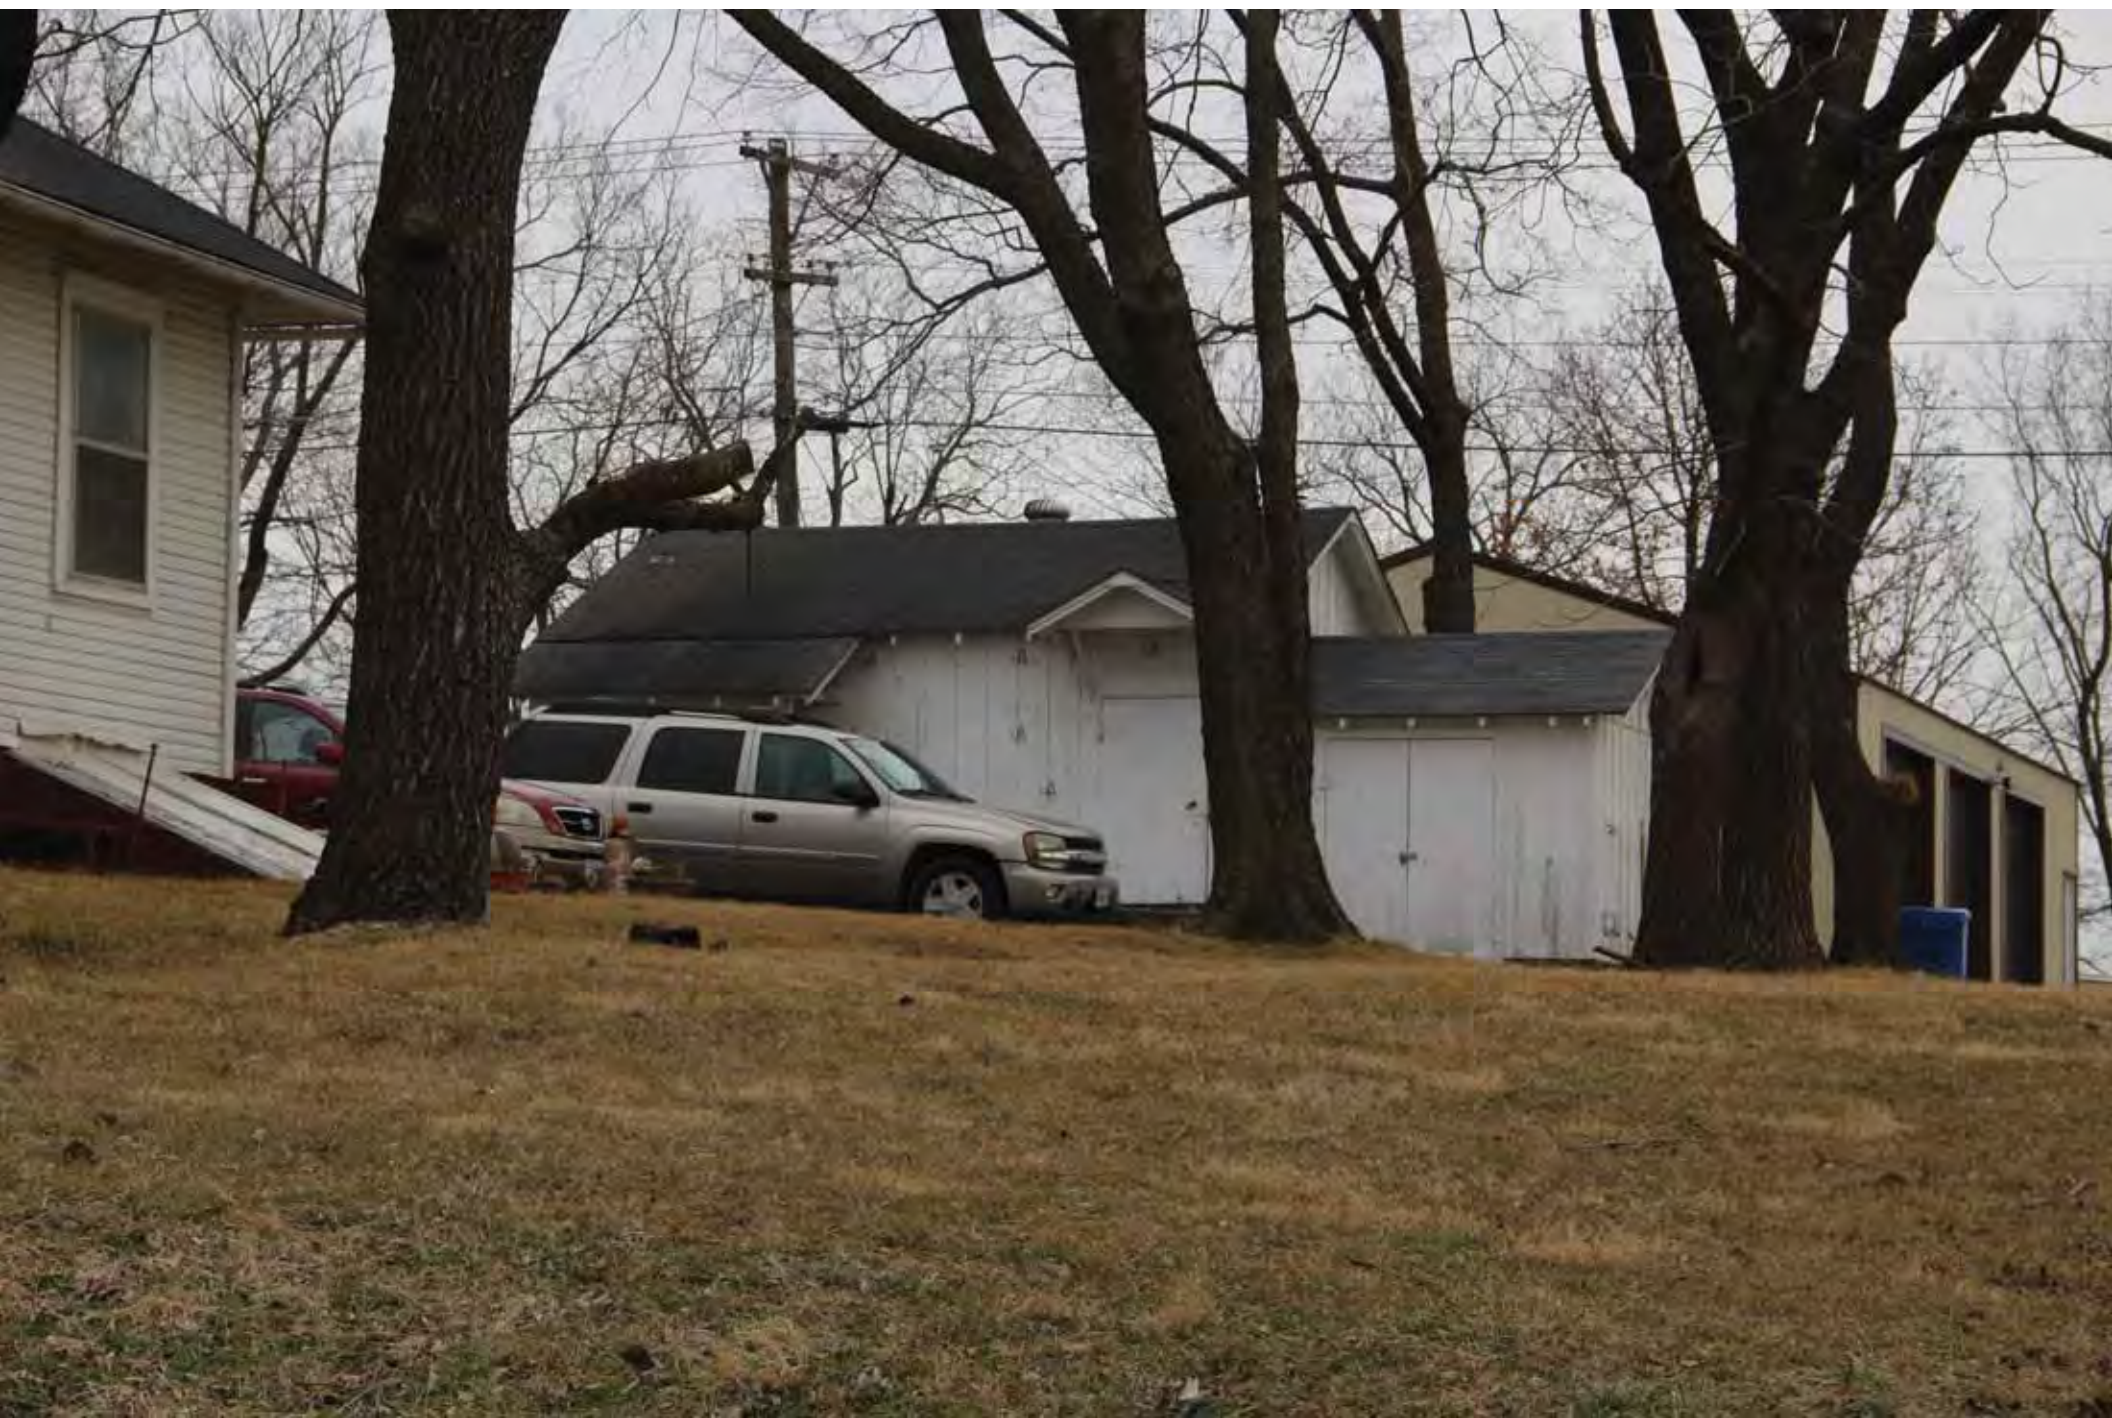
This dwelling has been extensively altered replacement of some of the original windows. It does not retain integrity that would render it individually eligible for the National Register of Historic Places and is not an exceptional example of its style. The dwelling is not situated in an area recommended as a historic district.

The property at 409 S. Mineral Avenue features a one story dwelling, with a medium-pitched hipped roof. It has exterior wood siding and an asphalt-shingled roof. At the roof on the front façade is a shed roof dormer. The front façade has a central entrance door flanked on either side by one-over-one windows. There is a wooden veranda, which extends the length of the front façade, and is sheltered by the hip roof of the house. It has round wood columns supported on brick masonry bases. On the side facades are four single one-over-one windows.

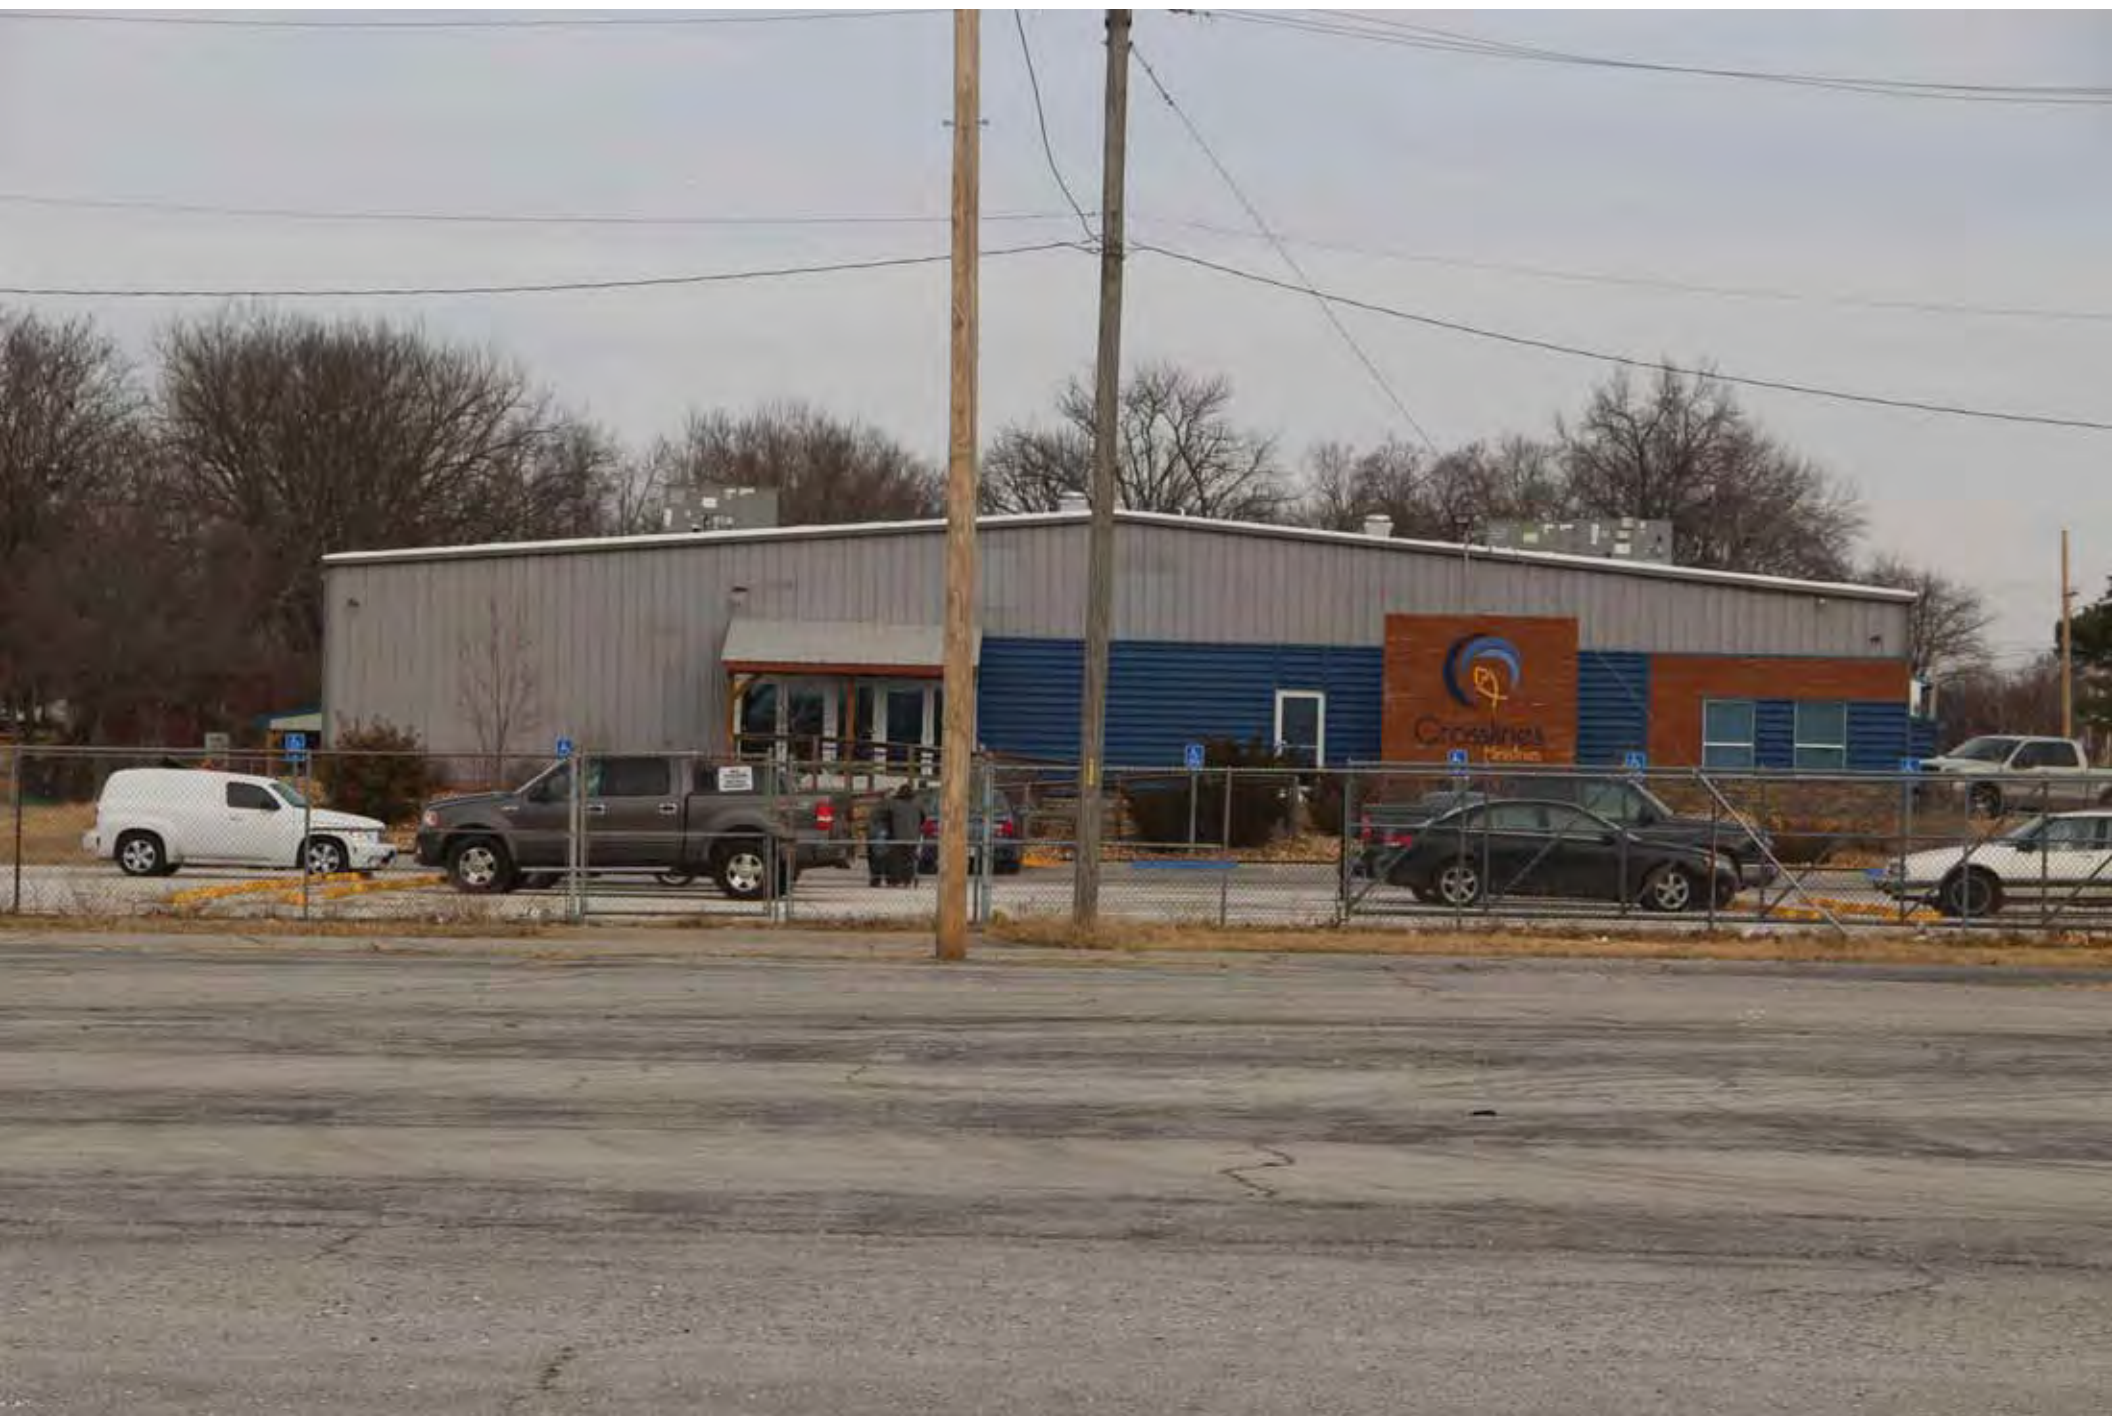
The building does not have enough integrity to be individually eligible for listing on the National Register of Historic Places. The property is not within an area recommended as a potential historic district.

The building associated with this parcel is a 1.0-story rectangular plan prefabricated metal warehouse. The building faces to the south and has a metal low gabled roof, exterior metal walls and a slab concrete foundation. The south elevation has an entrance bay slightly to the left of the center of the façade. It has three doors under a shed roof awning with a metal roof. To the right of the entrance blue horizontal metal has been added to the front façade. Within this section of horizontal metal are three one-over-one windows. A square brick panel has the Crosslines sign for the church, directly on the building. On the east side of the building is a rectangular one-story addition, with a shed roof and metal siding. On the north elevation, or rear of the building, is a single entrance door and one garage bay with a metal track garage door.
