MISSOURI DEPARTMENT OF NATURAL RESOURCES
STATE HISTORIC PRESERVATION OFFICE, P.O. Box 176, Jefferson City, MO 65102
ARCHITECTURAL/HISTORIC INVENTORY FORM

1. Survey No. JP-AS-007-001		2. Survey name: East Town (Original Joplin) Historic Survey Phase 2	
3. County: JASPER		4. Address (Street No.) 618	Street (name) E. 2 nd Street
5. City: Joplin	Vicinity: <input type="checkbox"/>	6. Geographical Reference:	7. Township/Range/Section: T: R: S:
8. Historic name (if known):		9. Present/other name (if known):	
10. Ownership: <input checked="" type="checkbox"/> Private <input type="checkbox"/> Public		11a. Historic use (if known): Domestic: Single Dwelling	11b. Current use: Domestic: Single Dwelling

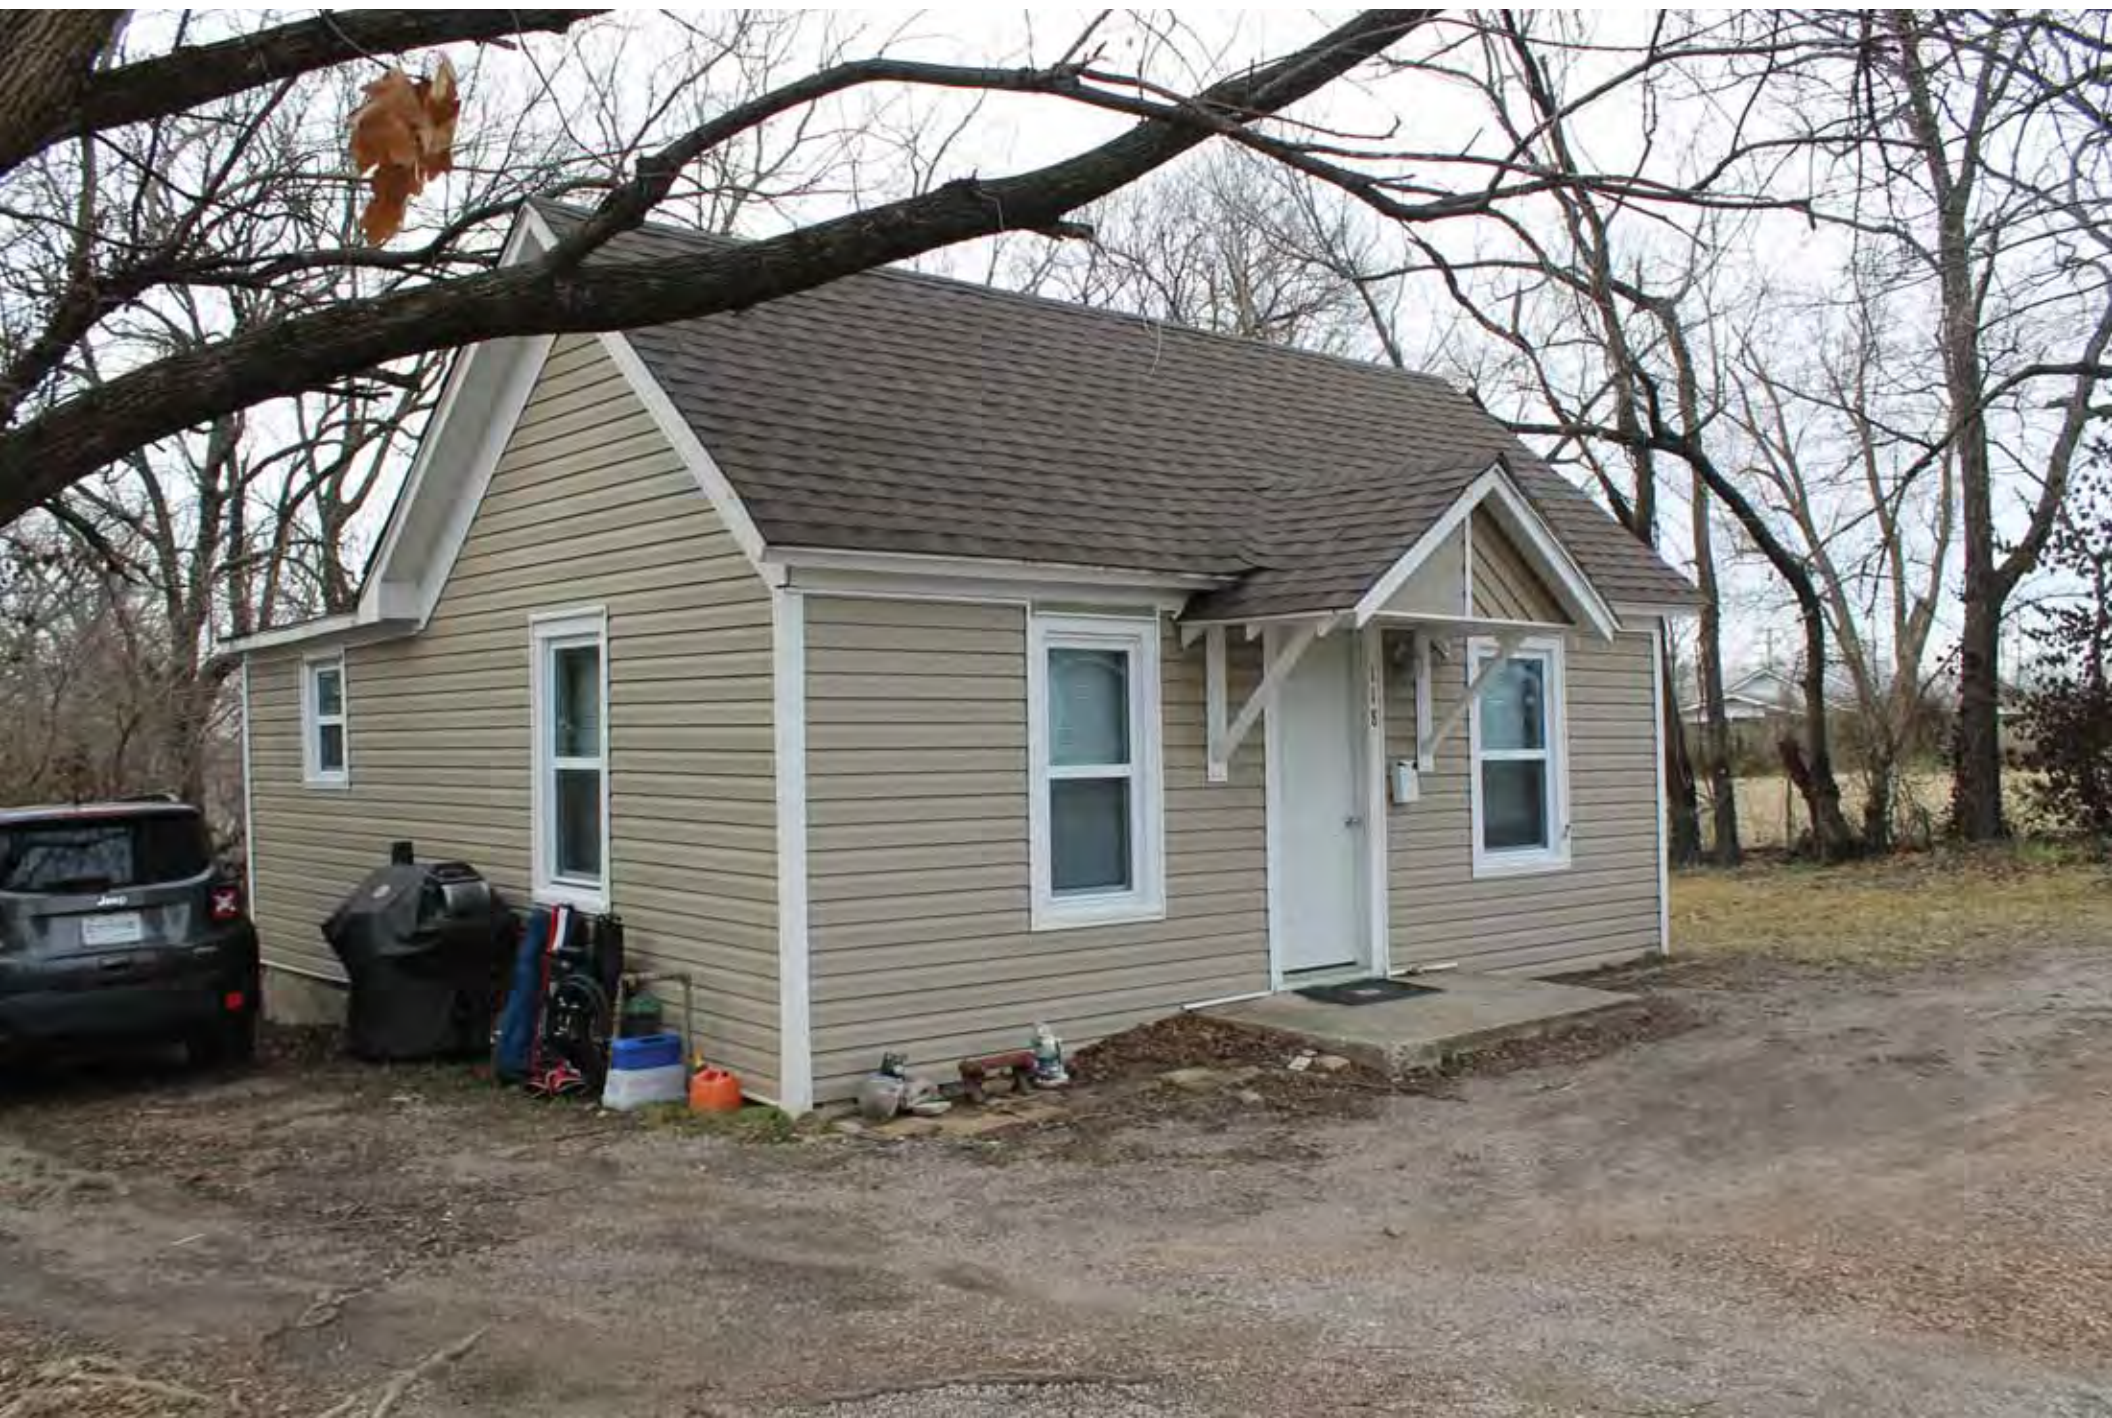
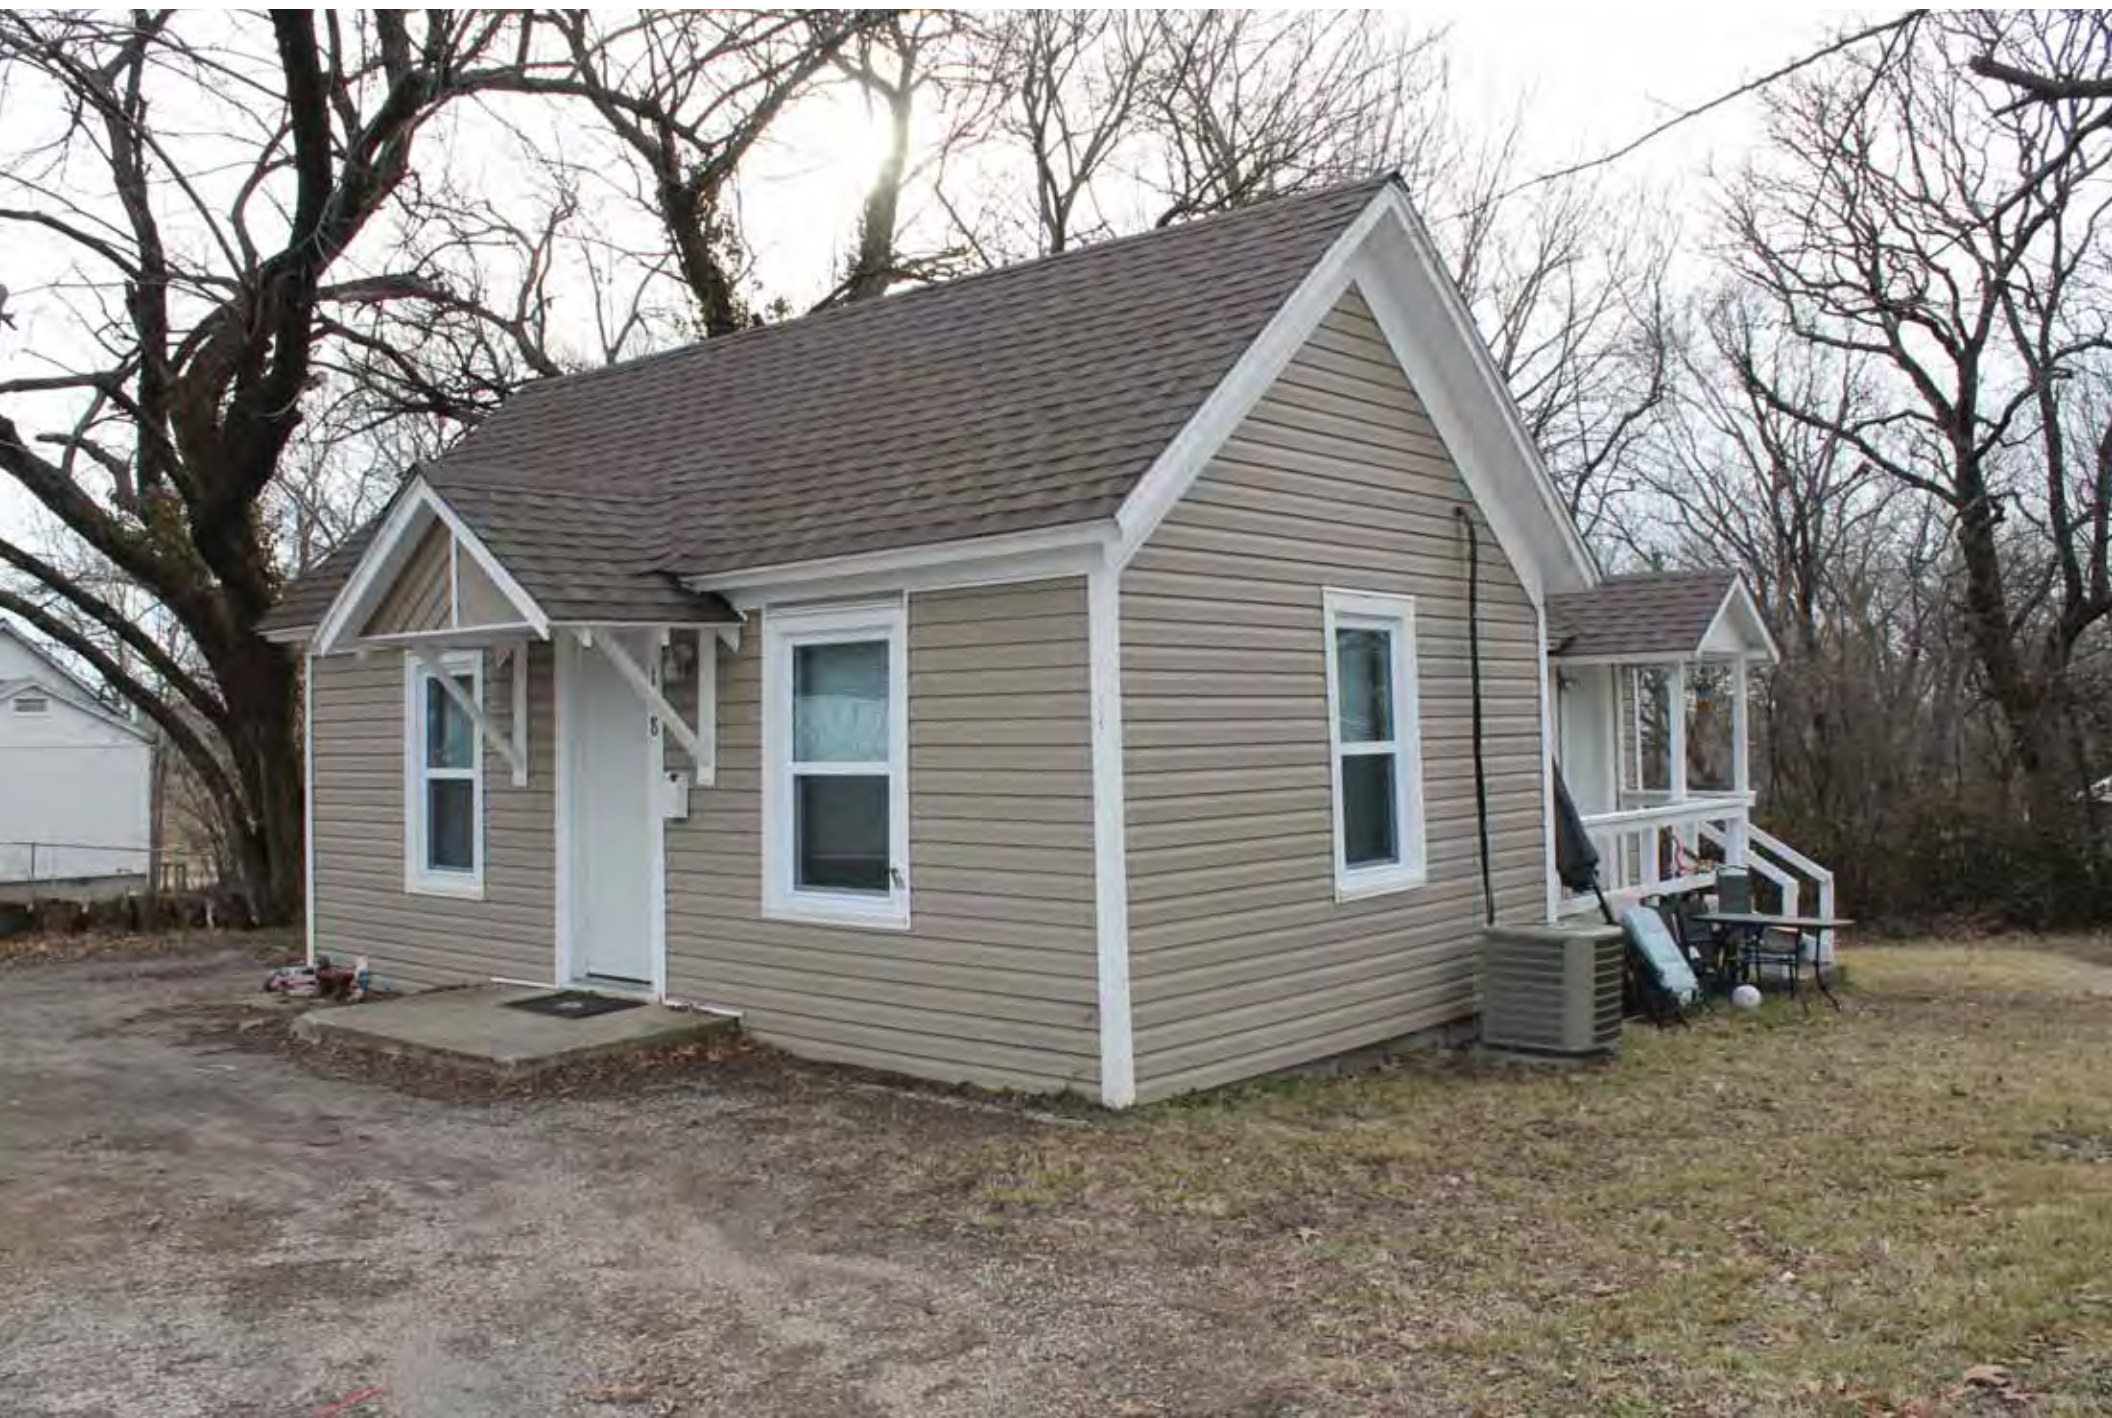
The property at 118 S. St. Louis Avenue features an altered single-story dwelling with an asphalt shingled roof, exterior vinyl siding and replacement one-over-one windows. The foundation is concrete. The primary (east) elevation has a gabled central portico supported by knee brace brackets. The portico roof has exposed rafter tails. Fronting the door is a low concrete stoop. The door is centered on the façade, filled with a c. 2019 paneled door. Flanking the door are single windows (1/1 replacement). The dwelling has a rear shed wing and a rear gabled wing. The south elevation of the house has a single window and smaller double-hung window on the rear shed wing's south elevation. The north elevation of the dwelling holds a single window. The rear gabled wing has a north elevation porch with a portico supported by columns. The porch supports an entry bay facing north.

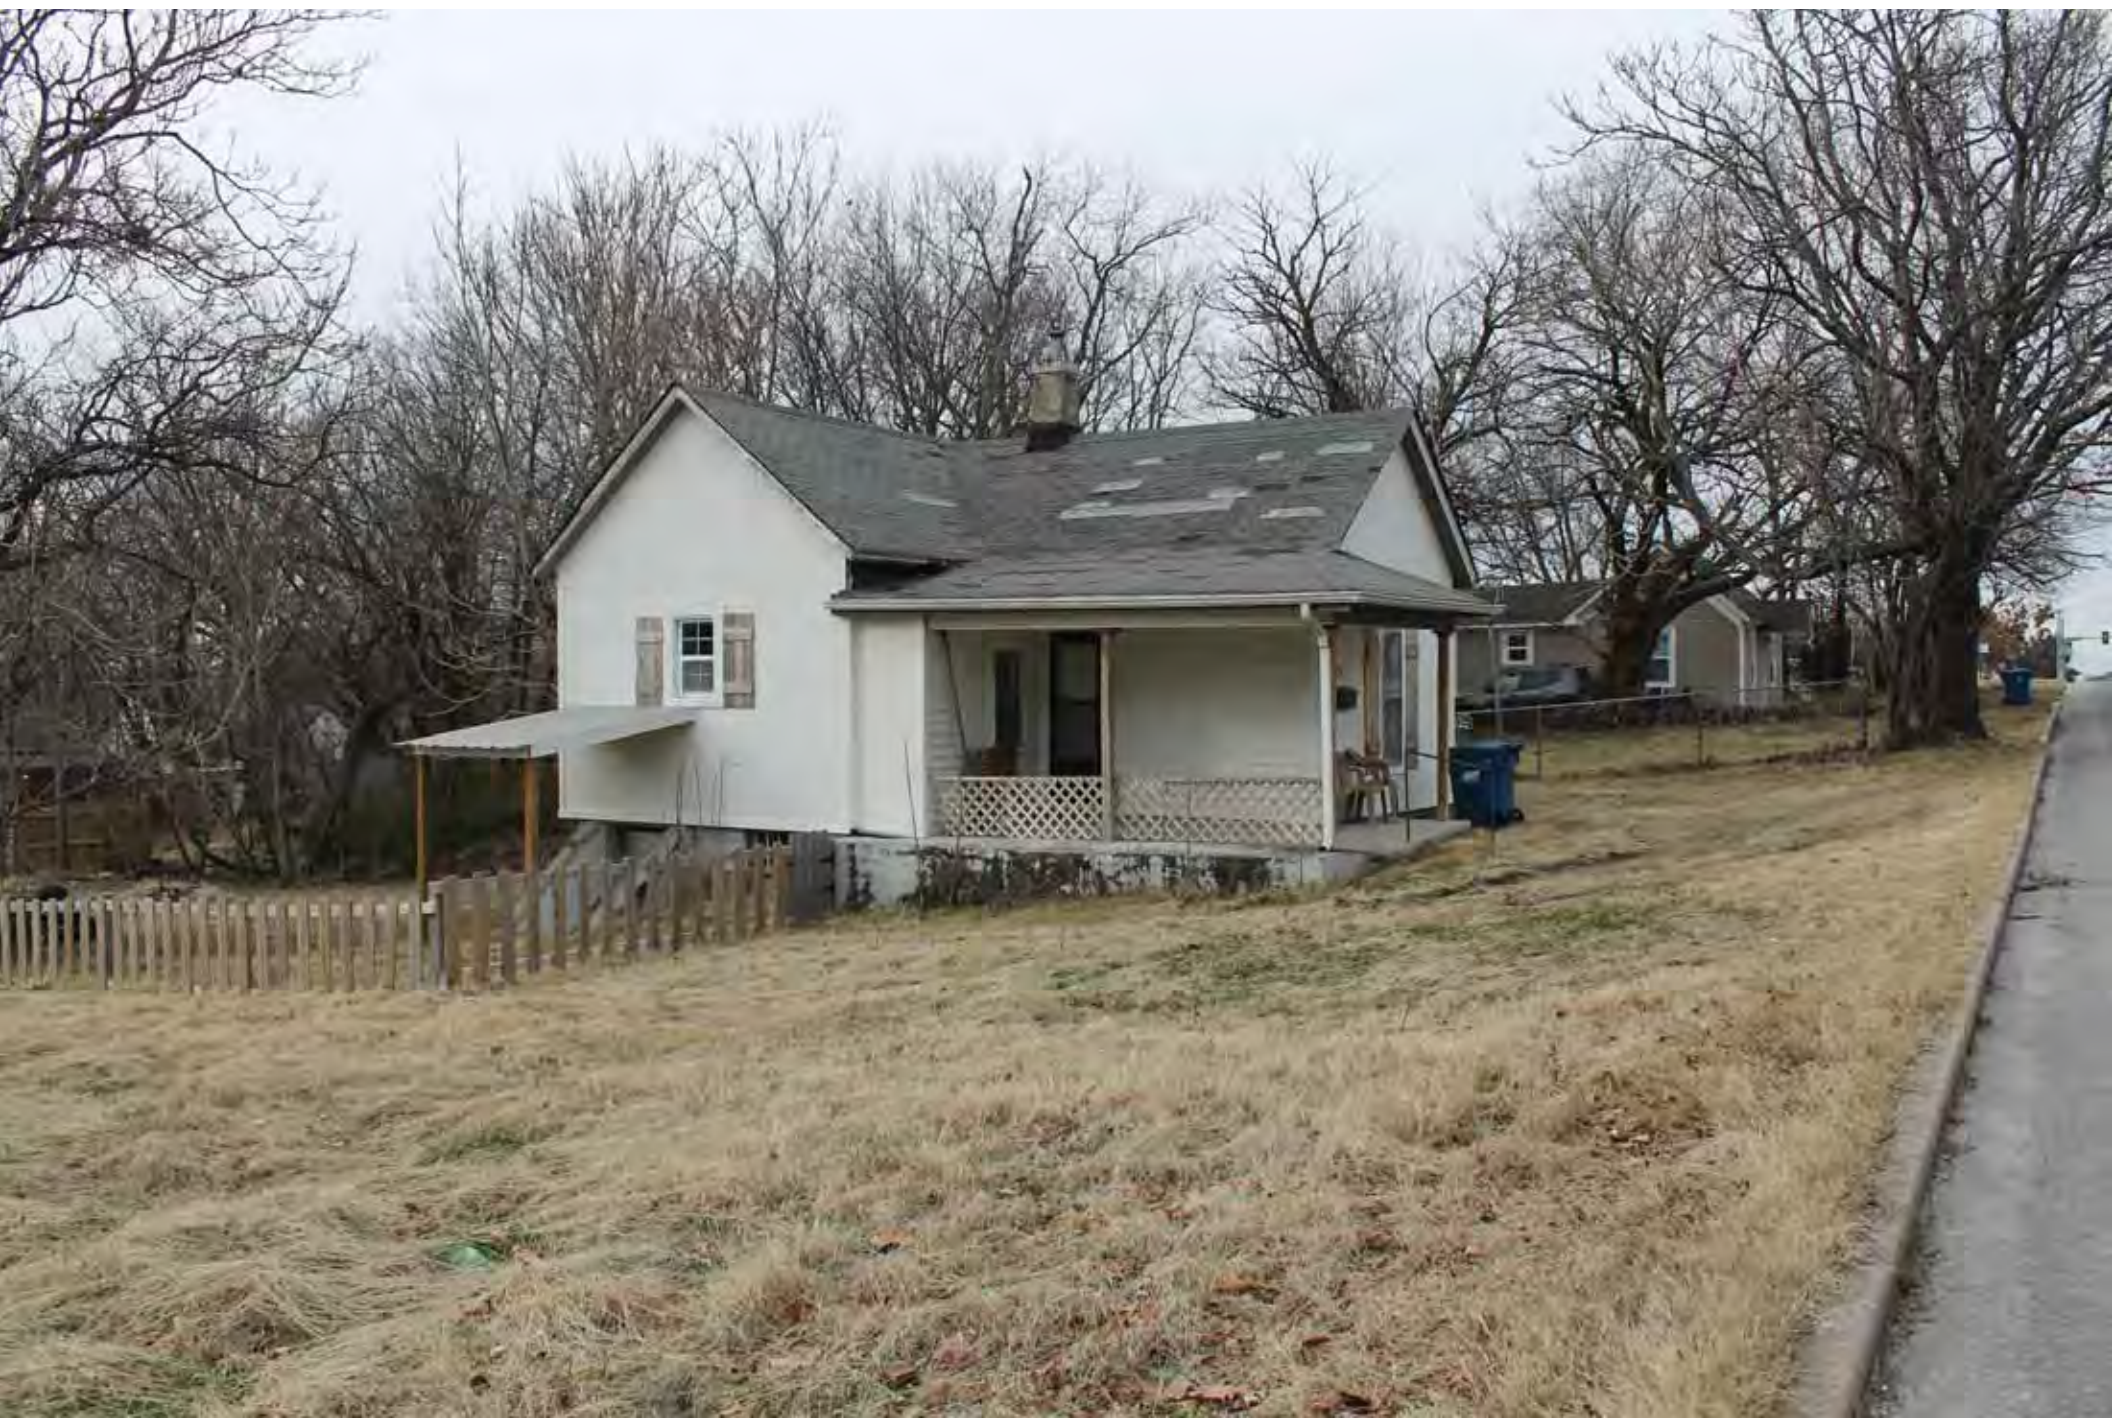
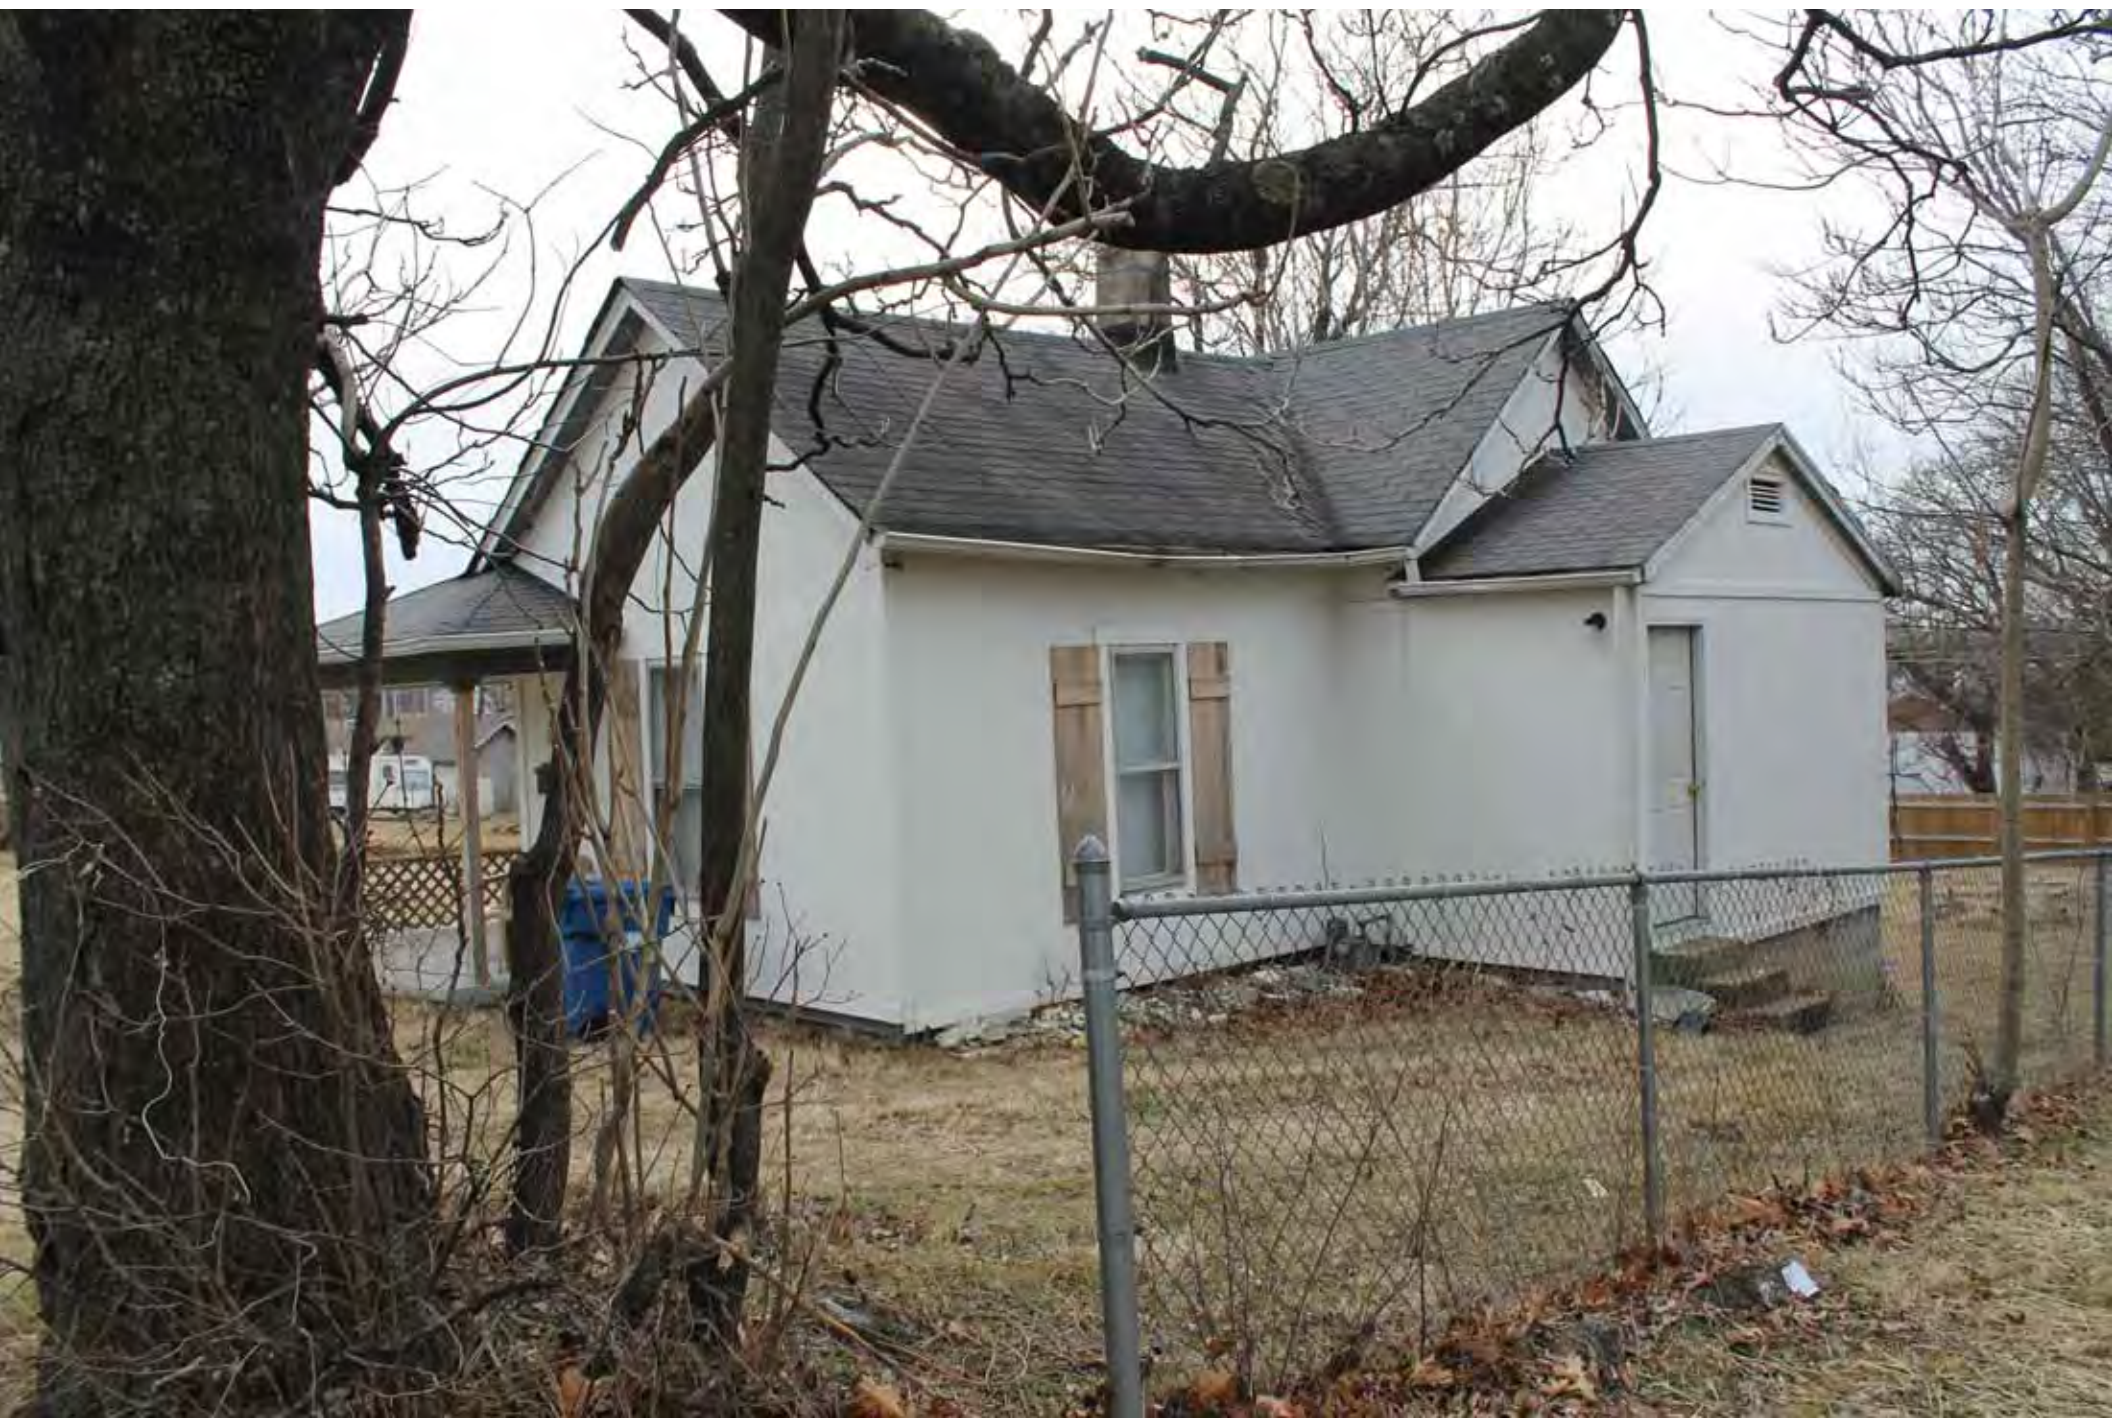
The property at 126 S. St. Louis Avenue features an altered gable and wing plan dwelling with an asphalt shingled roof, exterior vinyl and fiberboard siding and a concrete foundation. At the roofline ridge is an interior chimney covered with stucco. The primary (east) elevation features a projecting gabled wing, creating a porch within the southern half of the elevation. The porch roof is hipped, supported by slender wood replacement columns. Lattice extends along the south end of the porch. Within the porch bay are an entry filled with a replacement door on the front wing's south elevation. The east façade porch wall holds a 4/4 replacement (c. 2019) window. The east elevation of the front gabled wing holds an original 1/1 window with faux shutters. This window and a similar window on the wing's north elevation retain original Greek Revival-influenced hoods. The rear gabled cross-wing holds a small gabled wing on the north elevation. This wing holds a c. 2019 paneled door (north elevation). The gable field of the wing holds a louvered vent. The south elevation of the dwelling (rear gabled cross wing) holds a single original window with faux shutters. This window also retains its original shaped hood. Below the window is an attached open shed roof shelter supported by wood columns. Below the open shelter is a basement level entry bay.

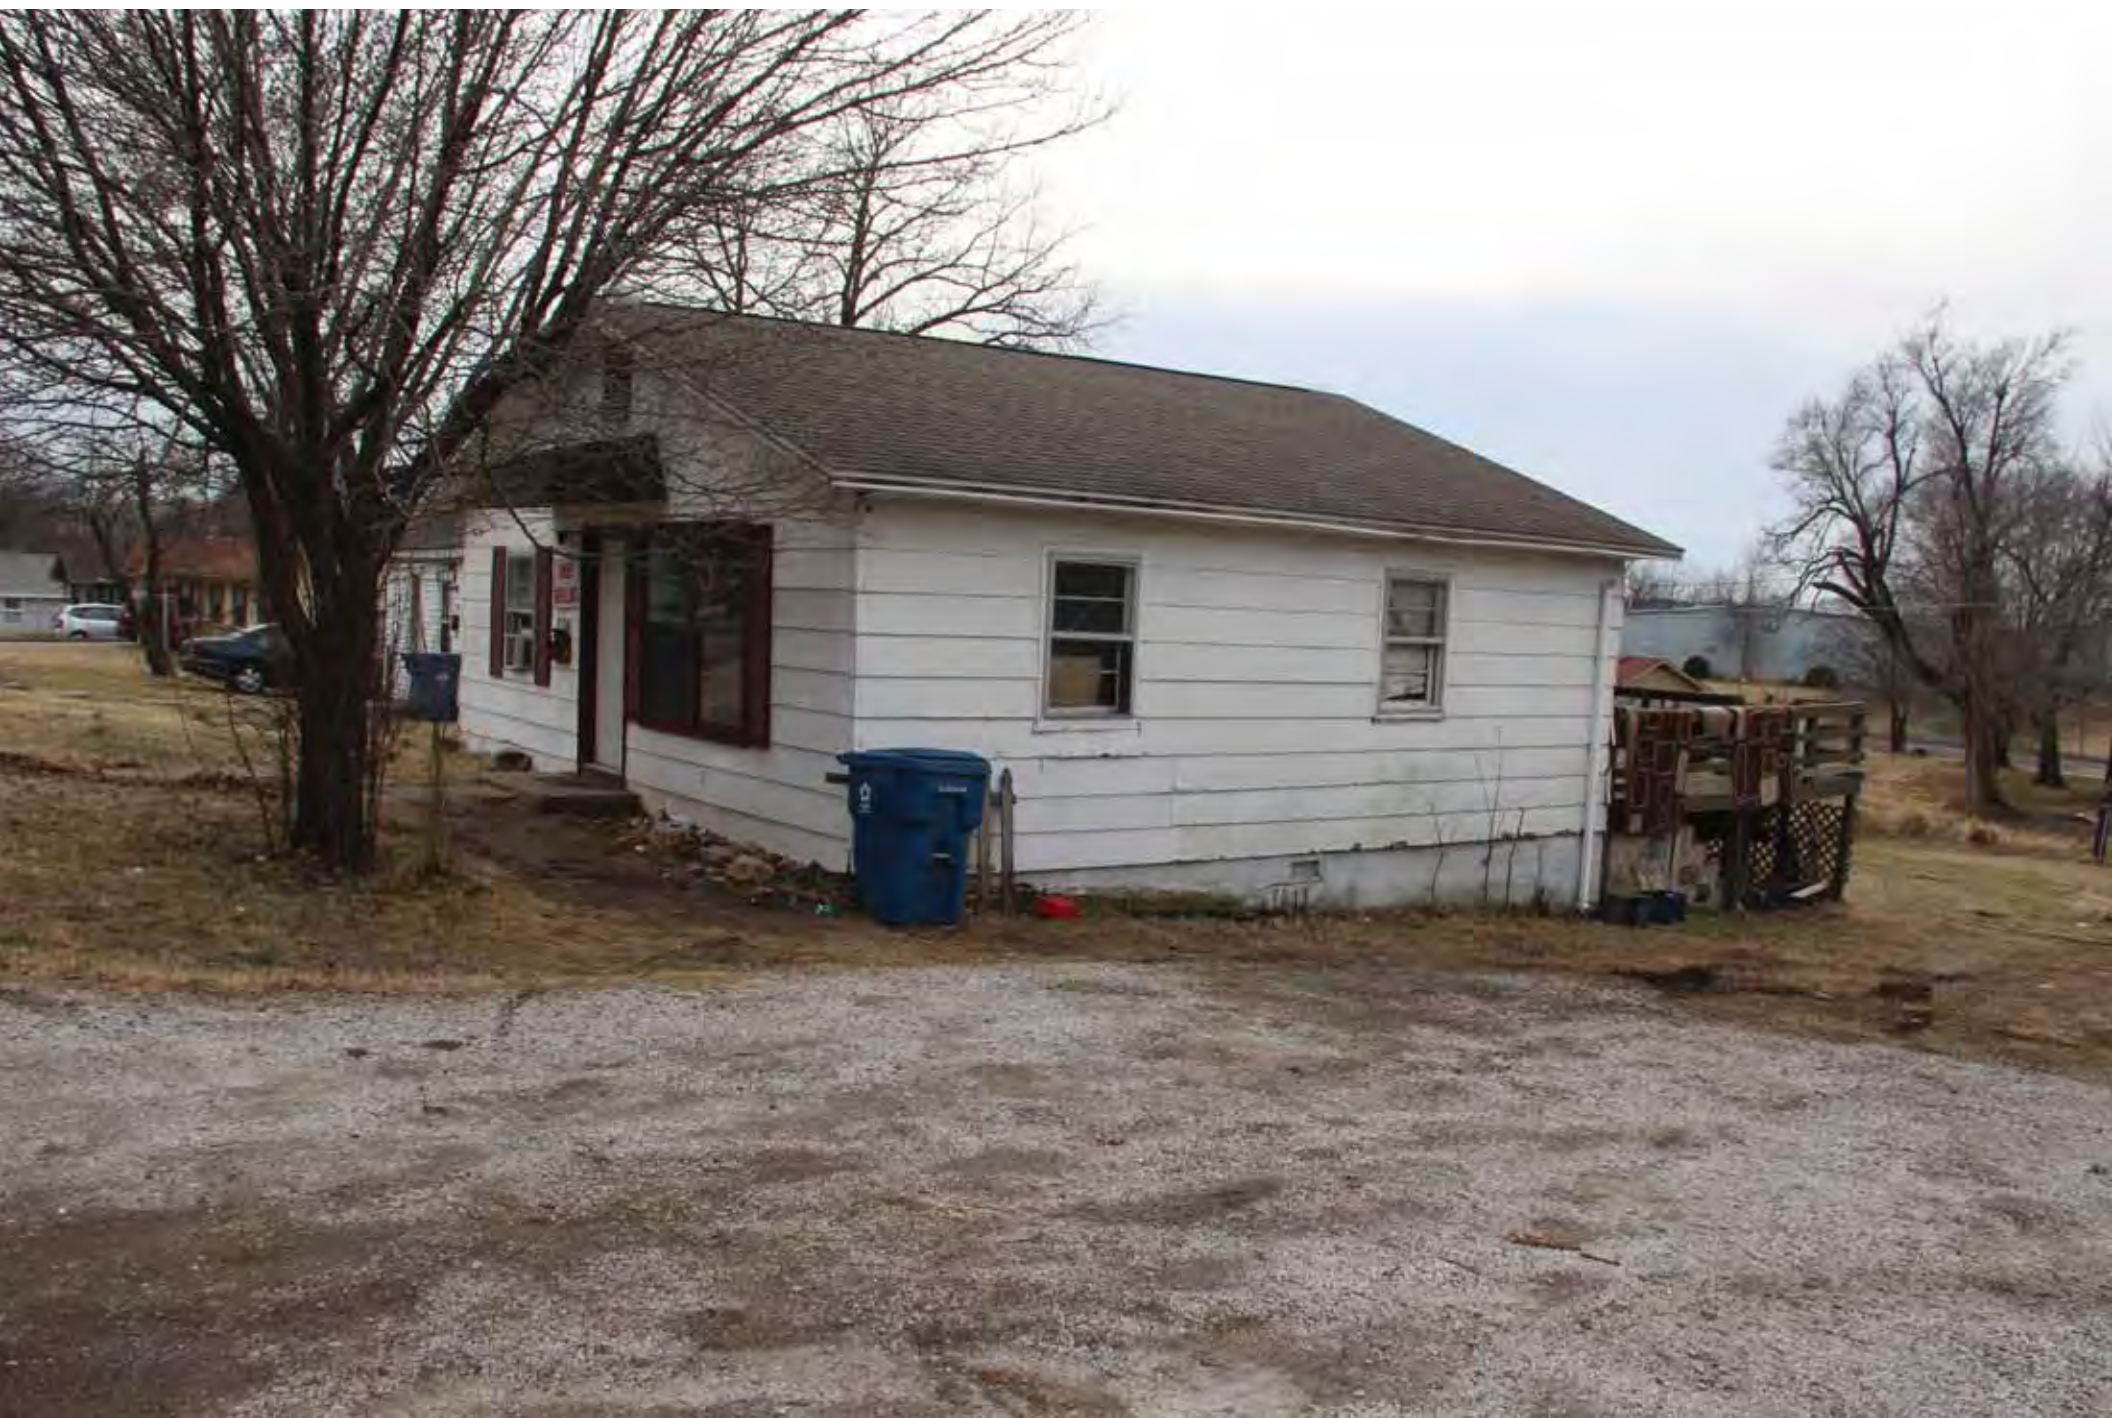
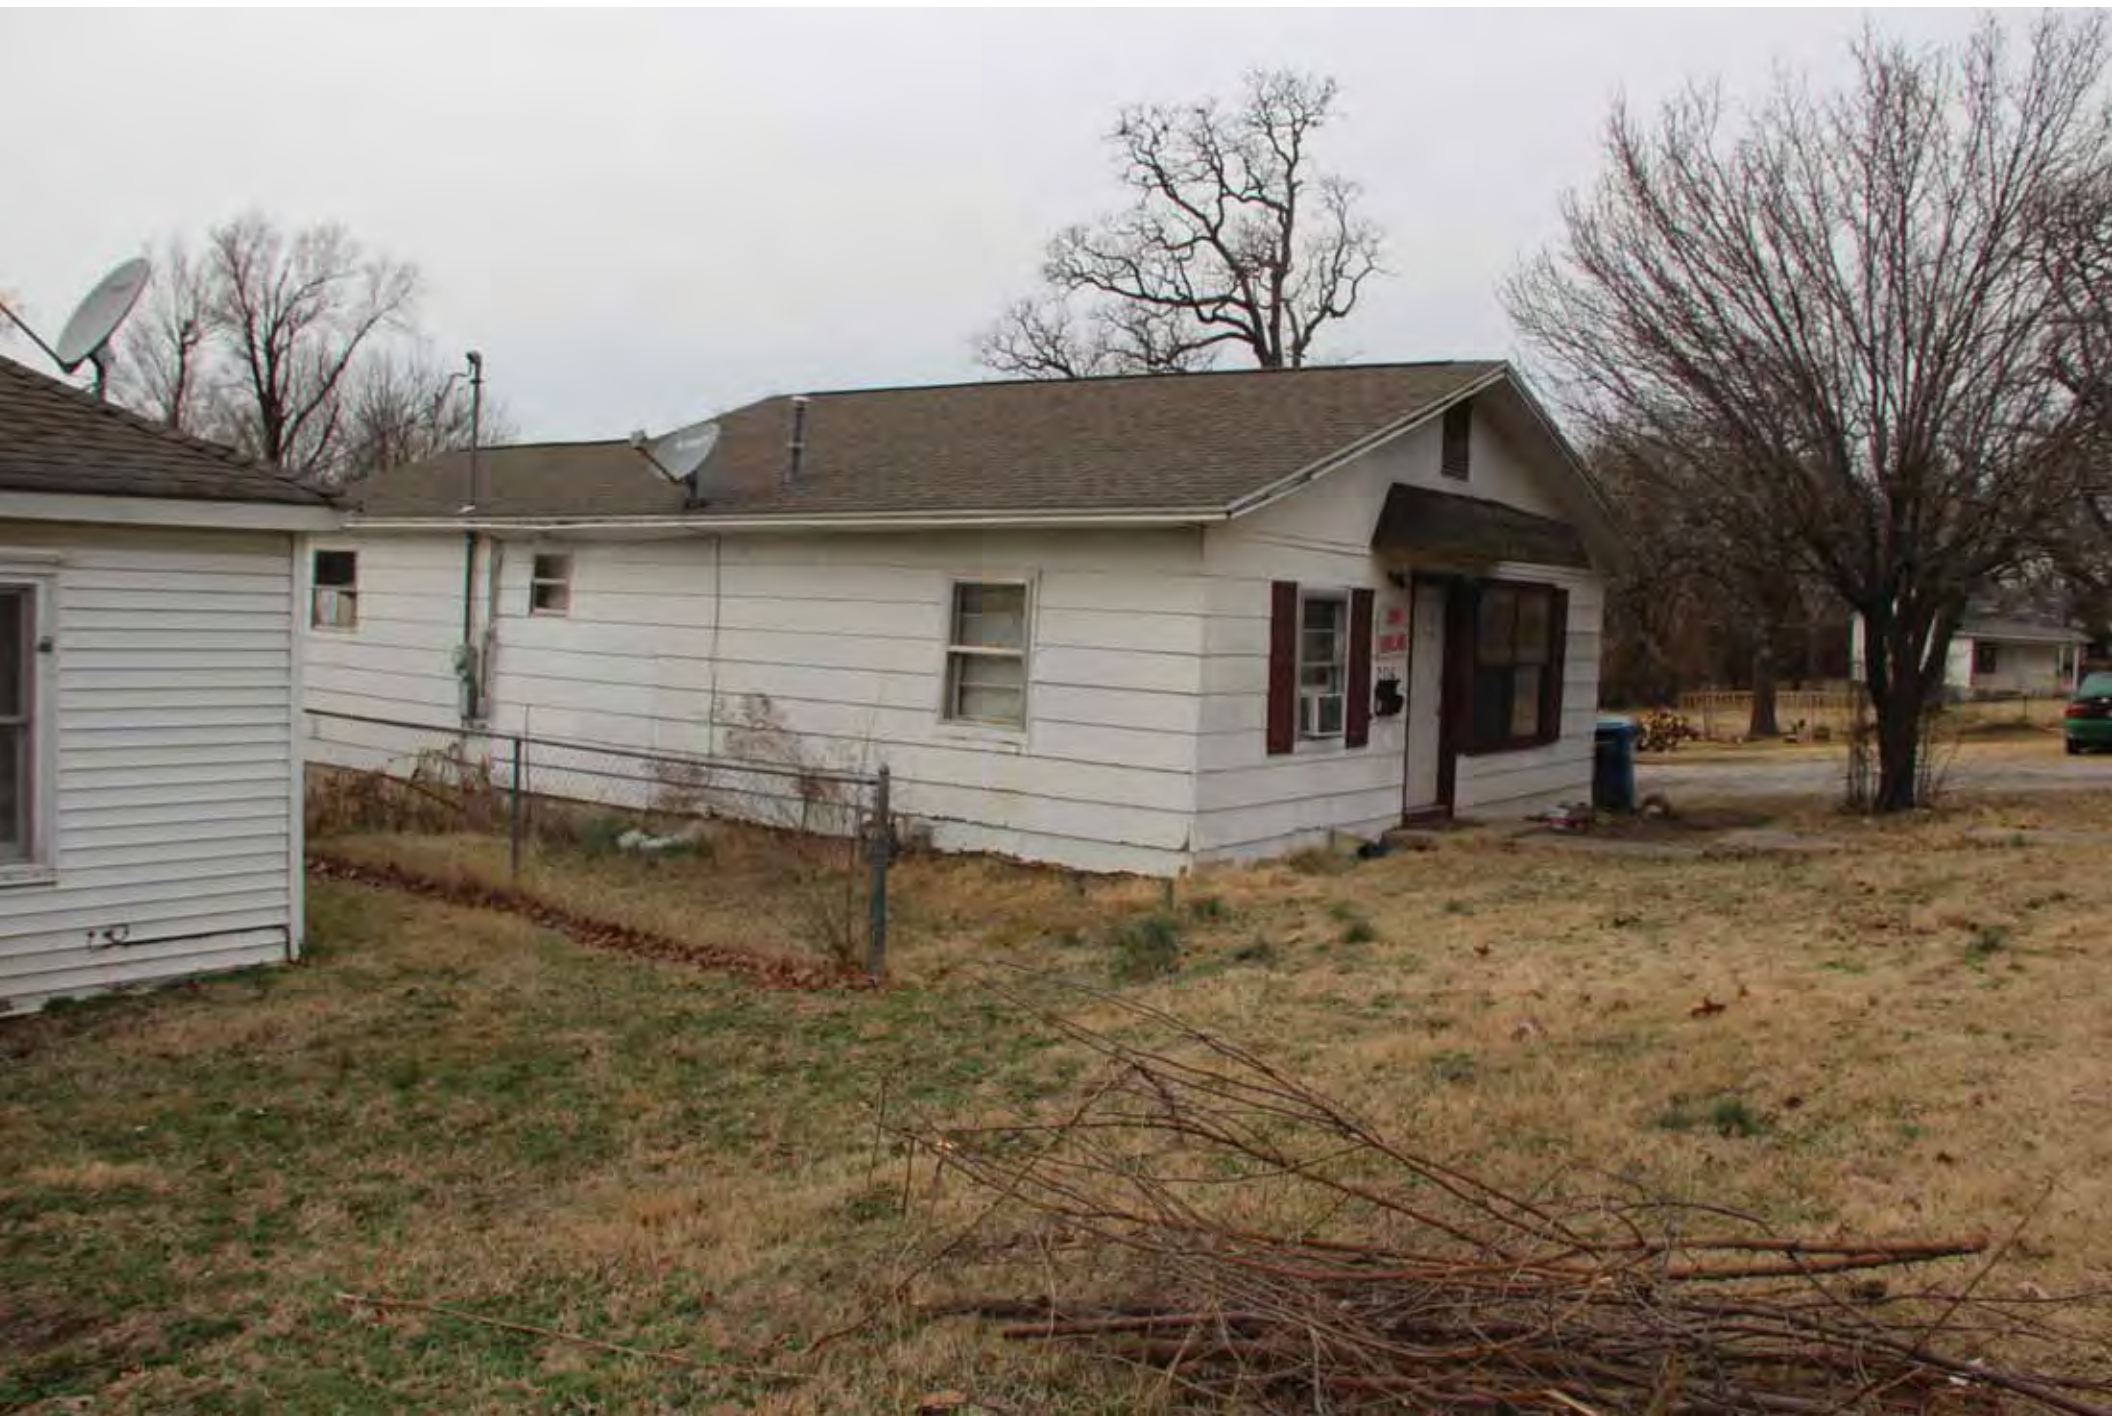
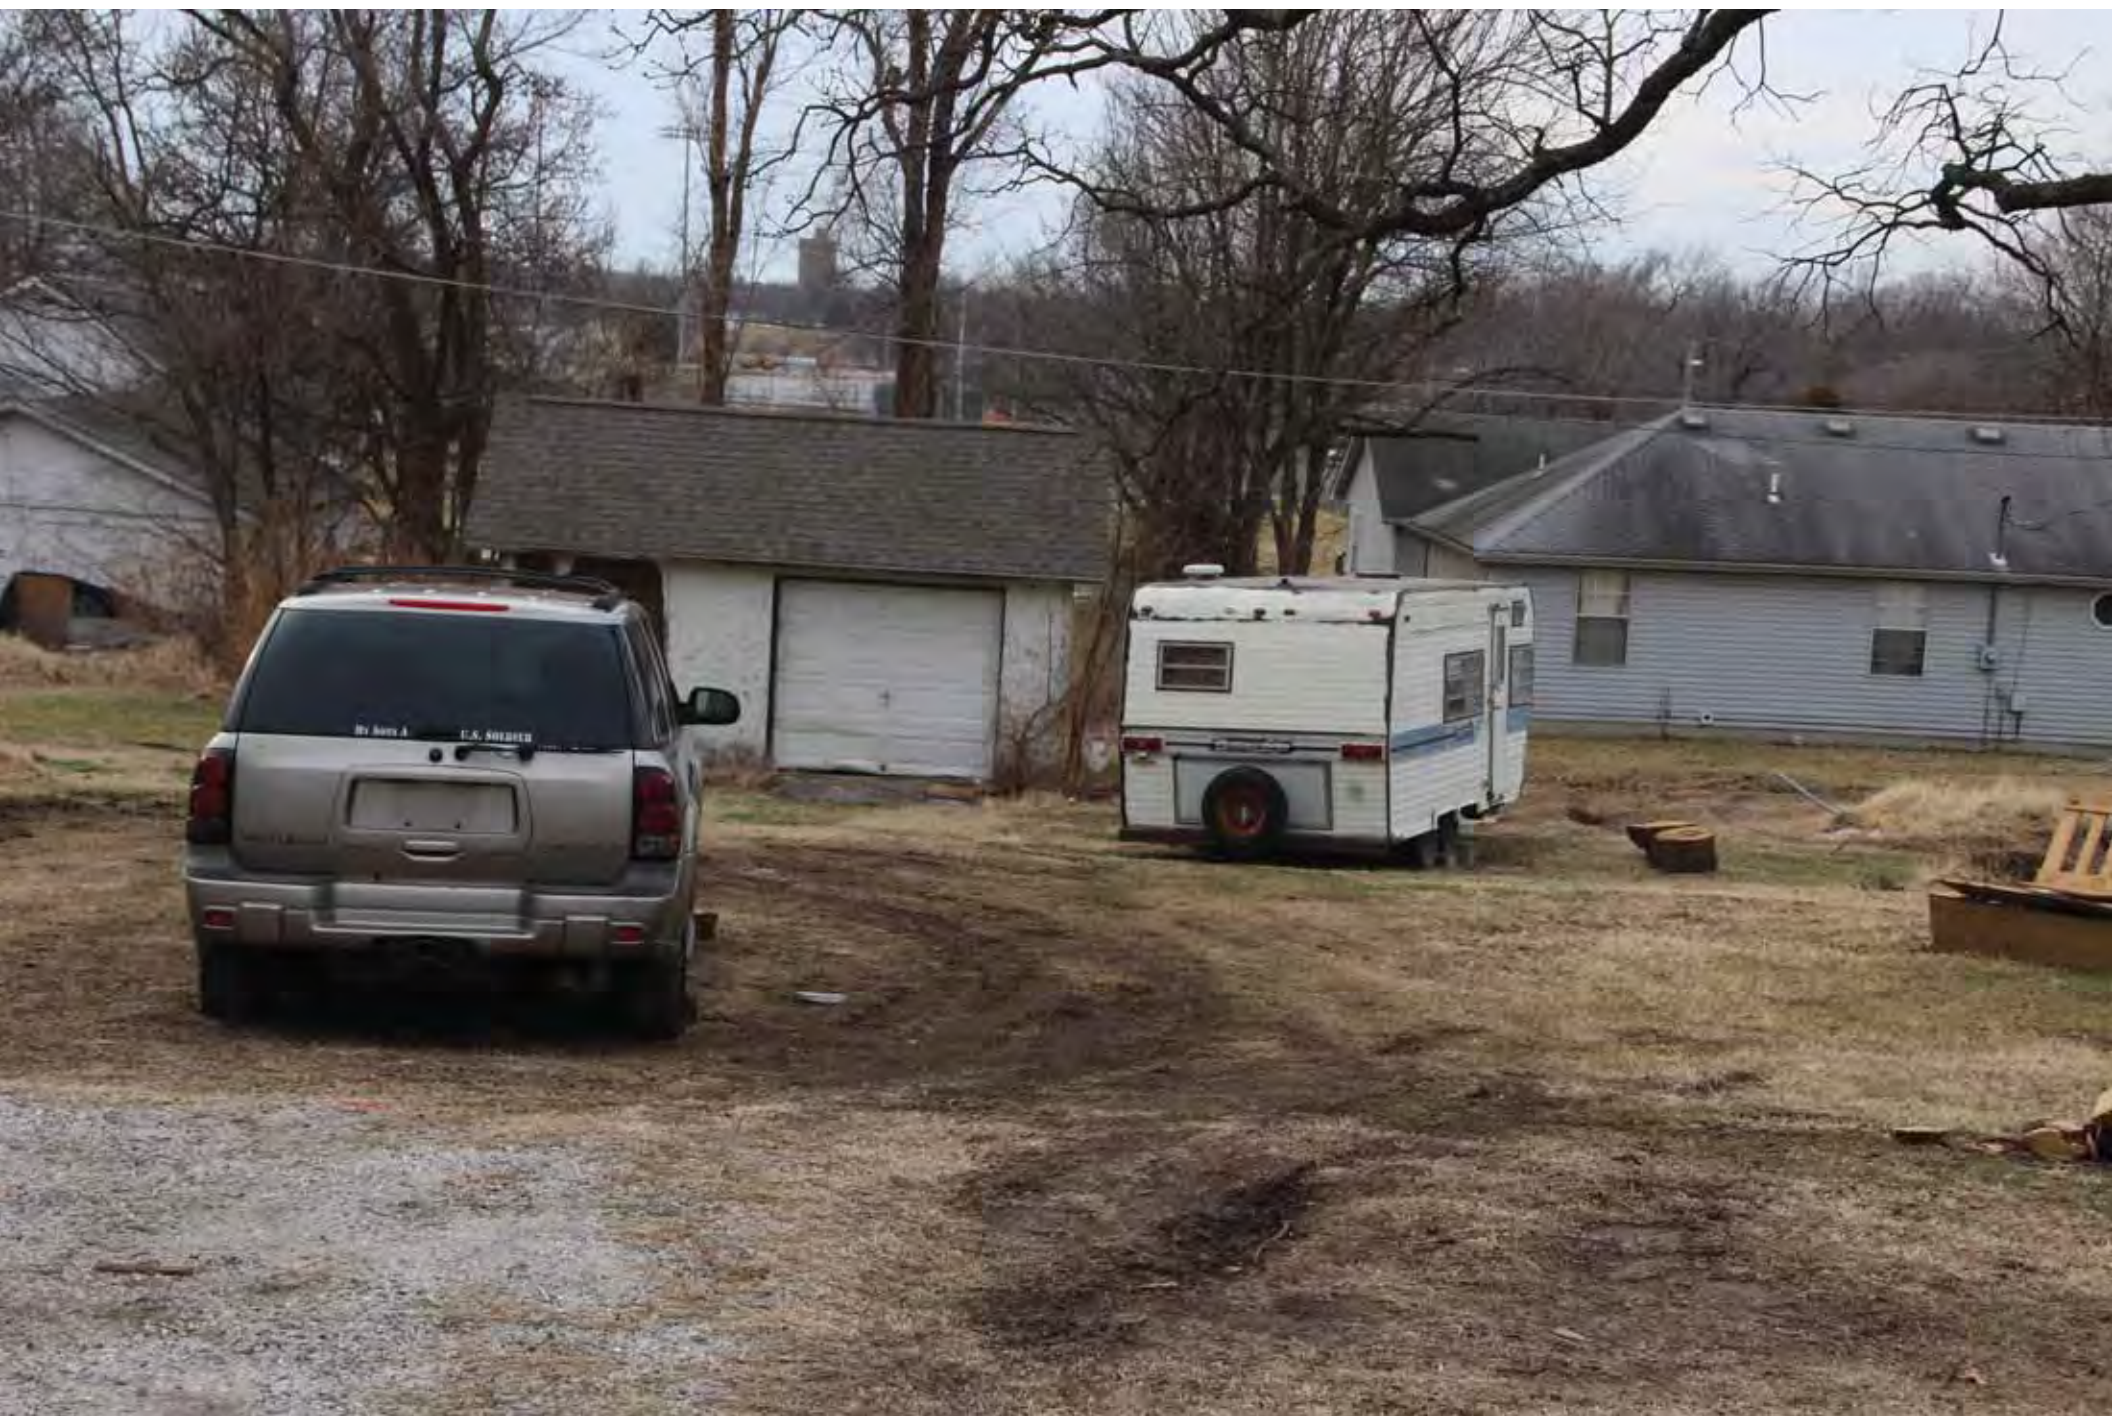
The property at 206 S. St. Louis Avenue features a mid-twentieth century dwelling with an asphalt shingled gabled roof, exterior wide board siding and a concrete foundation. The primary (east) elevation holds a central entry bay filled with a contemporary paneled door. Above the door is an asphalt covered awning (c. 1990). The entry bay is flanked by paired two-over-two windows on the north and a single window on the south. Windows are horizontal sash and have faux shutters. The north elevation holds two horizontal sash double-hung windows. The south elevation holds three windows. The dwelling has a rear wing at the southwest corner. Offsetting the wing on the north is a wood deck (c. 1990).
