MISSOURI DEPARTMENT OF NATURAL RESOURCES
STATE HISTORIC PRESERVATION OFFICE, P.O. Box 176, Jefferson City, MO 65102
ARCHITECTURAL/HISTORIC INVENTORY FORM

1. Survey No. JP-AS-007-001		2. Survey name: East Town (Original Joplin) Historic Survey Phase 2	
3. County: JASPER		4. Address (Street No.) 618	Street (name) E. 2 nd Street
5. City: Joplin	Vicinity: <input type="checkbox"/>	6. Geographical Reference:	7. Township/Range/Section: T: R: S:
8. Historic name (if known):		9. Present/other name (if known):	
10. Ownership: <input checked="" type="checkbox"/> Private <input type="checkbox"/> Public		11a. Historic use (if known): Domestic: Single Dwelling	11b. Current use: Domestic: Single Dwelling

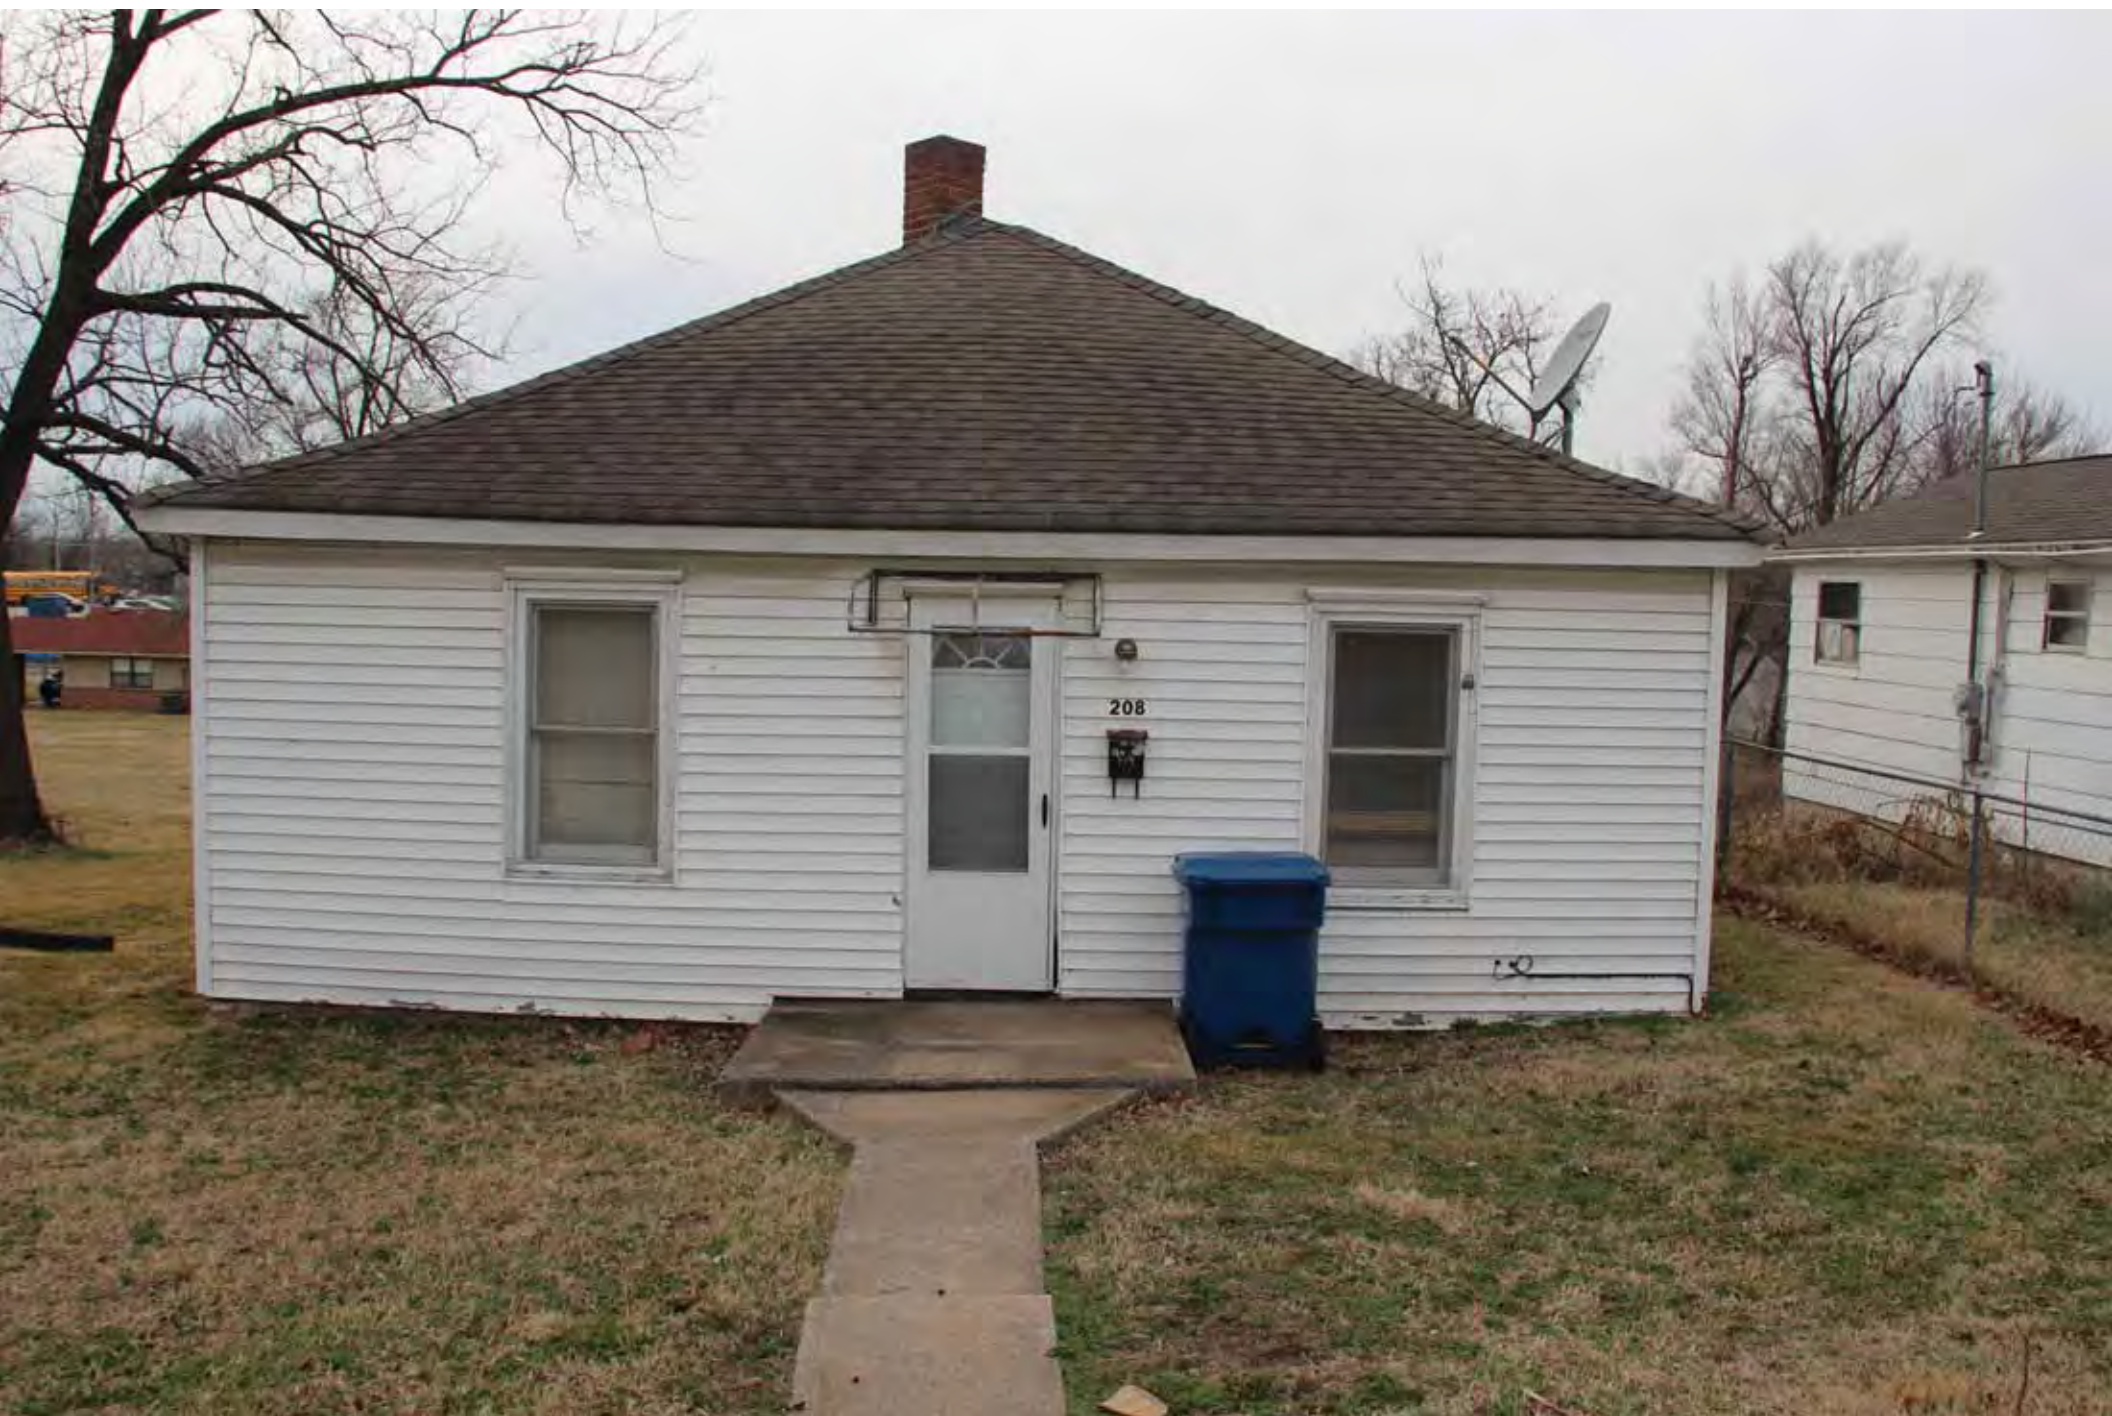
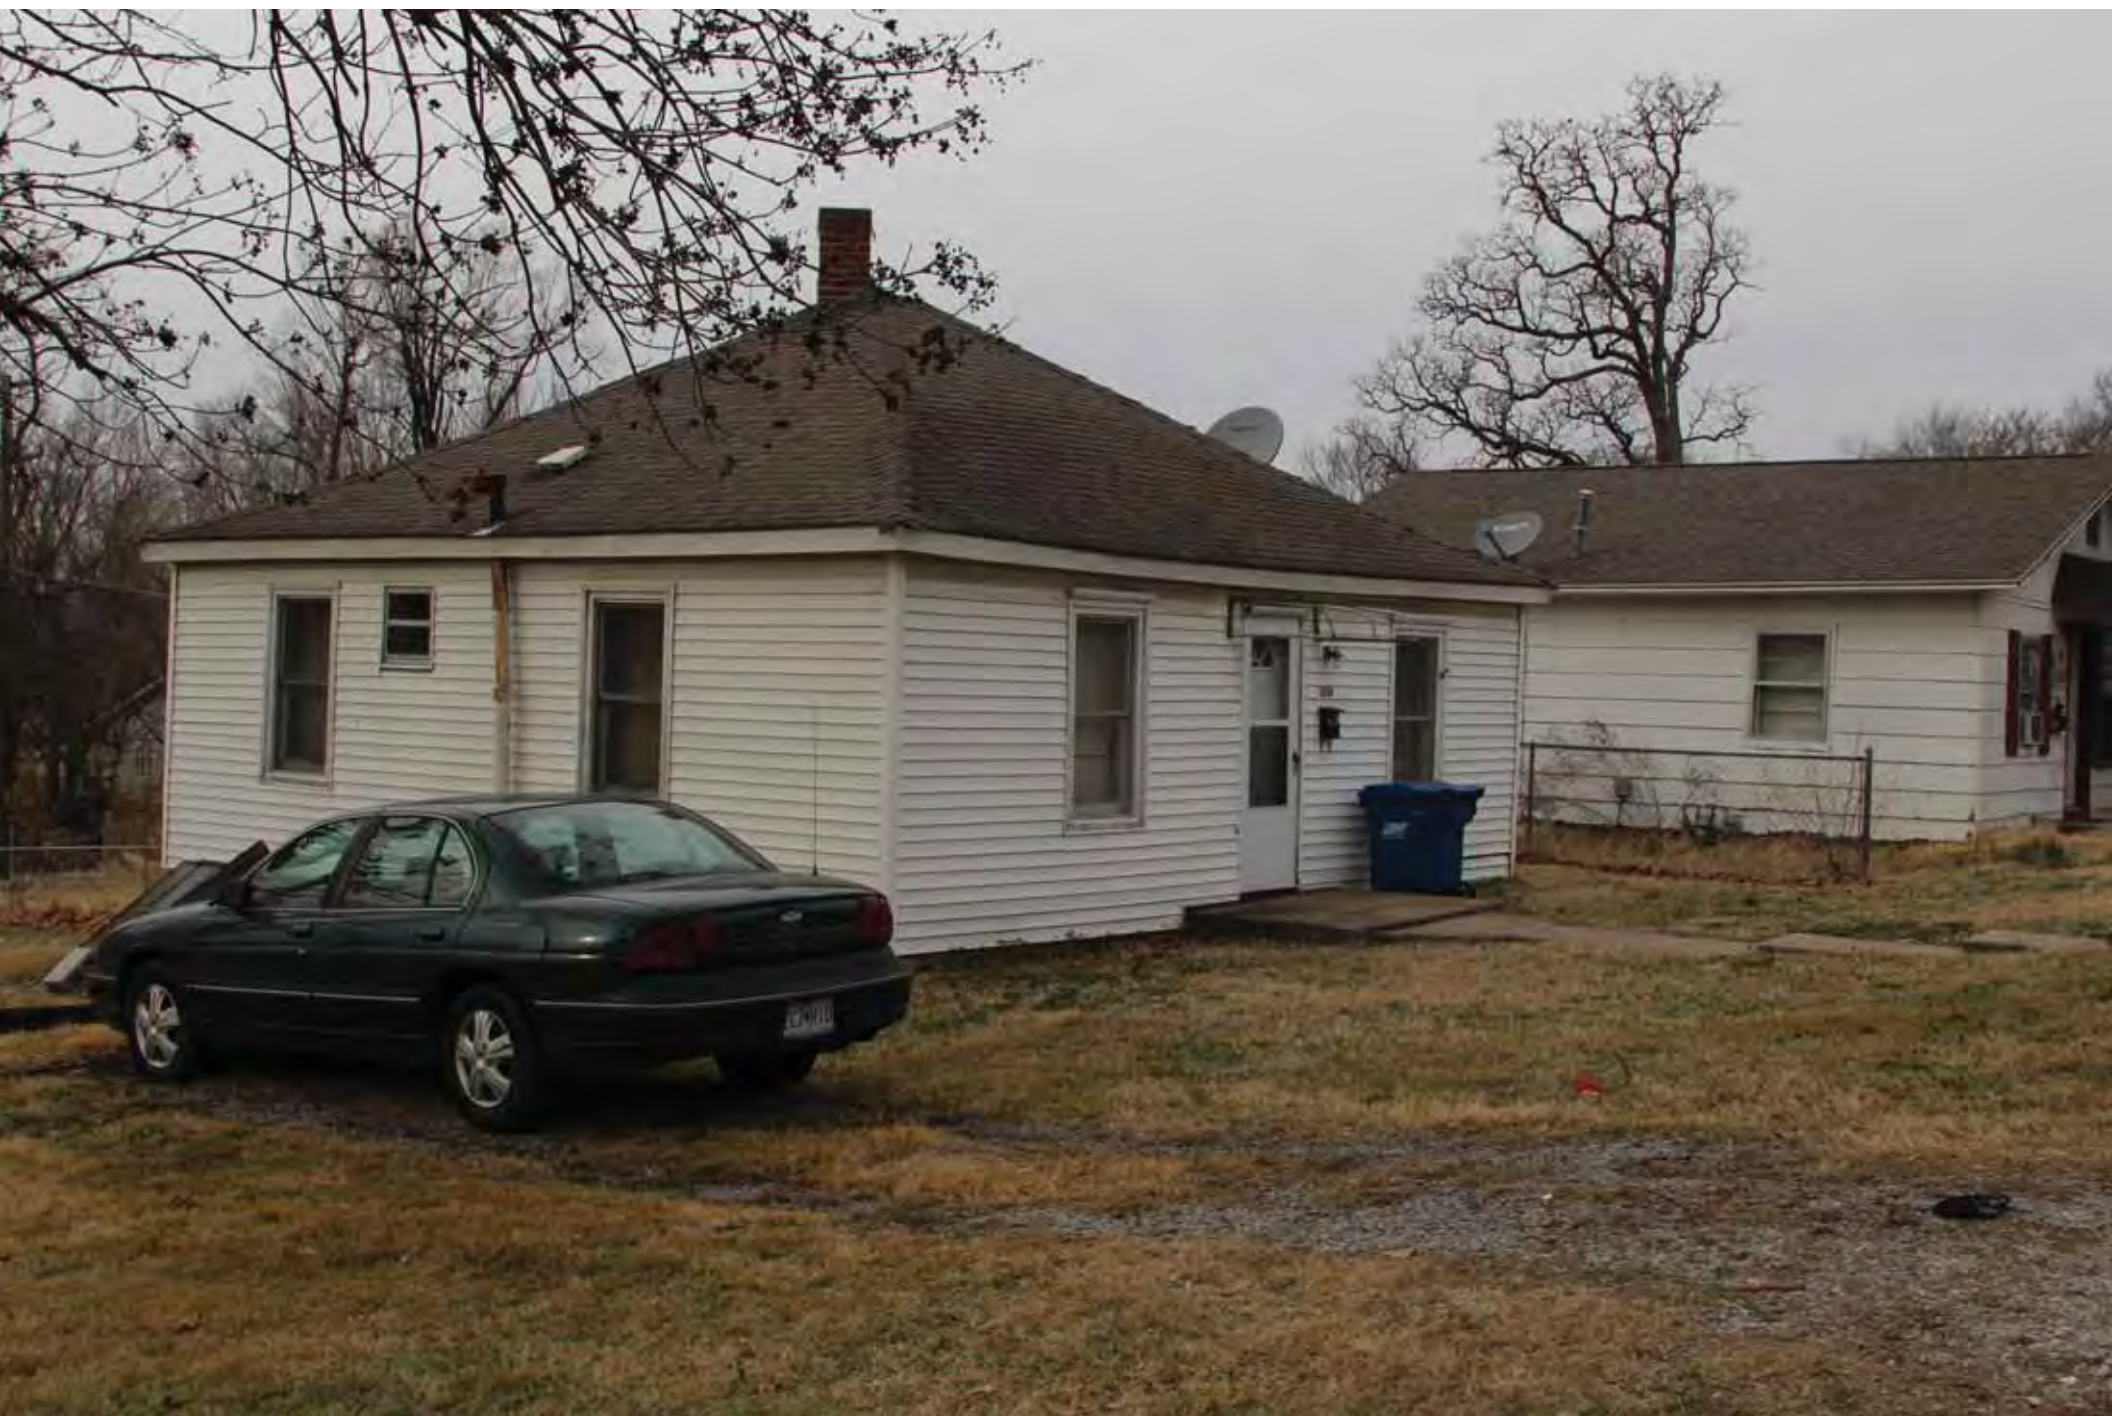
The property at 208 S. St. Louis Avenue features a mid-twentieth century dwelling with a hipped asphalt shingled roof, exterior vinyl siding (c. 2019) and a concrete foundation. At the peak of the roof is an interior brick chimney. The primary (east) elevation holds a central entry bay with a c. 2019 upper fanlight door. The door is flanked by one-over-one windows. In front of the entry bay is a low concrete stoop. The south elevation holds three windows, one of which is very small – windows are one-over-one. The north elevation has a secondary entry offset by a single window.

This dwelling is a common property type that lacks architectural or historical associations qualifying the property as individually eligible for the National Register of Historic Places. The property is not within an area recommended as a historic district.

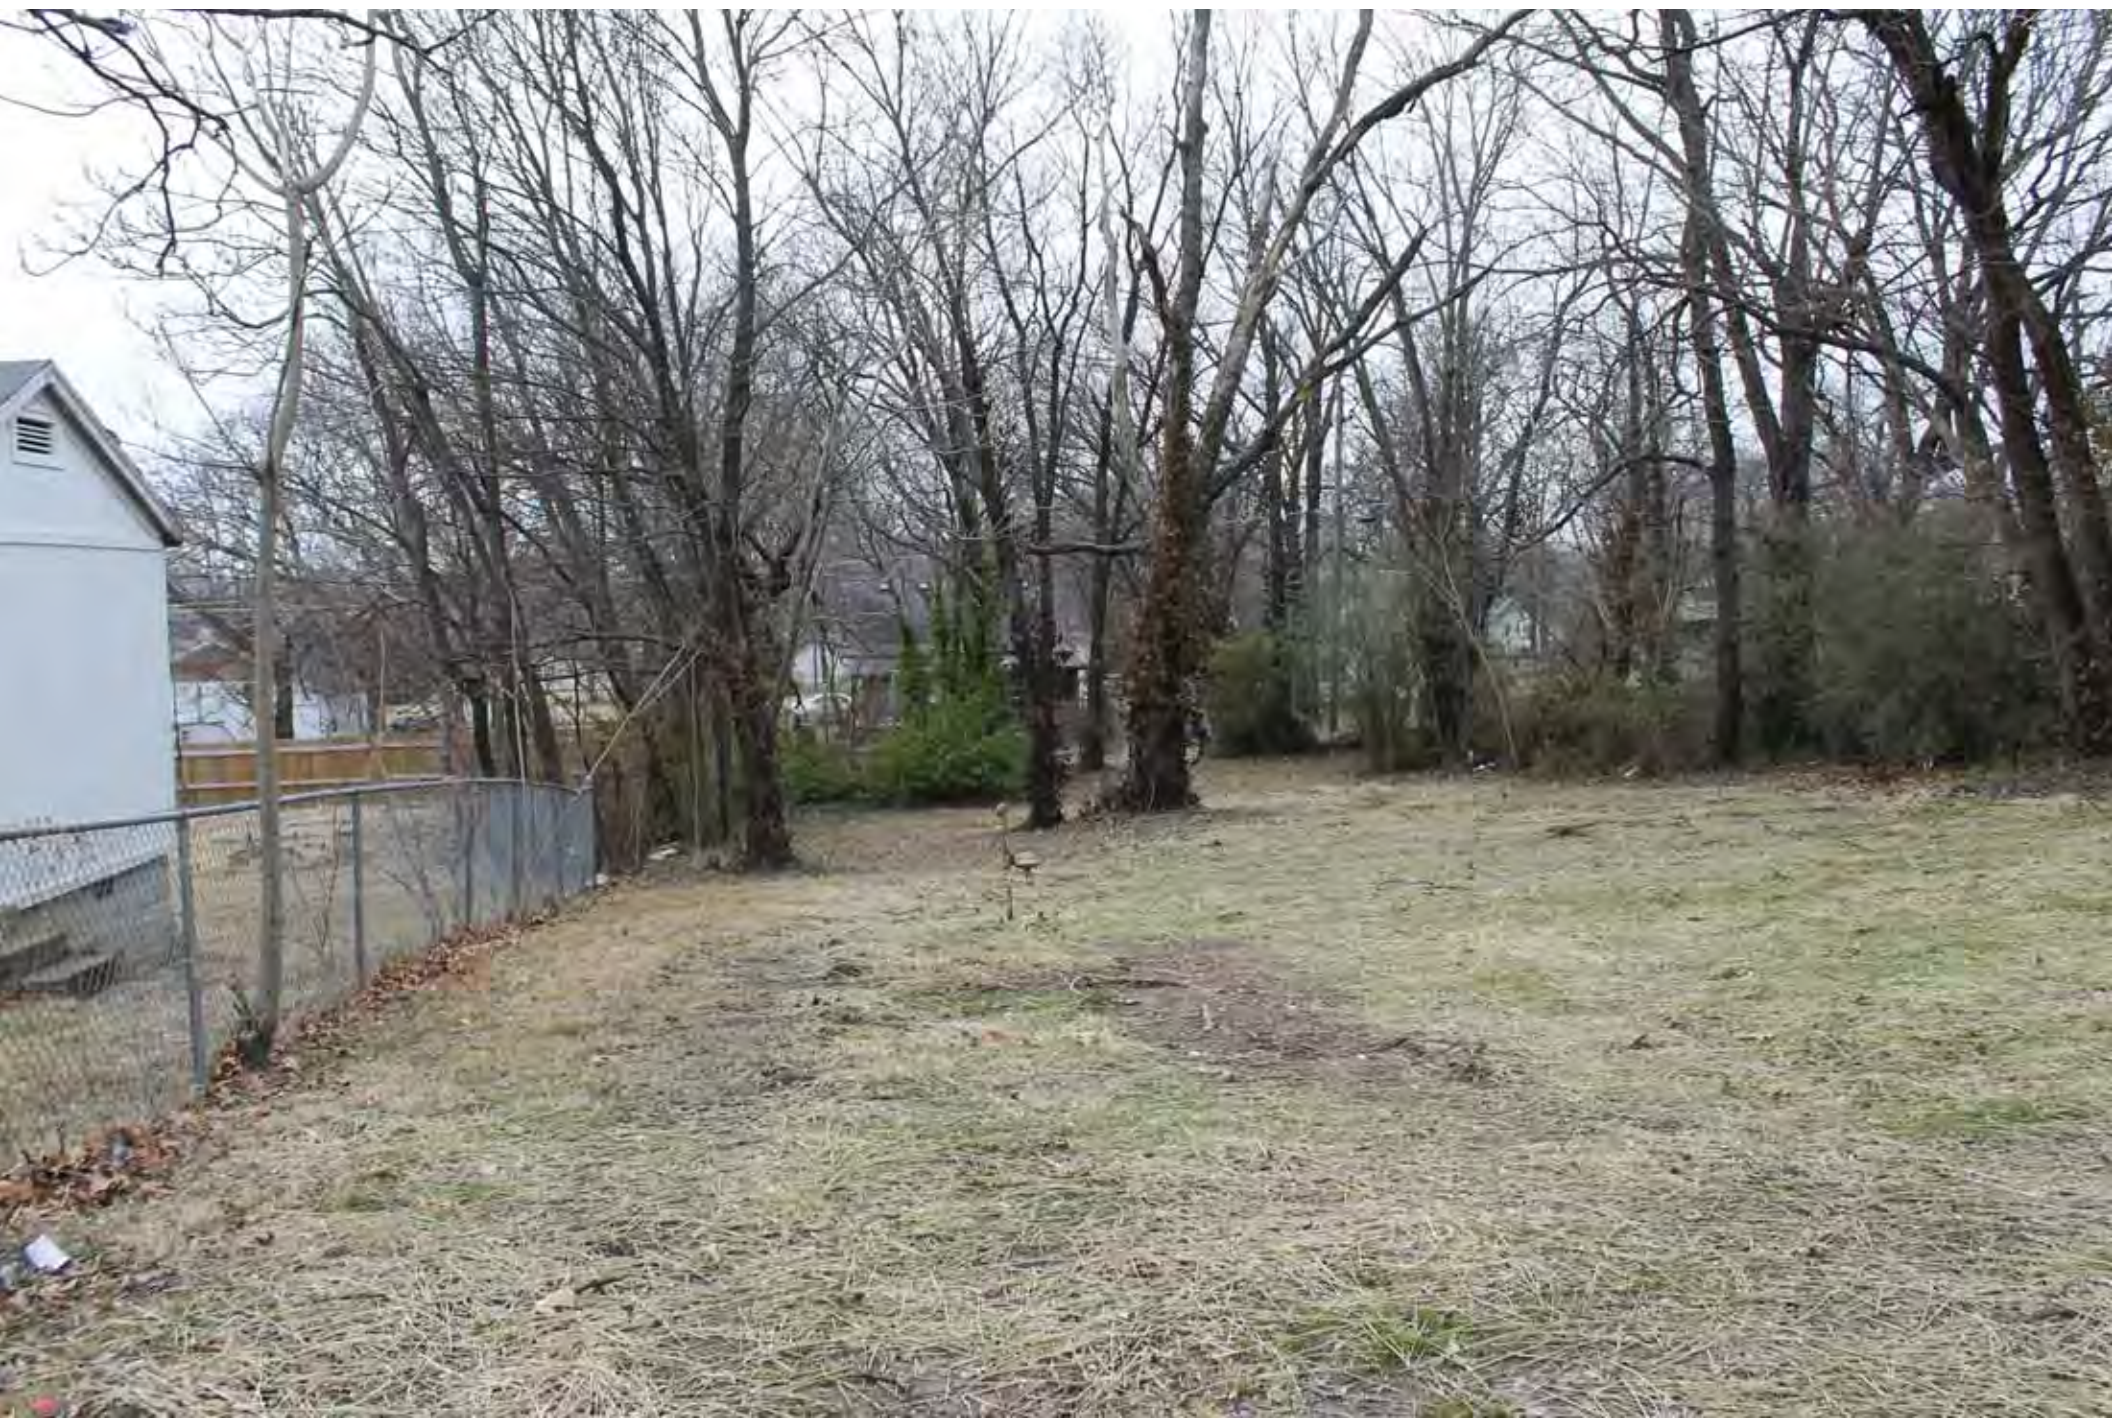
The vacant lot addressed as 220 S. St. Louis Avenue formerly held a single family dwelling, demolished in 2019. Due to the removal of the dwelling, the lot does not retain integrity that would render it individually eligible for the National Register of Historic Places. The property is not situated in an area recommended as a historic district.

The property at 220 S. St. Louis Avenue is a vacant grass covered lot, as described above.

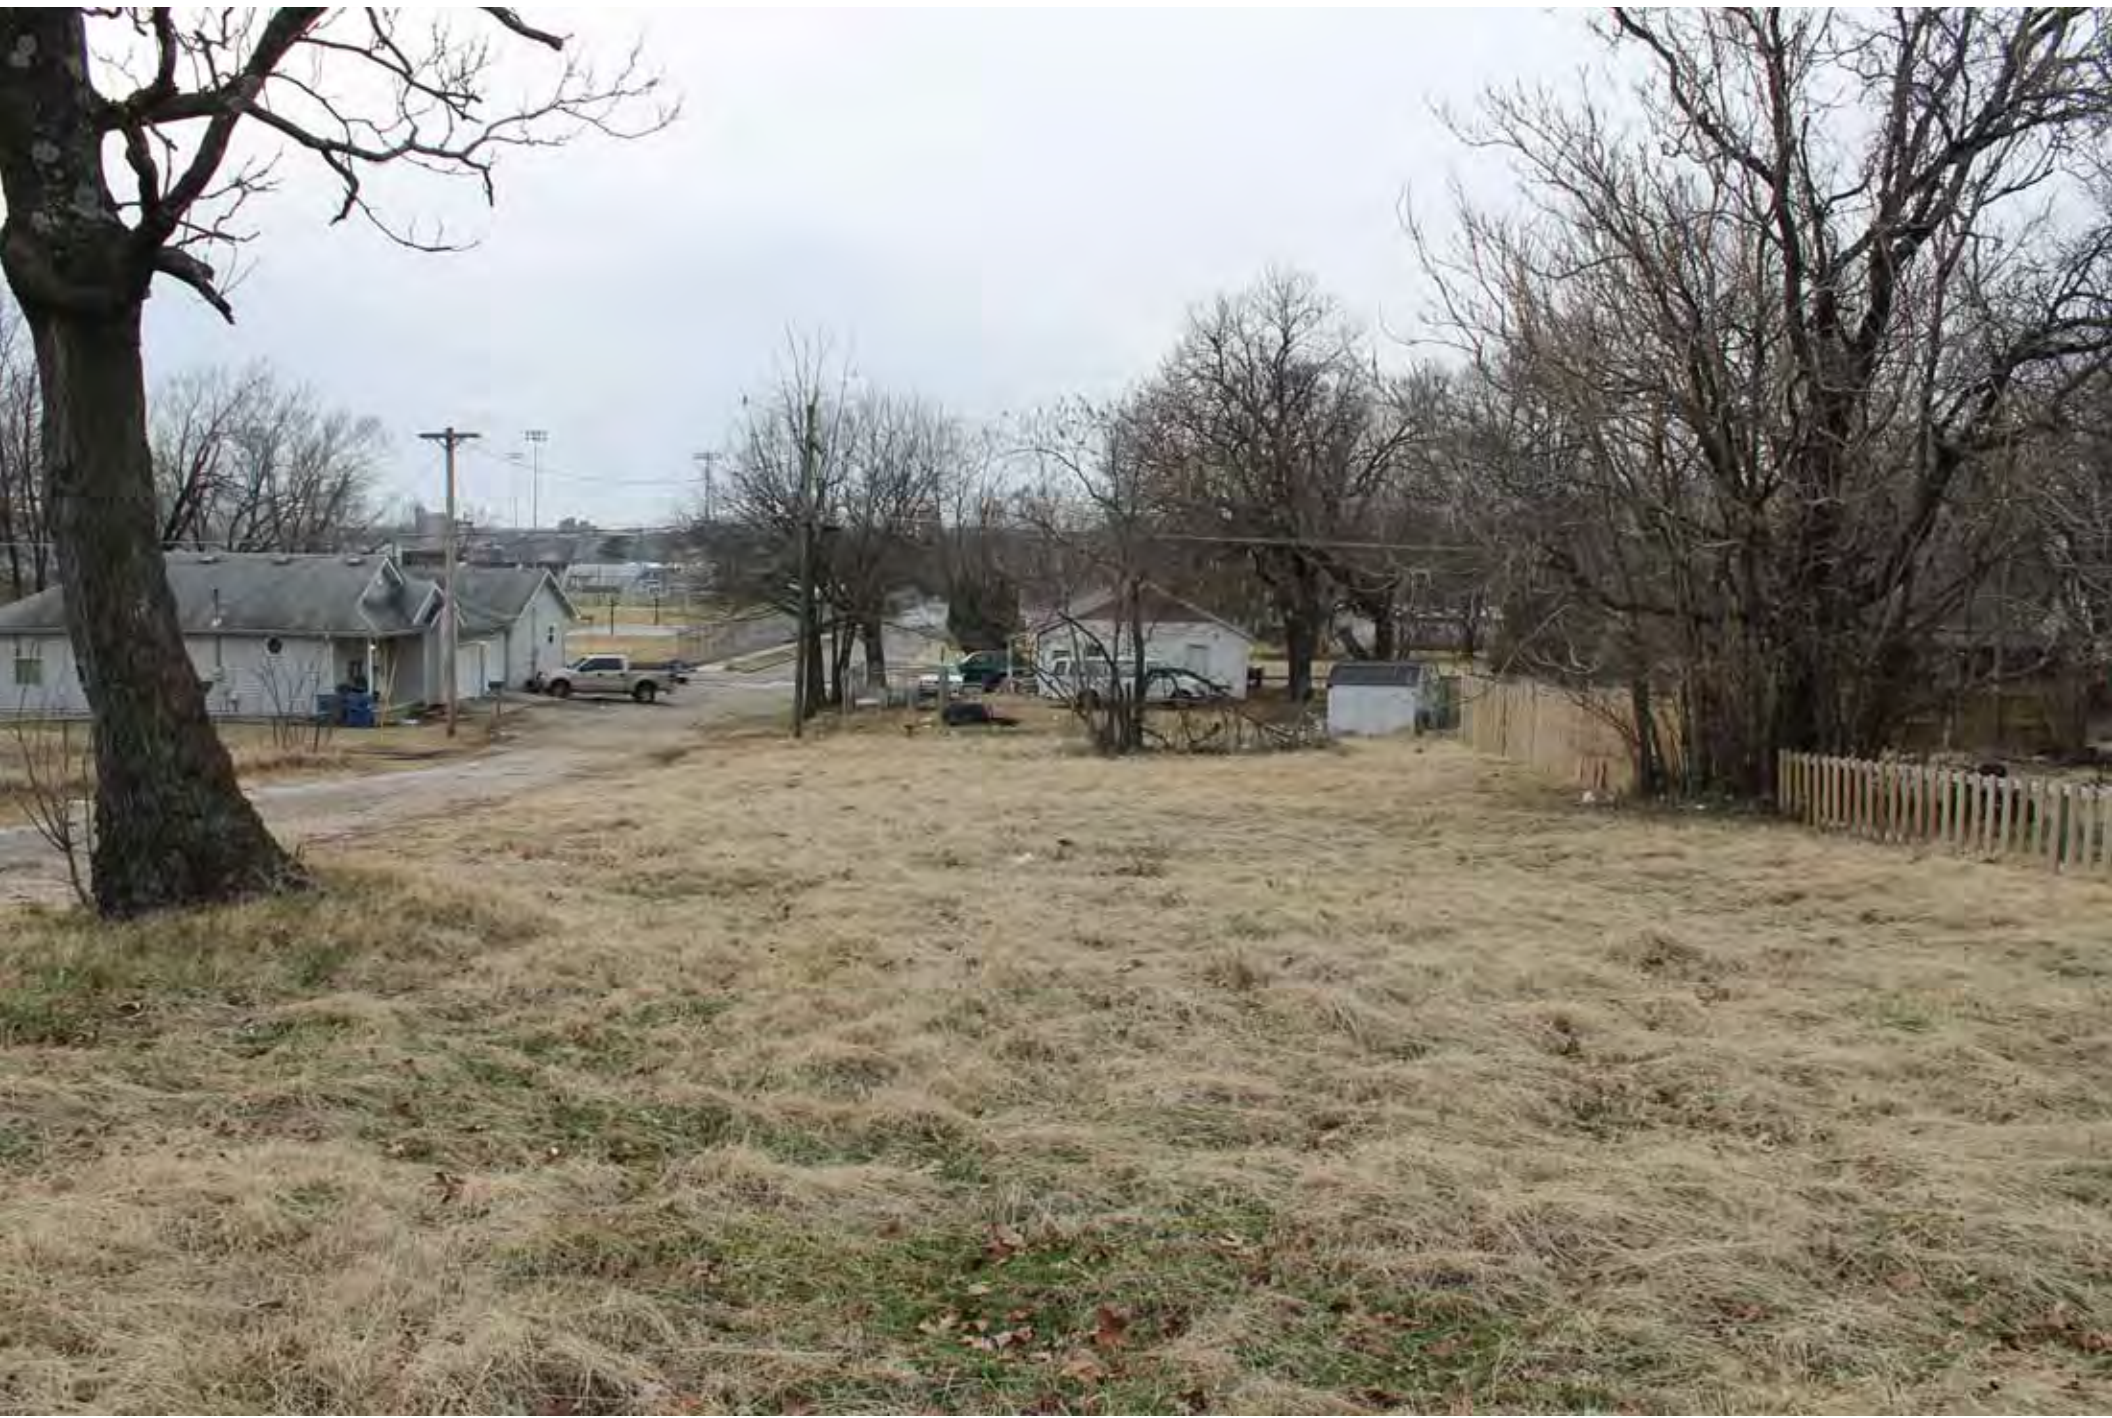
The vacant lot addressed as 224 S. St. Louis Avenue formerly held a single family dwelling, demolished in 2019. Due to the removal of the dwelling, the lot does not retain integrity that would render it individually eligible for the National Register of Historic Places. The property is not situated in an area recommended as a historic district.

The property at 224 S. St. Louis Avenue is a vacant grass covered lot, as described above.

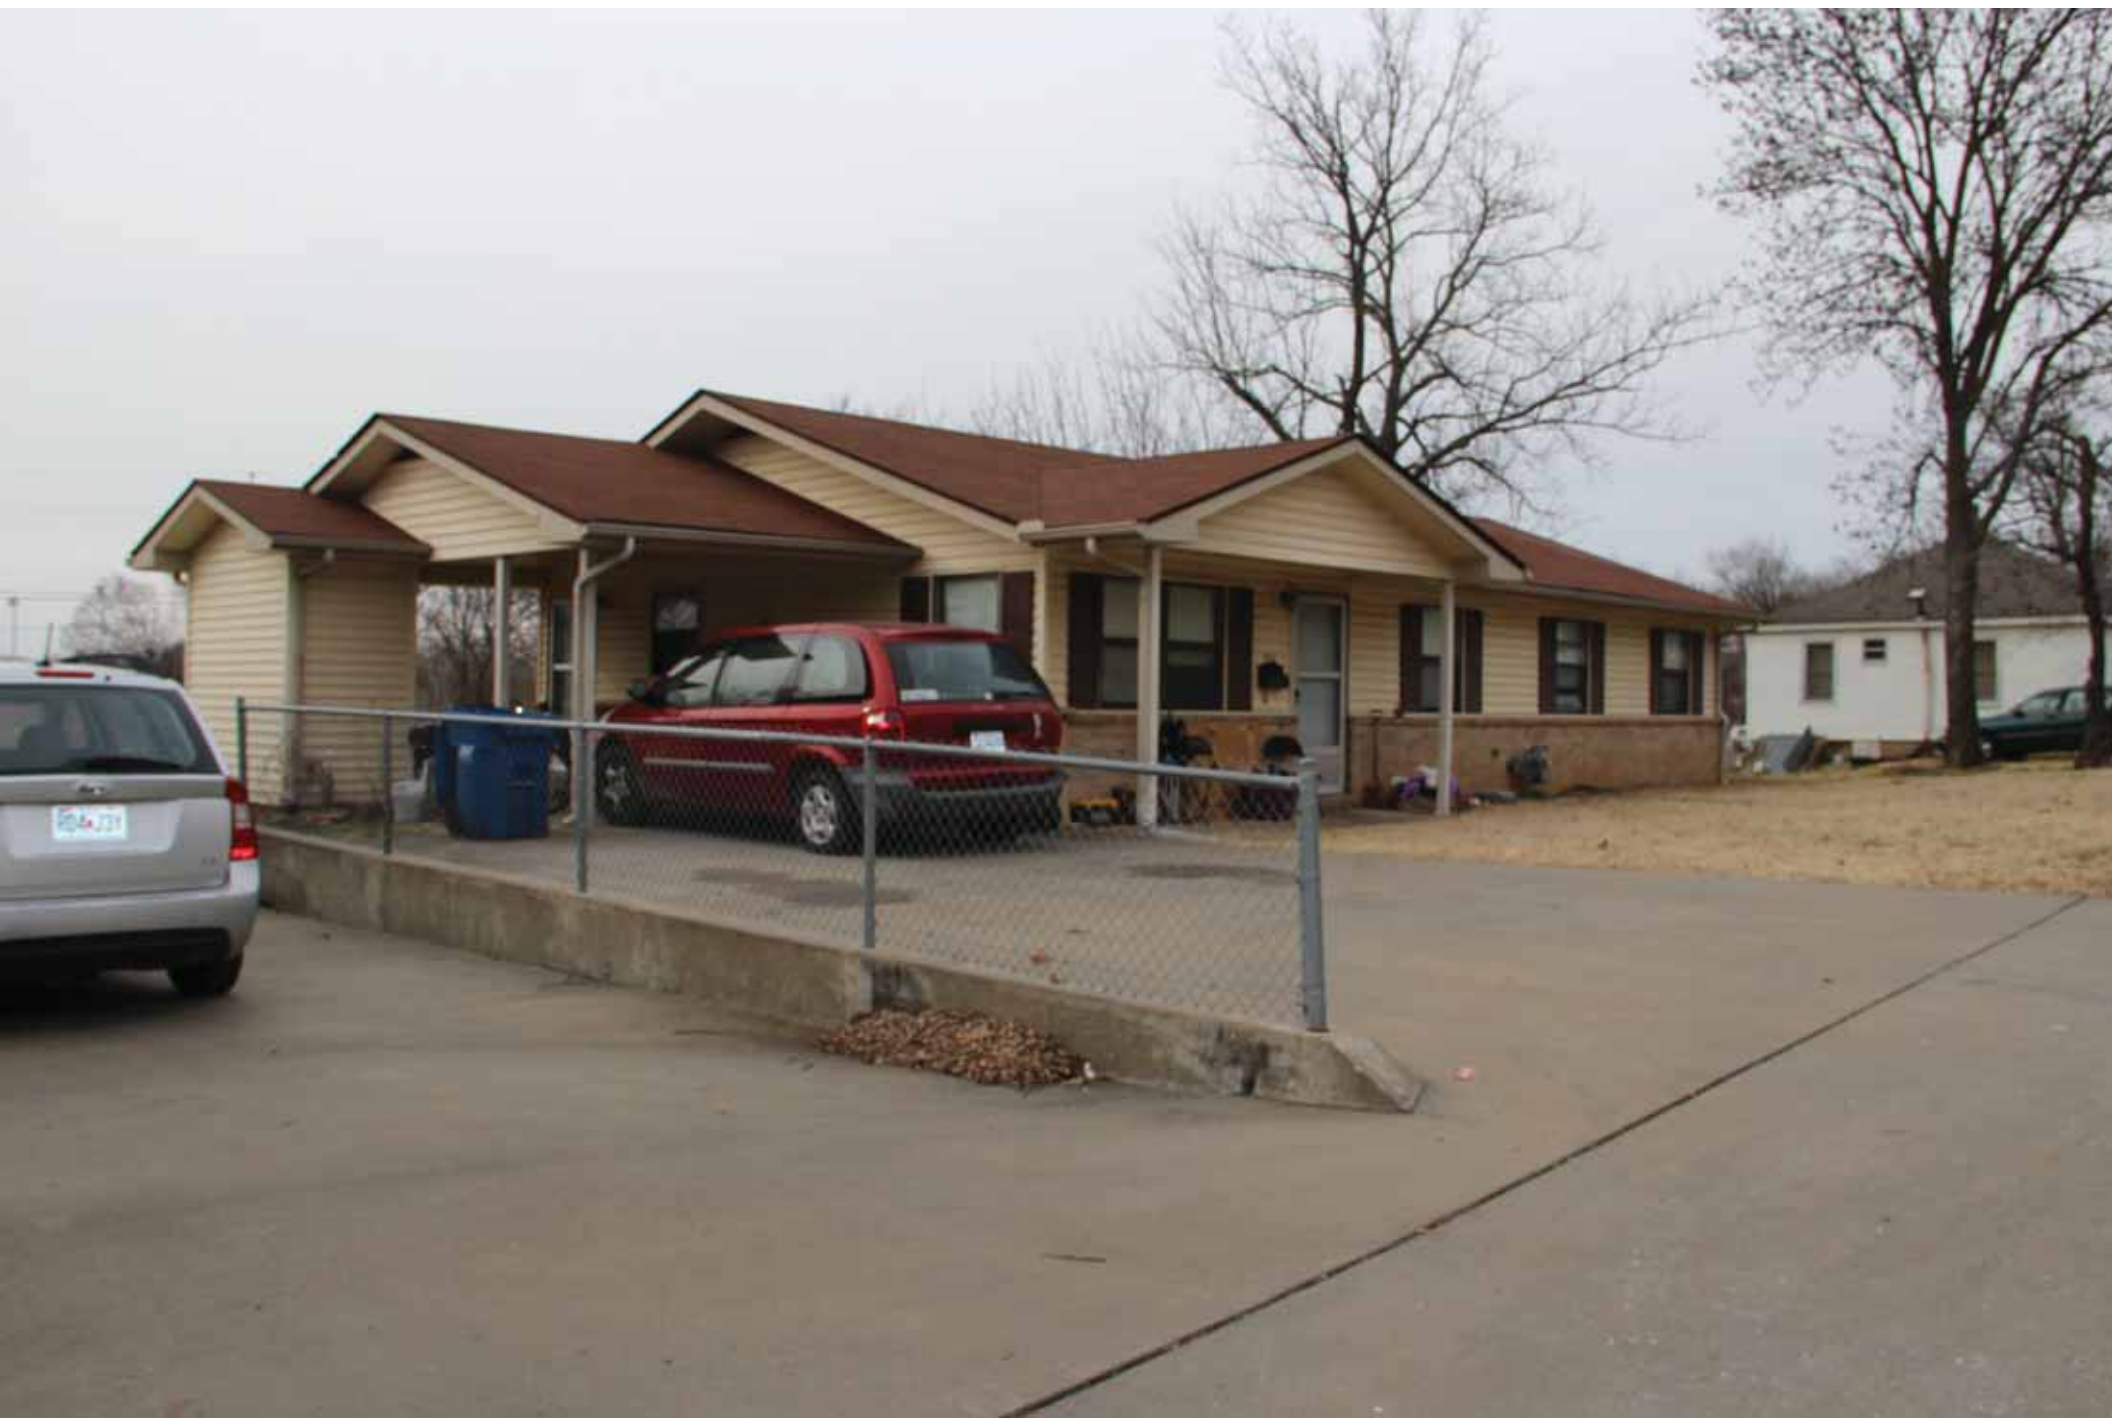
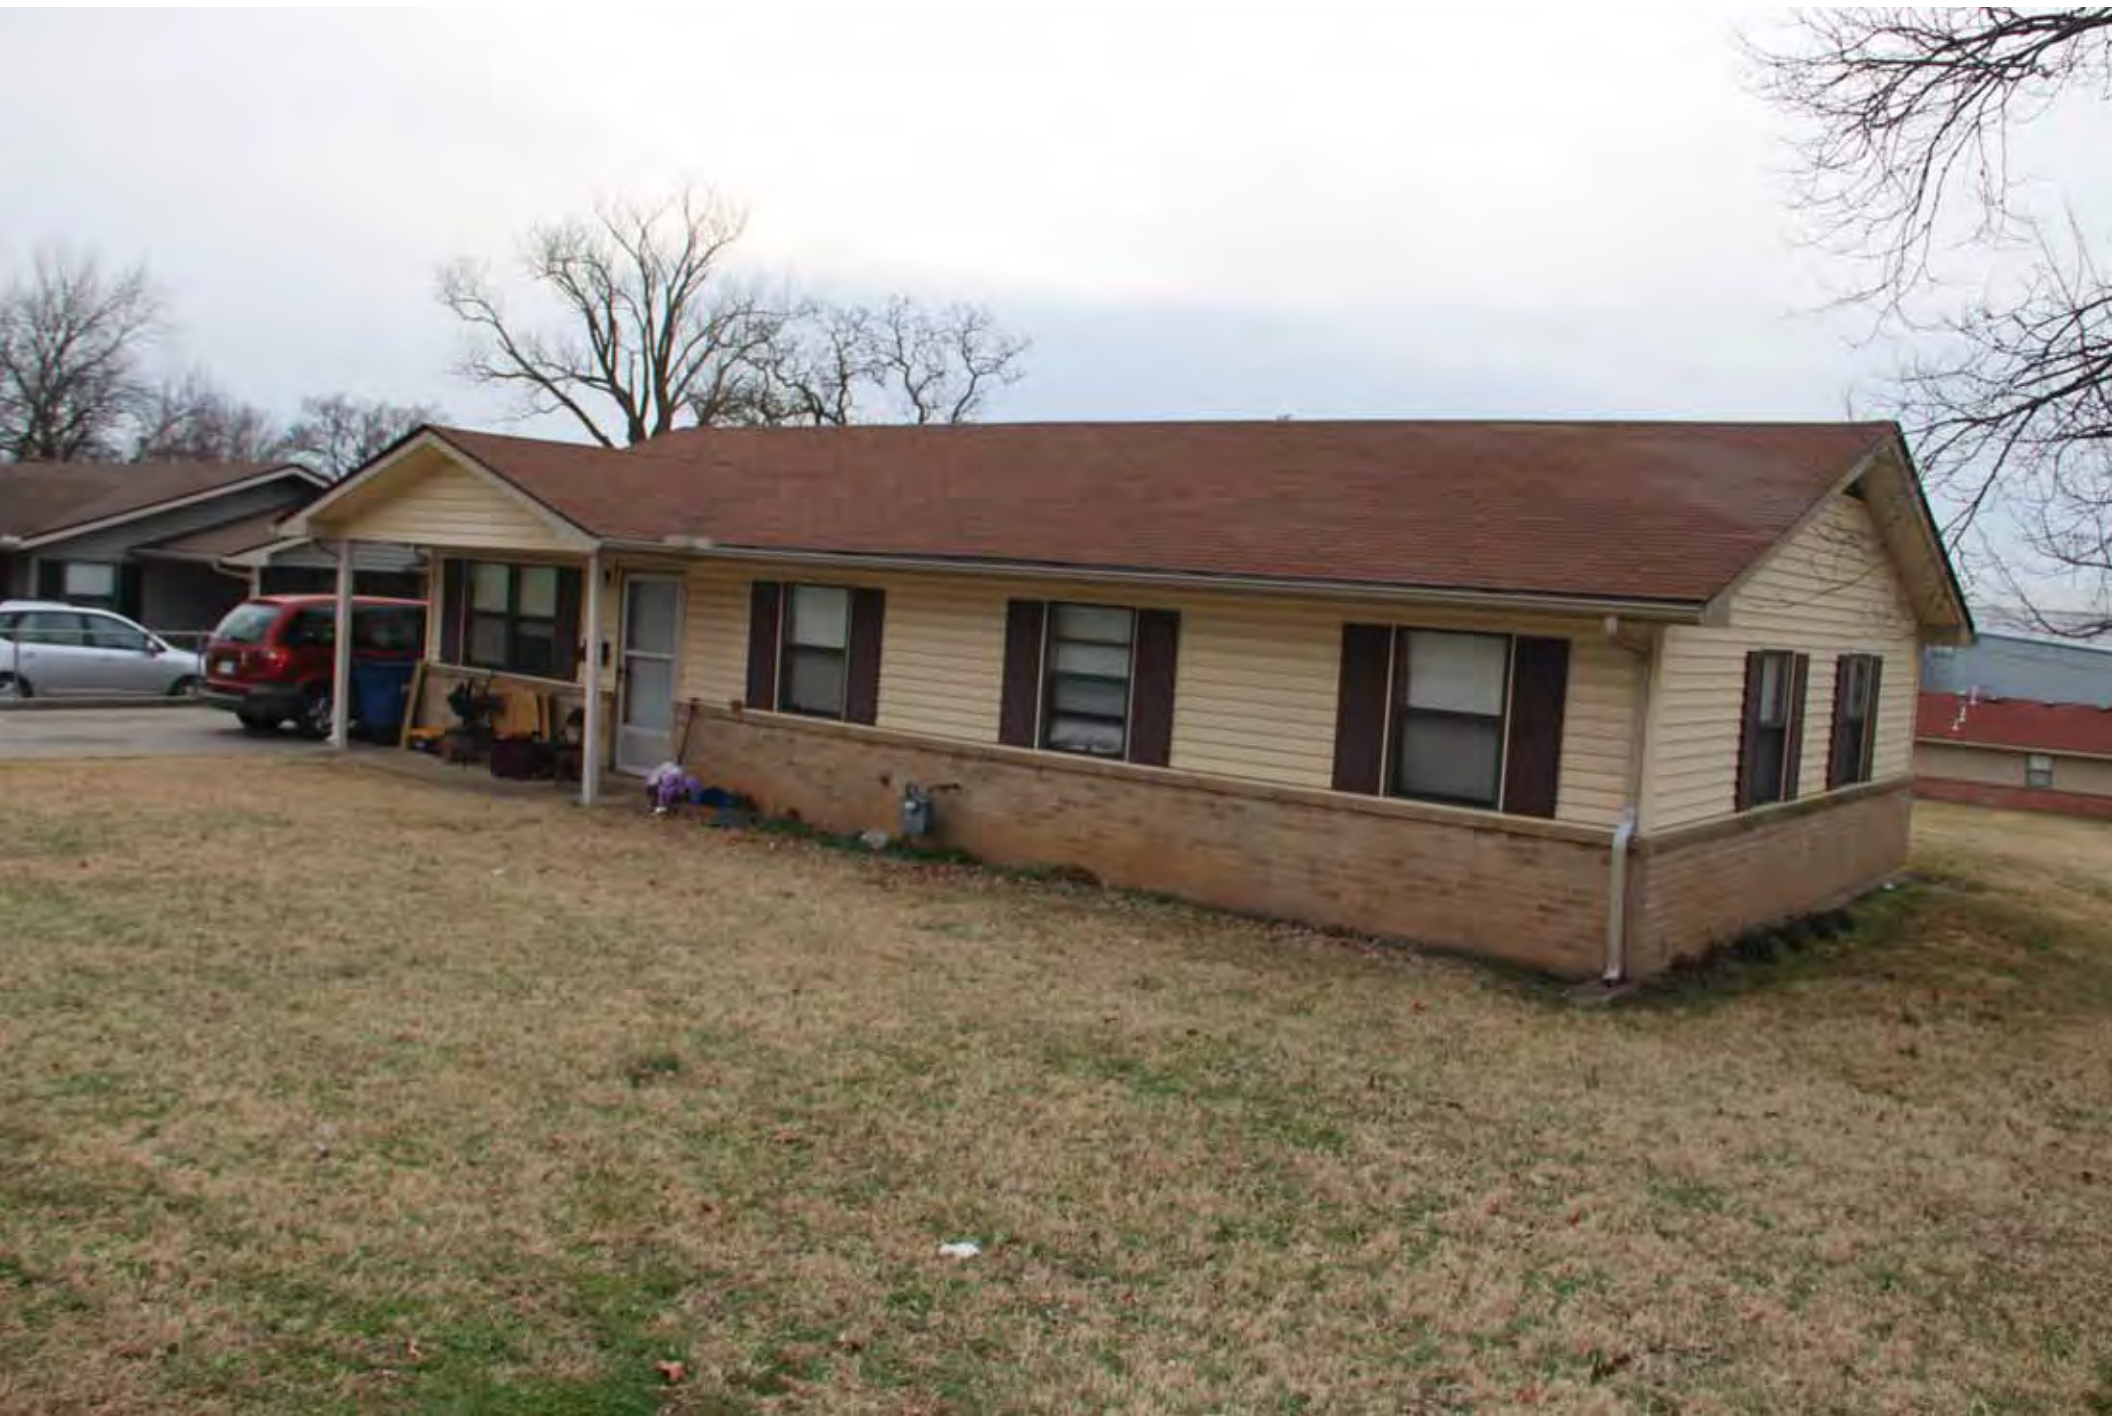
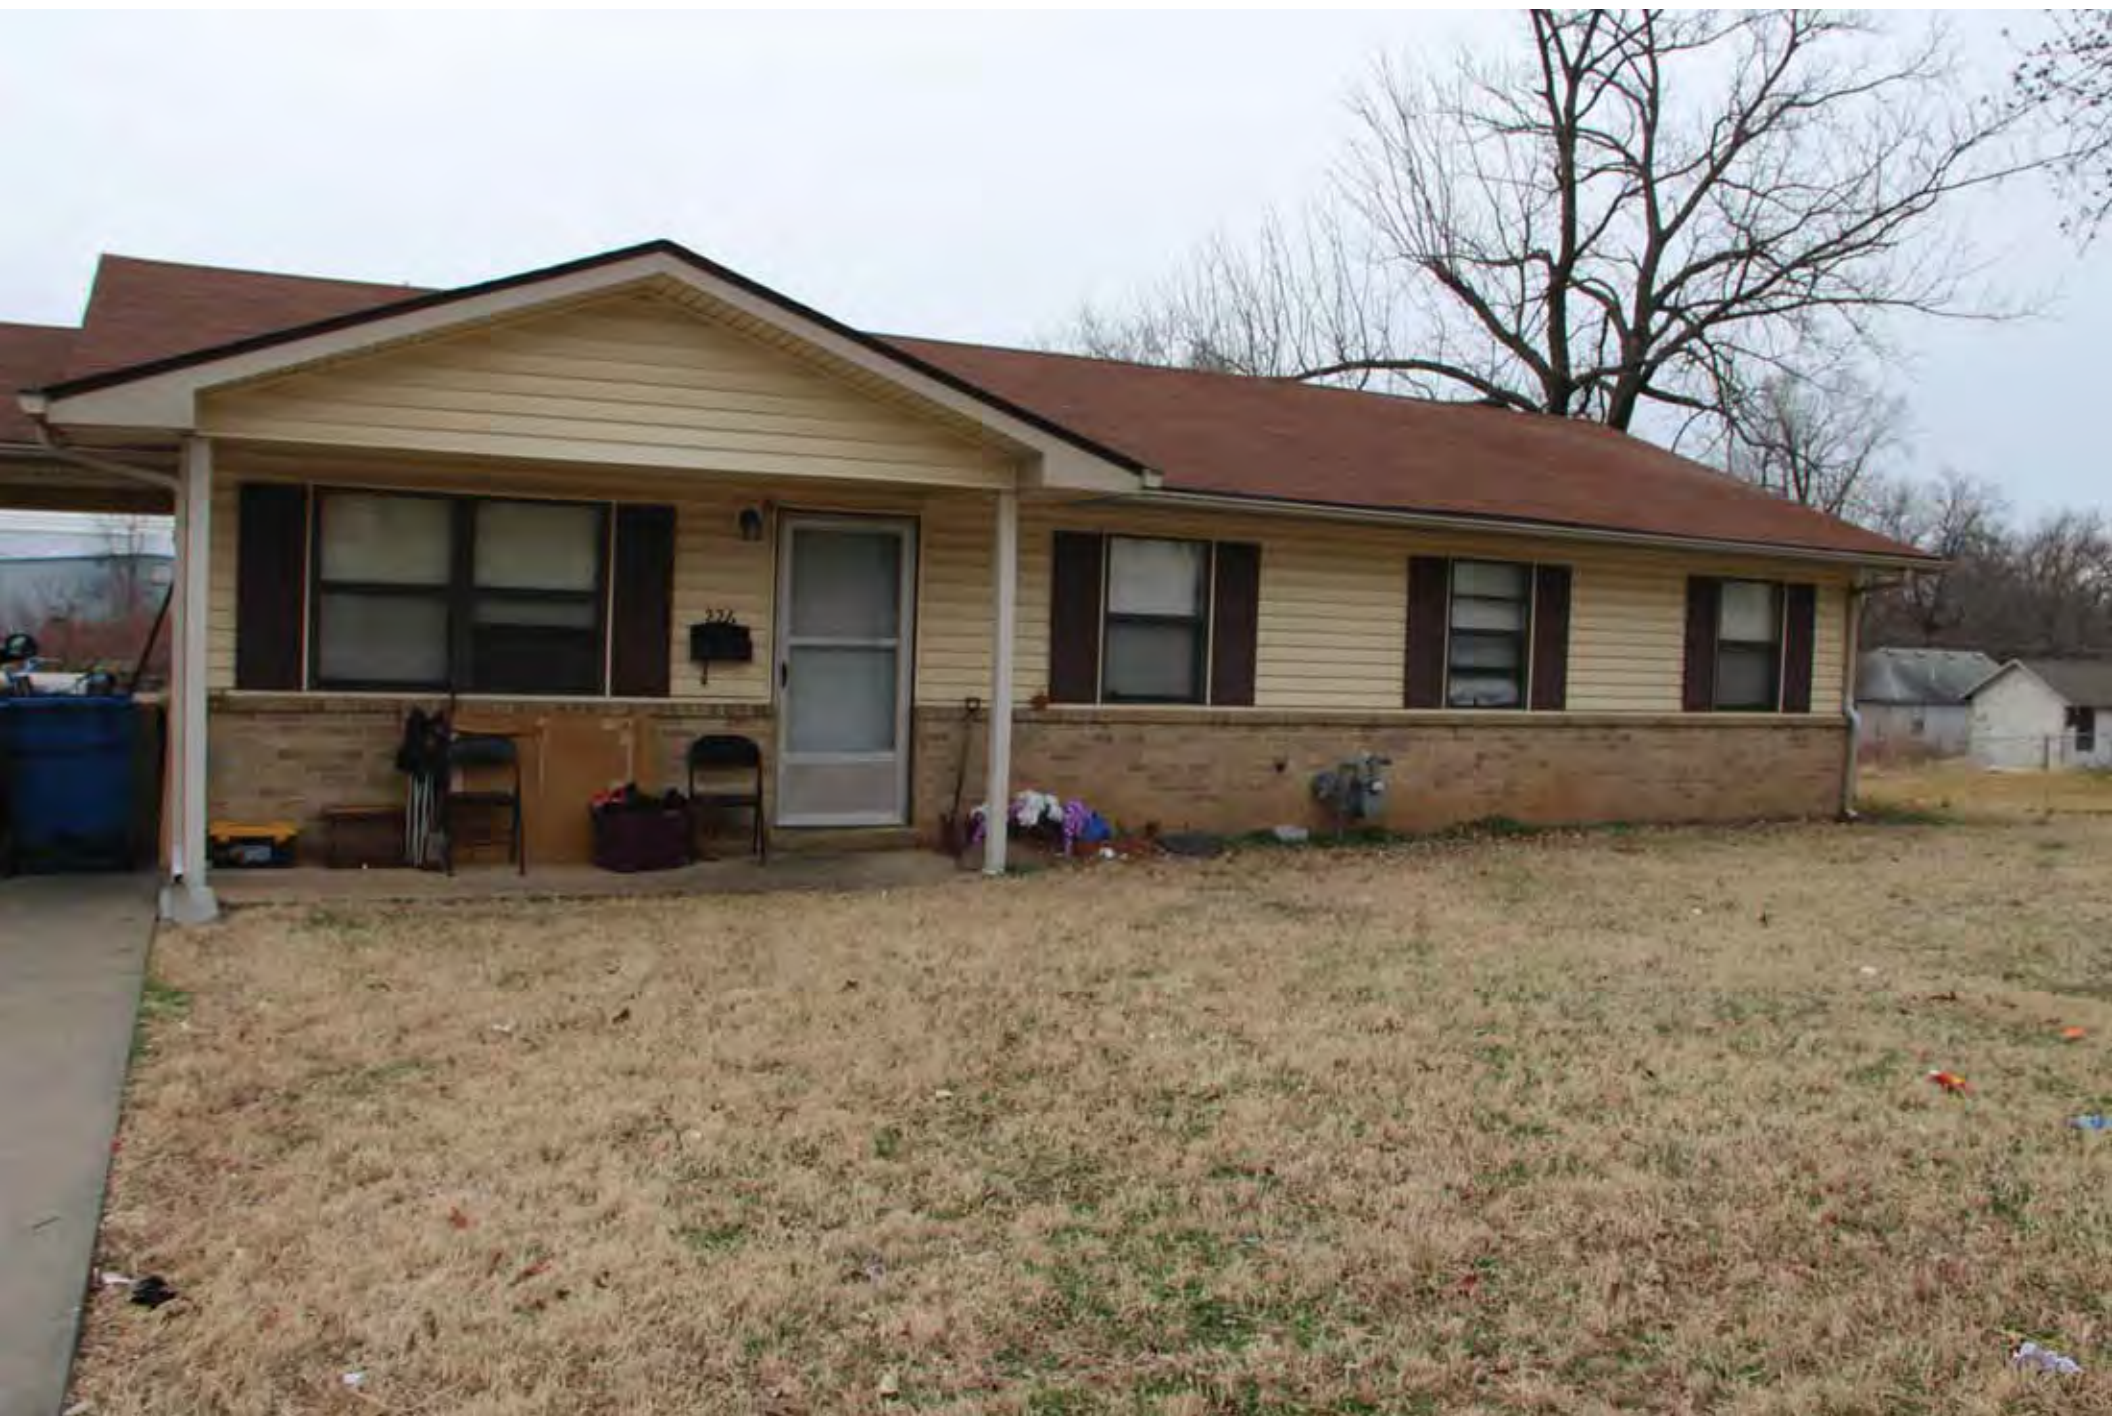
<p>41. (cont.) Description of primary resource. Expand box as necessary, or add continuation pages.</p> <p>The property at 226 S. St. Louis Avenue features a single-story dwelling with an asphalt-shingled gabled roof, exterior vinyl siding and a concrete foundation. The lower elevations (below windows) are clad with brick veneer capped by a band of continuous brick headers. Windows are one-over-one with faux shutters. On the façade (east elevation) is a small gabled porch near the south end of the elevation. The porch is supported by two columns resting on a concrete pad. Within the porch bay is a single solid door flanked by paired windows (south) and a single window (north). The remaining elevation supports two single windows. The north elevation holds two windows. At the south elevation is a gabled carport, which extends above the concrete drive. The south elevation of the dwelling holds a secondary entry below the carport roof. The entry is offset on the east by a single window. The south end of the carport roof attaches to a small utility shed clad with vinyl siding.</p>

<p>21. (cont.) History and significance. Expand box as necessary, or add continuation pages.</p> <p>The dwelling at 226 S. St. Louis Avenue was constructed c. 2018.</p> <p>This dwelling is less than 50 years of age and does not exhibit exceptional architectural and/or historical significance. The dwelling is not situated in an area recommended as a historic district. For these reasons, the property does not appear individually eligible for the National Register of Historic Places.</p>
<p>22. (cont.) Sources of information. Expand box as necessary, or add continuation pages.</p> <p>Jasper County GIS (Beacon) Database (https://beacon.schneidercorp.com/), Access date: 6 April 2020. McAlester, Virginia Savage. <i>A Field Guide to American Houses</i>. New York: Alfred A. Knopf, 2018.</p>
<p>40. (cont.) Description of environment and outbuildings. Expand box as necessary, or add continuation pages.</p> <p>The dwelling is situated in a mixed use neighborhood on the west side of S. St. Louis Avenue. The lot is bounded on the south by a chain link fence on a low concrete wall. The grassy lot supports no mature foliage.</p>
