MISSOURI DEPARTMENT OF NATURAL RESOURCES
STATE HISTORIC PRESERVATION OFFICE, P.O. Box 176, Jefferson City, MO 65102
ARCHITECTURAL/HISTORIC INVENTORY FORM

1. Survey No. JP-AS-007-001		2. Survey name: East Town (Original Joplin) Historic Survey Phase 2	
3. County: JASPER		4. Address (Street No.) 618	Street (name) E. 2 nd Street
5. City: Joplin	Vicinity: <input type="checkbox"/>	6. Geographical Reference:	7. Township/Range/Section: T: R: S:
8. Historic name (if known):		9. Present/other name (if known):	
10. Ownership: <input checked="" type="checkbox"/> Private <input type="checkbox"/> Public		11a. Historic use (if known): Domestic: Single Dwelling	11b. Current use: Domestic: Single Dwelling

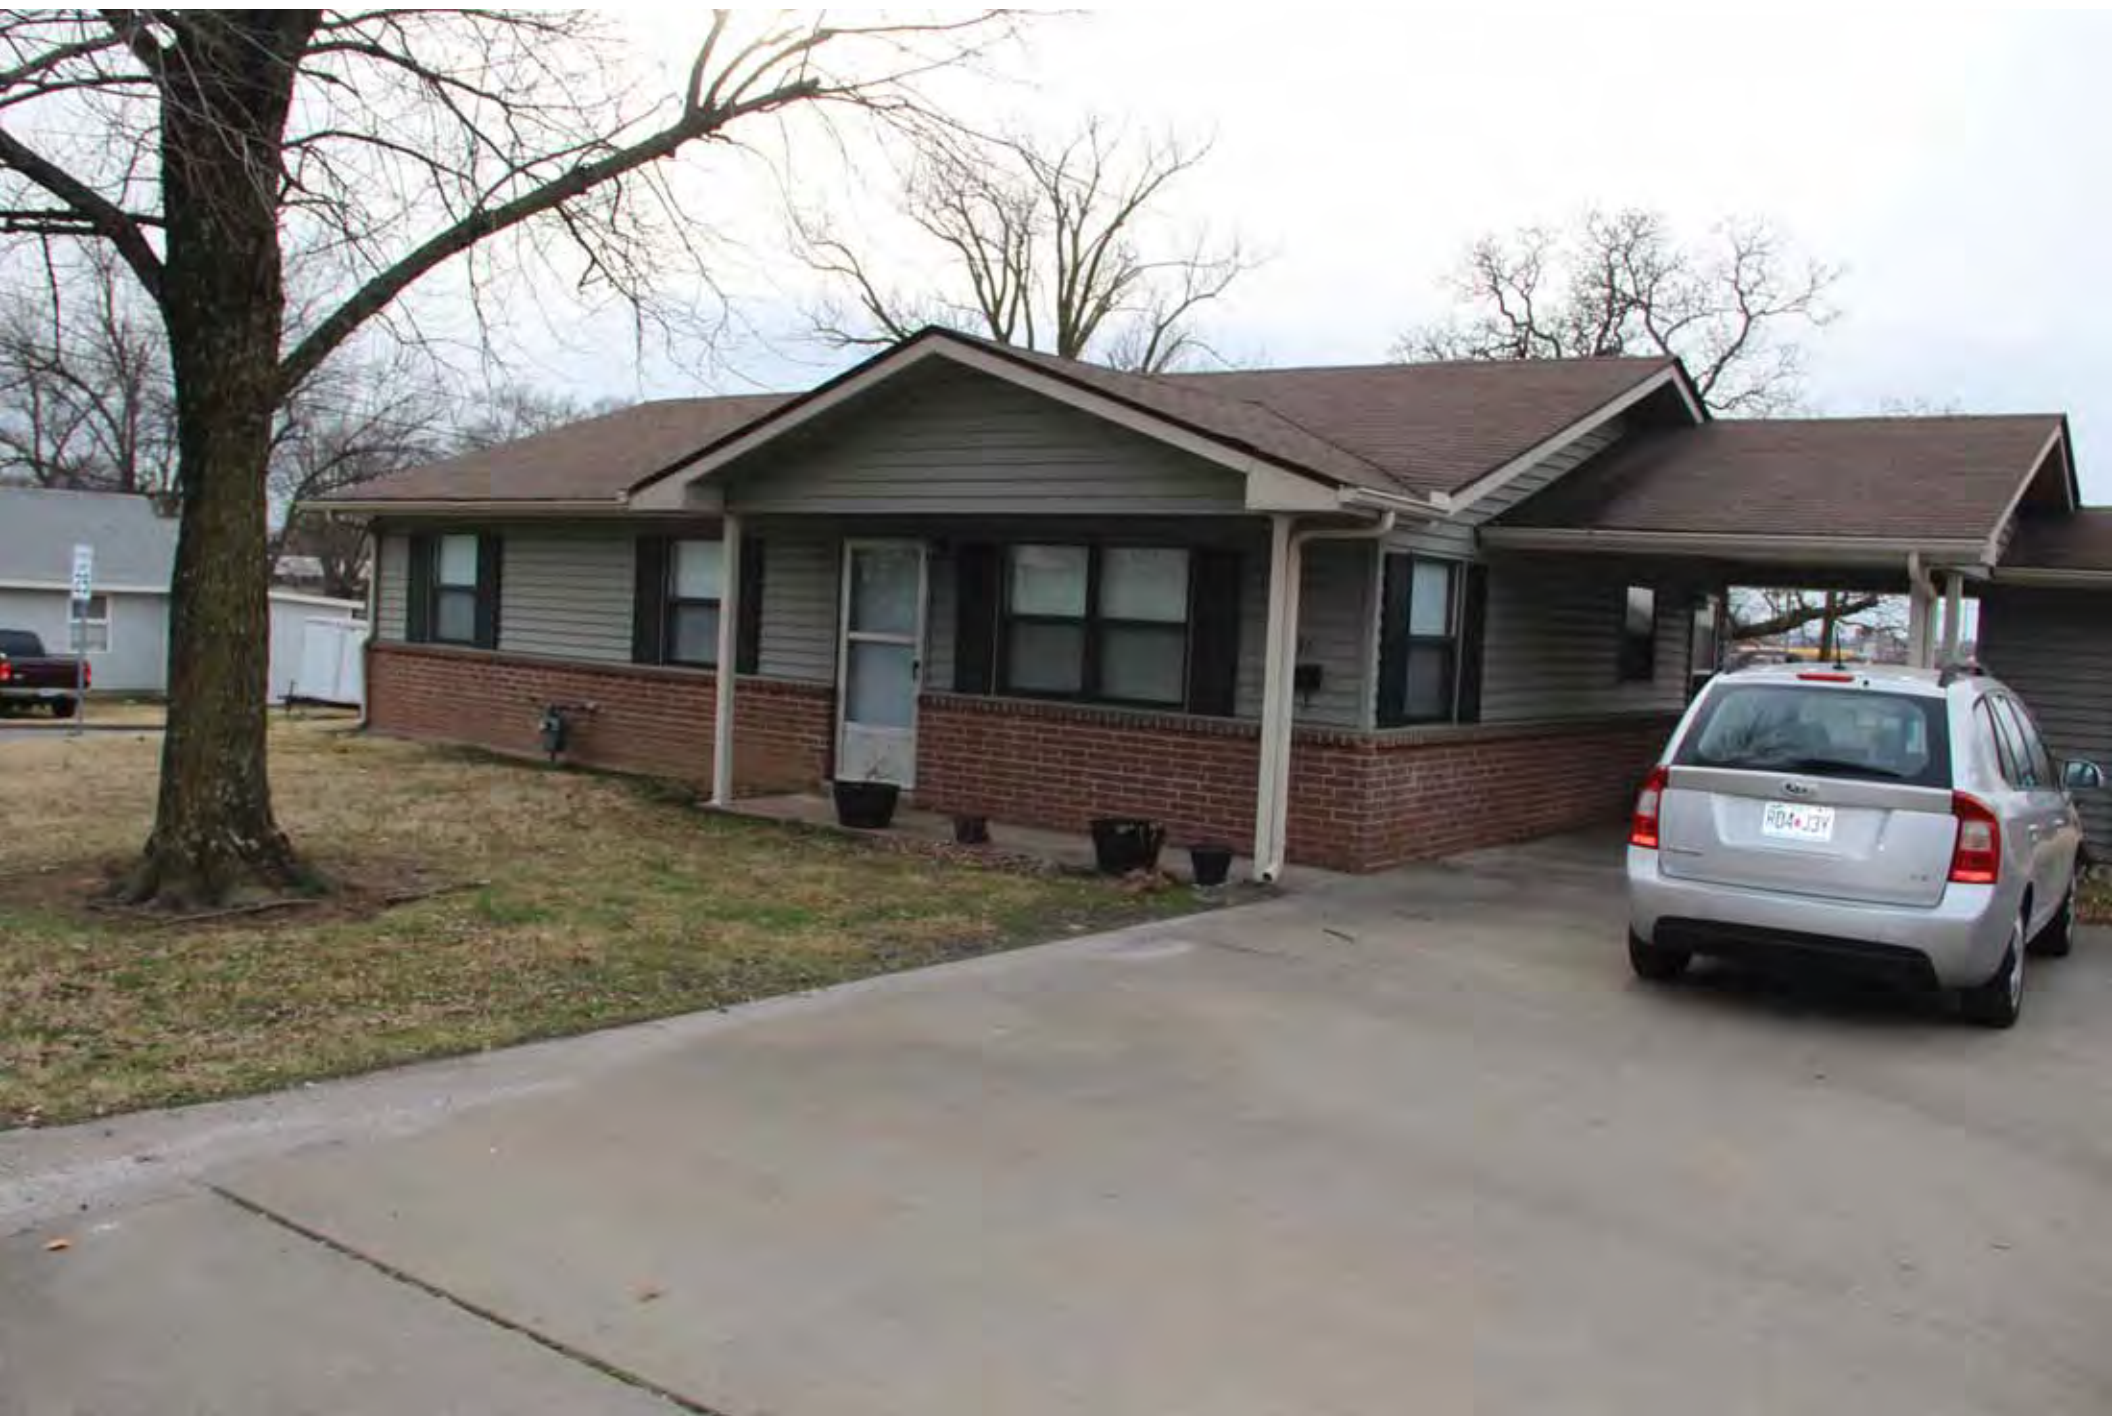
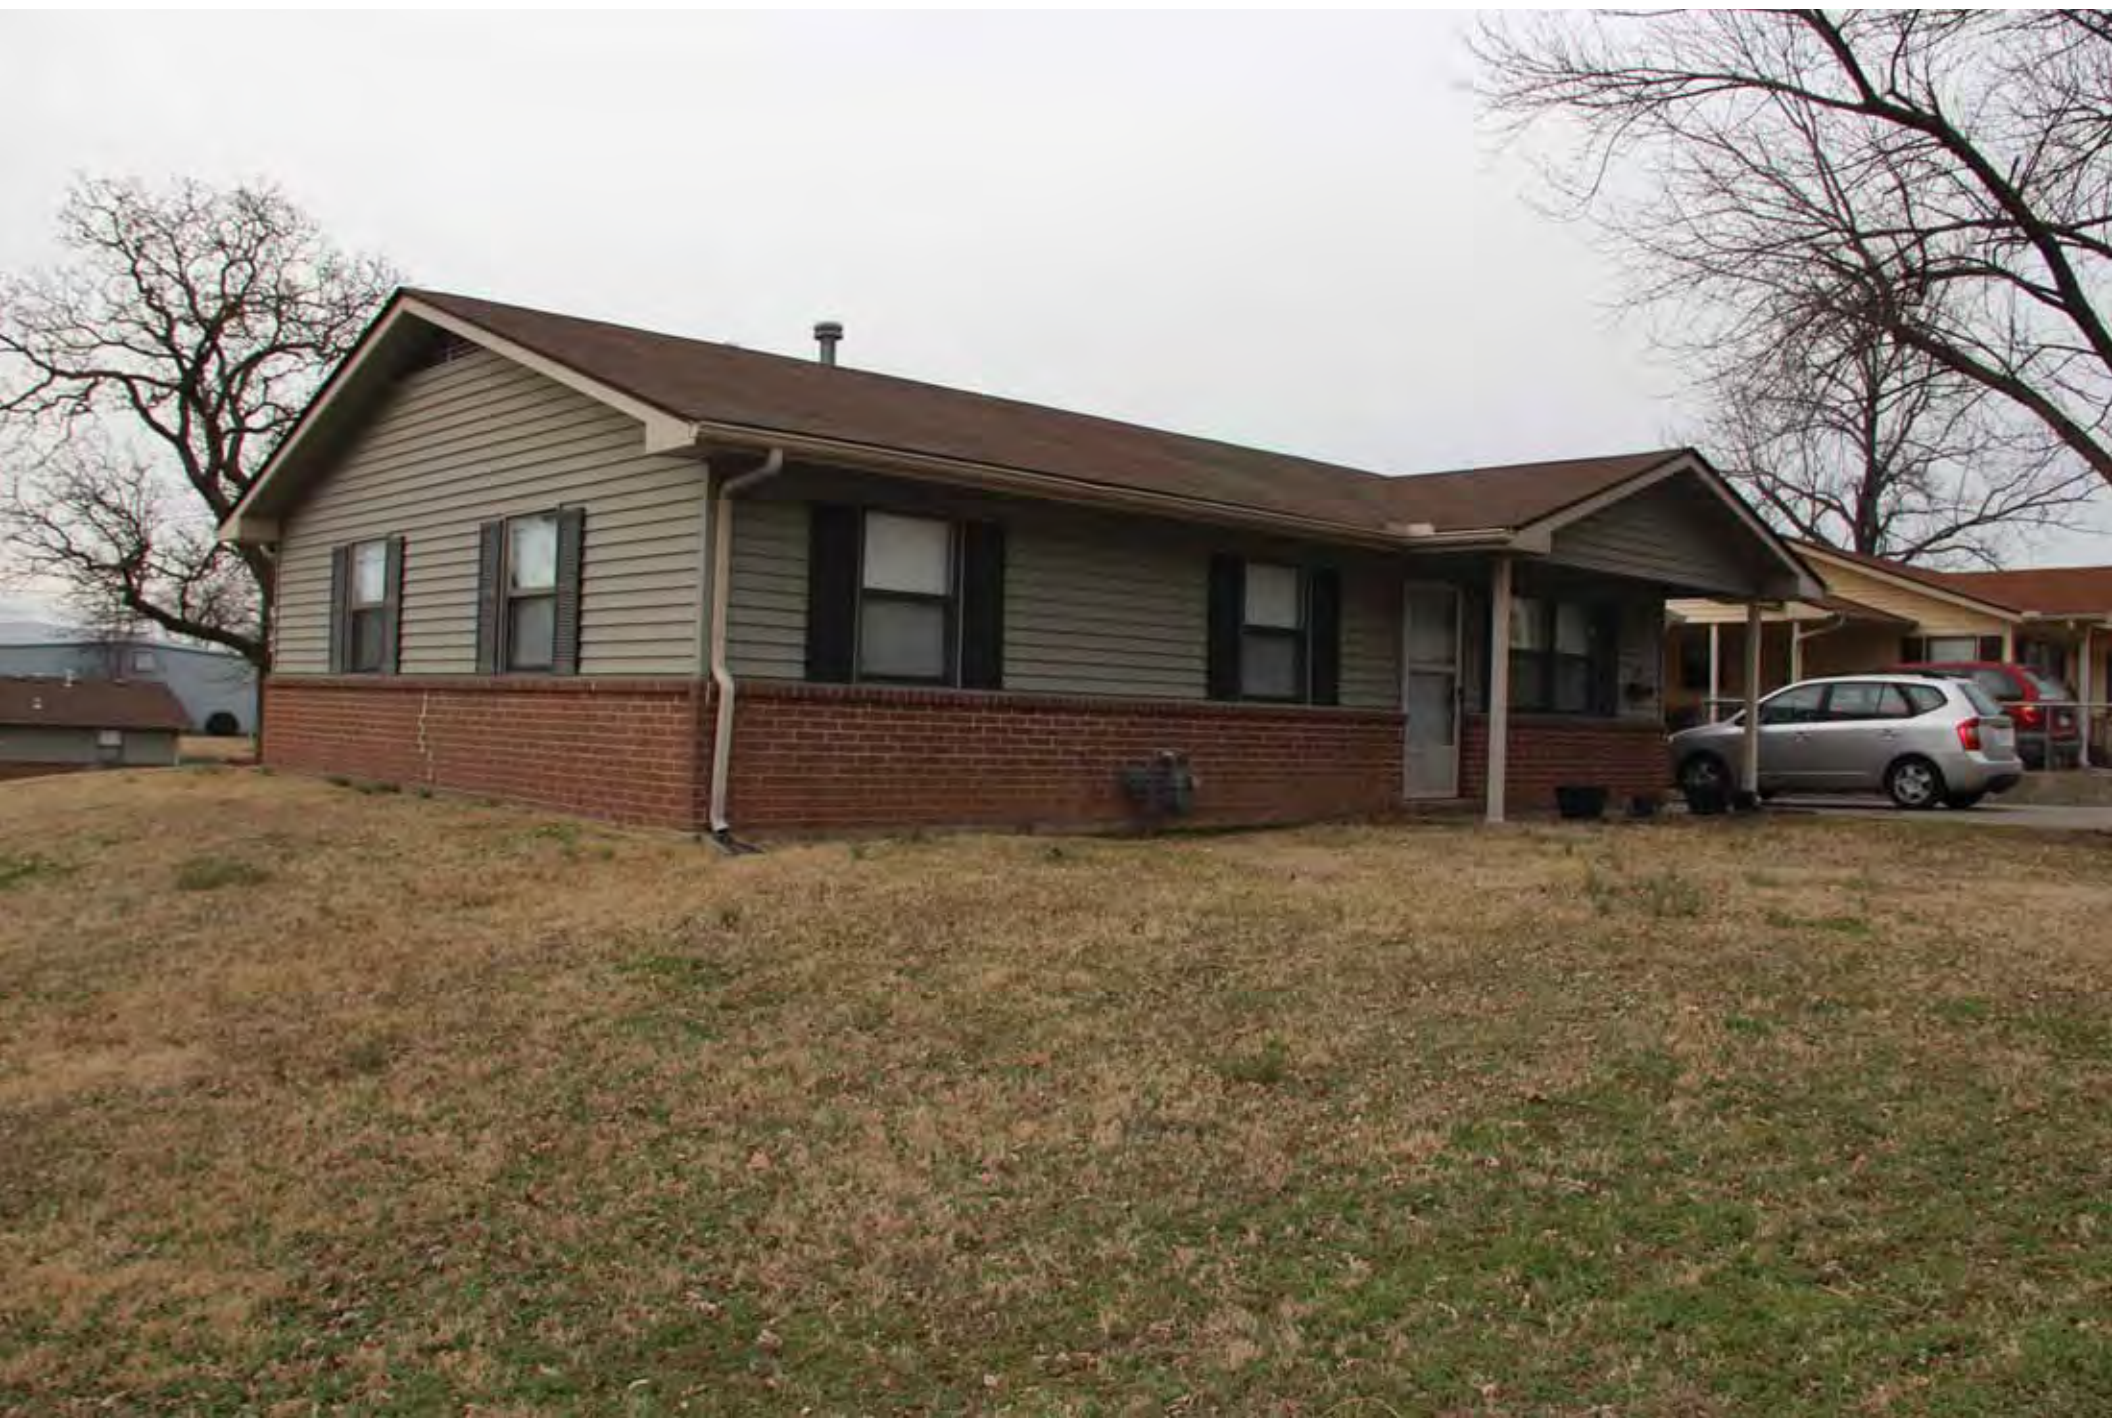
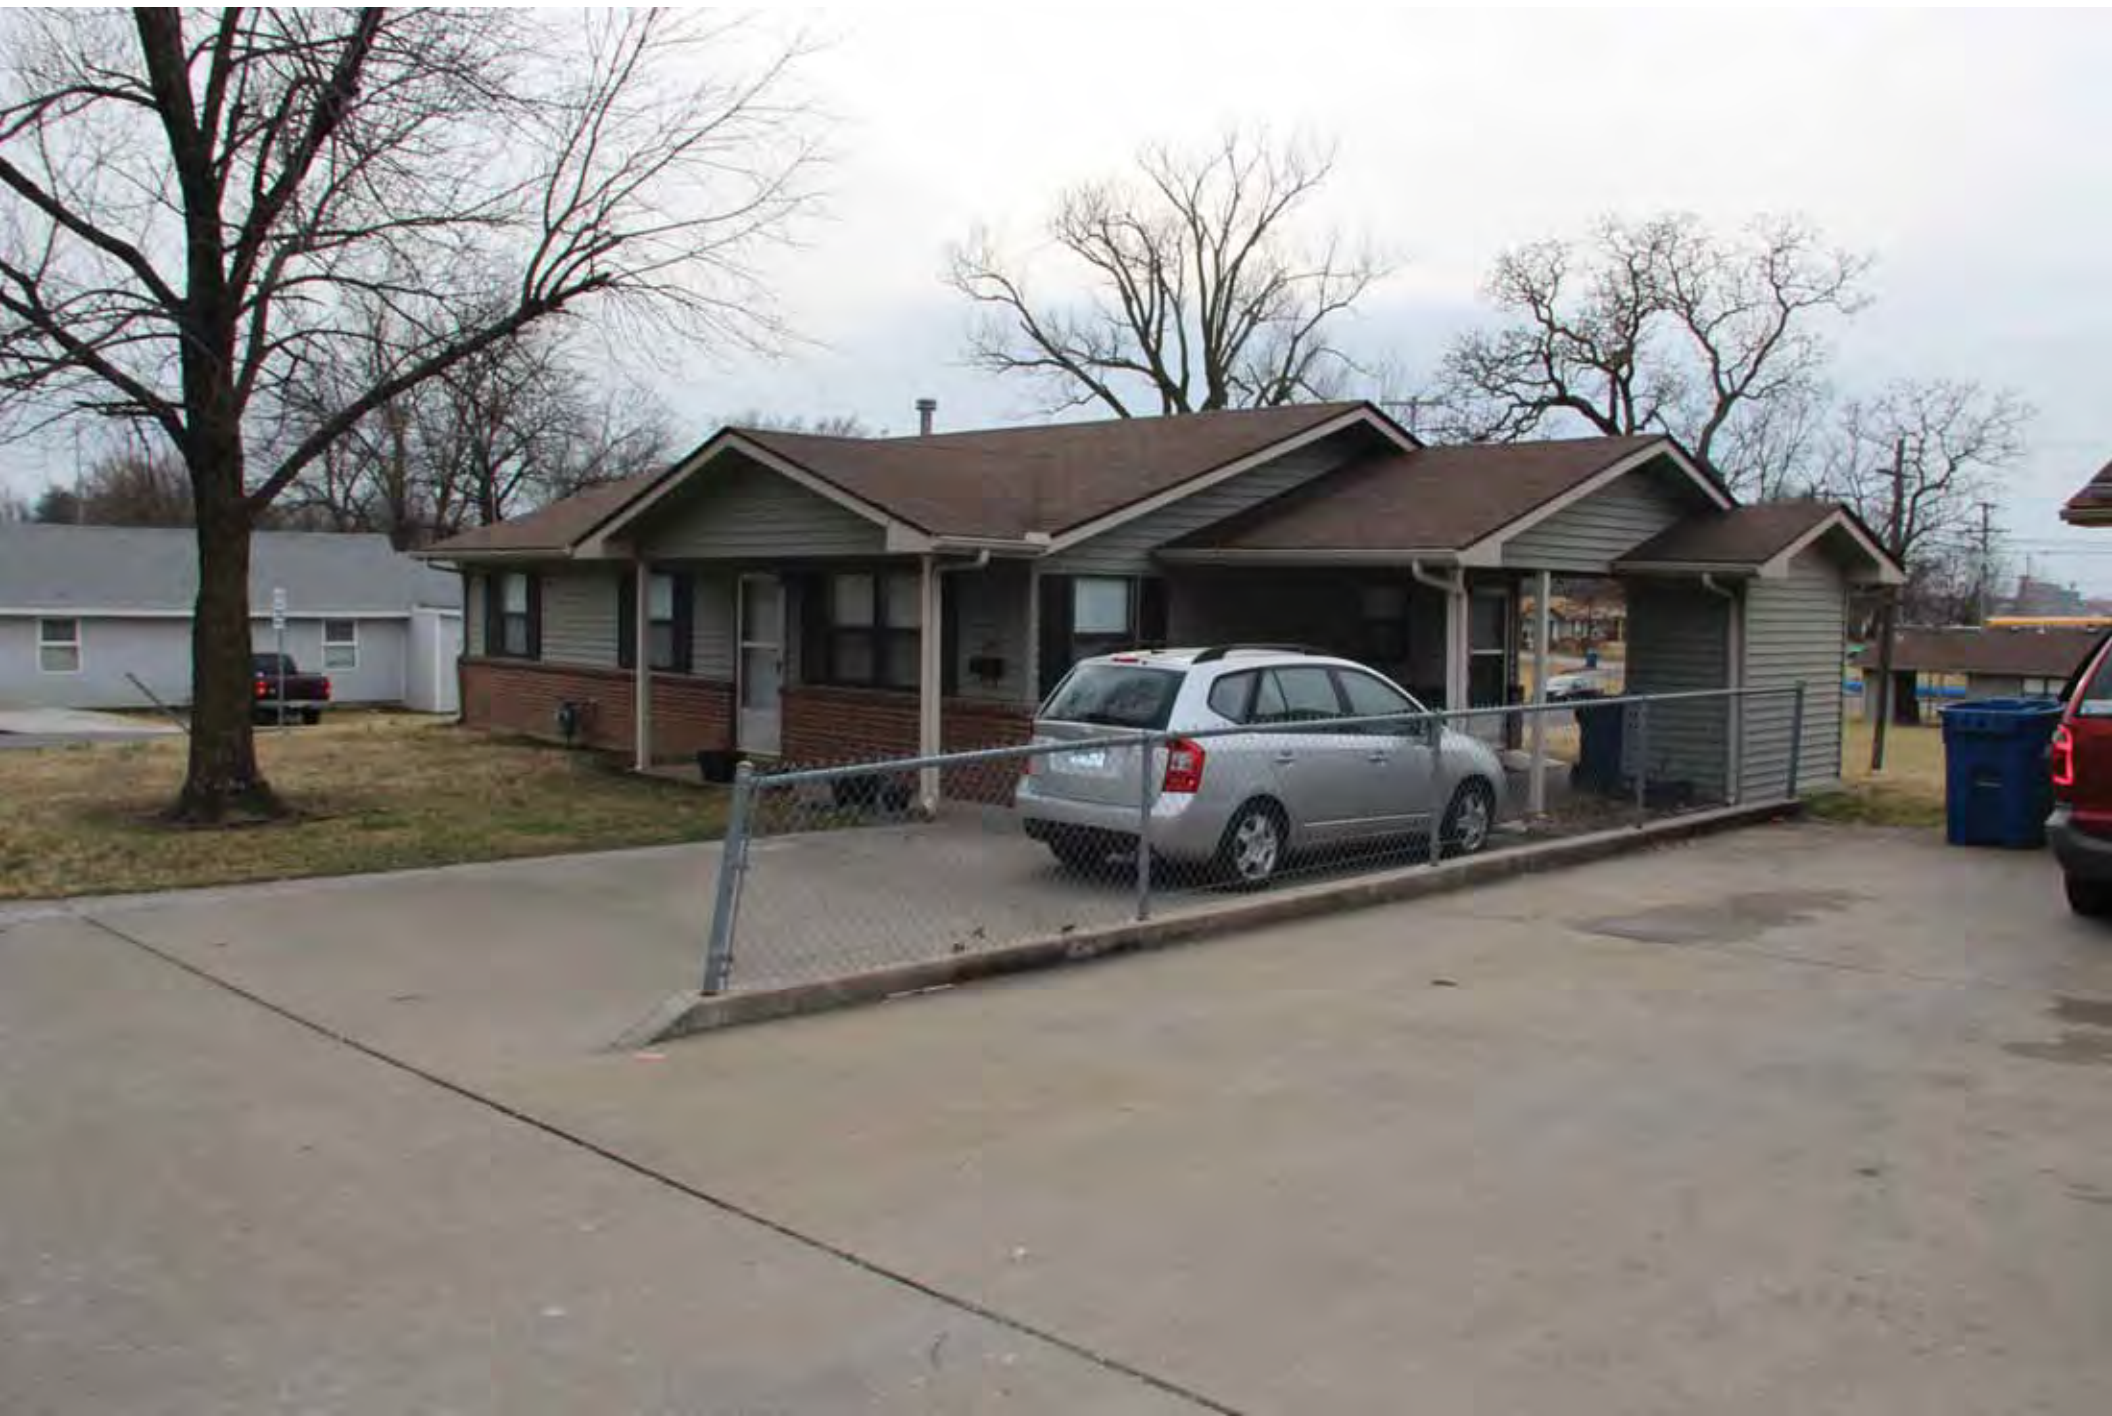
The property at 230 S. St. Louis Avenue features a single-story dwelling with an asphalt-shingled gabled roof, exterior vinyl siding and a concrete foundation. The lower elevations (below windows) are clad with brick veneer capped by a band of continuous brick headers. Windows are one-over-one with faux shutters. On the façade (east elevation) is a small gabled porch near the north end of the elevation. The porch is supported by two columns resting on a concrete pad. Within the porch bay is a single solid door flanked by paired windows (north) and a single window (south). The remaining elevation supports two single windows. The south elevation holds two windows. At the north elevation is a gabled carport, which extends above the concrete drive. The north elevation of the dwelling holds a secondary entry below the carport roof. The entry is offset on the east by a single window. The north end of the carport roof attaches to a small utility shed clad with vinyl siding.

This dwelling is less than 50 years of age and does not exhibit exceptional architectural and/or historical significance. The dwelling is not situated in an area recommended as a historic district. For these reasons, the property does not appear individually eligible for the National Register of Historic Places.

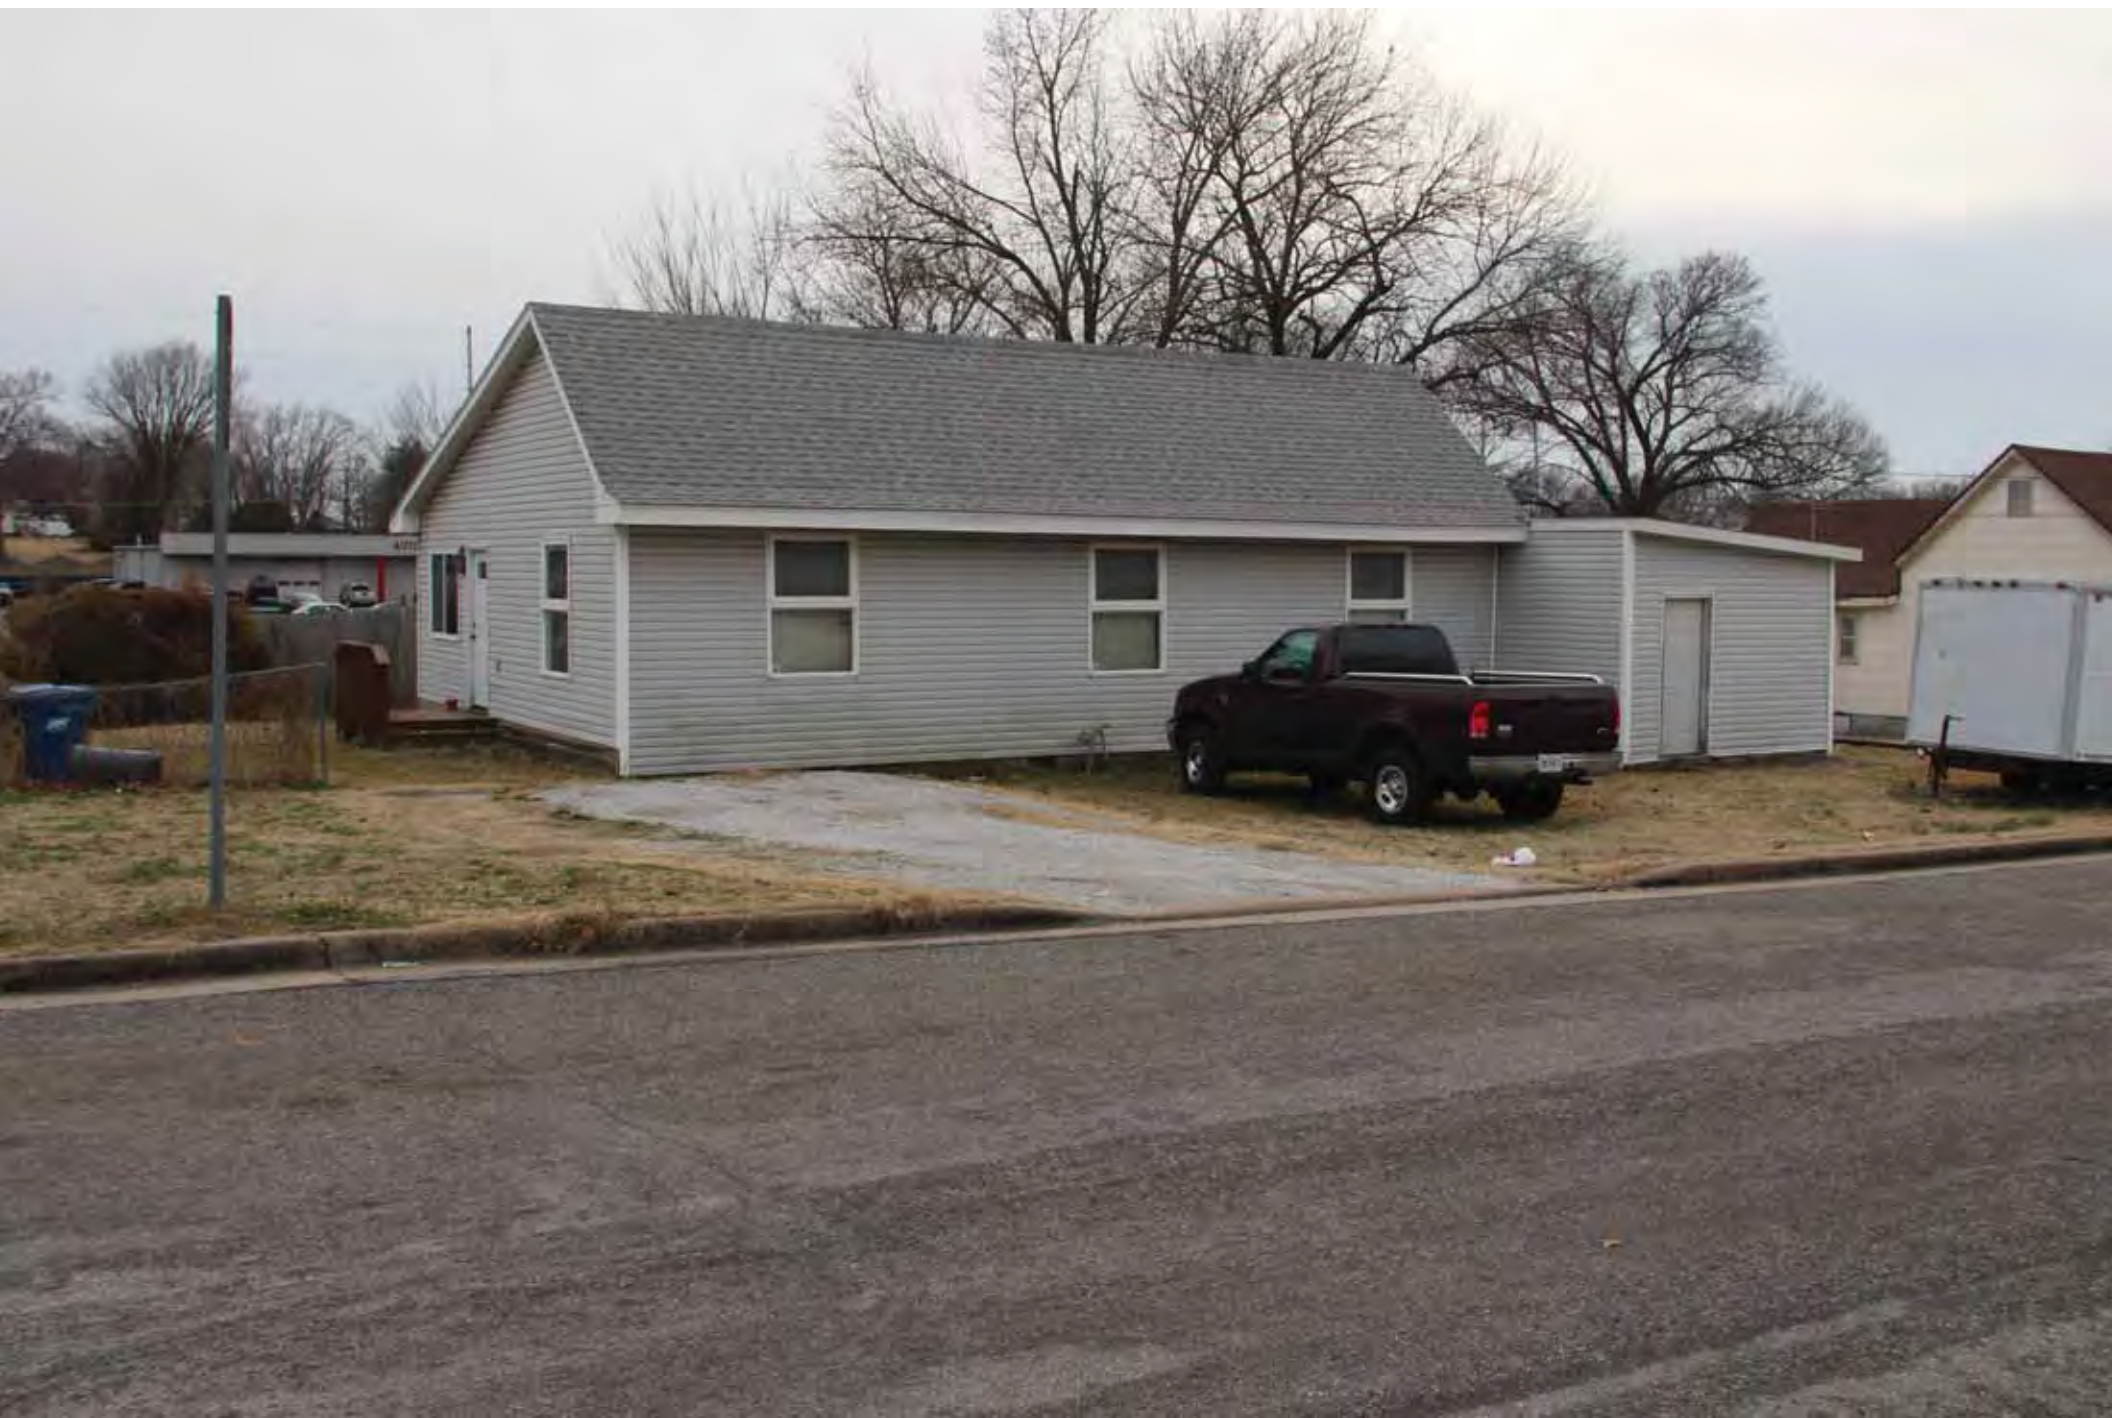
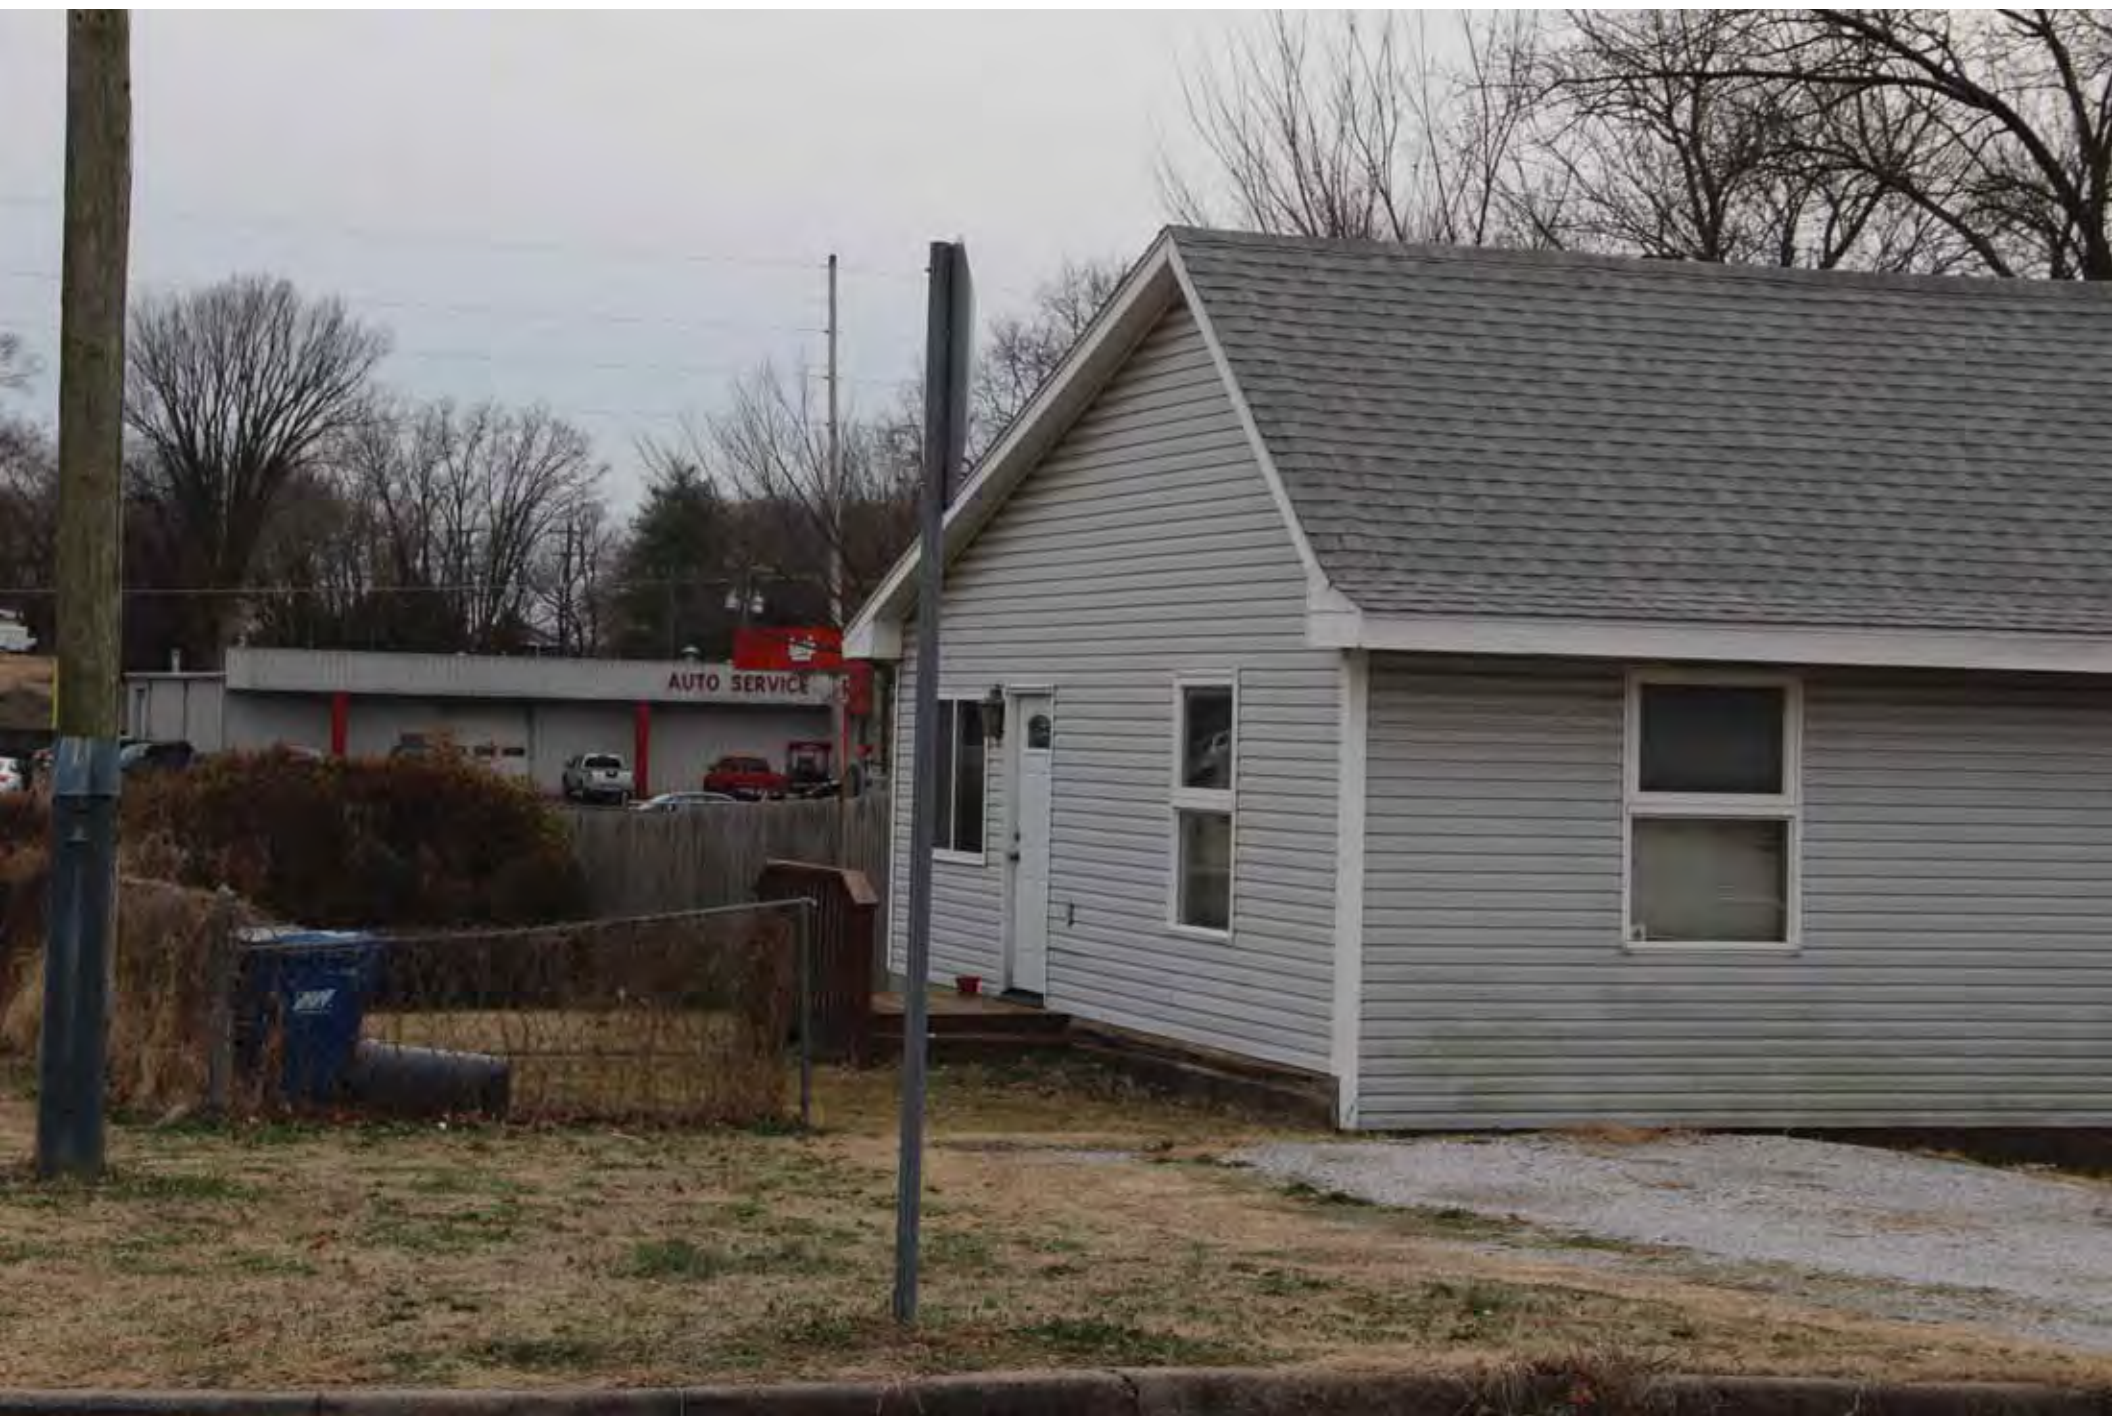
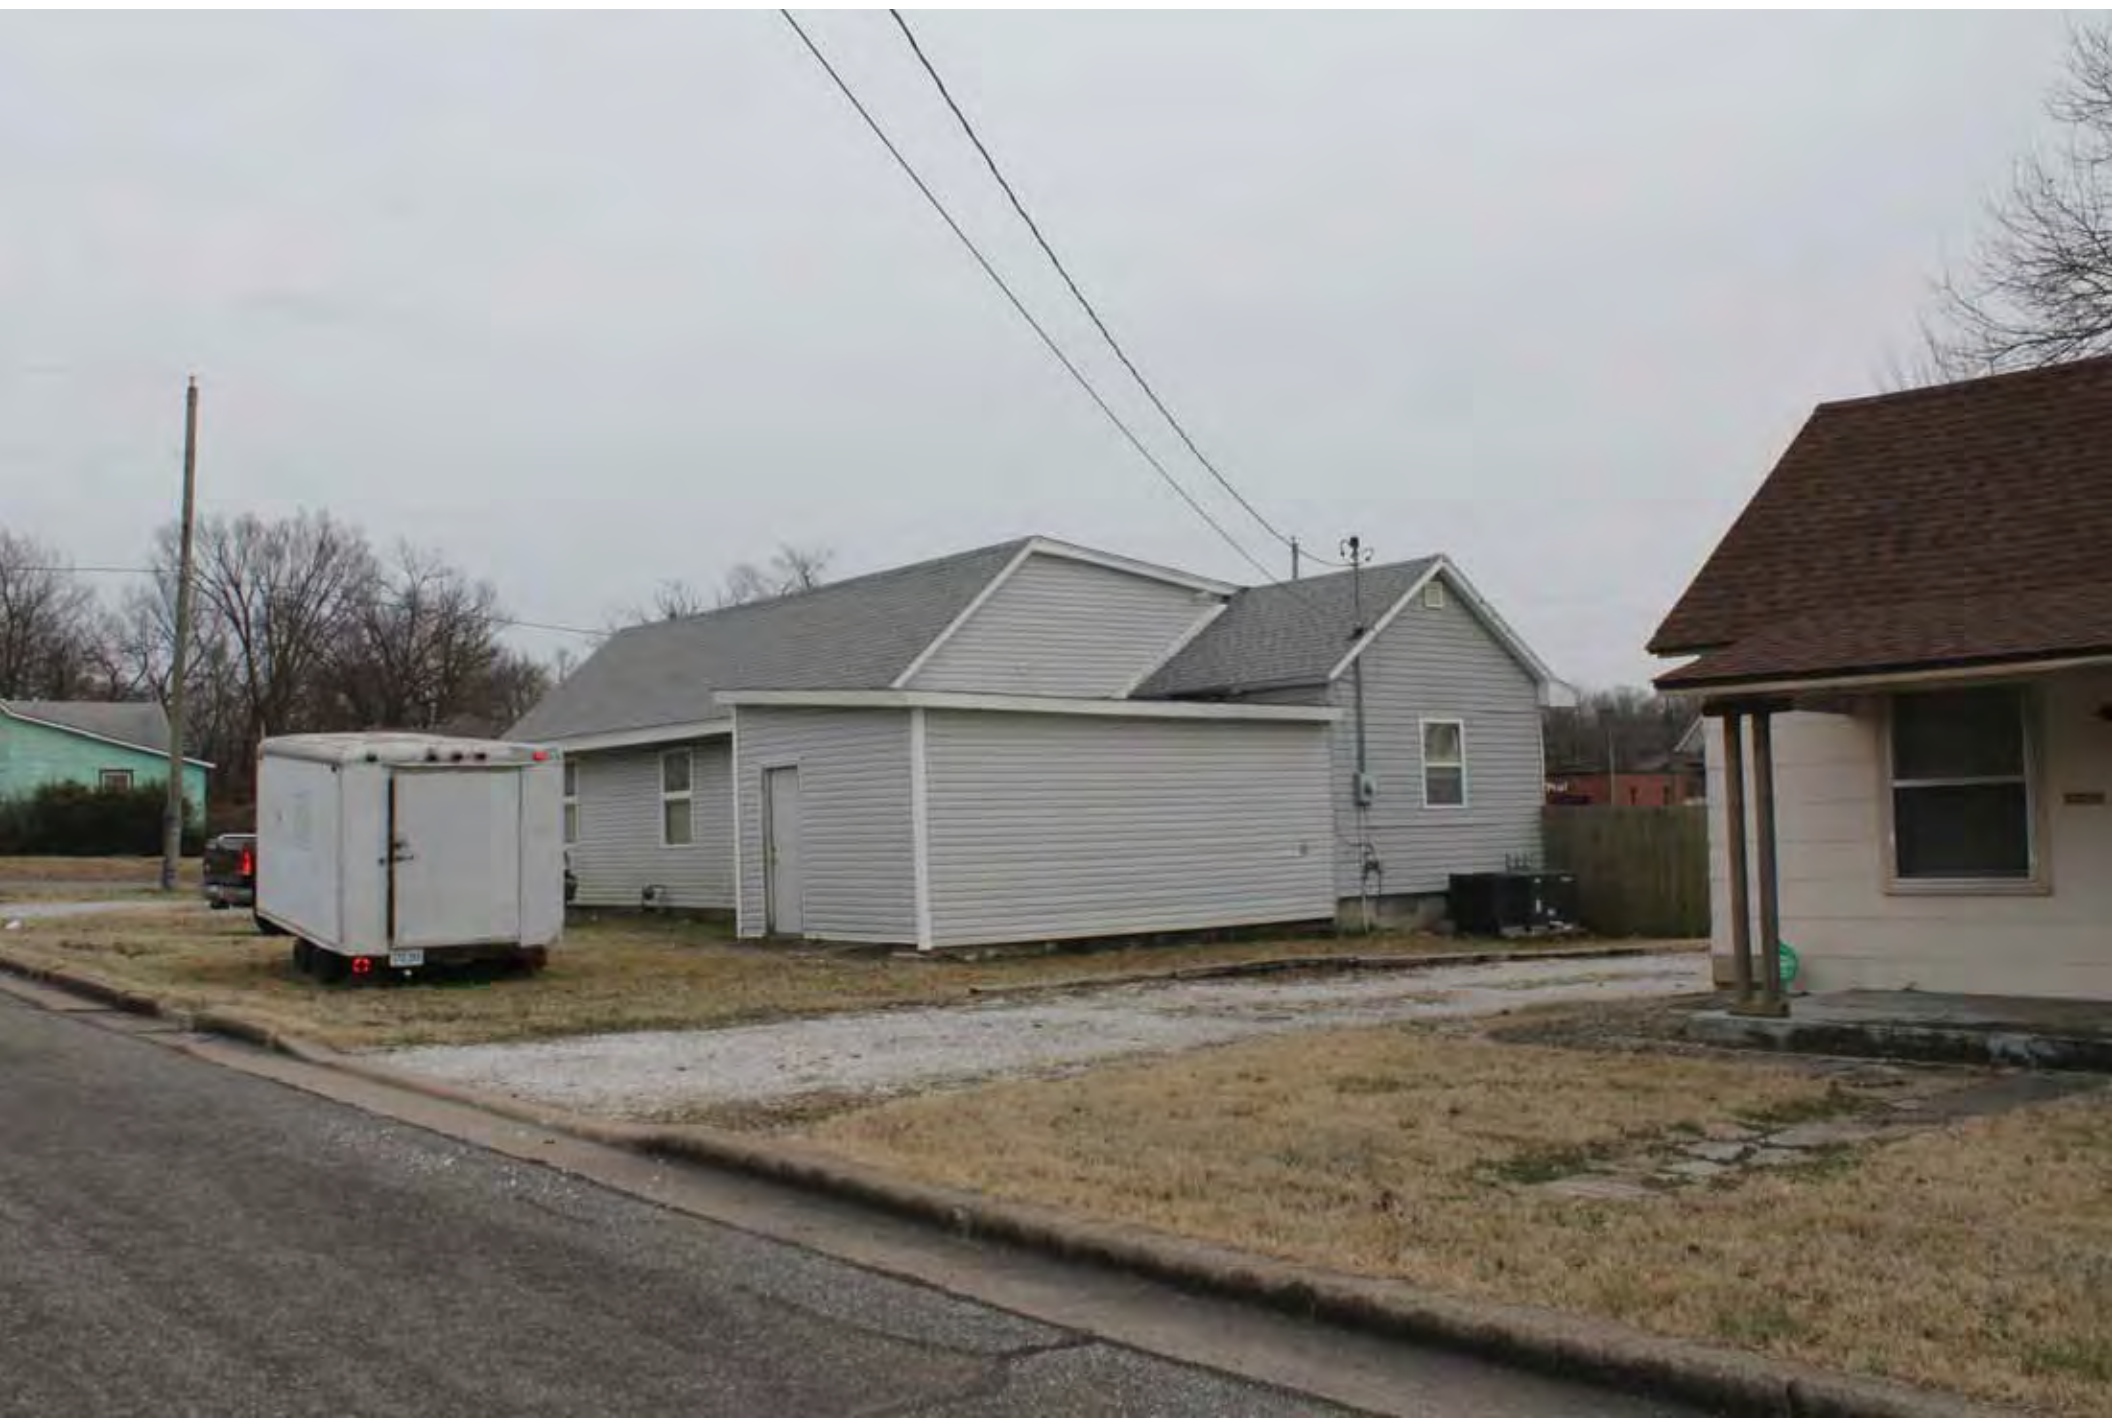
This dwelling has been extensively altered with c. 2019 siding, windows and doors. These alterations compromise the building's architectural integrity. The dwelling is not situated in an area recommended as a historic district. For these reasons, the property does not appear eligible for the National Register of Historic Places.

The property at 302 S. St. Louis Avenue features a single-story dwelling with an asphalt-shingled gabled roof, exterior vinyl siding and a concrete foundation. The façade (east elevation) supports a frame stoop leading to an off-center contemporary door flanked by a two-light sliding window (south) and one-over-one window (north). The north elevation holds three one-over-one windows. At the west end of the house is an attached shed wing. This wing projects north and holds a paneled pedestrian door on the north elevation. A rear gabled wing at the southwest corner of the dwelling holds a single window (west elevation). Alterations appear to date to c. 2019 and include new siding, windows, doors and additions.

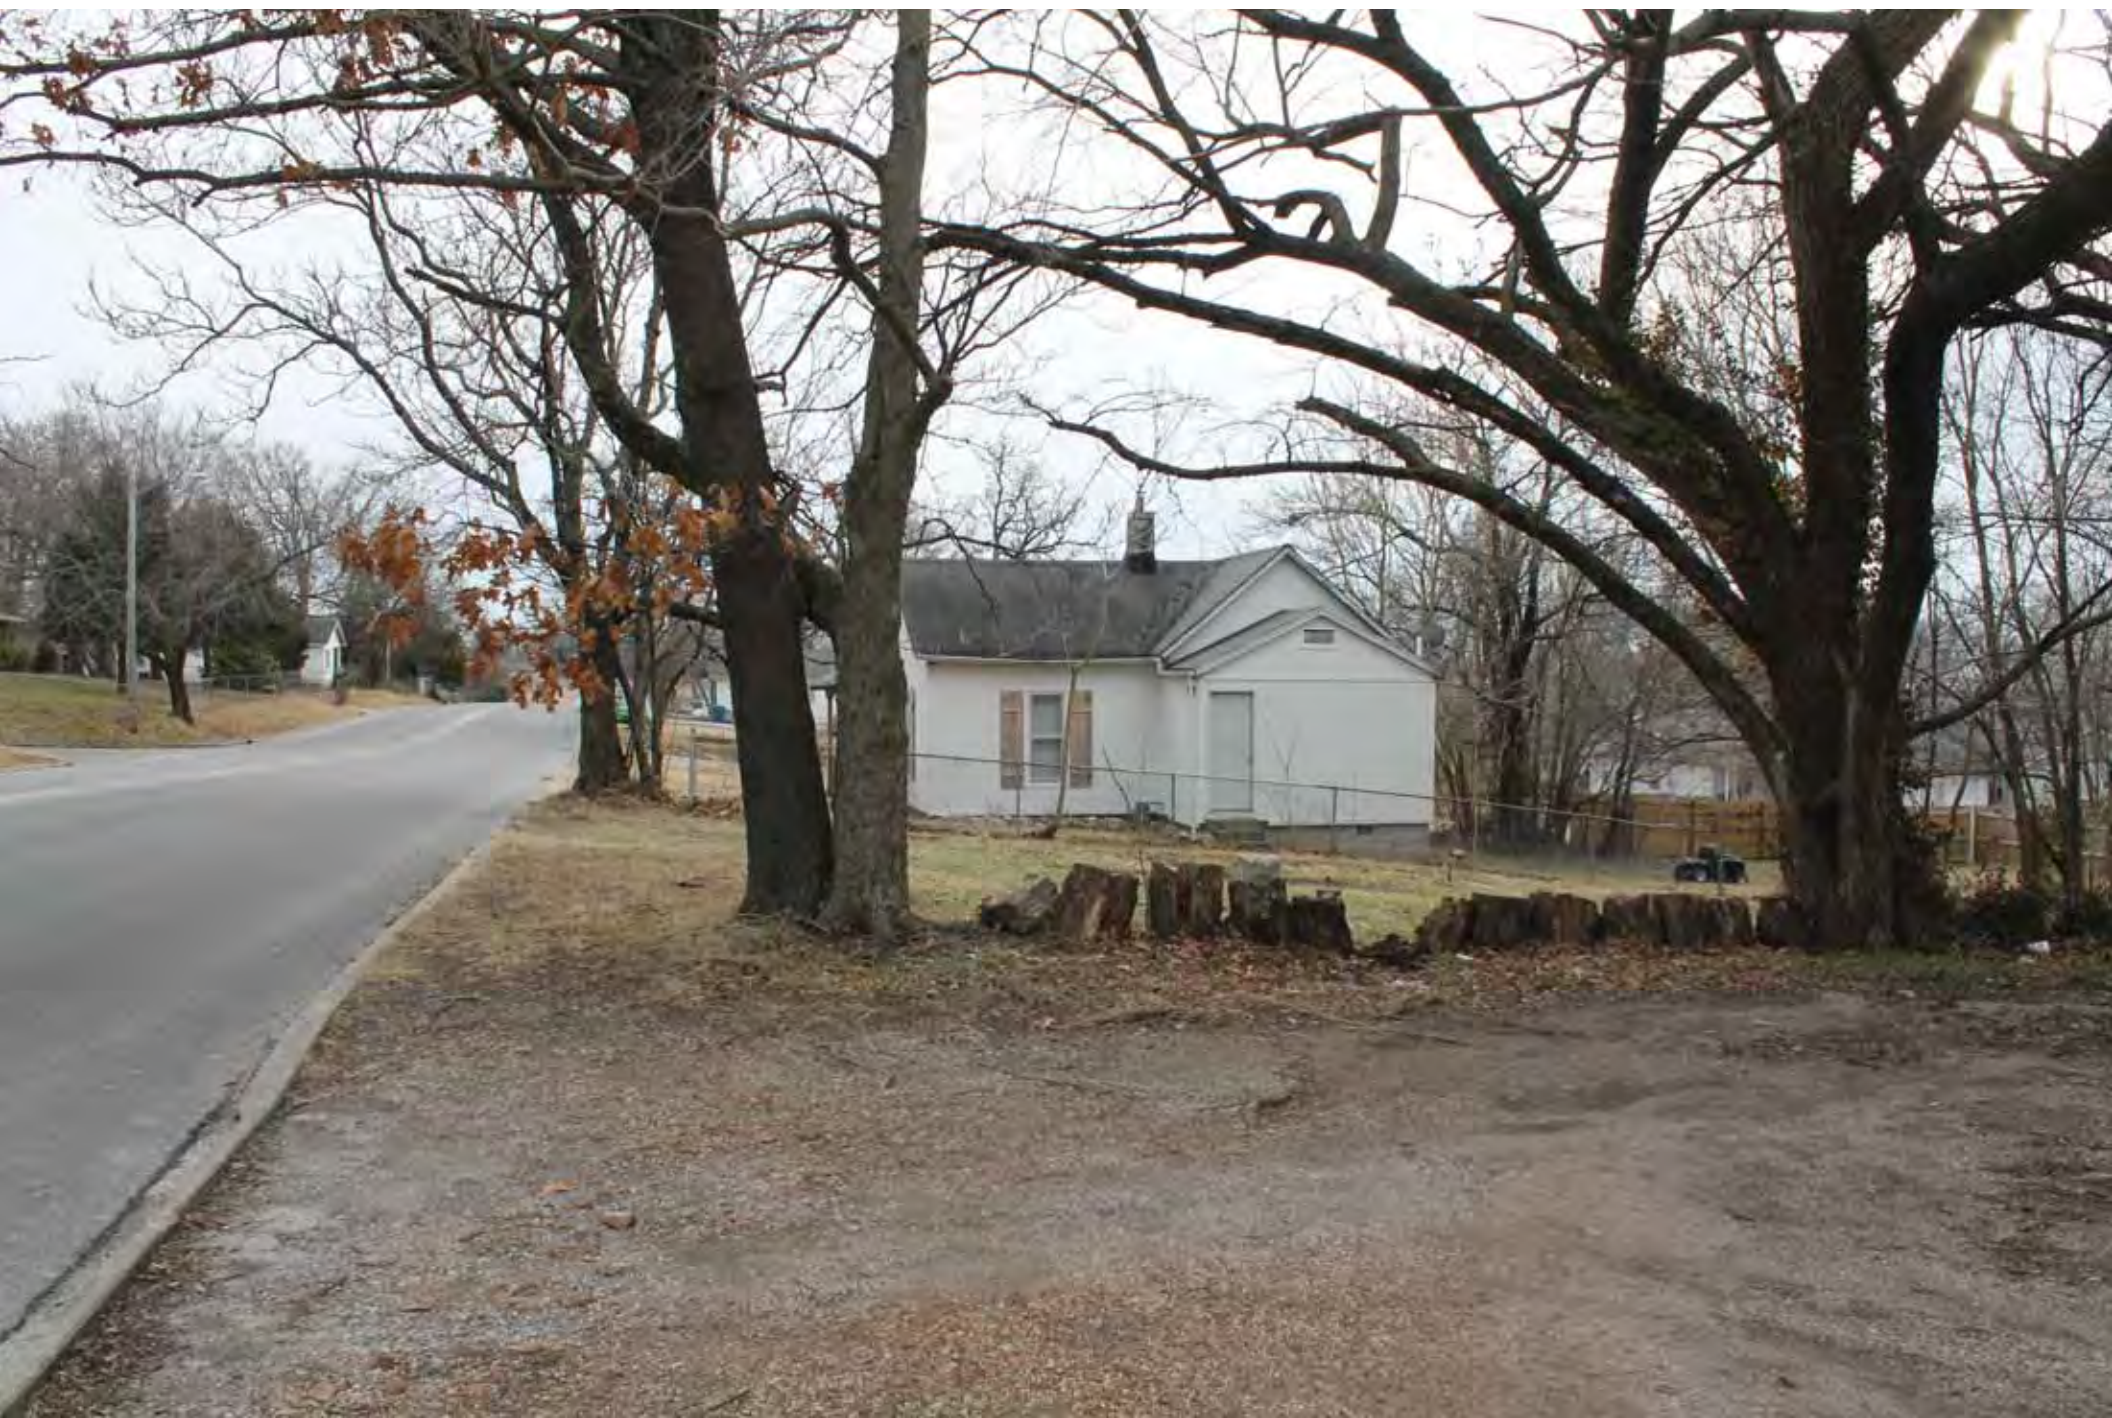
The lot situated north of 126 S. St. Louis Avenue is a vacant parcel as described above.
