MISSOURI DEPARTMENT OF NATURAL RESOURCES
STATE HISTORIC PRESERVATION OFFICE, P.O. Box 176, Jefferson City, MO 65102
ARCHITECTURAL/HISTORIC INVENTORY FORM

1. Survey No. JP-AS-007-001		2. Survey name: East Town (Original Joplin) Historic Survey Phase 2	
3. County: JASPER		4. Address (Street No.) 618	Street (name) E. 2 nd Street
5. City: Joplin	Vicinity: <input type="checkbox"/>	6. Geographical Reference:	7. Township/Range/Section: T: R: S:
8. Historic name (if known):		9. Present/other name (if known):	
10. Ownership: <input checked="" type="checkbox"/> Private <input type="checkbox"/> Public		11a. Historic use (if known): Domestic: Single Dwelling	11b. Current use: Domestic: Single Dwelling

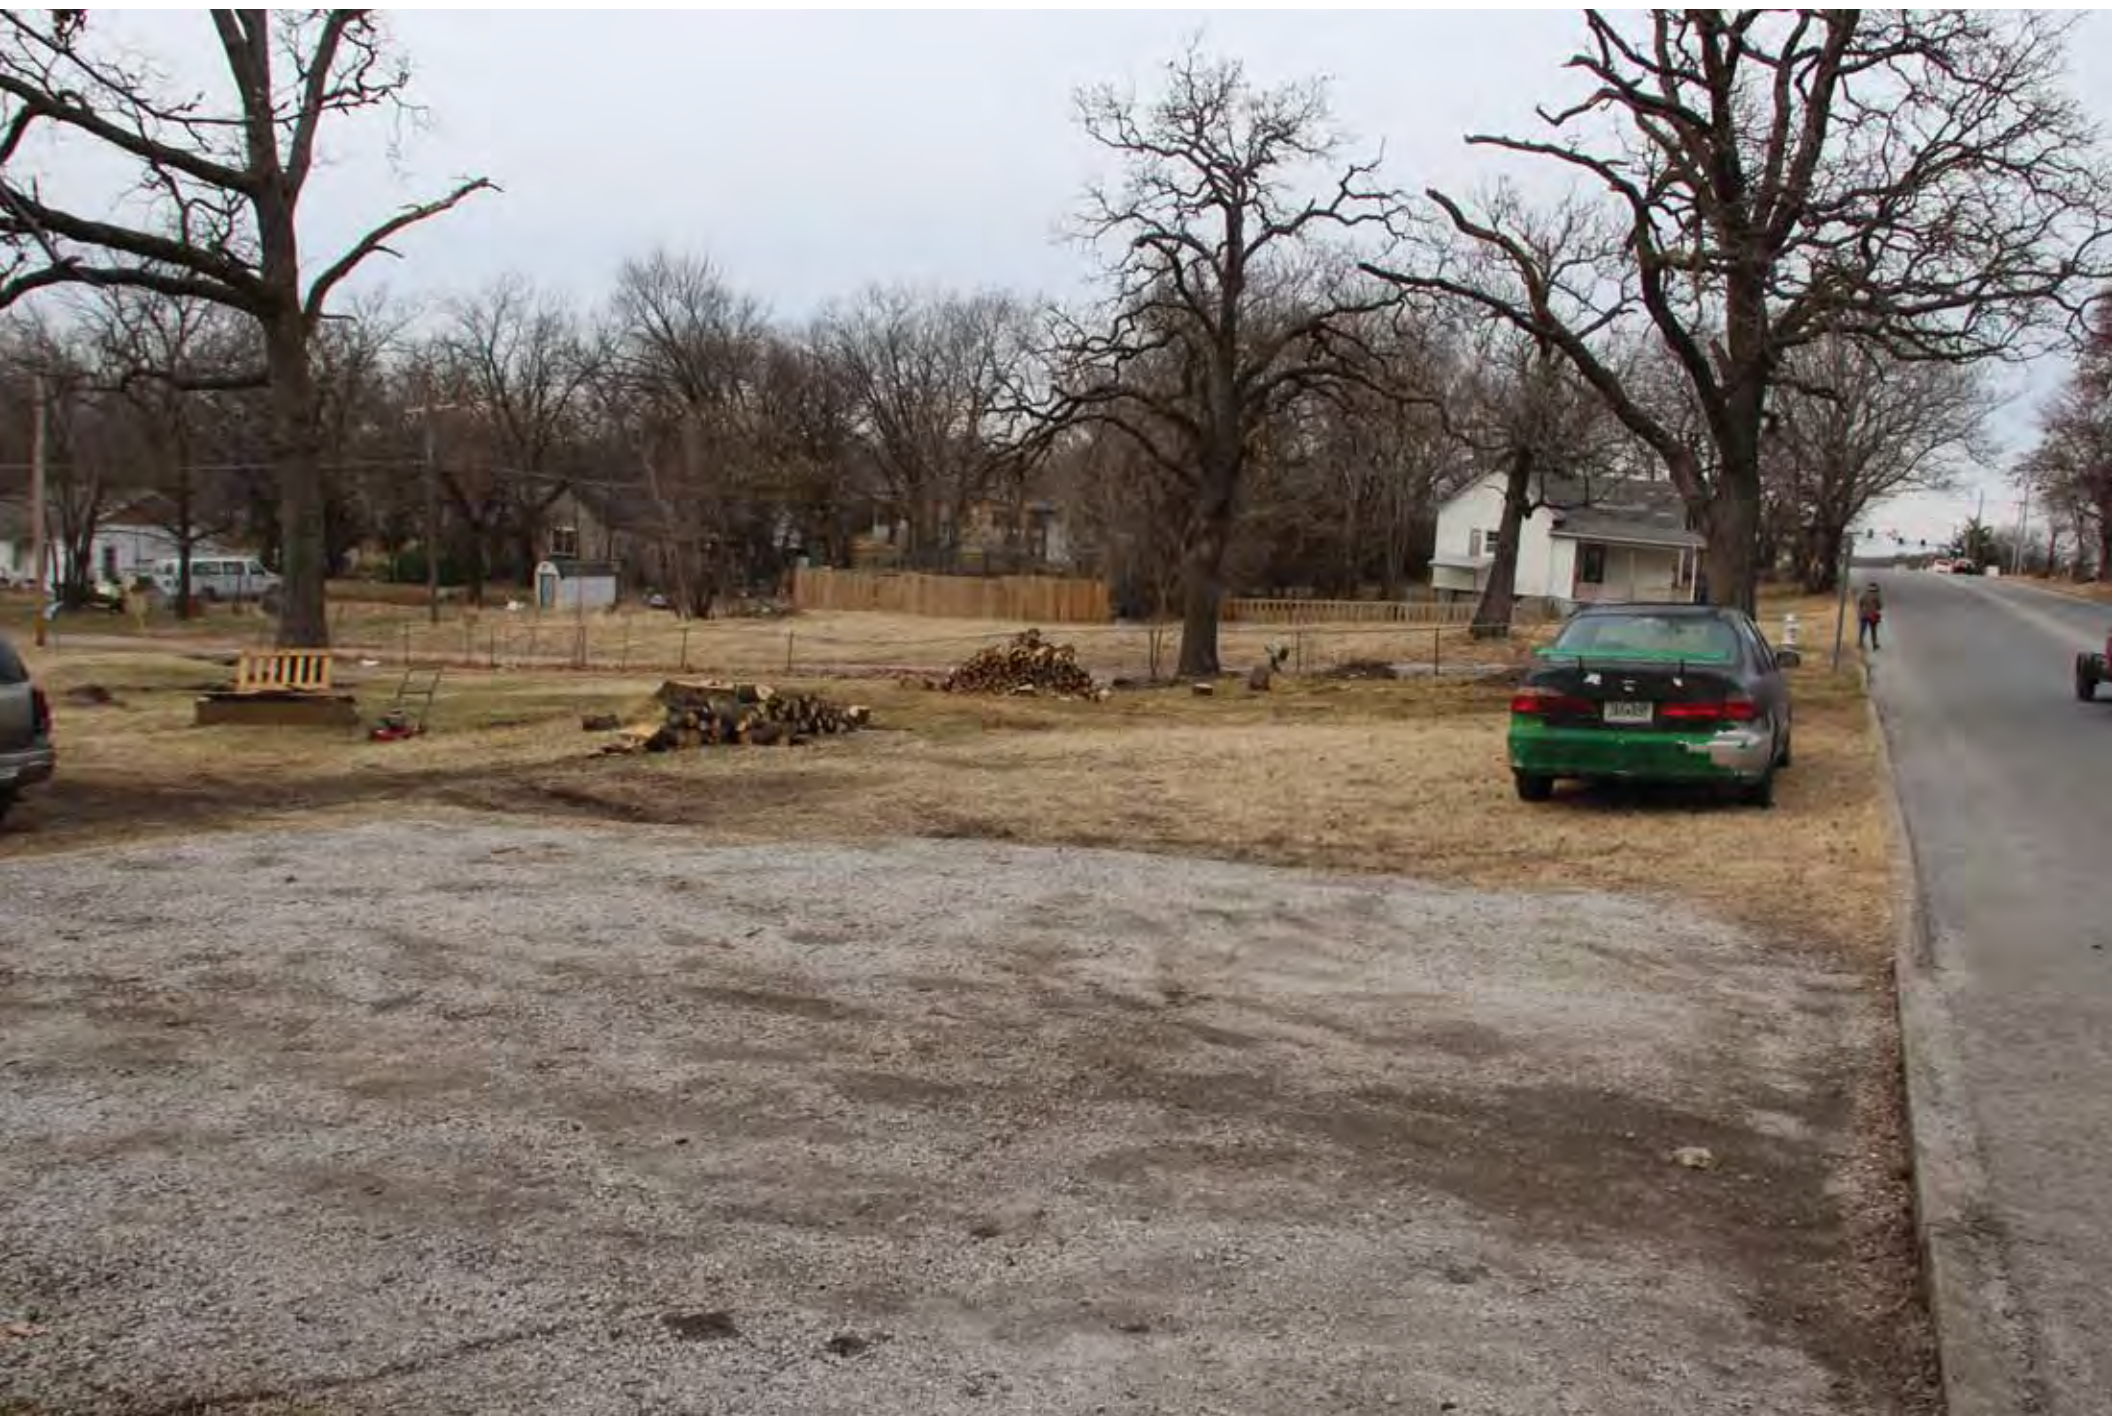
The property north of 206 S. St. Louis Avenue is a vacant grass and gravel covered lot, as described above.
