MISSOURI DEPARTMENT OF NATURAL RESOURCES
STATE HISTORIC PRESERVATION OFFICE, P.O. Box 176, Jefferson City, MO 65102
ARCHITECTURAL/HISTORIC INVENTORY FORM

1. SURVEY NO. FR-AS-007-0104		2. SURVEY NAME: International Shoe Factory Neighborhood	
3. COUNTY: Franklin		4. ADDRESS (STREET NO.) 301	STREET (NAME) High Street

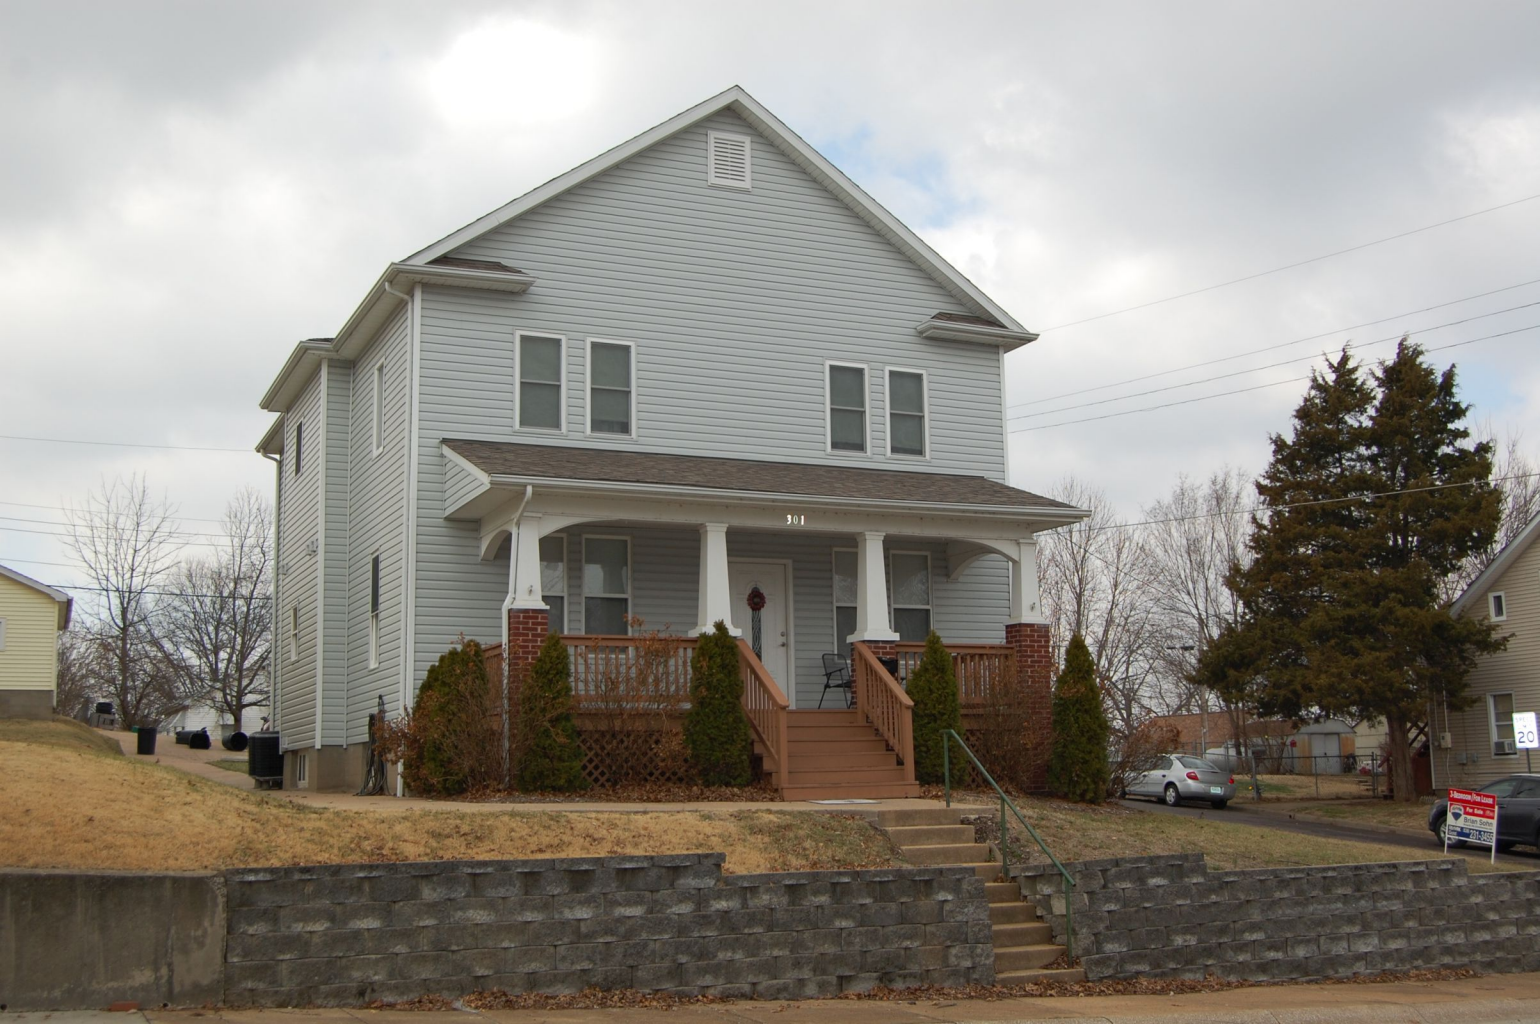
301

41 cont: and adding two, large central tapered columns were added to the front porch. Due to the heavy alterations (2nd floor addition, replacement vinyl siding and especially the removal of full bungalow elements (brackets in eaves, windows), the house is not a contributing resource to a potential NR district.

The 2 story frame dwelling has a concrete parged foundation, vinyl siding, and an asphalt shingle, front gable roof with gable ends that slightly return inward. The front façade is 3 bays wide. There is a ¾ width, 1-story frame porch centered on the façade. The porch has a dropped asphalt shingle shed roof, 2 small and 2 large tapered wood columns resting on brick piers, an open square wood baluster railing, and a wood deck with centered wood staircase. Sheltered within the porch is a slightly offset right single entry, consisting of a thin faux leaded arched glass light and paneled replacement door. On either side of the door are two 1/1 windows that were formerly paired in a flat wood surround but are now separated by vinyl siding. The 1st floor window fenestration locations carry to the 2nd story. Windows are 1/1 double hung vinyl sash. There is a rectangular vent in the upper story gable peak. On the W elevation is a centered 1 story frame extended bay on the 1st and a 2nd story wood deck with stairs running parallel to the home. Major alterations to the home took place in June 2013 (Google streetview) which altered the former 1.5 story side gable asphalt shingle roof by adding a second story. (Former features: brackets in all the eaves and a centered gable dormer along with a gable dormer though the roofline on the W elevation that had a 1-story frame addition and 2nd story deck). Post 1992 survey alterations include: removing bungalow features (roofline, brackets), replacing weatherboard siding with vinyl, replacing the original vertical 4/1 and vertical 3/1 wood sash, (See 40 cont)

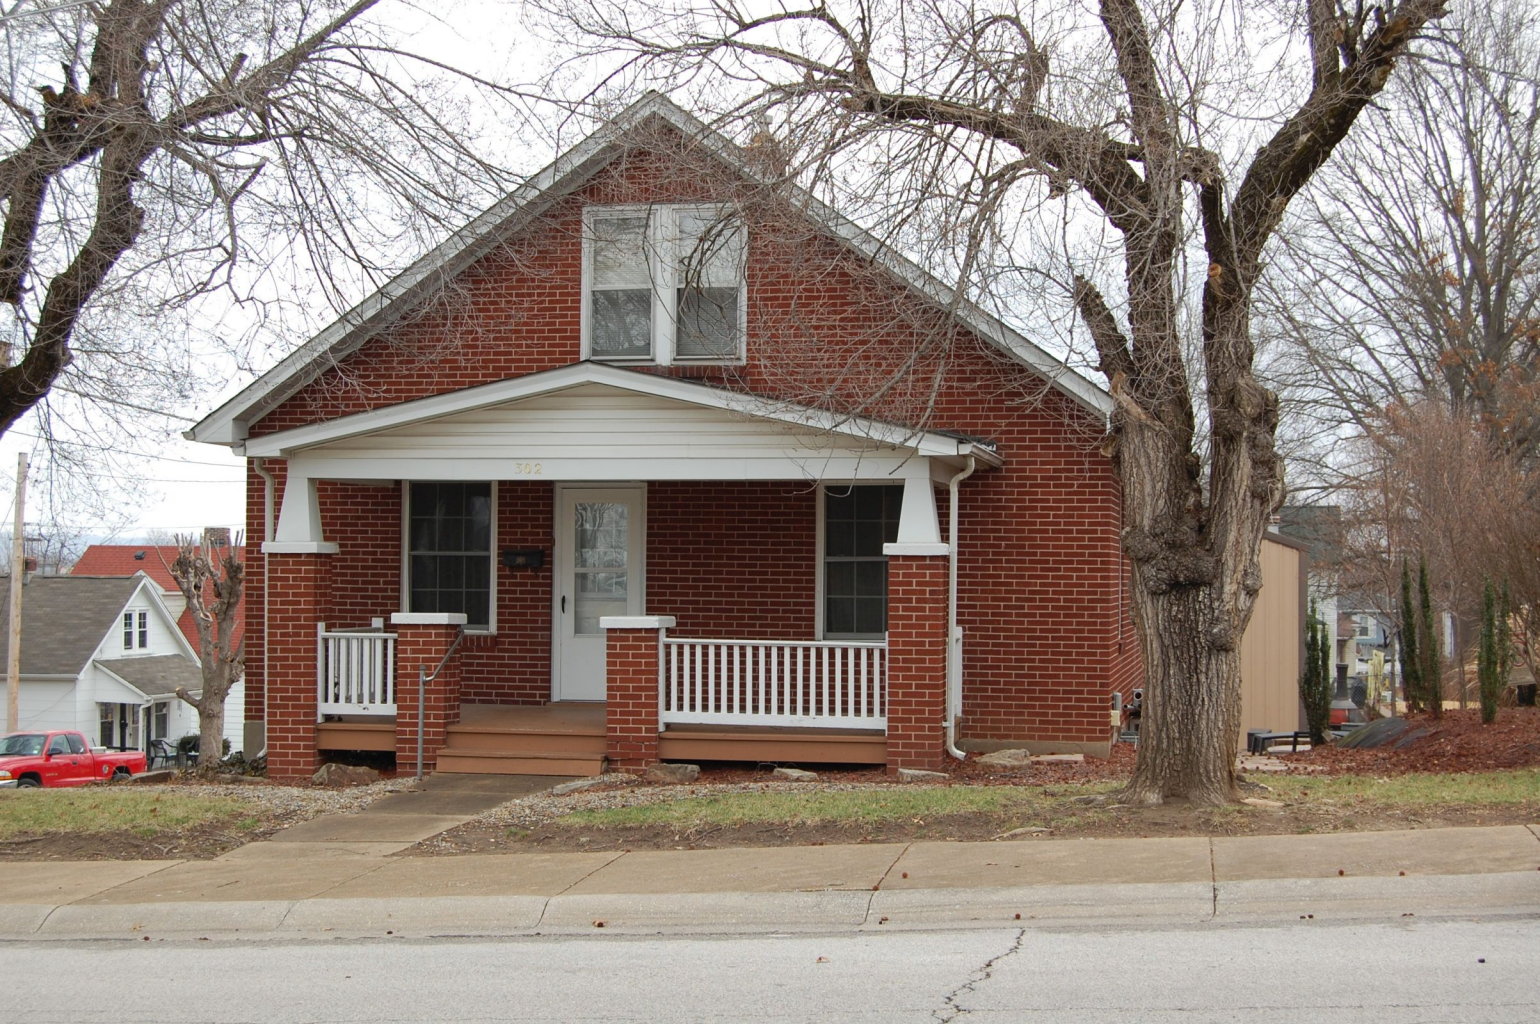
This 1.5 story brick, front gable home has an asphalt shingle roof and a concrete foundation. There is a central, 3/4 width wood platform front porch with an open wood balustrade with square wood balusters between brick piers. The two brick piers at either end of the porch are topped with battered wood columns that support a front gable porch roof. There are three bays beneath the porch roof. All have flat brick soldier course arches; the windows have rowlock brick lug sills. The central bay is the entry and it contains a multi light metal replacement door behind a storm door. On either side of the entry is a window bay containing a 1/1, double hung vinyl replacement window with false muntins that give the appearance of 6/6 lights. Centered on the gable end of the upper half story is a window bay with a brick soldier course arch and rowlock lug sill containing a pair of 1/1, double hung replacement windows with indeterminate sash material behind storm windows. Changes since the 1992 survey include replacement of first floor windows and doors and cladding the gable field of the porch roof with vinyl siding. Still the original porch with its battered wood and brick supports and the brick walls of this building qualify it as a contributing resource in a potential NR district.

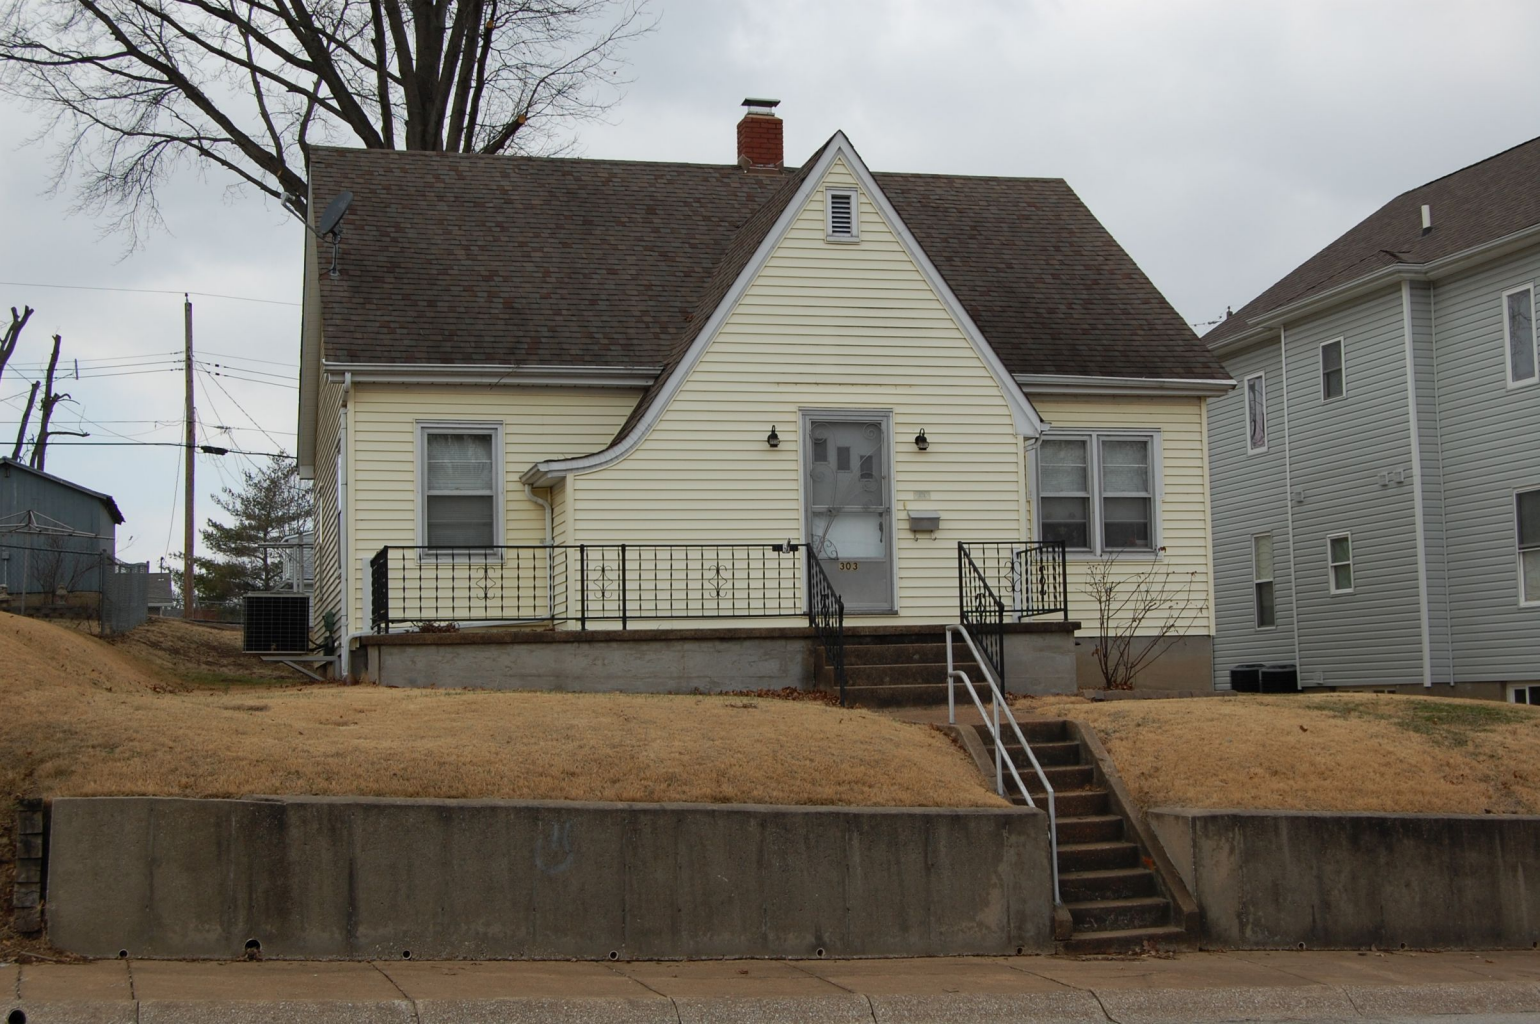
The 1.5 story frame dwelling has a concrete foundation, vinyl siding and a centered, asymmetrical gable, asphalt shingle roof. The front façade is 3 bays wide. The dominant, extended bay front gable has an asymmetrical sweeping curved gable eave side left. The bay contains a single entry of a 3 diagonal light glass and wood door. On the side right bay are paired horizontal 2/2 wood sash windows and one similar single window on the side left bay. There is a side left, partial width concrete platform porch with wrought iron railing. On the W elevation is a partial width, 1-story frame enclosed 3 season porch with shed roof and a gable dormer with a single window in the upper story. There is a central, straddle ridge brick chimney. The house was surveyed in 1992 but not much information is listed. The only alterations appear to be the removal of historic metal window awnings.

Due to the home's age and style, it is likely that the original siding was weatherboard and the vinyl siding profile is similar in profile. Since there are a lack of other changes, the building is considered contributing to a potential NR district.

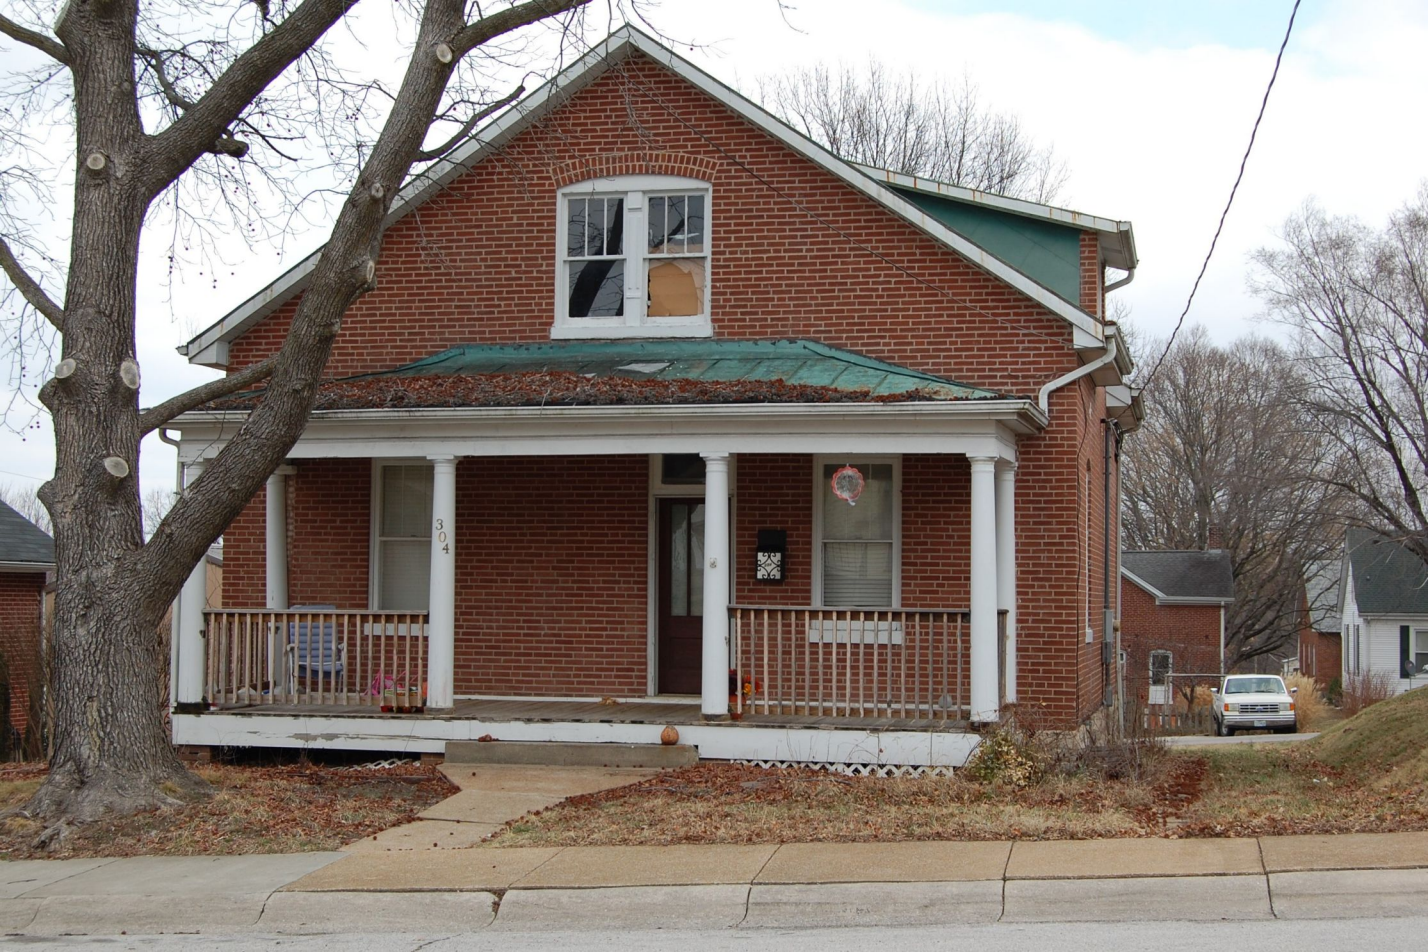
"The Frank Mense house is an excellent example of the Gable Front property type" (2000). "The dwelling is a ca. 1920, 1 1/2-story brick Open Gable plan with a stone foundation and a gable roof of standing seam metal. The front has 3 bays and the side has 2 bays. On the main facade is a 3/4 porch with a hipped roof of standing seam metal, wood Tuscan columns, and an open railing with square wood balusters. The main entrance is a multi-light glass and wood door with a single light transom set within a segmental arch of two course header brick. The windows are vertical 3/1 wood sash set within segmental arches of two course header brick. Shed roof dormers with 2 windows are on the south and north facades. There is an exterior wall brick chimney on the north facade." (1992)

Apparent changes from the 1992 survey and 2000 nomination include: removal of wood and glass storm door, replacement of porch decking, replacement of original square wood post balustrade with a simpler design and a broken window in the upper story. Changes were made post 2000 and pre 2007. Since the home is already listed on the National Register (NR), it is not a counted resource for this survey.

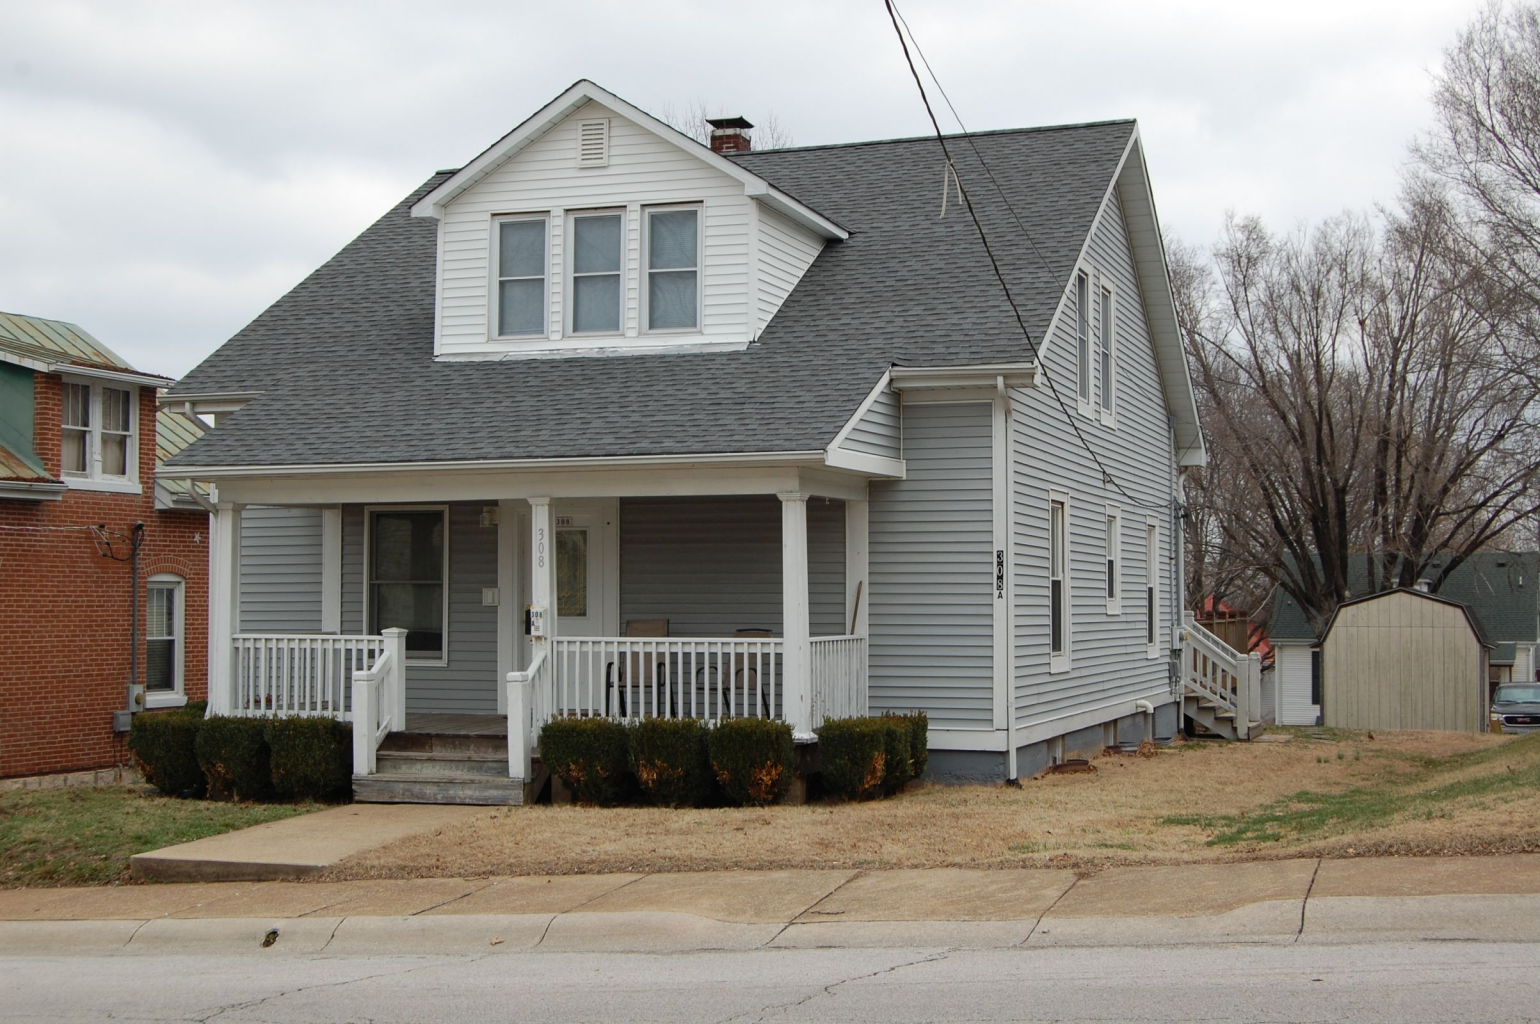
The 1.5 story frame dwelling has a concrete parged foundation, vinyl siding, and a side gable asphalt shingle roof. The front façade is 2 bays wide. There is a ¾ width, 1-story frame porch centered on the façade. It has a shed roof extended from the primary, 3 square wood posts with recessed panels, and an open, square post baluster railing. Sheltered within the porch is a slightly offset, left single entry of a rectangular, faux leaded light glass and paneled composite door set in a flat surround. There is a single window to the left of the entry. Centered in the upper story is a gable dormer with three individual windows and a rectangular vent within the open gable peak. Windows are replacement 1/1 vinyl sash, obscured by storms. On the E elevation is a gable front dormer through the primary roof. It contains a single entry with a wood deck and open wood staircase leading to a large 1-story floor wood deck. There is a central interior, rear slope brick chimney. The 1992 survey labeled the home as 306 High Street. Post 1992 survey alterations include: the replacement of vinyl siding with a smaller profile vinyl siding, replacement of 1/1 wood sash with 1/1 vinyl sash, replacement of multi-light glass and wood door and the addition of the porch railing. Due to the vinyl siding, the home is not contributing to a potential NR district.

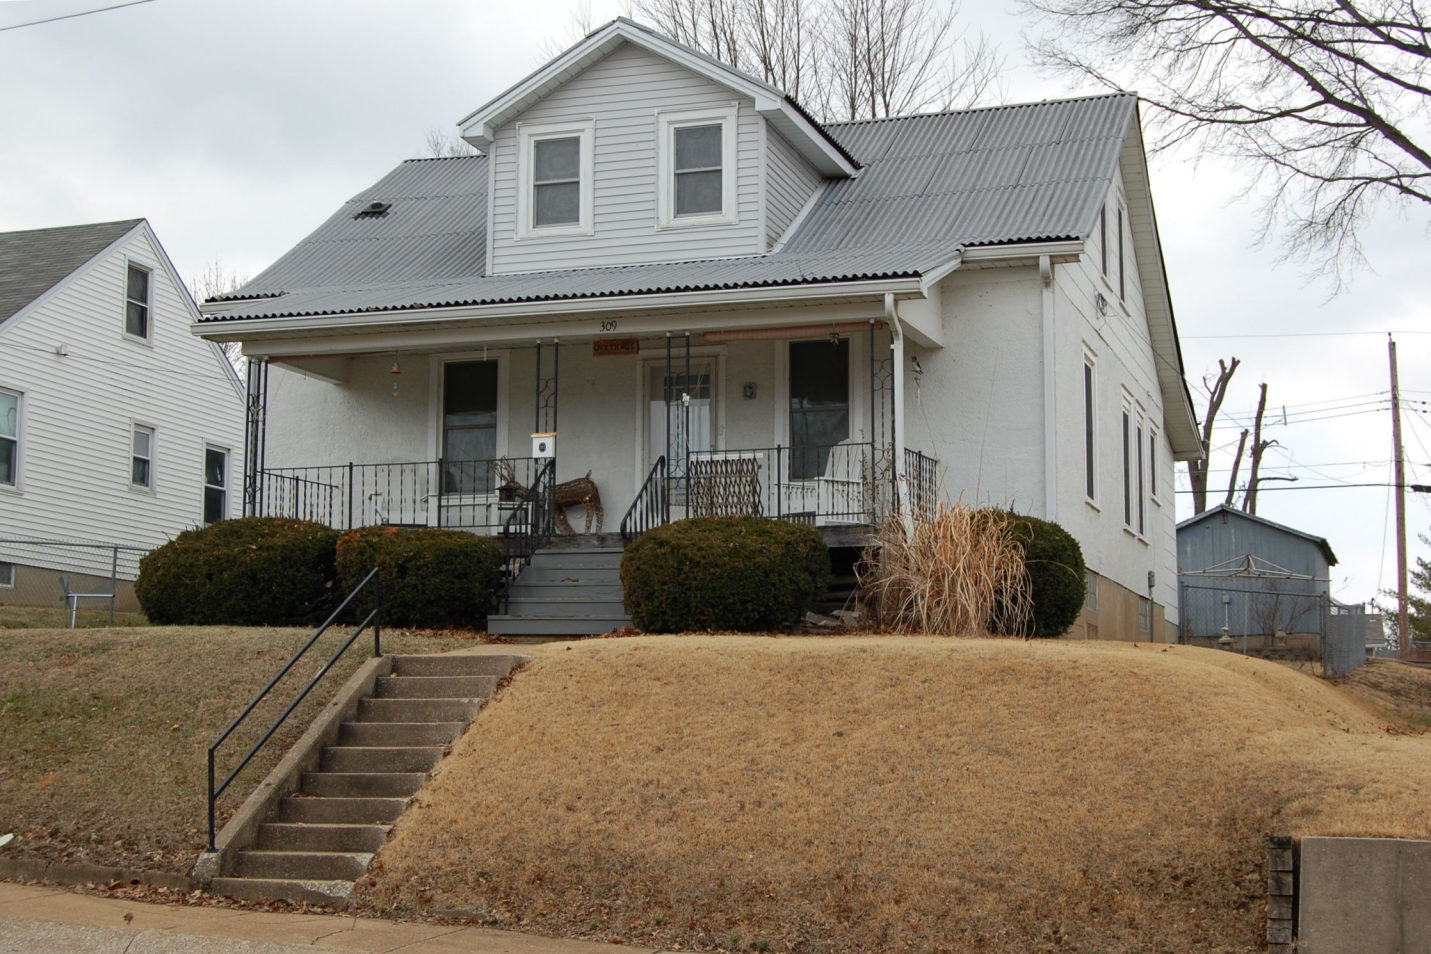
The 1.5 story frame dwelling has a concrete parged foundation, stucco covered sides, and a corrugated metal, side gable roof with asbestos shingles within the open gables. The front façade is 3 bays wide. There is a $\frac{3}{4}$ width, 1-story porch centered on the façade. It has an extended shed roof from the primary, wrought iron posts (4) and railing with an offset right wood stair entry. Sheltered within the porch is an offset right multi-light glass and wood door with single 1/1 wood sash windows on either side of the entry. Centered within the upper story is a vinyl clad gable dormer with two 1/1 wood sash windows. It is uncertain if windows are original, but appear to be replacements. On the W elevation is a 1-story, 3 seasons porch with an extended 1-story addition under an extended shed roof from the primary. In the upper story of the W elevation is a gabled dormer with a porch with solid knee wall. Post 1992 survey alterations include the removal of a central interior, front slope brick chimney and the replacement of the standing seam metal roof with corrugated metal sheets. Further research is needed to determine the date of the stucco exterior, but in comparison to the surrounding homes, it appears to be a later addition. Due to the homes replacement stucco siding and windows, it is not a contributing resource to a potential NR district.

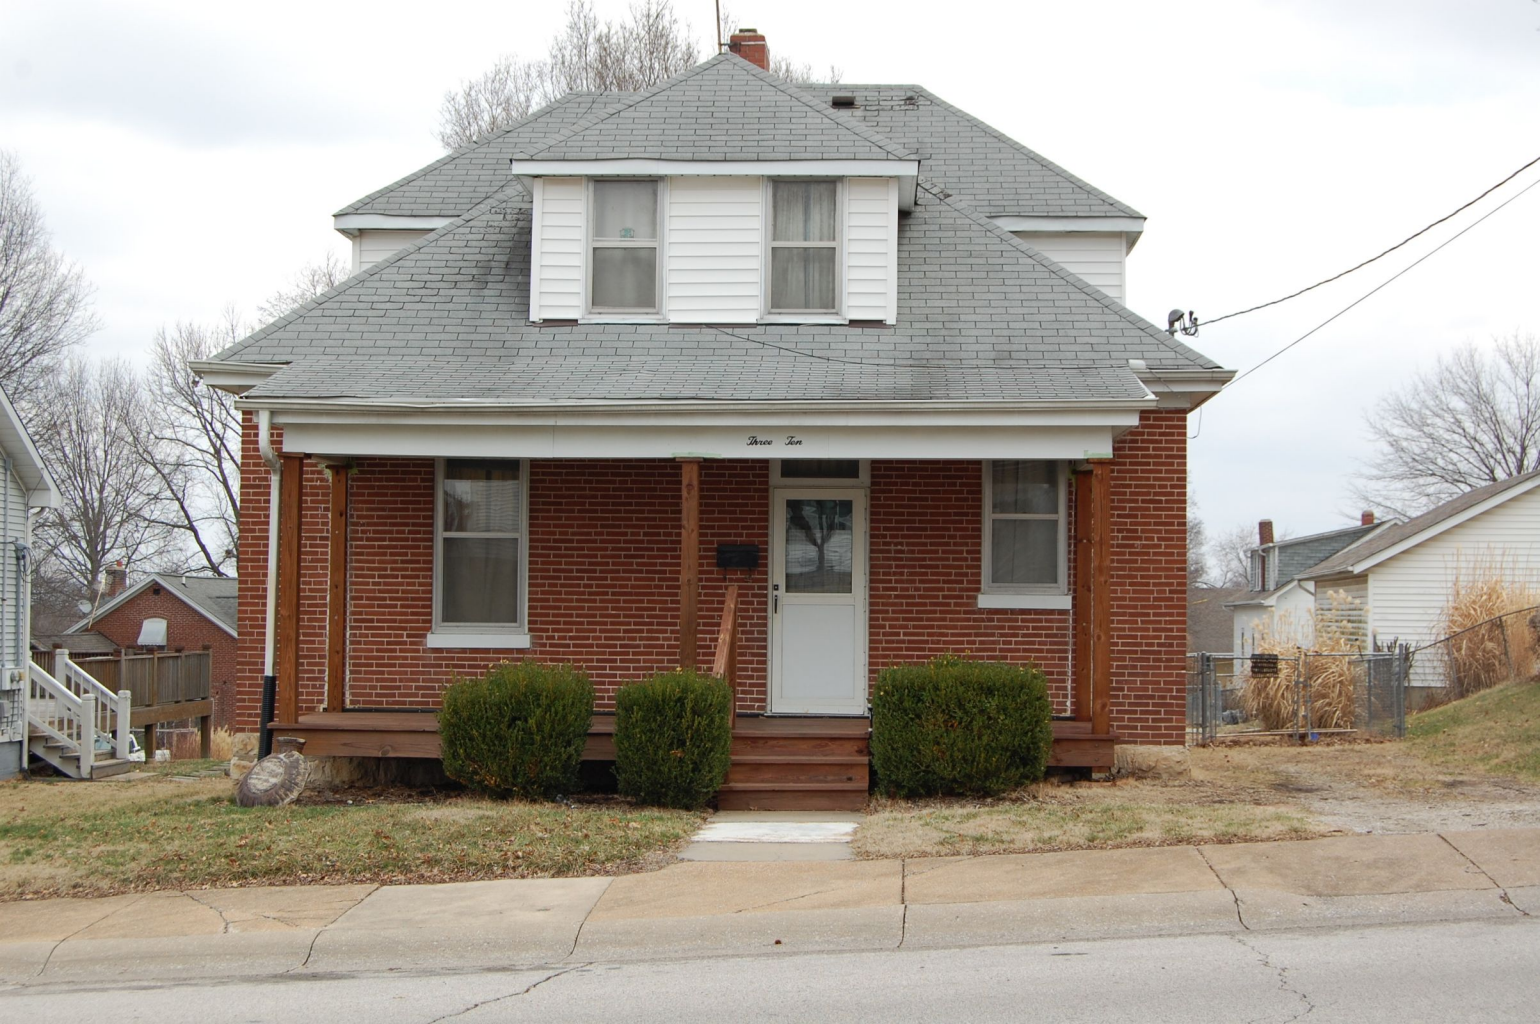
The 1.5 story masonry building has a limestone foundation, a 7course Flemish bond brick exterior, and a hipped asphalt shingle roof. The front façade is 3 bays wide. There is a $\frac{3}{4}$ width, 1-story frame porch centered on the front façade. The porch has a shed roof extended from the primary, square wood posts (3 single, 2 engaged), and a wood deck/platform. Sheltered within the porch is an offset right single entry with single light transom (door is obscured by metal and glass storm door) with single windows on either side. The first floor windows have a limestone sill but the arches were obscured by tall porch header (the 1992 survey notes them at segmental arches of 2 course header brick). Centered within the upper story is a hipped dormer with vinyl clad walls and two single windows. Windows are obscured by aluminum storms. There are larger hipped dormers on the N and S elevations The N elevation dormer has 2 windows and the S elevation dormer has 3 windows. On the rear (E) elevation is a hipped dormer with single window and multi-light and wood door with an open wood dogleg staircase leading to a first forty wood deck. There is a central interior, side right slope brick chimney. Post 1992 survey alterations include the removal of the porch's Tuscan columns which occurred post June 2013 (Google streetview). Minor alterations occurred on the porch, but due to the integrity and date of construction the home is a contributing resource to a potential NR district.

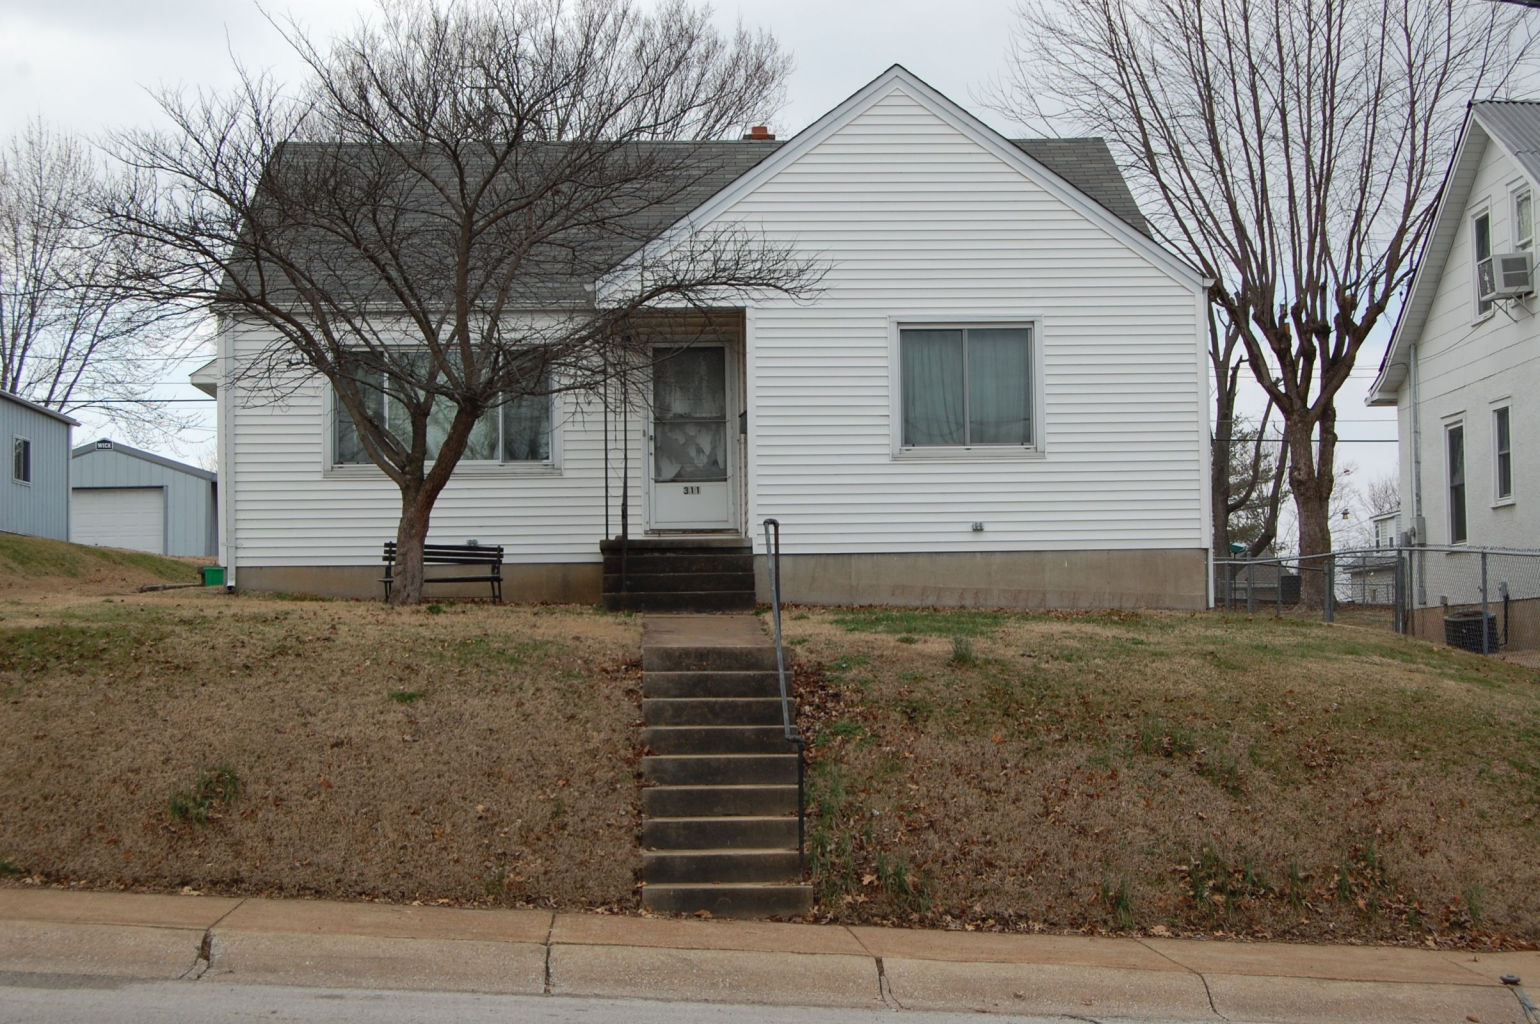
The 1.5 story frame dwelling has an rectangle plan with a poured concrete foundation, vinyl siding, and a side gable asphalt shingle roof. The front façade is 3 bays side. There is an extended, gable front, side left bay with a single aluminum sliding window and a concrete platform entry porch with single wrought iron post and stair railing under the eave. The entrance is a paneled wood door. The side left wing contains a 3-light aluminum picture window. On the S elevation is a single entry with shed roof hood and concrete platform. There is a central interior, rear slope brick chimney. The house was not surveyed in 1992.

The c1955 house is not contributing to a potential NR district due to its replacement vinyl siding, replacement door and altered windows.

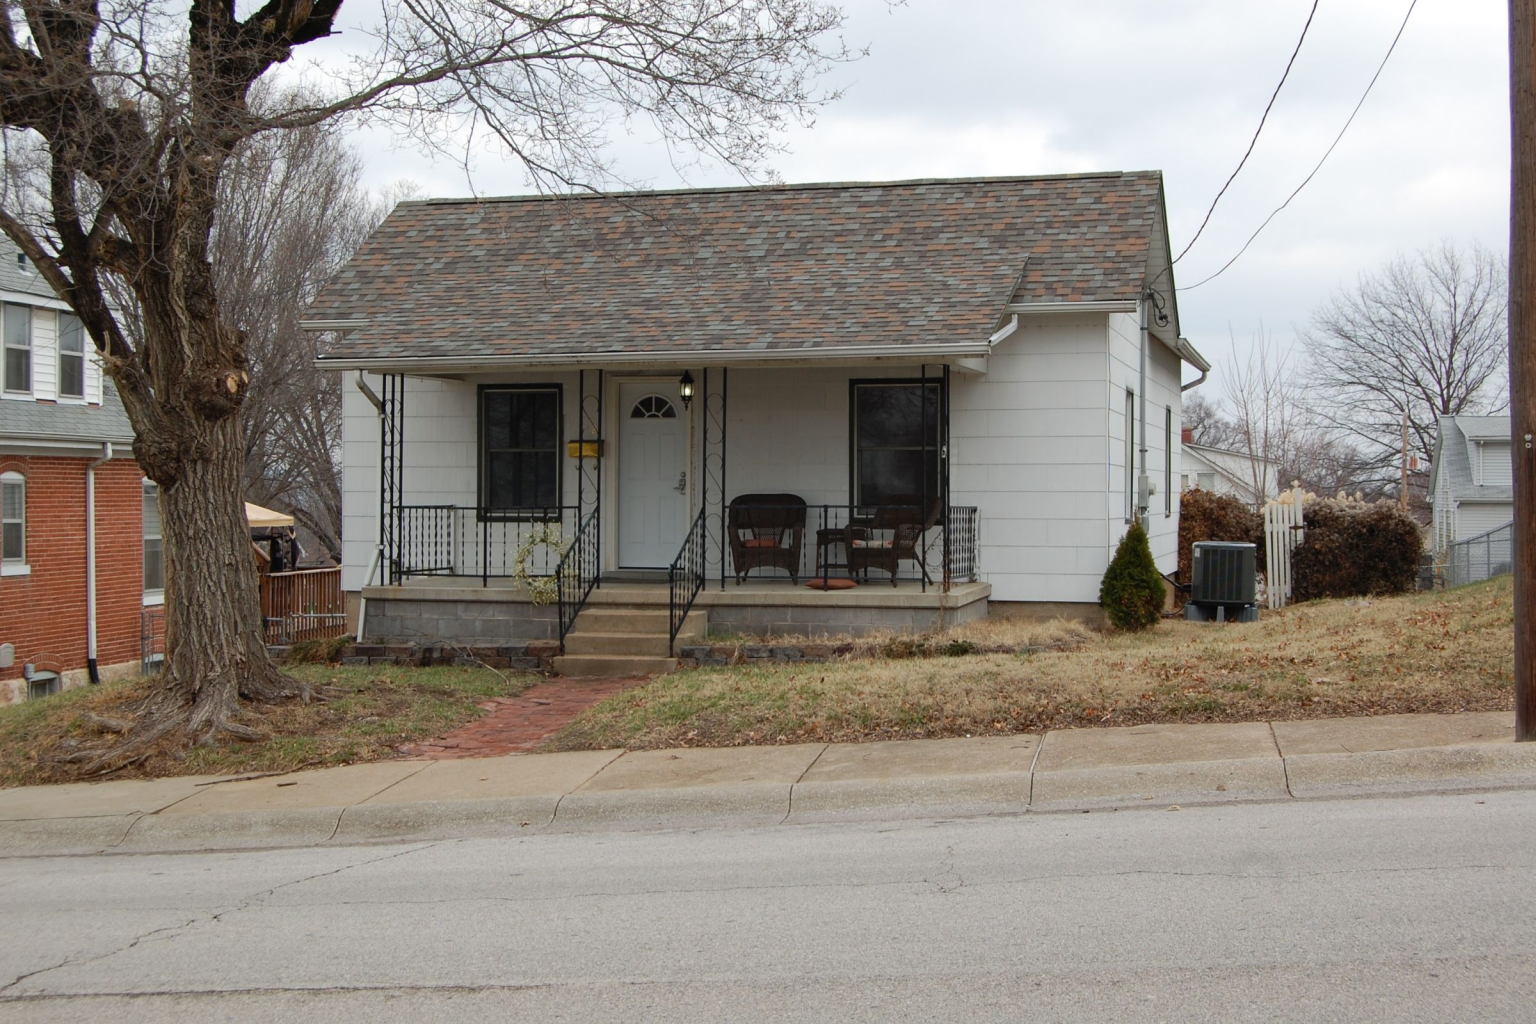
The 1-story frame dwelling has a concrete parged foundation, asbestos shingle siding, and a side gable and rear wing asphalt shingle roof. The front façade is 3 bays wide. There is a ¾ width, 1-story frame porch centered on the façade. The porch has a shed roof extended from the primary, wrought iron posts (\$) and railing on a concrete pad with cinder block foundation. Sheltered within the porch is an offset left single entry of a fanlight glass and paneled metal door with single windows on either side. Windows are replacement 1/1 vinyl sash obscured behind dark screens. There is a 1-story, shed roof frame addition within the ell, on the N and E elevations. The assessor's office notes the addition from 1984. Post 1992 survey alterations include the replacement of a paneled wood door, replacement of 1/1 wood sash to vinyl, replacement of a concrete sidewalk with brick, and replacement of the standing seam metal roof with asphalt shingles. These alterations occurred post June 2013 (Google Streetview).

Due to the alterations in the roof, the building is not contributing to a potential NR district.

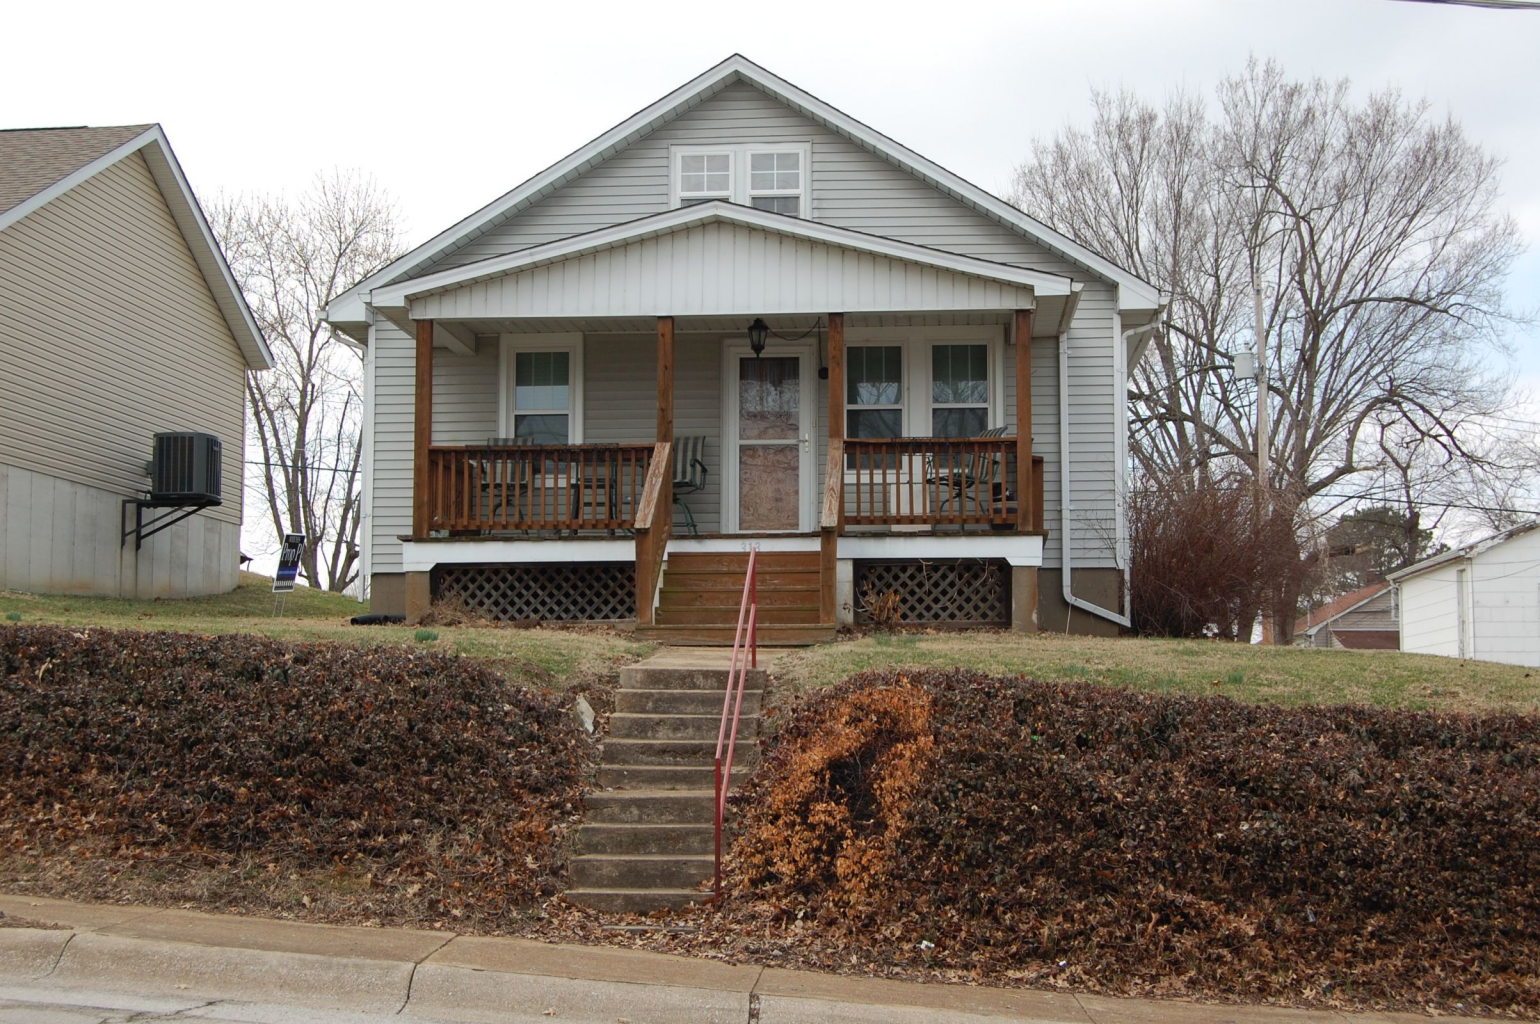
Due to the home's replacement vinyl siding and windows, it is not contributing to a potential NR district.

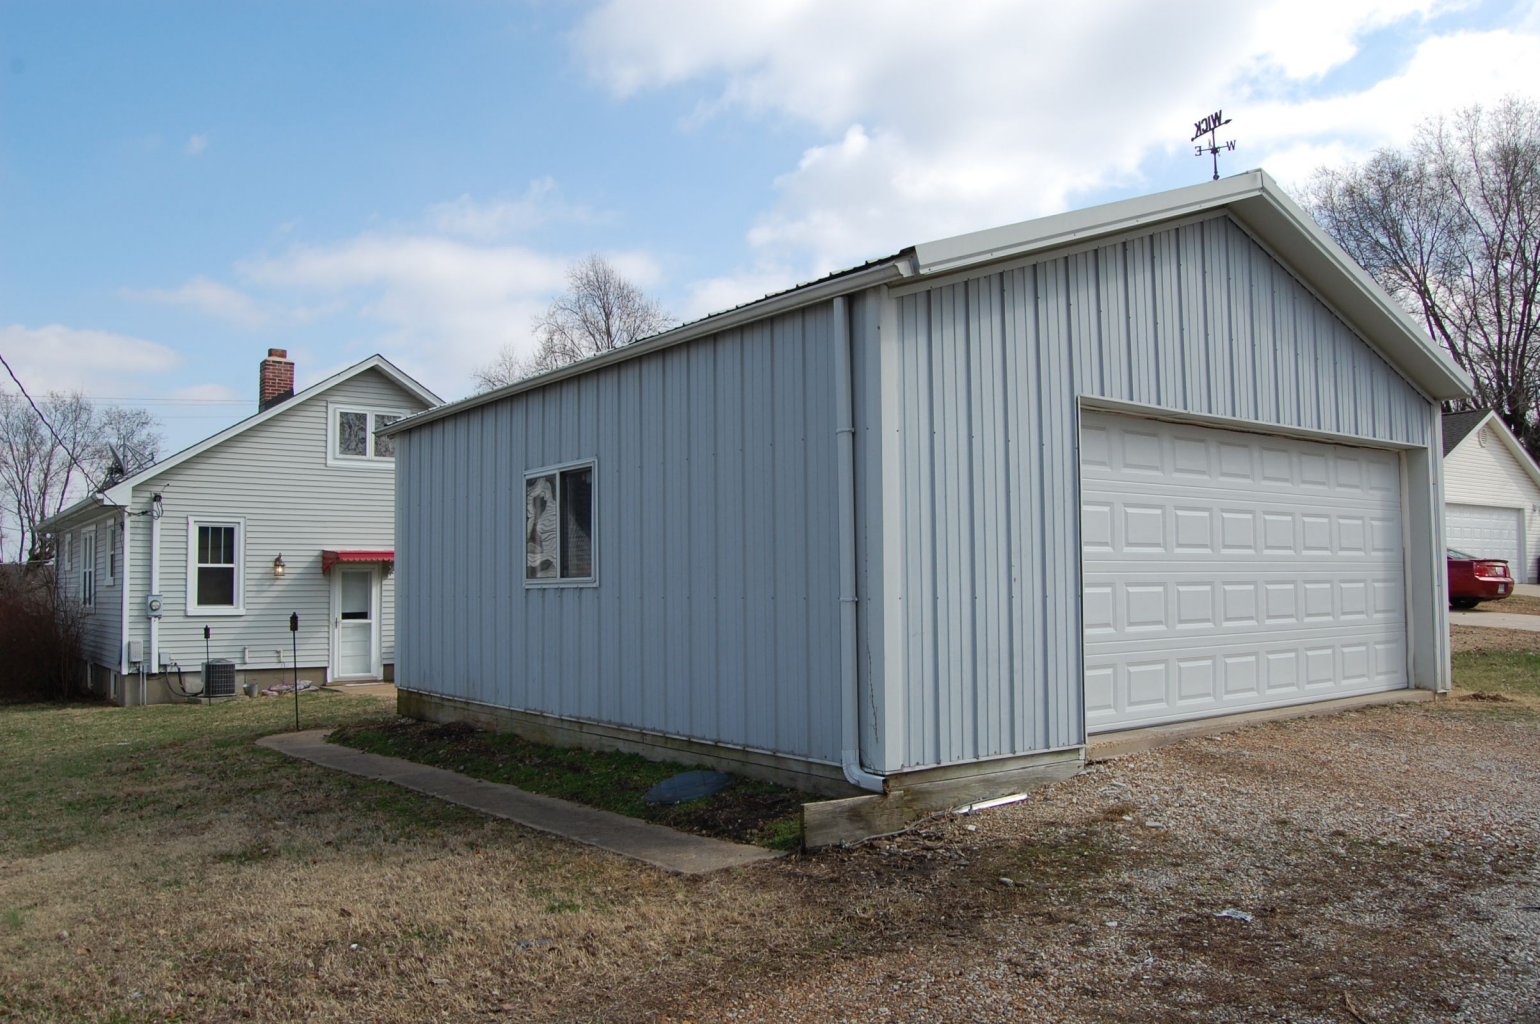
The 1.5-story frame dwelling has a concrete foundation, vinyl siding, and a front gable asphalt shingle roof. The front façade is 3 bays wide. There is a ¾ width, 1-story frame porch centered on the façade. The porch has a dropped front gable, asphalt shingle roof with vertical aluminum cladding within the open gable, 4 square wood posts, and an open square wood balustrade. Sheltered within the porch is an offset right single entry of a 3 vertical light glass and horizontal paneled wood door with paired windows side right and a single window side left. First floor windows are replacement vertical 3/1 false interior muntin, double hung vinyl sash. Centered in the upper story gable are paired 4/4 false interior muntin vinyl sash windows. The W elevation has a single entry with a metal awning. There is an interior wall, side slope right brick chimney on the N elevation. Post 1992 survey alterations include the replacement of wrought iron posts and porch railing with wood and replacement of original vertical 3/1 wood sash with vinyl sash.

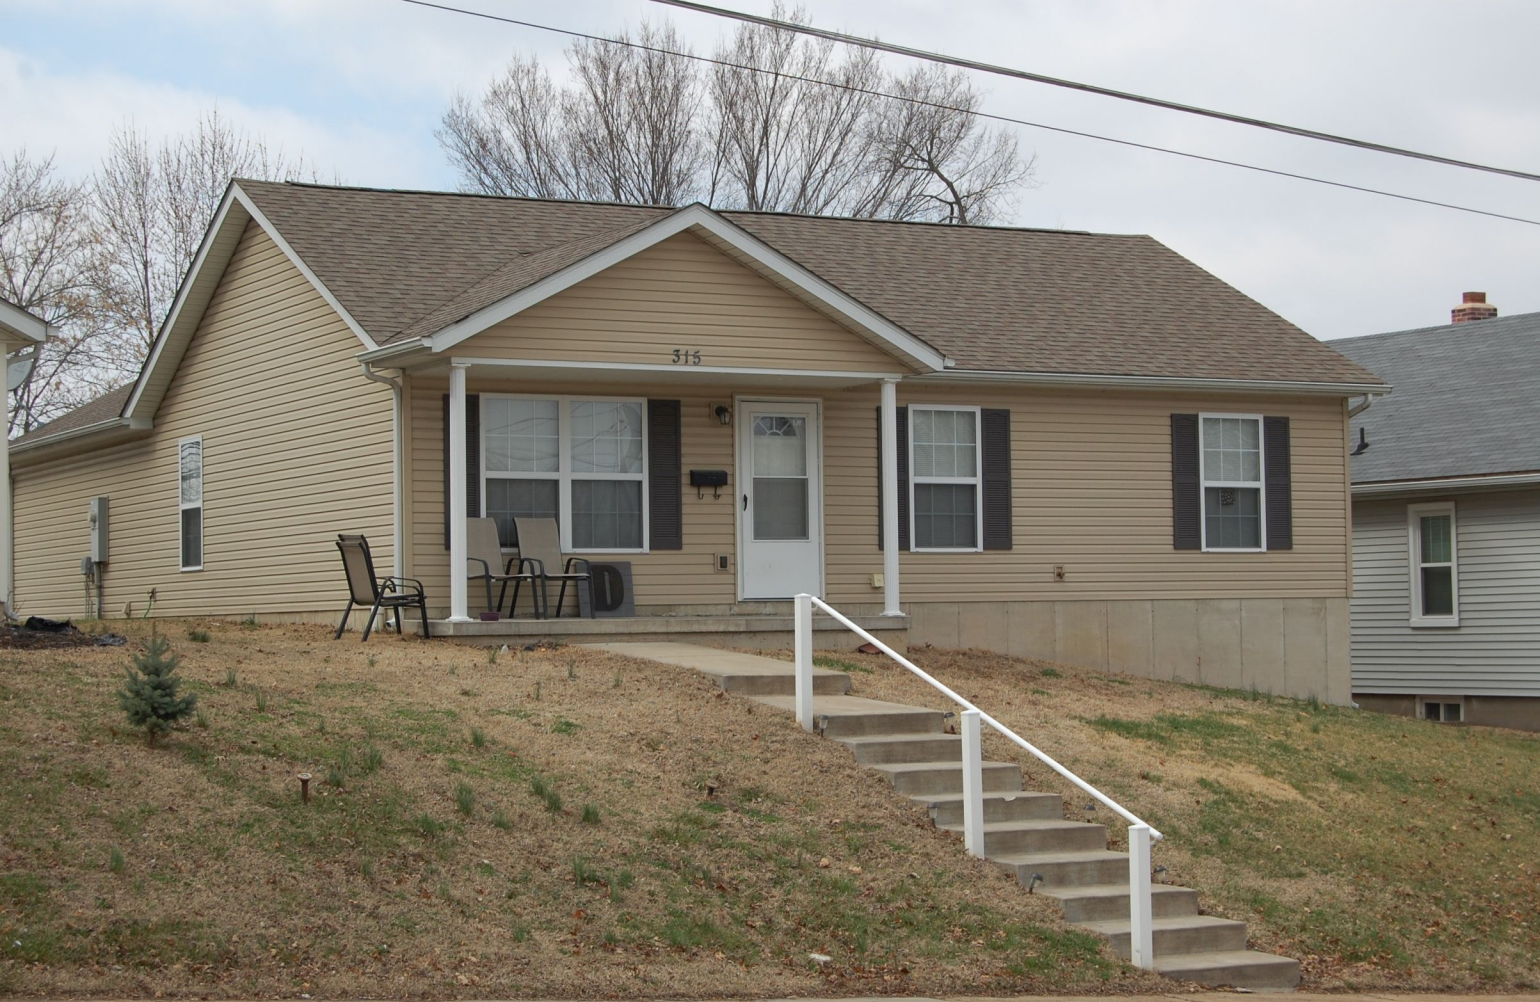
The 1-story frame dwelling has a concrete foundation, vinyl siding, and a cross gable asphalt shingle roof. The front façade is 4 bays wide. There is a 1-story portico side left. The porch has an extended front gable roof, two fluted metal Tuscan columns and a concrete platform. Sheltered within the porch are a fan-light glass and paneled metal door and paired windows, side left. To the right of the porch are two individual windows. Windows are 6/6 false interior muntin, double hung vinyl sash with ornamental shutters. The rear wing is a 1-story, 2-car attached garage with paneled metal overhead door. The wing is on the southern side of the W elevation. This property was not surveyed in 1992.

Due to the buildings recent date of construction it is not contributing to a potential NR district.
