MISSOURI DEPARTMENT OF NATURAL RESOURCES
STATE HISTORIC PRESERVATION OFFICE, P.O. Box 176, Jefferson City, MO 65102
ARCHITECTURAL/HISTORIC INVENTORY FORM

1. SURVEY NO. FR-AS-007-0104		2. SURVEY NAME: International Shoe Factory Neighborhood	
3. COUNTY: Franklin		4. ADDRESS (STREET NO.) 301	STREET (NAME) High Street

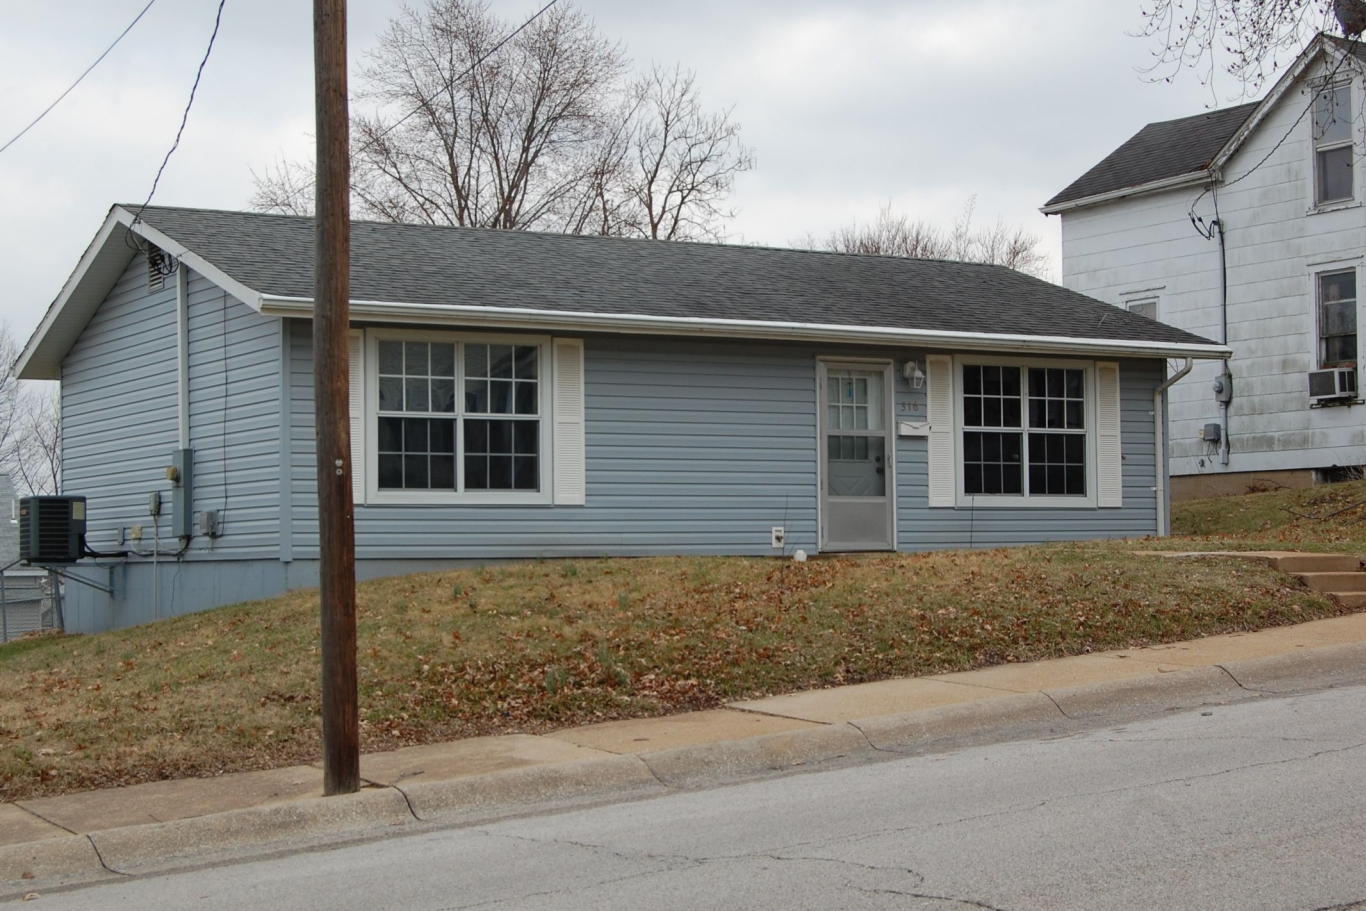
The 1-story frame dwelling has a concrete foundation, vinyl siding, and a side gable, asphalt shingle roof. The front façade is 3 bays wide. There is an offset right single entry of a multi-light and 4 panel cross door. On either side of the entry are paired 6/6 false exterior muntin, vinyl sash windows. On the E elevation is a side left, small porch with corrugated metal shed roof and square wood posts. The house was photographed in 1992 but not surveyed. Post 1992 survey photo (no form) alterations include replacement siding. The siding was originally composite in the appearance of vertical board, but was altered post June 2013 (Google streetview).

Due to the home's recent date of construction, it is not contributing to a potential NR district.

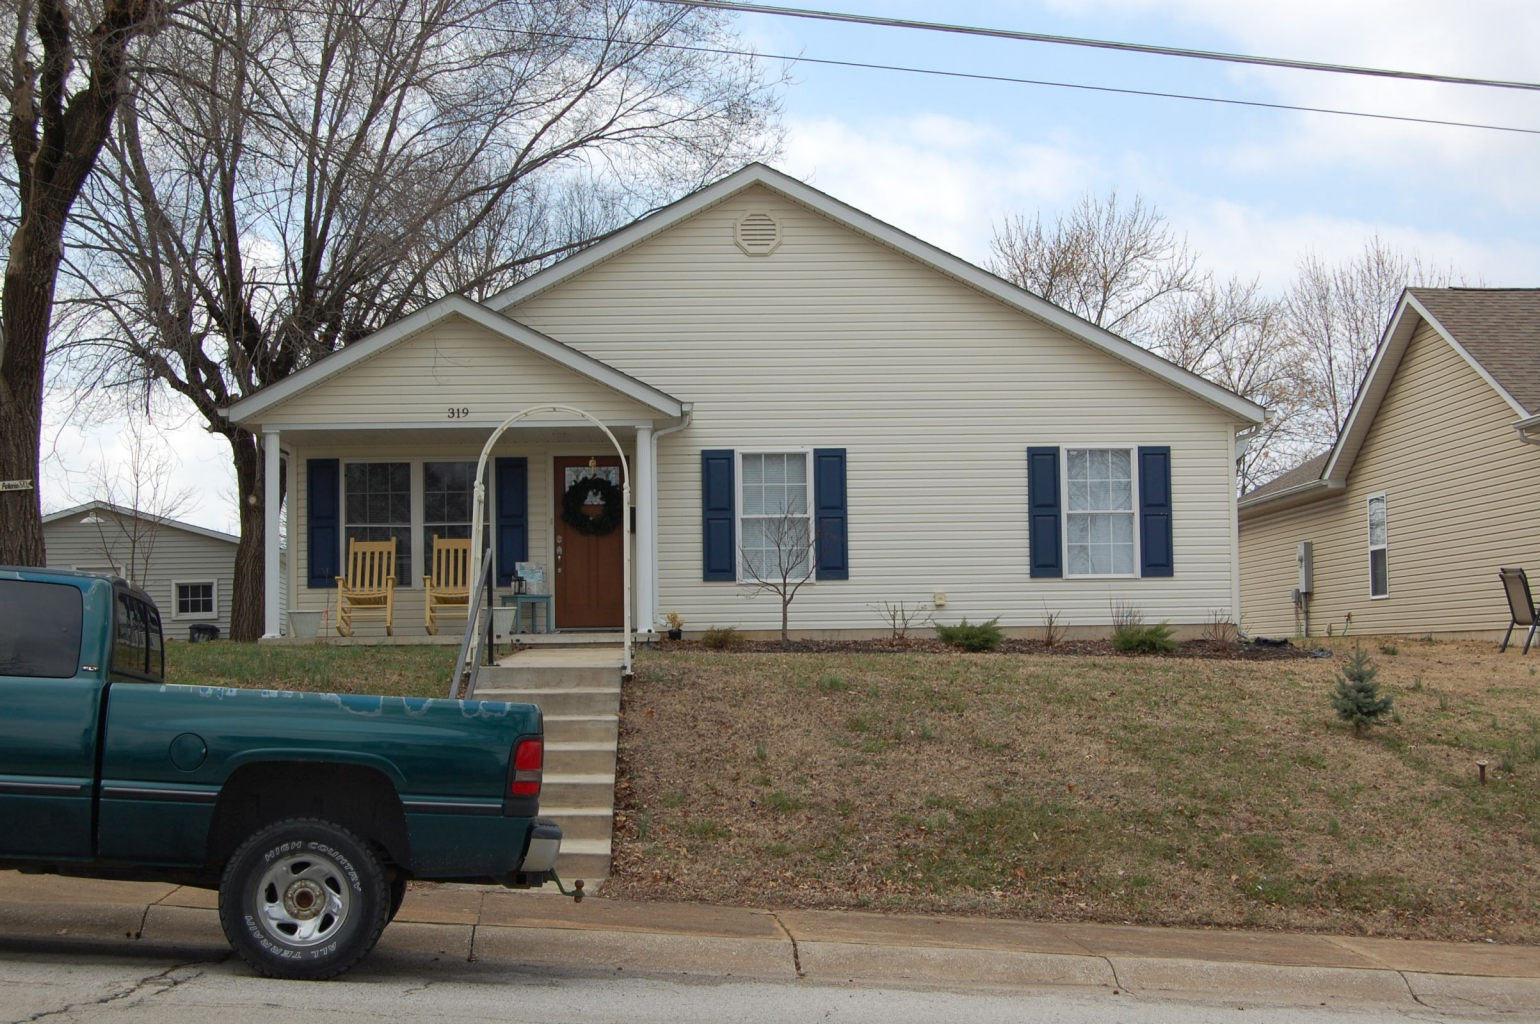
The 1-story frame dwelling has a concrete foundation, vinyl siding, and a front gable asphalt shingle roof. The front façade is 4 bays wide. There is a 1-story portico, side left. The porch has a dropped front gable roof of asphalt shingles, two fluted metal Tuscan columns and a concrete platform. Sheltered within the porch are square leaded light glass and paneled wood door and paired windows, side left. To the right of the porch are two individual windows. Windows are 6/6 false interior muntin, double hung vinyl sash with ornamental shutters. Within the primary open gable peak is an octagonal vent. There is an incised porch within the rear ell and an extended 2-car garage bay with paneled metal overhead door on the W elevation. This property was not surveyed in 1992.

Due to the buildings recent date of construction it is not contributing to a potential NR district.

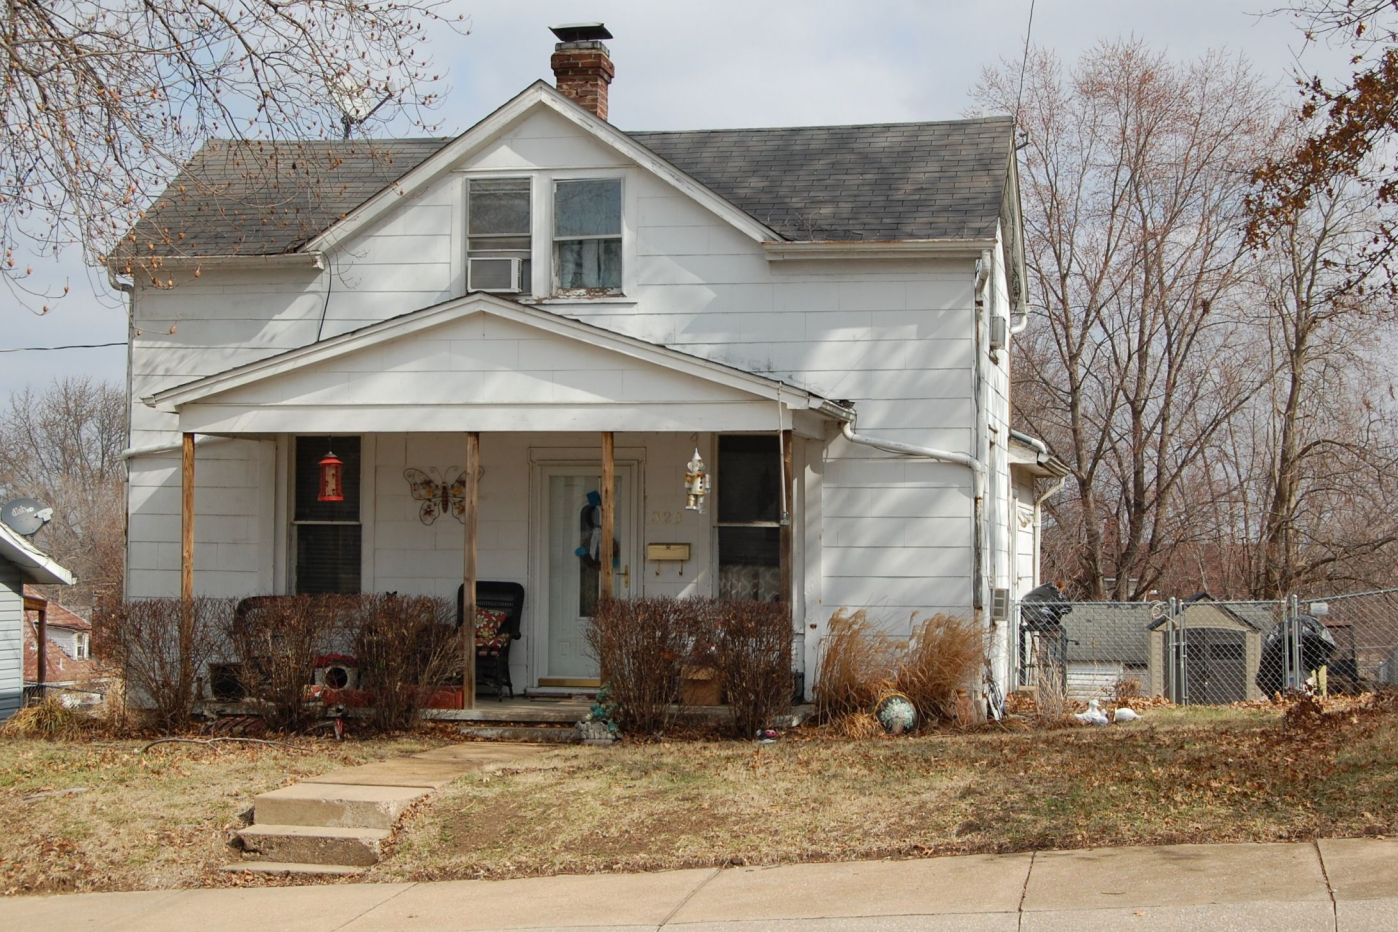
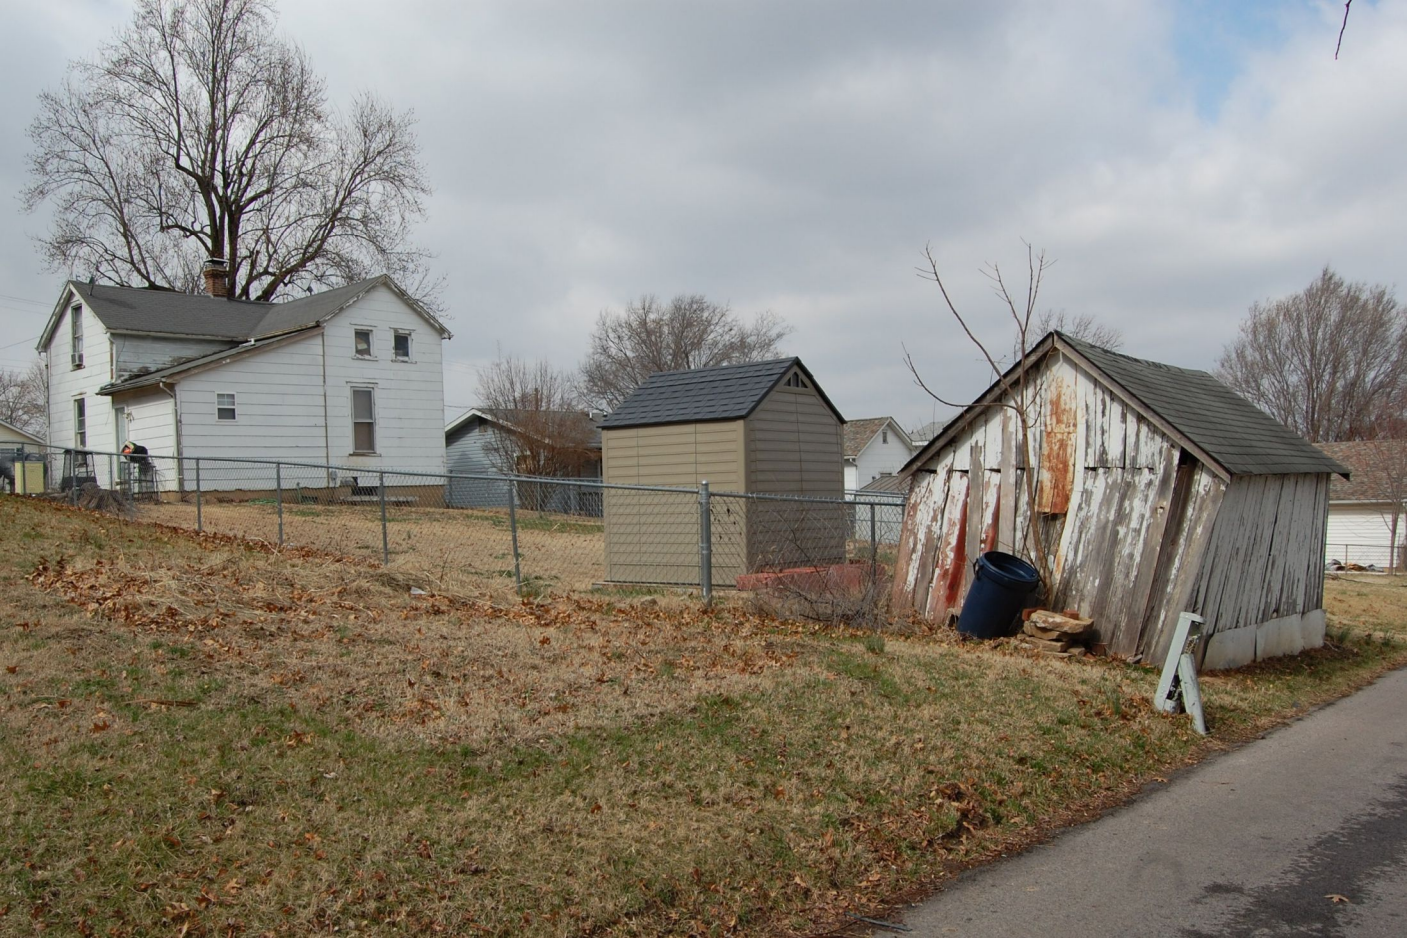
The 1.5 story frame dwelling has a concrete parged foundation, asbestos shingle siding, and a side gable and wing asphalt shingle roof. The front façade is 3 bays wide. There is a ¾ width, 1-story frame porch centered on the façade. The non-original porch has a dropped front gable asphalt shingle roof, asbestos or masonite shingles within the open gable, 4 slender square wood posts and a concrete platform. The porch appears to be a mid 1950 addition to the home. Sheltered within the porch is an offset right, single entry of an arched faux leaded glass and paneled composite door, with single windows on either side. Within the upper story is a centered gable dormer at the roofline with paired windows. Windows are 1/1 wood sash. On the E elevation is a 1-story shed roof addition within the original gabled ell added in 1992. There is a central interior straddle ridge brick chimney. Post 1992 survey alterations include: the removal of the porch's open railing with square wood balusters, replacement of the single light glass and wood door, and the rear ell infill addition. While there are minor changes, due to the buildings date of construction and integrity, it is contributing to a potential NR district.

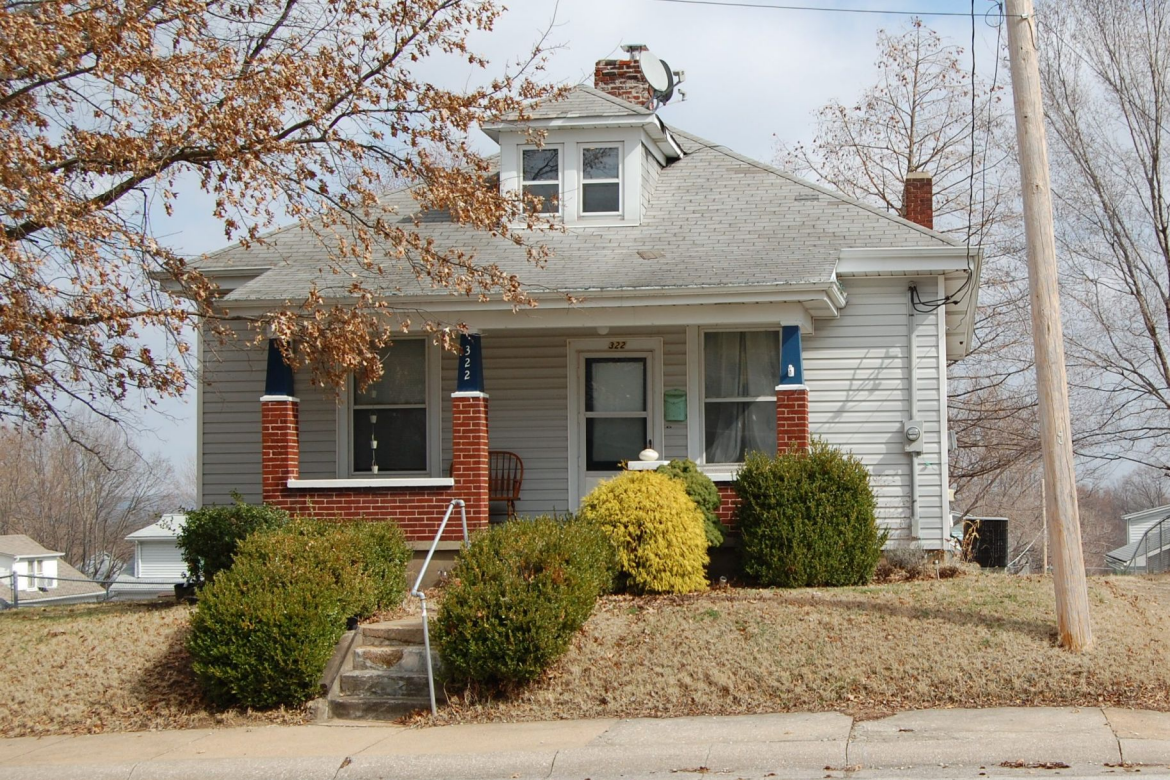
The 1.5 story frame dwelling has a parged concrete foundation, vinyl siding, and an asphalt shingle, hipped roof. The front façade is 3 bays wide. There is a $\frac{3}{4}$ width, 1-story porch centered on the façade. The porch has a shed roof extended from the primary, tapered wood columns on brick piers (3) and a solid brick railing. Sheltered within the porch is an offset right single entry of a rectangular light glass and wood door, with single windows on either side. Centered in the upper story is a small hipped dormer with paired windows. Windows are replacement 1/1 wood sash. On the E elevation is a small 1-story shed roof porch (in similar location as on 1926 and 1951 Sanborn map), and a single hipped dormer with sliding glass window centered in the upper story. The primary alterations since the 1992 survey is the replacement of asbestos shingles with vinyl siding. Due to this exterior alteration, the building is not contributing to a potential NR district.

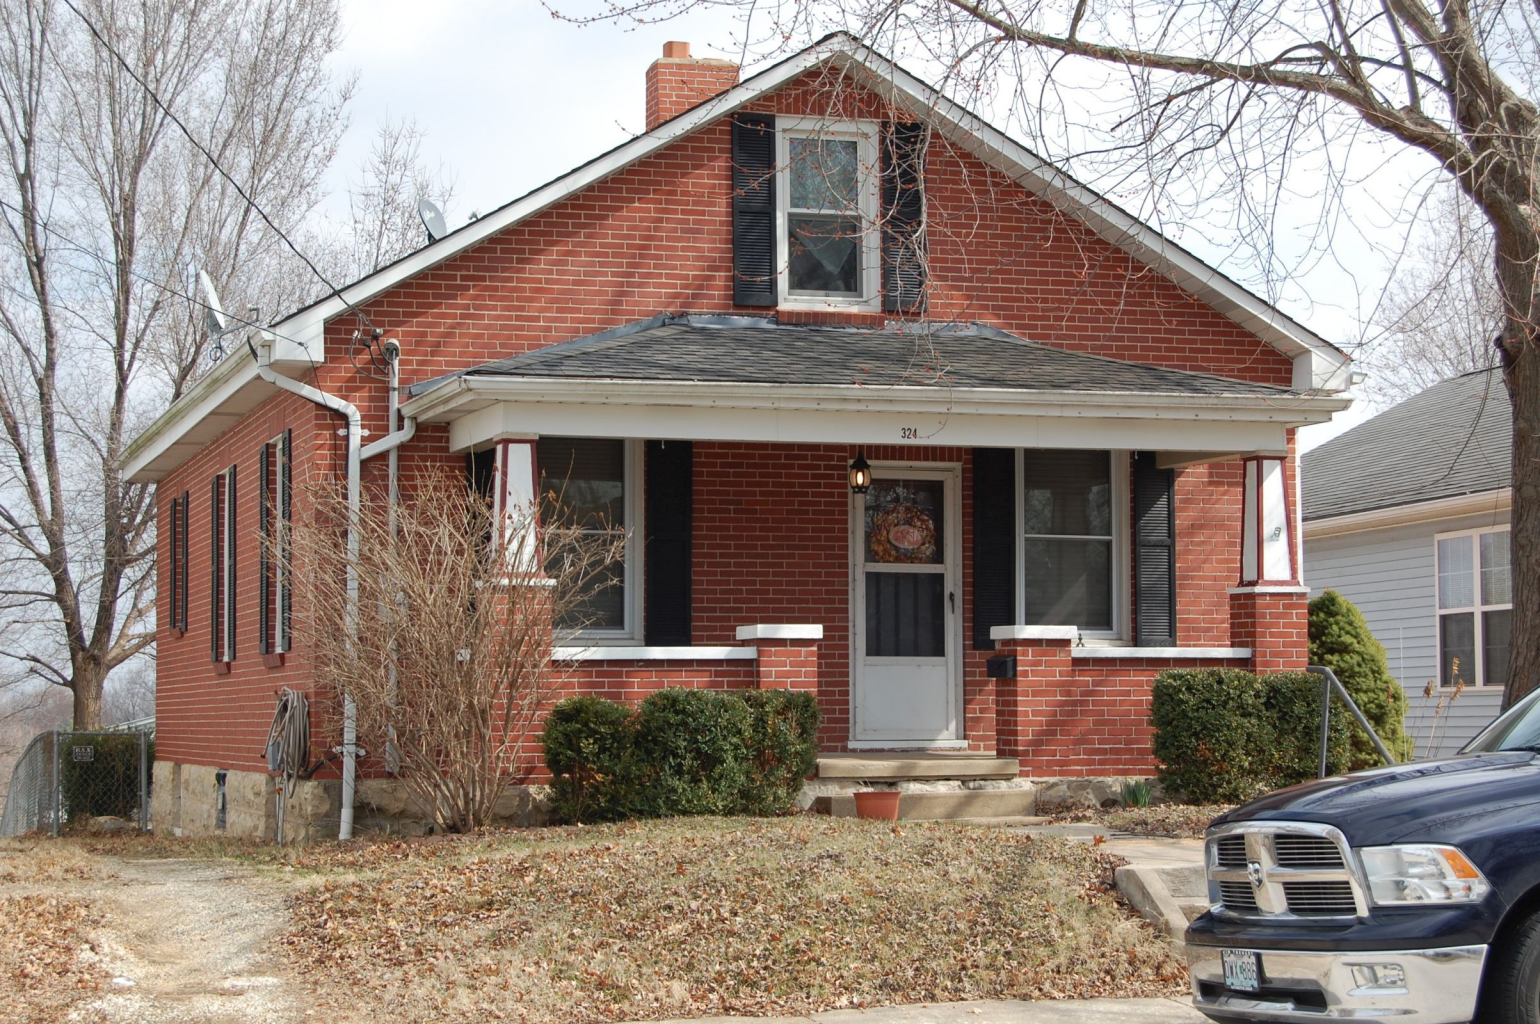
The 1.5 story frame dwelling has a limestone foundation, running bond brick veneer, and a front gable, asphalt shingle roof. The front façade is 3 bays wide. There is a ¾ width, 1-story porch centered on the face. The porch has a dropped asphalt shingle hipped roof with tapered wood columns on brick piers (2) and a solid brick railing. Sheltered within the porch is an offset right single entry of a multi-light glass and wood door with a single window on either side. Centered within the upper story gable is a single window. Windows are replacement 1/1 vinyl sash set within a brick soldier course jack arch with angled brick rowlock course lug sill and ornamental shutters. Elevation has a 1-story, side left porch with shed roof. There is a central interior straddle ridge brick chimney. Since the 1992 survey alterations include the replacement of original vertical 4/1 and vertical 3/1 wood sash with 1/1 vinyl sash windows. The 1992 survey also notes a solid wood railing but the correlating image shows brick. The 1951 Sanborn notes a 1-story brick building. Due to the limestone foundation the building is original, but the upper story could have been added early on or during the period of significance. There have been minor changes to the windows, however the home retains its integrity and is a contributing resource to a potential NR district.

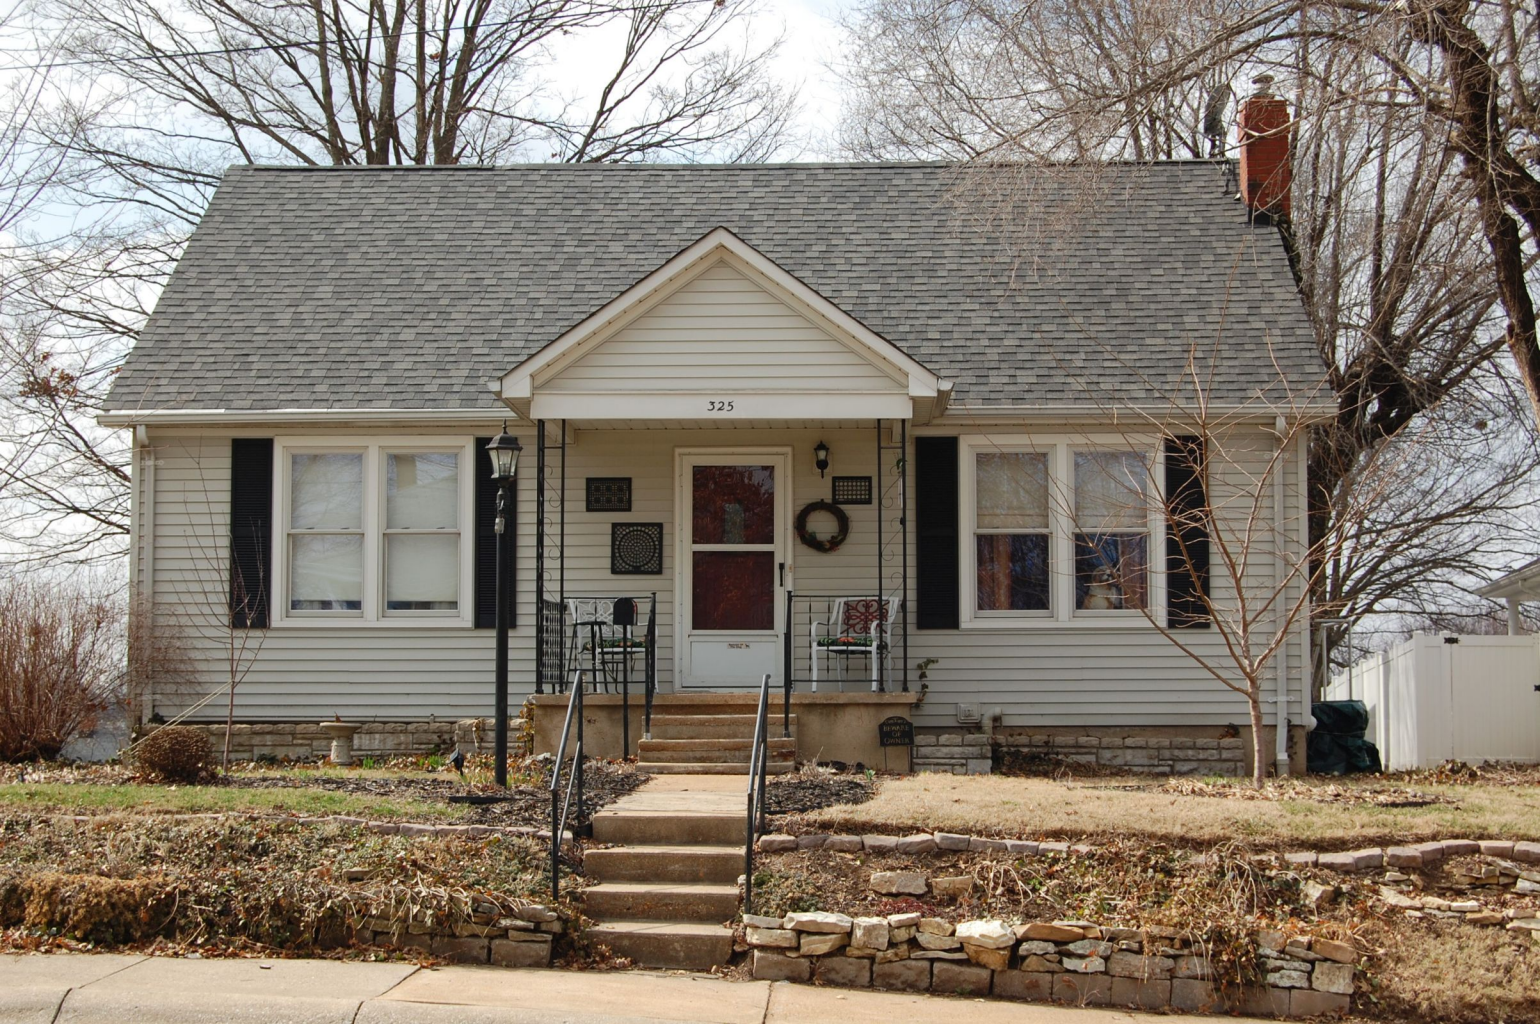
The 1.5 story frame dwelling has a concrete foundation, vinyl siding, and an asphalt shingle, side gable roof. The front façade is 3 bays wide. There is a centered front gable portico with wrought iron posts and railing and a concrete platform with centered concrete steps. Sheltered within the portico is a single entry of a small rectangular light glass and paneled composite replacement door. On either side of the portico are paired, 1/1 double-hung vinyl sash windows with ornamental shutters. There is an exterior wall brick chimney on the N elevation. On the W elevation is a 1-story, shed roof, partial width extended bay on the first floor and a centered shed roof dormer in the upper story. The house was not surveyed in 1992.

The house was constructed towards the mid 1950s and due to the replacement vinyl siding it is not contributing to a potential NR district.

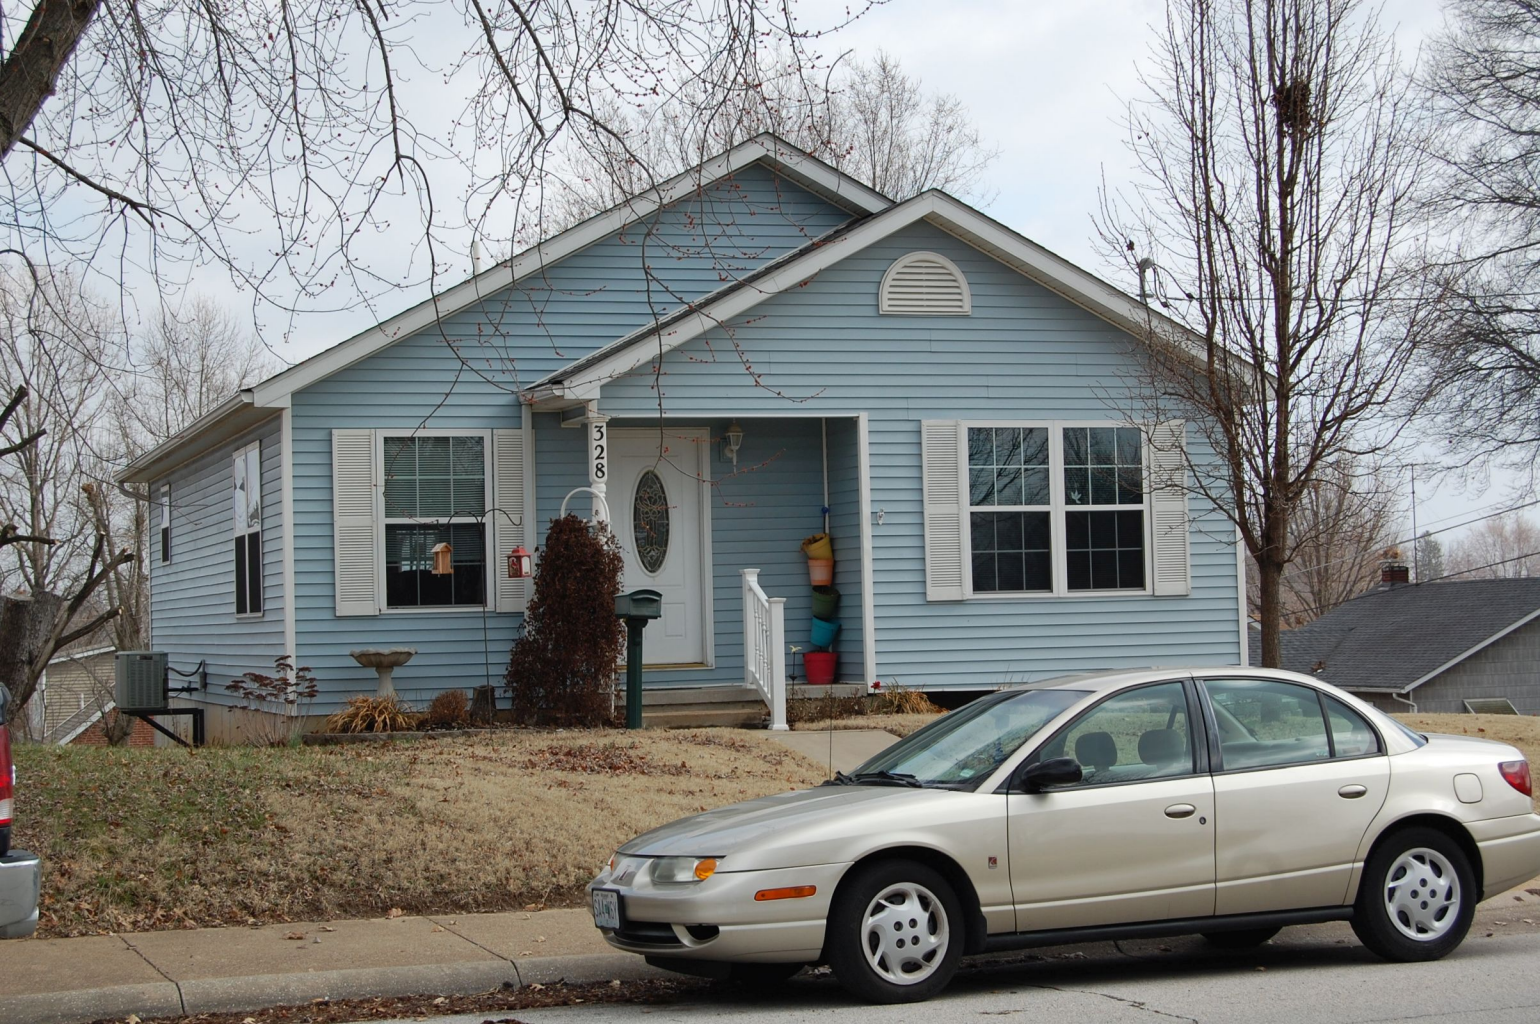
The 1 story frame dwelling has a concrete foundation, vinyl siding and a front gable, asphalt shingle roof. The front façade is 3 bays wide. There is a side right, extended bay with a dropped front gable roof. The side right bay has paired windows and a single entry below the side left bay eave. The incised entry has a newer leaded glass oval light and paneled wood door, a concrete platform with one turned composite post and a composite handrail with turned spindle rail. Within the side right open gable peak is an arched gable vent. The side left bay is on the primary building and has a single window. Windows on the facade are 6/6 false interior muntin, double hung vinyl sash windows with ornamental shutters. The E elevation (rear) has a walk out basement and a small, single bay porch, side right, on the first floor. This property was not surveyed in 1992. Due to the building's recent date of construction, it is not contributing to a potential NR district.

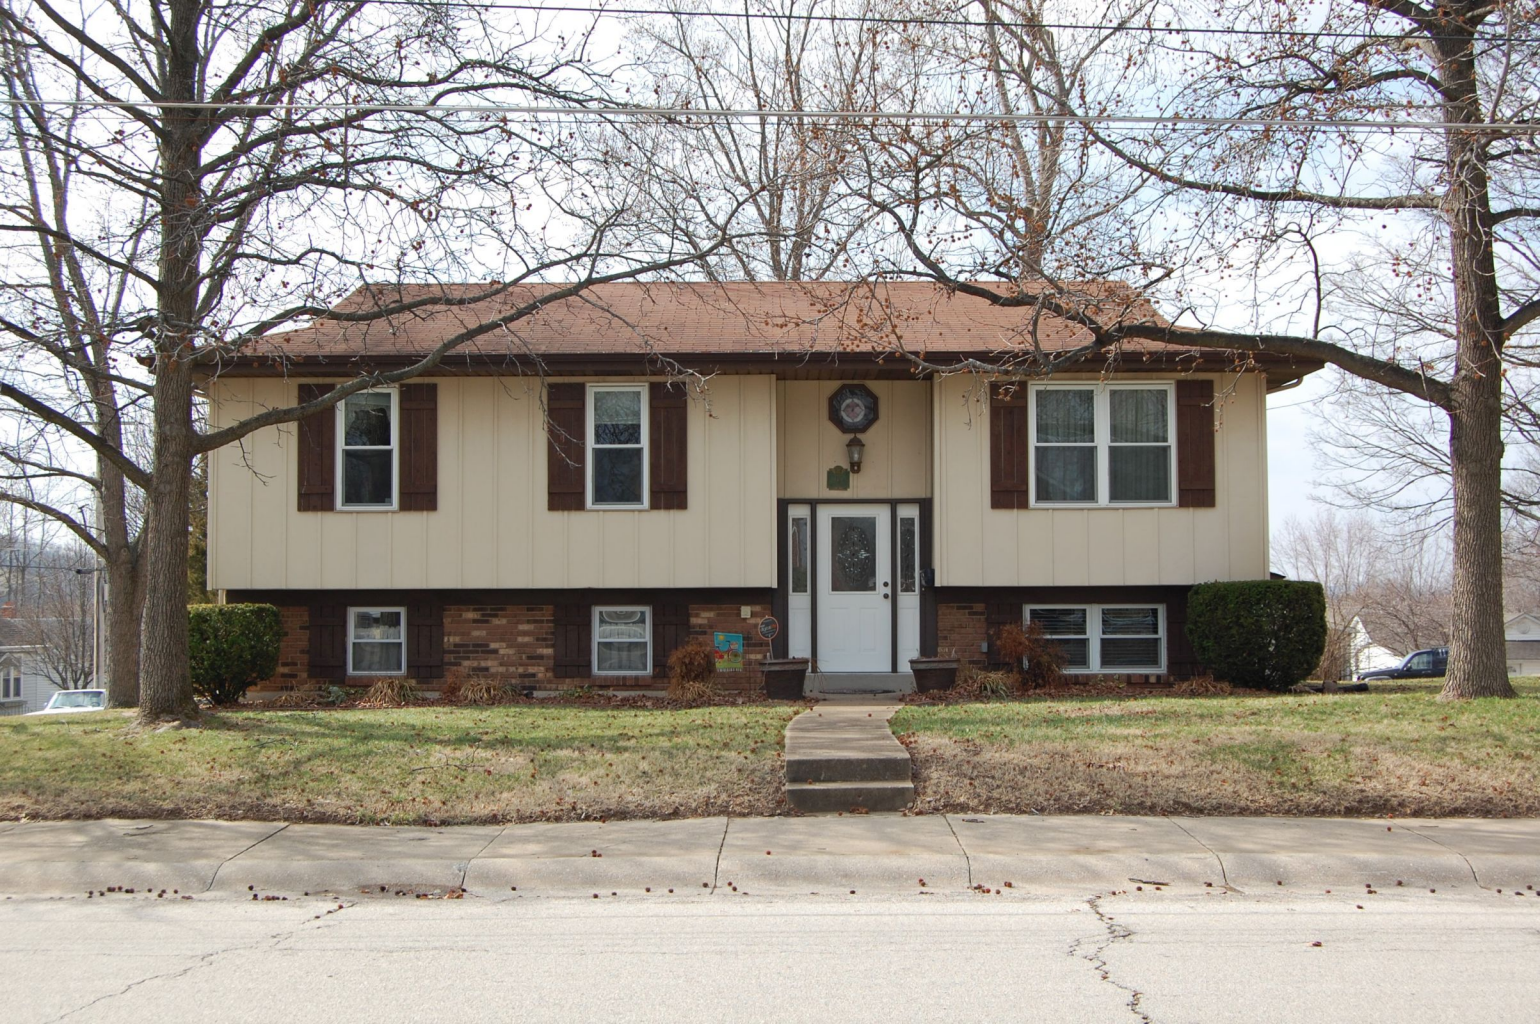
The split level foyer frame dwelling has a concrete foundation, multiple wall materials, and an asphalt shingle, gable on hip roof. The front façade is 4 bays wide. The lower level has a variegated brick veneer while the upper, overhang level is board and batten. There is an offset right entry recessed within the overhang. The entry consists of a concrete platform, rectangular light glass and paneled metal door with similar styled sidelights and an octagonal leaded light glass window towards the eave. The side right bay has paired windows in the upper and lower level. The side left bay contains two single windows in the upper and lower level. Fenestration locations are carried to each level. Windows are 1/1 double-hung vinyl sash with ornamental shutters. This house was not surveyed in 1992. Due to the recent date of construction, the home is not a contributing resource to a potential NR district.

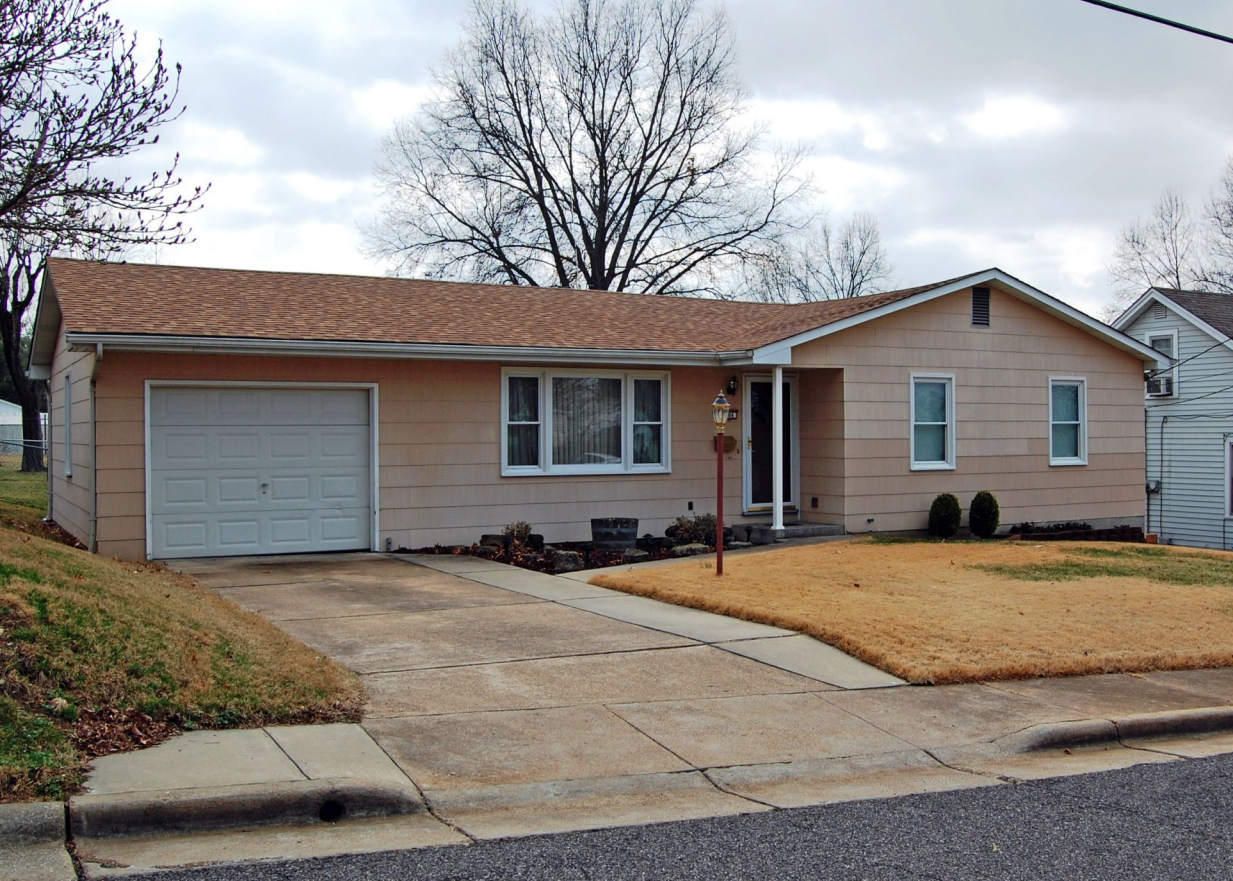
The c1960, 1-story frame dwelling has a concrete foundation, asbestos shingle siding, and an asphalt shingle gable front and wing roof. The front façade is 5 bays wide. There is a front facing gable, side right that does not protrude very far in front of the side left, side gable. This bay has two single 1/1 vinyl sash windows and an entry bay porch containing a square concrete platform, square wood post, and a single entry under the eave of the front gable. The main entrance is a 3 angled light glass (in shape of a sideways diamond) and wood door with glass and metal storm door. The entry is flush on the side gable wing. To the left of the entry is a picture windows with 1/1 indeterminate sash windows flanking the central fixed light. The far left bay is a built-in, 1-car garage bay with paneled metal overhead doors. Based on the city assessor's photos, there is a partial width wood deck on the rear (S) elevation. This home was not surveyed in 1992. Due to the home's date of construction within the period of significance, though towards the end, it retains its integrity and is a contributing resource to a potential NR district.

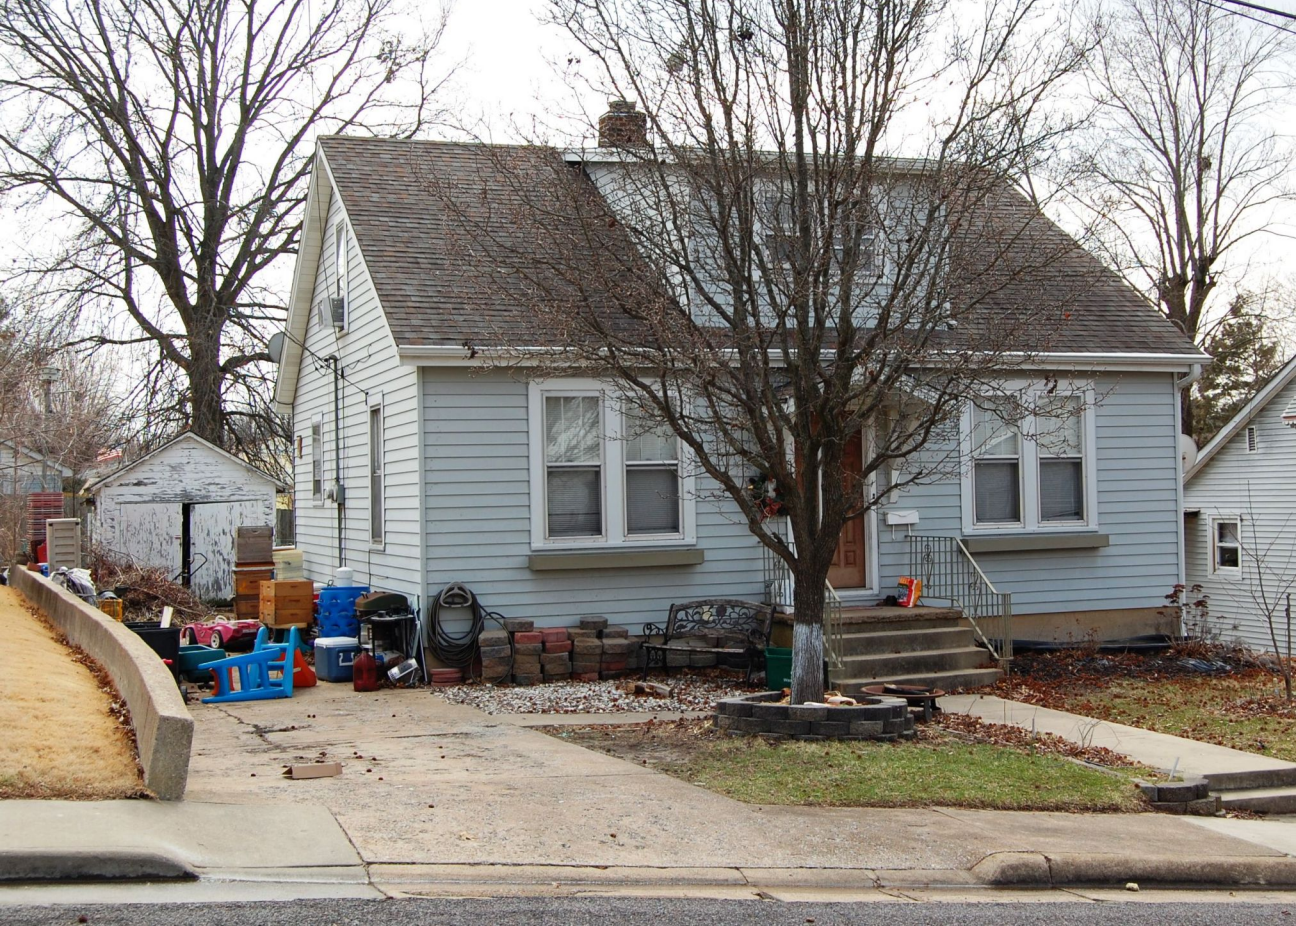
The c1932, 1.5 story frame dwelling has a concrete foundation, vinyl siding, and a side gable, asphalt shingle roof. The front façade is 3 bays wide. Centered on the façade is a single bay entry with concrete platform and stairs, wrought iron railing, and an asphalt shingled, front gable hood with large brackets. The main entrance is an arched faux leaded glass and paneled wood replacement door. There are paired 3/1 vertical wood sash windows set in flat surrounds, on either side of the entry. A large shed dormer with vinyl clad walls and paired 1/1 wood sash windows centered within the upper story are on the N and S elevations. There is a central, interior straddle ridge brick chimney. This property was not surveyed in 1992.

The house was built during the period of significance however the original siding is unknown. If it were weatherboard it could be contributing, but if it were asbestos shingles it would be noncontributing. Due to its retention of other materials (windows, entry hood & porch) but having unknown original siding, the house is not determined at this time for potential NR district contribution.

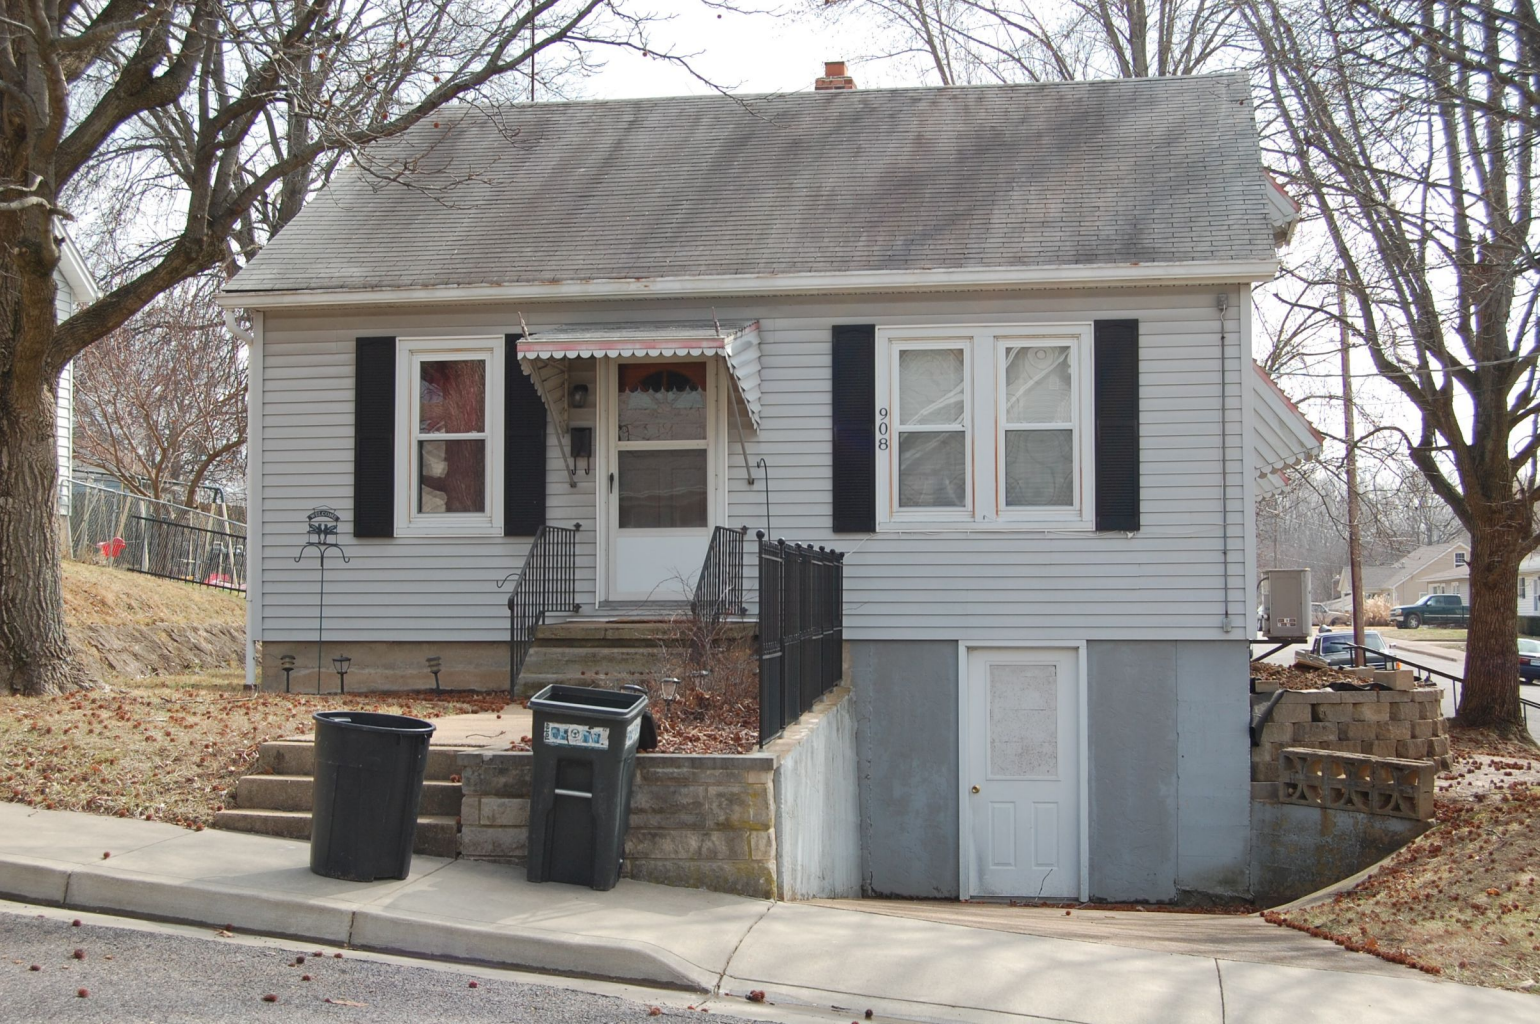
The 1.5 story frame dwelling has a concrete foundation, vinyl siding, and an asphalt shingle, side gable roof. The front façade is 3 bays wide. Offset left on the façade is a single bay entry with shallow concrete platform and stairs, metal railing and a traditional metal awning with scalloped trim. The main entrance is a fan light glass and paneled wood replacement door and glass and metal storm door. To the left of the entry is a single window and to the right is a paired window. Windows are replacement 1/1 vinyl sash with ornamental shutters. Within the foundation level, side right, is an enclosed, former built-in garage now containing a boarded rectangular light and paneled metal door. On the S elevation is a 1-story addition with extended shed roof and a concrete patio with corrugated metal shed roof and metal posts. There is a central interior, rear slope brick chimney. This house was not surveyed in 1992. Due to the home's exterior alterations in siding to vinyl, replacement of windows, and enclosure of the foundation level garage, it is not a contributing resource to a potential NR district.

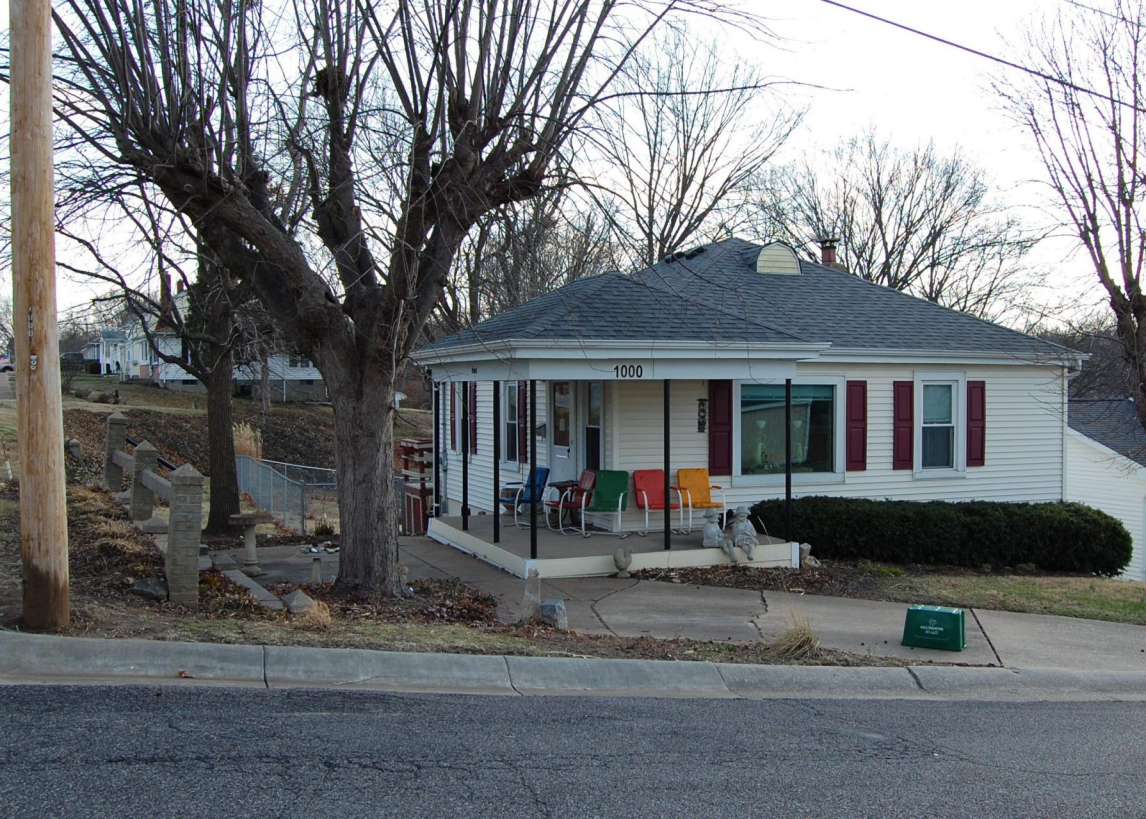
The 1-story frame dwelling has a concrete foundation, vinyl siding, and an asphalt shingle, hipped roof. The front façade facing James is 2 bays wide and the side facade facing Fair is 4 bays wide. The N elevation has a large, fixed single light picture window and a 1/1 indeterminate sash window. On the NE corner of the house is a concrete platform, wraparound porch with metal posts and a hipped, asphalt shingle roof. Sheltered within the porch, on the E elevation, is a single window and single entry consisting of a c1950, 4-light glass and wood paneled door with metal and glass screen door. To the left of the porch are two additional windows. Windows on the E elevation are 1/1 indeterminate sash with ornamental shutters. On both the S and E elevations is a single, small arched enclosed attic dormer vent. On the S elevation is a 1-story frame addition with shed roof and a walk out basement entry. This property was not surveyed in 1992.

This house was built during the period of significance, however it was constructed towards the beginning of the 1950s and the alteration of vinyl siding would be a later addition. It is therefore not a contributing resource to a potential NR district.

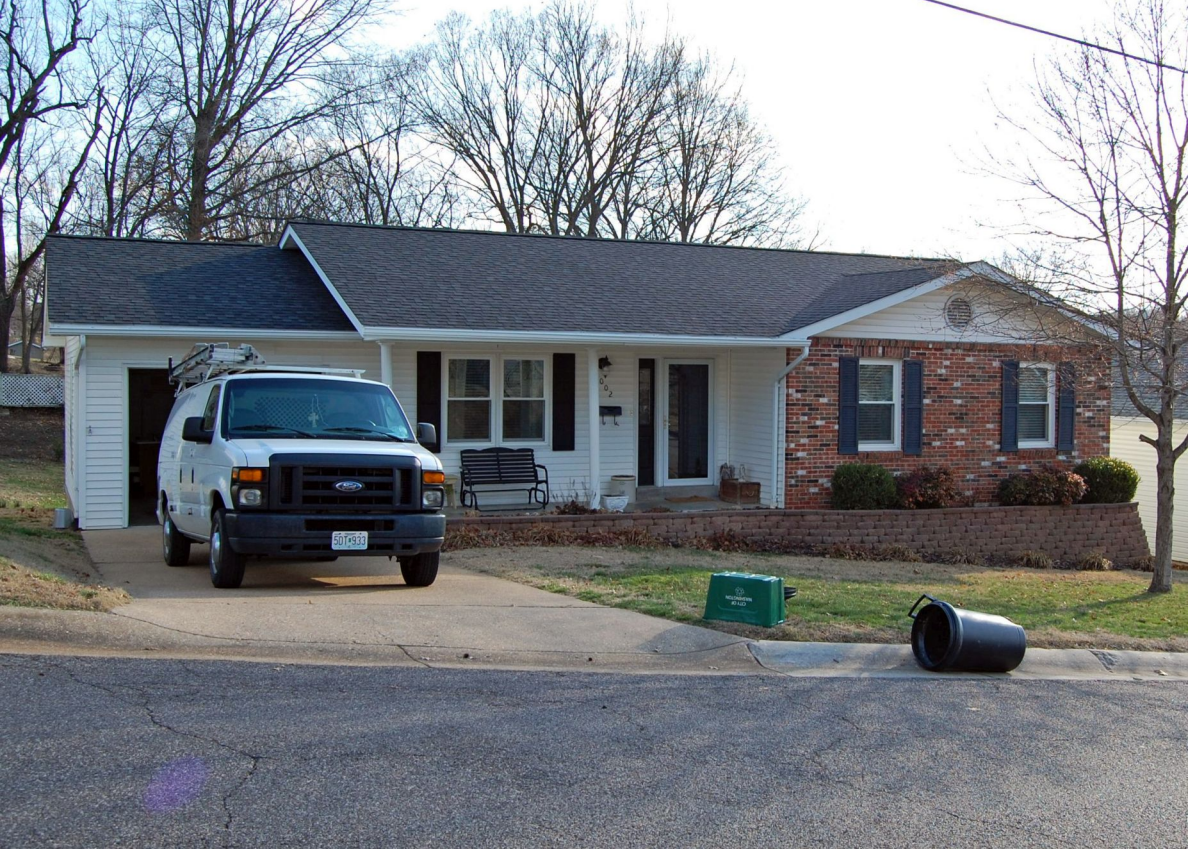
The 1-story frame dwelling has a concrete foundation, vinyl siding with brick veneer over a side right bay, and a side gable, asphalt shingle roof. The front façade is 5 bays wide. There is a front facing gable, side right that does not protrude very far in front of the side left, side gable wing. The side right bay has a variegated brick veneer containing two 1/1 vinyl windows with ornamental shutters set within a brick course jack arch with a rowlock course brick lug sill. The upper portion of the front gable has vinyl siding and a round vent. To the left of this bay is an incised porch with two fluted metal clad round columns under the primary side gable roof. Sheltered within the porch is a single entry, consisting of paneled composite door with a glass and metal storm door and one single light sidelight, and a paired 1/1 vinyl sash window with ornamental shutters. The far left bay is an attached, 1-car garage with a dropped side gable roof. On the S elevation is a partial width wood deck and a walk out basement. This property was not surveyed in 1992. Due to its recent date of construction, this home is not a contributing resource to a potential NR district.
