MISSOURI DEPARTMENT OF NATURAL RESOURCES
STATE HISTORIC PRESERVATION OFFICE, P.O. Box 176, Jefferson City, MO 65102
ARCHITECTURAL/HISTORIC INVENTORY FORM

1. SURVEY NO. FR-AS-007-0104		2. SURVEY NAME: International Shoe Factory Neighborhood	
3. COUNTY: Franklin		4. ADDRESS (STREET NO.) 301	STREET (NAME) High Street

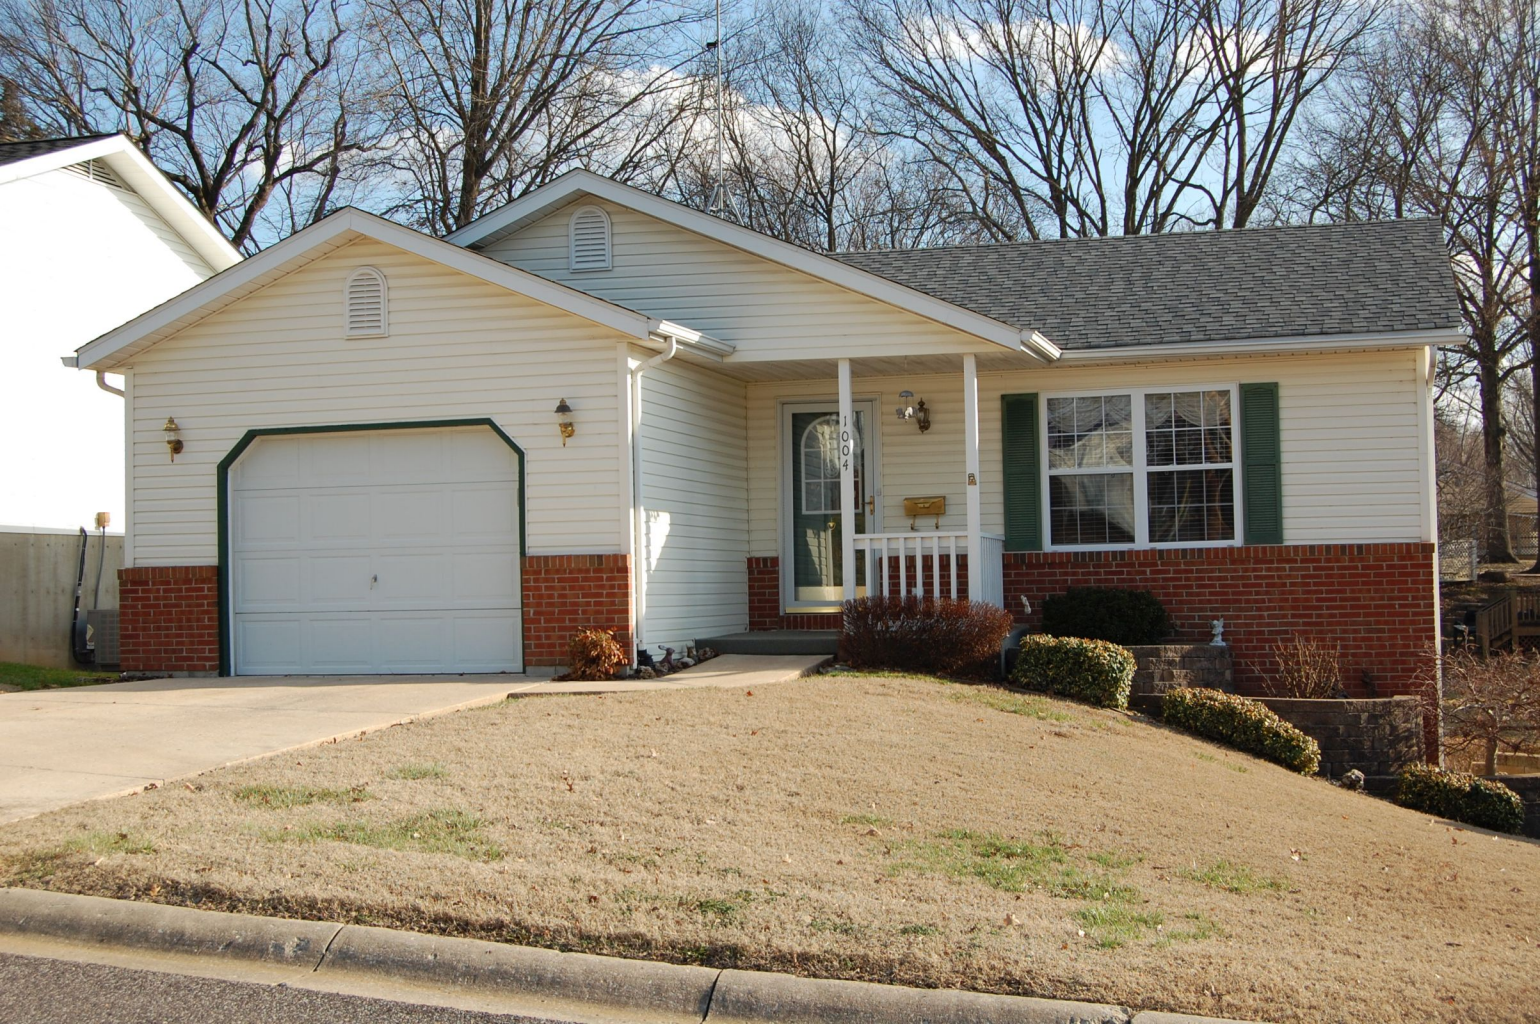
The 1-story frame dwelling has a concrete foundation, vinyl siding with a brick veneer dado along the front façade, and a gable front and wing asphalt shingle roof. The primary façade is 3 bays wide. The side left bay consists of a dropped, front gable built-in 1-car garage with a paneled metal overhead door set within a clipped surround. To the right of the garage bay, within the primary front gable roof is a single entry bay. There is a concrete platform with two wood posts, and open square wood post balustrade underneath the eave. Sheltered within the bay is a single entry consisting of an arched, faux multi-light glass and paneled metal door. The side right bay, set within the side gable wing, is paired 6/6 faux interior muntin, vinyl sash windows with ornamental shutters. This house was not surveyed in 1992. Due to its recent date of construction, this home is not a contributing resource to a potential NR district. Due to its recent date of construction, this home is not a contributing resource to a potential NR district.

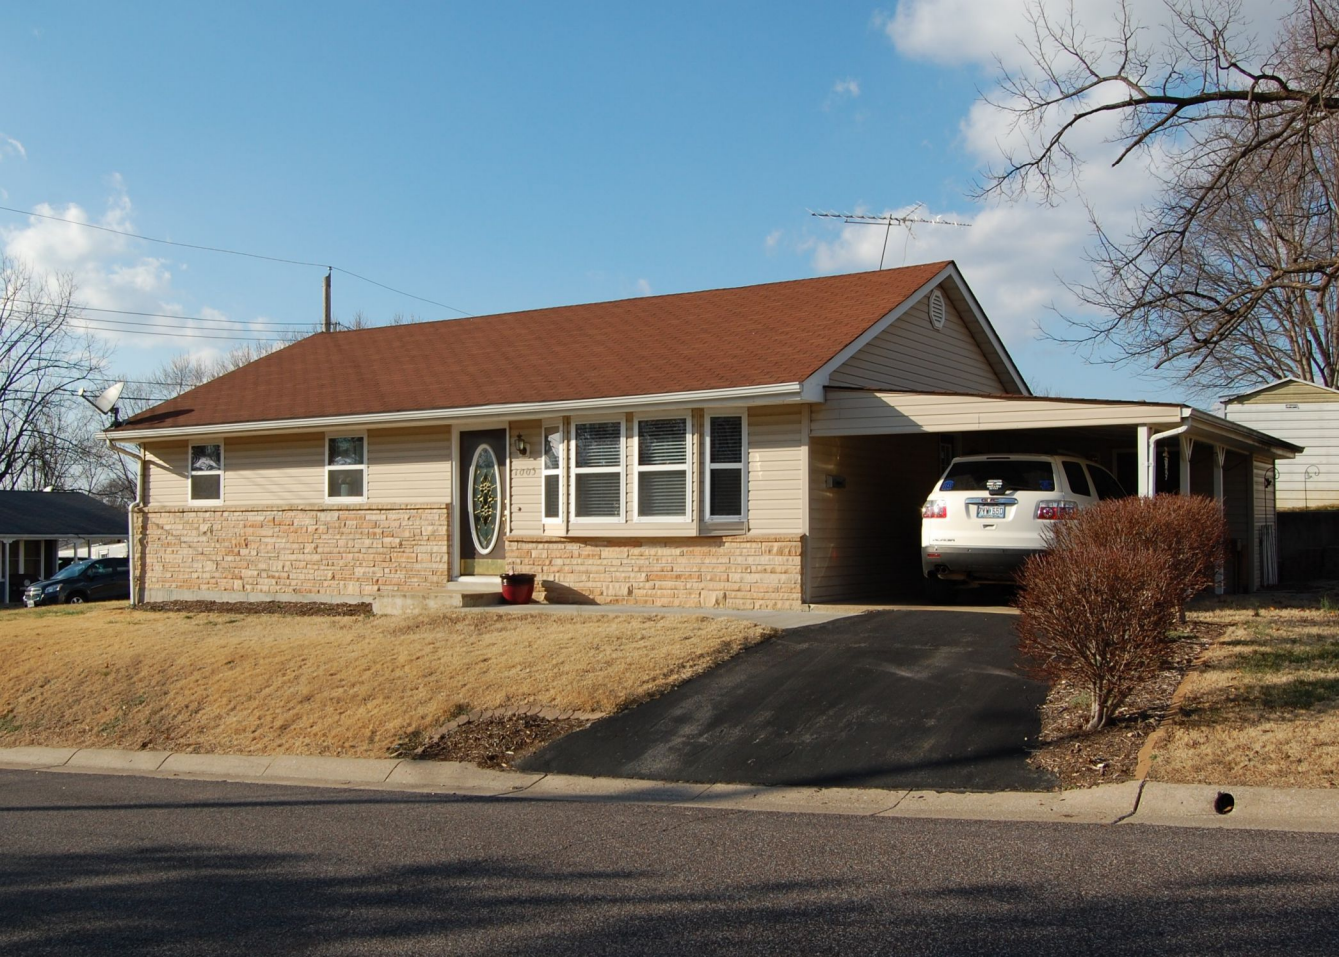
The 1-story frame dwelling has a concrete foundation, vinyl siding with a permastone dado wall on each elevation, and an asphalt shingle, side gable roof. The front façade is 4 bays wide. Offset right is a concrete platform and a single entrance consisting of an oval, faux leaded light and wood door. Side left are two smaller 1/1 vinyl sash windows. Side right is a canted bay window containing 4, 1/1 vinyl sash windows. On the E elevation is an attached shed roof carport with 3 square wood support posts and a rear enclosed utility closet. The 1-car structure has a concrete parking pad and an asphalt paved driveway connected to James Street. This home was not surveyed in 1992. Due to the replacement in windows and vinyl siding, the home is not a contributing resource to a potential NR district.

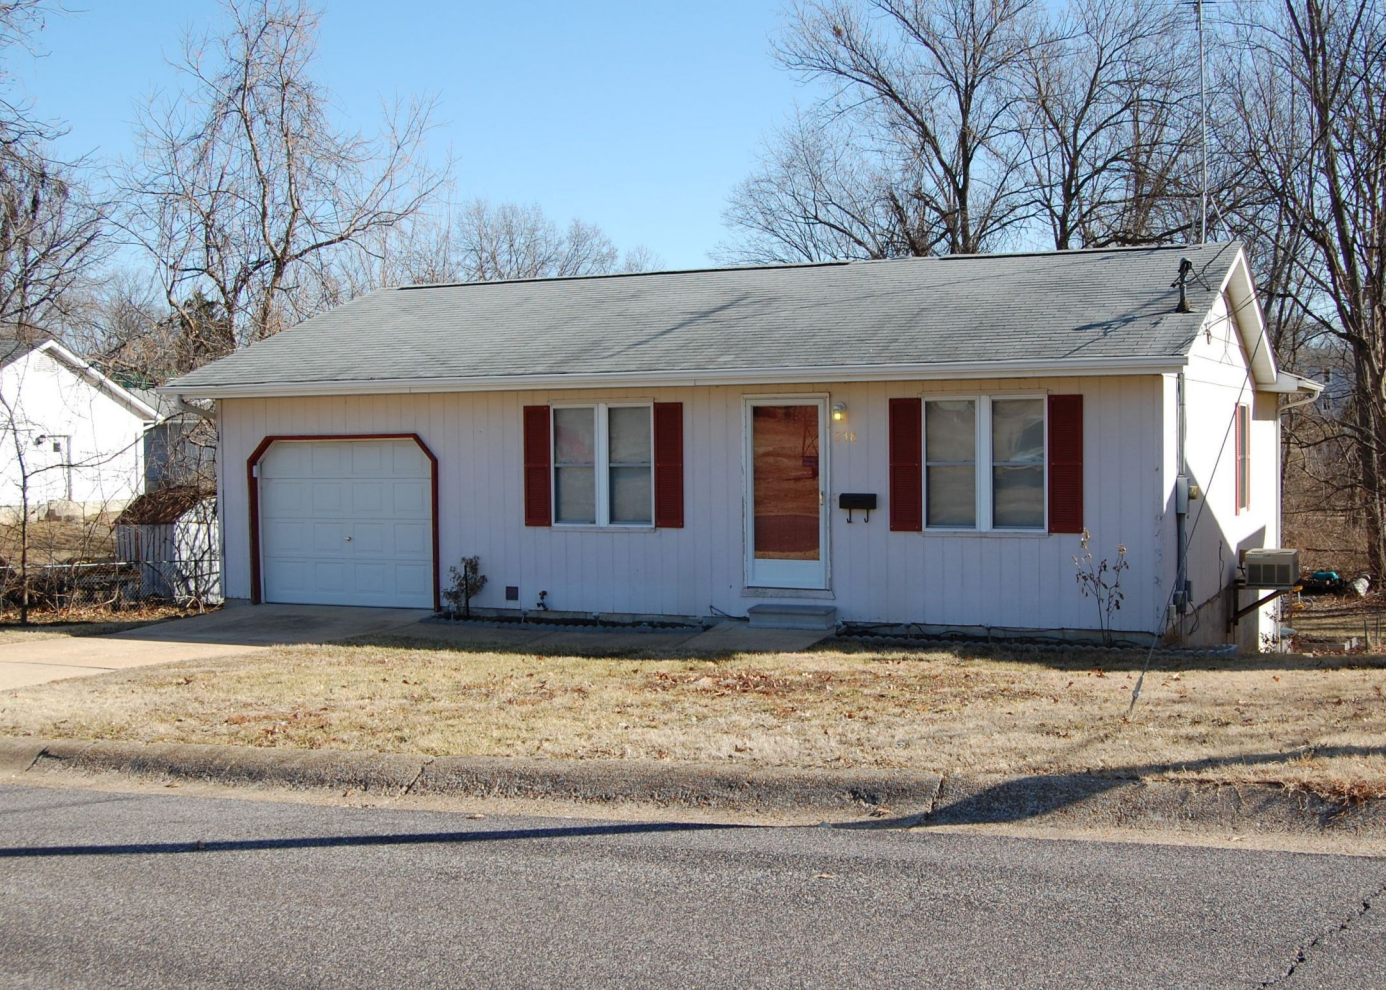
The 1-story dwelling has a poured concrete foundation, composite siding in the appearance of vertical boards, and a rear facing, cross gable asphalt shingle roof. The front façade is 4 bays wide, consisting of a built-in 1 car garage, side left, and paired 1/1 double-hung windows flanking a single entry door, side right. The garage bay has a clipped opening containing a paneled metal overhead door. The entry consists of a concrete block step on top of the sidewalk, a metal and glass storm door, and a solid wood door. The windows are vinyl 1/1 sash of indeterminate age and have ornamental shutters. The cross gable is at the rear of the home, side right, or the SE corner of the home. Within the side gables, the composite siding is horizontal and has a wider profile. The home was left out of the 1992 survey.

Due to its recent date of construction, this building is not considered eligible for listing as part of a potential NR district.

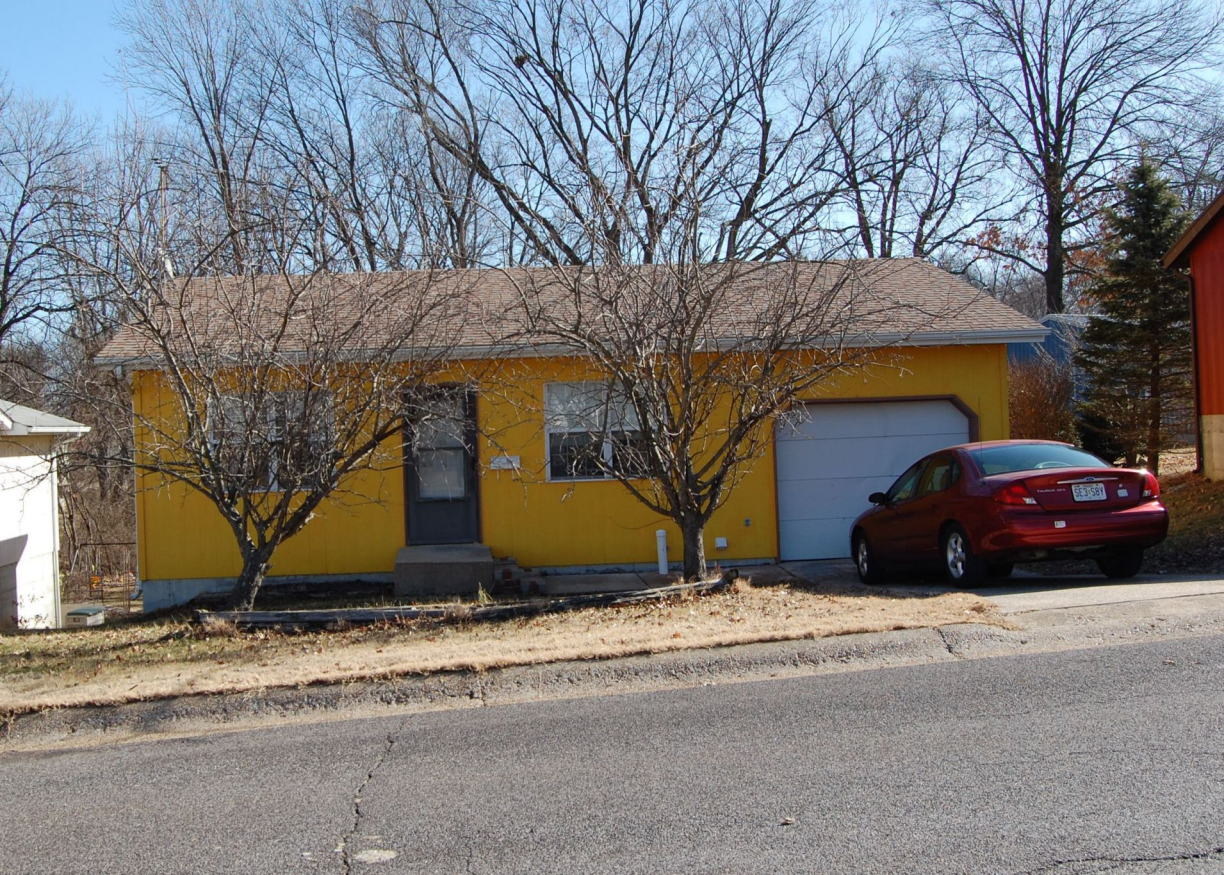
The 1-story dwelling has a poured concrete foundation, composite siding in the appearance of vertical boards, and a rear facing, cross gable asphalt shingle roof. The front façade is 4 bays wide, consisting of a built-in 1 car garage, side right, and paired 6/6 false interior muntin, double-hung vinyl windows flanking a single entry door, side left. The garage bay has a clipped opening containing an older metal overhead door. The entry consists of a small concrete platform with two steps running parallel to the building, a metal and glass overhead door and a paneled door of indeterminate material. The cross gable is at the rear of the home, side left, or the NE corner of the home. Within the side gables, the composite siding is horizontal and has a wider profile. The home was left out of the 1992 survey.

Due to its recent date of construction, 1988, this building is not considered eligible for listing as part of a potential NR district.

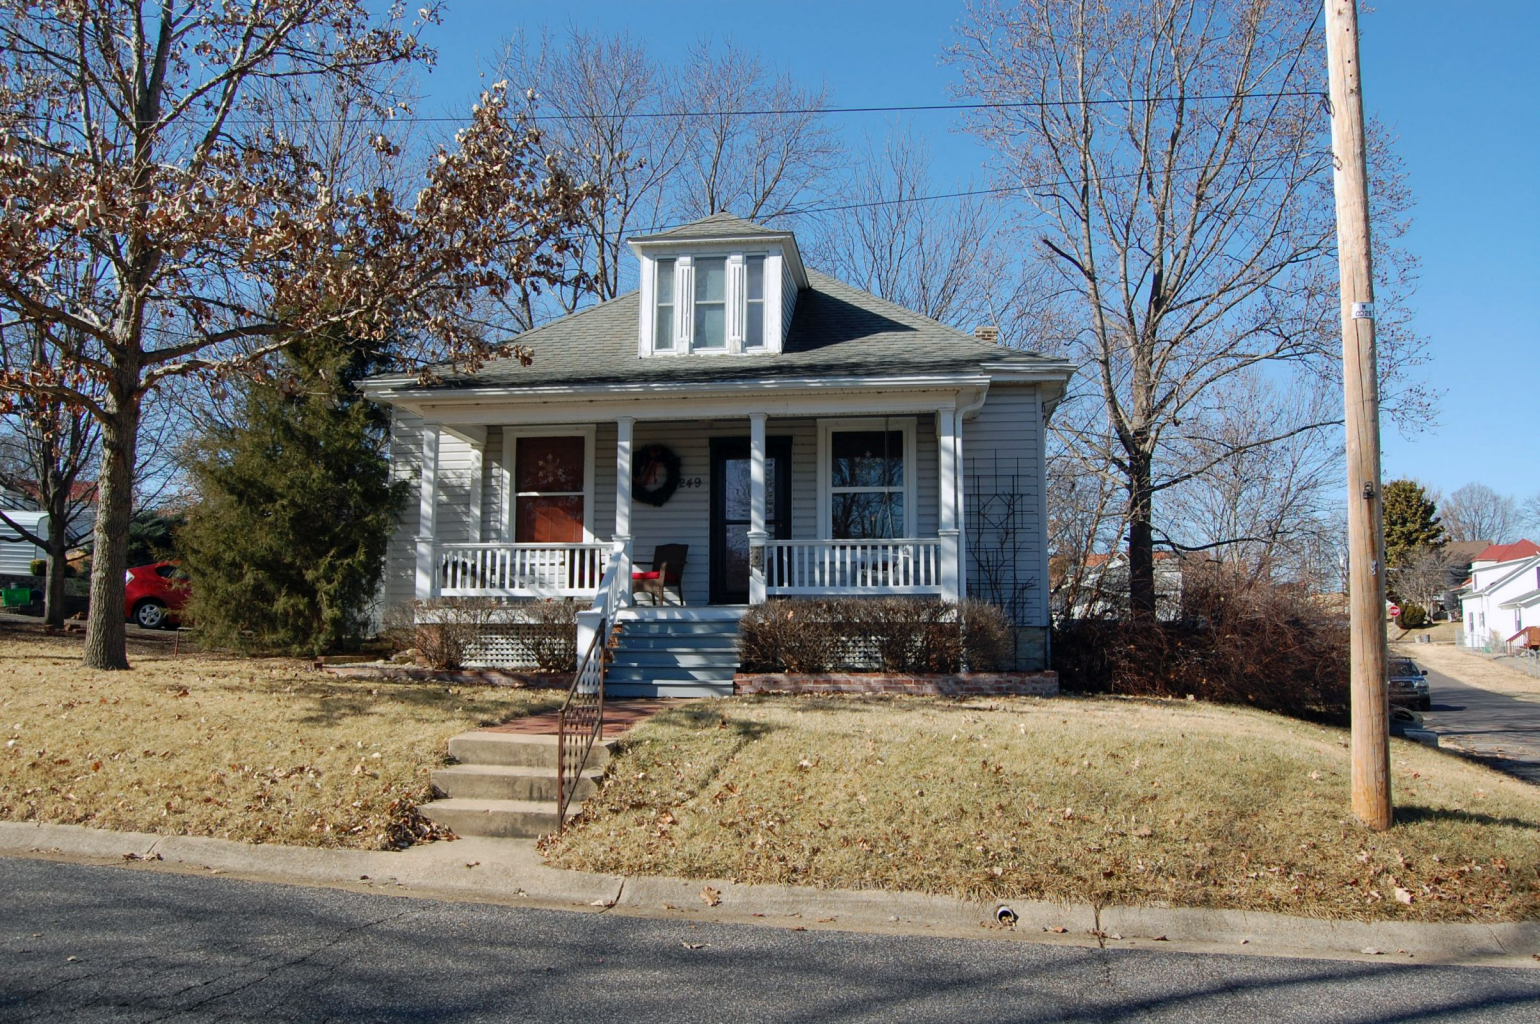
The 1.5-story frame dwelling has a limestone foundation, vinyl siding, and a hipped, asphalt shingle roof. The primary façade has 3 bays with a 3/4 width, 1-story open front porch with a shed roof extended from the primary roof. It's supported by four square wood posts and surrounded by an open, square wood post balustrade. The porch has centered, wood entry steps and wood decking resting on brick piers with a lattice in-fill. The entry is slightly off set right and contains an original rectangular single-light wood door and a screen door. On either side of the entry are single 1/1 double-hung windows obscured by wood storms. Centered on the upper half story of both E & W elevations are hipped dormers. The front dormer contains a central bay with a ribbon of three, 1/1 double-hung windows divided by mullions with engaged, fluted pilasters. Windows are set in flat wooden surrounds and are replacements of indeterminate material. There is an interior wall, side slope right brick chimney. A rear addition, post 1951 according to Sanborn maps, has a stone foundation unlike original (newer, more precise cut stone). Major alterations since the 1992 survey include: replacement of wrought iron staircase railing on entry steps with wood to match existing balustrade, removal of porch screen enclosure and original window screens, replacement of asbestos shingle cladding with vinyl, replacement of standing seam metal roof and pressed metal dormer siding with asphalt shingles, and removal of side right roof antenna. Due to the alterations in the siding and roof cladding, this building is noncontributing.

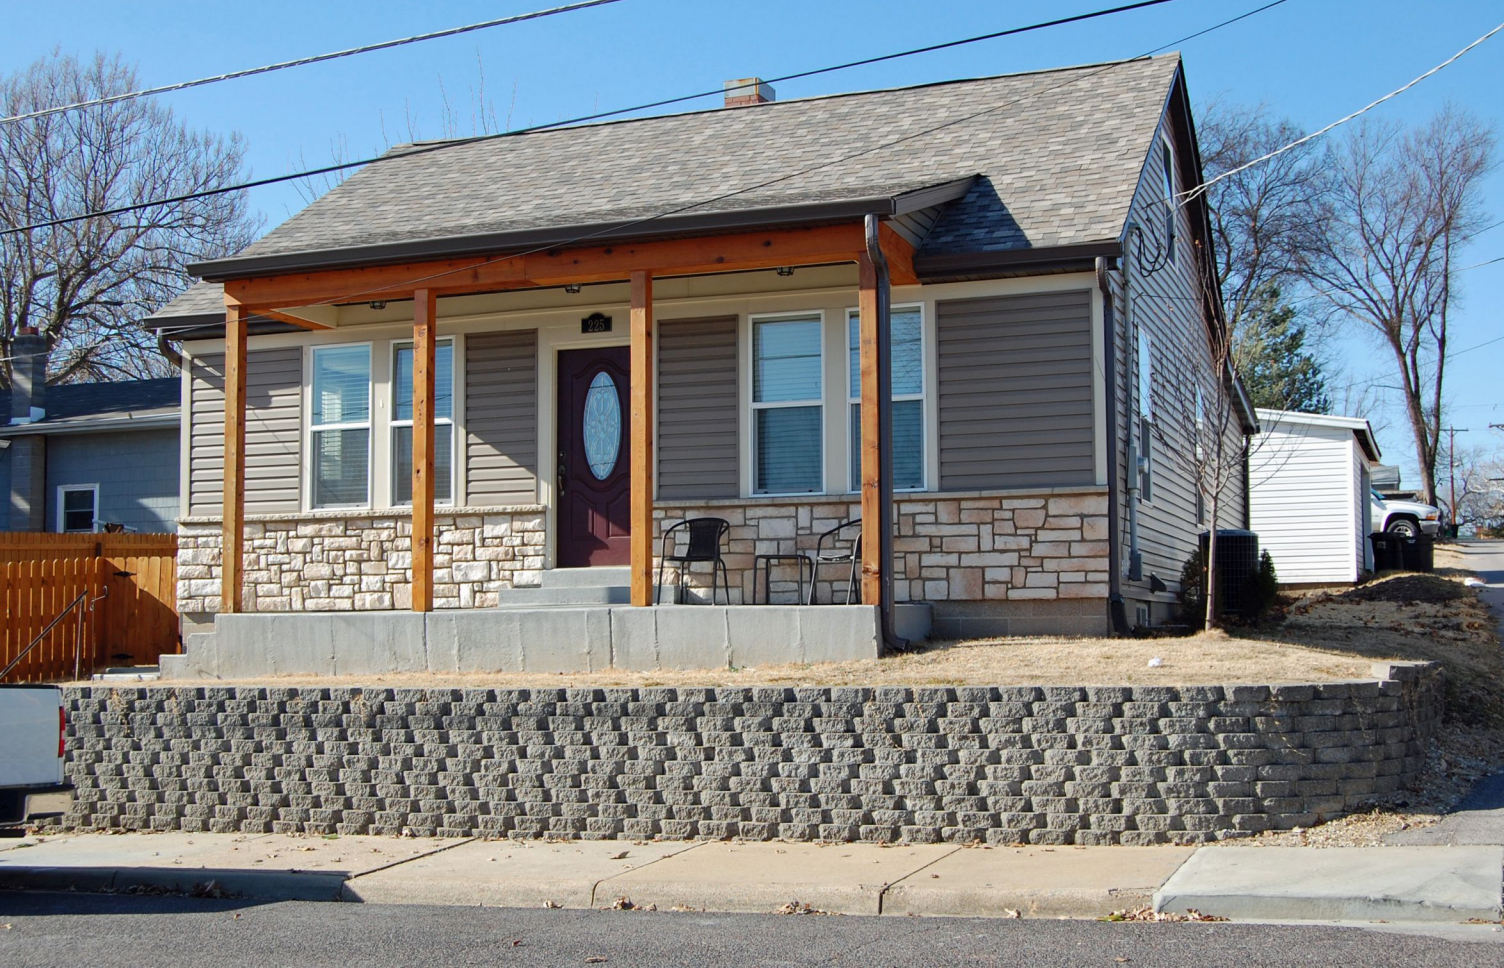
The 1.5 story wood frame, single family dwelling has a concrete block foundation, vinyl siding, and a side gable asphalt shingle roof. The primary façade has 3 bays with a centered $\frac{3}{4}$ width engaged porch. The porch has an extended shed roof from the primary, 4 wood posts, faux stone veneer dado wall, and a concrete platform. The concrete entry stairs, side left, run parallel to the home. Within the porch is a single entry, consisting of a replacement faux leaded oval light door, flanked by paired windows. Windows are c2015 replacement 1/1 double-hung vinyl sash. The west elevation has a wood frame, shed roof addition. The S elevation has a single entry into the side yard. Since the 1992 survey, major alterations include: post 2016 replacement of asbestos shingle cladding with vinyl siding and faux stone, newer fixed single light door with the current door, 1/1 wood sash windows and surround with 1/1 vinyl sash (no surrounds on side elevations), enclosed rear side entry on N elevation; c2017 changes include a newer asphalt shingle roof, replacement of centered stoop and bracketed front gable hood with new porch, and removal of side left roof antenna.

Due to the recent alterations in the siding, roof cladding, and porch, this building is not considered eligible for listing in a potential NR district.

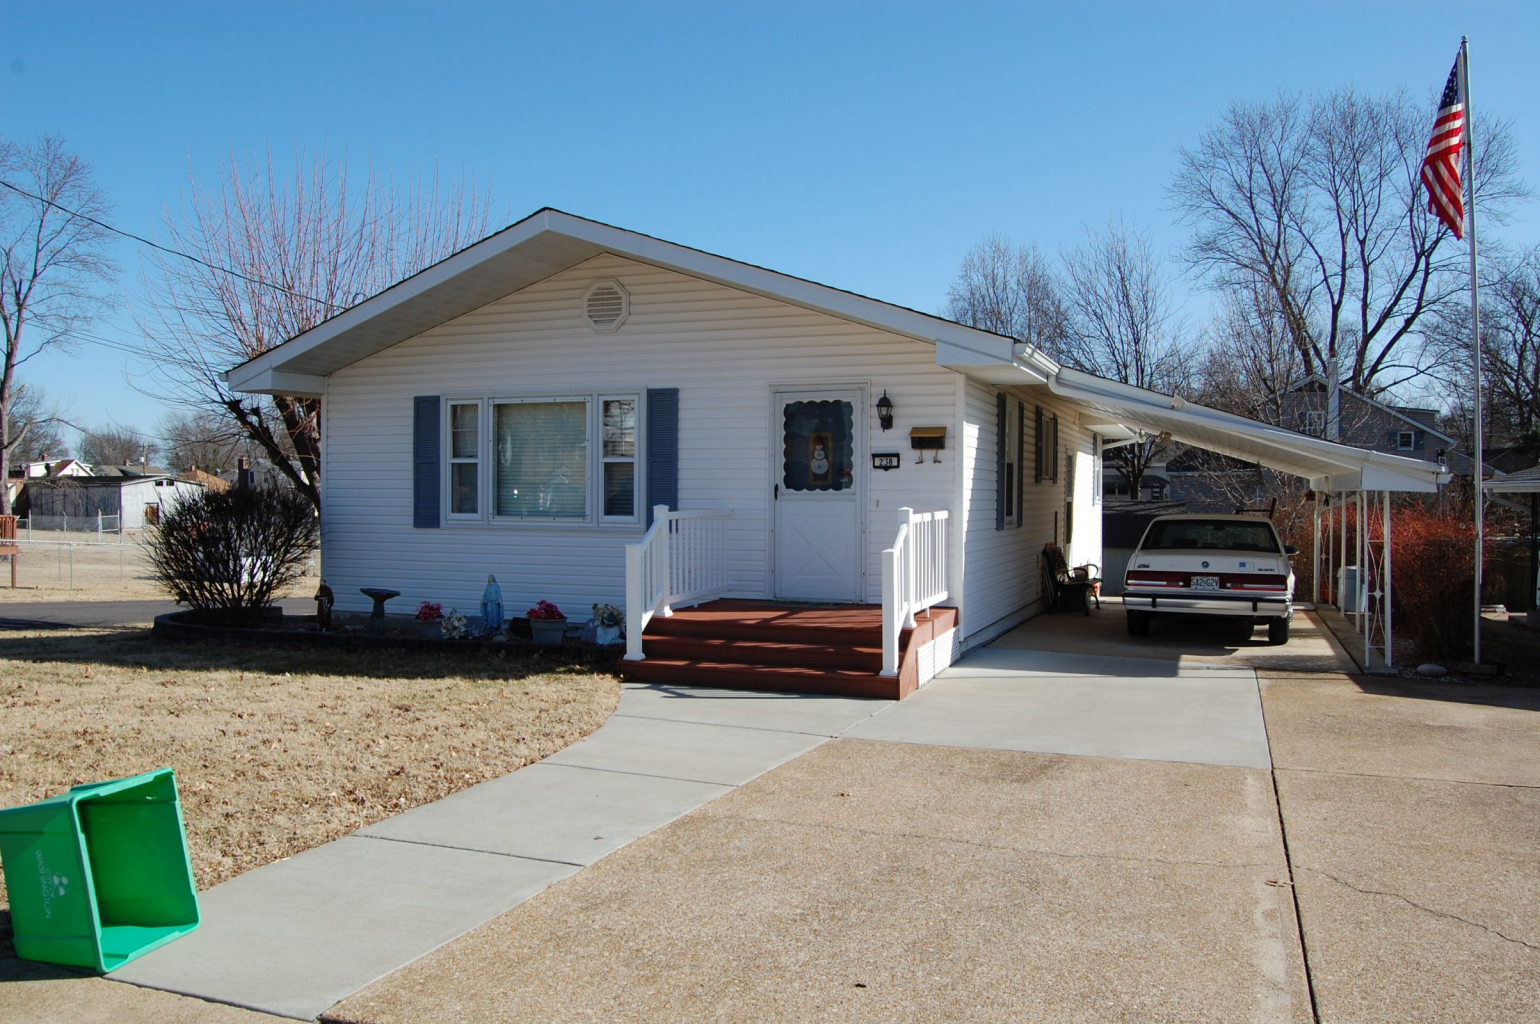
The 1-story frame dwelling has a formed concrete foundation, vinyl siding and a very low front gable, asphalt shingle roof that extends, side right, into a carport bay. The roof has character defining, wide overhanging eaves. The primary façade is 2 bays wide. It consists of a side right composite or hardy board stoop with composite square post and rectangular rail balustrade. The single entry within the stoop is a new door with small rectangular light. The left side bay contains a picture window of a fixed central light flanked by single, 2/2 horizontal muntin wood sash windows with ornamental shutters. Within the upper front gable is an octagonal vent. On the southern elevation is a carport with shed roof extended from the primary roof and small metal posts infilled with decorative wrought iron. Side elevation windows are 1/1 replacement vinyl sash. The 1992 survey photographed but did not fill out a form for this dwelling. Post 1992 alterations include replacement of aluminum siding with vinyl and replacing the original wood entry porch with composite materials. The assessor's office notes the date of construction as c1956, however due to the alterations in siding to vinyl, the building is not considered eligible for listing in a potential NR district.

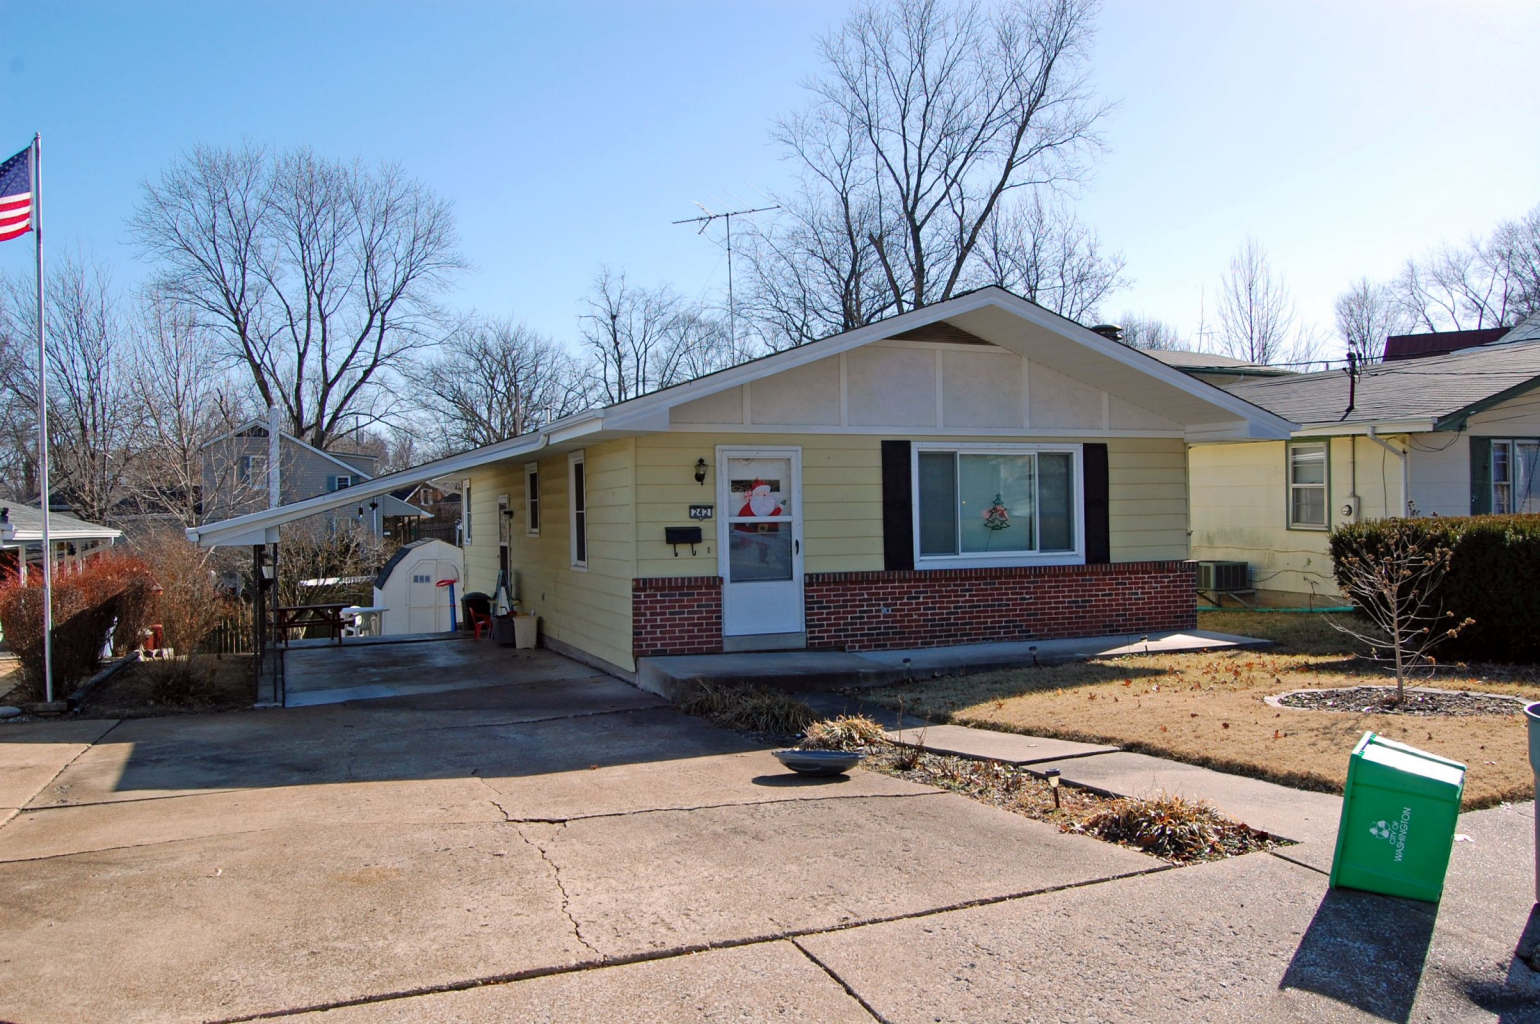
The 1-story frame dwelling has a formed concrete foundation, aluminum siding and a very low front gable, asphalt shingle roof that extends, side left into a carport bay. The roof has character defining, wide overhanging eaves. The primary façade is 2 bays wide. The front façade has a full width concrete sidewalk, parallel to the home, a brick veneer dado wall with angled rowlock sill course followed by aluminum siding and an indeterminate material and batten within the front gable. Due to the date of construction, these materials may be original, as it was built later than the similar other three homes on the block. There is a side left primary entry consisting of an older thin horizontal rectangle light glass and wood door. The side right bay has a three part picture window with replacement fixed single light glass (of indeterminate material) and ornamental shutters. On the northern elevation is a centered carport with shed roof extended from the primary roof with decorative wrought iron posts. On the southern elevation is a small, aluminum clad bump-out for the metal stack chimney. The 1992 survey photographed but did not fill out a form for this dwelling. Post 1992 alterations include replacement of the wood sash picture window with 2/2 horizontal wood sash side windows with a single light glass of indeterminate material. The assessor's office notes the date of construction as c1959 and due to its date of construction within the period of significance, the building is a contributing resource and eligible for potential district materials.

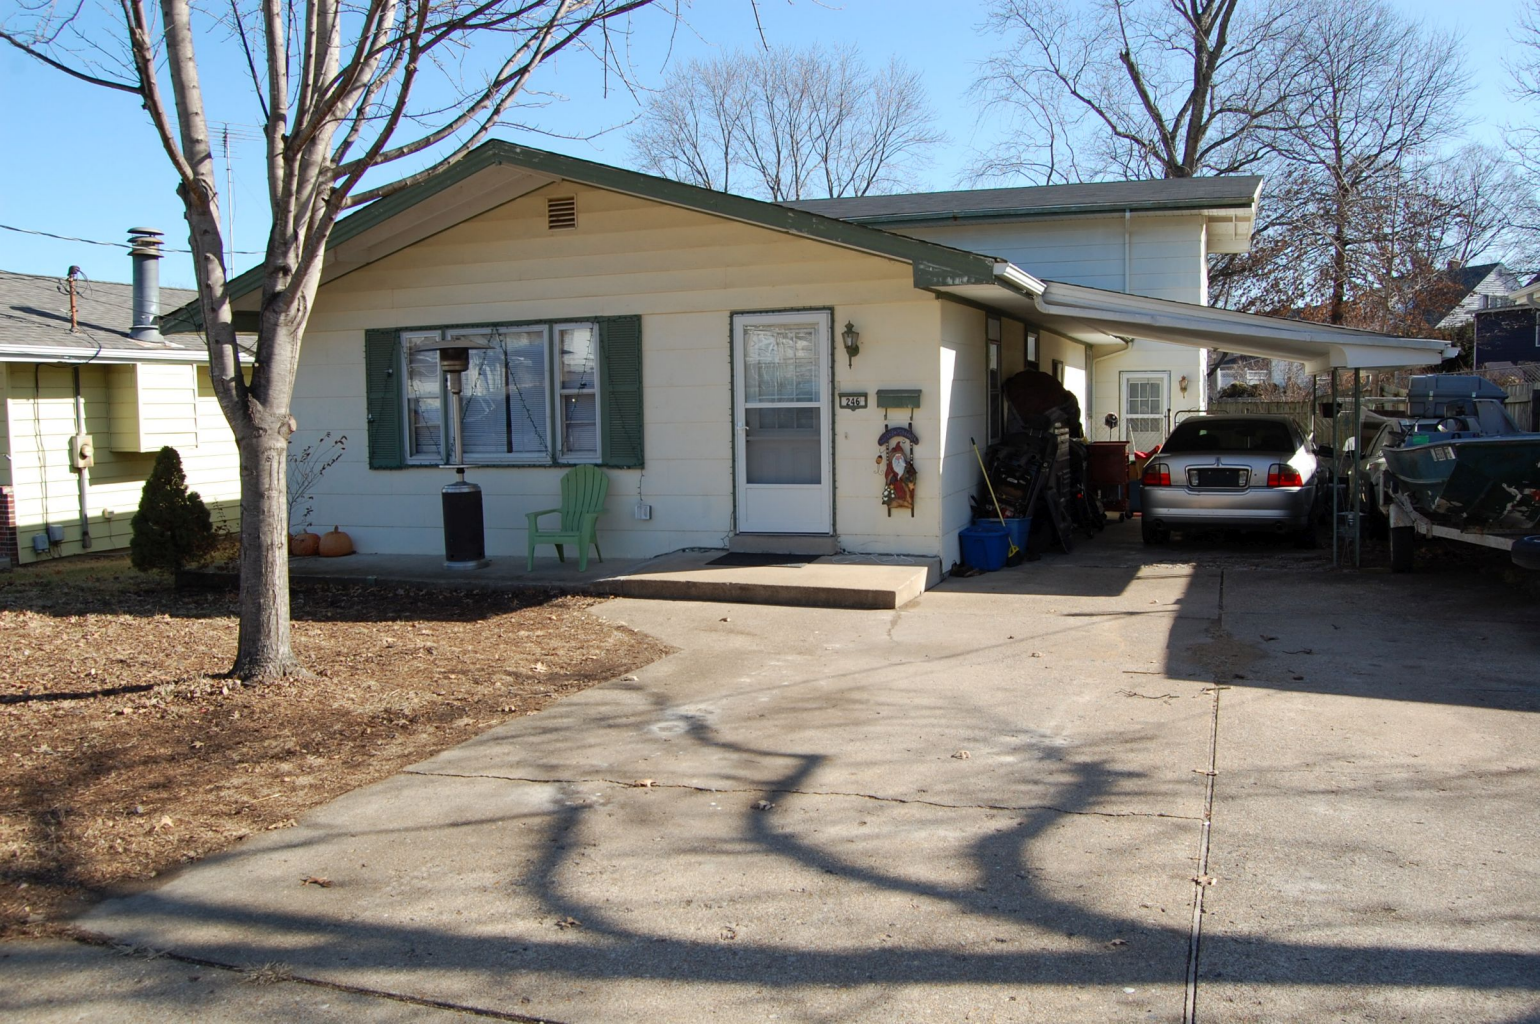
The 1-story frame dwelling has a formed concrete foundation, asbestos shingle siding and a very low front gable, asphalt shingle roof that extends, side right, into a carport bay. The roof has character defining, wide overhanging eaves. The primary façade is 2 bays wide. It consists of a side right raised concrete platform and single entry. The entry is a replacement 9-light and paneled aluminum door. The side left bay contains a lowered partial width concrete platform, single picture window with centered fixed light glass flanked by single, 2/2 horizontal wood sash with ornamental shutters. Within the upper front gable is aluminum siding and a rectangular gable vent. On the southern elevation is a centered carport with shed roof extended from the primary roof supported by metal posts with ornamental infill. There is a 2-story side gable addition at the eastern façade. The addition, noted as c1956 by the assessor's office, has aluminum siding and small rectangular single light windows and an open staircase leading to a 2nd story wood platform and. The 1992 survey photographed but did not fill out a form for this dwelling. There appears to be little to no alterations to home, however most of the front façade is obscured by trees in the 1992 photo. The assessor's office notes the date of construction as c1956 and due to its date of construction within the period of significance, the building is a contributing resource and eligible for potential district materials.

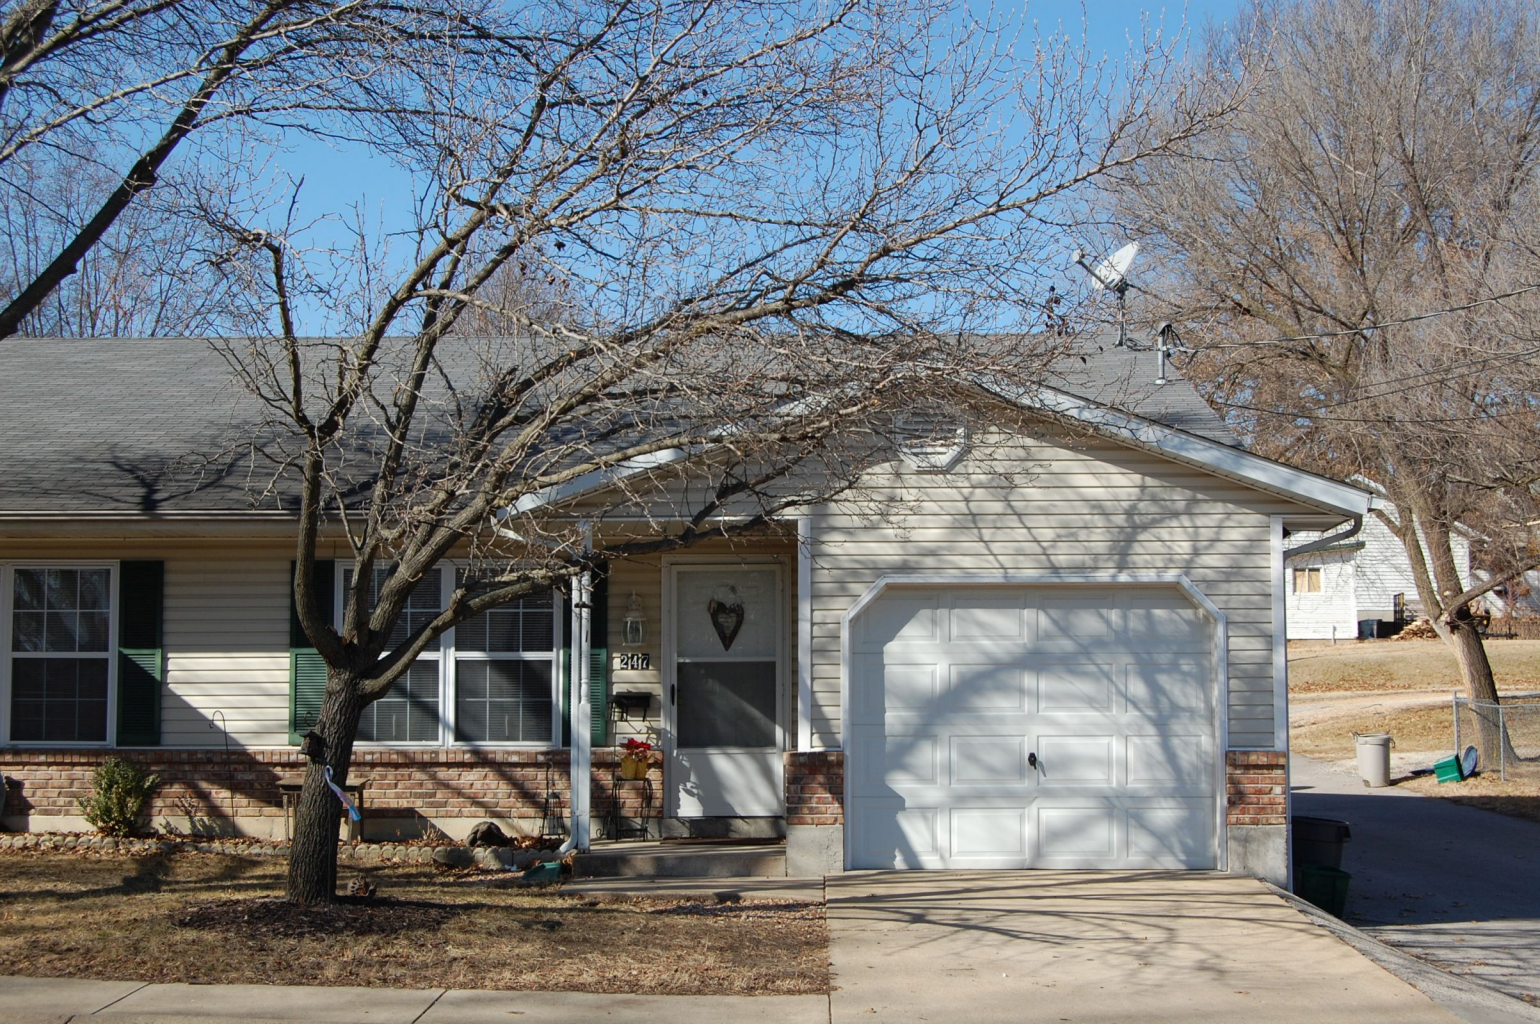
The 1-story, side right duplex was built in 1993. It has a concrete foundation, vinyl siding and a front gable and wing asphalt shingle roof. The primary façade is 3 bays wide with a brick veneer dado wall with rowlock sill course. The side right bay contains an extended gable front containing a 1-car garage bay. The garage has a paneled metal overhead door set within a clipped frame surround. To the left of the garage bay, sheltered within the same extended gable roof, is a single entry with a paneled door. This entry bay has a concrete slab platform and one turned spindle post supporting the eave. The side left bay, within the gabled wing, has paired 6/6 false interior muntin vinyl sash windows with ornamental shutters. (This property was not surveyed in 1992 as it was constructed post survey date). Due to the buildings date of construction outside the period of significance, it is a non-contributing resource and not eligible for potential district material.

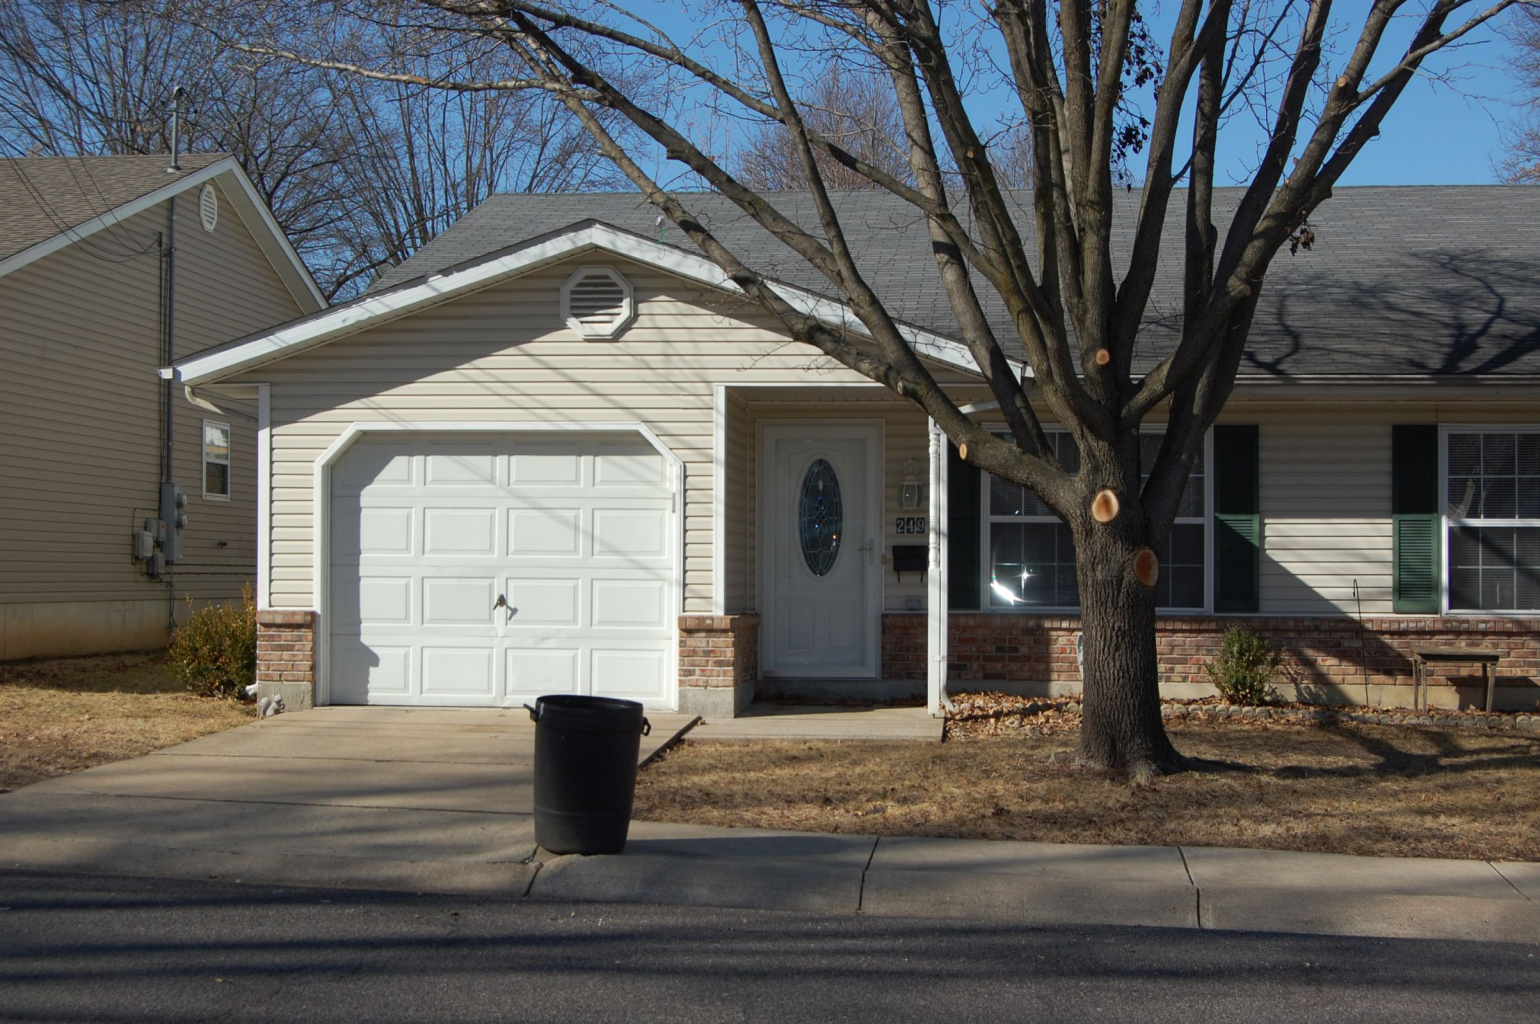
The 1-story, side left duplex was built in 1993. It has a concrete foundation, vinyl siding and a front gable and wing asphalt shingle roof. The primary façade is 3 bays wide with a brick veneer dado wall with rowlock sill course. The side left bay contains a projecting, gable front 1 car garage bay. The garage has a paneled metal overhead door set within a clipped frame surround. To the right of the garage bay, sheltered within the same extended gable roof, is a single entry bay with a concrete slab and one turned spindle post supporting the gable eave. The main entrance is a faux leaded oval light glass and paneled door. Within the front gable peak is an octagonal vent. The side right bay, within the gabled wing, has paired 6/6 false interior muntin vinyl sash windows with ornamental shutters. (This property was not surveyed in 1992 as it was constructed post survey date).

Due to the buildings date of construction outside the period of significance, it is a non-contributing resource and not eligible for potential district material.

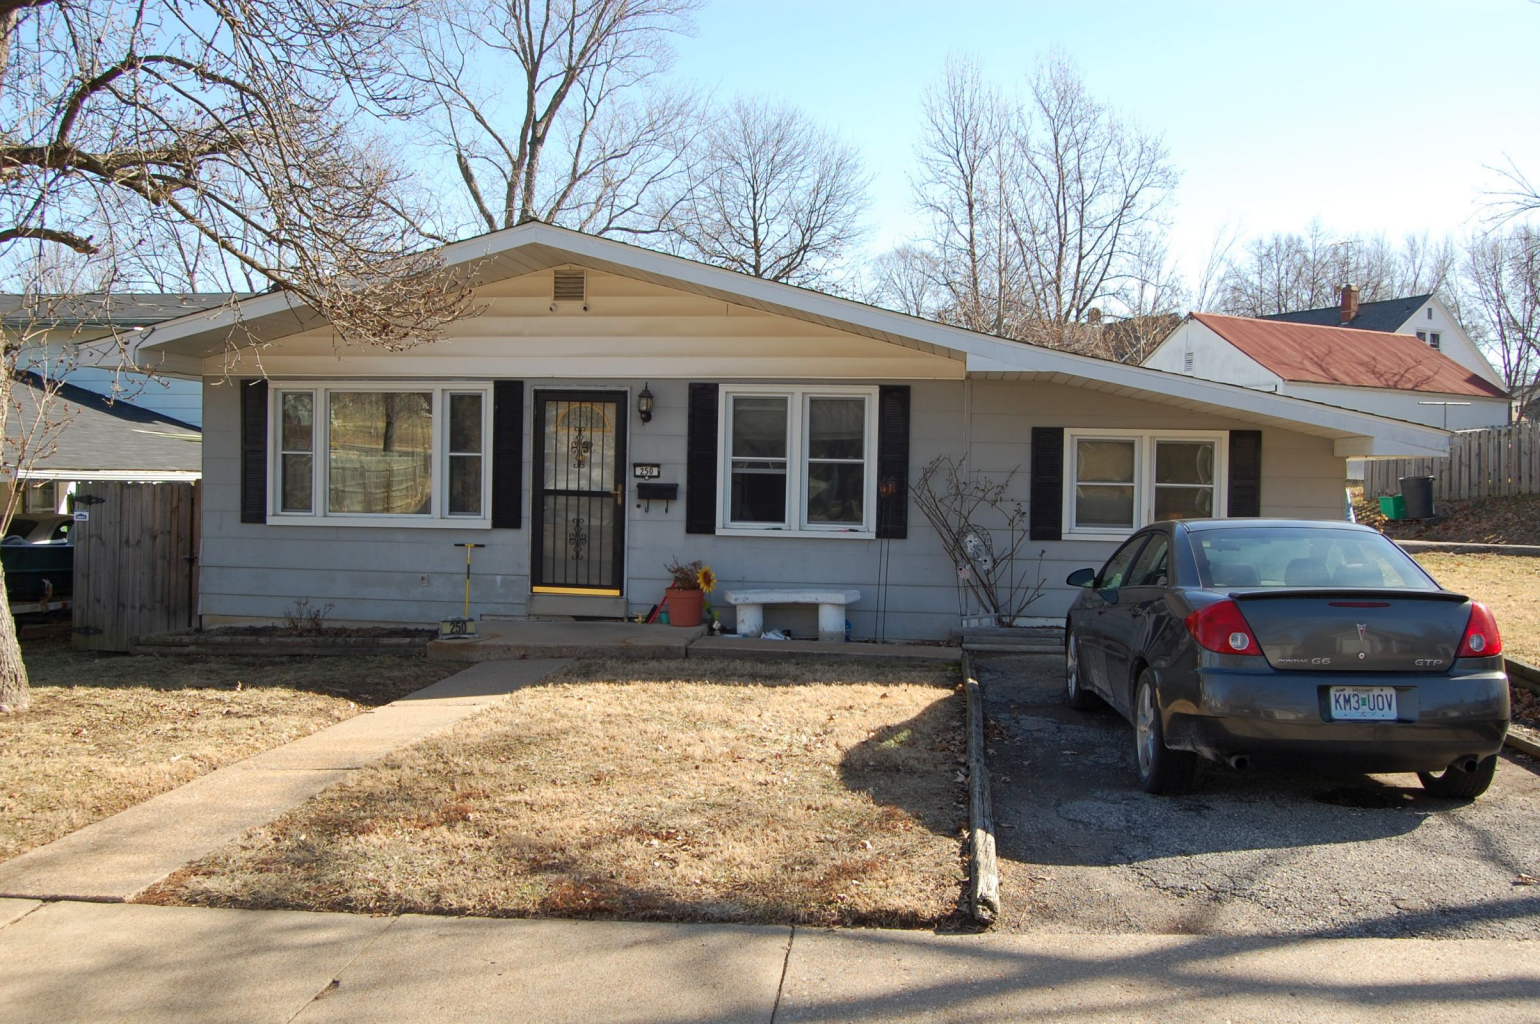
The 1-story frame dwelling has a formed concrete foundation, asbestos siding and a very low front gable, asphalt shingle roof that extends side right. The roof has character defining, wide overhanging eaves. The front façade is 4 bays wide. Centered upon the front elevation is a concrete stoop and single entry consisting of a replacement arched faux leaded glass light and paneled metal door with rectangular glass light and metal barred storm window. On the side left bay is a picture window with fixed center light and 1/1 vinyl sash windows. On the side right bay are paired 1/1 windows. Within the upper portion of the front gable is an indeterminate material siding and a rectangular vent. On the southern elevation is a 1-story enclosed former carport, with shed roof extended from the primary roof. There is a smaller paired 1/1 window within this bay addition. Front façade windows are vinyl sash with ornamental shutters. The south elevation has two fixed single light wood sash windows. Post 1950's the side right carport was enclosed. The 1992 survey photographed but did not fill out a form for this dwelling. There appears to be little to no alterations to home since the survey photo. While the historic windows were replaced and the carport enclosed, the home retains its historic cladding and character defining roof line. The building is considered a contributing resource for potential district materials.
