MISSOURI DEPARTMENT OF NATURAL RESOURCES
STATE HISTORIC PRESERVATION OFFICE, P.O. Box 176, Jefferson City, MO 65102
ARCHITECTURAL/HISTORIC INVENTORY FORM

1. SURVEY NO. FR-AS-007-0104		2. SURVEY NAME: International Shoe Factory Neighborhood	
3. COUNTY: Franklin		4. ADDRESS (STREET NO.) 301	STREET (NAME) High Street

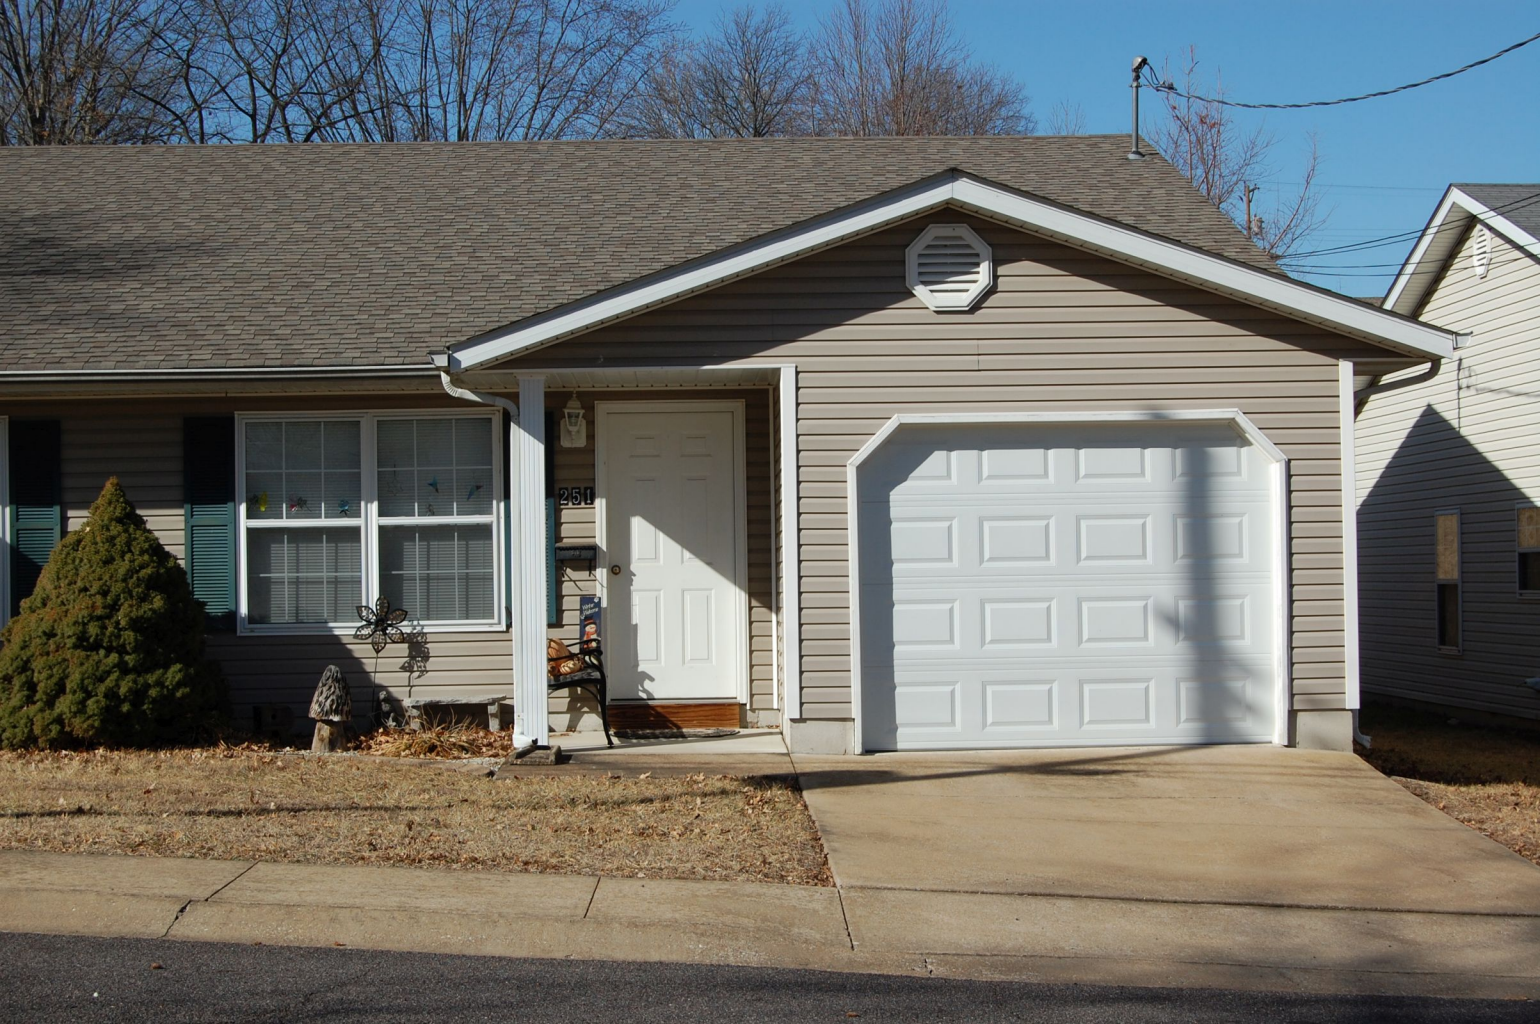
The 1-story, side right duplex was built in 1998 and is the mirror image of 253 Rand. It has a concrete foundation, vinyl siding and a front gable and wing asphalt shingle roof. The primary façade is 3 bays. The side right bay contains a projecting, gable front 1 car garage bay. The garage has a paneled metal overhead door set within a clipped frame surround. To the right of the garage bay, sheltered within the same extended gable roof, is a single entry bay containing a concrete slab, fluted square metal clad post and a single entry. The primary entrance is a paneled metal door. Within the gable peak is an octagonal vent. The side left bay, within the gabled wing, has paired 6/6 false interior muntin vinyl sash windows with ornamental shutters. (This property was not surveyed in 1992 as it was constructed post survey date).

Due to the buildings date of construction outside the period of significance, it is a non-contributing resource and not eligible for potential district material.

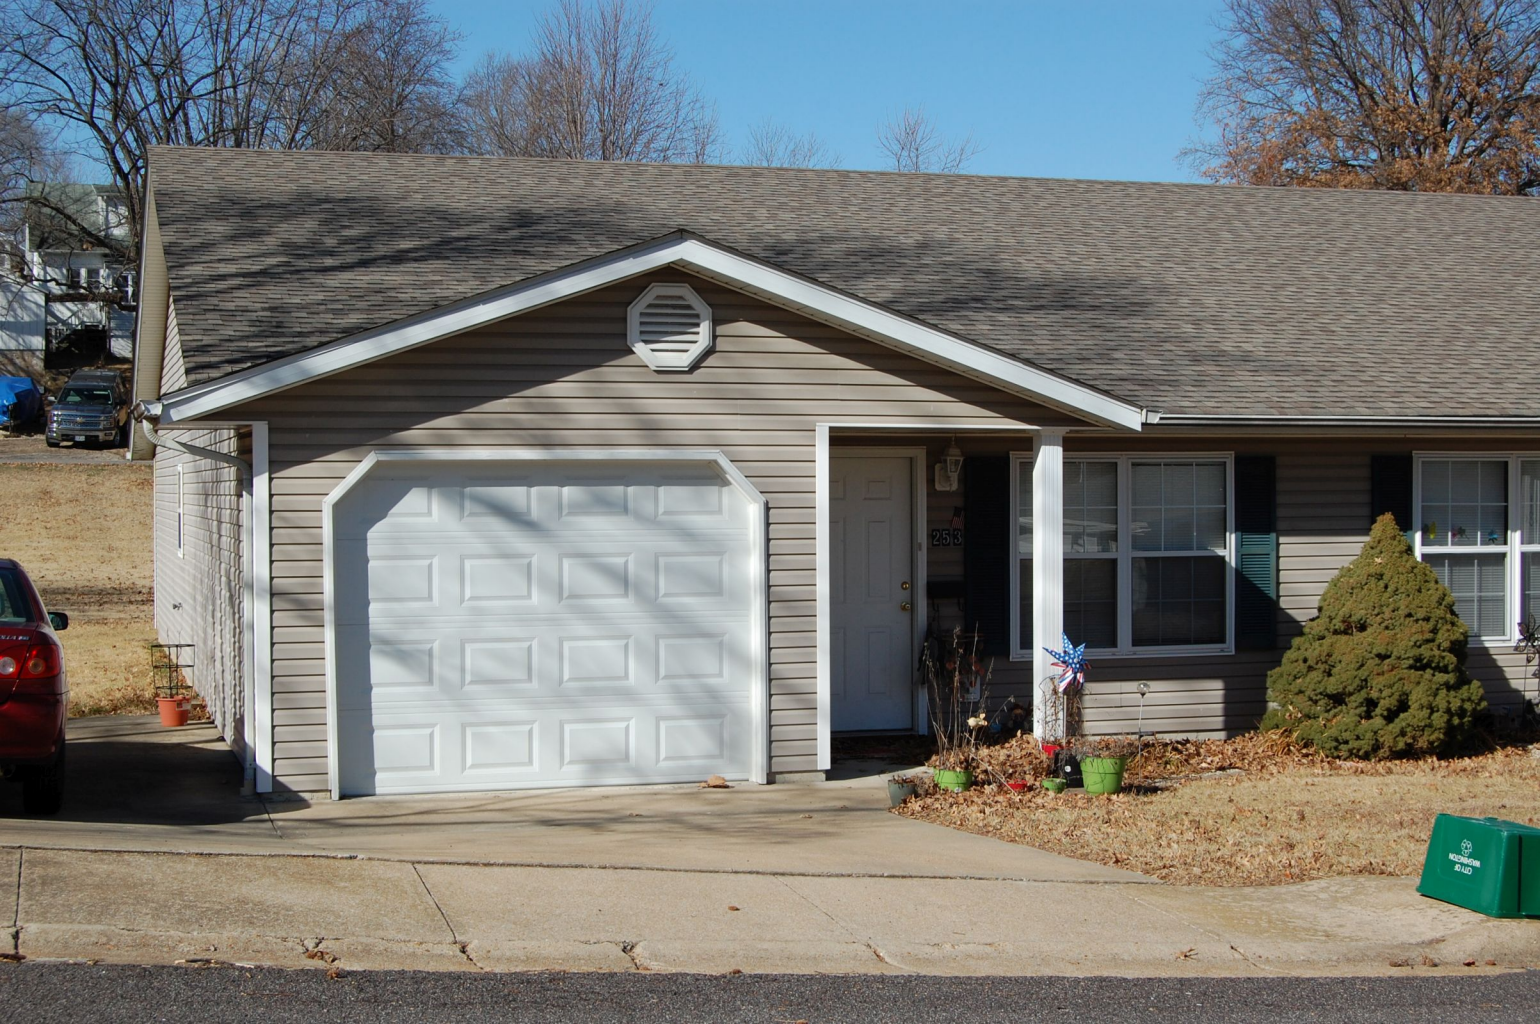
The 1-story, side left duplex was built in 1998 and is the mirror image of 253 Rand. It has a concrete foundation, vinyl siding and a front gable and wing asphalt shingle roof. The primary façade is 3 bays. The side left bay contains a projecting, gable front 1 car garage bay. The garage has a paneled metal overhead door set within a clipped frame surround. To the right of the garage bay, within the same extended gable roof, is a single bay entry porch containing a concrete slab, fluted square metal clad post and a single entry. The primary entrance is a paneled metal door. Within the gable peak is an octagonal vent. The side right bay, within the gabled wing, has paired 6/6 false interior muntin vinyl sash windows with ornamental shutters. (This property was not surveyed in 1992 as it was constructed post survey date).

Due to the buildings date of construction outside the period of significance, it is a non-contributing resource and not eligible for potential district material.

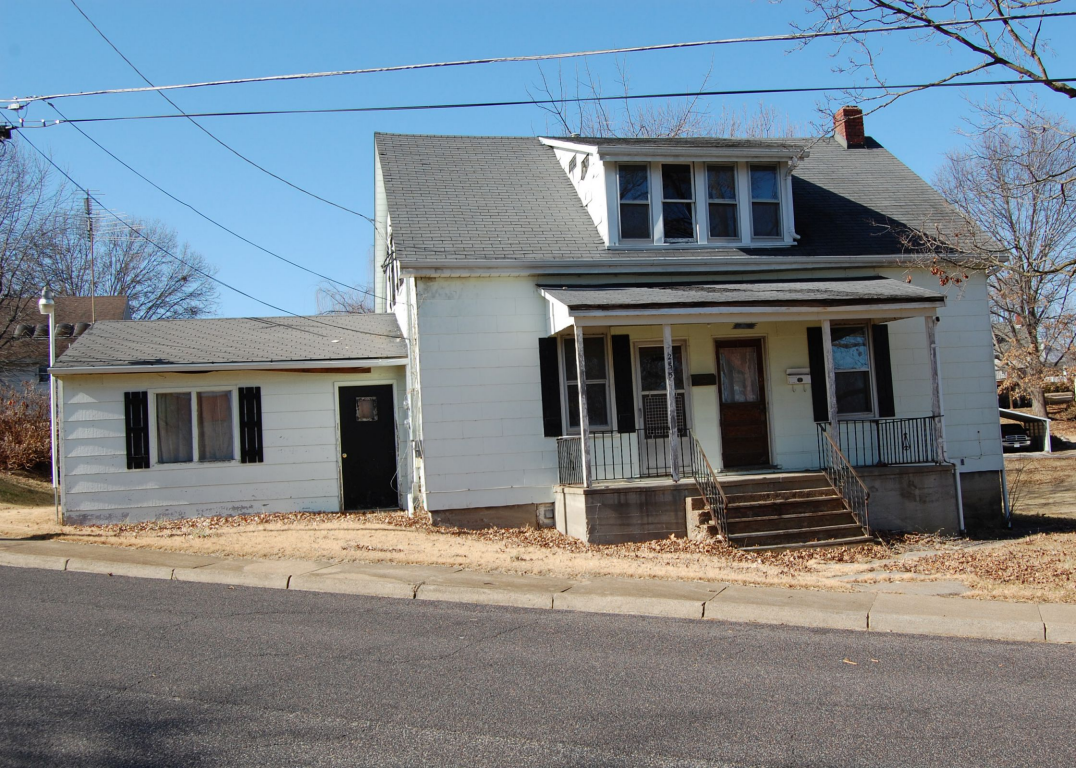
The c1935, 1-story frame dwelling has a concrete foundation, asbestos shingle siding, and a side gable asphalt shingle roof. The primary face is 4 bays wide. There is a 1-story, partial width porch centered on the façade. It has a dropped asphalt shingle shed roof, 4 wood square posts with wrought iron railing, and a tall concrete base. Sheltered within the porch are two entry doors. The offset right door is a 3 vertical light glass and wood door and the offset left door is a newer arched glass and paneled door. On either sides of the entry are single 1/1 wood sash windows with ornamental shutters. Set within the upper story is a centered shed roof dormer with a ribbon of four 1/1 wood sash windows. There is an interior, front slope chimney on the northwestern elevation. On the southeastern elevation is a post 1951, 1-story frame addition with side gable roof. It has a side right, single entry of a small square light and wood door and paired single fixed light wood windows with ornamental shutters side left. Post 1992 survey alterations were made to the SE addition. They include the replacement of a plain door with one small square light door and addition of ornamental shutters. The 1992 survey notes only one entry door, however it is difficult to determine from the image. The 1926 Sanborn does recognize the building as a flat. Due to the homes integrity and date of construction during the period of significance, it is a contributing resource and eligible for potential NR district material.

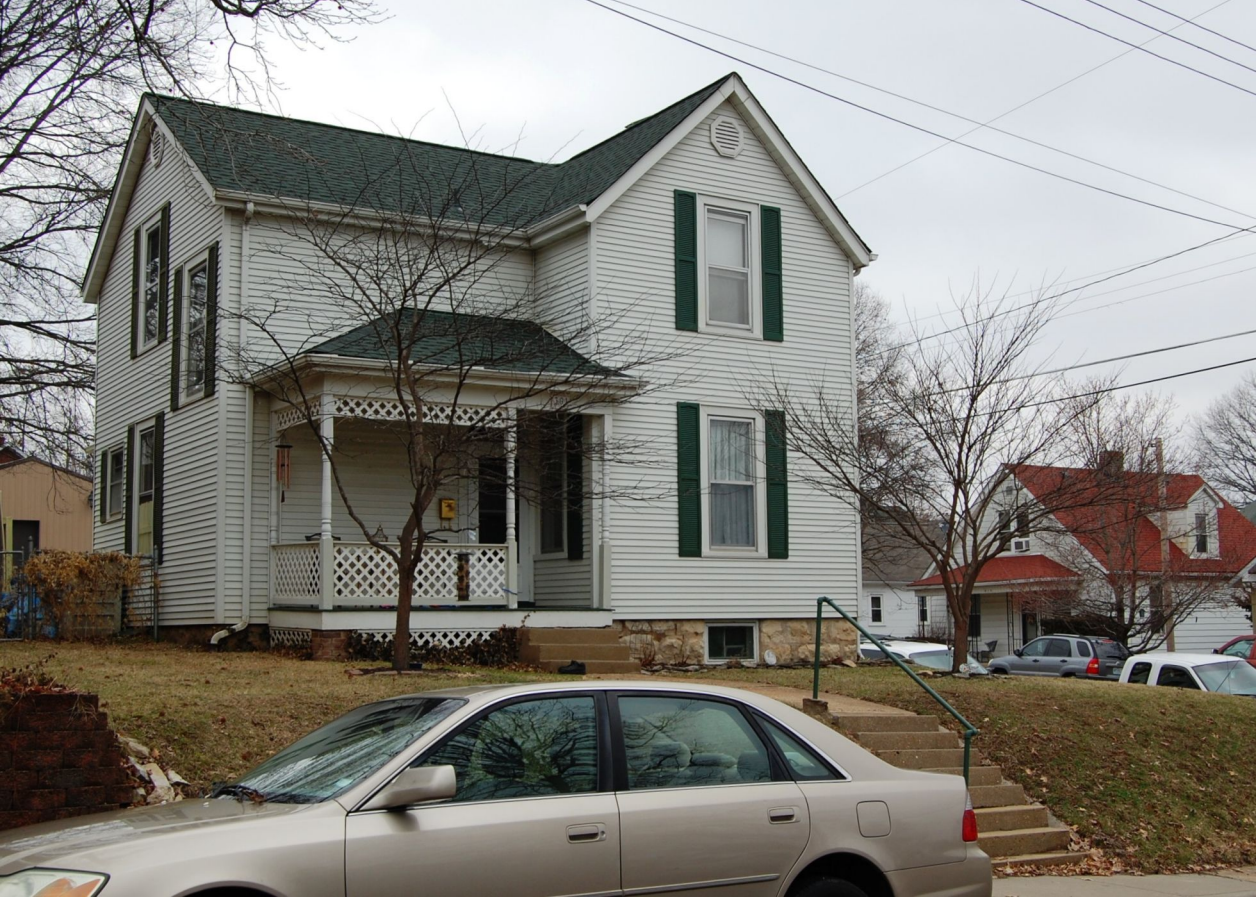
The 2-story frame dwelling has a limestone foundation, vinyl siding, and a cross gable (gable & wing) asphalt shingle roof. It has a Gabled Ell plan. The front façade is 2 bays wide. On the side right bay is an extended gable front bay with a single 1/1 wood sash window on both the 1st and 2nd story. There is an octagonal vent within the gable peak. Windows are older 1/1 wood sash with storm coverings and ornamental shutters. It is undetermined whether they are original. The side left bay contains an open 1-story frame, partial width porch within the ell. It has a dropped, asphalt shingle hipped roof with 3 turned wood columns with lattice rail and lattice railing. Sheltered within the porch, and centered upon the façade, is a single entry consisting of a rectangular light glass and paneled wood door with a single light transom. There is an interior wall, straddle ridge brick chimney on the N elevation. On the W elevation is an enclosed, 1-story frame porch within the ell. It has an asphalt shingle hipped roof. Post 1992 survey alterations include: replacement of asphalt shingle siding with vinyl, replacement of standing seam metal roof with asphalt shingle, replacement of square wood baluster railing with lattice, addition of lattice rail on porch. The house retains some significant materials such as windows, however too much is unknown (ie siding). It is uncertain whether the asphalt shingle siding was original. Further research is needed; the house's status is "not determined" for listing in a potential NR district.

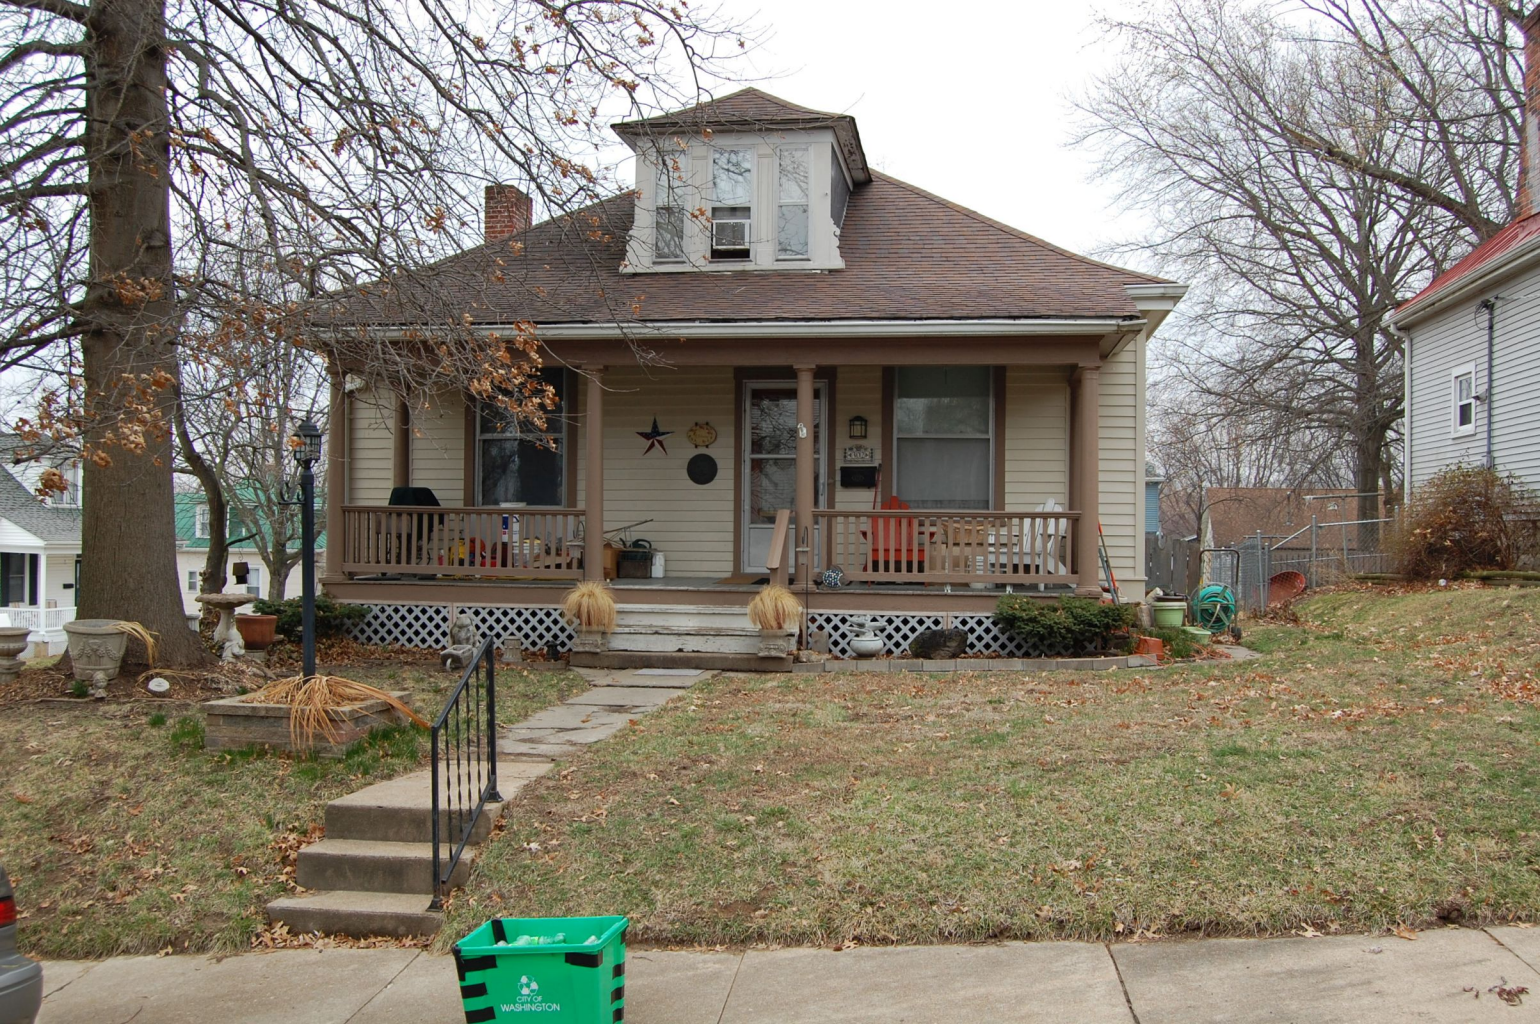
The 1.5 story frame dwelling has a limestone foundation, weatherboard siding, and a hipped asphalt shingle roof. The front façade is 3 bays wide. There is a 3/4 width, 1-story open porch centered on the façade. It has a shed roof extended from the primary, Tuscan wood columns (4 single and 2 engaged), and an open square wood baluster railing. Sheltered within the porch is an offset right single entry, consisting of large rectangular light glass and wood door, with single windows on either side of the entry. Centered within the upper story is a low, hipped dormer with a ribbon of three windows divided by mullions with engaged fluted pilasters and a milled appliqué detail at the base of the window surround. (This is a similar detail also used at 311 Rand). There is a similar dormer on the E elevation. Windows are 1/1 indeterminate sash, obscured by aluminum storms, but appear to be replacements. There is an interior wall brick chimney on the N elevation. On the rear (E) elevation is a partial width, side left, 1-story porch with shed roof and square wood posts. Post 1992 survey alterations include: replacement of standing seam metal roof with asphalt shingle and removal of metal awning from E elevation dormer. While there have been minor alterations, the house was built during the period of significance and retains its integrity; the property is a contributing resource and is eligible for district material.

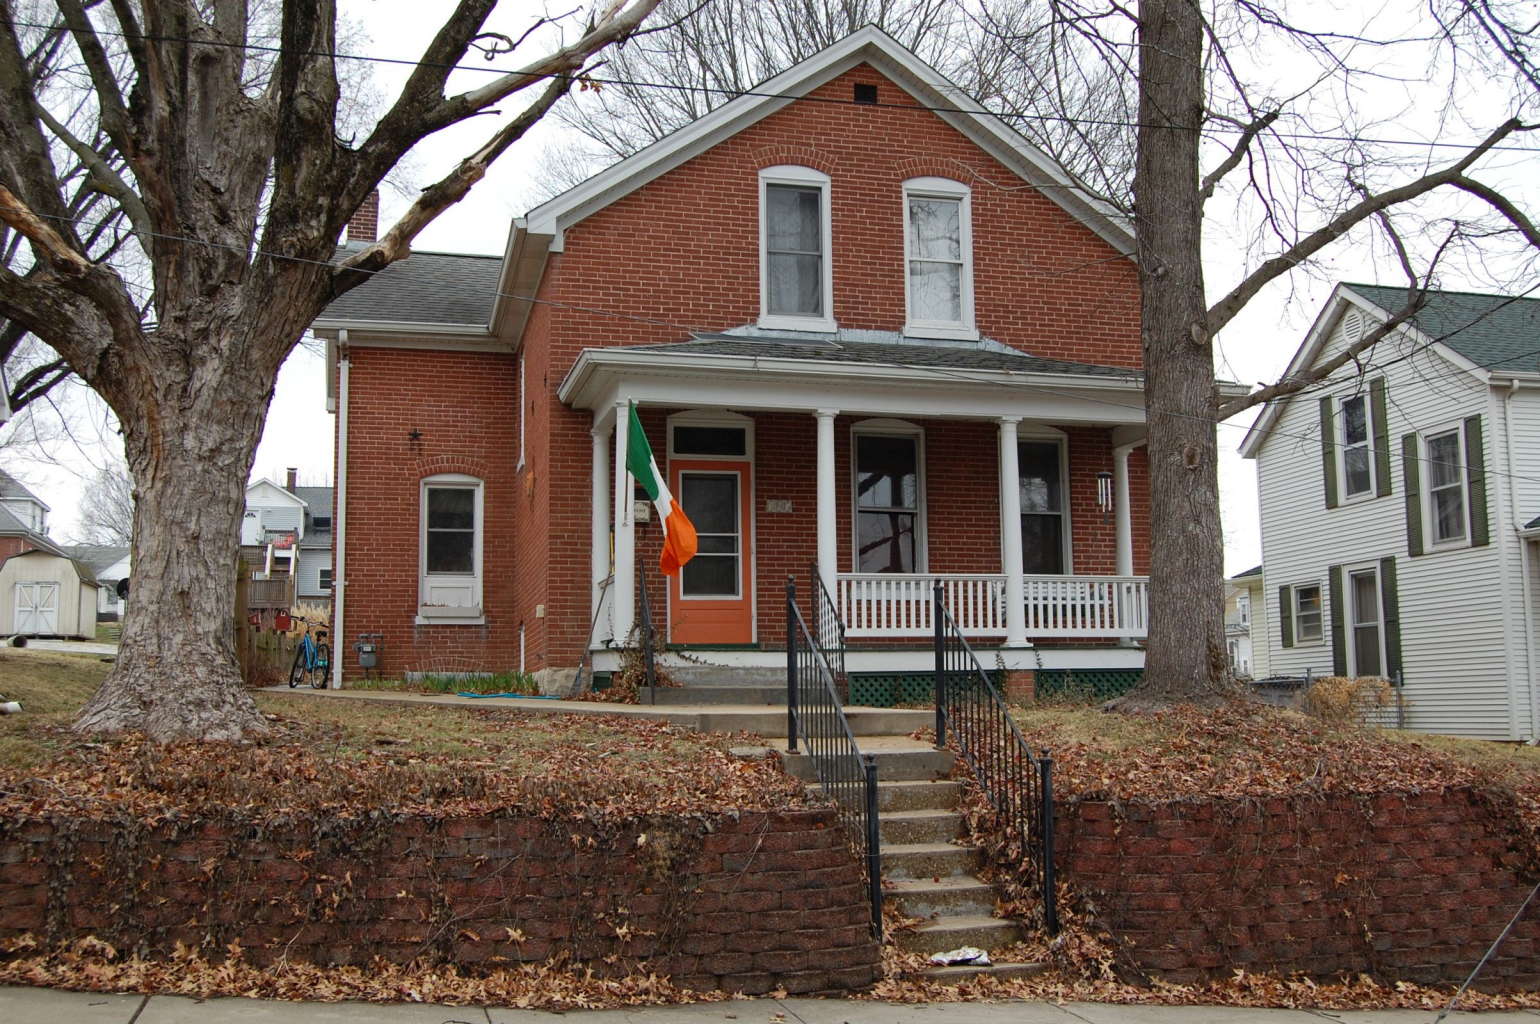
The 1.5 story brick dwelling has a coursed limestone foundation, 7-course Flemish bond brick exterior, and a cross gable (gable front and wing), asphalt shingle roof. The front façade is 4 bays wide. The side right bay contains the gable front extension with a 1-story frame porch with dropped, asphalt shingle hipped roof, 4 Tuscan wood columns with 2 engaged, and an open, square wood baluster railing. Sheltered within the porch are two 1/1 sash windows and a single entry consisting of a door obscured by a wood storm door and a single light transom within a segmental arch of 2-course rowlock brick. Set within the upper story of this bay are 2 single windows. The side left bay consists of the recessed wing containing a single 1/1 sash window that has been shortened with a wood panel infill at the bottom. Windows are older 1/1 wood sash windows set within 2-course rowlock brick segmental arches with limestone sills. It is undetermined whether they are original. There are interior wall, straddle ridge brick chimneys on the N and S facades. On the W façade is a 2010, 1-story 20x20 frame addition with asphalt shingle gable roof and wood or hardy board siding that replaced a partial width open porch with shed roof. Post 1992 survey alterations include: replacement of standing seam metal roof with asphalt shingles, altering the side left window bay, and the rear addition. Due to its integrity and date of construction during the period of significance, the property is a contributing resource and is eligible for district material.

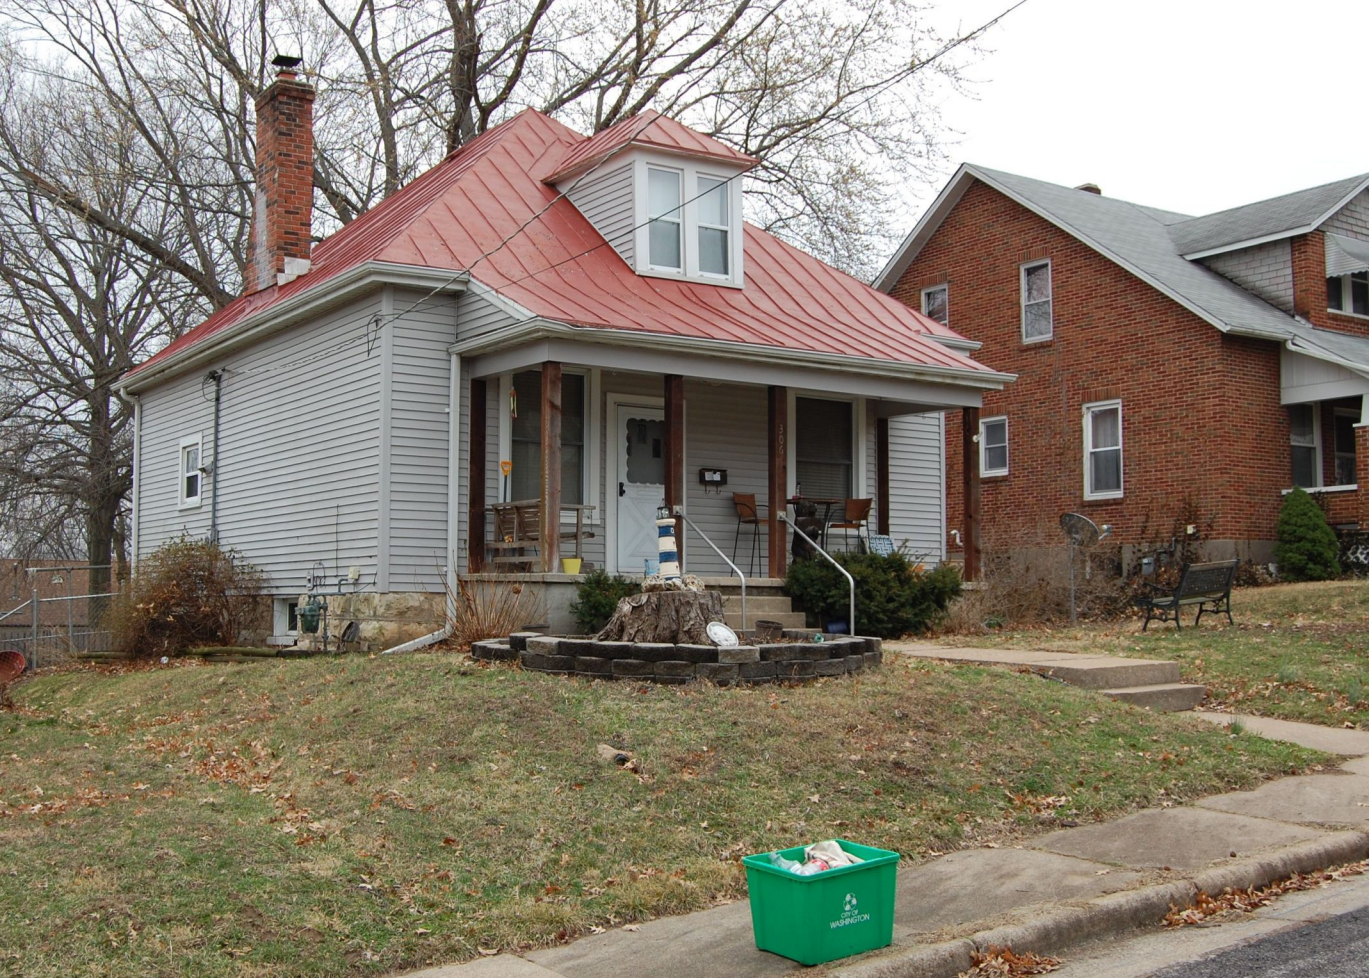
The 1.5 story frame dwelling has a limestone foundation, vinyl siding, and a standing seam metal, hipped roof. The front façade is 3 bays wide. There is a 3/4 width, 1-story open porch centered on the façade. It has a shed roof extended from the primary, concrete platform, square wood posts (4 single and 2 engaged), and no railing. Sheltered within the porch is an offset left single entry, consisting of a replacement door with 3 small lights, with single windows on either side of the entry. Centered within the upper story is a hipped dormer with paired windows on both the E & W elevations. Windows are replacement 1/1 vinyl sash. On the E (rear) elevation is a 1-story porch with shed roof. There is an interior wall brick chimney on the N elevation. Post 1992 survey alterations include: removal of later addition wrought iron porch posts and railing, replacement of original multi-light glass and wood door, replacement of 1/1 wood sash windows with vinyl, and removal of roof antenna. Due to the alterations in siding to vinyl, the property is a not contributing resource for a potential NR district.

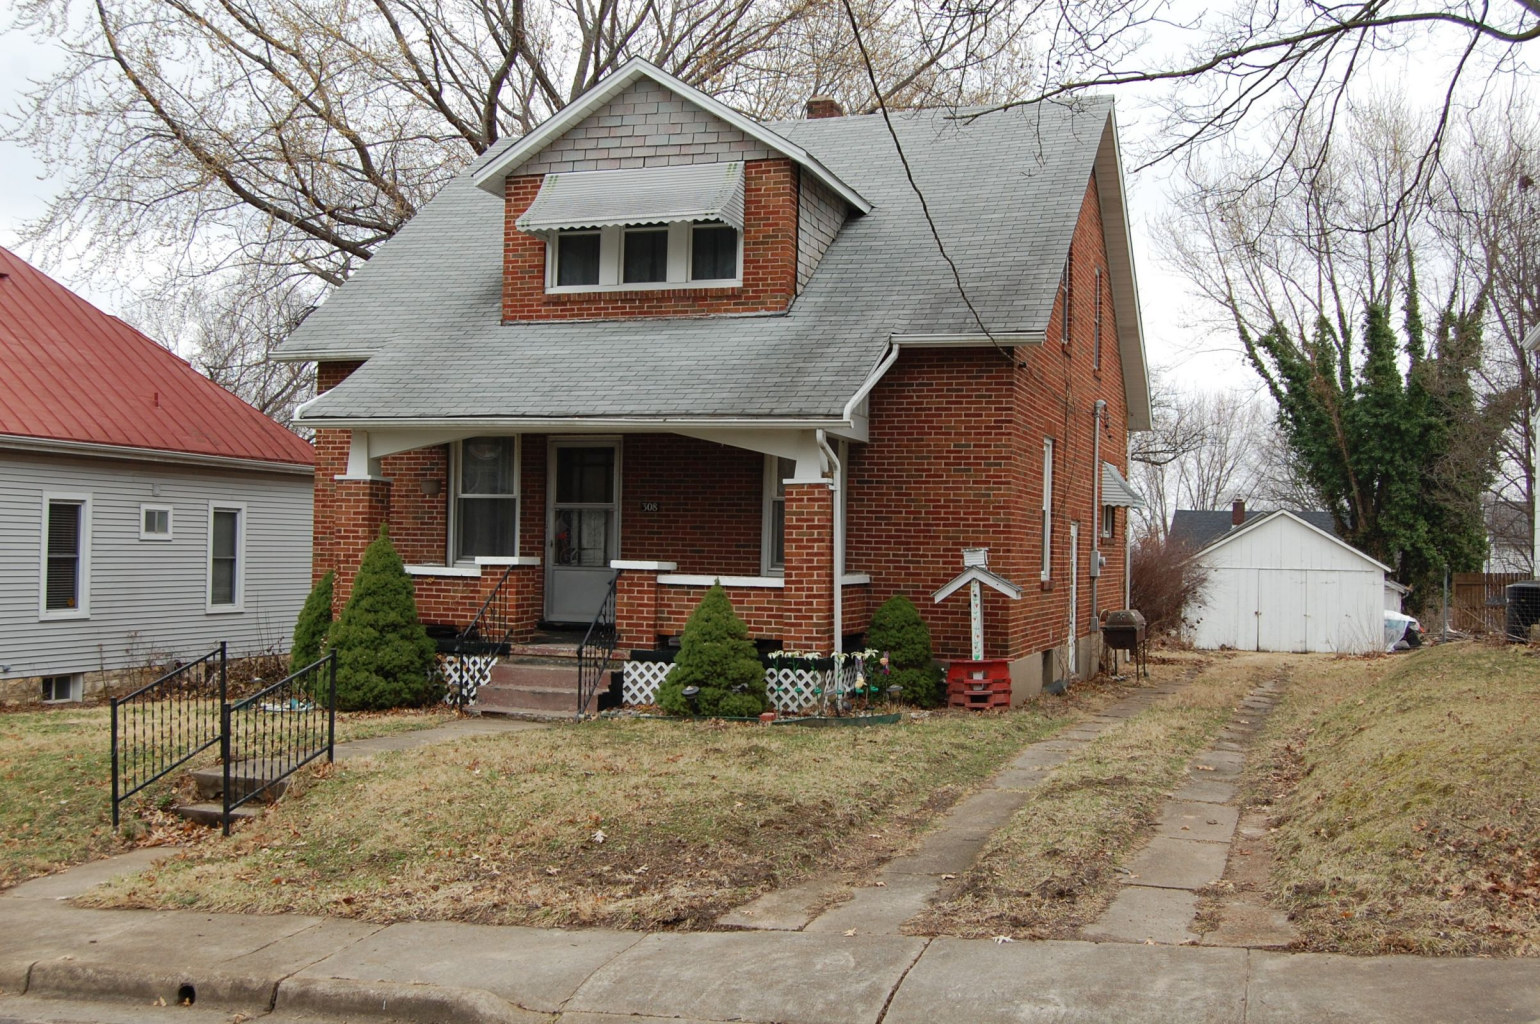
The 1.5 story frame dwelling has a concrete foundation, a running bond brick exterior, and a side gable asphalt shingle roof. The front façade is 3 bays wide. There is a 3/4, 1-story open porch centered on the façade. It has a shed roof extended from the primary, and very squat tapered wood posts resting on brick piers with a solid brick railing. Sheltered within the porch is an offset left single entry, consisting of a multi-light glass and wood door with storm door, flanked by single windows. Centered within the upper story is a gabled dormer with triple windows under a metal awning and older asphalt shingles on the dormer walls and within the gable. There is a shed roof dormer with paired windows on the E elevation. Windows are replacement 1/1 vinyl sash with a flat surround and brick rowlock lug sills. There is a central interior, rear slope brick chimney. Post 1992 survey alterations include the potential replacement of the 1/1 wood sash windows for vinyl sash. Due to its integrity and date of construction during the period of significance, the house is a contributing resource for a potential NR district.

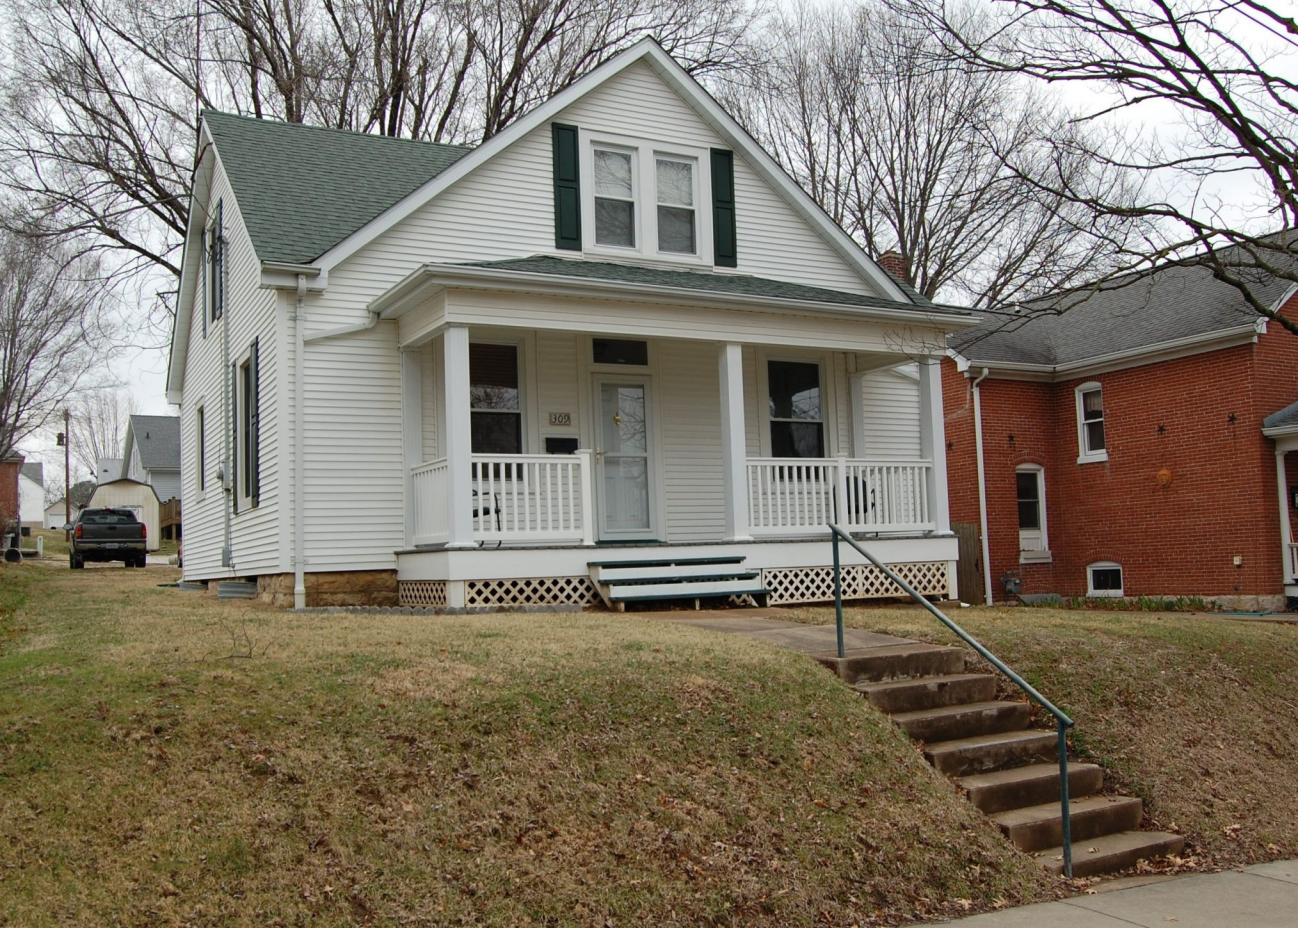
The 1.5 story frame dwelling has a limestone foundation, vinyl siding, and an asphalt shingle, cross gable roof. The front façade is 3 bays wide. There is a 3/4, 1-story open porch centered on the façade. It has a dropped, asphalt shingle hipped roof, fluted composite square posts (3 individual and 2 engaged) with an open square baluster composite railing. Sheltered within the porch is an offset right single entry consisting of a replacement paneled door and single light transom flanked by single windows. Centered within the upper story are paired windows with ornamental shutters. Windows are replacement 1/1 vinyl sash. On the west facade is a small 1-story porch with concrete platform, slender square wood posts and an asphalt shingle shed roof. Post 1992 survey alterations include: replacement of standing seam metal roof with asphalt shingles, replacement of weatherboard with vinyl siding, replacement of Tuscan porch columns with square posts, replacement of 1/1 wood sash windows with vinyl, replacement front door, addition of ornamental shutters, and removal of N & S elevation chimneys. Due to the many alterations, primarily exterior cladding, the home is not considered eligible for listing in a potential NR district.

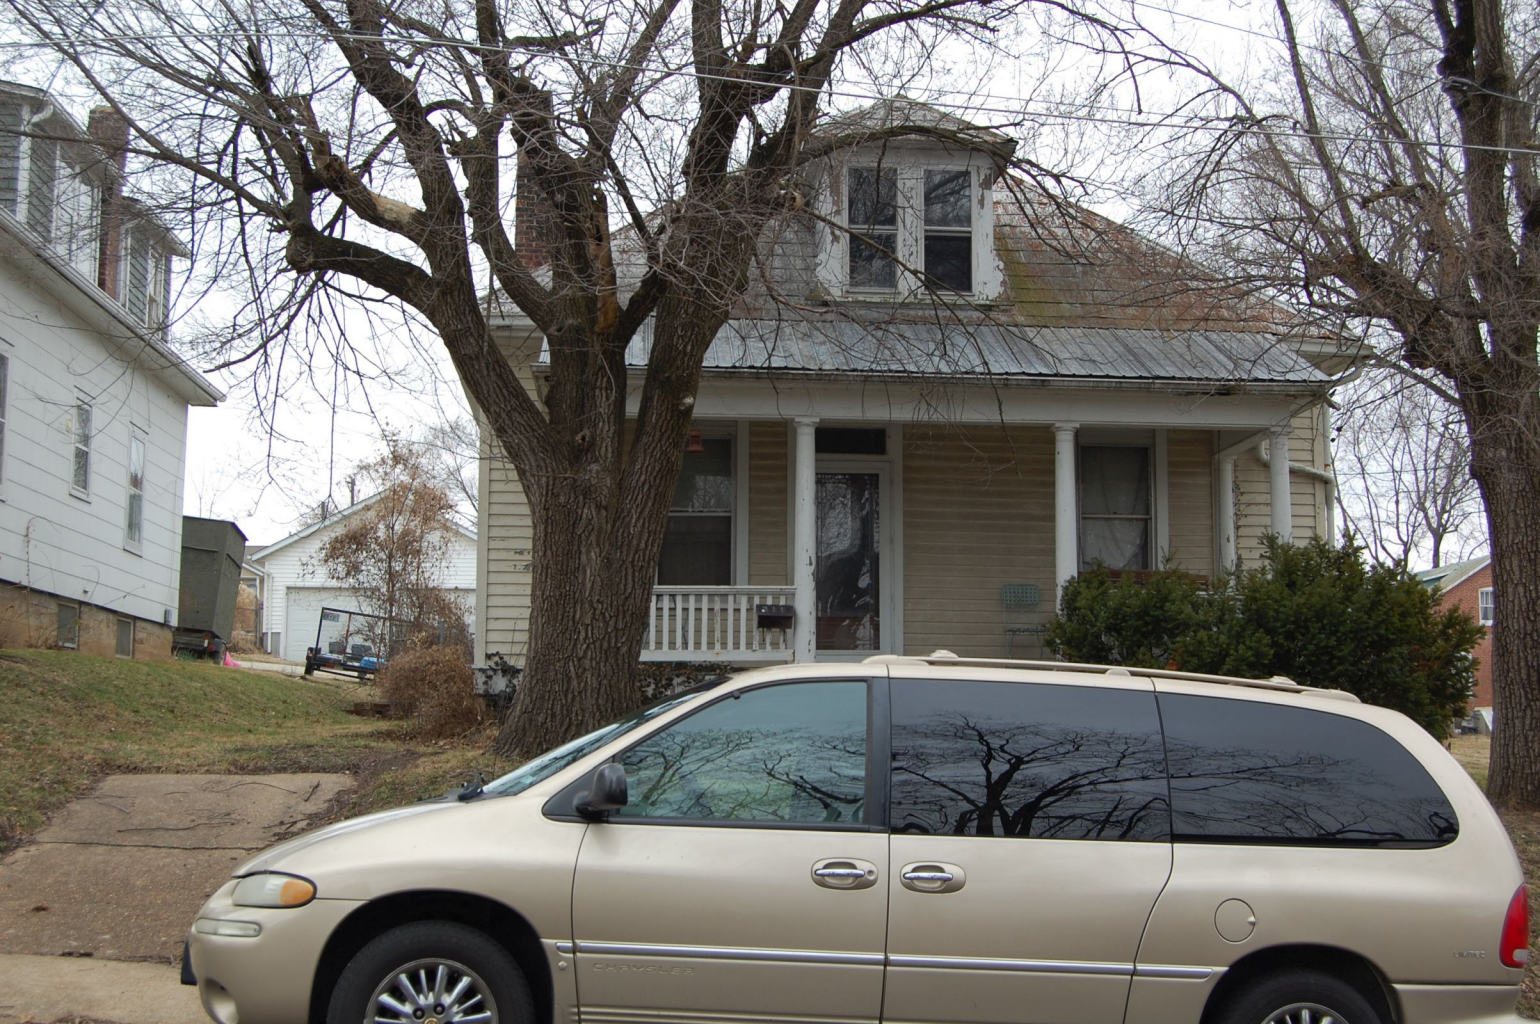
The 1.5 story frame dwelling has a limestone foundation, weatherboard siding, and a pyramidal hipped roof of tin shingle. The front façade is 3 bays wide. There is a 3/4 width, 1-story open porch centered on the façade. It has a shed roof of standing seam metal, Tuscan wood columns (4 single and 2 engaged), and an open square wood baluster railing. Sheltered within the porch is an offset left single entry consisting of large rectangular light glass and wood door with single light transom with single windows on either side of the entry. Centered within the upper story is a hipped dormer with paired windows and a milled appliqué detail at the base of the window surround. (This is a similar detail also used at 302 Rand). There is a similar dormer on the W elevation and a shed dormer on the S elevation. Windows are 1/1 wood sash. There is an interior wall brick chimney on the S elevation. On the W elevation is a 2005, 1-story frame addition attached to the side of the primary building via a small enclosed hall or breezeway. The addition has an asphalt shingle gable roof, vinyl siding and 6/ false interior muntin vinyl sash windows. Post 1992 survey alterations include the rear addition. Due to the building's date of construction during the period of significance and integrity, the property is a contributing resource and is eligible for district material.

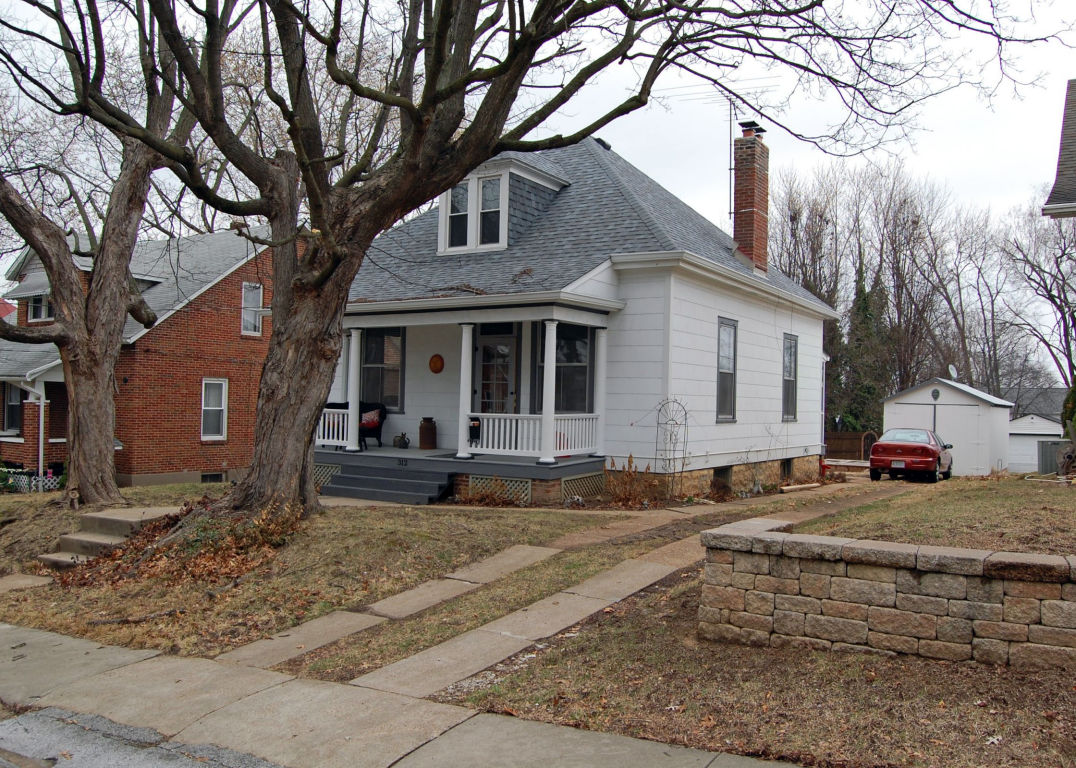
The 1.5 story frame dwelling has a limestone foundation, asbestos shingle siding, and a steeply pyramidal hipped asphalt shingle roof. The front façade is 3 bays wide. There is a ¾ width, 1-story open porch centered on the front façade. It has a shed roof extended from the primary, Tuscan wood columns (4 single and 2 engaged), and an open square wood baluster railing. Sheltered within the porch is an offset right single entry, consisting of a single light glass and wood door with single light transom and multi-light glass and wood storm door, and single windows on either side. Centered within the upper story is a hipped dormer with paired windows on both the E and W elevations. Windows are 1/1 wood sash. There is a rear, 1-story frame addition with enclosed porch on the E elevation. It is almost full width with a concrete foundation, asbestos shingle siding, and an asphalt shingle shed roof. There is an interior wall brick chimney on the S elevation. Post 1992 survey alterations include replacement of standing seam metal roof with asphalt shingles. Due to the home's integrity and date of construction during the period of significance it is a contributing resource to a potential NR district.

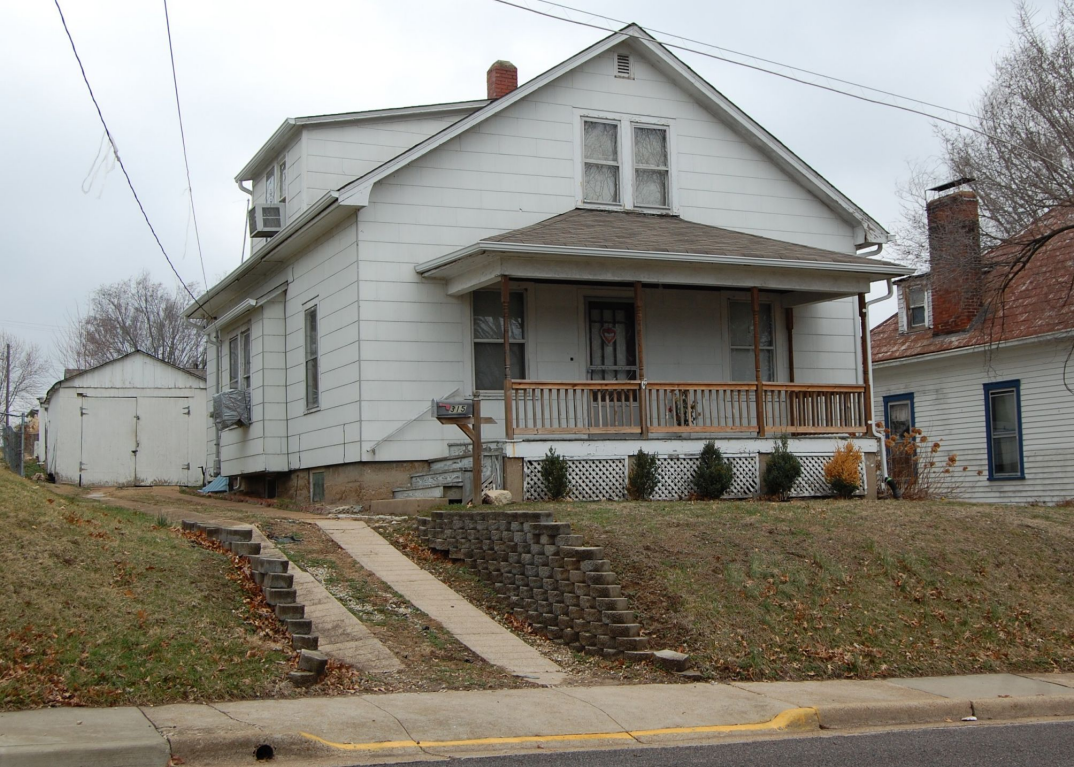
The 1.5 story wood frame home has a parged concrete foundation, asbestos shingle siding, and a gable front asphalt shingle roof with boxed eaves. The front façade is 3 bays wide. There is a 3/4 width, 1-story open porch centered on the façade. It has a dropped asphalt shingle hipped roof with replacement turned spindle posts (4 and 1 engaged) and an open square, wood post baluster railing. Entry to the porch is via wood stairs that run parallel to the front façade. Sheltered within the porch is a slightly offset left single entry consisting of a multi-light glass and wood door flanked by single windows. Centered within the upper story are paired windows and a rectangle vent within the gable peak. Windows are 1/1 wood sash. There is square window bay and a single shed roof dormer centered on the S elevation. There is one interior wall, brick chimney on the N elevation located between two shed dormers. The rear (W) elevation has a side right, 2-story open porch with open square wood baluster railing and open dogleg staircase leading to the upper story deck. Post 1992 survey alterations include: front porch square wood columns with recessed panels, and a solid wood railing altered post June 2013 (Google streetview) and rear (W) porch altered post march 2007 (assessor's photos). While there have been minor alterations, due to its overall integrity and date of construction during the period of significance (1926), the property is a contributing resource and is eligible for district material.

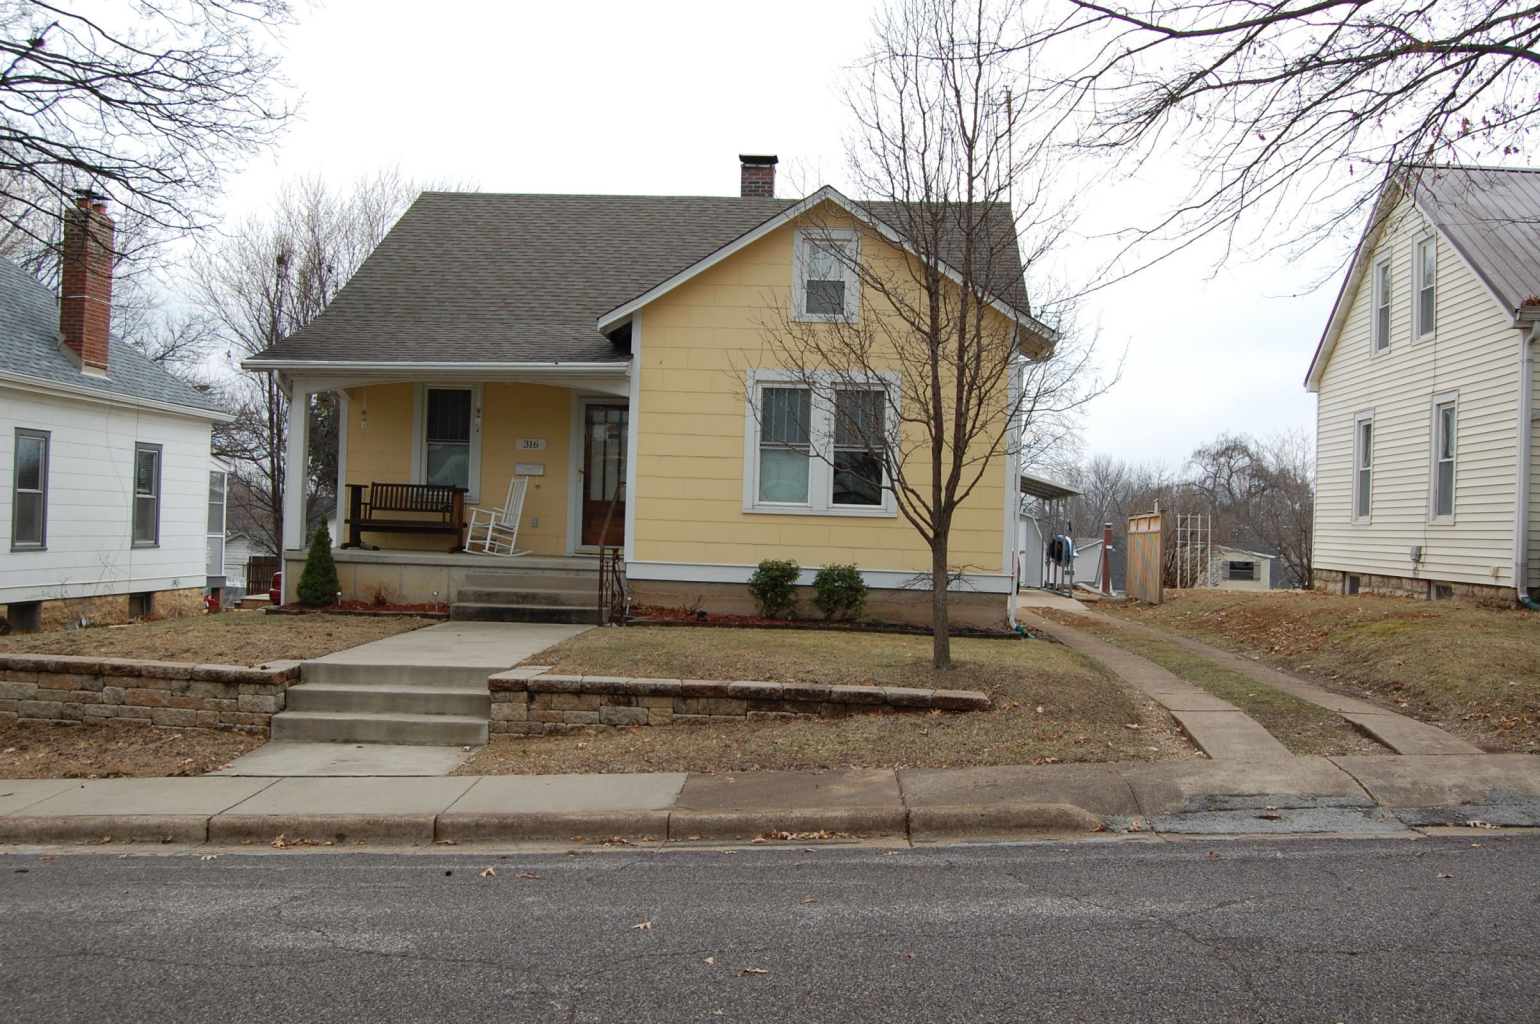
The 1.5 story frame dwelling has a concrete foundation, asbestos shingle siding, and an asphalt shingle, gable front and wing roof. The front façade is 3 bays wide. On the front facing gable bay, side right, are paired 4/1 windows with a 3/1 window within the upper story's gable. On the side right, is a 1-story open porch with shed roof extended from the primary, a single square wood post and a post 1992 concrete platform and no railing. Sheltered within the incised porch is a single entry of a vertical 3-light glass and wood door and a side left single 4/1 window. Windows are false, vertical interior muntin vinyl sash. There is a central, interior rear slope brick chimney. On the rear (E) elevation is a -story canted bay. Post 1992 survey alterations include: replacement of vertical 4/11 and 3/1 wood sash with vertical 4/1 and 3/1 false interior vinyl sash, removal of a metal awning and replacement of wood porch decking with a concrete platform. The windows were replaced relatively in kind, maintaining the same profile. While there have been minor alterations the building retains its integrity and is therefore a contributing resource to a potential NR district.
