MISSOURI DEPARTMENT OF NATURAL RESOURCES
STATE HISTORIC PRESERVATION OFFICE, P.O. Box 176, Jefferson City, MO 65102
ARCHITECTURAL/HISTORIC INVENTORY FORM

1. SURVEY NO. FR-AS-007-0104		2. SURVEY NAME: International Shoe Factory Neighborhood	
3. COUNTY: Franklin		4. ADDRESS (STREET NO.) 301	STREET (NAME) High Street

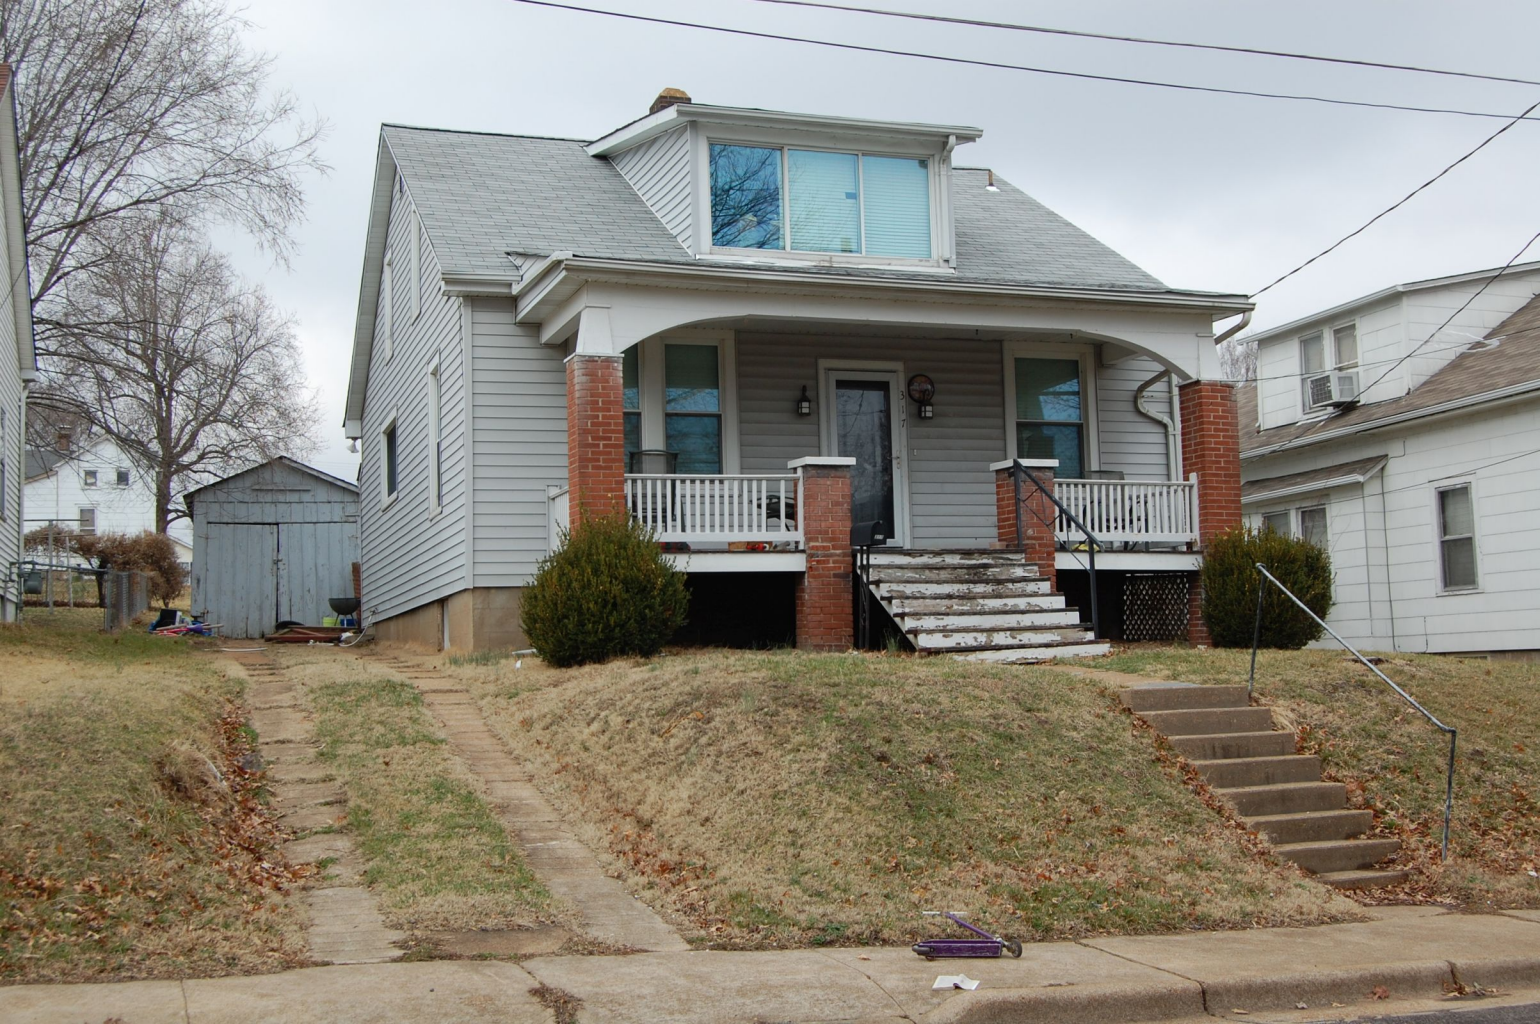
The 1.5 story frame dwelling has a concrete parged foundation etched to look like stone, vinyl siding, and a side gable, asphalt shingle roof. The front façade is 3 bays wide. There is a $\frac{3}{4}$ width, 1-story open porch centered on the façade. It has a shed roof extended from the primary roof, tapered, squat wood columns on brick piers and an open, square wood baluster railing. Centered wood stairs lead to the centered single entry sheltered within the porch. The entry consists of a large central light glass replacement door that has paired windows side left and a single window side right. First floor windows are replacement 1/1 indeterminate sash obscured by storms. Within the upper story is a large, centered shed roof dormer with vinyl sided walls and a large 3- single lights sliding window. There is a central interior, straddle ridge brick chimney. Post 1992 survey alterations include replacement of asbestos with vinyl siding and enclosure of the SW corner incised porch depicted on the 1951 Sanborn map. Due to the recent alterations in the siding, this building is not considered eligible for listing in a potential NR district.

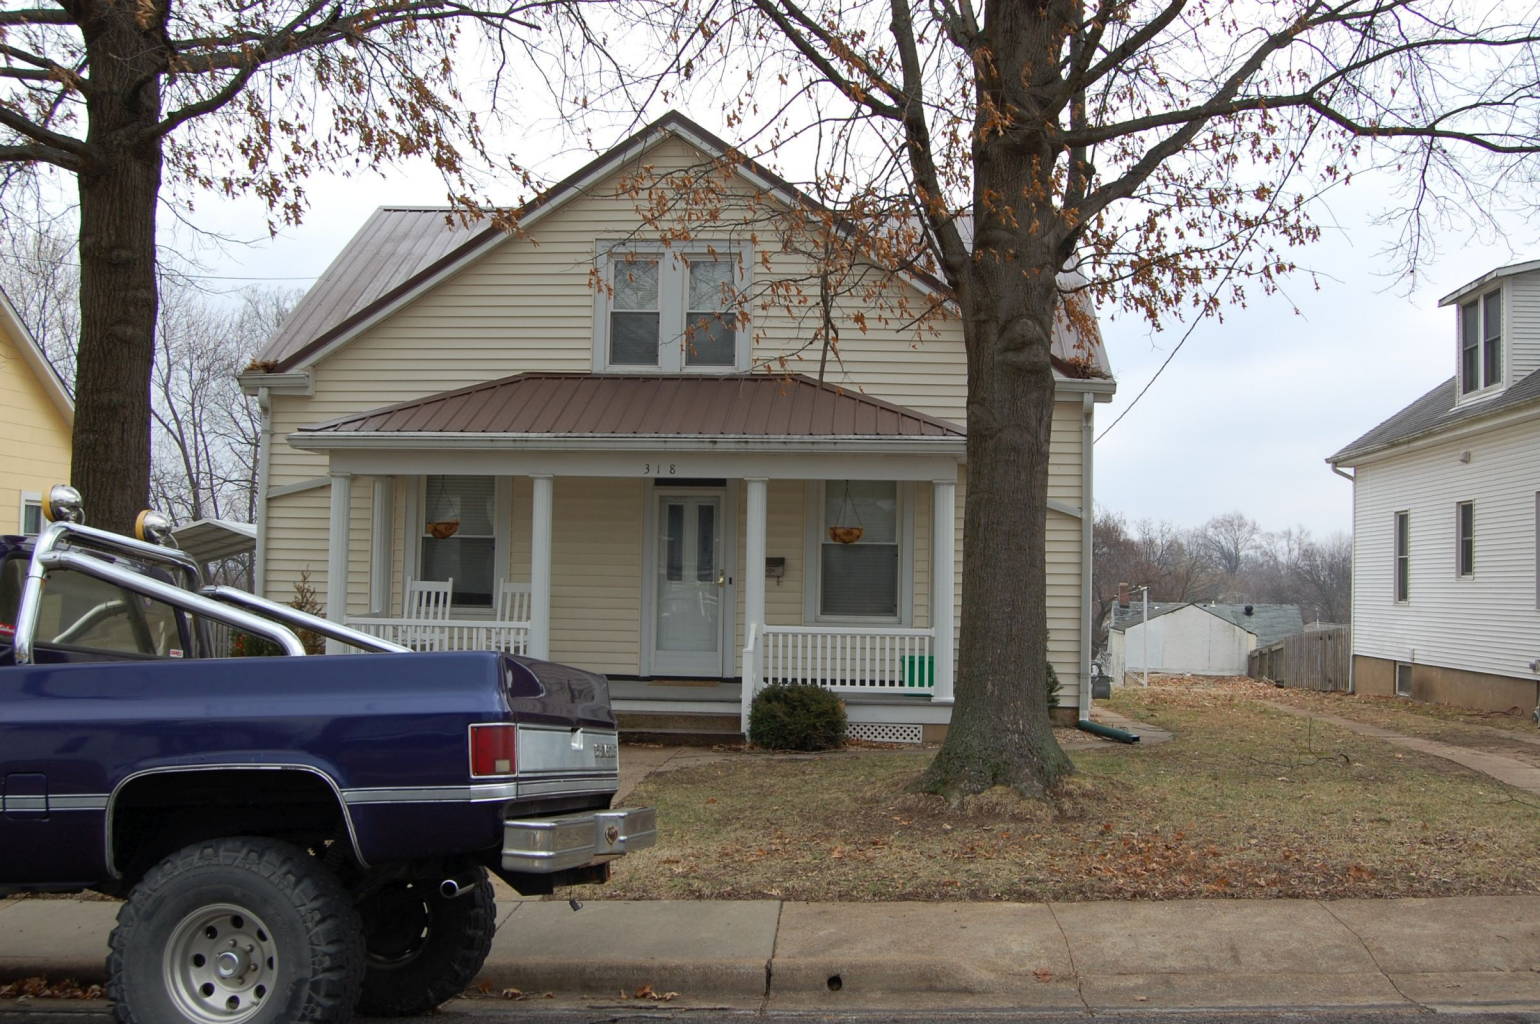
The 1.5-story frame dwelling has a limestone foundation, vinyl siding, and a corrugated metal, cross gable roof. The front façade is 3 bays wide. There is a 3/4 width, 1-story open porch centered on the front (W) façade. It has a dropped corrugated metal hip roof, fluted Tuscan composite columns (2 single, 2 engaged), and an open, square post baluster composite railing. Sheltered within the porch is a slightly offset right single entry, consisting of a replacement 2 vertical rectangle light glass and paneled composite door with single light transom, flanked by single windows. Centered within the upper story are paired windows in a flat surround. On the E elevation is a 1-story open porch with corrugated metal shed roof and a single hipped dormer with single window. Windows are replacement 1/1 vinyl sash. There is an interior wall, straddle ridge brick chimney on the S elevation. Post 1992 survey alterations include: replacement of asbestos shingle siding with vinyl, replacement of 1/1 wood sash windows with 1/1 vinyl sash, replacement of wood Tuscan columns and open wood post railings with in-kind composite. Due to the replacement siding, the building is not eligible for a potential NR district.

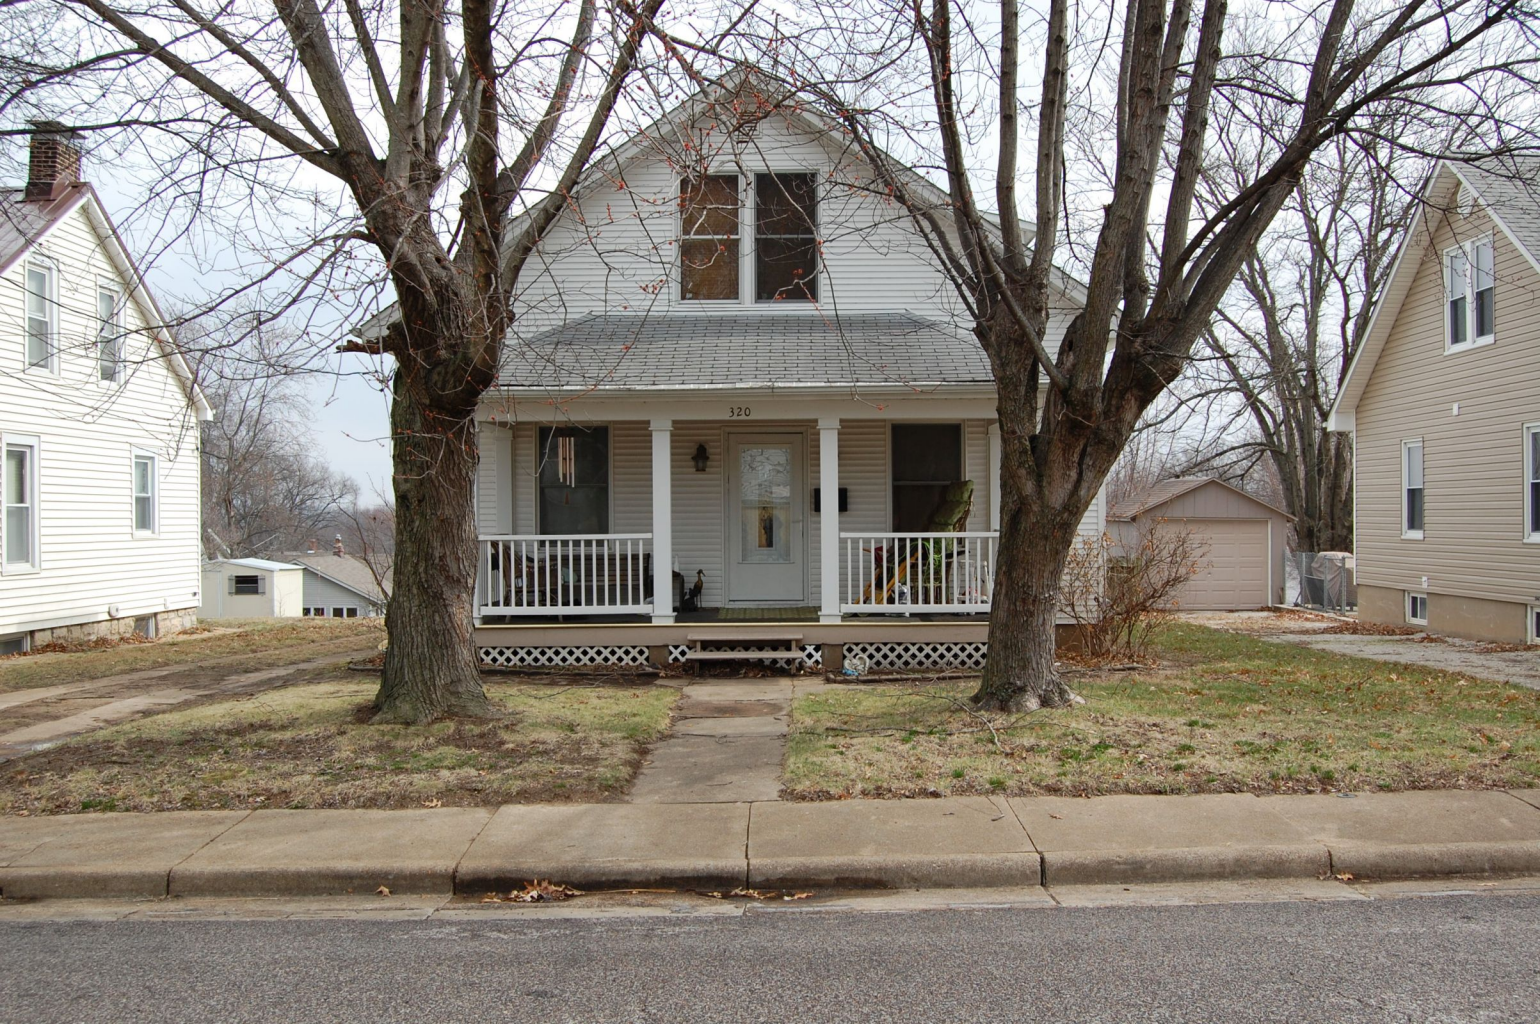
The 1.5-story frame dwelling has a concrete foundation, vinyl siding, and an asphalt shingle front gable roof. The front façade is 3 bays wide. There is a 3/4 width, 1-story open porch centered on the front (W) façade. It has a dropped, asphalt shingle hip roof, square wood posts (4 single, 2 engaged), and an open square post baluster composite railing. Sheltered within the porch is a slightly offset right entry, consisting of a thin, vertical arched faux leaded light and metal replacement door, flanked by single windows. Centered within the upper story gable are paired 1/1 windows. Windows are replacement 1/1 vinyl sash. There are shed roof dormers with two windows on the N and S elevations. There is a centered box bay and an interior wall brick chimney on the S elevation. Post 1992 survey alterations include: replacement of asbestos shingle and asphalt shingle dormer wall siding with vinyl, removal of a interior wall N elevation brick chimney, replacement of 1/1 wood sash windows with 1/1 vinyl sash, removal of cladding or replacement of porch columns, replacement of solid porch railing with open composite railing, and replacement entry door. Due to the replacement siding (vinyl) and porch alterations, the building is not eligible for a potential NR district.

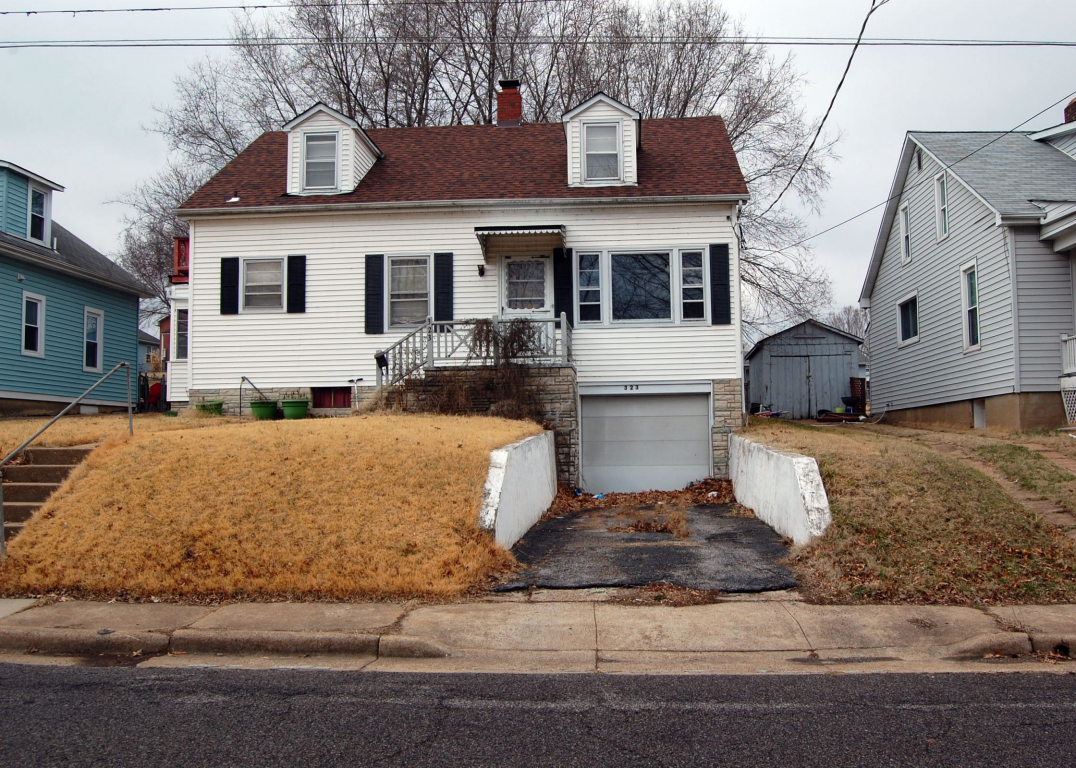
The c1950, 1.5 story frame dwelling has a concrete foundation with a permastone cladding on the front (E) façade, indeterminate siding and a side gable asphalt shingle roof. The assessor's office and the 1992 survey notes the siding as aluminum; however it has the appearance of vinyl. The primary façade is 4 bays wide. Offset right is a single entry stoop with a concrete platform with stairs running parallel to the façade, side left, and an open square wood baluster railing with a square bulls eye design. The entrance is a three horizontal light glass and wood door with storm door and traditional metal shed awning with scalloped edge detail. To the left of the entry are two, single 2/2 horizontal muntin wood sash windows of differing sizes, with ornamental shutters. To the right of the entry is a picture window with fixed single light flanked by 2/2 horizontal muntin wood sash windows. Built within the basement level below this bay is a built-in, 1-car garage with a metal overhead door. There are two gable front dormers on the upper half story containing single 2/2 horizontal muntin wood sash windows. On the S elevation is a 1-story, centered bump-out with a rear, open wood staircase leading to a 2nd story deck with flat sawn railing. There is a central interior, straddle ridge brick chimney. There are no apparent alterations post the 1992 survey. This home was built towards the end of the period of significance. It retains some significant materials however since the original siding is unknown, it is counted as "not determined" for listing in a potential NR district. Further research is needed.

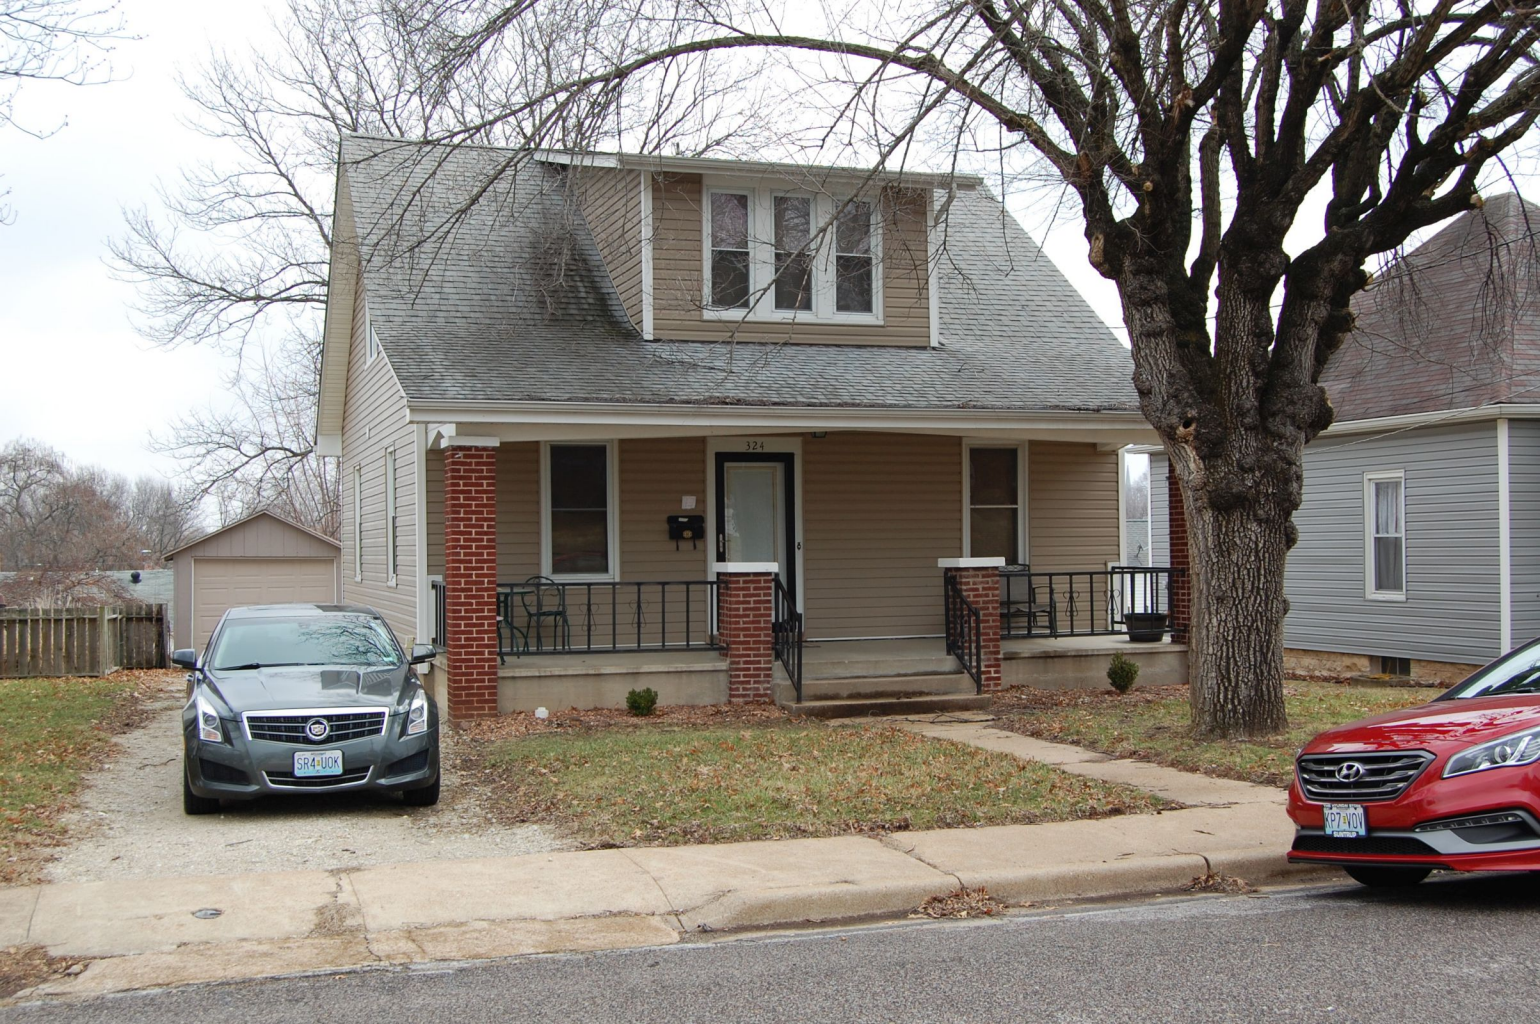
The 1.5 story frame dwelling has a concrete foundation, vinyl siding, and a side gable, asphalt shingle roof. The front façade is 3 bays wide. There is a full width front porch on the façade. It has an extended shed roof from the primary, square brick columns (2) and piers (2) with an open metal railing on a concrete platform. Sheltered within the porch is an offset left entry, consisting of a large rectangular light glass and composite door, with single windows on either side. A large shed roof dormer with vinyl clad walls and three windows set within a flat surround is centered within the upper story of the W elevation. There is smaller shed roof dormer with single windows on the rear (E) elevation. There is a canted bay window on the S elevation. Windows are vinyl 1/1 sash. Post 1992 survey alterations include: replacement of asbestos shingle siding with vinyl, replacement of 1/1 wood sash windows with 1/1 vinyl sash, replacement of the multi-light glass and wood door, and removal of the central interior wall brick chimney. Due to the exterior alterations in siding (vinyl), the home is not a contributing resource to a potential NR district.

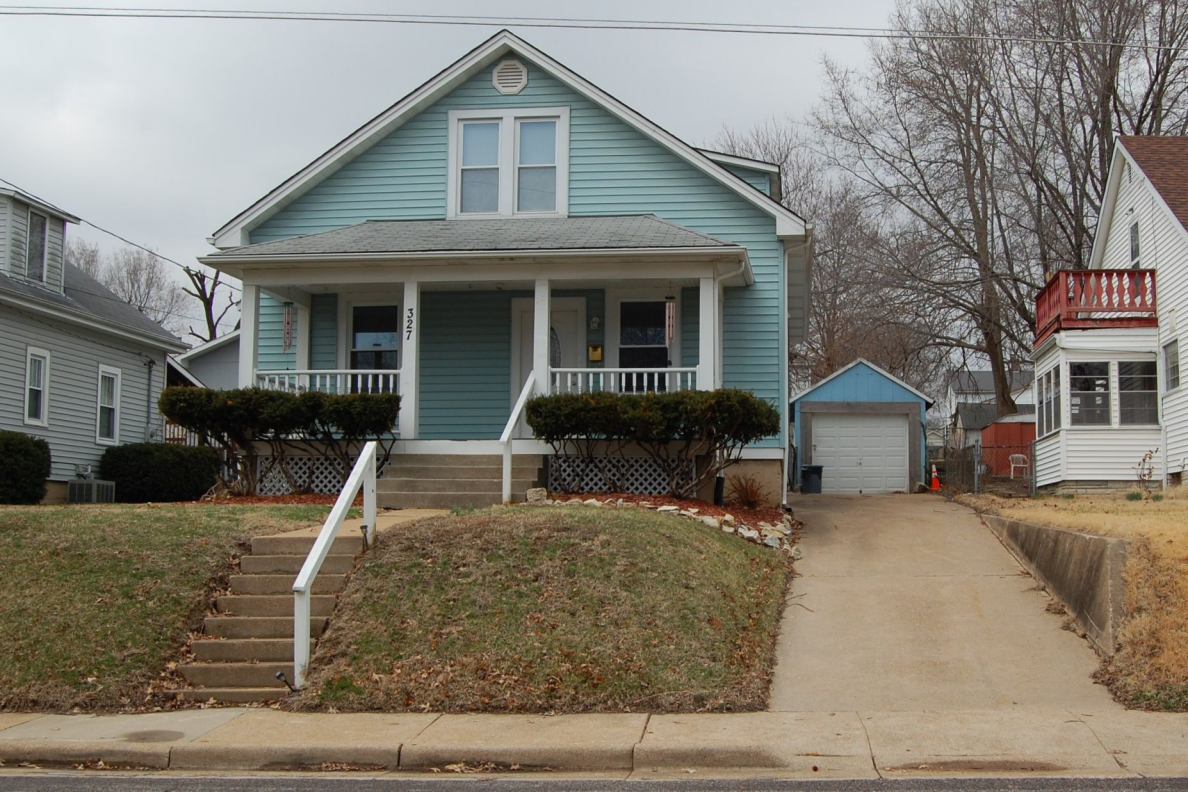
The c1920, 1.5 story frame dwelling has a concrete foundation, vinyl siding, and a gable front, asphalt shingle roof. The front façade is three bays wide. There is a 3/4 width, 1-story open frame porch centered upon the front façade. The porch has a dropped, hipped asphalt shingle roof, square wood posts and a turned wood spindle balustrade. Sheltered within the porch is an offset right single entry of a replacement door with faux leaded oval light flanked by single 1/1 vinyl sash windows. Set within the upper story gable are paired 1/1 vinyl sash windows. Shed roof dormers with paired windows are on the N and S elevations. On the S elevation is a 1-story box bay. On the W elevation is a 1-story addition with shed roof, which is possibly a former enclosed porch. Post 1992 survey alterations include: replacement of asbestos shingles with vinyl, replacement of 4/1 wood sash with 1/1 vinyl sash windows, alteration of front porch-replacing the square wood columns with recessed panels and a solid wood railing, replacement of multi-light glass and wood door, and removal of the interior wall brick chimney on the N elevation. Due to the alterations to the siding and windows, the dwelling is not considered eligible for listing in a potential NR district.

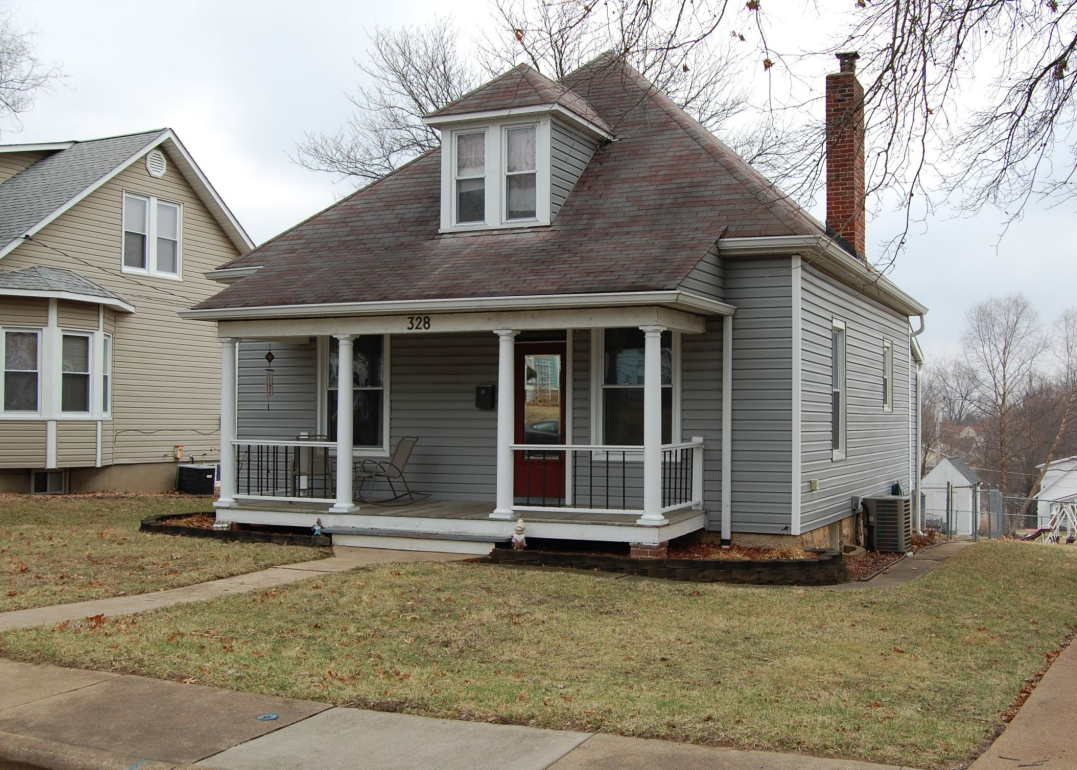
The 1.5 story frame dwelling has a limestone foundation, vinyl siding, and asphalt shingle, pyramidal hipped roof. The pyramidal Square dwelling was constructed in 1916. The front façade is 3 bays wide. There is a $\frac{3}{4}$, 1-story open porch centered on the front façade. It consists of an extended shed roof from the primary, 4 Tuscan wood columns and an open, round metal baluster and composite railing. Sheltered within the porch is an offset right single entry, consisting of a rectangular mirrored light glass and wood door and single light transom, with single windows on either side. A hipped dormer with paired windows is centered within the upper story of the W & E elevations. There is a side left, 1-story shed roof enclosed former porch on the E elevation. There is an interior wall brick chimney on the S elevation. Post 1992 survey alterations include: replacement of asbestos shingle siding with vinyl, replacement of 1/1 wood sash with 1/1 vinyl sash windows, replacement of open square wood baluster railing with metal balusters. Due to the exterior alterations in siding (vinyl), the home is not a contributing resource to a potential NR district.

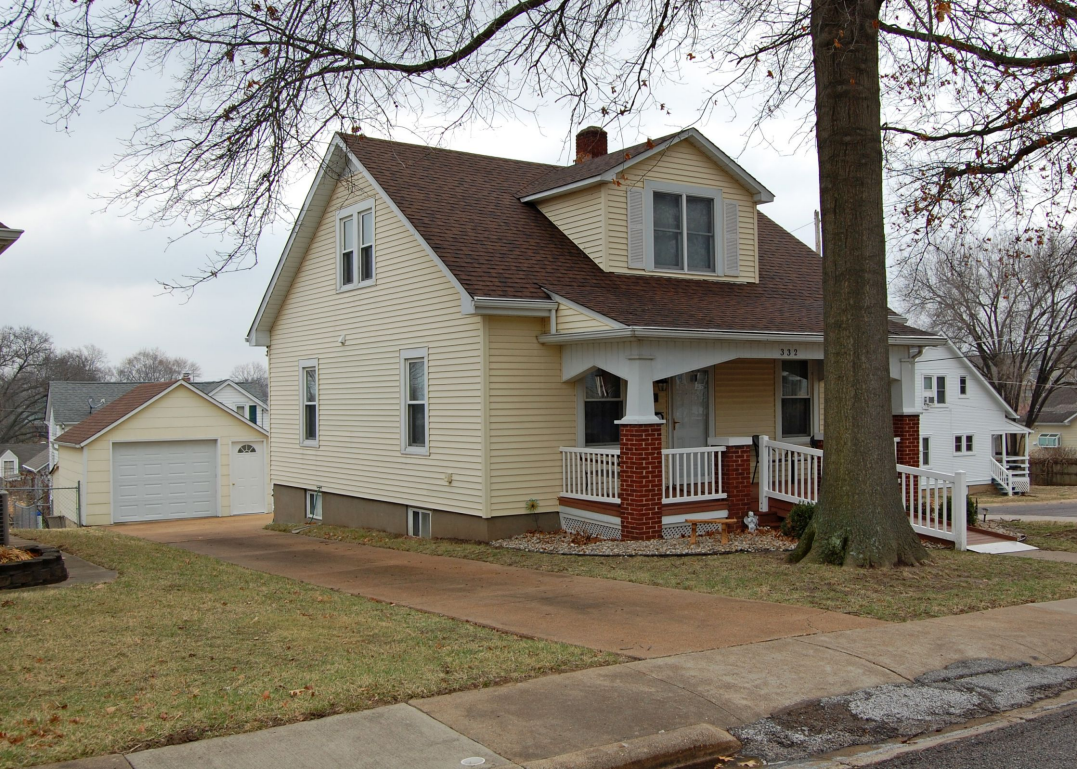
The 1.5 story frame dwelling has a concrete parged foundation, vinyl siding, and a side gable, asphalt shingle roof. The front façade is 3 bays wide. There is a 3/4 width, 1-story open porch centered on the façade. It has short, tapered wood columns resting on square brick piers with an open square composite baluster railing. Sheltered within the porch is an offset left single entry, consisting of small 2-light glass and paneled metal door, with single windows on either side of the entry. Centered within the upper story of the W elevation, is a gable dormer with paired windows and ornamental shutters. There is a shed roof dormer on the E elevation with paired windows and ornamental shutters. Windows are 1/1 indeterminate sash (potentially replacements) with aluminum framed screens. There is a bay window on the S elevation. On the E elevation is a partial width composite porch with composite open railing and a traditional metal awning over two bays. There is a central, interior straddle ridge brick chimney. The 1992 survey identifies the residence as 330 Rand. Post 1992 survey alterations include: replacement of wrought iron porch railing with composite, open square baluster railings. Due to the exterior alterations in siding (vinyl), the home is not a contributing resource to a potential NR district.

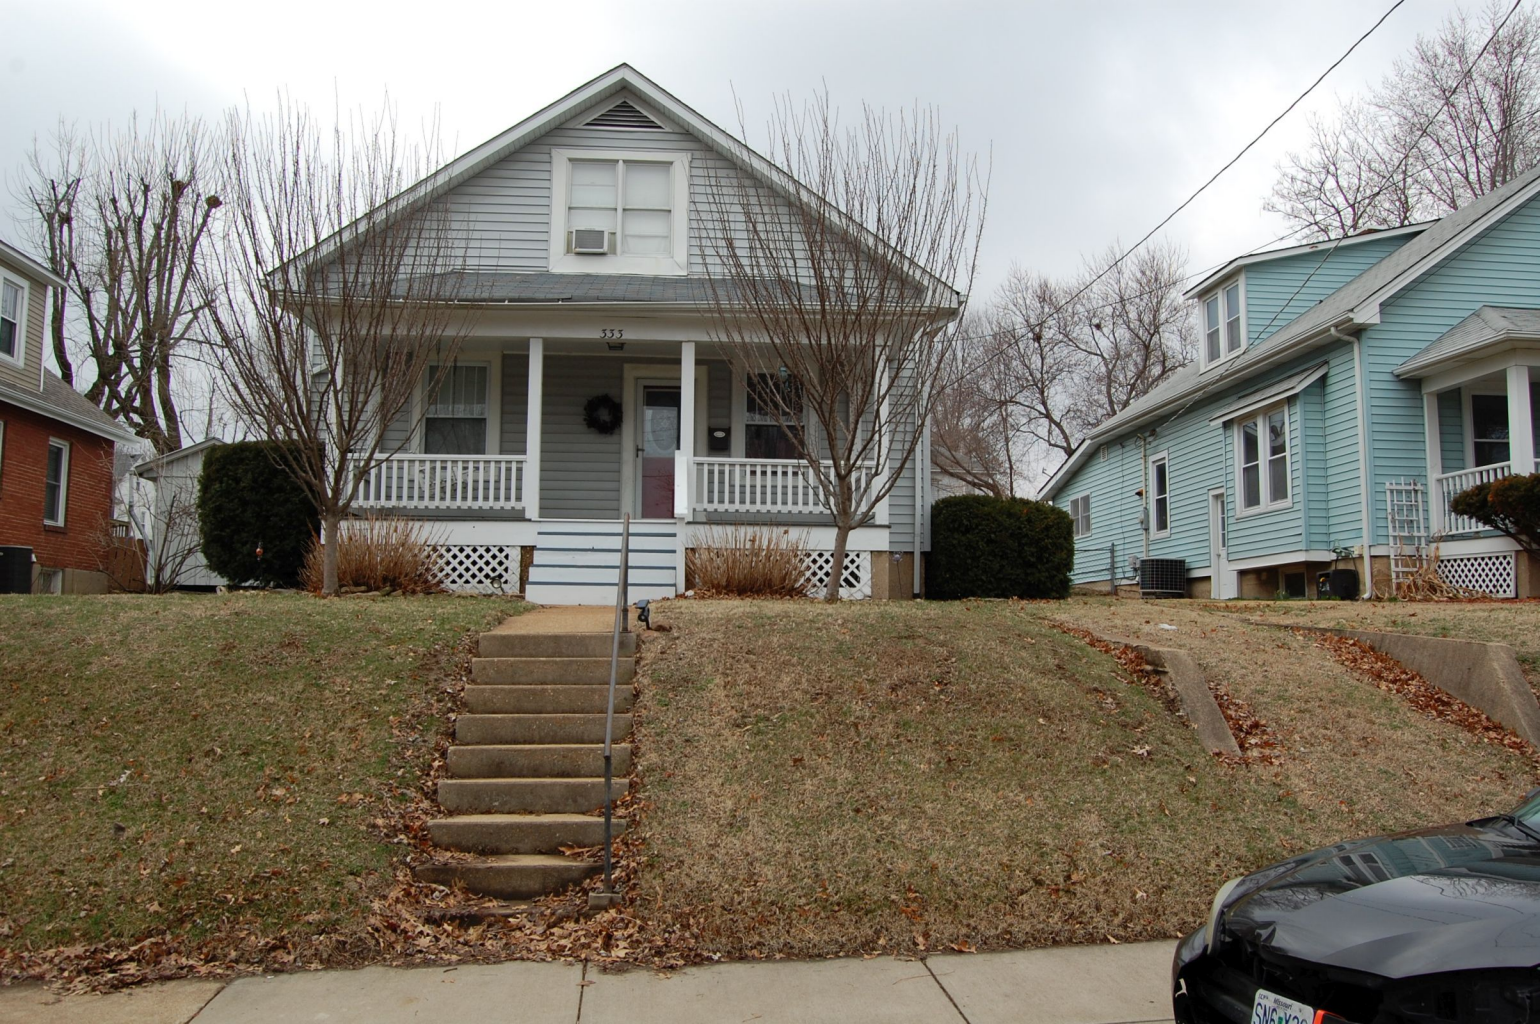
The c1915, 1.5 story frame dwelling has a concrete foundation, vinyl siding, and a gable front, asphalt shingle roof. The front façade is three bays wide. There is a 3/4 width, 1-story open frame porch centered upon the front façade. The porch has a dropped, hipped asphalt shingle roof, replacement square wood posts and an open square wood baluster railing. Sheltered within the porch is an offset right single entry of a rectangular light glass with oval etching and paneled replacement door flanked by single 5/1 false interior vertical muntin vinyl sash windows. Set within the upper story gable are paired 1/1 wood sash windows. Shed roof dormers with paired windows are on the N and S elevations. On the W elevation is a full width 1-story open shed roof porch with concrete slab foundation and square wood posts. There is a central interior straddle ridge brick chimney. Post 1992 survey alterations include: replacement of aluminum with vinyl, replacement of multi-light glass and wood door, replacement of 5/1 wood sash with 5/1 vinyl. Due to the alterations to the siding and windows, the dwelling is not considered eligible for listing in a potential NR district.

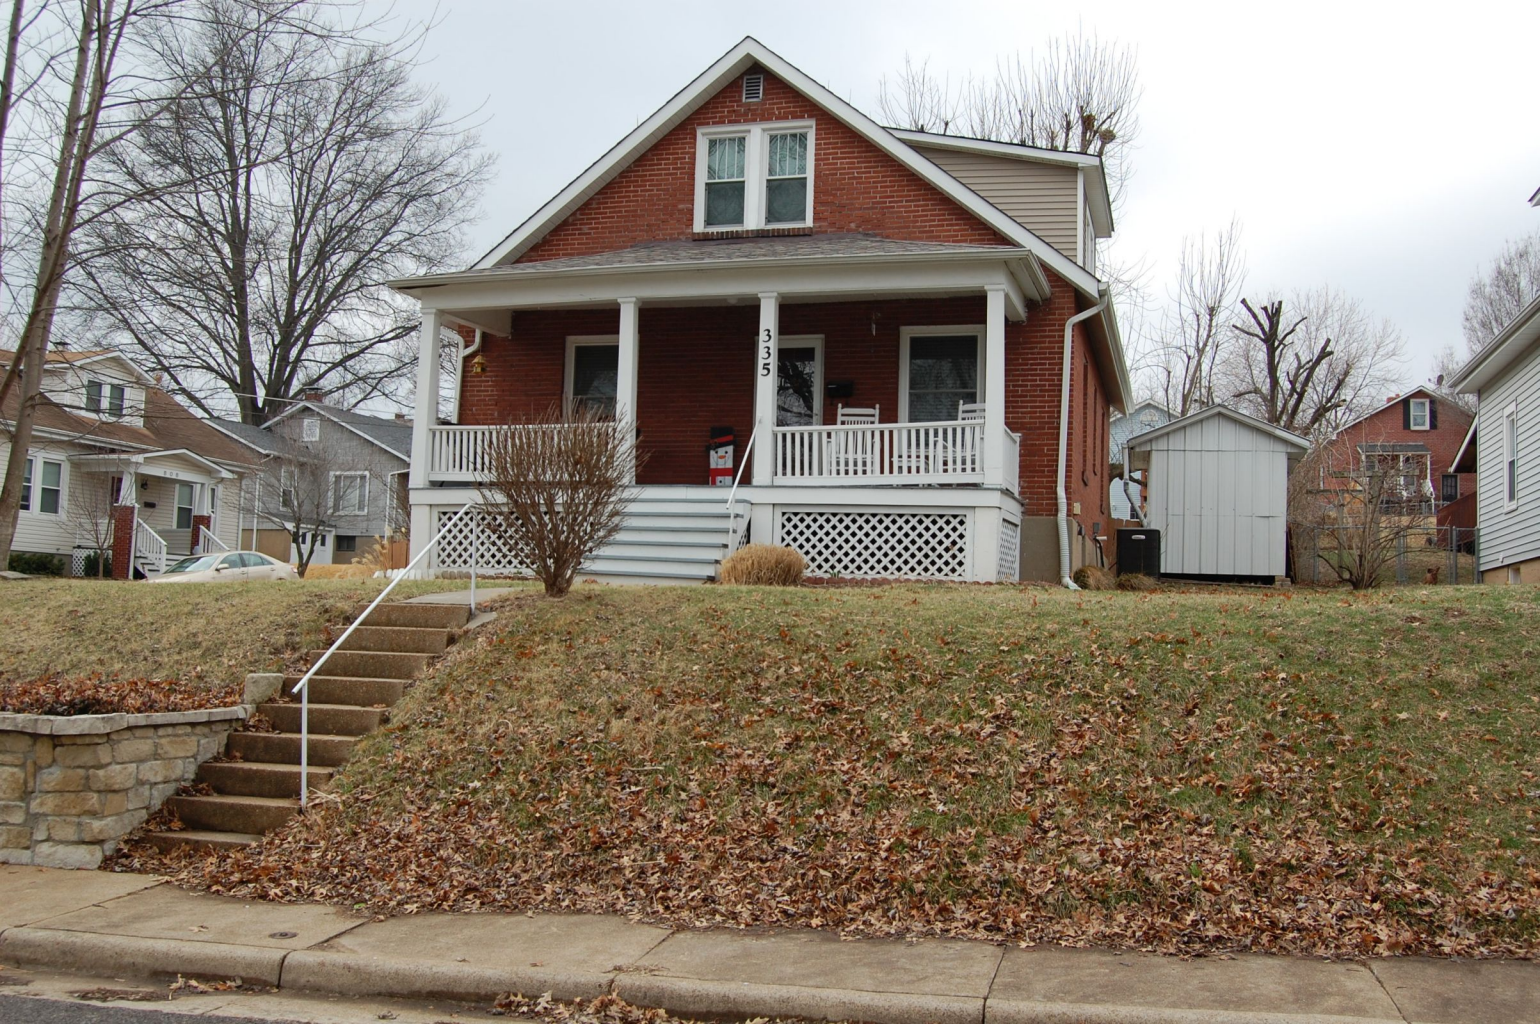
The 1.5 story frame dwelling has a concrete parged foundation, running bond brick exterior, and a front gable, asphalt shingle roof. The front façade is 3 bays wide. There is a 3/4 width, 1-story open front porch centered upon the façade. The porch has a dropped hipped asphalt shingle roof, slightly tapered square wood posts, and an open square wood baluster railing. Sheltered within the porch is an offset right single entry (door not visible), flanked by single windows. Set within the upper story's gable are paired similar windows. Shed roof dormers with paired windows and vinyl clad walls are on the N and S elevations. Windows are 4/1 vertical false interior muntins vinyl sash with flat surrounds and brick rowlock course lug sills. On the S elevation is a former 1-car garage built into the foundation. It has since been enclosed with vinyl siding and a one paneled metal door. On the west elevation is a partial width wood deck. Post 1992 survey alterations include: replacement of the wood sash windows with vinyl post June 2013 (Google street view), replacement of asphalt shingles on the dormer walls with vinyl, removal large antenna post 2013 (Google street view), and potential removal of chimney which was not visible from the street. The windows were replaced relatively in kind, maintaining the same profile. While there have been minor alterations the building retains its integrity and is therefore a contributing resource to a potential NR district.

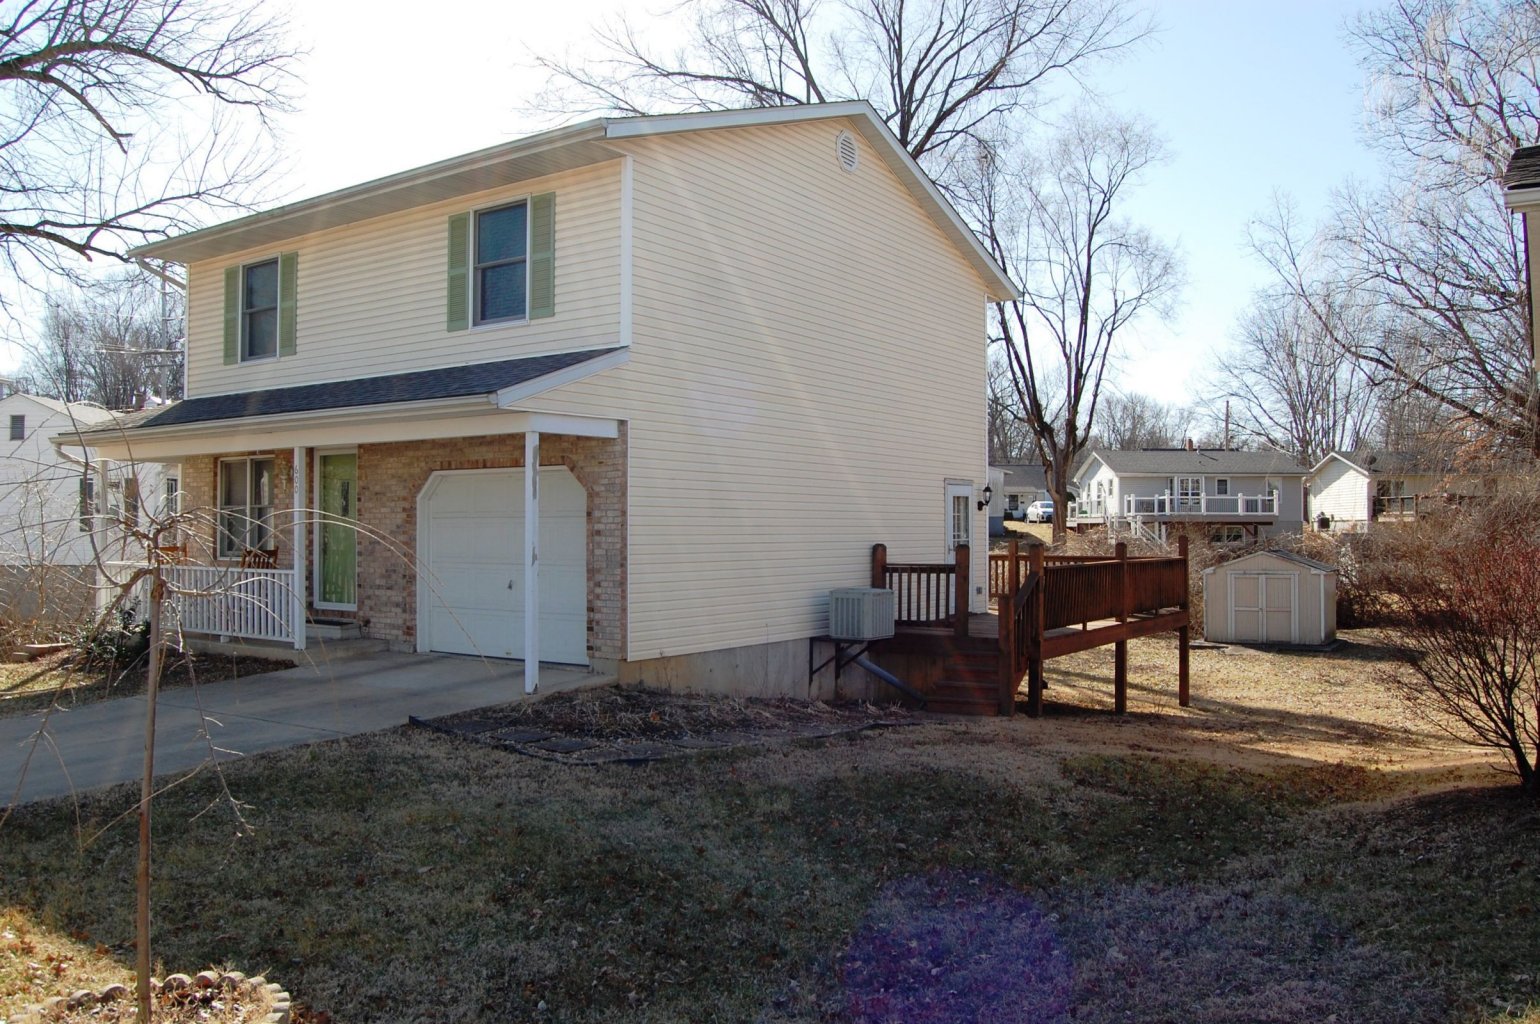
This 1994, frame 2-story dwelling has a concrete foundation, vinyl siding and a low, side-gable asphalt shingle roof. The primary façade is 3 bays wide set within a 1-story full width, gallery porch. The porch has a concrete platform (side left) and concrete driveway (side right) with three square wood posts and square post balustrade supporting a dropped asphalt shingle shed roof. Within the porch, side right, is a built-in, 1-car garage bay with a clipped opening containing a paneled metal or composite overhead door. The side left bay contains a centered single entry of a solid door with a small, centered vertical rectangular light and storm door and paired 1/1 double-hung windows with a brick rowlock sill. The second story contains 2 windows with ornamental shutters. All windows are 1/1 double-hung, vinyl sash. This residence was not part of the 1992 survey.

Due to its recent date of construction, this building is not considered eligible for listing as part of a potential NR district.

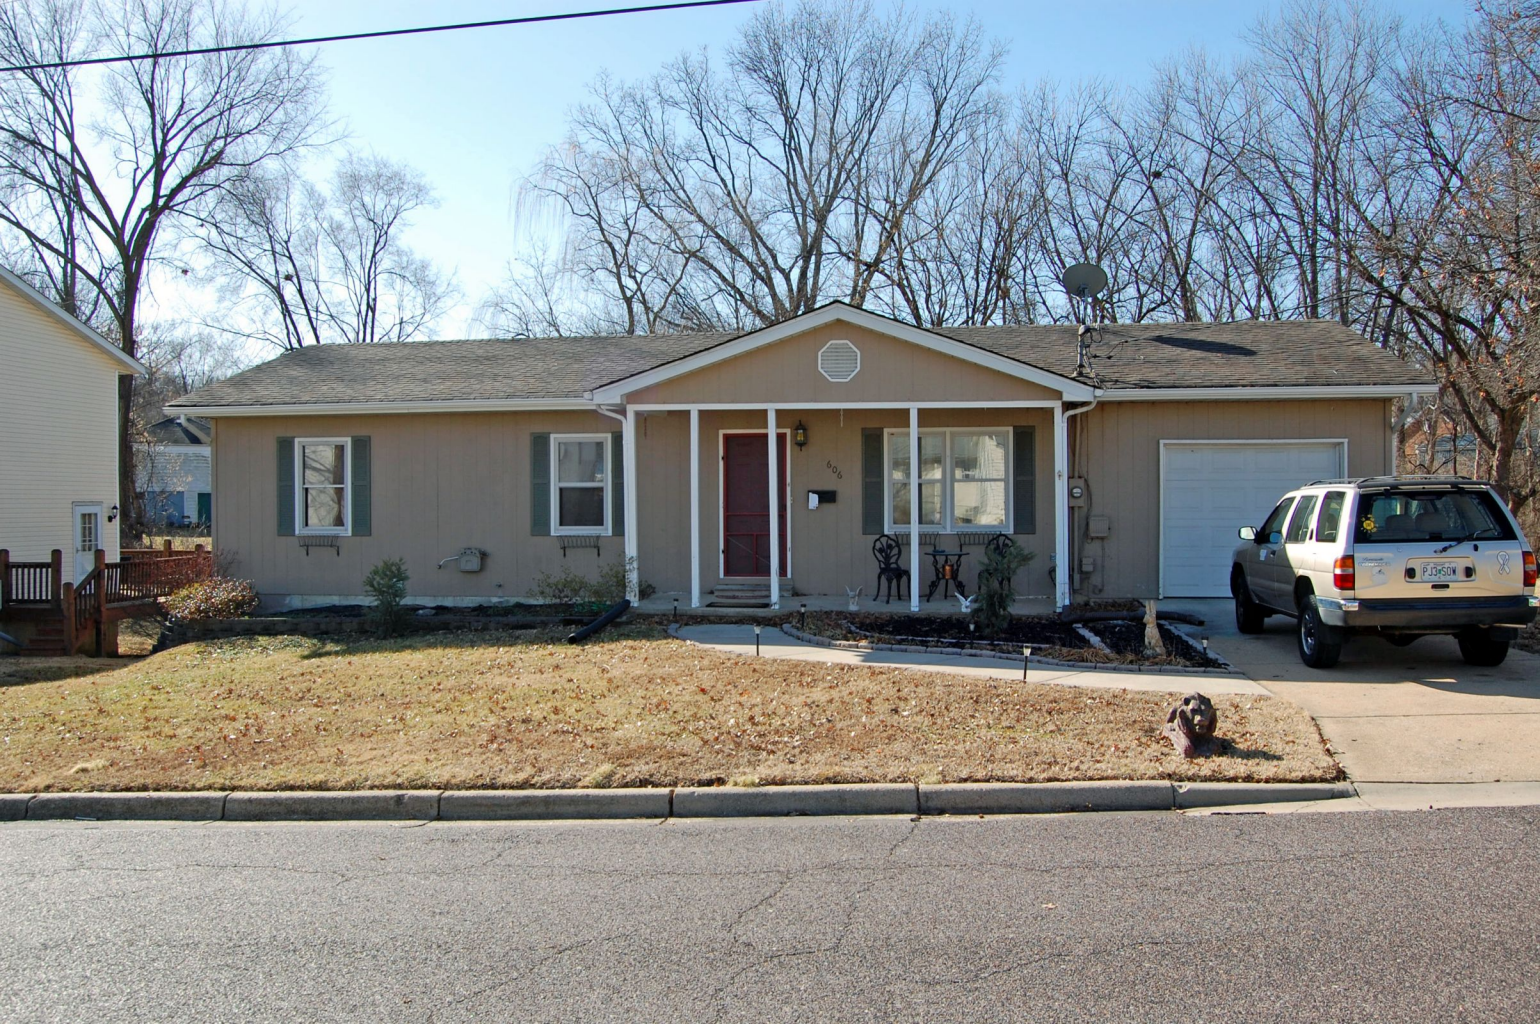
This 1986, frame 1-story dwelling has a concrete foundation, composite siding in the appearance of vertical boards, and a centered gable asphalt shingle roof. The primary face is 5 bays wide. The side right bay is a built-in, single car garage with a metal paneled overhead door. The center bay consists of the extended center gable into an open gallery porch with a concrete slab porch, slender square posts, and an octagonal vent within the gable. Within the porch is a single, replacement paneled door that is centered to the building and a paired 1/1 windows to its right. The side left bay has two single 1/1 windows. Windows are replacement vinyl sash and have ornamental shutters. This residence was not part of the 1992 survey.

Due to its recent date of construction, this building is not considered eligible for listing as part of a potential NR district.

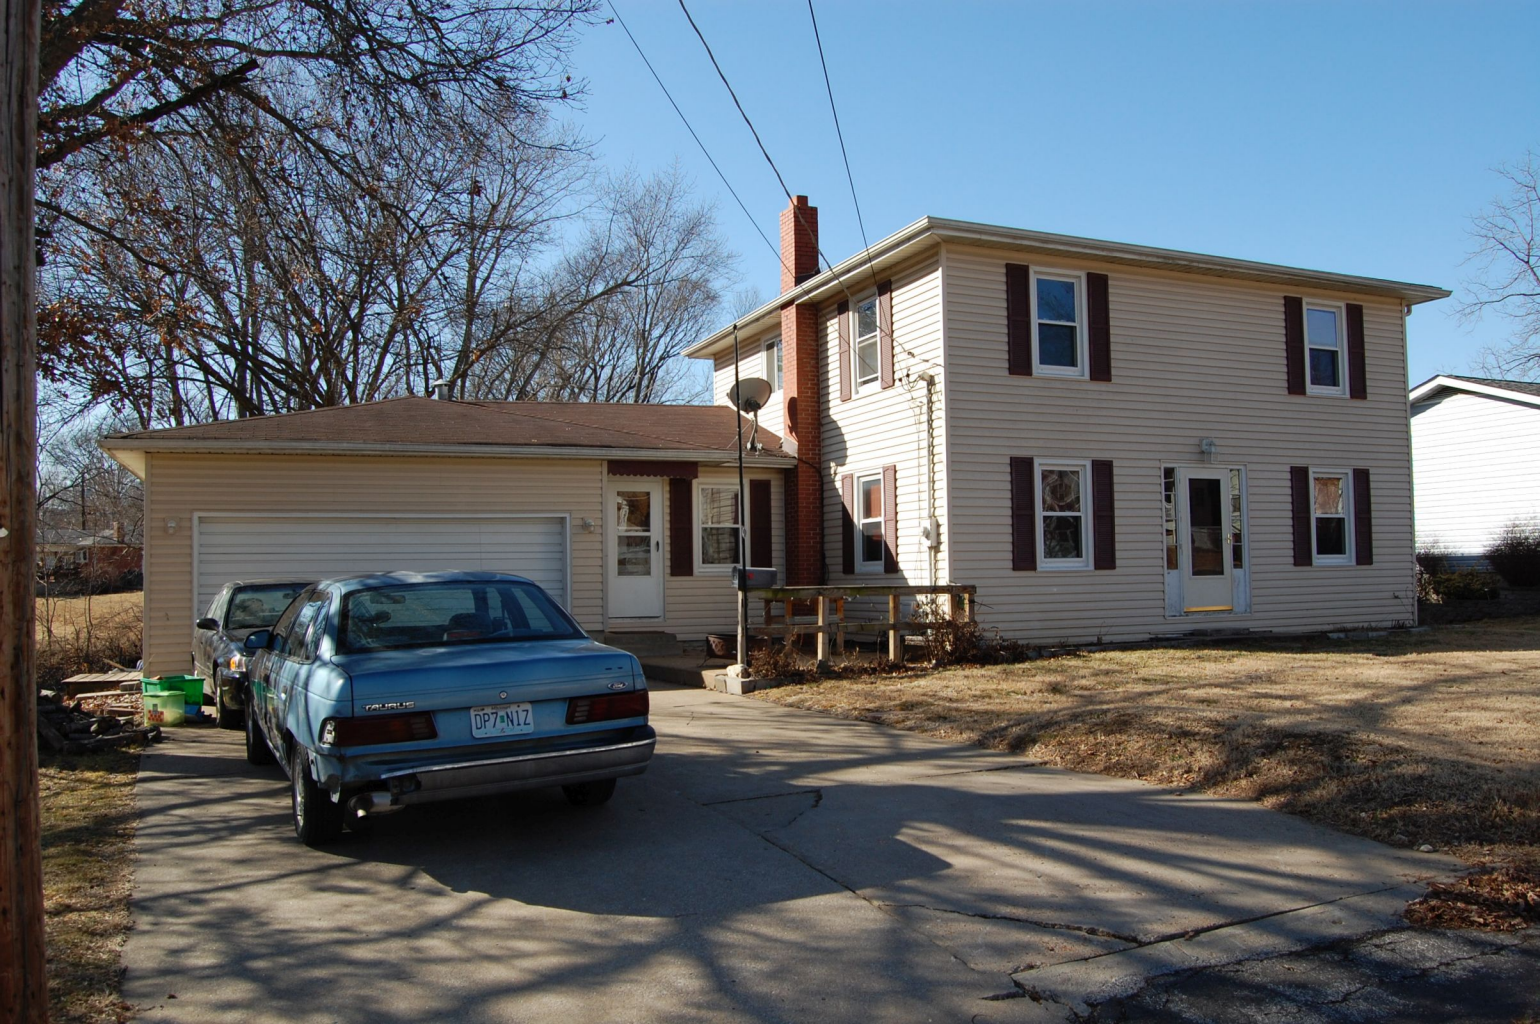
The original siding is unknown but the replacement vinyl siding overpowers the home; It has a thicker profile than the fenestrations. Due to this siding and newer vinyl windows is not considered eligible for listing as part of a potential NR district.
