MISSOURI DEPARTMENT OF NATURAL RESOURCES
STATE HISTORIC PRESERVATION OFFICE, P.O. Box 176, Jefferson City, MO 65102
ARCHITECTURAL/HISTORIC INVENTORY FORM

1. SURVEY NO. FR-AS-007-0104		2. SURVEY NAME: International Shoe Factory Neighborhood	
3. COUNTY: Franklin		4. ADDRESS (STREET NO.) 301	STREET (NAME) High Street

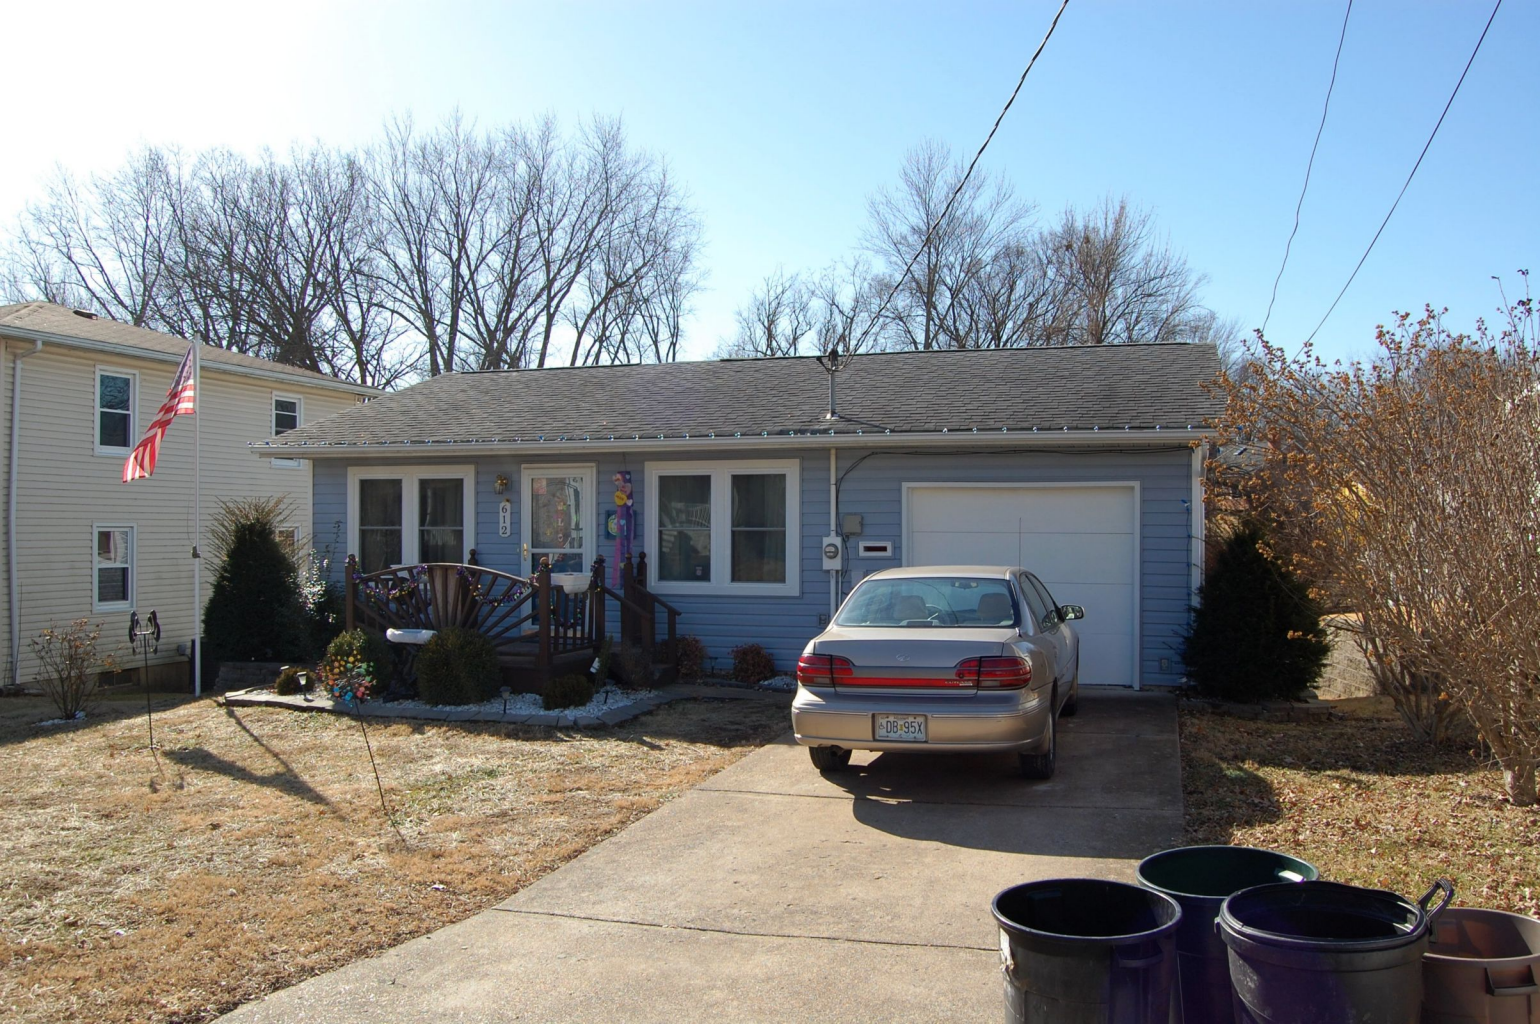
The 1-story dwelling has a poured concrete foundation, vinyl siding, and a rear facing, cross gable asphalt shingle roof. The front façade is 4 bays wide, consisting of a built-in 1 car garage, side right, and paired 1/1 double-hung vinyl windows flanking a single entry door, side left. The garage bay has a rectangular opening containing a metal overhead door. The slightly off center-left entry consists of a wood platform with a wood balustrade surround in the style of a sunburst, newer paneled door of indeterminate material and screen door. The cross gable is at the rear of the home, side left, or the SE corner of the home. The assessor's office notes that the home has a walkout basement. The home was left out of the 1992 survey; however changes were made post June 2013 according to Google street view. Vinyl siding replaced composite in the appearance of vertical boards, new windows were added and ornamental shutters were removed. The home is very similar in design to 238 and 240 Johnson Street, both constructed in 1988.

Due to its recent date of construction, 1988, this building is not considered eligible for listing as part of a potential NR district

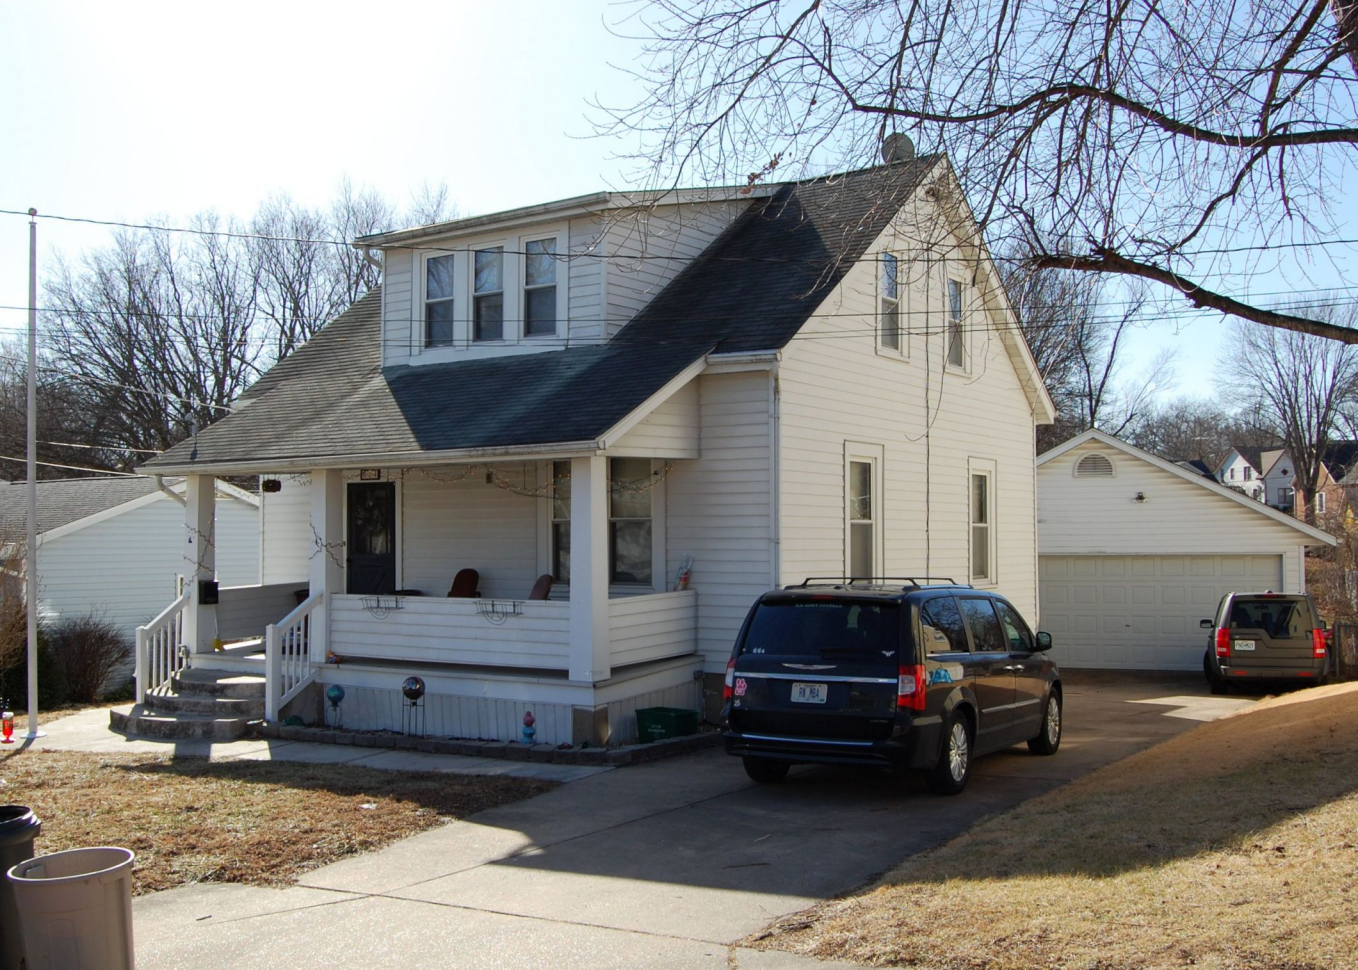
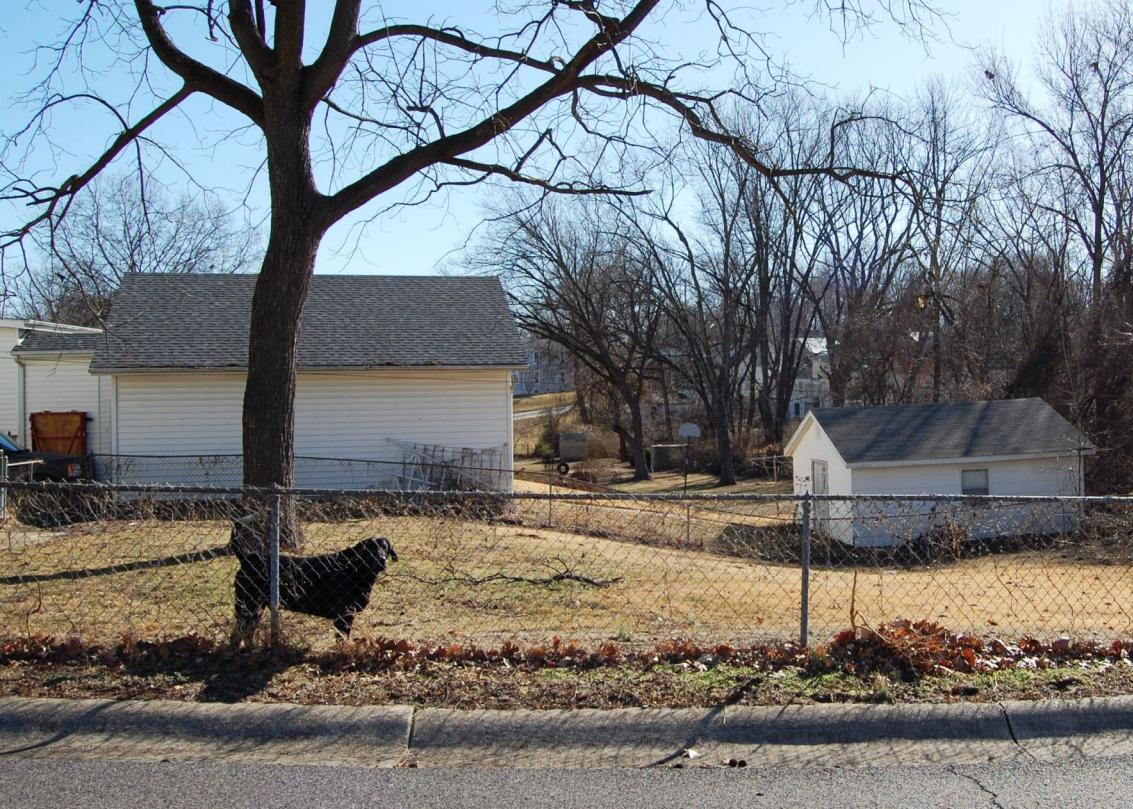
The 1.5 story frame dwelling has a concrete parged foundation, indeterminate siding, and a side gable, asphalt shingle roof. (The 1992 survey notes the siding as vinyl, the assessor's office list aluminum, and present street survey noticed a faux wood grain). The front façade is two bays wide with paired 1/1 double-hung windows side right and a single entry consisting of a multi-light glass and wood door. On the main façade is a 1-story, ¾ width centered open porch with an asphalt shingle shed roof extended from the primary roof. [Despite the 1926 & 1951 Sanborn map depicting a full-width porch, the current porch dimensions appear original.] The porch roof is supported by three large, square to slightly tapered wood posts with a solid, horizontal aluminum or vinyl clad railing. The 3 curved entry steps, side left, are newer poured concrete with a wood or composite railing on both sides. Centered in the upper story is a shed roof dormer with three 1/1 double-hung windows. Windows are vinyl sash. On the rear, south façade, the wood frame porch has since been altered into a 1-story wood frame addition with newer concrete foundation, and shed roof. (Post 1951). Since the 1992 survey alterations include the replacement of the straight concrete entry steps and wrought iron railing with the curved concrete stairs and wood or composite railing, as well as replacement of 1/1 wood sash for vinyl.

Due to the later exterior alterations in siding and windows, the dwelling is not considered eligible for listing in a potential NR district.

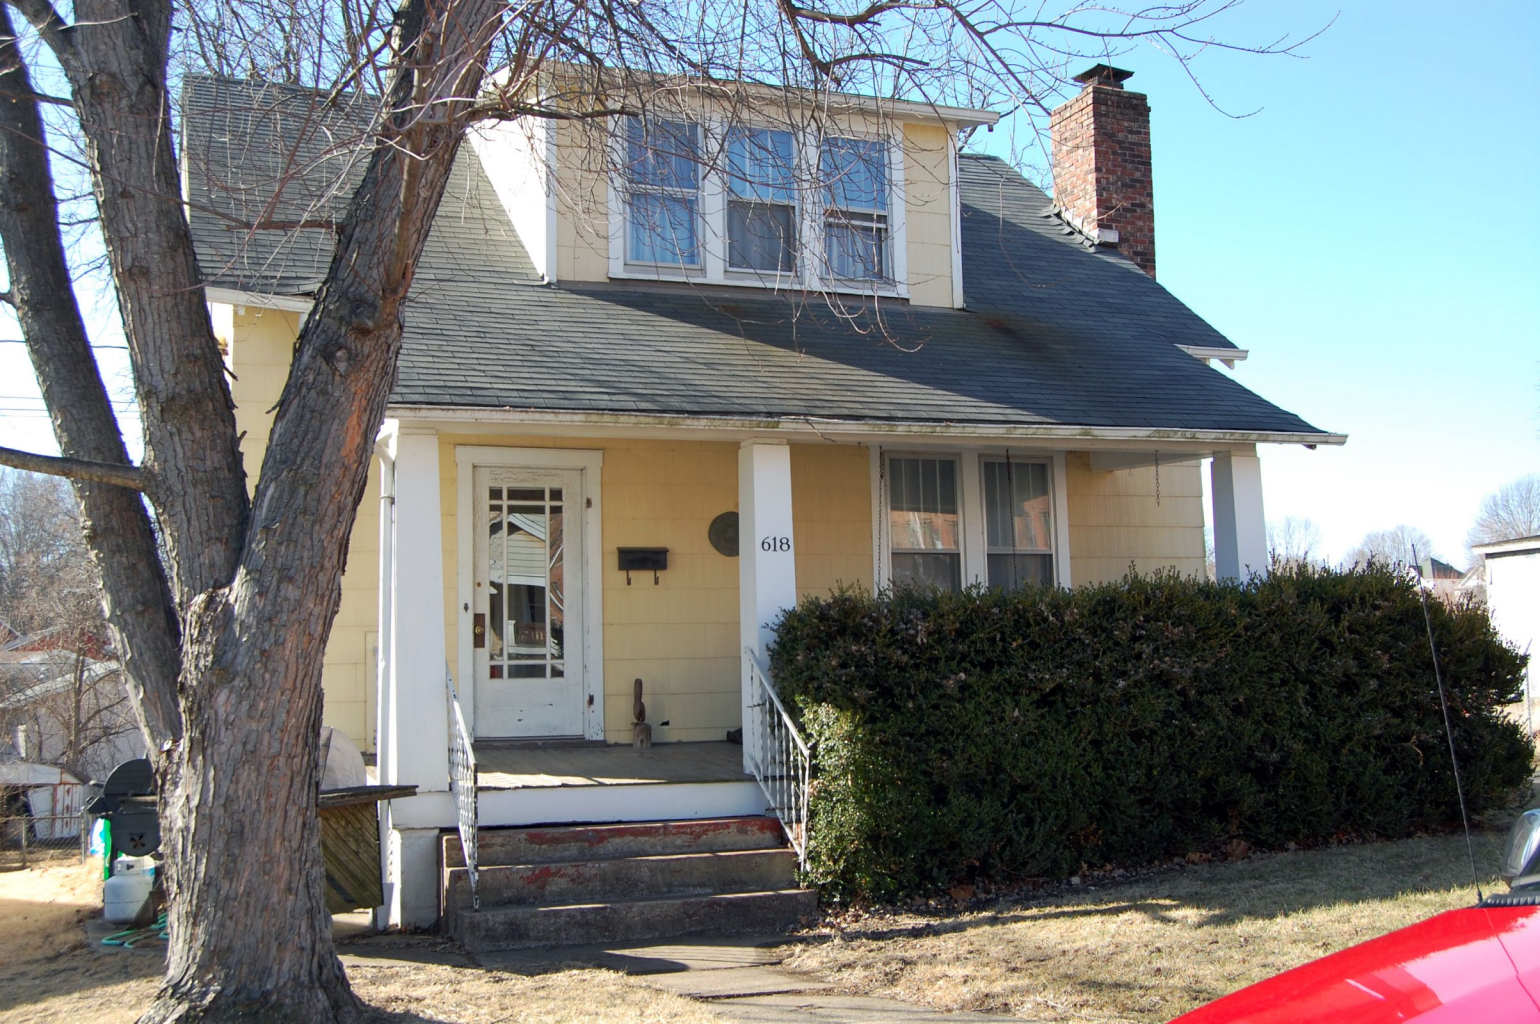
The 1.5 story frame dwelling has a concrete foundation, asbestos shingle siding, and a side gable, asphalt shingle roof. The front façade is two bays wide with paired 4/1 double-hung, vertical wood sash window, side right and a single entry consisting of an original multi-light glass and wood door. On the main façade is a 1-story, ¾ width centered open porch with an asphalt shingle shed roof extended from the primary roof. [Despite the 1926 & 1951 Sanborn map depicting a full-width porch, the current porch dimensions appear original.] The porch has three large tapered wood posts supporting the roof and a wrought iron railing. 3 concrete entry steps are on the side left. Centered in the upper story is a shed roof dormer with three 3/1 double-hung, vertical wood sash windows. Windows are all wood sash. There is a central interior brick chimney and an exterior, side right brick chimney on the western elevation. On the rear, southern elevation is a 1-story frame addition with concrete foundation and asbestos shingle siding with a SW deck. The home is very similar in design to 611 & 614 Roberts. There are no major alterations since the 1992 survey. This building is considered edible for listing in a potential NR district.

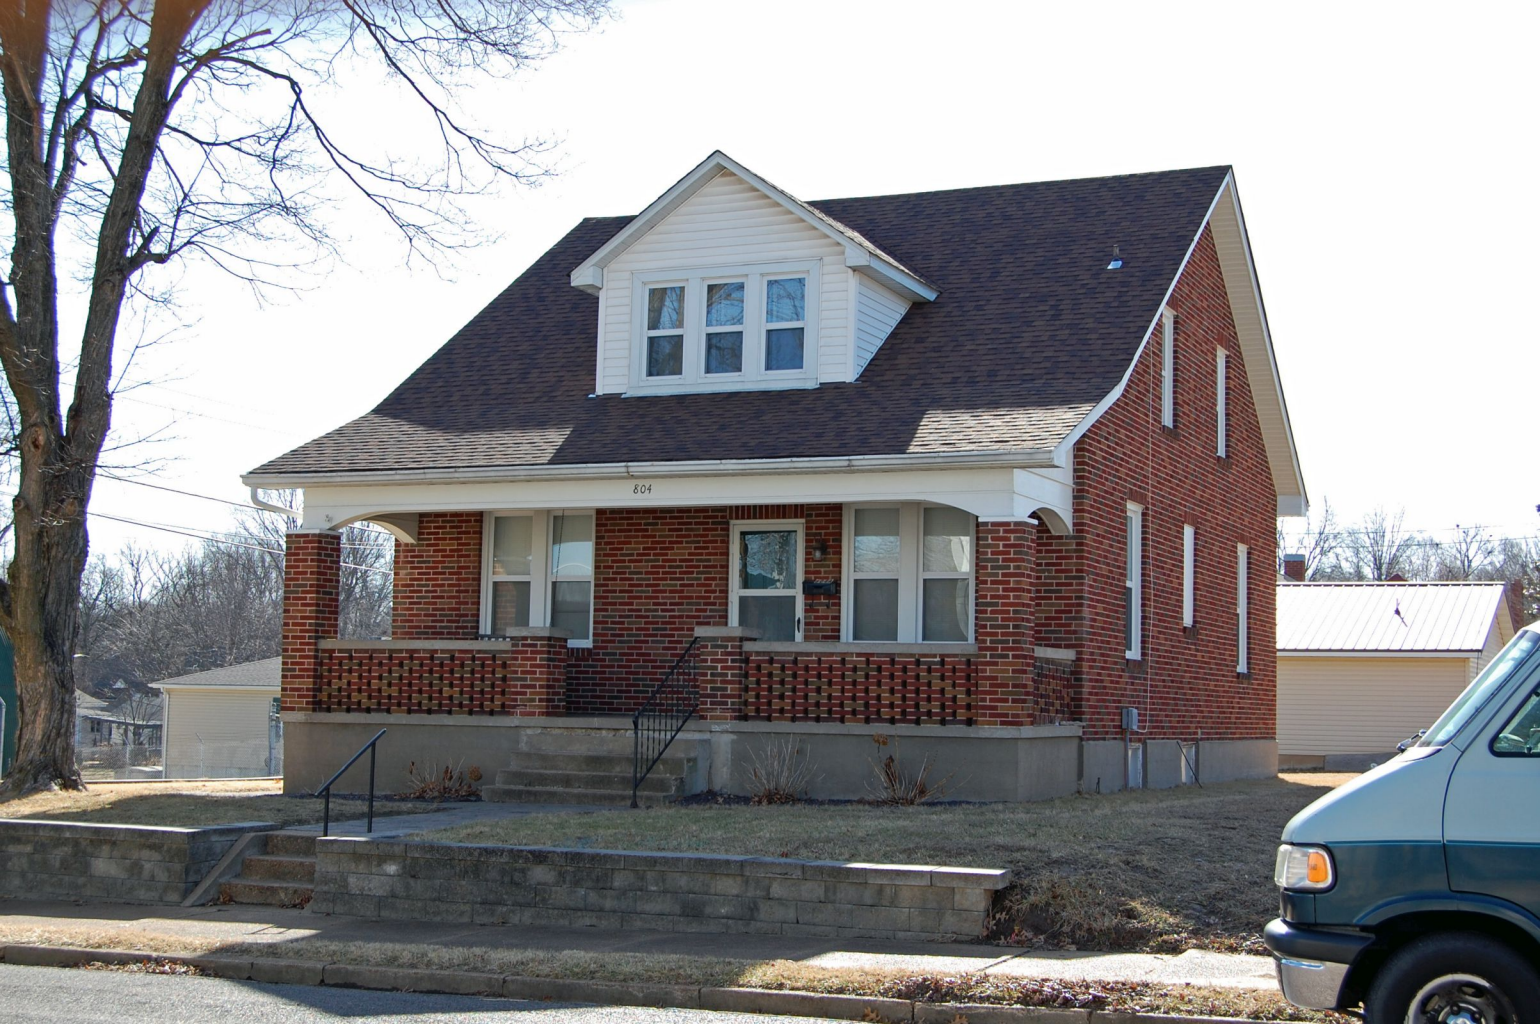
The 1.5-story brick masonry dwelling has a concrete parged foundation etched to look like stone blocks, an exterior of variegated brick in a running bond, and an asphalt shingle side gable roof. The primary façade has a full width, engaged front porch. The open porch has an extended shed roof, from the primary, supported by two large brick columns. It contains a raised concrete platform, centered concrete stairs, and an open brick weave balustrade. Within the porch are 3 bays: a slightly off center-right entry flanked by paired 1/1 double-hung windows. The entry has a flat soldier course lintel, storm door, and wood door. The windows have brick rowlock lug sills. Centered on the upper half story of both the front and rear facades are front gabled dormers. The front dormer contains a central bay with a ribbon of three, 1/1 double-hung replacement windows. The dormer is clad in vinyl siding and the windows are set in flat surrounds. Windows are replacement 1/1 double-hung vinyl sash. Both the sides (N & S) have 3 bays. The E façade has a basement entry with an open, wood stair and platform to the upper level entry. The platform has an open metal railing and a metal awning above the entry. On the W façade a centered first floor window is boarded. On the S façade is an asphalt shingle shed roof porch with concrete platform and open decorative wrought iron railing. Major alterations since the 1992 survey include replacement of original vertical 3/1 wood sash windows with 1/1 vinyl sash, replacement of dormer wood shingle siding with vinyl, and a new c2015 garage. This building is considered eligible for listing in a potential NR district.

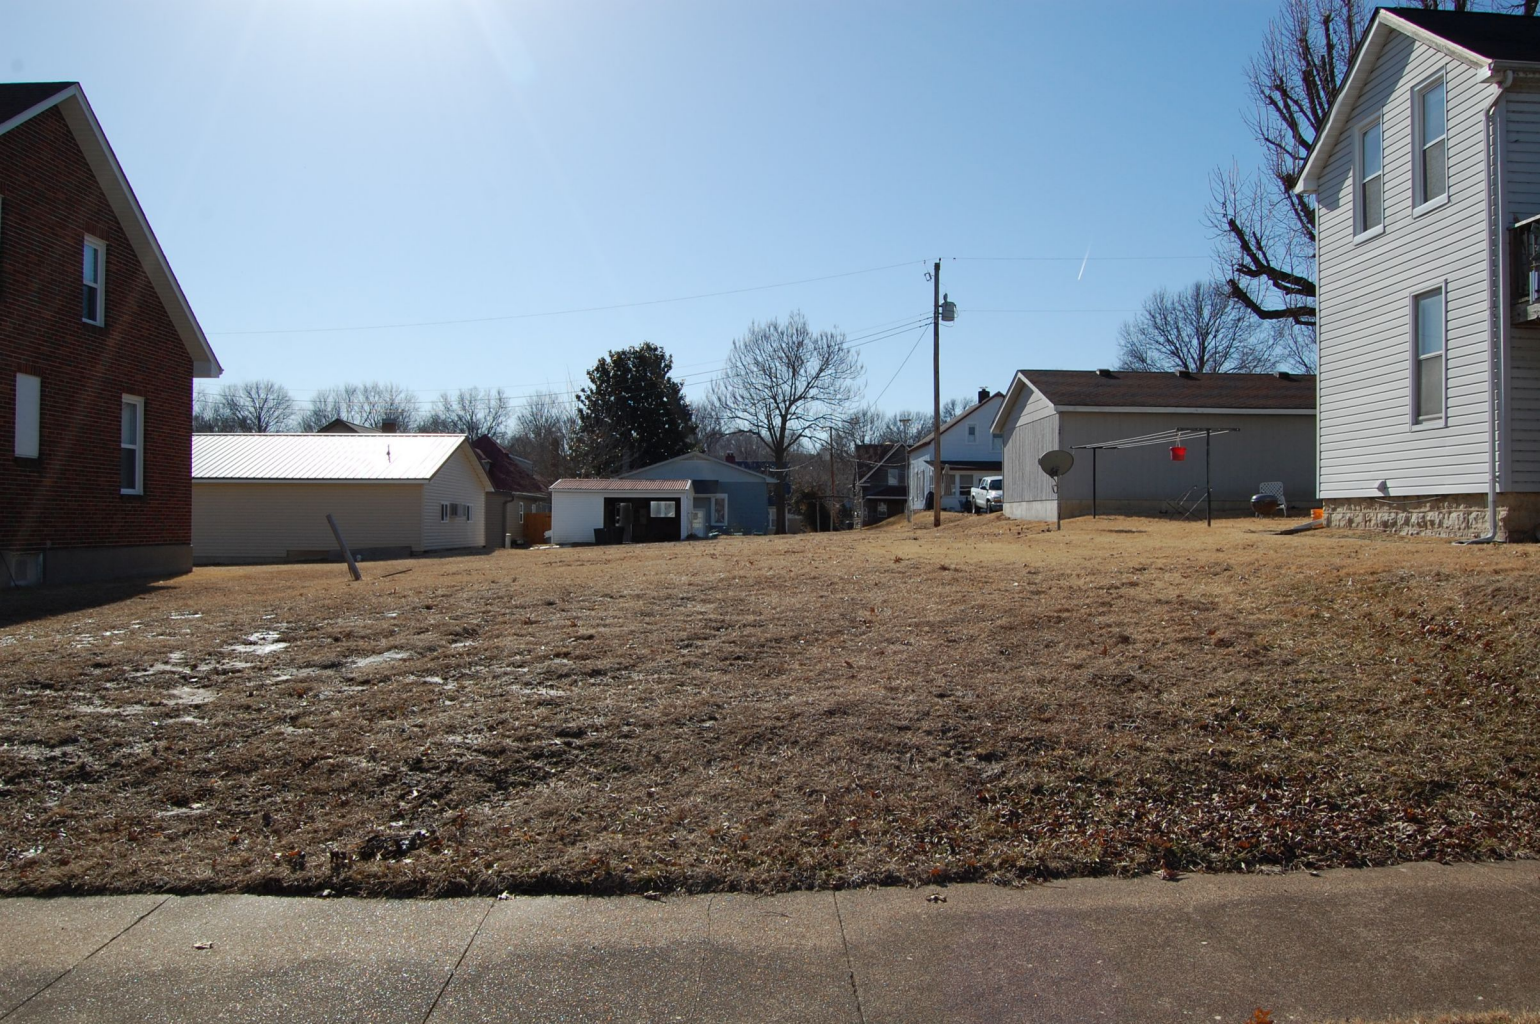
The grassy vacant lot is currently undeveloped. It was once occupied by 806 Roberts, which contained a c1910, 1.5-story wood frame dwelling with a Gable Ell plan and a 1-story frame garage and 1-story frame outbuilding. Google street view, (June 2013) and the assessor's office photos indicate deferred maintenance and demolition by neglect. The dwelling was demolished around Sept 2015 according to Google Earth. The lot is owned by the same owner of 804 Roberts. It remains undeveloped and does not contribute to the historic context of a potential district. (This property was surveyed in 1992 which includes the description of the original dwelling)

The vacant lot is not considered eligible for listing in a potential NR district due to the demolition of a historic structure.

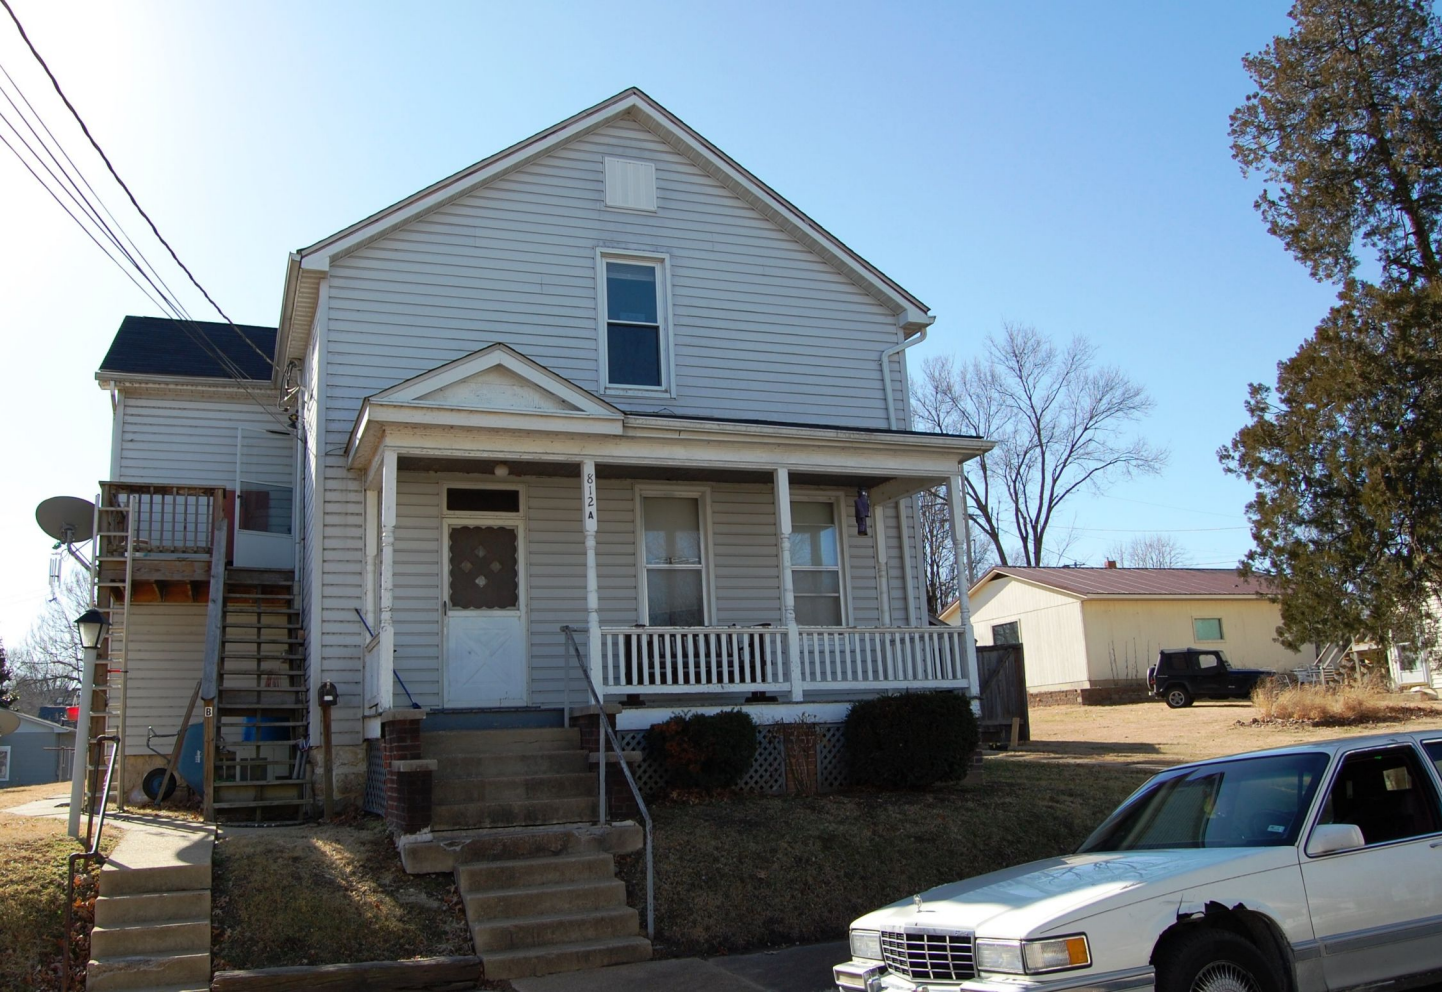
The 1.5-story wood frame dwelling has a rusticated limestone foundation, vinyl siding, and a gabled ell asphalt shingle roof. The front façade is three bays wide with a $\frac{3}{4}$ width, centered 1-story open porch. The porch has a dropped, hipped asphalt shingle roof with a side left gabled pediment over the entry bay, three turned wood columns with two additional engaged columns, and an open square wood baluster railing. Within the porch is a single, side left entry consisting of a solid wood door with 4 small diamond lights in the shape of a larger diamond, and a storm door. To the right of the entry are single 1/1 double-hung windows of indeterminate material. The windows are behind storm windows and appear to be earlier replacements. Centered within the upper half story are a single 1/1 double-hung window and a square vent within the gable. On the eastern façade is an upper story wood landing with open wood stairs leading to the upper apartment. Since the 1992 survey alterations include the replacement of a standing seam metal roof with asphalt shingles and the removal of 2 chimneys (brick interior wall, straddle ridge, on the east and west facades).

Due to the alterations, primarily in siding, this dwelling is not considered to be eligible for listing in a potential NR district.

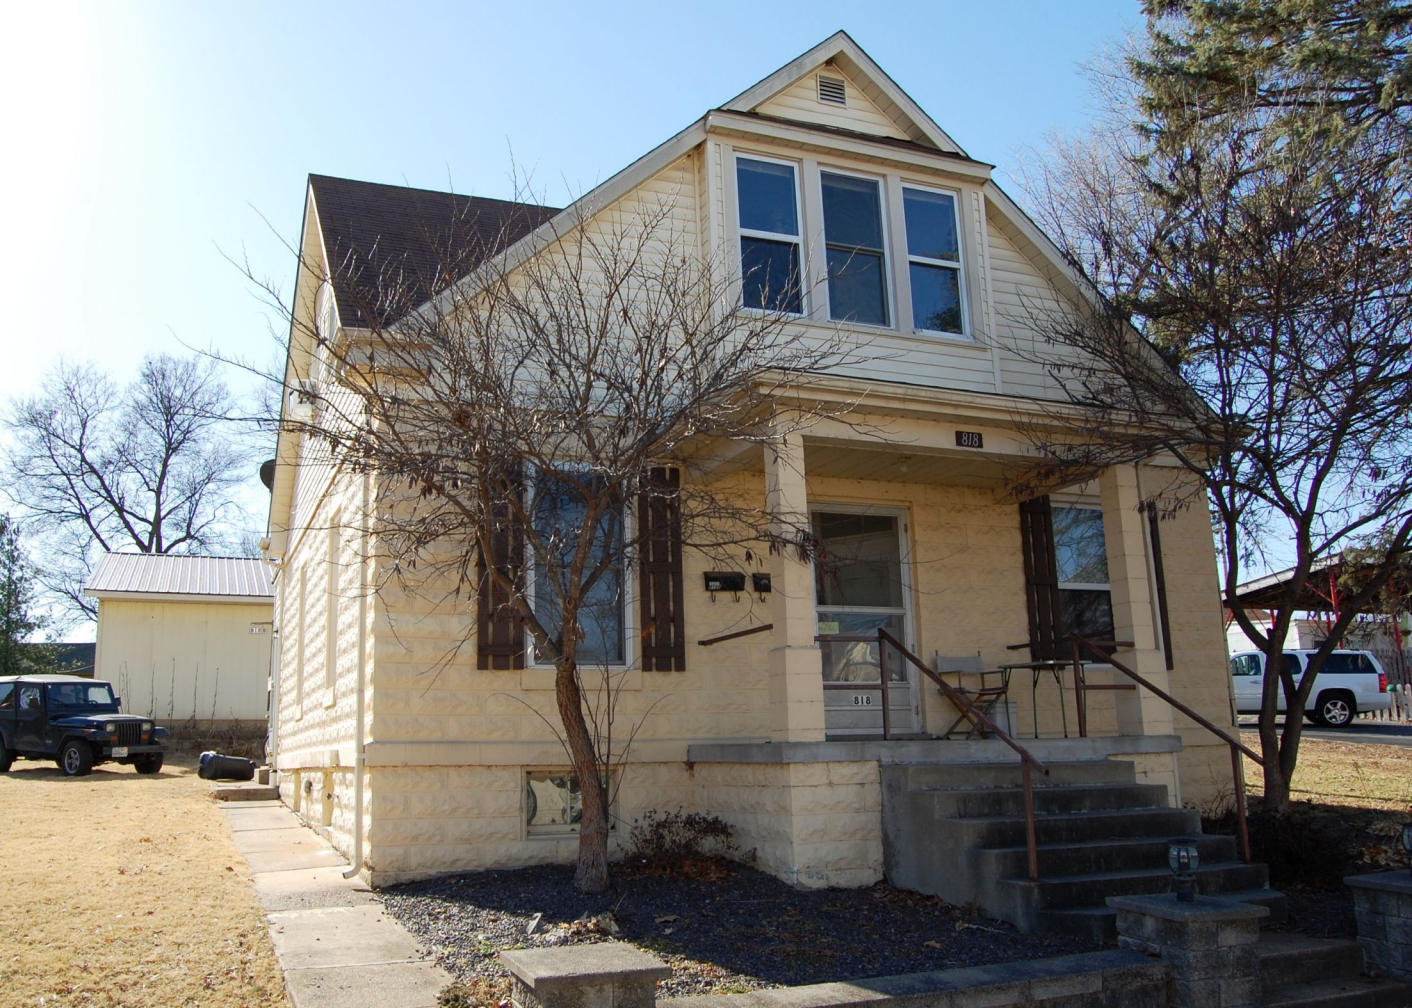
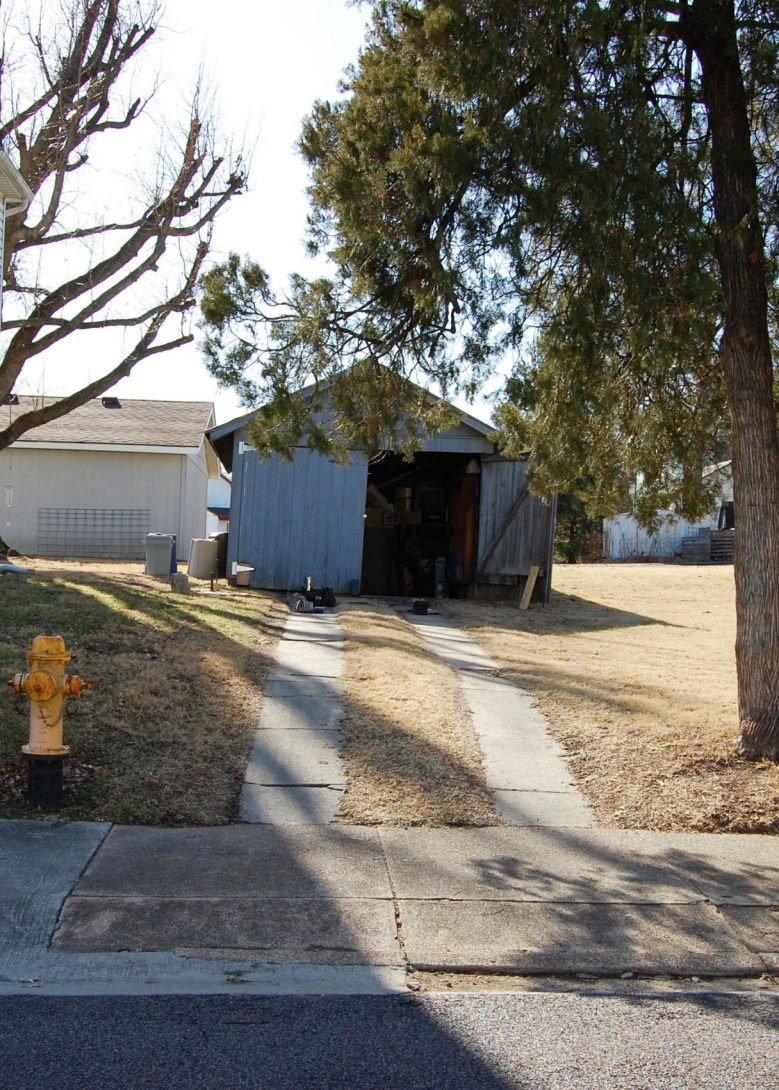
The 1.5 story, multi-family dwelling is a concrete block home with a concrete foundation, rusticated concrete block exterior with vinyl clad frame gables, and a cross gable asphalt shingle roof. The primary façade is 3 bays wide. The central bay contains a 1-story open porch with a cement block foundation, a non original square metal railing on the stairs and front, two cement block columns, and a very low, hipped asphalt shingle roof. Within the porch is a centered entry containing a glass and metal storm door and two original, paneled wood doors with square lights and single light transoms angled within the entry way. Flanking either side of the porch are single 1/1 double-hung vinyl sash windows with ornamental wood plank shutters. Centered within the upper half story is a pronounced window bay with asphalt shingle shed roof containing three 1/1 vinyl sash windows. There is one exterior, west elevation brick chimney. There is a 1-story frame addition at the rear or southern elevation. Since the 1992 survey, alterations include: replacement of standing seam metal roof with asphalt shingles, replacement of vinyl or aluminum siding in upper story with newer vinyl, addition of metal porch railing, and removal of the eastern, interior, straddle ridge chimney.

The alterations to the dwelling have been minor and it is therefore eligible for listing in a potential NR district.

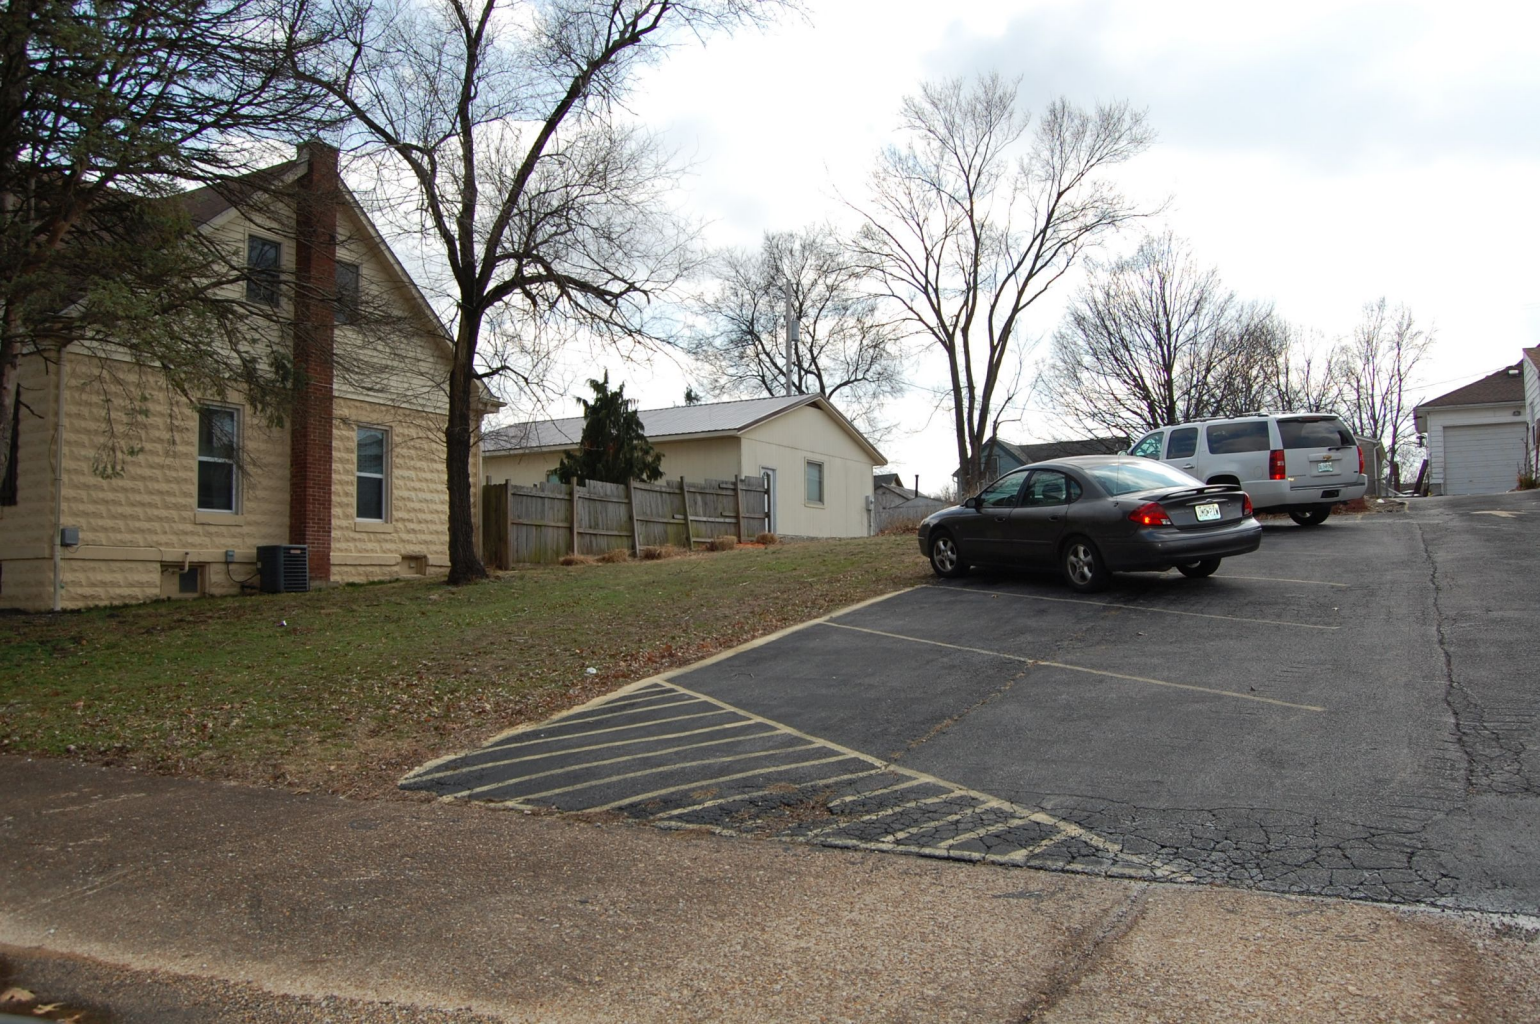
The vacant lot located between 818 Roberts and 210 High is split into two features. The eastern half is undeveloped and grassy while the western half is asphalt paving running from Roberts to the alley located between Roberts and Edith streets. The 800sqft paving contains 6 parking spots and was built in 2010 according to the assessor's office. The parking area, while a structure, is not accounted for due to its small size (fewer than 10 parking spots). This lot was not surveyed in 1992. The lot is currently owned by the adjacent Montessori school located at 210 High Street.

The lot is not considered eligible for listing in a potential NR district due to the demolition of previous structures.

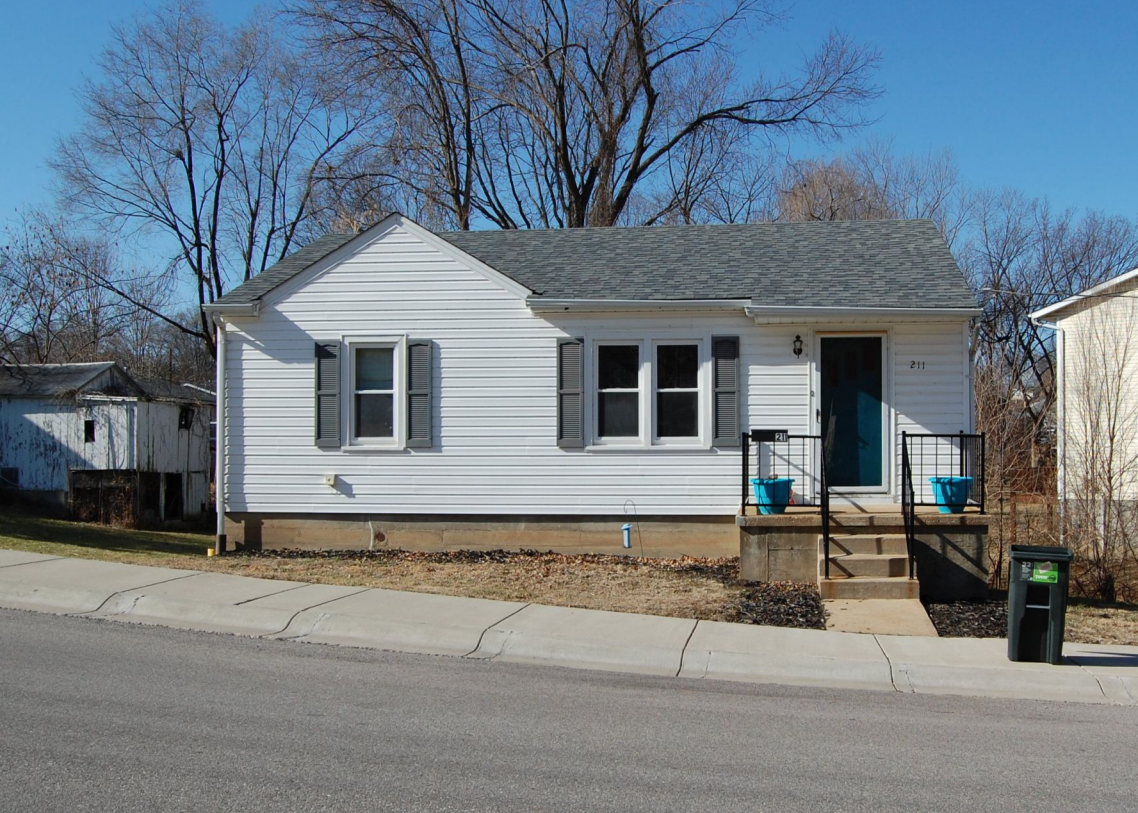
This 1 story wood frame, single family home has a raised, older formed concrete foundation, vinyl siding, and an asphalt shingled (North-South) side facing low gabled roof with front facing cross gable bay on the SE end. The primary façade is 3 bays wide: side left contains a single 1/1 window off center from the small front gable and side right has paired 1/1 windows and an entry bay. The side right entry bay consists of a formed concrete platform with centered concrete stairs, metal railing (straight balusters) and a single, centered door. There is a metal and glass storm door and a c1960-70s solid wood door with three rectangular lights ascending upward (L to R). All windows are replacement, 1/1 double-hung vinyl sash with a larger surround and faux shutters. The home is not depicted in the 1926 or 1951 Sanborn maps. The 1992 survey photographed but did not survey the dwelling. Post 1992 survey alterations include: removal of central interior, rear slope chimney; replacement of aluminum or asbestos siding with a smaller profile vinyl; replacement of older 2/2 horizontal wood sash with 1/1 double-hung vinyl sash windows; and replacement of slender wrought iron railing with a newer, metal railing.

Due to these exterior alterations (primarily vinyl siding) affecting its historic integrity, the building is considered non-contributing and not eligible for listing in a potential NR district.

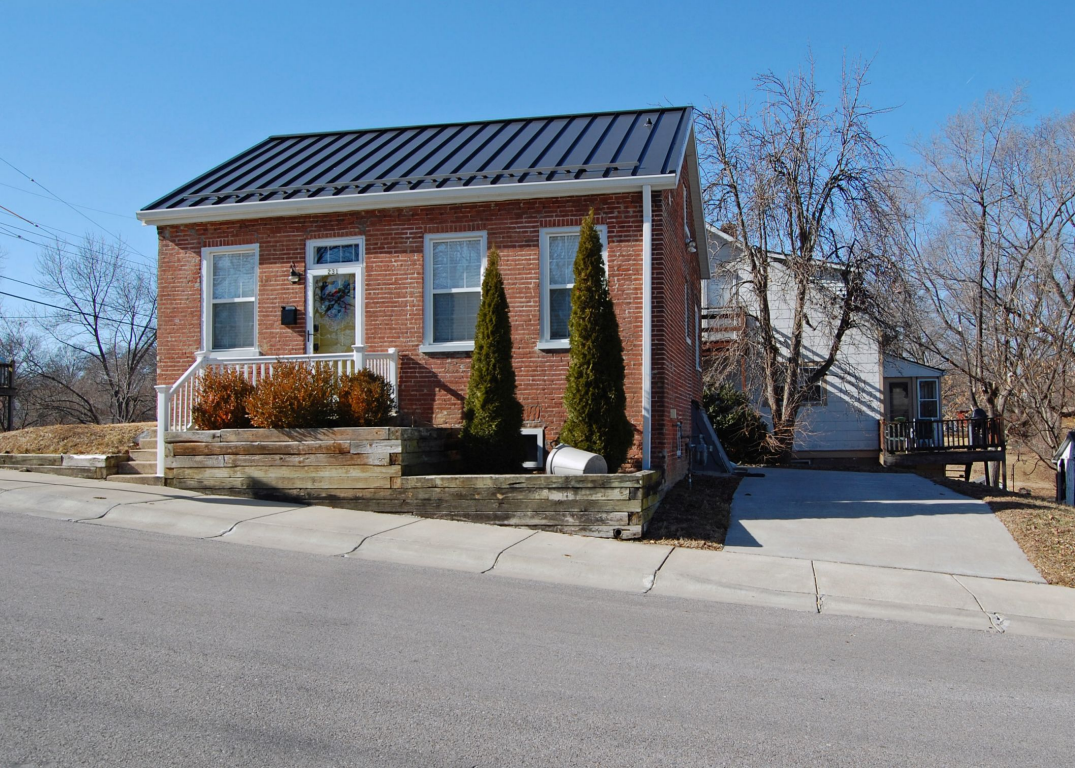
The 1.5-story masonry dwelling has a brick foundation, 5-course common bond brick exterior and a newer standing seam metal gable roof. The primary façade is 4 bays wide consisting of 2 individual windows side right and an entry and single window side left. The entry contains a storm door, replacement c1940s, paneled wood and 4 light door and 4-light transom set within a brick rowlock lintel. The façade windows are replacement 1/1 double-hung, vinyl sash with interior 6/6 faux muntins, with brick rowlock lintels and aluminum clad wood sills. At the roofline is a low-relief, brick dentil cornice. The south elevation (W 3rd) has two original 2/2 double-hung wood sash windows in the upper gable. The north elevation has 2 bays: 1 small, 1/1 replacement vinyl sash window with faux 4/4 interior muntins and a c1900 NW brick enclosed corner with a soldier course segmental arch lintel and a similar window from the front facade. N & S elevations have a single star tie rod anchor towards the E wall. Post 1992 survey alterations include new concrete porch platform and stair with composite railing, replacement of c1960s 1/1 wood sash with 6/6 vinyl sash windows (assessor photos); by June 2013 the current landscaping and railroad tie retaining wall was constructed (Google streetview); post 2013-2015 the older standing seam metal roof was replaced in kind and the 2 interior gable end chimneys removed (assessor); 10/2014-2015 The current side right concrete parking pad was added between 10/14 and 10/15 (Google Earth). The building maintains its historic form and is considered eligible for listing in a potential NR district.

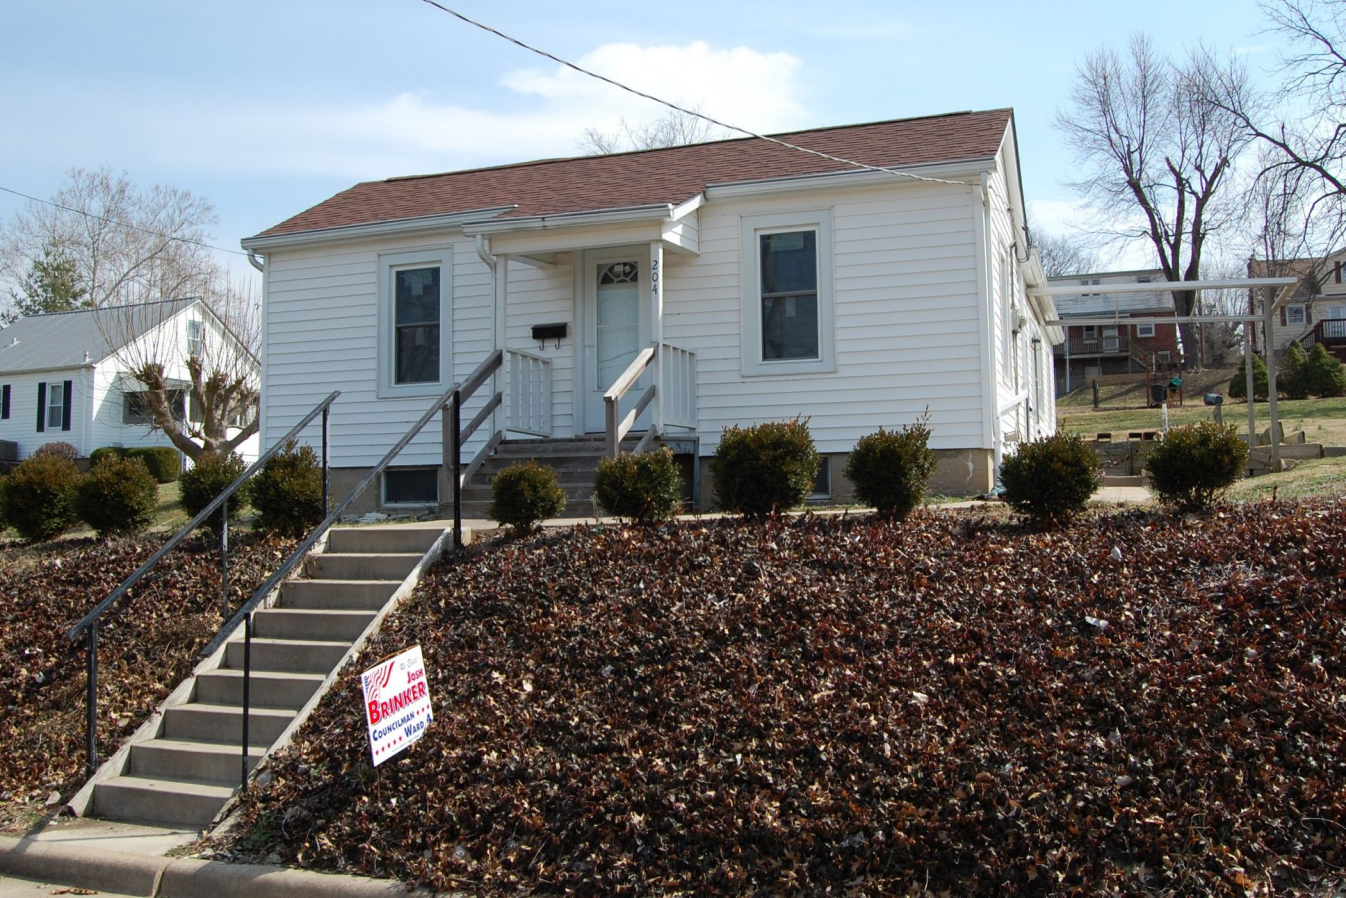
This one story frame home has a concrete foundation and a side gable roof covered with asphalt shingles. There are two window bays flanking an offset right entry on the primary elevation. The windows are 1/1 double hung vinyl replacement sash and the door is a non-historic metal replacement with a fanlight. There is a metal and glass storm door. There are two rectangular window bays at the basement level containing what appear to be either fixed or awning-sash single lights in aluminum frames. This property was not surveyed in 1992.

Due to the addition of vinyl siding and the replacement of windows and doors this building is considered ineligible for listing in a potential NR district.
