MISSOURI DEPARTMENT OF NATURAL RESOURCES
STATE HISTORIC PRESERVATION OFFICE, P.O. Box 176, Jefferson City, MO 65102
ARCHITECTURAL/HISTORIC INVENTORY FORM

1. SURVEY NO. FR-AS-007-0104		2. SURVEY NAME: International Shoe Factory Neighborhood	
3. COUNTY: Franklin		4. ADDRESS (STREET NO.) 301	STREET (NAME) High Street

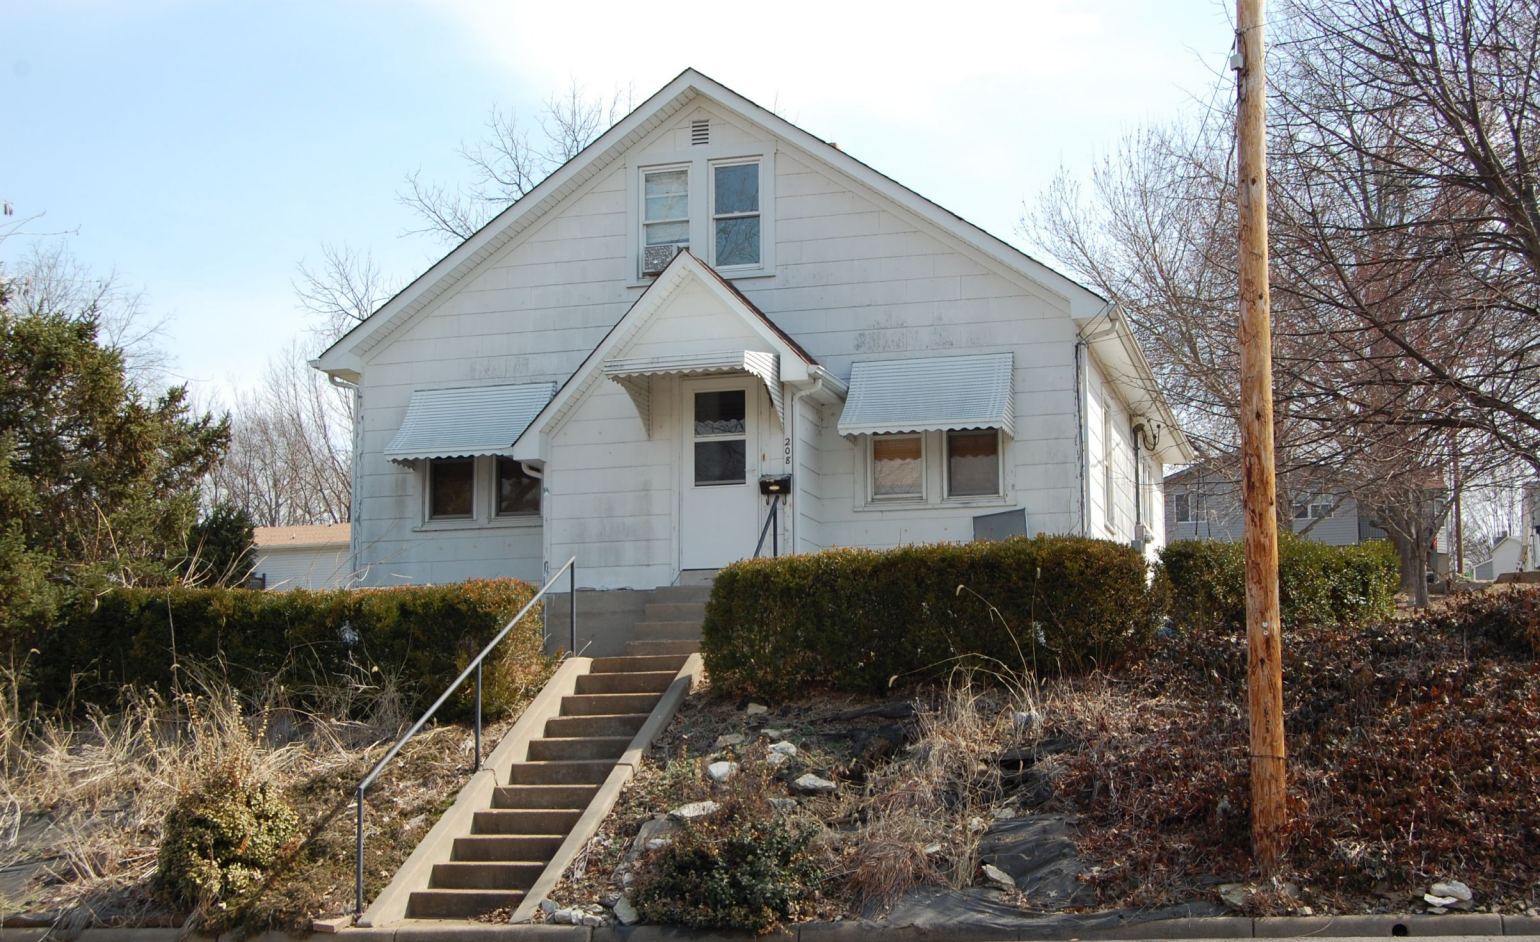
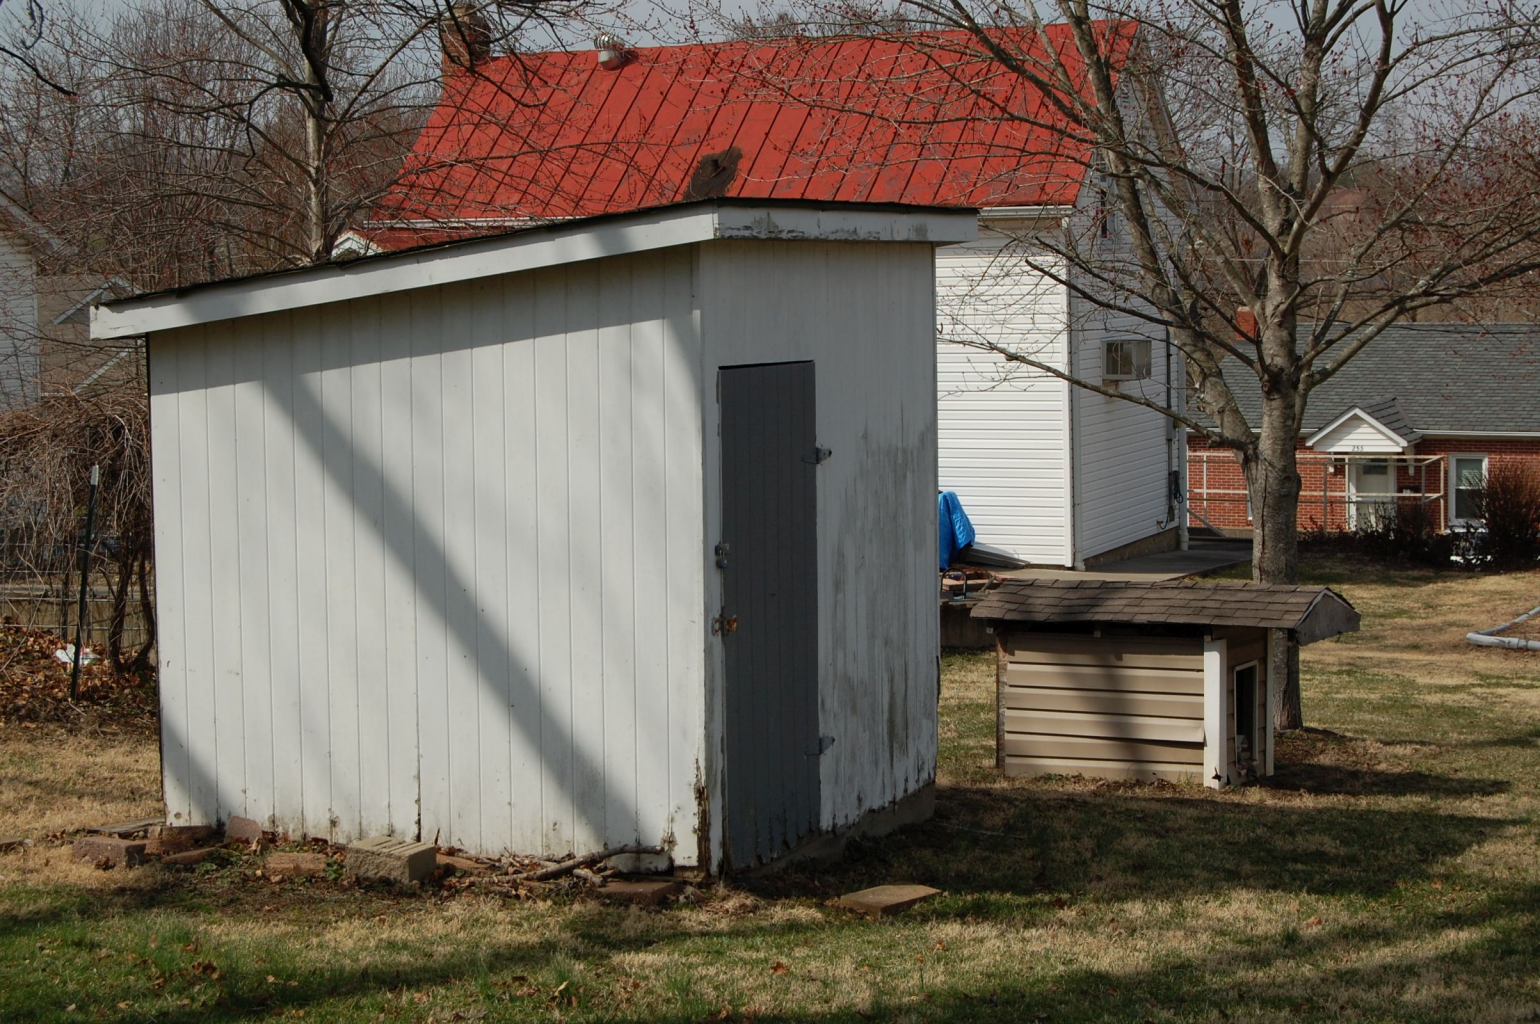
This 1.5 story frame home has a concrete foundation and a front gable roof covered with asphalt shingles. There are two window bays flanking an enclosed central entry on the primary elevation. The entry contains what may be an original wooden storm door with 1/1 double hung lights. The entry is situated beneath a front gable, "cat slide" roof. The window bays contain paired 1/1 double hung replacement sash of indeterminate material and are shaded by aluminum slat awnings. Centered on the upper half story is a window bay containing a pair of 1/1 double hung replacement sash of indeterminate material. Above the window is a louvered attic vent. The eaves project slightly and the soffit is clad with vinyl siding. This property was not surveyed in 1992.

This building is considered eligible for listing in a potential NR district.

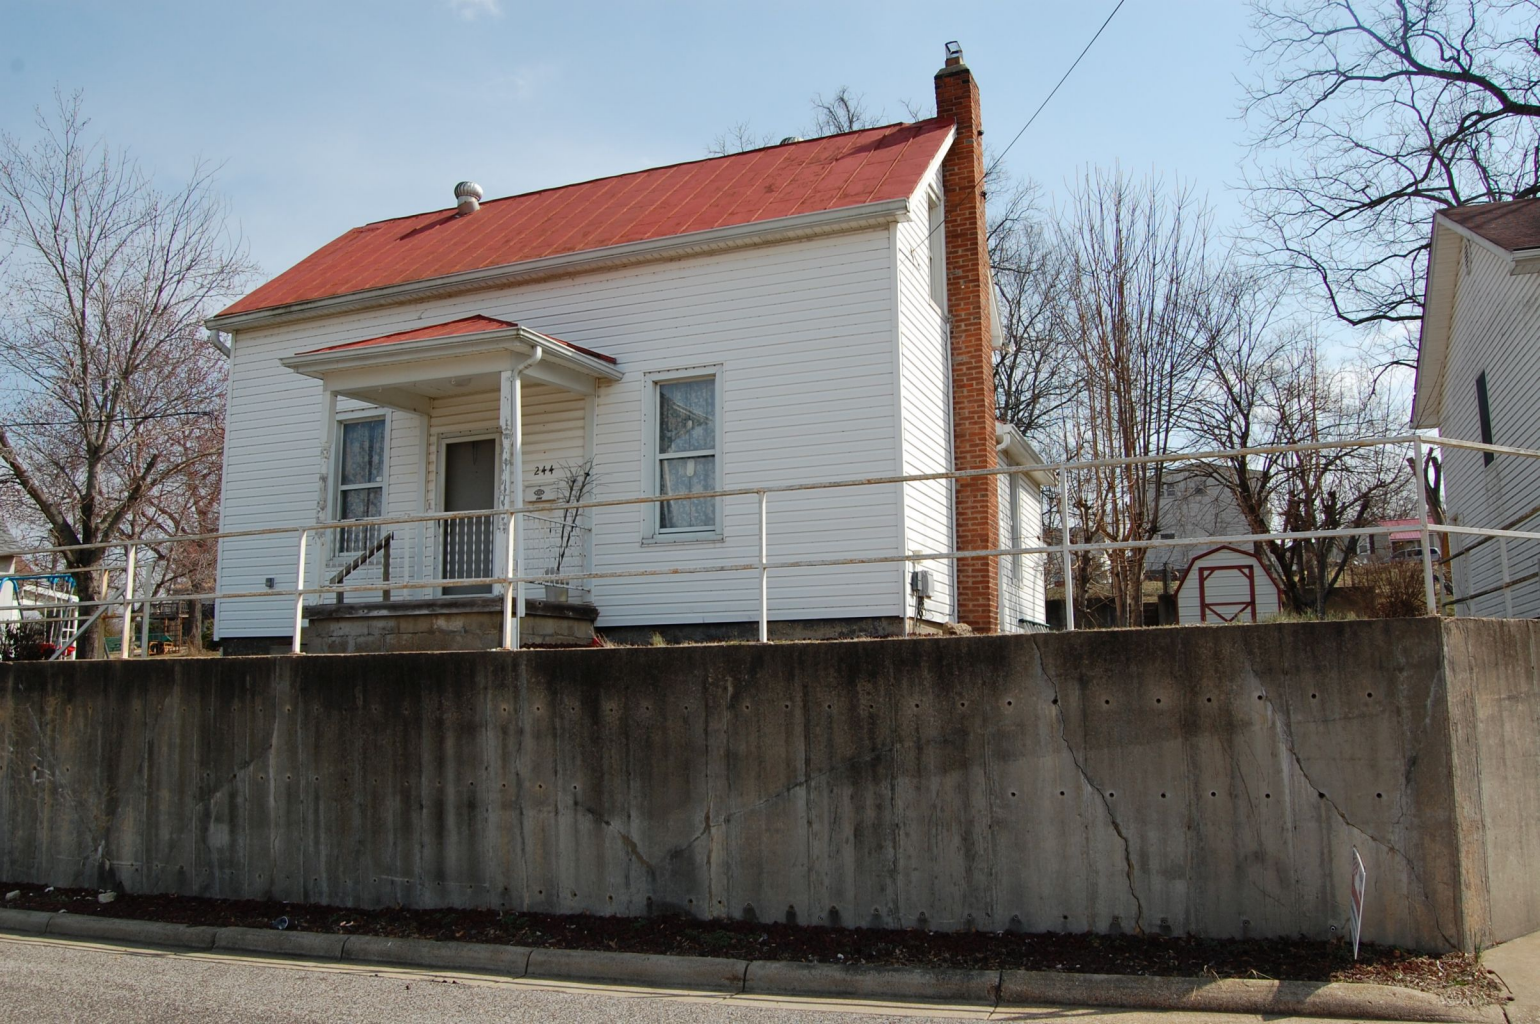
While the home retains its simple form, standing seam metal roof and brick chimney, due to the replacement vinyl siding, windows, door, and potential porch material alterations, the building is not considered eligible for listing in a potential NR district.

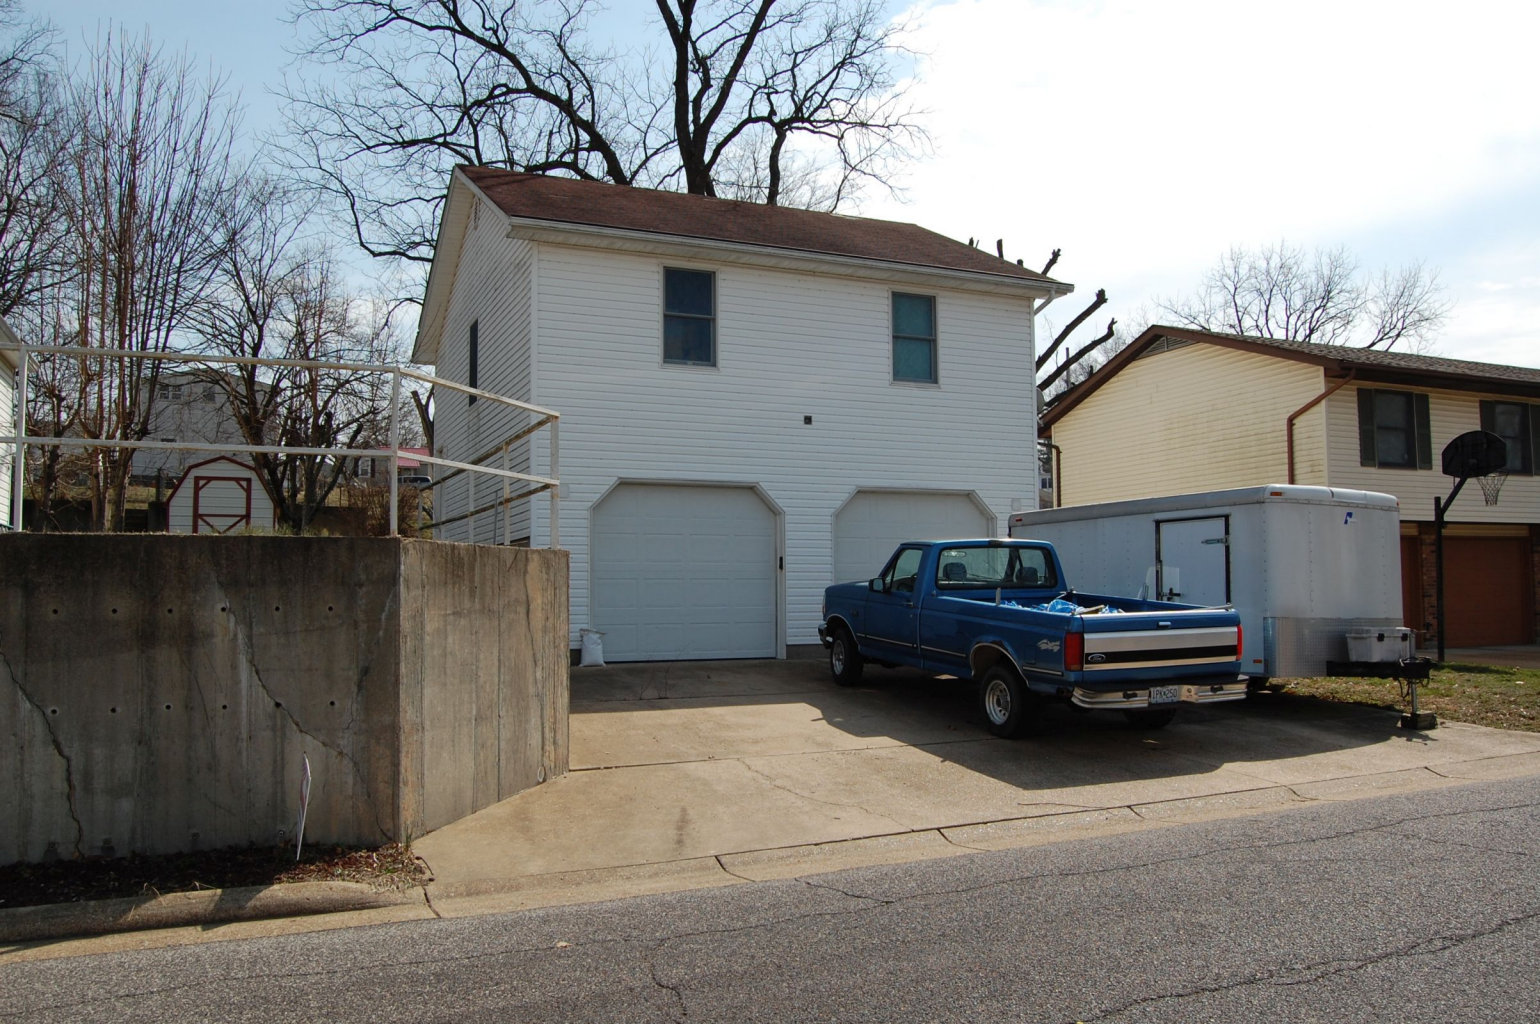
This 1 story frame home has a concrete foundation and a side gable, standing seam metal roof. There are two window bays flanking an offset left entry on the primary elevation. The windows are 1/1 double hung vinyl replacement sash and the entry contains a solid wooden door behind a replacement metal storm door. The entry is situated beneath a hipped roof portico with turned wooden supports and a wrought iron railing. The porch supports and cement block platform appear to be later alterations. There is an exterior brick chimney side right. This property was not surveyed in 1992.

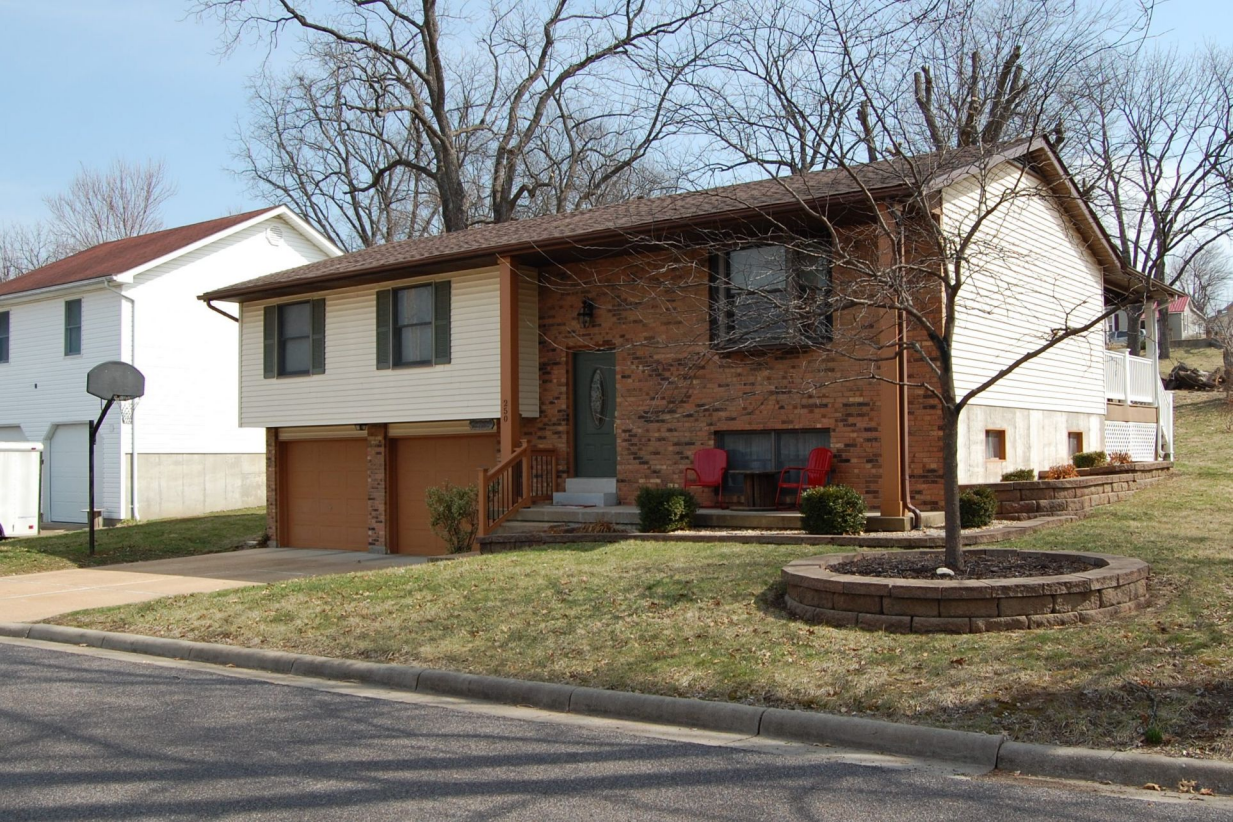
This 1.5 story split-level foyer, frame home has a concrete foundation and a side gable, asphalt shingle roof. There are two window bays to the right of the entry on the primary elevation. One bay is at the raised basement level and the other is at the upper story level. The basement level window sashes are obscured by storm windows. The upper level contains a projecting bay window with three, 1/1 double hung aluminum sash. The entry contains a metal door with a central oval light. The basement level of the left side of the facade contains two carports with overhead doors. Above the carport are two window bays containing 1/1 double hung aluminum sash. This section of the facade has vinyl siding. This property was not surveyed in 1992.

Due to its recent date of construction, this building is not considered eligible for listing in a potential NR district.

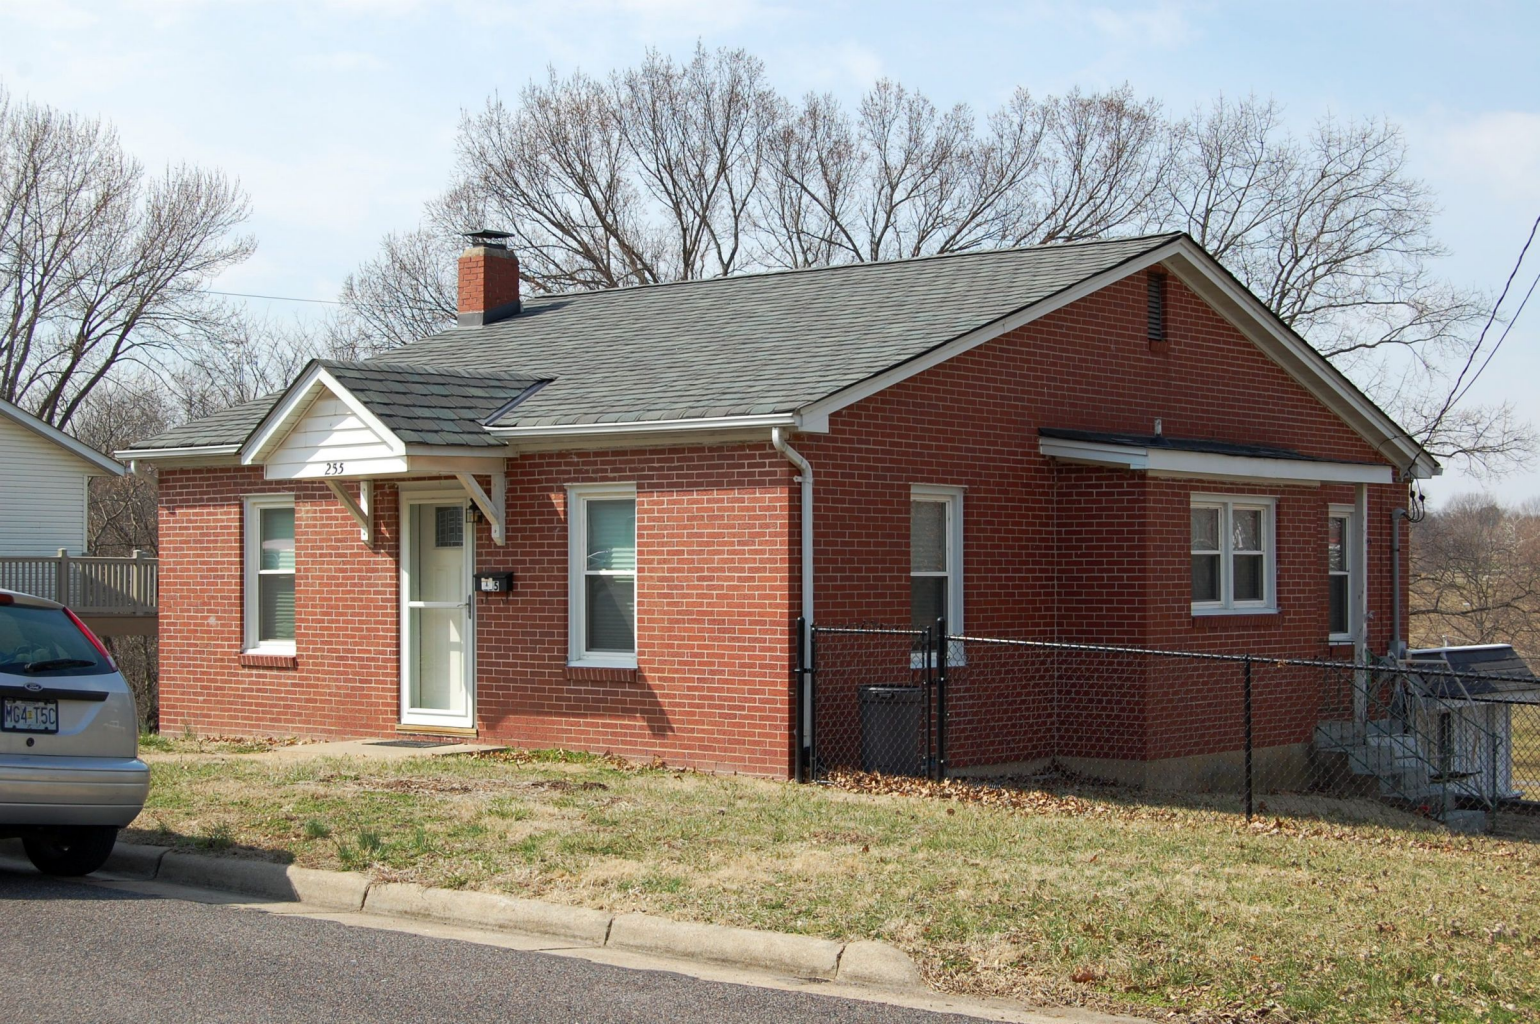
This 1 story home has a side gable asphalt shingle roof and a concrete foundation. The walls are masonry with a red brick veneer. There is a central entry containing a non-original door behind a storm door. The entry is situated beneath a front gable portico supported by wooden brackets. On either side of the entry is a window bay with a flat arch and a rowlock brick lug sill. The windows are 1/1, double hung vinyl replacements. This property was not surveyed in 1992.

This building is considered eligible for listing in a potential NR district due to it's date of construction during the period of significance and historic integrity.

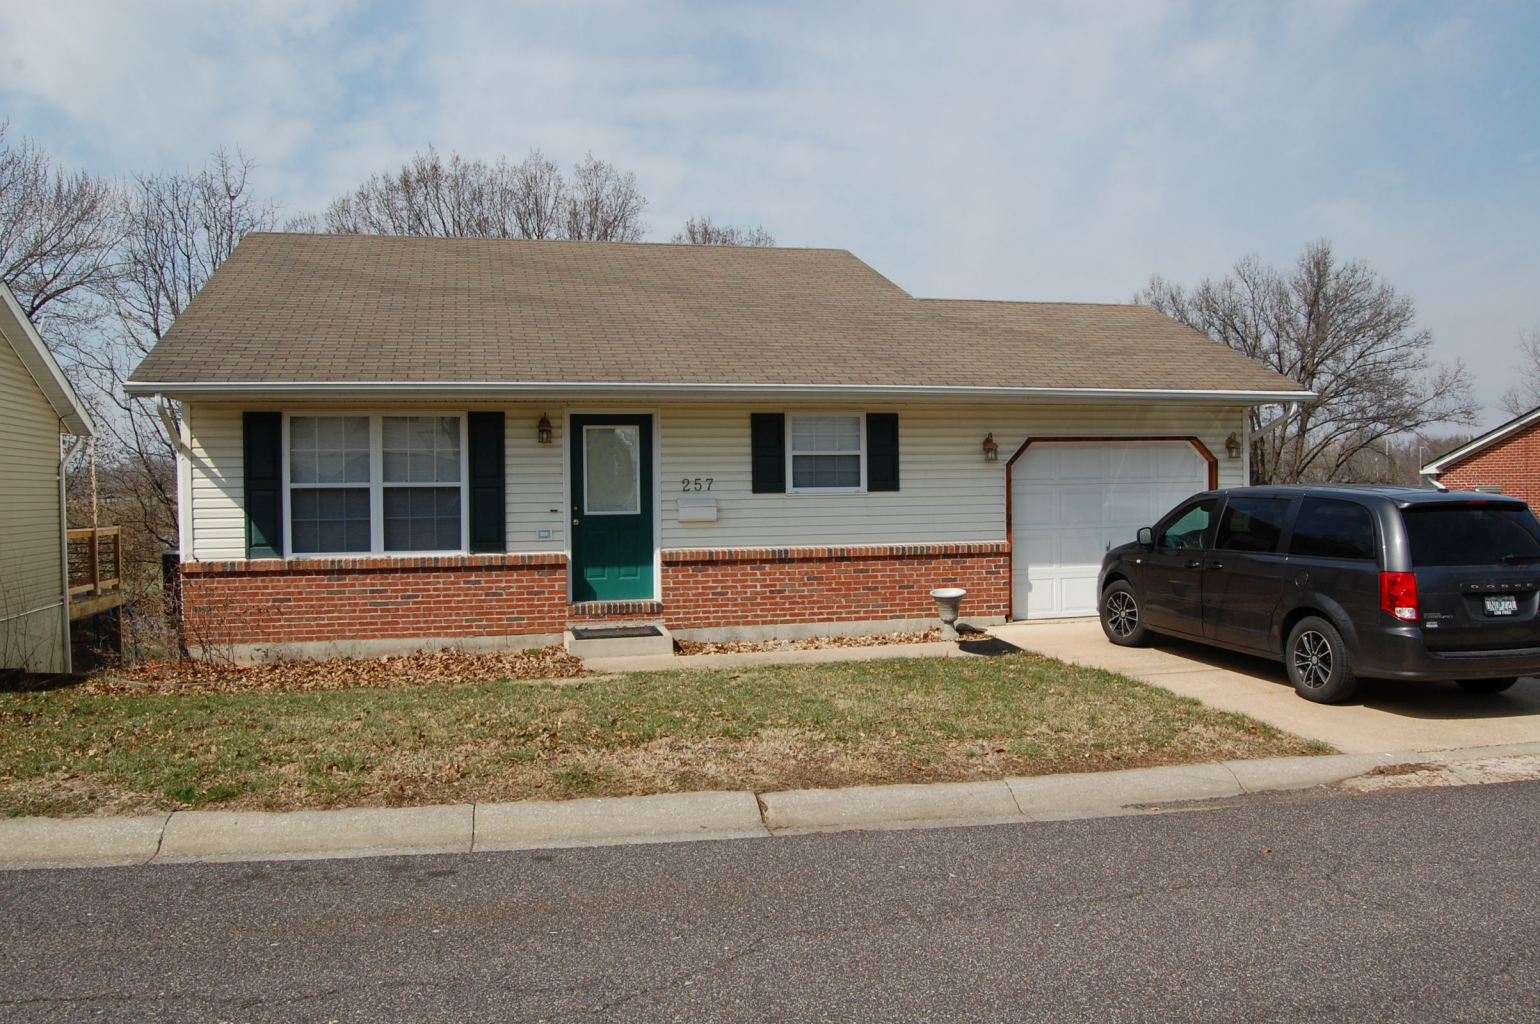
This 1 story home has a side gable asphalt shingle roof and a concrete foundation. There is a dado wall with red brick veneer above which the walls are clad with vinyl siding. There is an attached garage on the right side of the facade. There is a central entry flanked by window bays. The bay to the right of the entry contains a 1/1 double hung window with false 6/6 muntins. The bay to the left of the entry contains a pair of 1/1 double hung windows with false 6/6 muntins. This property was not surveyed in 1992.

Because of its recent construction date, this building is not considered eligible for listing in a potential NR district.

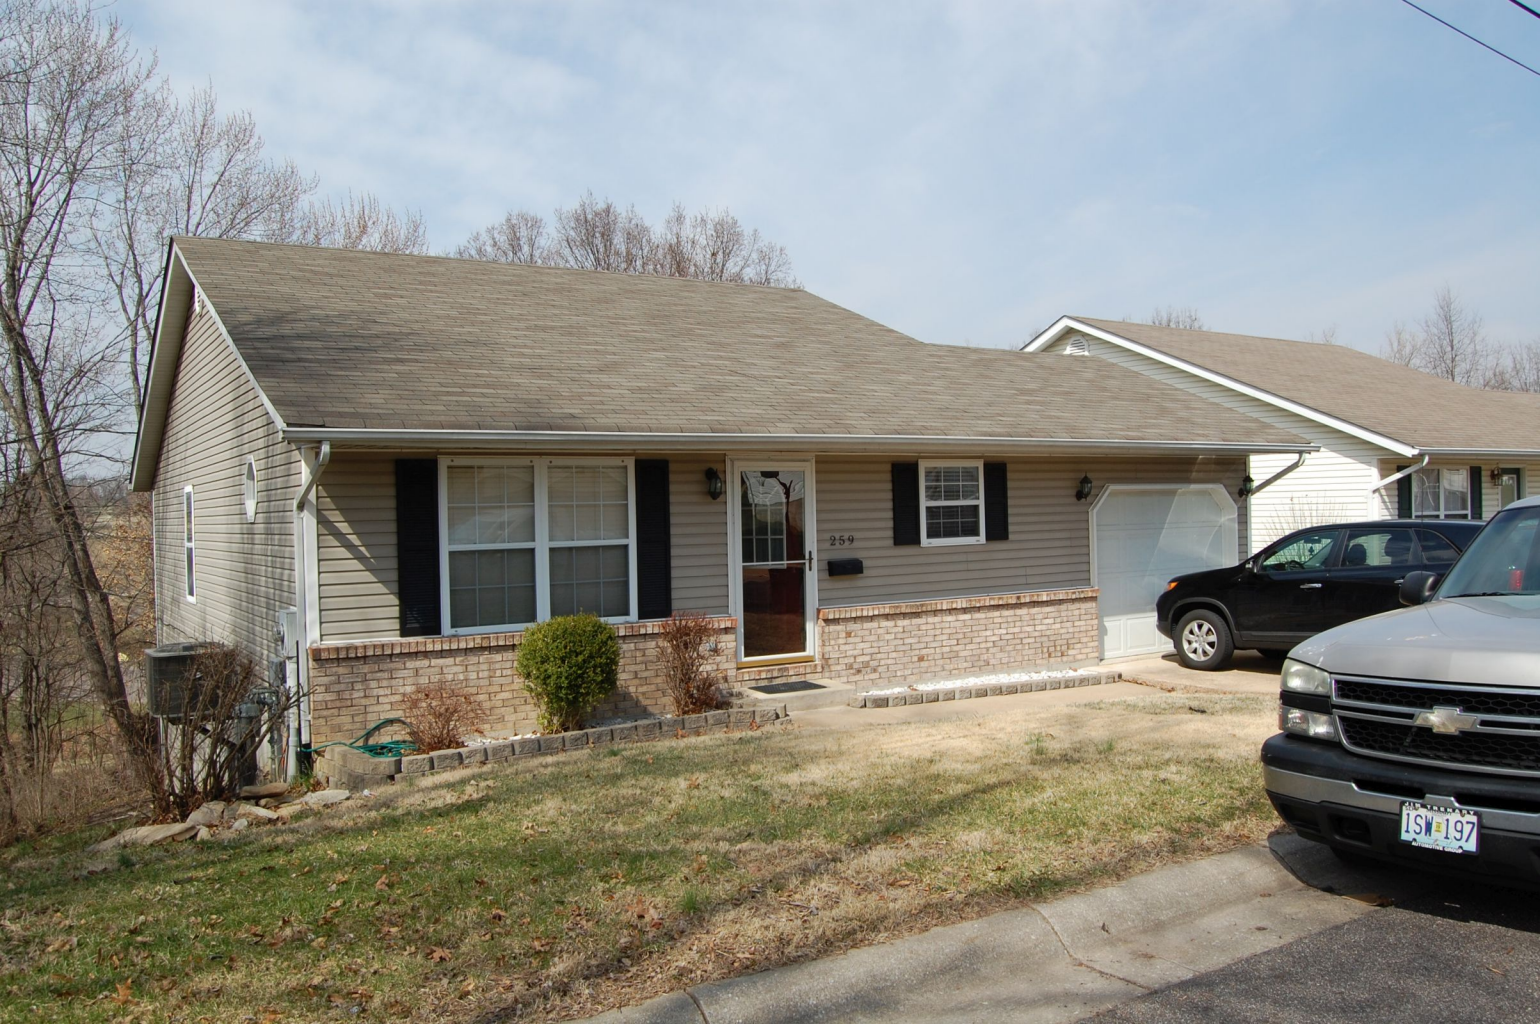
This 1 story home has a side gable asphalt shingle roof and a concrete foundation. There is a dado wall with gray brick veneer above which the walls are clad with vinyl siding. There is an attached garage on the right side of the facade. There is a central entry flanked by window bays. The bay to the right of the entry contains a 1/1 double hung window with false 6/6 muntins. The bay to the left of the entry contains a pair of 1/1 double hung windows with false 6/6 muntins. This property was not surveyed in 1992.

Because of its recent construction date, this building is not considered eligible for listing in a potential NR district.

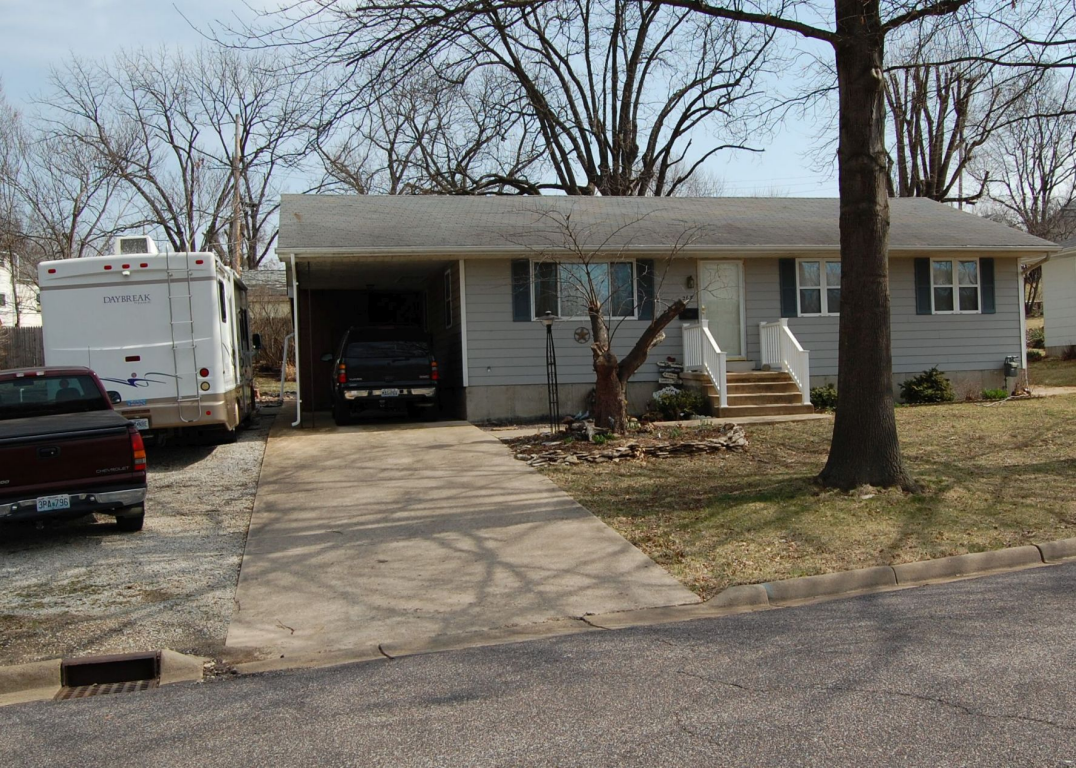
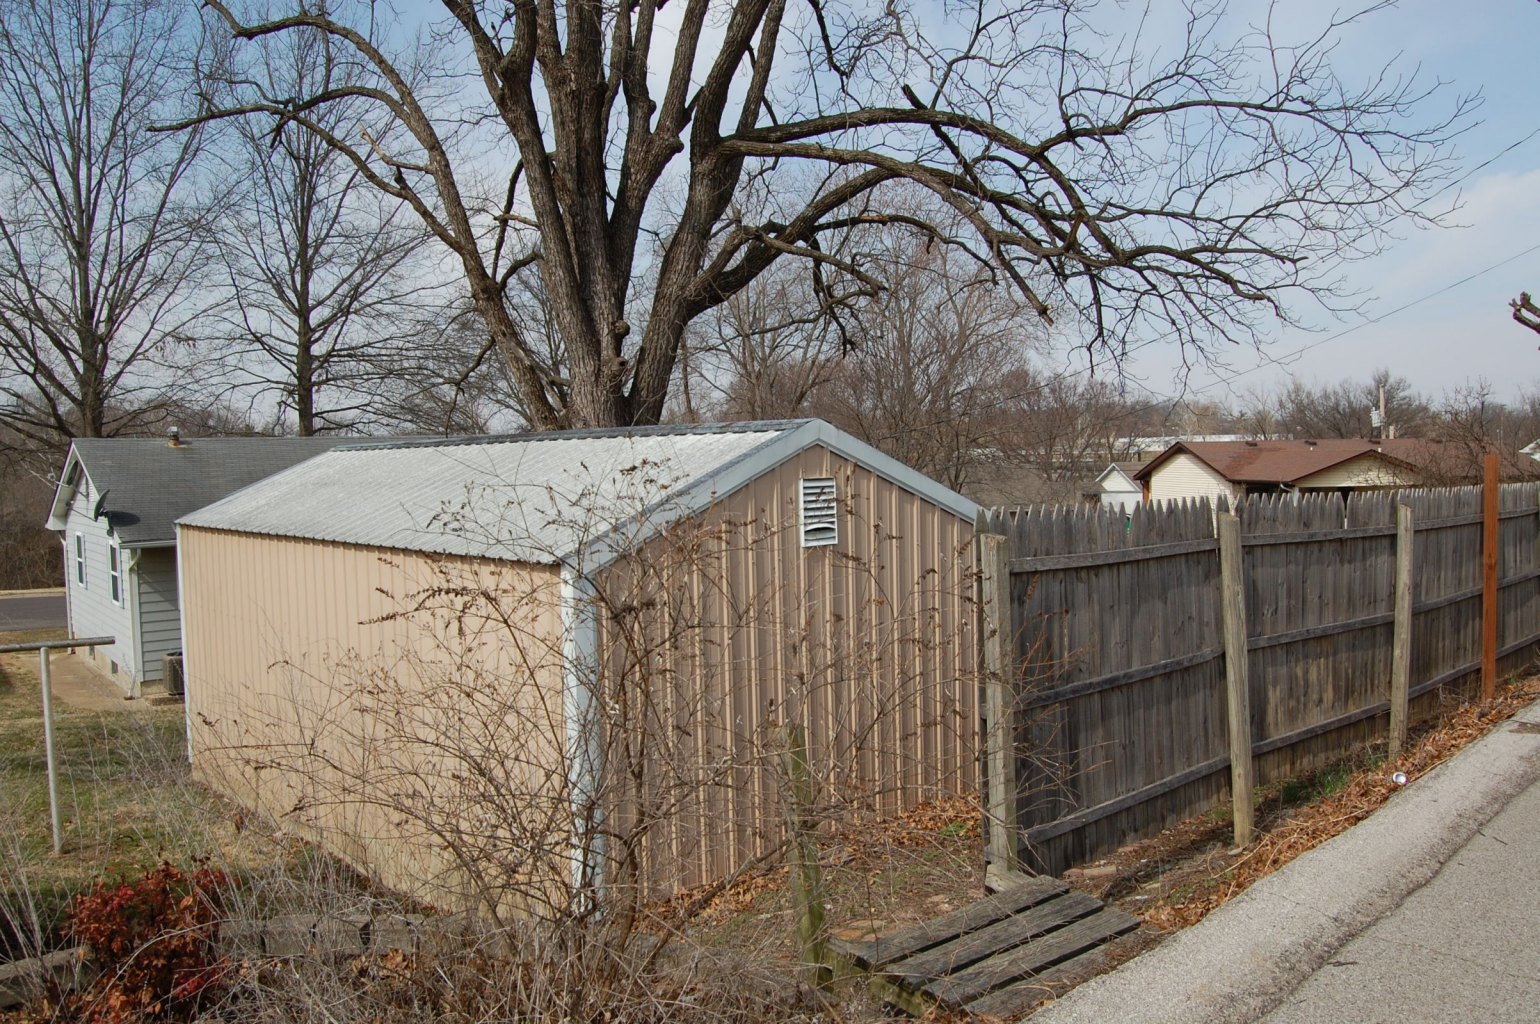
This one story home has a side gable asphalt shingle roof and a concrete foundation. The entry is offset left and contains a solid door. It is approached by a set of concrete steps. To the left of the entry is an open carport that is sheltered by an extension of the roof of the residence and a window bay containing a fixed light between operable casement lights. To the right of the entry are two window bays each containing a pair of 1/1 double hung sash windows. The walls are clad with vinyl siding. The Franklin County Assessor estimates the date of construction for this home to be 1959, but it may be newer than that. If it does date to 1959, its door is not original and its original siding and windows have been replaced with vinyl. This property was not surveyed in 1992.

Because the home is defined by new materials, this building is not considered eligible for listing in a potential NR district.

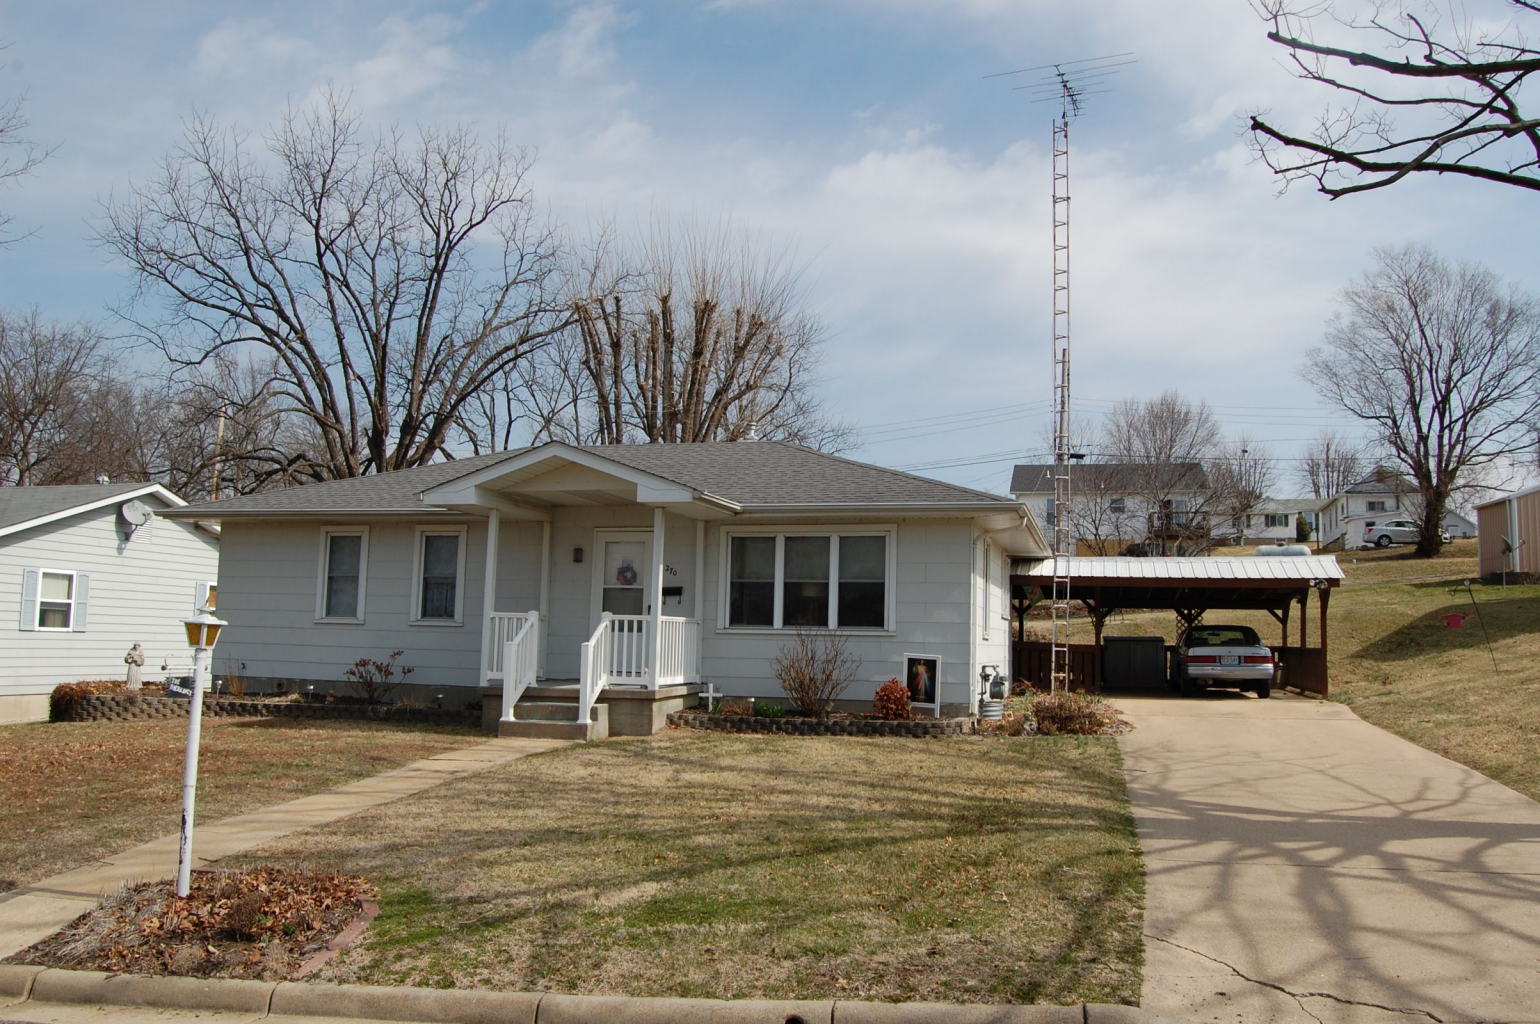
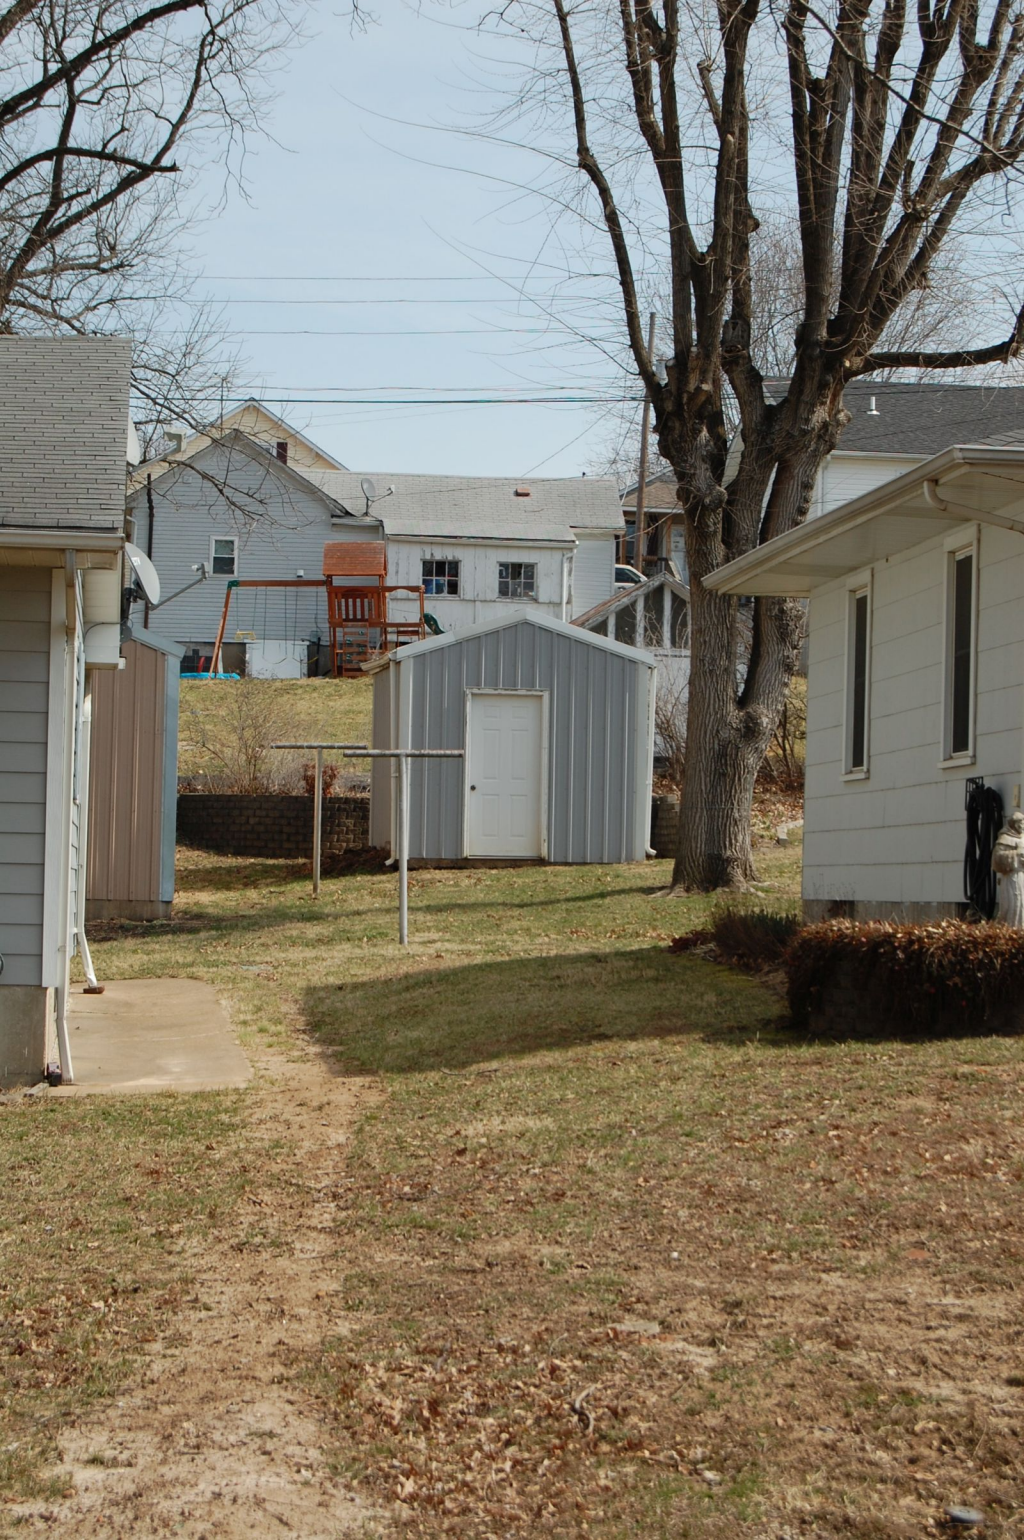
This 1 story home has a hipped asphalt shingle roof and a concrete foundation. The entry is offset right and is situated beneath a non-historic, front gable vinyl portico. The portico rests on vinyl clad supports extending from a concrete stoop approached by concrete stairs. The stoop is surrounded by a vinyl balustrade. The entry contains a paneled door of indeterminate material with a narrow central light. There is also a non-historic storm door. To the left of the entry are two window bays containing 1/1 double hung sash that are obscured by the frames of storm windows. To the right of the entry is a single bay containing a ribbon of three, 1/1 double hung sash windows also obscured by storm window frames. The walls are clad with asbestos or possibly Masonite shingles. This property was not surveyed in 1992.

Because the home was built in the 1950s and retains its original wall cladding and basic form, this building is considered eligible for listing in a potential NR district.

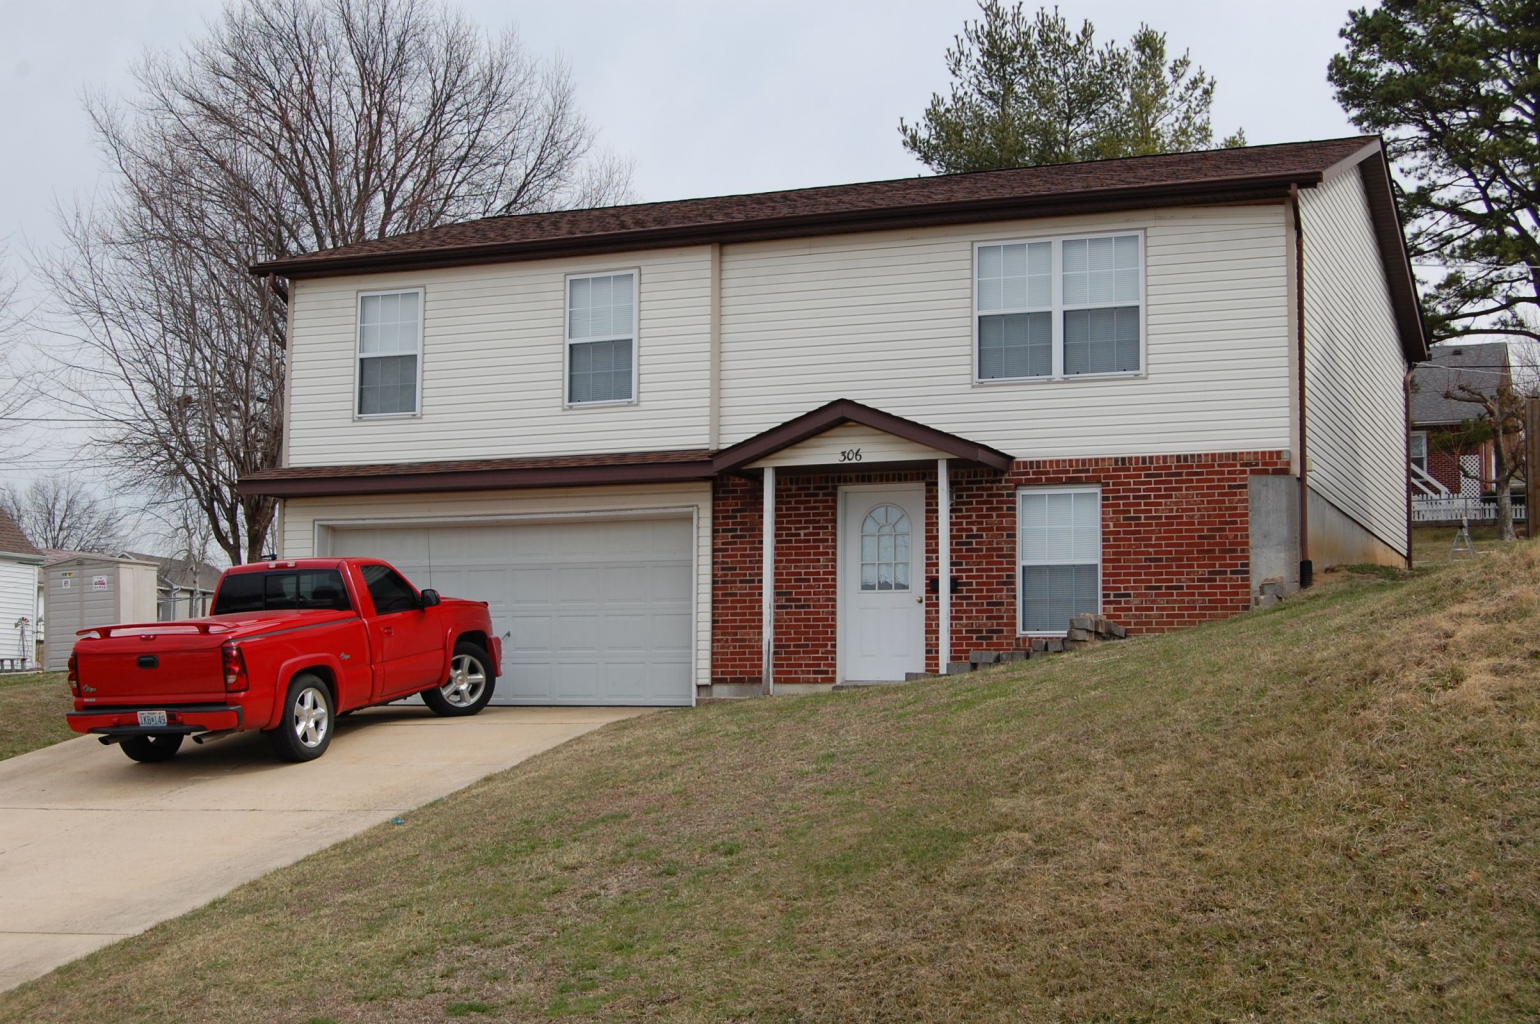
This 2-story home has a side gable asphalt shingle roof and a concrete foundation. The entry is offset right and is situated beneath a front gable frame and vinyl portico resting on square wooden supports. The entry contains a metal door with a Palladian light. To the left of the entry is a garage with a metal overhead door. To the right of the entry is a single window bay containing a 1/1 double hung sash with false muntins. The first floor facade is faced with brick veneer. The second floor is faced with vinyl siding and contains three window bays. Two of the bays contain single 1/1 double hung sash with false muntins. The other bay contains a pair of 1/1 double hung sash with false muntins. This property was not surveyed in 1992.

Because of its recent date of construction, this building is not considered eligible for listing in a potential NR district.
