MISSOURI DEPARTMENT OF NATURAL RESOURCES
STATE HISTORIC PRESERVATION OFFICE, P.O. Box 176, Jefferson City, MO 65102
ARCHITECTURAL/HISTORIC INVENTORY FORM

1. SURVEY NO. FR-AS-007-0104		2. SURVEY NAME: International Shoe Factory Neighborhood	
3. COUNTY: Franklin		4. ADDRESS (STREET NO.) 301	STREET (NAME) High Street

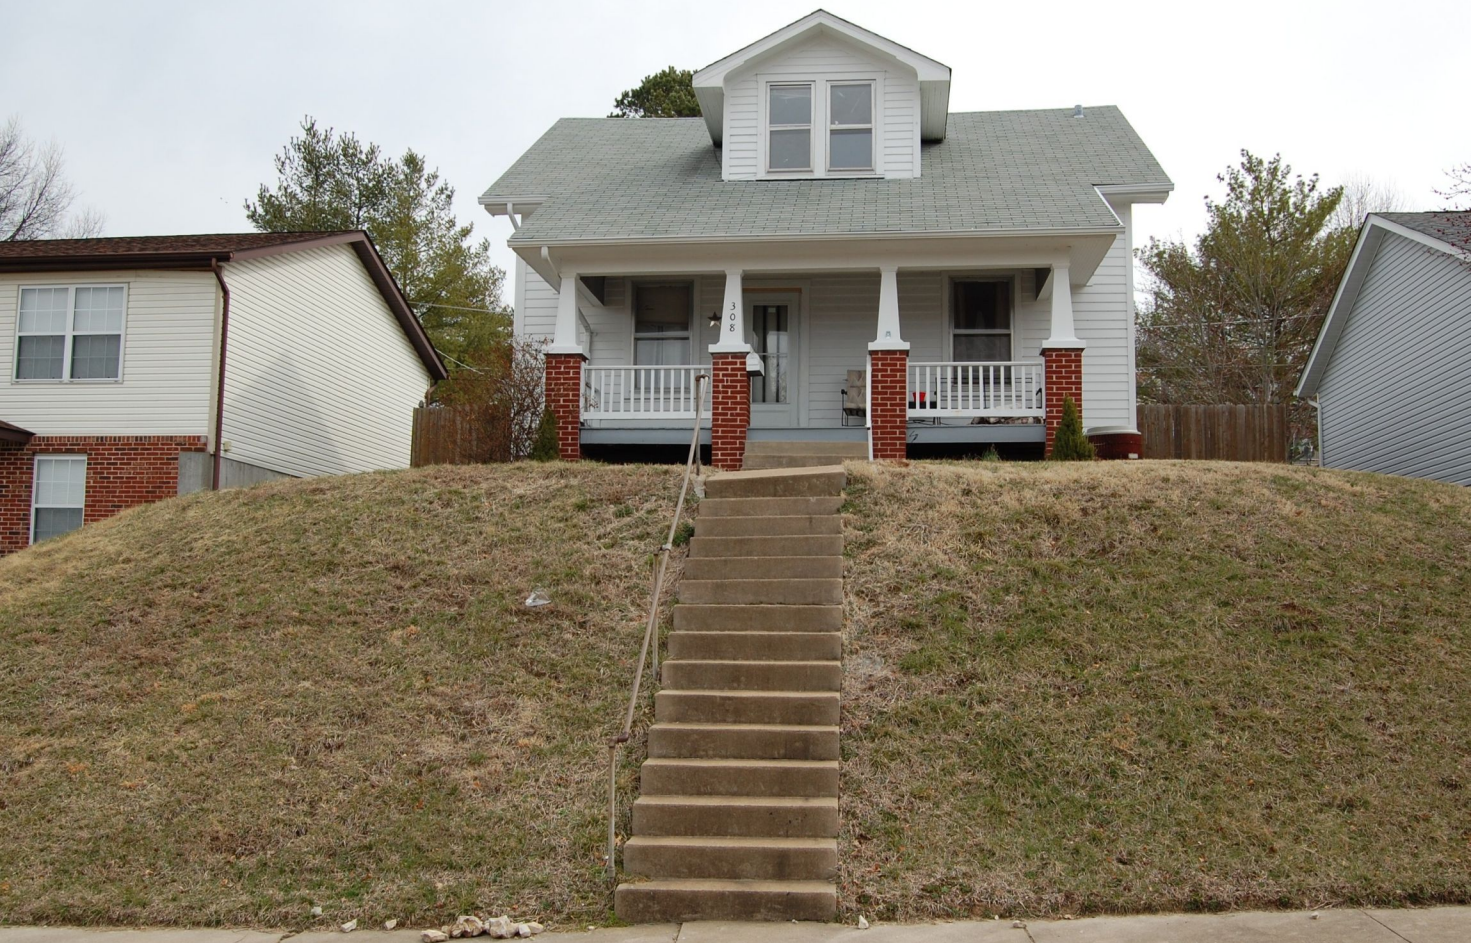
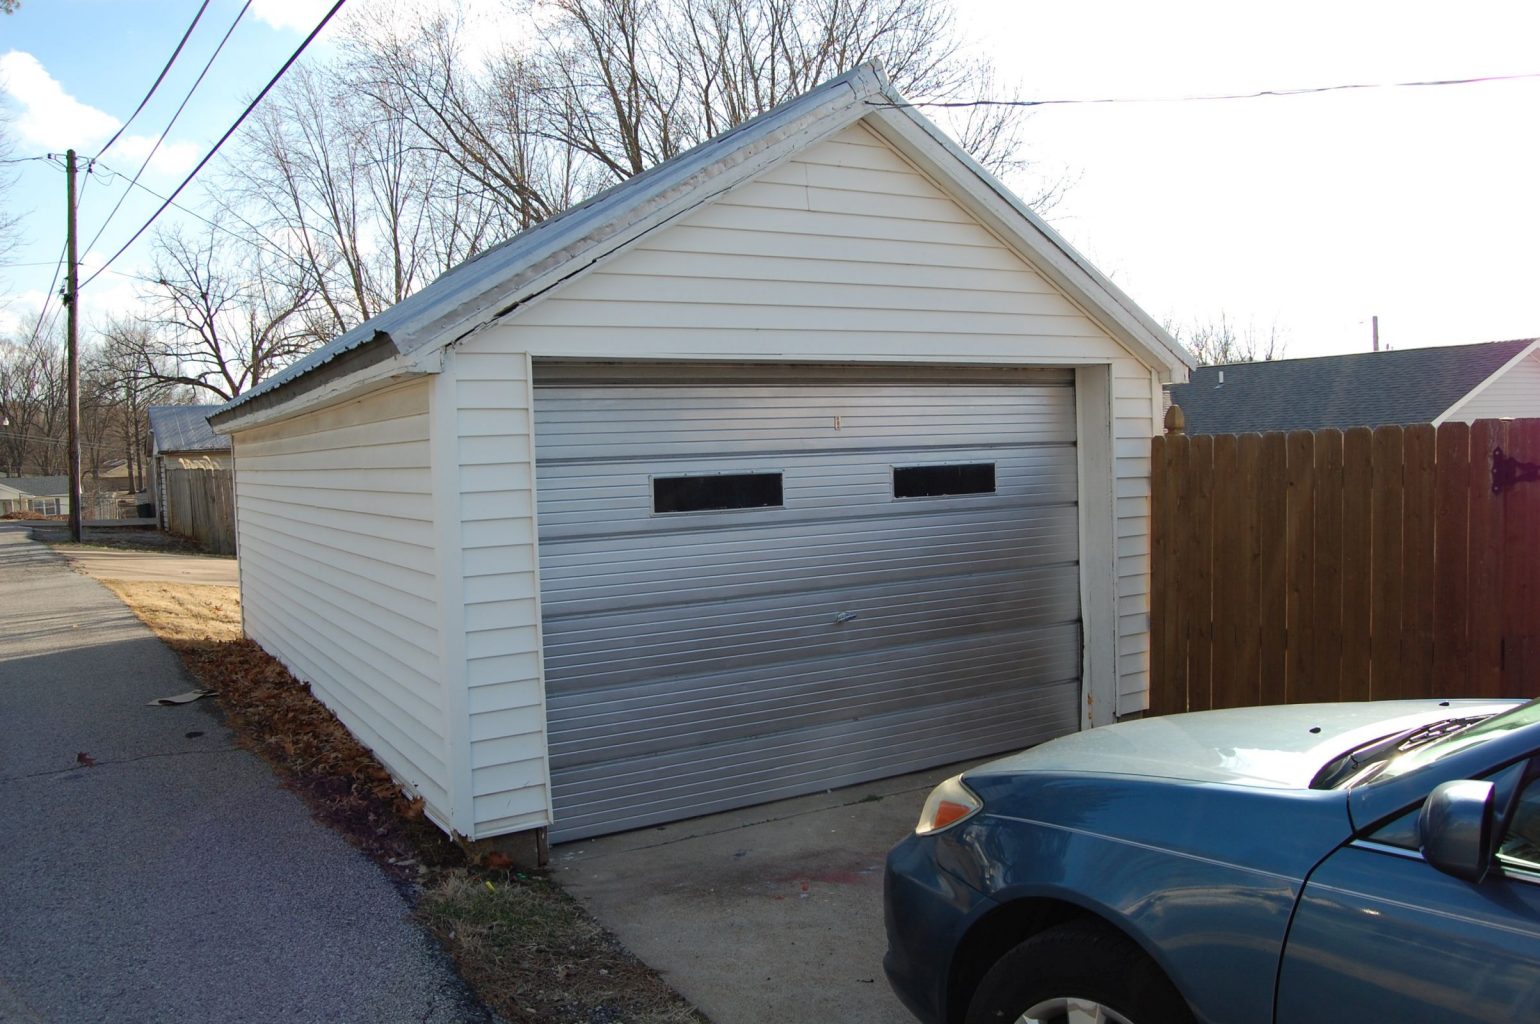
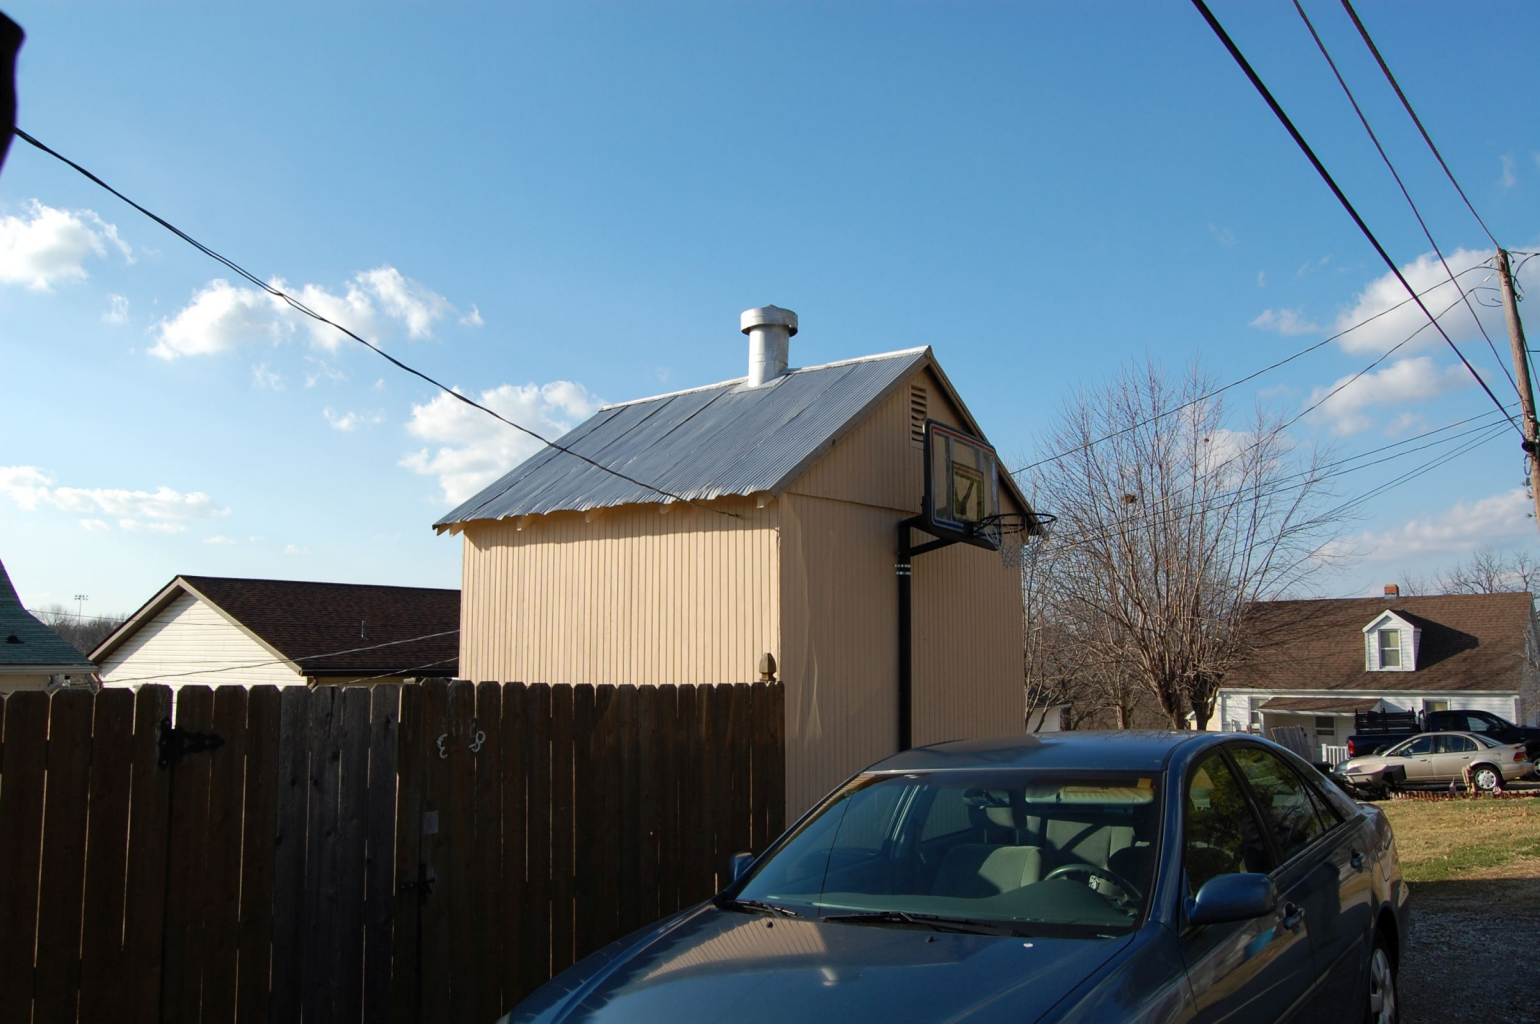
This 1.5 story home has a side gable asphalt shingle roof and a concrete foundation. The entry is offset left and situated beneath an engaged, 3/4 width porch protected by the slope of the home's roof. The porch roof is supported by four battered wooden supports resting on square brick piers and is approached by concrete stairs. The 3 vertical light glass and wood entry door is obscured by a storm door. On either side of the entry is a single window bay with a flat wooden surround containing a 1/1, double hung wooden sash behind a storm window. There is a front gable dormer centered on the upper half story containing a single window bay with a pair of 1/1, double hung sash. Sash construction is obscured by storm windows. Windows appear to be older. The home has intact historic wooden lap siding. This property was not surveyed in 1992.

This building is considered eligible for listing in a potential NR district due to its date of construction and integrity.

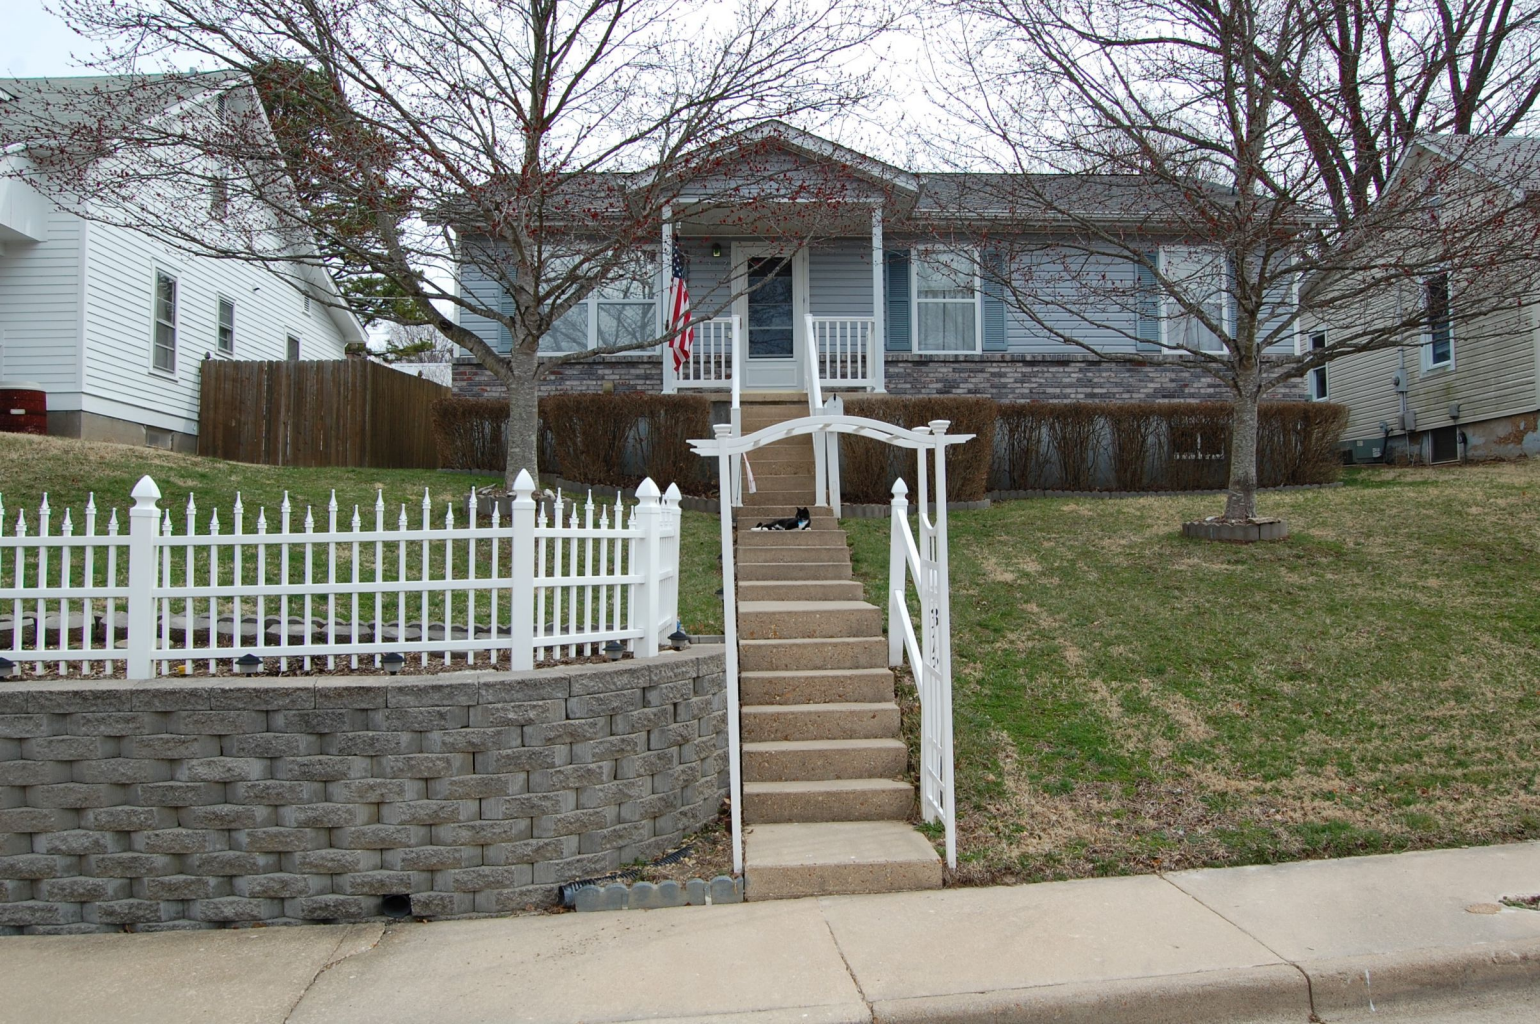
This 1 story home has a side gable asphalt shingle roof and a raised concrete foundation. There are two window bays at the basement level obscured by shrubbery. The entry is offset left and situated beneath a front gable portico supported by vinyl clad posts. Beneath the portico is a concrete stoop surrounded by a vinyl balustrade. There is a brick veneer dado wall above which the facade is clad with vinyl siding. To the right of the entry are two window bays containing 1/1 double hung vinyl sash. To the left of the entry is a single window bay containing a pair of double hung vinyl sash. This property was not surveyed in 1992.

Because of its recent construction date, this building is not considered eligible for listing in a potential NR district.

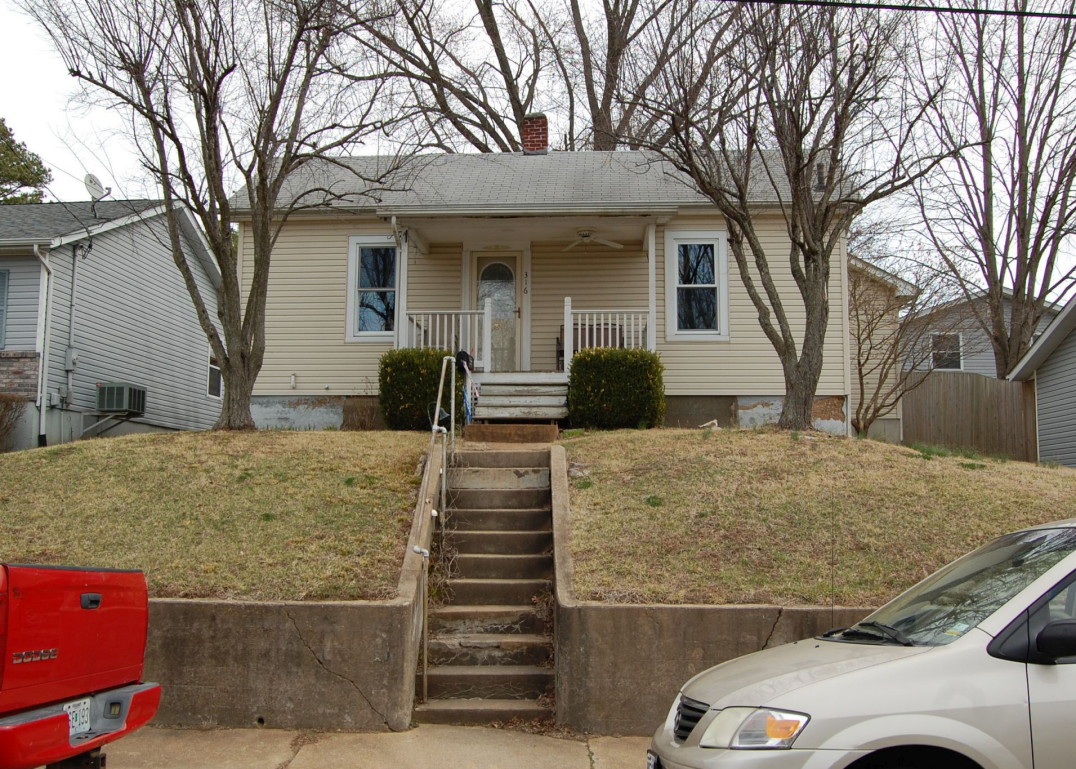
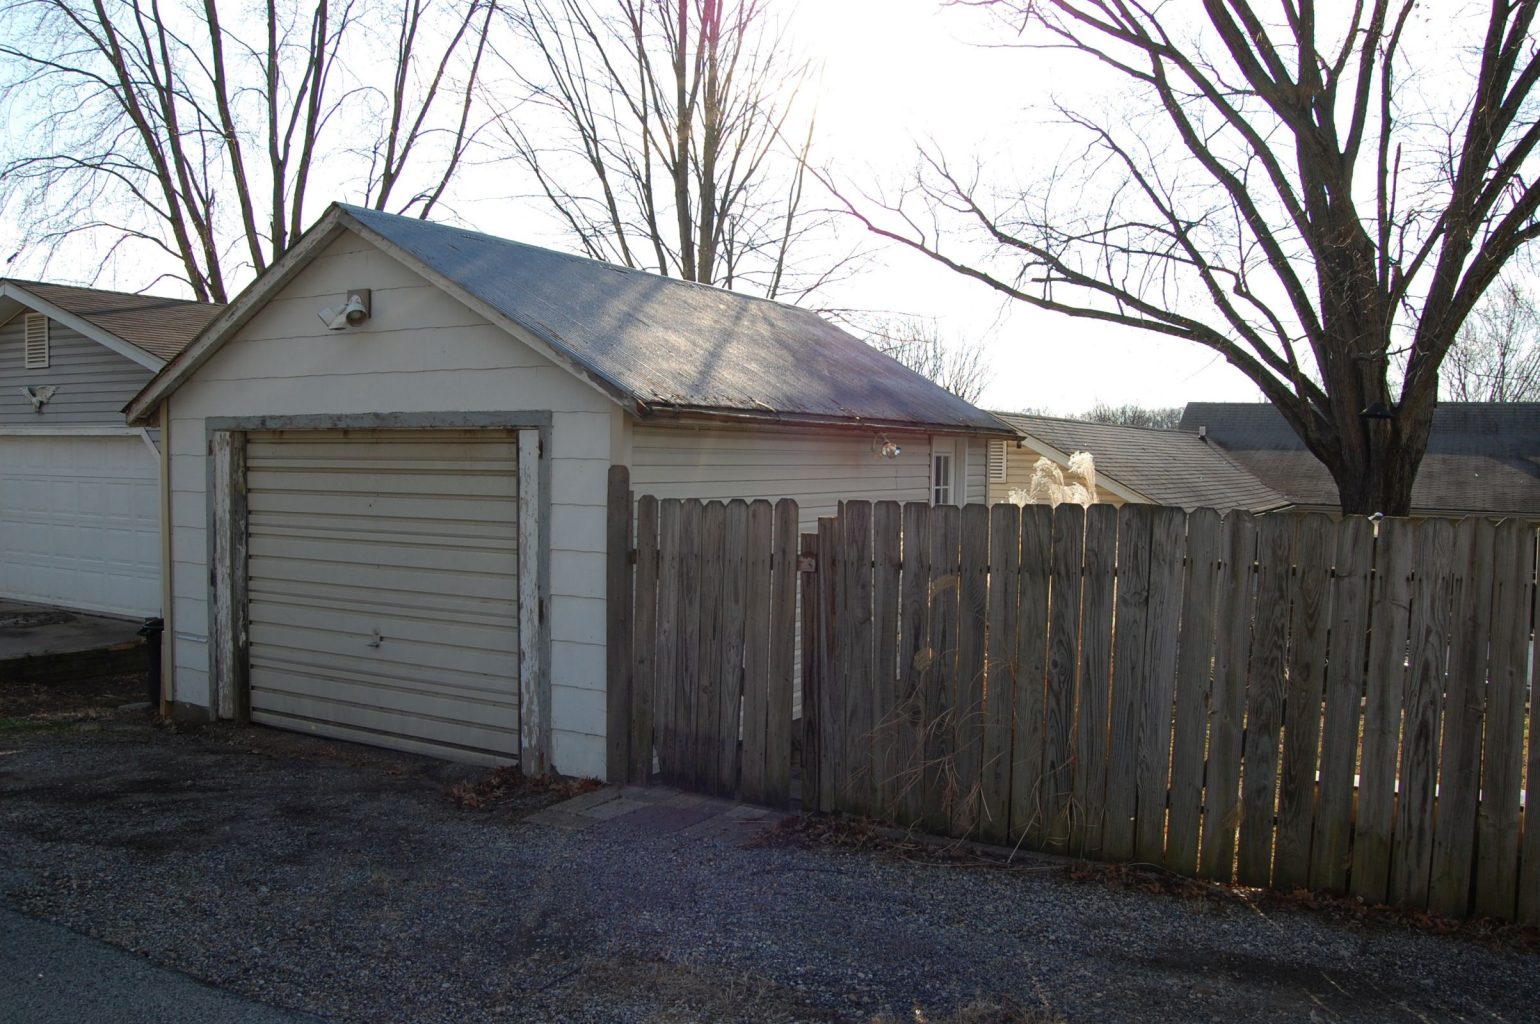
This 1 story home has a side gable asphalt shingle roof and a raised parged concrete foundation with heavy aggregate. The stairs that approach the home from the street also are of heavy aggregate (historic) concrete. There is an interior brick stove chimney centered on the roof ridge. There is a single window bay on either side of an offset left entry. Each window bay contains a 1/1 double hung vinyl replacement window. The entry is situated beneath a shed roof portico supported by square wooden posts and contains a glazed replacement door behind a storm door. Beneath the portico is a concrete stoop surrounded by a simple wooden balustrade. The stoop is approached by wooden steps. The facade is clad with vinyl siding that has a higher or thicker profile than the fenestrations. This property was not surveyed in 1992.

Due to the replacement vinyl siding, windows, and entry door this simple dwelling is considered noncontributing to a potential NR district.

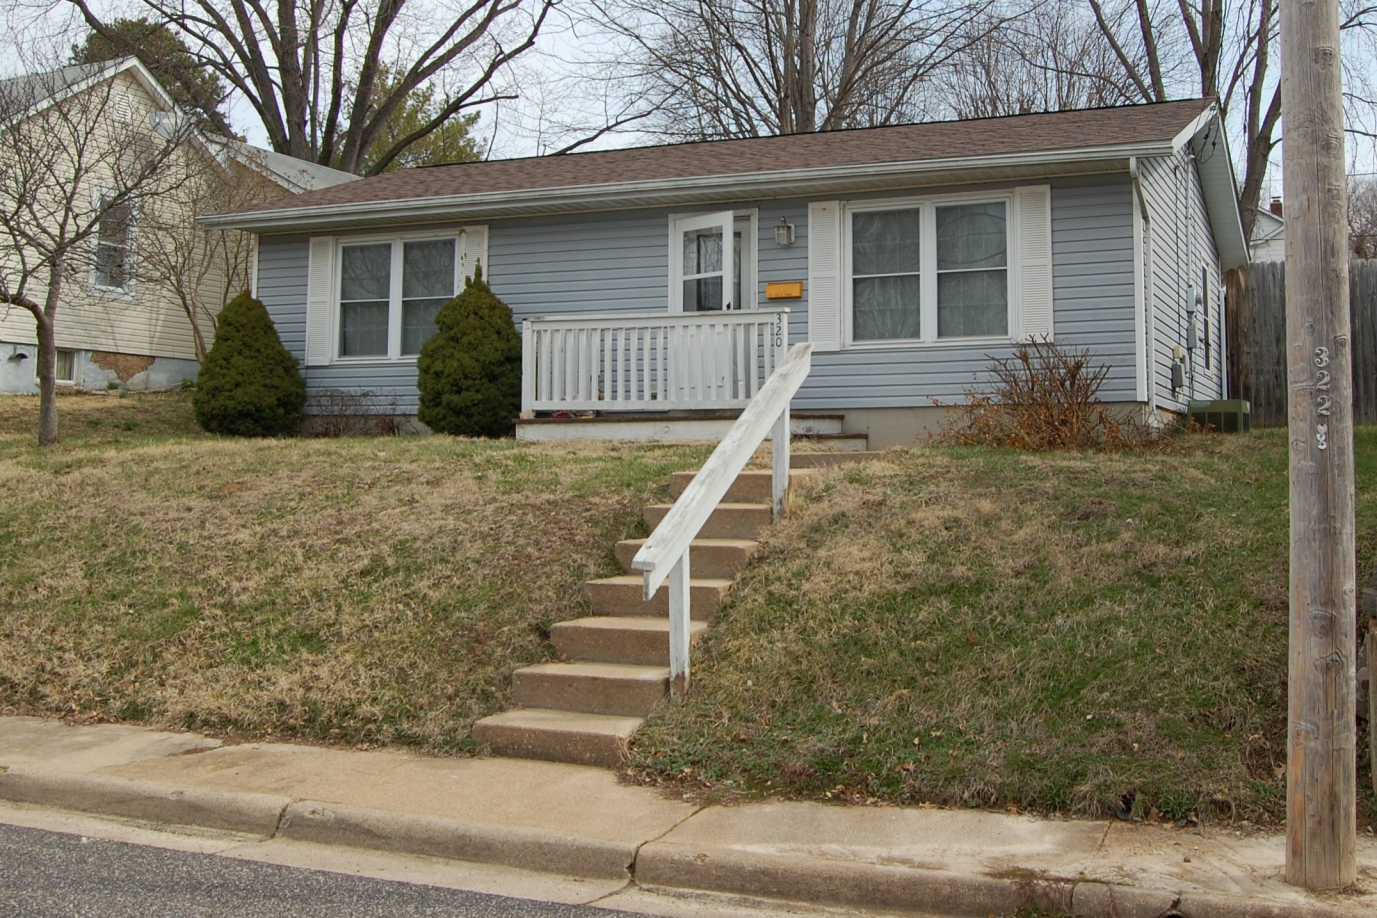
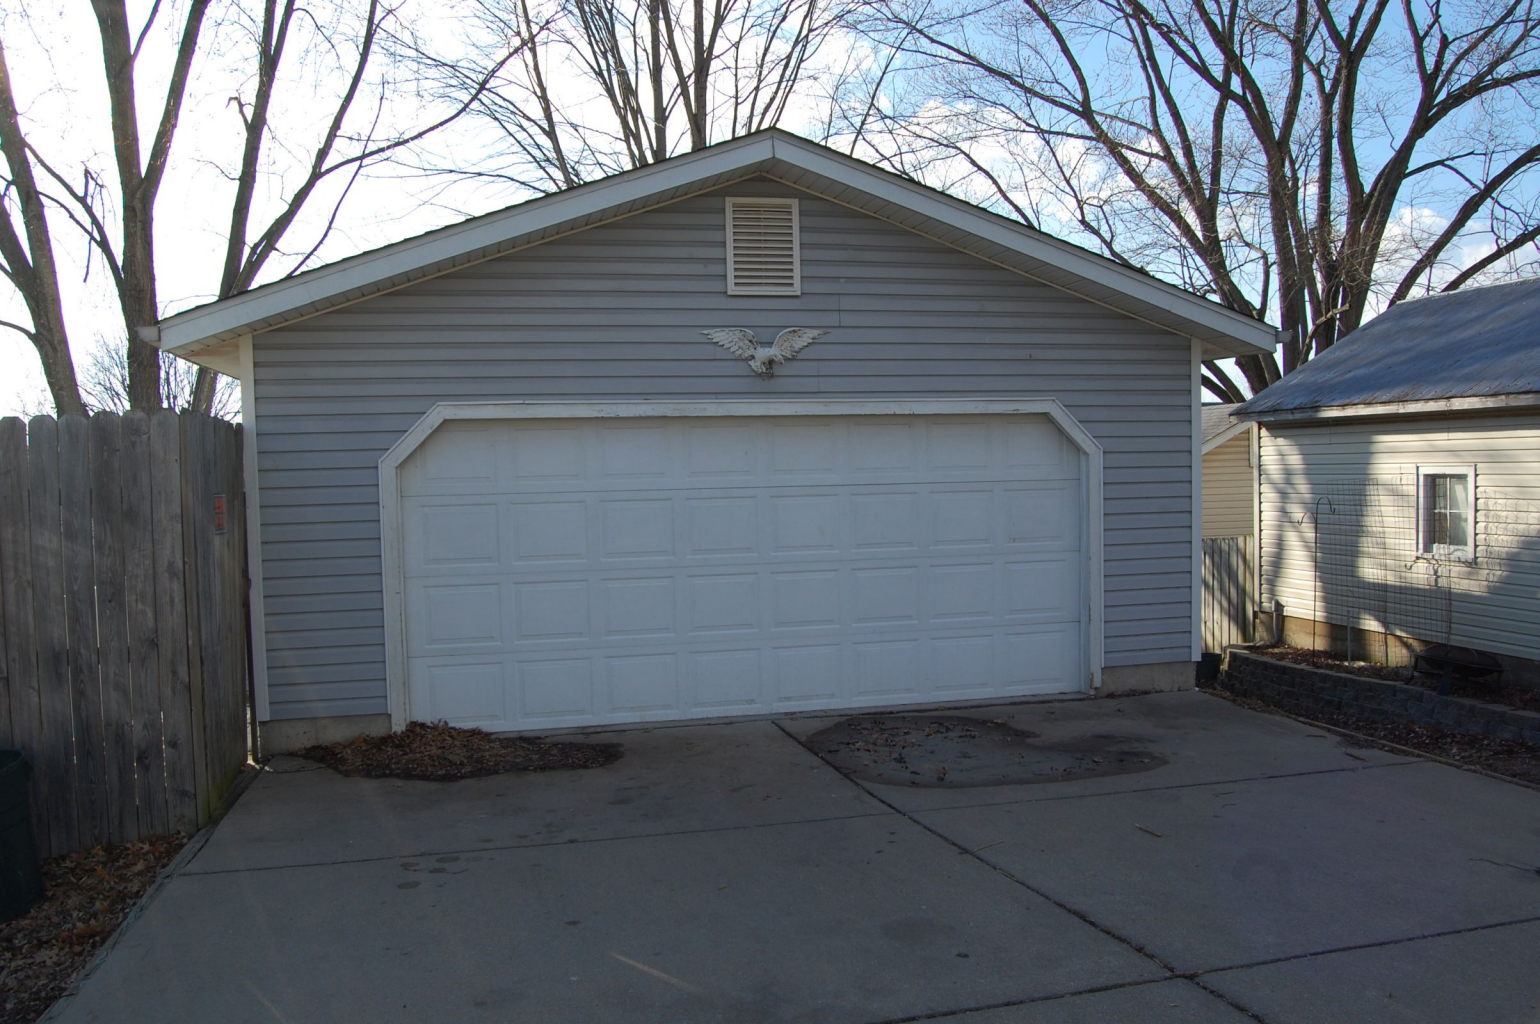
This 1 story home has a side gable asphalt shingle roof and a concrete foundation. The primary elevation is clad with vinyl siding. The entry is offset right. In front of the entry is a concrete slab stoop surrounded by a vinyl balustrade. On either side of the entry is a window bay containing a pair of 1/1 double hung vinyl windows. This property was not surveyed in 1992.

Due to its recent construction date, this building is not considered eligible for listing in a potential NR district.

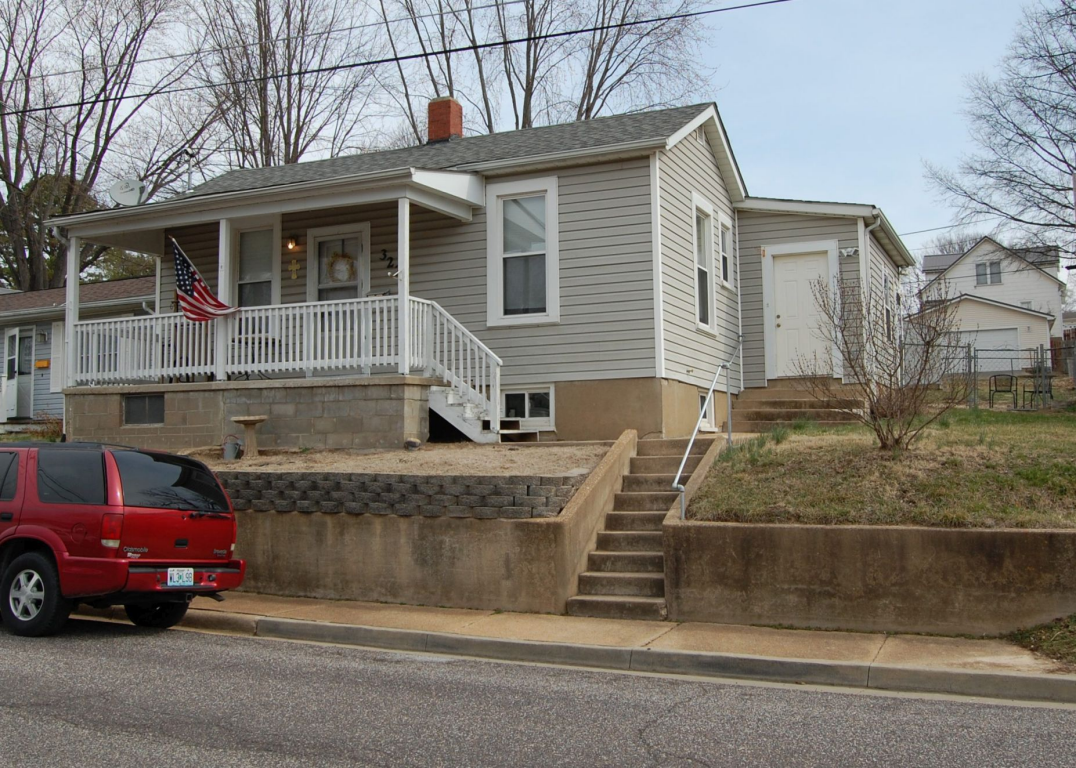
This 1 story home has a side gable asphalt shingle roof and a raised parged concrete foundation. There is a 3/4 width gallery porch with a CMU foundation, shed roof and wooden balustrade. The porch roof has square wooden supports and there is a rectangular window bay with a two light awning sash window in the porch foundation. There is an interior brick stove chimney centered on the roof ridge. There is a single window bay on either side of an offset left entry. Each window bay contains a 1/1 double hung vinyl replacement window. The entry contains a solid door that is obscured by a storm door. This property was not surveyed in 1992.

Because of the replacement siding, windows, and non-original porch, this home is not considered eligible for listing in a potential NR district.

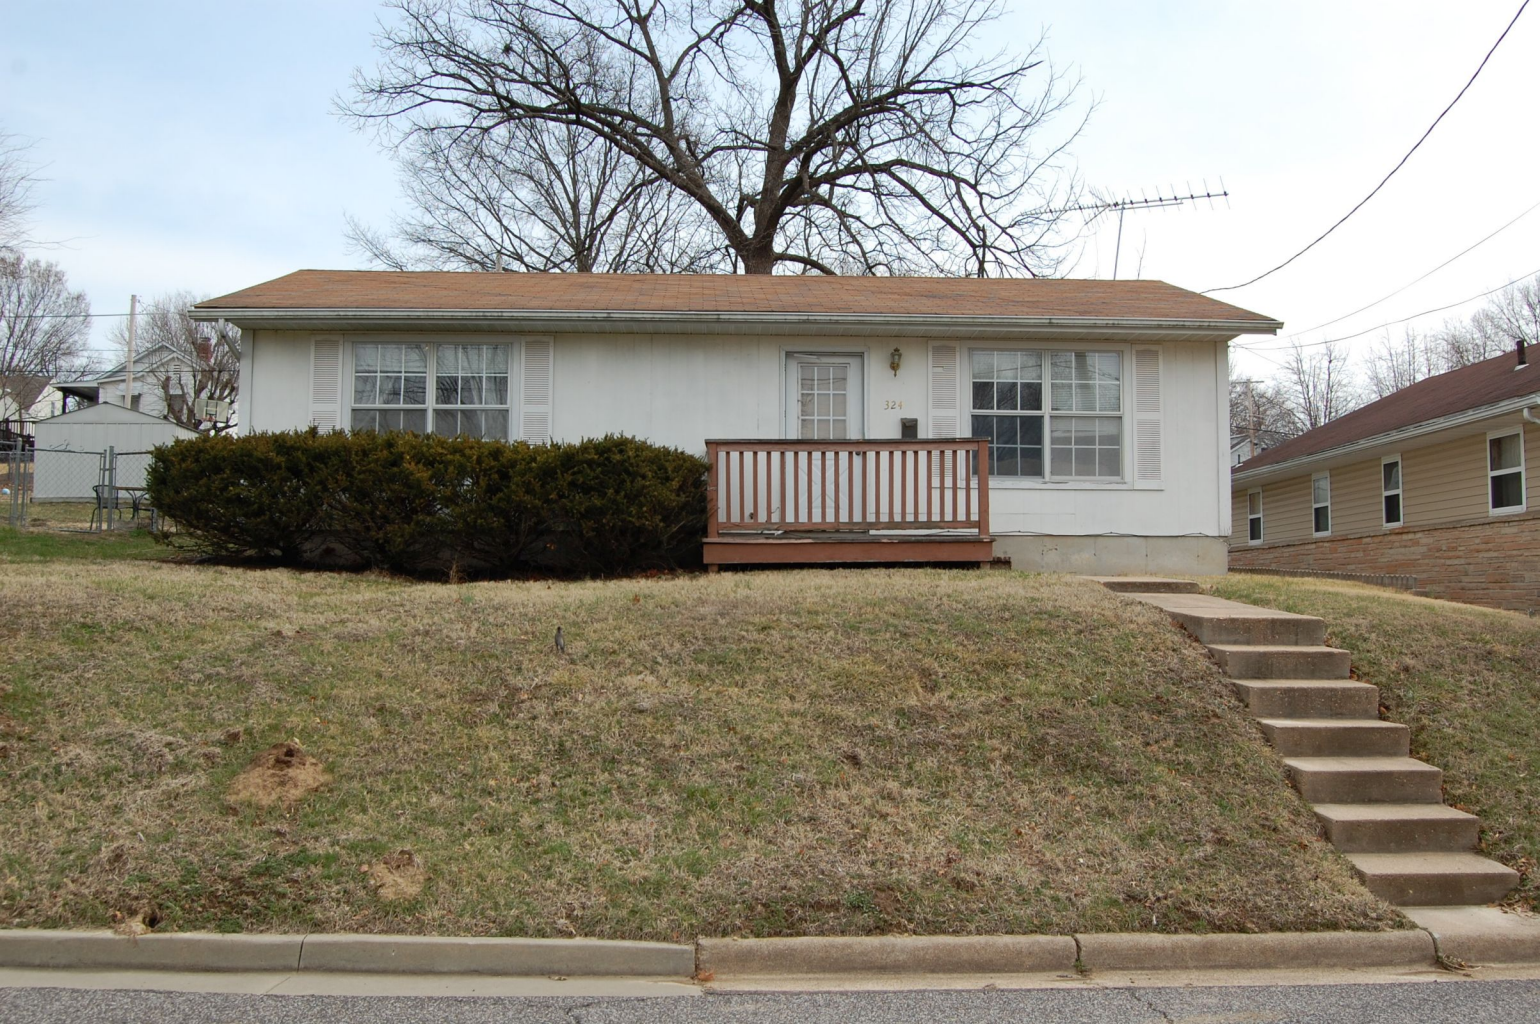
This 1 story home has a side gable asphalt shingle roof and a concrete foundation. There is a wooden platform with a wooden balustrade in front of the offset right entry. There is a single window bay on either side of the entry. Each window bay contains a pair of 1/1 double hung windows of vinyl sash. The windows have false muntins that give the appearance of 6/6 lights and are potentially later replacements. The entry contains a metal door (behind a storm door) with a single light divided by false muntins into 9 lights. This property was not surveyed in 1992.

Because of its recent date of construction, this home is not considered eligible for listing in a potential NR district.

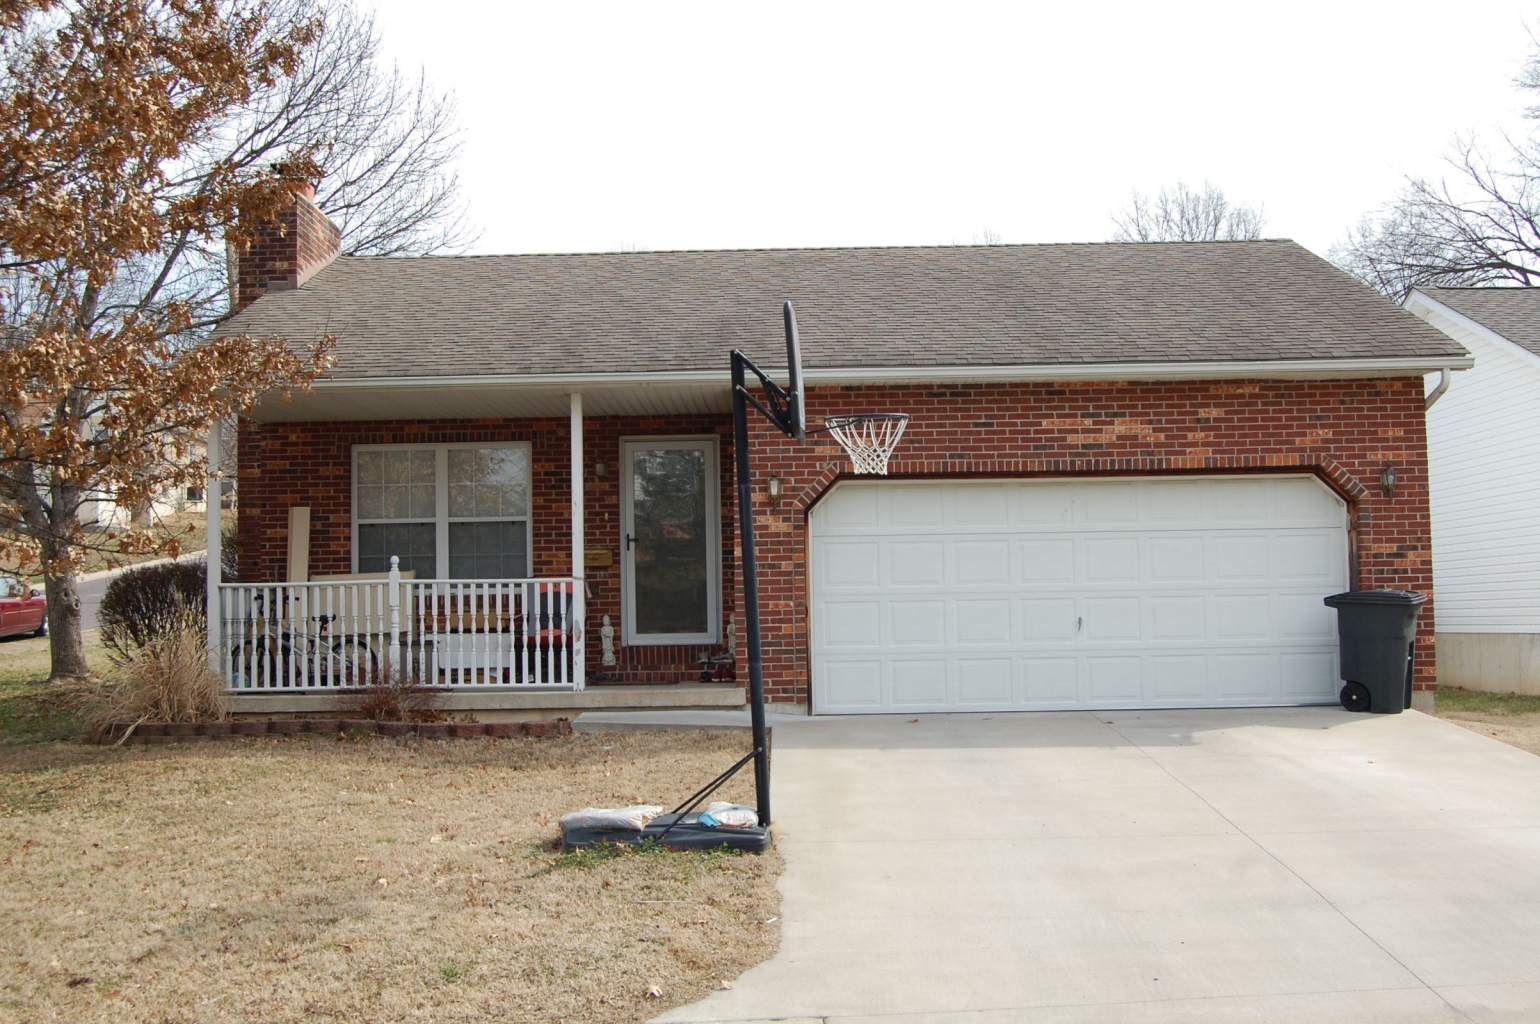
This 1 story brick home has a side gable asphalt shingle roof and a concrete foundation. There is an incised porch on the left side of the primary elevation that is approximately 1/3 the width of the facade. The porch is surrounded by a turned wooden balustrade and the porch roof has square wooden supports. Half of the facade is comprised of a two car garage with metal overhead door. The rest of the facade is faced with brick veneer. There is an offset right entry with a storm door. To the left of the entry is a single window bay containing a pair of 1/1 double hung vinyl windows with false muntins giving the appearance of 6/6 lights. There is an exterior chimney on the left (secondary) elevation. This property was not surveyed in 1992.

Because of its recent date of construction, this home is not considered eligible for listing in a potential NR district.

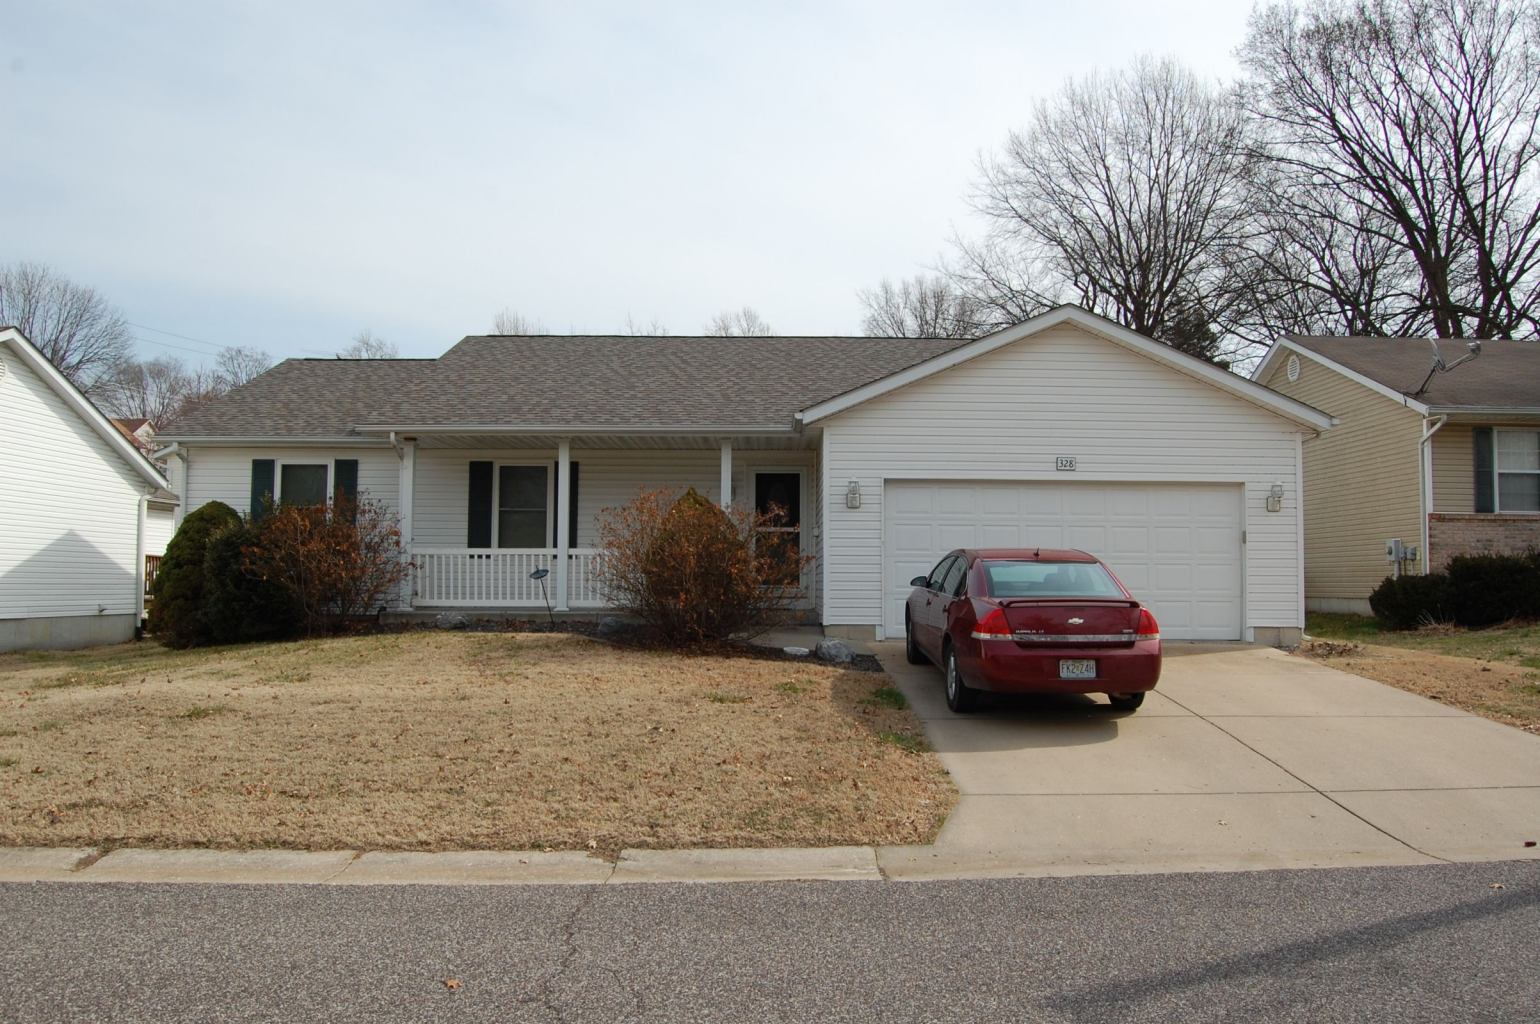
This 1 story home has a concrete foundation, vinyl siding, and a side gable shingle roof. The right side of the facade is dominated by a two car garage with metal overhead door. To the left of the gabled garage bay is a 1/3 width incised porch with composite square posts and square balustrade. There is a single entry and single window set within the porch. To the left of the porch is a single bay with a dropped side gable roof. It contains one widow. Windows are 1/1 double hung vinyl sash with ornamental shutters. This property was not surveyed in 1992.

Because of its recent date of construction, this home is not considered eligible for listing in a potential NR district.

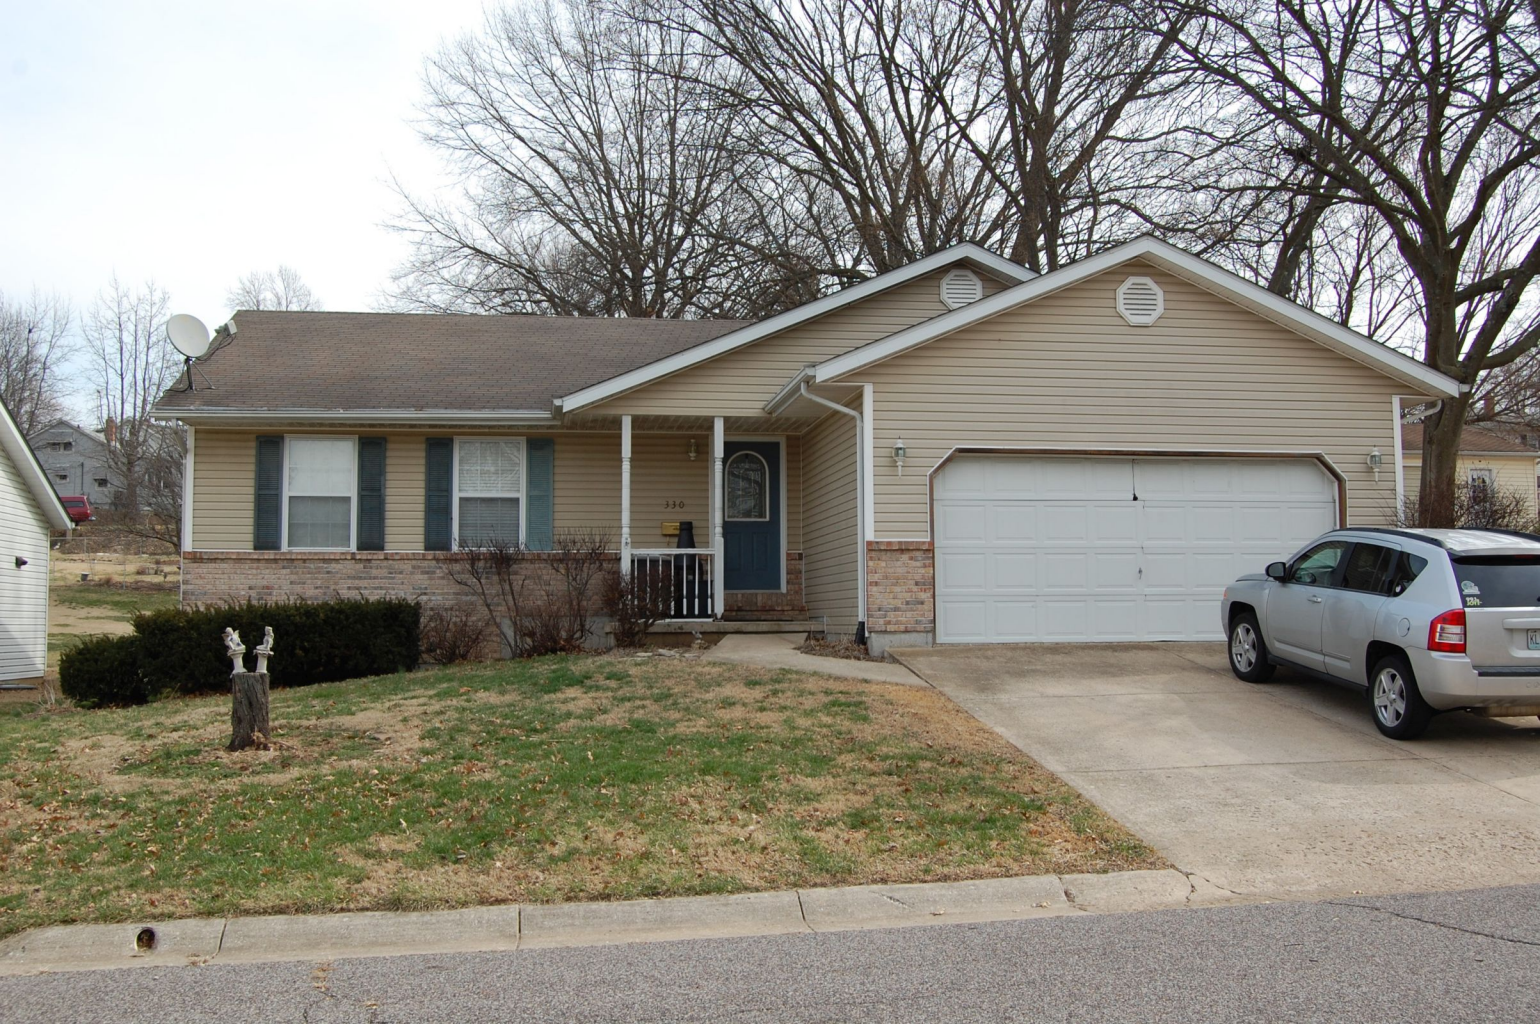
This 1 story home has a side right gable front with side gable asphalt shingle roof and a concrete foundation. There are two superimposed front gables on the right side of the facade above the garage. The end of one of these gables forms the roof of a central porch. The porch has a wooden balustrade. The right side of the facade is dominated by a two car garage with metal overhead door. To the left of the garage there is an offset right entry beneath the porch roof with a paneled door with a Palladian light. To the left of the entry are two window bays each containing a single 1/1 double hung window with vinyl sash and false muntins giving the appearance of 6/6 lights. Below the level of the window sills, the facade has a brick veneer dado wall. The rest of the facade is faced with vinyl siding. This property was not surveyed in 1992.

Because of its recent date of construction, this home is not considered eligible for listing in a potential NR district.
