MISSOURI DEPARTMENT OF NATURAL RESOURCES
STATE HISTORIC PRESERVATION OFFICE, P.O. Box 176, Jefferson City, MO 65102
ARCHITECTURAL/HISTORIC INVENTORY FORM

1. SURVEY NO. FR-AS-007-001		2. SURVEY NAME: International Shoe Factory Neighborhood	
3. COUNTY: Franklin		4. ADDRESS (STREET NO.) 605	STREET (NAME) West 3rd Street

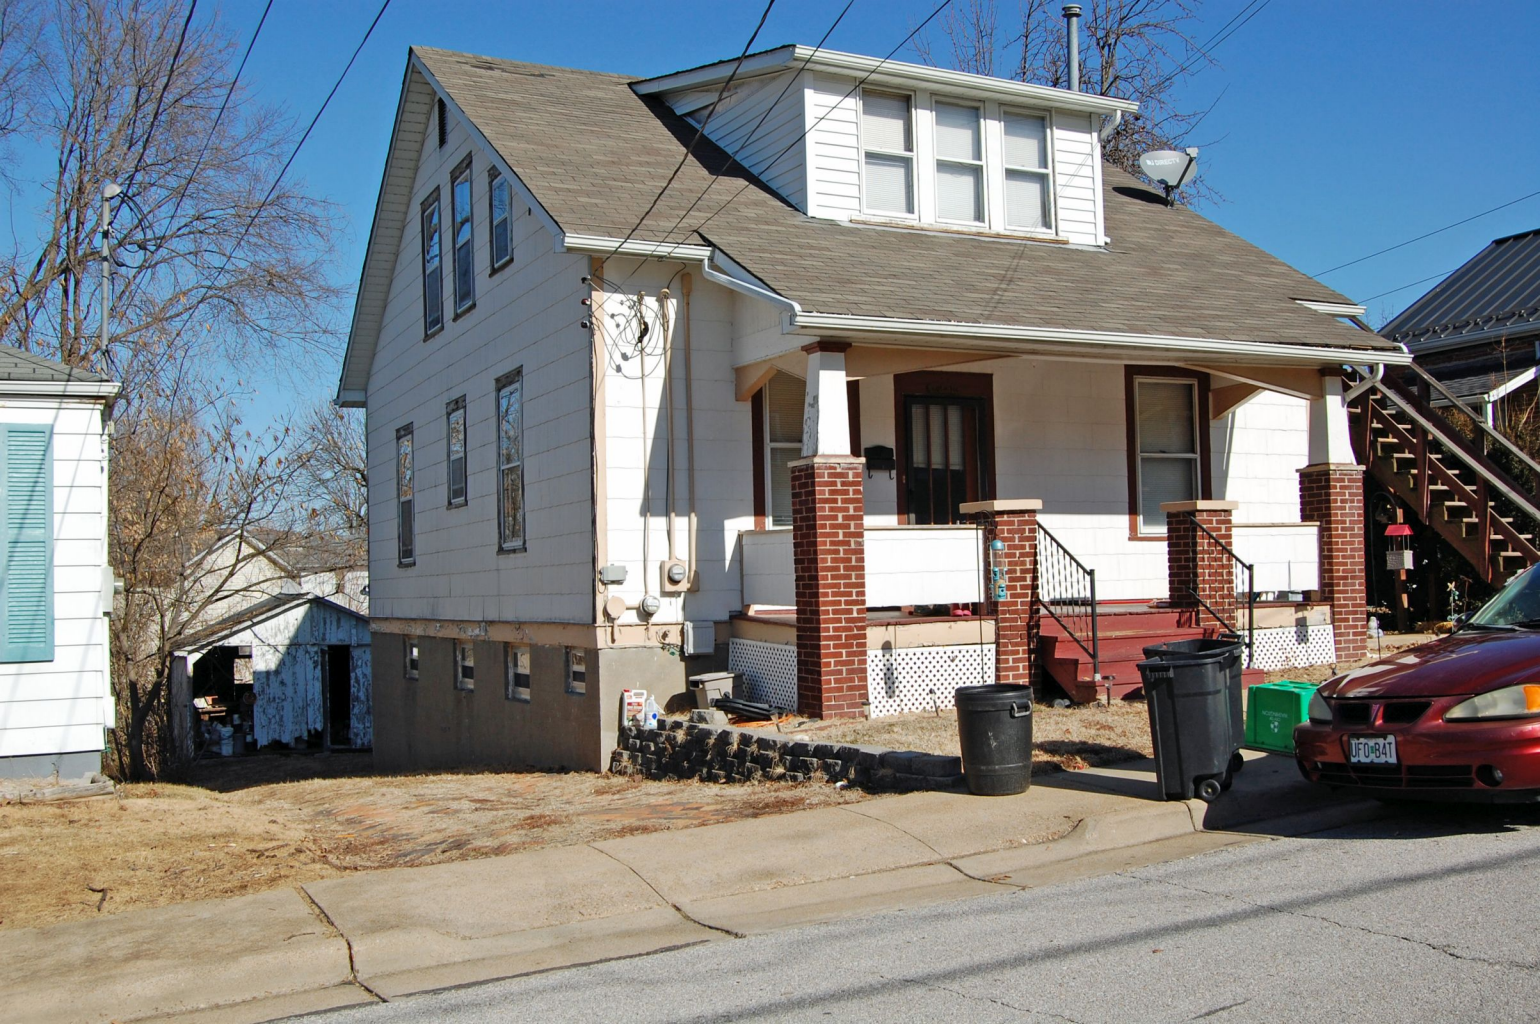
This 1.5 story frame bungaloid home has an asphalt shingle roof and a concrete foundation. There is a 1/2 width wood platform porch centered on the facade with a shed roof supported by squat, battered wooden columns atop square brick piers. Two more brick piers frame wooden steps that rise to the level of the porch floor. The entry is located beneath the porch roof and is offset slightly left. It contains a historic wooden panel door with three long vertical rectangular fixed lights. On either side of the entry is a single window bay containing what appears to be 1/1, double hung wood sash behind storm windows. Centered on the upper half story is a shed roof dormer clad with vinyl siding containing three window bays. Each bay contains a single 1/1 replacement sash of indeterminate material. An exterior wooden stair leads to an entrance to the upper half story on the right side of the elevation. The home appears unchanged from the way it was recorded by the 1992 survey.

Due to the presence of historic siding, windows, door, brick and wood porch details, this home is considered eligible for listing in a potential NR district.

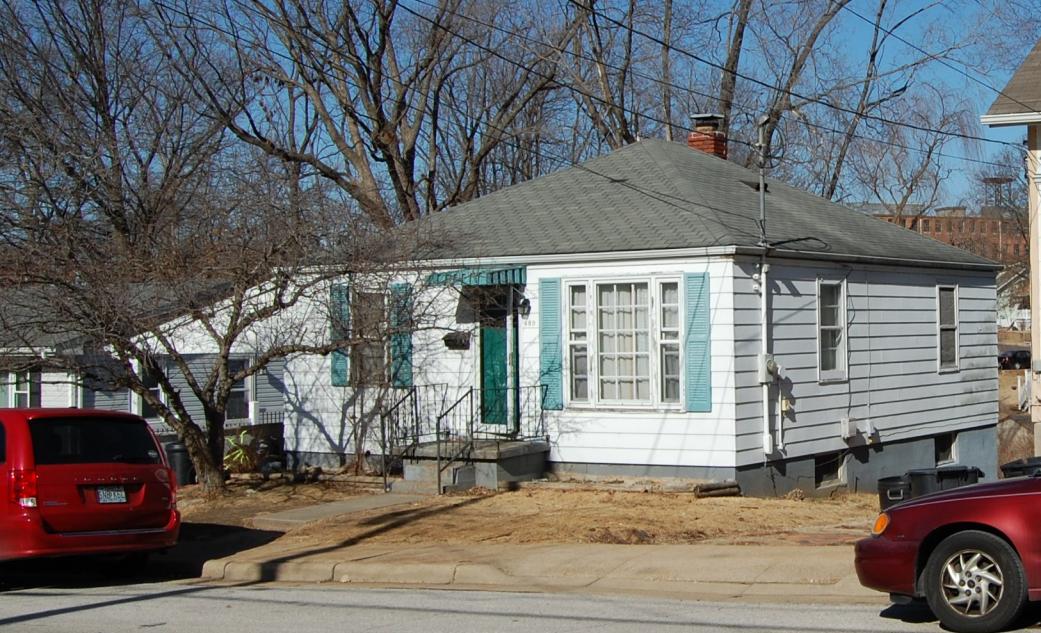
This 1-story frame pyramidal square home has an asphalt shingle Pyramidal Hipped roof, composite siding, and a concrete foundation. The entry consists of a narrow concrete platform porch centered on the facade with a wrought iron railing and an aluminum awning. The central entry contains a replacement metal panel door behind a storm door. On either side of the entry is a window bay flanked by non-operative plastic shutters. To the right of the entry is a fifteen light picture window with wooden muntins flanked by 2/3 double hung sidelights with wooden muntins. To the left of the entry is a single window bay of 2/2 horizontal muntin, double hung wood sash. At the left side of the facade is a frame, shed roof carport with square wooden supports, vertical board siding and a concrete floor. This property was not surveyed in 1992.

Due to the home date of construction during the period of significance and integrity, it is considered a contributing resource to a potential NR district.

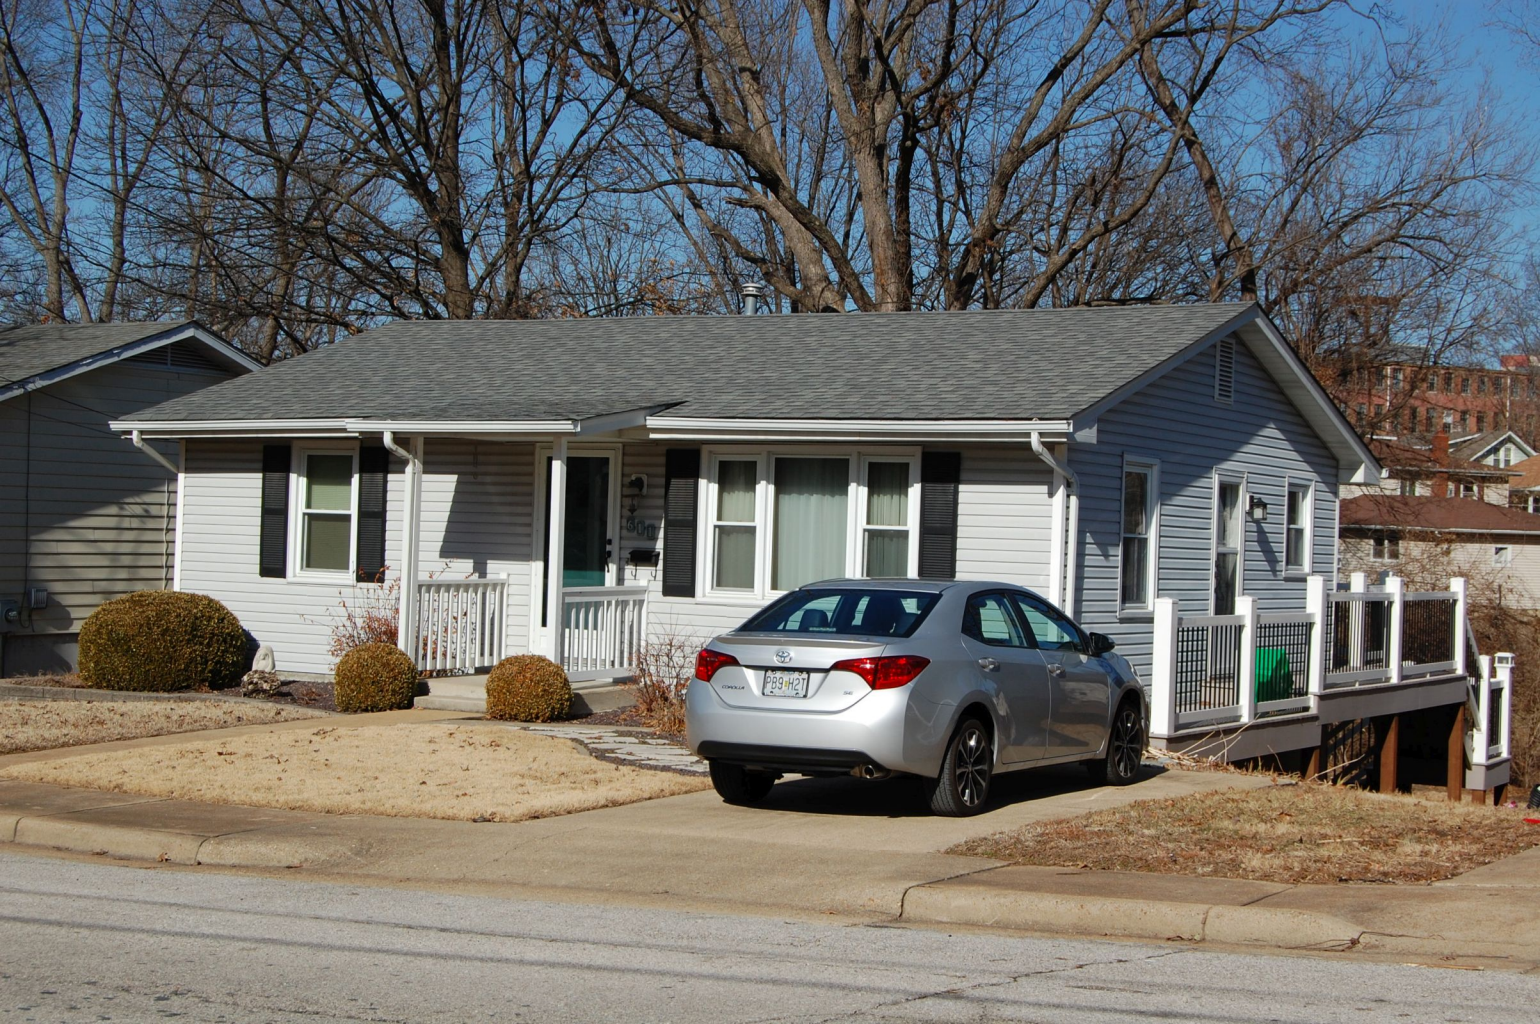
This 1 story frame home has a concrete foundation and asphalt shingle side gable roof. There is a central entry approached by a narrow concrete platform porch and sheltered by a shed roof with boxed vinyl supports. The entry contains a solid door of indeterminate material behind a storm door. To the right of the entry is a window bay containing a fixed light flanked by 1/1, double hung vinyl replacement sash. To the left of the entry is a window bay containing a single 1/1, double hung vinyl replacement sash. The windows have non-operative plastic shutters. The building is clad in vinyl siding. While the Franklin County Assessor assigns a construction date of 1954 to this home, it appears to be much newer and may be closer in age to its next door neighbor at 617 W. Third, which was constructed c. 1979. This property was not surveyed in 1992.

Due to the presence of non-historic siding and windows, this home is not considered to be eligible for listing in a potential NR district.

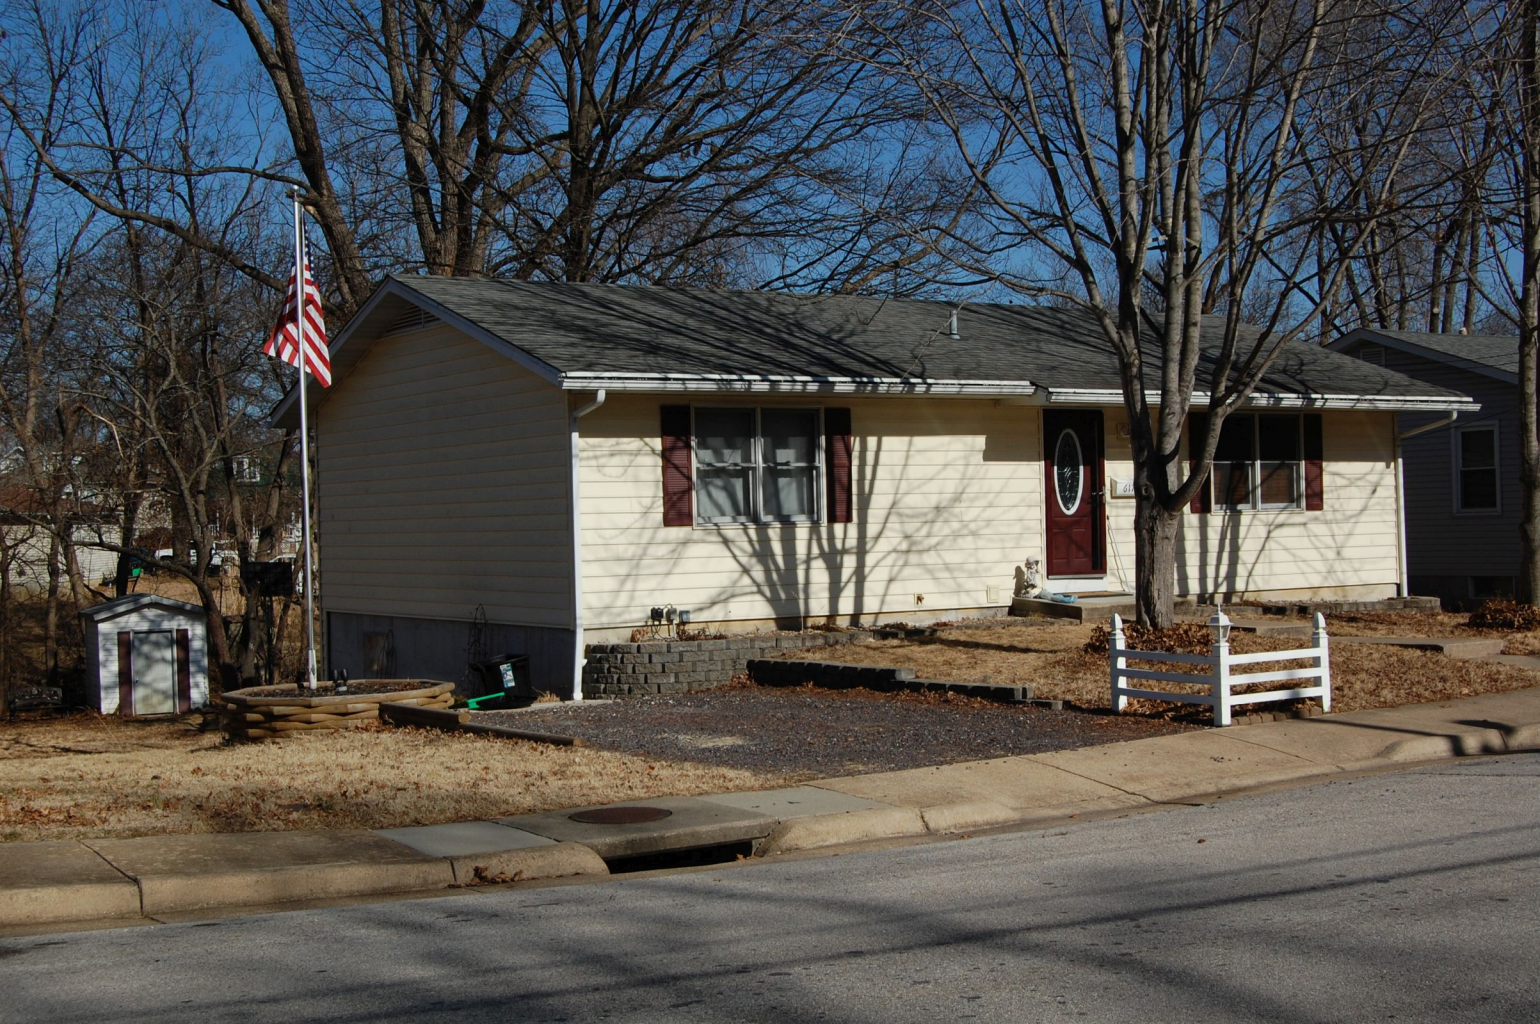
This 1 story frame home has a concrete foundation and asphalt shingle side gable roof. There is a central entry approached by a narrow concrete platform porch and sheltered by the overhanging roof eave. The entry contains a replacement metal door with an oval leaded light. To the right of the entry is a window bay containing two 1/1, double hung aluminum sash. To the left of the entry is a window bay containing two 1/1, double hung aluminum sash. The windows have non-operative plastic shutters. The building is clad in vinyl siding. This property was not surveyed in 1992.

Due to its recent construction date, this home is not considered to be eligible for listing in a potential NR district.

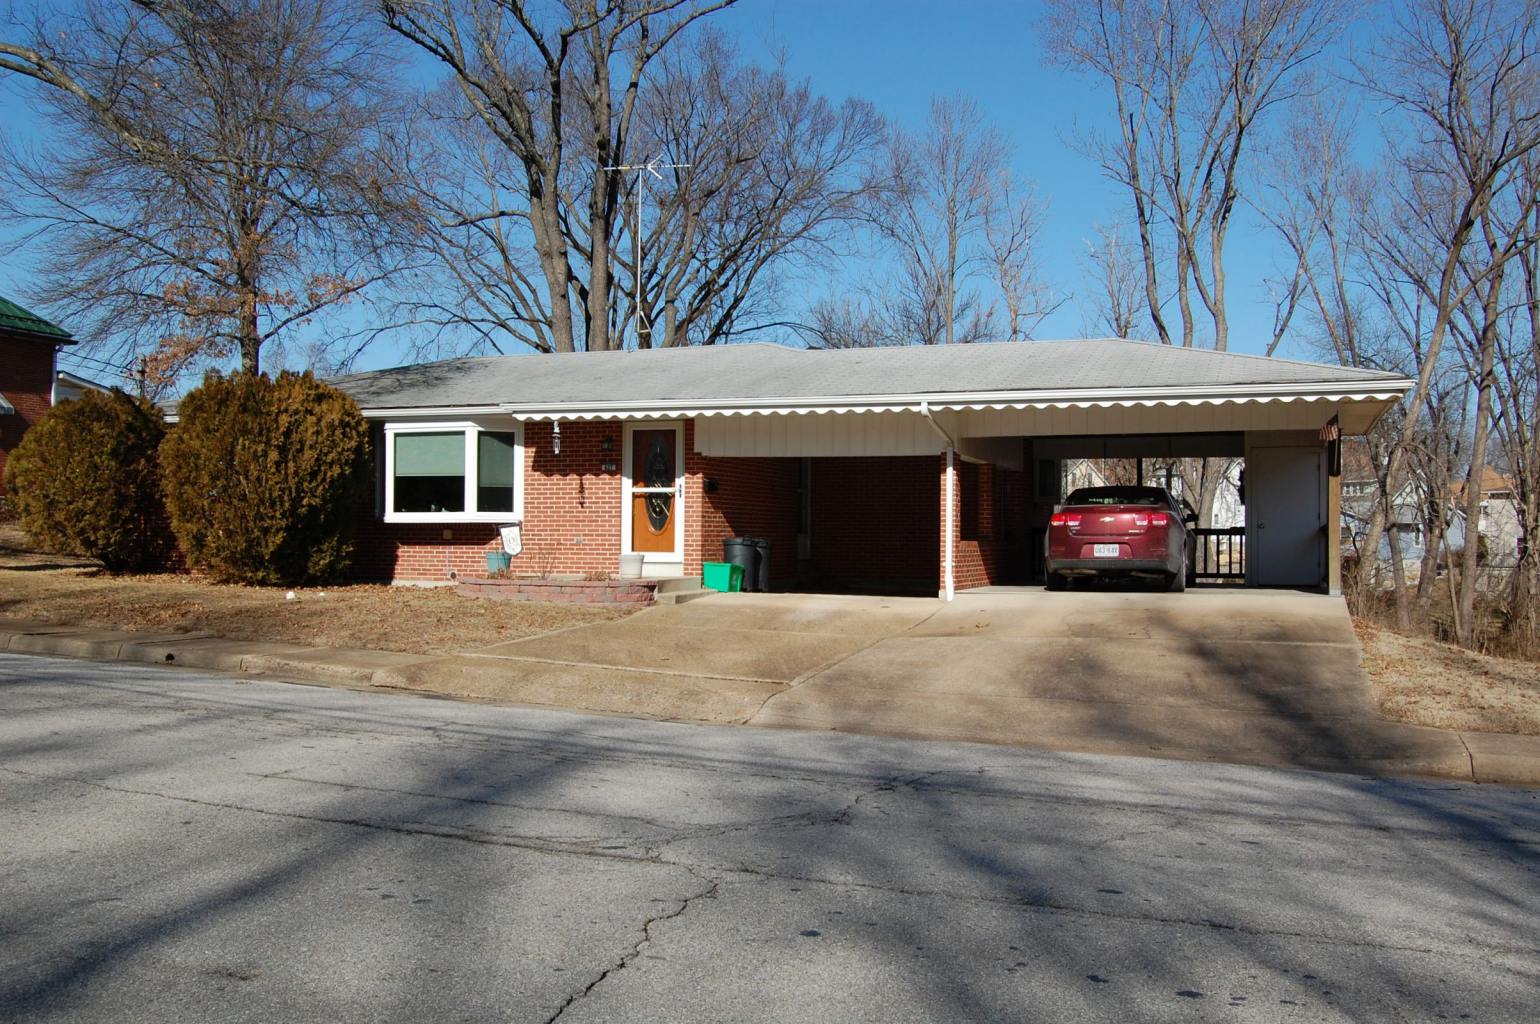
This 1-story masonry home has a concrete foundation and long and low asphalt shingle hipped roof. Less than half of the left side of the home is obscured by shrubbery, hindering the bay count. On the far right are two carports. The single carport (adjacent to the living space) with brick enclosed sides appears to be original. The other, 2 car garage with wood frame balustrade enclosure appears to be an addition. The two are separated by a brick dividing wall and both are situated beneath a continuation of the home's roof ridge. On the primary section of the home there is a side right entry with a wooden door with a central oval shaped leaded light behind a storm door. There is a wide overhanging eave over the entry and carport bays with a scalloped trim. To the left of the entry is a bay picture window with a fixed central light and flanking single light casements. Via Google streetview (June 2013) there is a window (potentially single bay) behind the shrubs. Sash material is indeterminate, but the windows do not appear to be of 1960 vintage. This property was not surveyed in 1992.

Based on the visible façade features, this home is not considered to be eligible for listing in a potential NR district due to the presence of replacement windows, door, and the apparent extension of the roof ridge to enclose a carport addition.

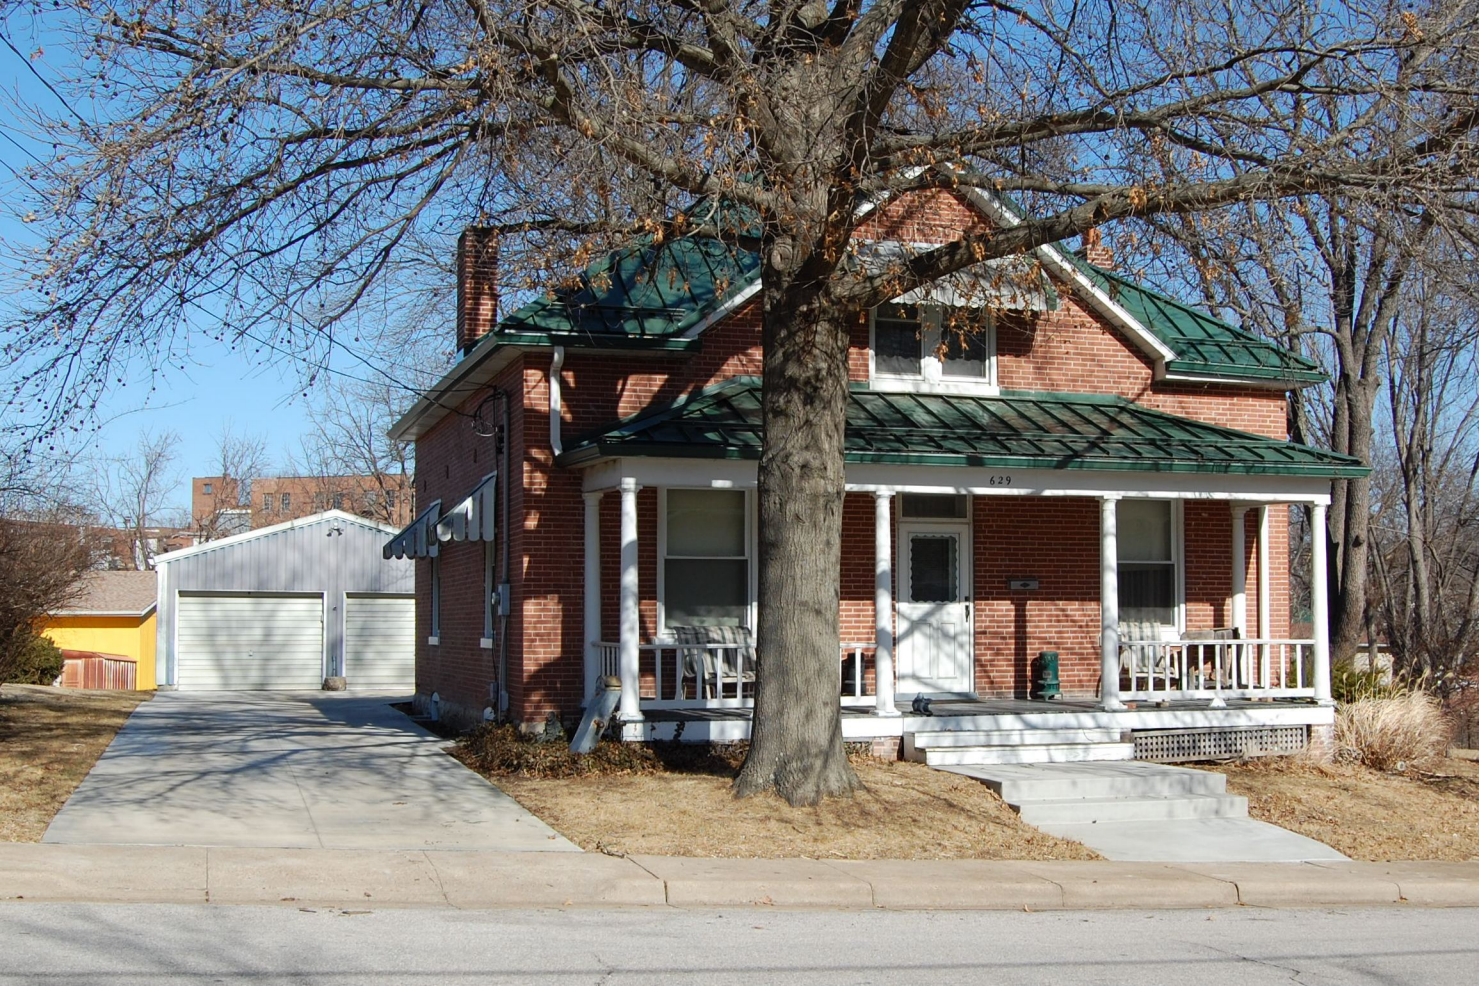
This 1.5 story brick home has a limestone foundation and a standing seam metal roof. The primary elevation has a central, 3/4 width porch with a pyramidal hipped roof of standing seam metal, wood Tuscan columns, and an open railing with square wood balusters. The main entrance is a single light glass and wood door behind a storm door, with a single light transom set within a segmental arch of two course header brick. On either side of the entrance is a single window bay containing a 1/1, double hung wood sash behind storm windows. The window bays have segmental arches of two course header brick and limestone lug sills. There are interior wall brick chimneys on the east and west walls. Centered on the front gable on the upper half story is a window bay containing a pair of 1/1, double hung sash. Sash material is obscured by storm windows. The window bay has a limestone lug sill, but its arch is obscured by an aluminum awning.

There are no major alterations since the 1992 survey.

This home retains its original form, original windows and wall surface and is considered to be eligible for listing in a potential NR district.

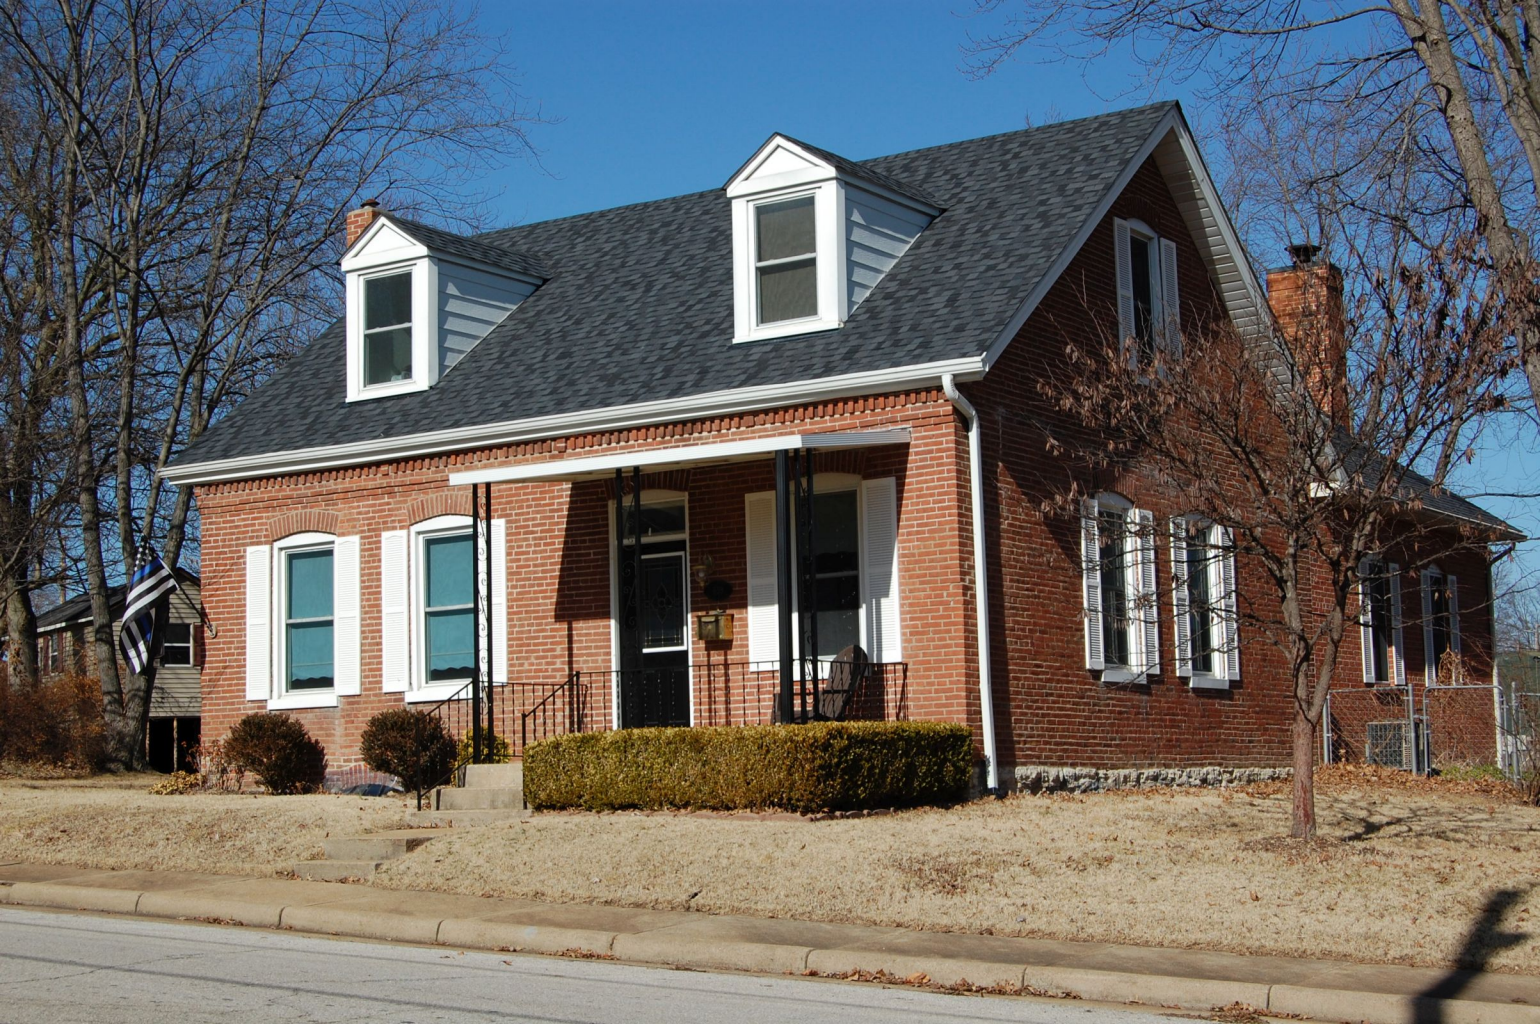
This 1.5 story brick home has a limestone foundation and an asphalt shingle roof. The primary elevation has a non-historic concrete pad porch with a shed roof with wrought iron supports and balustrade. The entry is situated beneath the porch roof and contains a non-historic wood panel door with leaded light and a glazed transom. To the right of the entry is a single window bay and to the left of the entry are two window bays. All contain 1/1, double hung replacement sash of indeterminate material. All the bays on the primary elevation have segmental, soldier course arches and wooden lug sills. The window bays have inoperative plastic shutters. There is a brick dentil cornice at the roof line. There are two front gable dormers on the upper half story containing 1/1, double hung replacement sash of indeterminate material. Since 1992, the home has effectively been doubled in size by a rear addition. This addition has a front gable roof, concrete foundation, and brick veneer. It has been designed to mimic historic construction and even has brick, segmental arch bays. While significant, the addition does not have an impact on the appearance of the primary elevation.

From the street, this home retains its original form and wall material and is considered to be eligible for listing in a potential NR district.

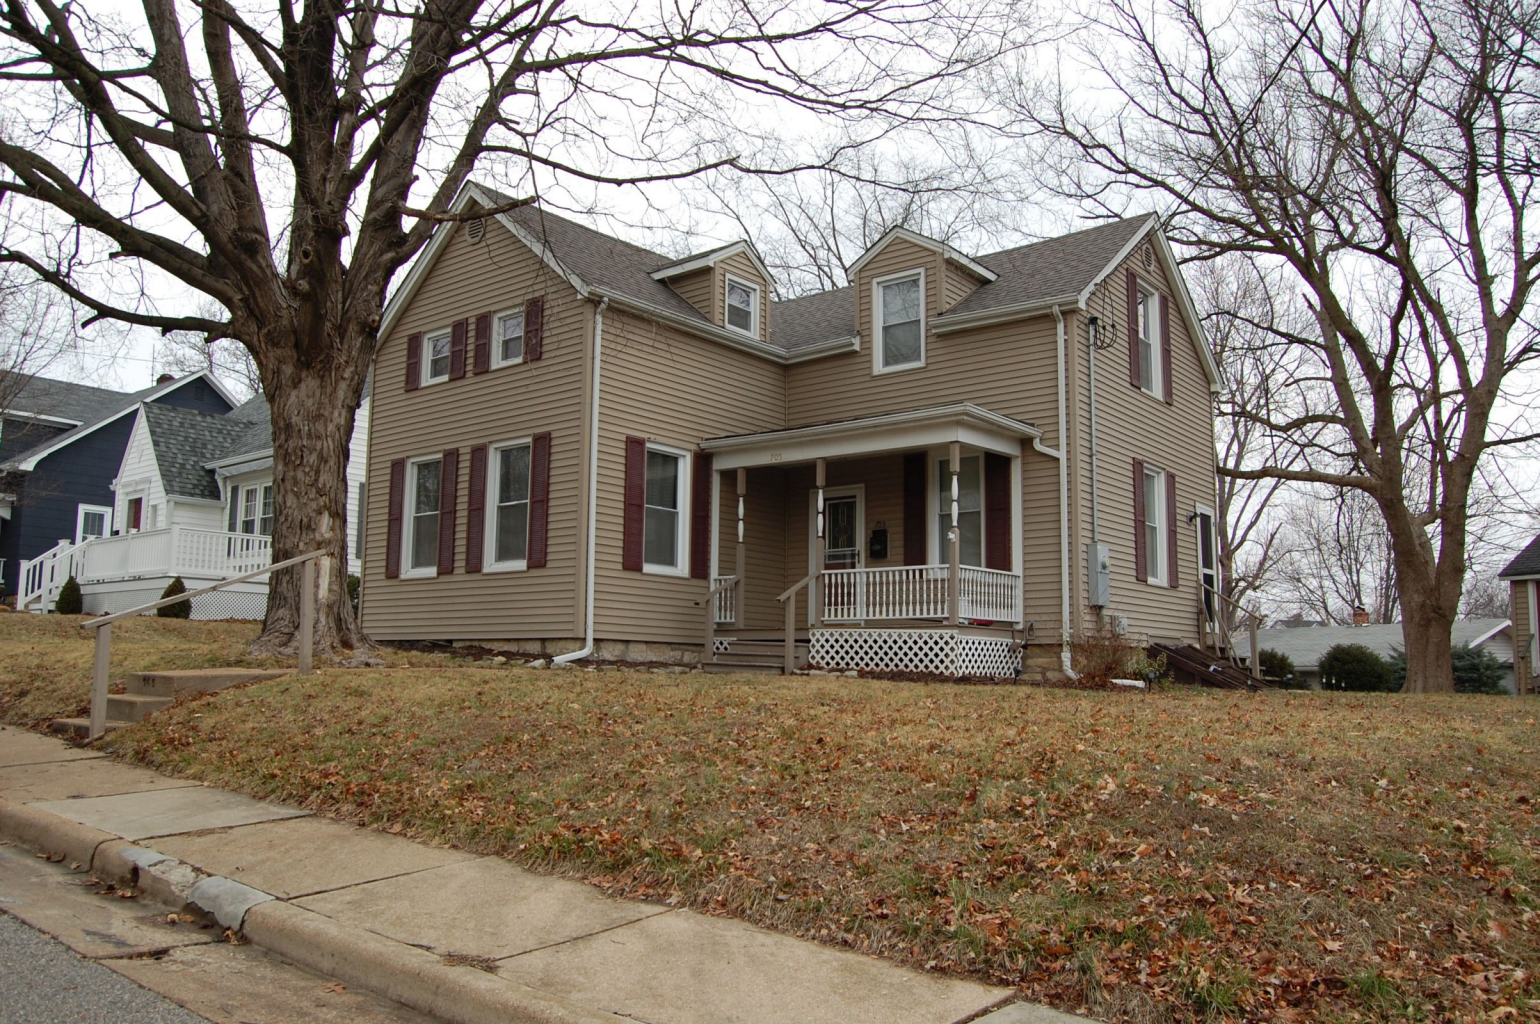
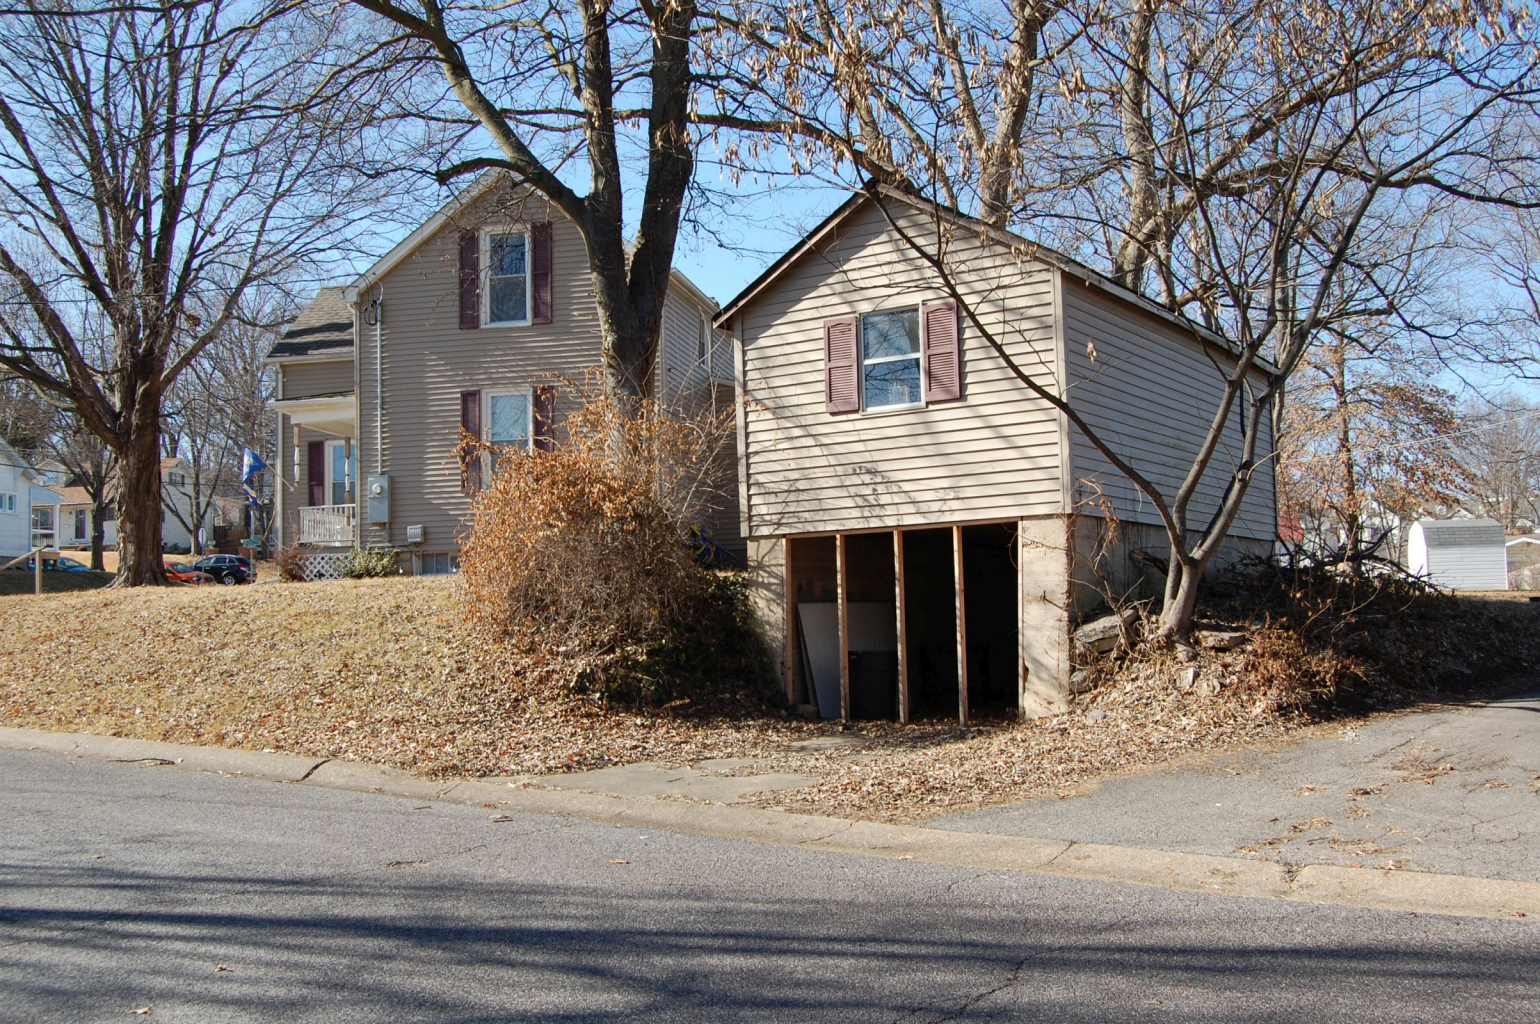
This 1.5 story frame home has a limestone foundation, vinyl siding, and an asphalt shingle roof. The primary elevation faces Third Street. The projecting gable front bay, side left has 2 window bays. Within the ell, side right is a 1/2 width frame porch with low, asphalt shingle hipped roof and three turned wooden posts with a turned wooden balustrade. Within the porch is a single entry of a replacement panel door with leaded glass light behind a storm door and a single window bay. The upper story of the side left bay (gable front) has 2 window bays. Within the upper half story of the ell are 2 dormers: a gable dormer with single window on the western side and a gable dormer with single window through the roofline on the wing. Windows are 1/1, double hung vinyl replacement sash with ornamental shutters. Post 1992 survey alterations include: replacement of asbestos shingles with vinyl, enclosure of secondary porch entry (left of primary entry) and transoms, replacement of single light glass and wood door, replacement of 1/1 wood sash windows with vinyl, and in kind replacement of original turned wood columns, and an open railing with square wood balusters (not exact design). The original siding is unknown, however, due to the replacement of asbestos with vinyl and the enclosure of an older entry, which signified a multi-unit dwelling (that is at least present by 1948 due to multiple listings in the city directory), this home is not considered to be eligible for listing in a potential NR district.

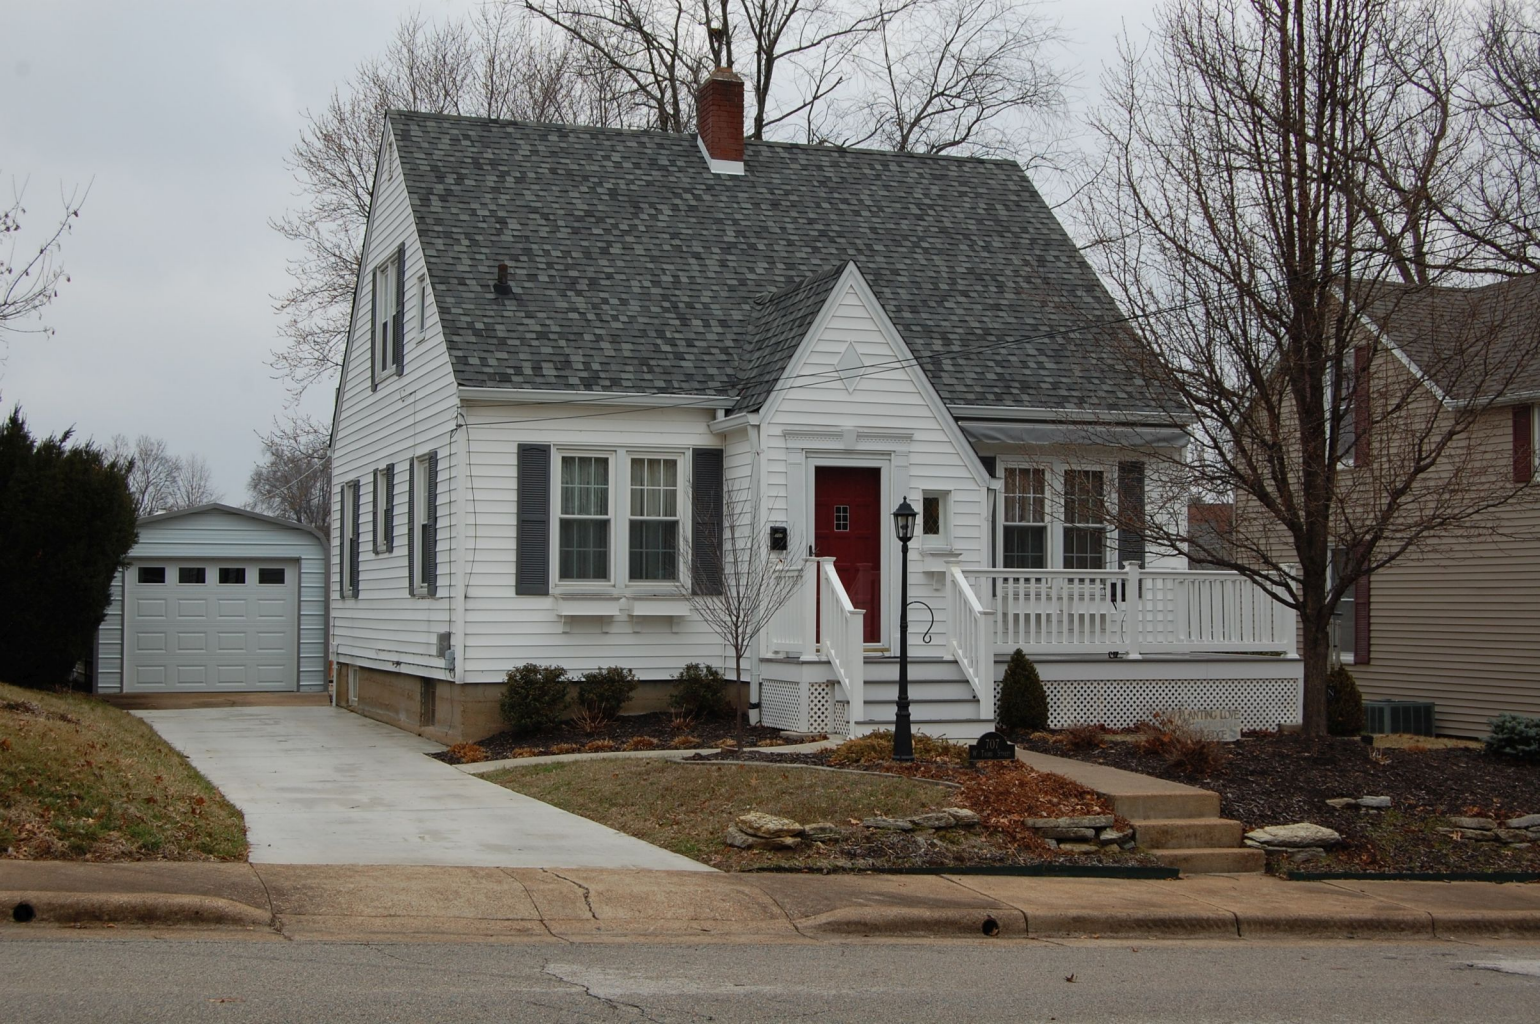
This 1.5 story frame home has a concrete foundation and an asphalt shingle roof. The primary elevation has a central projecting entry bay with a front gable, "cat slide" roof. The entry has a surrounding vinyl pediment and a multi-panel and rectangular multi-light glass door. To the right of the entry in the projecting bay is a small original leaded casement window. On either side of the entry bay is a pair of 1/1, double hung vinyl replacement sash with false muntins giving the appearance of 6/6 lights. The windows have non-operative plastic shutters and vinyl window boxes. A 3/4 width wooden porch with vinyl balustrade spans the right side of the facade and is approached by four steps. The building is clad with vinyl siding. Post 1992 survey alterations include: replacement of weatherboard with vinyl siding (though the diamond design within the gable was retained), replacement of 6/6 wood sash windows and awning, Removal of the metal awning over the door, potential replacement of single light glass and wood door, new door surround added, and the small concrete entry platform expanded to a 3/4 width porch.

Due to the presence of vinyl siding, non-operative plastic shutters, replacement windows, and a new porch, this home is not considered to be eligible for listing in a potential NR district.

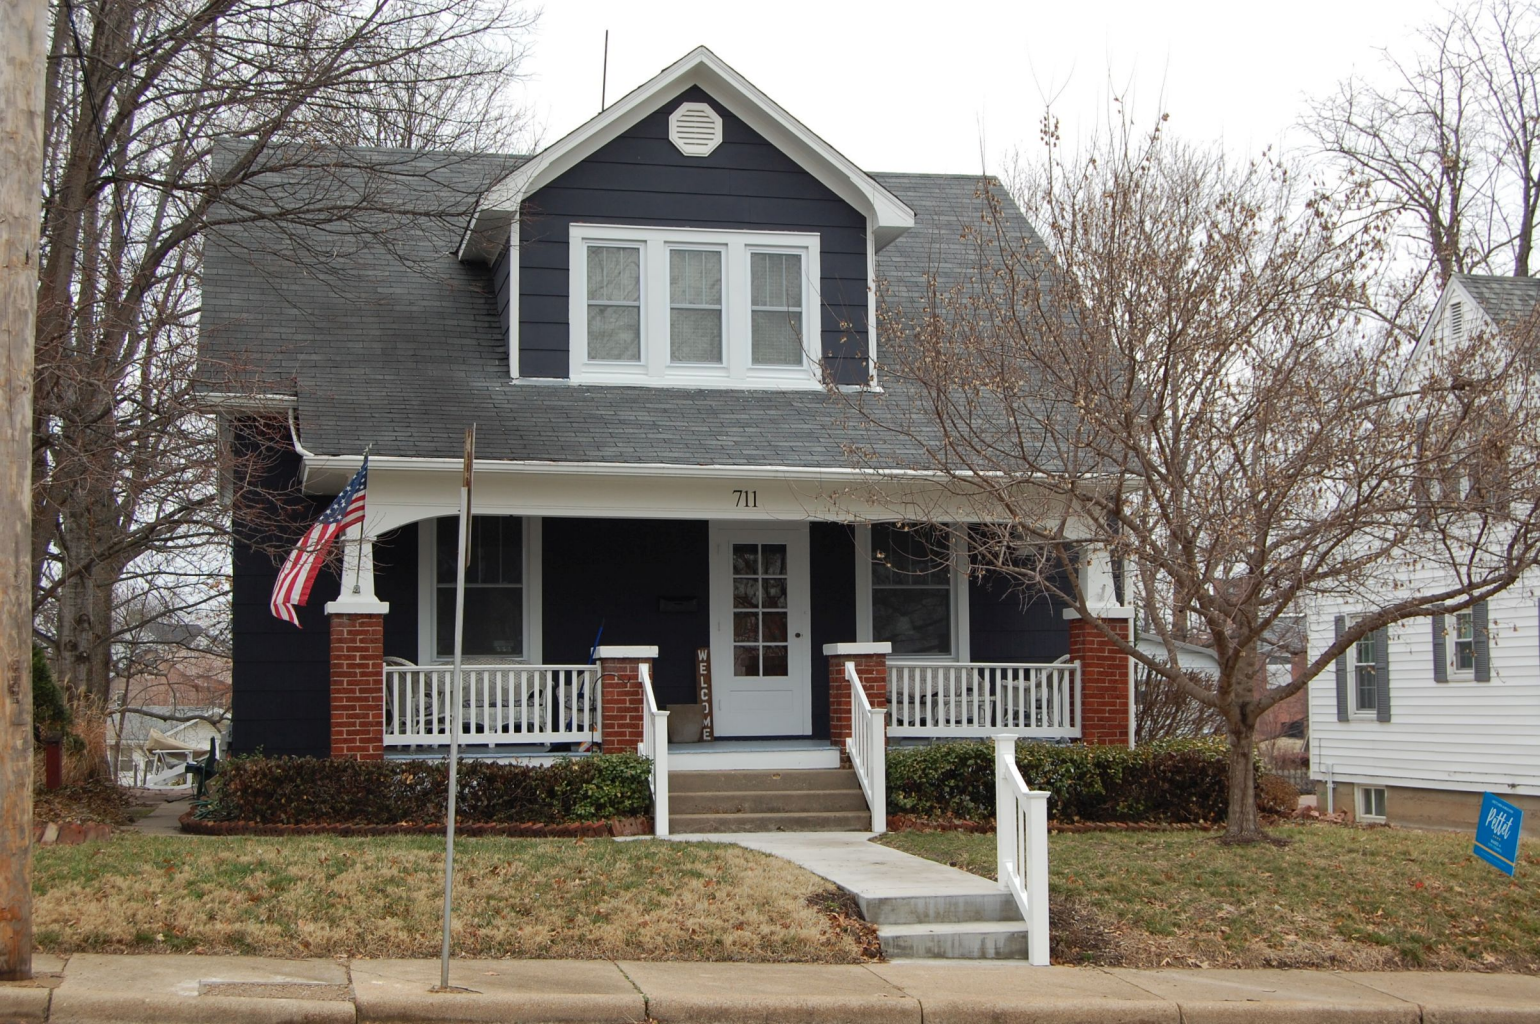
This home is considered to be eligible for listing in a potential NR district due to its date of construction and integrity.

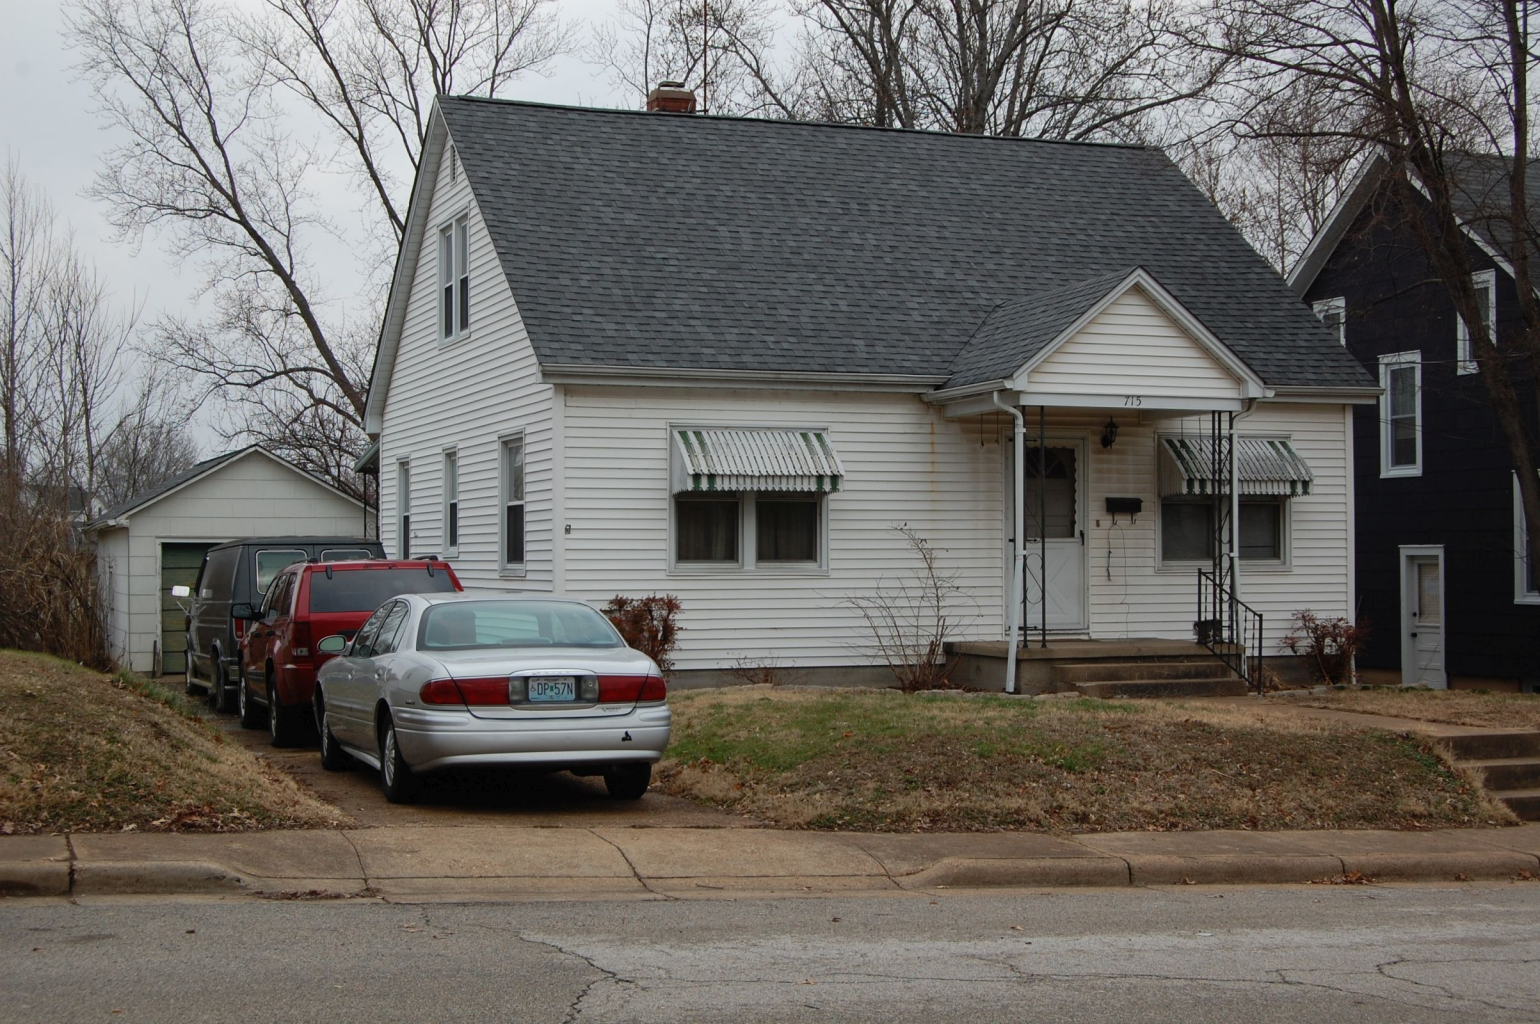
Due to vinyl siding and uncertainty in window material and inability to discern whether windows are original/historic, this building is not considered to be eligible for listing in a potential NR district.
