MISSOURI DEPARTMENT OF NATURAL RESOURCES
STATE HISTORIC PRESERVATION OFFICE, P.O. Box 176, Jefferson City, MO 65102
ARCHITECTURAL/HISTORIC INVENTORY FORM

1. SURVEY NO. FR-AS-007-001		2. SURVEY NAME: International Shoe Factory Neighborhood	
3. COUNTY: Franklin		4. ADDRESS (STREET NO.) 605	STREET (NAME) West 3rd Street

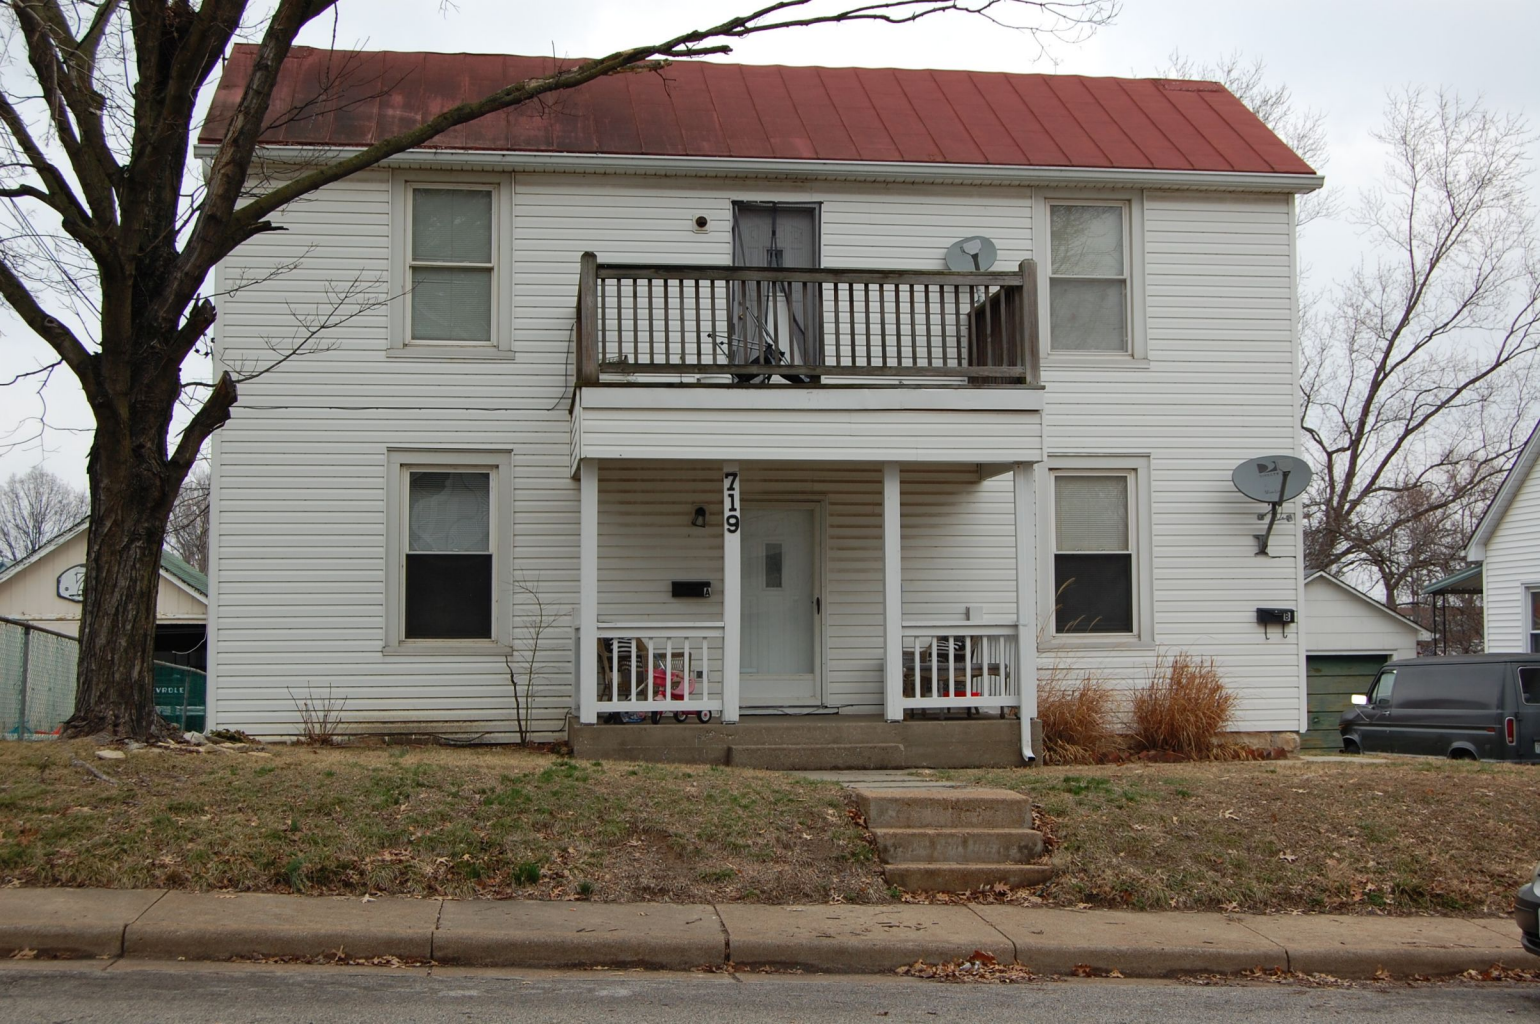
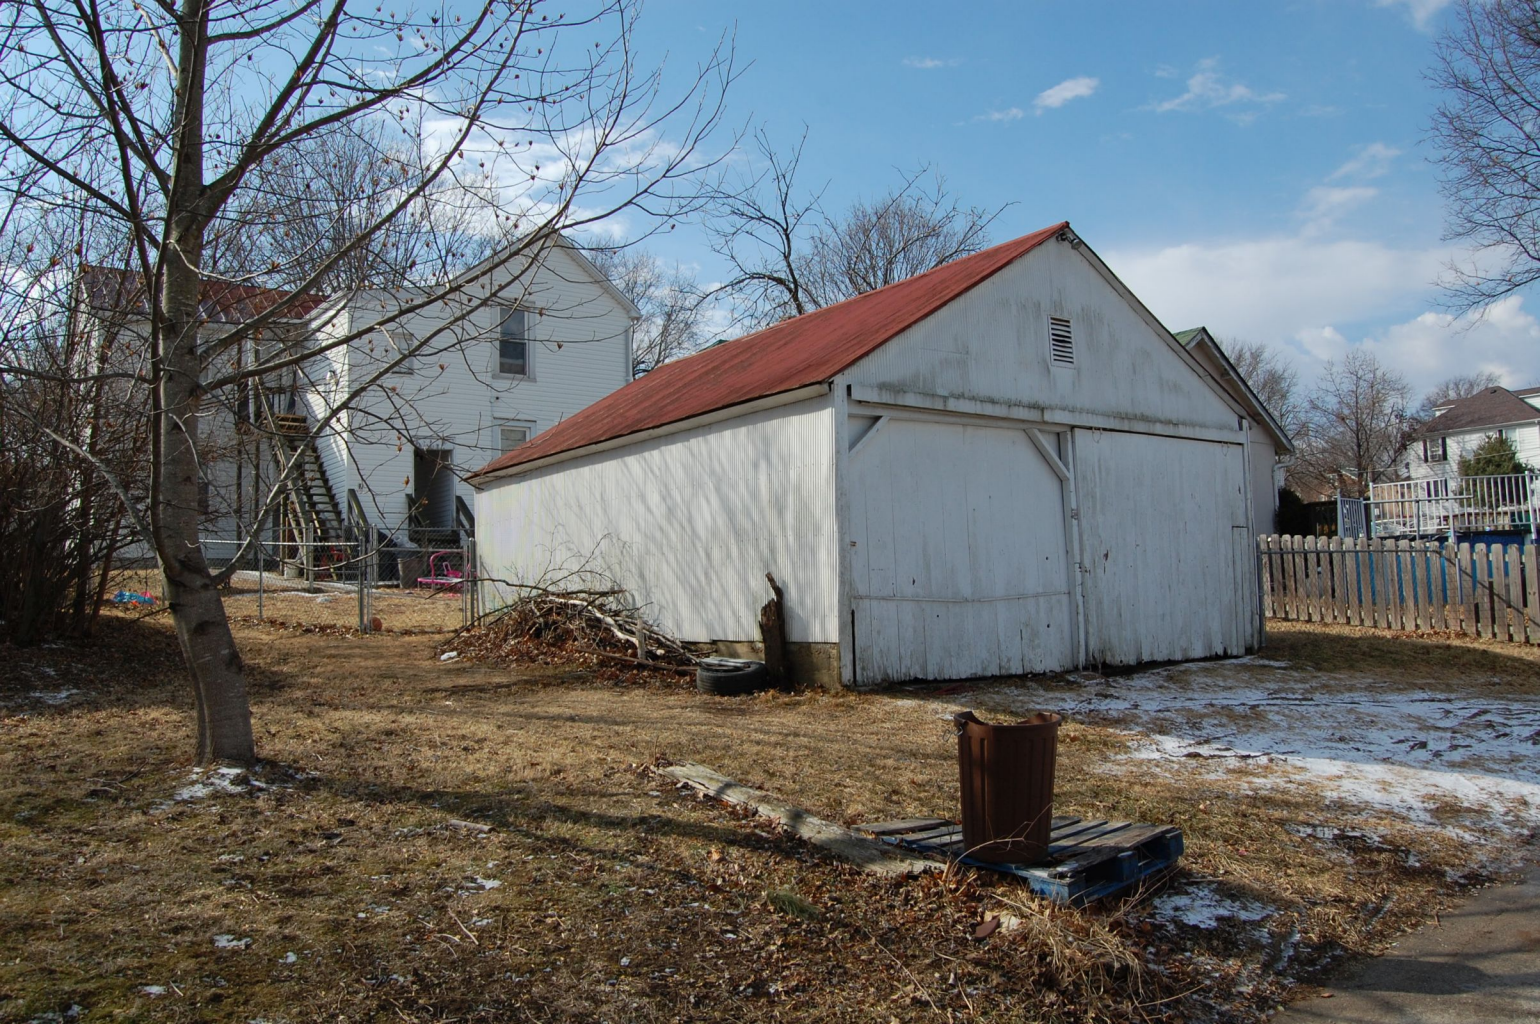
Due to vinyl siding, vinyl windows, vinyl porch supports, and replacement doors, this building is not considered to be eligible for listing in a potential NR district.

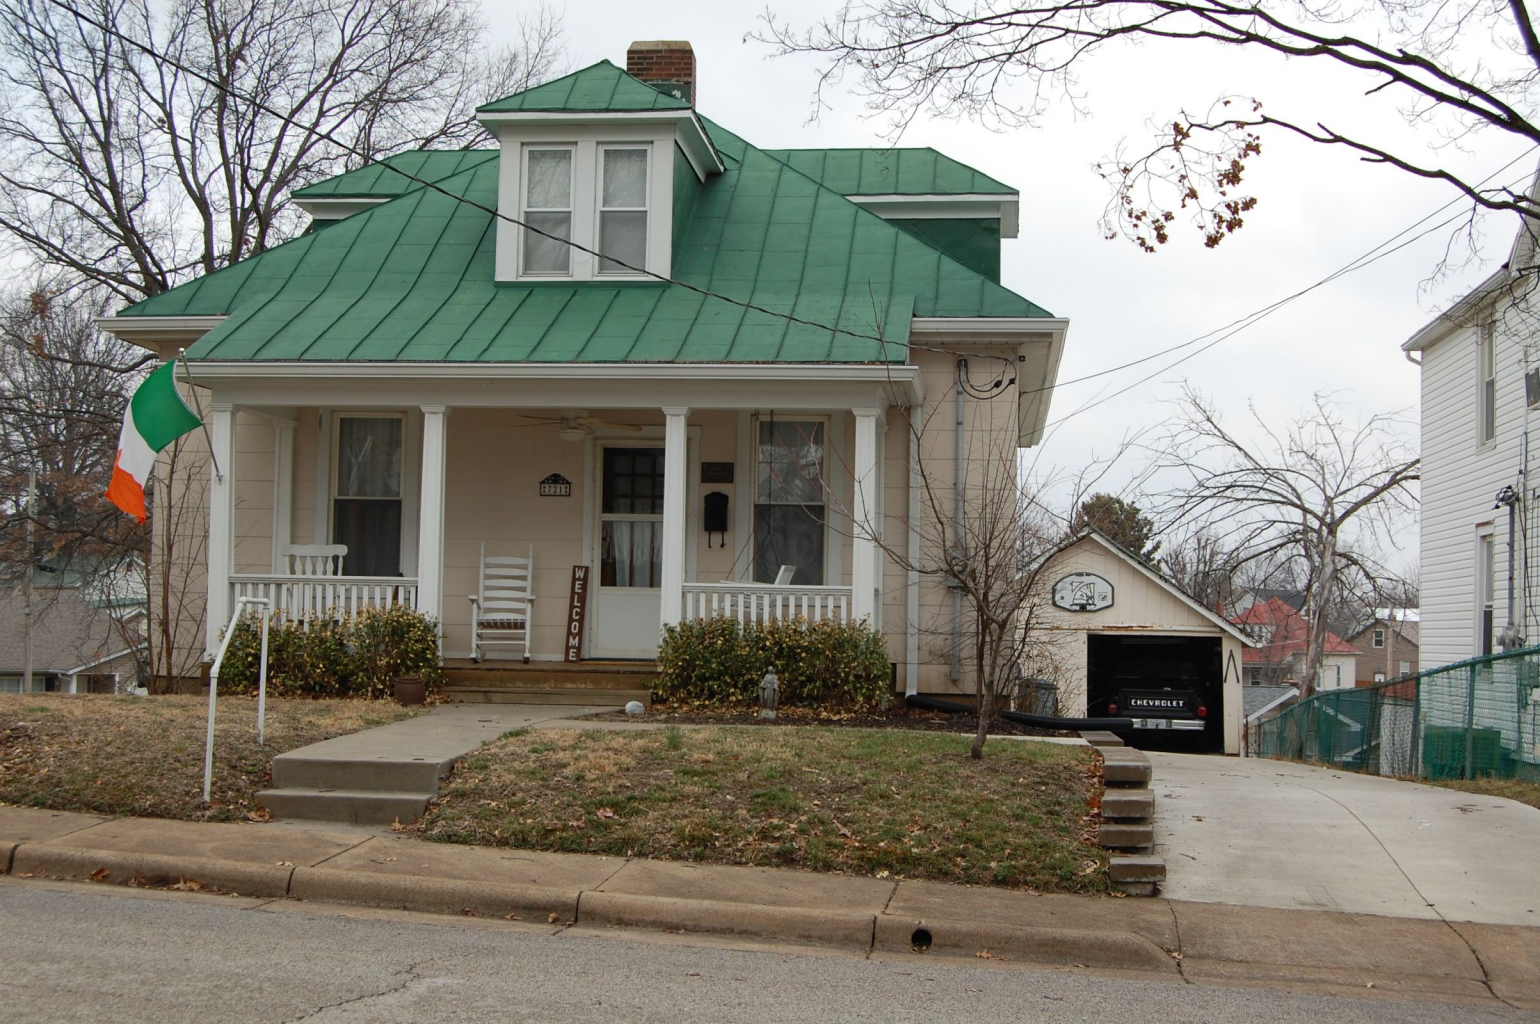
Due to the presence of historic siding, door, and roof material, this home is considered contributing to a potential NR district.

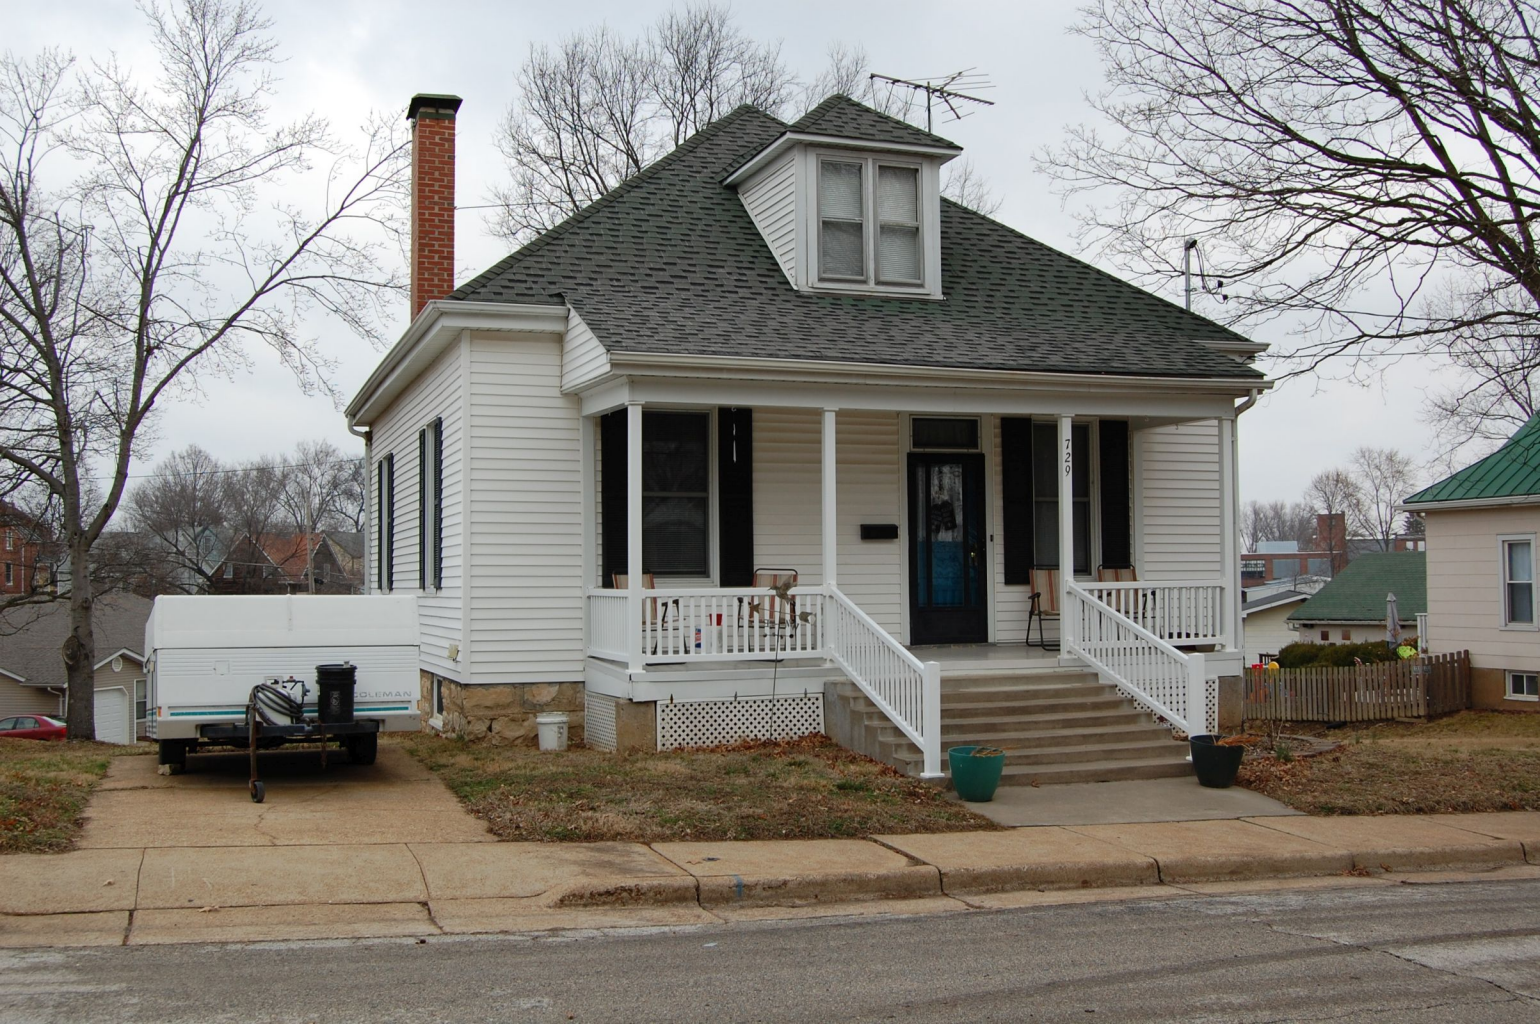
Due to the presence of vinyl siding and vinyl porch components, this building is not considered to be a contributing resource in a potential NR district.

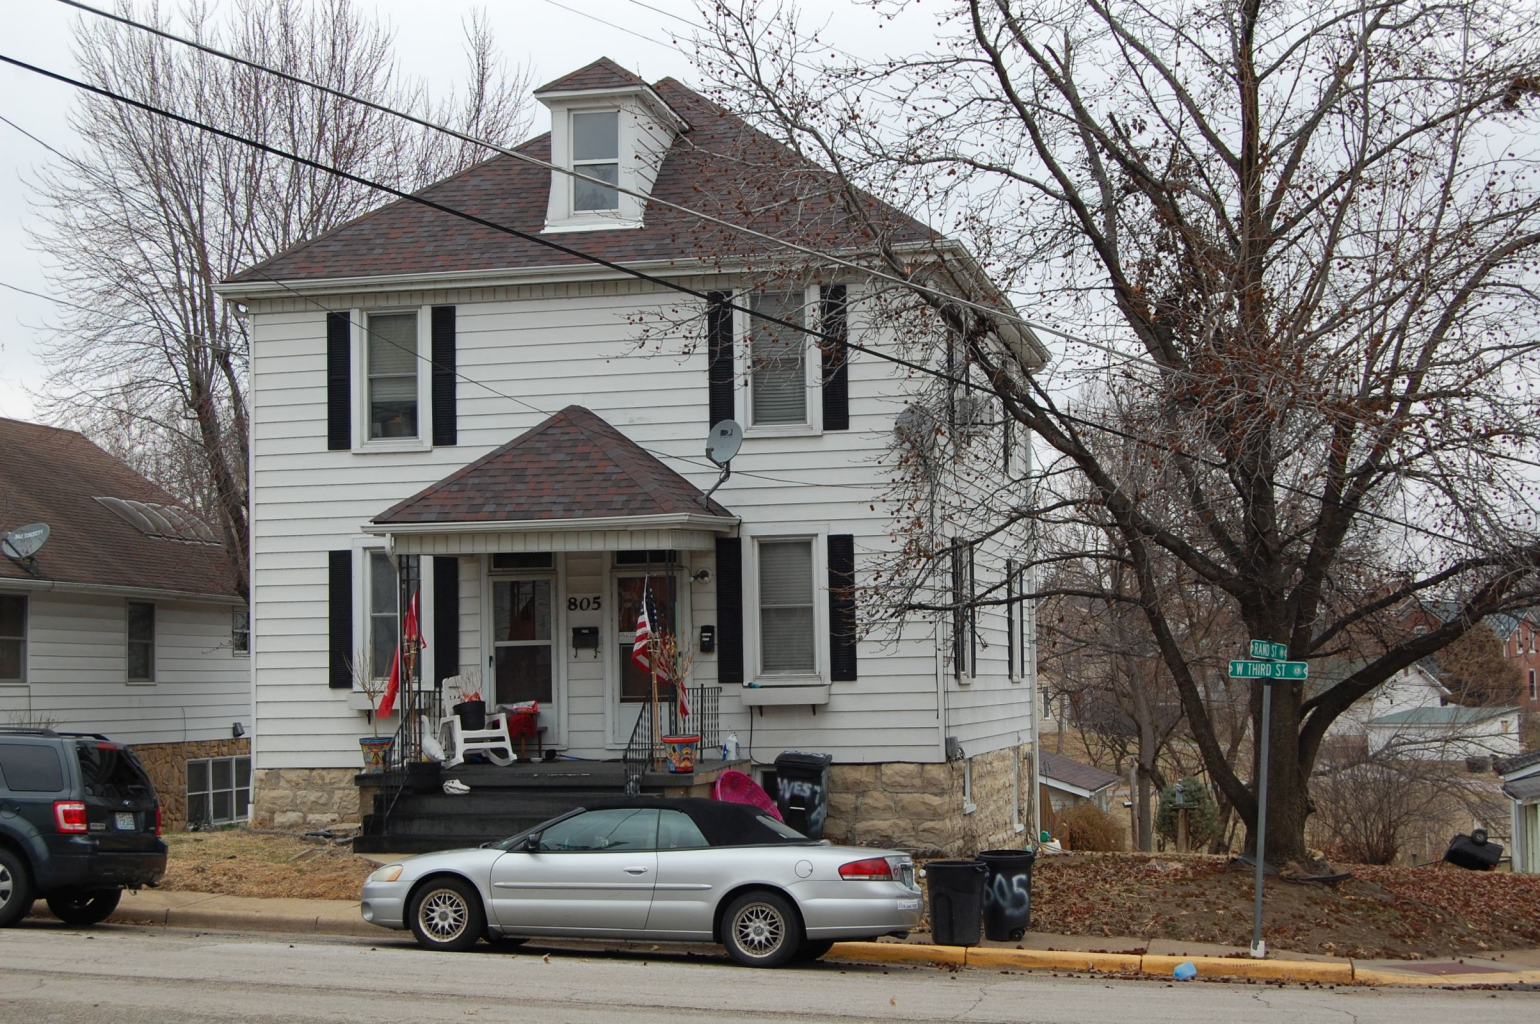
The aluminum siding, as a material, may have been added during the period of significance. However, due to the multiple alterations (siding, replacement windows and plastic shutters, porch alterations, replacement doors, chimney removal), this building is not considered to be a contributing resource in a potential NR district.

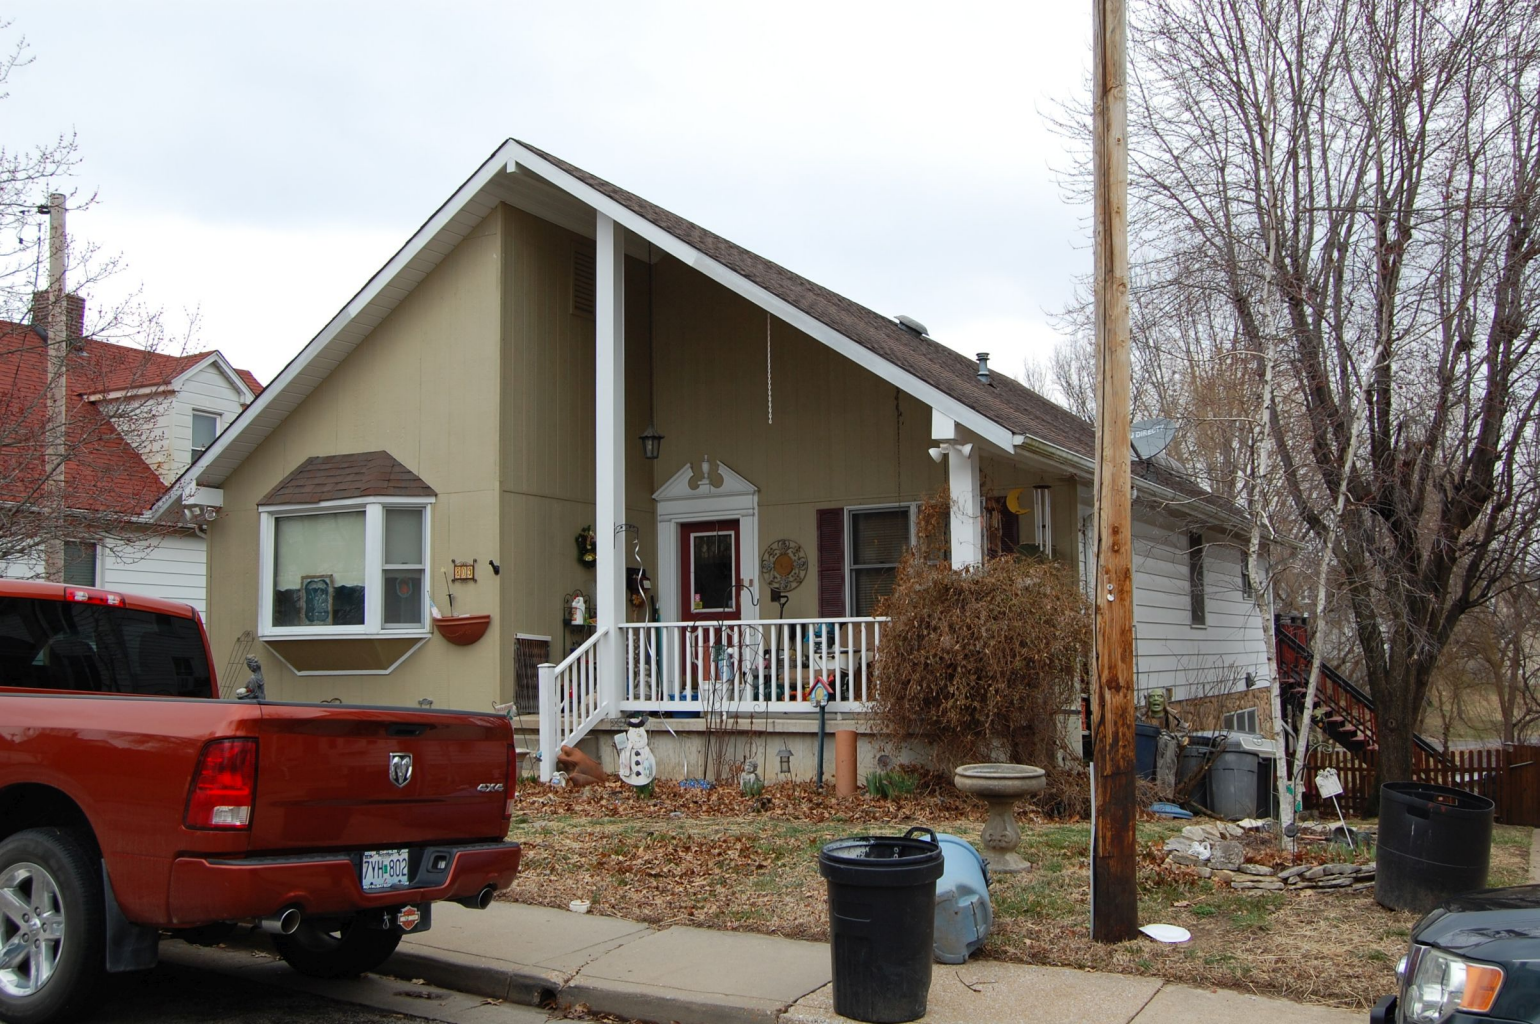
This 1 story frame front gable house has an asphalt shingle roof, concrete foundation, and vertical board siding on the primary facade. The concrete foundation and the exterior wide chimney (side left, W elevation) are clad with pre-cast stone veneer. There are three bays on the primary elevation. The right side of the facade is recessed beneath the front gable roof forming a partial width incised porch. The porch has a tall, offset right post supporting the roof and a concrete platform floor surrounded by a vinyl balustrade. The entry and is situated beneath the porch roof overhang and has a later added surround with fluted pilasters supporting a broken pediment. The entry contains a wooden door with rectangular leaded light in a diamond pattern and an appliquéed panel. To the right of the entry is a window bay containing a pair of 1/1, double hung vinyl sash flanked by non-operative plastic shutters. The projecting left section of the elevation contains a projecting bay window with a shallow hipped roof and a central fixed light flanked by 1/1, double hung vinyl sash. The side elevations are clad in aluminum siding. At the rear is a walk out basement with large concrete platform porch at the foundation level and a partial width, gable front addition (side right) and porch on the first story level. A photograph of this home that was included (without survey form) in the 1992 survey indicates that the primary elevation has been painted in the intervening years. Due to its recent date of construction, this building is not considered to be a contributing resource in a potential NR district.

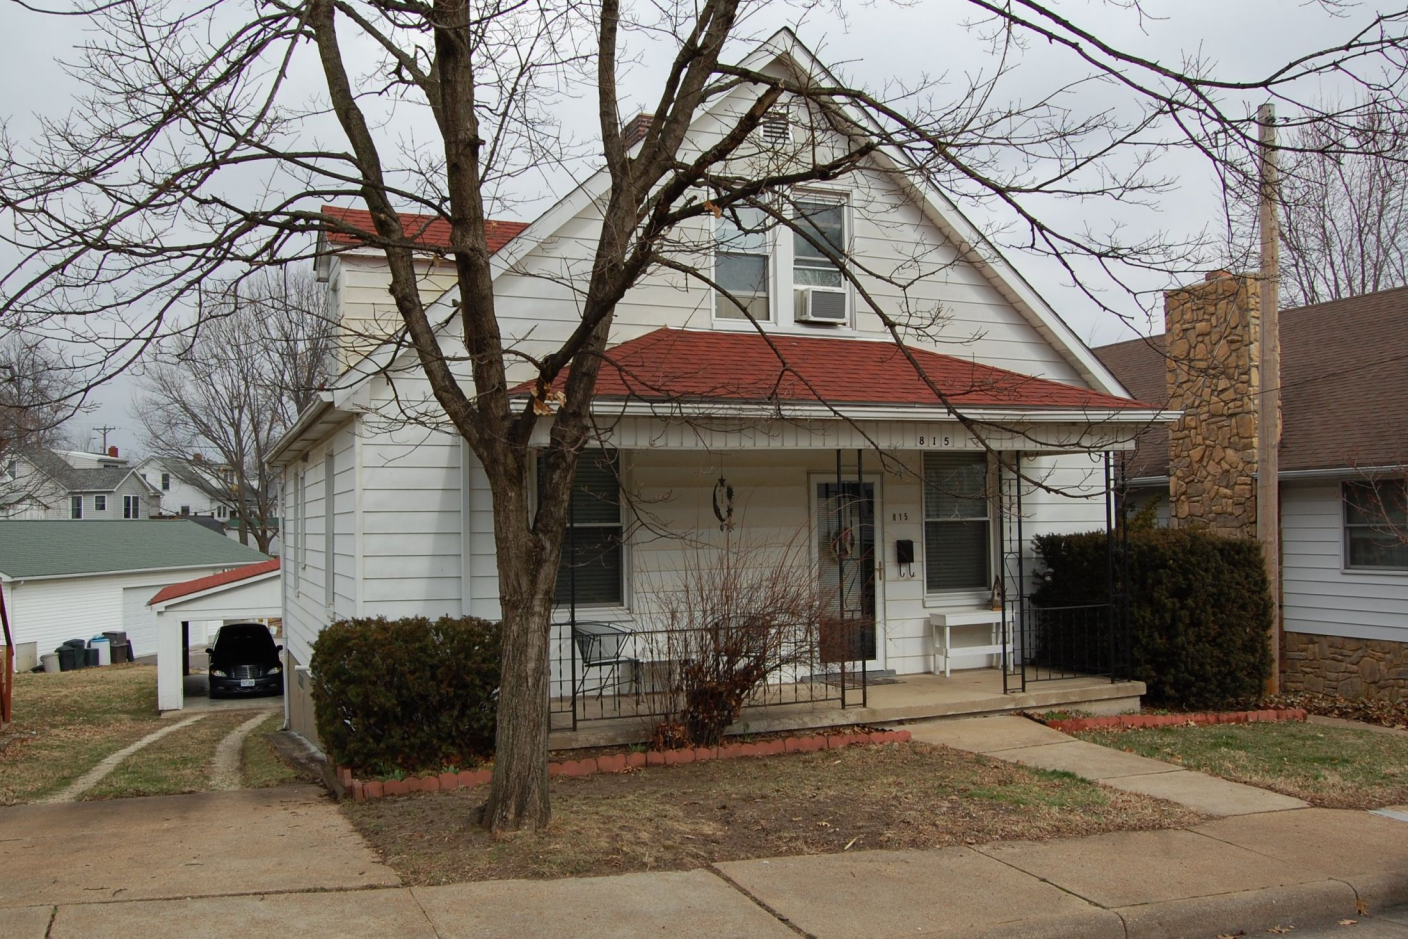
This 1.5 story frame front gable house has an asphalt shingle roof, concrete parged foundation etched to look like stone, and aluminum siding. There is a 3/4 width concrete platform porch with an asphalt shingle hipped roof centered on the primary elevation. The porch has a wrought iron balustrade and wrought iron supports. The entry is offset right and contains a wooden door with a large rectangular light behind a storm door. On either side of the entry is a single window bay. Centered on the upper half story is a single window bay containing paired windows. Windows are replacement 1/1, double hung vinyl sash. Within the gable is a small square vent. A gable roof dormer with single window is on the east and west façades. There is a 1-story addition on the north facade (rear). There is a central interior, side slope right brick chimney. Post 1992 survey alterations include replacement of the standing seam metal roof with asphalt shingles and removal of a metal awning shading the upper story window bay.

Due to the presence of aluminum siding and replacement windows, this home is not considered eligible for listing in a potential NR district.

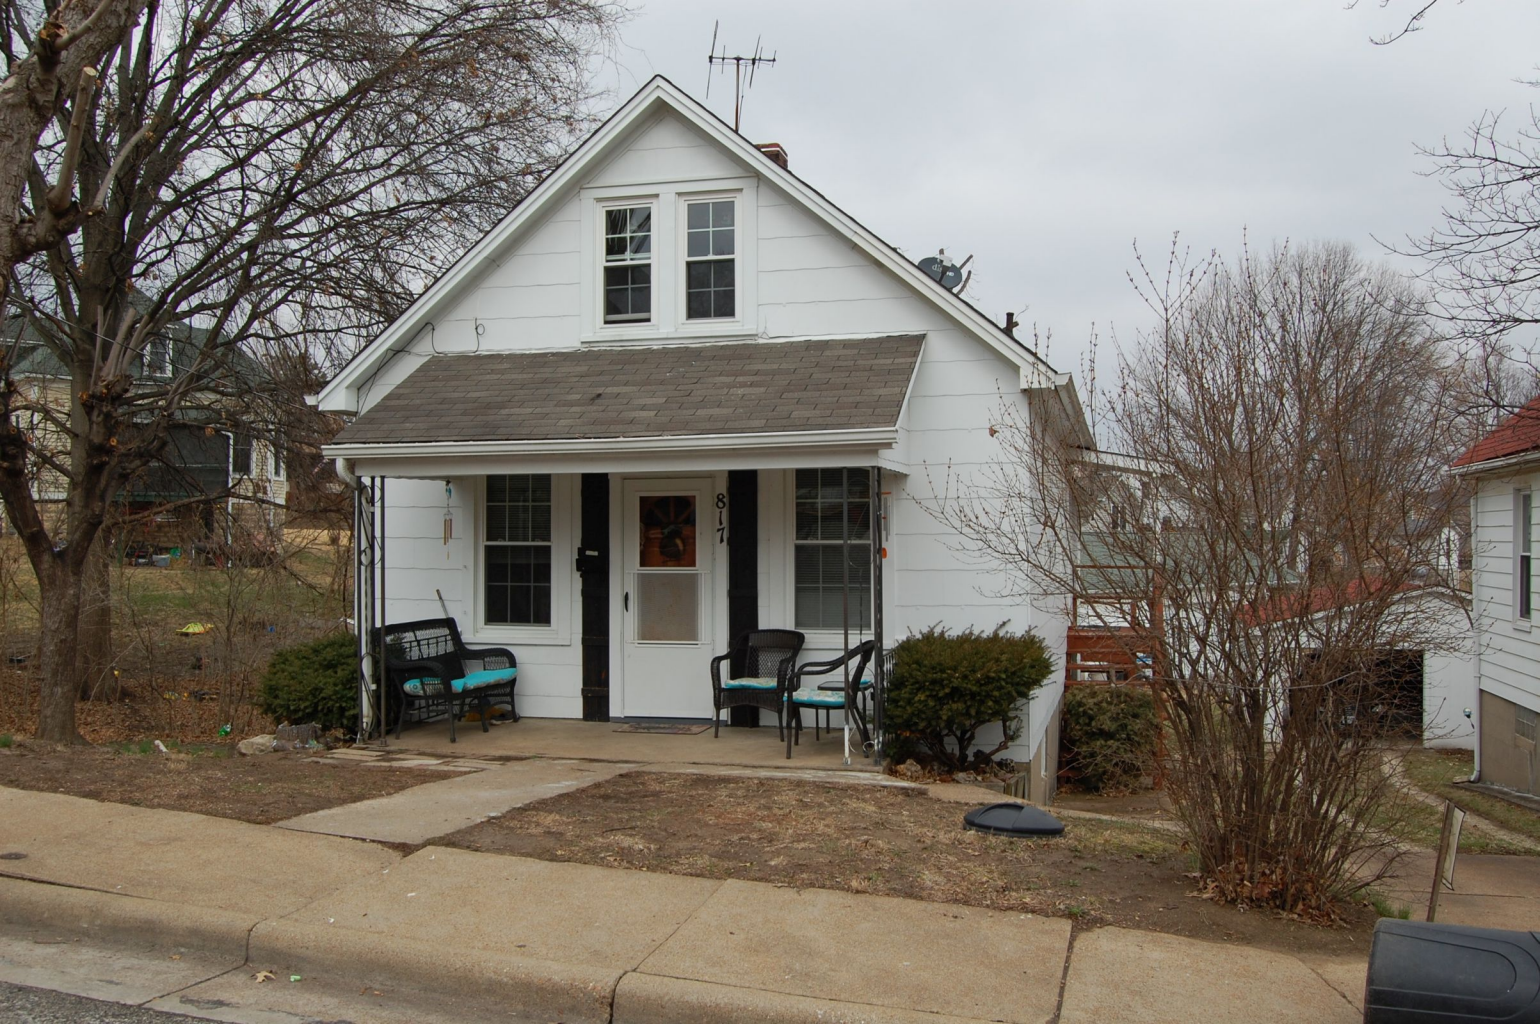
This 1.5 story frame front gable house has an asphalt shingle roof, concrete foundation, and asbestos shingle siding. There is a 3/4 width concrete platform porch with an asphalt shingle shed roof centered on the primary elevation. The porch has a wrought iron balustrade (E & W) and wrought iron supports. The entry is central and contains a paneled wood door with fanlight and storm door. On either side of the entry is a narrow vertical wood panel. On either side of the entry is also a window bay containing a 1/1, double hung vinyl replacement sash with false interior muntins giving the appearance of 6/6 lights. Centered on the upper half story is a window bay containing a pair of 1/1, double hung vinyl replacement sash with false muntins giving the appearance of 4/4 lights. On the east façade is are two entries; the southern one has a shed roof landing with wood stairs facing south and the northern one only has wood stairs with landing facing north. On the north façade is a 1-story hipped addition with CMU foundation walk out basement with an attached 1-story shed roof addition with open foundation level. There is a central interior wall straddle ridge brick chimney. Post 1992 survey alterations include: replacement of single light glass and wood door, addition of flanking door panels, and replacement of 1/1, double hung wood sash windows. Due to the presence of original siding and fenestration pattern, this home is considered eligible for listing in a potential NR district.

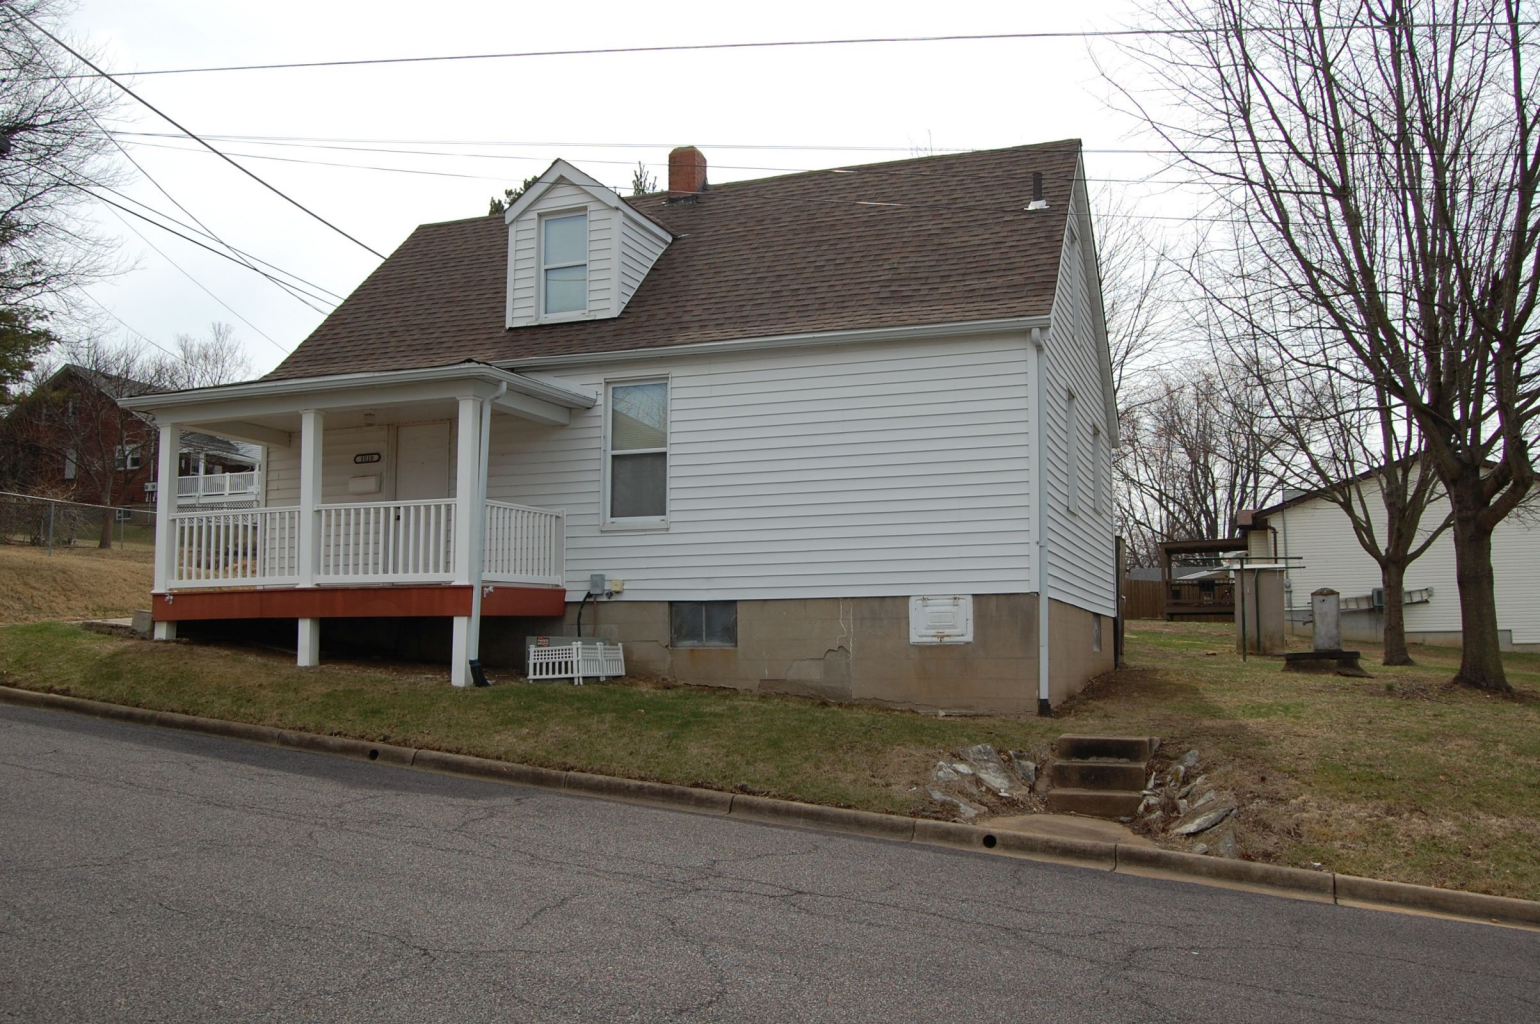
Due to the presence of vinyl siding, a vinyl replacement porch, replacement door, and vinyl replacement windows, this home is not considered eligible for listing in a potential NR district.

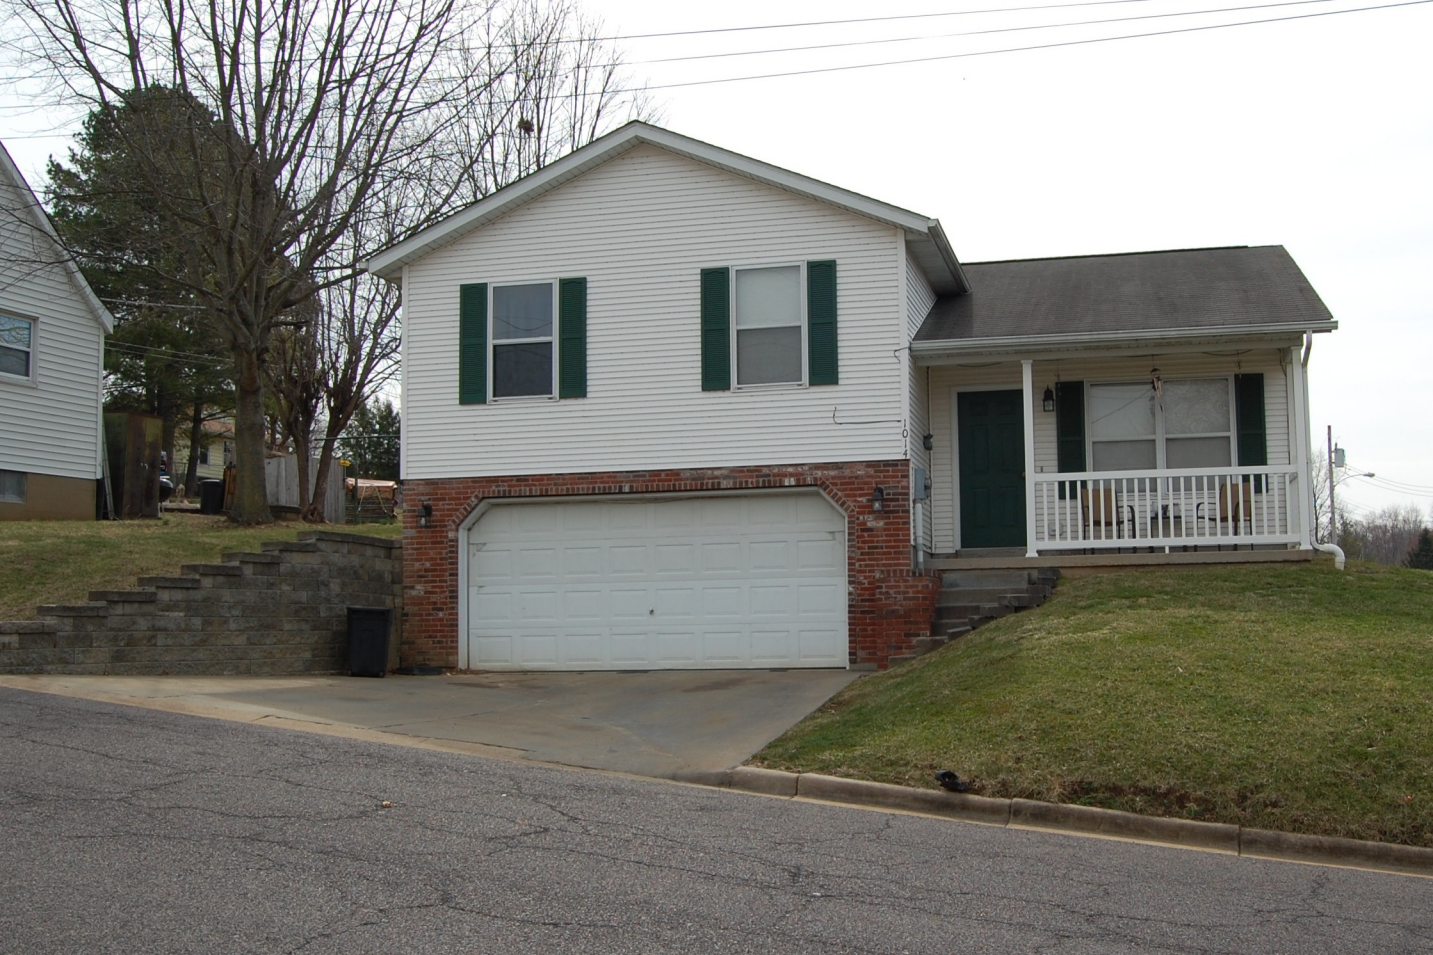
This 1 story frame split foyer house has a gable front with wing asphalt shingle roof, concrete foundation, and vinyl siding. The lot on which it sits slopes from left to right (east to west). This slope has been excavated on the east side of the lot to accommodate a "drive under" basement garage. The garage is situated at the basement level of the left side of the facade. It has an aluminum overhead door set within a clipped rowlock brick surround and its walls are faced with brick veneer. Above the garage is the front gable section of the building. It contains two window bays each of which have 1/1, double hung vinyl sash flanked by non-operative plastic shutters. The right half of the elevation is the side gable wing section. There is an incised porch with a concrete platform approached by steps from the driveway. The porch has a vinyl balustrade and vinyl boxed roof supports. Beneath the porch roof is the entry (central) and a window bay (side right). The entry contains a solid metal panel door. The window bay contains a pair of 1/1, double hung vinyl sash flanked by non-operative plastic shutters. This property was not surveyed in 1992.

Due to its recent date of construction, this home is not considered eligible for listing in a potential NR district.

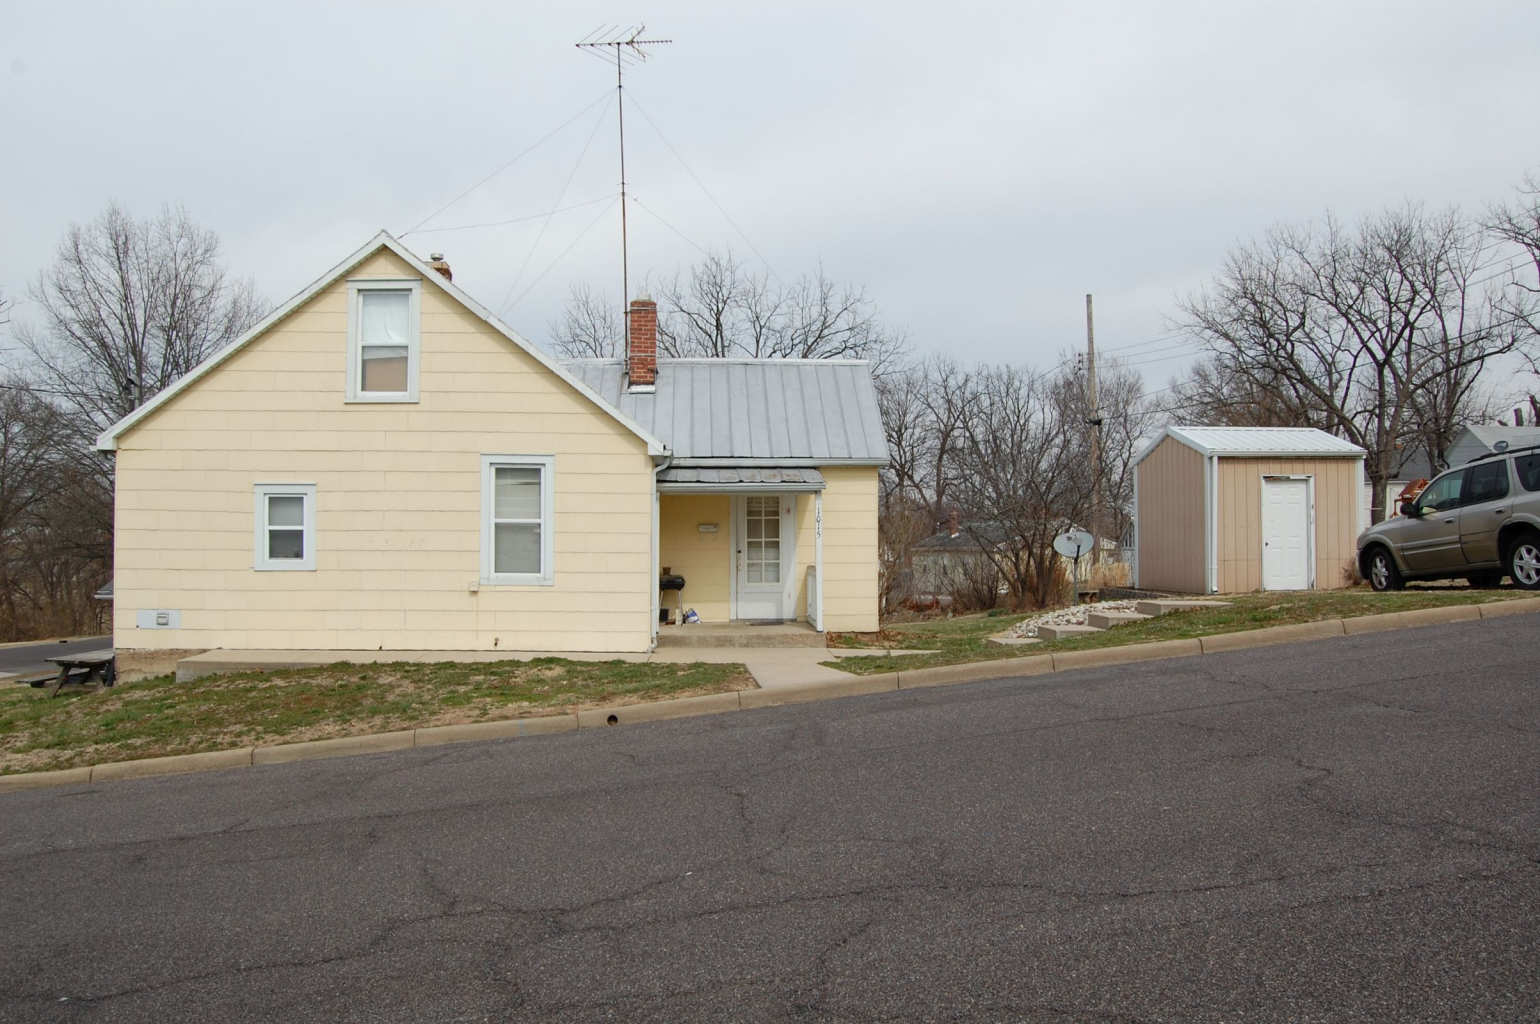
This 1.5 story frame gable front with wing home has asbestos shingle siding and a standing seam metal roof. The side gable wing section forms the right side of the facade. It has a concrete platform porch with square wooden supports holding up a standing seam metal shed roof. There is a wooden balustrade along the right side of the porch. Beneath the porch roof is the entry which contains a rectangular 8-light and wood storm door behind which is a wooden panel door with a single square light. A square brick chimney extends from the interior of the front side of the gable slope. The front gable section of the elevation contains two window bays on the first floor. These bays contain single, 1/1, double hung vinyl replacement sash. There is a window bay containing a 1/1, double hung vinyl replacement sash centered on the upper half story of the gable end. A square brick chimney extends from the interior, left side of the front gable slope. This property was not surveyed in 1992.

Due to the presence of historic siding material, stove chimneys, doors and standing seam metal roof, this home is considered eligible for inclusion in a potential NR district.

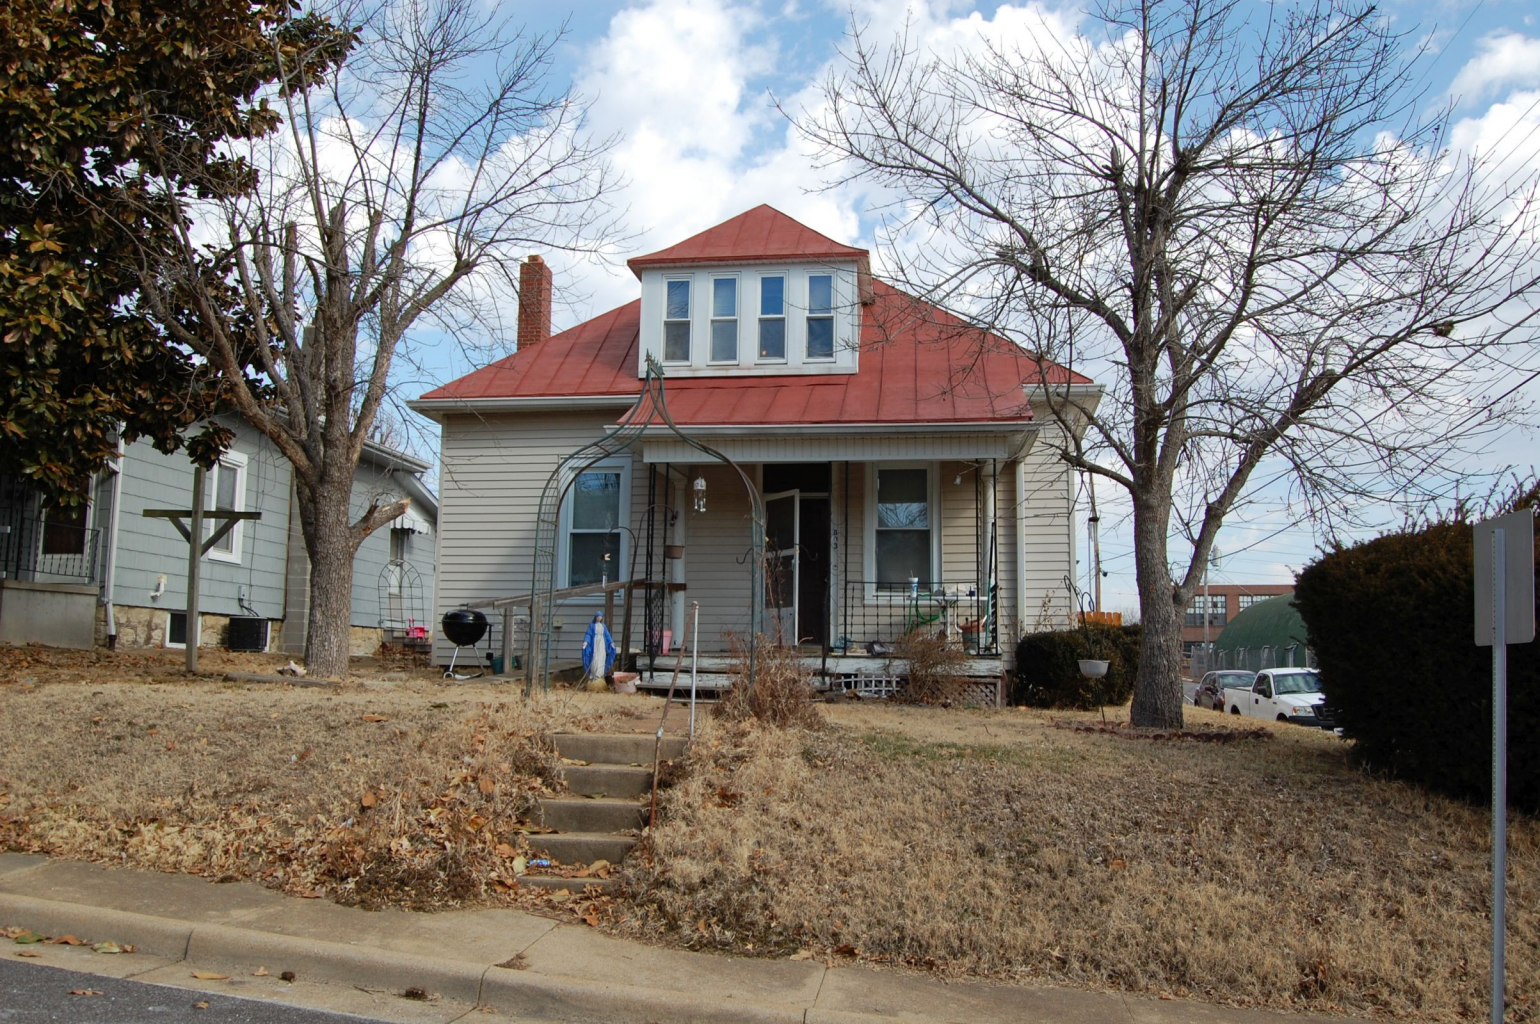
The 1.5 story frame dwelling has a limestone foundation, vinyl siding, and an older standing seam pyramidal hipped roof. The front façade is 3 bays wide. On the front façade is a 1-story partial width porch with a wood deck platform, wrought iron posts (3) and railings with two Tuscan columns pilasters and a shed roof extended from the primary. Sheltered within the porch is a single, off center right entry consisting of a single light transom and newer paneled metal door as well as a single 1/1 double-hung window. To the left of the porch bay is a single window. Windows are replacement 1/1 vinyl sash. Centered within the upper story is a hipped standing seam metal roof dormer with a ribbon of four 1/1 vinyl sash windows. There is an interior wall brick chimney on the west facade. The 1992 survey lists the address of this home as 801 Edith instead of 803. Post 1992 survey alterations include replacement of asbestos shingle siding with vinyl and replacement of wood sash with vinyl windows. Due to the exterior alterations (vinyl siding) affecting the historic integrity, the building is a noncontributing resource and not eligible for listing within a potential NR district.

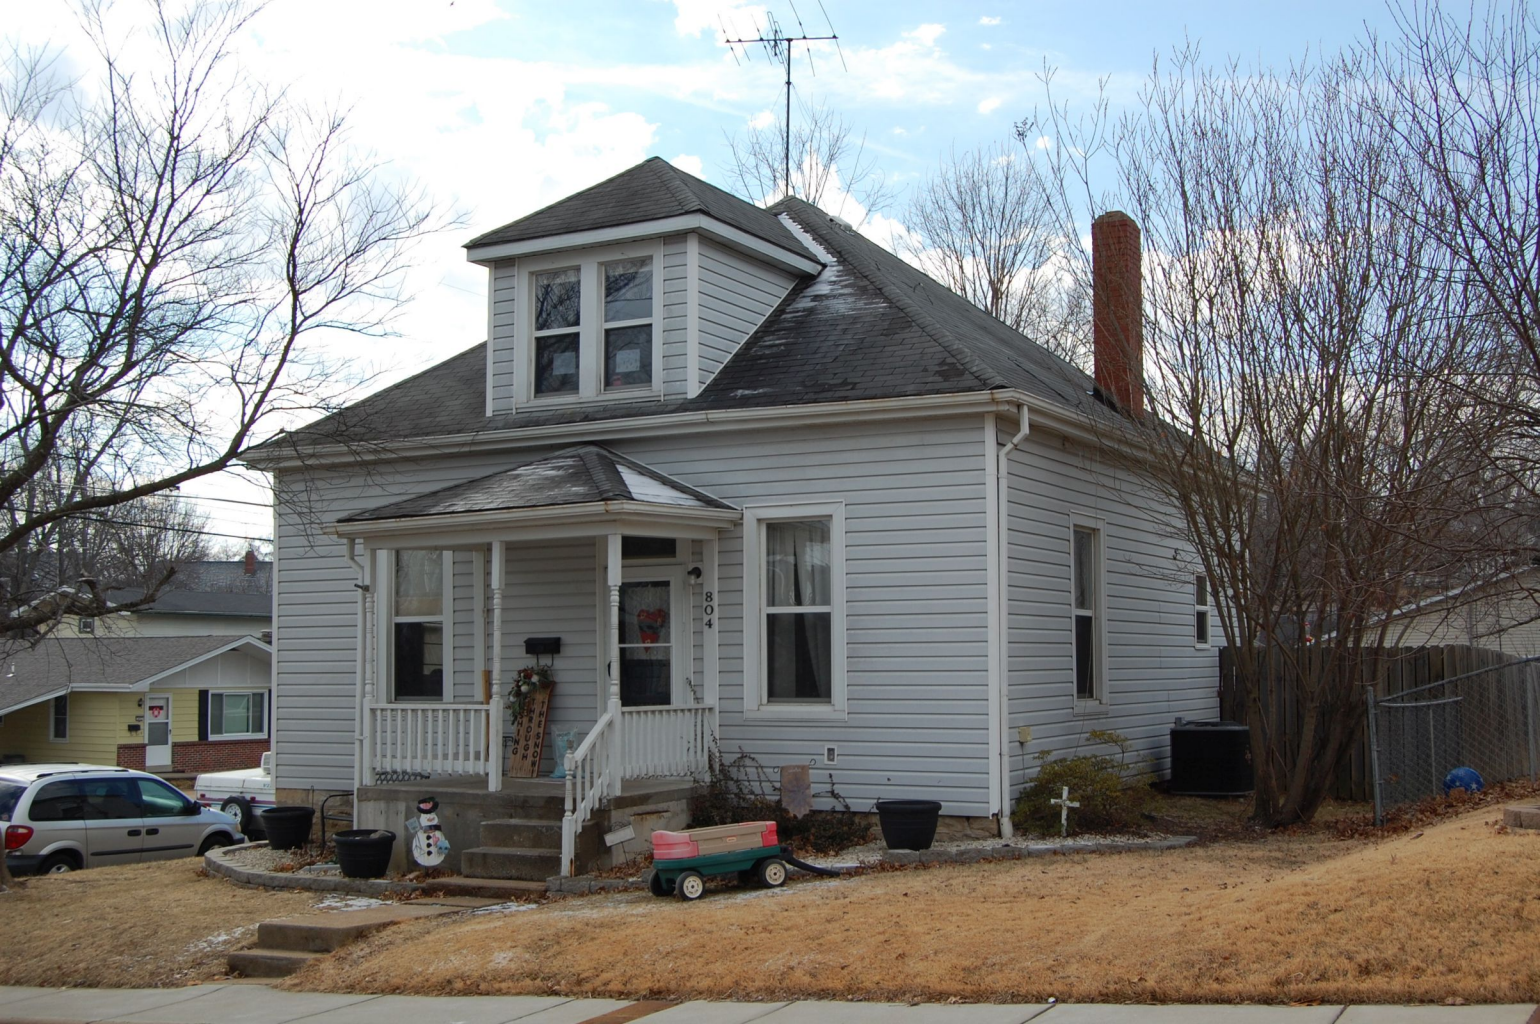
The 1.5 story frame dwelling has a limestone foundation, vinyl siding, and pyramidal hipped asphalt shingle roof. The front façade has 3 bays. On the front façade is a centered, 1-story porch with concrete platform, three turned wood posts with an open square wood post balustrade, and a hipped asphalt shingle roof. The porch shelters the main entry which consists of a single light transom and a rectangular light glass and paneled wood door. On either side of the central porch bay are single 1-1 vinyl sash windows set within a flat surround. Centered within the upper story is a hipped dormer with paired 1/1 vinyl sash windows. There is an interior brick chimney on the west elevation and a large antenna on the roof's ridge. Prior to the 1992 survey the entry portico was altered with a concrete platform and spindle woodwork. Post 1992 survey alterations include the replacement of weatherboard with vinyl, 1/1 wood sash with vinyl. Due to the alterations (siding, windows, porch), the dwelling is not a contributing resource and not eligible for listing within a potential NR district.
