MISSOURI DEPARTMENT OF NATURAL RESOURCES
STATE HISTORIC PRESERVATION OFFICE, P.O. Box 176, Jefferson City, MO 65102
ARCHITECTURAL/HISTORIC INVENTORY FORM

1. SURVEY NO. FR-AS-007-001		2. SURVEY NAME: International Shoe Factory Neighborhood	
3. COUNTY: Franklin		4. ADDRESS (STREET NO.) 605	STREET (NAME) West 3rd Street

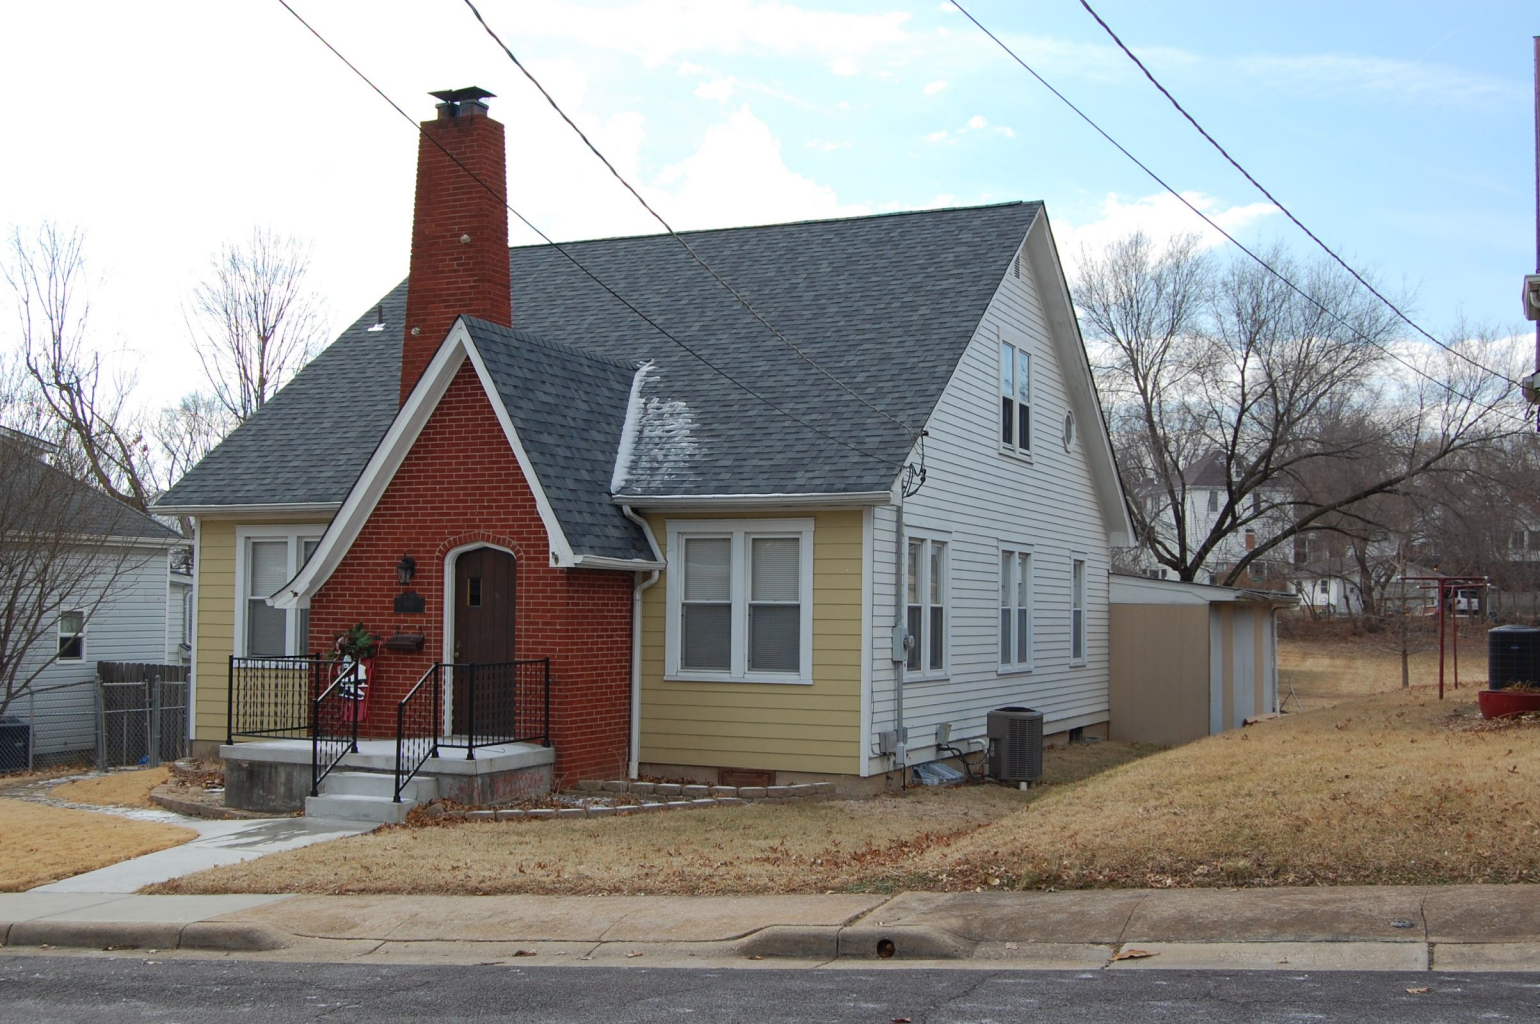
The 1.5 story frame dwelling has a formed concrete foundation, primarily weatherboard siding with an indeterminate sided front façade, and a side gable asphalt shingle roof. (The front siding appears to be aluminum or hardy board.) The front façade has 3 bays. On the main façade is a centered, extended bay with brick veneer, a single entry, and a steeply pitched, asymmetrical front gable roof. Preceding this bay is a concrete platform with wrought iron railing. The main entrance is a single light, rectangle glass and wood arched door set within a segmental Tudor arch of rowlock course brick. On either side of the extended central bay are paired 1/1 replacement aluminum sash windows. Within the north façade's extended central bay is an interior wall brick chimney. On the east facade is a shed roof porch with wrought iron posts and railing. On the south façade is a 1-story wood frame, shed roof enclosed porch and an attached gable roof garage. Post 1992 survey alterations include the addition of the indeterminate front façade siding. Historically, the wood frame dwelling has weatherboard siding with a centered brick veneer bay. The alteration to the front façade siding is almost similar in profile to the side elevations. Aluminum siding, as a material, may also have been added during the period of significance. Since the alterations have been minimal, the building is a contributing resource to a potential NR district.

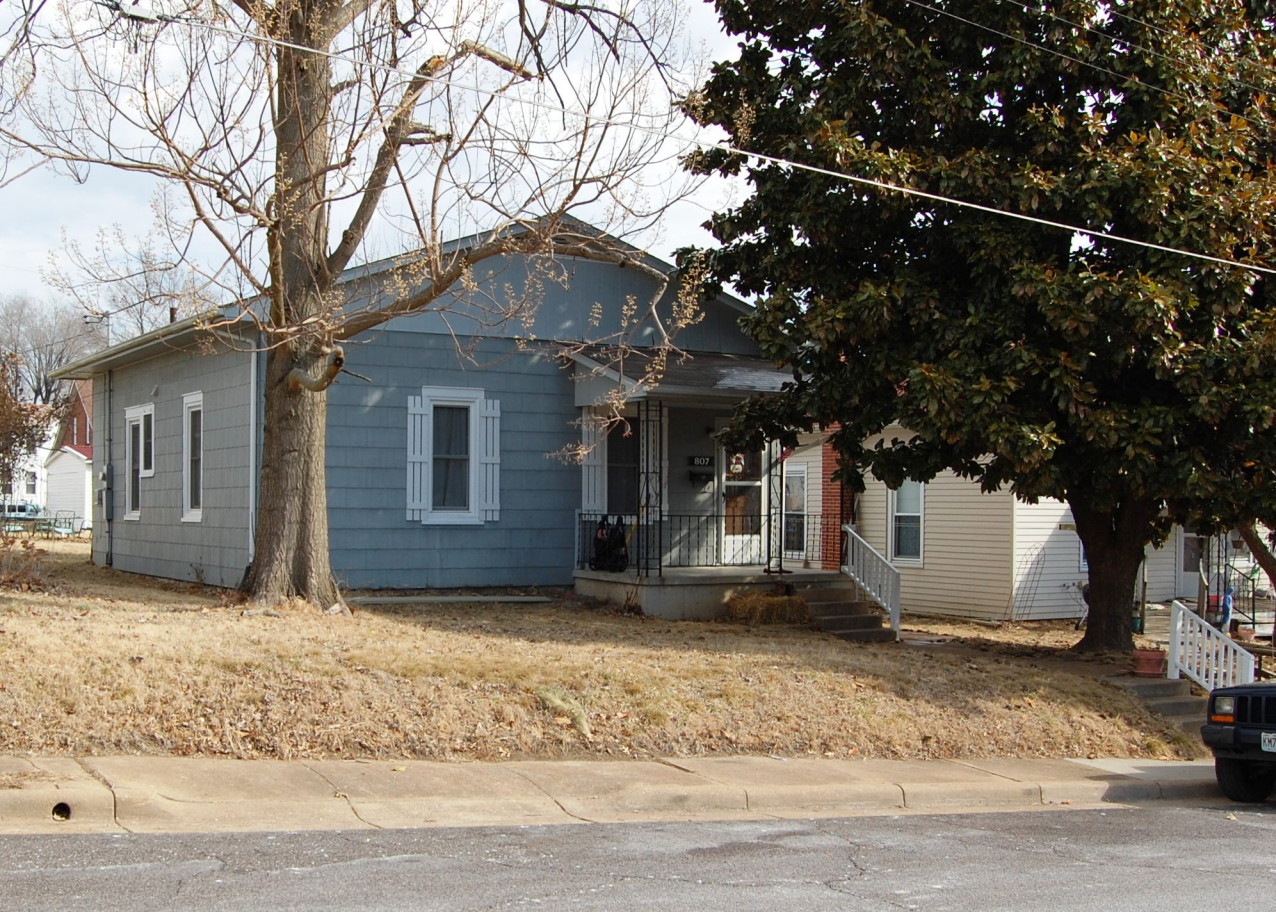
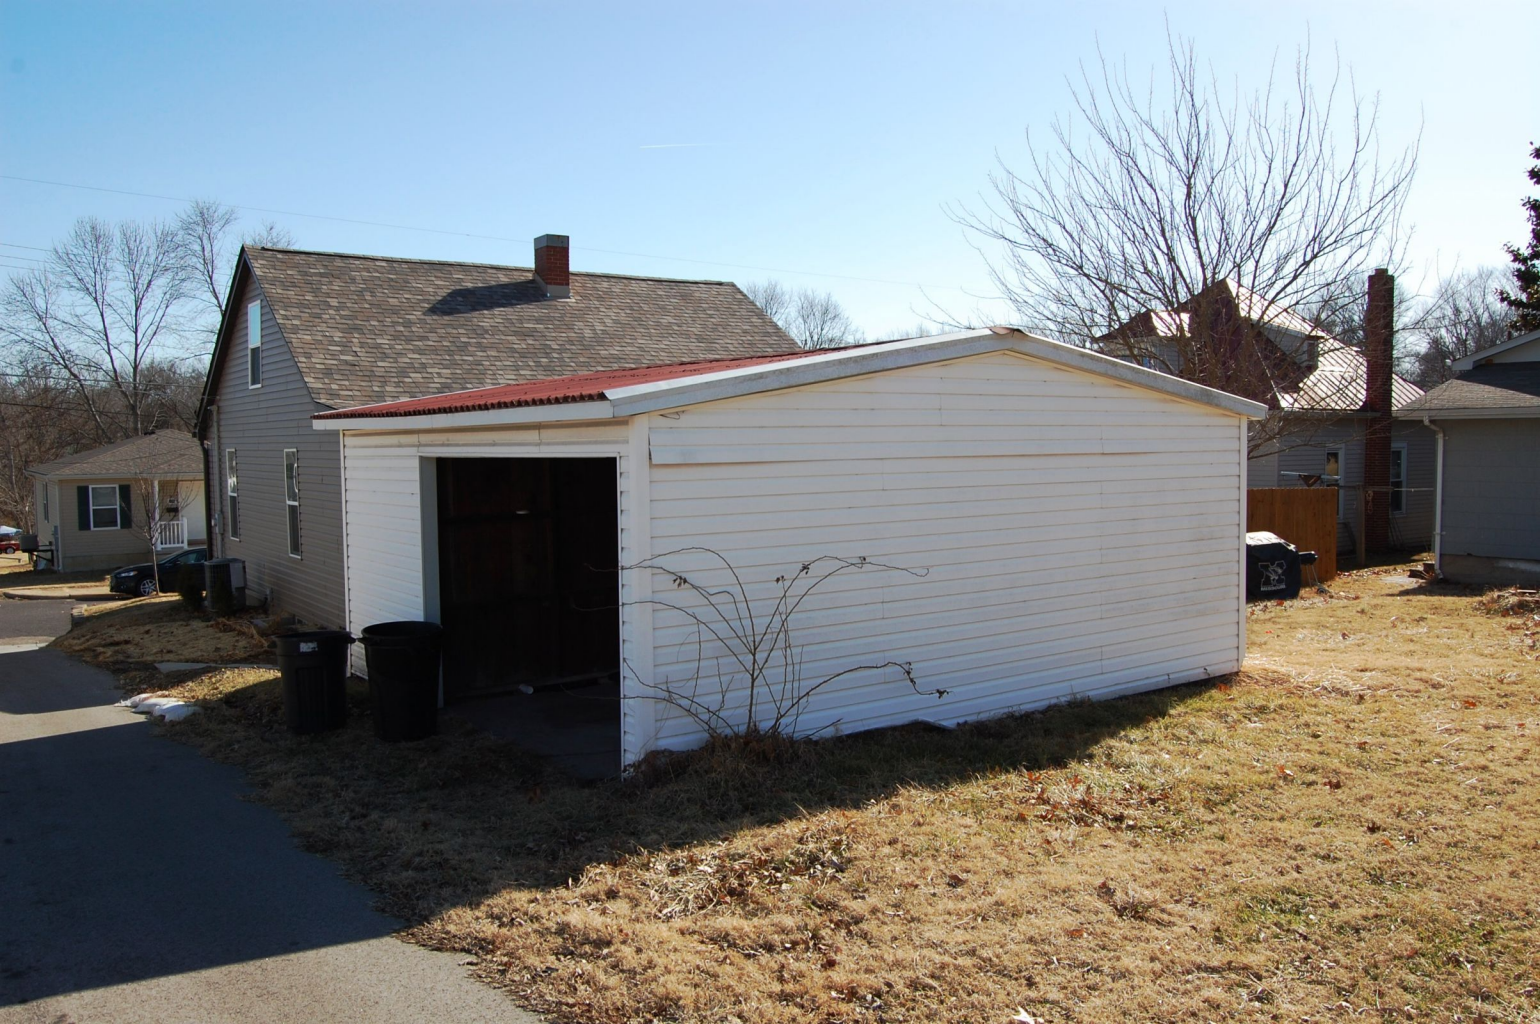
The c1923, 1-story frame dwelling has a limestone foundation, asbestos shingle siding, and a low front gable roof of asphalt shingles. The primary façade is 3 bays wide. There is a partial width porch, side right, with a concrete foundation, wrought iron posts and railings, and asphalt shingle shed roof. Sheltered within the porch are a side right single entry and a single window. The entry consists of a multi-light glass and wood door with glass and metal storm door. To the left of the entry bay is a single window. Windows are older, replacement 1/1 double-hung wood sash with ornamental wood slat shutters on the south façade. Dates of the windows are unknown. There is a rear, 1-story shed roof addition, located in the location of the former rear porch. On the east elevation is a newer, exterior cement block chimney (similar to 815 Edith). The 1992 survey photographed but did not fill out a form this home. According to the photo, alterations since the 1992 survey include potential replacement of 2/2 wood sash window within the porch bay and the addition of a square post wood railing on the eastern side of the entry steps. Due its integrity and date of construction during the period of significance, the property is a contributing resource and is eligible for district material. Further research may indicate that this building is ineligible to be considered as a contributing resource due the exterior alterations to asbestos shingles made outside the period of significance.

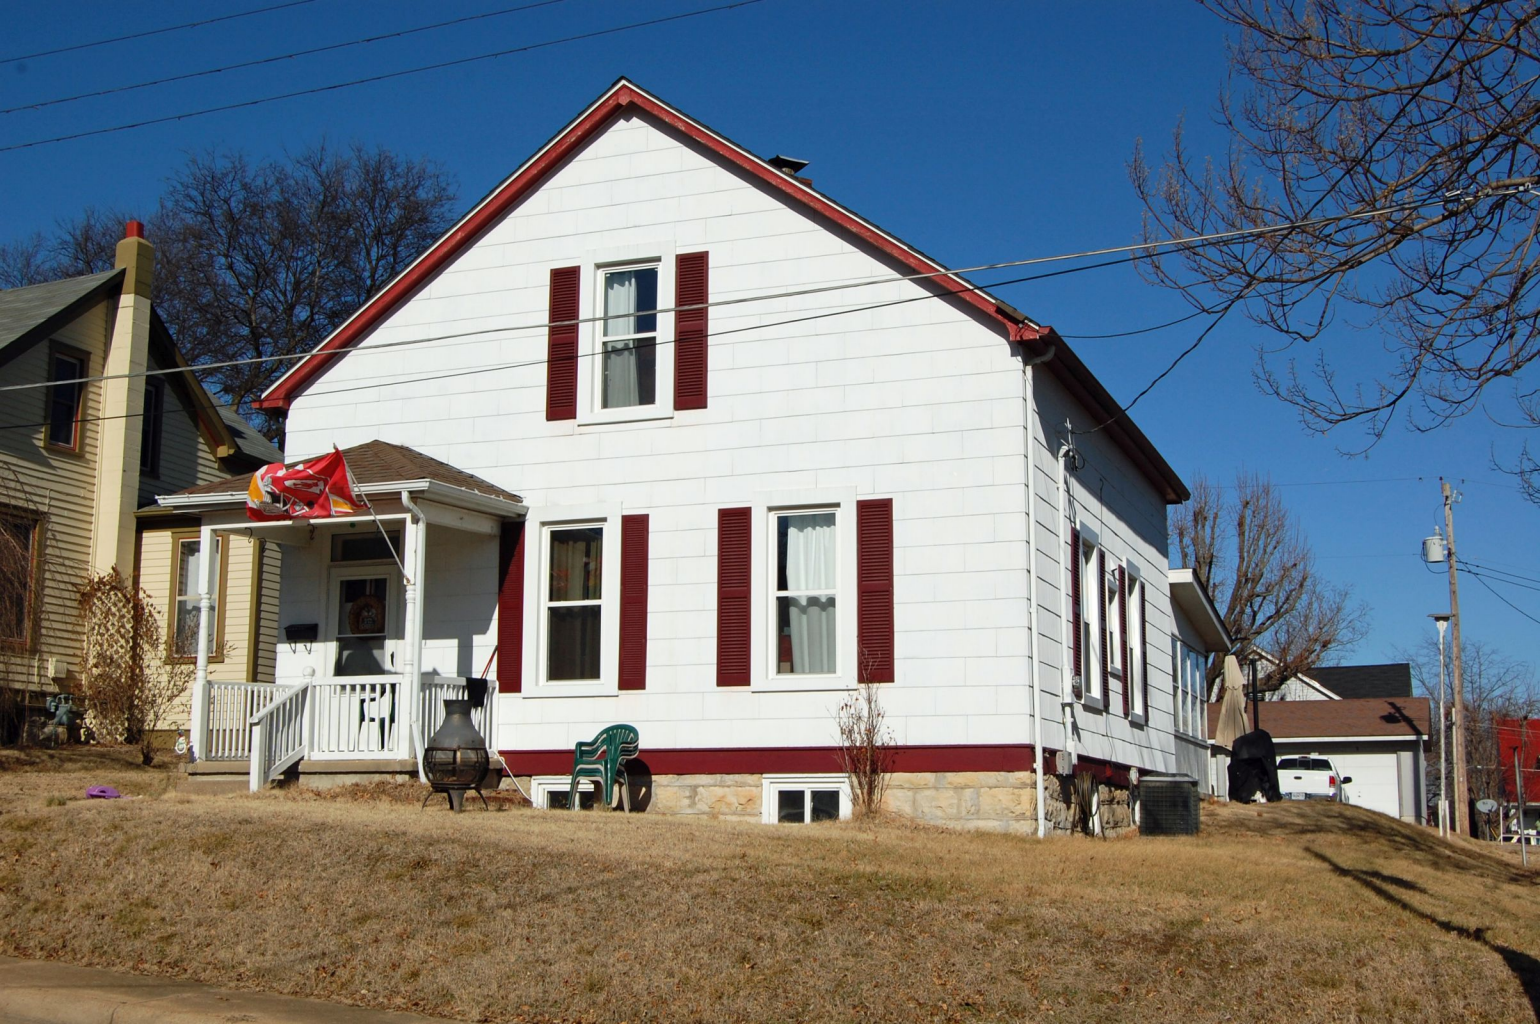
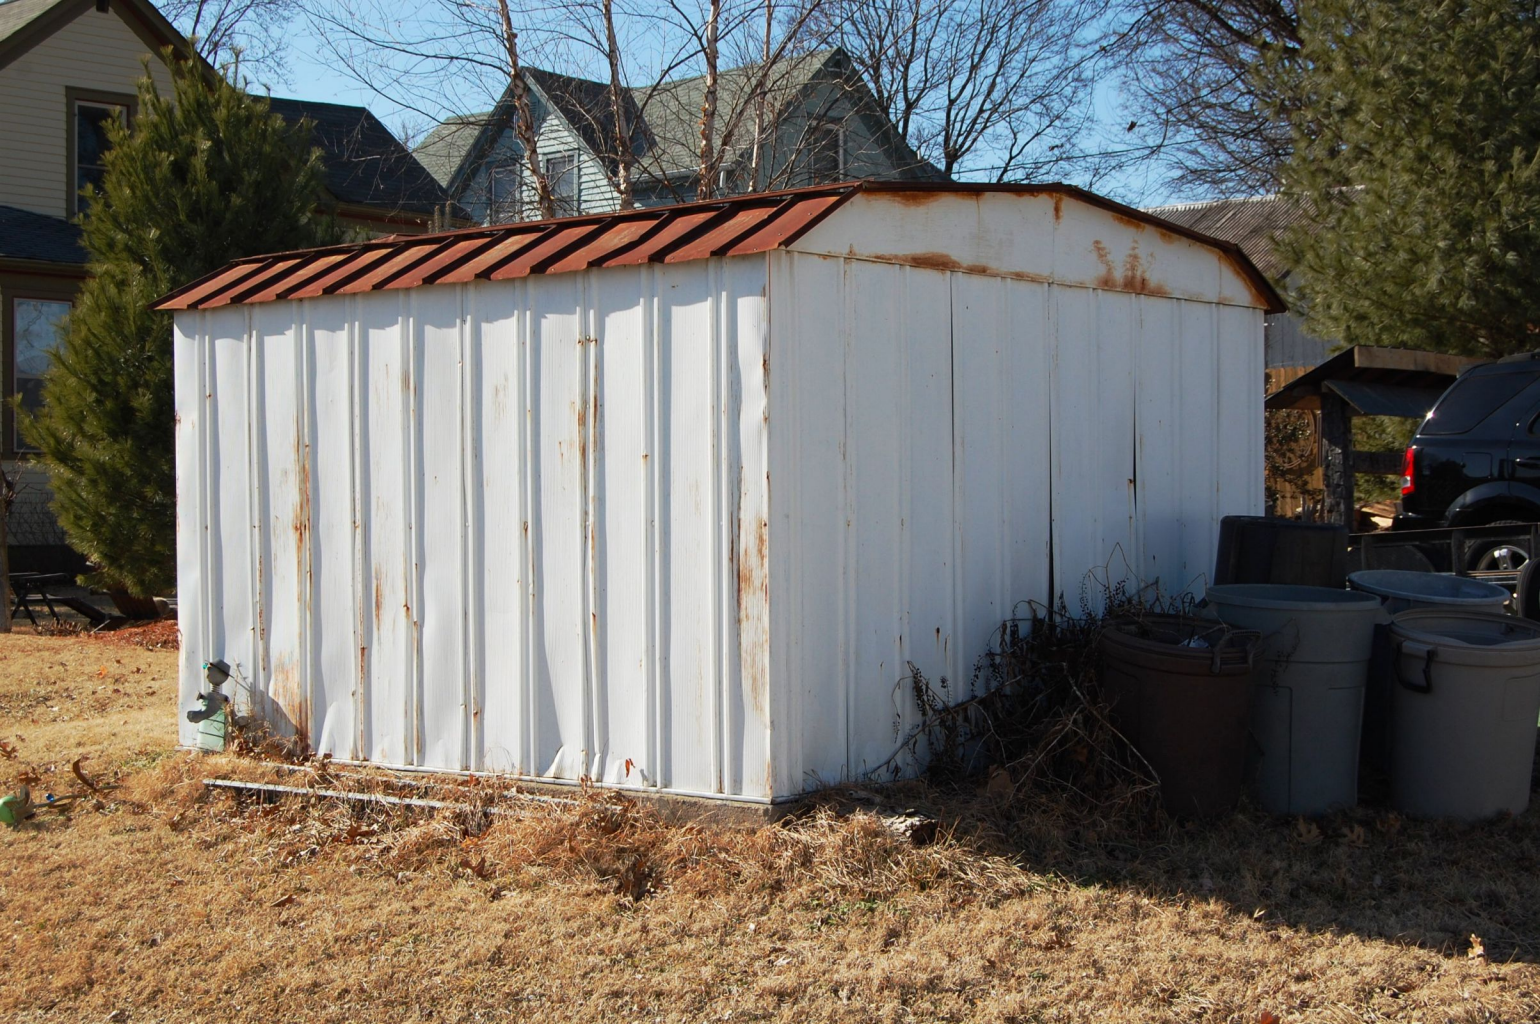
This 1.5-story wood frame home has a limestone foundation, asbestos shingle siding, and a front gable asphalt shingle roof. The primary façade has three bays. Side right (E) has two individual, 1/1 double-hung replacement windows (indeterminate material) with a thick frame surround and ornamental shutters. Side left (W) has a 1-story, portico with a concrete platform and step, a dropped, hipped asphalt shingle roof, and two, turned wood posts for support. The portico has an open, square post vinyl balustrade. The entry consists of a 2-light and paneled wood door, a storm door, and a single light transom. The rear of the dwelling has a full width, 1-story enclosed addition with an asphalt shingle shed roof. The addition was added post 1951, according to the Sanborn map of that year, which depicts a smaller, side left (W) wood frame porch. There is a central interior, straddle ridge brick chimney. Since the 1992 survey, major alterations include the vinyl balustrade and the thicker replacement window surrounds.

There have only been minor alterations. The building is considered eligible for listing in a potential NR district.

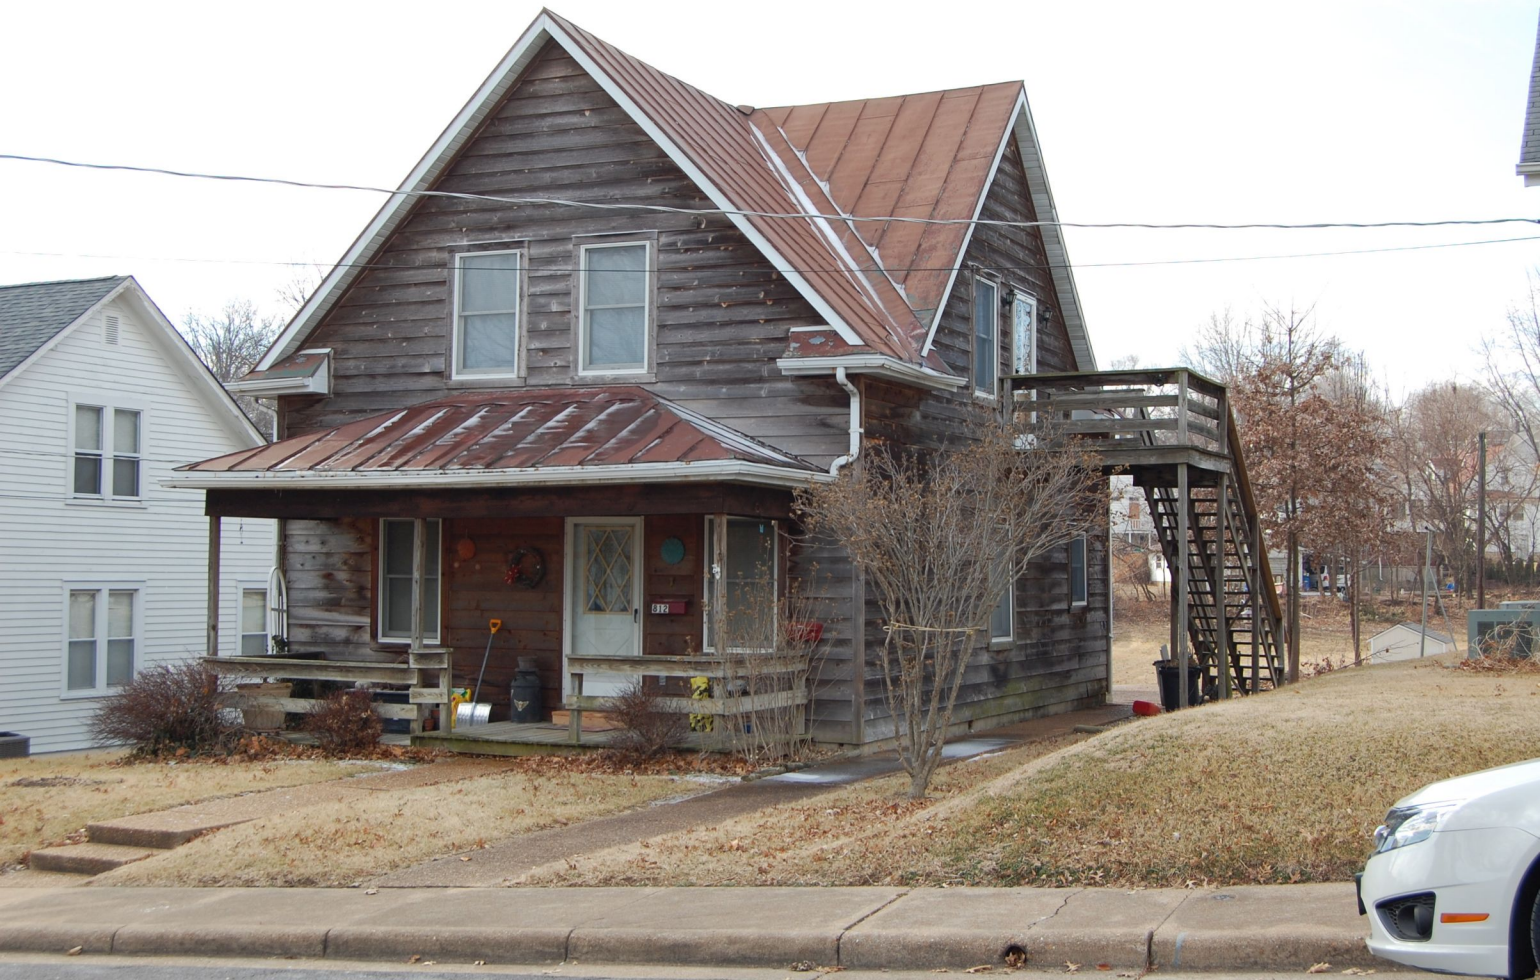
The 1.5 story frame dwelling has a formed concrete foundation cedar weatherboard siding, and a cross gable, older standing seam metal roof. The front façade is 3 bays wide. It has a $\frac{3}{4}$ width 1-story open frame porch with a dropped hipped roof of standing seam metal supported by three square wood posts with an open, horizontal wood board railing. Sheltered within the porch is a slightly off center right, single entry flanked by single 1/1 wood sash windows. The replacement entry door consists of a false exterior mention diamond light and 4 panels cross metal door. Within the upper story are two windows. The windows are older 1/1 double-hung wood sash but may not be original. On the western elevation is an open wood staircase and landing leading to an upper floor apartment. There is one interior front slope chimney covered in metal flashing. Post 1951, the rear, first floor incised SW corner was enclosed and new cedar siding added [seamlessly hiding this feature]. The front porch roof supports and balustrade was also altered prior to 1992. The 1992 survey included a photo of the property, labeled "810 Edith" but no form. There appears to be little to no alterations to the swelling since the survey.

Due to the alterations in the siding, this dwelling is not considered eligible for listing in a potential NR district. Further research may indicate that the exterior alterations were made during the period of significance, thus altering the conclusion.

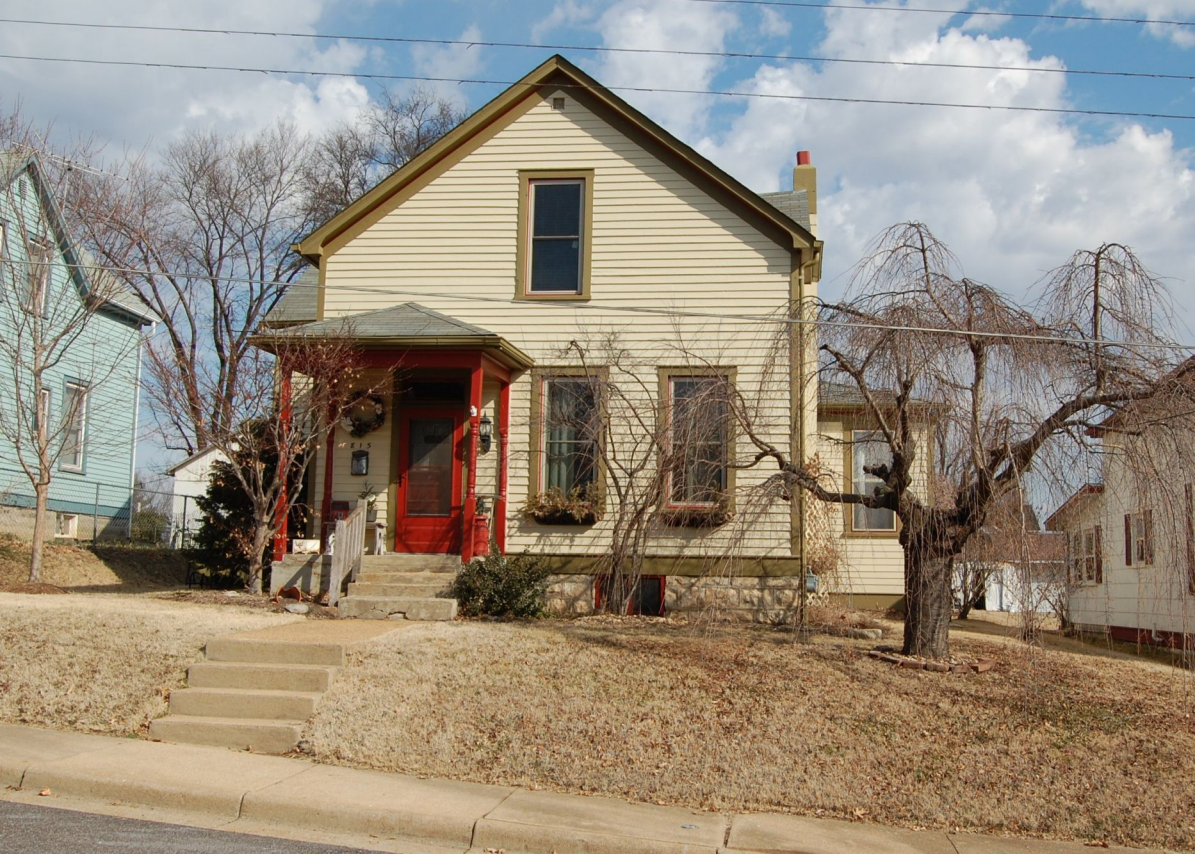
The 1.5 story frame dwelling has a coursed limestone foundation, weatherboard siding, and a cross gable asphalt shingle roof. The front façade has 4 bays. The front gabled primary façade has a 1-story open frame porch with a hipped asphalt shingle roof, turned wood columns and a concrete platform and steps. The side left entry porch shelters a single entry consisting of a single light transom, square light glass and paneled wood door and glass and wood storm door. To the right of the entry porch are two individual 1/1 vinyl sash windows. Centered within the upper front gable is a single window. On the western elevation is an extended bay with single window on its southern elevation. There is a newer, c1980 exterior wall concrete block chimney on the east façade. There is a post 1992, 1-story rear addition with weatherboard siding and hipped asphalt shingle roof to the NE corner of the home. The 1992 survey notes the siding as vinyl; however it appears to be wood in the survey images. Post 1992 alterations include removal of porch balustrade, replacement 1/1 double-hung vinyl sash windows, and rear addition.

Due to its date of construction and historic integrity, this home is a contributing resource and eligible for district materials.

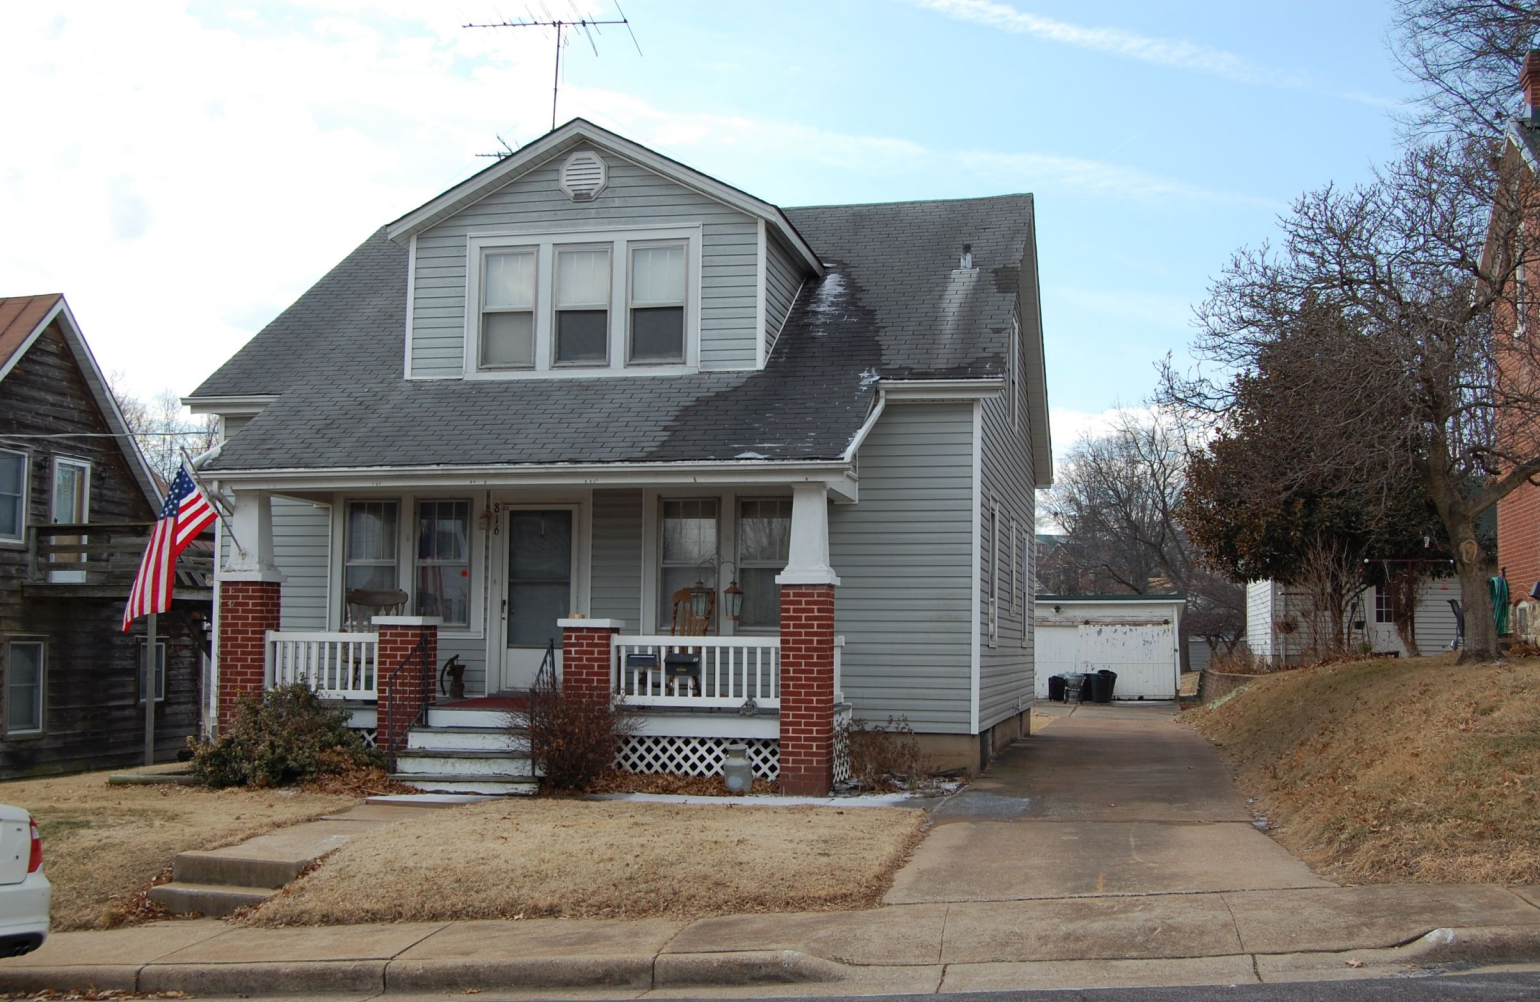
The 1.5 story frame dwelling, built in 1936, has a formed concrete foundation, vinyl siding, and a side gable asphalt shingle roof. The primary façade has 3 bays. There is a centered, $\frac{3}{4}$ width 1-story open frame porch with shed roof extended from the primary roof. The porch roof is supported by two short, tapered wooden columns resting on square brick piers and has an open railing with square composite or metal balustrade. Sheltered within the porch is a slightly off center, left entry flanked by paired windows. The entry consists of a newer, paneled metal door. Centered on the upper half story is a front gabled dormer. The dormer is clad in vinyl and has a ribbon of three windows and an octagonal vent within the upper gable. Windows are original 3/1 vertical wood sash. There is a very tall antenna on the eastern ridge of the roof. Alterations since the 1992 survey include: replacement of weatherboard with vinyl, replacement of wood railing with composite or metal, replacement of an original multi-light glass and wood door with a paneled metal door, and removal of central, interior front slope brick chimney.

The home retains its historic porch and windows and since the vinyl is somewhat a similar width as the weatherboard, it is considered a contributing resource in a potential NR district.

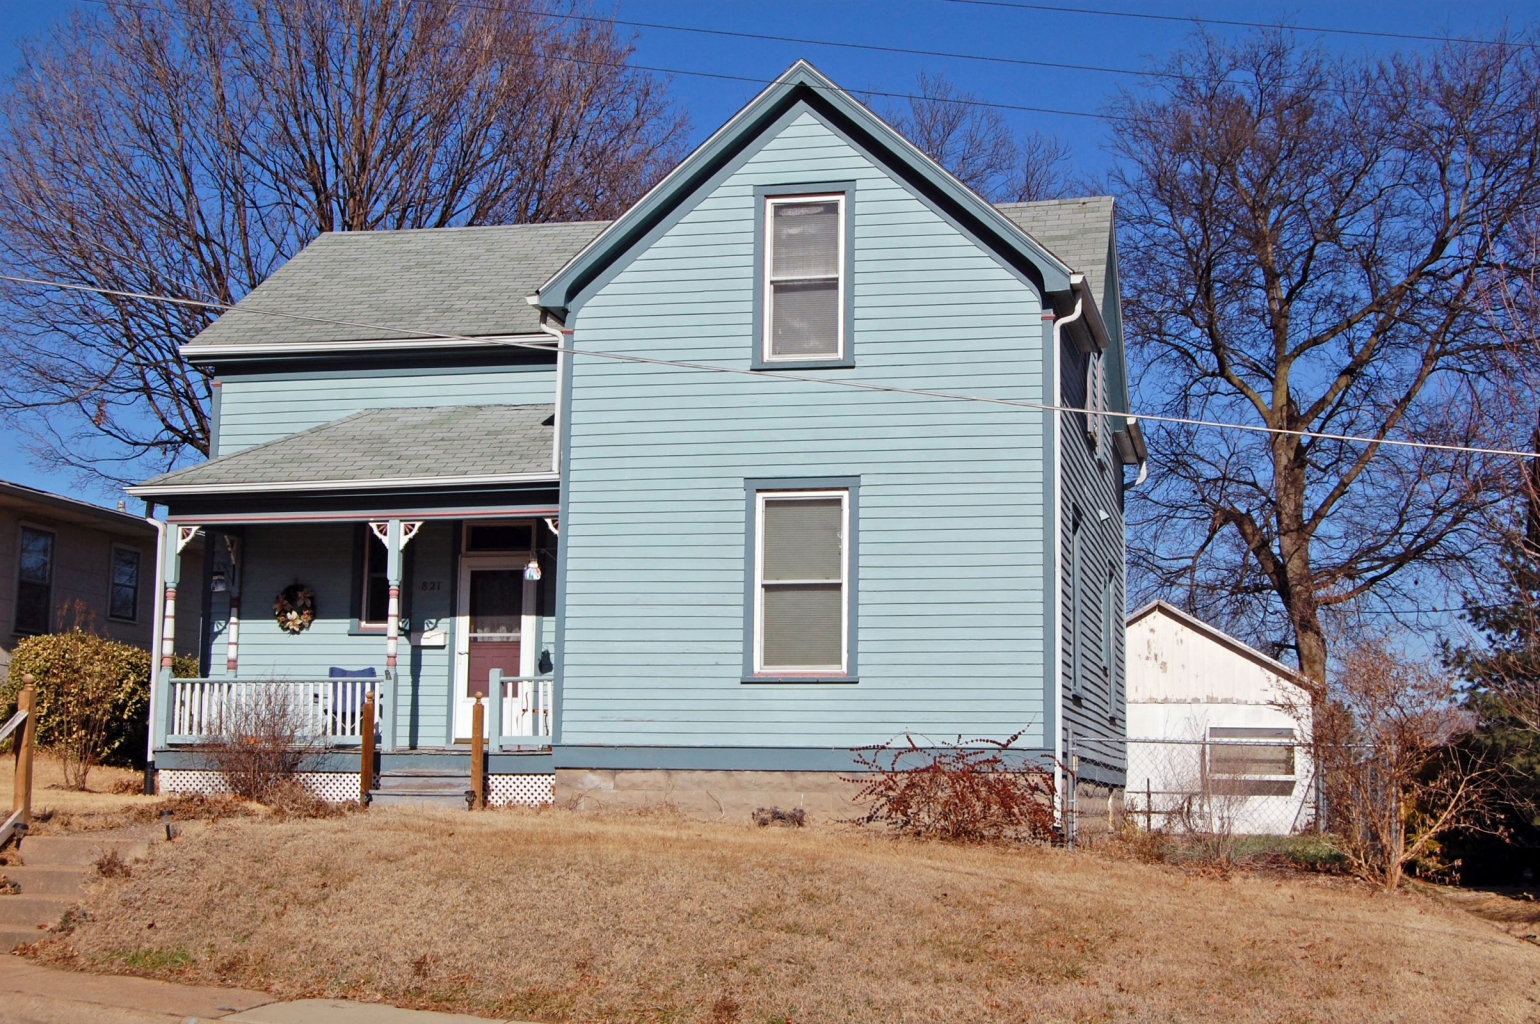
The 1.5-story frame dwelling has a rusticated concrete block foundation, weatherboard siding, and a cross gable asphalt shingle roof. The front façade has 3 bays. The front facing gable is side right with a single window. Within the side left ell is a 1-story, partial width porch with hipped asphalt shingle roof, turned wood posts and an open square post wood balustrade. Sheltered within the porch is a central entrance consisting of a rectangular light glass and paneled wood door with a single light transom. To the left of the entry is a smaller 1/1 window and to the right, on the extended right bay, a 1/1 window. Windows are replacement 1/1 double-hung vinyl sash set in a wood frame surround. Since the 1992 survey alterations include replacement of wood sash for vinyl windows and removal of ornamental shutters. The rear or south elevation contains an enclosed, 1-story hipped roof porch within the ell. Due to the home's integrity and date of construction, it is a contributing resource to a potential NR district.

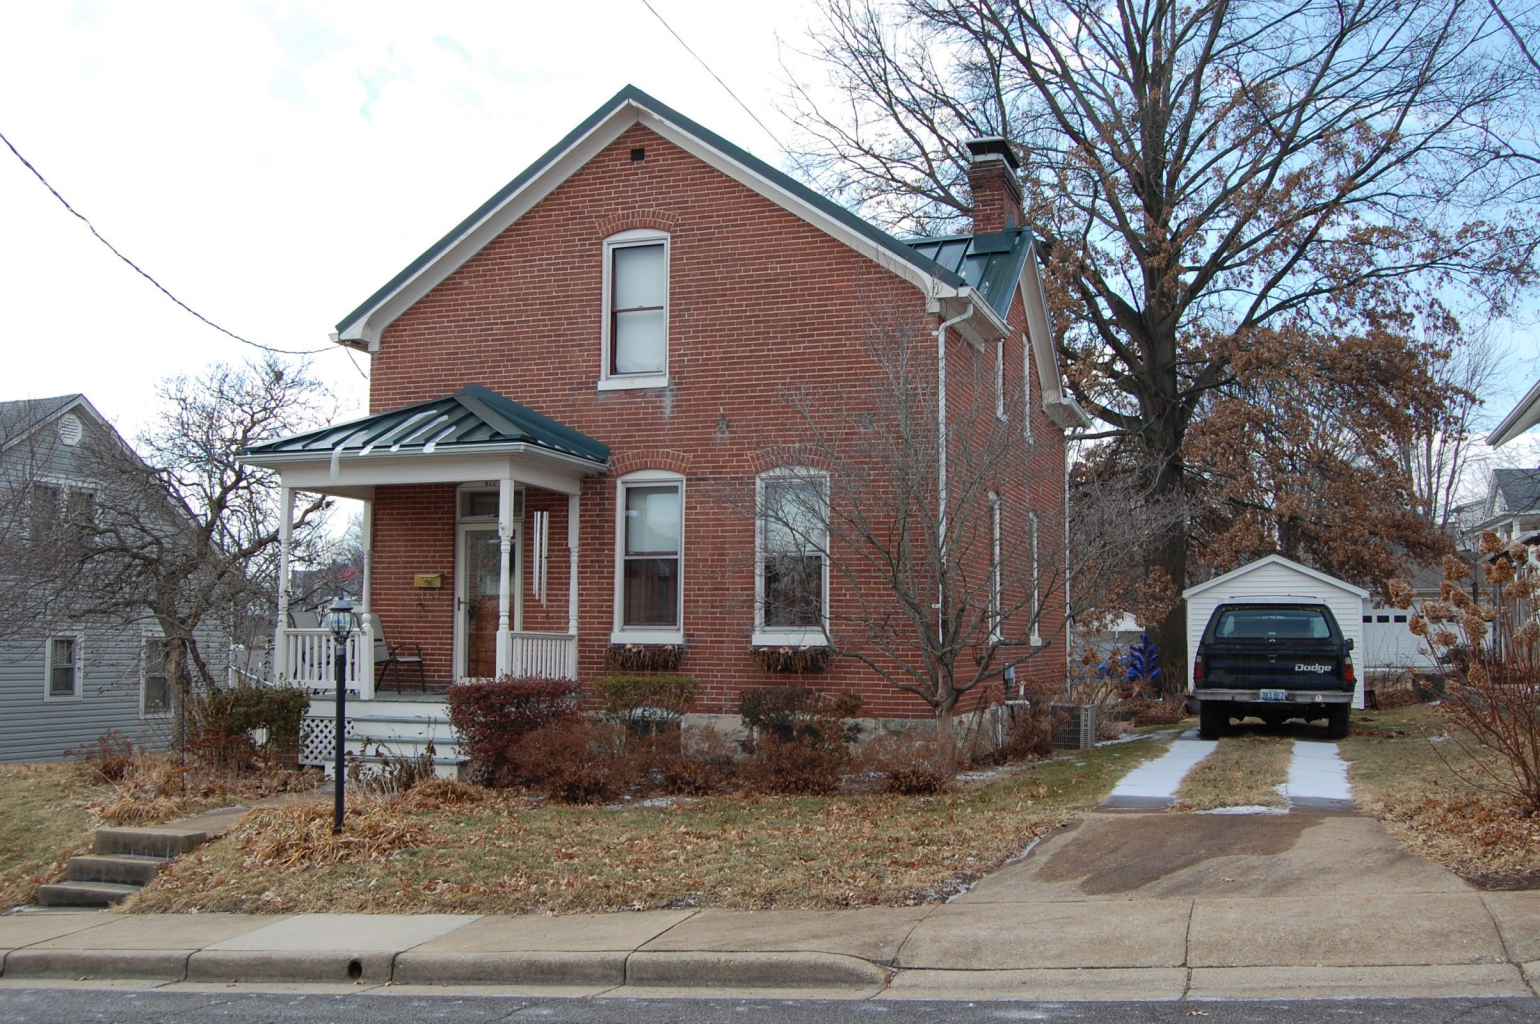
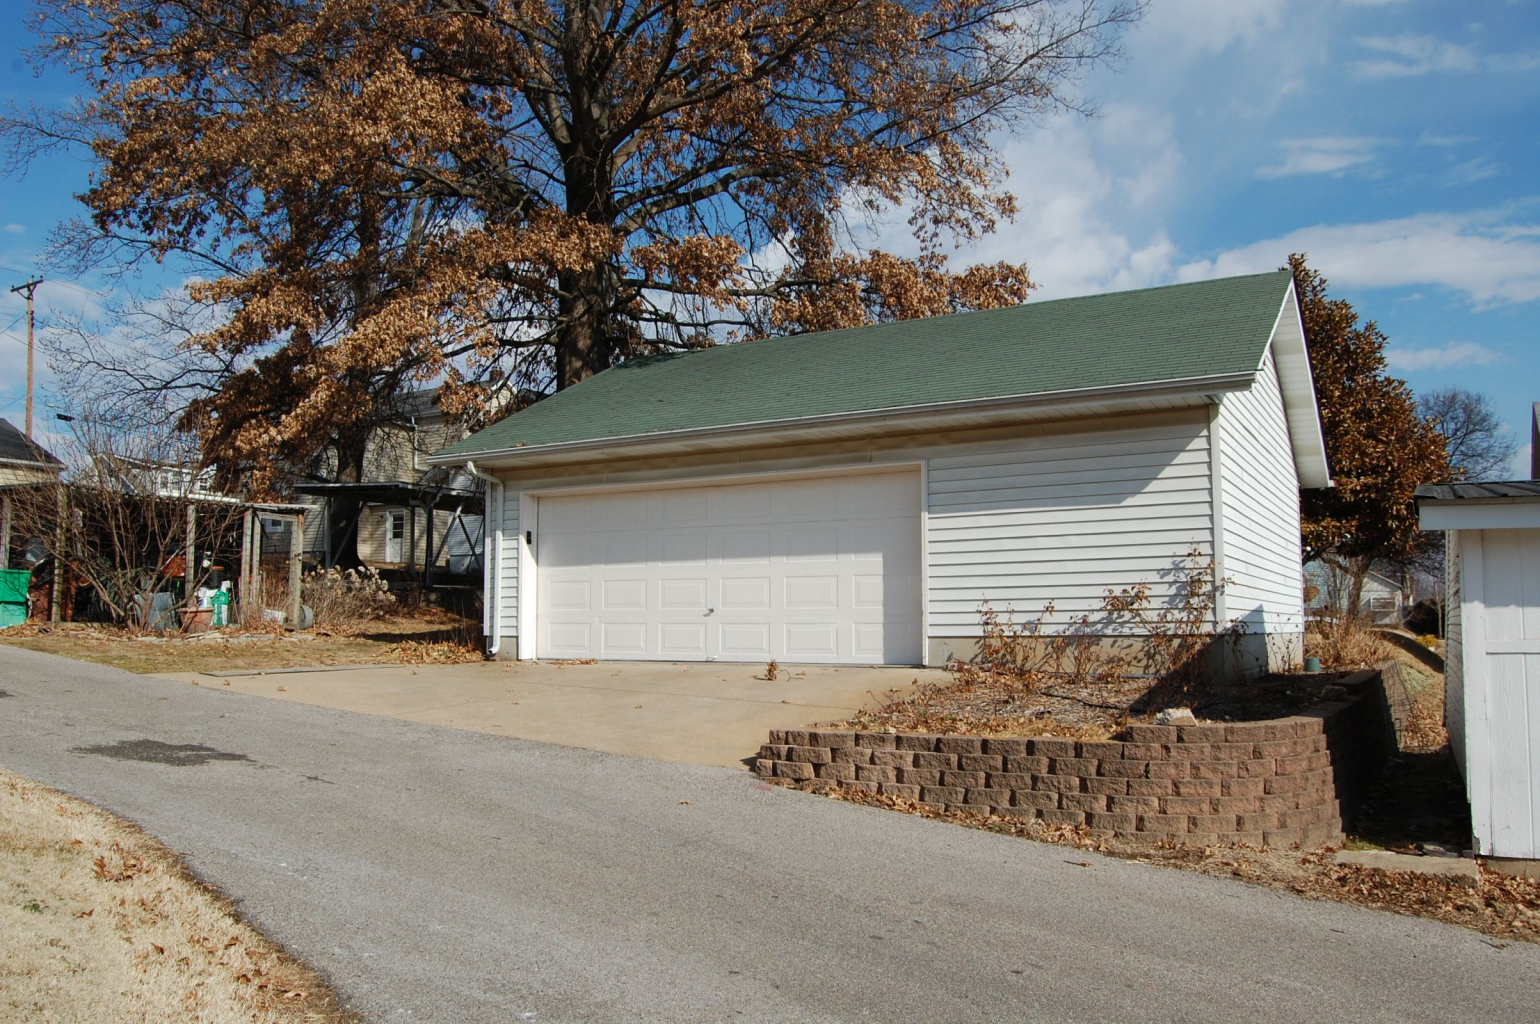
The 1.5 story brick dwelling has a limestone foundation, 7 course Flemish stretcher or common bond exterior, and a cross gable standing seam metal roof. The primary façade has 4 bays. There is a side left, 1-story open porch with a hipped, standing seam metal roof, turned wood posts, and an open square wood balustrade. Sheltered within the porch is the main entrance, consisting of a square light and wood paneled door with single light transom. Side right of the entry bay is two windows. Left of the entry bay is a rear extended bay on the SE corner of the elevation. It contains a single window. All fenestrations are set within segmental arches of two course rowlock brick. Windows are 1/1 double-hung wood sash with limestone sills. There is an interior, straddle ridge chimney on both the east and west elevations. Since 1992 survey there has been little to no changes other than replacing the older standing seam metal roof in kind.

The home retains its historic integrity and is considered a contributing resource to a potential NR district.

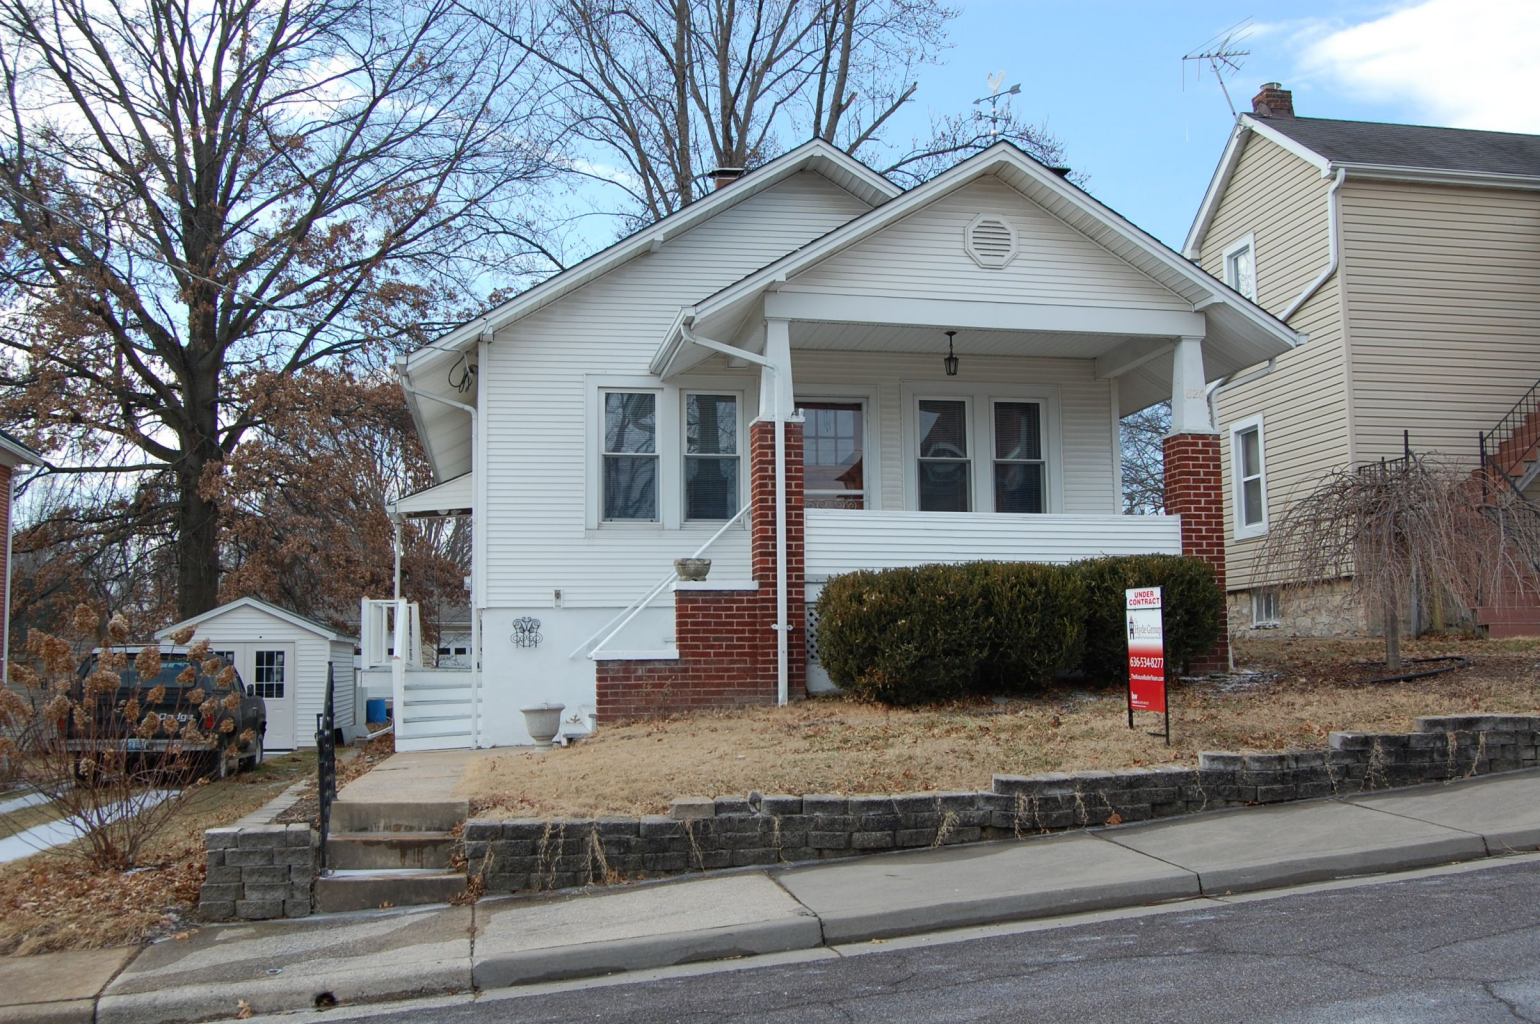
Due to the loss of integrity caused by the alteration in siding and windows, the property is not eligible for district material.

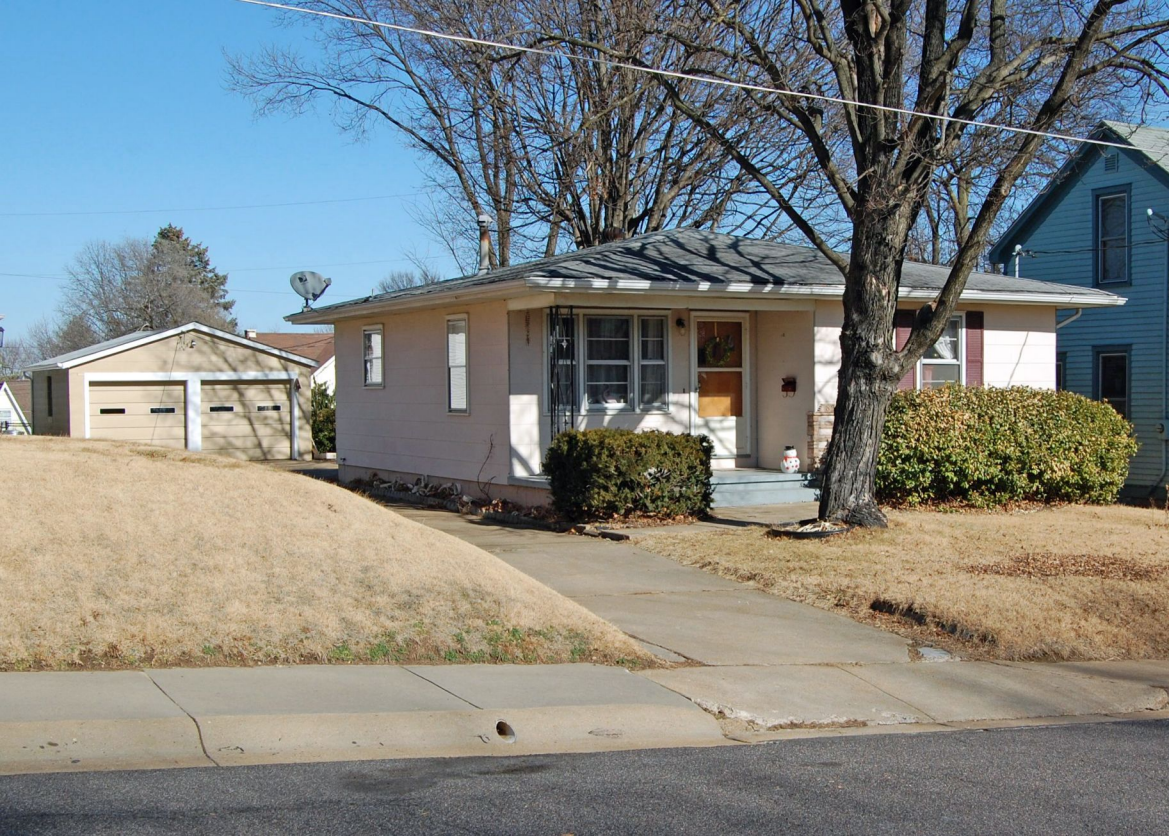
The 1 story frame dwelling has a concrete foundation, asbestos shingle siding, and a low, asphalt shingle hipped roof. The primary façade is 3 bays across. The side right bay consists of a single 2/2 horizontal wood sash window with a perma stone dado wall. There is a partial width, incised front porch side left, with a concrete platform and open, wrought iron square post. The porch shelters a single centered entry, consisting of a solid wood door and a metal and glass storm door with a ribbon of three 2/2 wood sash windows. The 1992 survey had a photo but no form for this property. There have been little to no apparent changes to the building since the 1992 survey other than the addition of ornamental shutters to the side right bay.

The assessor's office notes the dwelling's construction date as c1959. Further research is needed to verify this. While the home falls towards the end of the period of significance, its retention of its historic integrity and construction date during the period of significance, makes it a contributing resource and eligible for listing within a potential NR district.
