MISSOURI DEPARTMENT OF NATURAL RESOURCES
STATE HISTORIC PRESERVATION OFFICE, P.O. Box 176, Jefferson City, MO 65102
ARCHITECTURAL/HISTORIC INVENTORY FORM

1. SURVEY NO. FR-AS-007-001		2. SURVEY NAME: International Shoe Factory Neighborhood	
3. COUNTY: Franklin		4. ADDRESS (STREET NO.) 605	STREET (NAME) West 3rd Street

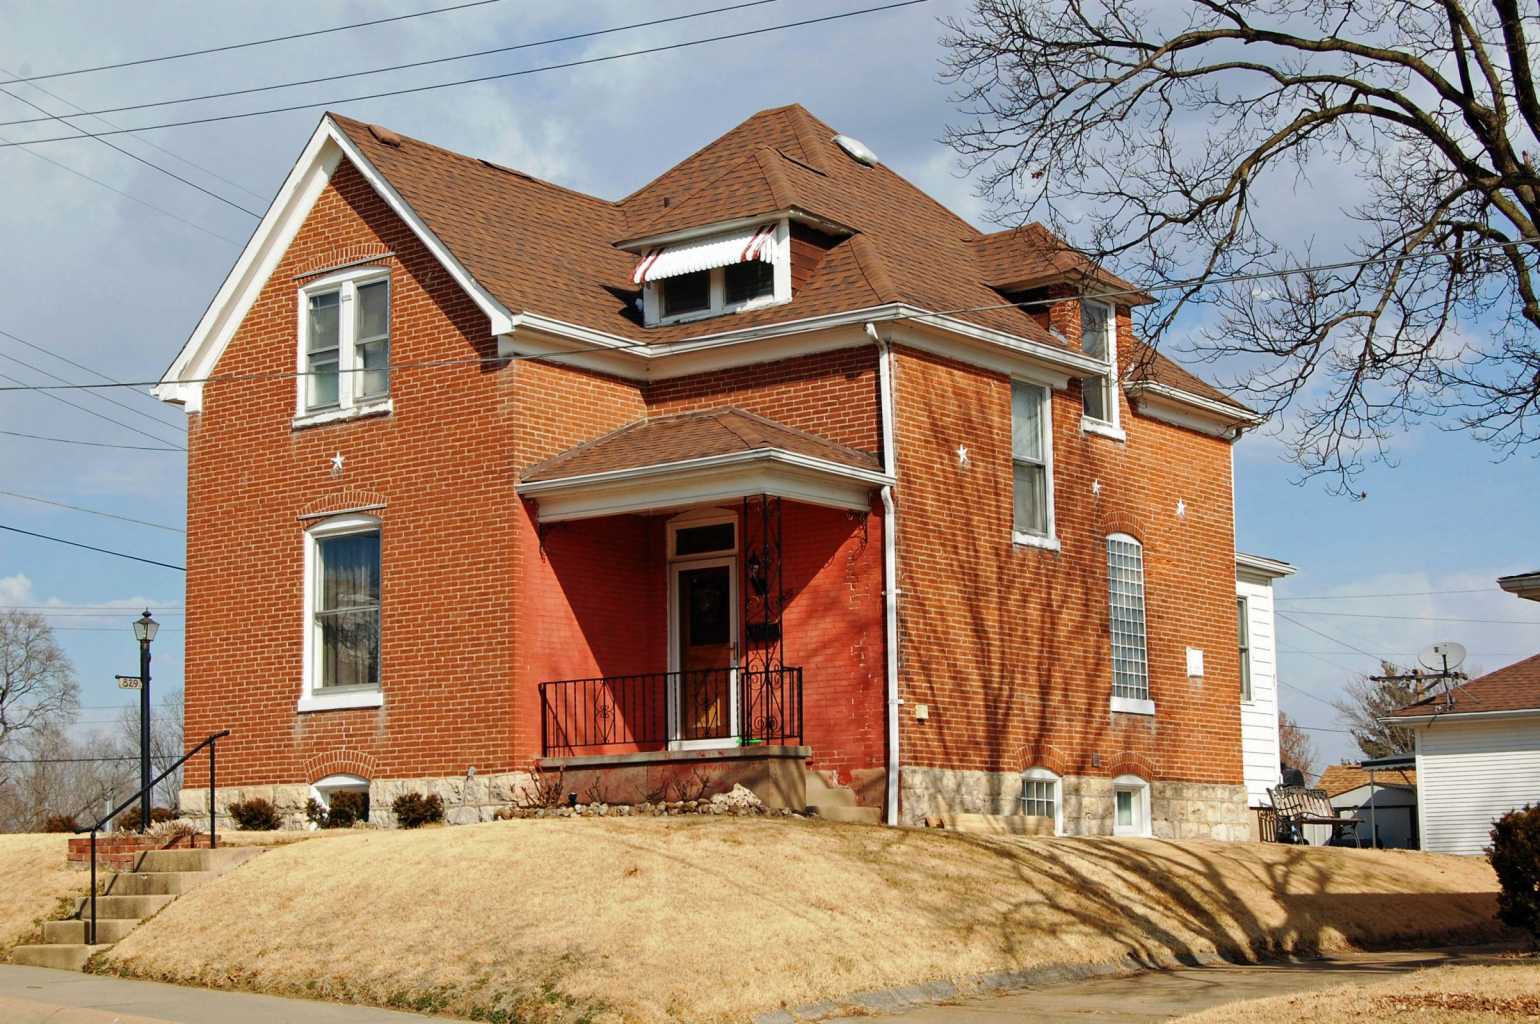
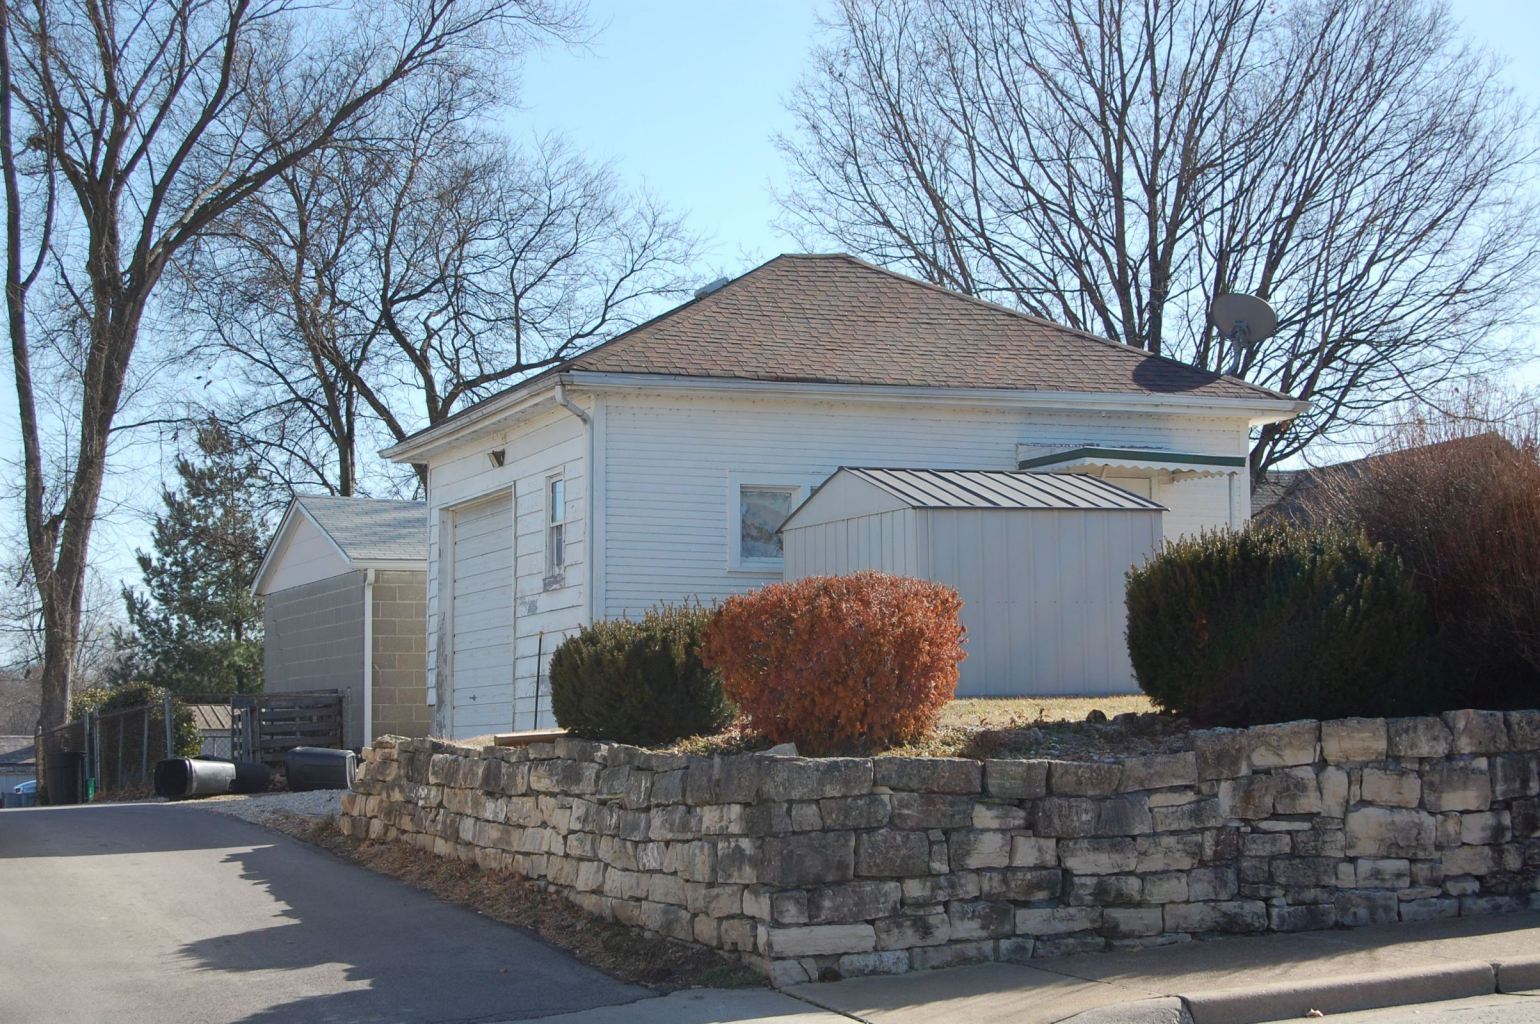
The 1.5 story brick dwelling has a coursed limestone foundation, a 7course common bond brick exterior, and a hipped asphalt shingle roof. The front façade is 2 bays wide. Side right bay is a recessed entry bay consisting of a 1-story open porch with concrete base, wrought iron railing and posts and a dropped, hipped asphalt shingle roof. Entry onto the porch is via an incised concrete stair that runs parallel to the home. The main entrance is an older, single rectangular light and paneled wood door with a single light transom. Side left bay is an extended bay with a gable front roof. There is a single 1/1 double-hung wood sash window on the first floor and paired 1/1 double-hung wood sash within the upper story, directly above. Fenestrations within the brick are set within a segmental arch of two-course, rowlock brick with 1/1 wood sash windows with limestone sills. Dates of the windows are unknown and further research is needed to verify. Directly above the entry bay, within the upper story's roof, is a hipped dormer with paired windows obscured by a metal awning. There is an interior side left brick chimney on the western elevation and an interior, straddle ridge brick chimney at the northwestern elevation. There is a 1-story wood frame enclosed porch on the north façade. Since the 1992 survey, some metal awnings have been removed and post June 2016 a rear, wood enclosed deck off the NE of the home was removed. Due to its integrity and date of construction during the period of significance, the property is a contributing resource and is eligible for district material.

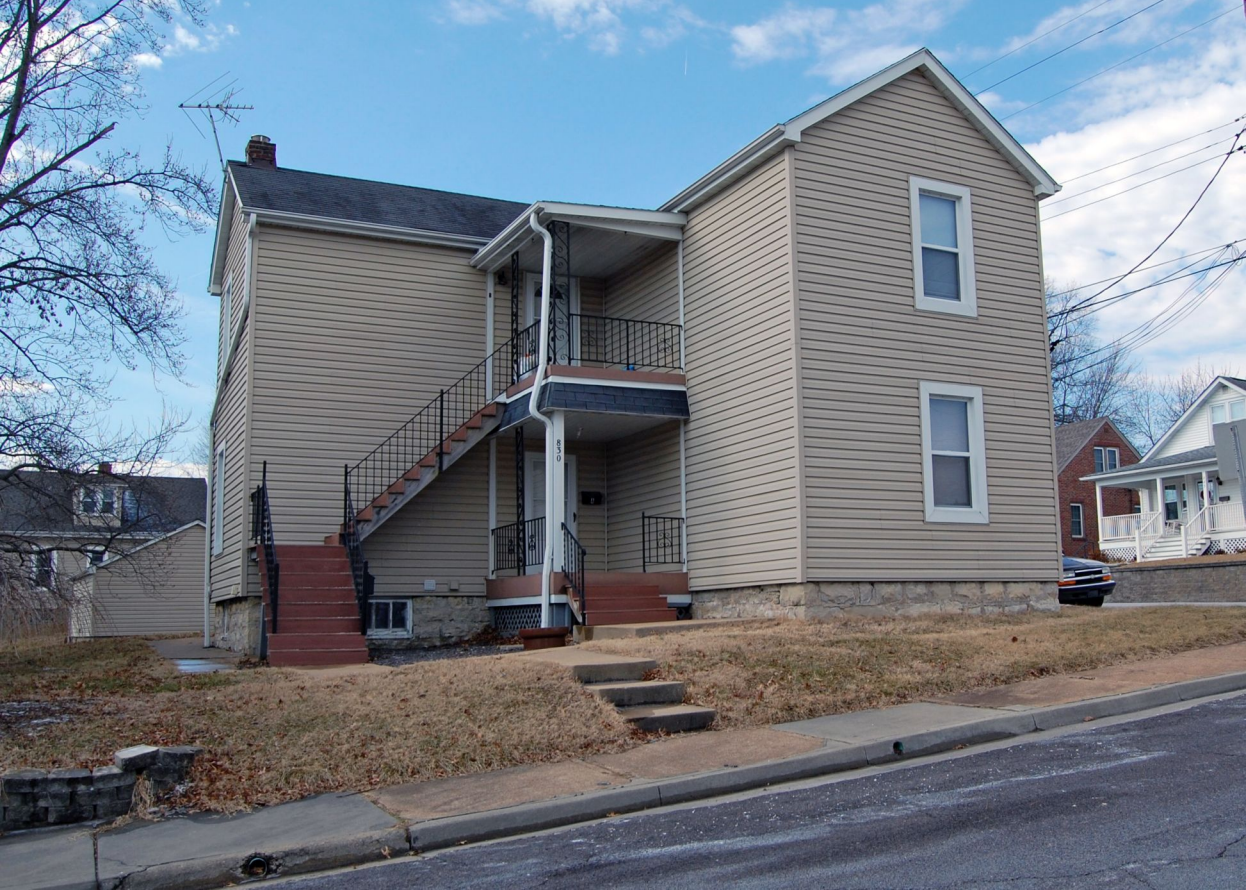
There is an interior, straddle ridge brick chimney on the eastern elevation. Since the 1992 survey, alterations include: replacement of asbestos shingles with vinyl, replacement of wood sash with vinyl, and removal of ornamental shutters.

Due to its loss of integrity caused by the alterations in siding, the building is not considered eligible for listing in a potential NR district.

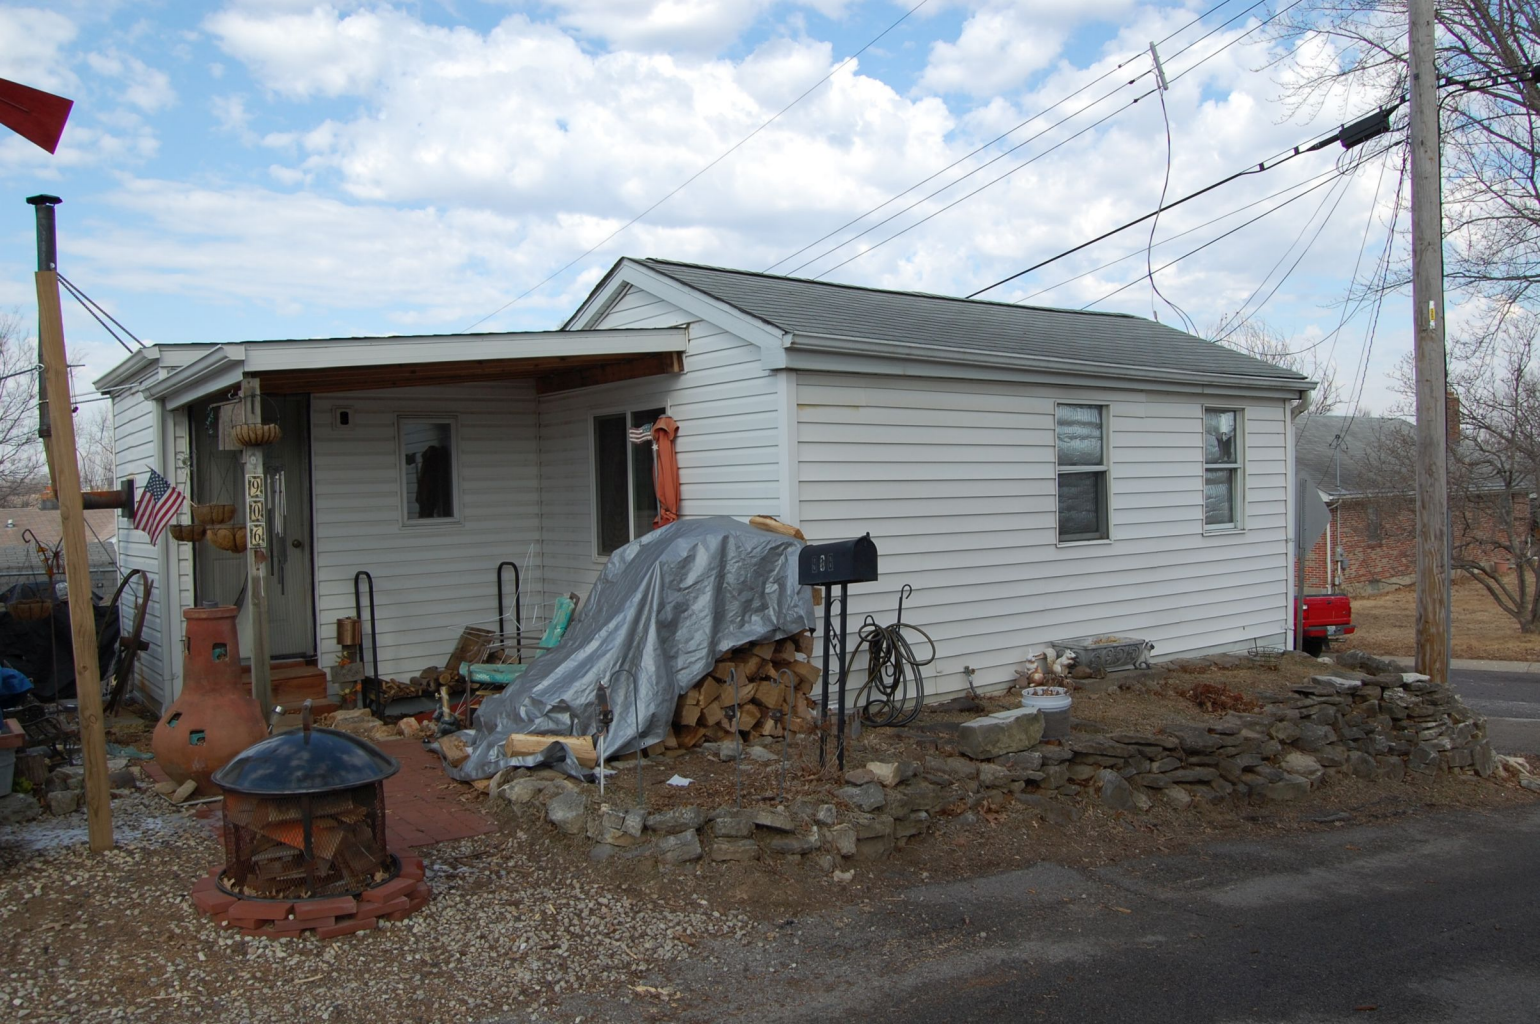
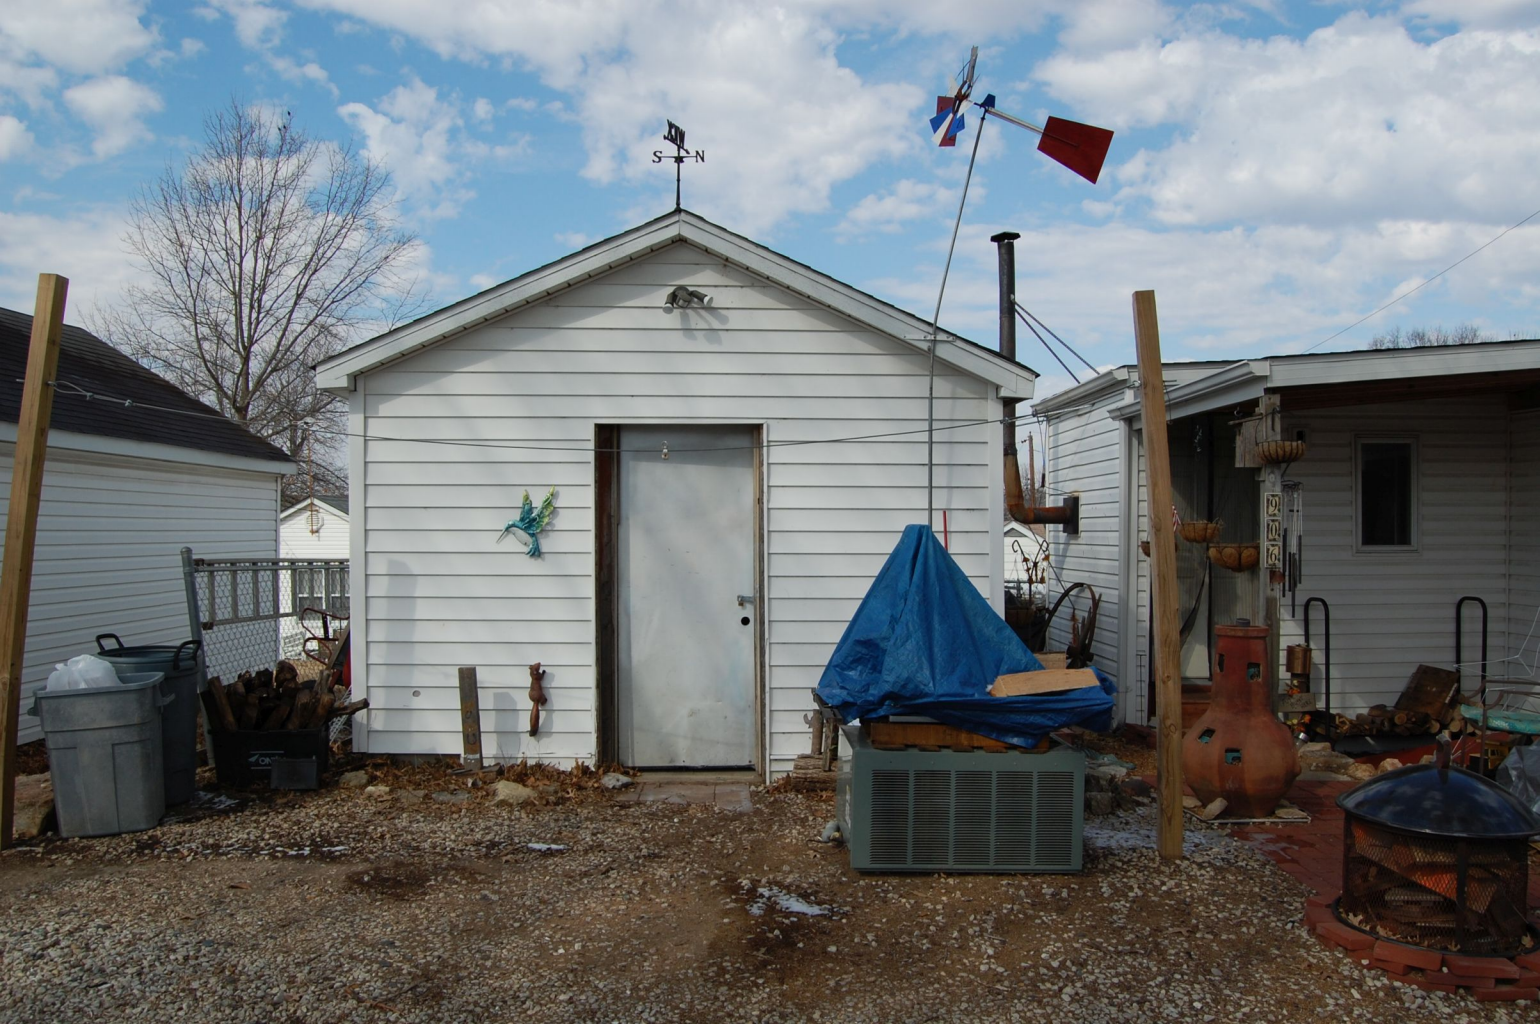
The 1-story frame dwelling has a concrete parged and stone foundation, vinyl siding, and a primary side gable roof with rear, front gable roof of asphalt shingles. The primary façade (E elevation) is 4 bays wide. The side right bay, under the primary side gable roof, has two 1/1 double-hung vinyl sash windows. The side left bay is a 1-story addition with shed roof containing a paneled metal door and a single, fixed light window. Fronting the addition is a brick, gravel and stone sidewalk/patio with a shed roof supported by a single square wood post. ON the S elevation of the addition is a metal, stove exhaust pipe. The W elevation has a 1-story frame addition with formed concrete foundation, vinyl siding and a gable front roof. This address was not in the 1992 survey. Due to the additions and the exterior alterations (siding/vinyl windows), it is not a contributing resource to a potential NR district.

(The photo was taken from the alley)

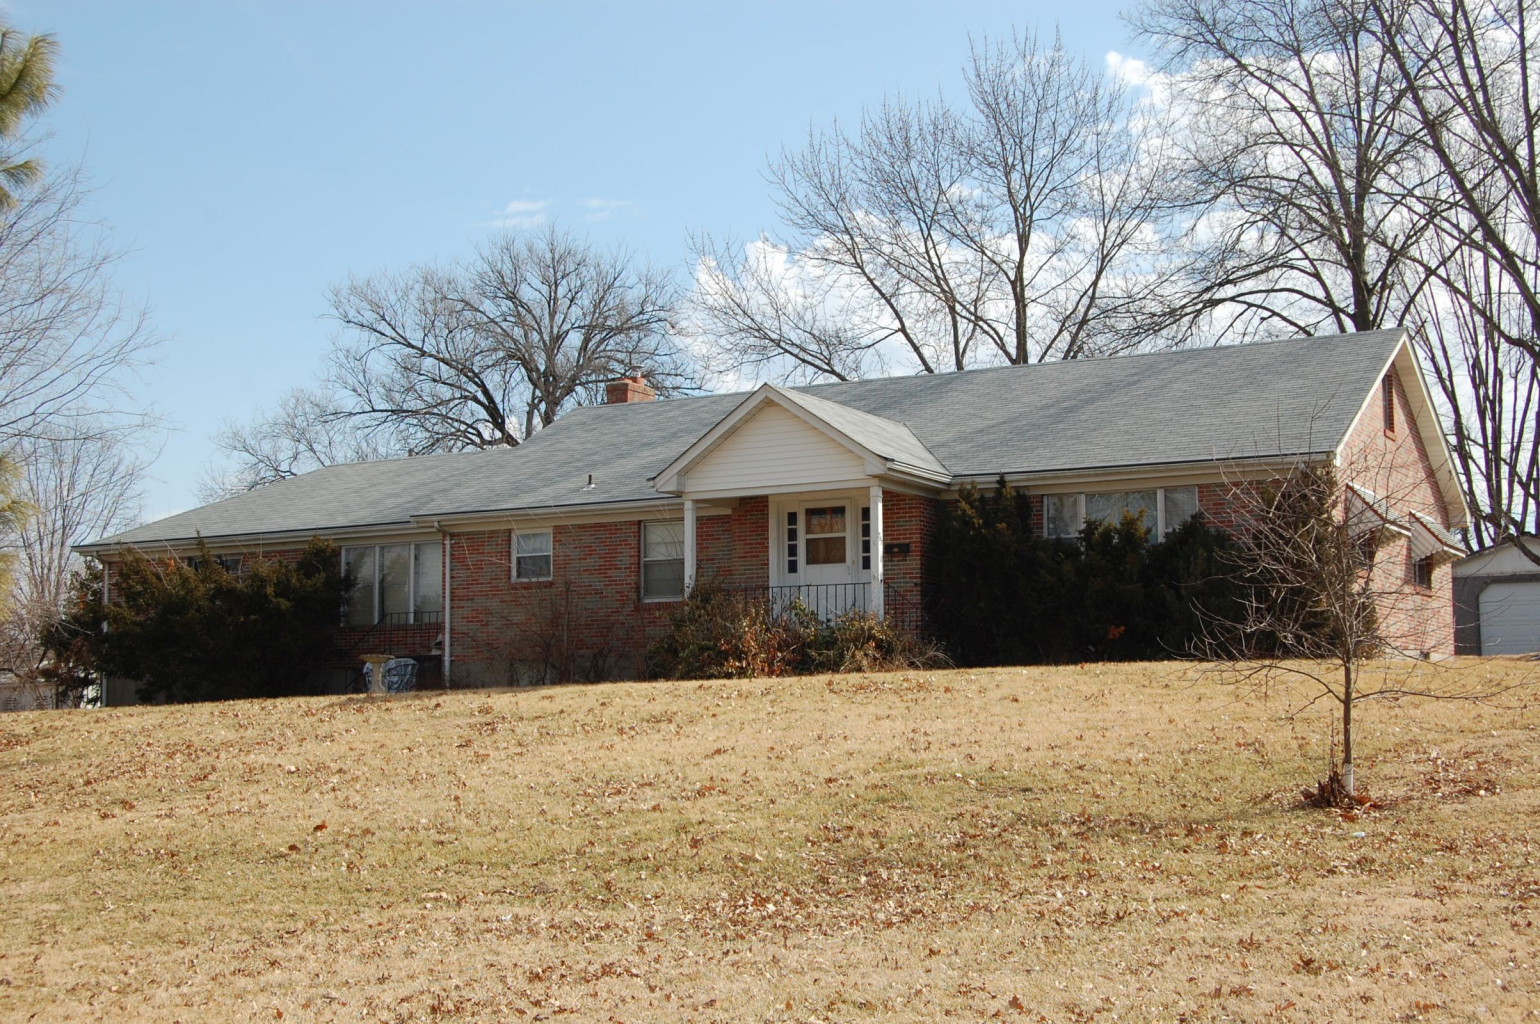
The 1-story frame dwelling has a concrete foundation, variegated brick veneer exterior and a side gable asphalt shingle roof. The front façade is 6 bays wide. Centered on the primary roof is an extended front gable bay containing a single entry portico. The portico has a concrete platform with side right stairs, parallel to the façade, wrought iron railing, and two square wood posts. The entrance consists of a wood door obscured by storm door and 4-light sidelights. The side right bay has a picture window of a central fixed light flanked by horizontal 2/2 aluminum sash windows. The side left of the primary building has 1 horizontal 2/2 aluminum sash window and 1 smaller 1/1 window. The far left bay is a single car garage attached to the primary building via an enclosed breezeway. It has a dropped, side gable roof a ribbon of three jalousie windows (breezeway) and a window obscured by a large bush (garage). Windows are set in a flat surround with a rowlock course brick lug sill. There is a former exterior brick chimney on the north elevation of the primary building that is now an interior due to the enclosed breezeway addition. This building was not surveyed in 1992. Due to the home's date of construction during the period of significance and its integrity, it is a contributing resource for a potential NR district.

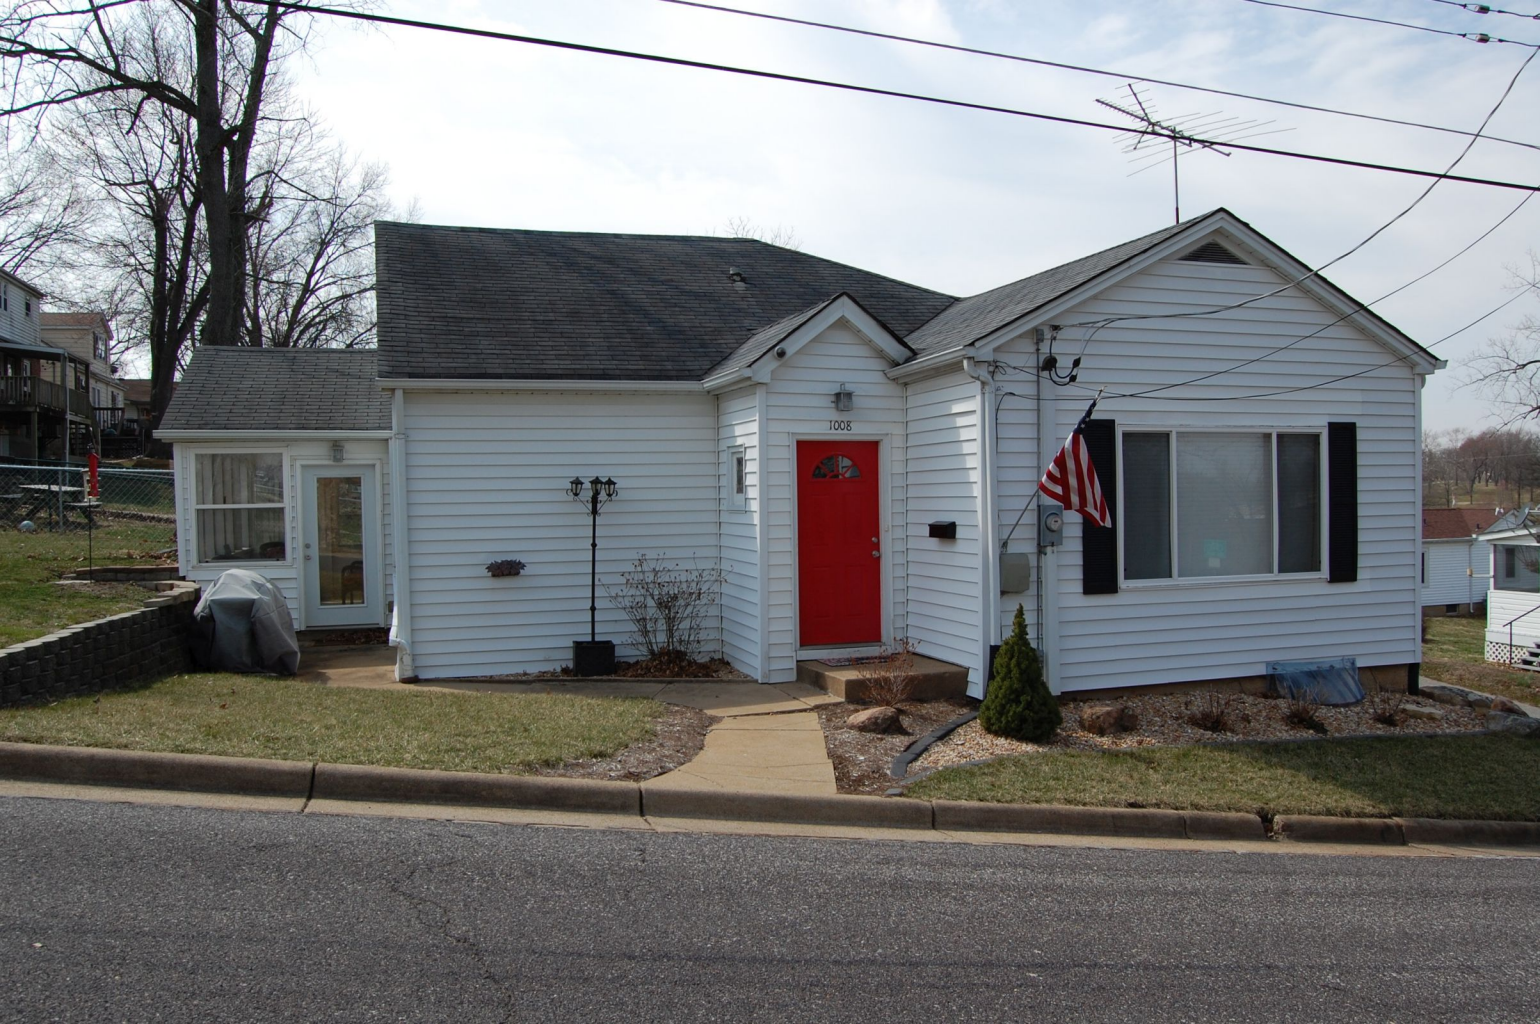
The 1.5 story dwelling has a concrete foundation, vinyl siding, and a cross gable, asphalt shingle roof. The primary façade is 4 bays wide. Side right is an extended front gable bay with a roofline lower than the primary, and containing a 3-light picture window with ornamental shutters. To the left of this bay is a shallower, extended gable front entry bay containing a concrete platform and a multi-light fanlight glass and paneled metal door. On the eastern elevation of this bay is a small, rectangular stain glass window. The far left bay is an enclosed porch with a dropped, side gable roof and a single 1/1 vinyl sash window and rectangular light glass and metal entry door on the N elevation. On the S elevation is a large shed roof dormer with a sliding glass window and a 1/1 vinyl sash window. The dormer is a later addition adding living space to the upper story. There is an exterior, brick chimney and a hipped roof corner on the western elevation. On the S elevation is a large shed roof dormer extending through the roofline. The dormer is a later addition. This property was not surveyed in 1992. Due to the exterior alterations in vinyl siding and replacement windows, the home is not eligible for potential NR district materials.

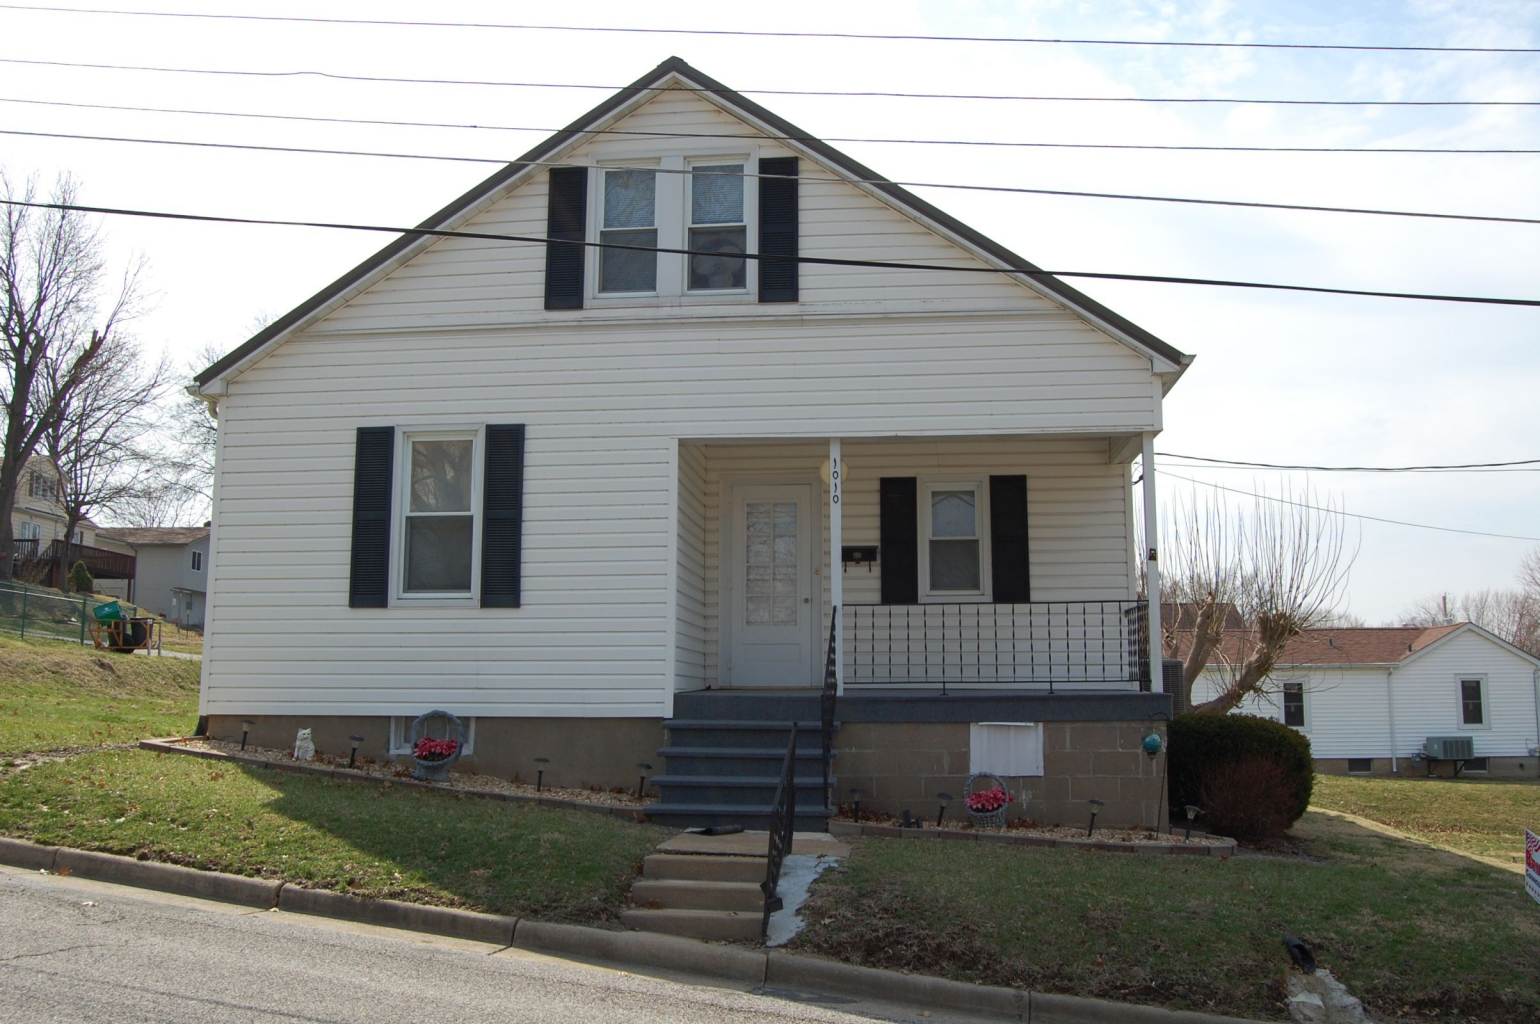
The 1.5 story frame dwelling has a concrete foundation, vinyl siding and a newer corrugated metal, front gable roof. The front façade is 3 bays wide. Side left is a single window with a 3-light wood sash awning window in the foundation. Side right is an incised porch with a cement block foundation wall, carpeted decking and stairs, wrought iron railing, and 2 square wood posts. Sheltered within the porch is a single window and a single entry consisting of an older square light glass and paneled wood door with multi-light glass and wood storm door. Within the upper story's gable are paired windows. Windows are replacement 1/1 double-hung vinyl sash with ornamental shutters. There is an enclosed, ¾ width shed roof porch centered on the S elevation. It has a vinyl sided knee wall and screened window bays. This house was not surveyed in 1992. Due to the exterior alterations in siding and windows, this house is not a contributing resource to a potential NR district.

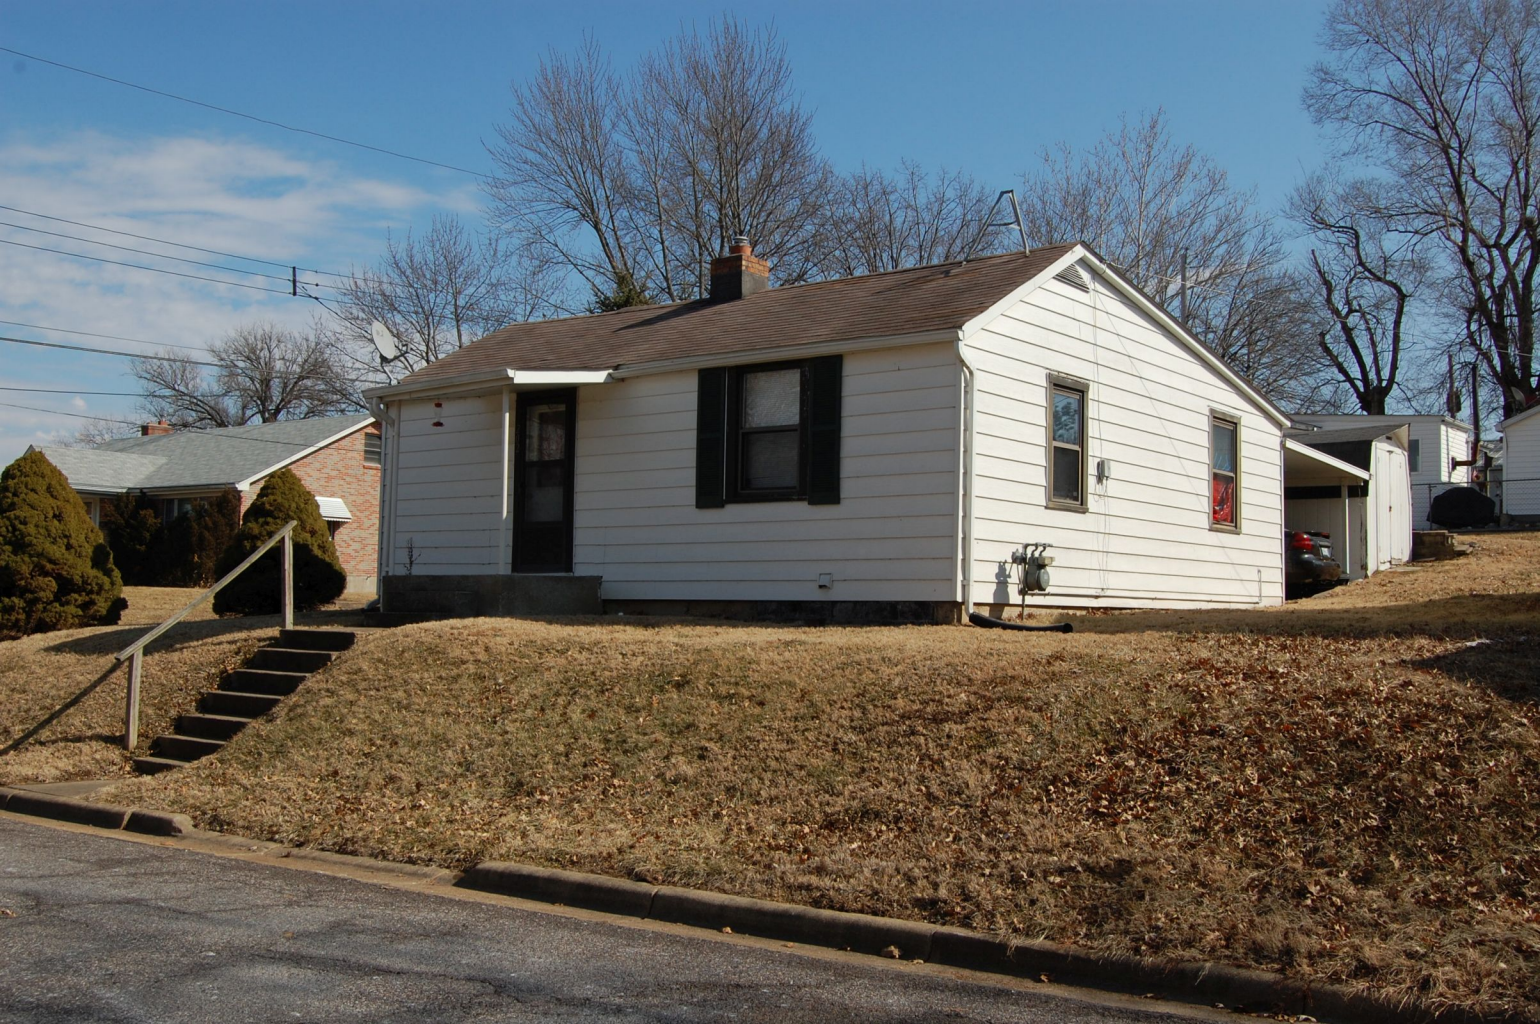
Due to the alterations in siding (asbestos shingle to large profile vinyl), replacement door, and non-historic window treatment, this home is not considered eligible for listing in a potential NR district.

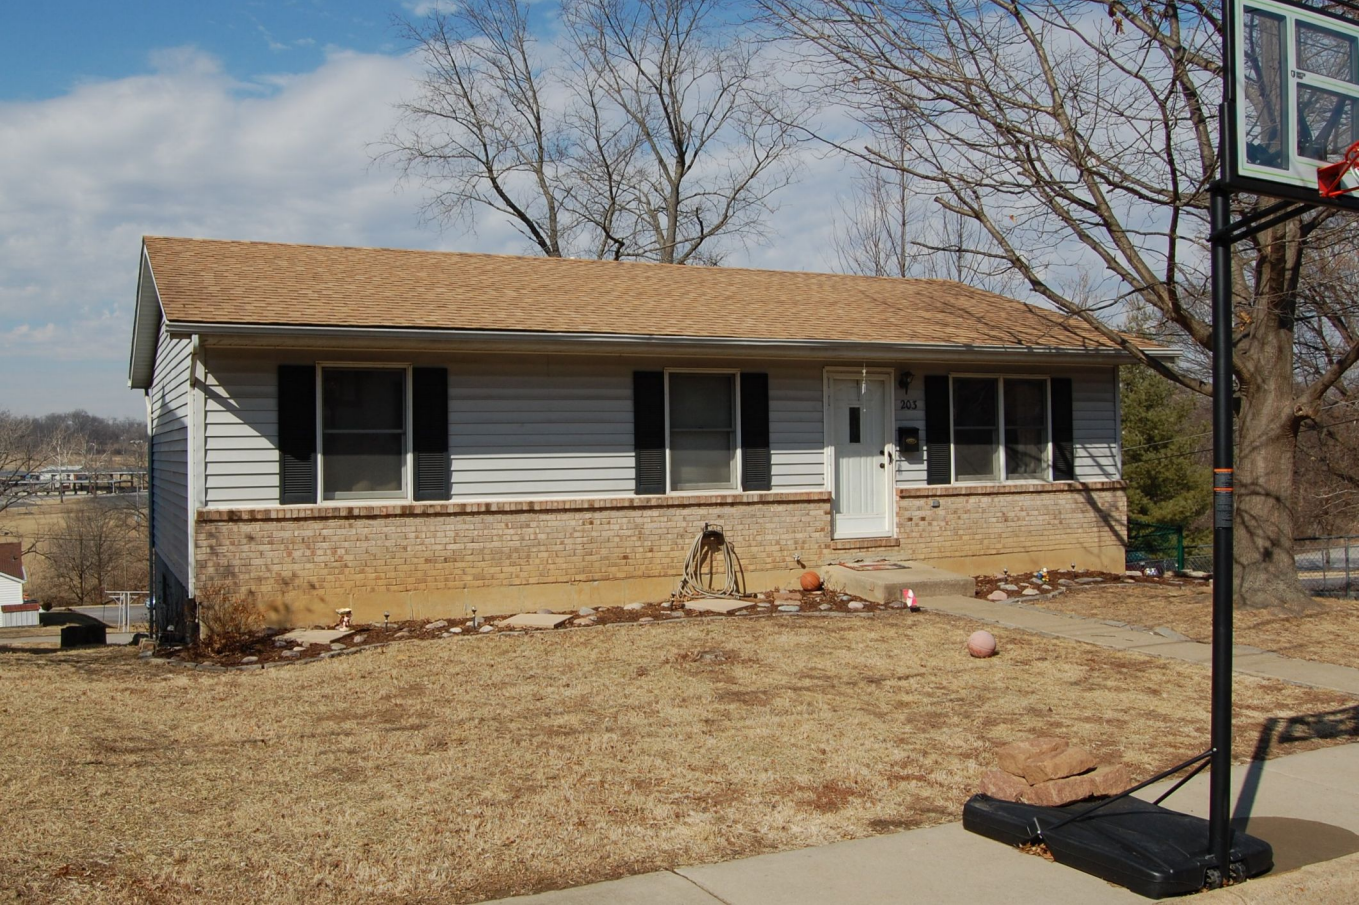
This 1 story frame side gable home has an asphalt shingle roof and a concrete foundation. The entry is offset right and is approached by a concrete porch platform. The entry contains a metal panel door with a rectangular light. To the right of the entry is a paired window bay. To the left of the entry are two window bays. Windows are 1/1 double hung vinyl windows with non-operative plastic shutters. The home is clad with vinyl siding although there is a brick veneer dado wall. This property was not surveyed in 1992.

Due to its recent date of construction, this building is not considered eligible for listing in a potential NR district.

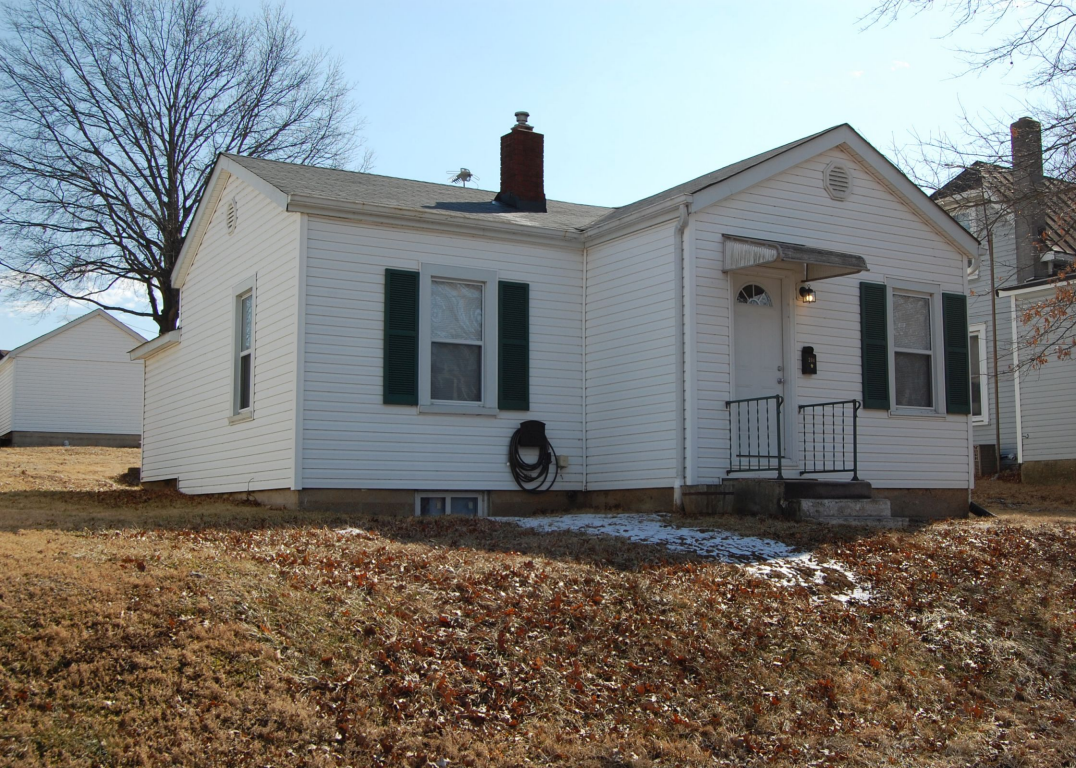
This 1 story home has an asphalt shingle Gable and Wing roof and a concrete foundation. There is a concrete slab porch on the left side of the front gable section with wrought iron railings and a metal shed roof hood protecting the entry. The entry contains a replacement metal door with fanlight. To the right of the entry is a single window bay containing a 1/1 double hung vinyl replacement sash flanked by non operative plastic shutters. There is an octagonal louvered attic vent centered on the gable. A brick stove chimney projects from the roof at the intersection of the gable and wing sections. The wing section has a single window bay containing a 1/1 double hung vinyl replacement sash flanked by non operative plastic shutters. There is a two light awning sash replacement window in a rectangular opening at the basement level of the wing. This property was not surveyed in 1992.

Because of its vinyl cladding, replacement door and windows and non-historic window treatment, this home is not considered eligible for listing in a potential NR district.

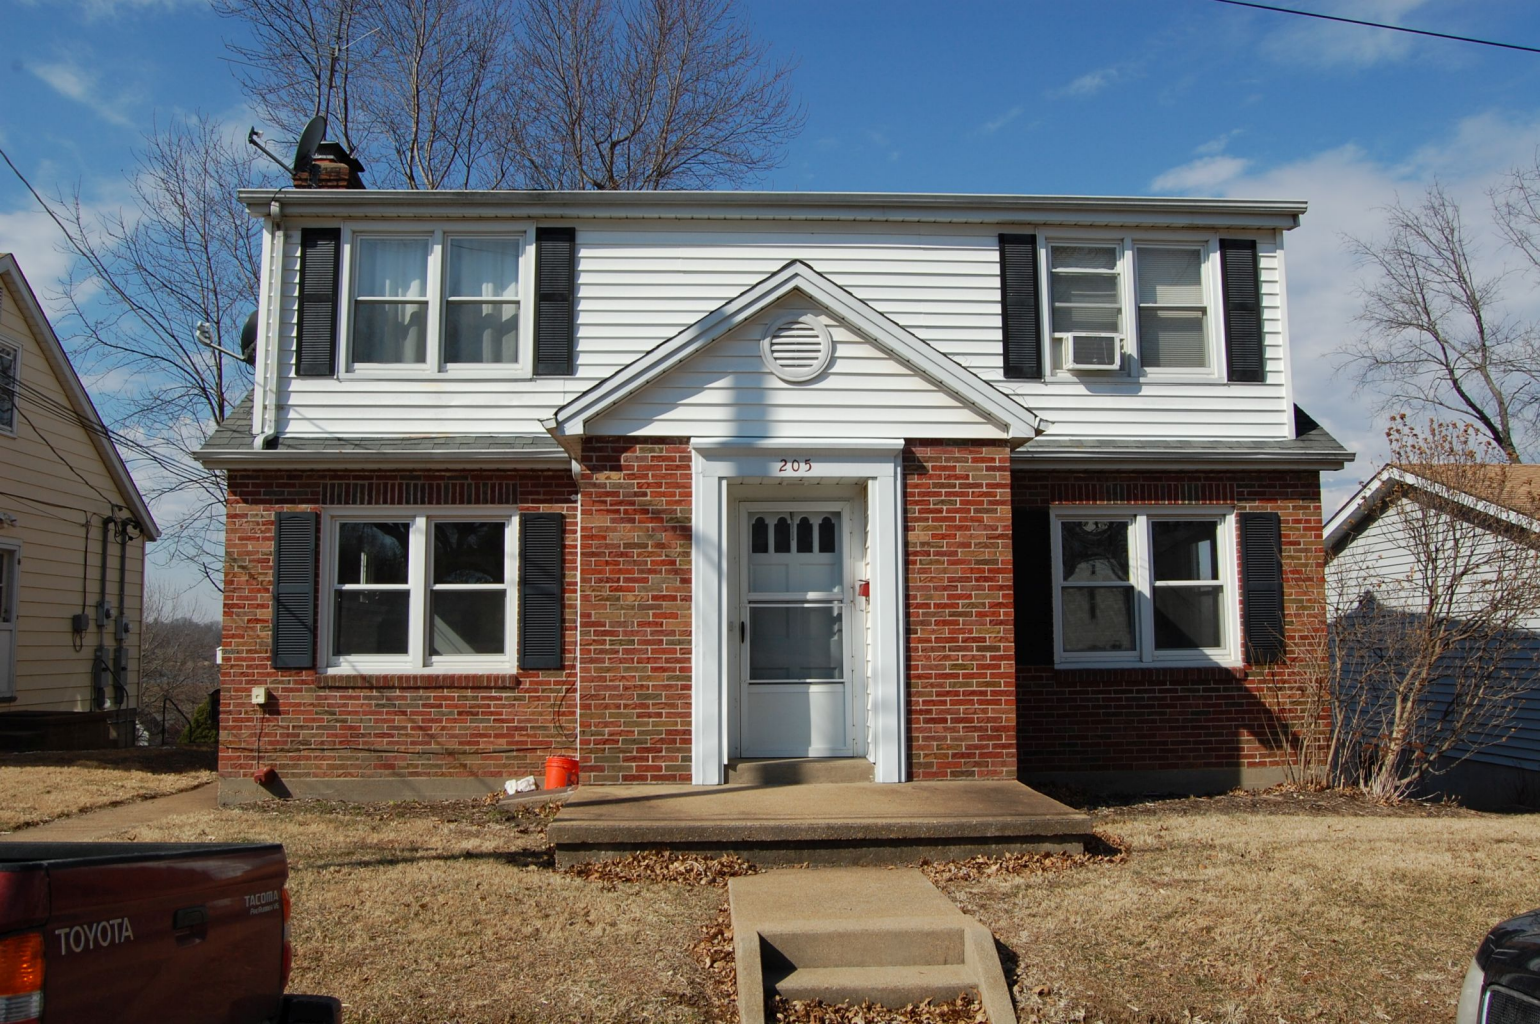
Due to the significant addition to the second floor of the building and the addition of vinyl siding and replacement windows, this building is not considered eligible for listing in a potential NR district.

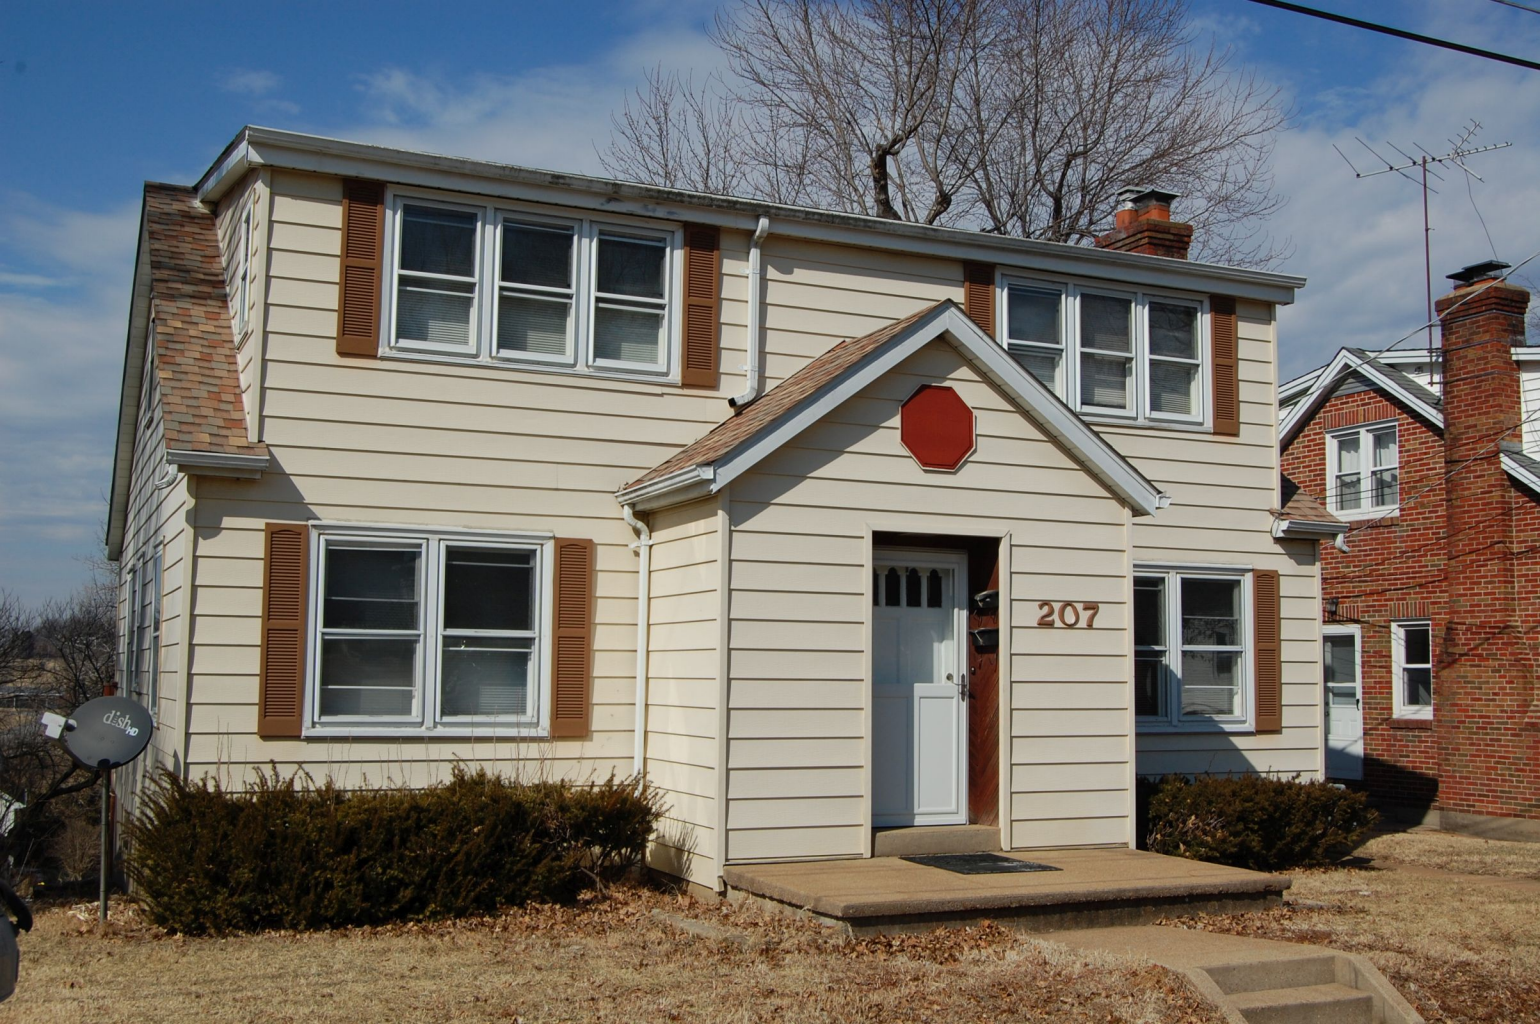
Due to the significant addition to the second floor of the building and the addition of vinyl siding and replacement windows, this building is not considered eligible for listing in a potential NR district.
