MISSOURI DEPARTMENT OF NATURAL RESOURCES
STATE HISTORIC PRESERVATION OFFICE, P.O. Box 176, Jefferson City, MO 65102
ARCHITECTURAL/HISTORIC INVENTORY FORM

1. SURVEY NO. FR-AS-007-001		2. SURVEY NAME: International Shoe Factory Neighborhood	
3. COUNTY: Franklin		4. ADDRESS (STREET NO.) 605	STREET (NAME) West 3rd Street

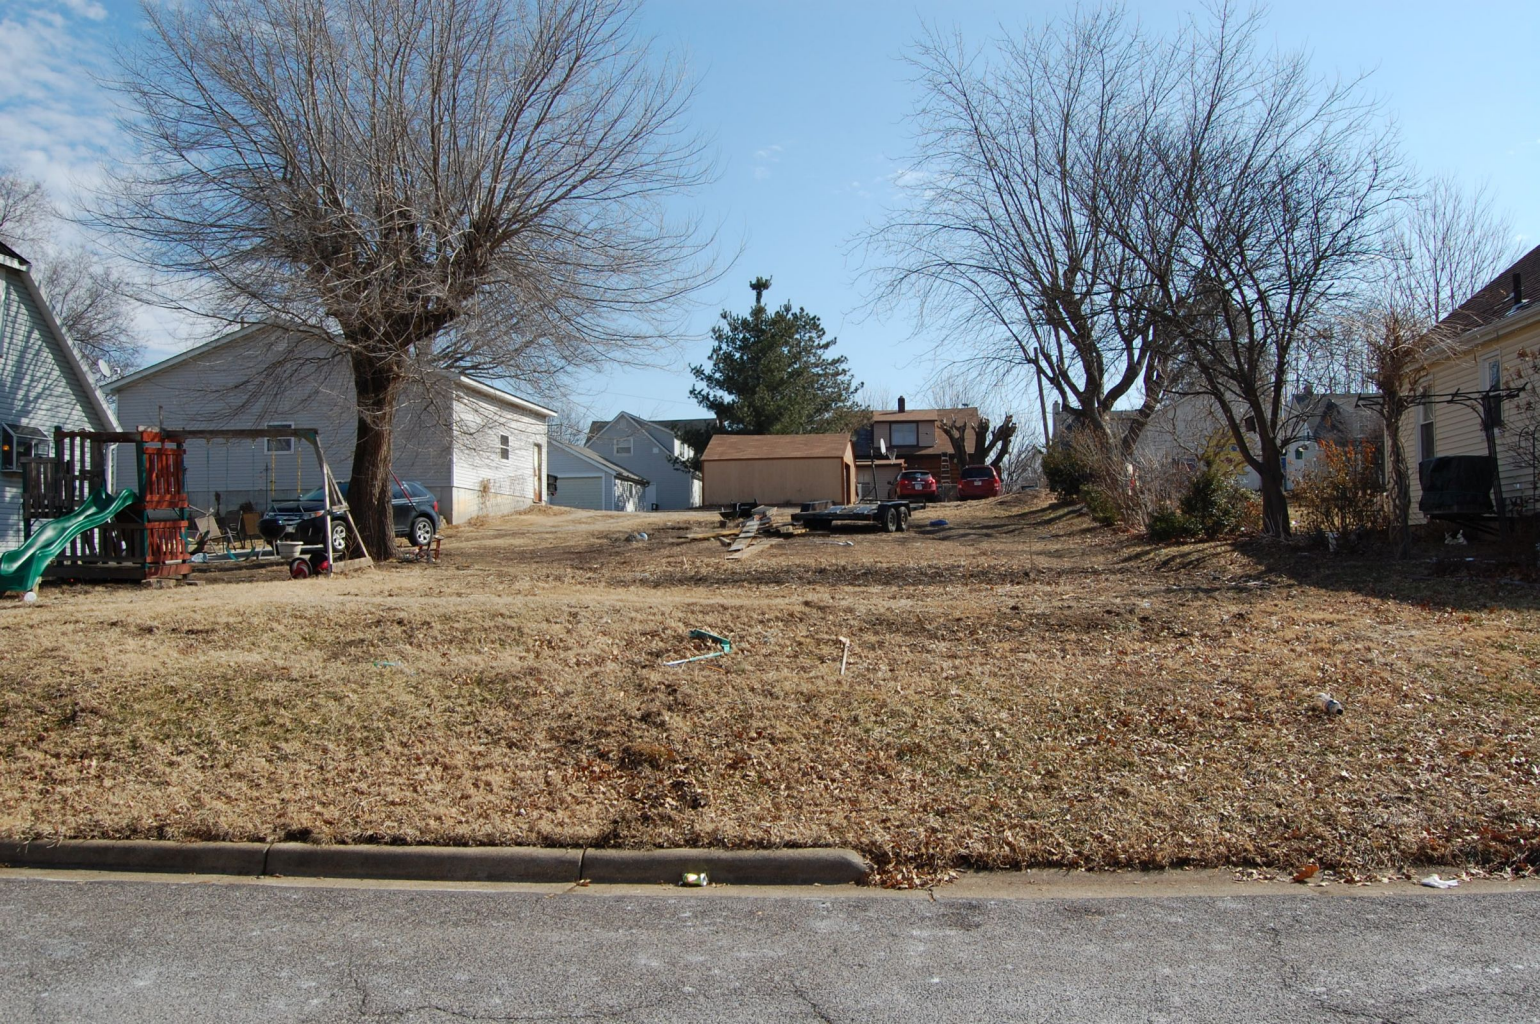
The lot is located in an urban neighborhood on the east side of Fair Street. It is situated between 206 and 210 Fair Street. The lot slopes upward toward the alley situated between Fair and High streets. The lot is grassy and is not currently being used for any obvious specific purpose. This property was not surveyed in 1992.

The lot is not considered eligible for listing in a potential NR district due to its creation through the demolition of a residence post 1958.

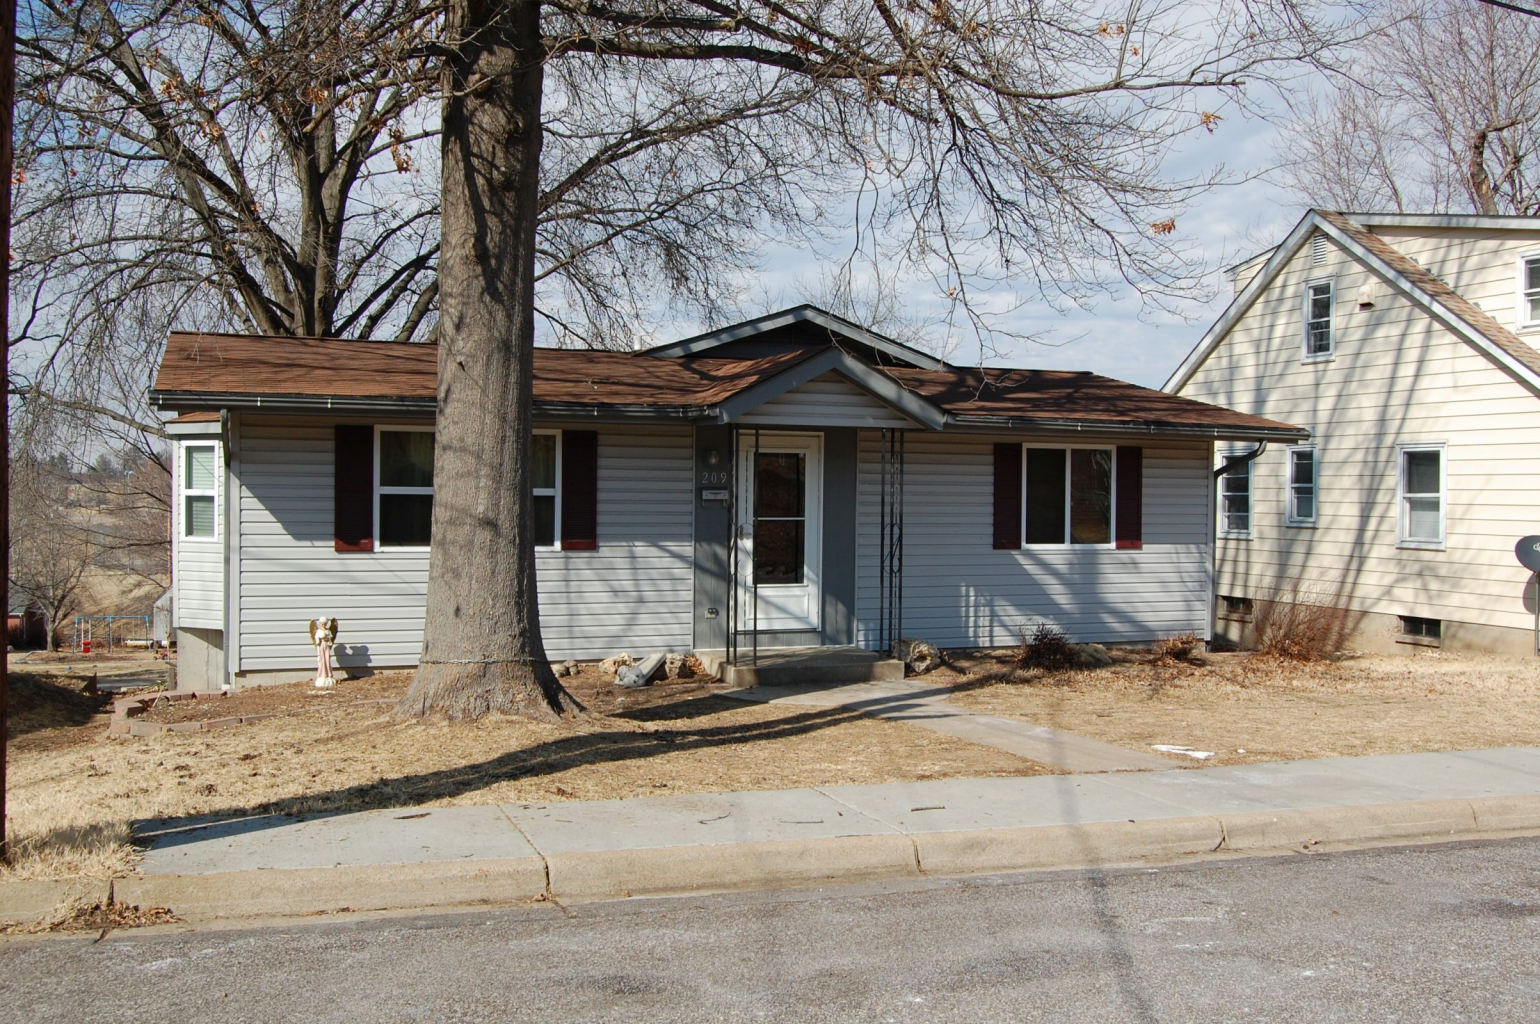
This 1 story frame side gable home has an asphalt shingle roof and a concrete foundation. The entry is centered and is approached by a concrete porch platform with wrought iron supports holding up a narrow front gable porch roof. The entry contains a storm door that obscures the primary door. To the right of the entry is a window bay containing a pair of single light vinyl casement windows with non-operative plastic shutters. To the left of the entry is a window bay containing a pair of 1/1 double hung vinyl windows with non-operative plastic shutters. The home is clad with vinyl siding. This property was not surveyed in 1992.

Due to its recent date of construction, this building is not considered eligible for listing in a potential NR district.

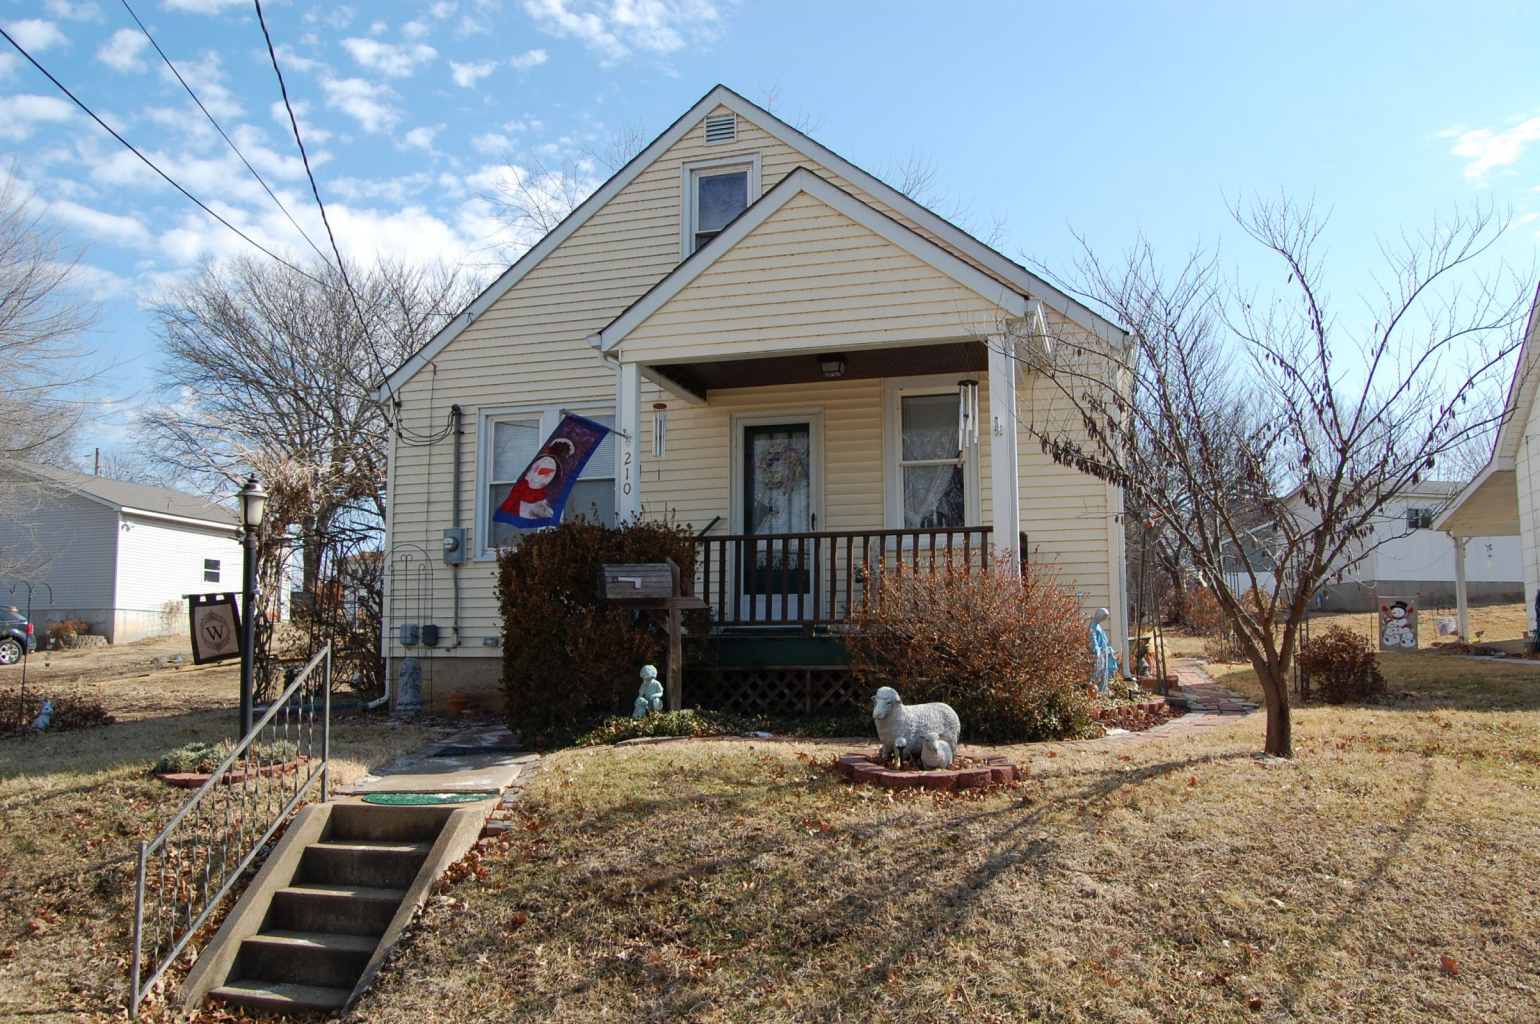
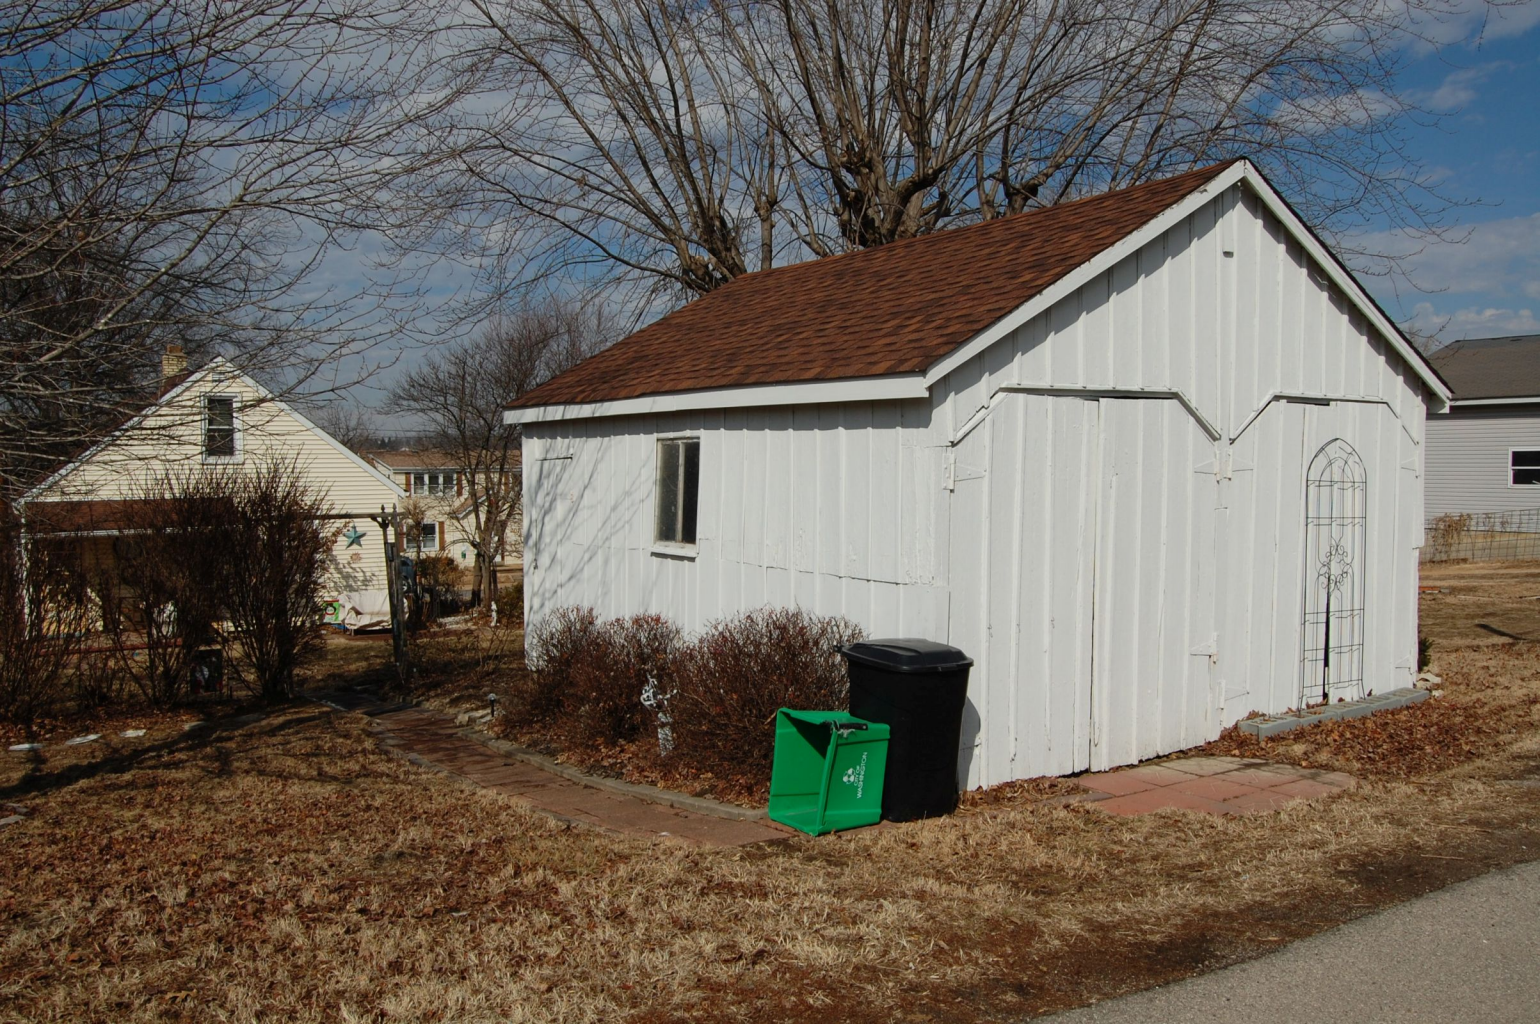
This one story home has a front gable asphalt shingle roof and a concrete foundation. There is a wooden platform porch on the right side of the front gable section with a non-historic wooden balustrade and non-historic boxed supports (material indeterminate) holding up a front gable roof. The porch roof appears to have a historic wooden bead board ceiling and protects the entry as well as a single window bay containing a 1/1 double hung vinyl replacement sash. There is a historic wooden door with three vertical lights behind a storm door. To the left of the porch is another window bay containing a pair of 1/1 double hung vinyl sash. Centered on the upper half story gable end is a single window bay containing a 1/1 double hung vinyl sash. The building and the porch gable end is clad in vinyl siding. This property was not surveyed in 1992.

Because of the vinyl siding and vinyl replacement windows, this building is not considered eligible for listing in a potential NR district.

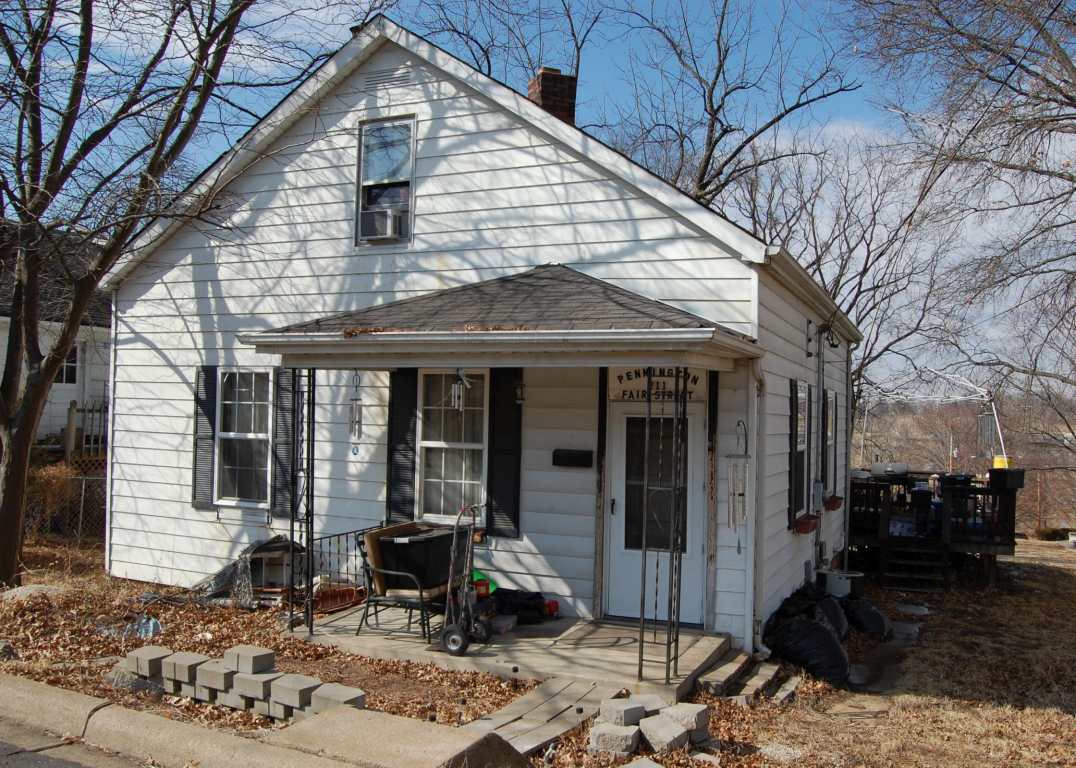
This 1 story frame front gable home has an asphalt shingle roof and a limestone foundation. The entry is side right and is approached by a concrete porch platform with wrought iron supports holding up a half width, hipped porch roof. The entry contains a storm door that obscures the primary door. To the left of the entry are two window bays containing 1/1 double hung vinyl windows with non-operative plastic shutters. The windows have false muntins giving the appearance of 6/6 lights. There is a 1/1 double hung wood sash centered on the gable end of the upper half story. The home is clad with vinyl siding. This property was not surveyed in 1992.

Due to the cladding with non-original aluminum siding and replacement windows this home is not considered eligible for listing in a potential NR district.

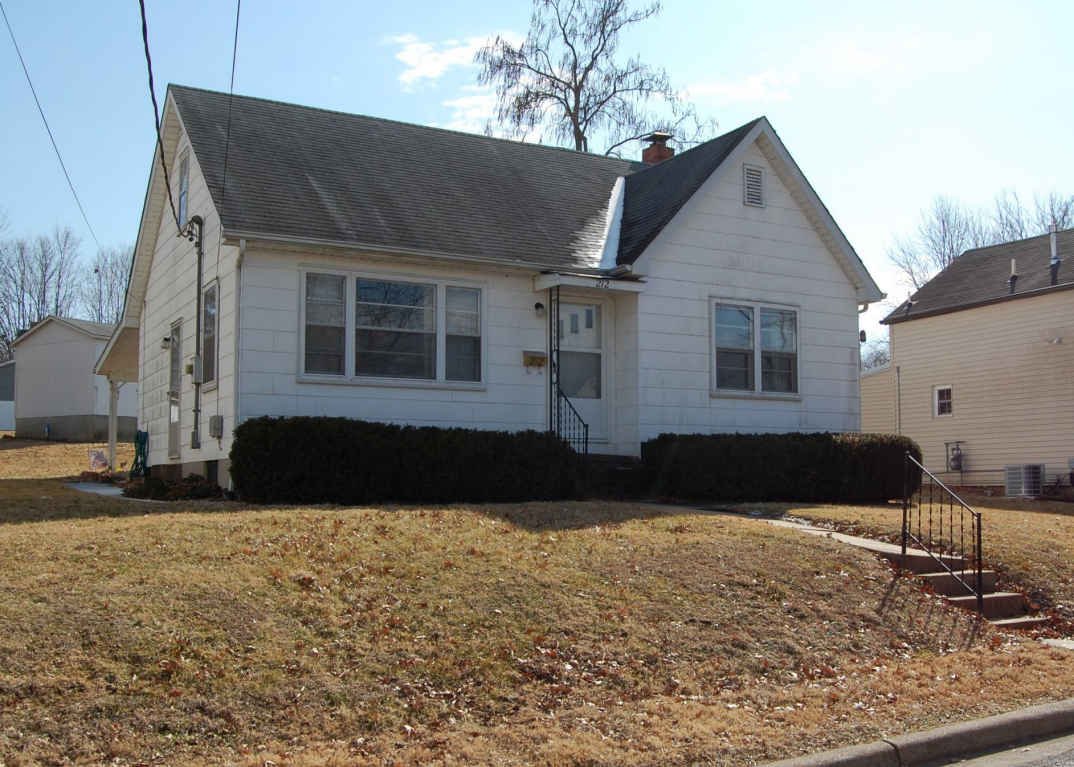
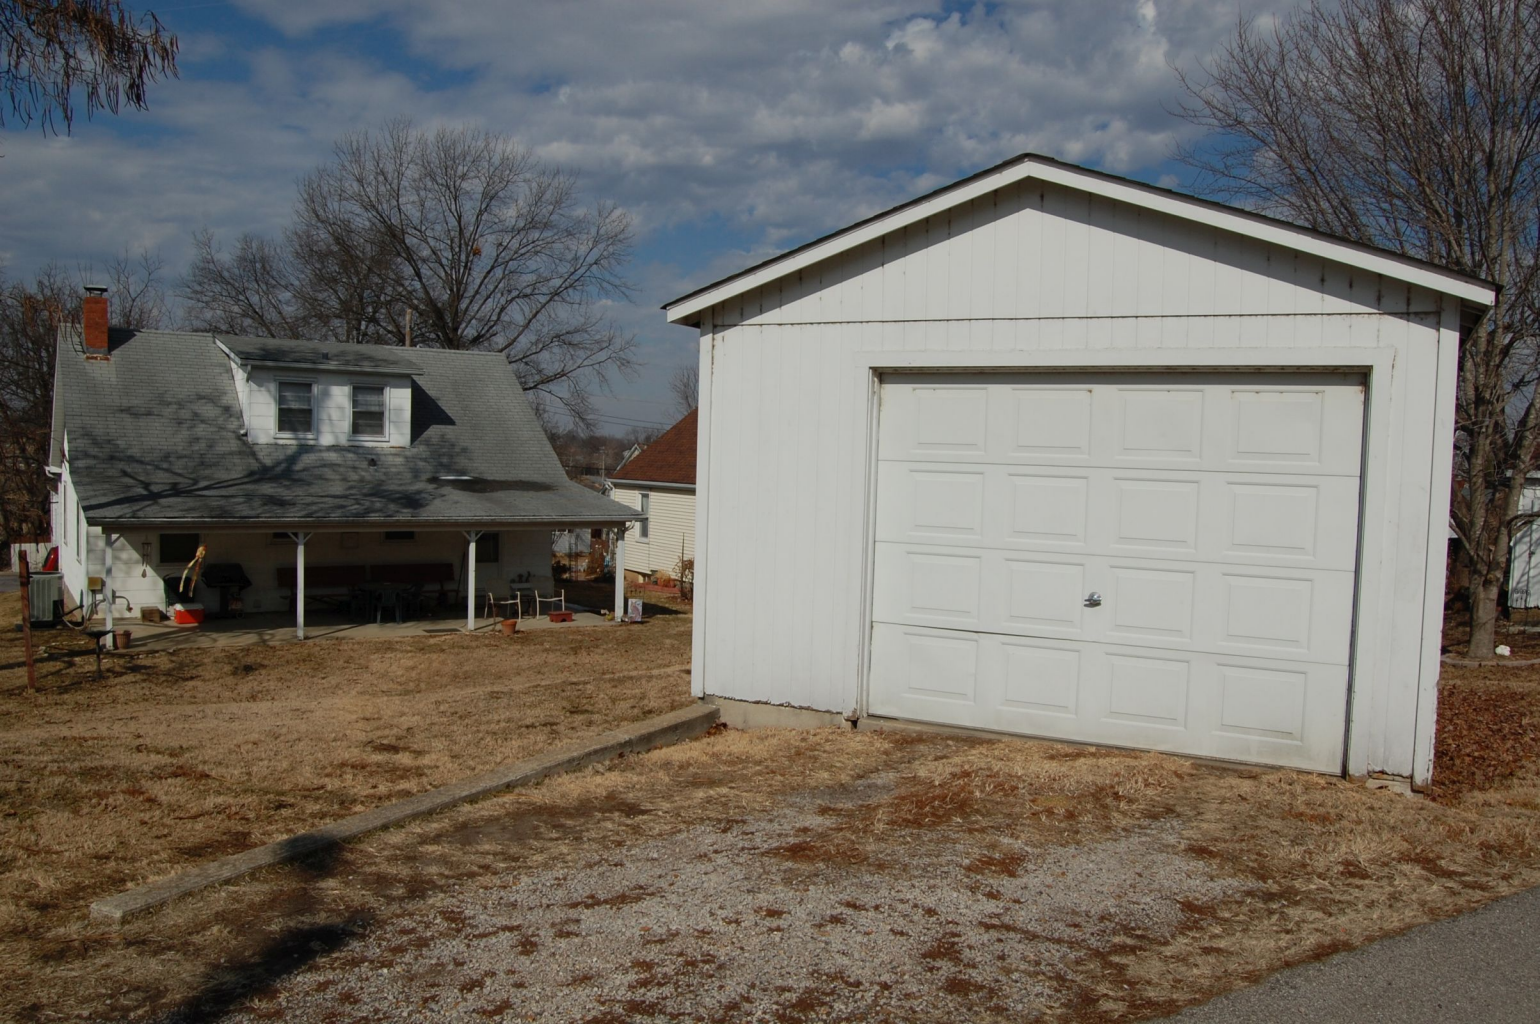
This one story home has a side gable asphalt shingle roof and a concrete foundation. There is a front gable bay at the right side of the facade. There is a concrete platform porch centered on the facade beneath a flat roof with a single wrought iron support. There is a simple wrought iron railing. There is a historic door with three vertical lights behind a storm door. To the left of the porch is a window bay containing three 2/2 double hung aluminum sash with horizontal mullions. The central light is wider than those that flank it. To the right of the entry in the front gable section is a pair of 2/2 double hung aluminum sash with horizontal mullions. Centered on the upper half story gable end is a single window bay containing a 1/1 double hung vinyl sash. The building is clad with asbestos shingle siding. On the rear elevation (E) is a full width incised porch. This property was not surveyed in 1992.

This building is considered eligible for listing in a potential NR district due to its date of construction and retention of historic materials.

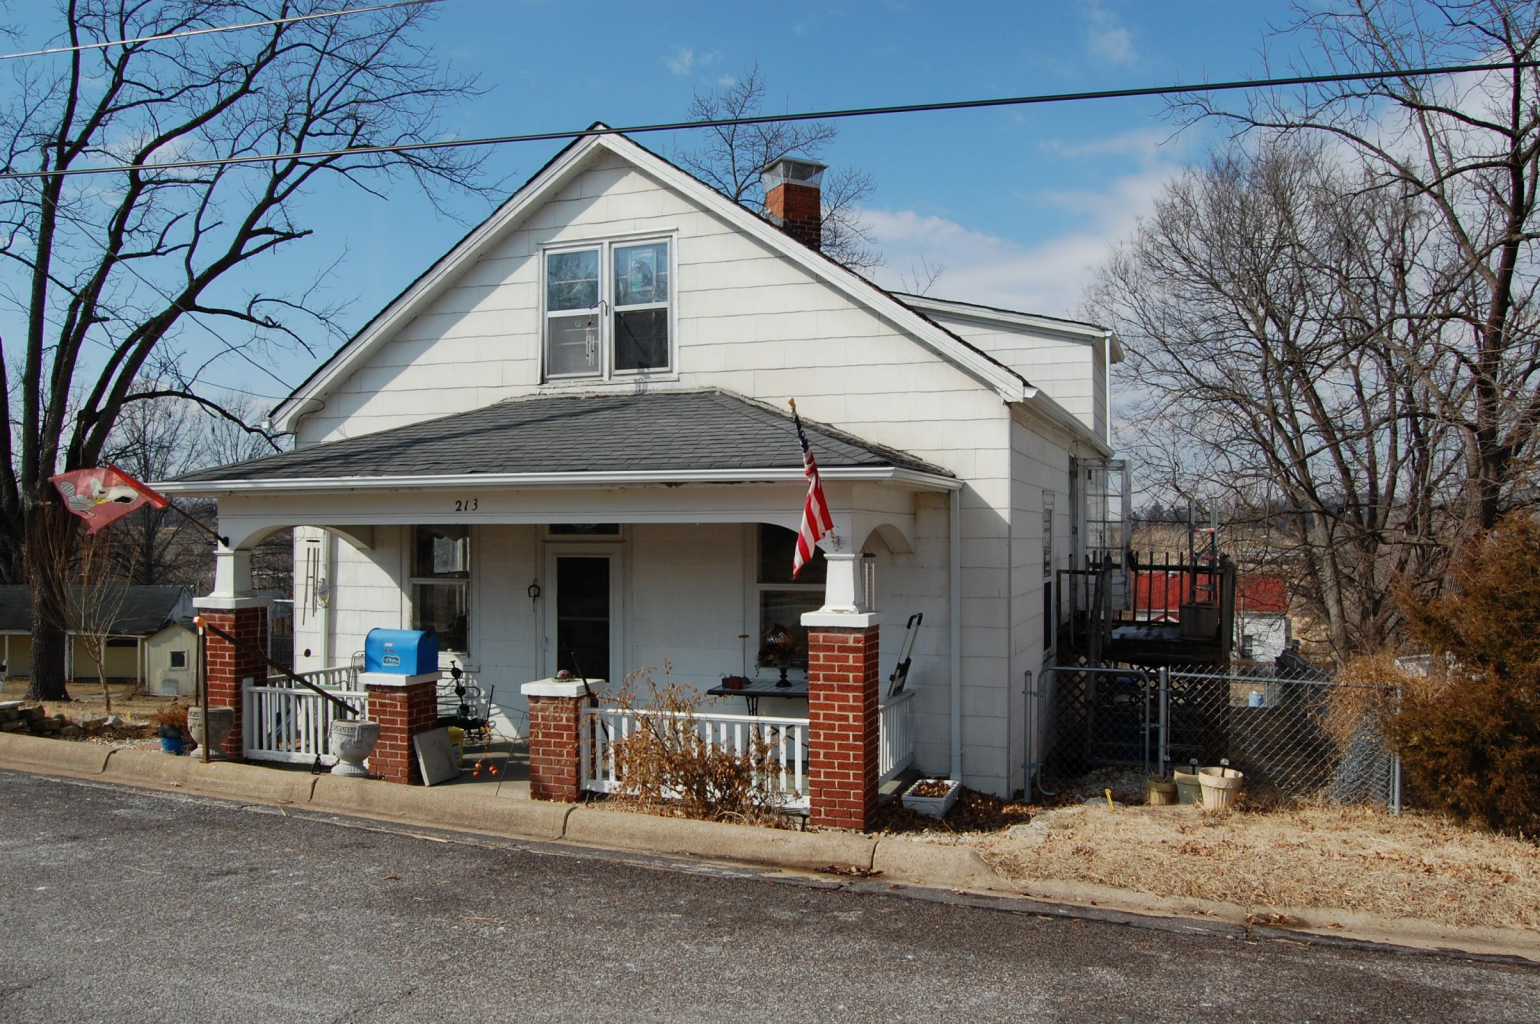
Due to the presence of historic (possibly original) siding, historic (possibly original) wooden sash windows and a historic (possibly original) porch, this building is considered eligible for listing in a potential NR district.

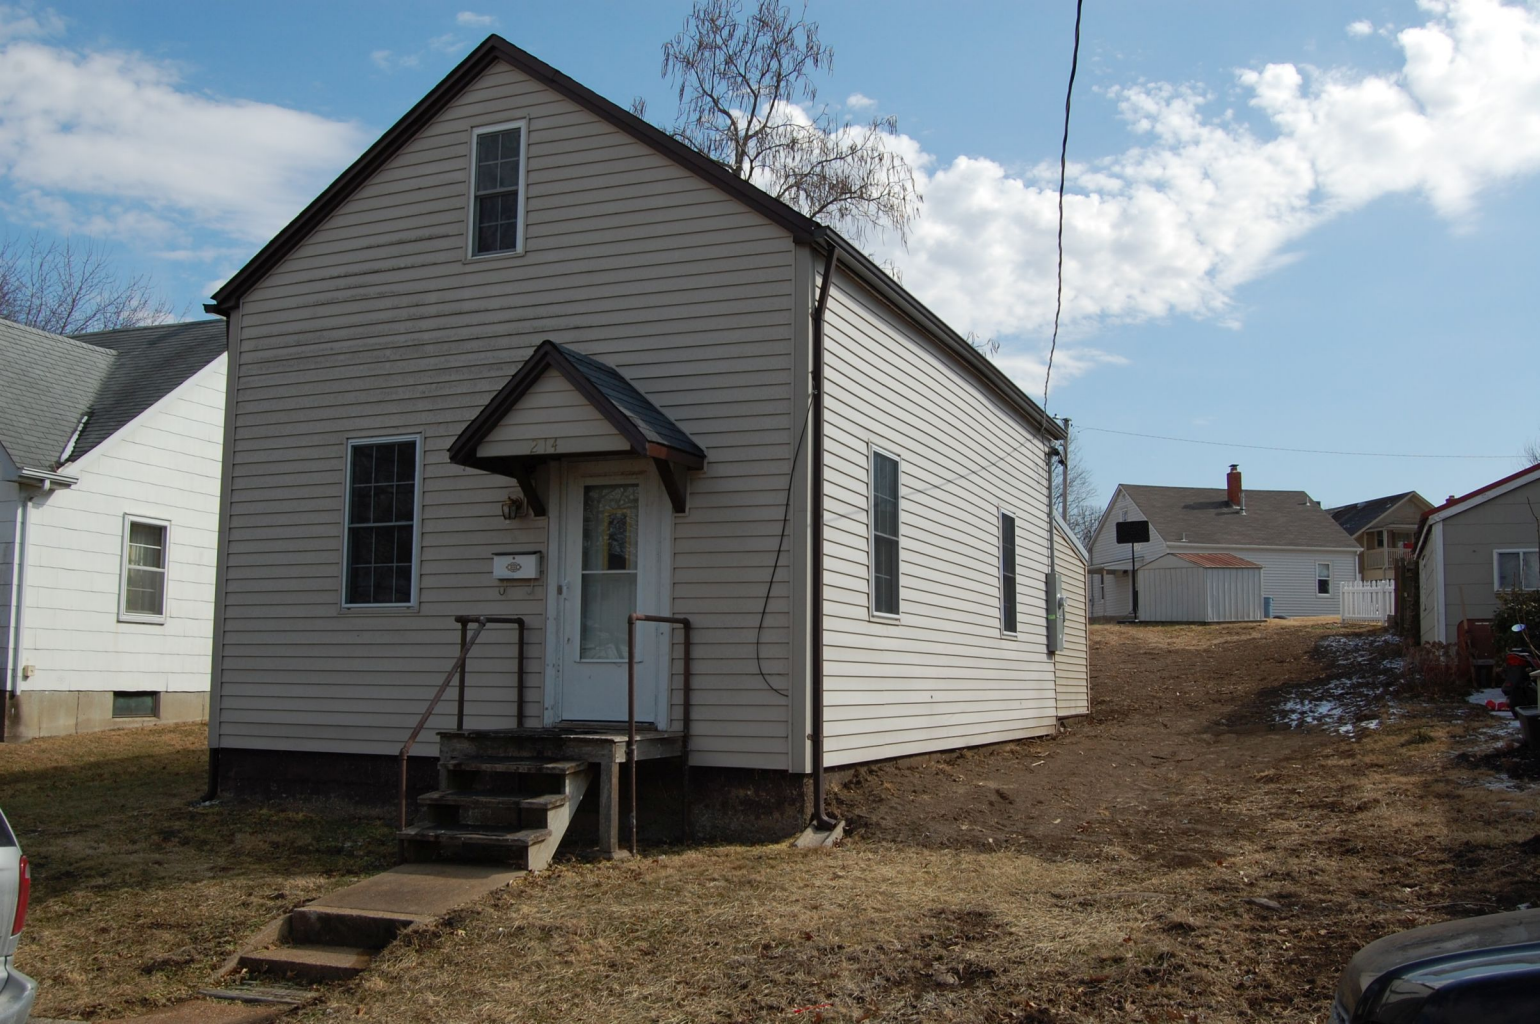
Due to the presence of vinyl siding and replacement windows, this building is not considered eligible for listing in a potential NR district.

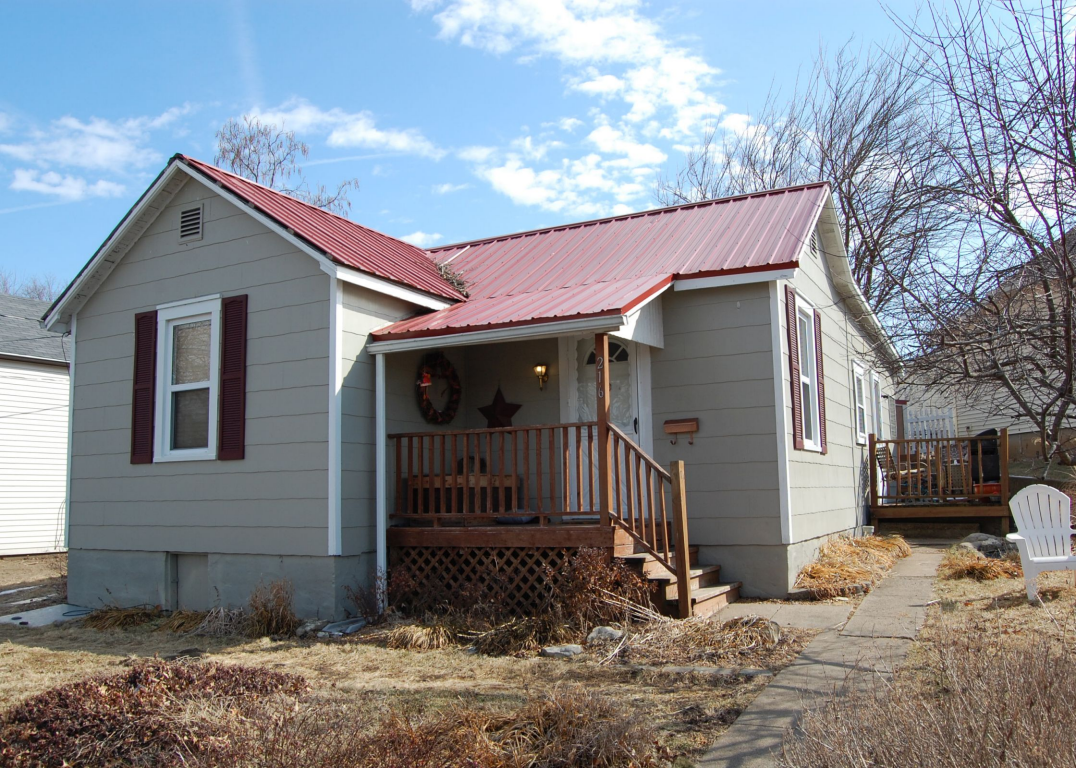
This one story frame gable front and wing home has a newer standing seam metal roof and a concrete foundation. The metal roof is not original and has been installed over an asphalt shingle roof system but has retained its historic exposed eaves. There is a non historic wooden platform porch within the front ell. It has a wooden balustrade with a single square wood post supporting a shed roof slightly extended from the primary. It is accessed via wooden stairs that run parallel to the facade. The entry contains a replacement metal door with a fanlight light behind a storm door. To the left of the porch, in the front gable section, is a window bay containing a 1/1 replacement vinyl sash with non-operative plastic shutters. Centered on the upper half story gable end is a louvered attic vent. The building is clad with asbestos shingles. This property was not surveyed in 1992.

Due to the accumulation of changes (new metal roof, non-historic porch, and replacement windows and door) this building is not considered eligible for listing in a potential NR district.

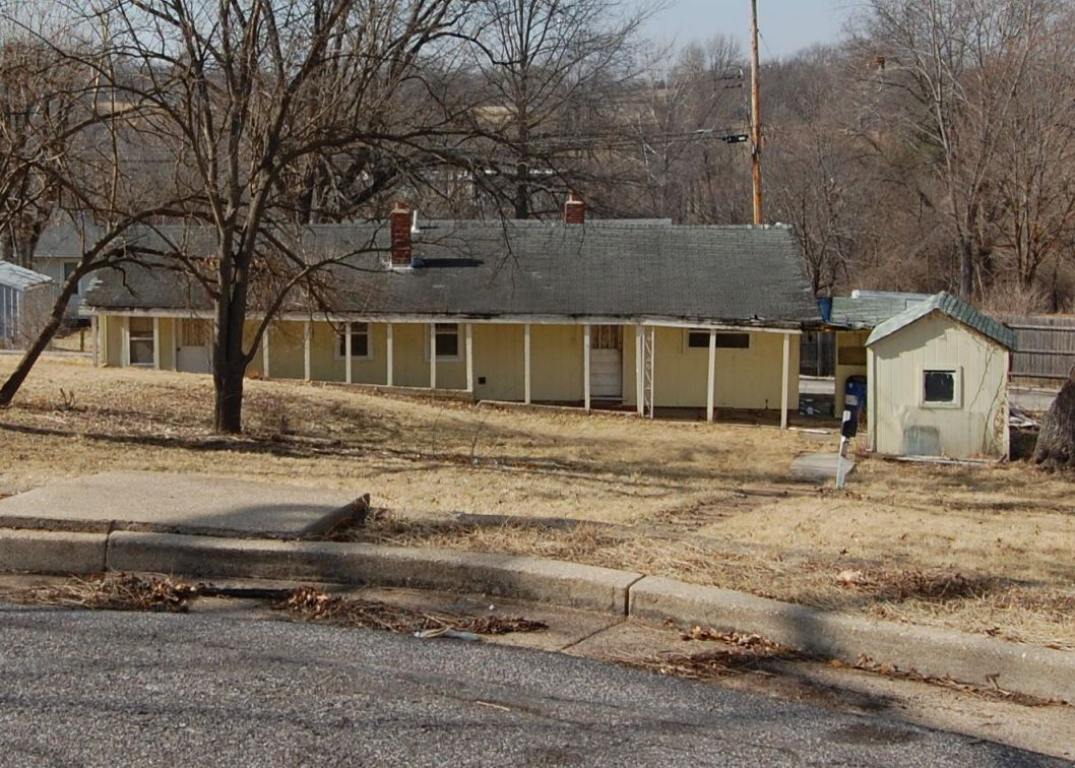
This 1 story frame side gable home has an asphalt shingle roof, plywood siding, and a concrete foundation. Two square brick chimneys extend from either side of the roof ridge. There is a full width veranda along the front facade which is 6 bays wide. There are three doors on the primary elevation. One entry is offset right and contains what is likely to be an original three horizontal panel door with three vertical lights. To the right of this entry is a window bay. To the left of this entry are two more window bays followed by a newer door with square light glass and a window bay. Windows are older 1/1 wood sash. Closer inspection along the alley side revealed that the windows are recessed in the walls and have non-historic window surrounds installed over plywood cladding. Deterioration of cladding in some areas revealed multiple layers of different cladding systems built up beneath the current wall surface. This property was not surveyed in 1992.

The house retains some significant materials however too much is unknown. Further research is needed and the house's status is therefore "not determined" for listing in a potential NR district.

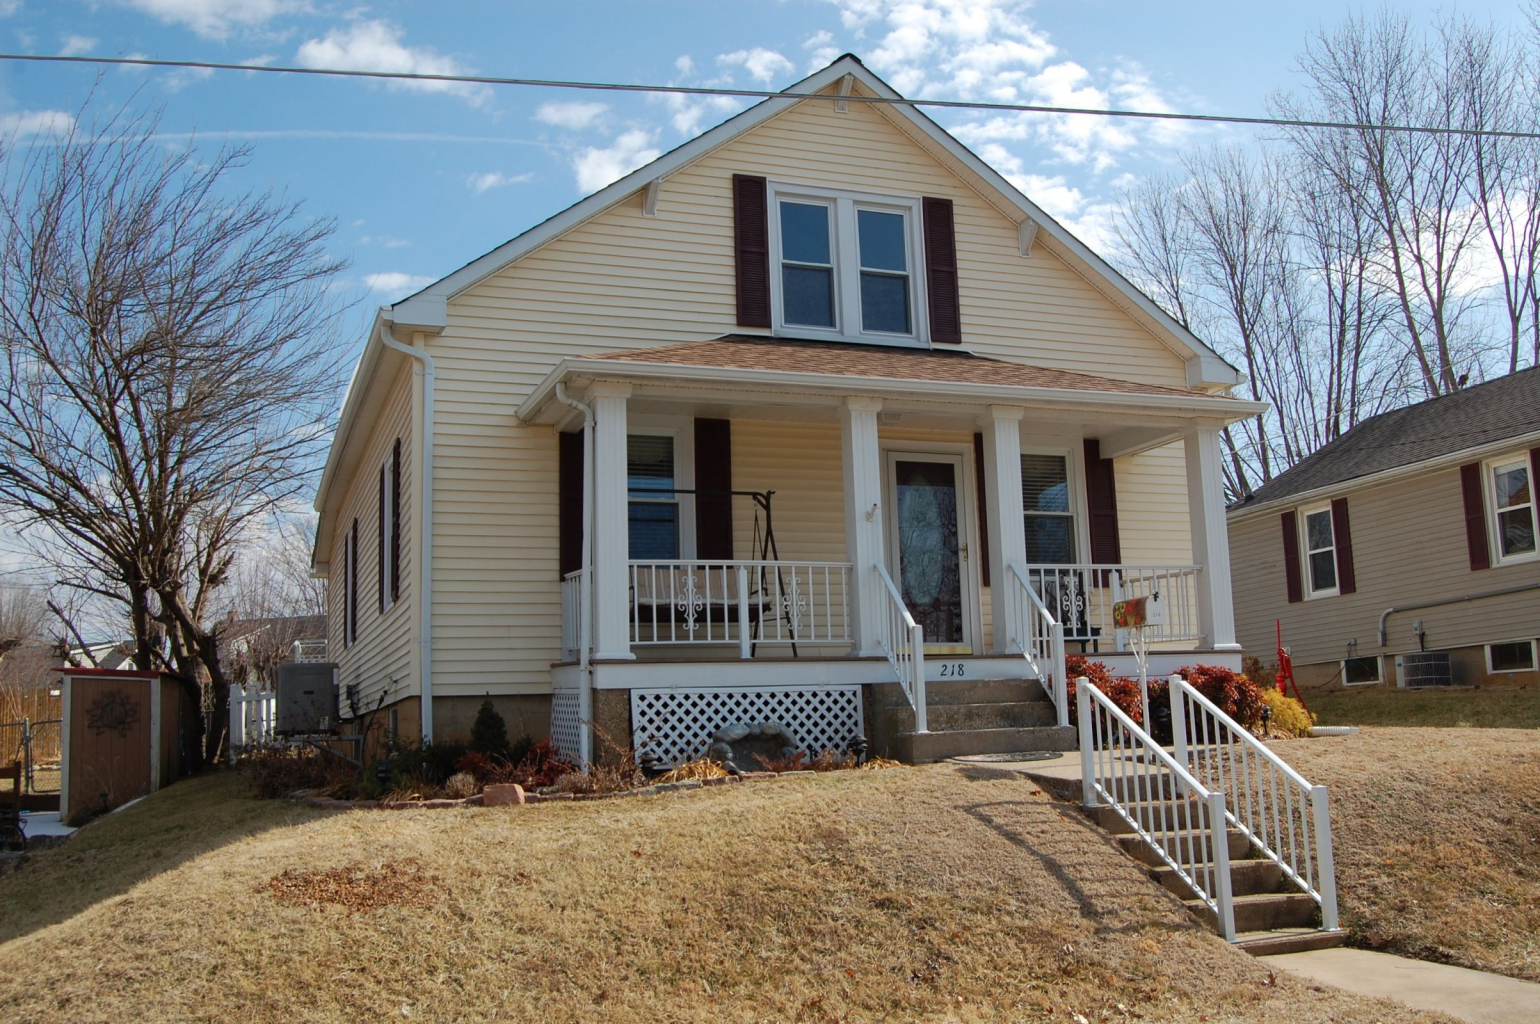
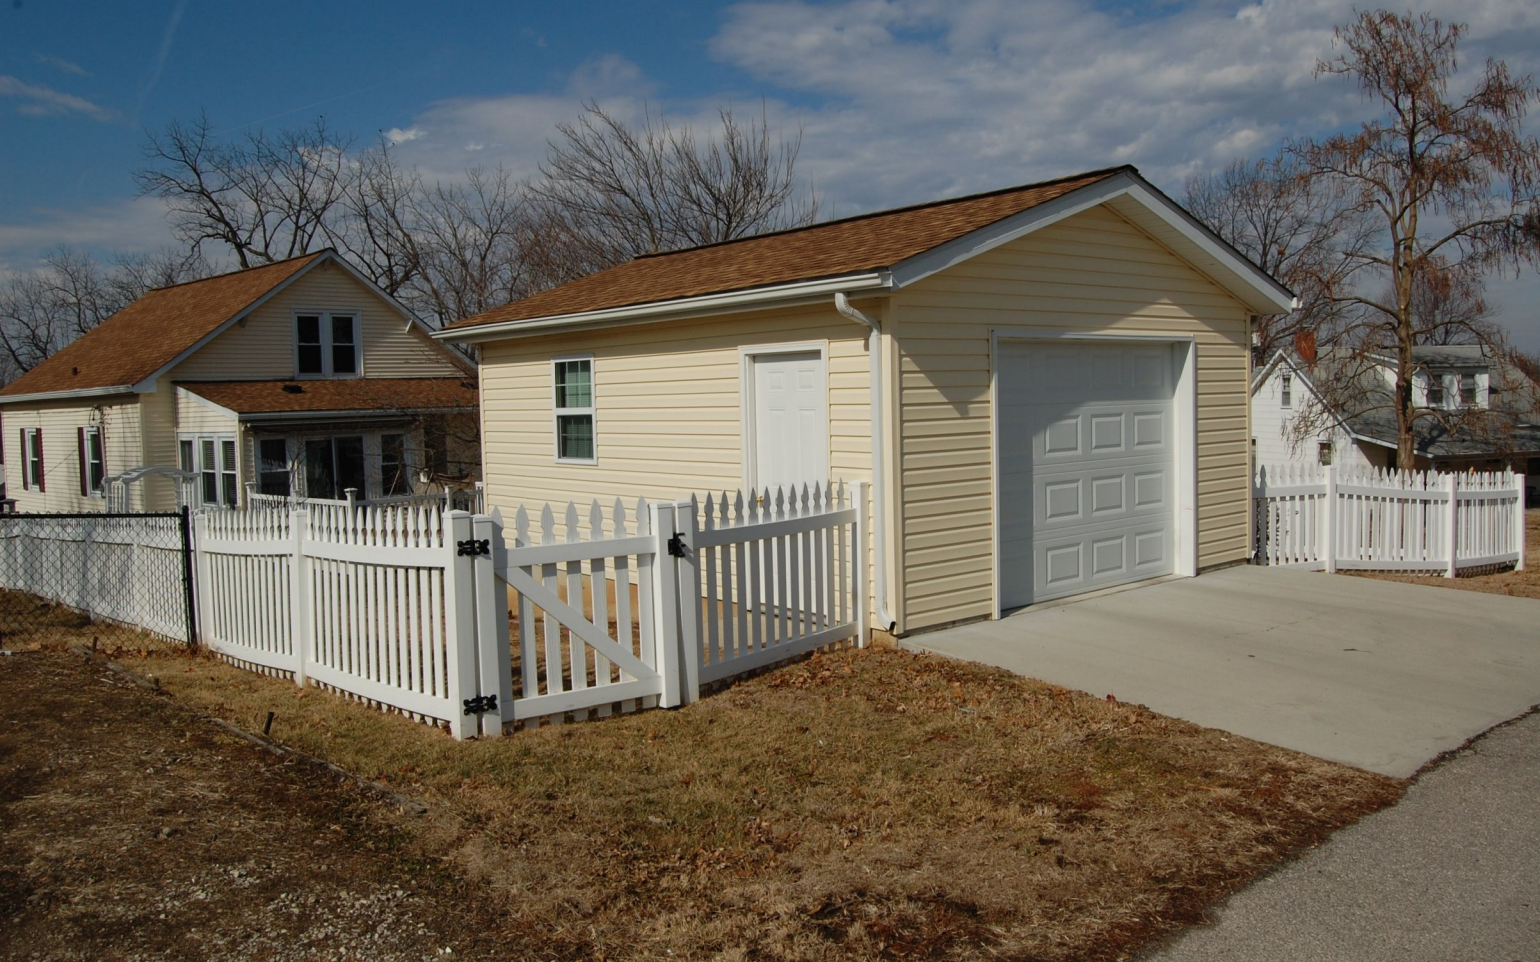
This one story frame front gable home has an asphalt shingle roof and a concrete foundation. There is a 3/4 width wooden porch with original concrete piers centered on the facade. The porch has a non-historic metal balustrade and fluted metal boxed columns supporting a hipped roof. The entry is offset right and contains a wooden door with a large oval light behind a storm door. On either side of the entry is a window bay containing a 1/1 double hung replacement vinyl sash. The window bays have non-operative plastic shutters. Centered on the upper half story gable end is a pair of 1/1 double hung replacement vinyl sash with non-operative plastic shutters. There are small faux brackets within the gable. The do not appear historic and have a plastic look. The building is clad with vinyl siding. This property was not surveyed in 1992.

Due to the presence of vinyl siding, a non-historic porch and replacement windows, this building is not considered eligible for listing in a potential NR district.

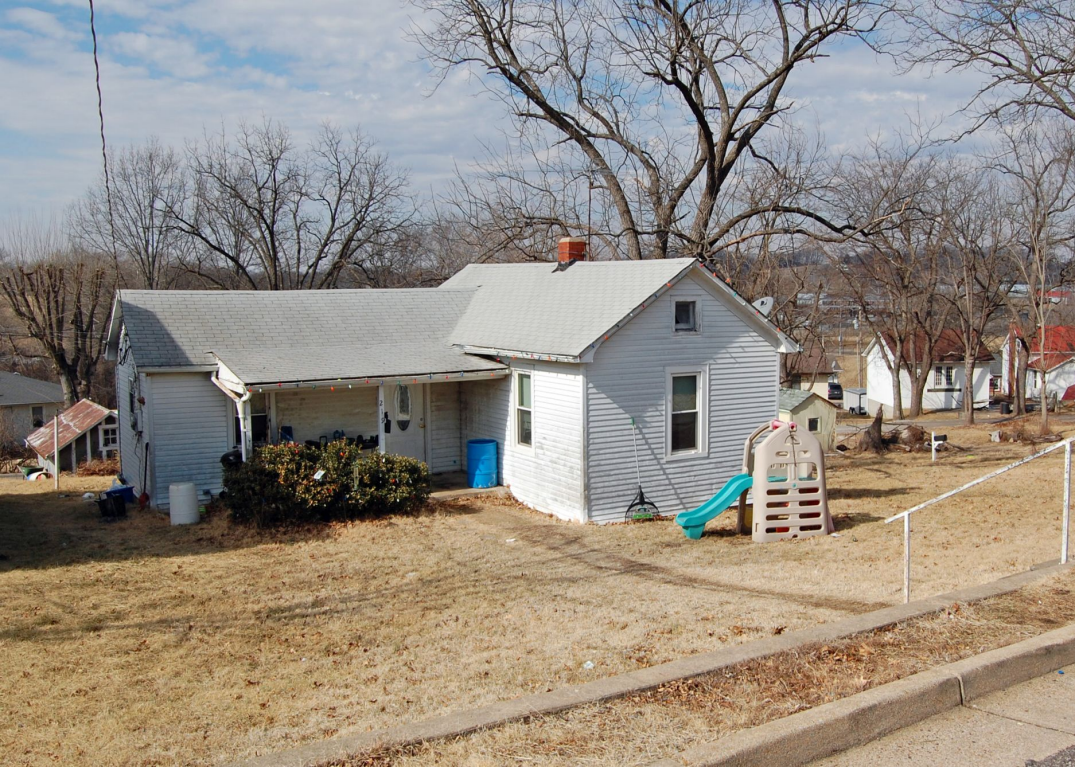
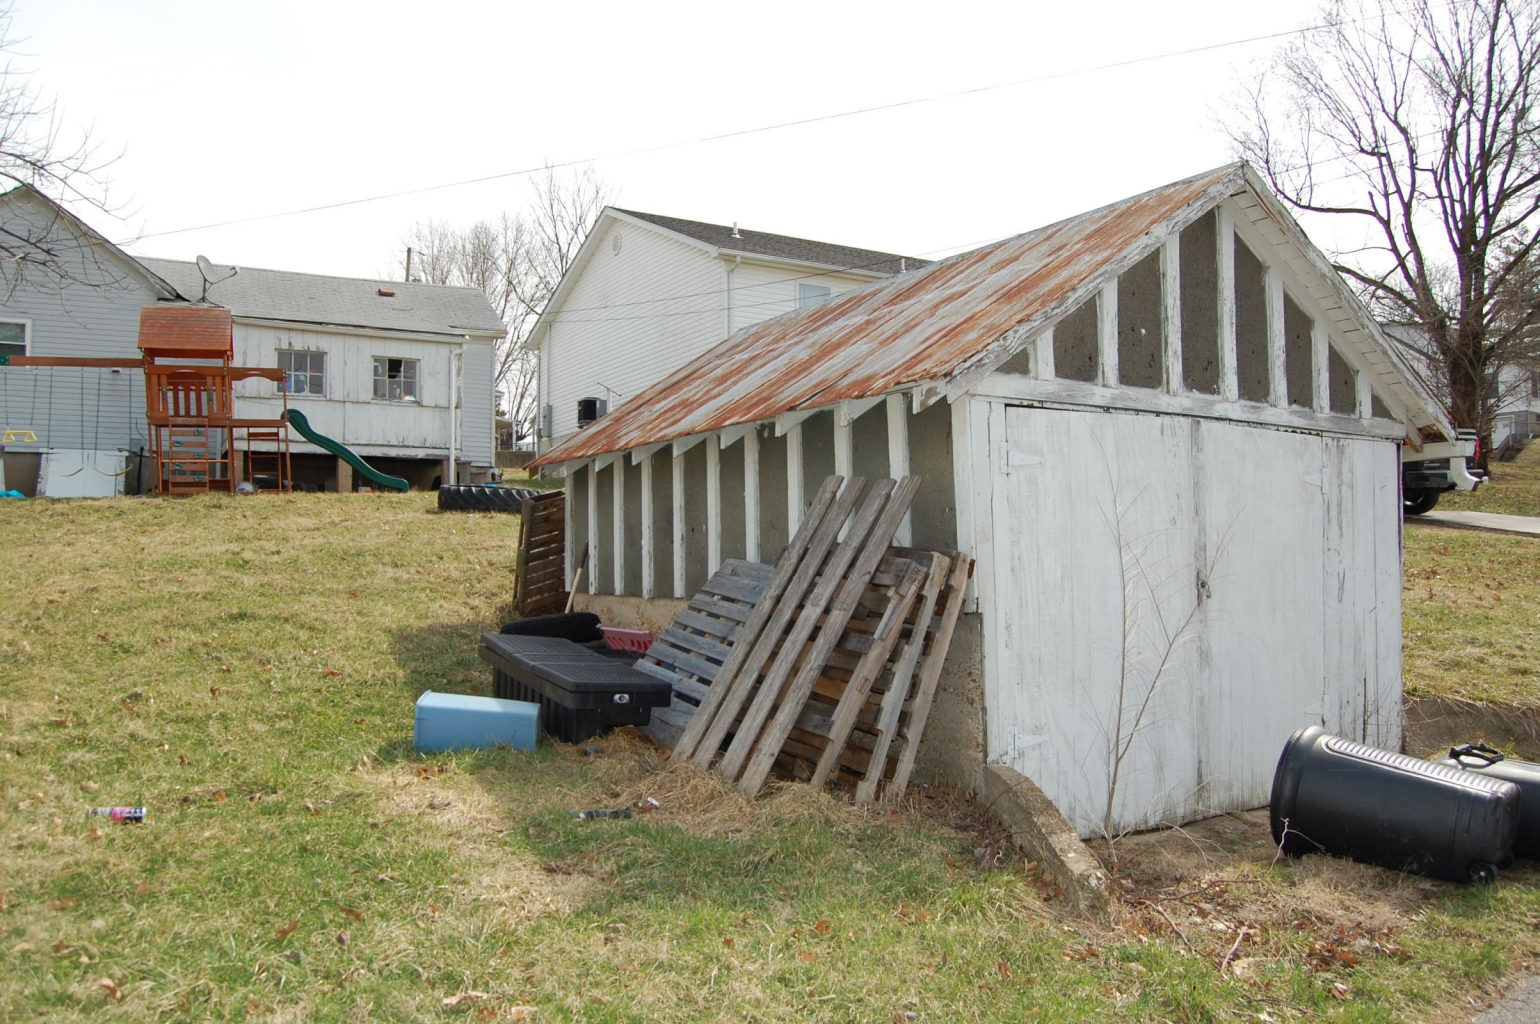
This 1.5 story frame gable front with wing home has an asphalt shingle roof and a concrete foundation. A square brick chimney extends from the center of the roof ridge of the front gable section. The front gable section has a window bay on the first floor and on the upper half story. The first floor window is a 1/1, double hung vinyl replacement sash. The upper floor has a single light wooden casement window. The side gable wing section has a concrete platform porch with two square wooden columns supporting a shed roof. The porch runs 3/4 width of the side gable section. The entry is accessed from the porch and contains a non-historic metal panel door with fixed light. To the left of the entry is a window bay with sash obscured by a storm window. The building is clad with aluminum siding. This property was not surveyed in 1992.

Due to the presence of replacement siding and replacement window sash this building is not considered eligible for listing in a potential NR district.
