MISSOURI DEPARTMENT OF NATURAL RESOURCES
STATE HISTORIC PRESERVATION OFFICE, P.O. Box 176, Jefferson City, MO 65102
ARCHITECTURAL/HISTORIC INVENTORY FORM

1. SURVEY NO. FR-AS-007-001		2. SURVEY NAME: International Shoe Factory Neighborhood	
3. COUNTY: Franklin		4. ADDRESS (STREET NO.) 605	STREET (NAME) West 3rd Street

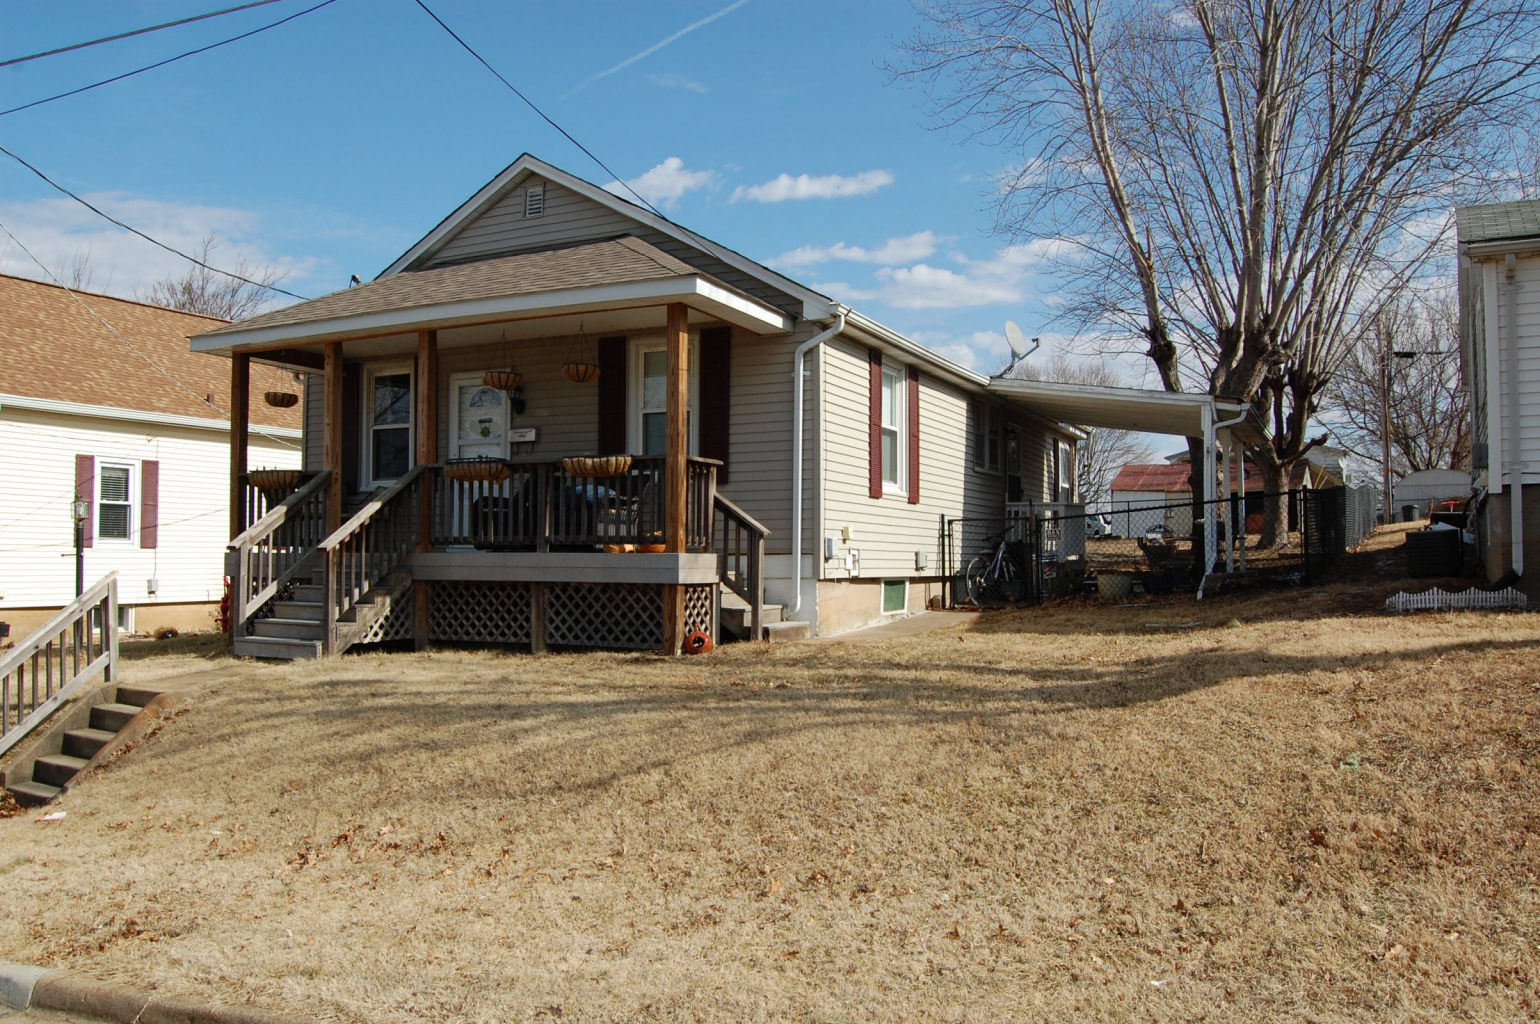
This one story frame front gable home has an asphalt shingle roof and a concrete foundation. There is a non-historic full width wooden porch with square wooden supports centered on the facade. The porch has a wooden balustrade and a hipped roof. The entry is offset left and contains a non-historic metal door with a fan light behind a storm door. On either side of the entry is a window bay containing a 1/1 double hung sash. Sash material is obscured by storm windows. The window bays have non-operative plastic shutters. The building is clad with vinyl siding. This property was not surveyed in 1992.

Due to the presence of vinyl siding, a non-historic porch and replacement windows and door, this building is not considered eligible for listing in a potential NR district.

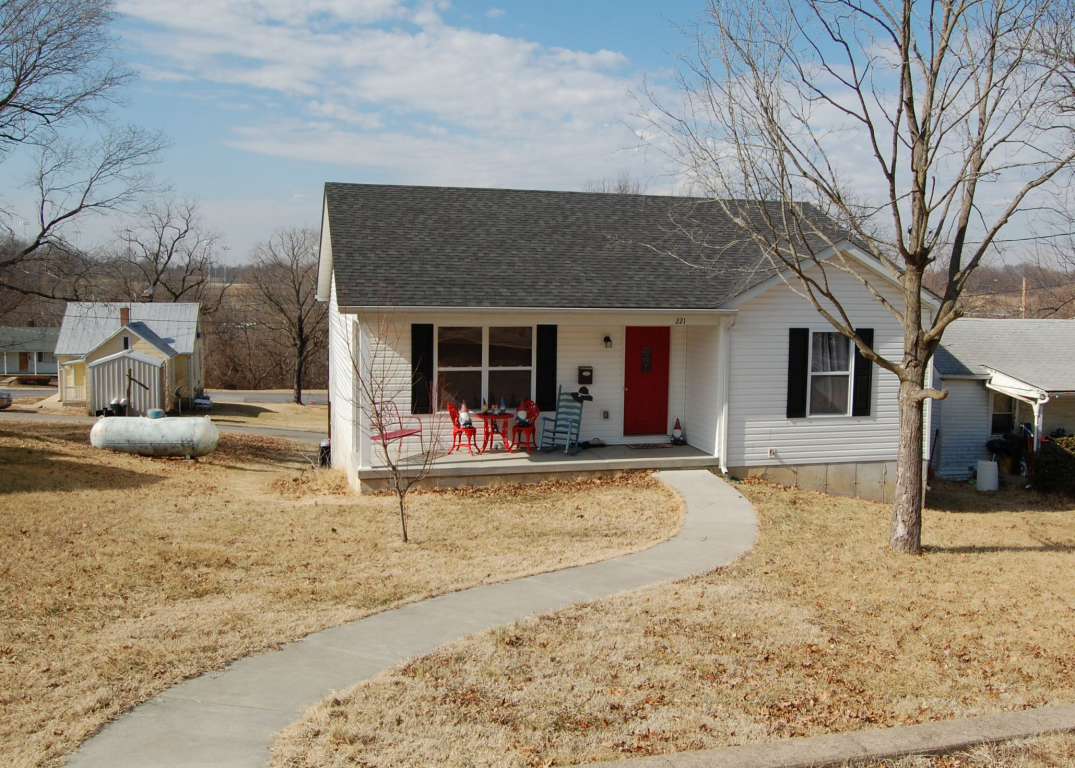
This 1 story frame Gable Front and Wing home has an asphalt shingle roof and a concrete foundation. A shallow front gable bay projects from the main body of the side gable building on the right side of the facade. The front gable section has a window bay containing a single 1/1 double hung vinyl sash with inoperative plastic shutters. To the left of the front gable section is the entry. The entry is situated beneath the overhanging eave of the roof which shelters a shallow 3/4 width concrete slab porch. The porch roof has two vinyl boxed square supports. The entry contains a panel door of indeterminate material with a small rectangular light. To the left of the entry is a pair of 1/1, double hung vinyl sash with inoperative plastic shutters. The building is clad with vinyl siding. This property was not surveyed in 1992.

Due to its recent date of construction, this building is not considered eligible for listing in a potential NR district.

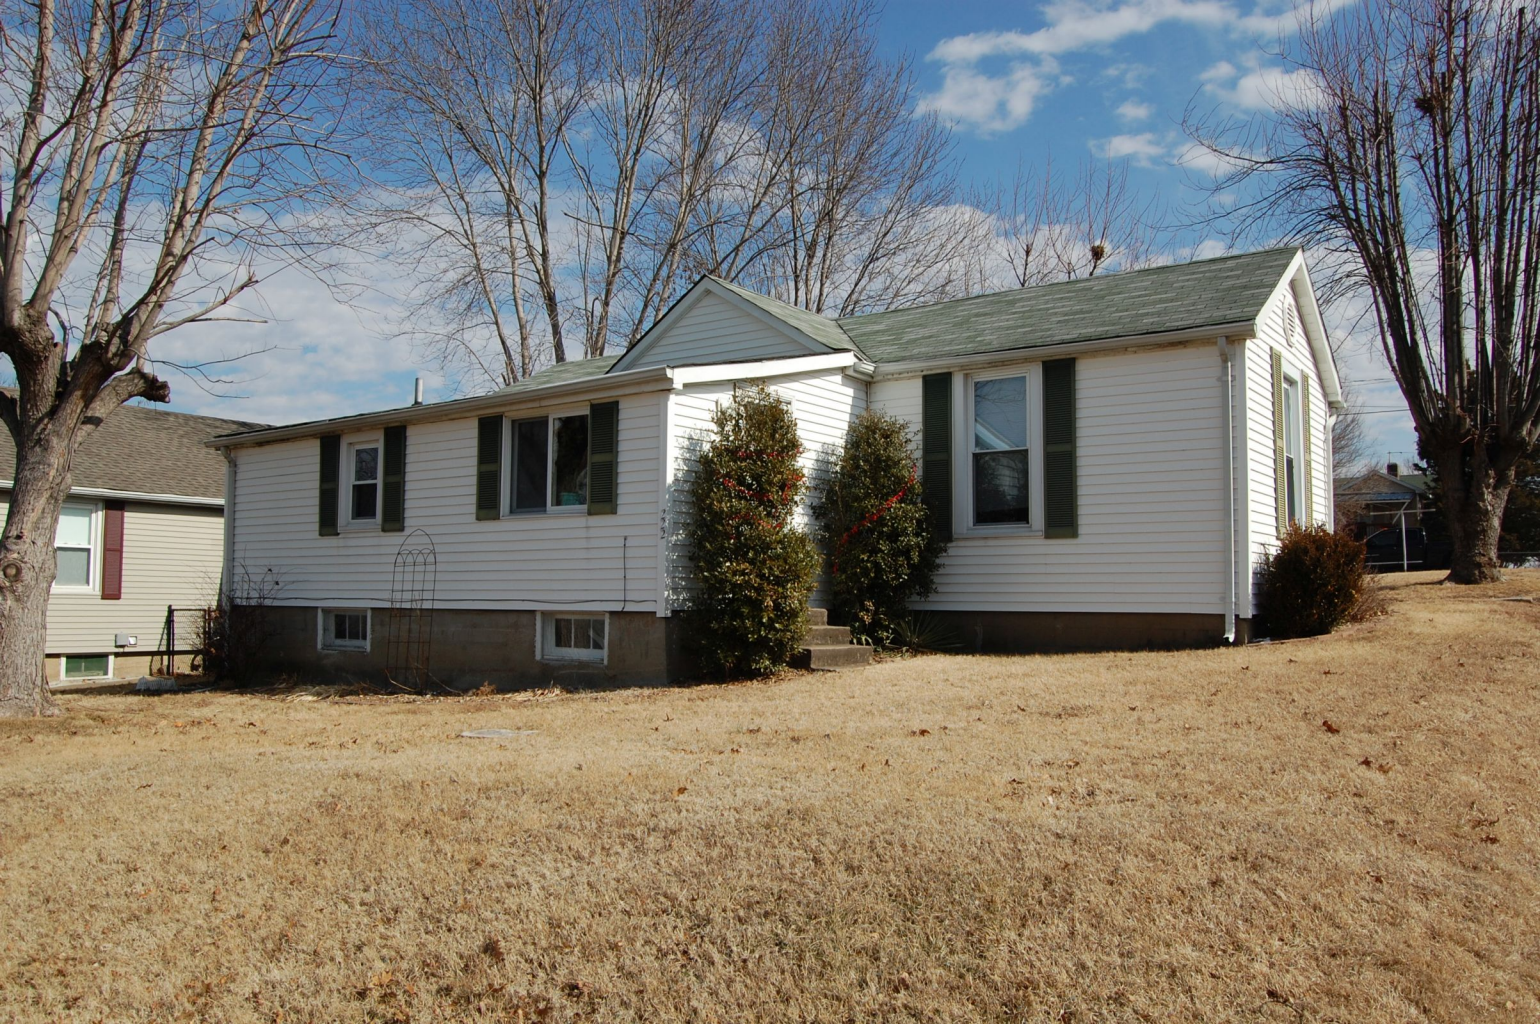
This one story frame cross gable home has an asphalt shingle roof and a concrete foundation. There is a $\frac{3}{4}$ width; side left 1-story shed roof addition to the front of the home. It appears to be an older addition. This section has a sliding glass window and a single window bay of 1/1 vinyl sash on the front and two, 3-light wood sash casement windows in the foundation. The foundation of the addition is a formed concrete while the older foundation is concrete parged and etched to look like stone. On the southern side of the addition is a single entry with a 3 light vertical glass and paneled wood door with older storm door. To the right of the addition, on the older section, is a single window bay with ornamental shutters. At the rear of the building is an additional entry, accessed via 3rd street. The entry is situated on the side of the front gable section beneath a shed roof with wooden supports. It has a square light glass and horizontal paneled wood door. This appears to be used as the primary entry. The building is clad with vinyl siding. There is an octagonal vinyl louvered attic vent above the single window on the gable end (S). Windows are 1/1 double hung vinyl replacement sash. This property was not surveyed in 1992.

Due to the presence of vinyl siding and a replacement window in the only window bay on the primary elevation, this building is not considered eligible for listing in a potential NR district.

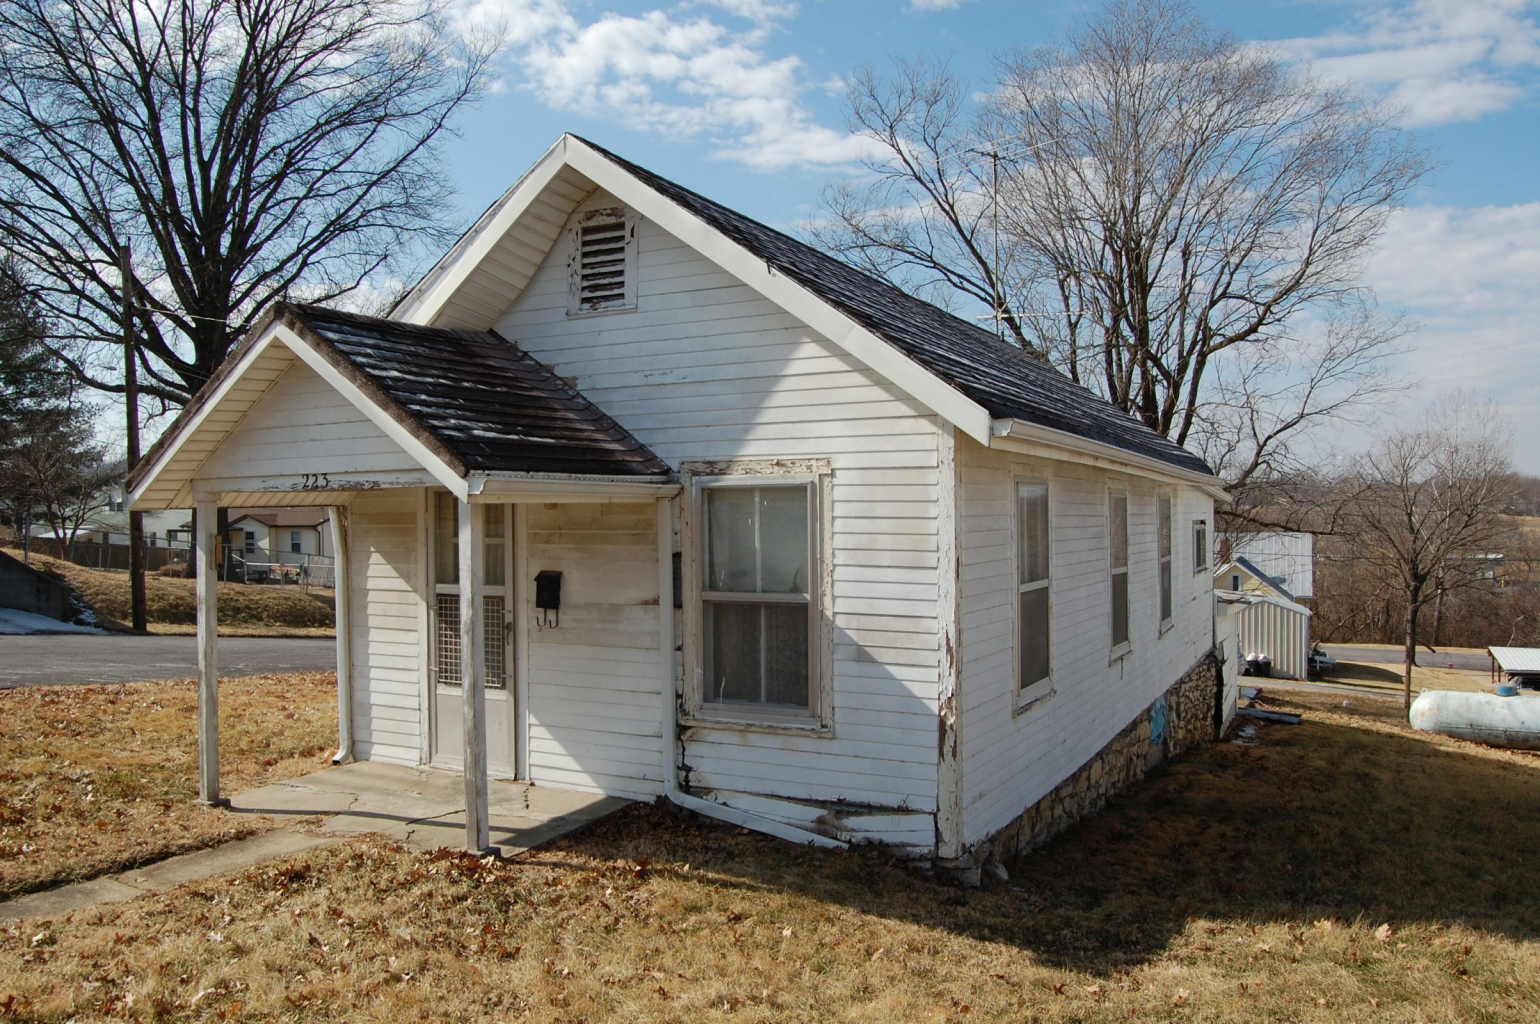
This 1 story frame front gable home has an asphalt shingle roof and a coarse limestone foundation. A shallow front gable porch roof projects from the main body of the home at the left side of the facade. The porch roof has two square brick supports extending from a concrete platform. The entry is situated beneath the porch roof and contains a historic wooden panel door with a four light fixed window with wooden muntins behind an aluminum storm door. To the right of the entry is a window bay containing a single 2/2 double hung wood sash window in a flat wooden surround. The home is clad with deteriorating composite wood lap siding (board segments of 3 rows of lap) which is laid over asphalt shingle siding. There is a louvered attic vent centered on the attic level of the gable end. This property was not surveyed in 1992.

The house retains much of its historic integrity (windows, doors, exposed limestone foundation); however it is unclear what was the original siding. If it was originally weatherboard it would be considered contributing but if it was originally asphalt shingles it would be noncontributing. Due to the unknown nature, it is a "not determined" resource.

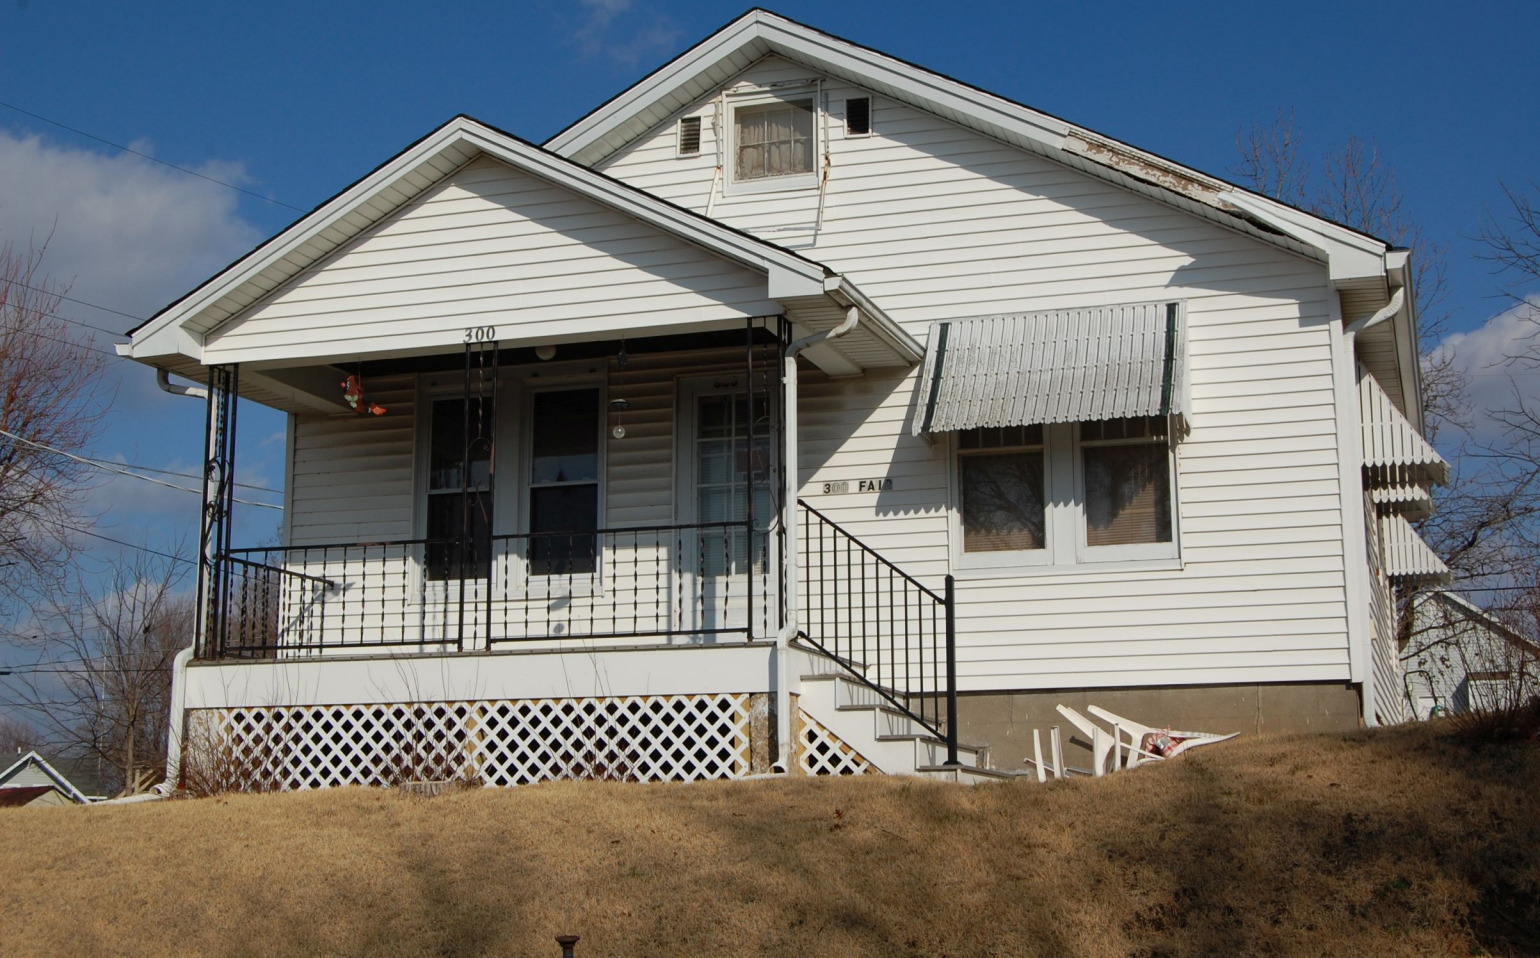
This 1.5 story frame front gable home has an asphalt shingle roof and a concrete foundation. The entry is offset slightly to the left and is situated beneath a front gable porch roof with non-historic wrought iron supports. The porch (side left) is wooden with original concrete piers and is half the width of the facade. The entry is a 3 light vertical glass and wood door obscured by a 8 light glass and wood storm door. To the left of the entry is a window bay containing a pair of a 1/1 double hung vinyl replacement sash. The frame for the paired windows retain historic hardware for storms. To the right of the entry is a window bay containing a pair of original 3/1 double hung wooden sash shaded by an aluminum awning. The building is clad with vinyl siding. The original cladding is unknown. There is an original wooden casement window with six lights centered on the upper half story gable end. The window is flanked by louvered attic vents. This property was not surveyed in 1992.

The house was built during the period of significance and retains significant materials (such as windows, door, and porch placement); however the original siding is unknown. It is uncertain whether the original siding was weatherboard, making the vinyl a similar profile replacement. Further research is needed; the house's status is "not determined" for listing in a potential NR district.

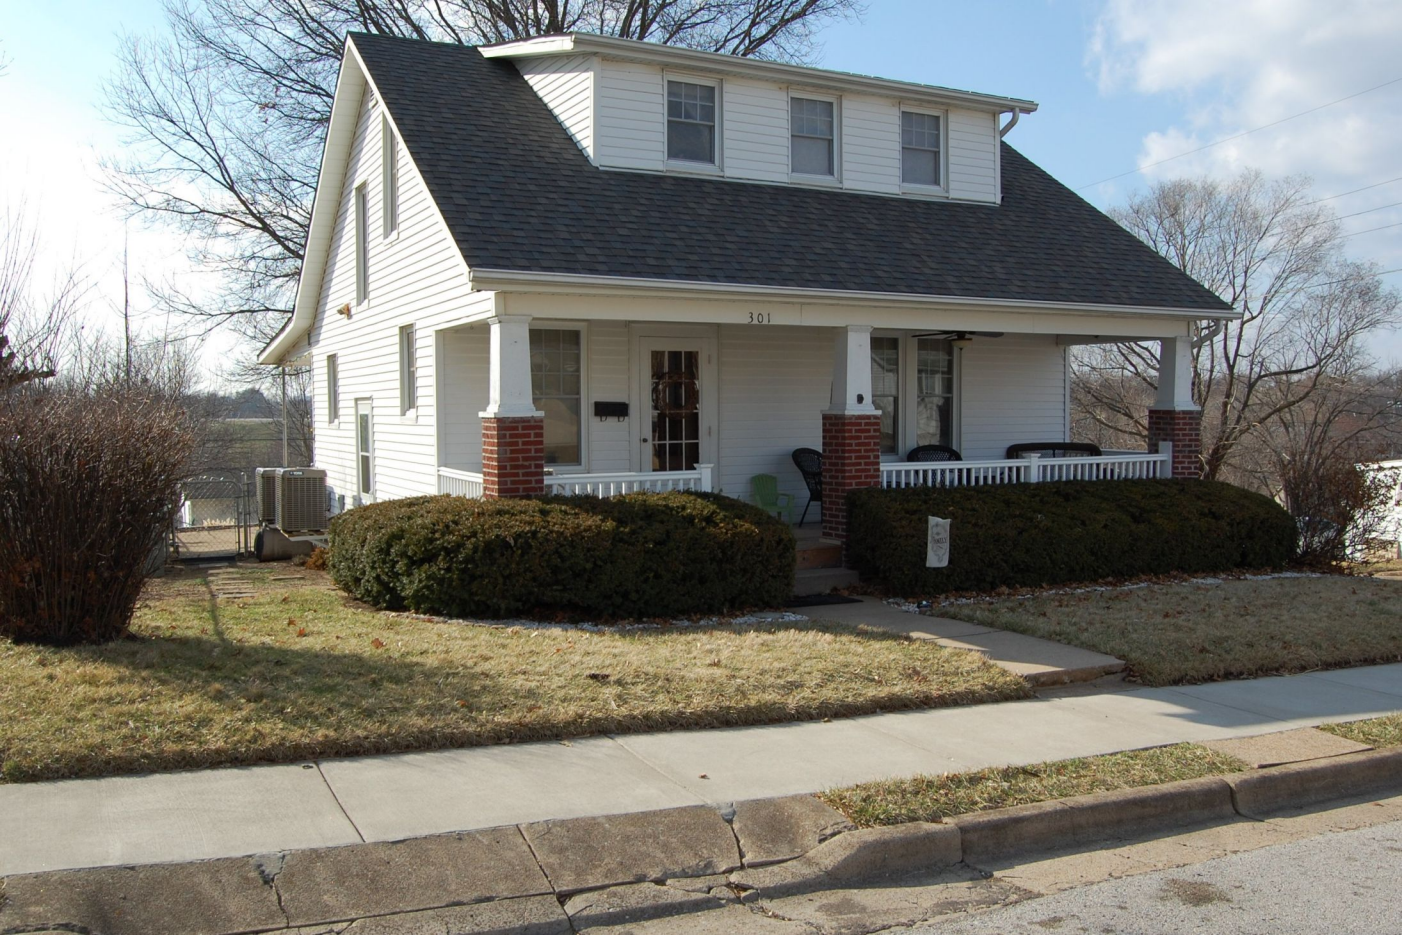
This 1.5 story frame side gable home has an asphalt shingle roof and a concrete foundation. The first floor is dominated by a full width incised porch with a concrete pad floor and vinyl balustrade. The porch roof is supported by three square brick piers capped with battered wooden columns. The entry is offset left and contains a historic wooden single panel door with twelve fixed lights with wooden muntins. On either side of the entry is a window bay. To the left of the entry, the window bay contains a single 1/1 double hung vinyl replacement sash with false muntins giving the appearance of 9/1 lights. To the right of the entry, the window bay contains a pair of 1/1 double hung vinyl replacement sash with false muntins giving the appearance of 9/1 lights. On the upper half story is a 3/4 width shed roof dormer containing three window bays. Each bay contains a 1/1 double hung vinyl sash with false muntins giving the appearance of 6/1 lights. The home is clad with vinyl siding. This property was not surveyed in 1992.

Due to the presence of vinyl siding and replacement windows, this building is not considered eligible for listing in a potential NR district.

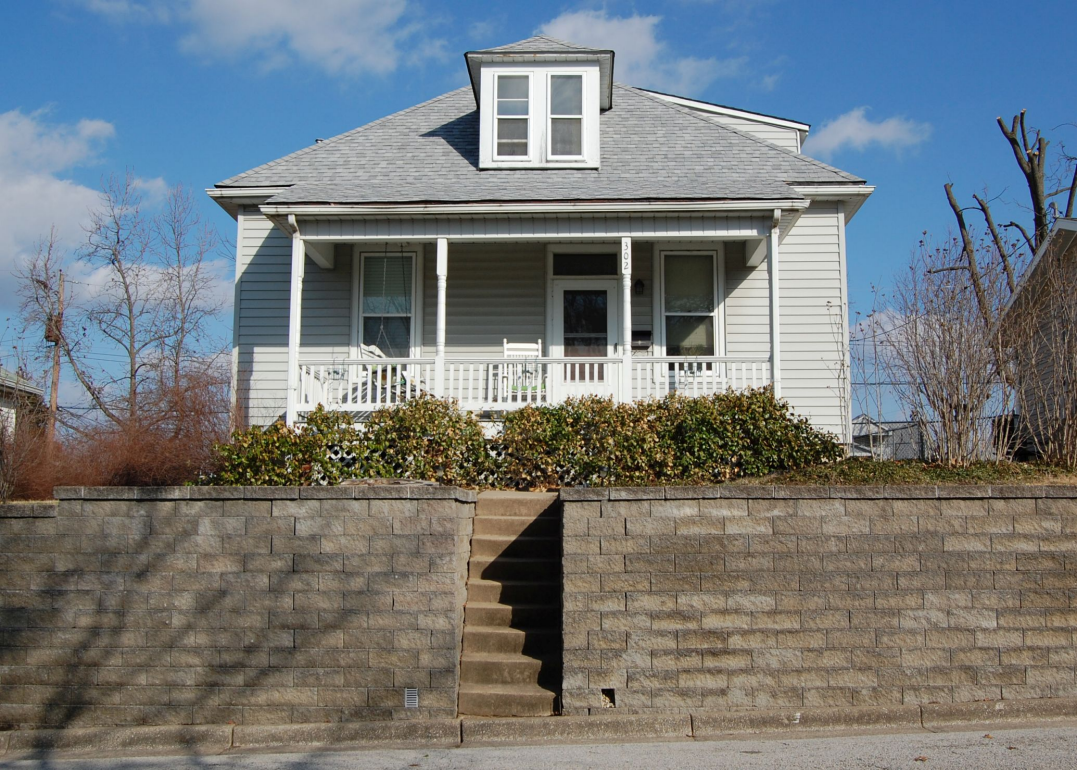
This 1.5 story frame front gable home has an pyramidal hipped asphalt shingle roof and a concrete foundation. The entry is offset right and situated beneath the shed roof of a 3/4 width centered wooden porch. The porch has a non-historic wooden balustrade and non-historic 4 turned wooden supports. The door is obscured by a storm door but appears to be wooden. There is a glazed transom. On either side of the entry is a window bay containing a 1/1 double hung sash. Sash material is obscured by storm windows and cannot be identified. The building is clad with vinyl siding. Centered on the upper half story is a hipped roof dormer with a single window bay containing a pair of 1/1 double hung replacement sash of indeterminate material. This property was not surveyed in 1992.

Due to the presence of vinyl siding and a replacement porch and windows on the primary elevation, this building is not considered eligible for listing in a potential NR district.

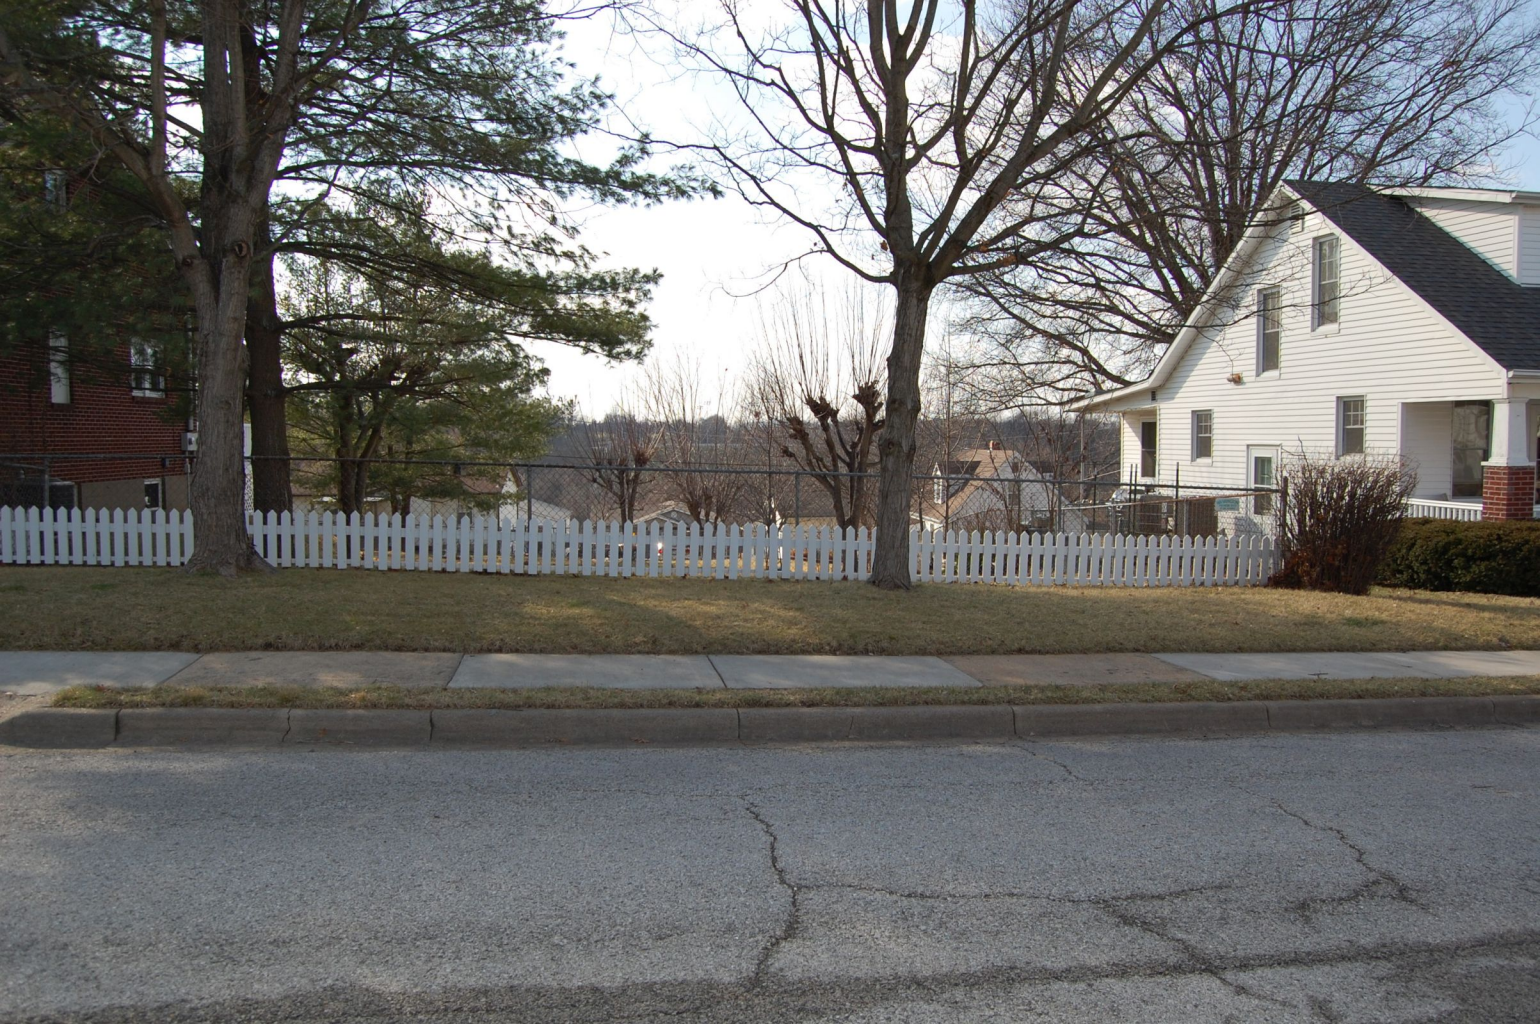
The lot is located in an urban neighborhood on the southern side of Roberts Street. It is situated between 301 and 305 Fair Street. The lot slopes downward toward the alley situated between Fair and State streets. The lot is fenced with both a low (non historic) composite picket fence and chain link. It is maintained as a grassy side yard for 305 Fair and is not currently being used for any obvious specific purpose.

While it is possible that this lot has always been used as a side yard for 305 Fair, definitive evidence has not been located. For this purpose, the lot is considered to be a contributing resource in a potential NR district until proven otherwise.

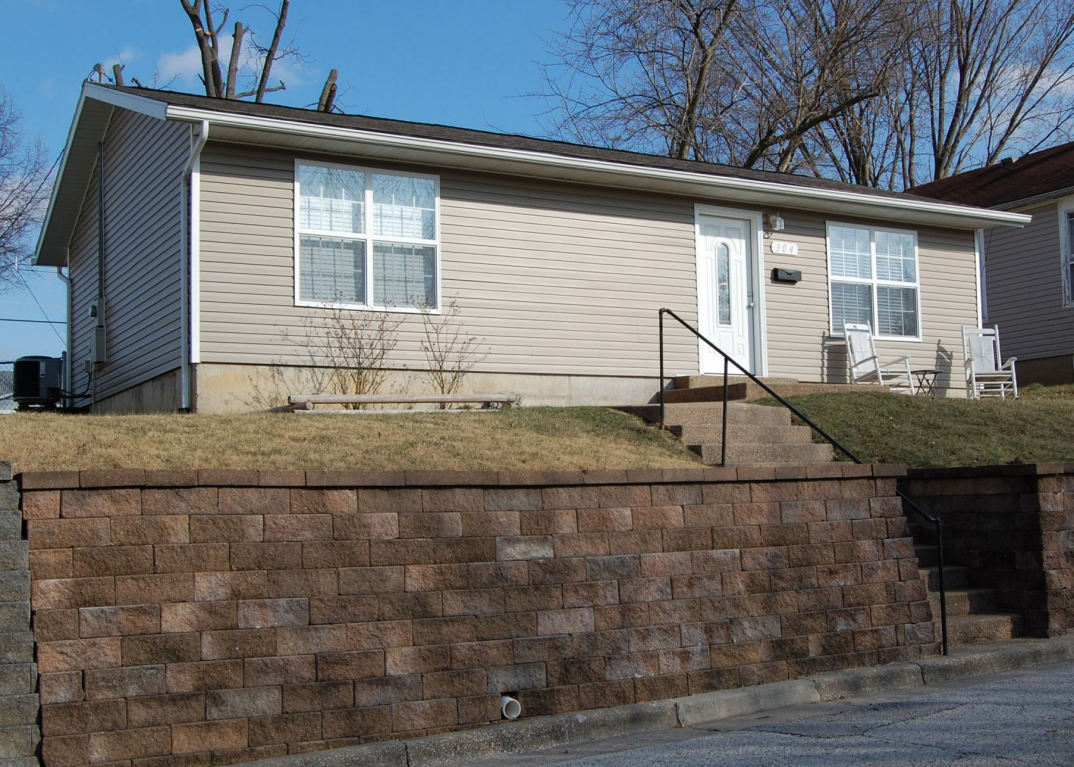
This 1 story frame side gable home has an asphalt shingle roof and a concrete foundation. The entry is offset right and contains a metal door with a arched central light. On either side of the entry is a window bay containing a pair of 1/1 double hung vinyl sash with false muntins giving the appearance of 6/6 lights.

Due to its recent date of construction, this building is not considered eligible for listing in a potential NR district.

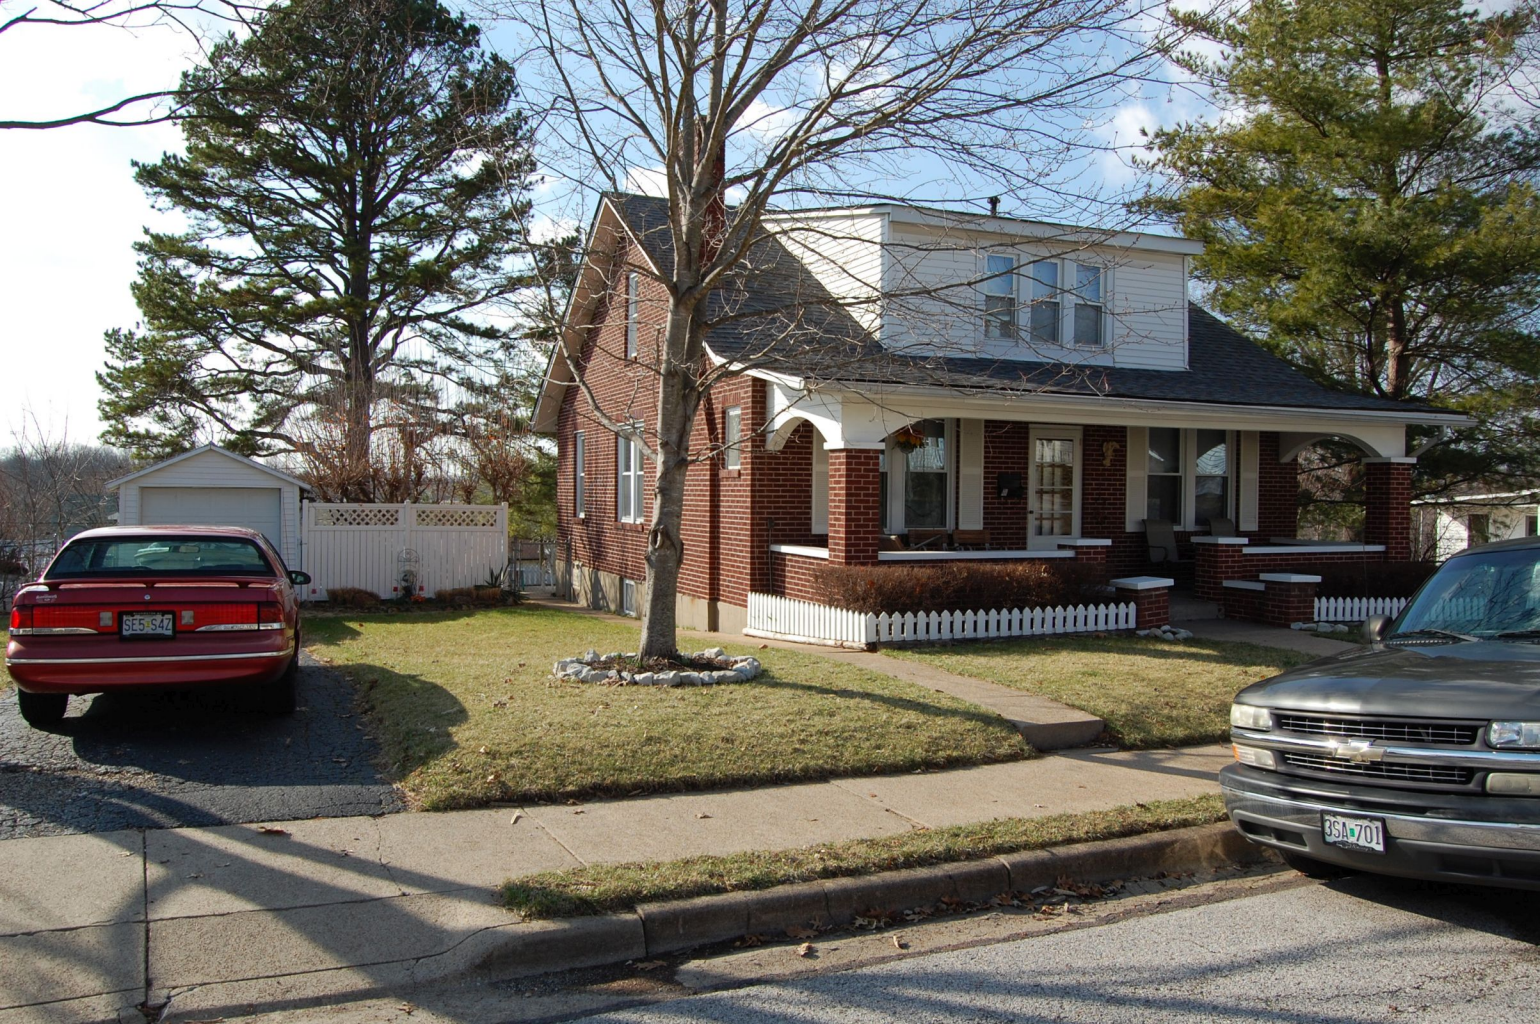
A majority of the surface area of the home as well as the prominent porch has its original brick veneer. In addition, some of the home's limited original stylistic components including the front door and curved wooden porch supports are intact. This building is considered eligible for listing in a potential NR district.

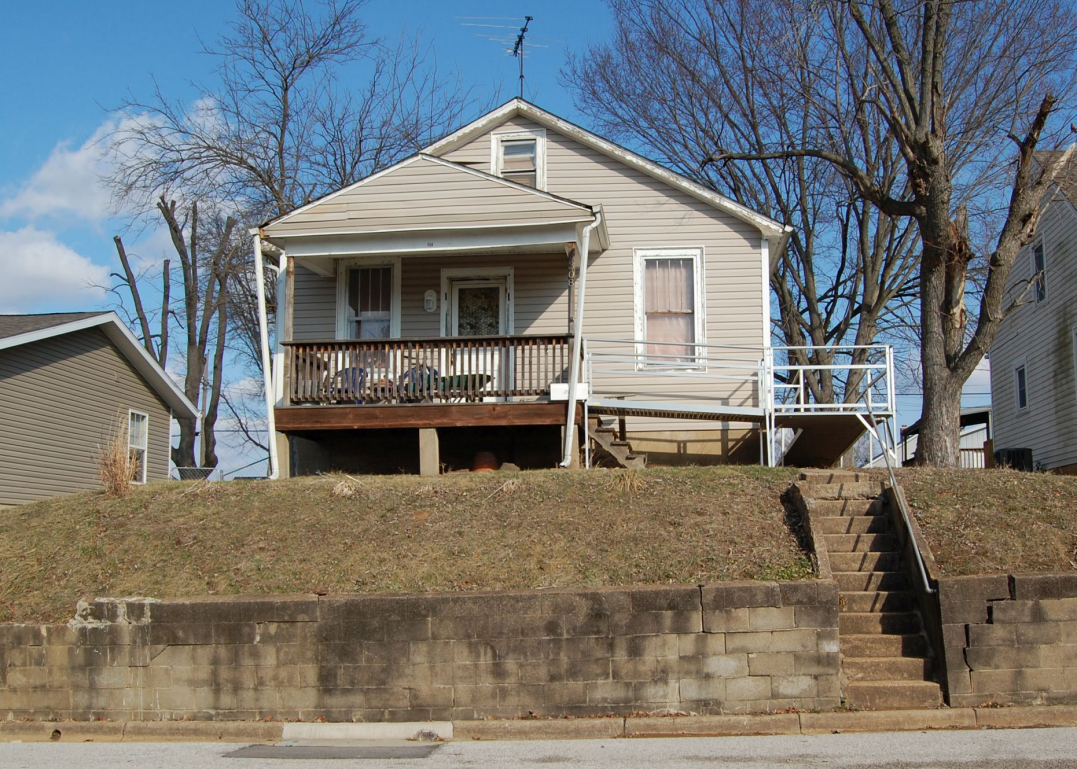
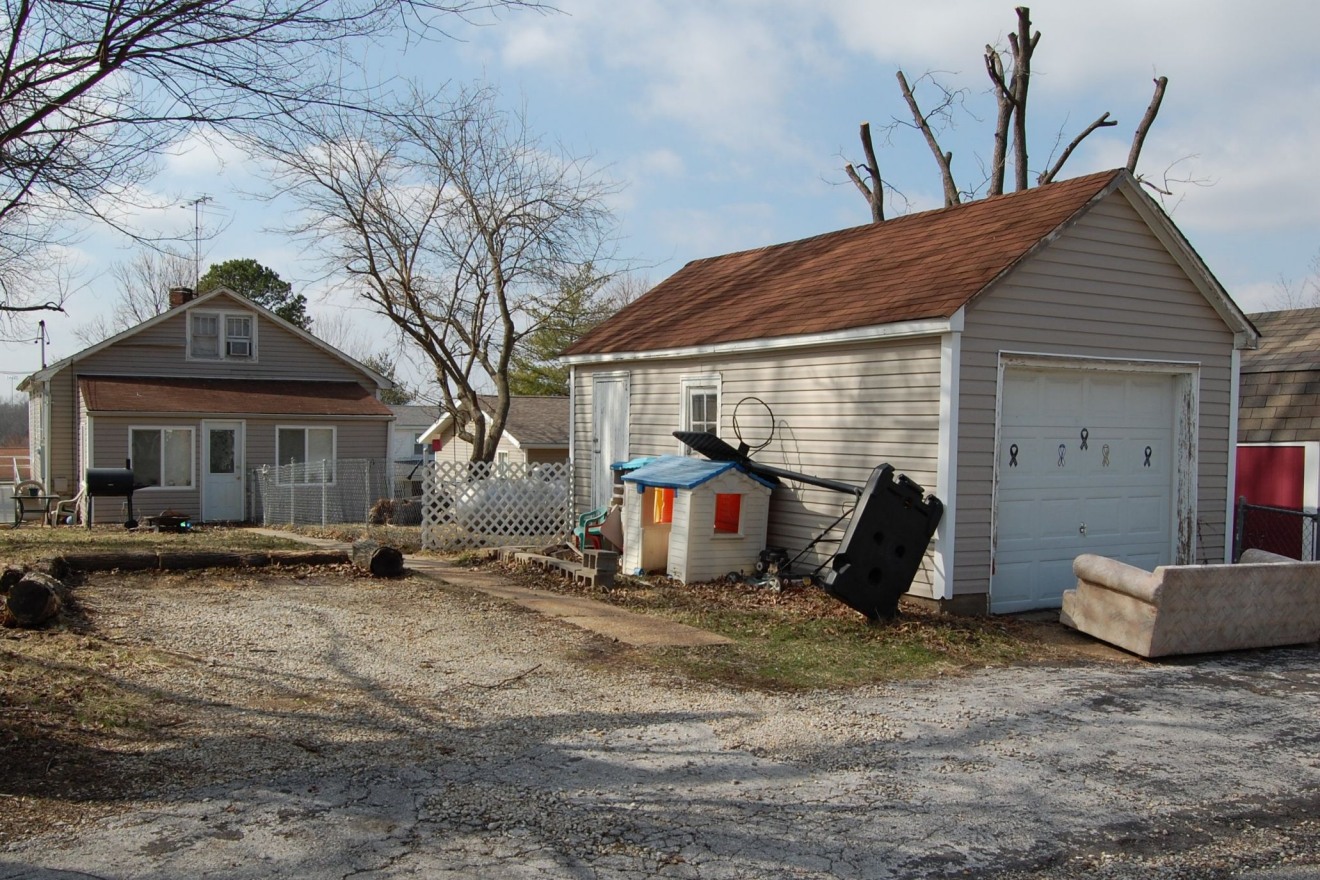
The home is situated on a lot that is at a higher grade than Fair Street and it is accessed by formed concrete stairs. These stairs pass through an older and possibly historic CMU retaining wall. At the rear of the lot is a gravel parking area and a front gable frame garage. It has a concrete foundation, vinyl siding, paneled aluminum overhead door, and an asphalt shingle roof. An original four light casement window and vertical wood board door on the S elevation indicate that it is a historic building. Due to its date of construction it is considered a contributing resource.

This 1 story frame front gable home has an asphalt shingle roof and a concrete foundation. The primary roof has a slight eave overhang with wood details at the gable eave. The entry is offset left and situated beneath a front gable porch roof. There is an offset left frame porch with non historic wooden balustrade, two square wood posts, and non-historic formed concrete piers. The porch is accessed by a metal wheelchair ramp that runs parallel to the façade and turns back to the rear yard. The gable end of the porch roof is covered with vinyl siding as is the rest of the elevation (original siding is unknown). Set within the porch is a single entry, offset left, and a single window to the left. The entry appears to contain a historic square light glass and three horizontal panel wood door. To the right of the entry porch is a single window. Windows on the first floor are vertical 4/1 double hung wooden sash. Centered on the gable end of the upper half story is a horizontal 2/2 double hung wood sash window. This property was not surveyed in 1992. Similar to 300 Fair, the house was built during the period of significance and retains significant materials (such as windows, door, eave details, and porch placement); however the original siding is unknown. It is uncertain whether the original siding was weatherboard, making the vinyl a similar profile replacement. Further research is needed; the house's status is "not determined" for listing in a potential NR district.

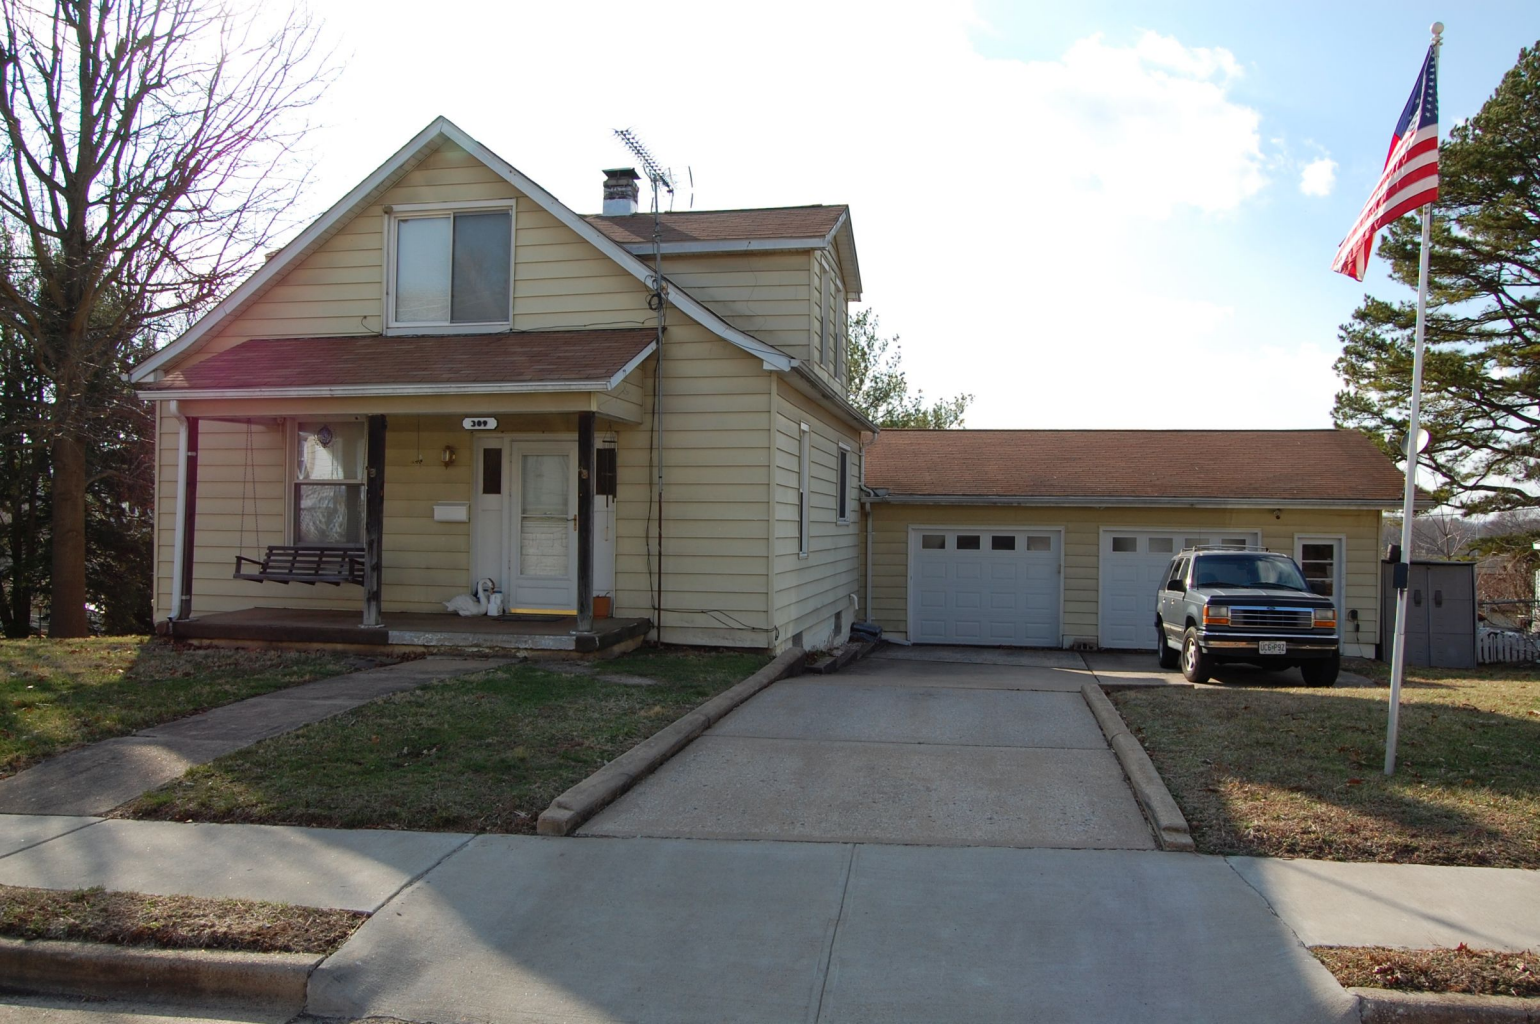
Due to the aluminum siding, replacement windows and porch alterations this building is not considered eligible for listing in a potential NR district.

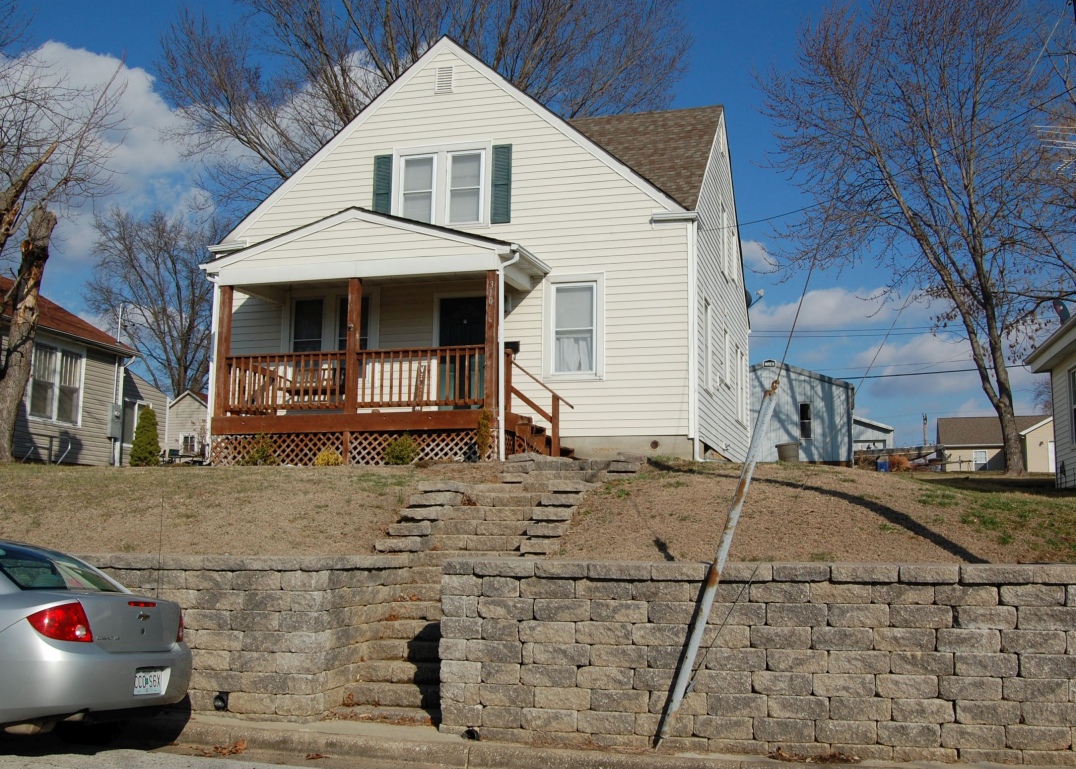
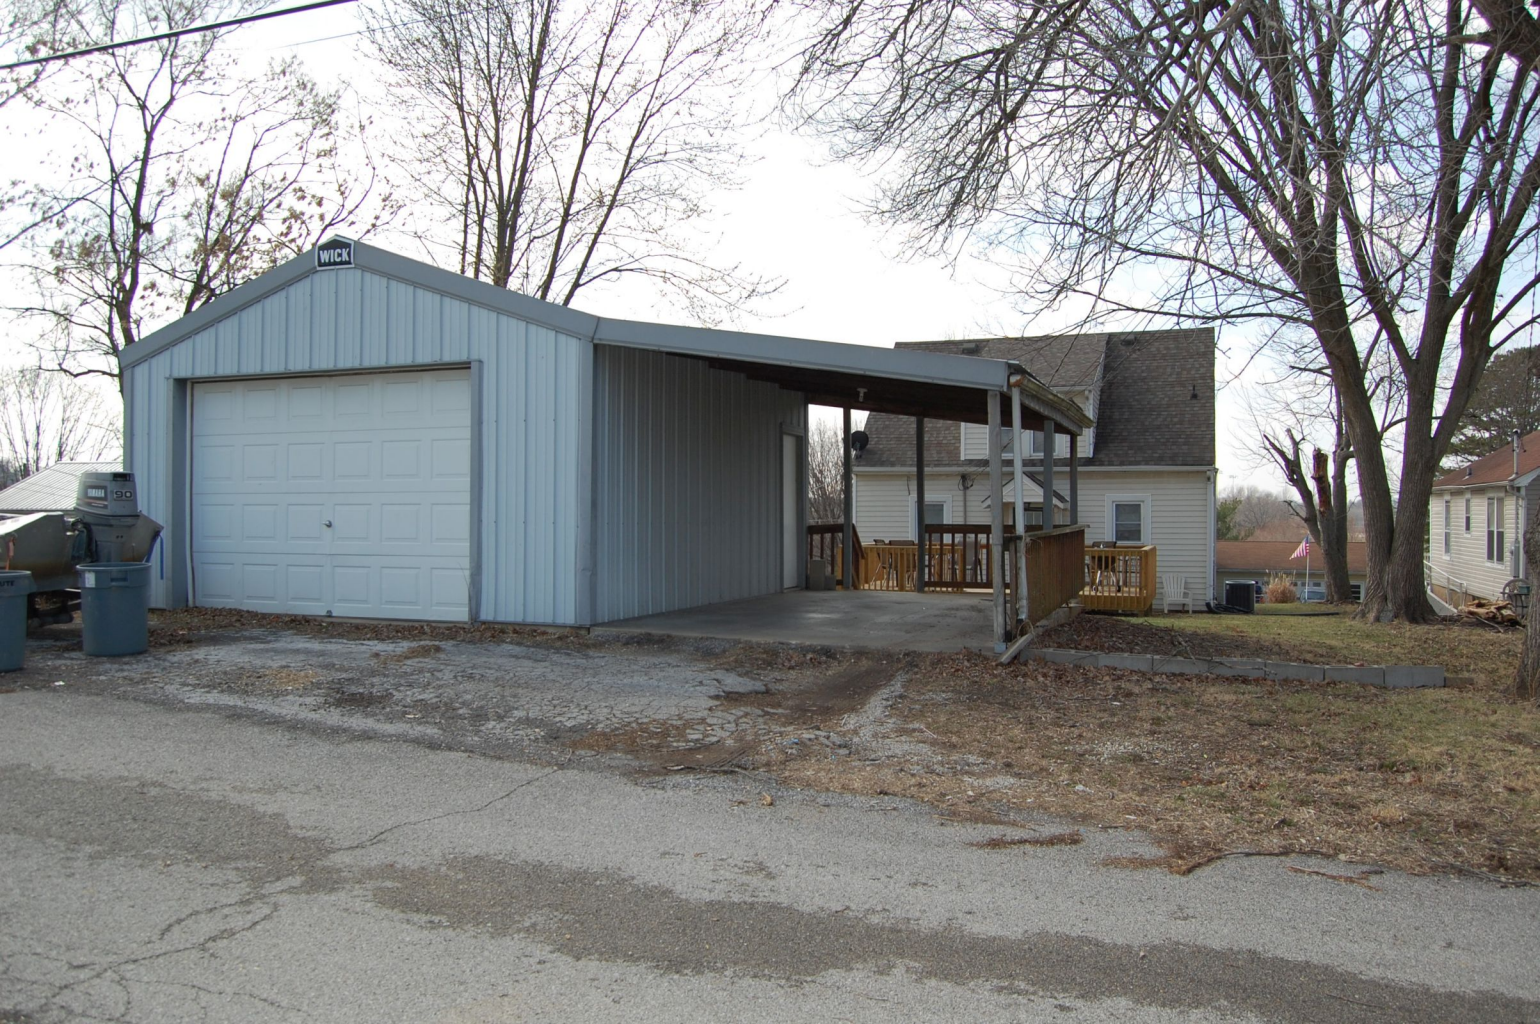
This 1.5 story frame cross gable home has an asphalt shingle roof and a concrete foundation. The entry is offset right and situated beneath a front gable porch roof. The porch is not historic. It is offset left and has a simple wooden balustrade and square wooden supports. The gable end of the porch roof is covered with vinyl siding as is the rest of the elevation. The entry contains a solid wooden panel door. To the right of the entry is a window bay containing a 1/1 double hung vinyl replacement window. To the left of the entry is a window bay containing a pair of 1/1 double hung vinyl replacement windows. Centered on the gable end of the upper half story is a window bay containing a pair of 1/1 double hung vinyl replacement windows with non-operative plastic shutters. This property was not surveyed in 1992.

Due to the presence of vinyl siding, a non-historic porch and replacement windows, this building is not considered eligible for listing in a potential NR district.
