MISSOURI DEPARTMENT OF NATURAL RESOURCES
STATE HISTORIC PRESERVATION OFFICE, P.O. Box 176, Jefferson City, MO 65102
ARCHITECTURAL/HISTORIC INVENTORY FORM

1. SURVEY NO. FR-AS-007-001		2. SURVEY NAME: International Shoe Factory Neighborhood	
3. COUNTY: Franklin		4. ADDRESS (STREET NO.) 605	STREET (NAME) West 3rd Street

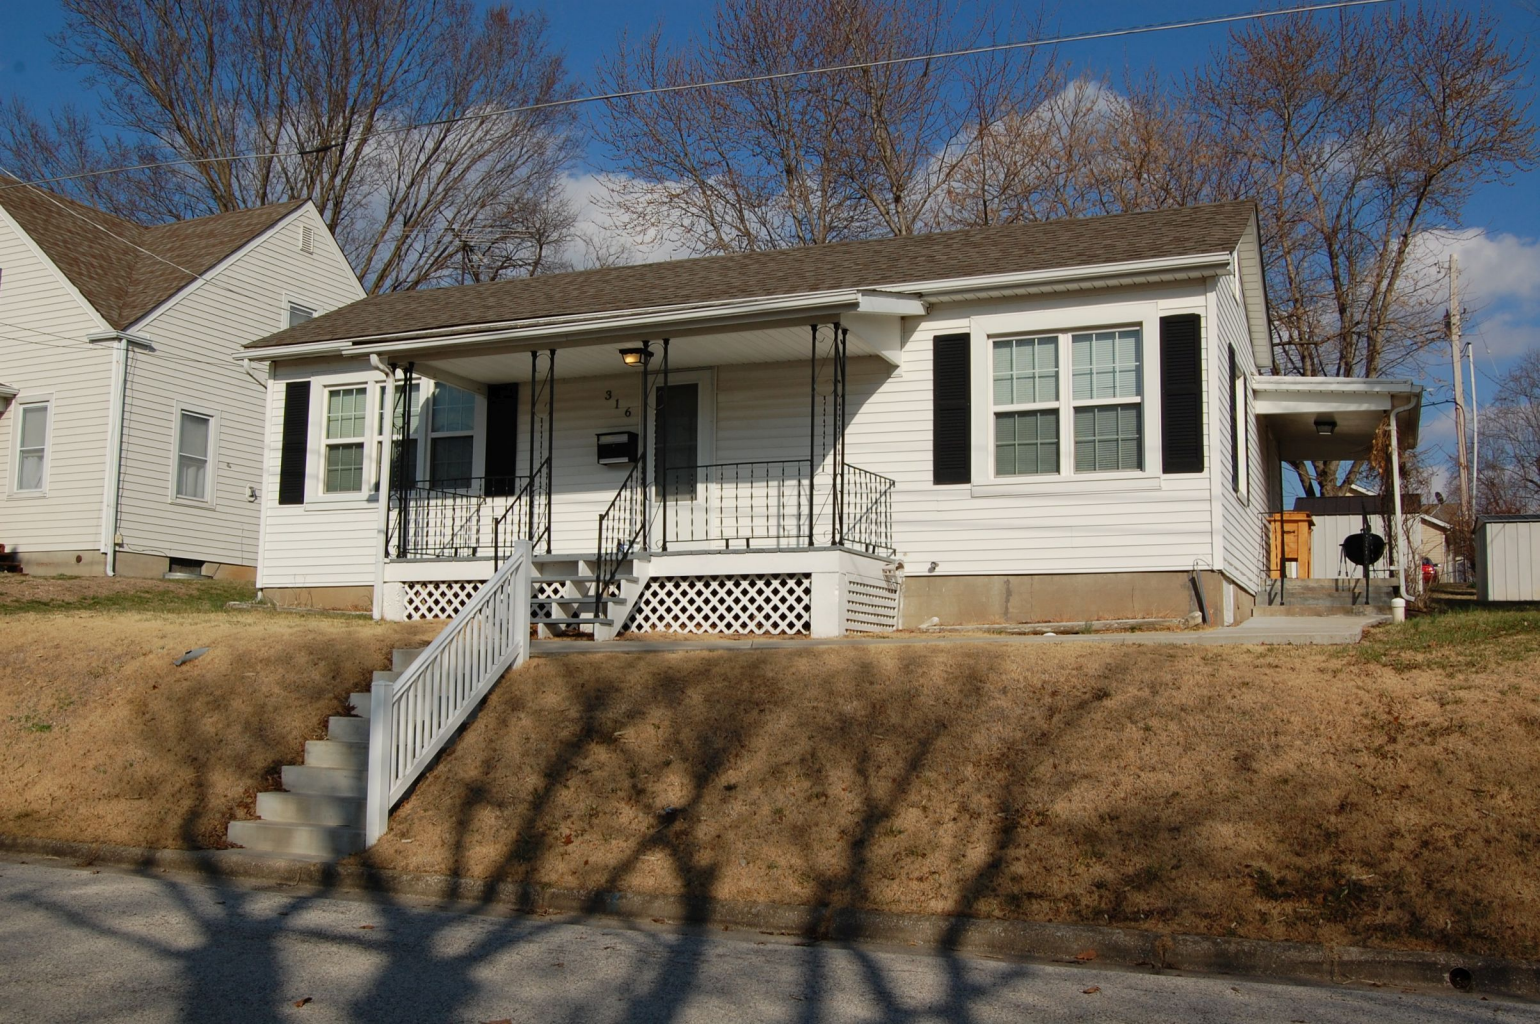
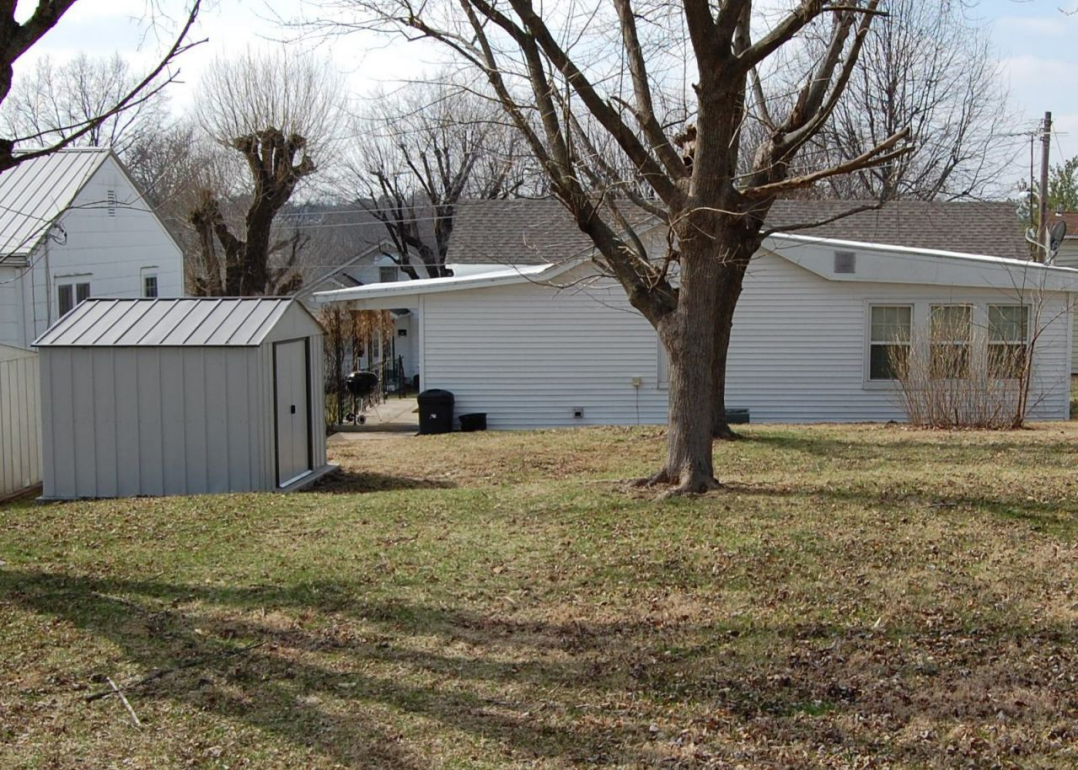
This 1 story frame side gable home has an asphalt shingle roof and a concrete foundation. The entry is centered and situated beneath a shed porch roof with wrought iron supports. The porch deck is wooden and rests on historic concrete piers. It has a non-historic wrought iron railing. The entry contains a non historic solid door obscured by a storm door. To the right of the entry is a window bay containing a pair of 1/1 double hung vinyl replacement windows. To the left of the entry is a window bay containing a ribbon of three 1/1 double hung vinyl replacement windows. All windows have false muntins giving the appearance of 6/6 lights and non-operative plastic shutters. The home is clad with vinyl siding. This property was not surveyed in 1992.

Due to the presence of vinyl siding, non-historic porch alterations and replacement windows, this building is not considered eligible for listing in a potential NR district.

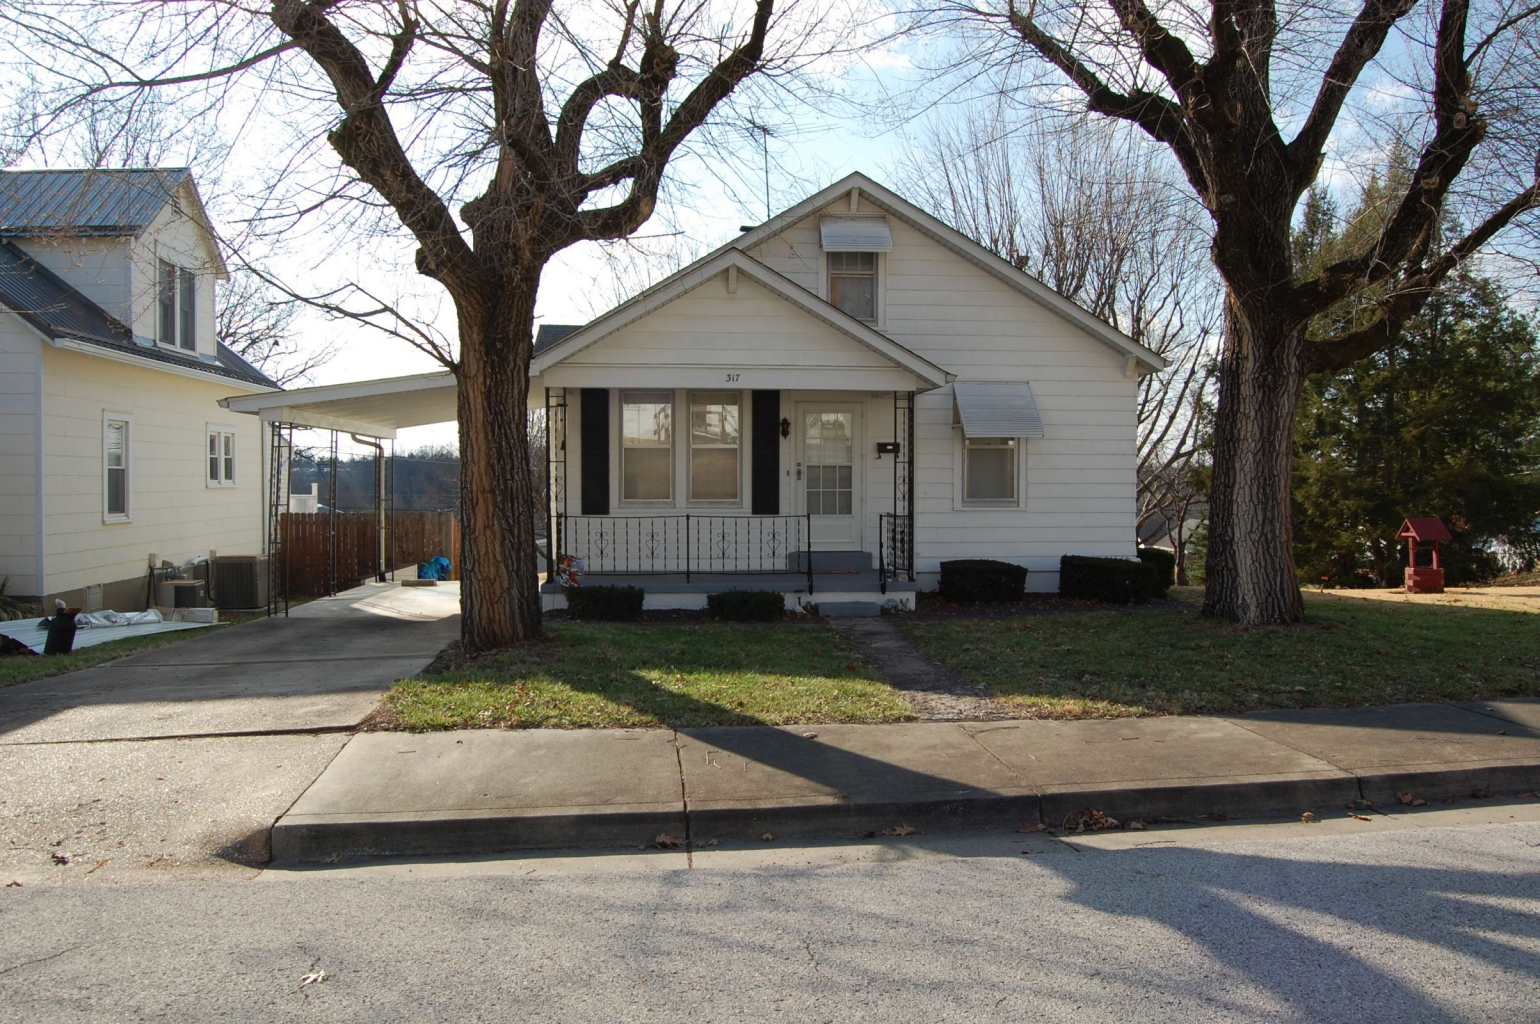
The original siding is unknown, but the aluminum is a larger profile than typical clapboard. Due to the replacement siding, it is not considered eligible for listing in a potential NR district.

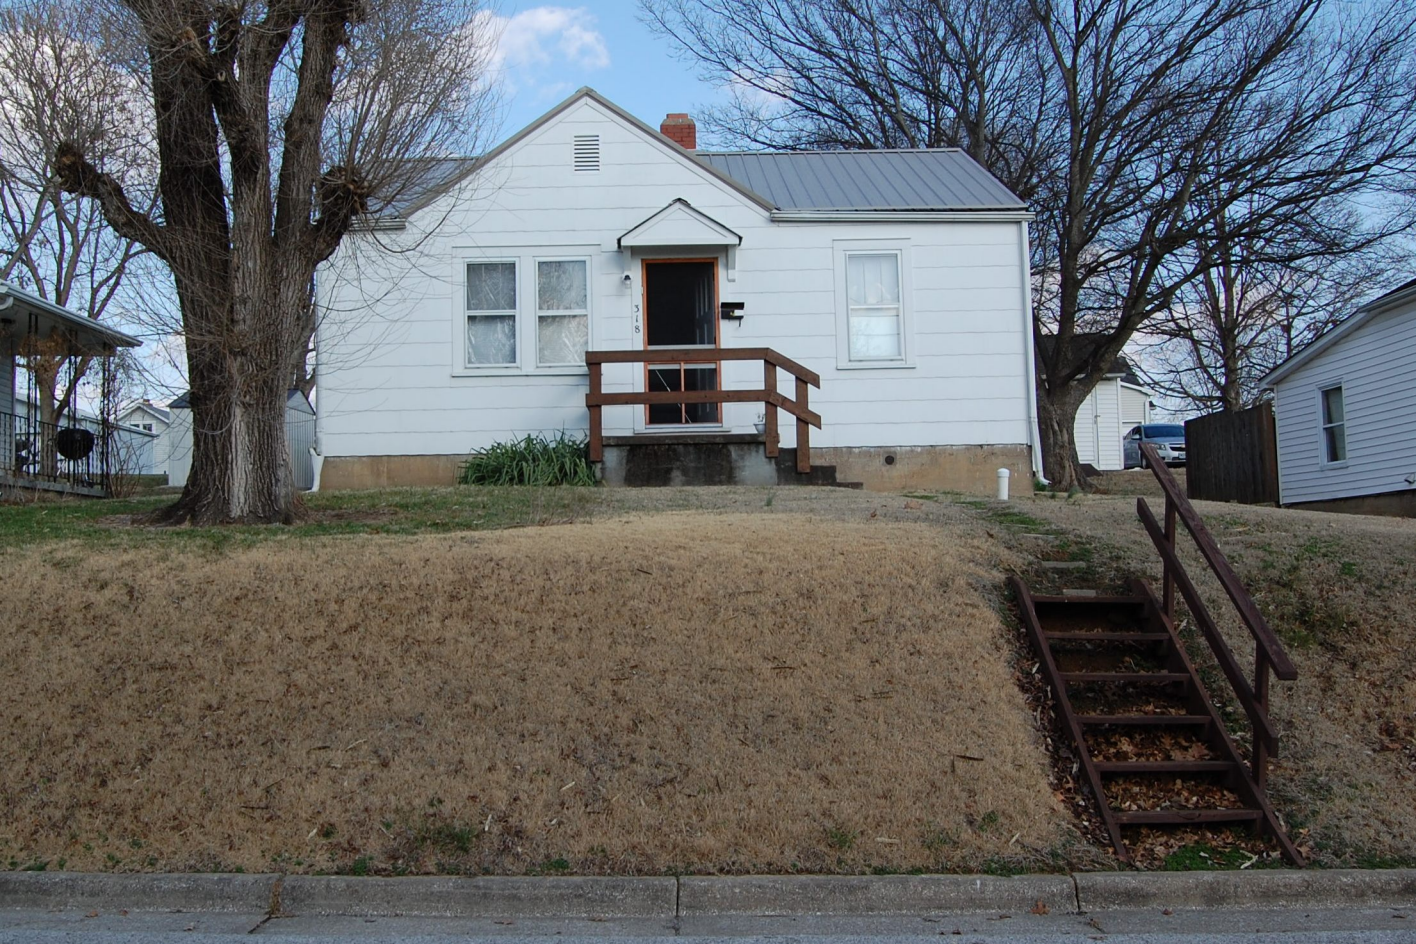
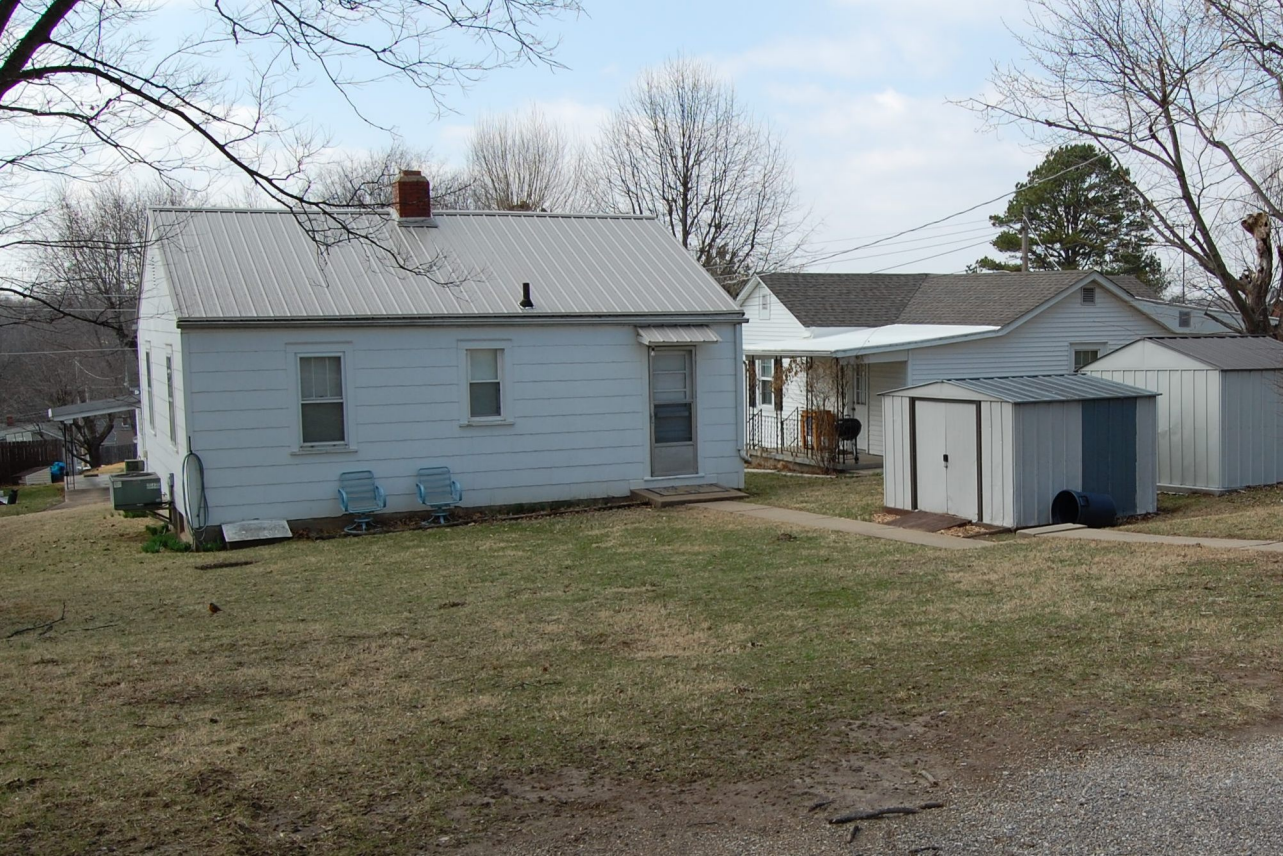
This 1 story frame side gable home has an asphalt shingle roof and a concrete foundation. The entry is centered and situated beneath the shallow front gable portion of the roof. The entry contains a non-historic solid panel door beneath a front gable hood supported by brackets. There is a concrete platform porch with a non-historic wooden railing with stairs running parallel to the façade (side right). To the right of the entry is a window bay containing a single 3/1 double hung wooden sash. To the left of the entry is a window bay containing a pair of 3/1 double hung wooden sash. The home is clad with asbestos shingles. This property was not surveyed in 1992.

Due to the presence of original asbestos siding and original 3/1 windows, this building is considered eligible for listing in a potential NR district.

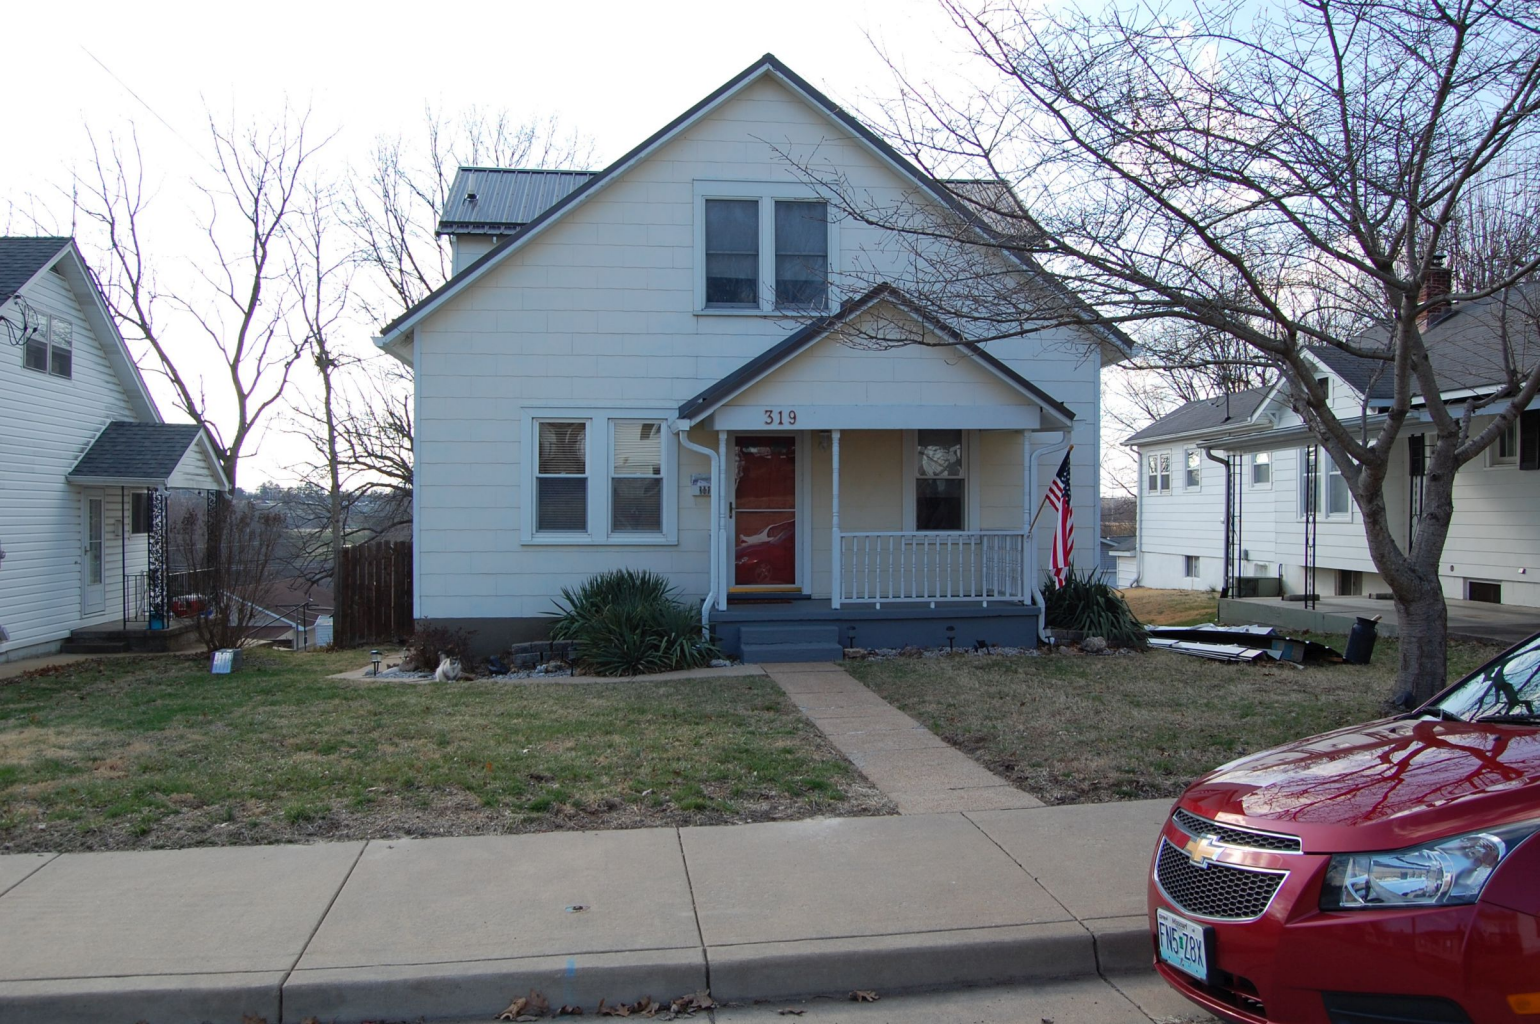
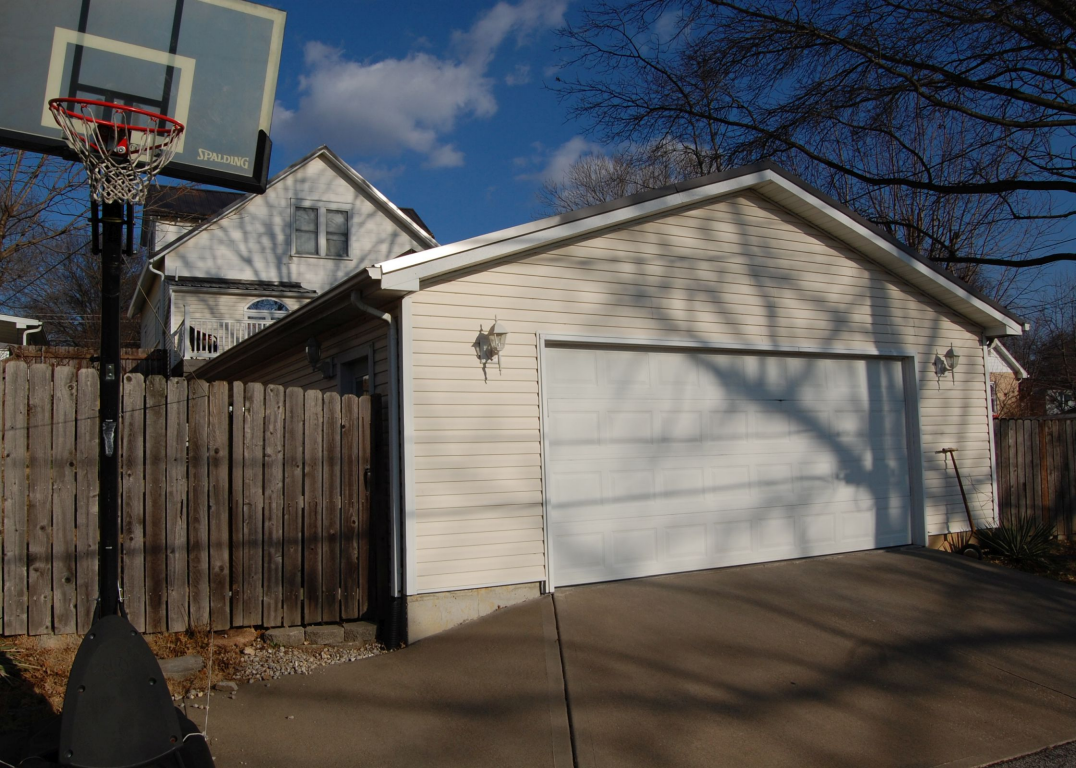
This 1.5 story frame front gable home has new standing seam metal roof and a concrete foundation. Per the owner, the house is clad with Masonite shingles. There are 3 bays on the front façade. There is a 1/2 width concrete slab porch offset right with a front gable roof supported by turned wooden posts and surround by a turned wooden balustrade. The entry is offset slightly left beneath the porch roof and appears to contain a solid metal panel replacement door, but it is obscured by a storm door. To the right of the entry is a window bay that contains a single window. To the left of the porch is a paired window bay. Centered on the upper half story is a centered, paired window bay. There are standing seam metal gabled front dormers with paired windows and exposed rafter tail ends on the N and S elevations. Per the owner, the windows are replacement vinyl, 1/1 double-hung vinyl sash. The owner also noted that they added an addition to the rear that had to be clad in vinyl since they could not match the masonite. This property was not surveyed in 1992.

Due to its date of construction and historic integrity this building is a contributing resource to a potential NR district.

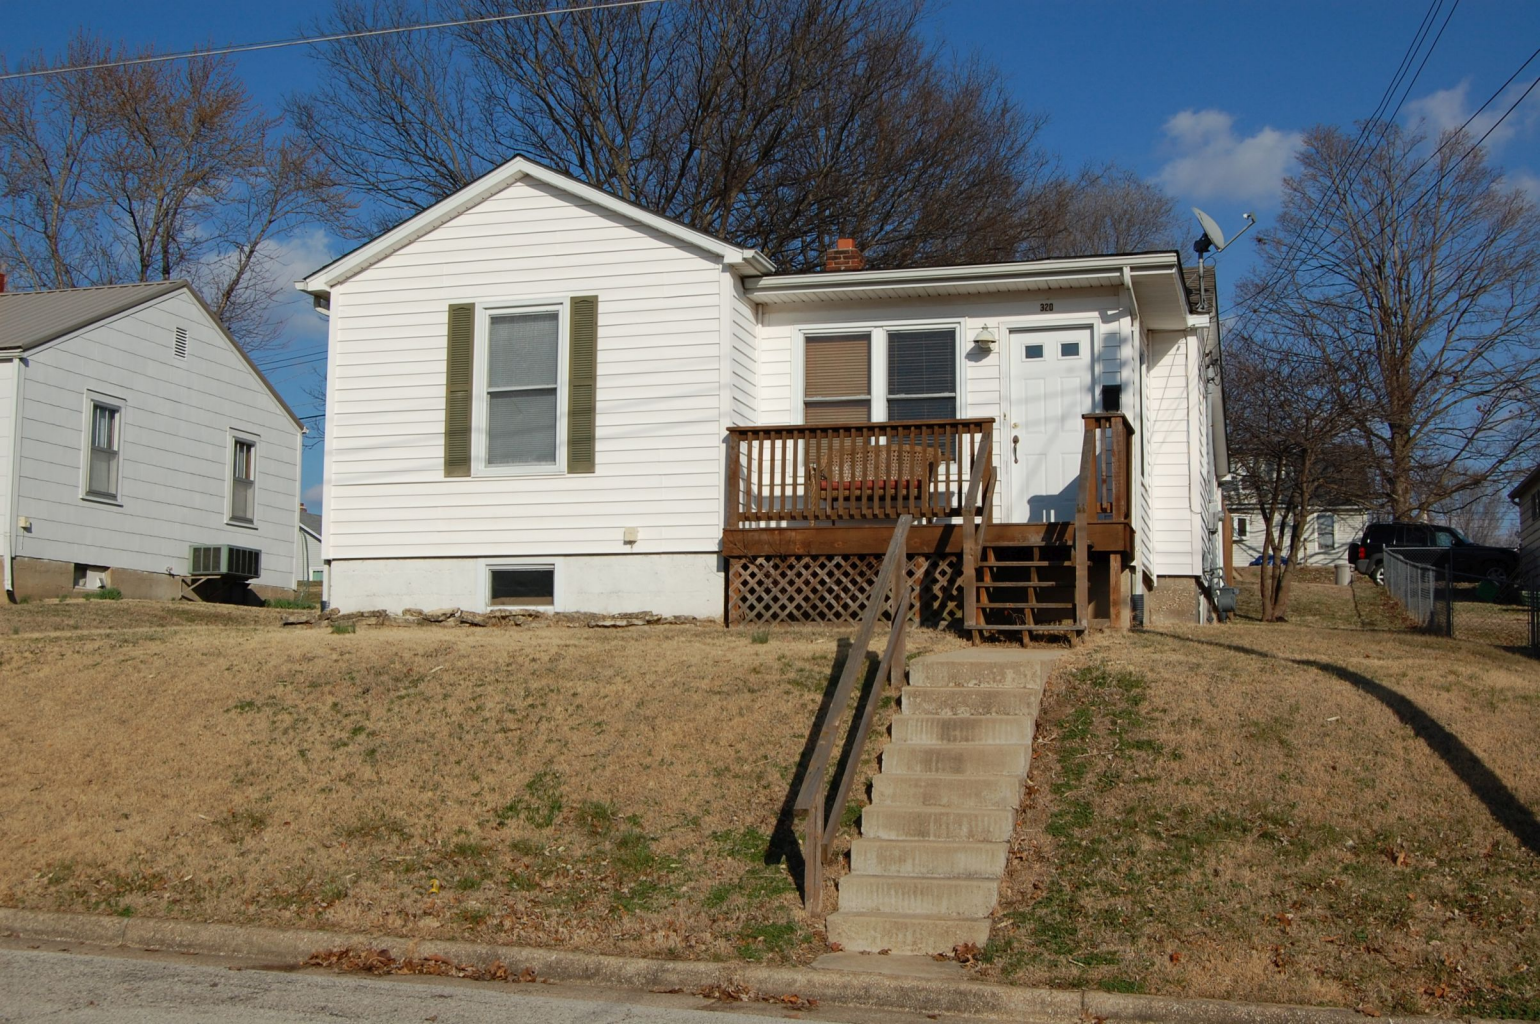
This 1 story frame gable front and wing home has an asphalt shingle roof and a concrete foundation. The entry is offset right and appears to be situated within a former porch that has been enclosed. The enclosed porch section contains a non-historic solid panel door and a window bay containing a pair of 1/1 double hung vinyl replacement windows. There is a non-historic wooden platform porch with a non-historic wooden balustrade. To the left of the porch in the front gable section is a window bay containing a single, 1/1 double hung vinyl replacement window with non-operative plastic shutters. There is a rectangular window opening at the basement level of the front gable section containing a single light awning sash of indeterminate material. This property was not surveyed in 1992.

Due to the presence of a non-historic porch, vinyl siding, and replacement windows, this building is not considered eligible for listing in a potential NR district.

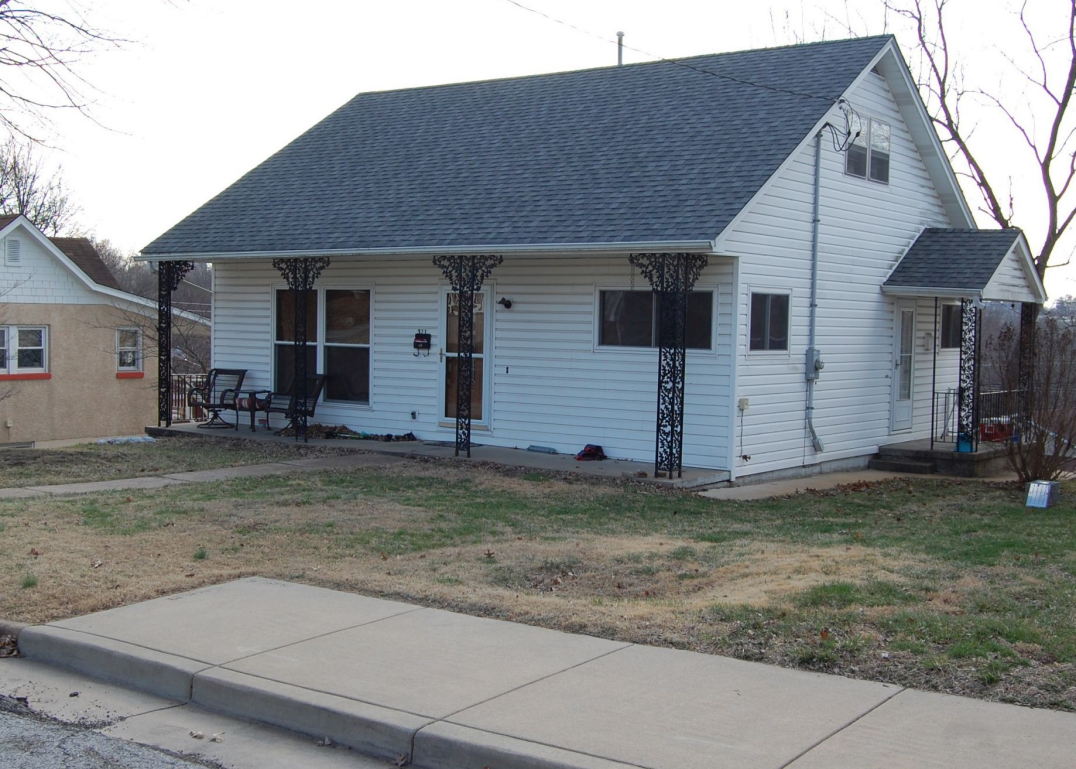
This 1 story frame side gable home has an asphalt shingle roof and a concrete foundation. There is a full width incised concrete slab porch with elaborate wrought iron supports holding up the porch roof, which is also the overhanging eave of the home. The entry is offset slightly right and contains a door that is obscured by a storm door. To the right of the entry is a window bay that contains a sliding sash window with two lights. To the left of the entry is a window bay that contains a pair of what are likely 1/1 double hung vinyl sash. All sashes are obscured by modern thermal storm windows. The house is clad with vinyl siding. This property was not surveyed in 1992.

Due to its recent date of construction and the presence of vinyl siding, this building is not considered eligible for listing in a potential NR district.

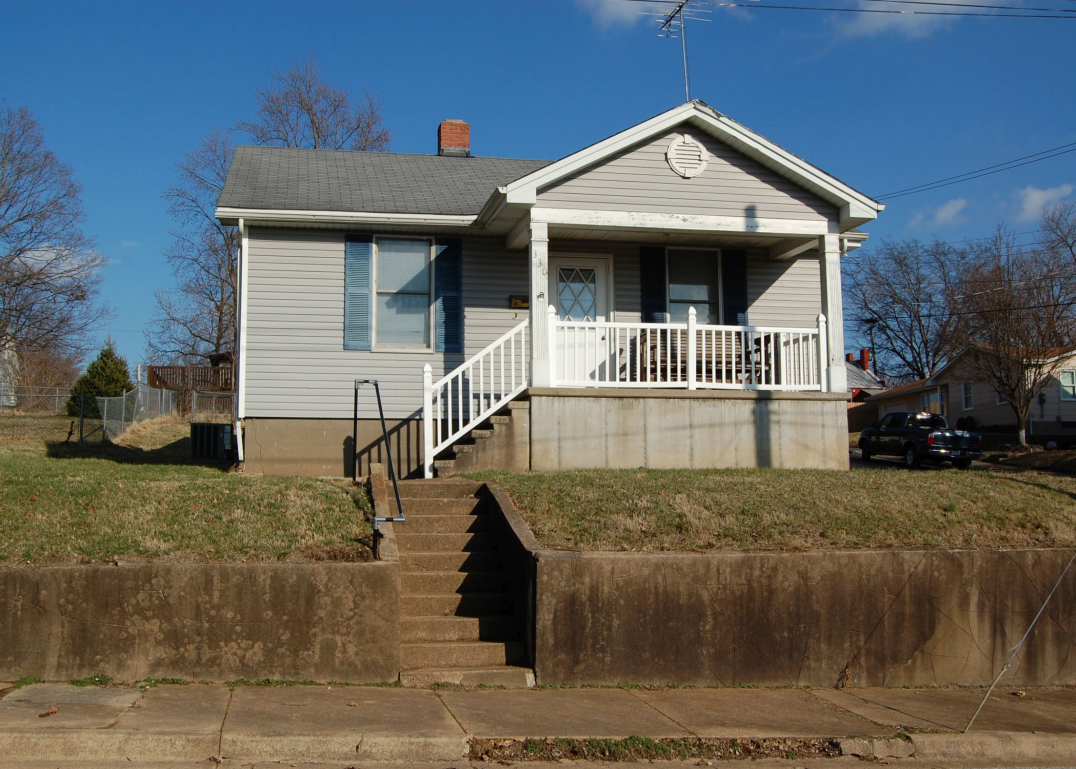
This 1 story frame side gable home has an asphalt shingle roof and a concrete foundation. The entry is offset right and is approached by concrete stairs and a vinyl composite balustrade that runs parallel to the home, side left. The entry porch has a tall non-historic concrete platform with a vinyl composite balustrade and two fluted wooden posts supporting a front gable porch roof. Set within the porch are a single window bay and a wooden door with a rectangle light glass with diamond pattern exterior muntins. To the left of the porch is a single window bay. Windows are 1/1 double hung replacement wood sash with ornamental shutters. The home is clad with vinyl siding. This property was not surveyed in 1992.

Due to the presence of a non-historic porch, composite siding, and replacement windows, this building is not considered eligible for listing in a potential NR district.

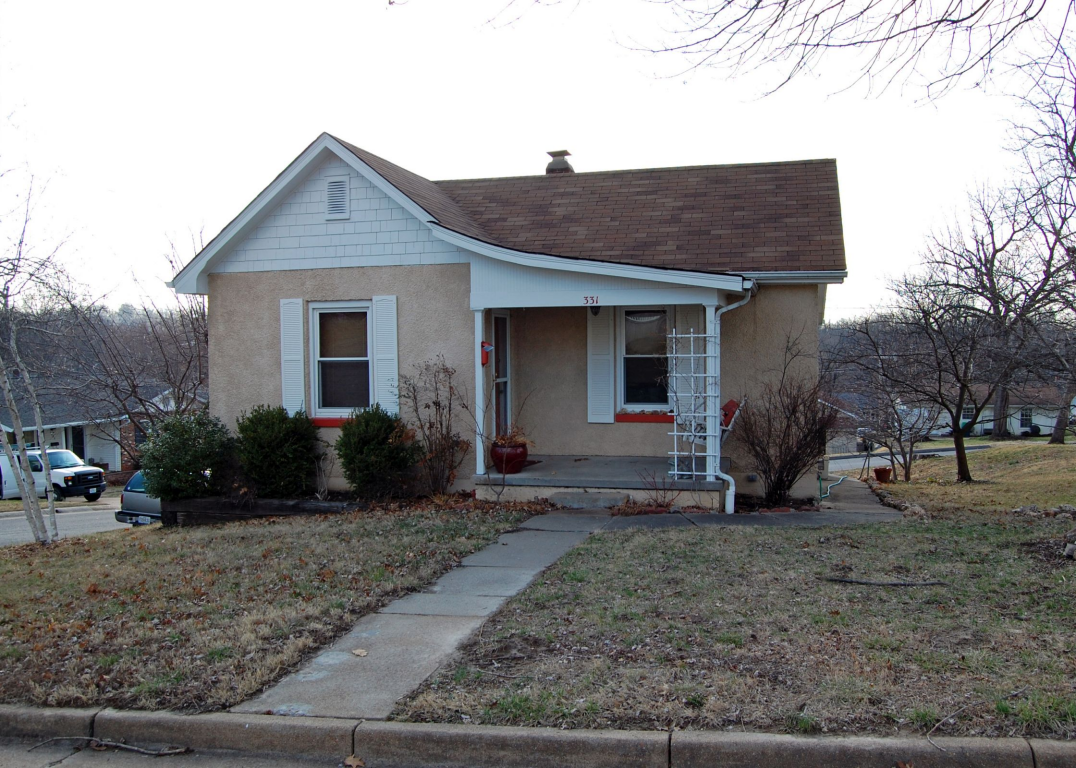
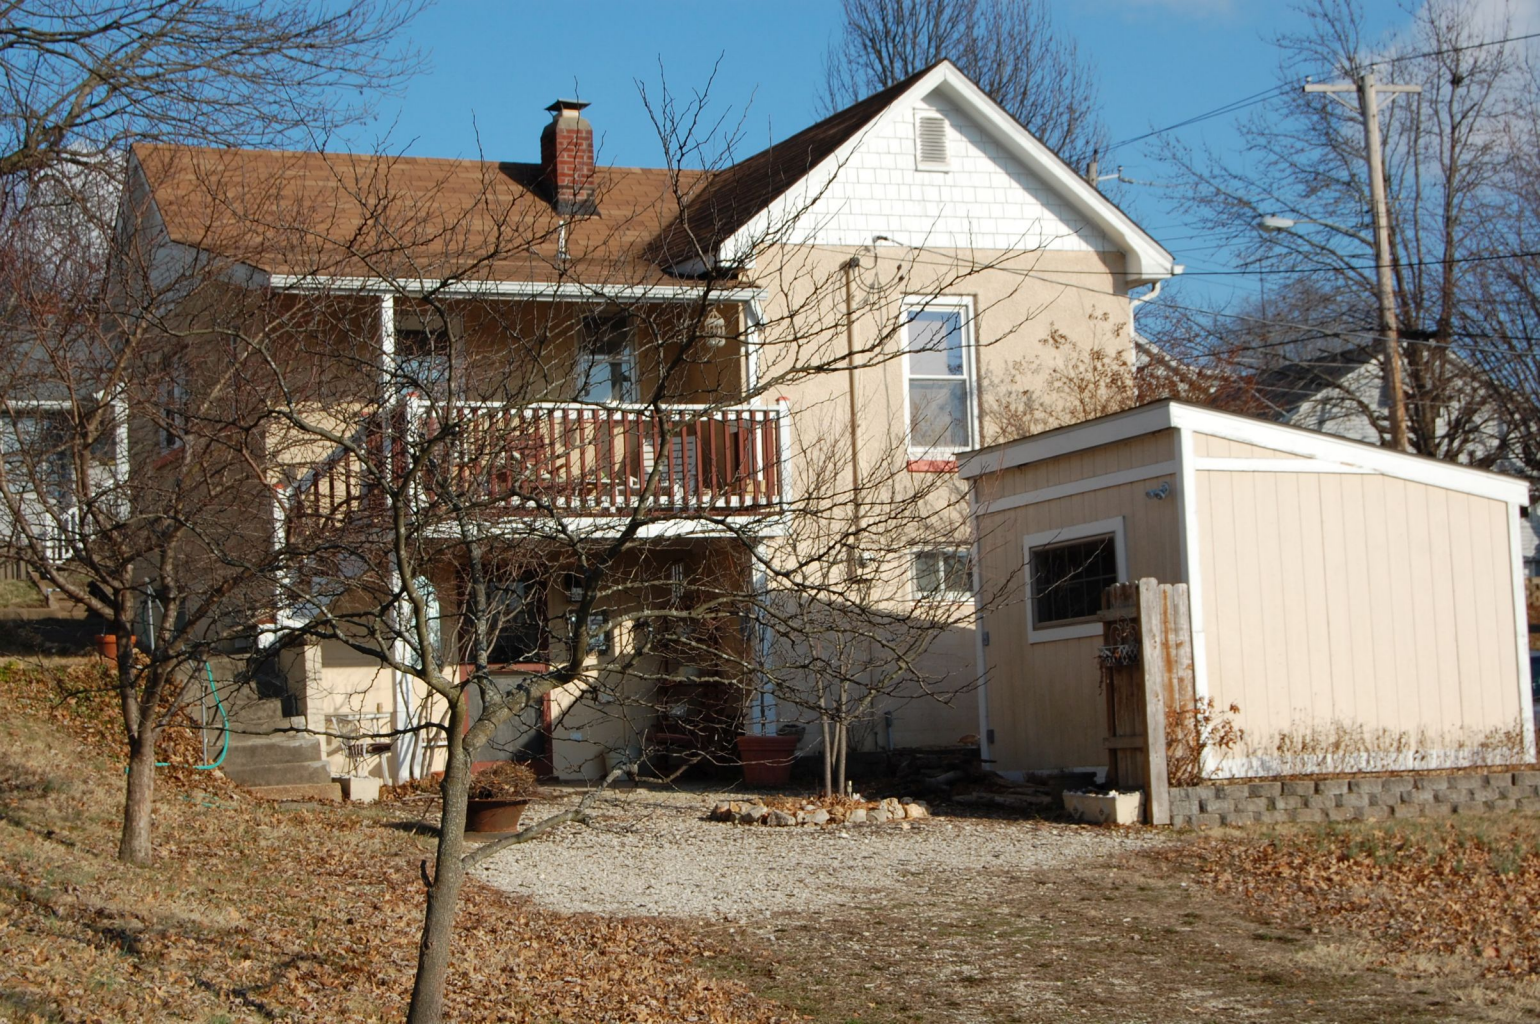
This 1 story frame gable front with wing home has an asphalt shingle roof and a concrete foundation. There is a 1/2 width concrete platform porch centered on the wing portion of the elevation with a shed roof supported by two vinyl boxed columns. The porch roof has a soffit that appears to be wooden bead board. The entry is located in the front gable wall perpendicular to the plane of the wing and cannot be seen clearly from the public right of way. The end gable section and the wing section each contain a single window bay containing a 1/1 double hung vinyl replacement sash with inoperative plastic shutters. The attic section of the end gable has painted wood shingle siding and the rest of the home is parged with stucco. It is unclear if the home originally had stucco siding, but it looks to be newer and is an unusual treatment when compared with other homes of this form and vintage in the area. This property was not surveyed in 1992.

Due to the presence of replacement windows and window treatments as well as siding that is estimated to not be original, this building is not considered eligible for listing in a potential NR district.

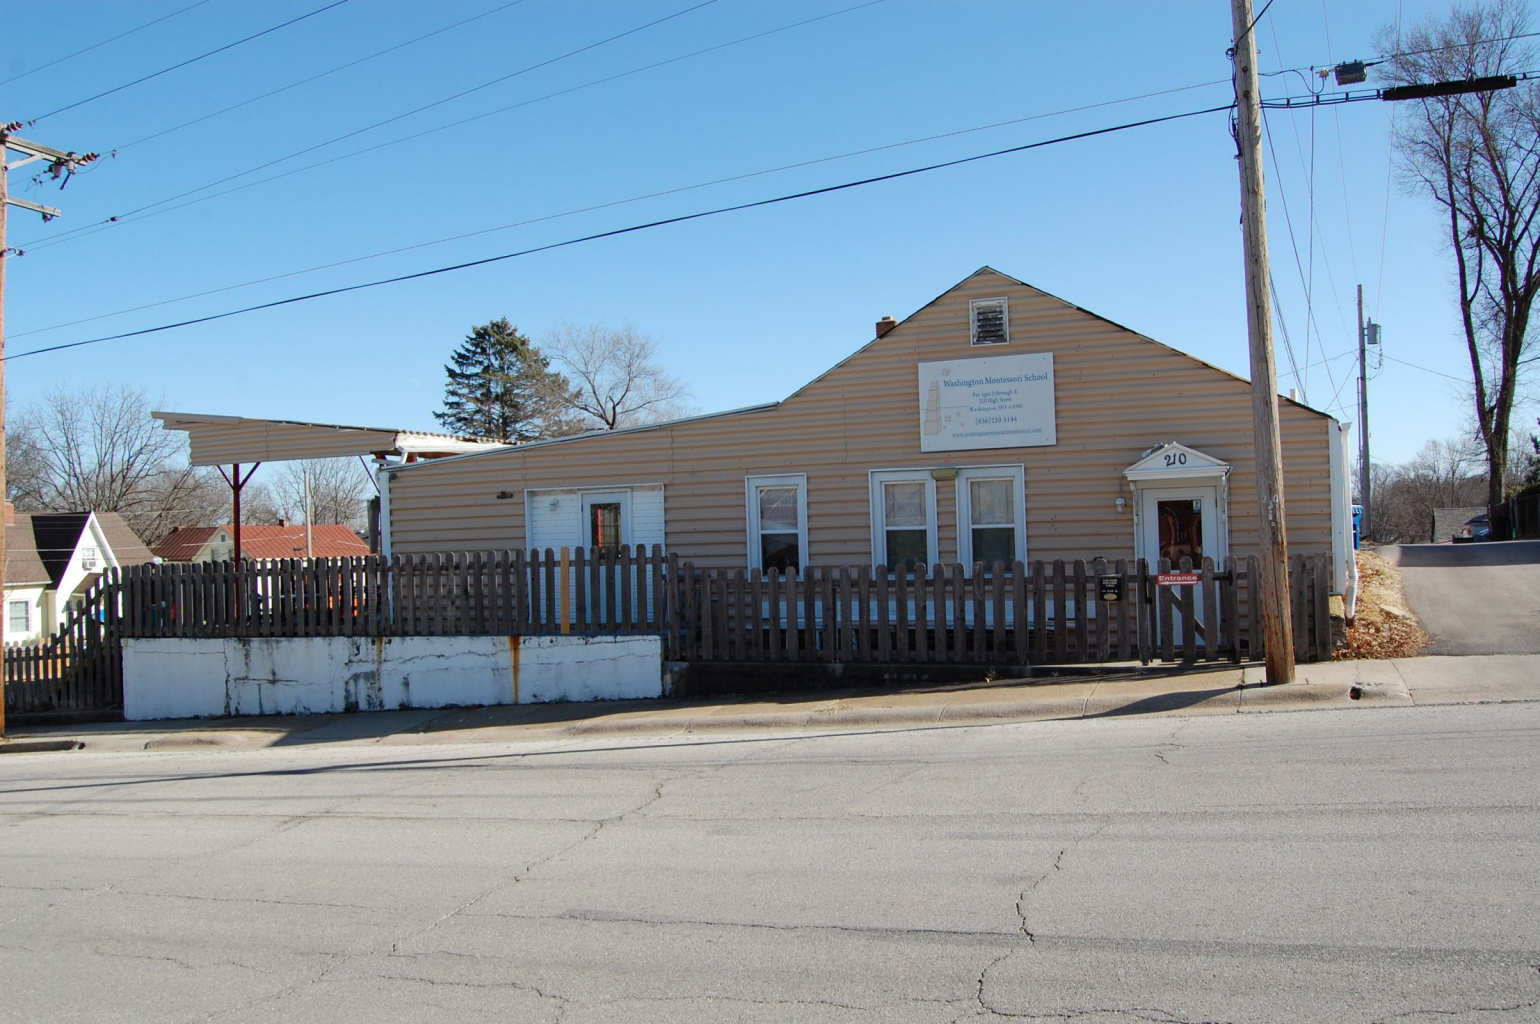
The Montessori school is a 1-story frame building with a concrete foundation, corrugated metal siding and a gable front with extended shed (side left) asphalt shingle roof. The building is on the SW corner of the parcel, adjacent to the alley. The primary façade is 5 bays wide and has a wood picket fence enclosed front. Within the primary front gable, side right portion, is a single entry bay consisting of a rectangular light and metal door with a pediment metal hood with ornamental, open scrolled metal brackets. To the left of the entry are three single 1/1 vinyl sash windows. A rectangular vent is in the upper gable. Within the shed roof extension, side left portion, is a former garage door bay enclosed with vinyl siding and a single entry door consisting of a faux, multi-light and paneled metal door. There is a northern addition or portion that has been enclosed with cement blocks and has paired 12-light, false interior muntins casement windows and a sliding door with similar lights on the N elevation. There is an interior brick chimney within this area (NE corner). There are 4 bays on the S elevation, along the alley, with a higher gabled section on the SW portion of the building. The eastern elevation has vinyl siding and a shed roof, entry bump out containing a single entry on the north. Since the 1992 survey photo a 2-light garage bay has been enclosed. Further investigation is needed to confirm the date of major changes; however due to these alterations (enclosure of bay & N elevation), the building is not eligible for listing in a potential NR district.

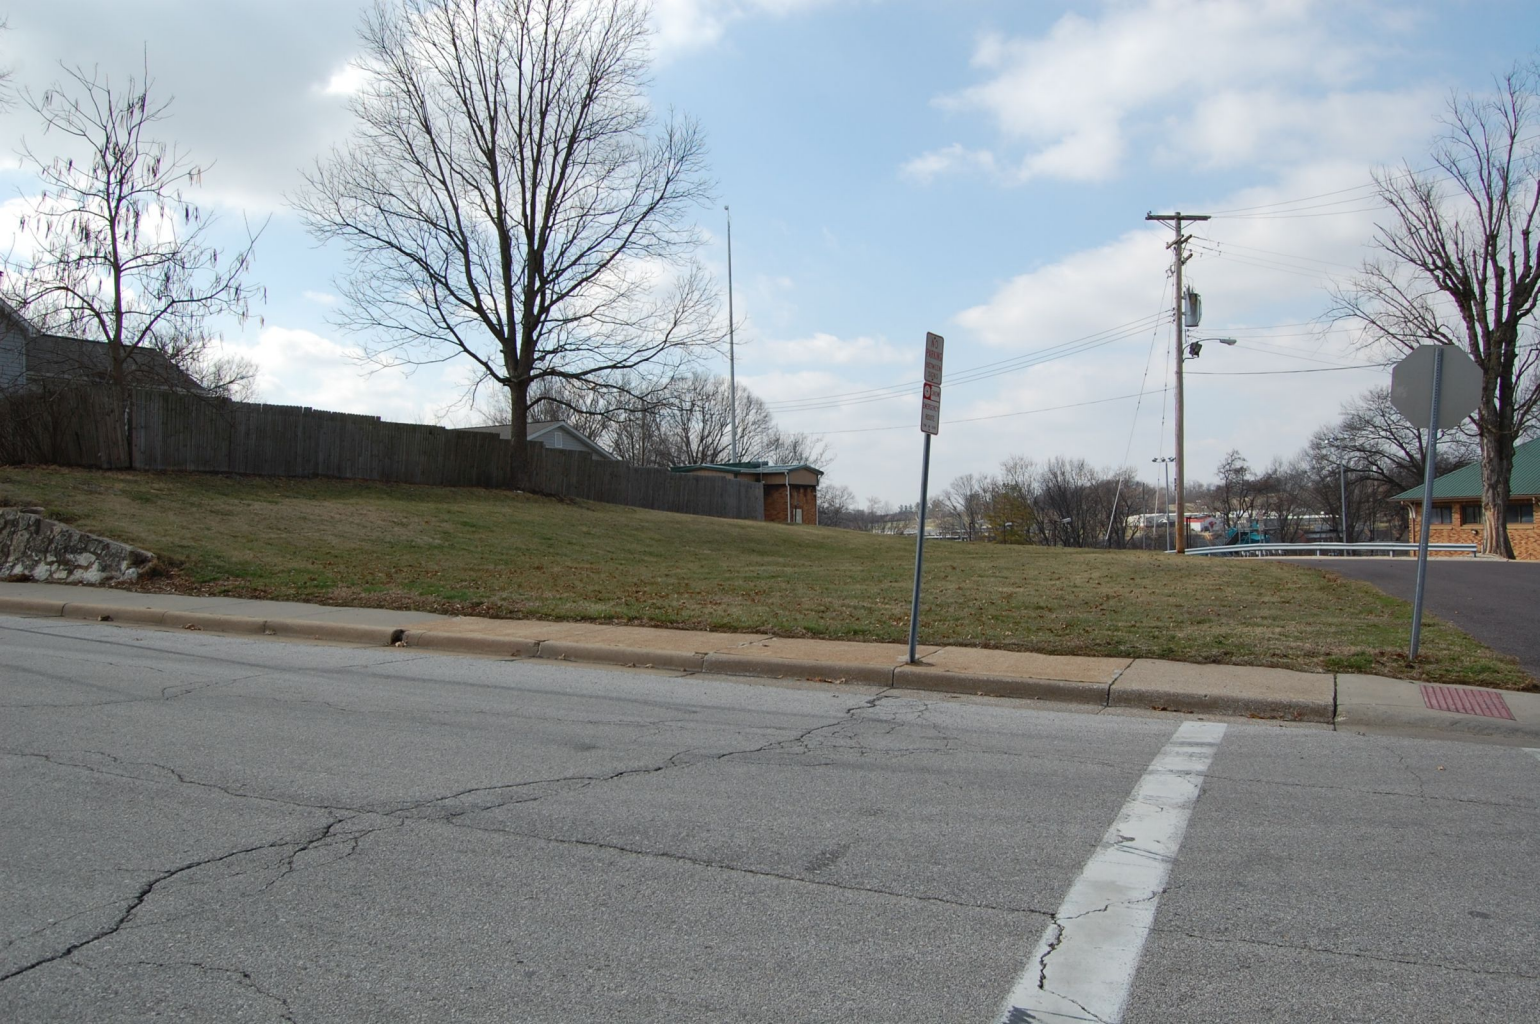
The vacant grassy lot is situated on the corner of High St. and Circle Drive. The undeveloped lot is currently owned by the City of Washington. This property was not surveyed in 1992. It appears that the parcel has historically remained vacant and is therefore considered eligible for potential NR district materials.
