MISSOURI DEPARTMENT OF NATURAL RESOURCES
STATE HISTORIC PRESERVATION OFFICE, P.O. Box 176, Jefferson City, MO 65102
ARCHITECTURAL/HISTORIC INVENTORY FORM

1. SURVEY NO. FR-AS-007-001		2. SURVEY NAME: International Shoe Factory Neighborhood	
3. COUNTY: Franklin		4. ADDRESS (STREET NO.) 605	STREET (NAME) West 3rd Street

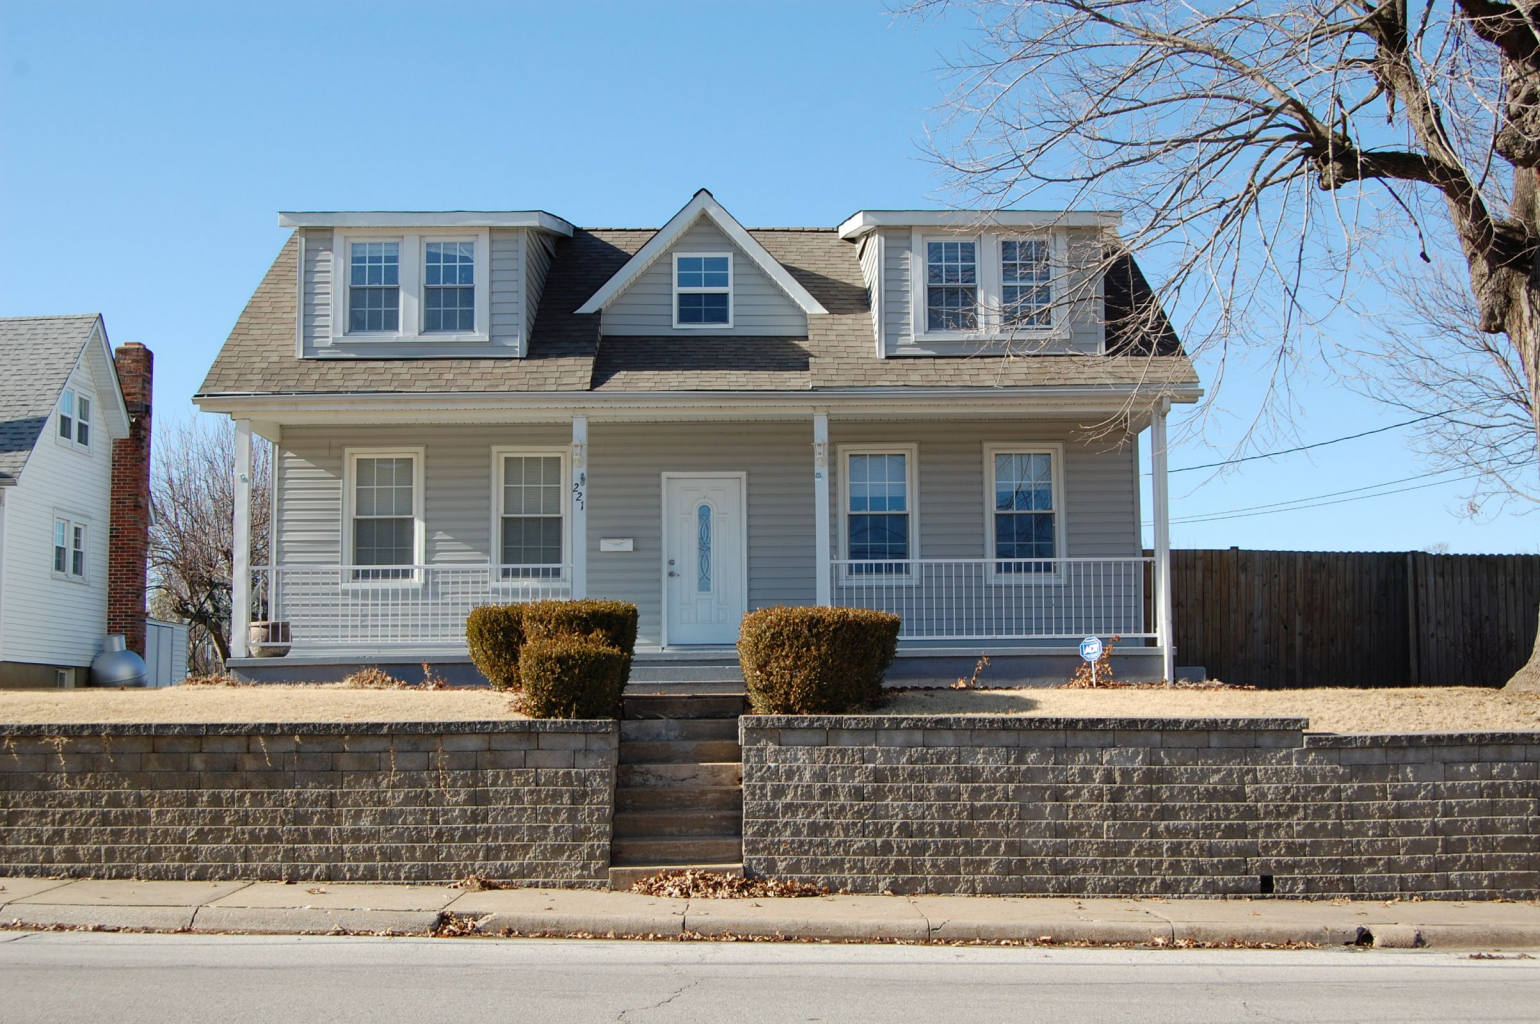
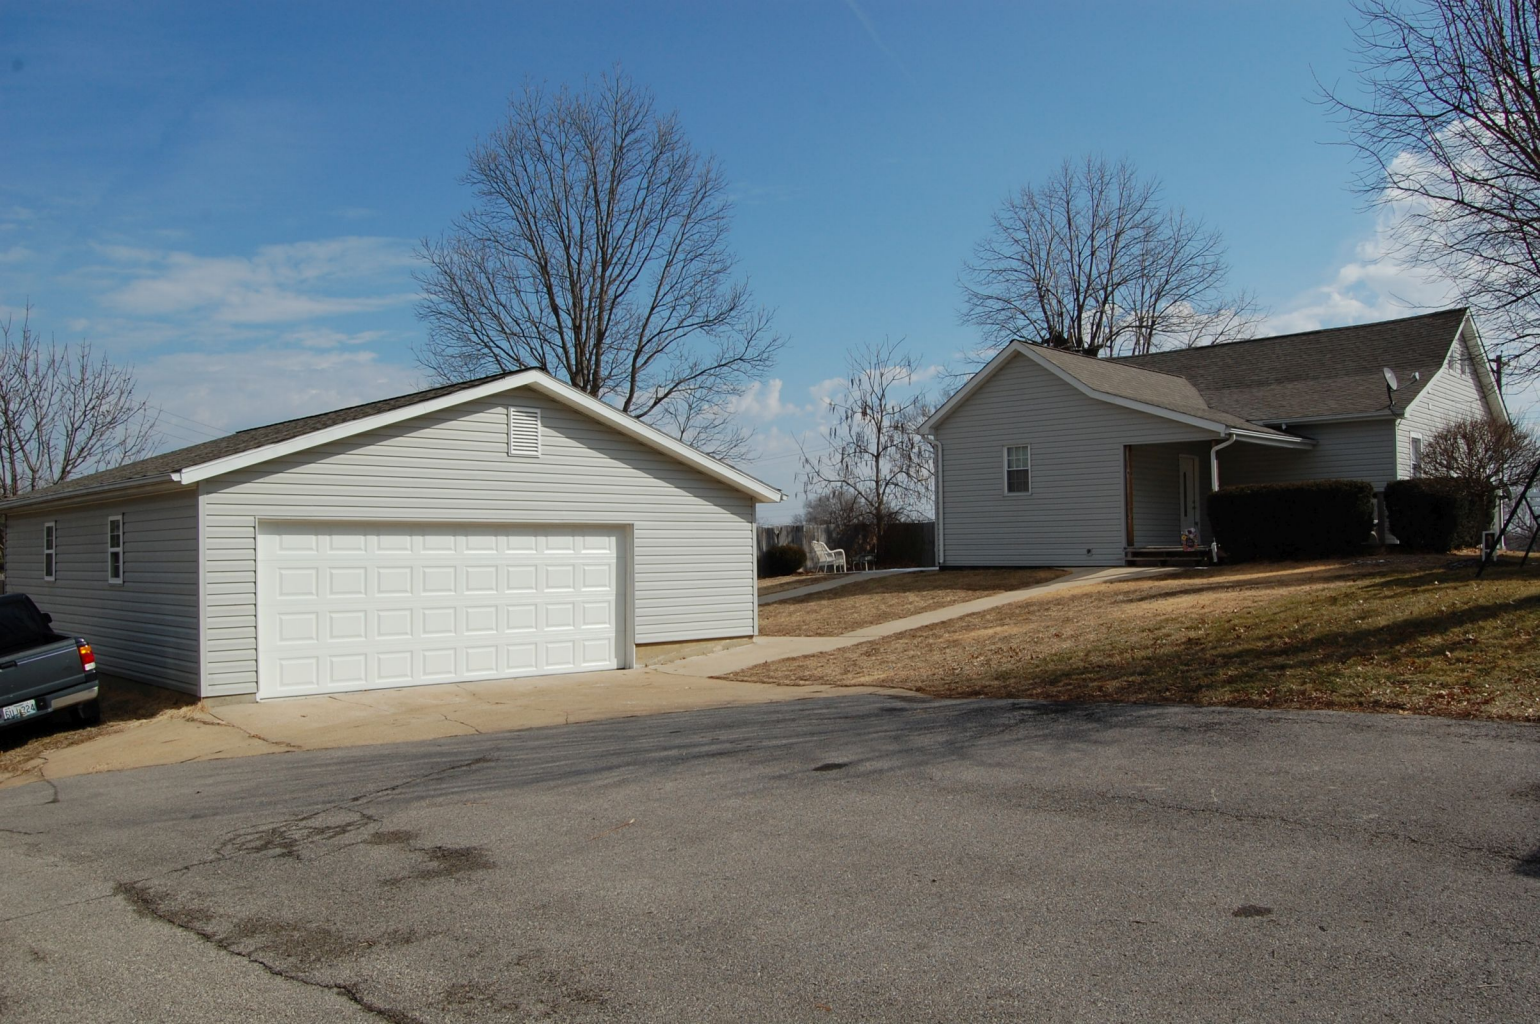
The 1.5 story frame dwelling is a c1880, Central Passage-double pile plan with a concrete parged stone foundation, vinyl siding, and a side gable, asphalt shingle roof. The front façade is 5 bays wide with an incised, full width front porch or gallery. The porch has a cement block foundation, 4 aluminum clad square posts, and an open slender square metal post railing. Sheltered within the porch is a centered, single entry consisting of a faux leaded arched glass light and paneled composite replacement door. On either side of the entry are two windows. Centered within the upper story is a gabled peak, wall-less dormer with 4/4 false interior muntin window. On either side of the gable are shed roof dormers with paired windows. The rest of the windows are replacement 6/6 false interior muntin, double-hung vinyl sash. On the W elevation is a 1-story frame addition with a gable roof with extended shed over a porch. Post 1992 alterations include: replacement of weatherboard with vinyl; porch replacement of the chamfered wood columns, milled brackets and a flat sawn wood balustrade; replacement of entrance's single light glass and wood door with single light transom; removal of the milled wood garlands at the eaves of the gabled dormer; removal of the single light glass and wood door and flat sawn railing on the centered upper story balcony; replacement of 1st story 6/6 wood sash with operational wood shutters; replacement of the 2nd story 1/1 and vertical 2/2 wood sash windows; and removal of the interior wall brick chimney. (See 40 for continuation.)

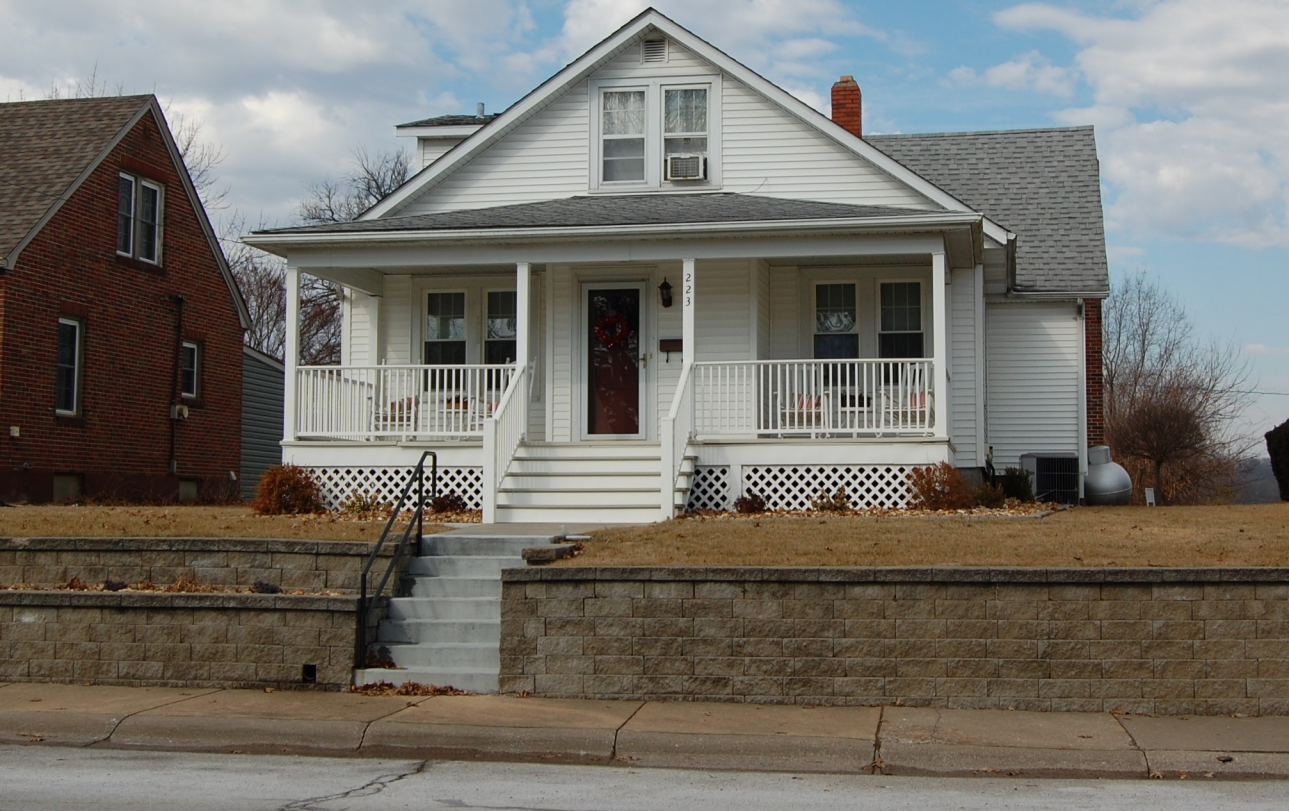
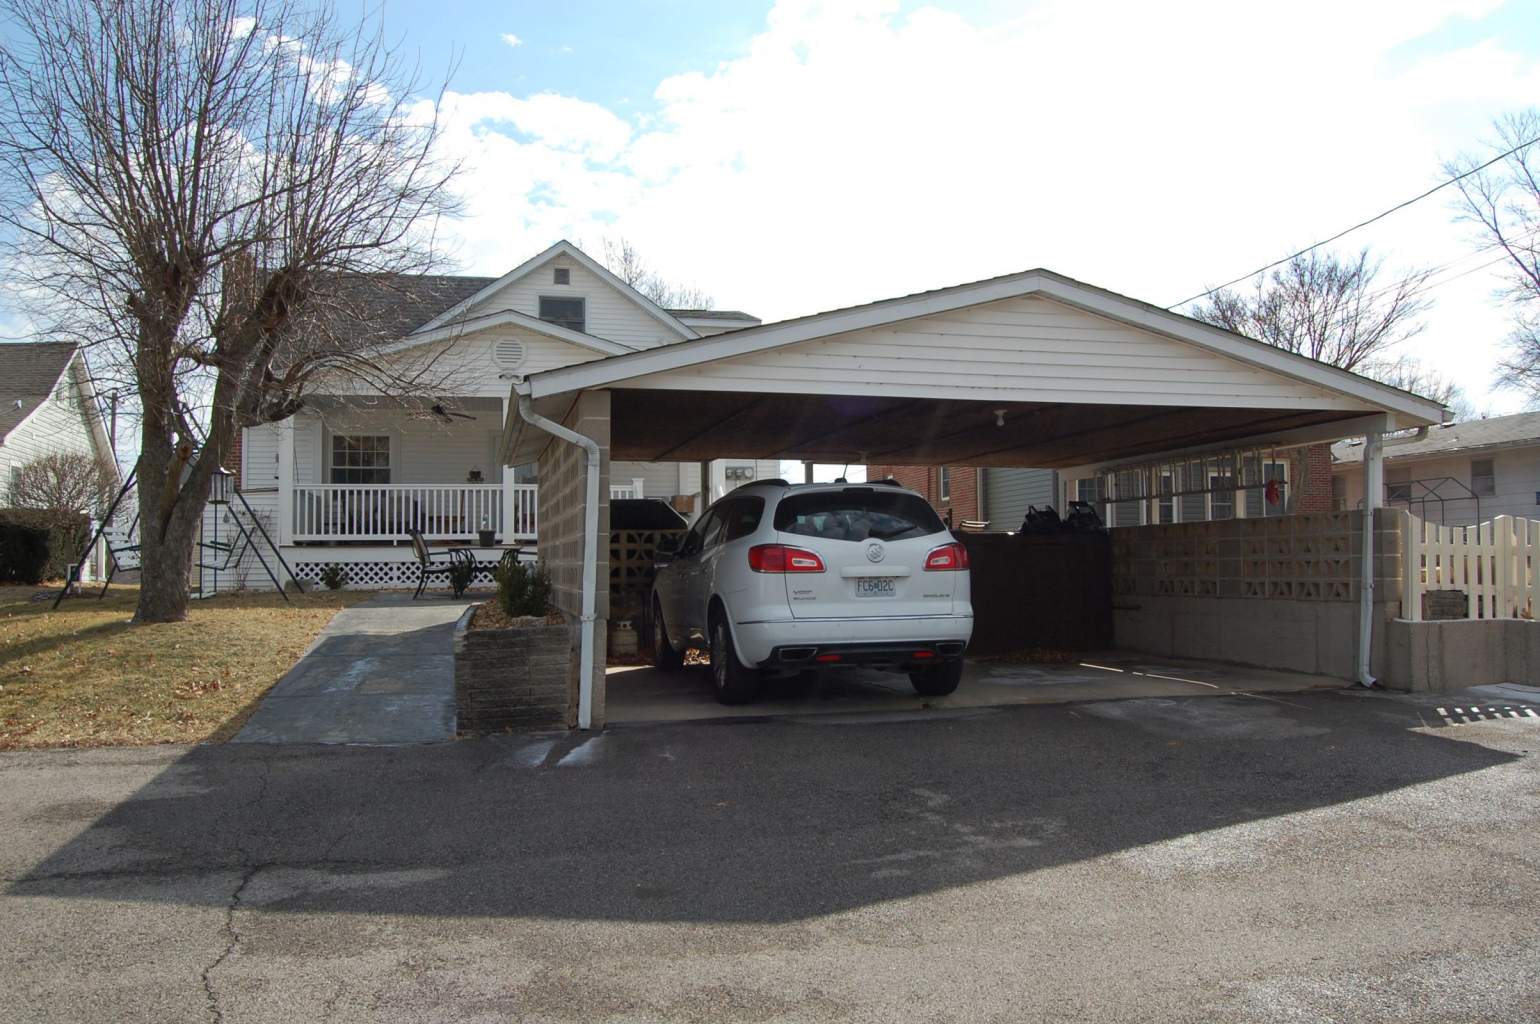
The 1.5 story frame dwelling has a concrete block foundation, vinyl siding, and affront gable, asphalt shingle roof. The front façade is 3 bays wide. There is a 1-story, $\frac{3}{4}$ to almost full width frame porch centered on the front façade. The porch has a dropped hipped roof of asphalt shingles, square composite posts, and an open square post metal or composite railing. Sheltered within the porch is an extended, centered bay containing an offset left single entry of a 3 light glass and wood door. On either side of the extended bay are paired 6/6 false interior muntin, double hung vinyl sash windows. Centered in the upper story front gable are paired vertical 3/1 wood sash windows. On the S elevation is a gable dormer with 1 paired and 1 single window. On the N elevation is one interior wall, side slope side right and one exterior brick chimney and a front gable bay. On the W elevation is a 1-story, front gable, partial width porch with square posts and an open square baluster railing [metal or composite]. Post 1992 survey alterations include: replacement of some of the 3/1 wood sash windows and major alterations to the front façade. The former front façade had an extended entry bay with a steeply pitched, asymmetrical front gable roof and a concrete landing. The porch was added post 1992. Due to the major alterations (front entry, windows, siding-vinyl), the house is not contributing to a potential NR district.

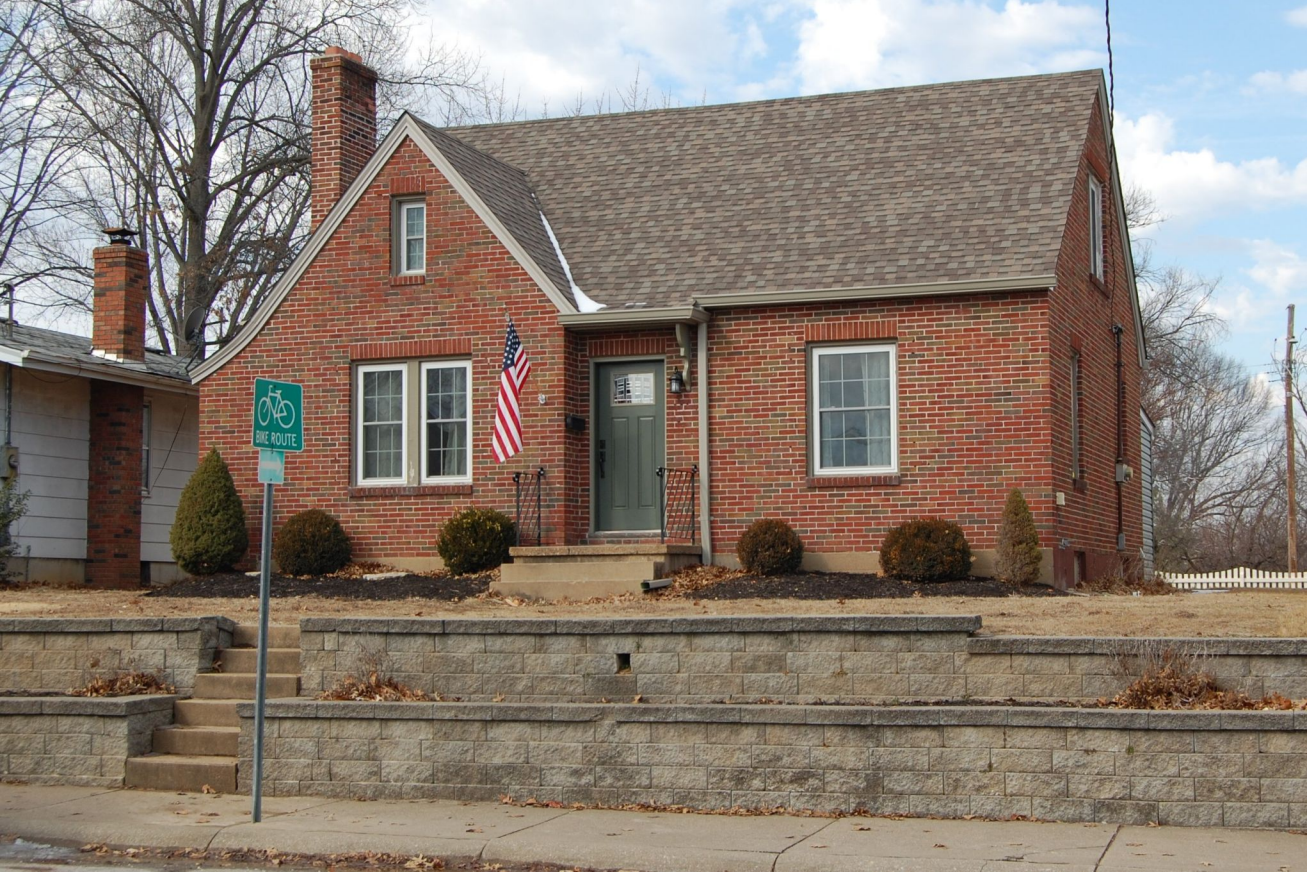
The 1.5 story masonry dwelling has a concrete foundation, variegated brick exterior in a running bond, and a side gable, asphalt shingle roof with an asymmetrical, slightly extended front gable bay (side left). The front façade is 3 bays wide. Centered on the façade are a single entry stoop with a slightly extended and dropped roof, one milled bracket, and a concrete platform with wrought iron railing. The entry door is a faux leaded square light glass and paneled metal replacement door. The side right bay has a single window. The side left bay, slightly extends from the primary buildings with a gable front roof. The first story has paired windows and the upper story has a single, smaller window in the gable. Windows on the first floor are 6/6 false interior muntins, double hung vinyl sash and the upper story gable window is a 4/4 false interior muntins, vinyl sash. Windows are set within a brick soldier course jack arch and a slightly angled rowlock course brick lug sill. On the S elevation is an exterior wall brick chimney. On the W elevation is a 1-story frame addition with an asphalt shingle shed roof and vinyl siding. Post 1992 survey alterations include: removal of ornamental shutters, replacement of 6/6 and 8/8 fixed wood sash windows with similar vinyl sash, and replacement of wood door. Due to the buildings date of construction and minimal alterations, it is contributing to a potential NR district.

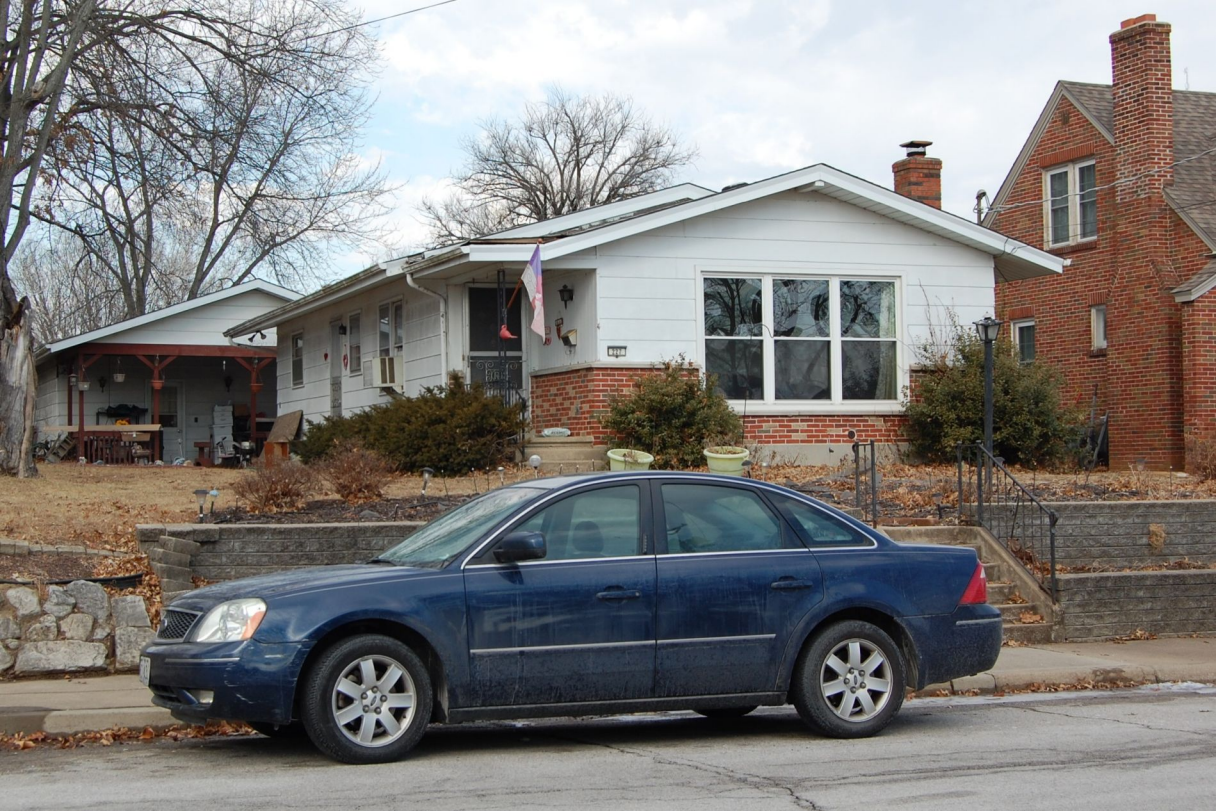
The 1-story frame dwelling has a concrete foundation, hardboard lap siding with a brick veneer dado wall on the front elevation, and an asphalt shingle, front gable roof. The roof has wide overhanging eaves. The front façade is 2 bays wide. The front section of the home is a slightly dropped gable extended bay with a slightly extended eave, side left, over the incised entry porch. The single entry has aluminum and screened storm door obscuring the primary door. The side right bay has a ribbon of three 1/1 double-hung, vinyl sash replacement windows. (Windows on the W elevation are horizontal 2/2 wood sash). There is one exterior wall brick chimney on the N elevation. This house was not surveyed in 1992. Due to the building's recent date of construction, c1968, it is not contributing to a potential NR district.

*If further research into the date of construction identifies it as 1959-1960, the status could be reassessed.

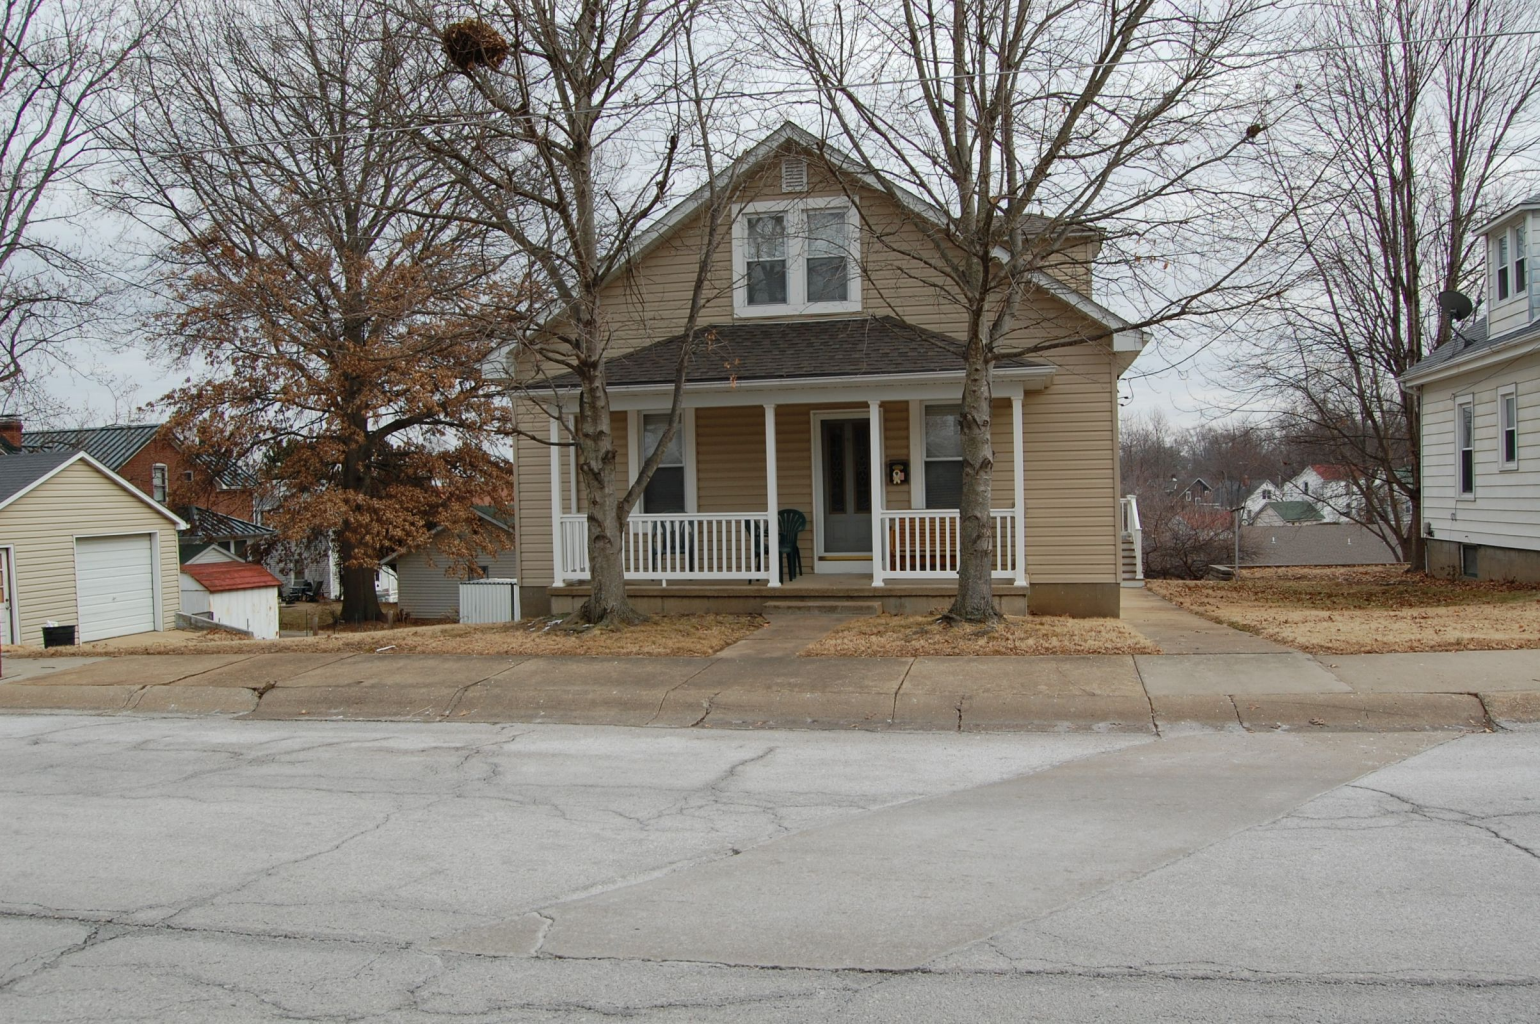
Due to the presence of vinyl siding, replacement windows and a new porch balustrade and roof supports, this home is not considered eligible for inclusion in a potential NR district.

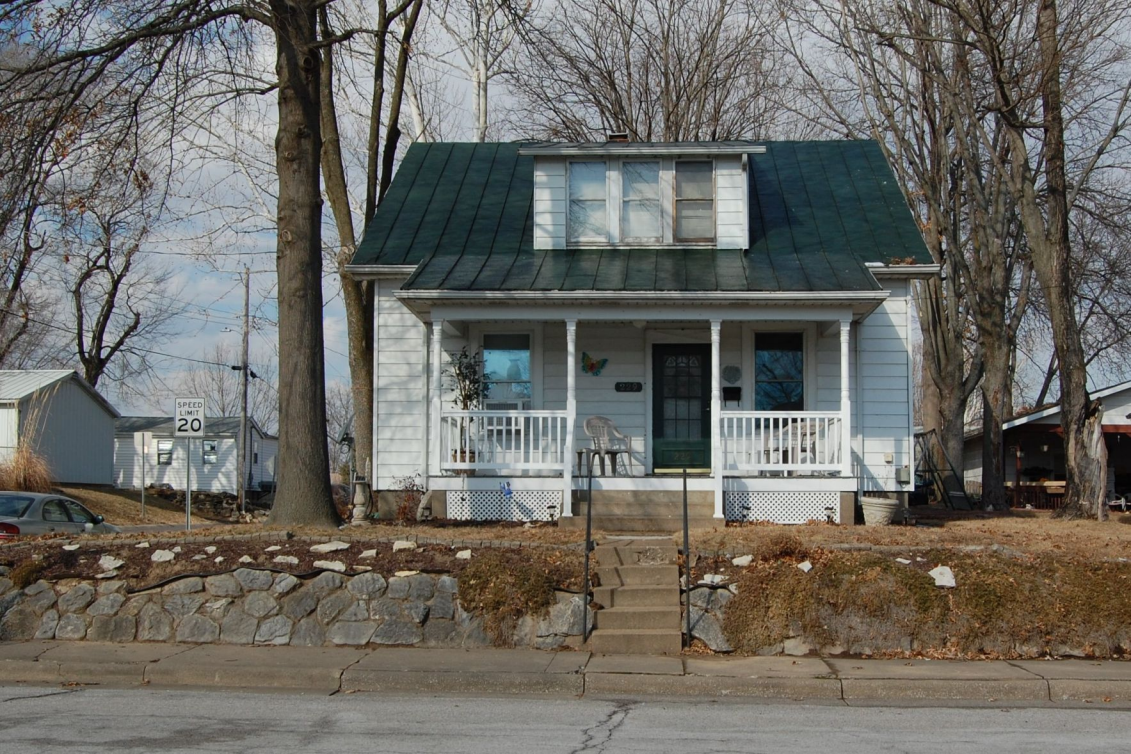
The 1.5 story frame dwelling has a concrete parged foundation, indeterminate siding, and a standing seam metal, side gable roof. The front facade is 3 bays wide. . The assessor's office notes the siding as aluminum while the 1992 survey notes vinyl. The current siding has a faux wood grain and taller profile, which is not original to the 1928 home. There is a 1-story, 3/4 width frame porch centered on the façade. It has an extended shed roof from the primary, 4 turned composite columns and an open square post composite balustrade. Sheltered within the porch is an offset right single entry consisting of fanlight and paneled metal replacement door with a multi-light and wood storm door with single windows on either side. 1st floor windows are 1/1 potentially replacement sash. Centered within the upper story is a shed roof dormer with a ribbon of three 1/1 windows obscured by wood storms. There is a shed roof dormer with 2 windows on the W elevation along with a 1-story frame addition with shed roof. There is a central interior, rear slope brick chimney. Post 1992 alterations include: replacement of the multi-light glass and wood door and replacement of the square wood columns with recessed panels, and a solid wood railing. These alterations occurred post June 2013 (Google Streetview). Due to the alterations in siding (vinyl), porch, and potentially windows, the home is not a contributing resource to a potential NR district.

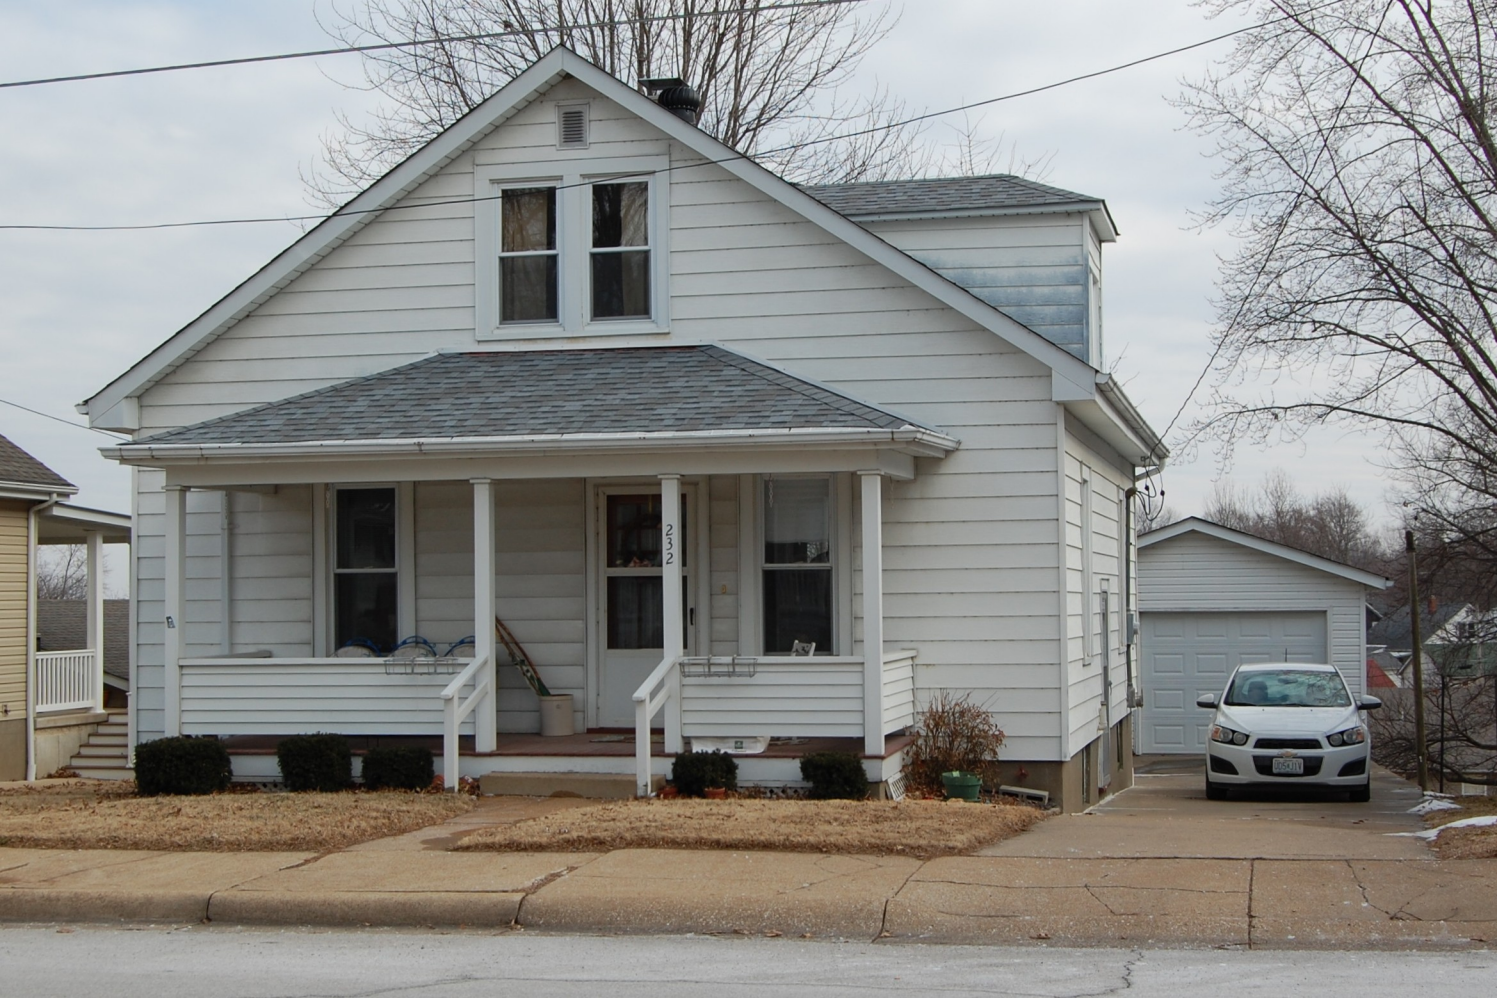
Since the 1992 survey, it appears that the original 1/1 wood sash windows have been replaced. The earlier survey also recorded vinyl siding, but the photo from that time looks the same as current condition.

Due to the presence of replacement siding, replacement windows and a non-historic porch balustrade and roof supports, this home is not considered eligible for inclusion in a potential NR district.

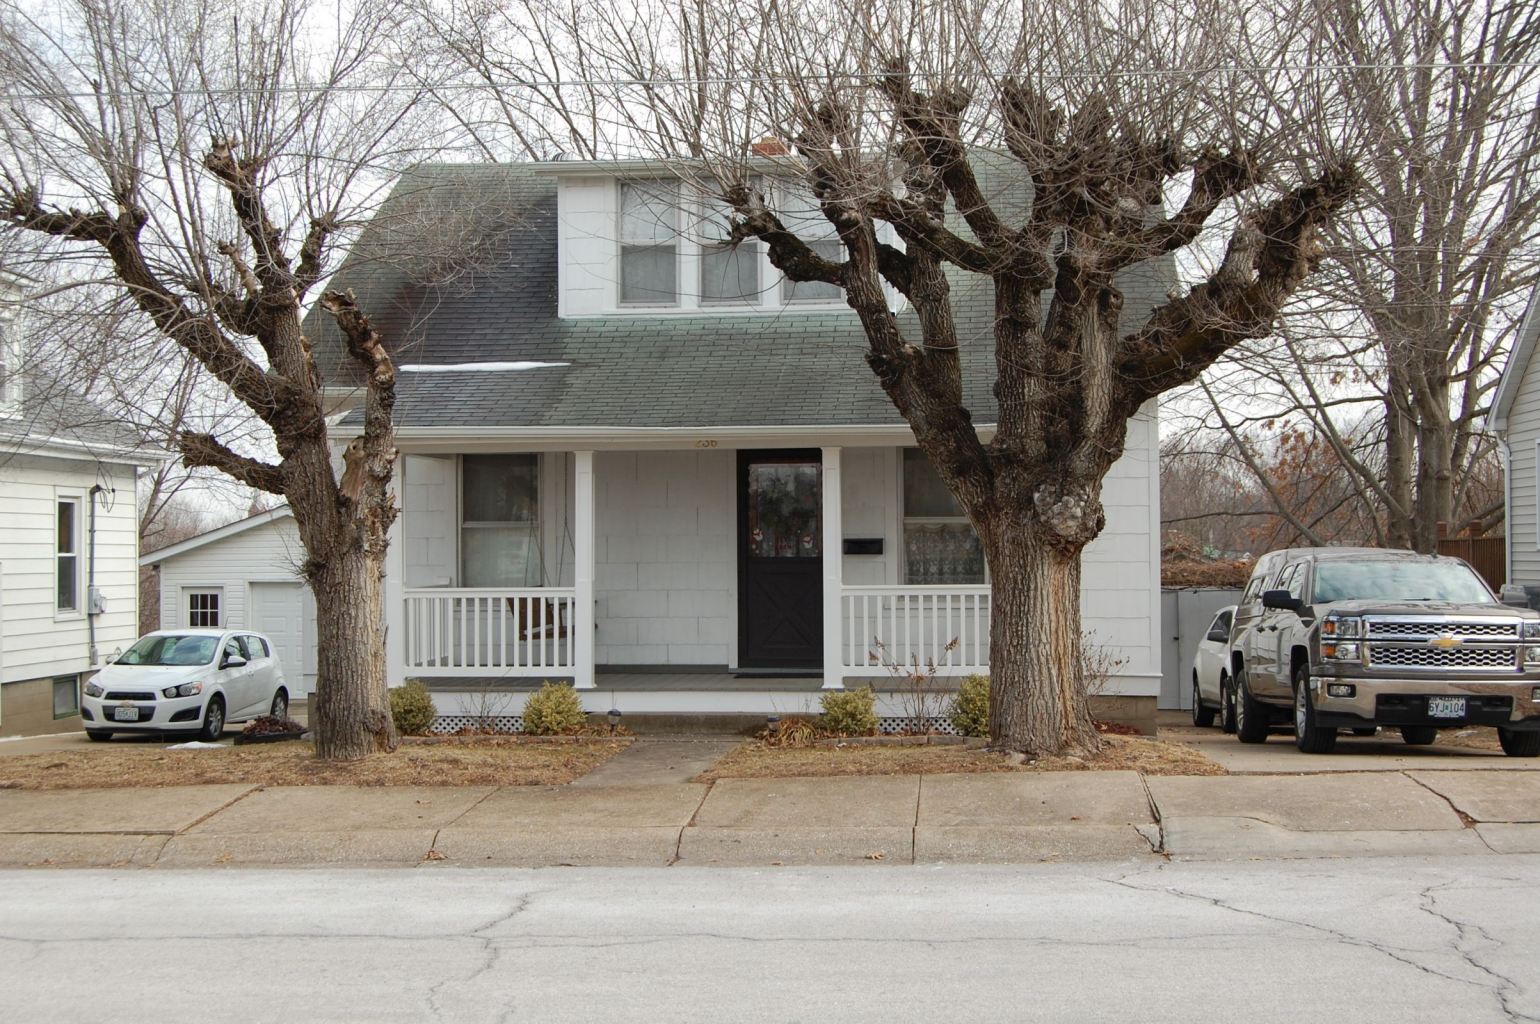
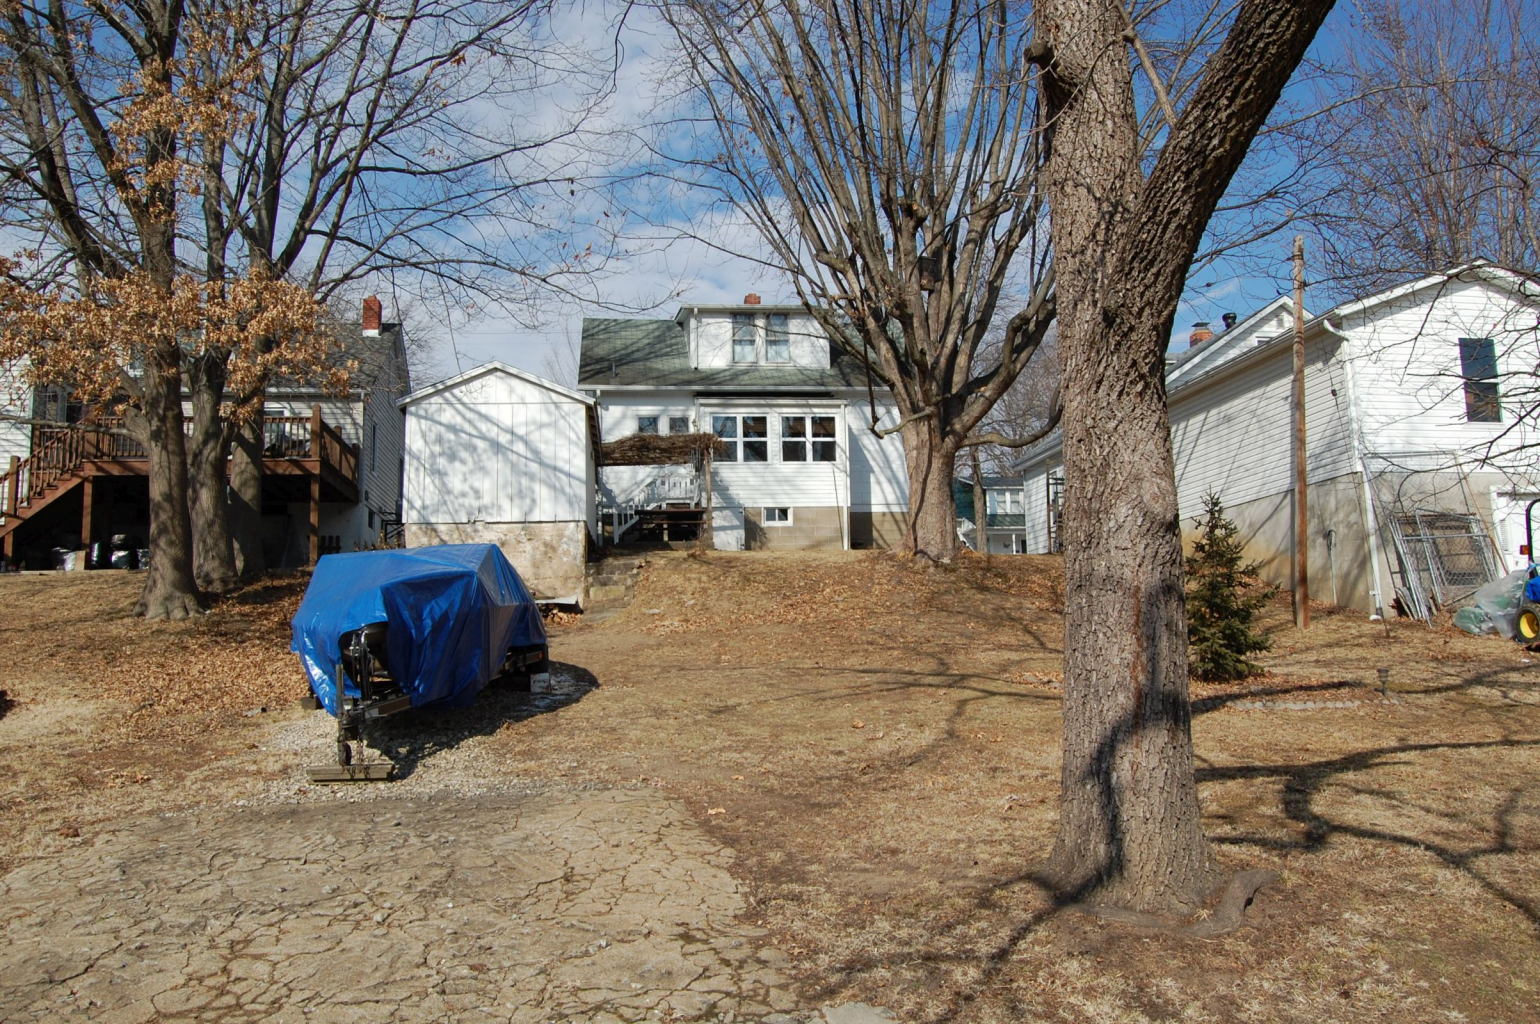
This 1.5 story frame side gable home has asbestos shingle siding, an asphalt shingle roof, and a concrete foundation. Centered on the primary elevation is a wooden platform porch with composite balustrade and asphalt shingled shed porch roof with square wood supports with recessed panels. The entry is situated beneath the porch roof and is offset right. The entry contains a multi light wooden door behind a storm door. On either side of the entry is a 1/1, double hung wood sash behind a storm window. Centered on the gable end of the upper half story is a window bay containing a ribbon of 1/1, double hung wood sash behind storm windows. Since the 1992 survey, the square wood columns with recessed panels and open railing with square wood balusters has been replaced with similarly styled composite materials.

Due to the presence of historic siding, windows and doors, this home is considered eligible for inclusion in a potential NR district.

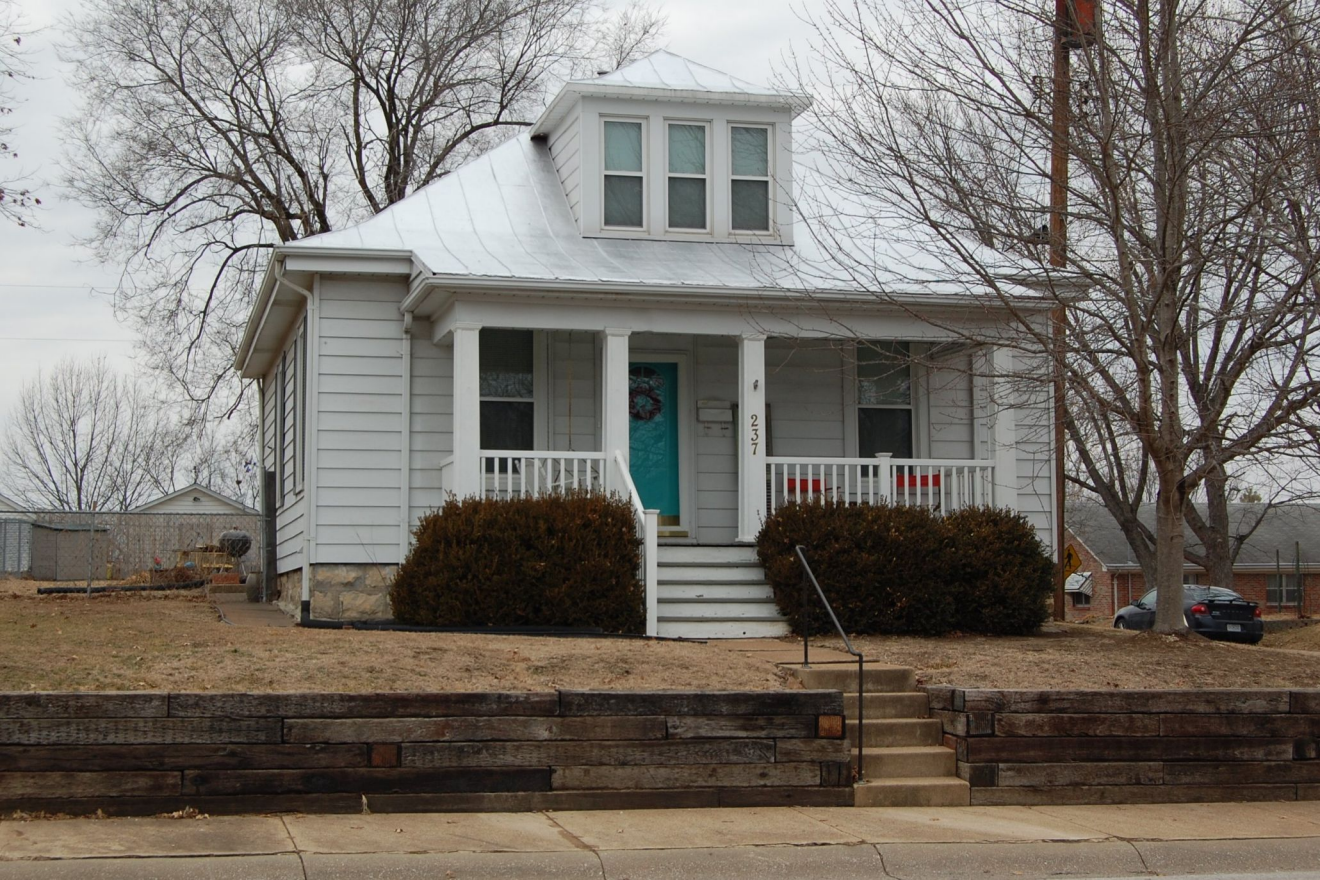
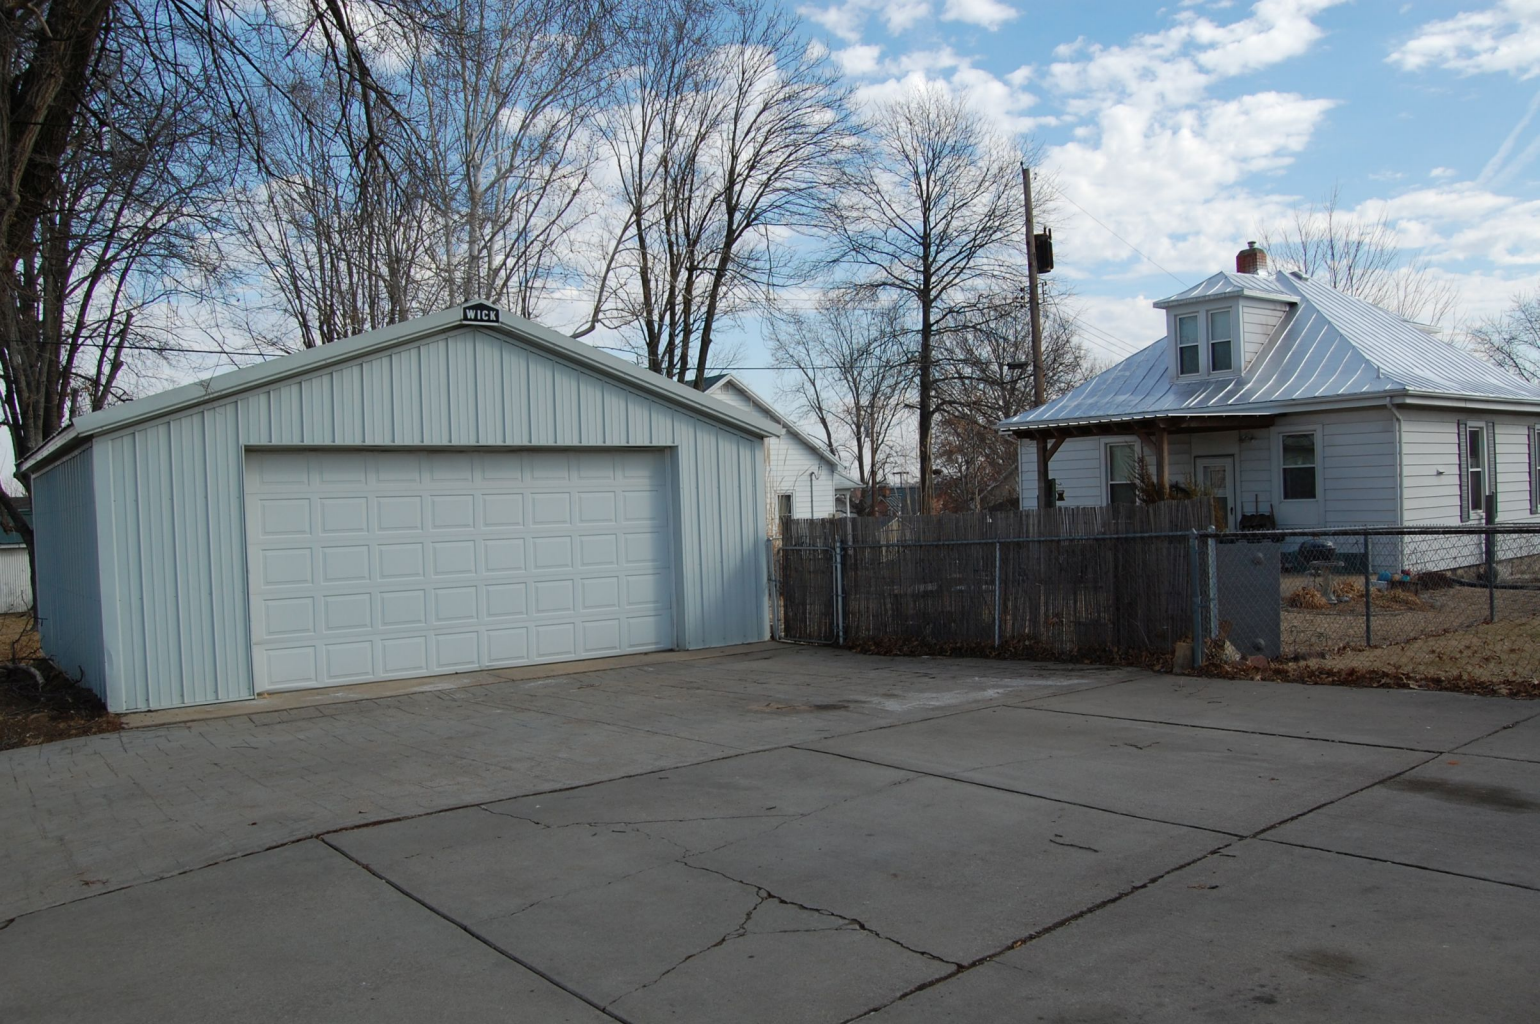
The 1.5 story frame dwelling has a coursed limestone block foundation, aluminum siding, and a hipped, standing seam metal roof. The front façade is 3 bays wide. There is a ¾ width, 1-story frame porch centered on the façade. It has a shed roof extended from the primary, four chamfered square wood posts with recessed panels, and an open square post composite balustrade. Sheltered within the porch is an offset right single entry, consisting of a fanlight glass and paneled metal door, with single windows on either side. Centered within the upper story is a hipped dormer with a ribbon of 3 windows. Windows are replacement 1/1 vinyl sash. On The W elevation is a 1-story corrugated metal shed roof porch and a 2 window hipped dormer. There is a central interior, side right slope brick chimney. Post 1992 Survey alterations include: replacement of the original single light glass and wood door, replacement of wood sash with 1/1 vinyl sash, the addition of the balustrade post March 2007 (assessor's office) and removal of ornamental shutters and the addition of the rear porch post June 2013 (Google streetview).

Due to the replacement aluminum siding, the house is not contributing to a potential NR district.

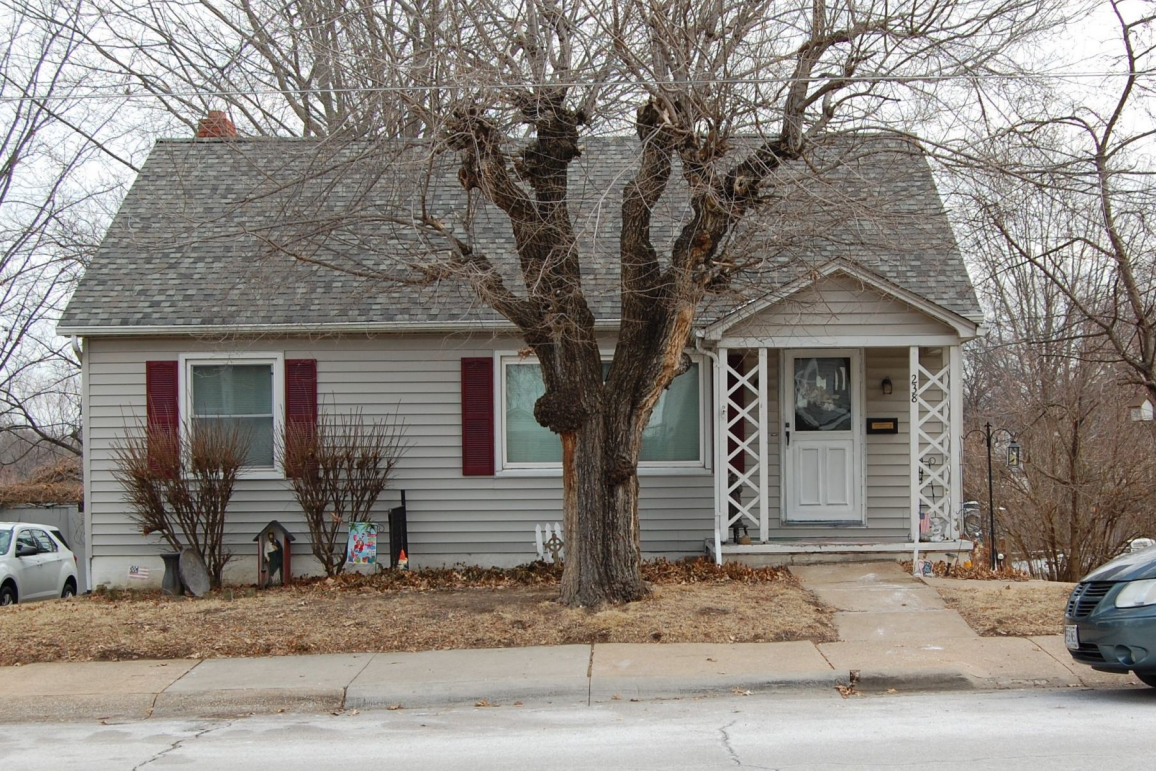
This 1 story frame side gable home has vinyl siding, an asphalt shingle roof, and a concrete foundation. On the right side of the primary elevation is a concrete platform porch with paired, square wooden supports holding up a front gable, asphalt shingle porch roof. The entry is situated beneath the porch roof and contains a metal and glass storm door that obscures the interior door. To the left of the entry are two window bays. One contains an arrangement of three single lights of vinyl sash. The central light is fixed and the flanking lights are sliding sash. The next bay contains a 1/1, double hung vinyl sash. The window bays are both flanked by non-operative plastic shutters. There are no apparent changes since the 1992 survey photo (there is no form).

Due to the presence of vinyl siding, replacement windows, and plastic shutters, this home is not considered eligible for inclusion in a potential NR district.
