MISSOURI DEPARTMENT OF NATURAL RESOURCES
STATE HISTORIC PRESERVATION OFFICE, P.O. Box 176, Jefferson City, MO 65102
ARCHITECTURAL/HISTORIC INVENTORY FORM

1. SURVEY NO. FR-AS-007-001		2. SURVEY NAME: International Shoe Factory Neighborhood	
3. COUNTY: Franklin		4. ADDRESS (STREET NO.) 605	STREET (NAME) West 3rd Street

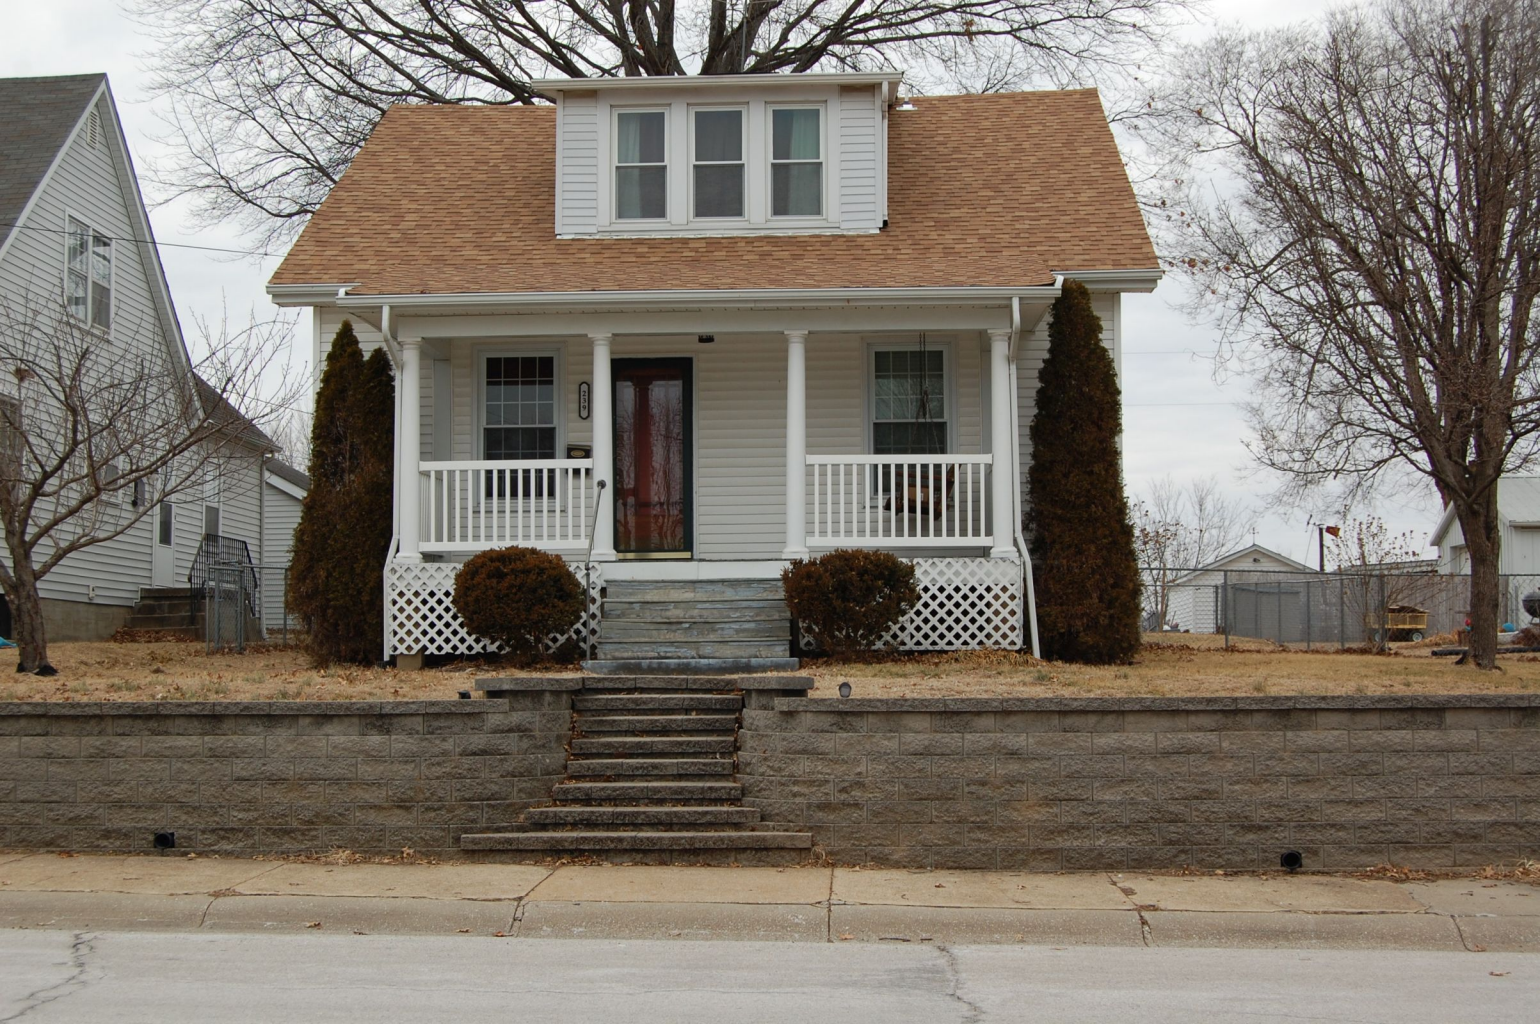
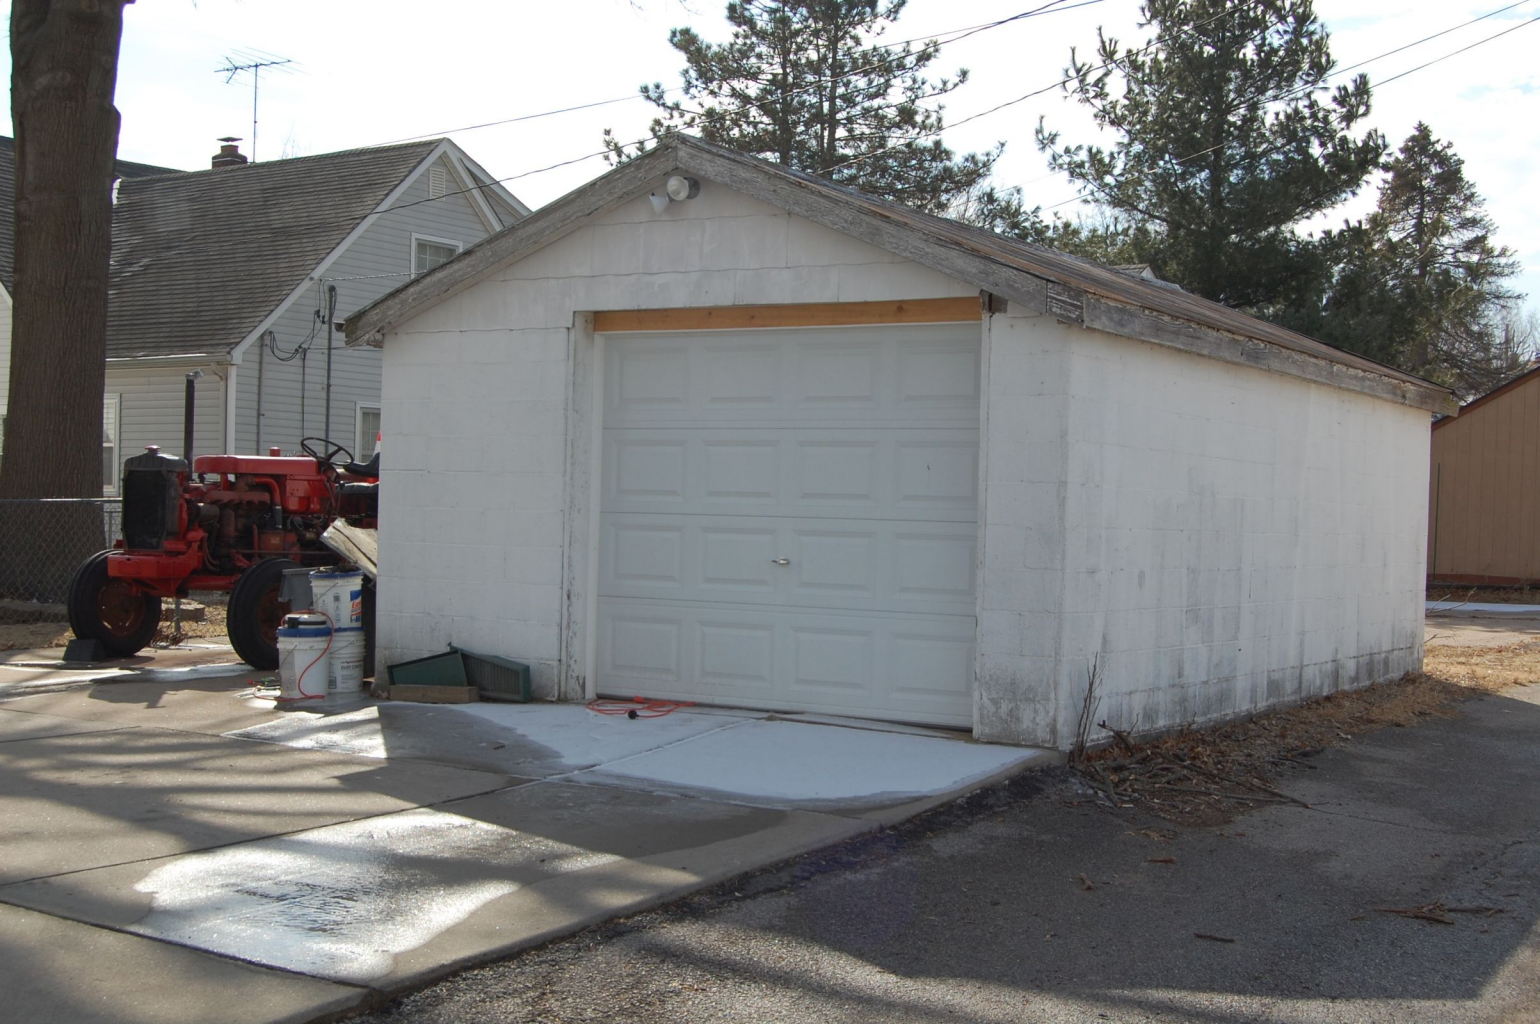
The 1.5 story frame dwelling has a concrete parged foundation etched to look like stone, vinyl siding, and a side gable, asphalt shingle roof. The front facade is 3 bays wide. There is a 1-story, 3/4 width frame porch centered on the façade. It has an extended shed roof from the primary, 4 composite Tuscan columns and an open square post composite balustrade. Sheltered within the porch is an offset left single entry, consisting of an older multi-light glass and wood door, with single 12/12 faux interior muntin vinyl sash windows on either side. Centered within the upper story is a shed roof dormer with a ribbon of three 1/1 vinyl sash windows. There is a gabled hood entry on the S elevation. On the W elevation is a small deck with a shed roof awning over the rear French doors and a 3/4 width shed roof dormer with 4 single windows in the upper story. There is a central interior, rear slope brick chimney with a large antenna perched on top. Post 1992 alterations include the replacement of the porch's square wood posts and wood railing with composite, replacement of 1/1 wood sash with 12/12 and 1/1 vinyl sash. According to the assessor's office the porch alterations occurred prior to 2007. Due to the alterations in vinyl replacement siding, the home is not contributing to a potential NR district.

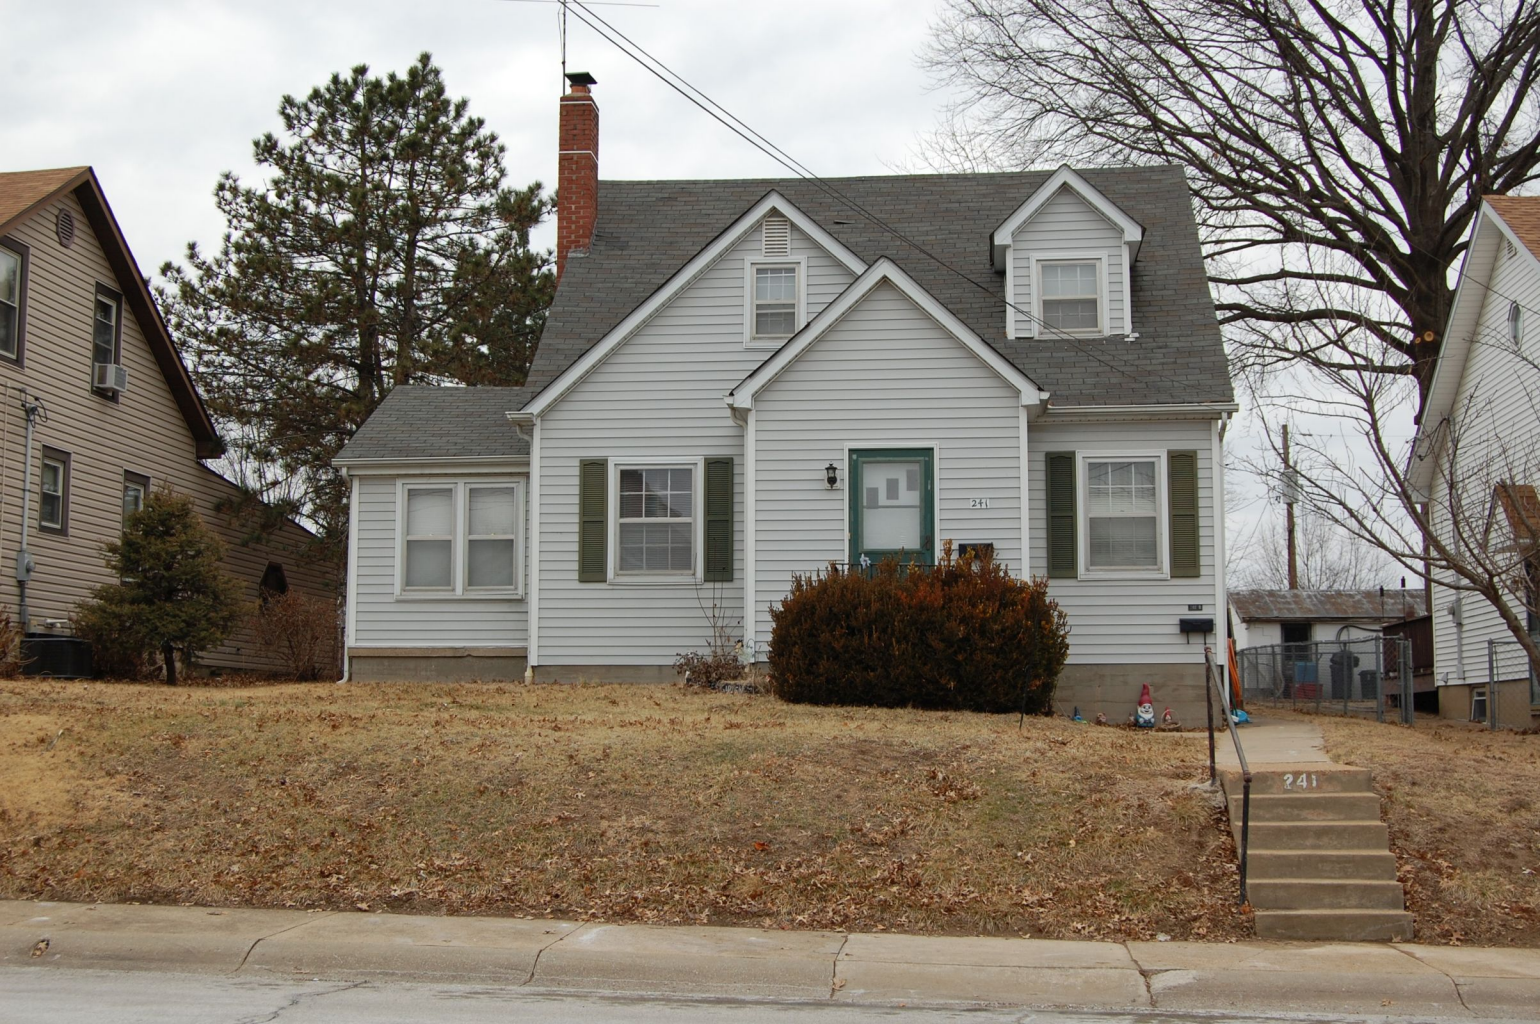
Due to the replacement in siding to vinyl, the home is not contributing to a potential NR district.

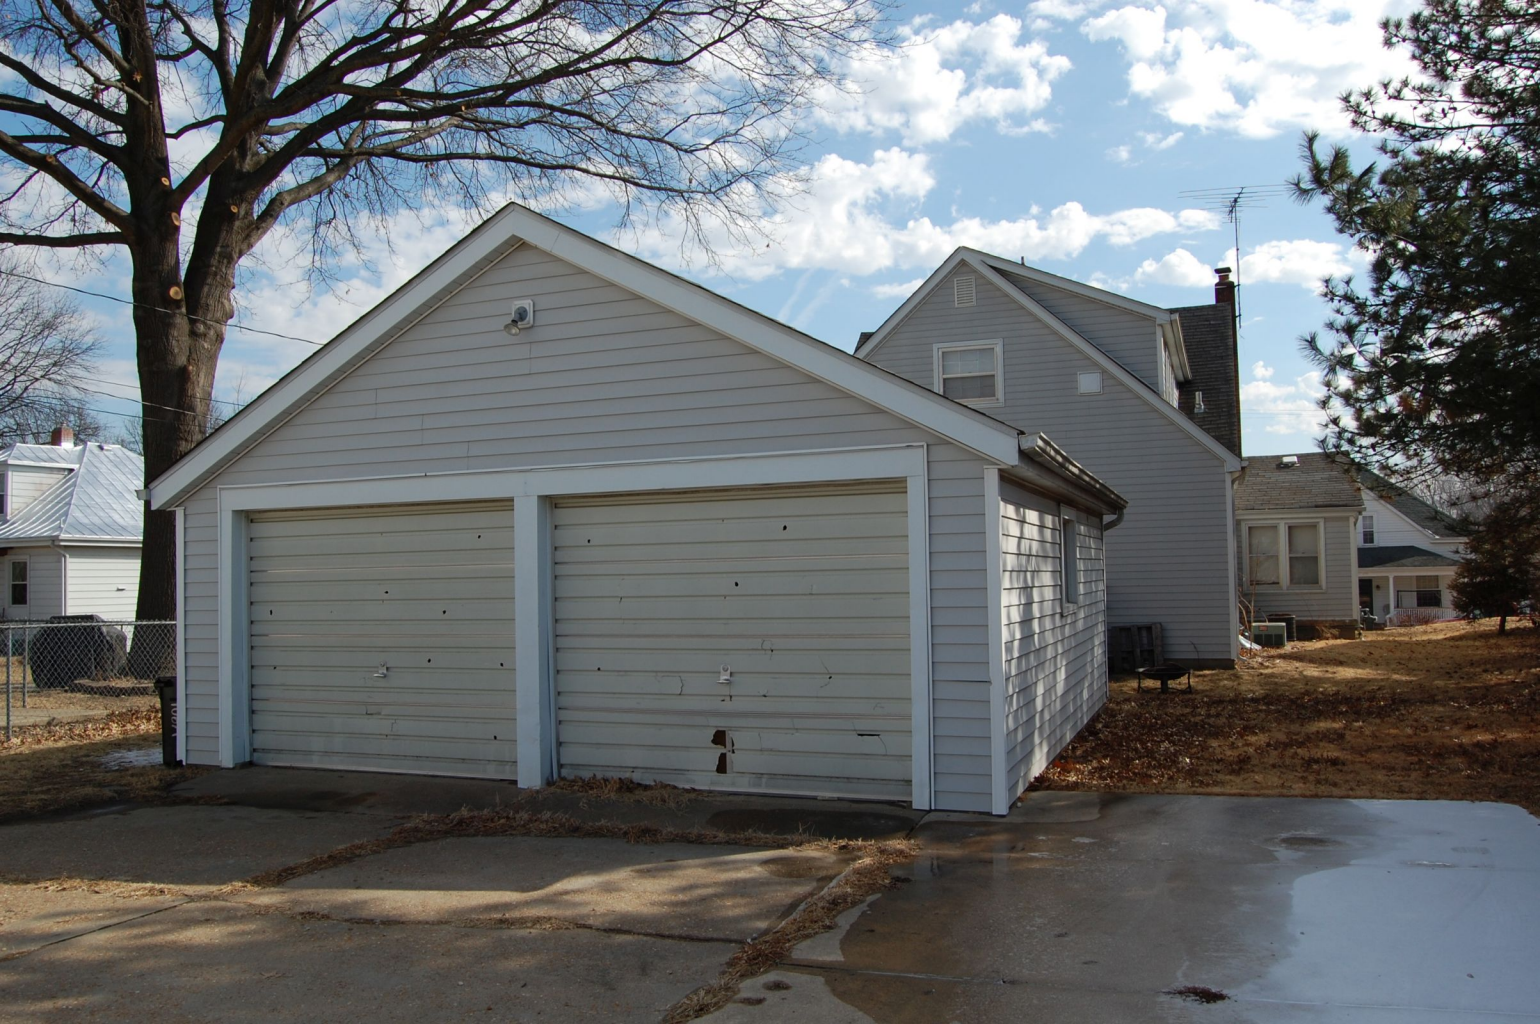
241

The 1.5 story frame, 2 family dwelling has a concrete foundation, vinyl siding, and a side gable asphalt shingle roof. The front façade is 4 bays wide. On the main façade is a side left gable bay, slightly dropped from the primary roofline. This bay does not extend from the façade's primary plane. Extended from this bay, and centered on the main façade, is a 1-story entry bay with a dropped gable front roof. The main entrance has a concrete platform with wrought iron railing and stairs parallel to the façade, side right, and a 3 light diagonal glass and wood door. The side left bay contains a single window on the first floor and a single window in the upper story gable. The side right bay has a single window on the first floor and a hipped dormer with single window within the upper story. Windows on the primary façade are 6/6 wood sash with ornamental shutters on the first floor. On the S elevation is a 1-story frame addition with side gable roof and paired 1/1 wood sash windows. There is an exterior wall brick chimney situated between the primary building's S wall and the addition. There is a single entry with concrete platform on the N elevation and a 1-story frame addition on the W elevation. Post 1992 survey alterations include the replacement of the asbestos shingle with vinyl siding and the removal of metal awning over front (E) and N entries.

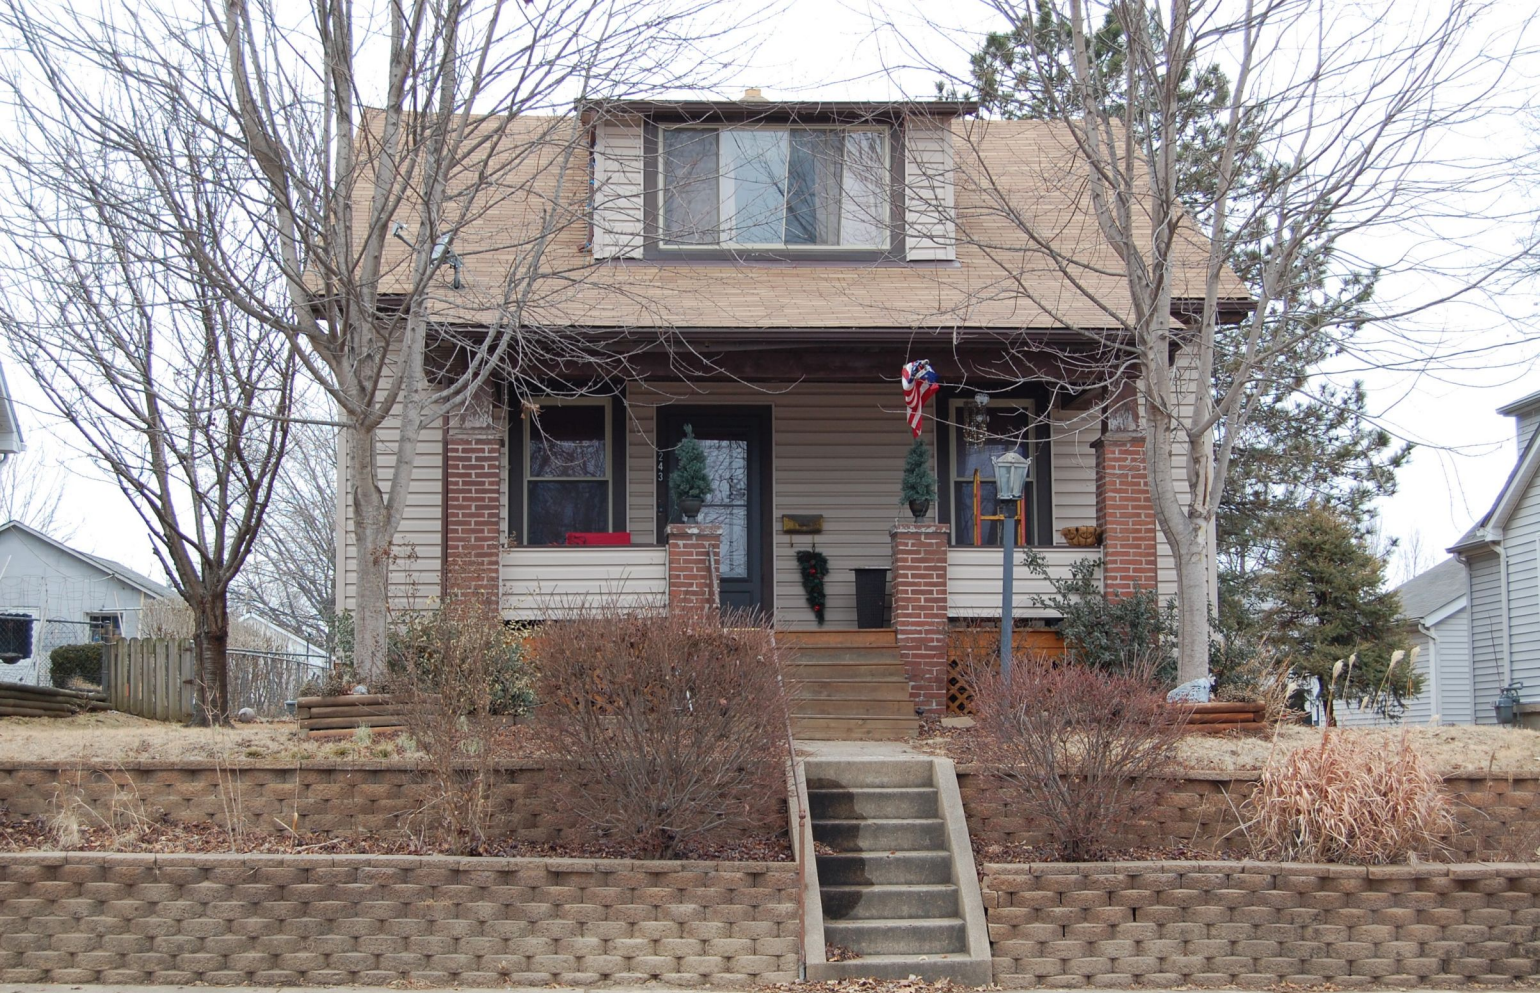
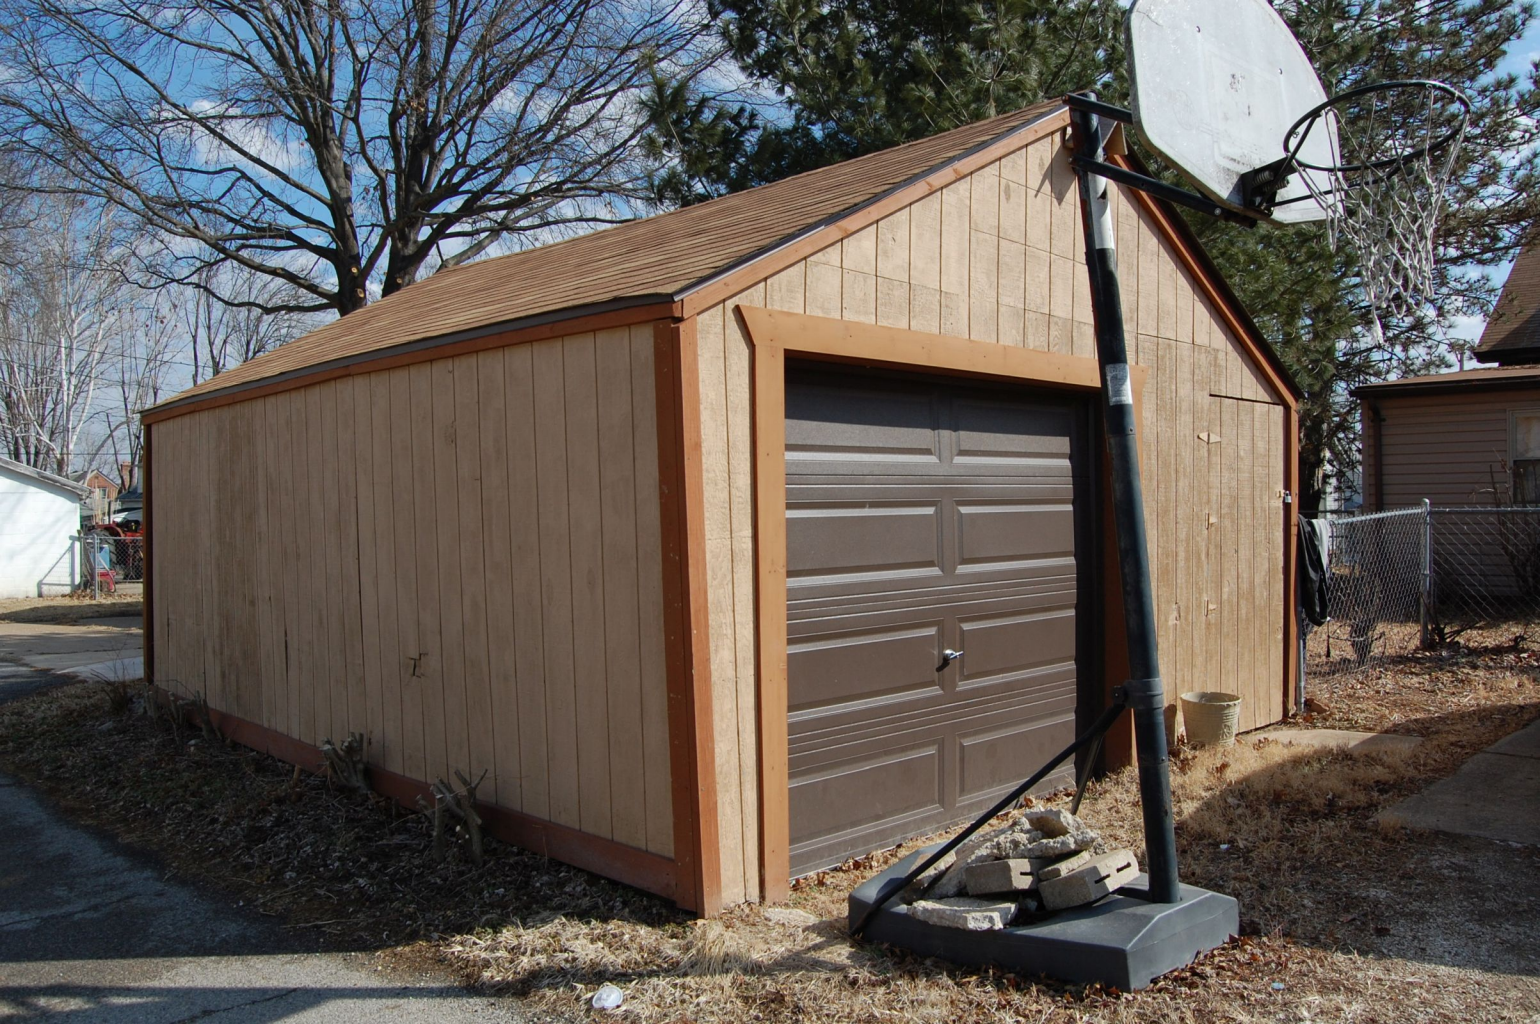
The 1.5 story frame dwelling has a limestone foundation, vinyl siding, and an asphalt shingle, side gable roof. The front façade is 3 bays wide. There is a partial to ¾ width, 1-story frame porch centered on the façade. It has two tapered wood posts on brick piers, a solid vinyl clad railing, wood deck, and centered wood entry stairs. Sheltered within the porch is an offset left single entry of a multi-light glass and wood door flanked by 1/1 double hung vinyl sash windows. Centered in the upper story is a shed roof dormer with a large 3 light sliding glass window. On the W elevation is a 1984, 1-story shed roof addition. On the S elevation is a single entry on the first story. There is a central interior, rear slope brick chimney. Post 1992 survey alterations include: replacement of the 1/1 wood sash windows with vinyl and a sliding glass window in the dormer. The 1992 survey photo shows a larger profile siding and solid, wood railing on the porch. Due to the later replacement vinyl siding the building is not contributing to a potential NR district.

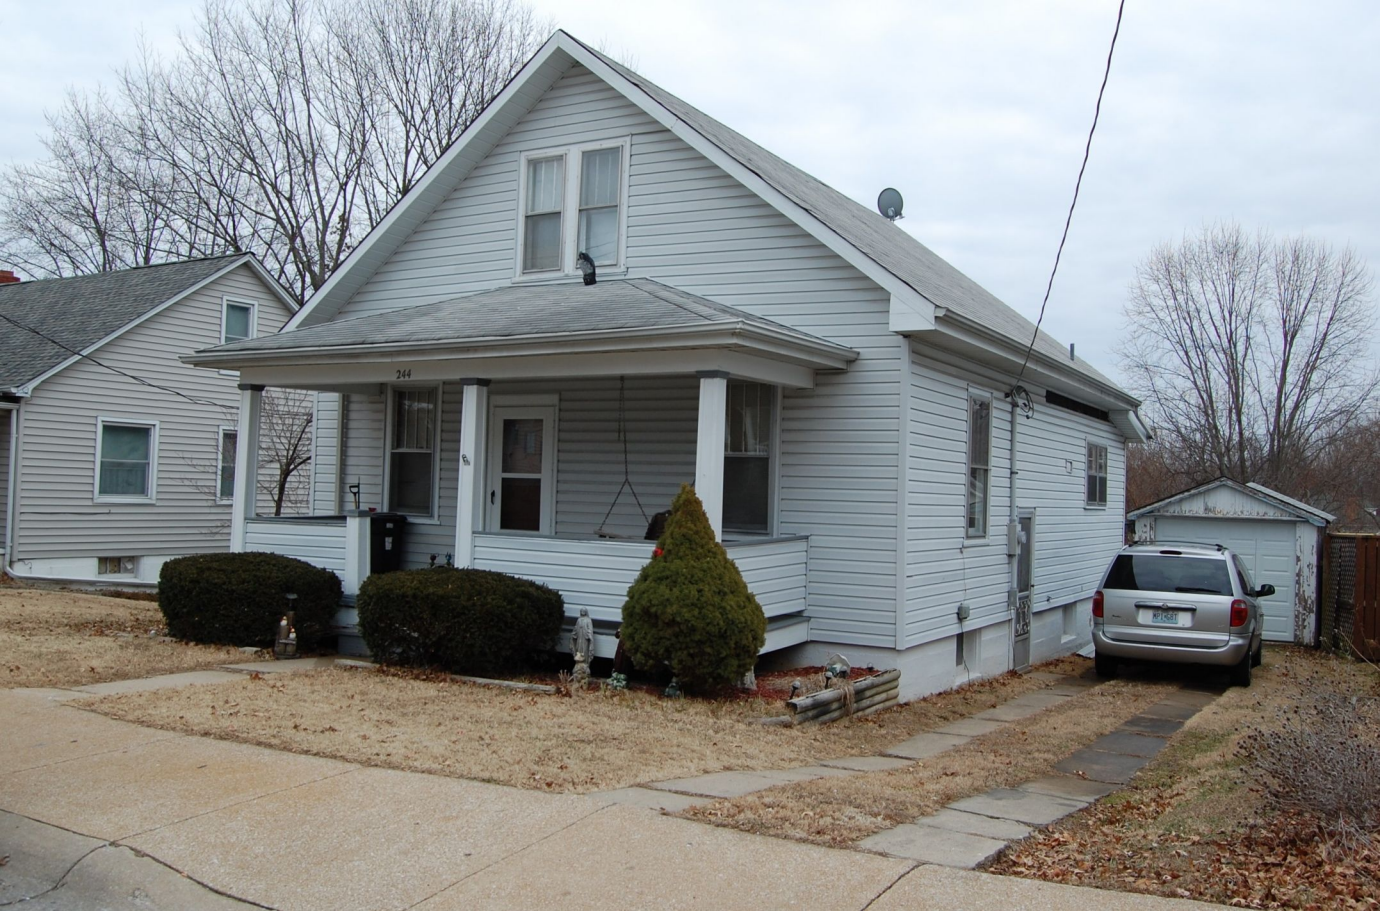
This 1.5 story frame front gable home has vinyl siding, an asphalt shingle roof, and a concrete foundation. Centered on the primary elevation is a wooden platform porch with a lap vinyl balustrade and asphalt shingled hip porch roof with square, slightly tapered wood supports with recessed panels. The entry is situated beneath the porch roof and is offset left. The entry contains a 3 descending rectangular light glass and wooden door behind a storm door. On either side of the entry is a 4/1, double hung wood sash behind a storm window. Centered on the gable end of the upper half story is a window bay containing a pair of 3/1, double hung wood sash behind storm windows.

Since the 1992 survey, the only visible alteration to this home is the removal of the chimney.

Due to the presence of historic windows and porch roof supports, this home is considered eligible for inclusion in a potential NR district.

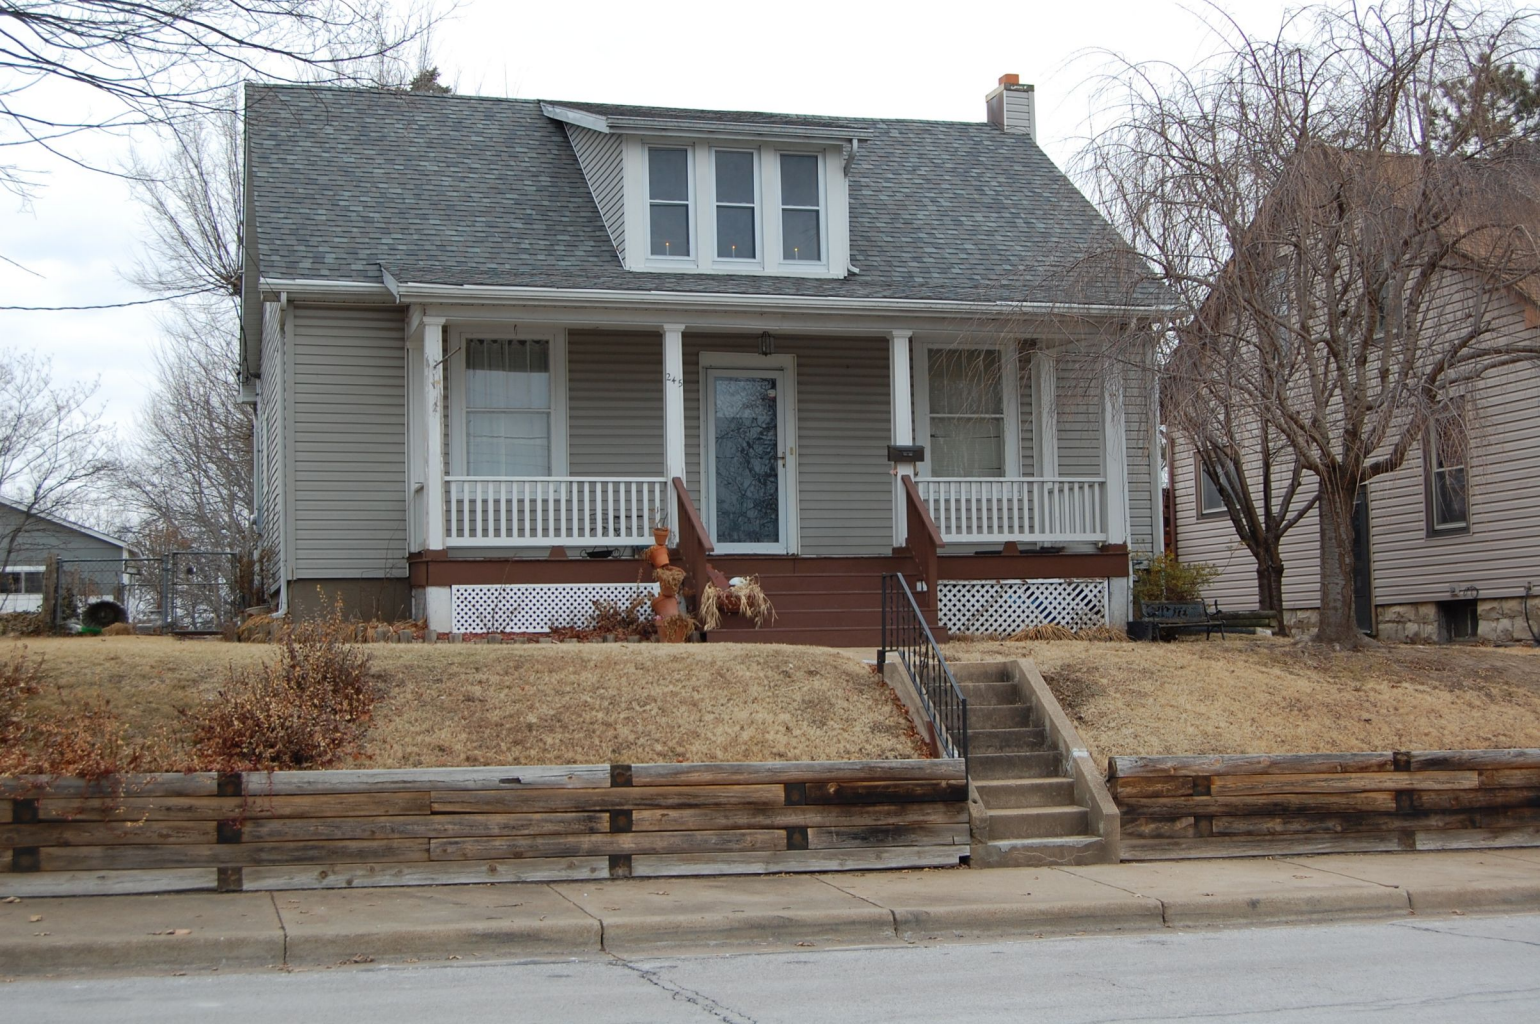
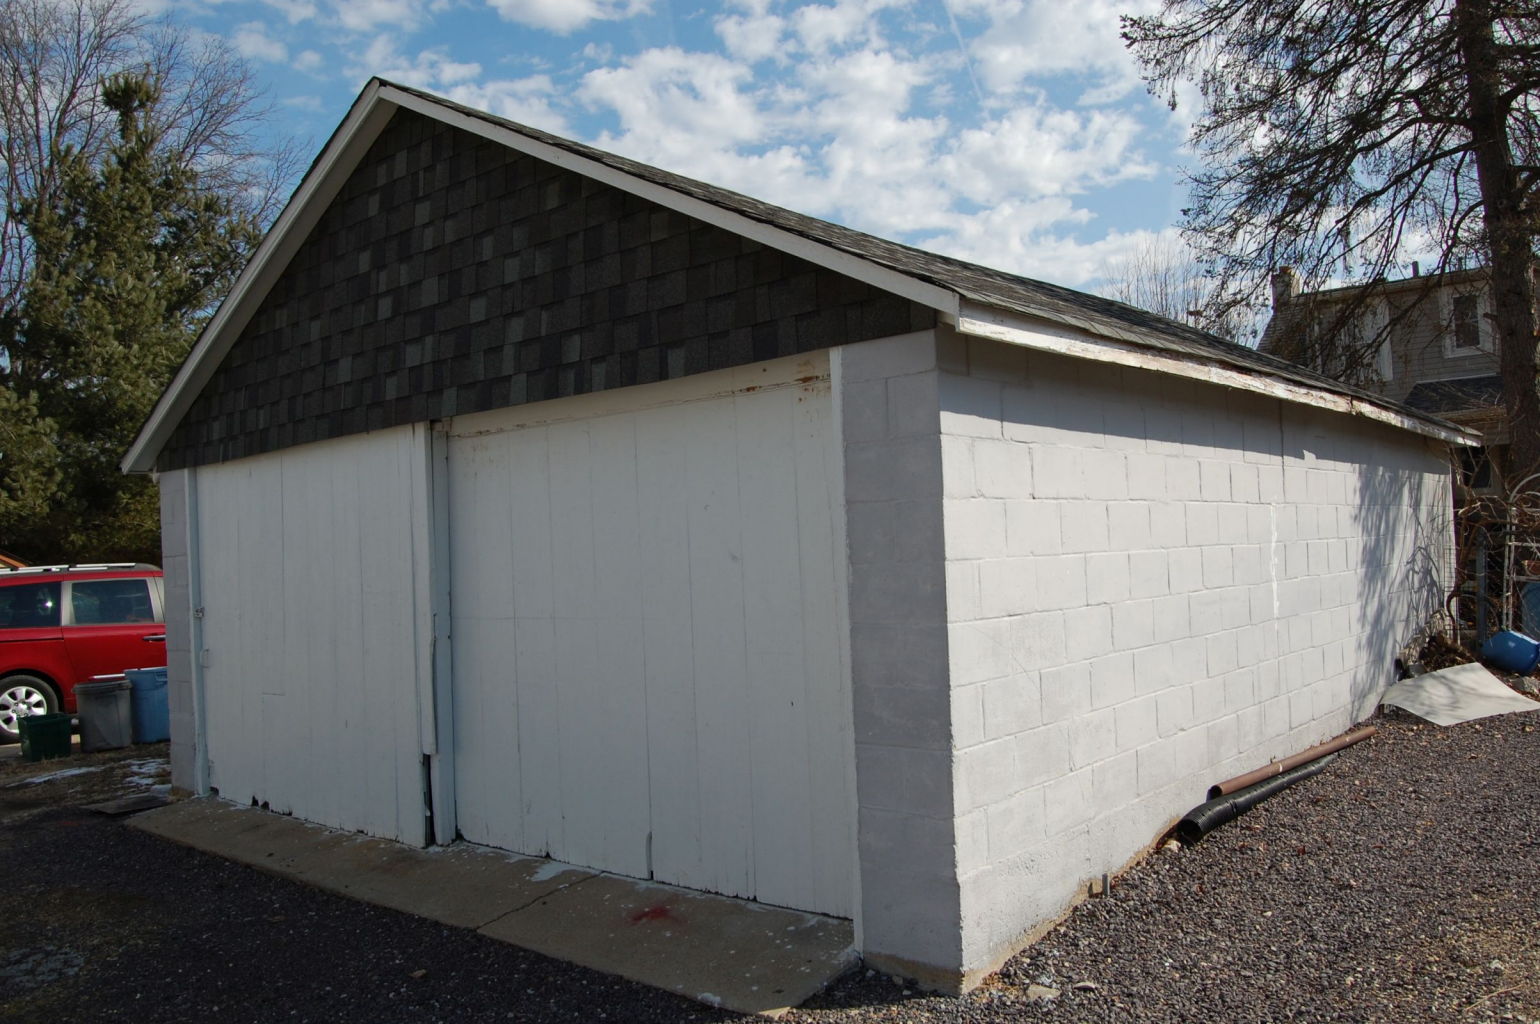
The 1.5 story frame dwelling has a concrete parged foundation, vinyl siding, and a side gable, asphalt shingle roof. The front façade is 3 bays wide. There is a 1-story frame, $\frac{3}{4}$ width porch with a shed roof extended from the primary centered on the façade. The porch has square wood posts with recessed panels (4 single, 2 engaged), an open square wood baluster railing, and a wood deck with centered stairs. Sheltered within the porch is a single, centered entry of a square, leaded light glass and paneled wood replacement door flanked by vertical $\frac{4}{1}$ wood sash windows. Centered in the upper story is a shed roof dormer with ribbon of three $\frac{1}{1}$ vinyl sash windows. On the N elevation is an exterior wall, vinyl clad chimney. On the W elevation is a large, $\frac{3}{4}$ width shed roof dormer with 2 windows. Post 1992 survey alterations include: replacement of asbestos shingles with vinyl, replacement of vertical $\frac{3}{1}$ wood sash with $\frac{1}{1}$ vinyl sash windows in the E elevation dormer and removal of the interior wall N and S elevation brick chimneys. Due to the replacement vinyl siding and dormer windows, the house is not contributing to a potential NR district.

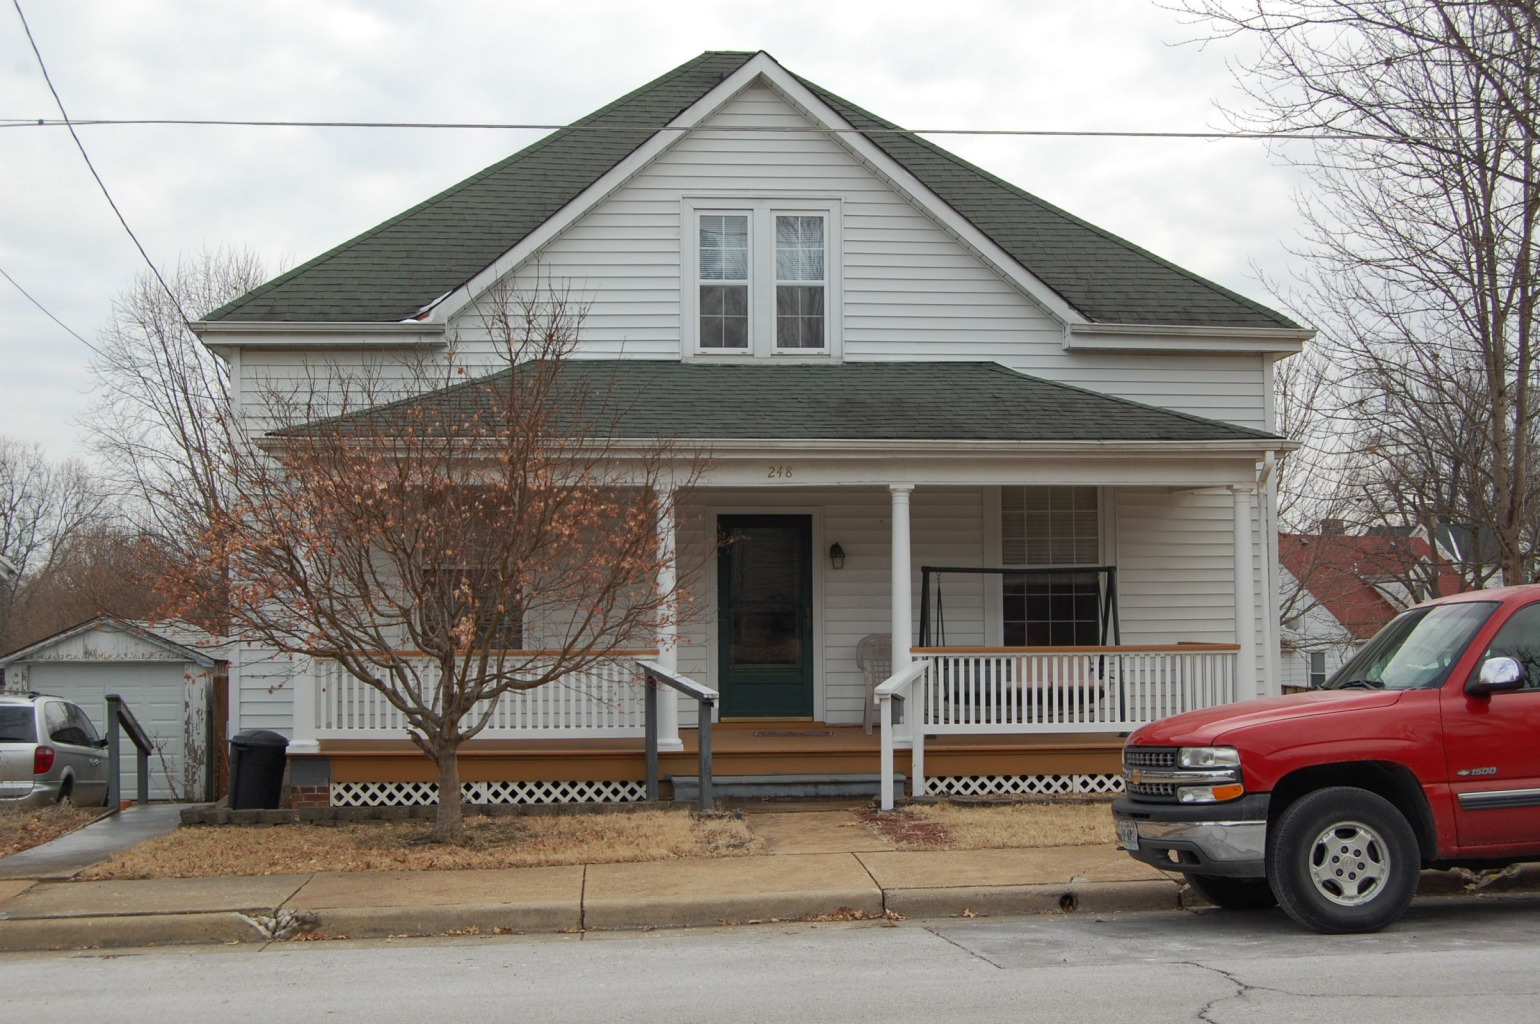
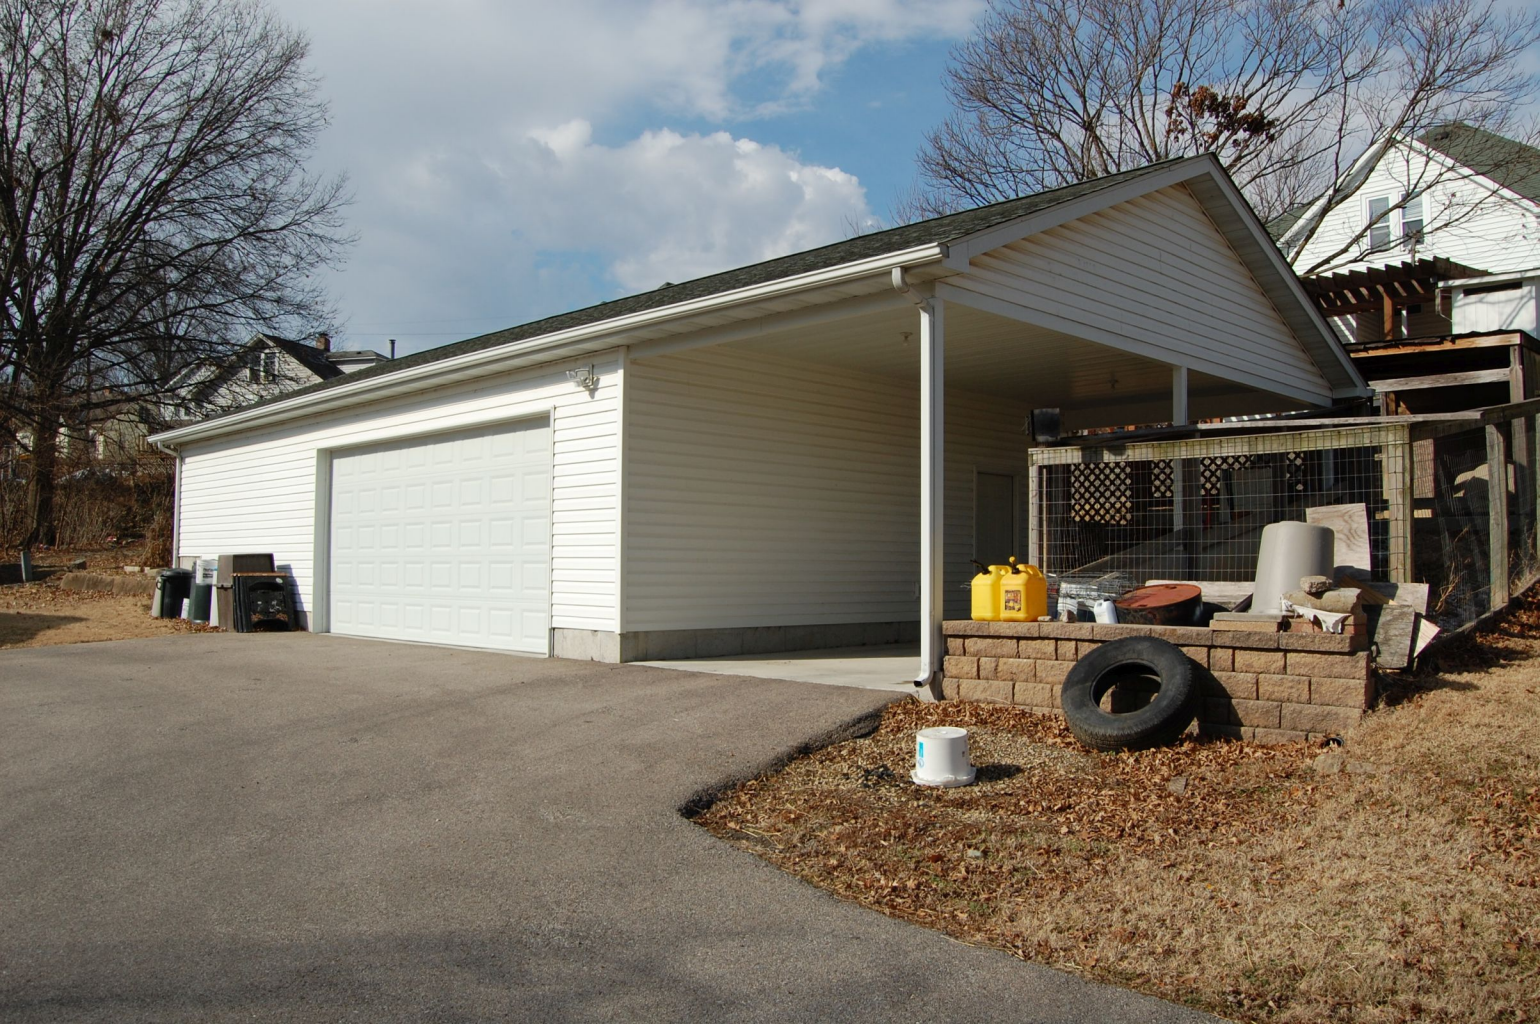
This 1.5 story frame pyramid square home has vinyl siding, an asphalt shingle pyramidal hipped roof, and a limestone foundation. There is an essentially full width wood platform porch centered on the primary elevation with wooden Tuscan columns supporting a hip asphalt shingle porch roof. The porch deck appears to have recently been replaced and a new wooden balustrade added. The entry is centered beneath the porch roof and contains a replacement wood storm door that obscures the interior door. On either side of the entry is a window bay containing a 1/1, double hung vinyl replacement sash with false muntins giving the appearance of 12/12 lights. There is a front gable centered on the attic level which contains a single window bay with a pair of 1/1, double hung vinyl replacement sash with false muntins giving the appearance of 4/4 lights.

Since the 1992 survey, the porch deck has been replaced and a new balustrade constructed, 1/1 wood sash have been replaced with vinyl, and the storm door has been replaced. Due to the presence of vinyl siding, replacement windows, replacement porch deck and balustrade, this home is not considered eligible for inclusion in a potential NR district.

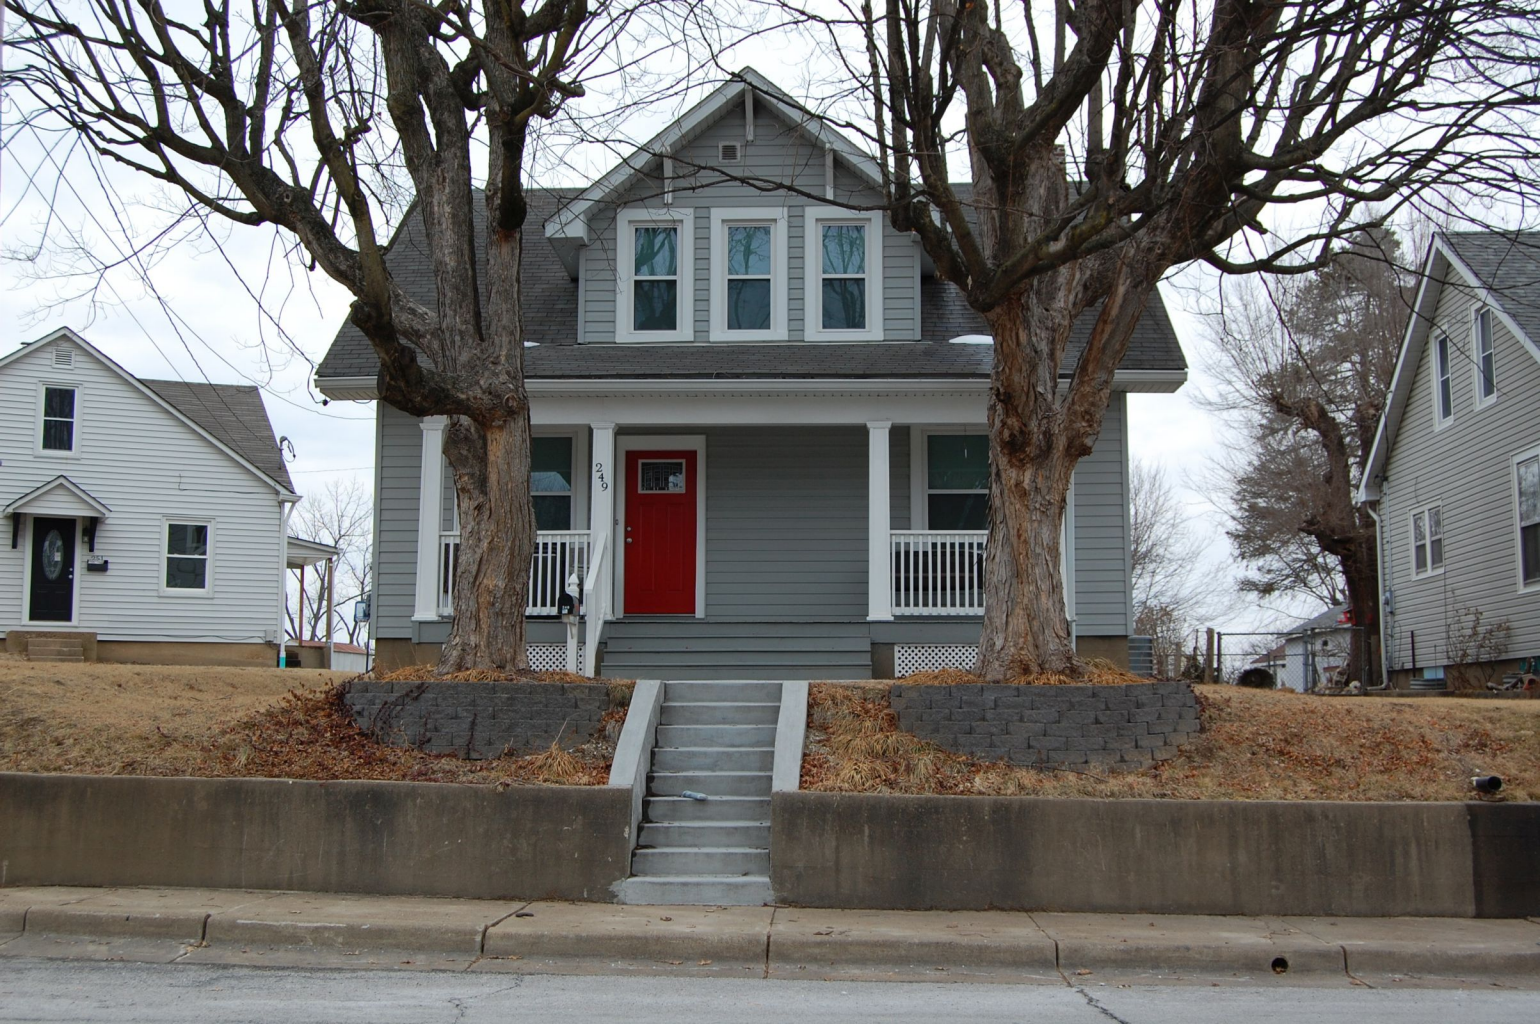
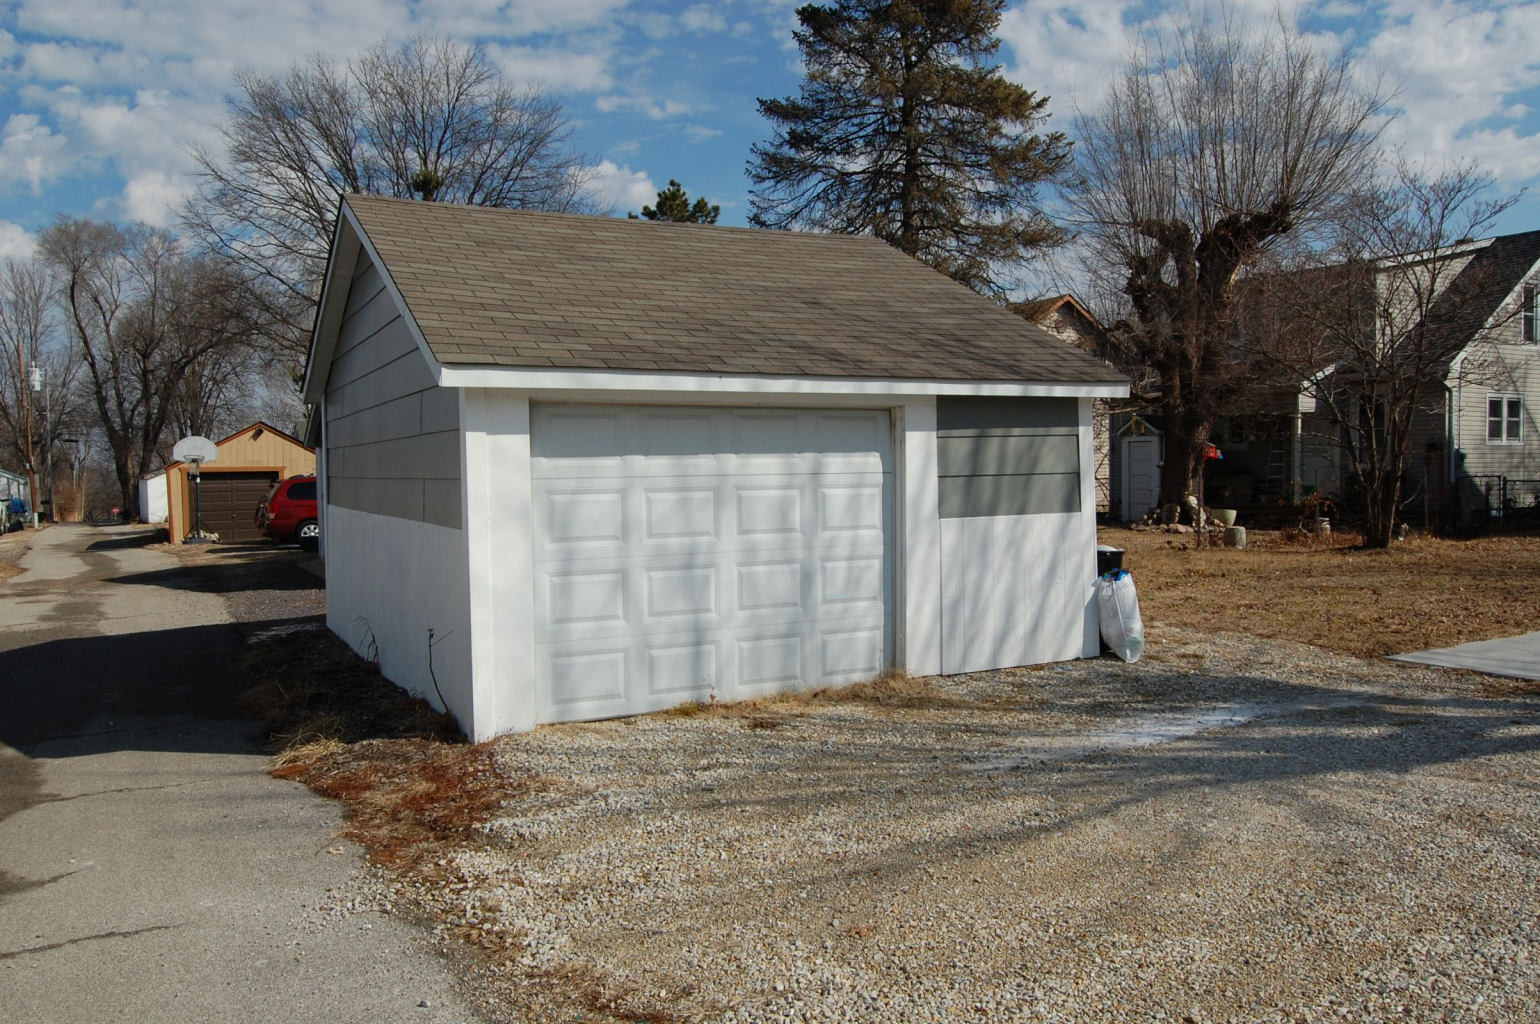
The 1.5 story frame dwelling has a concrete parged foundation, vinyl siding, and a side gable, asphalt shingle roof. The front façade is 3 bays wide. There is a 1-story frame, $\frac{3}{4}$ width porch with a shed roof partially extended from the primary centered on the façade. The porch has square wood posts with recessed panels (4 single, 2 engaged), an open square wood baluster railing, and a wood deck with centered stairs. Sheltered within the porch is a single, offset left entry of a square, faux leaded light glass and paneled replacement door flanked by vertical 1/1 vinyl sash windows. Centered in the upper story is a gable roof dormer with three separate 1/1 vinyl sash window and three gable brackets. On the W elevation has a 1-story shed roof enclosed porch. There is an interior wall, front slope brick chimney on the N elevation. Since the 1992 survey, alterations include: replacement of asbestos shingles with vinyl, replacement of standing seam metal roof with asphalt shingles, replacement of wrought iron porch railing with open square wood balusters, replacement of the multi-light glass and wood door, and the replacement of the original vertical 5/1, vertical 4/1, and vertical 3/1 wood sash with 1/1 vinyl sash. Due to the replacement vinyl siding and replacement vinyl sash windows, the house is not contributing to a potential NR district.
