MISSOURI DEPARTMENT OF NATURAL RESOURCES
STATE HISTORIC PRESERVATION OFFICE, P.O. Box 176, Jefferson City, MO 65102
ARCHITECTURAL/HISTORIC INVENTORY FORM

1. SURVEY NO. FR-AS-007-001		2. SURVEY NAME: International Shoe Factory Neighborhood	
3. COUNTY: Franklin		4. ADDRESS (STREET NO.) 605	STREET (NAME) West 3rd Street

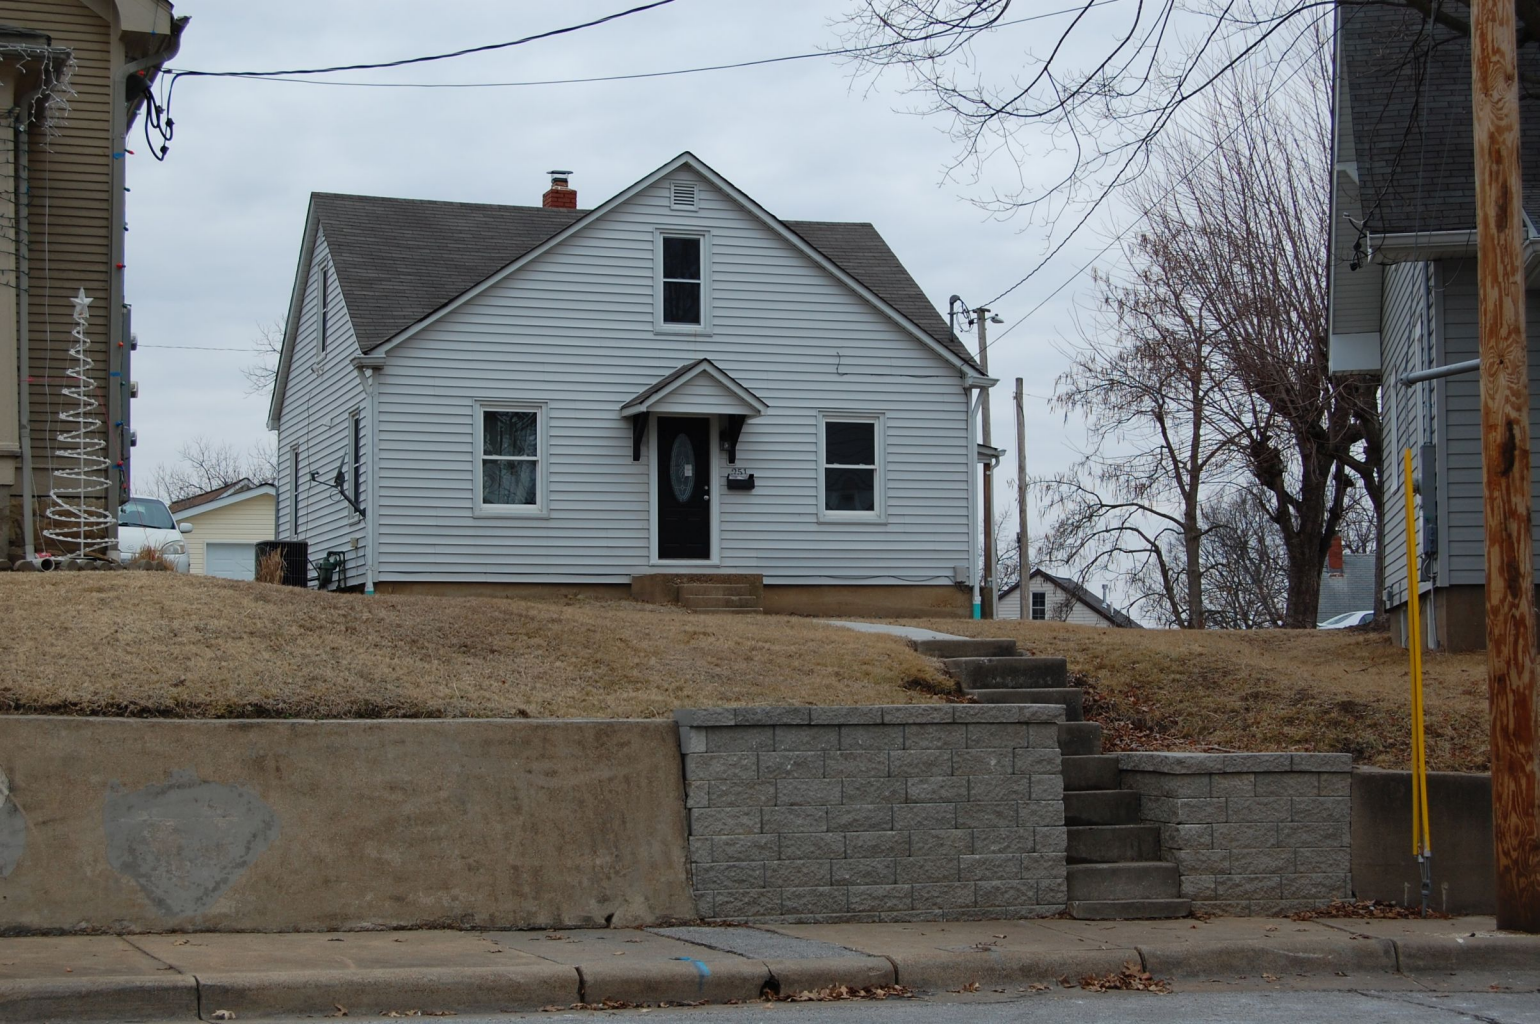
The 1.5 story dwelling has a concrete foundation, vinyl siding, and an asphalt shingle gable roof. The front façade is 3 bays wide. Centered on the façade is a single entry consisting of an oval faux leaded light and metal replacement door with a concrete platform and a gable hood with brackets. On either side of the entry are single windows. Centered in the upper story gable is a single window. On the N elevation is a single entry with concrete platform and shed roof with two wood posts. There is a central, rear slope brick chimney on the W elevation. Post 1992 survey alterations include: replacement of weatherboard siding with vinyl, replacement of multi-light glass and wood door, replacement of one 8/8 wood sash window and general replacement with vinyl sash.

Due to the replacement vinyl siding and the general replacement of original 8/8 wood sash windows, the building is not contributing to a potential NR district.

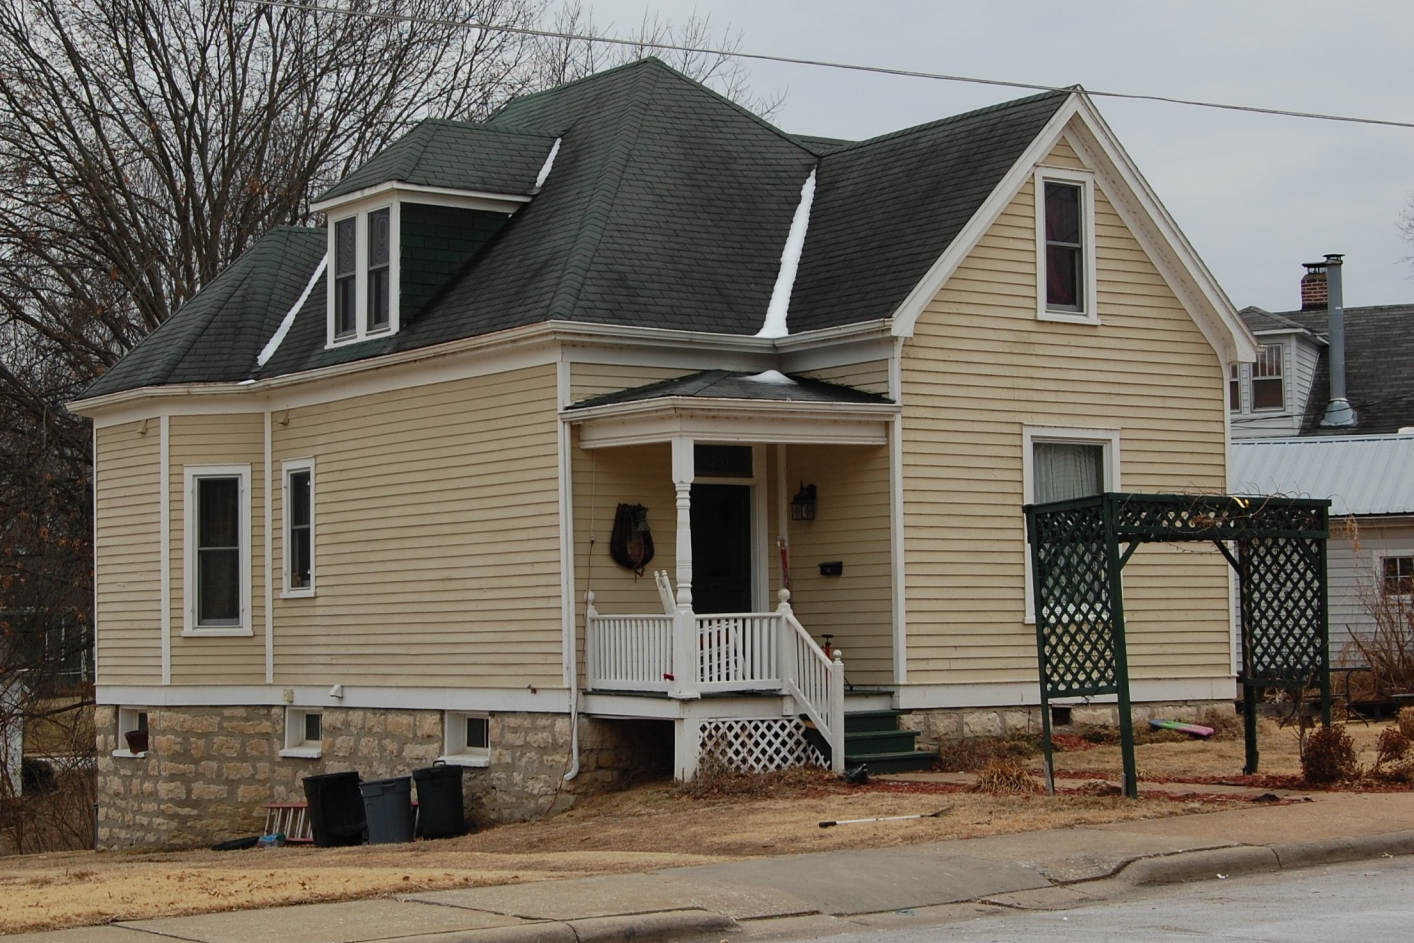
This 1.5 story frame gabled ell home has wooden lap siding, an asphalt shingle roof, and a limestone foundation. The roofline is complex and is essentially consists of a projecting front gable section attached to a pyramid square section, from which a projecting octagonal bay extends at the rear of the left (north) side of the building (something seen from the Folk Victorian style but lacking the details) The first floor of the front gable section contains a 1/1, double hung wood sash that may be historic, but is unlikely to be original. There is a partial width, wood platform porch at the junction of the front gable and pyramid square sections. This porch has an open wood balustrade with square balusters and turned wooden posts supporting a hipped roof. The entry is situated beneath the porch roof and contains a wooden door with a single light and a single light transom. There is a single window bay centered on the front gable end on the upper half story. It contains a 1/1, double hung wood sash.

Since the 1992 survey, the siding and windows seem to have been restored rather than replaced. The only change appears to be the removal of a central, interior wall brick chimney. This building is considered eligible for inclusion in a potential NR district.

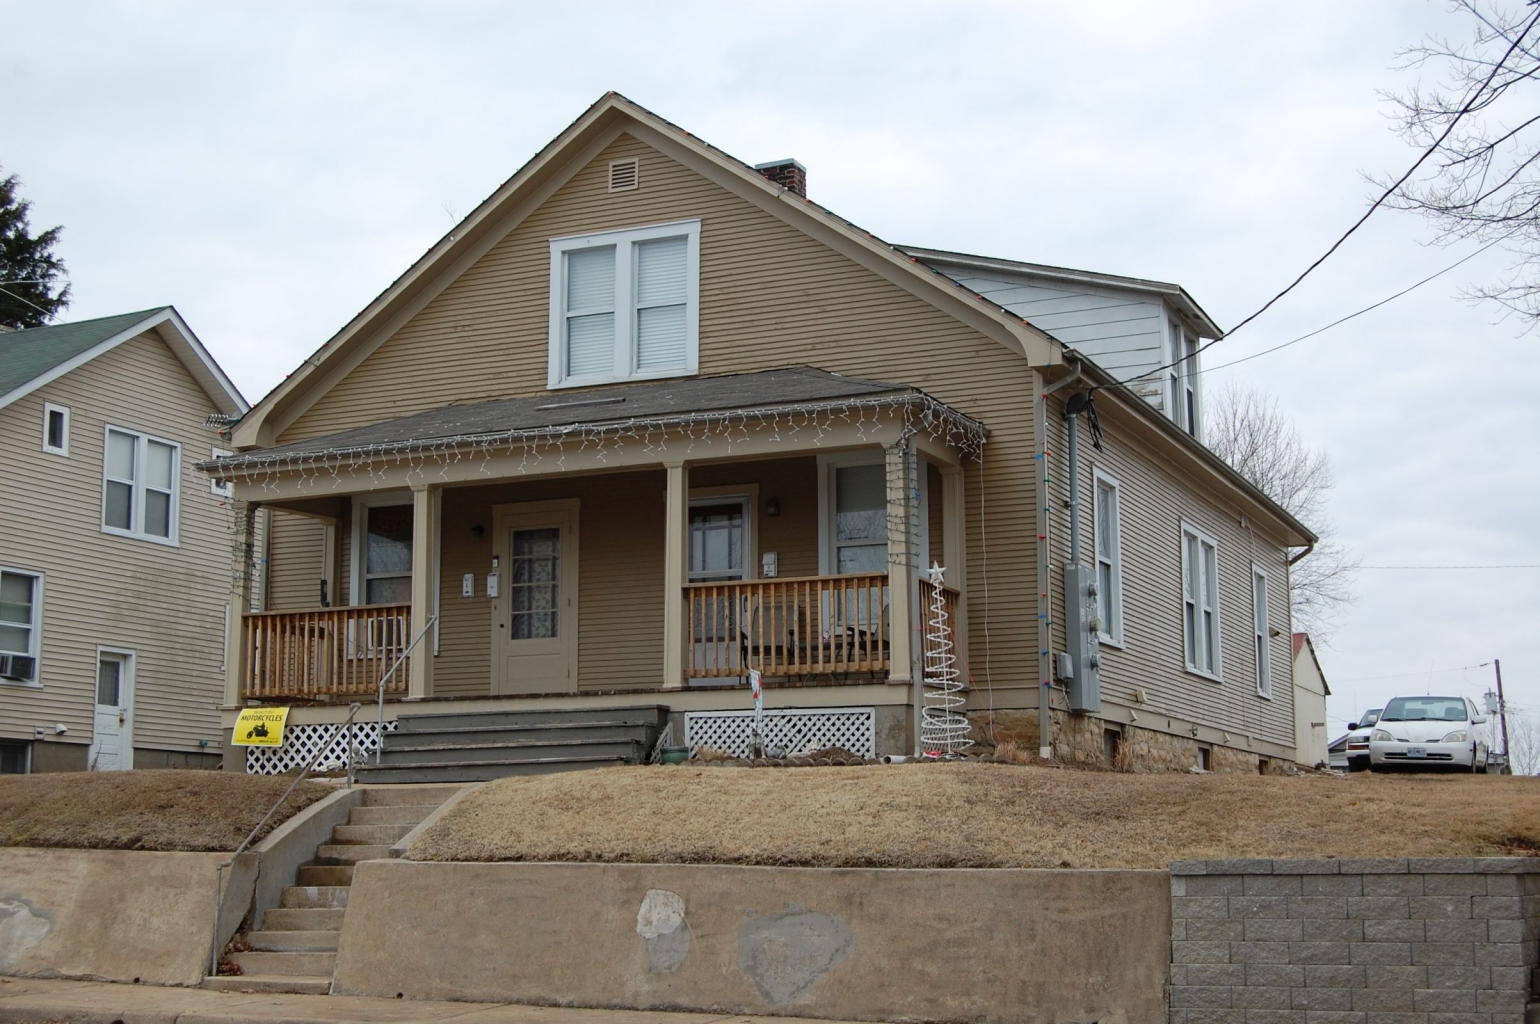
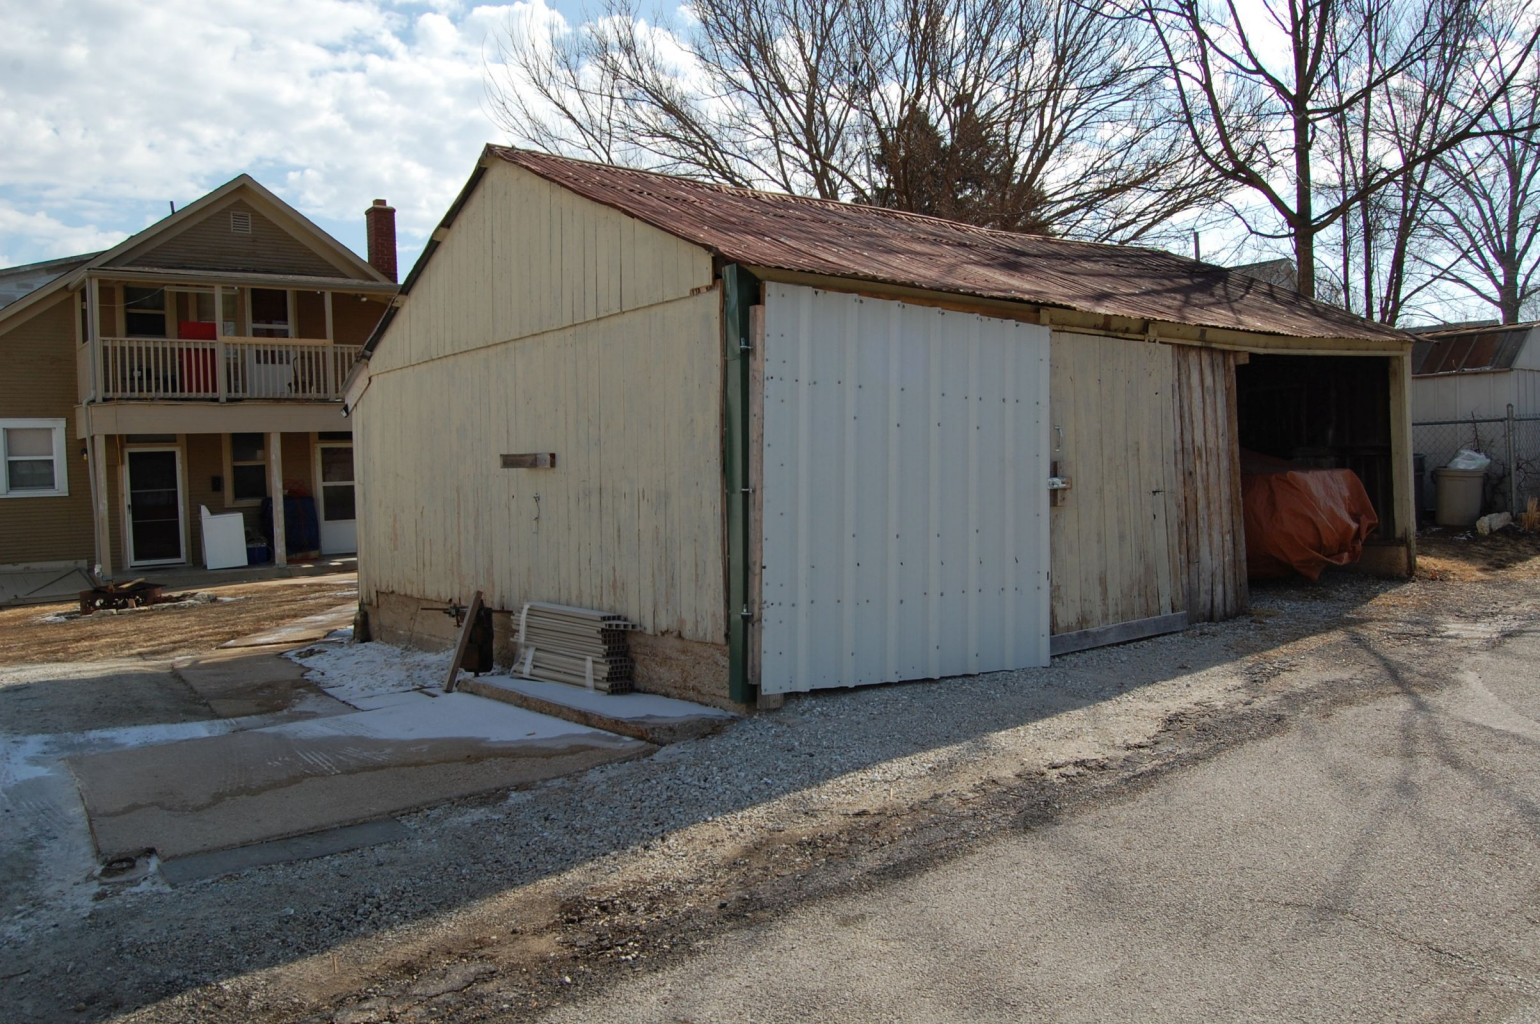
The 1.5 story frame dwelling has a limestone foundation, weatherboard siding, and a front gable, asphalt shingle roof. The front façade is 4 bays wide. There is a 1-story, ¾ width frame porch with a dropped asphalt shingle hipped roof centered on the façade. The porch has square wood posts with recessed panels (4 single, 2 engaged), an open square wood baluster railing, and a wood deck with centered stairs. Sheltered within the porch are two multi-light glass and wood doors with a single window on the side left and right. The side left door has a multi-light horizontal glass and wood storm door while the side right has a 2 light glass and metal storm door. Centered within the upper story gable are paired windows. Windows are 1/1 double-hung vinyl sash. Shed roof dormers with paired windows are on the S and N elevations. The W elevation has a 2 story porch with a shed roof. There is a central interior straddle ridge brick chimney and an interior wall, side left slope brick chimney on the S elevation. Post 1992 survey alterations include: replacement of the solid wood porch railing and replacement of 1/1 wood sash with 1/1 vinyl. The current porch railing was added post 2007 (assessor's photos). There have been minor changes in the exterior but the home retains its integrity and is therefore contributing to a potential NR district.

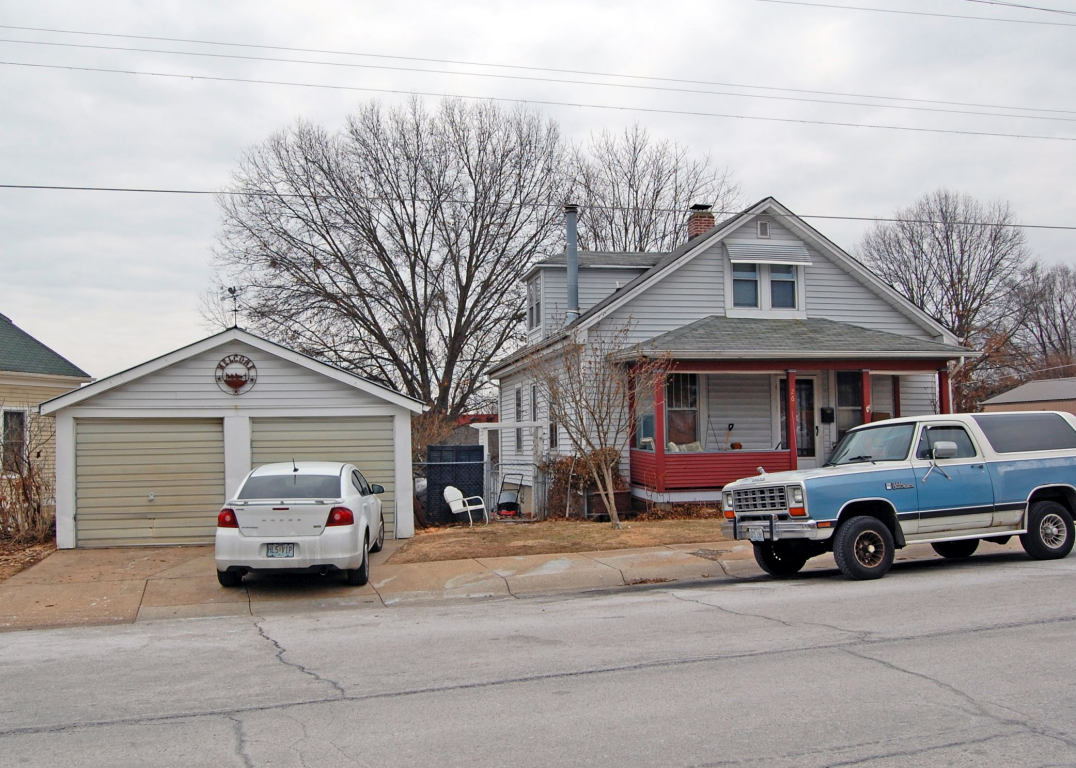
The photo provided by the 1992 survey shows the first floor of the facade obscured by fabric sun shades mounted on the porch. The only visible alteration since that time seems to be a change in the paint color of the porch and the replacement of 4/1, double hung wood sash in the upper half story bay with 1/1 replacement sash.

Due to the presence of vinyl siding, replacement windows, and a replacement porch, this home is not considered eligible for listing in a potential NR district.

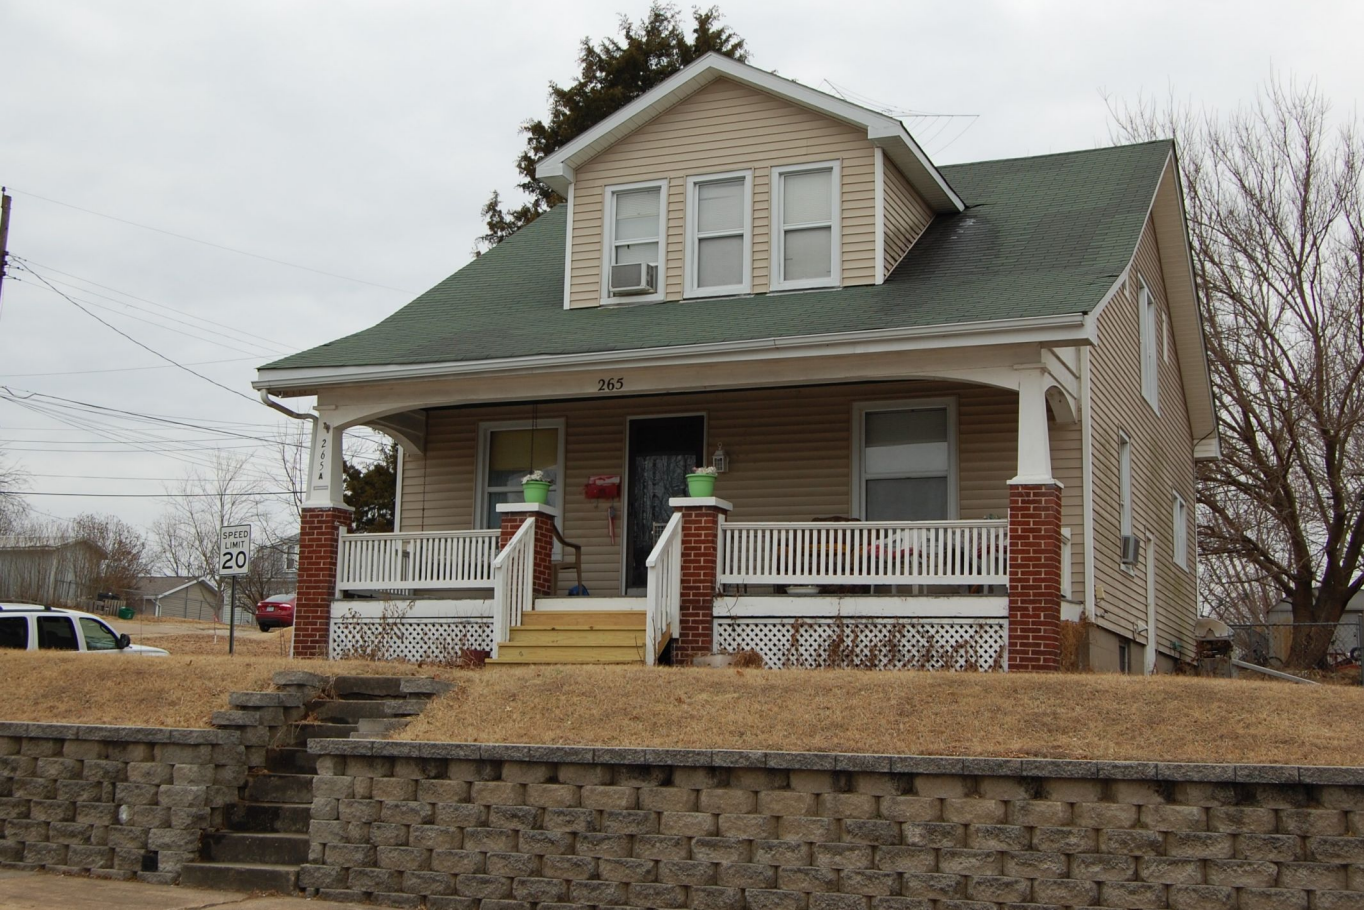
265

The 1.5-story frame dwelling has a concrete parged foundation etched to look like stone, vinyl siding, and a side gable, asphalt shingle roof. The front façade is 3 bays wide. There is a full width 1-story porch with extended shed roof from the primary on the façade. The porch has tapered wood columns resting on brick piers, an open square wood baluster railing and a centered staircase. Sheltered within the porch is an offset left entry of an older multi-light glass and wood door with single windows on either side. Centered in the upper story is a gable dormer with three individual windows. Windows are replacement 1/1 double-hung vinyl sash. On The W elevation is a gable dormer through the roofline with a 2nd story porch with corrugated metal shed roof and wood staircase parallel to the façade. There is a central, rear slope brick chimney. Post 1992 survey alterations include: removal of knee braced brackets in all the eaves, replacement of weatherboard with vinyl, and replacement of original vertical 5/1, vertical 4/1, and vertical 3/1 wood sash with 1/1 vinyl. Due to the replacement vinyl siding and especially the removal of full bungalow elements (brackets in eaves, windows), the house is not a contributing resource to a potential NR district.
