National Register of Historic Places Registration Form

Historic name Sedalia Downtown Commercial Historic District Boundary Increase Amendment

Street & number 112-116 S. Osage Ave.; 202, 201-203, 301-305 W. Main St.; 112-120 W. Second St.; 101-109 W. Pacific St.; 200 S. Kentucky Ave., 102 E. Fifth St.

City or town Sedalia

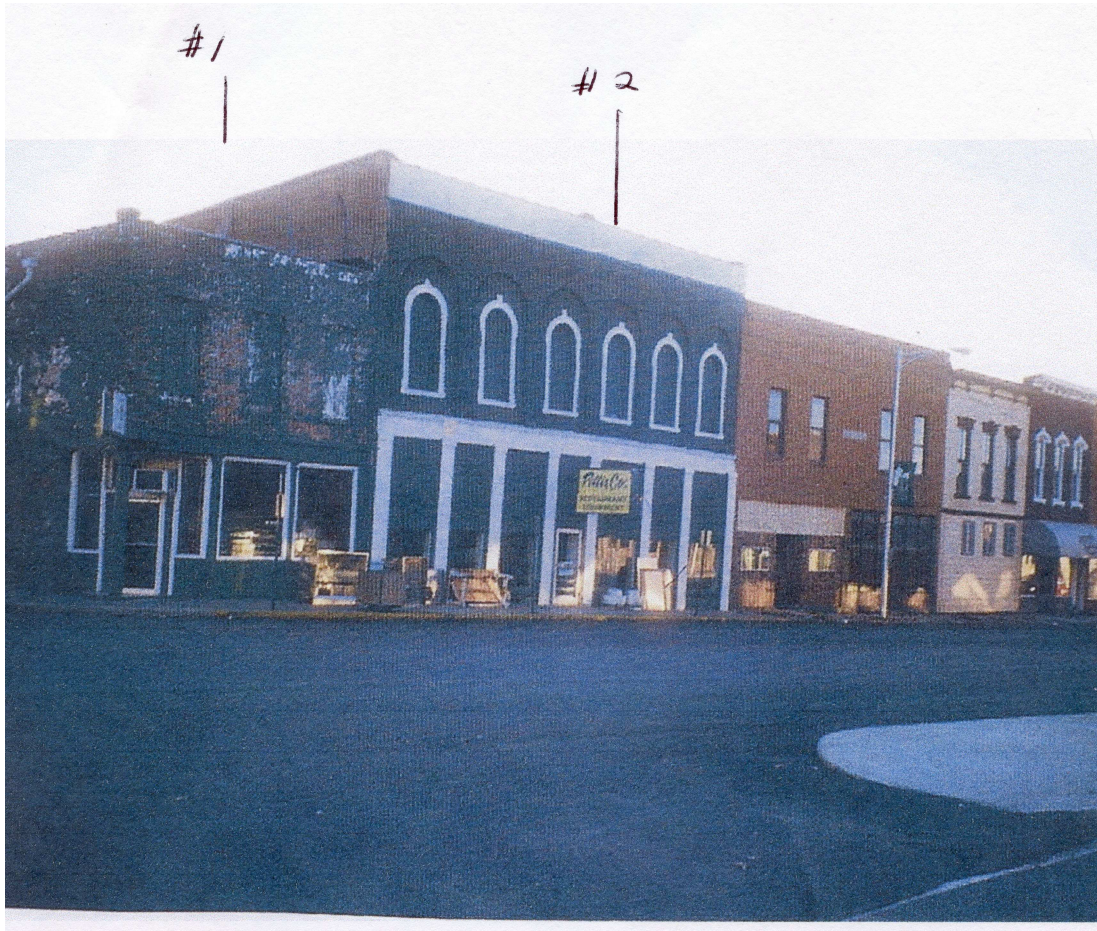
Figure 3: Photograph of 201-205 West Main Street, c. 1976, provided by Rhonda Chalfant.

Figure 3: Photograph of West Main Street, c. 1976, showing 201 (#1) and 203-205 (#2), provided by Chalfant

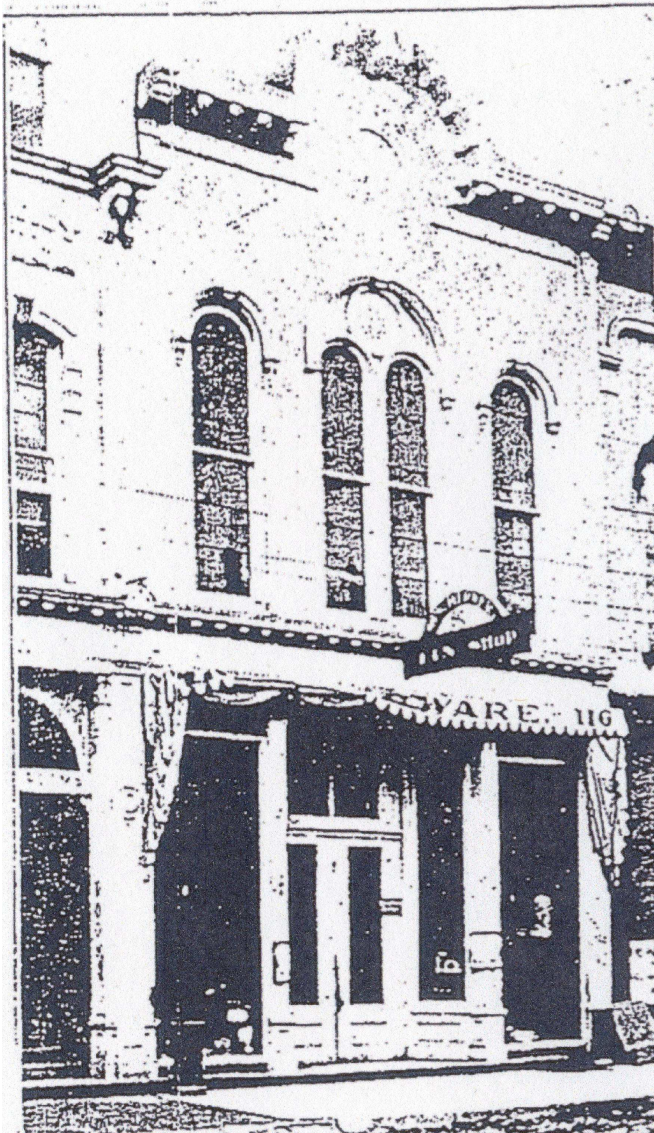
Figure 4: Image of 112 South Osage, courtesy Charles Wise

Figure 4: Image of 112 South Osage Avenue, c. 1910, courtesy Charels Wise

112 South Osage Avenue- This building housed the printing offices of the *Sedalia Democrat*. It later functioned as a furniture store and a grocery store. The 1925 City Directory listed Farmer's Supply Company, and the 1935 City Directory listed Herbert Wetzel's shoe and harness repair shop there. During the 1940s, the building, along with the adjacent building at 114 South Osage Avenue was home to Howell's Seed Store. The building is best known

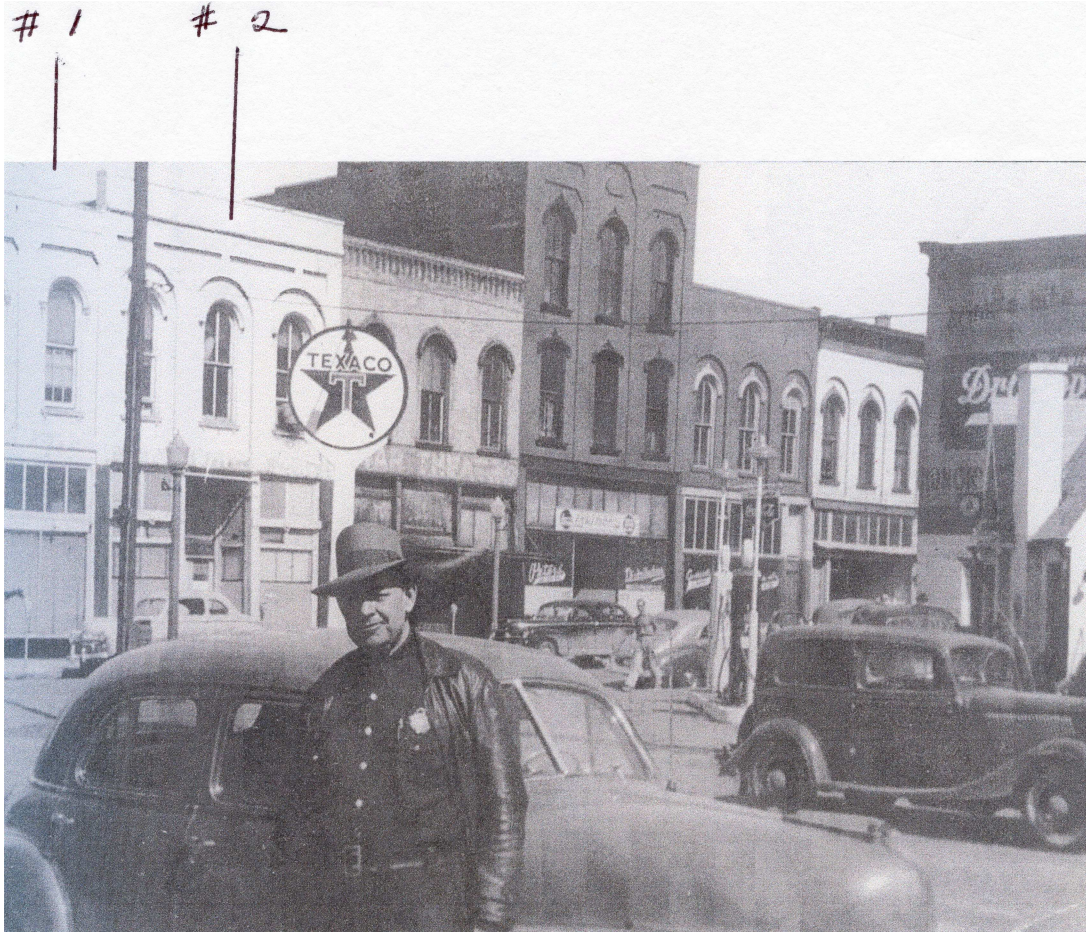
Figure 6: Photograph showing 118 (# 1) and 120 (#2) West Second Street, 1940s, from Chalfant, Claycomb, and Wise, *Sedalia, Then and Now*, 35

Figure 6: Photograph of 118 (# 1) and 120 (#2) West Second Street, c. 1940s, from Chalfant, Claycomb, and Wise, *Sedalia: Then And Now*, 35.

120 West Second Street—This building was the home of Beck and Messerly's Dry Goods Store in 1882. By 1890, it and the building at 118 West Second Street were Beck and Vitt's Store. In 1908 Kroenke and Corder General Store was at this location. The building housed a hardware store in the 1920s and the Golden Eagle Department Store in the 1930s. In 1950, Dr. Everett Hudson, a podiatrist, maintained offices in the building until the 1980s. In 1990, the Country Stove store was in the building.¹³ At the time of the Boundary Increase, the building was in poor condition. It continued to deteriorate until the city was forced to demolish it in 2014.

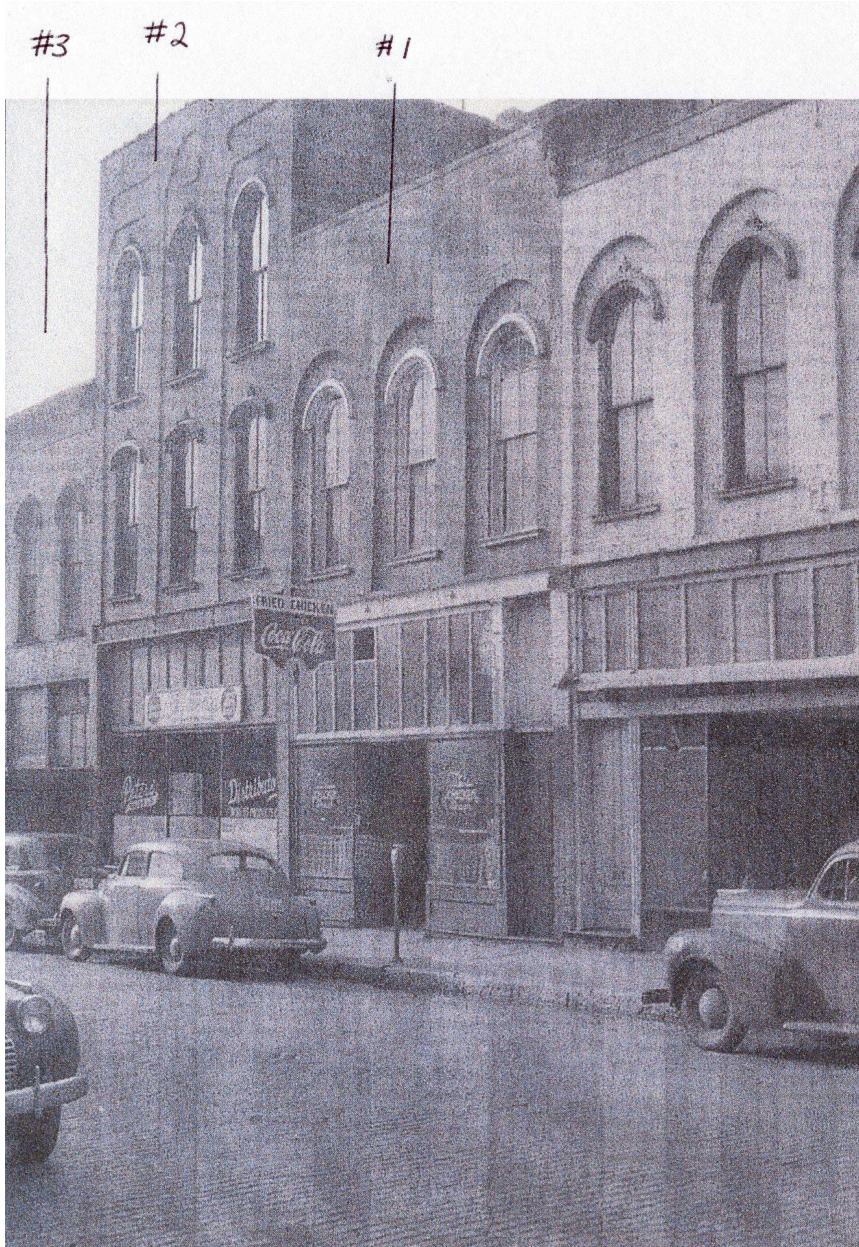
Figure 7: Photograph of 112 (#1), 114 (#2), and 116 (#3) West Second Street, from Chalfant, Claycomb, and Wise, *Sedalia: Then and Now*, 36

Figure 7: Photograph of 112 (# 1), 114 (# 2), and 116 (# 3) West Second Street, c. 1940s, from Chalfant, Claycomb, and Wise, *Sedalia: Then and Now*, 36.

112-116 West Second Street—This non-contributing parking lot was built in the late 1960s, after the period of significance for the Sedalia Downtown Commercial Historic District Boundary Increase. It replaced three Italianate buildings erected during the 1880s. During the nineteenth century, the building at 112 West Second Street was a sewing machine store and later a gun and sporting goods store. The building at 114 West Second Street was D.H. Holcomb's China Shop. The building at 116 West Second Street was Ludemann's Carpet Store. By 1900, 114 and 116 West Second Street were part of Smith, Marshall and Howe Hardware Store. In 1927, 116 West Second Street was the Star Theater, one of Sedalia's store front theaters that operated during the 1920s. In the 1940s, 112 West Second Street was Mil's Chicken Shack, notorious for the gambling hall located upstairs, and 114 West Second Street was Peter's Distributing.¹⁵ In the late 1950s, 112 West Second Street was the Interlude Bar (Figure 7).

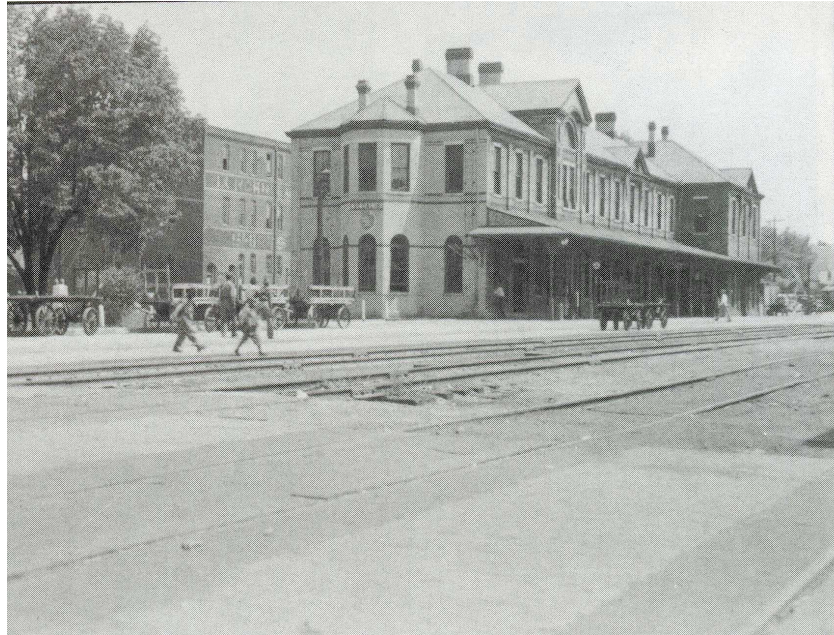
Figure 8: Photograph of Missouri Pacific Depot and areas to the west of the depot for loading passengers and baggage, c. 1935, from Chalfant, Claycomb, and Wise, *Sedalia: Then and Now*, 123. This area became a parking lot when the depot was rebuilt in 1952.

Figure 8: Photograph of 1886 Missouri Pacific Railroad Depot, 101-109 West Pacific Street, c. 1910, showing area on east side of depot for unloading passengers and baggage, from Chalfant, Claycomb, and Wise, *Sedalia: Then and Now*, 123.

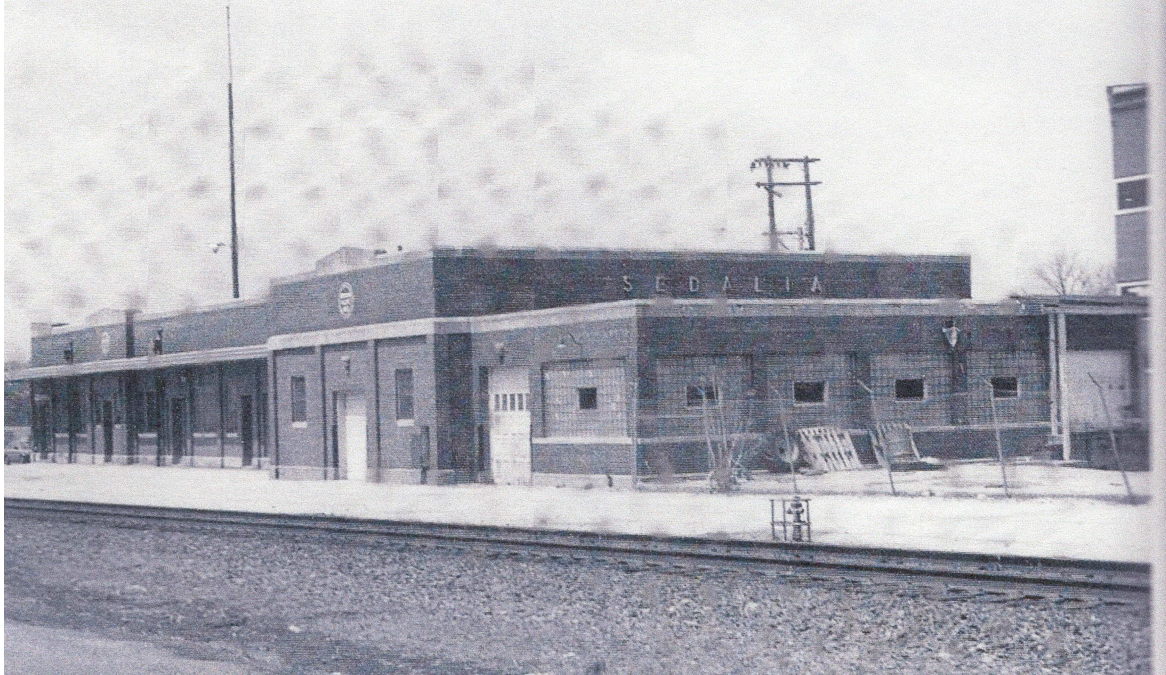
Figure 9: Photograph of 1952 Missouri Pacific Depot, c. 1960, from William Claycomb, *Pettis County, Missouri: A Pictorial History*. The railroad had temporarily suspended passenger service and the parking lot to the east of the building was surrounded by wire fencing.

Figure 9: Photograph of 1952 Missouri Pacific Railroad Depot, 101-109 West Pacific Street, c. 1960, from Claycomb, *Pettis County, Missouri: A Pictorial History*, 168. Train service had been temporarily suspended in 1960 and the parking area to the east of the depot was enclosed with a wire fence.
